# Visual Site Inspection Report

<b>Project Name</b> H-600 Pipeline Spread H		<b>AFE</b> 124300138	<b>Spread</b> H-600 Pipeline Spread H
<b>Contractor</b> Precision		<b>Report #</b> 20859	
<b>Inspector</b> John Brcic		<b>Date/Time</b> 3/8/2021 1:22 PM	
<b>Permit #</b> TBD	<b>Inspection Type</b> VA SWPP	<b>Station Begin</b>	12005+00
<b>State</b> VA	<b>Inspection Area</b> Partial	<b>Station End</b>	12119+17
<b>County</b> Montgomery	<b>Ground</b> Dry	<b>Temperature (°F)</b>	55.00
<b>Municipality</b> N/A	<b>Weather</b> Sunny	<b>Rain Gauge (in)</b>	0.00
			<b>Rain Accumulation Time (days)</b> 1.00

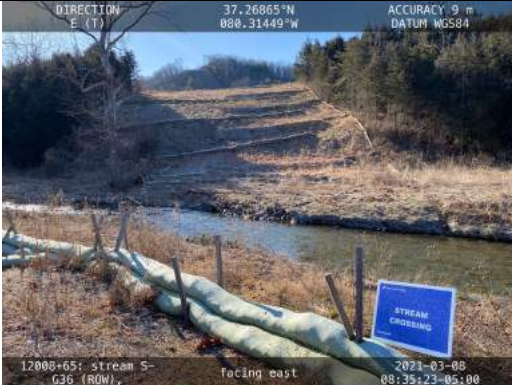
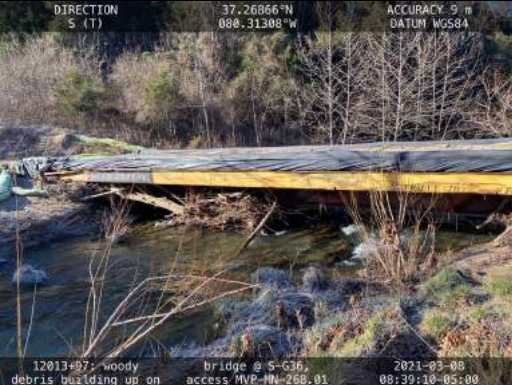
<b>GPS Location</b>	See photo	<b>GPS Location</b>	See photo		
<b>Field Station#</b>	12008+65	<b>Field Station#</b>	12013+97		
<b>Pic 1 Desc.</b>	Stream S-G36 (ROW), facing east	<b>Pic 2 Desc.</b>	Woody debris building up against upstream side of bridge at stream S-G36 on access road MVP-MN-268.01.

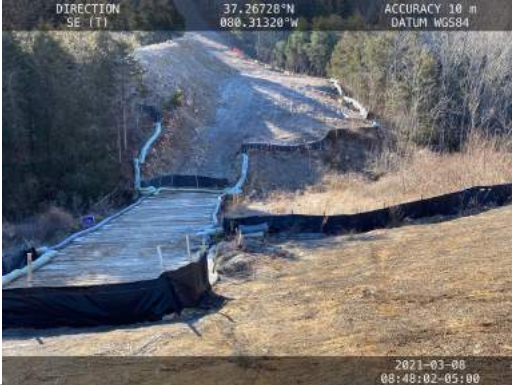
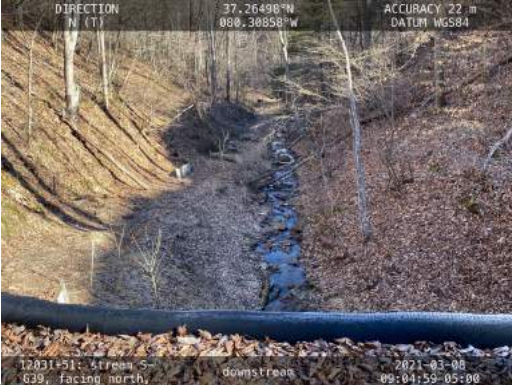
<b>GPS Location</b>	See photo	<b>GPS Location</b>	See photo		
<b>Field Station#</b>	12015+84	<b>Field Station#</b>	12031+51		
<b>Pic 3 Desc.</b>	Bridge, buffer zone and ECDs in satisfactory condition at stream S-G36.	<b>Pic 4 Desc.</b>	Stream S-G39, facing north, downstream

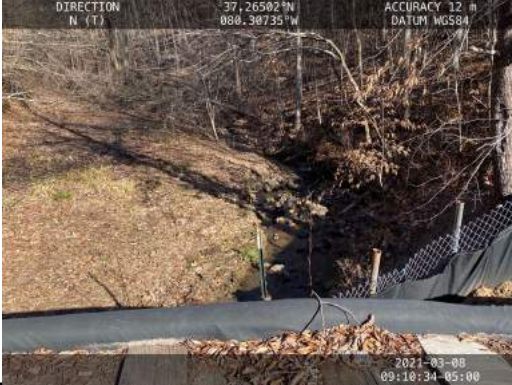
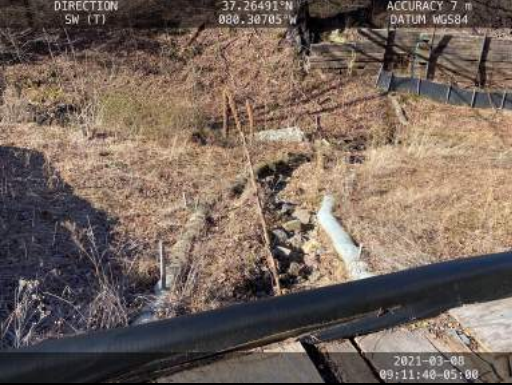
<b>GPS Location</b>	See photo	<b>GPS Location</b>	See photo		
<b>Field Station#</b>	12035+11	<b>Field Station#</b>	12035+75		
<b>Pic 5 Desc.</b>	Stream S-G40, facing north, downstream	<b>Pic 6 Desc.</b>	Stream S-PP23, facing southwest, downstream

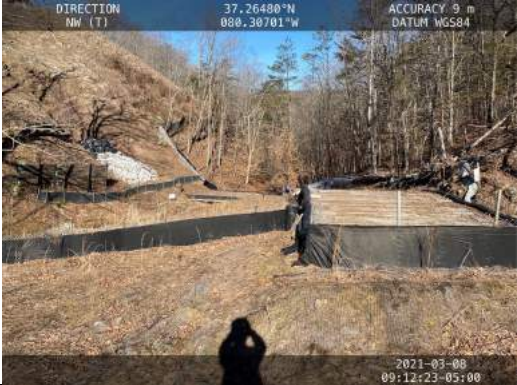
<p>DIRECTION SW (T) 37.26451°N 888.38659°W ACCURACY 14 m DATUM WGS84 2021-03-08 09:13:26-05:00</p>	
<b>GPS Location</b>	See photo	<b>GPS Location</b>	See photo
<b>Field Station#</b>	12036+50	<b>Field Station#</b>	12038+00
<b>Pic 7 Desc.</b>	Bridges, buffer zones and ECDs in satisfactory condition at streams S-G40 and S-PP23.	<b>Pic 8 Desc.</b>	Clean water diversion pipe outlet plunge pool in satisfactory condition.

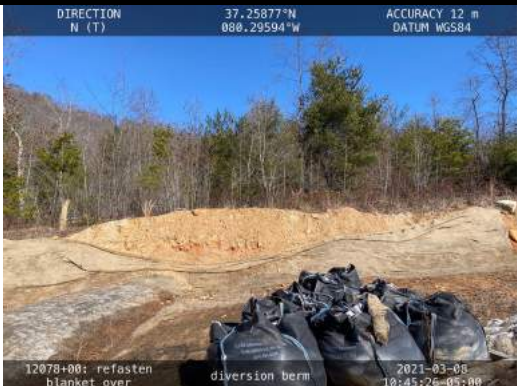
<p>DIRECTION N (T) 37.25877°N 888.29594°W ACCURACY 12 m DATUM WGS84 12078+00: refasten blanket over diversion berm 2021-03-08 10:45:26-05:00</p>	
<b>GPS Location</b>	See photo	<b>GPS Location</b>	See photo

<b>Field Station#</b>	12076+95	<b>Field Station#</b>	12078+00
<b>Pic 9 Desc.</b>	Stream S-MM15, facing south, downstream	<b>Pic 10 Desc.</b>	Erosion control blanket has fallen off this diversion berm.

E&S BMPs	Compliance Level	Corrective Action	Corrective Time Frame	Date Repaired
Compost Filter Sock	Acceptable			
Silt Fence (Filter Fabric Fence)	Acceptable			
Silt Fence (Reinforced Filter Fabric Fence)	Acceptable			
Waterbar	Acceptable			
Waterbar End Treatment	Acceptable			
Cleanwater Diversion Pipe	Acceptable			
Plunge Pool	Acceptable			
Sensitive Resource Buffer	Acceptable			
Erosion Control Blanket	Communication	12078+00: refasten on div berm	Addressed	3/8/2021

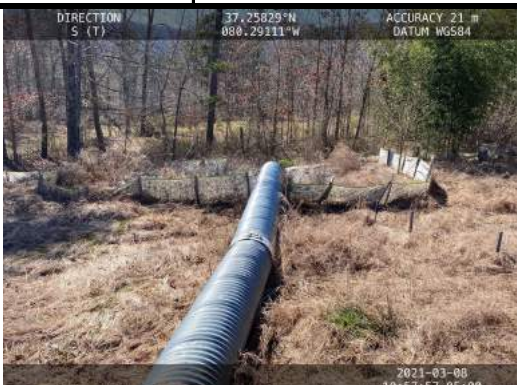
<p>DIRECTION S (T) 37.25829°N 888.29111°W ACCURACY 21 m DATUM WGS84 2021-03-08 10:57:57-05:00</p>	
<b>GPS Location</b>	See photo	<b>GPS Location</b>	See photo
<b>Field Station#</b>	12086+50	<b>Field Station#</b>	12194+00
<b>Pic 11 Desc.</b>	Bridge, buffer zone and ECDs in satisfactory condition at stream S-MM14.	<b>Pic 12 Desc.</b>	Clean water diversion pipe and outlet in satisfactory condition.

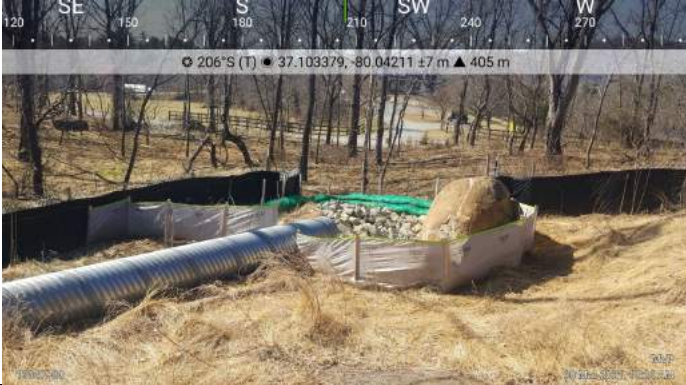
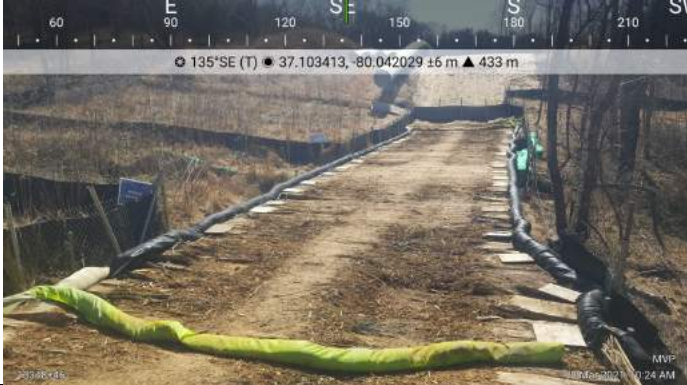
<b>GPS Location</b>	See Above	<b>GPS Location</b>	See Above
<b>Field Station#</b>	13347+80	<b>Field Station#</b>	13348+46
<b>Pic 7 Desc.</b>	ROW Overview. Cleanwater diversion pipe. ECDs are functional and ROW is stable.	<b>Pic 8 Desc.</b>	Overview of Waterbody S-RR08. ECDs are functional and ROW is stable.

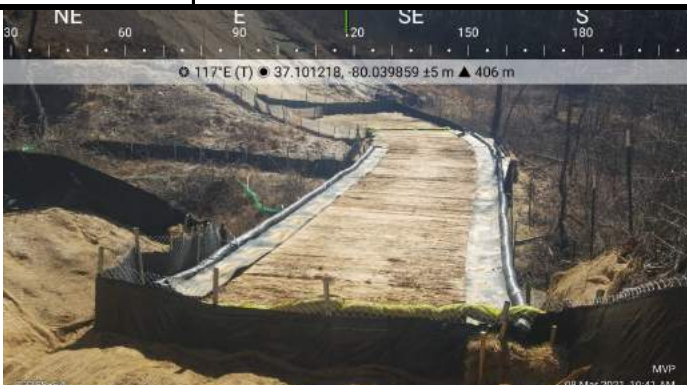
<b>GPS Location</b>	See Above	<b>GPS Location</b>	See Above
<b>Field Station#</b>	13352+23	<b>Field Station#</b>	13354+50
<b>Pic 9 Desc.</b>	Overview of Waterbody S-RR09. ECDs are functional and ROW is stable.	<b>Pic 10 Desc.</b>	ROW Overview. Bridge of "grassy swale". ECDs are functional and ROW is stable.

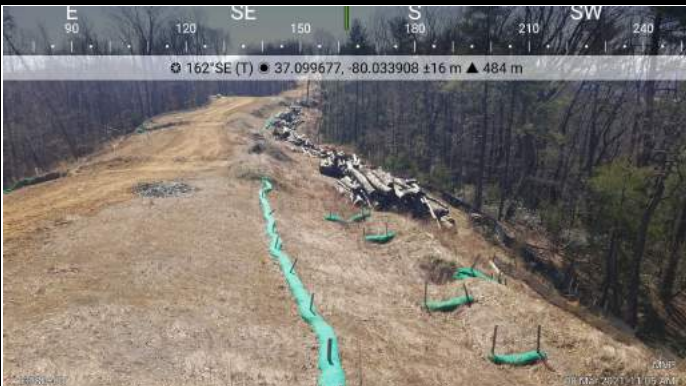
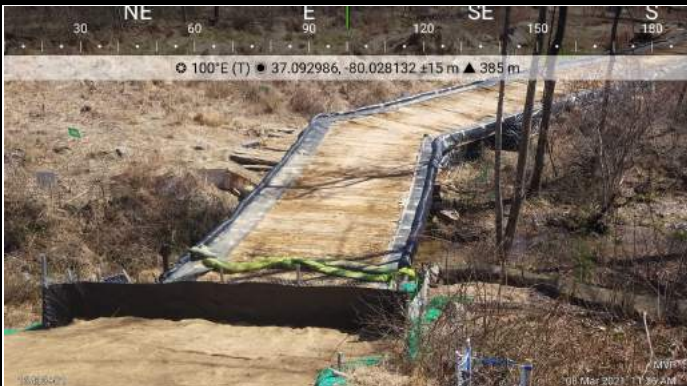
<b>GPS Location</b>	See Above	<b>GPS Location</b>	See Above
<b>Field Station#</b>	13380+00	<b>Field Station#</b>	13413+01
<b>Pic 15 Desc.</b>	ROW Overview. ECDs are functional and ROW is stable.	<b>Pic 16 Desc.</b>	Overview of Waterbody S-IJ1. ECDs are functional and ROW is stable.

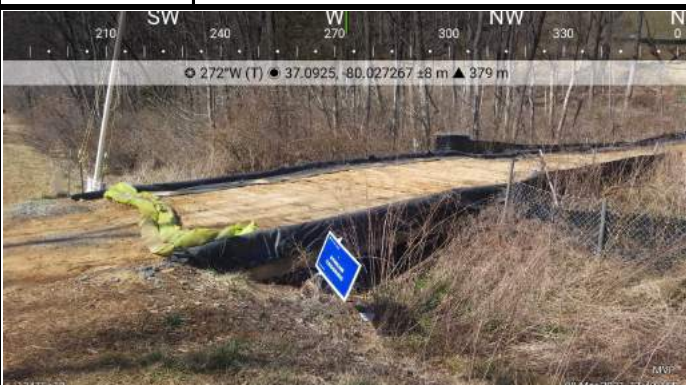
<b>GPS Location</b>	See Above	<b>GPS Location</b>	See Above
<b>Field Station#</b>	13415+19	<b>Field Station#</b>	13422+00
<b>Pic 17 Desc.</b>	Overview of Waterbody S-IJ3. ECDs are functional and ROW is stable.	<b>Pic 18 Desc.</b>	ROW Overview. ECDs are functional and ROW is stable.

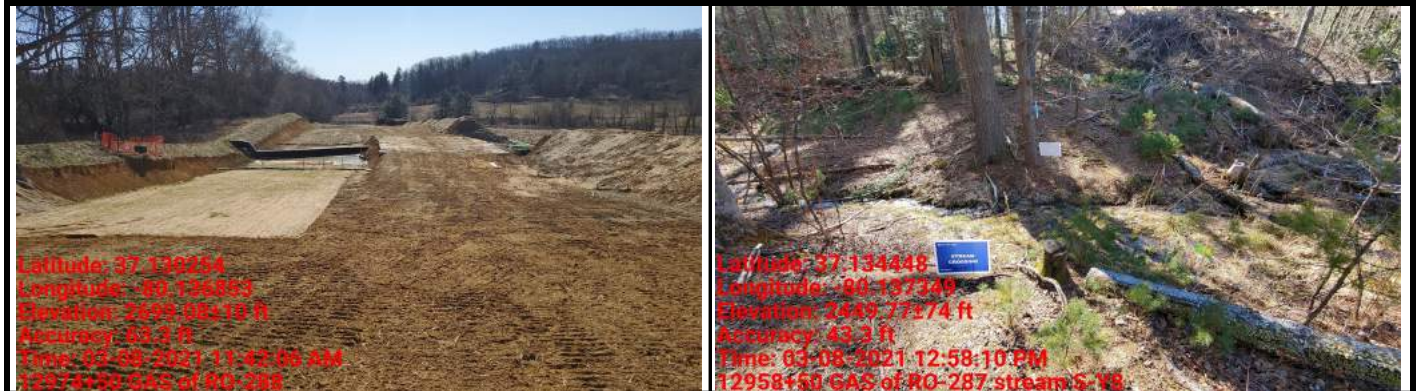
<b>GPS Location</b>	See pic for GPS location	<b>GPS Location</b>	See pic for GPS location
<b>Field Station#</b>	12974+50	<b>Field Station#</b>	12958+50
<b>Pic 11 Desc.</b>	GAS of RO-288	<b>Pic 12 Desc.</b>	Stream S-Y8 on the downstream side of the ROW.

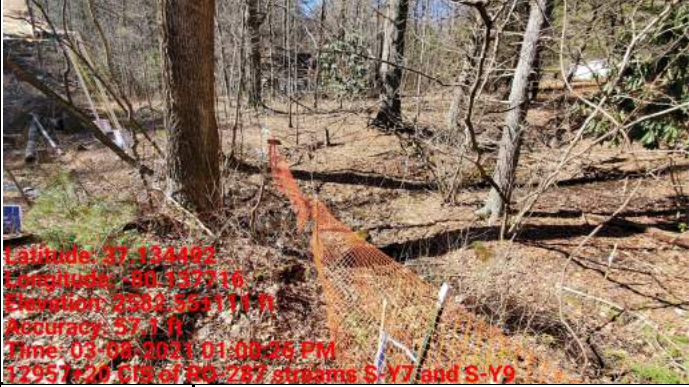
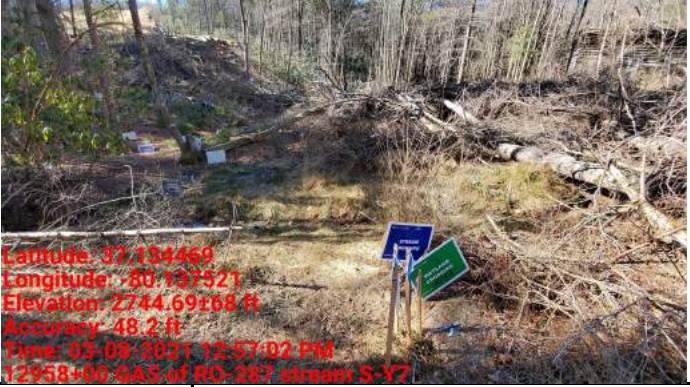
<b>GPS Location</b>	See pic for GPS location	<b>GPS Location</b>	See pic for GPS location
<b>Field Station#</b>	12957+20	<b>Field Station#</b>	12958+00
<b>Pic 13 Desc.</b>	Streams S-Y7 and S-Y9 on the upstream side of the ROW.	<b>Pic 14 Desc.</b>	Stream S-Y7 on the downstream side of the ROW.

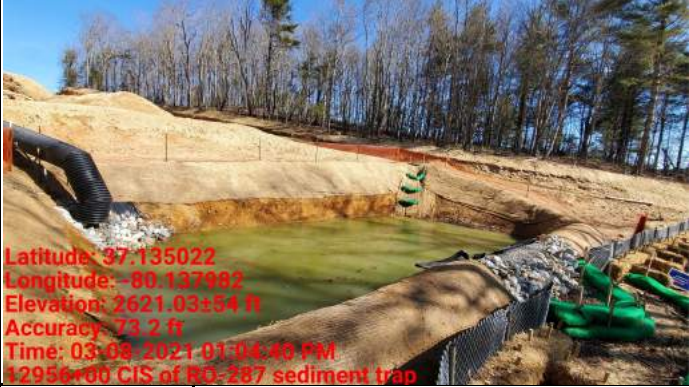
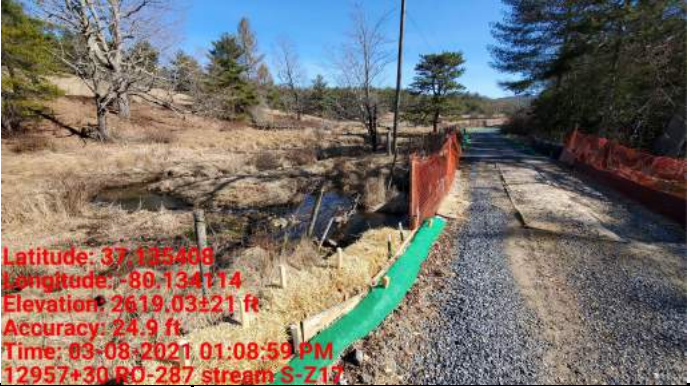
<b>GPS Location</b>	See pic for GPS location	<b>GPS Location</b>	See pic for GPS location
<b>Field Station#</b>	12956+00	<b>Field Station#</b>	12957+30
<b>Pic 15 Desc.</b>	Sediment trap on the CIS of RO-287.	<b>Pic 16 Desc.</b>	RO-287 at stream S-Z17.

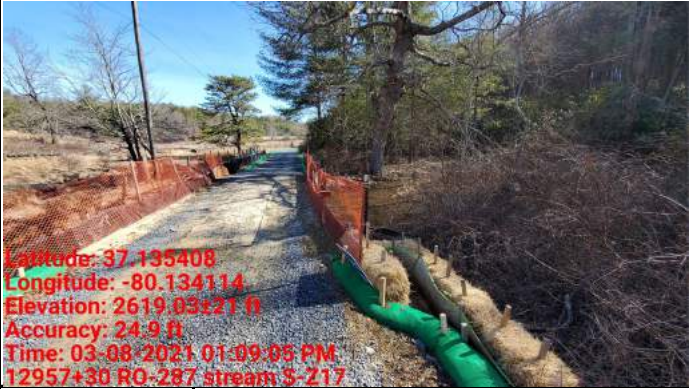
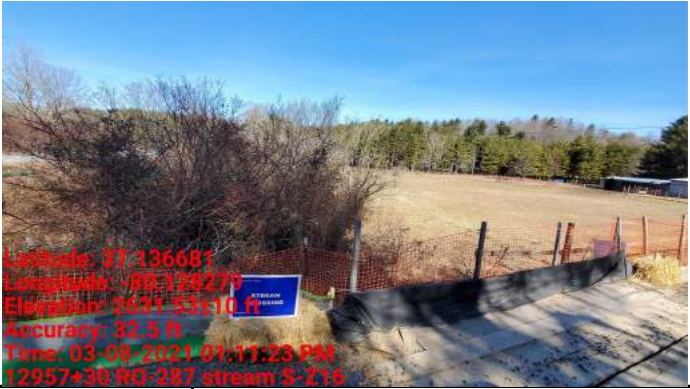
<b>GPS Location</b>	See pic for GPS location	<b>GPS Location</b>	See pic for GPS location
<b>Field Station#</b>	12957+30	<b>Field Station#</b>	12957+30
<b>Pic 17 Desc.</b>	RO-287 at stream S-Z17.	<b>Pic 18 Desc.</b>	RO-287 at stream S-Z16.

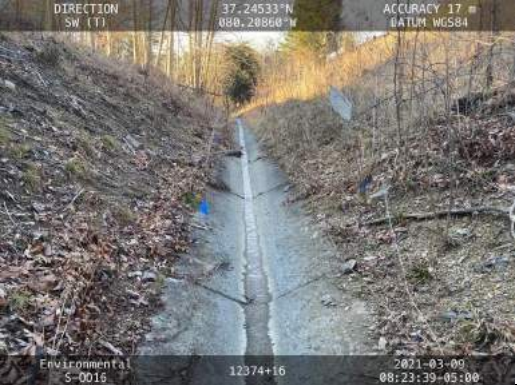
<b>GPS Location</b>	See photo	<b>GPS Location</b>	See photo
<b>Field Station#</b>	12361+02	<b>Field Station#</b>	12374+16
<b>Pic 7 Desc.</b>	Silt dyke on unused access road is in satisfactory condition.	<b>Pic 8 Desc.</b>	Stream S-0016, facing southwest, downstream

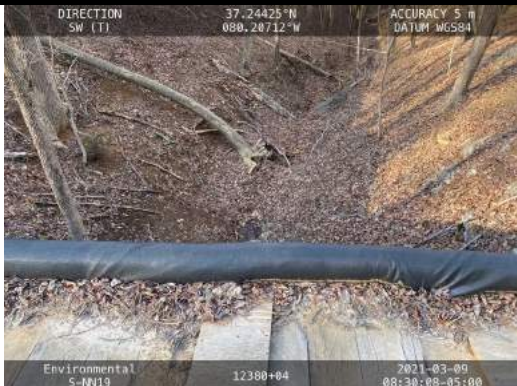
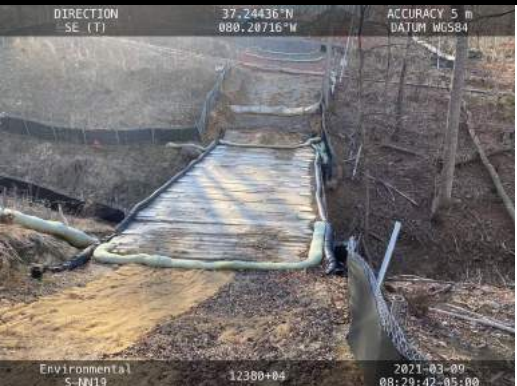
<b>GPS Location</b>	See photo	<b>GPS Location</b>	See photo
<b>Field Station#</b>	12380+04	<b>Field Station#</b>	12380+04
<b>Pic 9 Desc.</b>	Stream S-NN19, facing southwest, downstream	<b>Pic 10 Desc.</b>	Bridge, buffer zone and ECDs in satisfactory condition at stream S-NN19.

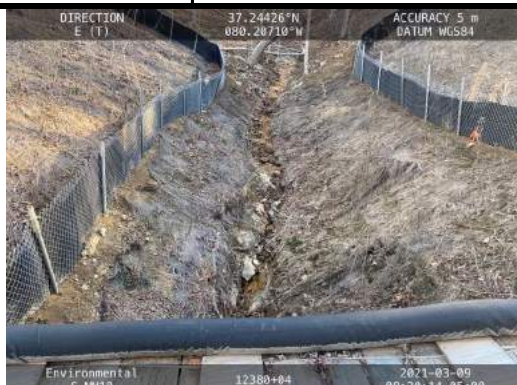
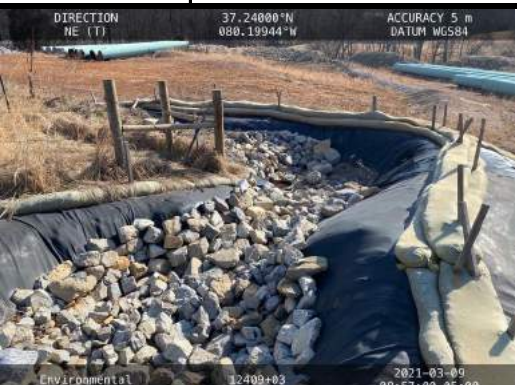
<b>GPS Location</b>	See photo	<b>GPS Location</b>	See photo
<b>Field Station#</b>	12380+04	<b>Field Station#</b>	12409+03
<b>Pic 11 Desc.</b>	Stream S-NN19, facing east, upstream	<b>Pic 12 Desc.</b>	Clean water diversion pipe inlet is free of sediment and in good condition.

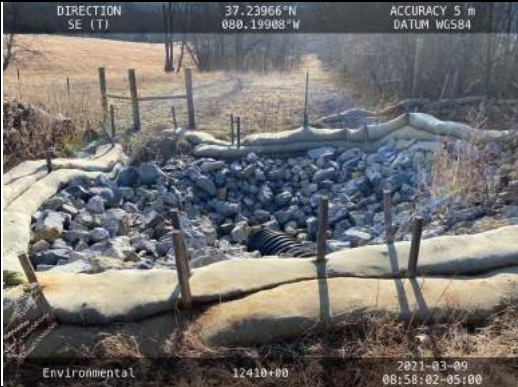
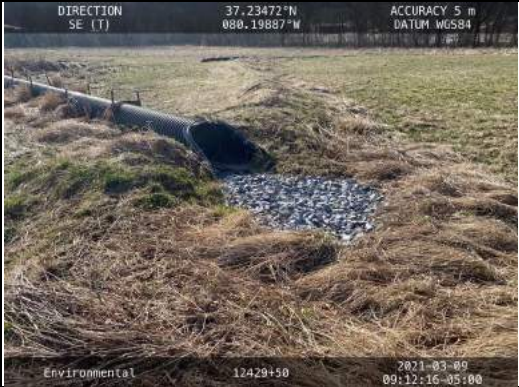
<b>GPS Location</b>	See photo	<b>GPS Location</b>	See photo
<b>Field Station#</b>	12410+00	<b>Field Station#</b>	12429+50
<b>Pic 13 Desc.</b>	Clean water diversion pipe outlet plunge pool is free of sediment and in good condition.	<b>Pic 14 Desc.</b>	Clean water diversion pipe inlet in satisfactory condition.

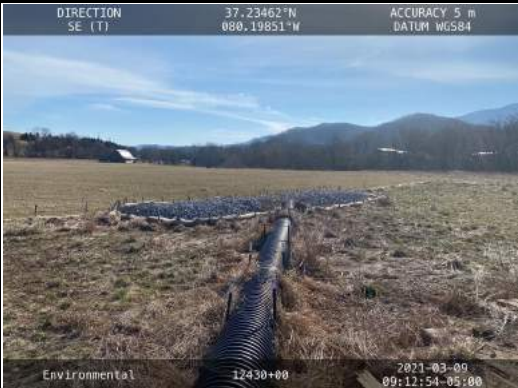
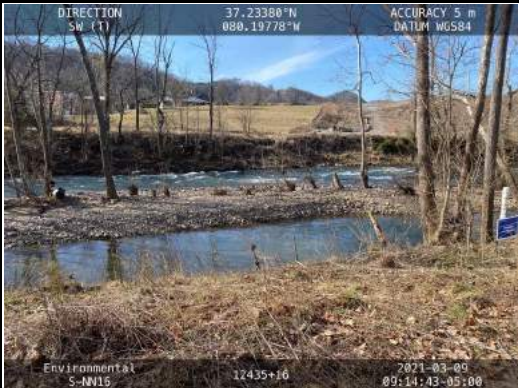
<b>GPS Location</b>	See photo	<b>GPS Location</b>	See photo
<b>Field Station#</b>	12430+00	<b>Field Station#</b>	12435+16
<b>Pic 15 Desc.</b>	Clean water diversion pipe outlet in good condition.	<b>Pic 16 Desc.</b>	Stream S-NN16, Roanoke River, facing southwest towards Lafayette Road.

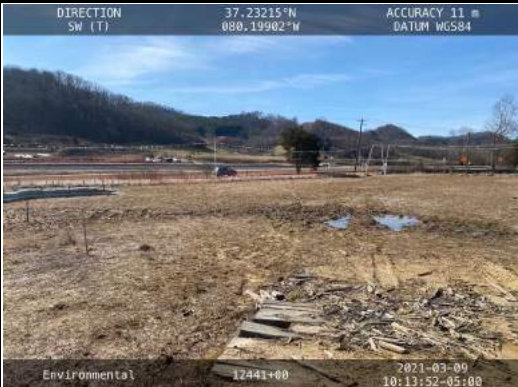
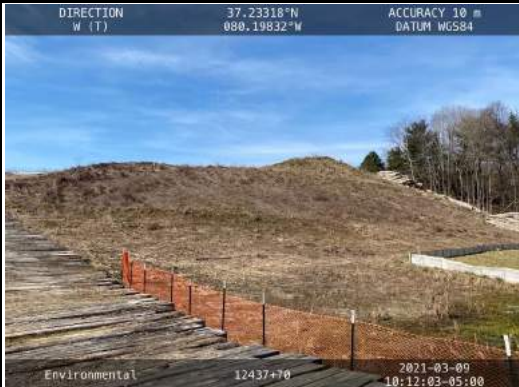
<b>GPS Location</b>	See photo	<b>GPS Location</b>	See photo
<b>Field Station#</b>	12441+00	<b>Field Station#</b>	12437+70
<b>Pic 17 Desc.</b>	ROW stable	<b>Pic 18 Desc.</b>	Slope stable on going away side of Lafayette Road.

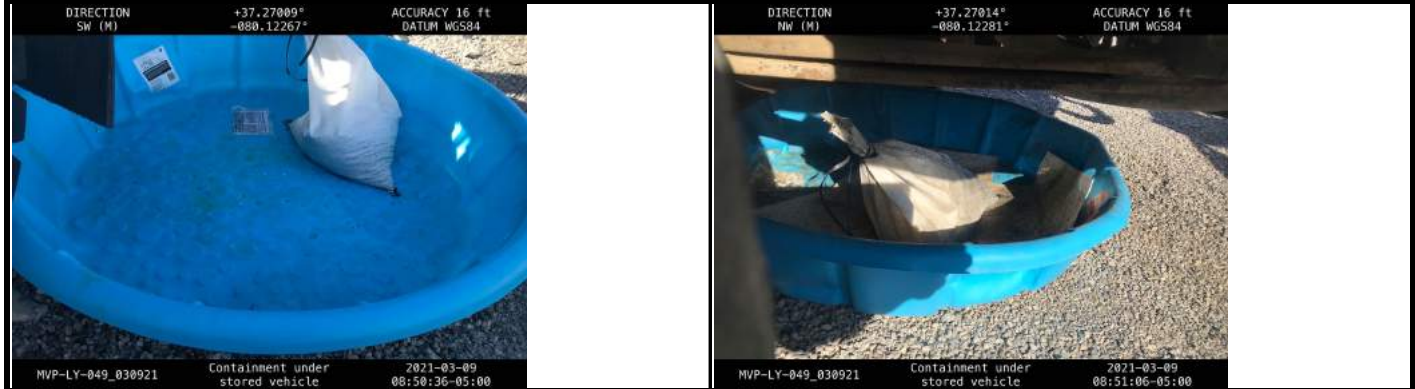
<b>GPS Location</b>	MVP-LY-049 See photo for gps data	<b>GPS Location</b>	MVP-LY-049 See photo for gps data
<b>Field Station#</b>	+0	<b>Field Station#</b>	+0
<b>Pic 13 Desc.</b>	Condition of containment under stored vehicle. Looking SW.	<b>Pic 14 Desc.</b>	Condition of containment under stored vehicle. Looking NW.

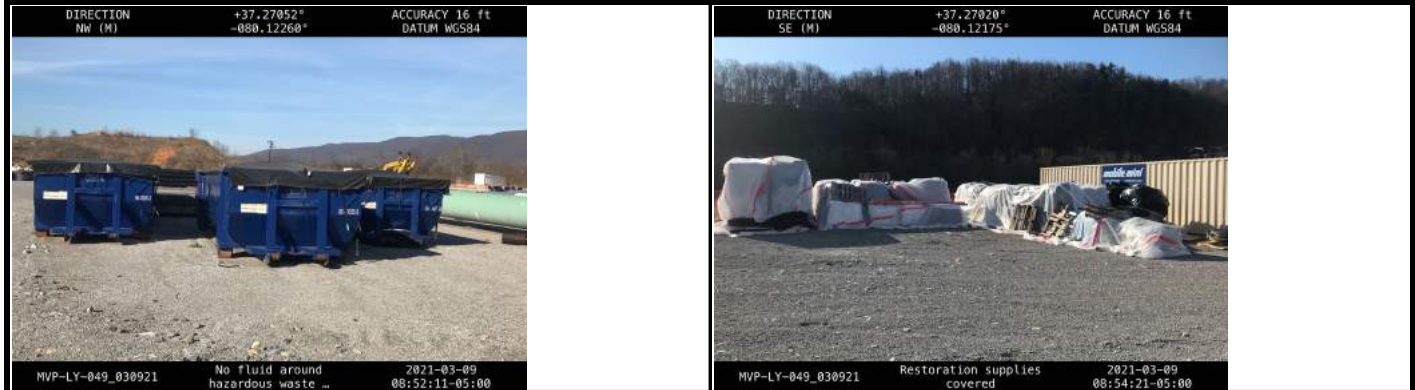
<b>GPS Location</b>	MVP-LY-049 See photo for gps data	<b>GPS Location</b>	MVP-LY-049 See photo for gps data
<b>Field Station#</b>	+0	<b>Field Station#</b>	+0
<b>Pic 15 Desc.</b>	No fluids or deposits around hazardous waste dumpsters. Looking NW.	<b>Pic 16 Desc.</b>	Restoration supplies covered and protected from the weather. Looking SW.

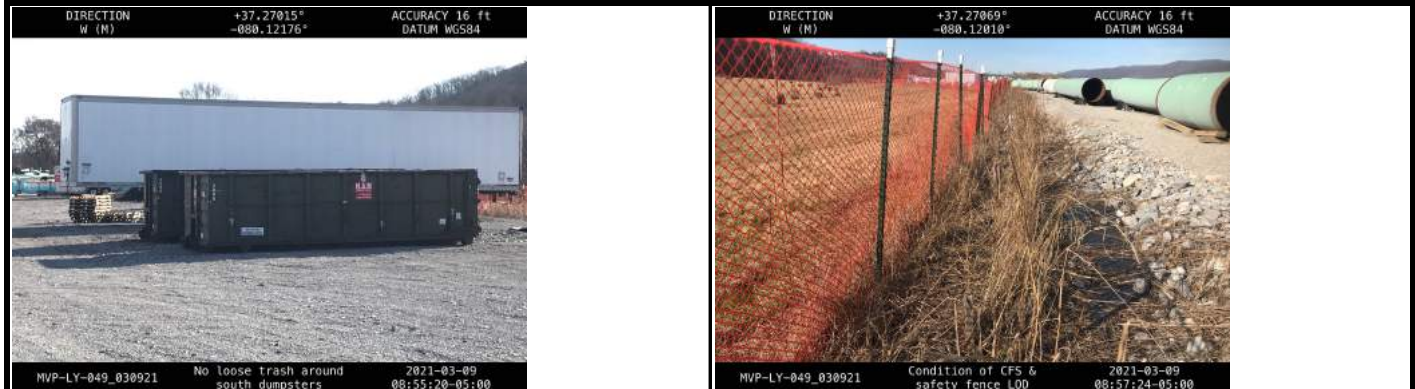
<b>GPS Location</b>	MVP-LY-049 See photo for gps data	<b>GPS Location</b>	MVP-LY-049 See photo for gps data
<b>Field Station#</b>	+0	<b>Field Station#</b>	+0
<b>Pic 17 Desc.</b>	No loose trash around south dumpsters or in the yard. Looking SE.	<b>Pic 18 Desc.</b>	Condition of compost filter sock and safety fence along south LOD. Looking W.

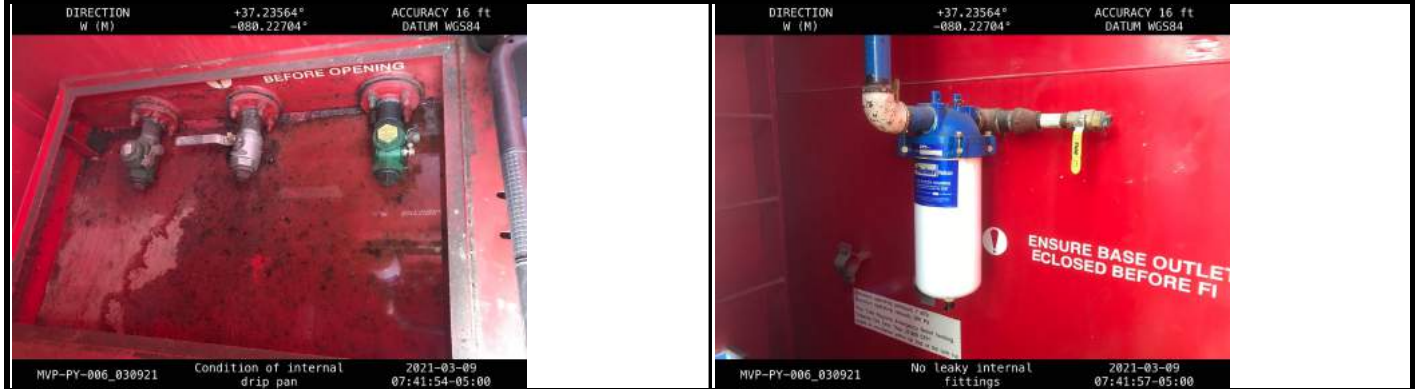
<b>GPS Location</b>	MVP-PY-006 See photo for gps data	<b>GPS Location</b>	MVP-PY-006 See photo for gps data
<b>Field Station#</b>	+0	<b>Field Station#</b>	+0
<b>Pic 7 Desc.</b>	Off Road Fuel unit condition of internal drip pan. Looking W.	<b>Pic 8 Desc.</b>	Off Road Fuel unit no leaky internal fittings. Looking W.

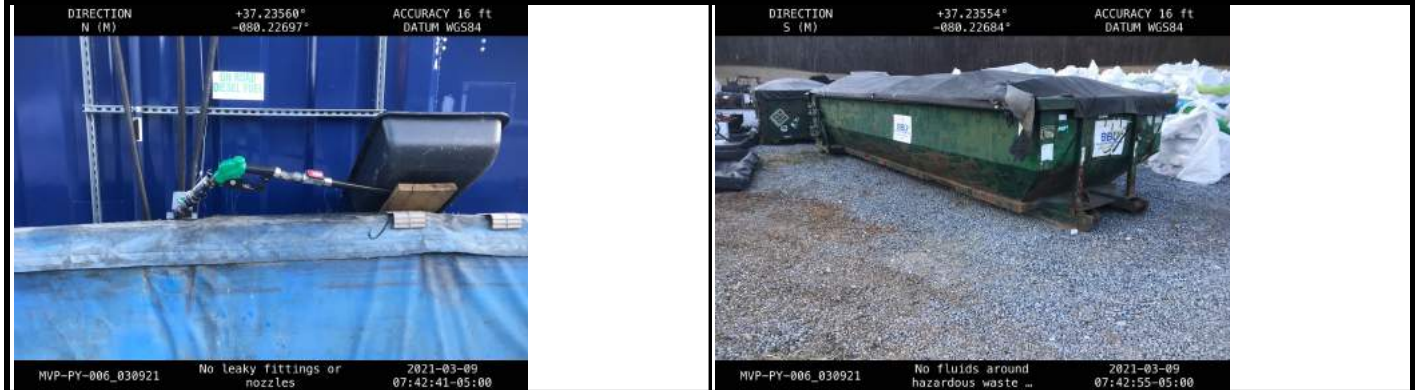
<b>GPS Location</b>	MVP-PY-006 See photo for gps data	<b>GPS Location</b>	MVP-PY-006 See photo for gps data
<b>Field Station#</b>	+0	<b>Field Station#</b>	+0
<b>Pic 9 Desc.</b>	Blue Bulk Fuel tanks no leaky fittings or nozzles. Looking N.	<b>Pic 10 Desc.</b>	No fluids or deposits around hazardous waste dumpsters. Looking S.

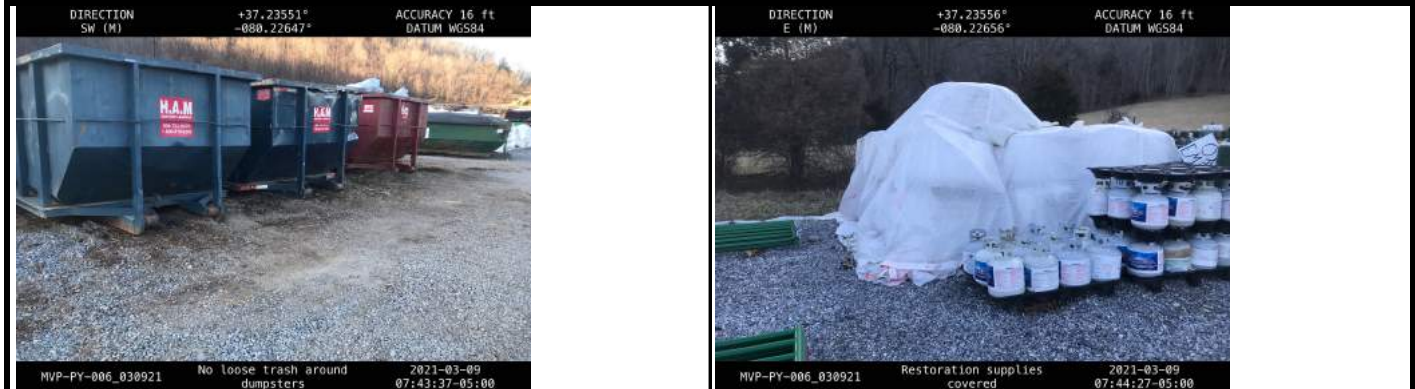
<b>GPS Location</b>	MVP-PY-006 See photo for gps data	<b>GPS Location</b>	MVP-PY-006 See photo for gps data
<b>Field Station#</b>	+0	<b>Field Station#</b>	+0
<b>Pic 11 Desc.</b>	No loose trash around dumpsters or in the yard. Looking SW.	<b>Pic 12 Desc.</b>	Restoration supplies covered and protected from the weather. Looking E.

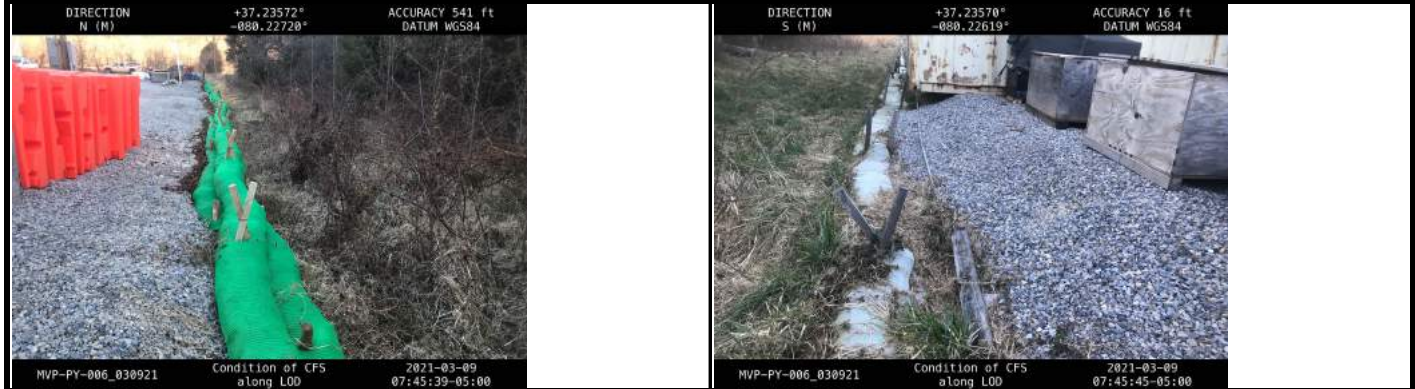
<b>GPS Location</b> MVP-PY-006 See photo for gps data	<b>GPS Location</b> MVP-PY-006 See photo for gps data
<b>Field Station#</b> +0	<b>Field Station#</b> +0
<b>Pic 13 Desc.</b> Condition of compost filter sock along east LOD. Looking N.	<b>Pic 14 Desc.</b> Condition of compost filter sock along east LOD. Looking S.

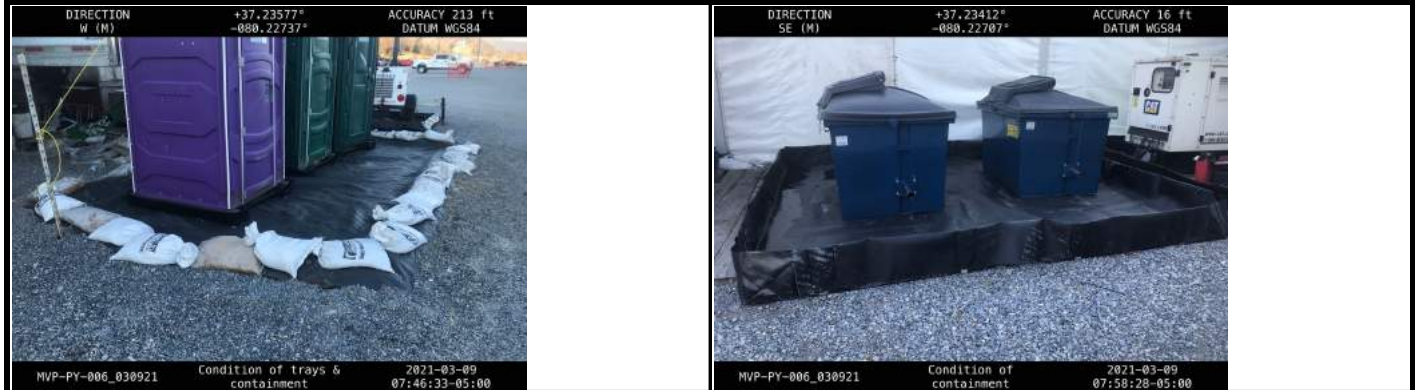
<b>GPS Location</b> MVP-PY-006 See photo for gps data	<b>GPS Location</b> MVP-PY-006 See photo for gps data
<b>Field Station#</b> +0	<b>Field Station#</b> +0
<b>Pic 15 Desc.</b> Condition of trays and containment under toilets. Looking W.	<b>Pic 16 Desc.</b> Condition of containment under hazardous waste dumpsters. No deposits, fluids and free of stormwater. Looking SE.

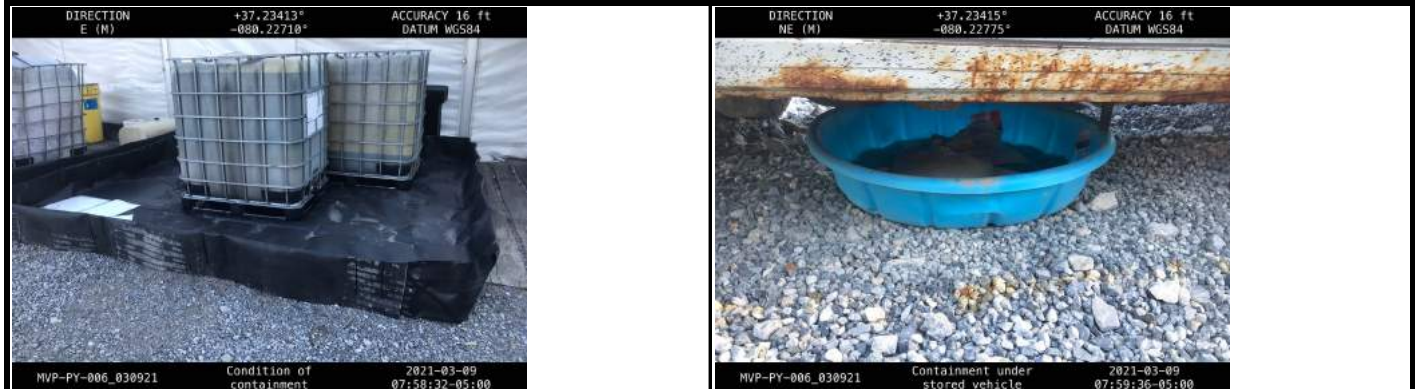
<b>GPS Location</b> MVP-PY-006 See photo for gps data	<b>GPS Location</b> MVP-PY-006 See photo for gps data
<b>Field Station#</b> +0	<b>Field Station#</b> +0
<b>Pic 17 Desc.</b> Condition of containment under used oil containers. No deposits, fluids or stormwater. Looking E.	<b>Pic 18 Desc.</b> Condition of containment under stored vehicle. Looking NE.

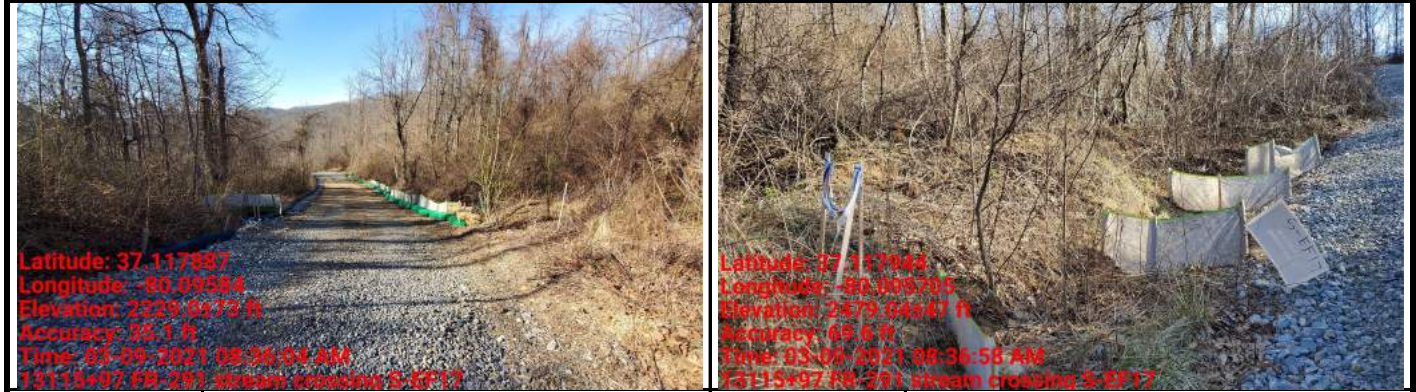
Latitude: 37.11787  
Longitude: -80.09584  
Elevation: 2329.0473 ft  
Accuracy: 35.1 ft  
Time: 03-09-2021 08:36:04 AM  
13115+97 FR-291 stream crossing S-EF17

<b>GPS Location</b>	See pic for GPS location	<b>GPS Location</b>	See pic for GPS location
<b>Field Station#</b>	13115+97	<b>Field Station#</b>	13115+97
<b>Pic 1 Desc.</b>	Access road FR-291.	<b>Pic 2 Desc.</b>	P1 silt fence checks along edge of FR-291.

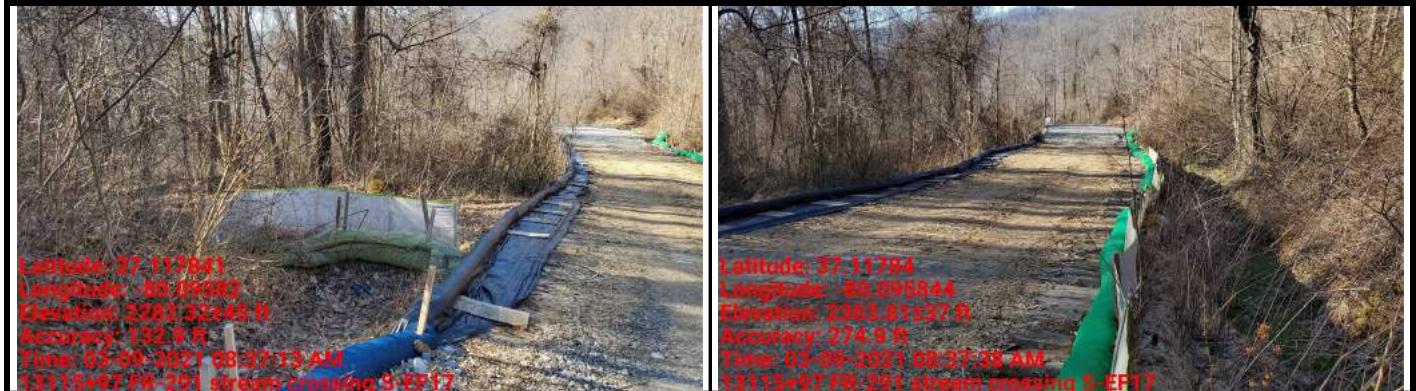
Latitude: 37.11784  
Longitude: -80.09582  
Elevation: 2281.31445 ft  
Accuracy: 132.5 ft  
Time: 03-09-2021 08:37:13 AM  
13115+97 FR-291 stream crossing S-EF17

<b>GPS Location</b>	See pic for GPS location	<b>GPS Location</b>	See pic for GPS location
<b>Field Station#</b>	13115+97	<b>Field Station#</b>	13115+97
<b>Pic 3 Desc.</b>	Sump and end treatment along FR-291.	<b>Pic 4 Desc.</b>	Equipment bridge over S-EF17.

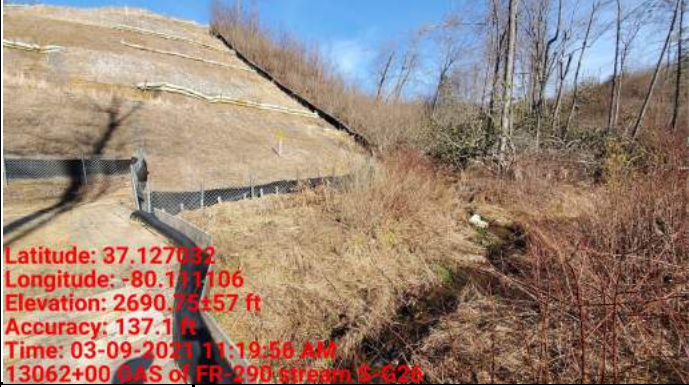
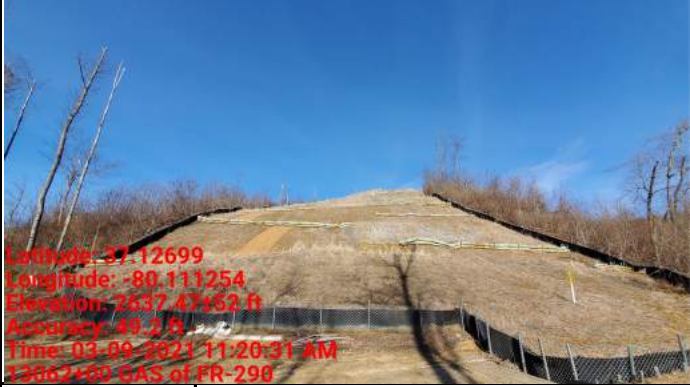
<p>Latitude: 37.12699 Longitude: -80.111254 Elevation: 2637.47±52 ft Accuracy: 49.2 ft Time: 03-09-2021 11:20:31 AM 13062+00 GAS of FR-290</p>	
<b>GPS Location</b>	See pic for GPS location	<b>GPS Location</b>	See pic for GPS location
<b>Field Station#</b>	13062+00	<b>Field Station#</b>	13062+00
<b>Pic 13 Desc.</b>	Upstream side of stream S-G26.	<b>Pic 14 Desc.</b>	CIS of FR-290.

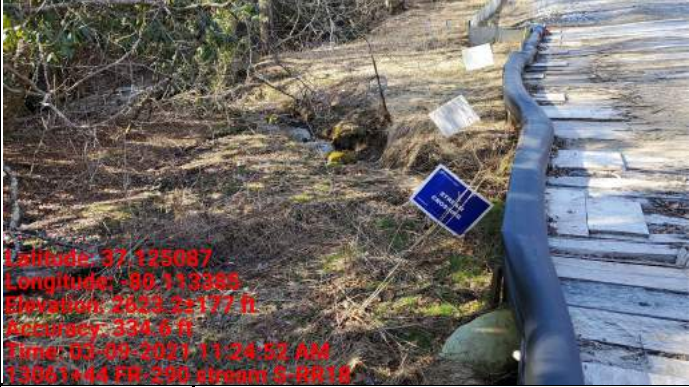
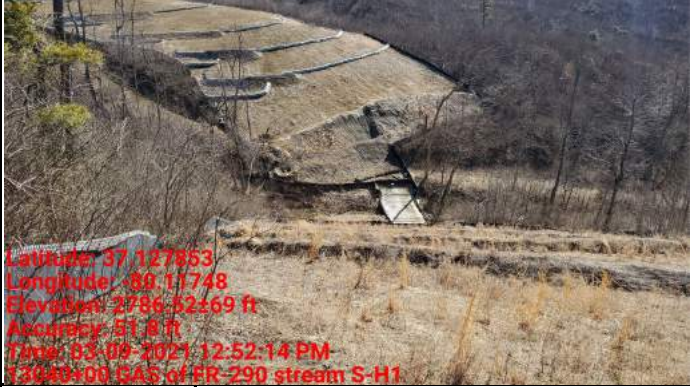
<b>Field Station#</b>	13061+44	<b>Field Station#</b>	13040+00
<b>Pic 15 Desc.</b>	Stream S-RR18 along access road FR-290.	<b>Pic 16 Desc.</b>	Stream S-H1 on the GAS of FR-289.

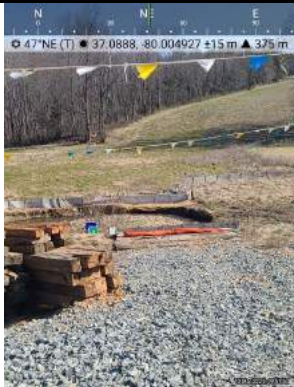
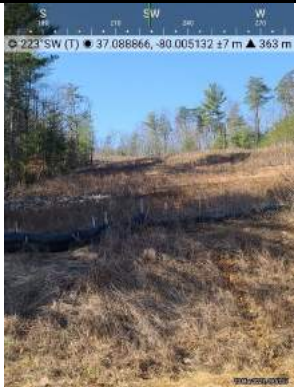
<b>GPS Location</b>	00000		<b>GPS Location</b>	0000	
<b>Field Station#</b>	13497+87		<b>Field Station#</b>	13496+76	
<b>Pic 1 Desc.</b>	Observed stream crossing problem land owner tract , monitored ECDs on stream banks, no issues observed at the time of inspection.		<b>Pic 2 Desc.</b>	Monitored ECDs and vegetation at CAHAS #2 crossing.

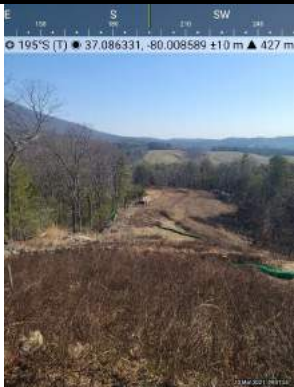
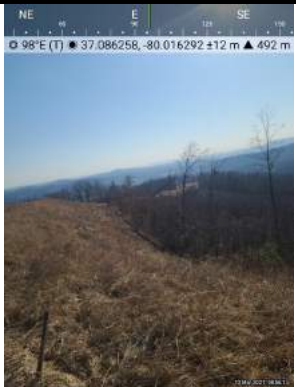
<b>GPS Location</b>	00000		<b>GPS Location</b>	00000	
<b>Field Station#</b>	13488+90		<b>Field Station#</b>	13460+21	
<b>Pic 3 Desc.</b>	Row photo showing vegetation, ECDs in place and functioning, no environmental issues observed at the time of inspection.		<b>Pic 4 Desc.</b>	Monitored ECDs and vegetation growth while checking row conditions throughout.

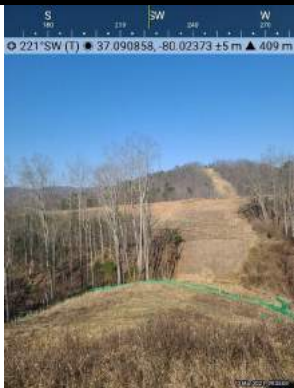
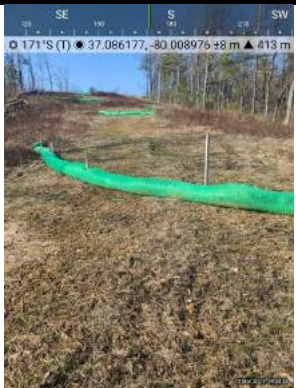
<b>Pic 5 Desc.</b>	Row photo showing vegetation and ECDs in place and functioning, no environmental issues observed at the time of inspection.		<b>Pic 6 Desc.</b>	Photo showing new vegetation growing in travel lane, ECDs in place and functioning.

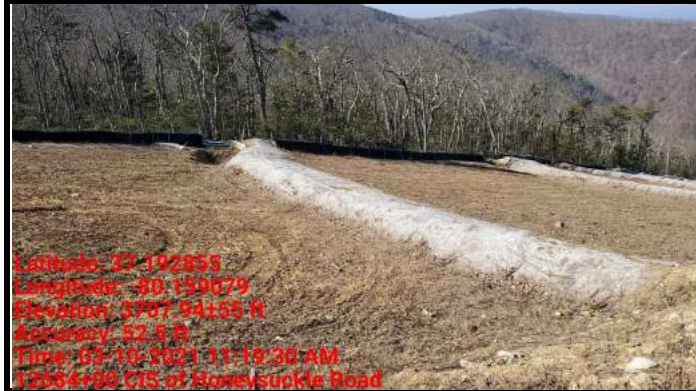
<b>Pic 13 Desc.</b>	Waterbars, sumps and end treatments remain in acceptable condition.
---------------------	---

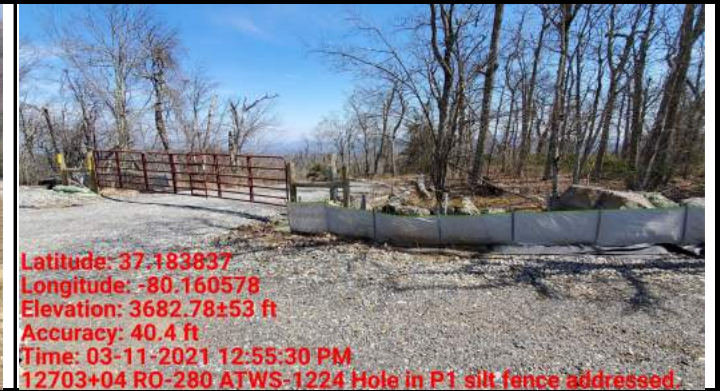
<b>Pic 14 Desc.</b>	Hole in the P1 silt fence next to the gate for access road RO-280 added to the PL to be corrected by the contractor. Repaired 3/11
---------------------	--

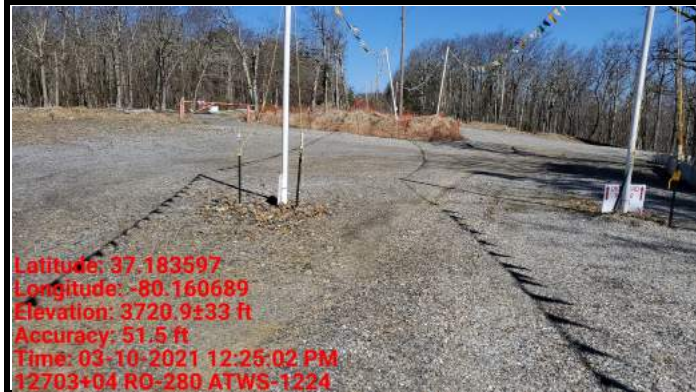
<b>Pic 15 Desc.</b>	ATWS-1224 on access road RO-280 at Honeysuckle Road.
---------------------	--

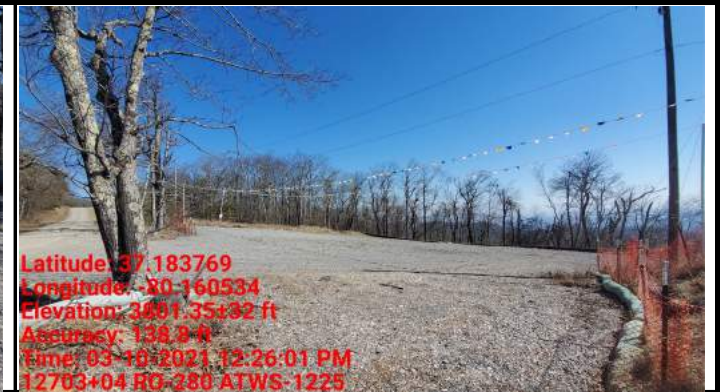
<b>Pic 16 Desc.</b>	ATWS-1225 on access road RO-280 at Honeysuckle Road.
---------------------	--

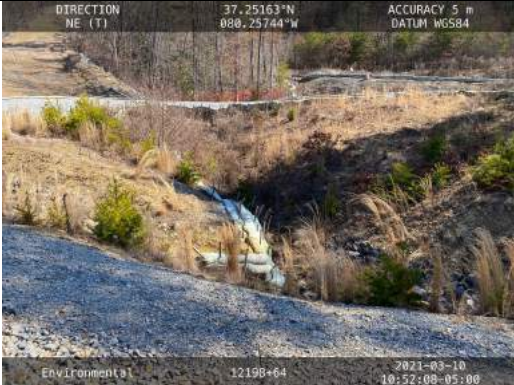
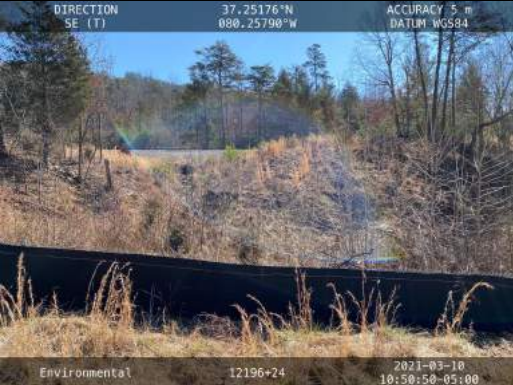
<b>GPS Location</b> See photo		<b>GPS Location</b> See photo			
<b>Field Station#</b> 12198+64		<b>Field Station#</b> 12196+24			
<b>Pic 1 Desc.</b> Stream crossing S-OO11 on the E side of the rail road tracks in acceptable condition		<b>Pic 2 Desc.</b> Stream crossing S-OO11 on west side of the railroad crossing in acceptable condition

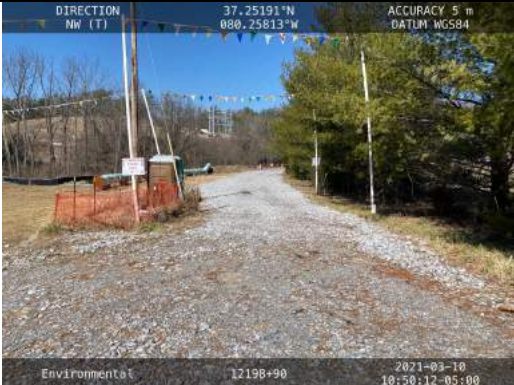
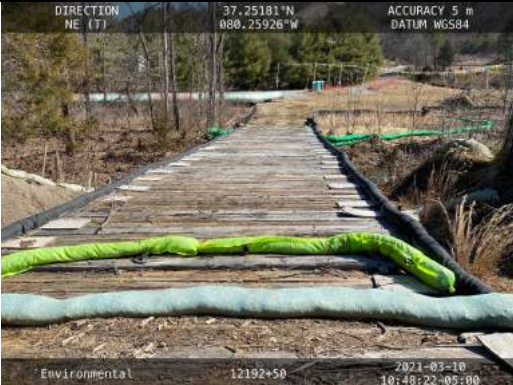
<b>GPS Location</b> See photo		<b>GPS Location</b> See photo			
<b>Field Station#</b> 12198+90		<b>Field Station#</b> 12192+50			
<b>Pic 3 Desc.</b> Access Road MVP-MN-275 in acceptable condition		<b>Pic 4 Desc.</b> Bridge and ECDs crossing S-C21 in acceptable condition

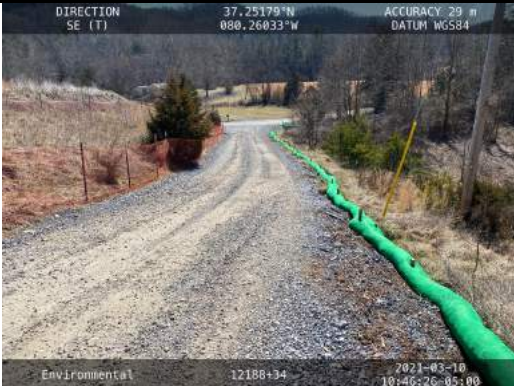
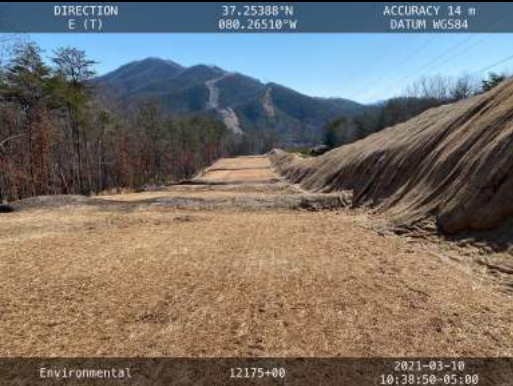
<b>GPS Location</b> See photo		<b>GPS Location</b> See photo			
<b>Field Station#</b> 12188+34		<b>Field Station#</b> 12175+00			
<b>Pic 5 Desc.</b> Access Road MVP-MN-274 in acceptable condition		<b>Pic 6 Desc.</b> Stabilized ROW in acceptable condition

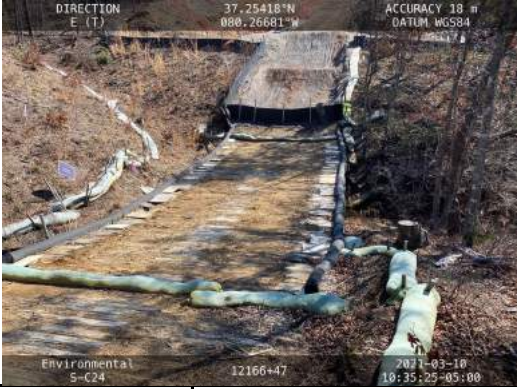
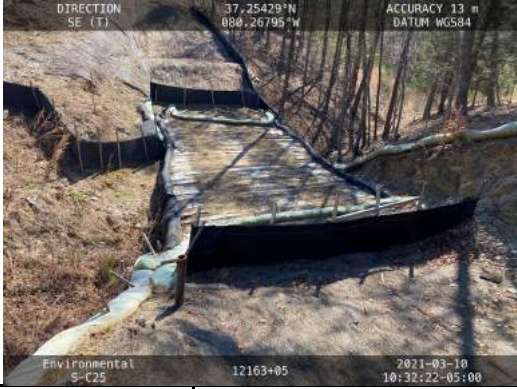
<b>GPS Location</b>	See photo		<b>GPS Location</b>	See photo
<b>Field Station#</b>	12166+47		<b>Field Station#</b>	12163+05
<b>Pic 7 Desc.</b>	Bridge and ECDs at stream crossing S-C24 in acceptable condition		<b>Pic 8 Desc.</b>	Bridge and ECDs at S-C25 in acceptable condition

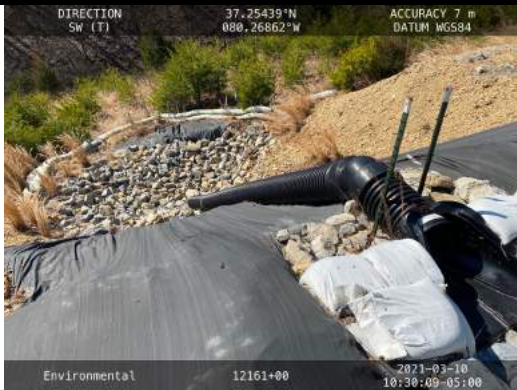
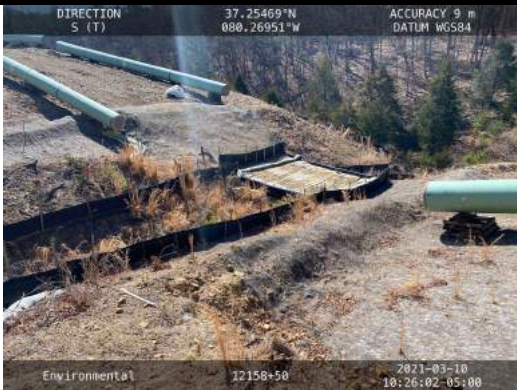
<b>GPS Location</b>	See photo		<b>GPS Location</b>	See photo
<b>Field Station#</b>	12161+00		<b>Field Station#</b>	12158+50
<b>Pic 9 Desc.</b>	Fill slope drain in acceptable condition		<b>Pic 10 Desc.</b>	Clean water crossing in acceptable condition
