# Visual Site Inspection Report

<b>Project Name</b> H-600 Pipeline Spread H		<b>AFE</b> 124300138	<b>Spread</b> H-600 Pipeline Spread H
<b>Contractor</b> Precision		<b>Report #</b> 20859	
<b>Inspector</b> John Brcic		<b>Date/Time</b> 3/8/2021 1:22 PM	
<b>Permit #</b> TBD	<b>Inspection Type</b> VA SWPP	<b>Station Begin</b>	12005+00
<b>State</b> VA	<b>Inspection Area</b> Partial	<b>Station End</b>	12119+17
<b>County</b> Montgomery	<b>Ground</b> Dry	<b>Temperature (°F)</b>	55.00
<b>Municipality</b> N/A	<b>Weather</b> Sunny	<b>Rain Gauge (in)</b>	0.00
			<b>Rain Accumulation Time (days)</b> 1.00

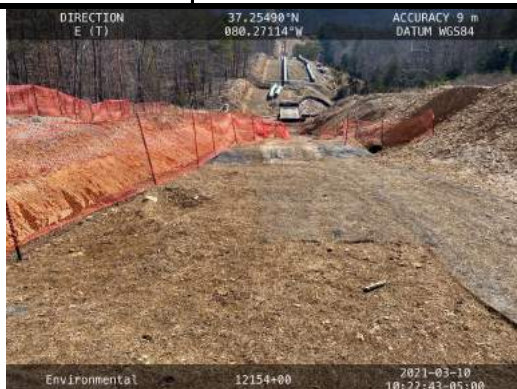
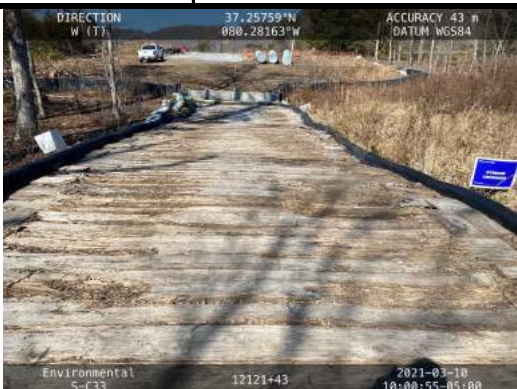
<b>GPS Location</b>	See photo		<b>GPS Location</b>	See photo
<b>Field Station#</b>	12154+00		<b>Field Station#</b>	12121+43
<b>Pic 11 Desc.</b>	Stabilized ROW in acceptable condition		<b>Pic 12 Desc.</b>	ECDs and bridge crossing S-C33 is in acceptable condition

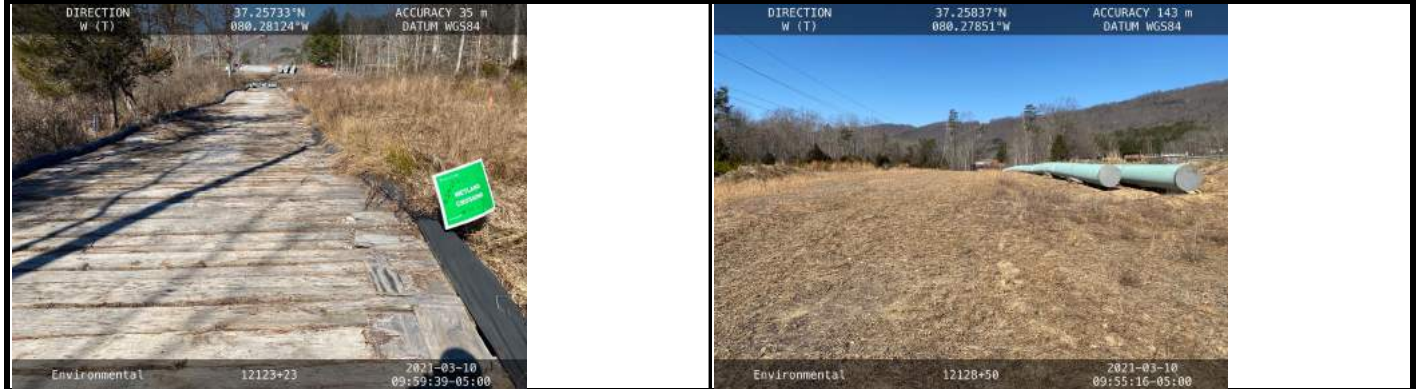
<b>GPS Location</b>	See photo	<b>GPS Location</b>	See photo
<b>Field Station#</b>	12123+23	<b>Field Station#</b>	12128+50
<b>Pic 13 Desc.</b>	W-C11 in acceptable condition	<b>Pic 14 Desc.</b>	Stabilized ROW in acceptable condition

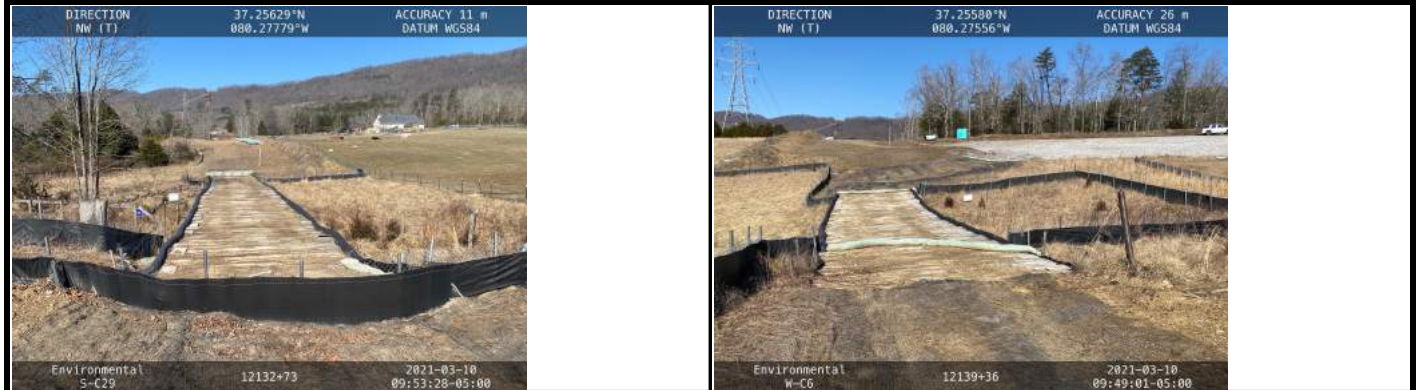
<b>GPS Location</b>	See photo	<b>GPS Location</b>	See photo
<b>Field Station#</b>	12132+73	<b>Field Station#</b>	12139+36
<b>Pic 15 Desc.</b>	Bridge and ECDs at S-C29 in acceptable condition	<b>Pic 16 Desc.</b>	ECDs and bridge crossing W-C6 in acceptable condition

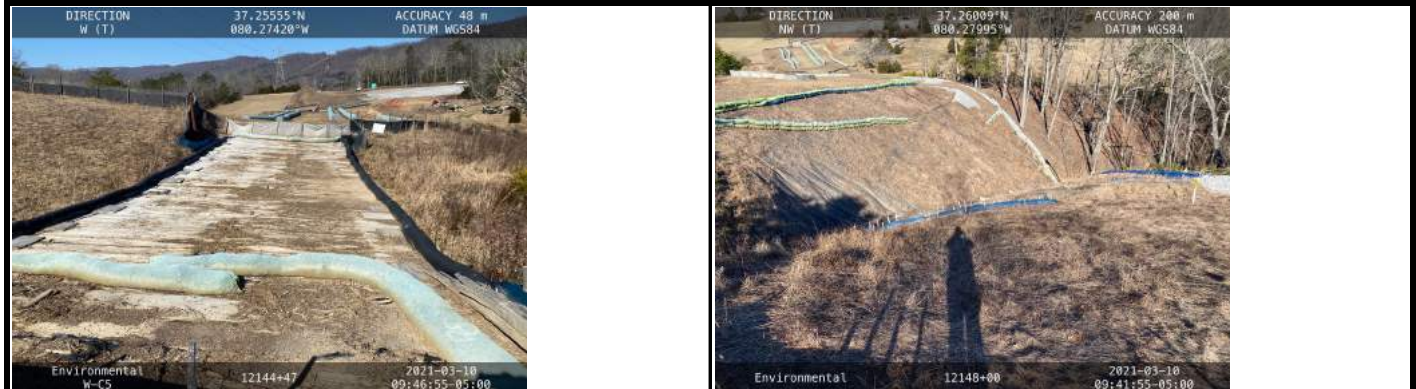
<b>GPS Location</b>	See photo	<b>GPS Location</b>	See photo
<b>Field Station#</b>	12144+47	<b>Field Station#</b>	12148+00
<b>Pic 17 Desc.</b>	Bridge and ECDs at W-C5 in acceptable condition	<b>Pic 18 Desc.</b>	Stabilized drainage area in acceptable condition with no signs of erosion

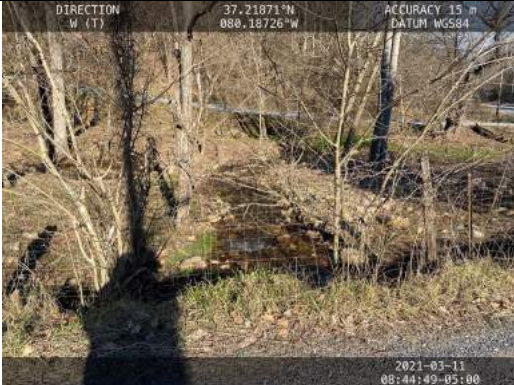
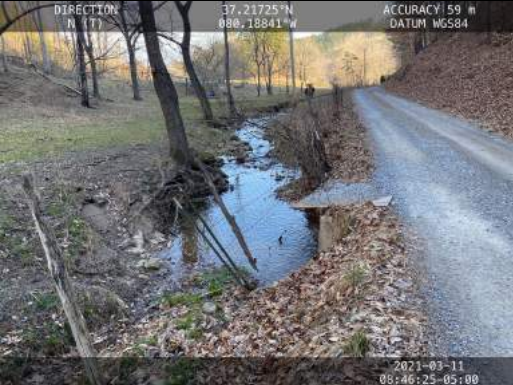
<b>GPS Location</b>	See photo		<b>GPS Location</b>	See photo	
<b>Field Station#</b>	12544+06		<b>Field Station#</b>	12544+06	
<b>Pic 1 Desc.</b>	Stream S-KL32, facing west, downstream from Yellow Finch Lane		<b>Pic 2 Desc.</b>	Stream S-EF20b, facing north, downstream from Yellow Finch Lane

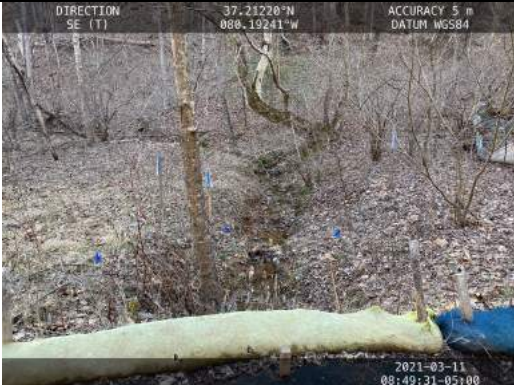
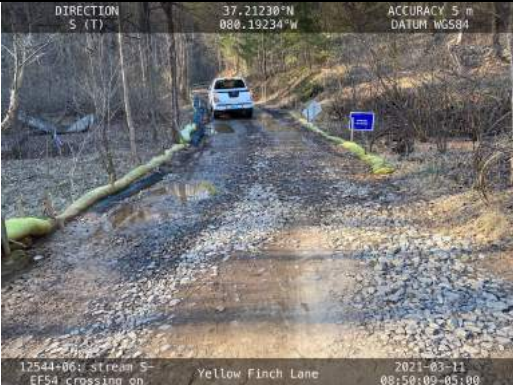
<b>GPS Location</b>	See photo		<b>GPS Location</b>	See photo	
<b>Field Station#</b>	12544+06		<b>Field Station#</b>	12544+06	
<b>Pic 3 Desc.</b>	Stream S-EF54, facing southeast, downstream from Yellow Finch Lane		<b>Pic 4 Desc.</b>	Yellow Finch Lane crossing over stream S-EF54.

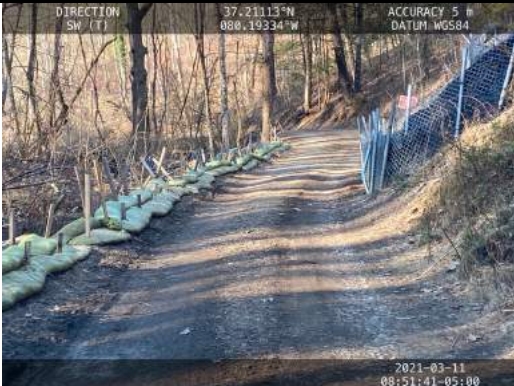
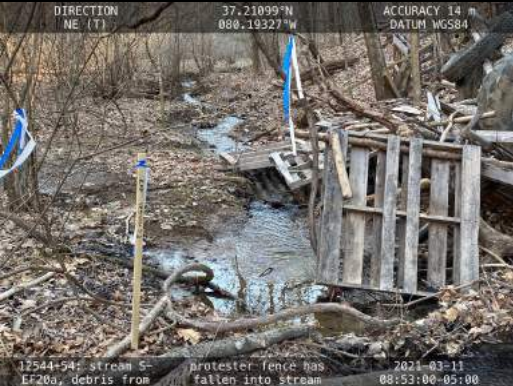
<b>GPS Location</b>	See photo		<b>GPS Location</b>	See photo	
<b>Field Station#</b>	12544+06		<b>Field Station#</b>	12544+54	
<b>Pic 5 Desc.</b>	MVP ROW crossing on Yellow Finch Lane.		<b>Pic 6 Desc.</b>	Pallets from protester barricade have fallen over stream S-EF20a outside, downstream of, MVP ROW.

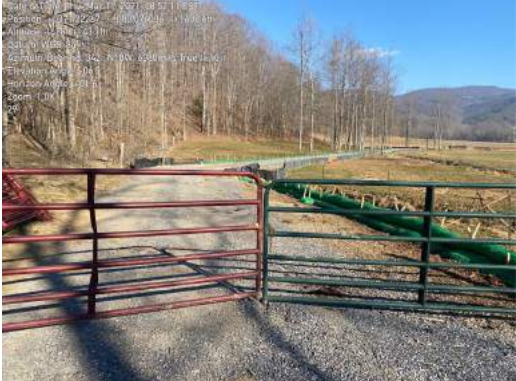
<b>GPS Location</b>	See photo for coordinates.	<b>GPS Location</b>	See photo for coordinates.		
<b>Field Station#</b>	13190+00	<b>Field Station#</b>	13190+00		
<b>Pic 1 Desc.</b>	MVP-MLV-AR-29, access road in acceptable condition.	<b>Pic 2 Desc.</b>	S-D10, downstream of air bridge on MVP-MLV-AR-29, typical cattle disturbance noted along banks.

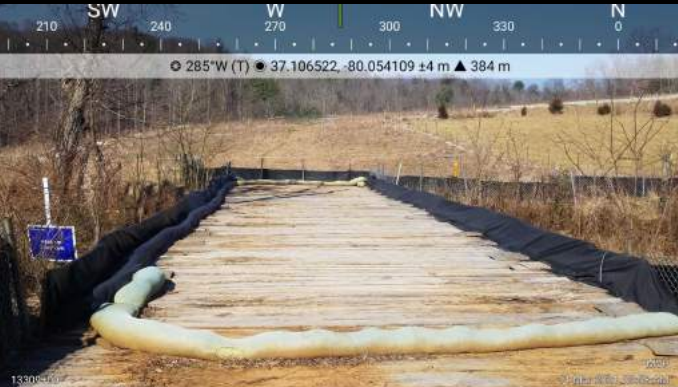
<b>GPS Location</b>	See photo for coordinates.	<b>GPS Location</b>	See photo for coordinates.		
<b>Field Station#</b>	13309+09	<b>Field Station#</b>	13306+00		
<b>Pic 3 Desc.</b>	S-GH7, bridge in acceptable condition at stream crossing, no impacts noted.	<b>Pic 4 Desc.</b>	ROW stable with acceptable vegetative cover across LOD.

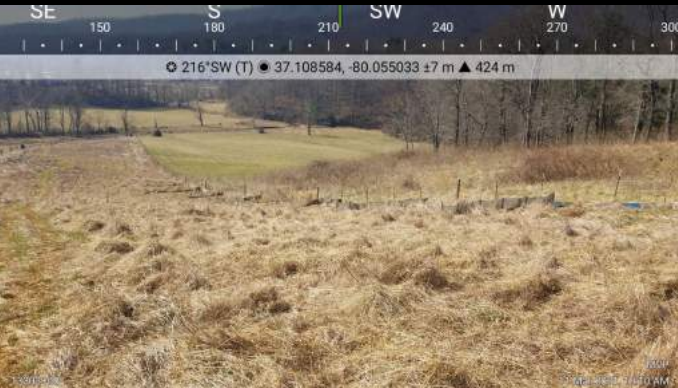
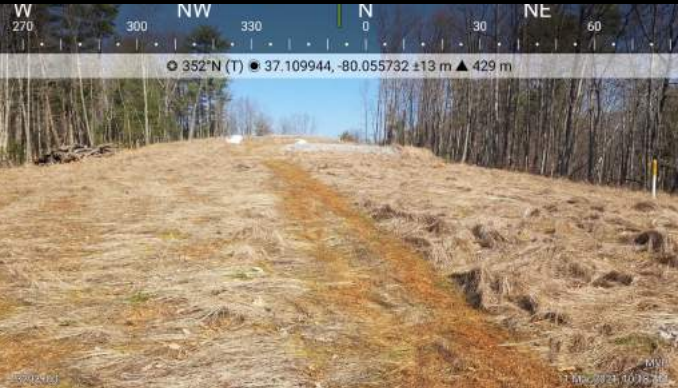
<b>GPS Location</b>	See photo for coordinates.	<b>GPS Location</b>	See photo for coordinates.		
<b>Field Station#</b>	13302+00	<b>Field Station#</b>	13293+00

<b>Pic 5 Desc.</b>	ROW stable with acceptable vegetative cover across LOD.	<b>Pic 6 Desc.</b>	ROW stable with acceptable vegetative cover across LOD, ATV trail noted.

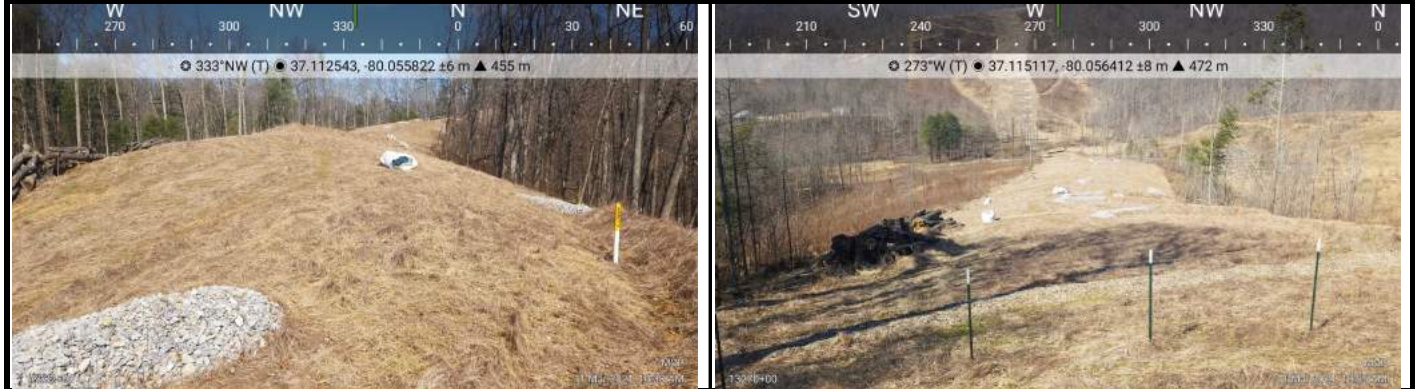
<b>GPS Location</b>	See photo for coordinates.	<b>GPS Location</b>	See photo for coordinates.
<b>Field Station#</b>	13282+00	<b>Field Station#</b>	13270+00
<b>Pic 7 Desc.</b>	ROW stable with acceptable vegetative cover across LOD.	<b>Pic 8 Desc.</b>	ROW stable with acceptable vegetative cover across LOD.

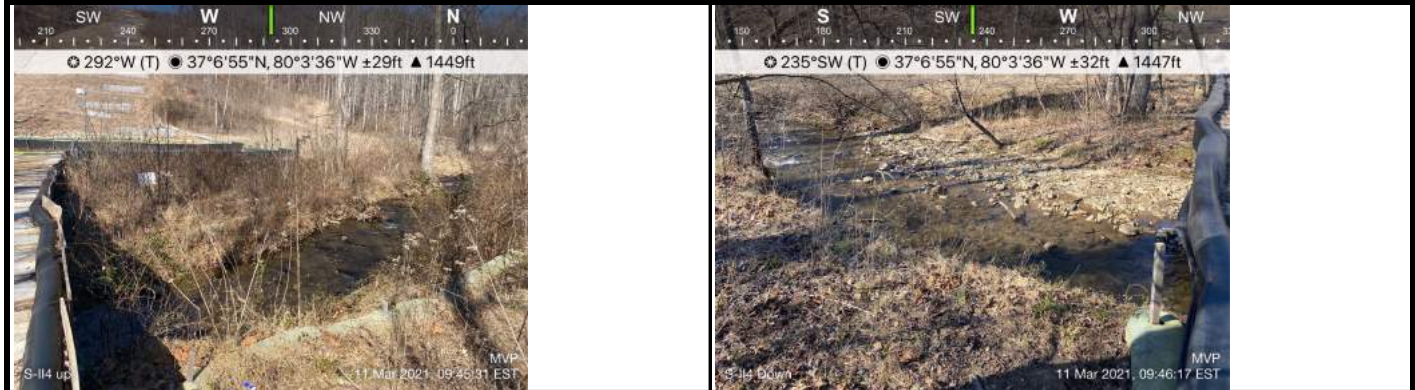
<b>GPS Location</b>	See photo for coordinates.	<b>GPS Location</b>	See photo for coordinates.
<b>Field Station#</b>	13260+60	<b>Field Station#</b>	13260+60
<b>Pic 9 Desc.</b>	S-II4, upstream of equipment bridge, no changes or impacts noted, banks well vegetated.	<b>Pic 10 Desc.</b>	S-II4, downstream of equipment bridge, no changes noted to stream bed or banks.

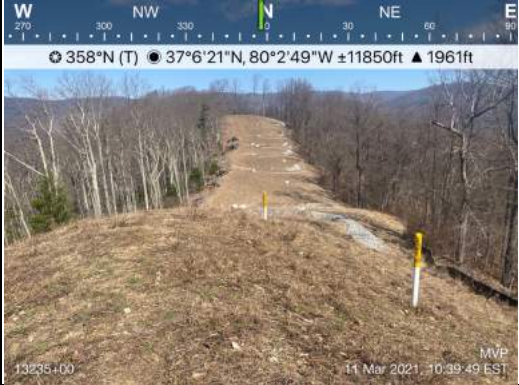
<b>GPS Location</b>	See photo for coordinates.	<b>GPS Location</b>	See photo for coordinates.
<b>Field Station#</b>	13242+00	<b>Field Station#</b>	13235+00
<b>Pic 13 Desc.</b>	ROW stable with acceptable vegetative cover across LOD.	<b>Pic 14 Desc.</b>	ROW stable with acceptable vegetative cover across LOD.

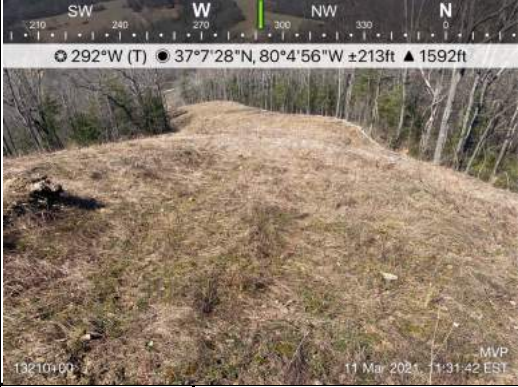
<b>GPS Location</b>	See photo for coordinates.	<b>GPS Location</b>	See photo for coordinates.
<b>Field Station#</b>	13210+00	<b>Field Station#</b>	13200+00
<b>Pic 17 Desc.</b>	ROW stable with acceptable vegetative cover across LOD.	<b>Pic 18 Desc.</b>	ROW stable with acceptable vegetative cover across LOD.

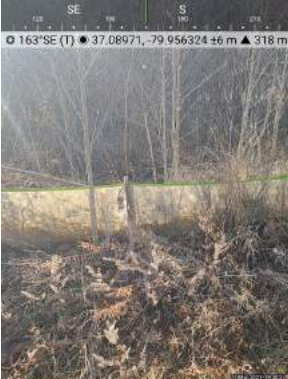
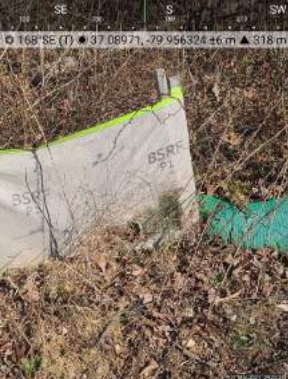
Throughout today's inspections the EI noticed several location where P1 required maintenance due to being weathered and torn or wildlife damage . Documented in photos and sent in to be added to the punch list for repairs.

<b>GPS Location</b>	00000		<b>GPS Location</b>	00000	
<b>Field Station#</b>	13657+50		<b>Field Station#</b>	13658+70	
<b>Pic 1 Desc.</b>	P1 requires maintenance due to being weathered and torn, documented and sent in to be added to the punch list.		<b>Pic 2 Desc.</b>	P1 requires maintenance due to being weathered and torn, documented and sent in to be added to the punch list.

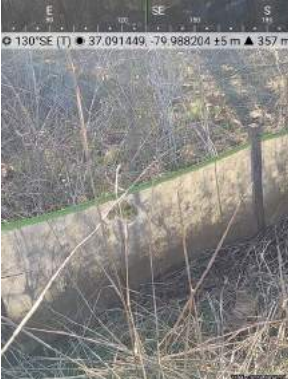
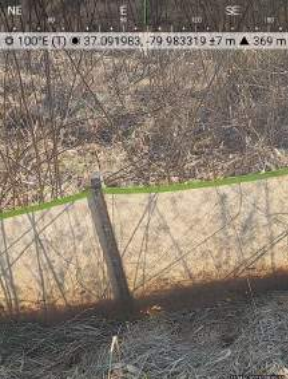
<b>GPS Location</b>	00000		<b>GPS Location</b>	00000	
<b>Field Station#</b>	13550+50		<b>Field Station#</b>	13564+75	
<b>Pic 3 Desc.</b>	P1 requires maintenance due to being weathered and torn, documented and sent in to be added to the punch list.		<b>Pic 4 Desc.</b>	P1 requires maintenance due to wildlife damage , documented and sent in to be added to the punch list.

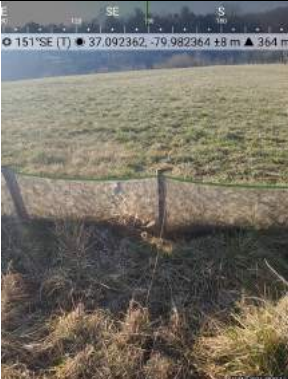
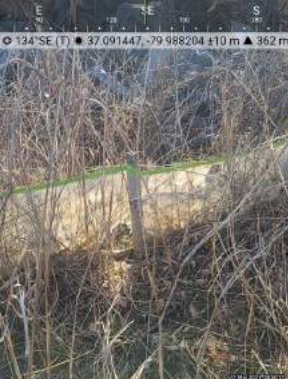
<b>GPS Location</b>	00000		<b>GPS Location</b>	00000

<b>Field Station#</b>	13568+79		<b>Field Station#</b>	13550+50	
<b>Pic 5 Desc.</b>	P1 requires maintenance due to wildlife damage , documented and sent in to be added to the punch list.		<b>Pic 6 Desc.</b>	Additional photo showing P1 that requires maintenance due to wildlife damage , documented and sent in to be added to the punch list.

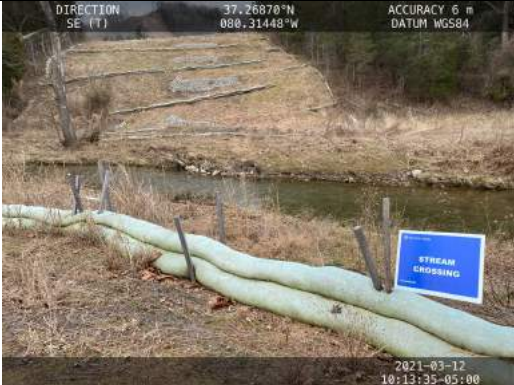
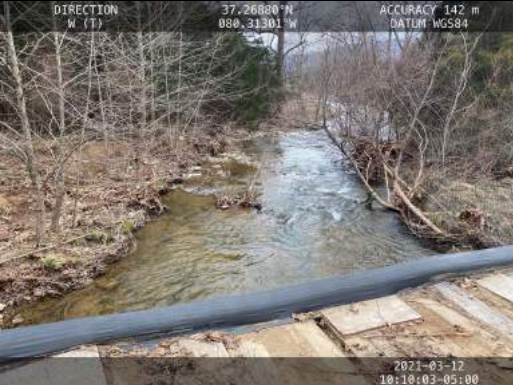
<p>DIRECTION W (T) 37.26880°N 080.31301°W ACCURACY 142 m DATUM WGS84 2021-03-12 10:18:03-05:00</p>	
<b>GPS Location</b>	See photo	<b>GPS Location</b>	See photo
<b>Field Station#</b>	12008+65	<b>Field Station#</b>	12013+97
<b>Pic 1 Desc.</b>	Stream S-G36(ROW), facing southeast	<b>Pic 2 Desc.</b>	Stream S-G36(access road), facing west, downstream

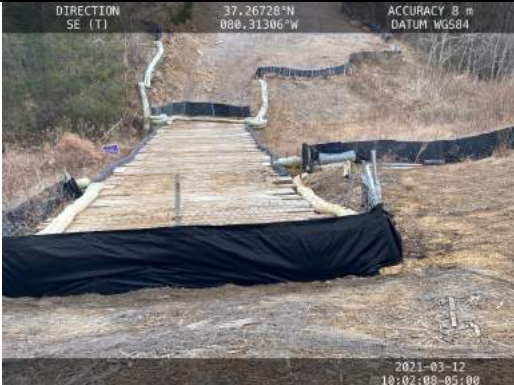
<p>DIRECTION E (T) 37.26730°N 080.31299°W ACCURACY 7 m DATUM WGS84 12015+00: undermined CFS repaired 2021-03-12 10:01:53-05:00</p>	
<b>GPS Location</b>	See photo	<b>GPS Location</b>	See photo
<b>Field Station#</b>	12015+84	<b>Field Station#</b>	12015+00
<b>Pic 3 Desc.</b>	The bridge, buffer zone and ECDs are in satisfactory condition at stream S-G38.	<b>Pic 4 Desc.</b>	Undermined CFS was repaired on this end treatment per MBP action item.

Stations 12005+00 to 12119+17.....Activity since last SWPPP inspection. On access road MVP-MN-268.01, woody debris was removed where it had been building up against the bridge over stream S-G36. CFS perimeter controls were replaced along access roads MVP-MN-268 and 271. An undermined CFS end treatment at station 12015+00 was repaired.

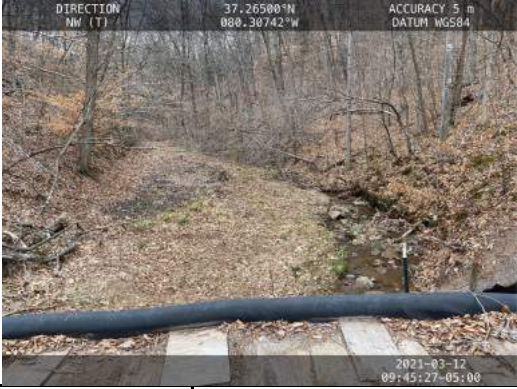
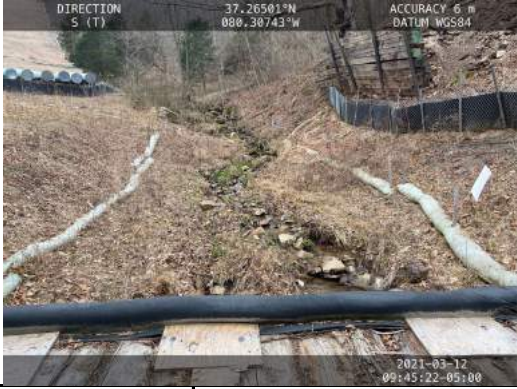
<b>GPS Location</b>	See photo	<b>GPS Location</b>	See photo
<b>Field Station#</b>	12035+11	<b>Field Station#</b>	12035+11
<b>Pic 7 Desc.</b>	Stream S-G40, facing northwest, downstream	<b>Pic 8 Desc.</b>	Stream S-G40, facing south, upstream

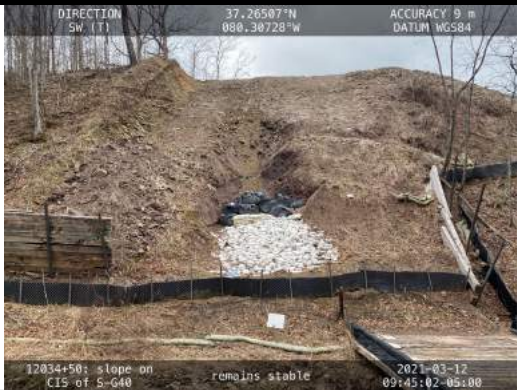
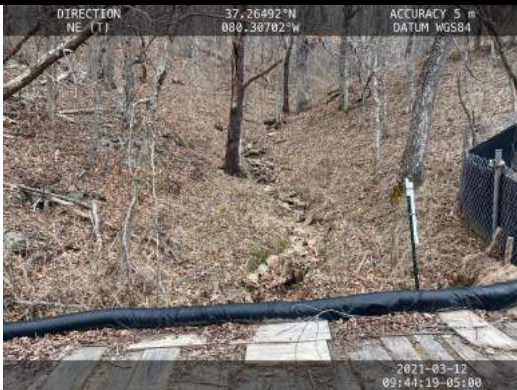
<b>GPS Location</b>	See photo	<b>GPS Location</b>	See photo
<b>Field Station#</b>	12034+50	<b>Field Station#</b>	12035+75
<b>Pic 9 Desc.</b>	The steep slope on the coming in side of stream S-G40 remains stable.	<b>Pic 10 Desc.</b>	Stream S-PP23, facing northeast, upstream

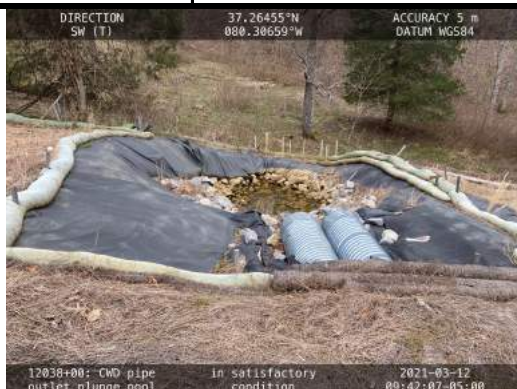
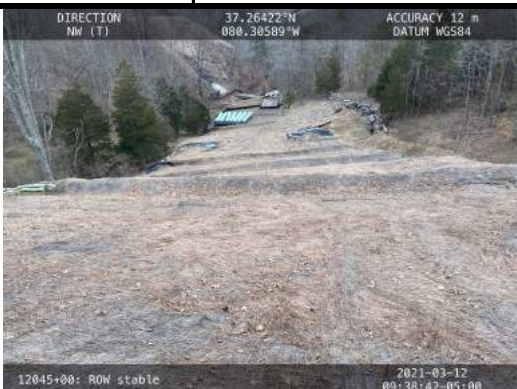
<b>GPS Location</b>	See photo	<b>GPS Location</b>	See photo
<b>Field Station#</b>	12038+00	<b>Field Station#</b>	12045+00
<b>Pic 11 Desc.</b>	Clean water diversion pipe outlet is in satisfactory condition.	<b>Pic 12 Desc.</b>	ROW stable

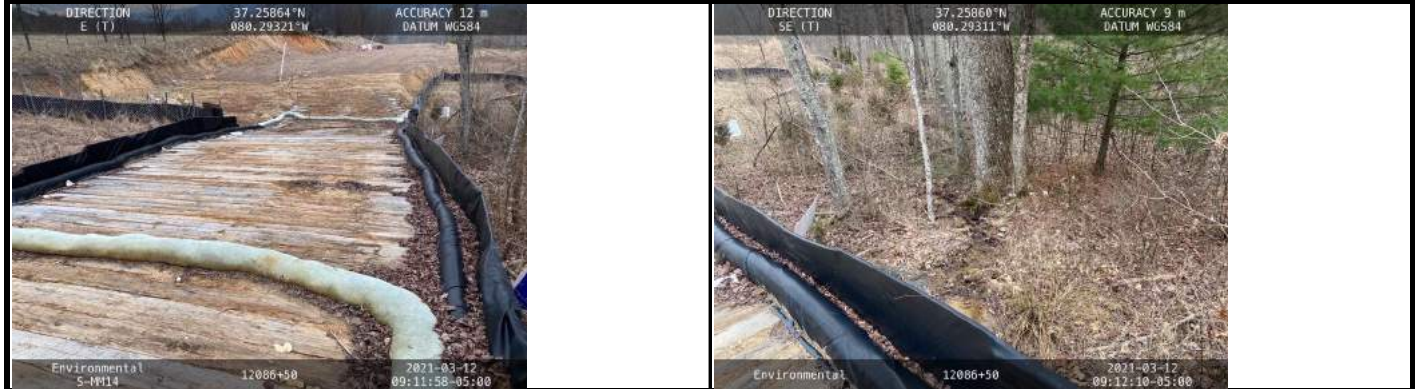
<b>GPS Location</b>	See photo	<b>GPS Location</b>	See photo
<b>Field Station#</b>	12086+50	<b>Field Station#</b>	12086+50
<b>Pic 13 Desc.</b>	Bridge and ECDs in satisfactory condition at stream S-MM14.	<b>Pic 14 Desc.</b>	Stream S-MM14, facing southeast, downstream

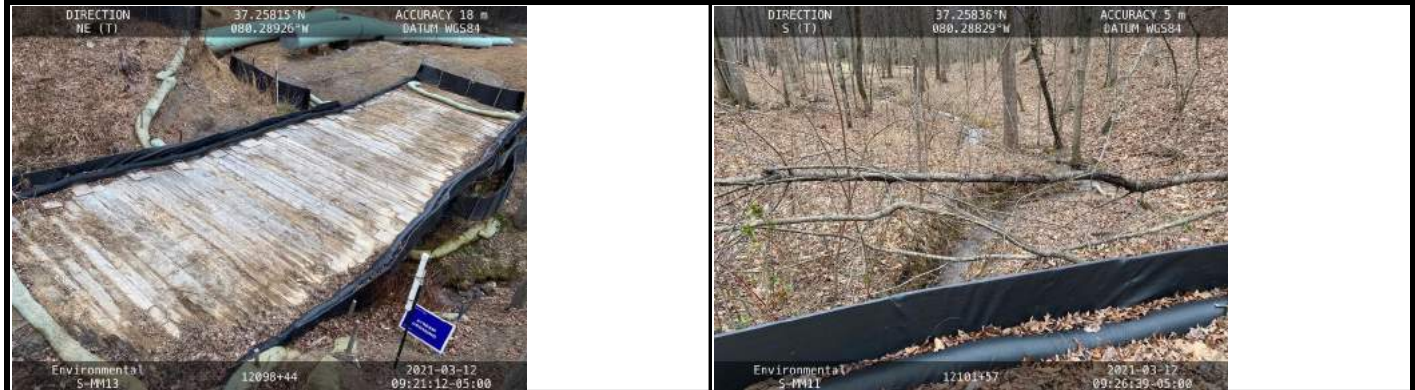
<b>GPS Location</b>	See photo	<b>GPS Location</b>	See photo
<b>Field Station#</b>	12098+44	<b>Field Station#</b>	12101+57
<b>Pic 15 Desc.</b>	Bridge and ECDs in satisfactory condition at stream S-MM13.	<b>Pic 16 Desc.</b>	Stream S-MM11, facing south, downstream

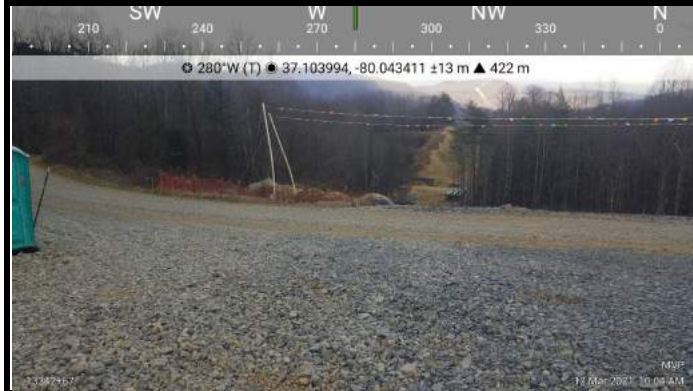
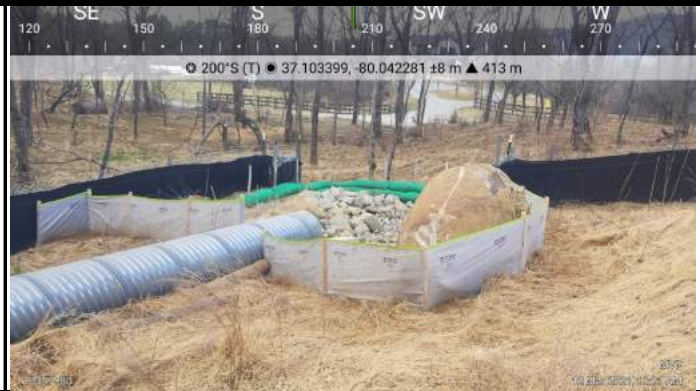
<b>Pic 7 Desc.</b>	Overview of Webster Corner Road ROW crossing. ECDs are functional and ROW is stable.
--------------------	--

<b>Pic 8 Desc.</b>	ROW Overview. Cleanwater diversion pipe. ECDs are functional and ROW is stable.
--------------------	---

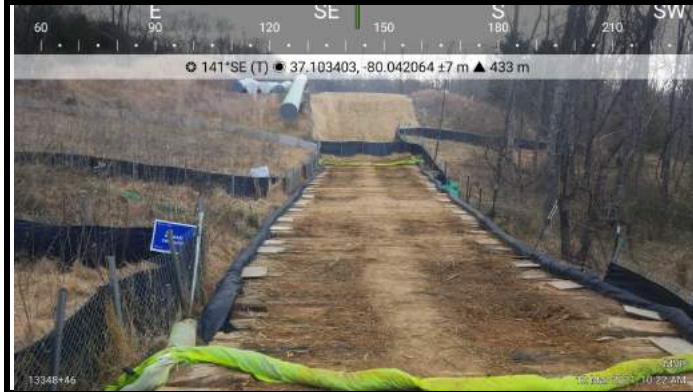
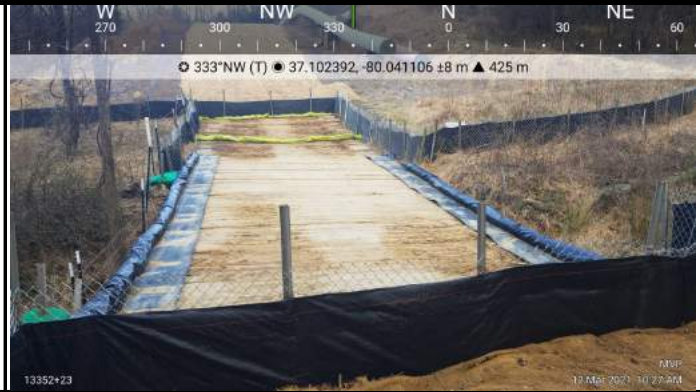
<b>Pic 9 Desc.</b>	Overview of Waterbody S-RR08. ECDs are functional and ROW is stable.
--------------------	--

<b>Pic 10 Desc.</b>	Overview of Waterbody S-RR09. ECDs are functional and ROW is stable.
---------------------	--

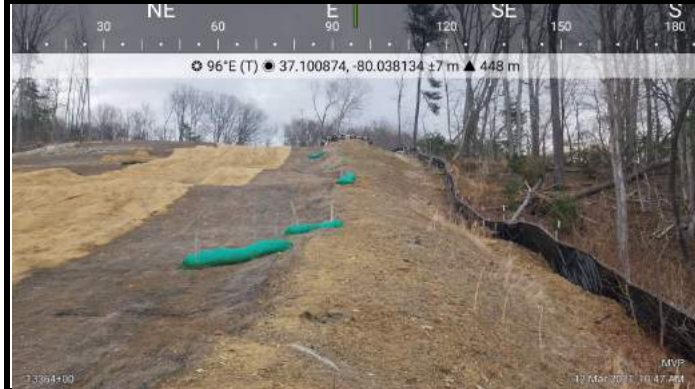
**Field Station#** 13364+00

**Pic 13 Desc.** ROW Overview. ECDs are functional and ROW is stable.

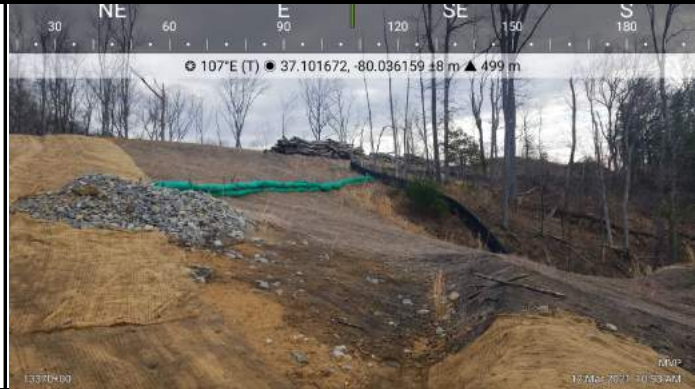
**Field Station#** 13370+00

**Pic 14 Desc.** ROW Overview. ECDs are functional and ROW is stable.

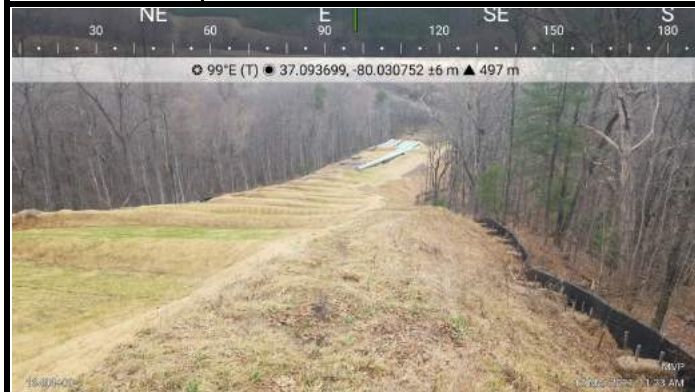
**Field Station#** 13404+00

**Pic 15 Desc.** ROW Overview. ECDs are functional and ROW is stable.

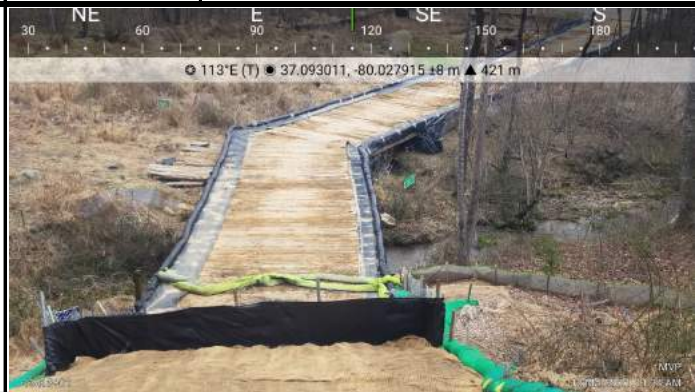
**Field Station#** 13413+01

**Pic 16 Desc.** Overview of Waterbody S-IJ1. ECDs are functional and ROW is stable.

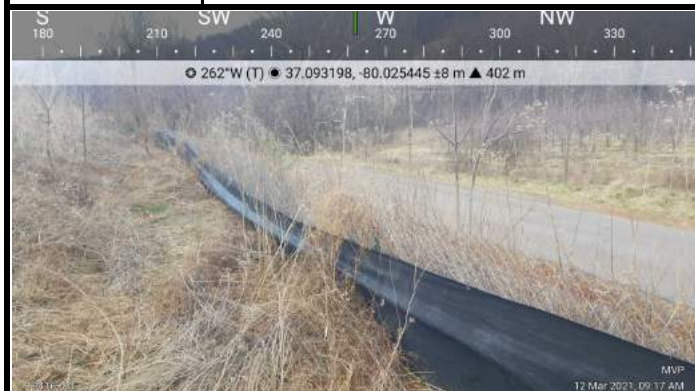
**Field Station#** 13416+00

This section of right of way received 0.0" precipitation in the last 24 hours and has received 0.0" precipitation for the week thus far. One new 72 hour punchlist item near station 13416+00 was added and completed today (see photos below). All observed erosion control devices (ECDs) and best management practices (BMPs) are in satisfactory condition and continue to function properly. ROW remains stable throughout the inspection area.

**Pic 17 Desc.** Punchlist item: Repair super silt fence.

An Environmental crew repaired a punchlist item near station 13416+00 today, super silt fence has been repaired.

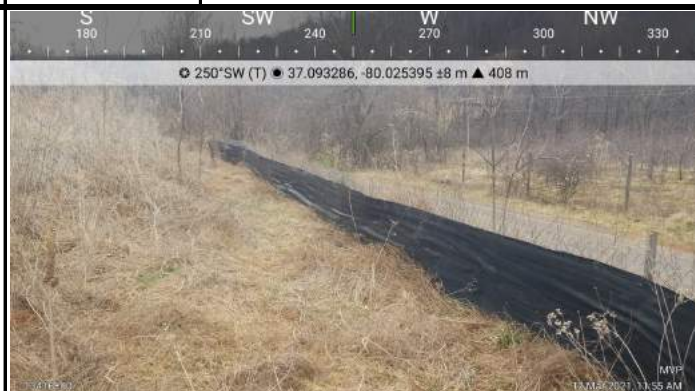
**Field Station#** 13416+00

**Pic 18 Desc.** Punchlist item: Super silt fence repaired.

Two punchlist items have been completed since last SWPPP inspection: Station 13337+13, super silt fence repaired. Station 13416+00, super silt fence repaired.

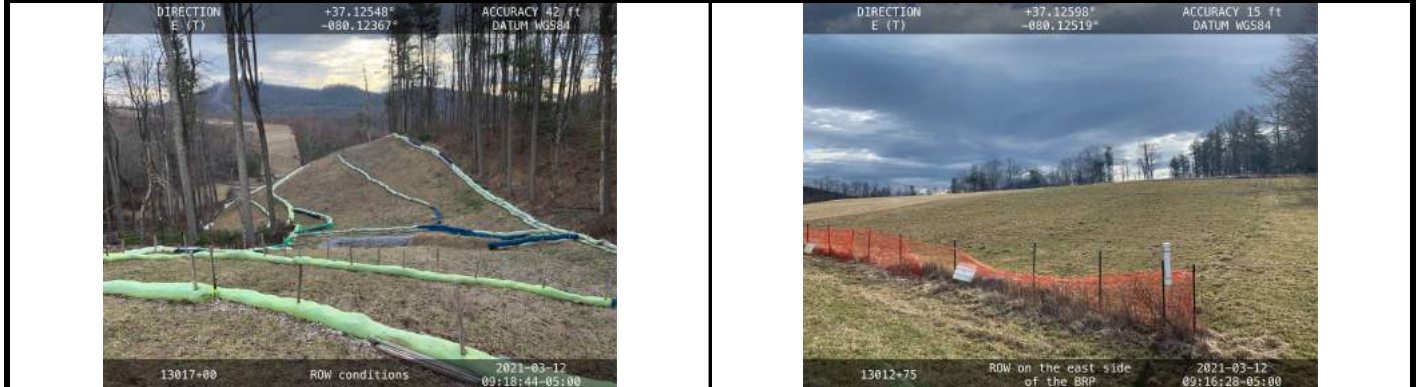
<b>GPS Location</b>	See pic for GPS location	<b>GPS Location</b>	See pic for GPS location
<b>Field Station#</b>	13017+00	<b>Field Station#</b>	13012+75
<b>Pic 1 Desc.</b>	Wooded portion of the BRP.	<b>Pic 2 Desc.</b>	GAS of the BRP motorway.

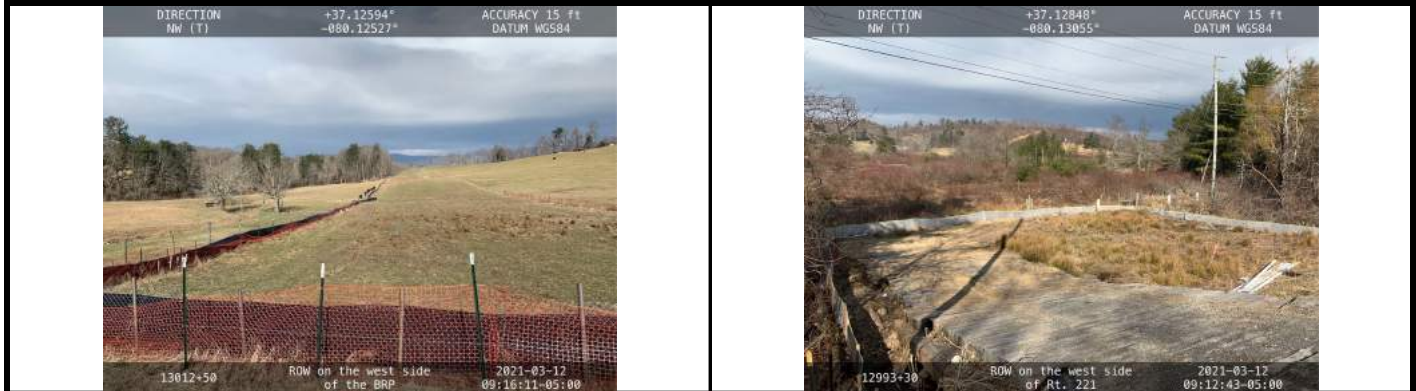
<b>GPS Location</b>	See pic for GPS location	<b>GPS Location</b>	See pic for GPS location
<b>Field Station#</b>	13012+50	<b>Field Station#</b>	12994+00
<b>Pic 3 Desc.</b>	CIS of the BRP motorway.	<b>Pic 4 Desc.</b>	CIS of the US-221 road crossing.

P1 silt fence replaced on CIS of US-221 road crossing, where deteriorating.

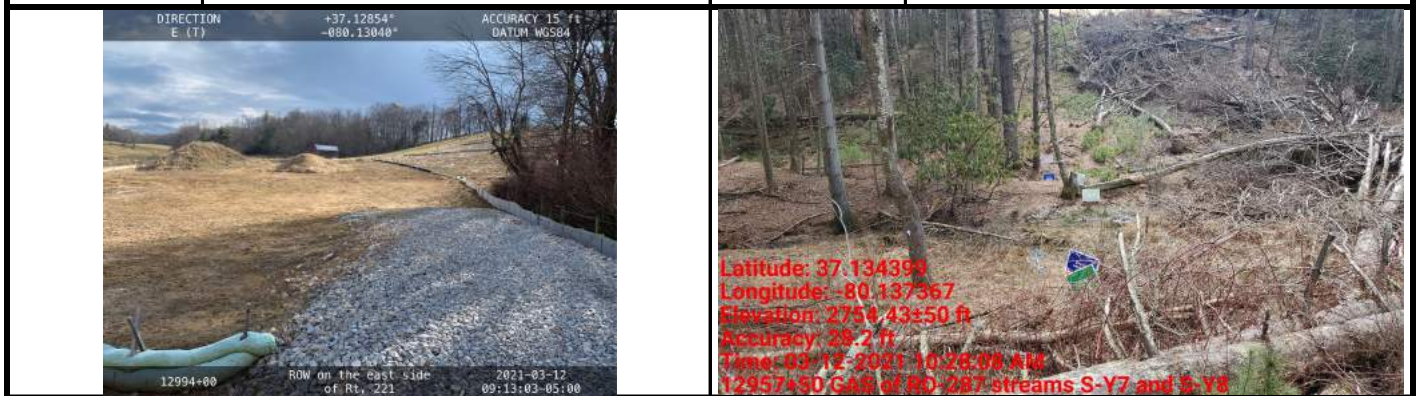
<b>GPS Location</b>	See pic for GPS location	<b>GPS Location</b>	See pic for GPS location
<b>Field Station#</b>	12994+20	<b>Field Station#</b>	12957+50
<b>Pic 5 Desc.</b>	GAS of the US-221 road crossing.	<b>Pic 6 Desc.</b>	Streams S-Y7 and S-Y8 on the GAS of RO-287.

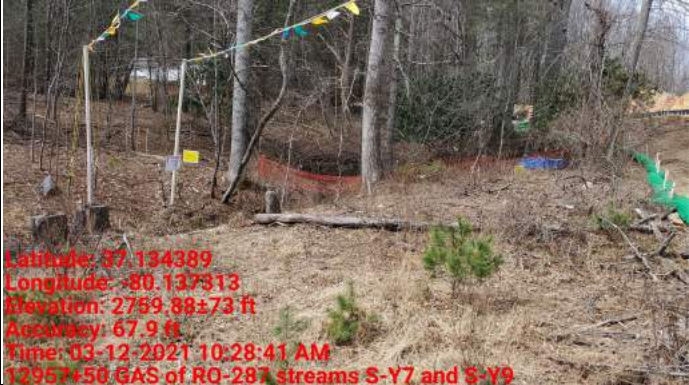
<p><b>Latitude:</b> 37.134389 <b>Longitude:</b> -80.137913 <b>Elevation:</b> 2759.88±73 ft <b>Accuracy:</b> 67.9 ft <b>Time:</b> 03-12-2021 10:28:41 AM <b>12957+50 GAS of RO-287 streams S-Y7 and S-Y9</b></p>

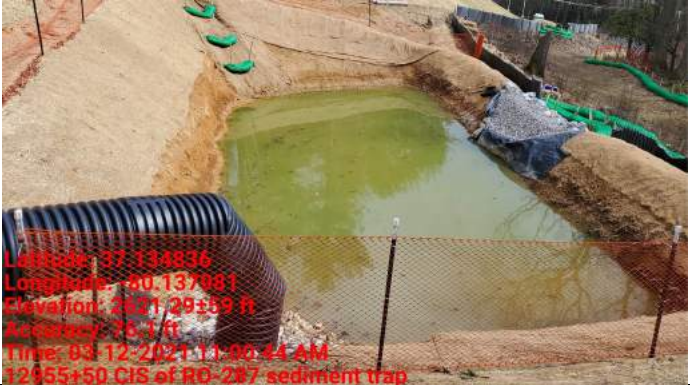
<p><b>Latitude:</b> 37.134836 <b>Longitude:</b> -80.137961 <b>Elevation:</b> 2827.29±59 ft <b>Accuracy:</b> 75.4 ft <b>Time:</b> 03-12-2021 11:00:44 AM <b>12955+50 CIS of RO-287 sediment trap</b></p>	
<b>GPS Location</b>	See pic for GPS location	<b>GPS Location</b>	See pic for GPS location
<b>Field Station#</b>	12957+50	<b>Field Station#</b>	12955+50
<b>Pic 7 Desc.</b>	Streams S-Y7 and S-Y9.	<b>Pic 8 Desc.</b>	Sediment trap on the CIS of RO-287.

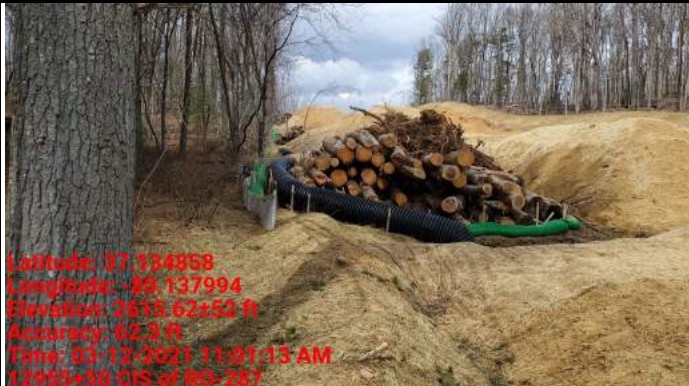
<p><b>Latitude:</b> 37.134858 <b>Longitude:</b> -80.137994 <b>Elevation:</b> 2615.62±52 ft <b>Accuracy:</b> 62.3 ft <b>Time:</b> 03-12-2021 11:21:33 AM <b>12955+50 CIS of RO-287</b></p>

<b>GPS Location</b>	See pic for GPS location	<b>GPS Location</b>	See pic for GPS location
<b>Field Station#</b>	12955+50	<b>Field Station#</b>	12957+50
<b>Pic 9 Desc.</b>	No maintenance issues or impacts observed in the area.	<b>Pic 10 Desc.</b>	Landowner's spring box at RO-287.

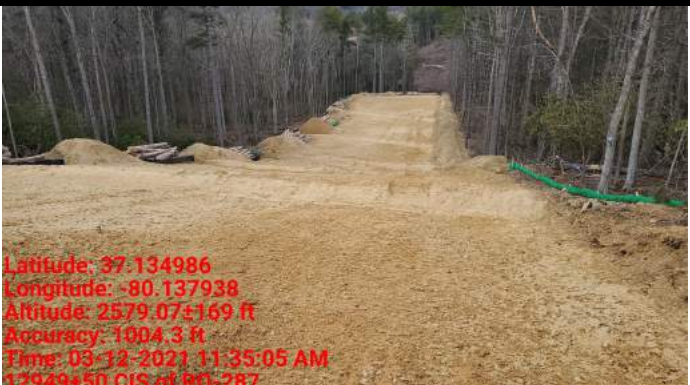
<p><b>Latitude:</b> 37.134986 <b>Longitude:</b> -80.137938 <b>Altitude:</b> 2579.07±169 ft <b>Accuracy:</b> 1004.3 ft <b>Time:</b> 03-12-2021 11:35:05 AM <b>12949+50 CIS of RO-287</b></p>	
<b>GPS Location</b>	See pic for GPS location	<b>GPS Location</b>	See pic for GPS location
<b>Field Station#</b>	12951+50	<b>Field Station#</b>	12949+50
<b>Pic 11 Desc.</b>	Current ROW conditions on the CIS of RO-287.	<b>Pic 12 Desc.</b>	Current ROW conditions on the GAS of stream S-IJ43.

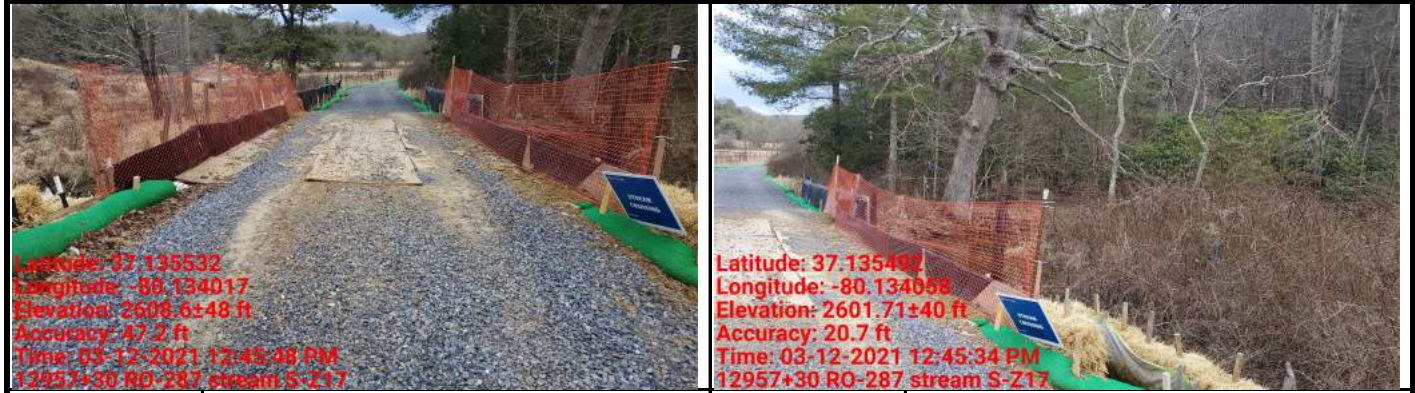
<b>GPS Location</b>	See pic for GPS location	<b>GPS Location</b>	See pic for GPS location
<b>Field Station#</b>	12957+30	<b>Field Station#</b>	12957+30
<b>Pic 13 Desc.</b>	Access road RO-287 at stream S-Z17.	<b>Pic 14 Desc.</b>	Access road RO-287 at stream S-Z17.

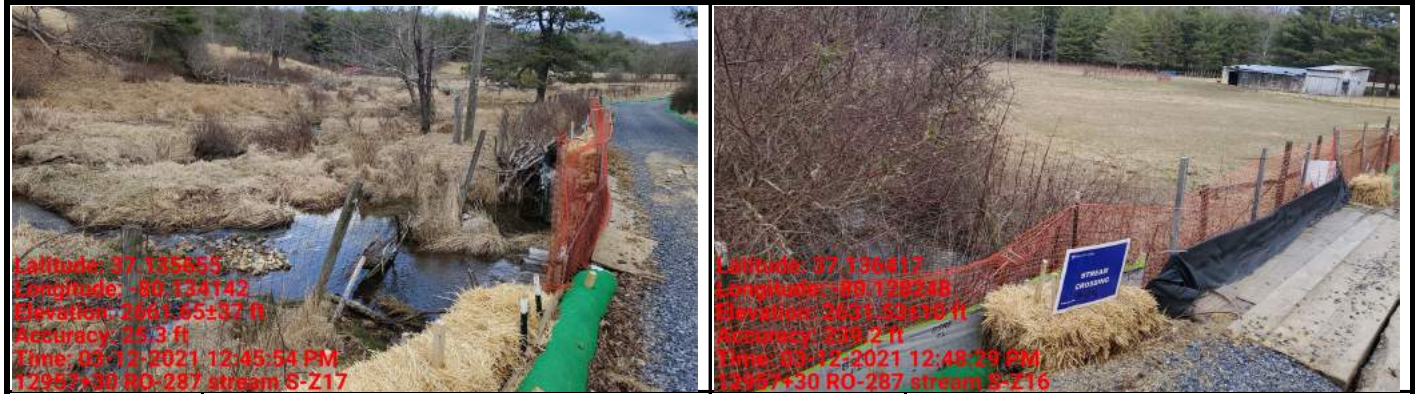
<b>GPS Location</b>	See pic for GPS location	<b>GPS Location</b>	See pic for GPS location
<b>Field Station#</b>	12957+30	<b>Field Station#</b>	12957+30
<b>Pic 15 Desc.</b>	Access road RO-287 at stream S-Z17.	<b>Pic 16 Desc.</b>	Access road RO-287 at stream S-Z16.

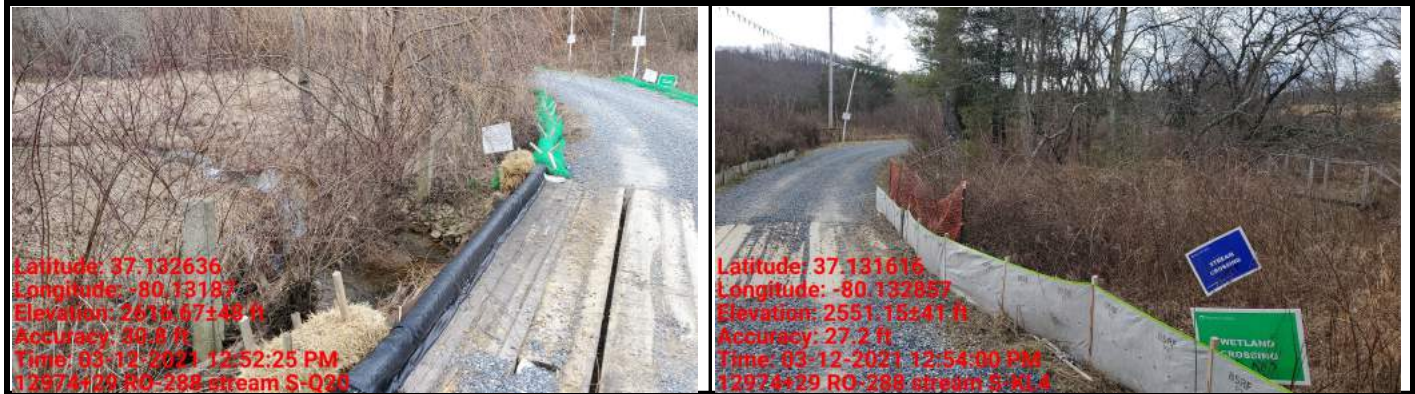
<b>GPS Location</b>	See pic for GPS location	<b>GPS Location</b>	See pic for GPS location
<b>Field Station#</b>	12974+29	<b>Field Station#</b>	12974+29
<b>Pic 17 Desc.</b>	Access road RO-288 at stream S-Q20	<b>Pic 18 Desc.</b>	Access road RO-288 at stream S-KL4.
