Visual Site Inspection Report

Project Name	H-600 Pipeline Spread H	AFE	124300138	Spread	H-600 Pipeline Spread H
Contractor	Precision			Report #	24568
Inspector	Jason Nielsen			Date/Time	6/14/2021 7:14 PM
Permit #	TBD	Inspection Type	VA SWPP	Station Begin	12284+75
State	VA	Inspection Area	Partial	Station End	12443+75
County	Montgomery	Ground	Damp	Temperature (°F)	87.00
Municipality	N/A	Weather	Sunny	Rain Gauge (in)	1.00
				Rain Accumulation Time (days)	1.00

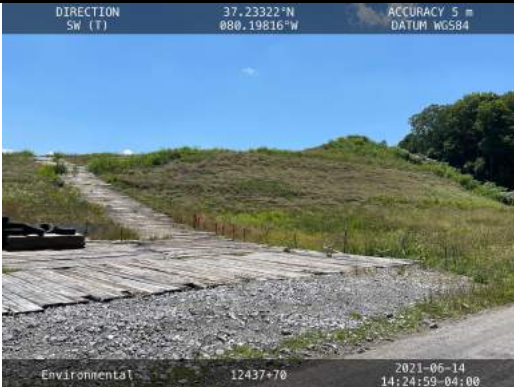
GPS Location	see photo		GPS Location	See photo	
Field Station#	12437+70		Field Station#	12435+50	
Pic 1 Desc.	Stabilized slope in acceptable condition		Pic 2 Desc.	Stream crossing S-NN16 in acceptable condition

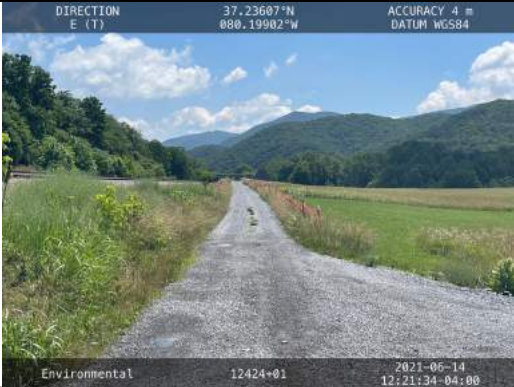
GPS Location	See photo		GPS Location	See photo	
Field Station#	12424+01		Field Station#	12421+00	
Pic 3 Desc.	Access Road MVP-MN-279 in acceptable condition		Pic 4 Desc.	Clean water crossing pipe inlet in acceptable condition

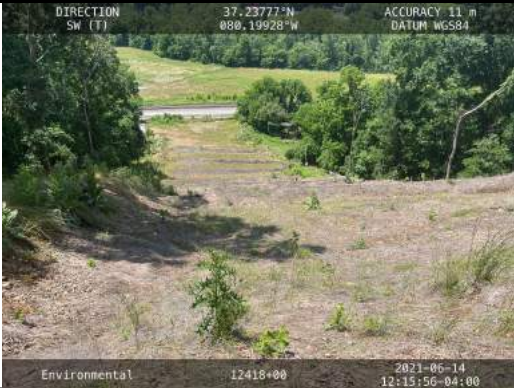
GPS Location	See photo		GPS Location	See photo	
Field Station#	12418+00		Field Station#	12410+20	
Pic 5 Desc.	Stabilized slope in acceptable condition		Pic 6 Desc.	Clean water crossing pipe outlet in acceptable condition

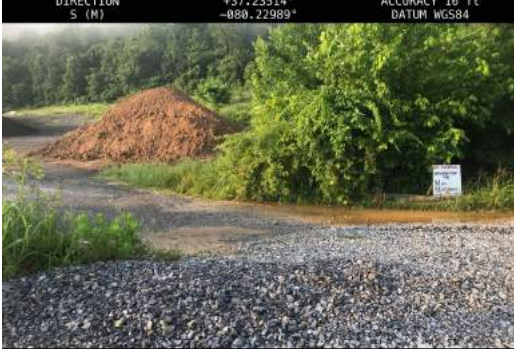
<p>DIRECTION S (M) +37.23514° -080.22989° ACCURACY 16 ft DATUM WGS84</p> <p>MVP-PY-006_061421 Status of spoil pile adjacent to LOD 2021-06-14 07:13:57-04:00</p>

<p>DIRECTION N (M) +37.23540° -080.22962° ACCURACY 16 ft DATUM WGS84</p> <p>MVP-PY-006_061421 Condition of trays & containment 2021-06-14 07:14:48-04:00</p>			
GPS Location	MVP-PY-006 See photo for gps data	GPS Location	MVP-PY-006 See photo for gps data		
Field Station#	+0	Field Station#	+0		
Pic 1 Desc.	Status of spoil pile adjacent to LOD on VDOT property. No impacts to west rock entrance. Looking S.	Pic 2 Desc.	Condition of trays and containment under toilets. Looking N.		
  <p>DIRECTION E (M) +37.23570° -080.22877° ACCURACY 16 ft DATUM WGS84</p> <p>MVP-PY-006_061421 Condition of signage & CFS at feature 2021-06-14 07:20:09-04:00</p>		  <p>DIRECTION SE (M) +37.23545° -080.22880° ACCURACY 16 ft DATUM WGS84</p> <p>MVP-PY-006_061421 Condition of containment 2021-06-14 07:20:40-04:00</p>

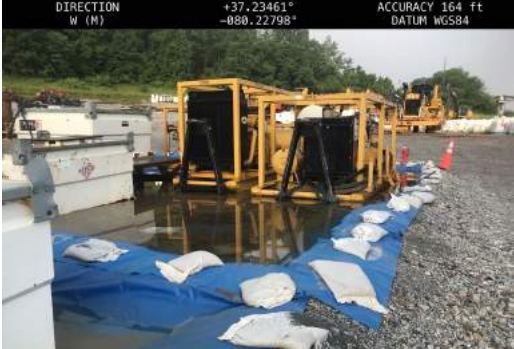
<p>DIRECTION W (M) +37.23461° -080.22798° ACCURACY 16 ft DATUM WGS84</p> <p>MVP-PY-006_061421 Condition of poly lined containments 2021-06-14 07:34:53-04:00</p>		  <p>DIRECTION E (M) +37.23413° -080.22706° ACCURACY 16 ft DATUM WGS84</p> <p>MVP-PY-006_061421 Condition of containment 2021-06-14 07:37:54-04:00</p>			
GPS Location	MVP-PY-006 See photo for gps data	GPS Location	MVP-PY-006 See photo for gps data		
Field Station#	+0	Field Station#	+0		
Pic 5 Desc.	Condition of poly lined rock berm containments. Holding stormwater. No sheen. Looking W.	Pic 6 Desc.	Condition of containment under hazardous waste dumpsters. Holding stormwater and sheen noted. Looking E.

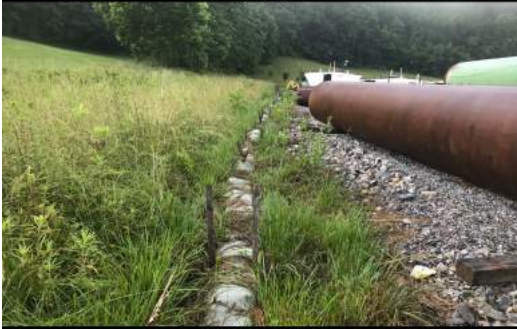
MVP-PY-006_061421 Condition of CFS along LOD 2021-06-14 07:40:14-04:00		MVP-PY-006_061421 Condition of CFS along LOD 2021-06-14 07:40:19-04:00			
GPS Location	MVP-PY-006 See photo for gps data		GPS Location	MVP-PY-006 See photo for gps data	
Field Station#	+0		Field Station#	+0	
Pic 7 Desc.	Condition of compost filter sock along east LOD. Looking SW.		Pic 8 Desc.	Condition of compost filter sock along east LOD. Looking N.	
DIRECTION W (M) +37.23567° -080.22679° ACCURACY 16 ft DATUM WGS84

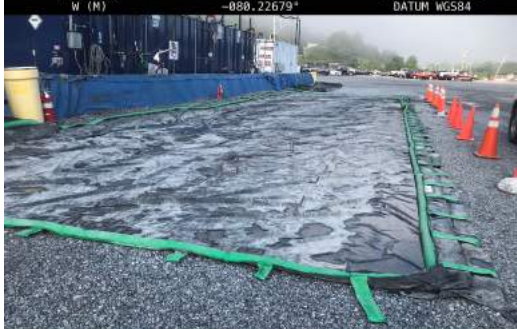
MVP-PY-006_061421 Secondary containment on site for tankers 2021-06-14 07:41:56-04:00		MVP-PY-006_061421 No leaky internal fittings 2021-06-14 07:42:52-04:00

GPS Location	MVP-PY-006 See photo for gps data		GPS Location	MVP-PY-006 See photo for gps data	
Field Station#	+0		Field Station#	+0	
Pic 9 Desc.	Secondary containment on site and in place for tankers offloading fuel. Looking W.		Pic 10 Desc.	Blue Bulk Fuel tanks no leaky internal fittings. Looking W.	
DIRECTION N (M) +37.23561° -080.22698° ACCURACY 98 ft DATUM WGS84

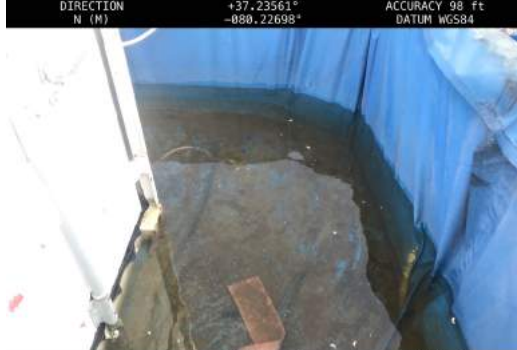
MVP-PY-006_061421 Condition of containment 2021-06-14 07:44:04-04:00		MVP-PY-006_061421 Condition of internal drip pan 2021-06-14 07:44:41-04:00			
GPS Location	MVP-PY-006 See photo for gps data		GPS Location	MVP-PY-006 See photo for gps data	
Field Station#	+0		Field Station#	+0	
Pic 11 Desc.	Off Road Fuel unit containment holding stormwater. A sheen was noted. Looking N.		Pic 12 Desc.	Off Road Fuel unit condition of internal drip pan. No fluids. Looking N.

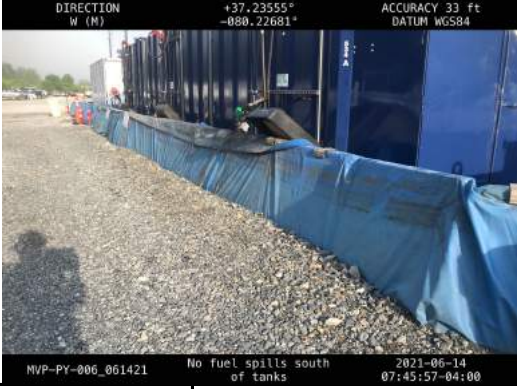
GPS Location	MVP-PY-006 See photo for gps data		GPS Location	MVP-PY-006 See photo for gps data	
Field Station#	+0		Field Station#	+0	
Pic 15 Desc.	Blue Bulk Fuel tanks no fuel spills south of the tanks. Looking W.		Pic 16 Desc.	No loose trash around dumpsters or in the yard. Looking S.

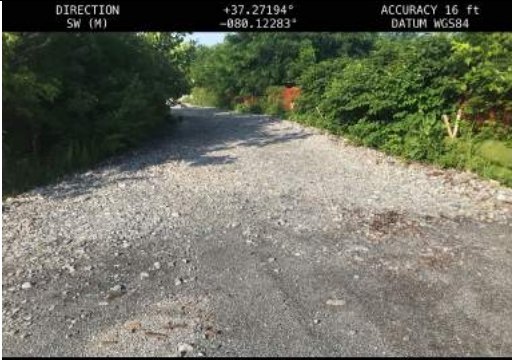
<p>DIRECTION SW (M) +37.27194° -080.12283° ACCURACY 16 ft DATUM WGS84</p> <p>MVP-LY-049_061421 Condition of rock entrance 2021-06-14 08:28:23-04:00</p>

<p>DIRECTION S (M) +37.27098° -080.12212° ACCURACY 16 ft DATUM WGS84</p> <p>MVP-LY-049_061421 Condition of containment 2021-06-14 08:30:25-04:00</p>			
GPS Location	MVP-LY-049 See photo for gps data		GPS Location	MVP-LY-049 See photo for gps data	
Field Station#	+0		Field Station#	+0	
Pic 1 Desc.	Condition of rock entrance on north drive. No sediment on stone. Looking SW.		Pic 2 Desc.	Condition of containment under light plant. Holding stormwater. Looking S.

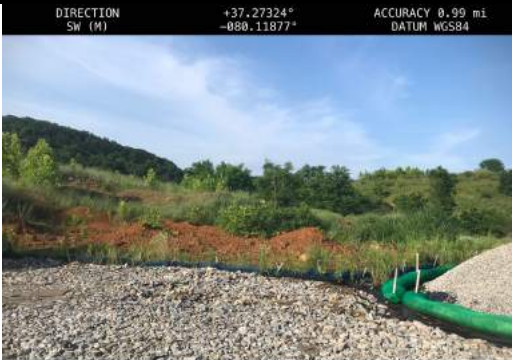
<p>DIRECTION SW (M) +37.27324° -080.11877° ACCURACY 0.99 mi DATUM WGS84</p> <p>MVP-LY-049_061421 Landowner disturbance along CFS 2021-06-14 08:31:49-04:00</p>

GPS Location	MVP-LY-049 See photo for gps data		GPS Location	MVP-LY-049 See photo for gps data	
Field Station#	+0		Field Station#	+0	
Pic 3 Desc.	Landowner soil disturbance along compost filter sock. No impacts to installed ECD's. Area not stabilized. Looking SW.		Pic 4 Desc.	Landowner soil disturbance along feature W-CV21A. Area not stabilized. Looking NW.

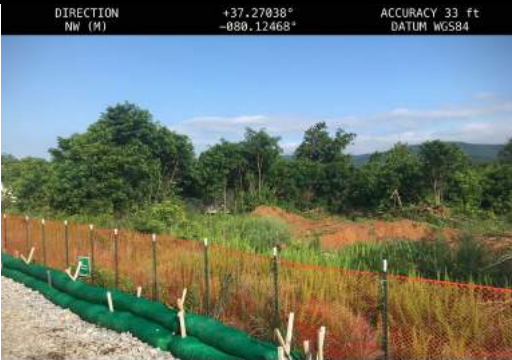
<p>DIRECTION NW (M) +37.27038° -080.12468° ACCURACY 33 ft DATUM WGS84</p> <p>MVP-LY-049_061421 Landowner disturbance along feature 2021-06-14 08:32:30-04:00</p>

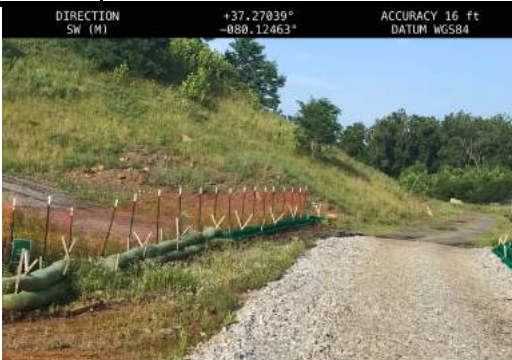
<p>DIRECTION SW (M) +37.27039° -080.12463° ACCURACY 16 ft DATUM WGS84</p> <p>MVP-LY-049_061421 Landowner disturbance within 66' of feature 2021-06-14 08:32:35-04:00</p>

<p>DIRECTION SW (M) +37.27039° -080.12463° ACCURACY 16 ft DATUM WGS84</p> <p>MVP-LY-049_061421 Landowner disturbance along CFS & feature 2021-06-14 08:32:40-04:00</p>			
GPS Location	MVP-LY-049 See photo for gps data		GPS Location	MVP-LY-049 See photo for gps data	
Field Station#	+0		Field Station#	+0	
Pic 5 Desc.	Landowner soil disturbance within 66' and 120' west of feature W-CV21B. Areas not stabilized. Looking SW.		Pic 6 Desc.	Landowner soil disturbance along compost filter sock and feature W-CV21B. Area not stabilized. Looking SW.

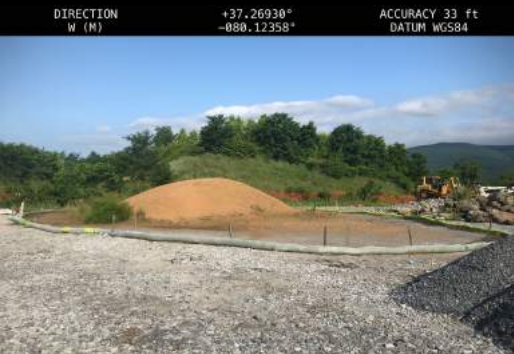
GPS Location	MVP-LY-049 See photo for gps data		GPS Location	MVP-LY-049 See photo for gps data	
Field Station#	+0		Field Station#	+0	
Pic 9 Desc.	Condition of temporary trash transfer pit. Most debris has been removed. Looking SW.		Pic 10 Desc.	Condition of of compost filter sock around sand pile. In place and functioning. Looking W.

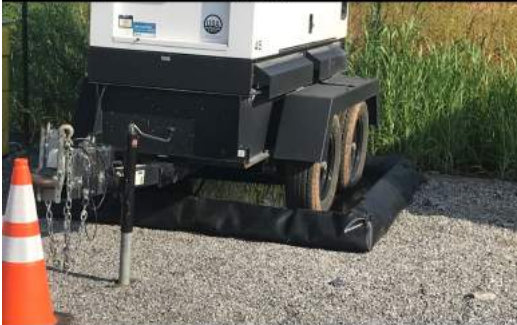
MVP-LY-049_061421 Condition of containment 2021-06-14 08:40:34-04:00			
GPS Location	MVP-LY-049 See photo for gps data		GPS Location	MVP-LY-049 See photo for gps data	
Field Station#	+0		Field Station#	+0	
Pic 13 Desc.	Condition of containment under generator. Holding stormwater. Looking NW.		Pic 14 Desc.	Condition of containment under barrel of toilet chemical. Hold some fluid. Looking SE.	
DIRECTION SW (M) +37.27071° -080.12005° ACCURACY 16 ft DATUM WGS84

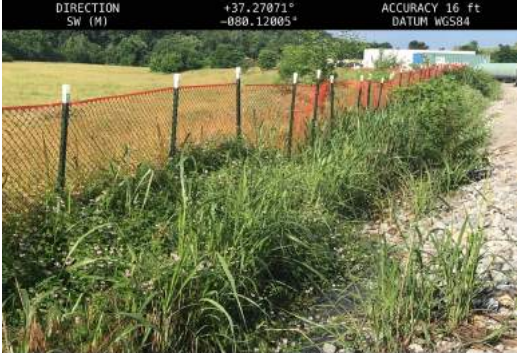
MVP-LY-049_061421 Condition of CFS & safety fence 2021-06-14 08:50:30-04:00		DIRECTION W (M) +37.27053° -080.12239° ACCURACY 98 ft DATUM WGS84

GPS Location	MVP-LY-049 See photo for gps data		GPS Location	MVP-LY-049 See photo for gps data	
Field Station#	+0		Field Station#	+0	
Pic 15 Desc.	Condition of compost filter sock and safety fence along south LOD. Over grown with vegetation. Looking SW.		Pic 16 Desc.	No deposits or fluids around hazardous waste dumpsters. Ten rubber tarp straps broken or missing. Looking W.	
DIRECTION S (M) +37.27013° -080.12266° ACCURACY 16 ft DATUM WGS84

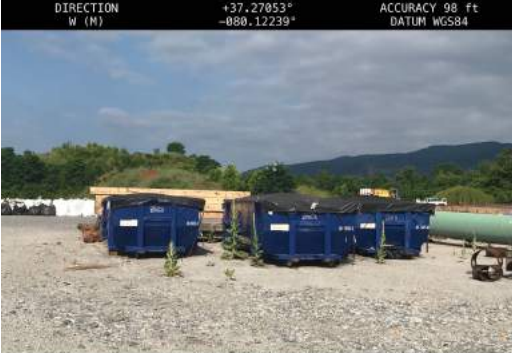
MVP-LY-049_061421 No fluids around hazardous waste dump... 2021-06-14 08:53:50-04:00

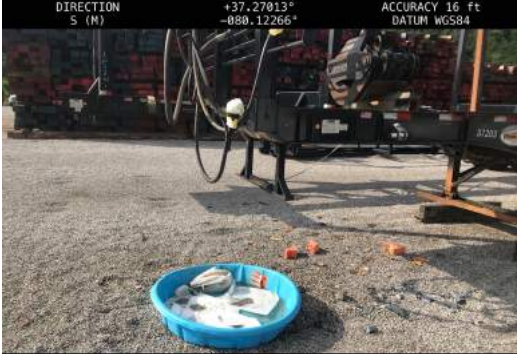
MVP-LY-049_061421 Containment under stored trailer 2021-06-14 08:54:31-04:00		DIRECTION N (M) +37.27019° -080.12266° ACCURACY 16 ft DATUM WGS84

MVP-LY-049_061421 Containment under stored vehicle 2021-06-14 08:54:41-04:00			
GPS Location	MVP-LY-049 See photo for gps data		GPS Location	MVP-LY-049 See photo for gps data	
Field Station#	+0		Field Station#	+0	
Pic 17 Desc.	Condition of containment under stored trailer. Looking S.		Pic 18 Desc.	Condition of containment under stored vehicle. Looking N.

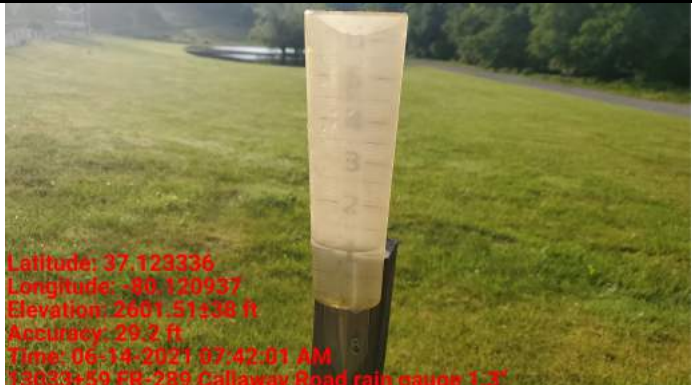
<p>Latitude: 37.123336 Longitude: -80.120937 Elevation: 2601.51±38 ft Accuracy: 29.2 ft Time: 06-14-2021 07:42:01 AM 13033+59 FR-289 Callaway Road rain gauge 1.3"</p>

<p>Latitude: 37.12546 Longitude: -80.121011 Elevation: 2598.98±58 ft Accuracy: 47.6 ft Time: 06-14-2021 09:17:06 AM 13026+00 CIS of FR-289 streams S-G24 and S-G25</p>		
GPS Location	See pic for GPS location		GPS Location	See pic for GPS location	
Field Station#	13033+59		Field Station#	13026+00	
Pic 1 Desc.	1.3" total precipitation at Callaway Road.		Pic 2 Desc.	Streams S-G24 and S-G25 on the GAS of the BRP.

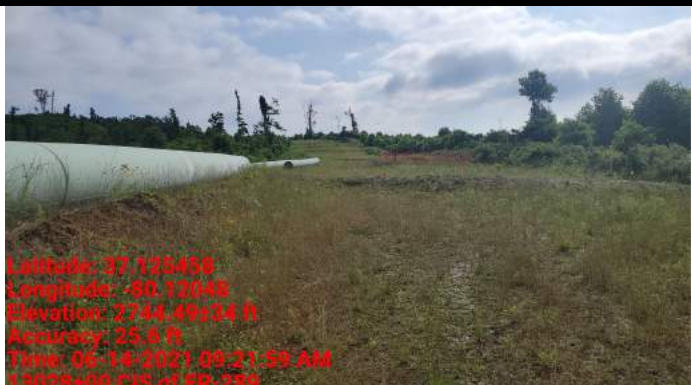
<p>Latitude: 37.125458 Longitude: -80.12048 Elevation: 2744.49±34 ft Accuracy: 25.6 ft Time: 06-14-2021 09:21:59 AM 13028+00 CIS of FR-289</p>

GPS Location	See pic for GPS location		GPS Location	See pic for GPS location	
Field Station#	13028+00		Field Station#	13041+00	
Pic 3 Desc.	Current ROW conditions on the CIS of FR-289.		Pic 4 Desc.	Stream crossing S-H1 from the CIS.

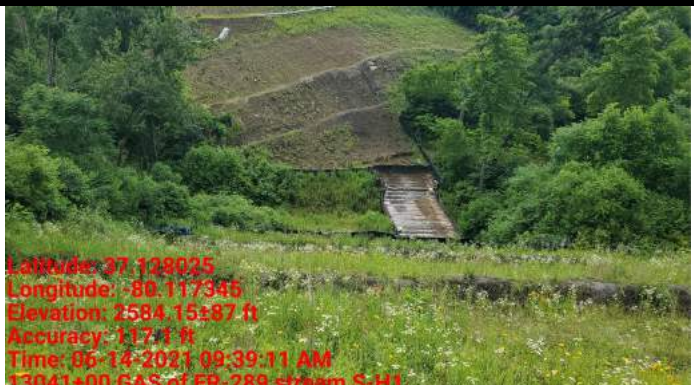
<p>Latitude: 37.129025 Longitude: -80.117345 Elevation: 2584.15±87 ft Accuracy: 117.1 ft Time: 06-14-2021 09:39:11 AM 13041+00 GAS of FR-289 stream S-H1</p>

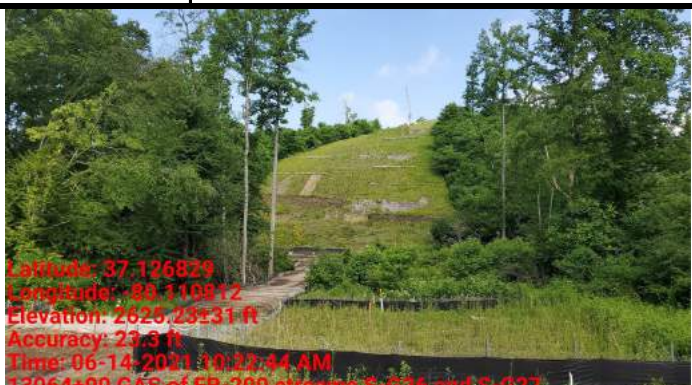
<p>Latitude: 37.126829 Longitude: -80.110812 Elevation: 2626.23±31 ft Accuracy: 23.3 ft Time: 06-14-2021 10:22:44 AM 13064+00 GAS of FR-290 streams S-G26 and S-G27</p>

<p>Latitude: 37.127129 Longitude: -80.112136 Elevation: 2581.23±81 ft Accuracy: 57.4 ft Time: 06-14-2021 10:15:35 AM 13060+00 CIS of FR-290 streams S-G26 and S-G27</p>		
GPS Location	See pic for GPS location		GPS Location	See pic for GPS location	
Field Station#	13064+00		Field Station#	13060+00	
Pic 5 Desc.	Streams S-G26 and S-G27 from the GAS.		Pic 6 Desc.	Streams S-G26 and S-G27 from the CIS.

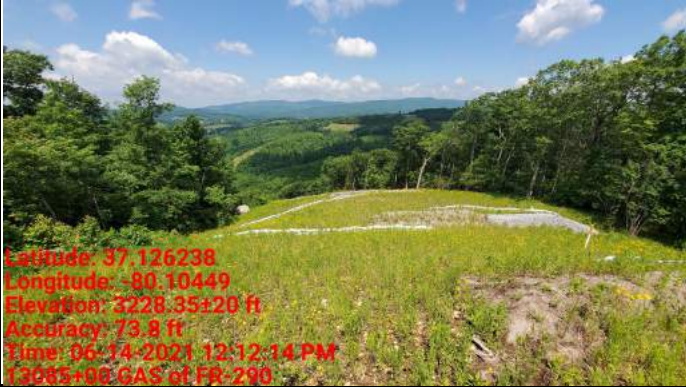
GPS Location	See pic for GPS location		GPS Location	See pic for GPS location	
Field Station#	13085+00		Field Station#	13090+00	
Pic 7 Desc.	Current ROW conditions on the GAS of FR-290.		Pic 8 Desc.	Current ROW conditions on the CIS of FR-291.

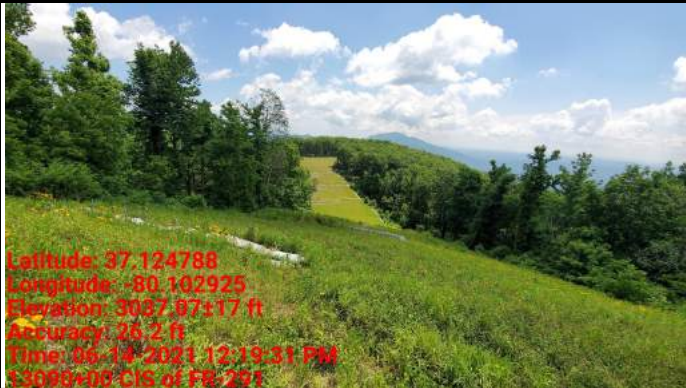
GPS Location	See pic for GPS location		GPS Location	See pic for GPS location	
Field Station#	13090+00		Field Station#	13096+00	
Pic 9 Desc.	Current ROW conditions on the CIS of FR-291.		Pic 10 Desc.	Current ROW conditions on the CIS of FR-291.

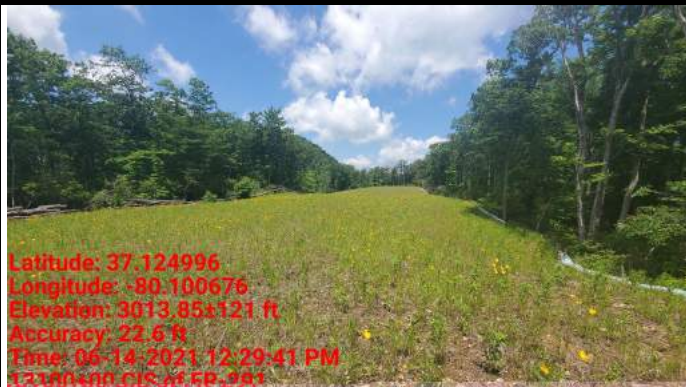
GPS Location	See pic for GPS location		GPS Location	See pic for GPS location	
Field Station#	13100+00		Field Station#	13101+00	
Pic 11 Desc.	Current ROW conditions on the CIS of FR-291.		Pic 12 Desc.	Current ROW conditions on the CIS of FR-291.

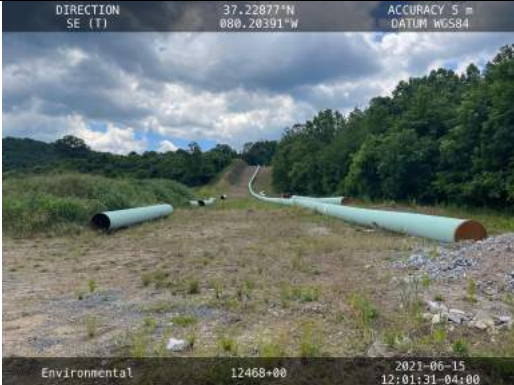
GPS Location	See photo		GPS Location	See photo	
Field Station#	12468+00		Field Station#	12485+00	
Pic 1 Desc.	Stabilized ROW in acceptable condition		Pic 2 Desc.	Stabilized slope in acceptable condition

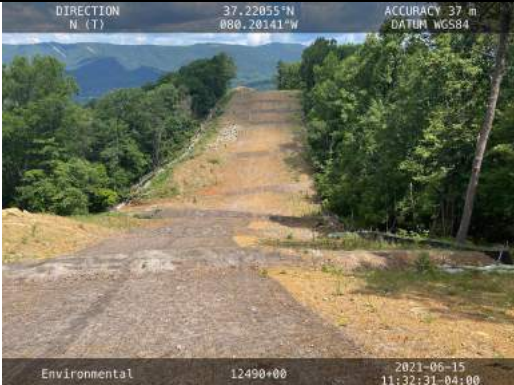
GPS Location	See photo		GPS Location	See photo	
Field Station#	12490+00		Field Station#	12506+00	
Pic 3 Desc.	Stabilized ROW in acceptable condition		Pic 4 Desc.	Stabilized slope in acceptable condition

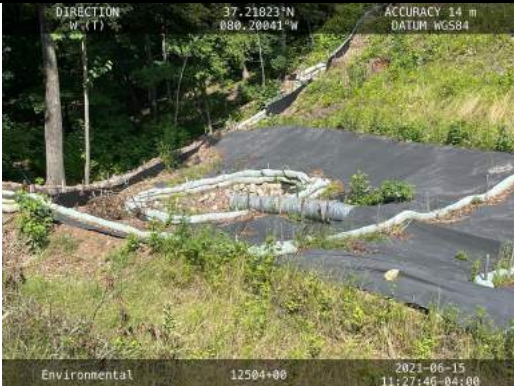
GPS Location	See photo		GPS Location	See photo	
Field Station#	12504+00		Field Station#	12521+00	
Pic 5 Desc.	Clean water crossing pipe outlet in acceptable condition		Pic 6 Desc.	Stabilized slope in acceptable condition on the GAS of S-EF19

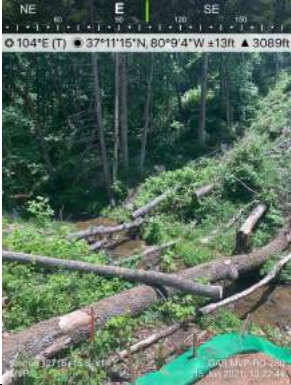
GPS Location	See photo	GPS Location	See photo		
Field Station#	12716+15	Field Station#	12718+00		
Pic 7 Desc.	S-Y14 Stream flowing free and clear of sediment	Pic 8 Desc.	Stockpiles well stabilized and ECDs in place and in compliance

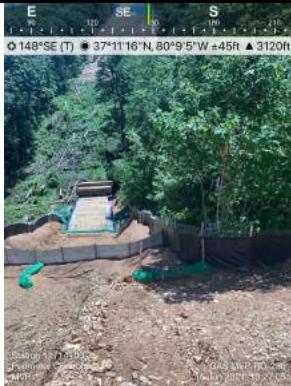
GPS Location	See photo	GPS Location			
Field Station#	12714+00	Field Station#			
Pic 9 Desc.	CIS of S-Y13 Perimeter controls in place and in compliance	Pic 10 Desc.

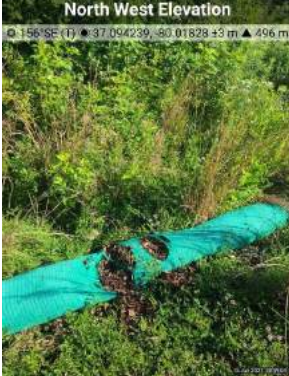
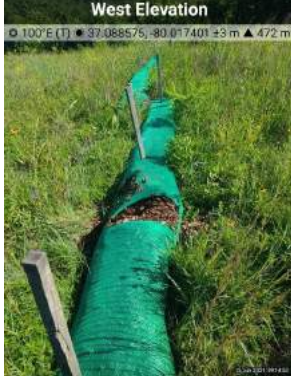
GPS Location	00000	GPS Location	0000		
Field Station#	13437+75	Field Station#	13450+00		
Pic 1 Desc.	CFS requires maintenance due to wildlife damage. Documented and added to the punch list.		Pic 2 Desc.	CFS requires maintenance due to wildlife damage. Documented and added to the punch list.	
	North Elevation  			North West Elevation

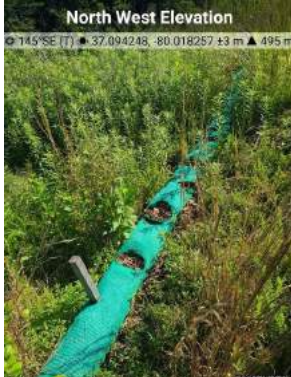
GPS Location	0000	GPS Location	00000		
Field Station#	13450+30	Field Station#	13437+75		
Pic 3 Desc.	CFS requires maintenance due to wildlife damage. Documented and added to the punch list.		Pic 4 Desc.	CFS requires maintenance due to wildlife damage. Documented and added to the punch list.	
	West Elevation  			North Elevation

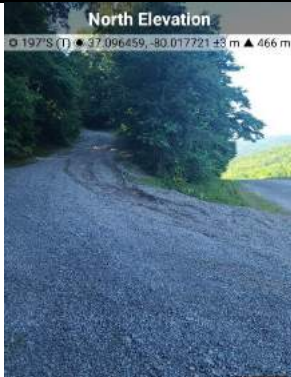
GPS Location	00000	GPS Location	0000		
Field Station#	13437+75	Field Station#	13437+75		
Pic 5 Desc.	Contractor repairing access rd .		Pic 6 Desc.	Access rd MVP-FR-293.02 requires maintenance due to washing during heavy rain events. Documented and added to the punch list.

E&S BMPs	Compliance Level	Corrective Action	Corrective Time Frame	Date Repaired
Rock Construction Entrance	Communication	Contractor repaired access rd with a	Addressed	6/15/2021
Compost Filter Sock	Communication			
Equipment Bridge	Acceptable			
Vegetative Stabilization (Permanent)	Acceptable

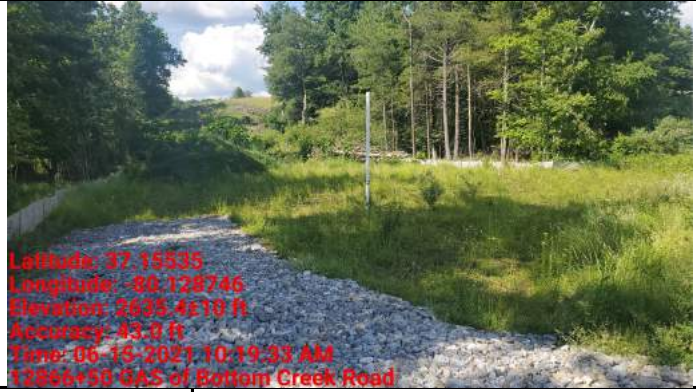
<p>Latitude: 37.15535 Longitude: -80.128746 Elevation: 2635.4±10 ft Accuracy: 43.0 ft Time: 06-15-2021 10:19:33 AM 12866+50 GAS of Bottom Creek Road</p>

<p>Latitude: 37.155277 Longitude: -80.12898 Elevation: 2633.2±10 ft Accuracy: 39.0 ft Time: 06-15-2021 10:28:19 AM 12866+00 CIS of Bottom Creek Road</p>			
GPS Location	See pic for GPS location		GPS Location	See pic for GPS location	
Field Station#	12866+50		Field Station#	12866+00	
Pic 1 Desc.	Current ROW conditions on the GAS of Bottom Creek Road.		Pic 2 Desc.	Current ROW conditions on the CIS of Bottom Creek Road.

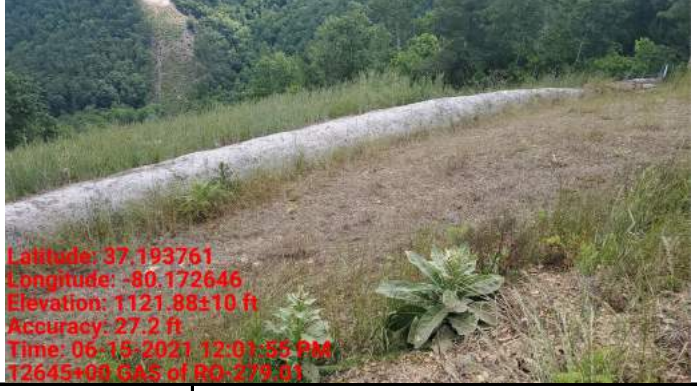
<p>Latitude: 37.193761 Longitude: -80.172646 Elevation: 1121.88±10 ft Accuracy: 27.2 ft Time: 06-15-2021 12:01:35 PM 12645+00 GAS of RO-279.01</p>			
GPS Location	See pic for GPS location		GPS Location	See pic for GPS location	
Field Station#	12645+00		Field Station#	12645+00	
Pic 5 Desc.	View of the CIS of Honeysuckle from the GAS of RO-279.01.		Pic 6 Desc.	Waterbars, sumps and end treatments remain in compliance throughout the area.

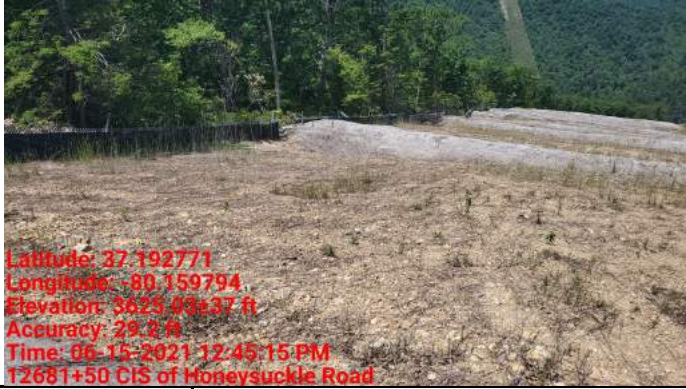
<p>Latitude: 37.192771 Longitude: -80.159794 Elevation: 3625.03137 ft Accuracy: 29.8 ft Time: 06-15-2021 12:45:15 PM 12681+50 CIS of Honeysuckle Road</p>

GPS Location	See pic for GPS location		GPS Location	See pic for GPS location	
Field Station#	12681+50		Field Station#	12701+00	
Pic 9 Desc.	Waterbars, sumps and end treatments remain in compliance throughout the area.		Pic 10 Desc.	Current ROW conditions on the CIS of RO-280, GAS of Honeysuckle Road.

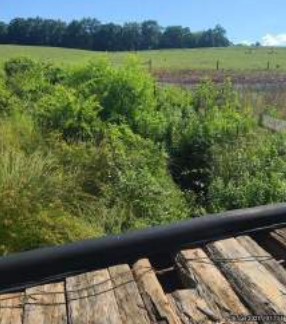
GPS Location	0000	GPS Location	0000		
Field Station#	13666+27	Field Station#	13666+27		
Pic 1 Desc.	Stream observation photo facing upstream during routine inspection today. No issues observed at the time of inspection.		Pic 2 Desc.	Stream observation photo facing downstream during routine inspection today. No issues observed at the time of inspection.	
	North West Elevation <small>165°SE (T) 37.090295, -79.96393 ±3 m 333 m</small>

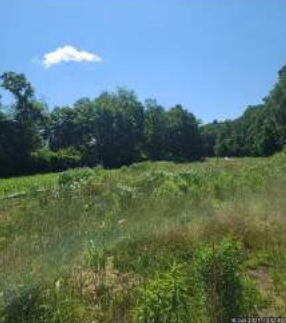
GPS Location	00000	GPS Location	00000		
Field Station#	13634+43	Field Station#	13666+20		
Pic 3 Desc.	Vegetation observation photo facing down row. Good coverage noted.		Pic 4 Desc.	Monitored equipment bridge and protection while monitoring row conditions. No environmental issues observed at the time of inspection.

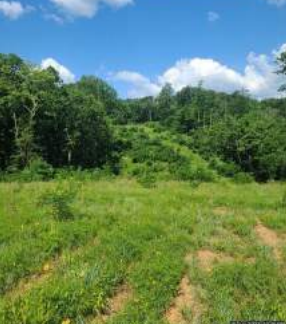
GPS Location	0000	GPS Location	0000		
Field Station#	13620+00	Field Station#	13589+10		
Pic 5 Desc.	Row photo showing vegetation during routine inspection today.		Pic 6 Desc.	Row photo showing vegetation, good grass coverage with photo showing locusts trees on row.

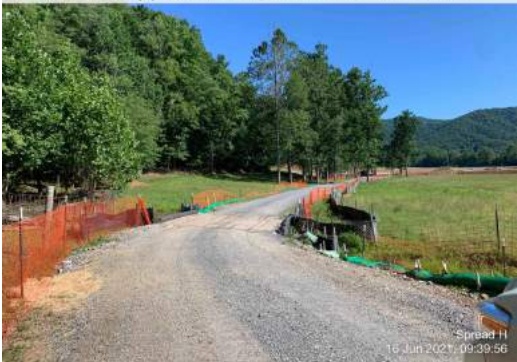
AFE	124300138	Date/Time	6/16/2021 12:51 PM	Report #	
Pictures					
GPS Location	See Photograph	GPS Location	See Photograph		
Field Station#	292+00	Field Station#	13140+00		
Pic 1 Desc.	The access road 292.00 is in acceptable condition.	Pic 2 Desc.	The ROW is well vegetated and all areas used for access have perimeter controls installed.		
GPS Location	See Photograph	GPS Location	See Photograph		
Field Station#	13160+00	Field Station#	13162+00		
Pic 3 Desc.	Resource S-D11 is protected by perimeter controls and established vegetation.	Pic 4 Desc.	Flume pipes are in acceptable condition.		
GPS Location	See Photograph	GPS Location	See Photograph		
Field Station#	13173+00	Field Station#	13185+84		
Pic 5 Desc.	The active ROW is stabilized with straw and seeding was ongoing during the inspection.	Pic 6 Desc.	Precision crews were actively conducting remediation activities.

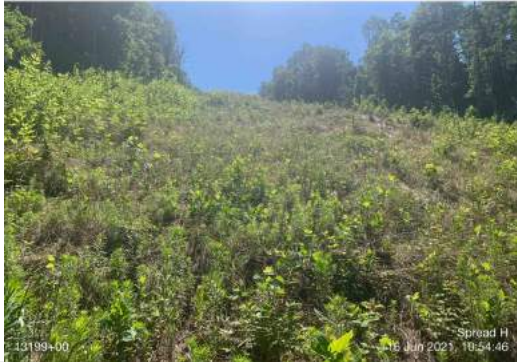
GPS Location	See photograph		GPS Location	See Photograph	
Field Station#	292+00		Field Station#	13199+00	
Pic 7 Desc.	Access Road is in acceptable condition.		Pic 8 Desc.	ROW area is active and stabilized with straw.	
97°E (T) 37°7'22"N, 80°4'26"W ±13ft ▲ 1510ft

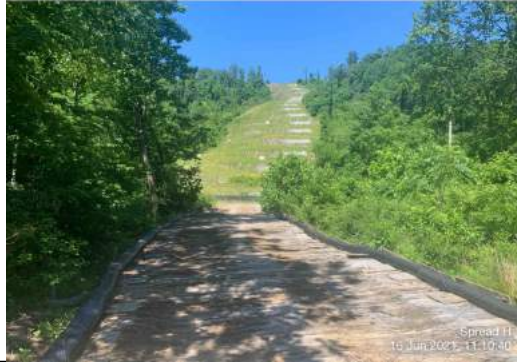
190°S (T) 37°7'22"N, 80°4'26"W ±13ft ▲ 1518ft  			
GPS Location	See Photograph		GPS Location	See Photograph	
Field Station#	13204+00		Field Station#	13204+00	
Pic 9 Desc.	ROW is well vegetated with permanent vegetation.		Pic 10 Desc.	Waterbar is stable and functional.	
263°W (T) 37°6'56"N, 80°3'36"W ±13ft ▲ 1454ft

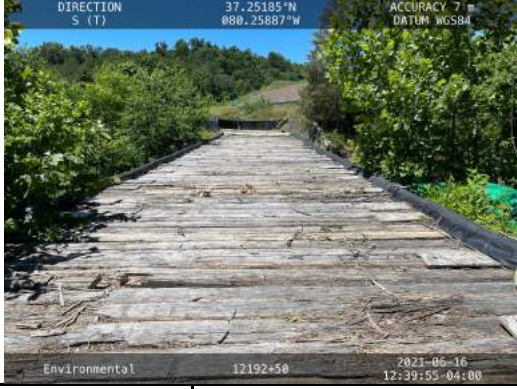
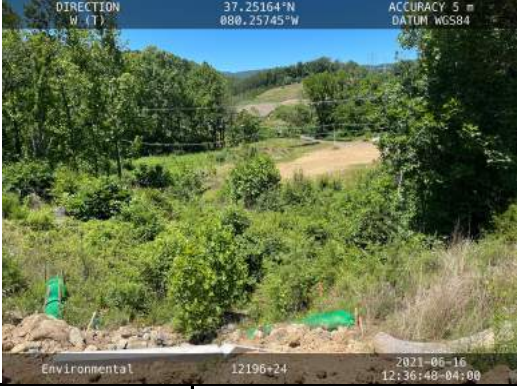
GPS Location	See photo		GPS Location	See photo	
Field Station#	12192+50		Field Station#	12196+24	
Pic 9 Desc.	Bridge and ECDs crossing stream S-C21 in acceptable condition		Pic 10 Desc.	Stream crossing S-OO11 on the west side of the road in acceptable condition

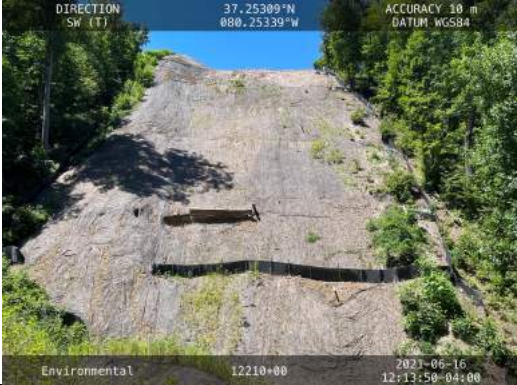
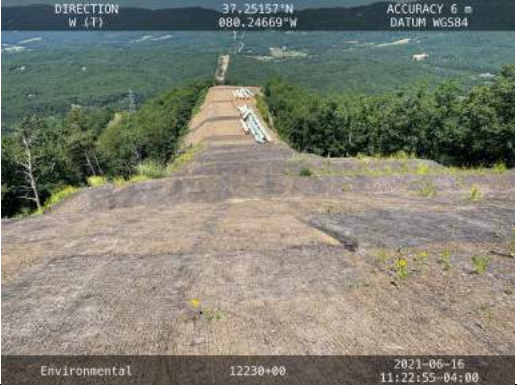
GPS Location	See photo		GPS Location	See photo	
Field Station#	12210+00		Field Station#	12230+00	
Pic 13 Desc.	Stabilized slope in acceptable condition		Pic 14 Desc.	Stabilized ROW in acceptable condition

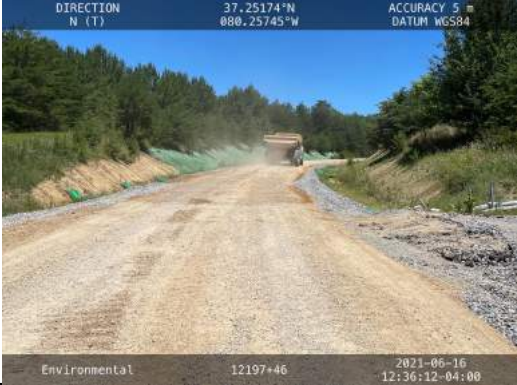
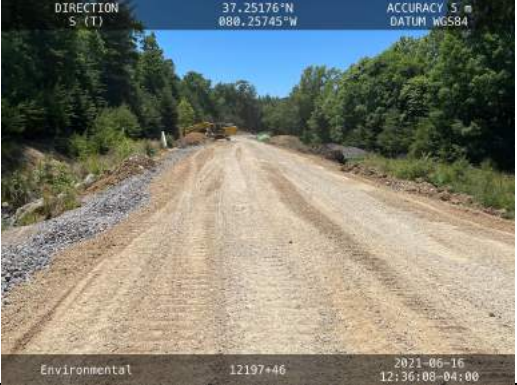
GPS Location	See photo		GPS Location	See photo	
Field Station#	12197+46		Field Station#	12197+46	
Pic 15 Desc.	Non projects related work hauling dirt along the newly converted road.		Pic 16 Desc.	Non project related excavator digging out additional culvert ends that drain into Bradshaw creek.

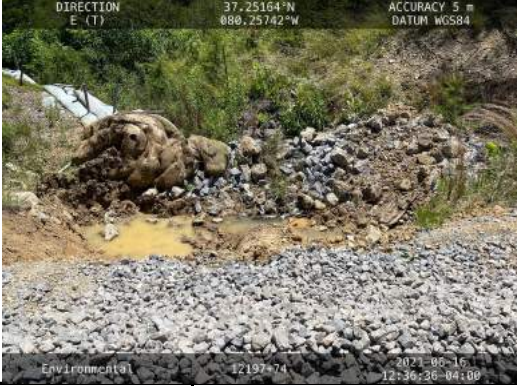
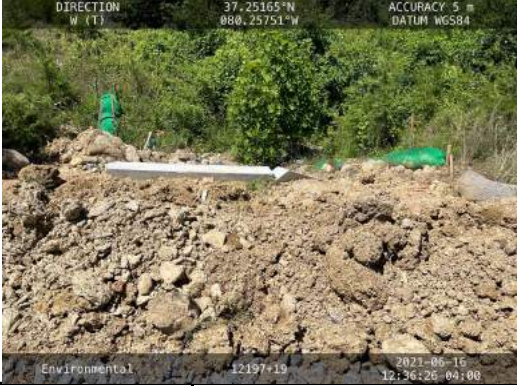
7. Identify all remedial measures that have been taken since the previous inspection was conducted.					
Comments (Reference above questions as appropriate.)					
<p>A SWPPP inspection was performed today between Flatwoods Road and the right-of-way(ROW) crossing on access road MVP-MN-276.03 on Reese Mountain, stations 12119+17 to 12284+75. Included in today's inspection were streams S-C33, S-C36, S-MM31, S-C29, S-C25, S-C24, S-C21, and S-OO11. No impacts were observed at any of these streams or their corresponding buffer zones. All erosion control devices (ECDS) were in acceptable condition. The ROW remains stable throughout the inspected area with no signs of erosion. There was no PPL activity being performed in the inspected area.</p> <p>Within the inspected area at STA#12197+46 there is a non project related contractor that is continuing with converting the rail road tracks into a road. The contractor has removed ECDs places by PPL that was for protection of S-OO11 and the culvert going underneath the railroad. The contractor has also dug out the ends of the culvert to install concrete culvert ends, this disturbance is within the S-OO11 boundaries and stream bank.</p>

GPS Location	See photo		GPS Location	See photo	
Field Station#	12197+74		Field Station#	12197+19	
Pic 17 Desc.	Up stream end of the S-0011 culvert dug out and ECDs removed to install concrete culvert ends by non project related contractor		Pic 18 Desc.	Down stream end of culvert in S-0011 concrete end installed and disturbance not stabilized by Non project related contractor.

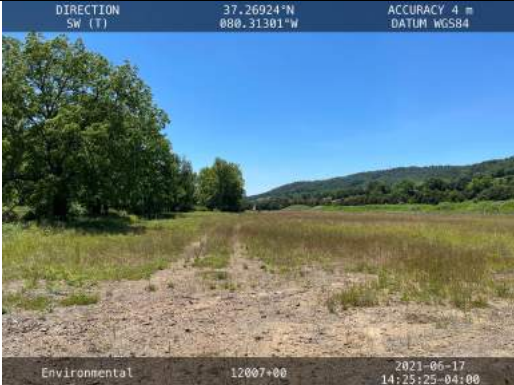
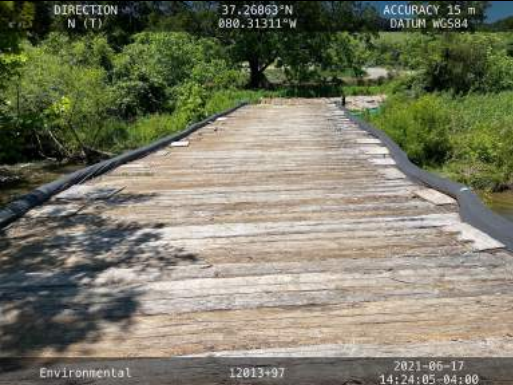
GPS Location	See photo		GPS Location	See photo	
Field Station#	12007+00		Field Station#	12013+97	
Pic 1 Desc.	Stabilized ROW in acceptable condition		Pic 2 Desc.	Bridge and ECDs at stream crossing S-G36 in acceptable condition

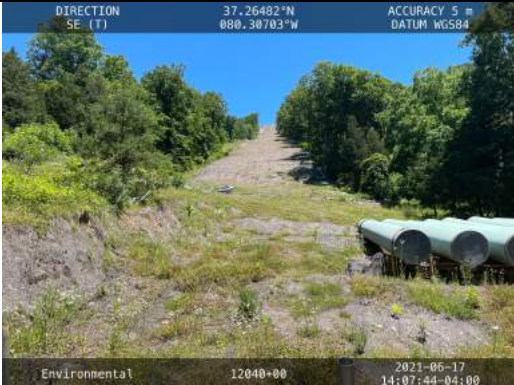
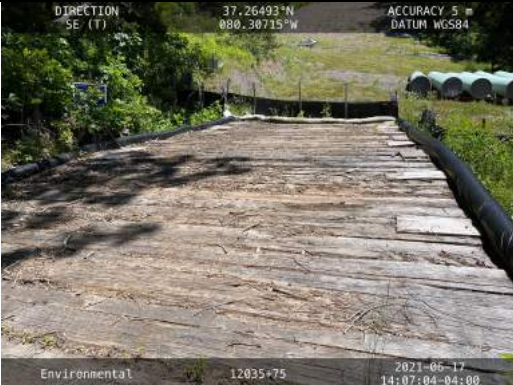
GPS Location	See photo		GPS Location	See photo	
Field Station#	12040+00		Field Station#	12035+75	
Pic 3 Desc.	Stabilized ROW in acceptable condition		Pic 4 Desc.	Bridge and ECDs at stream crossing S-PP23 in acceptable condition

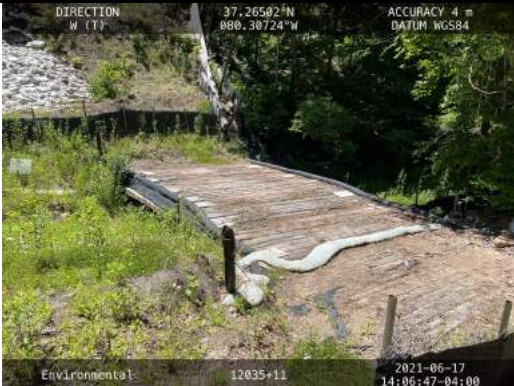
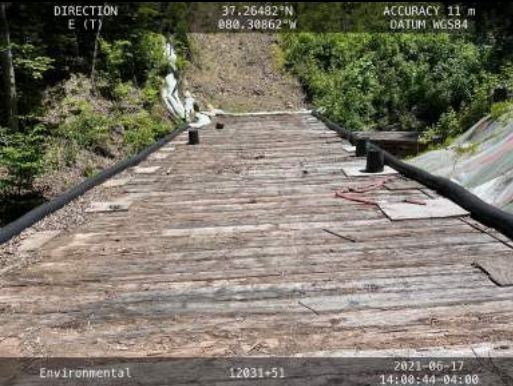
GPS Location	See photo		GPS Location	See photo	
Field Station#	12035+11		Field Station#	12031+51	
Pic 5 Desc.	Bridge and ECDs at stream crossing S-G40 in acceptable condition		Pic 6 Desc.	Bridge and ECDs crossing stream S-G39 in acceptable condition

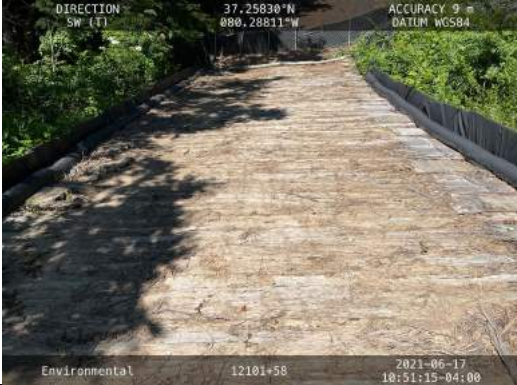
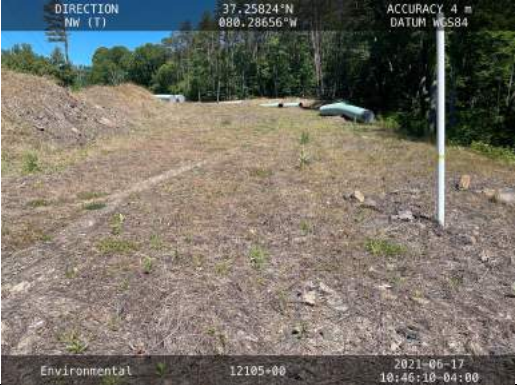
GPS Location	See photo		GPS Location	See photo	
Field Station#	12101+58		Field Station#	12105+00	
Pic 13 Desc.	Bridge and ECDs at stream crossing S-MM11 in acceptable condition		Pic 14 Desc.	Stabilized ROW in acceptable condition

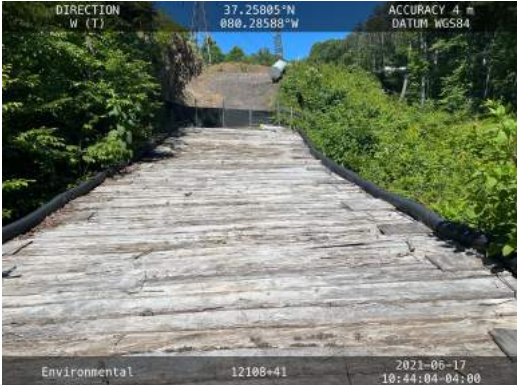
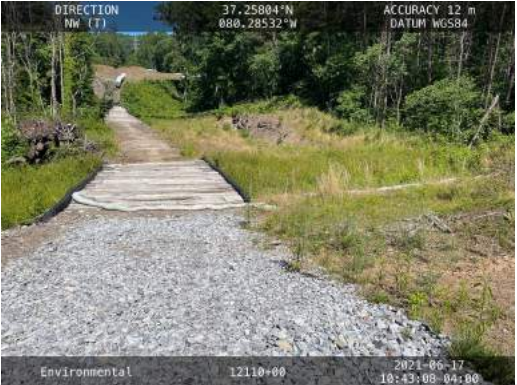
GPS Location	See photo		GPS Location	See photo	
Field Station#	12108+41		Field Station#	12110+00	
Pic 15 Desc.	Bridge and ECDs at stream crossing S-F15 in acceptable condition		Pic 16 Desc.	Clean water crossing in acceptable condition

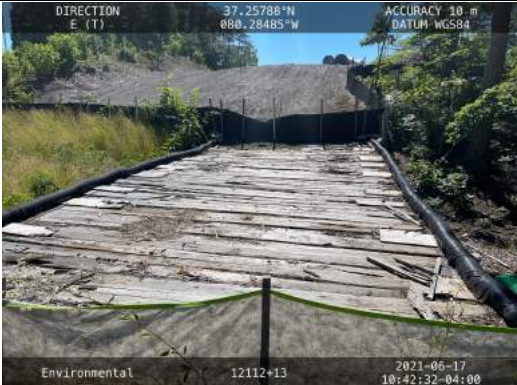
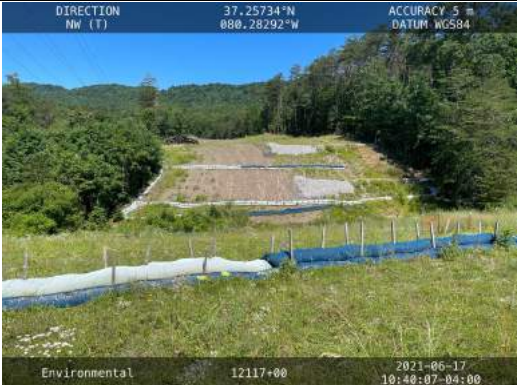
GPS Location	See photo		GPS Location	See photo	
Field Station#	12112+13		Field Station#	12117+00	
Pic 17 Desc.	Bridge and ECDs at stream crossing S-F16A/B in acceptable condition		Pic 18 Desc.	Stabilized ROW in acceptable condition

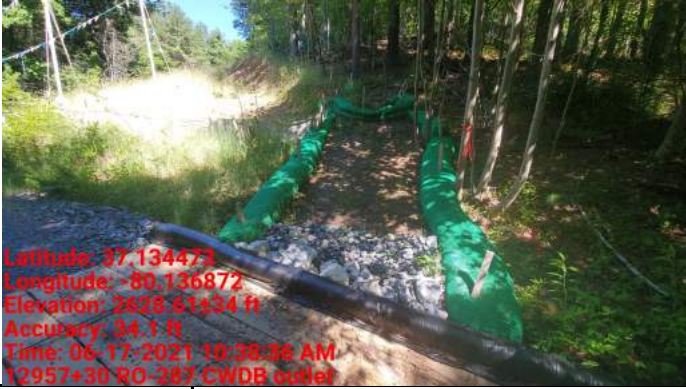
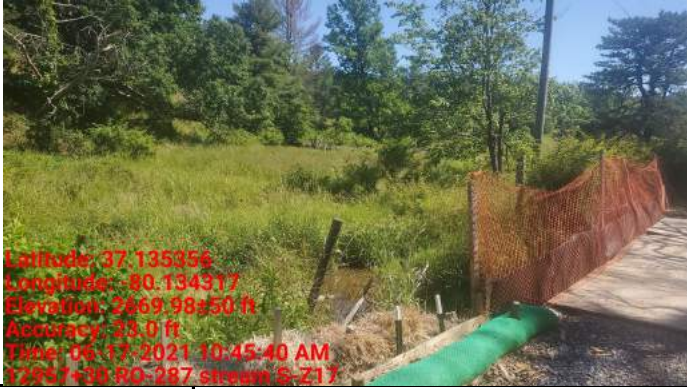
<p>Latitude: 37.135356 Longitude: -80.134317 Elevation: 2869.98±50 ft Accuracy: 33.0 ft Time: 06-17-2021 10:45:40 AM 12957+30 RO-287 stream S-Z17</p>			
GPS Location	See pic for GPS location		GPS Location	See pic for GPS location	
Field Station#	12957+30		Field Station#	12957+30	
Pic 7 Desc.	CWDB outlet at RO-287.		Pic 8 Desc.	Stream S-Z17 at RO-287.

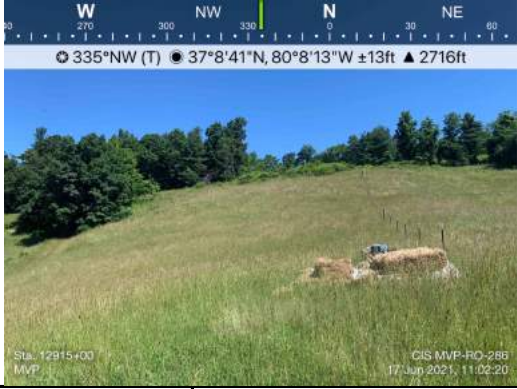
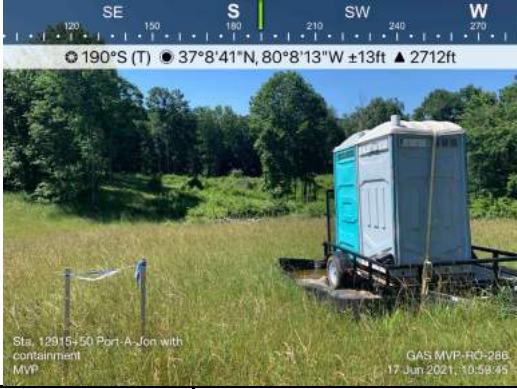
Field Station#	12915+00		Field Station#	12915+00	
Pic 9 Desc.	Undisturbed ROW at RO-286.		Pic 10 Desc.	Porta-Johns in containment at RO-286.

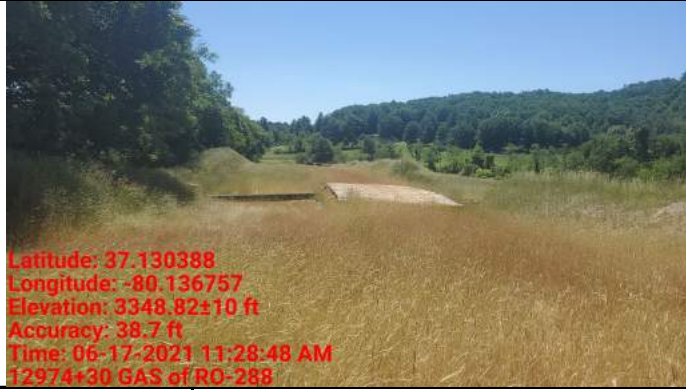
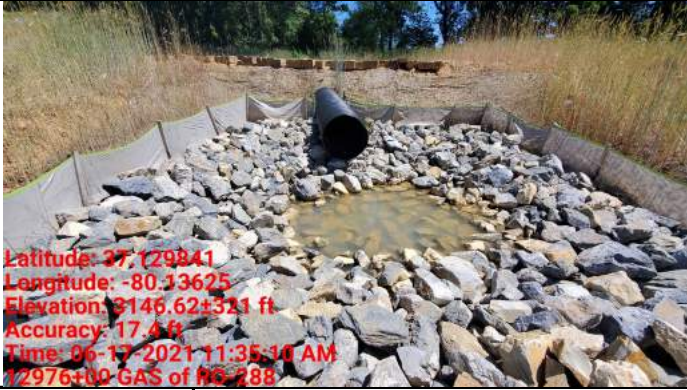
<p>Latitude: 37.129841 Longitude: -80.13625 Elevation: 3146.62±321 ft Accuracy: 17.4 ft Time: 06-17-2021 11:35:14 AM 12976+00 GAS of RO-288</p>			
GPS Location	See pic for GPS location		GPS Location	See pic for GPS location	
Field Station#	12974+30		Field Station#	12976+00	
Pic 11 Desc.	Current ROW conditions on the GAS of RO-288.		Pic 12 Desc.	Plunge pool and CWDP on GAS of RO-288.

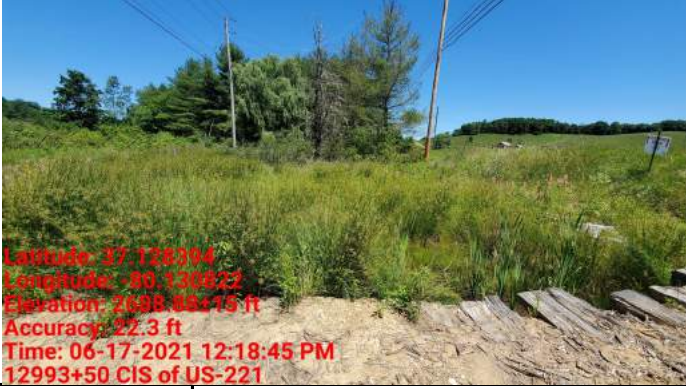
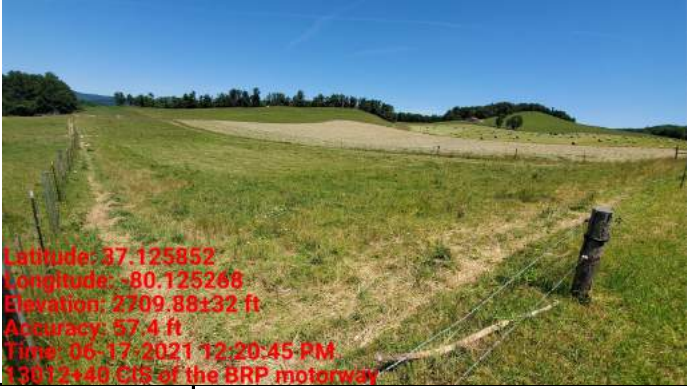
GPS Location	See pic for GPS location		GPS Location	See pic for GPS location	
Field Station#	12993+50		Field Station#	13012+40	
Pic 15 Desc.	CIS of the US-221 road crossing.		Pic 16 Desc.	CIS of the BRP motorway.

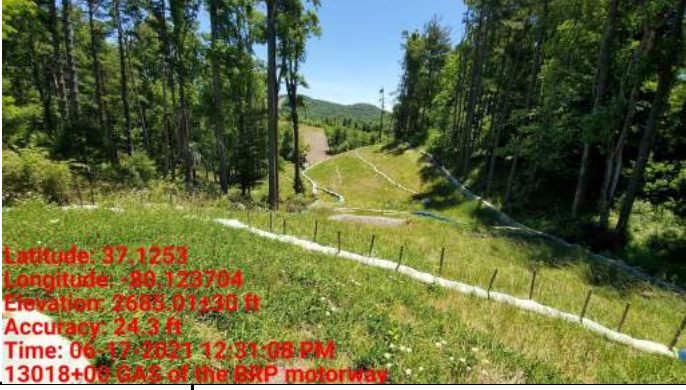
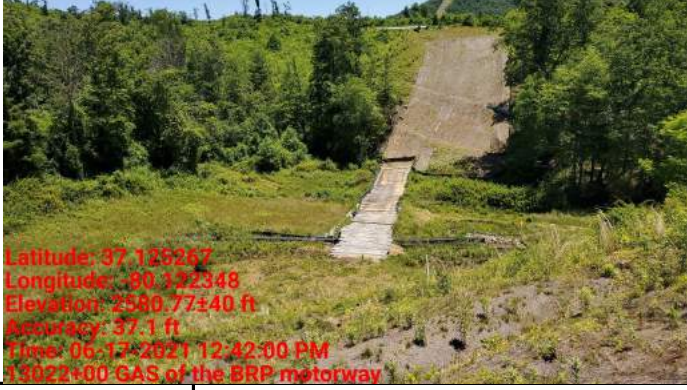
GPS Location	See pic for GPS location		GPS Location	See pic for GPS location	
Field Station#	13018+00		Field Station#	13022+00	
Pic 17 Desc.	BRP wooded portion on the GAS of the motorway.		Pic 18 Desc.	CWDB, CWDP and plunge pool on the GAS of the BRP.

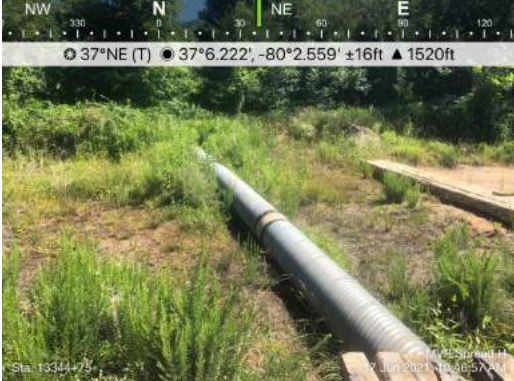
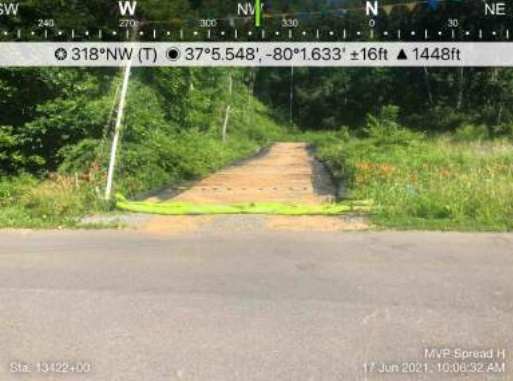
GPS Location	See Picture Watermark		GPS Location	See Picture Watermark	
Field Station#	13344+75		Field Station#	13422+00	
Pic 1 Desc.	Clean water diversion pipe and bridge material in good condition. No maintenance needed.		Pic 2 Desc.	Access point at Cahas Mountain Road. No tracking observed or maintenance needed.

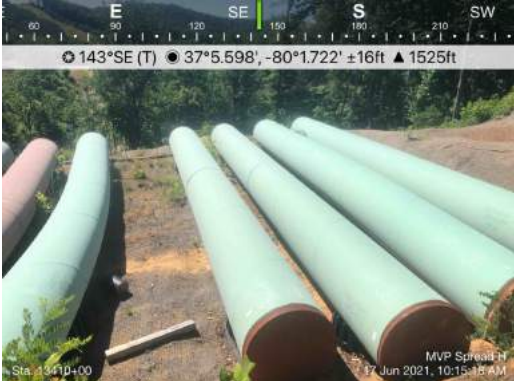
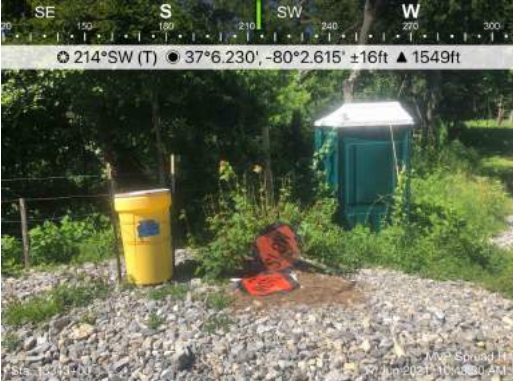
GPS Location	See Picture Watermark		GPS Location	See Picture Watermark	
Field Station#	13410+00		Field Station#	13343+00	
Pic 3 Desc.	Pipe storage area along ROW in good condition. No maintenance needed.		Pic 4 Desc.	Portable toilets are stored within secondary containments, and spill kits are located at road crossings.

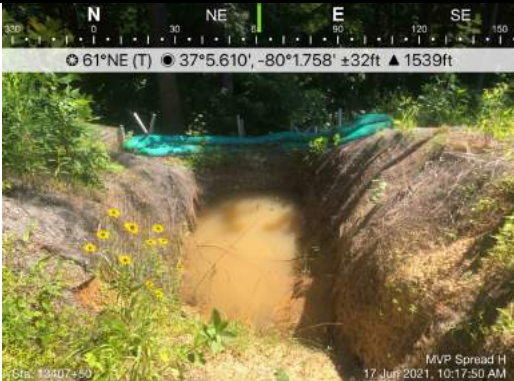
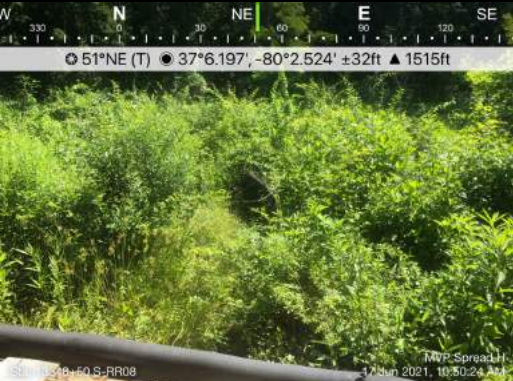
GPS Location	See Picture Watermark		GPS Location	See Picture Watermark	
Field Station#	13407+50		Field Station#	13348+50	
Pic 5 Desc.	Sump pit and CFS end treatments in good condition. No maintenance needed.		Pic 6 Desc.	Stream and buffer zone at S-RR08 are in good condition and remain undisturbed.

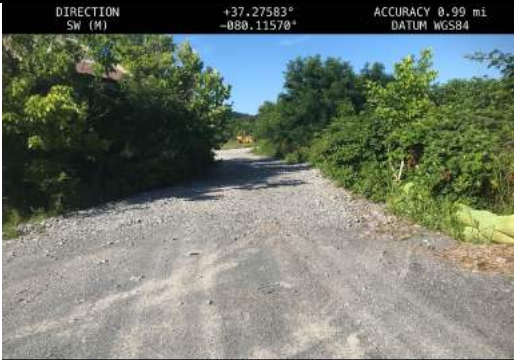
<p>DIRECTION SW (M) +37.27583° -080.11570° ACCURACY 0.99 m DATUM WGS84</p> <p>MVP-LY-049_061821 Condition of rock entrance 2021-06-18 08:52:44-04:00</p>
