Visual Site Inspection Report

Project Name	H-600 Pipeline Spread H	AFE	124300138	Spread	H-600 Pipeline Spread H
Contractor	Precision			Report #	24568
Inspector	Jason Nielsen			Date/Time	6/14/2021 7:14 PM
Permit #	TBD	Inspection Type	VA SWPP	Station Begin	12284+75
State	VA	Inspection Area	Partial	Station End	12443+75
County	Montgomery	Ground	Damp	Temperature (°F)	87.00
Municipality	N/A	Weather	Sunny	Rain Gauge (in)	1.00
				Rain Accumulation Time (days)	1.00

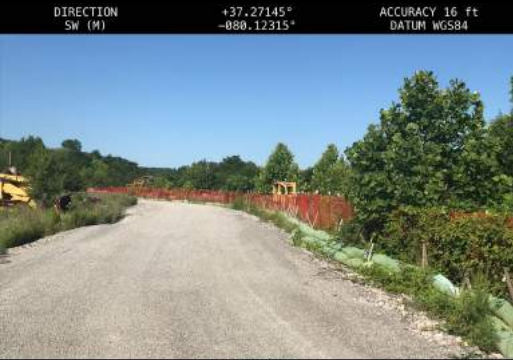
<p>DIRECTION SW (M) +37.27145° -080.12315° ACCURACY 16 ft DATUM WGS84</p> <p>MVP-LY-049_061821 Condition of CFS & safety fence LOD 2021-06-18 08:53:58-04:00</p>			
GPS Location	MVP-LY-049 See photo for gps data		GPS Location	MVP-LY-049 See photo for gps data	
Field Station#	+0		Field Station#	+0	
Pic 1 Desc.	Condition of north rock entrance. No sediment on stone. Looking SW.		Pic 2 Desc.	Condition of compost filter sock and safety fence along north LOD. Looking SW.

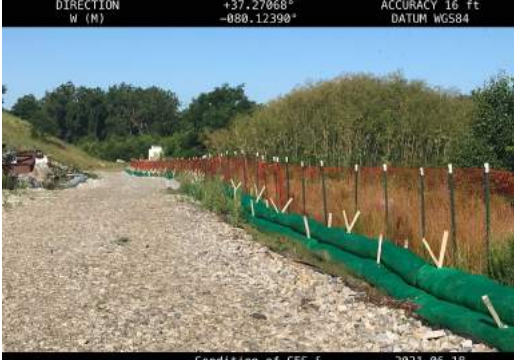
<p>DIRECTION W (M) +37.27068° -080.12390° ACCURACY 16 ft DATUM WGS84</p> <p>MVP-LY-049_061821 Condition of CFS & safety fence LOD 2021-06-18 08:54:43-04:00</p>

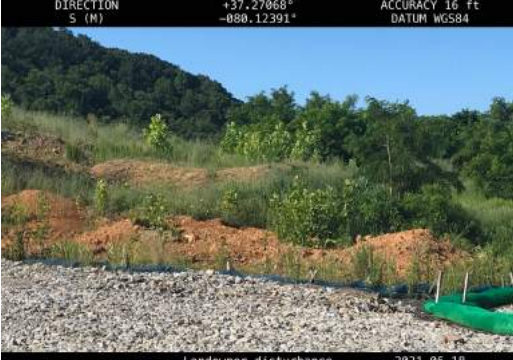
<p>DIRECTION S (M) +37.27068° -080.12391° ACCURACY 16 ft DATUM WGS84</p> <p>MVP-LY-049_061821 Landowner disturbance along CFS & feature 2021-06-18 08:54:51-04:00</p>

GPS Location	MVP-LY-049 See photo for gps data		GPS Location	MVP-LY-049 See photo for gps data	
Field Station#	+0		Field Station#	+0	
Pic 3 Desc.	Condition of compost filter sock and safety fence along north LOD. Looking W.		Pic 4 Desc.	Landowner soil disturbance along compost filter sock. No damage to installed ECD's. Looking S.	
  <p>DIRECTION W (M) +37.27043° -080.12456° ACCURACY 16 ft DATUM WGS84</p> <p>MVP-LY-049_061821 Landowner disturbance along feature 2021-06-18 08:55:33-04:00</p>

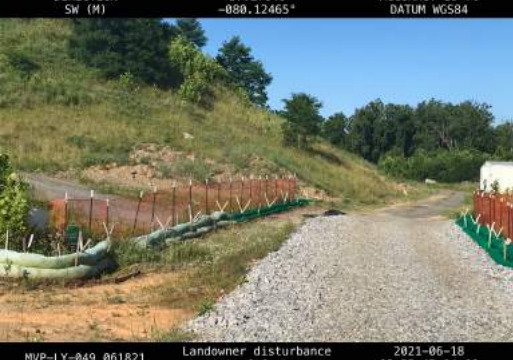
<p>DIRECTION SW (M) +37.27040° -080.12465° ACCURACY 16 ft DATUM WGS84</p> <p>MVP-LY-049_061821 Landowner disturbance west of feature 2021-06-18 08:55:42-04:00</p>			
GPS Location	MVP-LY-049 See photo for gps data		GPS Location	MVP-LY-049 See photo for gps data	
Field Station#	+0		Field Station#	+0	
Pic 5 Desc.	Landowner soil disturbance along feature W-CV21A. Area not stabilized. Not project related. Looking W.		Pic 6 Desc.	Landowner soil disturbance west of feature W-CV21B. Both Areas not stabilized. Looking SW.

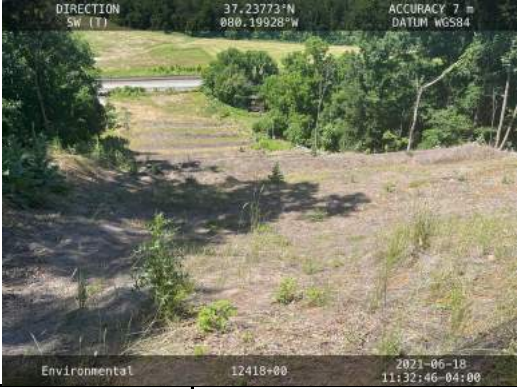
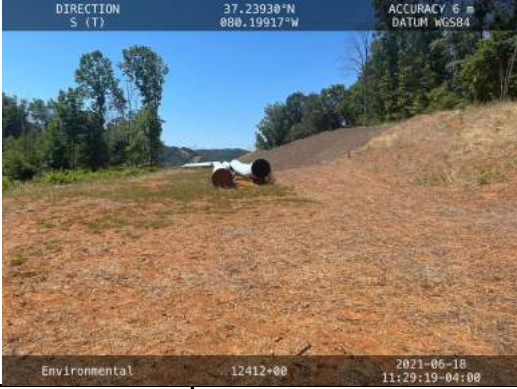
GPS Location	See photo		GPS Location	See photo	
Field Station#	12418+00		Field Station#	12412+00	
Pic 7 Desc.	Stabilized slope in acceptable condition		Pic 8 Desc.	Stabilized ROW in acceptable condition

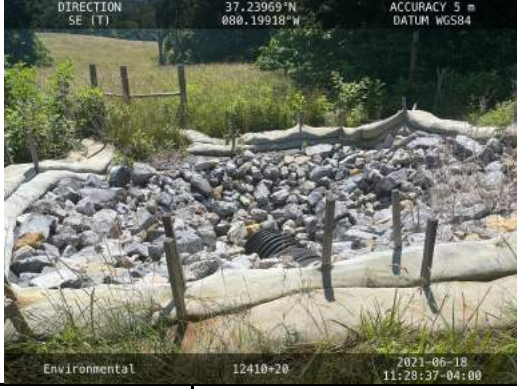
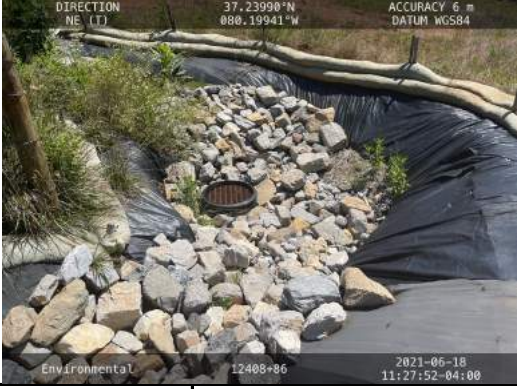
GPS Location	See photo		GPS Location	See photo	
Field Station#	12410+20		Field Station#	12408+86	
Pic 9 Desc.	Clean water crossing outlet in acceptable condition		Pic 10 Desc.	Clean water crossing pipe inlet in acceptable condition

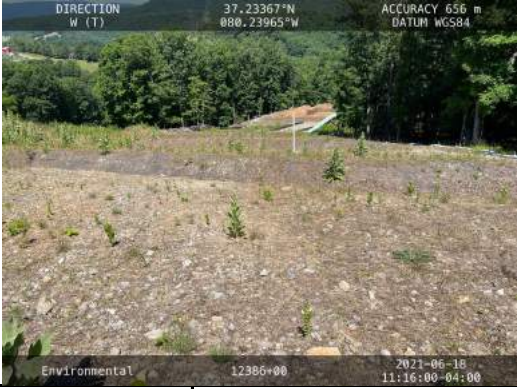
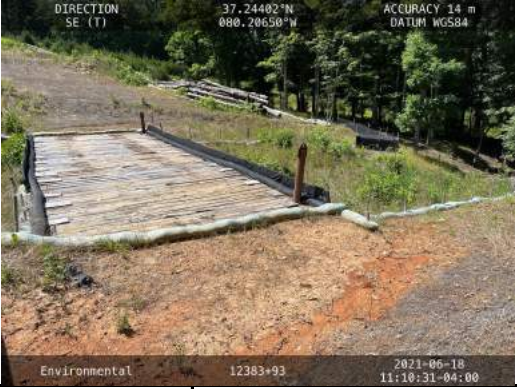
GPS Location	See photo		GPS Location	See photo	
Field Station#	12386+00		Field Station#	12383+93	
Pic 13 Desc.	Stabilized ROW in acceptable condition		Pic 14 Desc.	Clean water crossing in acceptable condition

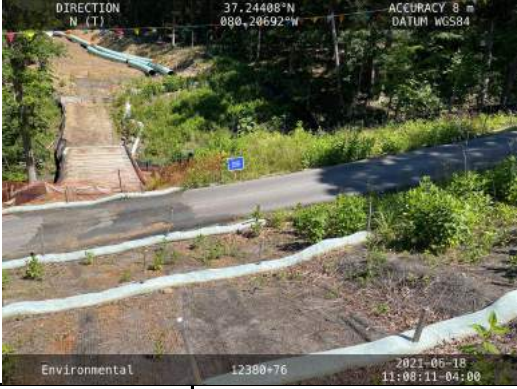
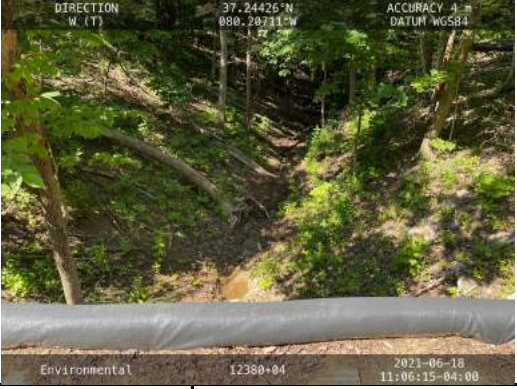
GPS Location	See photo		GPS Location	See photo	
Field Station#	12380+76		Field Station#	12380+04	
Pic 15 Desc.	Canary Rd crossing in acceptable condition		Pic 16 Desc.	Down stream of S-NN19 in acceptable condition

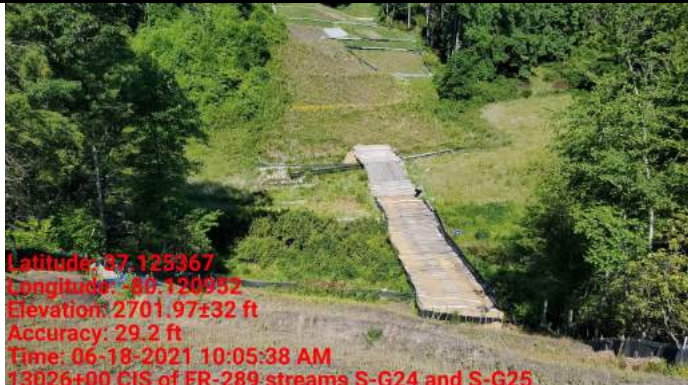
<p>Latitude: 37.125367 Longitude: -80.130552 Elevation: 2701.97±32 ft Accuracy: 29.2 ft Time: 06-18-2021 10:05:38 AM 13026+00 CIS of FR-289 streams S-G24 and S-G25</p>

<p>Latitude: 37.125424 Longitude: -80.130673 Elevation: 2758.65±39 ft Accuracy: 17.4 ft Time: 06-18-2021 10:09:43 AM 13029+00 CIS of FR-289</p>		
GPS Location	See pic for GPS location		GPS Location	See pic for GPS location	
Field Station#	13026+00		Field Station#	13029+00	
Pic 1 Desc.	Streams S-G24 and S-G25 from the GAS.		Pic 2 Desc.	Current ROW conditions on the CIS of FR-289.

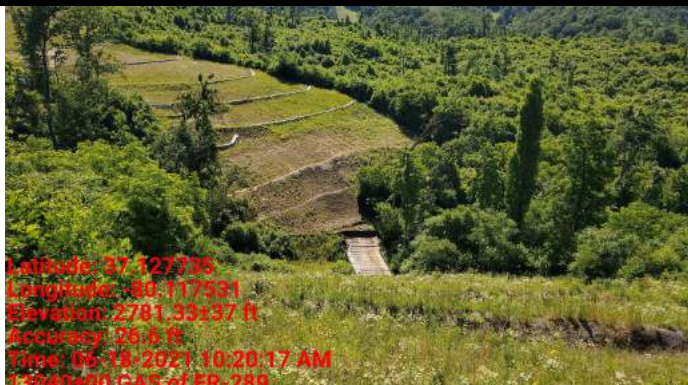
<p>Latitude: 37.127735 Longitude: -80.117531 Elevation: 2781.33±37 ft Accuracy: 26.6 ft Time: 06-18-2021 10:20:17 AM 13040+00 GAS of FR-289</p>

GPS Location	See pic for GPS location		GPS Location	See pic for GPS location	
Field Station#	13040+00		Field Station#	13062+00	
Pic 3 Desc.	Stream crossing S-H1 on the GAS of FR-289.		Pic 4 Desc.	Upstream side of stream S-G26.

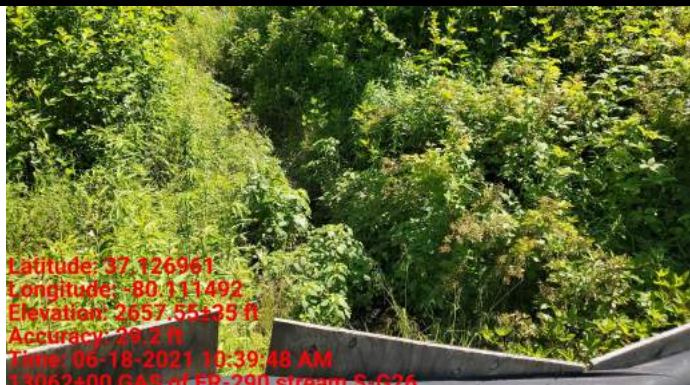
<p>Latitude: 37.126961 Longitude: -80.111492 Elevation: 2657.55±35 ft Accuracy: 29.2 ft Time: 06-18-2021 10:39:48 AM 13062+00 GAS of FR-290 stream S-G26</p>

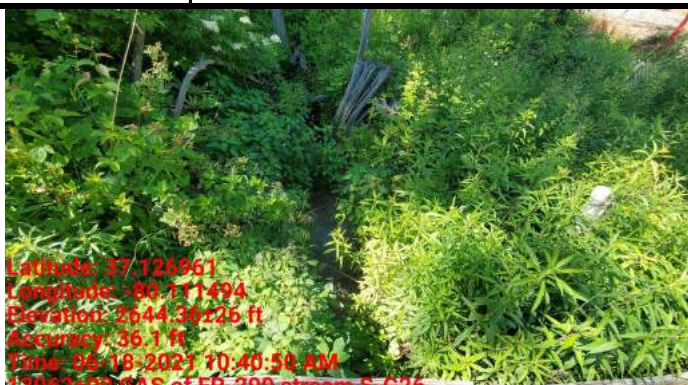
<p>Latitude: 37.126961 Longitude: -80.111494 Elevation: 2644.36±26 ft Accuracy: 36.1 ft Time: 06-18-2021 10:40:54 AM 13062+00 GAS of FR-290 stream S-G26</p>

<p>Latitude: 37.126966 Longitude: -80.111477 Elevation: 2436.55±21 ft Accuracy: 128.9 ft Time: 06-18-2021 10:41:36 AM 13063+00 GAS of FR-290 stream S-G27</p>		
GPS Location	See pic for GPS location		GPS Location	See pic for GPS location	
Field Station#	13062+00		Field Station#	13063+00	
Pic 5 Desc.	Downstream side of stream S-G26		Pic 6 Desc.	Upstream side of stream S-G27.
