Visual Site Inspection Report

Project Name	H-600 Pipeline Spread G	AFE	124300137	Spread	H-600 Pipeline Spread G
Contractor	Precision			Report #	26141
Inspector	Brian Shields			Date/Time	7/19/2021 8:38 AM
Permit #	TBD	Inspection Type	VA SWPP	Station Begin	10859+34
State	VA	Inspection Area	Full	Station End	11064+53
County	Giles	Ground	Dry	Temperature (°F)	82.00
Municipality	N/A	Weather	Sunny	Rain Gauge (in)	0.00
				Rain Accumulation Time (days)	1.00

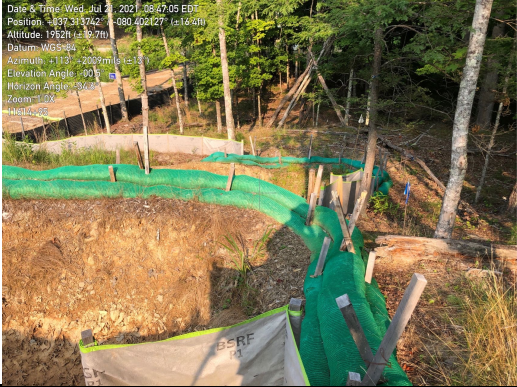
<p><small>Date & Time: Wed, Jul 21, 2021 08:47:05 EDT Position: +037.313742° / -080.402127° (±16.4ft) Altitude: 1952ft (±19.7ft) Datum: WGS-84 Azimuth: +014° (±229mils (±13°)) Elevation Angle: +02.5° Horizon Angle: 0° Zoom: 1.0x 11614+75 - S-RR14 crossing</small></p>

<p><small>Date & Time: Wed, Jul 21, 2021 08:48:43 EDT Position: +037.313673° / -080.402623° (±16.4ft) Altitude: 1926ft (±19.7ft) Datum: WGS-84 Azimuth: +014° (±229mils (±13°)) Elevation Angle: +14.5° Horizon Angle: 0° Zoom: 1.0x 11614+20 - S-RR14 crossing</small></p>			
GPS Location	On photo	GPS Location	On photo		
Field Station#	11614+75	Field Station#	11614+20		
Pic 7 Desc.	Perimeter ECDs in place.	Pic 8 Desc.	The S-RR14 crossing is stable.

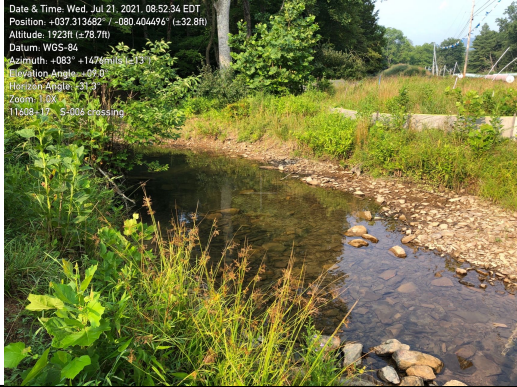
GPS Location	On photo	GPS Location			
Field Station#	11608+17	Field Station#			
Pic 9 Desc.	The S-006 crossing is stable.	Pic 10 Desc.			
<p style="text-align: center;">Insert image here</p>		<p style="text-align: center;">Insert image here</p>			
GPS Location		GPS Location			
Field Station#		Field Station#			
Pic 11 Desc.		Pic 12 Desc.

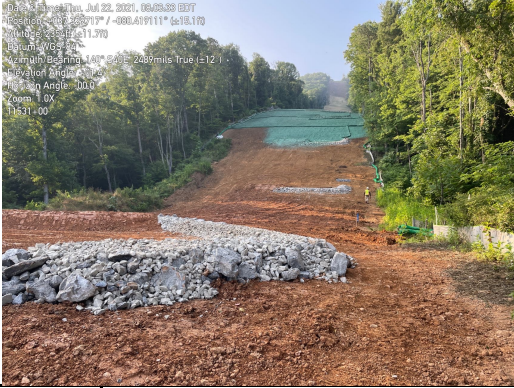
GPS Location	See photo	GPS Location	See photo		
Field Station#	11531+00	Field Station#	11538+00		
Pic 1 Desc.	Permanent waterbars with level spreaders in place	Pic 2 Desc.	Seed and hydro mulch applied

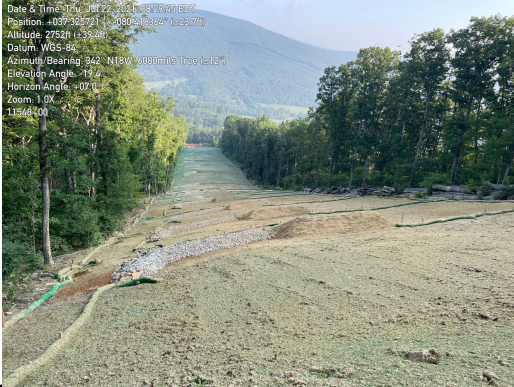
GPS Location	See photo	GPS Location	See photo		
Field Station#	11548+00	Field Station#	11563+00		
Pic 3 Desc.	ROW has been restored	Pic 4 Desc.	Waterbars in place

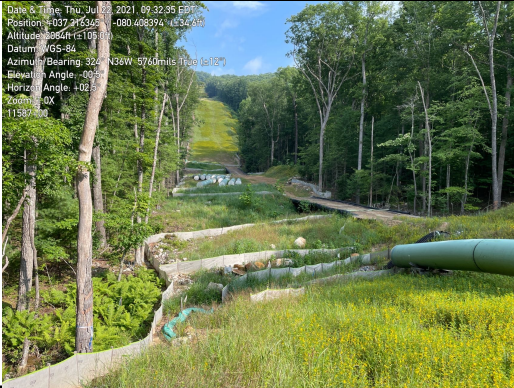
GPS Location	See photo	GPS Location	See photo		
Field Station#	11587+00	Field Station#	11583+00		
Pic 5 Desc.	Steam buffers in place	Pic 6 Desc.	P1 silt fence perimeter control in place

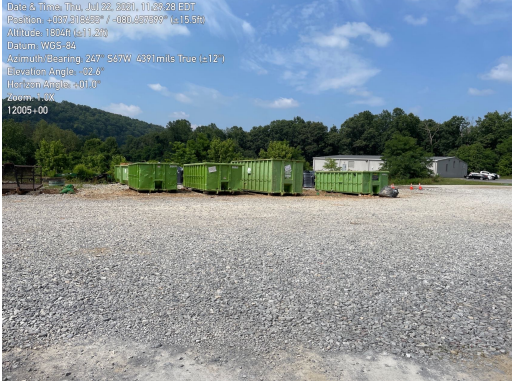
GPS Location	See photo		GPS Location	See photo
Field Station#	12005+00		Field Station#	12005+00
Pic 3 Desc.	Dumpsters in place		Pic 4 Desc.	Fuel island maintained in acceptable condition

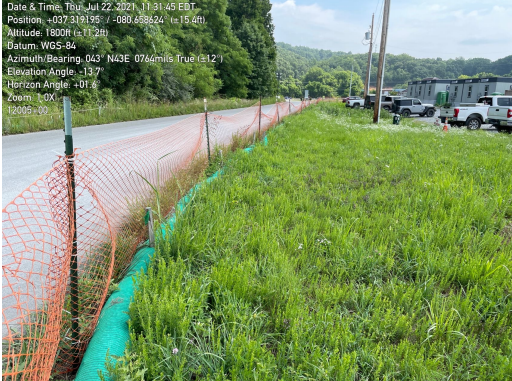
<p>Date & Time: Thu Jul 22, 2021, 11:32:35 EDT Position: +037 3181577 / -080 652297 (±15.5ft) Altitude: 1796ft (±11.2ft) Datum: WGS-84 Azimuth/Bearing: 222° S42W 3947mils True (±12°) Elevation Angle: -15.4° Horizon Angle: -05.2° Zoom: 1.0X 12005+00</p>		
GPS Location	See photo		GPS Location	See photo
Field Station#	12005+00		Field Station#	12005+00
Pic 5 Desc.	CFS perimeter control in place		Pic 6 Desc.	Secondary containment in place

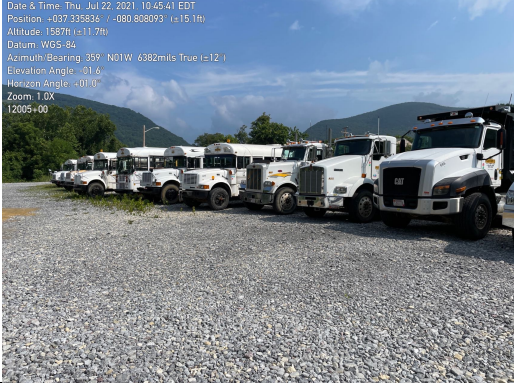
GPS Location	See photo		GPS Location	See photo	
Field Station#	12005+00		Field Station#	12005+00	
Pic 1 Desc.	Vehicles parked at yard		Pic 2 Desc.	RCE in place

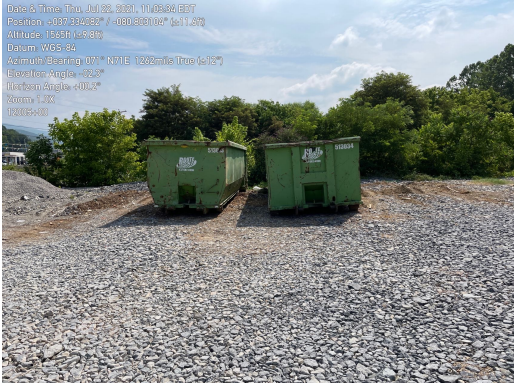
GPS Location	See photo		GPS Location	See photo	
Field Station#	12005+00		Field Station#	12005+00	
Pic 3 Desc.	Dumpsters in place		Pic 4 Desc.	Secondary containment in place

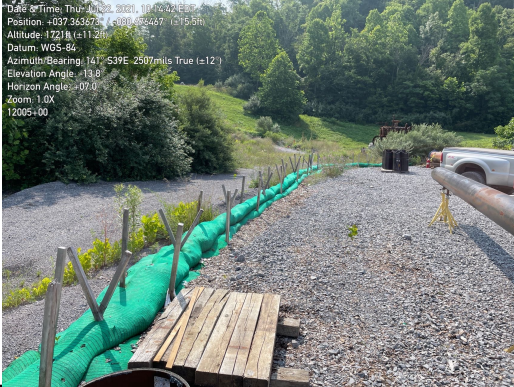
GPS Location	See photo		GPS Location	See photo	
Field Station#	12005+00		Field Station#	12005+00	
Pic 3 Desc.	CFS perimeter control in place		Pic 4 Desc.	Culvert functional

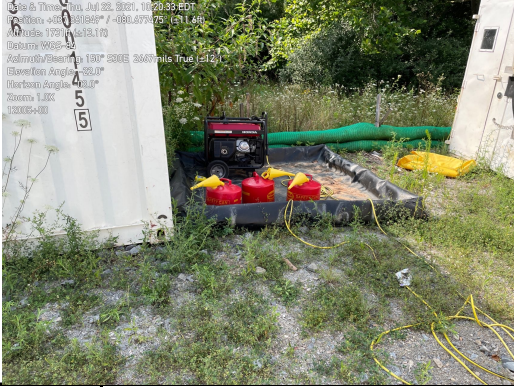
GPS Location	See photos		GPS Location	See photo	
Field Station#	12005+00		Field Station#	12005+00	
Pic 5 Desc.	Secondary containment in place		Pic 6 Desc.	Fuel cell on site

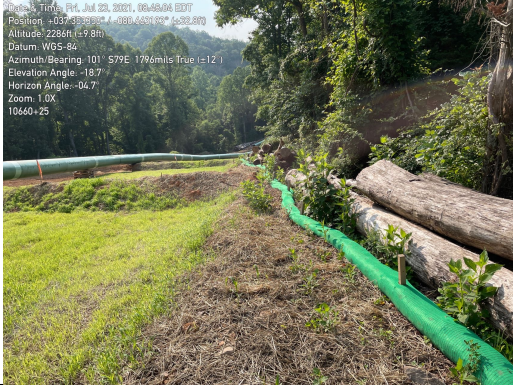
<p>Date & Time: Fri, Jul 23, 2021, 06:54:04 EDT Position: +037.493997° / +080.459497° (+58.870) Altitude: 2280ft (+9.8m) Datum: WGS-84 Azimuth/Bearing: 101° S79E 179mils True (+12°) Elevation Angle: -18.7° Horizon Angle: -04.7° Zoom: 1.0X 10660+25</p>				<p>Date & Time: Fri, Jul 23, 2021, 06:52 EDT Position: +037.53555° / +080.45822° (+24.7m) Altitude: 2062ft (+9.4m) Datum: WGS-84 Azimuth/Bearing: 078° N78E 1387mils True (+12°) Elevation Angle: -13.1° Horizon Angle: -02.5° Zoom: 1.0X 10679+00</p>							
GPS Location				See photo				GPS Location			
Field Station#				10660+25				Field Station#			
Pic 1 Desc.				CFS perimeter control in place				Pic 2 Desc.

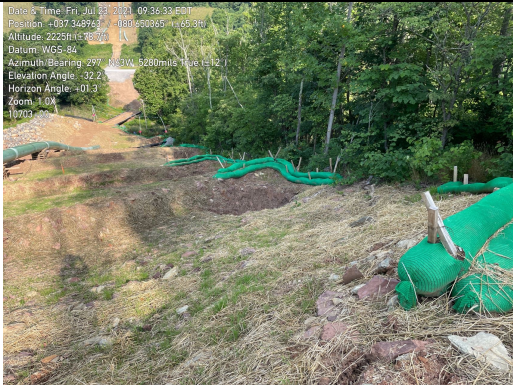
GPS Location				See photo				GPS Location			
Field Station#				10703+00				Field Station#			
Pic 3 Desc.				End treatments in place				Pic 4 Desc.

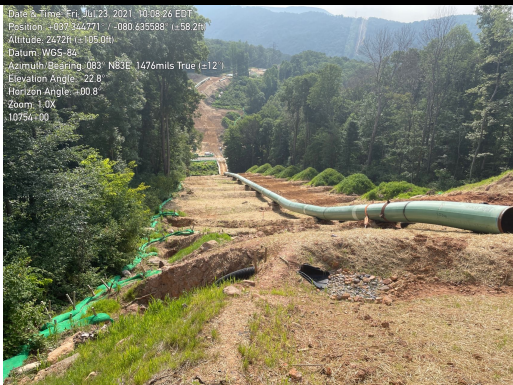
<p>Date & Time: Fri, Jul 23, 2021, 10:08:26 EDT Position: +037.56171° / +080.63588° (+58.2m) Altitude: 2472ft (+10.0m) Datum: WGS-84 Azimuth/Bearing: 083° N83E 1476mils True (+12°) Elevation Angle: -22.8° Horizon Angle: +00.8° Zoom: 1.0X 10754+00</p>				<p>Date & Time: Fri, Jul 23, 2021, 10:28:29 EDT Position: +037.54545° / +080.62608° (+18.0m) Altitude: 2176ft (+8.2m) Datum: WGS-84 Azimuth/Bearing: 036° N36E 864mils True (+12°) Elevation Angle: -07.3° Horizon Angle: -04.1° Zoom: 1.0X 10780+00</p>							
GPS Location				See photo				GPS Location			
Field Station#				10754+00				Field Station#			
Pic 5 Desc.				Waterbars in place				Pic 6 Desc.

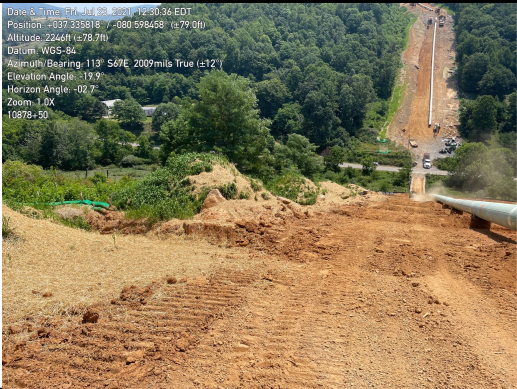
<p>Date & Time: Fri, Jul 23, 2021, 12:30:36 EDT Position: +037 335818 / -080 598458 (±79.0ft) Altitude: 2246ft (±78.7ft) Datum: WGS-84 Azimuth/Bearing: 113° S67E 2009mils True (±12°) Elevation Angle: -17.8° Horizon Angle: -02.7° Zoom: 1.0X 10878+50</p>			
GPS Location	See photo	GPS Location	See photo		
Field Station#	10865+50	Field Station#	10878+50		
Pic 11 Desc.	CFS perimeter control in place	Pic 12 Desc.	Topsoil piles stabilized

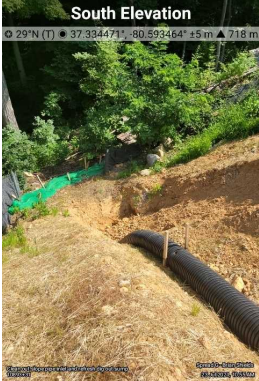
<p>South Elevation © 11°N (T) • 37.334415° -80.593403° ±9 m ▲ 708 m</p>							
GPS Location		1							
Field Station#		10893+31							
Pic 7 Desc.		sump maintenance needed							
<div style="text-align: center; height: 150px;">Insert image here</div>		<div style="text-align: center; height: 150px;">Insert image here</div>							
						GPS Location		1	
						Field Station#		10893+31	
						Pic 8 Desc.		Slope drain clogged and Rock inlets needs replaced	
GPS Location									
Field Station#									
Pic 9 Desc.									
<div style="text-align: center; height: 150px;">Insert image here</div>		<div style="text-align: center; height: 150px;">Insert image here</div>							
						GPS Location			
						Field Station#			
						Pic 10 Desc.			
GPS Location
