Visual Site Inspection Report

Project Name	H-600 Pipeline Spread H	AFE	124300138	Spread	H-600 Pipeline Spread H
Contractor	Precision			Report #	25087
Inspector	Logan Box			Date/Time	6/28/2021 3:55 PM
Permit #	TBD	Inspection Type	VA SWPP	Station Begin	13525+99
State	VA	Inspection Area	Partial	Station End	13670+00
County	Franklin	Ground	Dry	Temperature (°F)	90.00
Municipality	N/A	Weather	Sunny	Rain Gauge (in)	0.00
				Rain Accumulation Time (days)	0.00

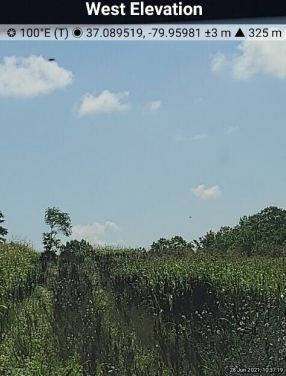
GPS Location	0000	GPS Location	0000		
Field Station#	13650+00	Field Station#	13659+03		
Pic 1 Desc.	Vegetation observation photo facing showing good coverage in a permanent area of row.		Pic 2 Desc.	Monitored equipment bridge and protection during routine inspection today. No environmental issues observed at the time of inspection.	
	West Elevation

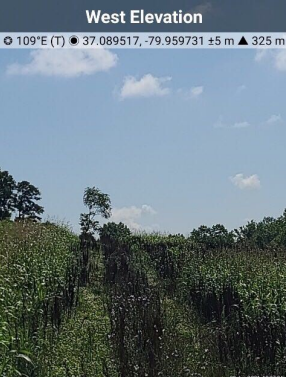
GPS Location	0000	GPS Location	0000		
Field Station#	13649+20	Field Station#	13657+00		
Pic 3 Desc.	Vegetation observation photo facing showing good coverage in a permanent area of row.		Pic 4 Desc.	Row photo showing vegetation growth. No issues observed at the time of inspection.	
	North East Elevation

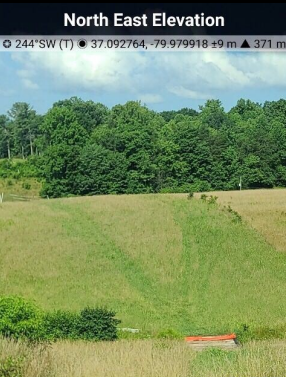
GPS Location	0000	GPS Location	0000		
Field Station#	13574+98	Field Station#	13658+30		
Pic 5 Desc.	Vegetation observation photo showing good growth. No environmental issues observed at the time of inspection.		Pic 6 Desc.	Monitored sump pit and end treatment. No issues observed at the time of inspection.

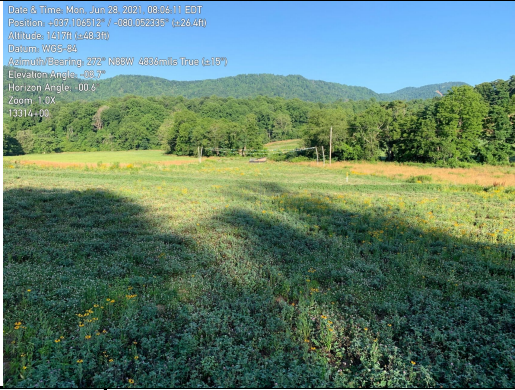
GPS Location	0	GPS Location	0		
Field Station#	13316+21	Field Station#	13314+00		
Pic 1 Desc.	Wades Gap Road Crossing in good condition, RCE in good condition and functioning properly		Pic 2 Desc.	ROW and ECDs in good condition, with good vegetation establishing across LOD.	
<p>Date & Time: Mon, Jun 28, 2021 08:09:20 EDT Position: +037 106221 / -080 054033 (±32.0m) Altitude: 1378ft (±36.1m) Datum: WGS-84 Azimuth/Bearing: 284° N74W 5049mils True (±10°) Elevation Angle: -00.7° Horizon Angle: +00.3° Zoom: 1.0X 13309+09 S-GH7</p>

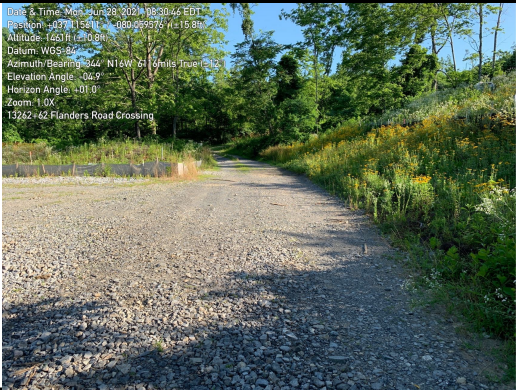
GPS Location	0	GPS Location	0		
Field Station#	13262+62	Field Station#	13360+66		
Pic 5 Desc.	Flanders Road Crossing in good condition, RCE in good condition and functioning properly		Pic 6 Desc.	MVP-S-II4 in good condition

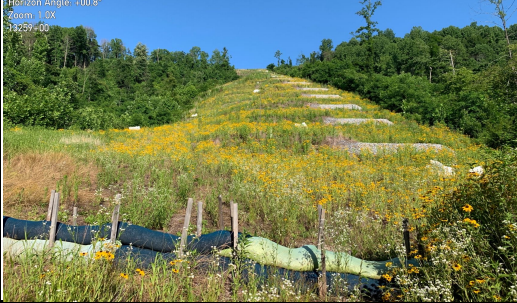
</div></div></div>			
GPS Location			0			
Field Station#			13259+00			
Pic 7 Desc.			ROW and ECDs in good condition, with good vegetation establishing across LOD.			
GPS Location			0			
Field Station#			13196+79			
Pic 8 Desc.			MVP-S-D8 in good condition			
<div><div><div>Date & Time: Mon, Jun 28, 2021, 10:28:08 EDT Position: +037.123346 / -080.073149 (+50.5ft) Altitude: 1423ft (+43.3ft) Datum: WGS-84 Azimuth/Bearing: 111° N42W 5559mils True (+12.1°) Elevation Angle: -03.1° Horizon Angle: +00.6° Zoom: 1.0X 13195+00</div><div>

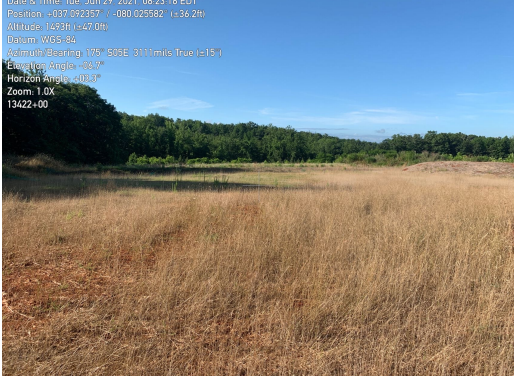
GPS Location	0	GPS Location	0		
Field Station#	13422+00	Field Station#	13415+51		
Pic 1 Desc.	ROW and ECDs in good condition, with good vegetation establishing across LOD		Pic 2 Desc.	Cahas Mountain Road Crossing in good condition, RCE in good condition and functioning properly	
<p>Date & Time: Tue Jun 29, 2021 08:28:01 EDT Position: -037.032411, -080.027588 (+238.5ft) Altitude: 1444ft (+10.1ft) Datum: WGS-84 Azimuth Bearing: 296.26NW 5227mils True (+12.1) Elevation Angle: -06.3 Horizon Angle: -02.8 Zoom: 1.0X 13413+05 S-IJ1</p>

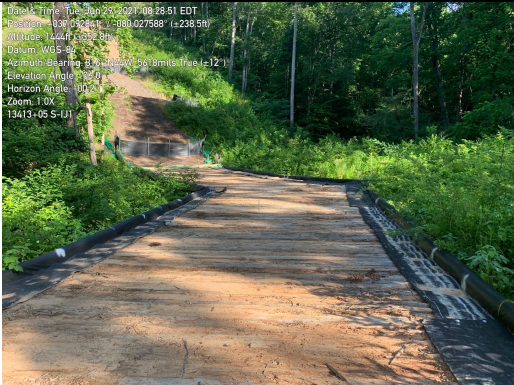
GPS Location	0	GPS Location	0		
Field Station#	13413+05	Field Station#	13410+00		
Pic 3 Desc.	MVP-S-IJ1 in good condition		Pic 4 Desc.	ROW and ECDs in good condition, with good vegetation establishing across LOD	
<p>Date & Time: Tue Jun 29, 2021 09:10:52 EDT Position: -037.101040, -080.038705 (+27.3ft) Altitude: 1545ft (+42.2ft) Datum: WGS-84 Azimuth Bearing: 090.19SE 1600mils True (+13.1) Elevation Angle: -11.0 Horizon Angle: -02.8 Zoom: 1.0X 13363+50</p>

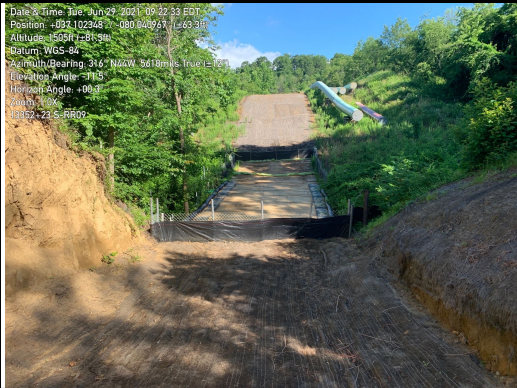
GPS Location			0		GPS Location		0	
Field Station#			13352+23		Field Station#		13351+50	
Pic 9 Desc.			MVP-S-RR09 in good condition		Pic 10 Desc.		ROW and ECDs in good condition and stable

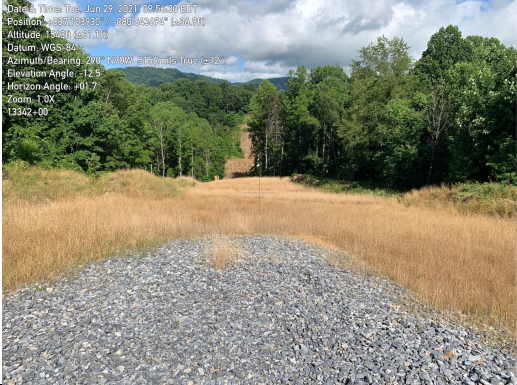
GPS Location	0	GPS Location	0		
Field Station#	13342+00	Field Station#	13337+13		
Pic 13 Desc.	ROW and ECDs in good condition, with good vegetation establishing across LOD	Pic 14 Desc.	MVP-S-GH9 in good condition		
<p>Date & Time: Tue Jun 29, 2021, 10:06:26 EDT Position: +037.104673 / -080.046305 (e=49.6ft) Altitude: 1458ft (e=53.5m) Datum: WGS-84 Azimuth/Bearing: 301° N59W 5351mils True (e=12.1) Elevation Angle: +17.6 Horizon Angle: +00.4 Zoom: 1.0X 13334-17 S-GH11</p>

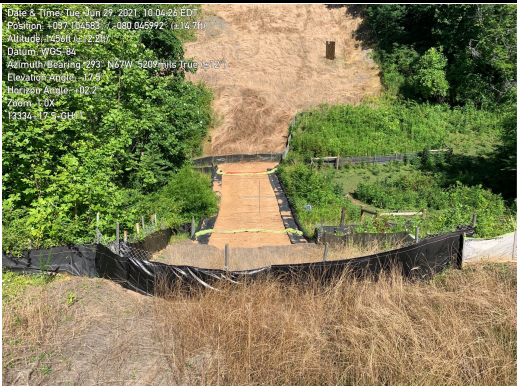
GPS Location	0	GPS Location	0		
Field Station#	13334+17	Field Station#	13333+75		
Pic 15 Desc.	MVP-S-GH11 in good condition	Pic 16 Desc.	ROW and ECDs in good condition, with good vegetation establishing across LOD		
<p>Date & Time: Tue Jun 29, 2021, 10:38:01 EDT Position: +037.106182 / -080.050674 (e=49.6ft) Altitude: 1512ft (e=51.3m) Datum: WGS-84 Azimuth/Bearing: 308° N55W 5422mils True (e=12.1) Elevation Angle: +18.0 Horizon Angle: +03.0 Zoom: 2.0X 13321-47 S-GH15</p>

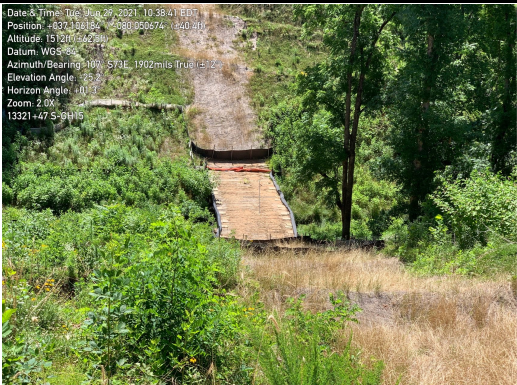
GPS Location	0	GPS Location	0		
Field Station#	13321+47	Field Station#	13319+00		
Pic 17 Desc.	MVP-S-GH15 in good condition	Pic 18 Desc.	ROW and ECDs in good condition, with good vegetation establishing across LOD

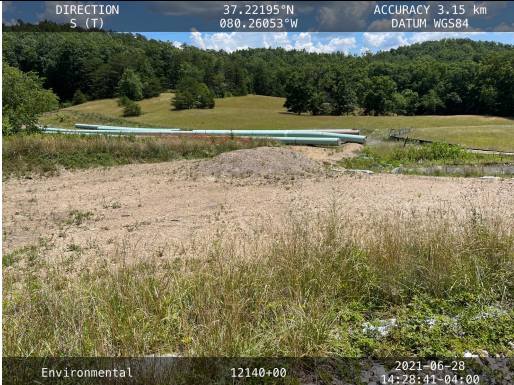
GPS Location	See photo		GPS Location	See photo	
Field Station#	12140+00		Field Station#	12157+00	
Pic 1 Desc.	Section of ATWS-701 that needs to be stabilized.		Pic 2 Desc.	Travel lane being stabilized by PPL to prevent additional erosion

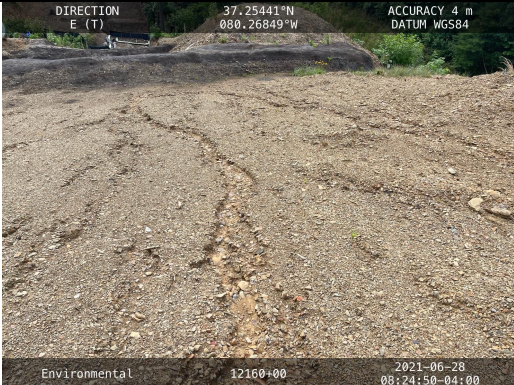
GPS Location	See photo		GPS Location	See photo	
Field Station#	12160+00		Field Station#	12137+00	
Pic 3 Desc.	Erosion within the travel lane.		Pic 4 Desc.	Stabilized ROW needs additional stabilization added within the travel lane.

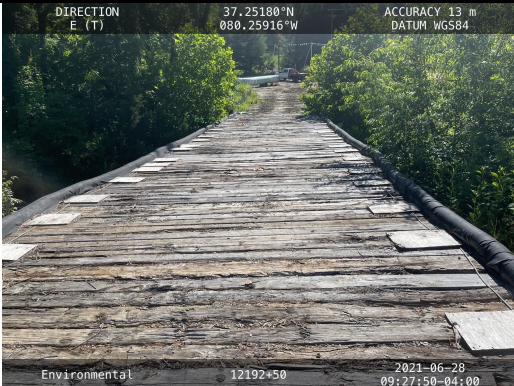
GPS Location	See photo		GPS Location	See photo	
Field Station#	12192+50		Field Station#	12140+00	
Pic 5 Desc.	Bridge and ECDs crossing stream S-C21 in acceptable condition		Pic 6 Desc.	ATWS-701 stabilized

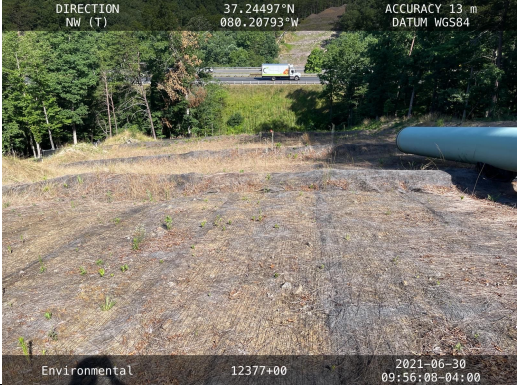
<p>DIRECTION SW (T) 37.24530°N 080.20861°W ACCURACY 4 m DATUM WGS84</p> <p>Environmental 12374+16 2021-06-30 09:50:34-04:00</p>			
GPS Location	See photo		GPS Location	See photo	
Field Station#	12377+00		Field Station#	12374+16	
Pic 13 Desc.	Stabilized ROW in acceptable condition		Pic 14 Desc.	Stream crossing S-0016 in acceptable condition

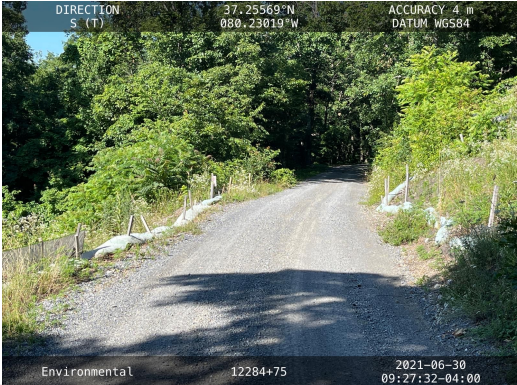
Pic 15 Desc.	Access Road MVP-MN-276.03 crossing in acceptable condition		Pic 16 Desc.	Stabilized ROW in acceptable condition

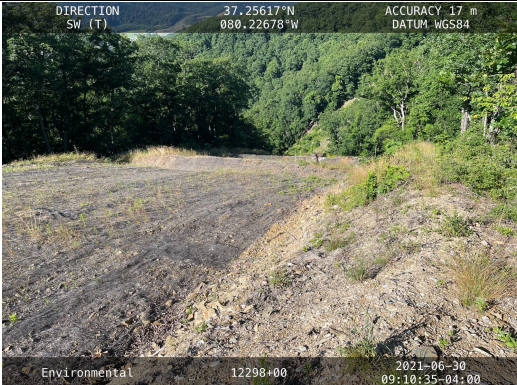
<p>DIRECTION S (T) 37.25678°N 080.22699°W ACCURACY 13 m DATUM WGS84</p> <p>Environmental 12299+24 2021-06-30 09:04:46-04:00</p>			
GPS Location	See photo		GPS Location	see photo	
Field Station#	12298+00		Field Station#	12299+24	
Pic 17 Desc.	Stabilized ROW in acceptable condition		Pic 18 Desc.	Stabilized access Road in acceptable condition

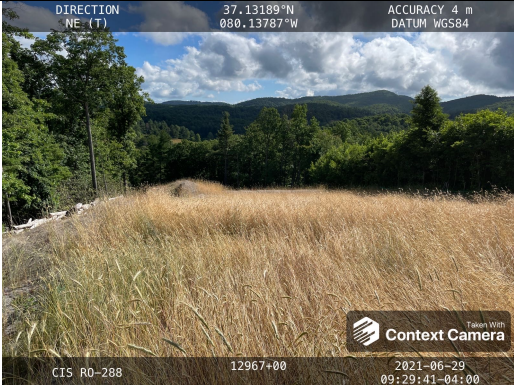
GPS Location	See photo		GPS Location	See photo	
Field Station#	12967+00		Field Station#	12970+50	
Pic 1 Desc.	Current ROW conditions on CIS of RO-288		Pic 2 Desc.	Current ROW conditions on CIS of RO-288

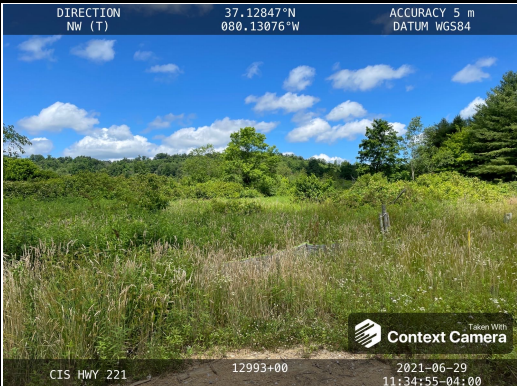
GPS Location	See photo		GPS Location	See photo	
Field Station#	12993+00		Field Station#	13012+00	
Pic 15 Desc.	Current ROW conditions on CIS HWY 221		Pic 16 Desc.	Current ROW conditions on CIS Blue Ridge Parkway

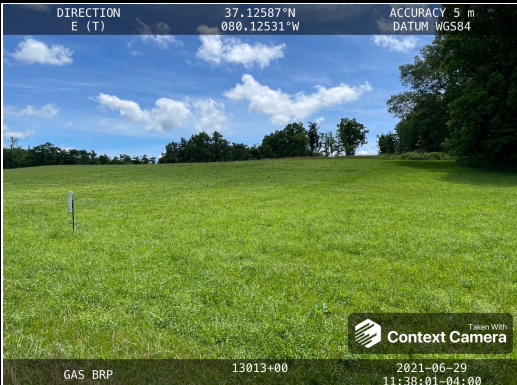
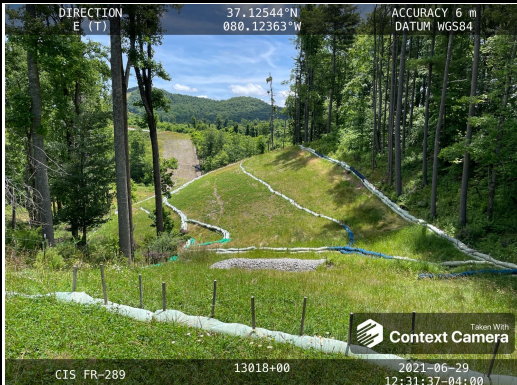
GPS Location	See photo		GPS Location	See photo	
Field Station#	13013+00		Field Station#	13018+00	
Pic 17 Desc.	Current ROW conditions on GAS Blue Ridge Parkway		Pic 18 Desc.	Current ROW conditions on CIS FR-289. Level Spreader and Perm. Slope breakers functioning correctly

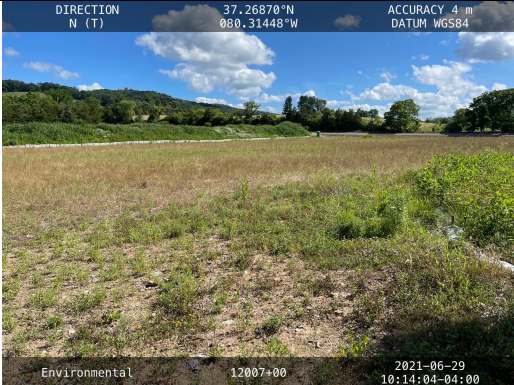
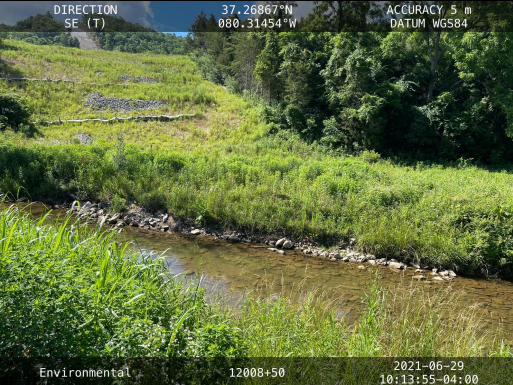
GPS Location	See photo		GPS Location	See photo	
Field Station#	12007+00		Field Station#	12008+50	
Pic 1 Desc.	Stabilized ROW in acceptable condition		Pic 2 Desc.	Stream crossing S-G36 in acceptable condition

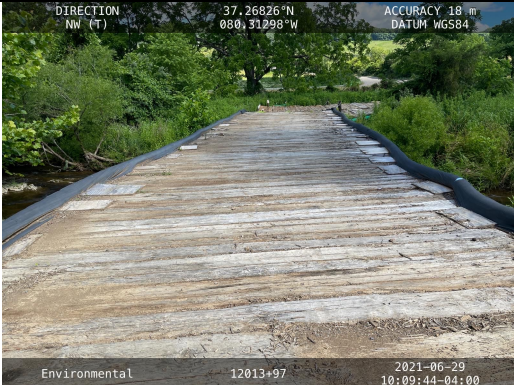
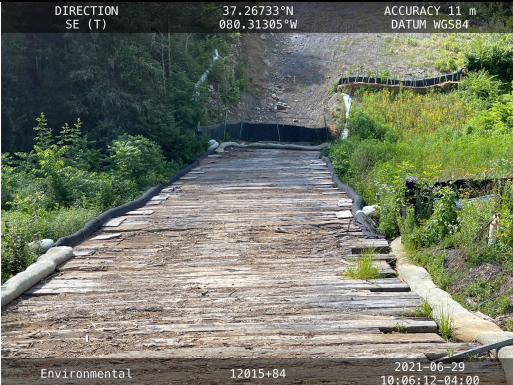
GPS Location	See photo		GPS Location	See photo	
Field Station#	12013+97		Field Station#	12015+84	
Pic 3 Desc.	Bridge and ECDs crossing stream S-G36 along access road MVP-MN-268.01		Pic 4 Desc.	Bridge and ECDs crossing stream S-G38 in acceptable condition

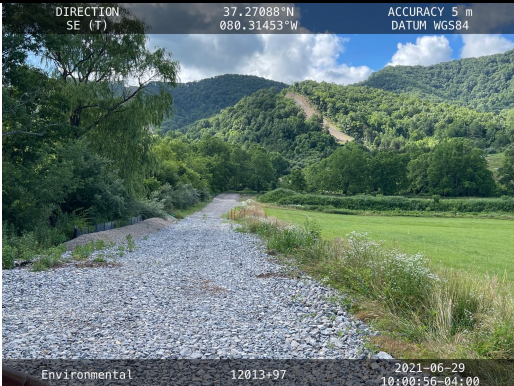
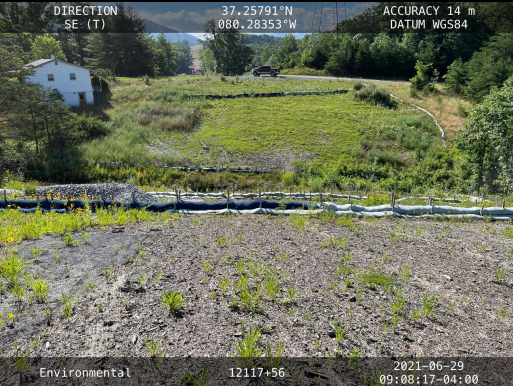
GPS Location	See photo		GPS Location	See photo	
Field Station#	12013+97		Field Station#	12117+56	
Pic 5 Desc.	Access Road MVP-MN-268.01 in acceptable condition		Pic 6 Desc.	Stabilized ROW in acceptable condition

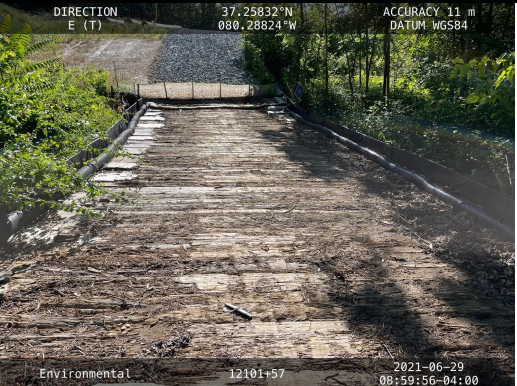
GPS Location	See photo		GPS Location	See photo	
Field Station#	12108+41		Field Station#	12101+57	
Pic 9 Desc.	Bridge and ECDs at stream crossing S-F15 in acceptable condition		Pic 10 Desc.	Bridge and ECDs at stream crossing S-MM11 in acceptable condition

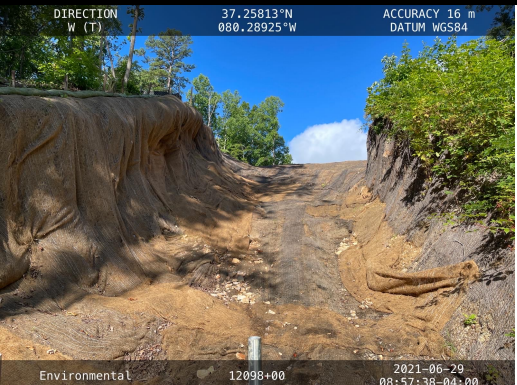
GPS Location	See photo		GPS Location	See photo	
Field Station#	12098+44		Field Station#	12098+00	
Pic 11 Desc.	Bridge and ECDs crossing stream S-MM13 in acceptable condition		Pic 12 Desc.	Stabilized cut bank in acceptable condition

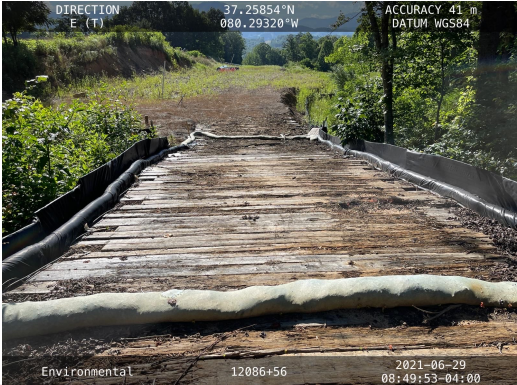
GPS Location	See photo		GPS Location	See photo	
Field Station#	12086+56		Field Station#	12076+95	
Pic 15 Desc.	Bridge and ECDs at stream crossing S-MM14 in acceptable condition		Pic 16 Desc.	Bridge and ECDs crossing stream S-MM15 in acceptable condition

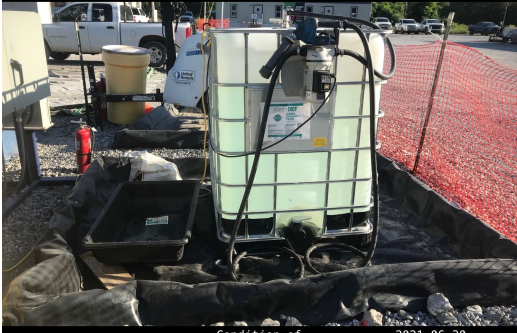
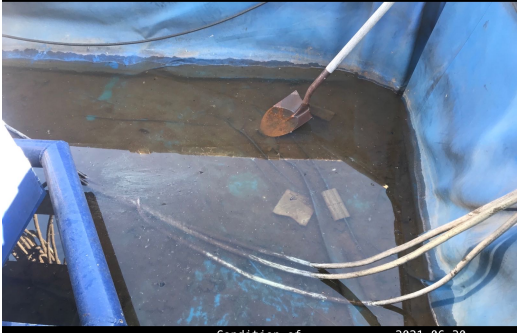
MVP-PY-006_063021 Condition of containment 2021-06-30 07:44:41-04:00		MVP-PY-006_063021 Condition of containment 2021-06-30 07:44:55-04:00			
GPS Location	MVP-PY-006 See photo for gps data		GPS Location	MVP-PY-006 See photo for gps data	
Field Station#	+0		Field Station#	+0	
Pic 7 Desc.	Condition of containment under DEF container. Looking N.		Pic 8 Desc.	Blue Bulk Fuel tanks containment holding stormwater. Looking N.	
DIRECTION SW (M) +37.23564° -080.22676° ACCURACY 16 ft DATUM WGS84

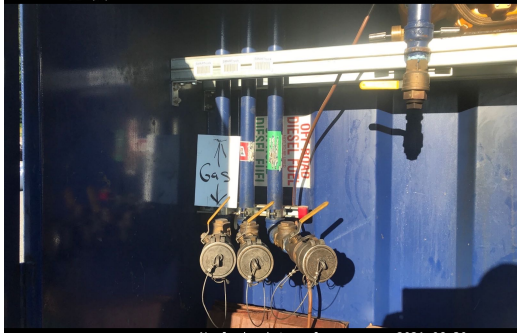
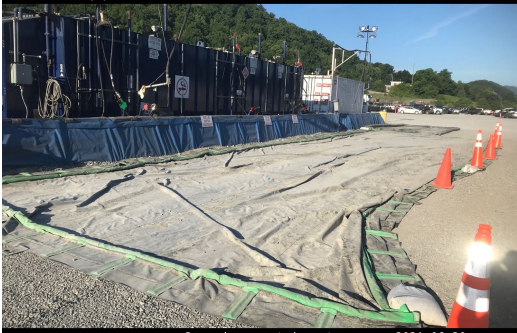
MVP-PY-006_063021 No leaky internal fittings 2021-06-30 07:45:09-04:00		MVP-PY-006_063021 Secondary containment on site for tankers 2021-06-30 07:45:47-04:00

GPS Location	MVP-PY-006 See photo for gps data		GPS Location	MVP-PY-006 See photo for gps data	
Field Station#	+0		Field Station#	+0	
Pic 9 Desc.	Blue Bulk Fuel tanks no leaky internal fittings. Looking SW.		Pic 10 Desc.	Secondary containments on site and in place for tankers offloading fuel. Looking SW.	
DIRECTION S (M) +37.23567° -080.22673° ACCURACY 16 ft DATUM WGS84

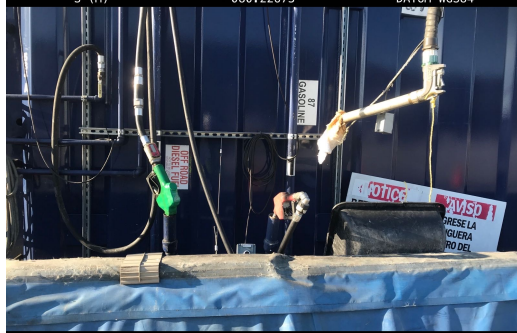
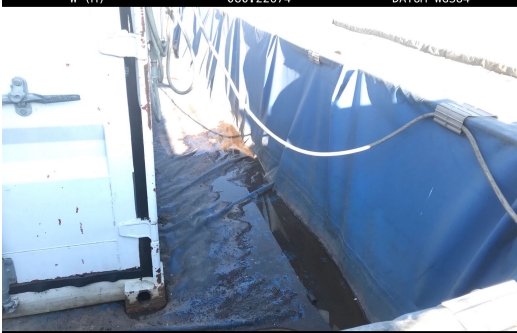
MVP-PY-006_063021 No leaky fittings or nozzles 2021-06-30 07:46:02-04:00		MVP-PY-006_063021 Condition of containment 2021-06-30 07:46:36-04:00			
GPS Location	MVP-PY-006 See photo for gps data		GPS Location	MVP-PY-006 See photo for gps data	
Field Station#	+0		Field Station#	+0	
Pic 11 Desc.	Blue Bulk Fuel tanks no leaky fittings or nozzles. Looking S.		Pic 12 Desc.	Off Road Fuel unit containment basically free of stormwater. Looking W.

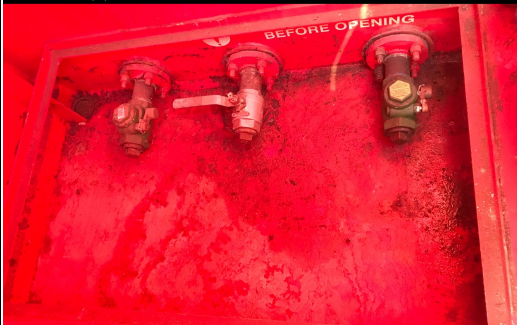
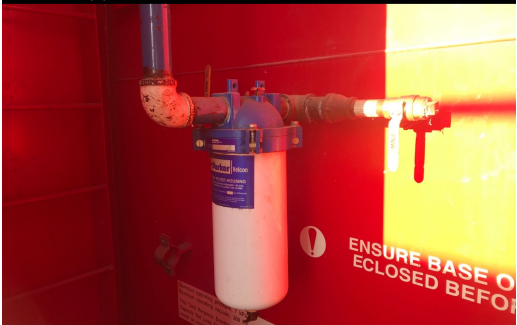
MVP-PY-006_063021 Condition of internal drip pan 2021-06-30 07:47:07-04:00								MVP-PY-006_063021 No leaky internal fittings 2021-06-30 07:47:11-04:00							
GPS Location		MVP-PY-006 See photo for gps data													
Field Station#		+0													
Pic 13 Desc.		Off Road Fuel unit condition of internal drip pan. Free of fluids. Looking SW.													
GPS Location		MVP-PY-006 See photo for gps data													
Field Station#		+0													
Pic 14 Desc.		Off Road Fuel unit no leaky internal fittings. Looking SW.													
<div>DIRECTION SE (M) +37.23556° -080.22690° ACCURACY 16 ft DATUM WGS84</div>

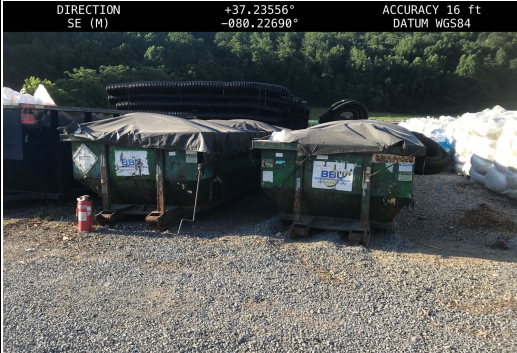
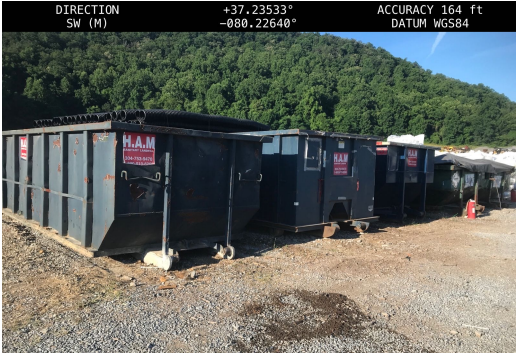
MVP-PY-006_063021 No fluids around hazardous waste dump... 2021-06-30 07:48:04-04:00								MVP-PY-006_063021 No loose trash around dumpsters 2021-06-30 07:48:40-04:00							
GPS Location		MVP-PY-006 See photo for gps data													
Field Station#		+0													
Pic 15 Desc.		No fluids or deposits around hazardous waste dumpsters. Looking SE.													
GPS Location		MVP-PY-006 See photo for gps data													
Field Station#		+0													
Pic 16 Desc.		No loose trash around dumpsters or in the yard. Looking SW.													
<div>DIRECTION E (M) +37.23566° -080.22643° ACCURACY 16 ft DATUM WGS84</div>  								<div>DIRECTION SW (M) +37.23612° -080.22744° ACCURACY 33 ft DATUM WGS84</div>

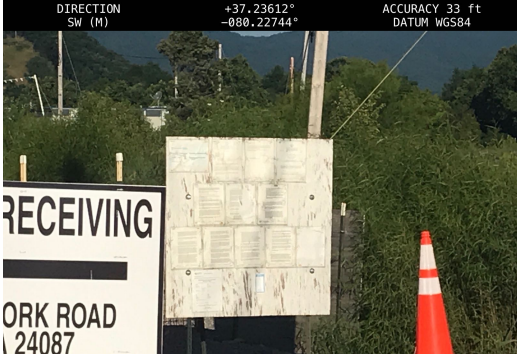
MVP-PY-006_063021 Restoration supplies under cover 2021-06-30 07:49:00-04:00								MVP-PY-006_063021 Posted project documents 2021-06-30 07:52:23-04:00							
GPS Location		MVP-PY-006 See photo for gps data

Field Station#		+0													
Pic 17 Desc.		Restoration supplies under cover. Looking E.													
GPS Location		MVP-PY-006 See photo for gps data													
Field Station#		+0													
Pic 18 Desc.		Posted project documents at the main entrance. Looking SW.

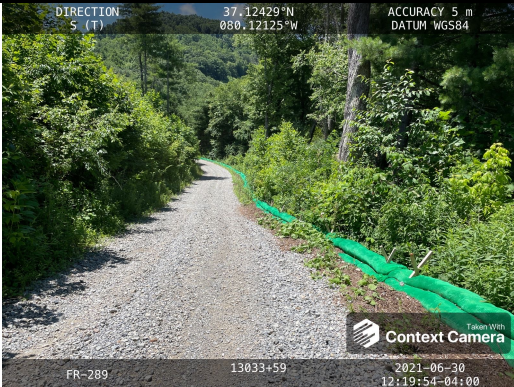
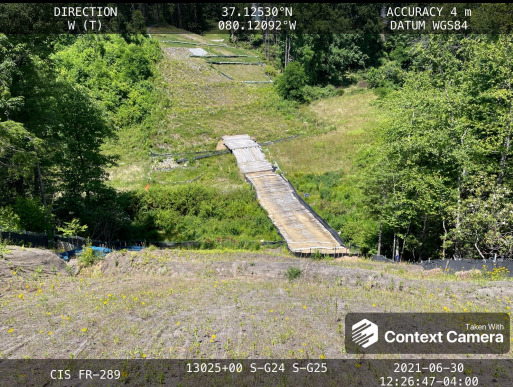
GPS Location	See photo		GPS Location	See photo	
Field Station#	13033+59		Field Station#	13025+00	
Pic 1 Desc.	FR-289 Perimeter controls in place and functional		Pic 2 Desc.	Streams S-G24 and S-G25 on CIS FR-289

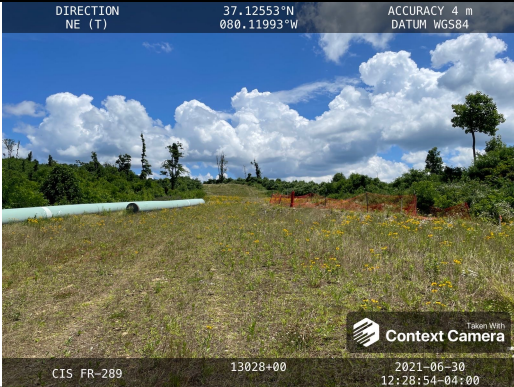
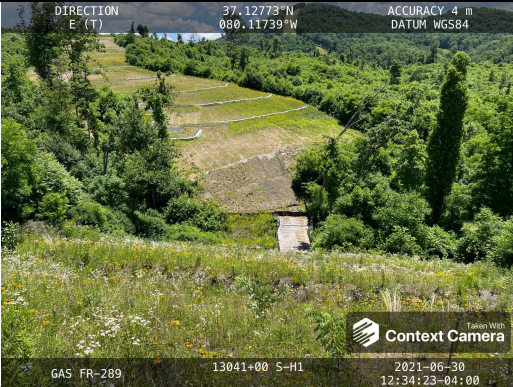
GPS Location	See photo		GPS Location	See photo	
Field Station#	13028+00		Field Station#	13041+00	
Pic 3 Desc.	Current ROW conditions on CIS FR-289		Pic 4 Desc.	Stream S-H1 on GAS FR-289

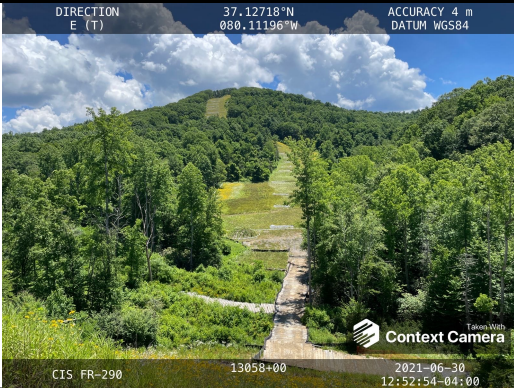
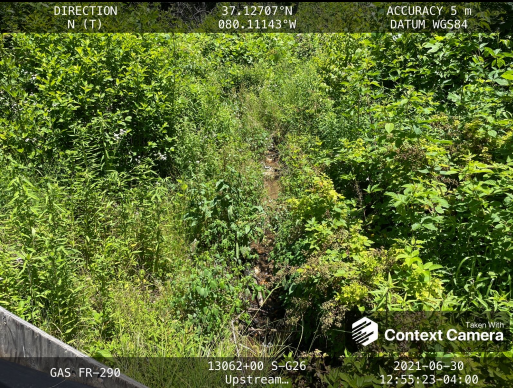
GPS Location	See photo		GPS Location	See photo	
Field Station#	13058+00		Field Station#	13062+00	
Pic 5 Desc.	Current ROW conditions on CIS FR-290		Pic 6 Desc.	Stream S-G26 on GAS FR-290

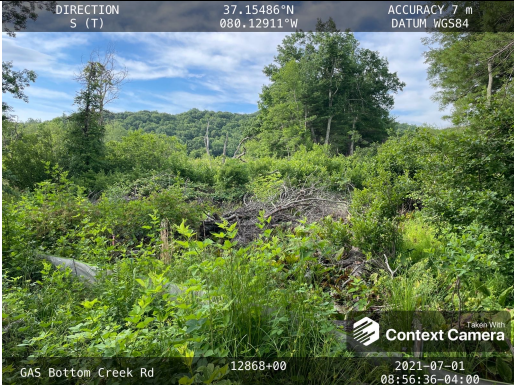
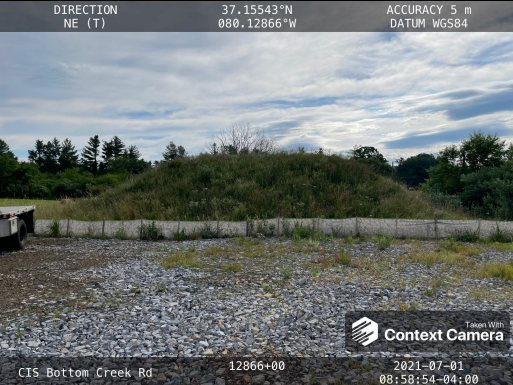
GPS Location	See photo		GPS Location	See photo	
Field Station#	12868+00		Field Station#	12866+00	
Pic 1 Desc.	Current ROW conditions on GAS Bottom Creek Rd		Pic 2 Desc.	Stockpile stabilized and perimeter controls installed and maintained

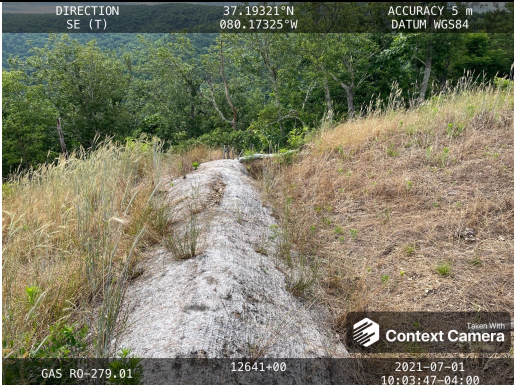
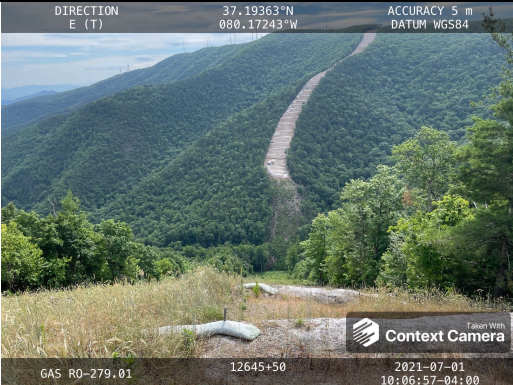
GPS Location	See photo		GPS Location	See photo	
Field Station#	12641+00		Field Station#	12645+50	
Pic 3 Desc.	Waterbar on GAS RO-279.01		Pic 4 Desc.	Current ROW conditions on GAS of RO-279.01

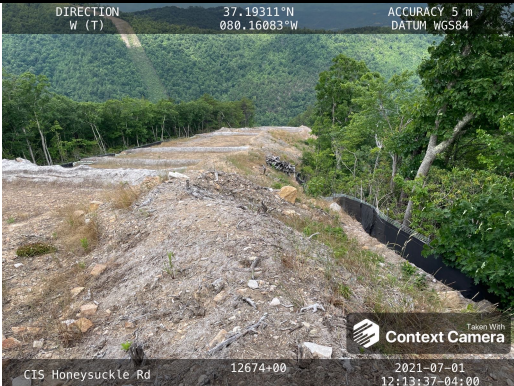
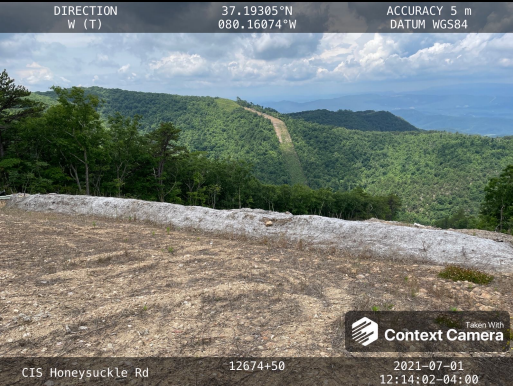
GPS Location	See photo		GPS Location	See photo	
Field Station#	12674+00		Field Station#	12674+50	
Pic 5 Desc.	Current ROW conditions on CIS of Honeysuckle Road		Pic 6 Desc.	Current ROW conditions on CIS of Honeysuckle Road

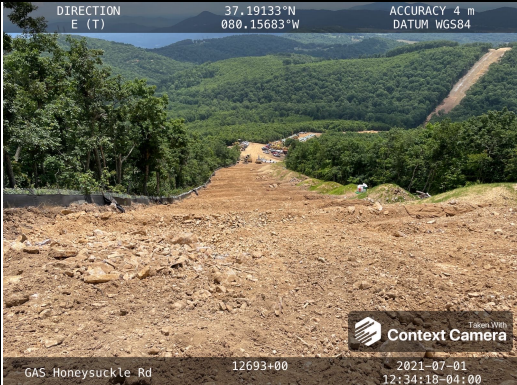
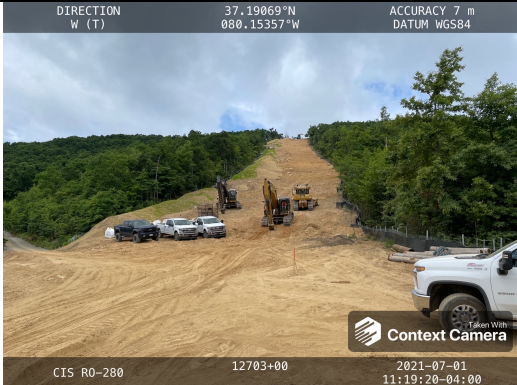
GPS Location	See photo		GPS Location	See photo	
Field Station#	12693+00		Field Station#	12703+00	
Pic 7 Desc.	Current ROW conditions on GAS of Honeysuckle Road. All ECDs in compliance		Pic 8 Desc.	Current ROW conditions at RO-280

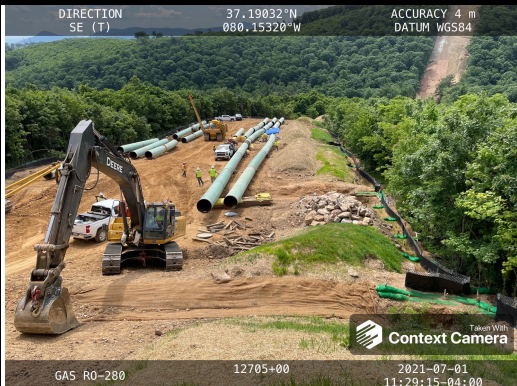
GPS Location	See photo		GPS Location	See photo	
Field Station#	12705+00		Field Station#	12705+00	
Pic 9 Desc.	Current ROW conditions on GAS RO-280. Stockpiles stabilized		Pic 10 Desc.	Crews installing Curlex in steep slope area around S-Y13 and S-Y14

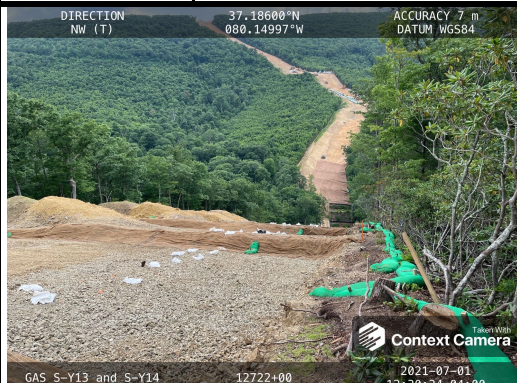
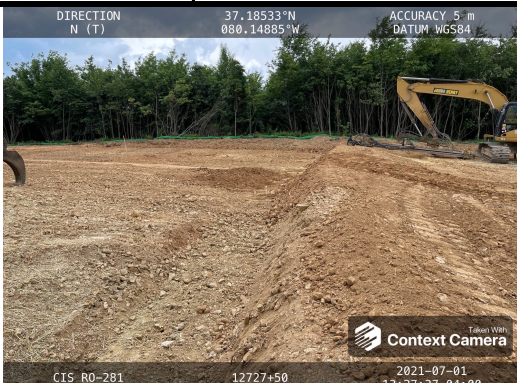
GPS Location	See photo		GPS Location	See photo	
Field Station#	12722+00		Field Station#	12727+50	
Pic 11 Desc.	Current ROW conditions on steep slope adjacent to streams S-Y13 and S-Y14		Pic 12 Desc.	Waterbar in compliance and functional

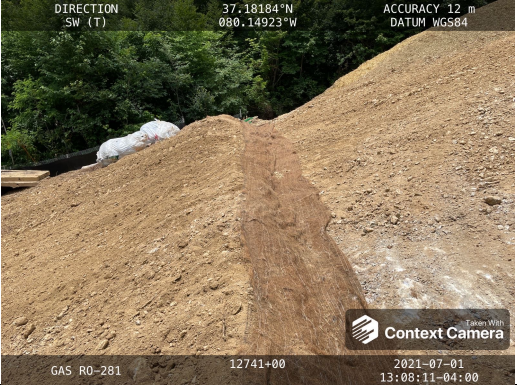
Context Camera GAS RO-281 12741+00 2021-07-01 13:08:11-04:00			
GPS Location	See photo		GPS Location	See photo	
Field Station#	12729+00		Field Station#	12741+00	
Pic 13 Desc.	Stockpiles stabilized at RO-281		Pic 14 Desc.	Waterbars Curlexed in steep slope area adjacent to Stream S-EF34B	
DIRECTION S (T) 37.18158°N 080.14914°W ACCURACY 4 m DATUM WGS84

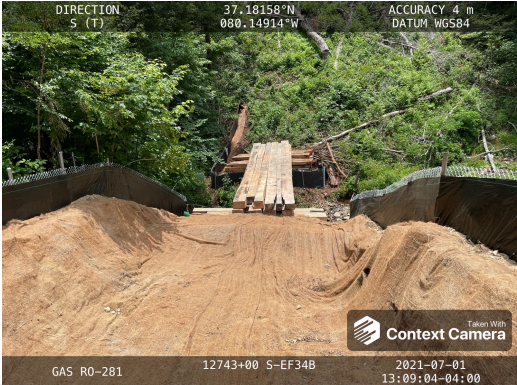
Pic 15 Desc.	Stream S-EF34B travel lane curlexed		Pic 16 Desc.	Buffer at S-EF34B stabilized	
DIRECTION W (T) 37.17923°N 080.14203°W ACCURACY 4 m DATUM WGS84   Context Camera CIS RO-282 12775+00 2021-07-01 13:54:26-04:00		DIRECTION SW (T) 37.17928°N 080.14196°W ACCURACY 4 m DATUM WGS84

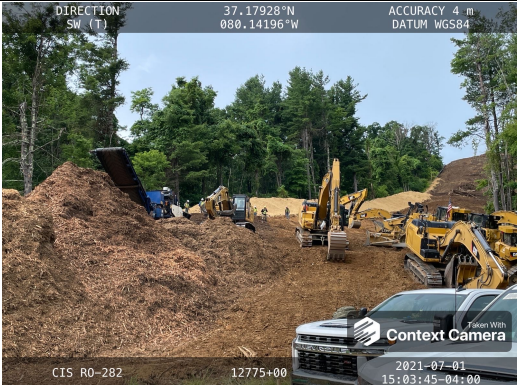
Context Camera CIS RO-282 12775+00 2021-07-01 15:03:45-04:00			
GPS Location	See photo		GPS Location	See photo	
Field Station#	12775+00		Field Station#	12775+00	
Pic 17 Desc.	Northern Crews hauling mulch at RO-282		Pic 18 Desc.	Precision reinstalling waterbars at end of day at RO-282

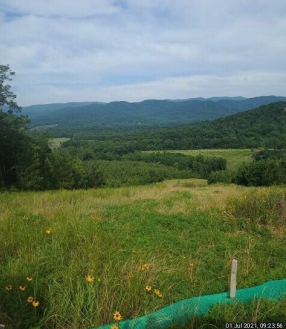
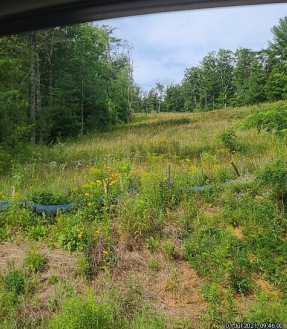
GPS Location	0000	GPS Location	0000		
Field Station#	13420+90	Field Station#	13422+00		
Pic 1 Desc.	Photo showing open ditch with safety panels in place . No environmental issues observed at the time of inspection.		Pic 2 Desc.	Row photo showing vegetation in permanent area. No issues observed at the time of inspection.	
	North East Elevation <small>244°SW (T) 37.090329, -80.020686 ±8 m ▲ 498 m</small>

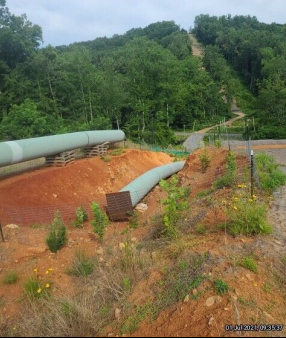
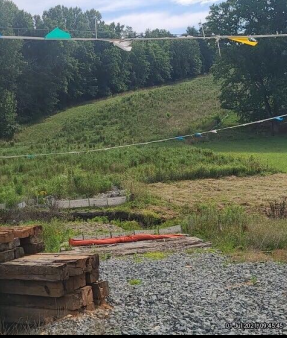
GPS Location	0000	GPS Location	0000		
Field Station#	13436+33	Field Station#	13496+62		
Pic 3 Desc.	Row photo observation of permanent vegetation area. Monitored ECDs . No environmental issues observed at the time of inspection.		Pic 4 Desc.	Vegetation observation photo. Monitored ECDs at road crossing with no environmental issues observed at the time of inspection.

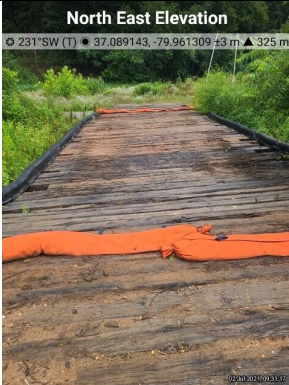
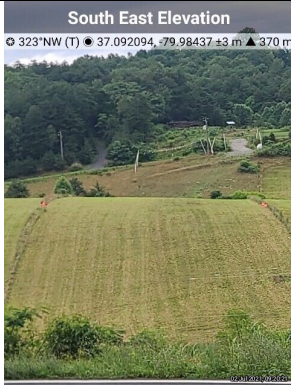
GPS Location	0000	GPS Location	00000		
Field Station#	13643+67	Field Station#	13564+00		
Pic 1 Desc.	Monitored equipment bridge and protection after overnight rain events. No environmental issues observed at the time of inspection.		Pic 2 Desc.	Photo showing area of row were a land owner has cut hay from . Monitored all ECDs in the area. No environmental issues observed at the time of inspection.	
	North East Elevation

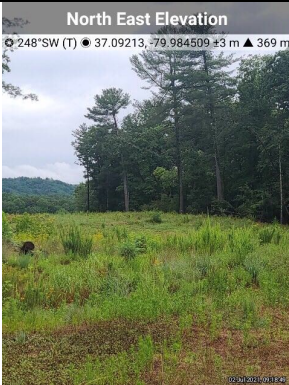
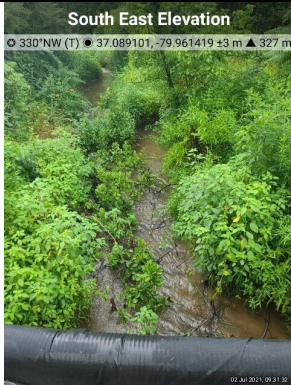
GPS Location	0000	GPS Location	00000		
Field Station#	13561+30	Field Station#	13643+67		
Pic 3 Desc.	Vegetation observation photo after recent overnight rain showers. No environmental issues observed at the time of inspection.		Pic 4 Desc.	Stream observation photo facing downstream during routine inspection today. No environmental issues observed at the time of inspection after recent overnight rain events.

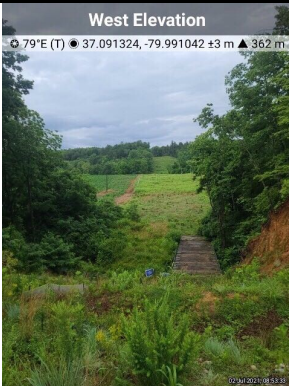
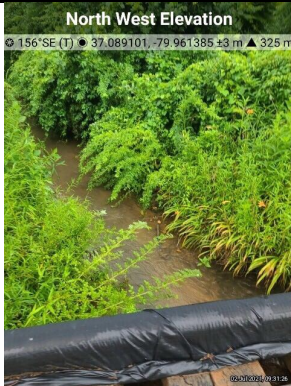
GPS Location	0000	GPS Location	00000		
Field Station#	13542+00	Field Station#	13643+67		
Pic 5 Desc.	Monitored ECDs and equipment bridge after recent rain events. No environmental issues observed at the time of inspection.		Pic 6 Desc.	Stream observation photo facing upstream during routine inspection today. No environmental issues observed at the time of inspection after overnight rain events.

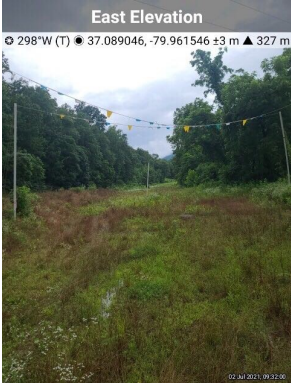
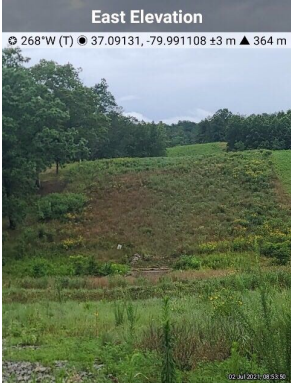
GPS Location	0000	GPS Location	0000		
Field Station#	13643+00	Field Station#	13541+50		
Pic 7 Desc.	Saturated row photo . Good vegetation coverage in the area. No environmental issues observed at the time of inspection.		Pic 8 Desc.	Row photo taken after recent rain events. Row conditions were saturated. No environmental issues observed at the time of inspection.	
Insert image here		Insert image here			
GPS Location		GPS Location			
Field Station#		Field Station#			
Pic 9 Desc.			Pic 10 Desc.		
Insert image here		Insert image here			
GPS Location		GPS Location			
Field Station#		Field Station#			
Pic 11 Desc.			Pic 12 Desc.

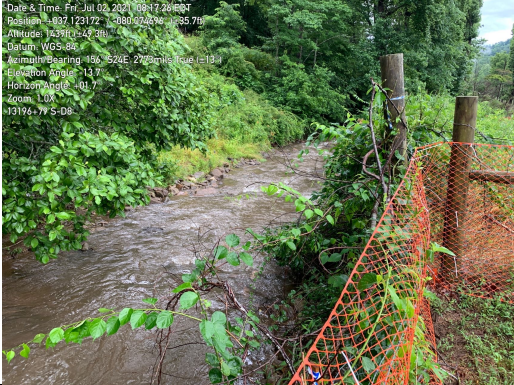
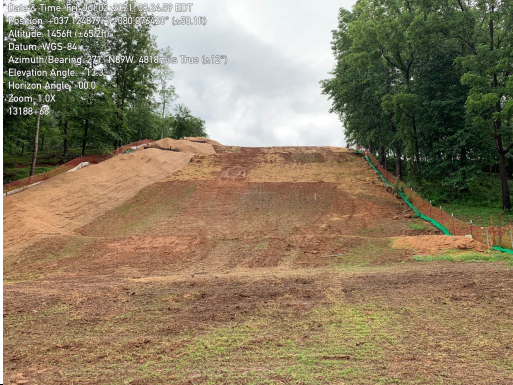
GPS Location	0	GPS Location	0		
Field Station#	13196+79	Field Station#	14188+66		
Pic 1 Desc.	MVP-S-D8 in good condition		Pic 2 Desc.	ROW and ECDs in good condition condition and stable after rain event

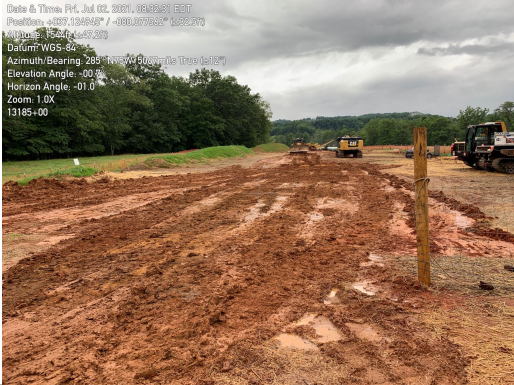
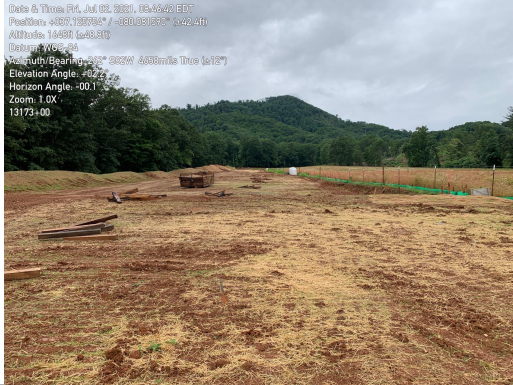
GPS Location	0	GPS Location	0		
Field Station#	13185+00	Field Station#	13173+00		
Pic 3 Desc.	Contractor removing saturated material and stockpiled it along ROW		Pic 4 Desc.	ROW and ECDs in good condition condition and stable after rain event

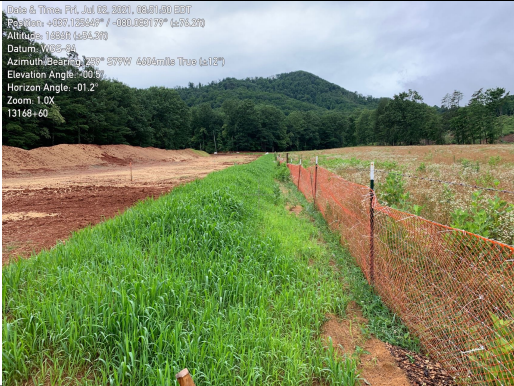
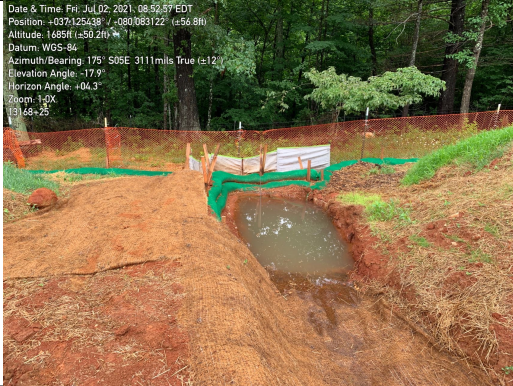
GPS Location	0	GPS Location	0		
Field Station#	13168+60	Field Station#	13168+25		
Pic 5 Desc.	Clean water diversion berm in good condition		Pic 6 Desc.	Sumps in good condition, they were working properly with very little sediment in them after the rain event

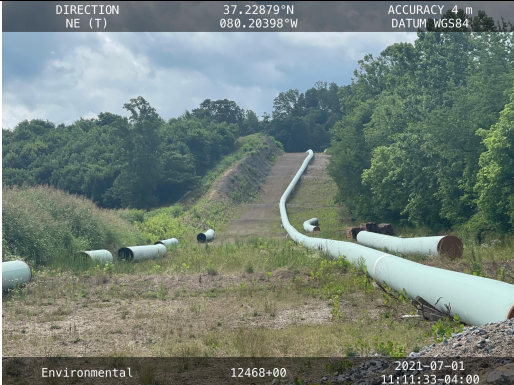
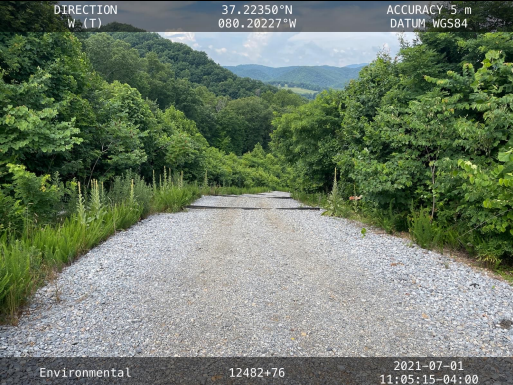
GPS Location	See photo		GPS Location	See photo	
Field Station#	12468+00		Field Station#	12482+76	
Pic 1 Desc.	Stabilized ROW in acceptable condition		Pic 2 Desc.	Access Road MVP-MLV-AR-28 in acceptable condition

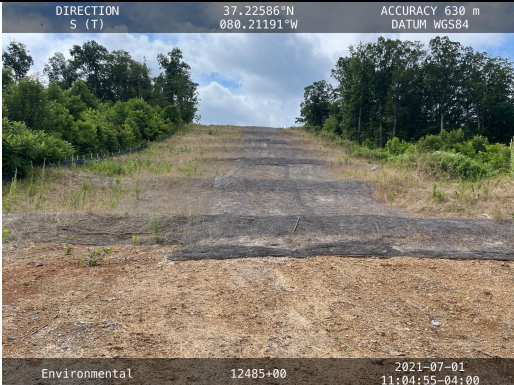
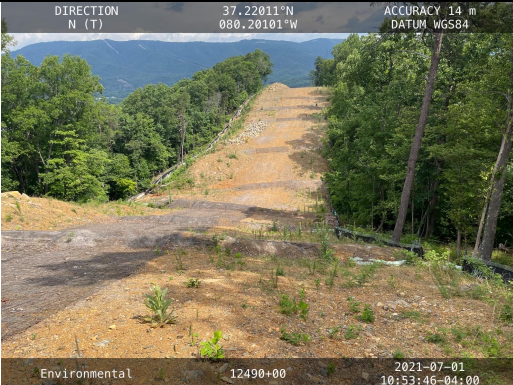
GPS Location	See photo		GPS Location	see photo	
Field Station#	12485+00		Field Station#	12490+00	
Pic 3 Desc.	Stabilized slope in acceptable condition		Pic 4 Desc.	Stabilized ROW in acceptable condition

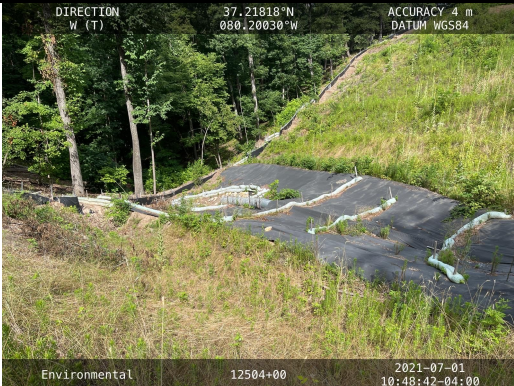
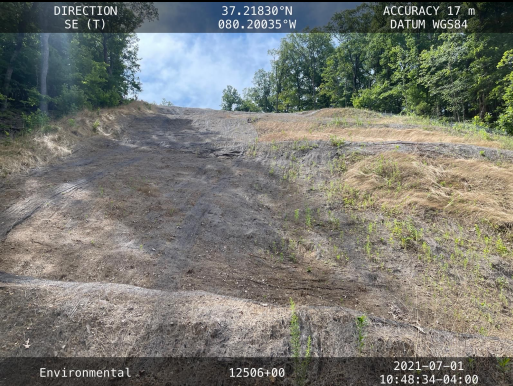
GPS Location	See photo		GPS Location	See photo	
Field Station#	12504+00		Field Station#	12506+00	
Pic 5 Desc.	Clean water crossing in acceptable condition		Pic 6 Desc.	Stabilized slope in acceptable condition

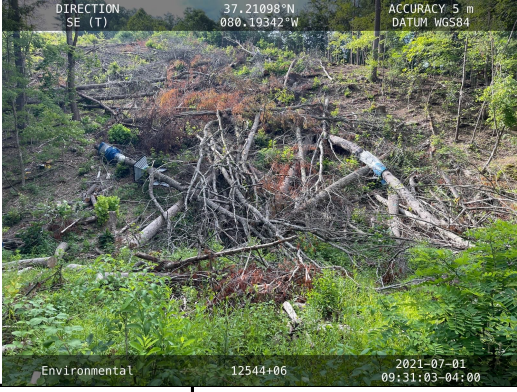
GPS Location	See photo		GPS Location	See photo	
Field Station#	12544+10		Field Station#	12544+06	
Pic 17 Desc.	ROW conditions		Pic 18 Desc.	Stabilized cut caused by the opposition extraction

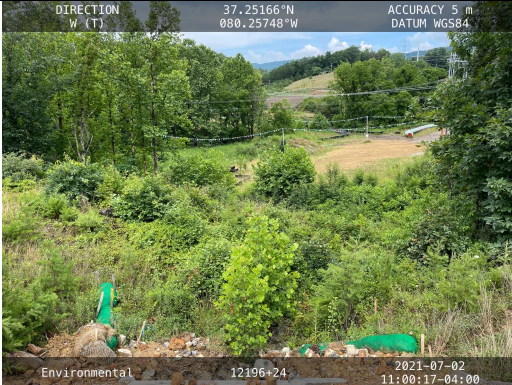
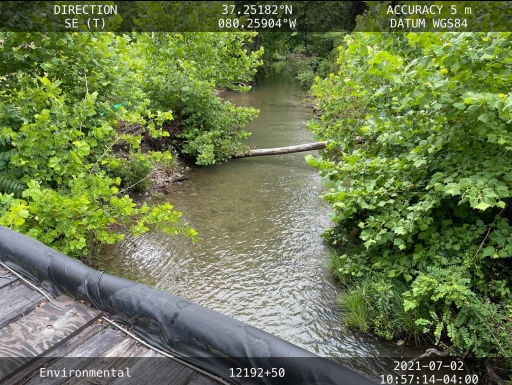
GPS Location	See photo		GPS Location	See photo	
Field Station#	12196+24		Field Station#	12192+50	
Pic 1 Desc.	Stream crossing S-OO11 on the COS of the railroad crossing		Pic 2 Desc.	Down stream of S-C21 in acceptable condition

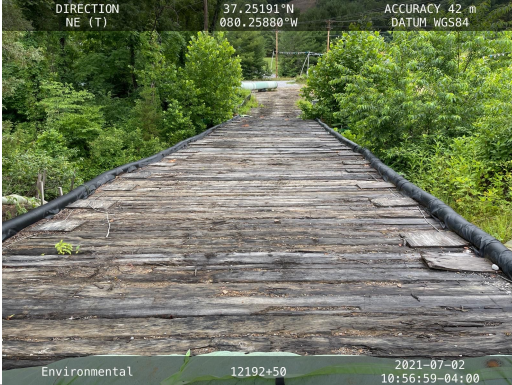
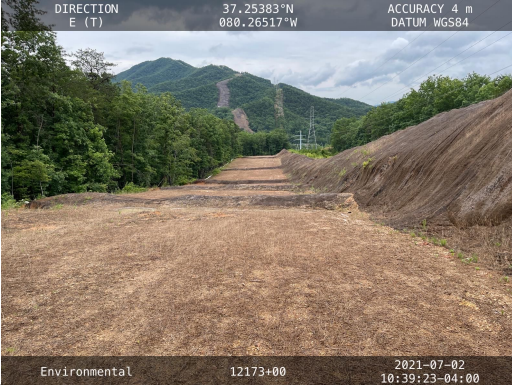
GPS Location	see photo		GPS Location	see photo	
Field Station#	12192+50		Field Station#	12173+00	
Pic 3 Desc.	Bridge and ECDs crossing S-C21 in acceptable condition		Pic 4 Desc.	Stabilized ROW in acceptable condition

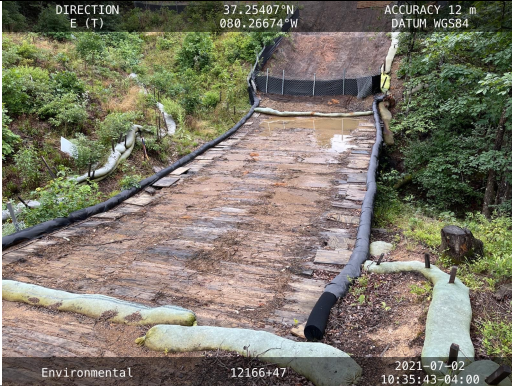
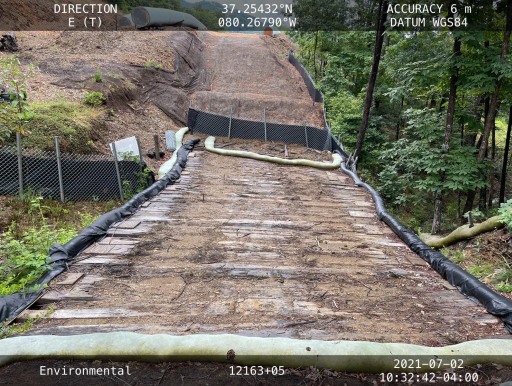
GPS Location	See photo		GPS Location	See photo	
Field Station#	12166+47		Field Station#	12163+05	
Pic 5 Desc.	Bridge and ECDs crossing S-C24 in acceptable condition		Pic 6 Desc.	Bridge and ECDs crossing S-C25 in acceptable condition

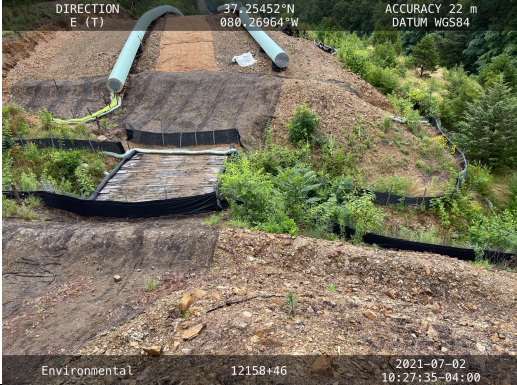
GPS Location	See photo		GPS Location	See photo	
Field Station#	12159+50		Field Station#	12158+46	
Pic 7 Desc.	Fill slope drain in acceptable condition		Pic 8 Desc.	Clean water crossing in acceptable condition
