Visual Site Inspection Report

Project Name	H-600 Pipeline Spread H	AFE	124300138	Spread	H-600 Pipeline Spread H
Contractor	Precision			Report #	25087
Inspector	Logan Box			Date/Time	6/28/2021 3:55 PM
Permit #	TBD	Inspection Type	VA SWPP	Station Begin	13525+99
State	VA	Inspection Area	Partial	Station End	13670+00
County	Franklin	Ground	Dry	Temperature (°F)	90.00
Municipality	N/A	Weather	Sunny	Rain Gauge (in)	0.00
				Rain Accumulation Time (days)	0.00

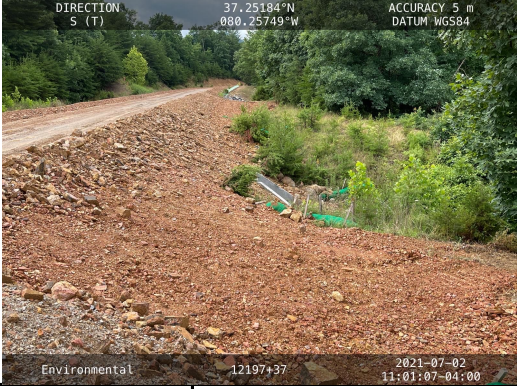
GPS Location	See photo		GPS Location	See photo	
Field Station#	12197+37		Field Station#	12197+50	
Pic 15 Desc.	Railroad to road conversion progress and conditions.		Pic 16 Desc.	Railroad to road conversion progress and conditions.

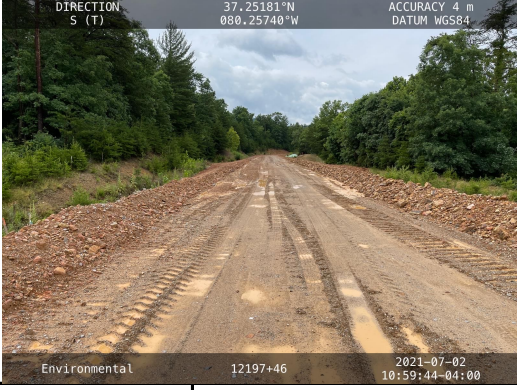
GPS Location	See photo		GPS Location	See photo	
Field Station#	12197+46		Field Station#	12197+46	
Pic 17 Desc.	Railroad to road conversion progress and conditions.		Pic 18 Desc.	Railroad to road conversion progress and conditions.
