Visual Site Inspection Report

Project Name	H-600 Pipeline Spread H	AFE	124300138	Spread	H-600 Pipeline Spread H
Contractor	Precision			Report #	25411
Inspector	Bryan Cole			Date/Time	7/5/2021 6:26 PM
Permit #	TBD	Inspection Type	VA SWPP	Station Begin	13316+21
State	VA	Inspection Area	Partial	Station End	13422+00
County	Franklin	Ground	Dry	Temperature (°F)	93.00
Municipality	N/A	Weather	Sunny	Rain Gauge (in)	0.00
				Rain Accumulation Time (days)	0.00

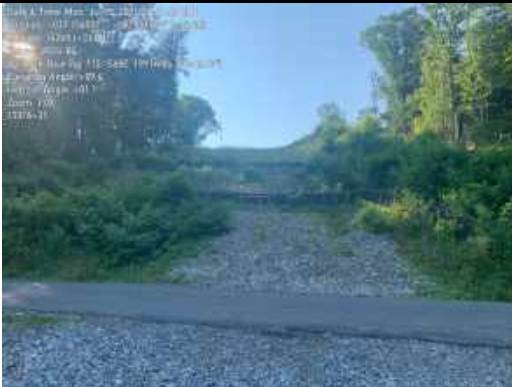
GPS Location				0				GPS Location				0			
Field Station#				13316+21				Field Station#				13317+02			
Pic 1 Desc.				Wades Gap Road Crossing in good condition and RCE in good condition and functioning properly				Pic 2 Desc.				Private driveway in good condition

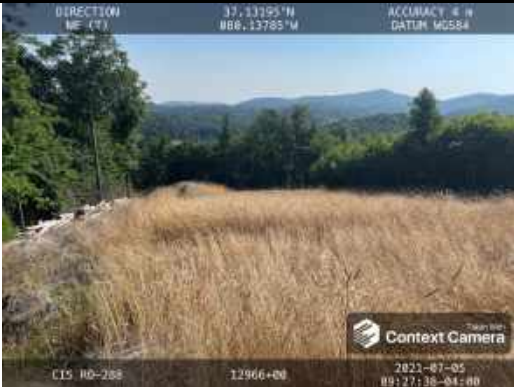
GPS Location	See photo		GPS Location	See photo	
Field Station#	12966+00		Field Station#	12968+00	
Pic 1 Desc.	Current ROW conditions on CIS of RO-288		Pic 2 Desc.	Current ROW conditions on CIS of RO-288

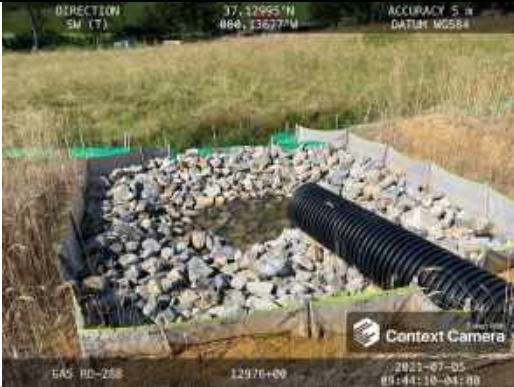
GPS Location	See photo		GPS Location	See photo	
Field Station#	12976+00		Field Station#	12979+00	
Pic 3 Desc.	CWD outlet and plunge pool		Pic 4 Desc.	Current ROW conditions on GAS of RO-288

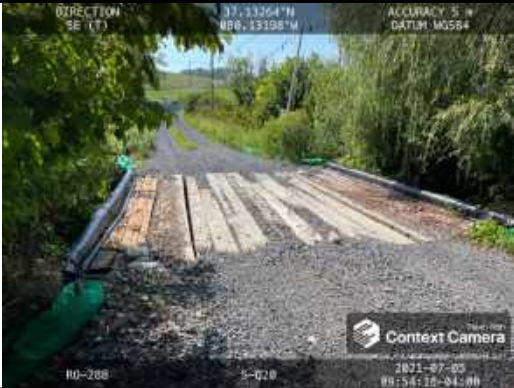
GPS Location	See photo		GPS Location	See photo	
Field Station#	+0		Field Station#	12966+00	
Pic 5 Desc.	Stream S-Q20 on RO-288		Pic 6 Desc.	Current ROW on GAS of 221

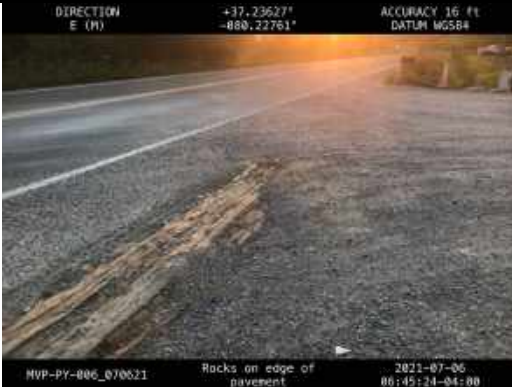
GPS Location	MVP-PY-006 See photo for gps data		GPS Location	MVP-PY-006 See photo for gps data	
Field Station#	+0		Field Station#	+0	
Pic 1 Desc.	MVP-PY-006 north rock entrance stone on pavement edge. Looking E.		Pic 2 Desc.	MVP-PY-006 north rock entrance stone swept back from pavement edge. Looking E.

E&S BMPs	Compliance Level	Corrective Action	Corrective Time Frame	Date Repaired
Compost Filter Sock	Acceptable			
Housekeeping	Acceptable			
Rock Construction Entrance	Communication	Swept stone away from pavement	Addressed	7/6/2021
Secondary Containment	Acceptable			
Sensitive Resource Buffer	Acceptable			
Sensitive Resource Signage	Acceptable			
Waste Management	Acceptable

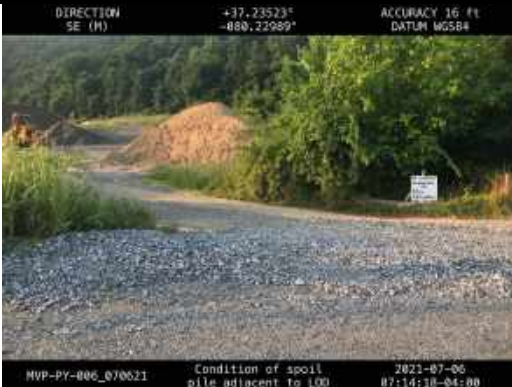
GPS Location	MVP-PY-006 See photo for gps data		GPS Location	MVP-PY-006 See photo for gps data	
Field Station#	+0		Field Station#	+0	
Pic 3 Desc.	Condition of spoil pile adjacent to LOD on VDOT property. Not stabilized. Looking SW.		Pic 4 Desc.	Condition of signage and compost filter sock along feature W-008. Over grown with vegetation. Looking E.

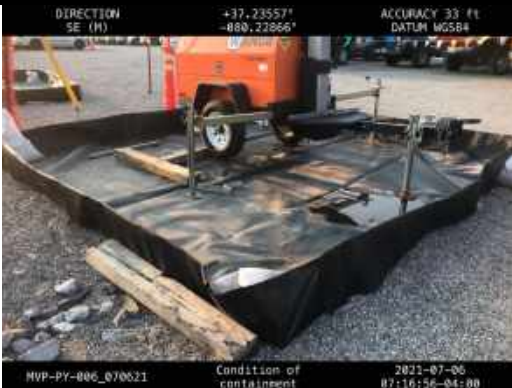
GPS Location	MVP-PY-006 See photo for gps data		GPS Location	MVP-PY-006 See photo for gps data	
Field Station#	+0		Field Station#	+0	
Pic 5 Desc.	Condition of containment holding light plant. Free of stormwater. Looking SE.		Pic 6 Desc.	Blue Bulk Fuel tanks no fuel spills south of the tanks. Looking NE.

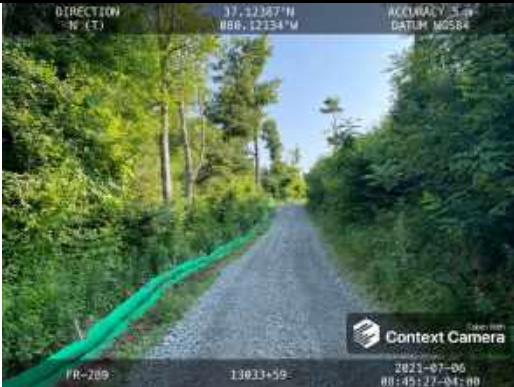
GPS Location	See photo		GPS Location	See photo	
Field Station#	13033+59		Field Station#	13024+50	
Pic 1 Desc.	Access road FR-289 maintained		Pic 2 Desc.	Streams S-G24 and S-G25 on CIS of FR-289

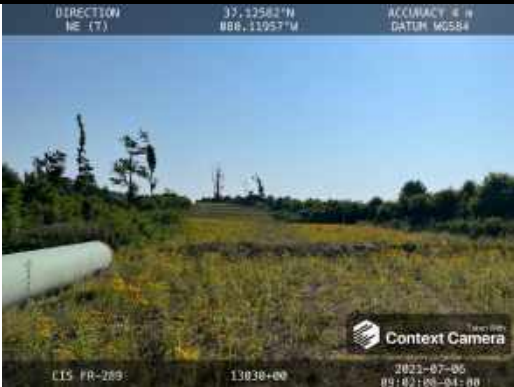
GPS Location	See photo		GPS Location	See photo	
Field Station#	13030+00		Field Station#	13040+00	
Pic 3 Desc.	Current ROW conditions on CIS of FR-289		Pic 4 Desc.	Current ROW conditions on GAS of FR-289

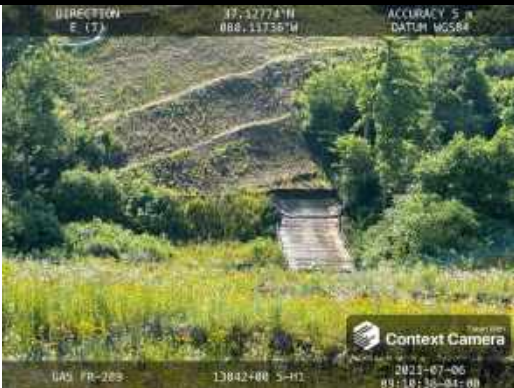
GPS Location	See photo		GPS Location	See photo	
Field Station#	13042+00		Field Station#	13059+00	
Pic 5 Desc.	Stream S-H1 on GAS of FR-289		Pic 6 Desc.	Current ROW conditions at FR-290

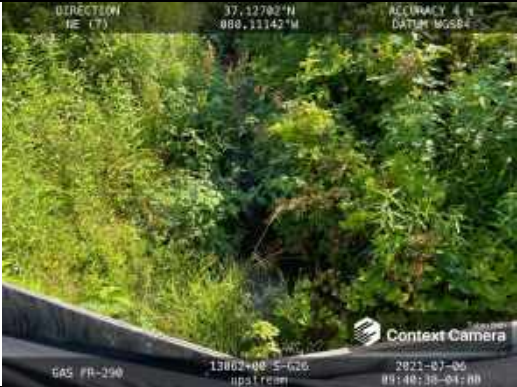
GPS Location	See photo		GPS Location	See photo	
Field Station#	13062+00		Field Station#	13063+00	
Pic 7 Desc.	Upstream of Stream S-G26		Pic 8 Desc.	Downstream of Stream S-G27

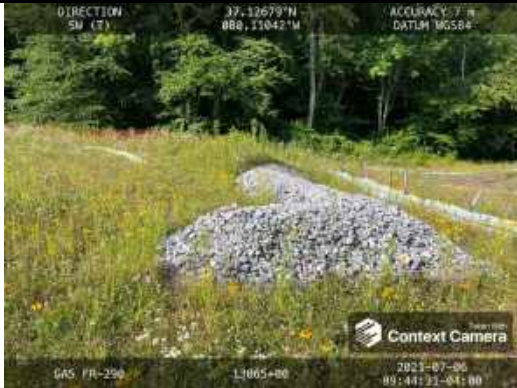
GPS Location	See photo		GPS Location	See photo	
Field Station#	13065+00		Field Station#	13066+50	
Pic 9 Desc.	Level Spreader and permanent slope breaker on GAS FR-290		Pic 10 Desc.	Current ROW conditions on GAS of FR-290

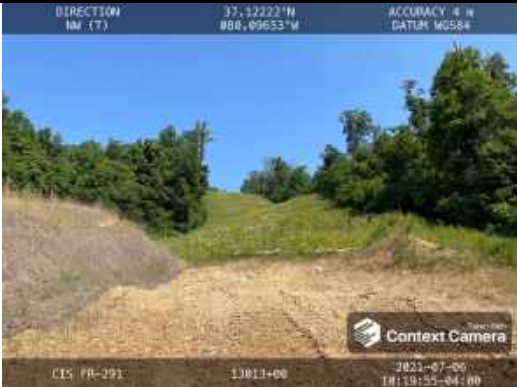
GPS Location	See photo		GPS Location	See photo	
Field Station#	13061+44		Field Station#	13013+00	
Pic 11 Desc.	Stream S-RR16 on FR-290		Pic 12 Desc.	End of restoration on CIS of FR-291

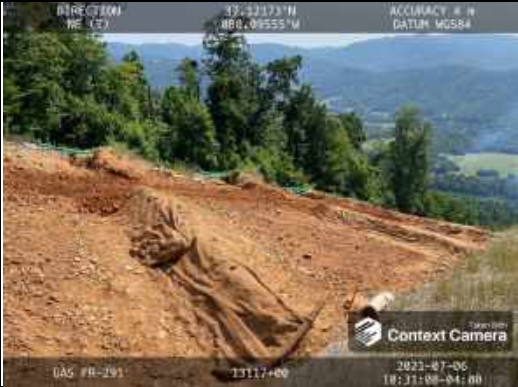
GPS Location	See photo		GPS Location	See photo	
Field Station#	13117+00		Field Station#	13137+33	
Pic 13 Desc.	Current ROW conditions on GAS FR-291		Pic 14 Desc.	Stream S-D17 on CIS FR-292

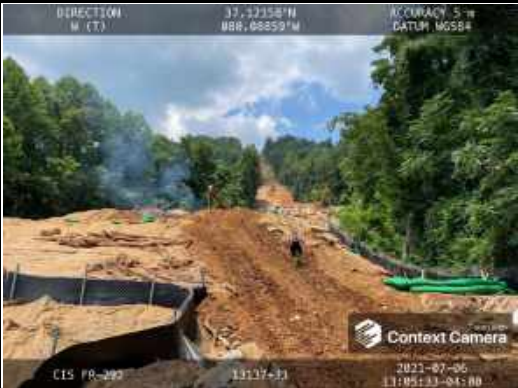
GPS Location	See photo		GPS Location	See	
Field Station#	13137+33		Field Station#	13141+53	
Pic 15 Desc.	Current ROW conditions on CIS FR-292		Pic 16 Desc.	Stream S-D14 on FR-292

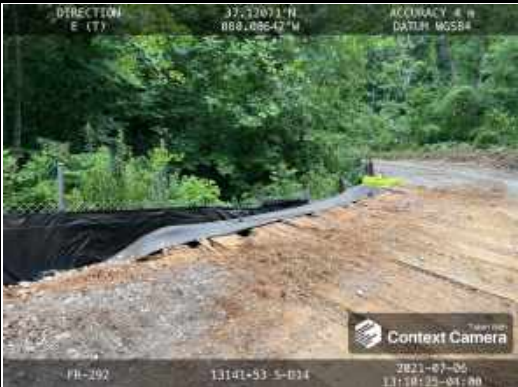
GPS Location	See photo		GPS Location	See photo	
Field Station#	13141+53		Field Station#	13141+53	
Pic 17 Desc.	Bridge over Stream S-D14 on FR-292		Pic 18 Desc.	Gravel stockpiled on FR-292

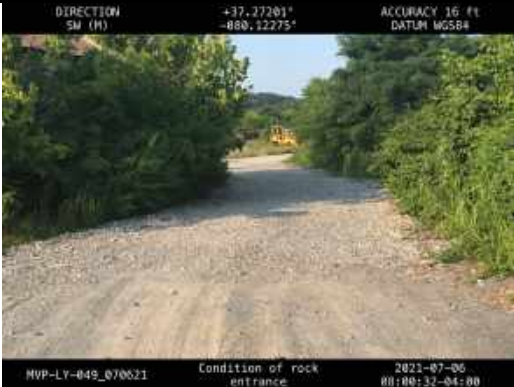
GPS Location	MVP-LY-049 See photo for gps data		GPS Location	MVP-LY-049 See photo for gps data	
Field Station#	+0		Field Station#	+0	
Pic 1 Desc.	Condition of rock entrance on north drive. No sediment on stone. Looking SW.		Pic 2 Desc.	Condition of triple stack compost filter sock and safety fence along east side of center drive. Looking N.

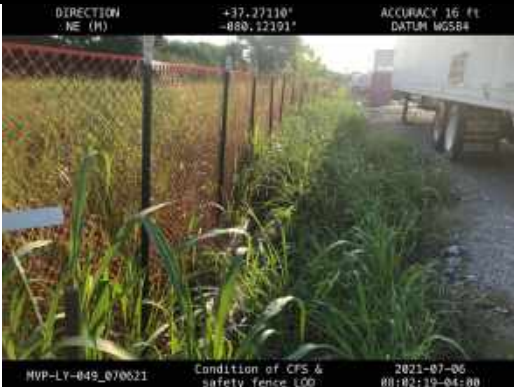
GPS Location	MVP-LY-049 See photo for gps data		GPS Location	MVP-LY-049 See photo for gps data	
Field Station#	+0		Field Station#	+0	
Pic 3 Desc.	Condition of triple stack compost filter sock and safety fence along north LOD. Looking NE.		Pic 4 Desc.	Condition of containment holding light plant. Free of stormwater. Looking SW.

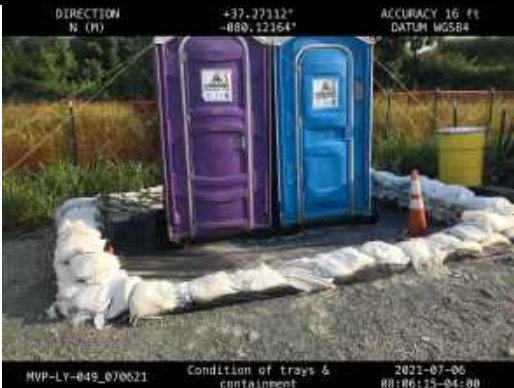
Pic 5 Desc.	Condition of trays and containment under toilets. Looking N.		Pic 6 Desc.	Condition of containment under generator. Free of fluids. Looking NW.

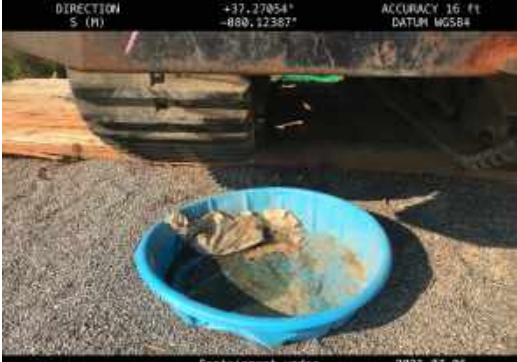
GPS Location	MVP-LY-049 See photo for gps data		GPS Location	MVP-LY-049 See photo for gps data	
Field Station#	+0		Field Station#	+0	
Pic 13 Desc.	Condition of containment under stored equipment. Looking S.		Pic 14 Desc.	No loose trash around north dumpster or in the yard. Looking SE.

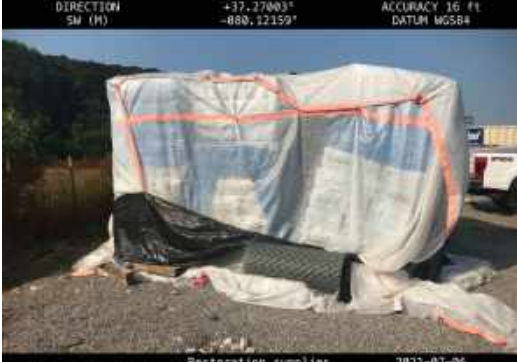
GPS Location	MVP-LY-049 See photo for gps data		GPS Location	MVP-LY-049 See photo for gps data	
Field Station#	+0		Field Station#	+0	
Pic 17 Desc.	Restoration supplies under cover. Looking SW.		Pic 18 Desc.	Compost filter sock around sand pile in place and functioning. Looking S.

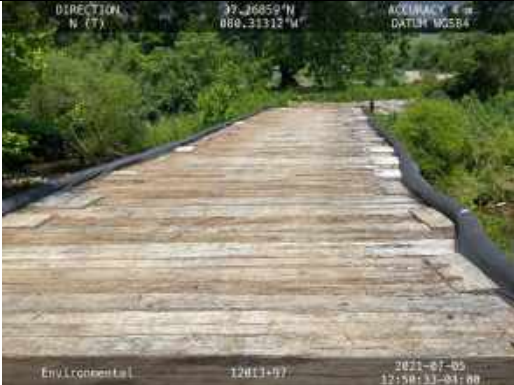
GPS Location	See photo		GPS Location	See photo	
Field Station#	12013+97		Field Station#	12010+00	
Pic 1 Desc.	Bridge and ECDs at stream crossing S-G36 in acceptable condition		Pic 2 Desc.	Stabilized slope in acceptable condition

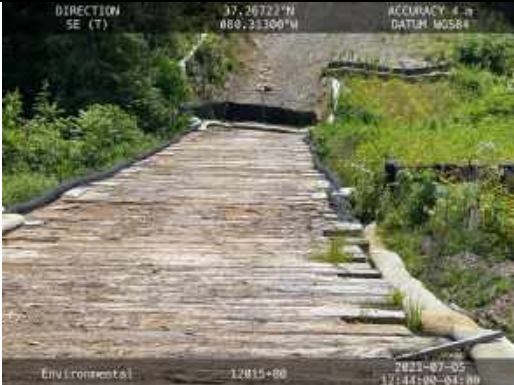
GPS Location	See photo		GPS Location	See photo	
Field Station#	12015+80		Field Station#	12040+00	
Pic 3 Desc.	Bridge and ECDs at stream crossing S-G38 in acceptable condition		Pic 4 Desc.	Stabilized slope in acceptable condition

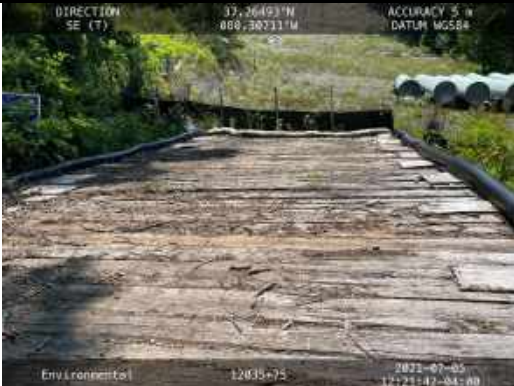
GPS Location	See photo		GPS Location	See photo	
Field Station#	12035+75		Field Station#	12035+11	
Pic 5 Desc.	Bridge and ECDs at stream crossing S-PP22 in acceptable condition		Pic 6 Desc.	Bridge and ECDs at stream crossing S-G40 in acceptable condition

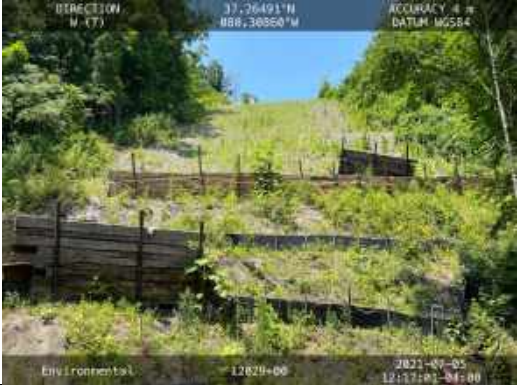
GPS Location	See photo		GPS Location	See photo	
Field Station#	12029+00		Field Station#	12031+51	
Pic 7 Desc.	Stabilized slope in acceptable condition		Pic 8 Desc.	Bridge and ECDs at stream crossing S-G39 in acceptable condition

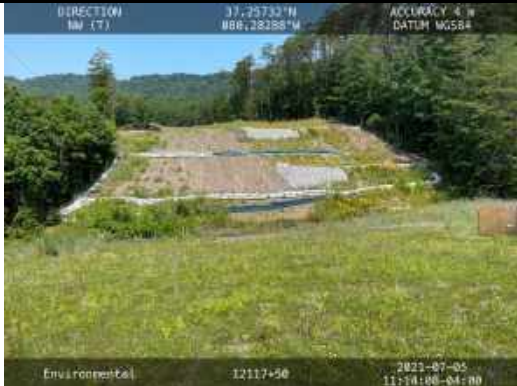
GPS Location	See photo		GPS Location	See photo	
Field Station#	12117+50		Field Station#	12112+13	
Pic 9 Desc.	Stabilized ROW in acceptable condition		Pic 10 Desc.	Bridge and ECDs at stream crossing S-F16A/B in acceptable condition

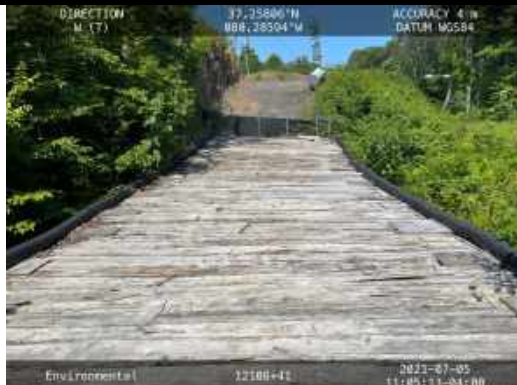
GPS Location	See photo		GPS Location	See photo	
Field Station#	12108+41		Field Station#	12102+00	
Pic 11 Desc.	Bridge and ECDs at stream crossing S-F15 in acceptable condition		Pic 12 Desc.	RCE in acceptable condition

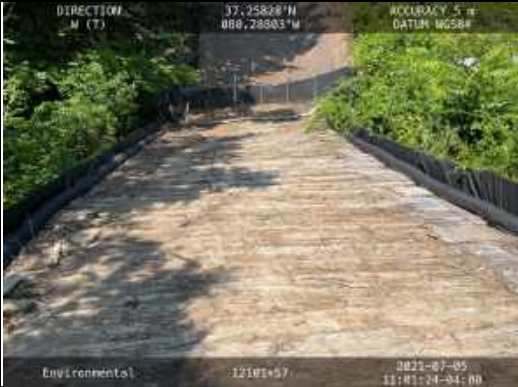
GPS Location	See photo		GPS Location	See photo	
Field Station#	12101+57		Field Station#	12098+44	
Pic 13 Desc.	Bridge and ECDs at stream crossing S-MM11 in acceptable condition		Pic 14 Desc.	Bridge and ECDs at stream crossing S-MM13 in acceptable condition

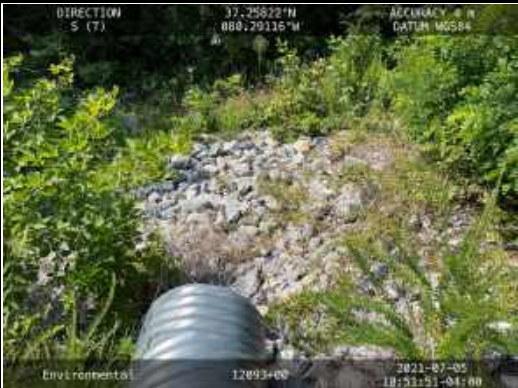
GPS Location	See photo		GPS Location	See photo	
Field Station#	12093+00		Field Station#	12086+56	
Pic 15 Desc.	Clean water crossing pipe outlet in acceptable condition		Pic 16 Desc.	Bridge and ECDs at stream crossing S-MM14 in acceptable condition

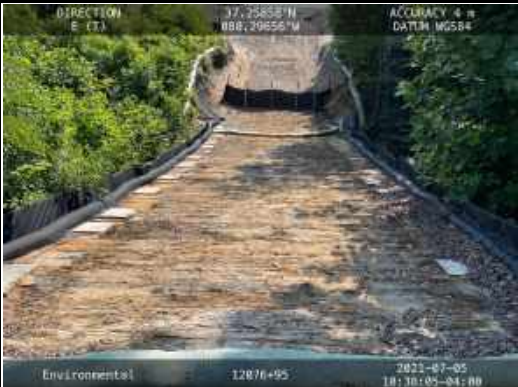
GPS Location	See photo		GPS Location	See photo	
Field Station#	12076+95		Field Station#	12070+00	
Pic 17 Desc.	Bridge and ECDs at stream crossing S-MM15 in acceptable condition		Pic 18 Desc.	Stabilized slope in acceptable condition

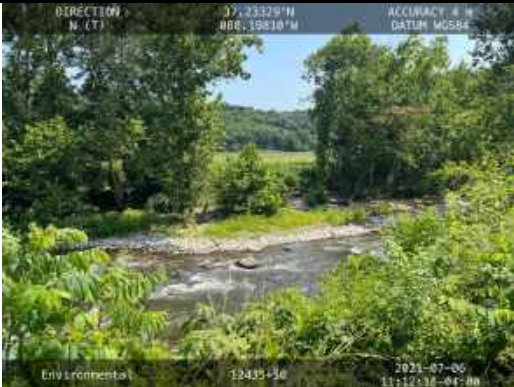
GPS Location	See photo		GPS Location	See photo	
Field Station#	12435+50		Field Station#	12424+01	
Pic 1 Desc.	Stream crossing S-NN16 in acceptable condition		Pic 2 Desc.	Access Road MVP-MN-279 in acceptable condition

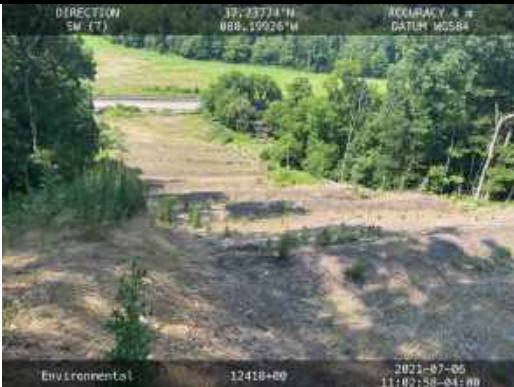
GPS Location	See photo		GPS Location	See photo	
Field Station#	12418+00		Field Station#	12410+20	
Pic 3 Desc.	Stabilized slope in acceptable condition		Pic 4 Desc.	Clean water crossing pipe outlet in acceptable condition

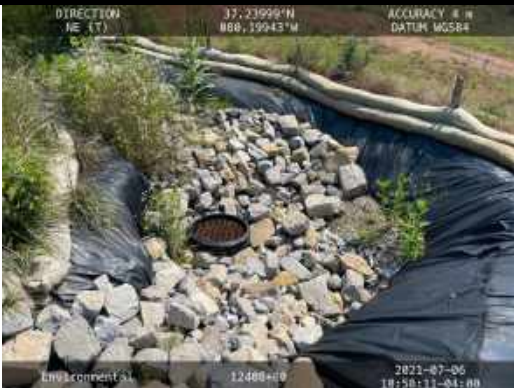
GPS Location	See photo		GPS Location	See photo	
Field Station#	12408+80		Field Station#	12393+23	
Pic 5 Desc.	Clean water crossing pipe inlet in acceptable condition		Pic 6 Desc.	Stabilized ROW in acceptable condition

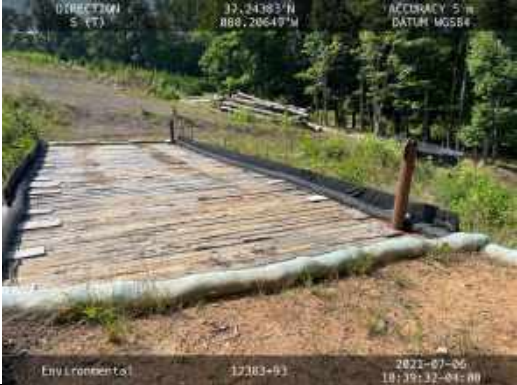
GPS Location	See photo		GPS Location	See photo	
Field Station#	12383+93		Field Station#	12380+04	
Pic 7 Desc.	Clean water crossing in acceptable condition		Pic 8 Desc.	Bridge and ECDs at stream crossing S-NN19 in acceptable condition

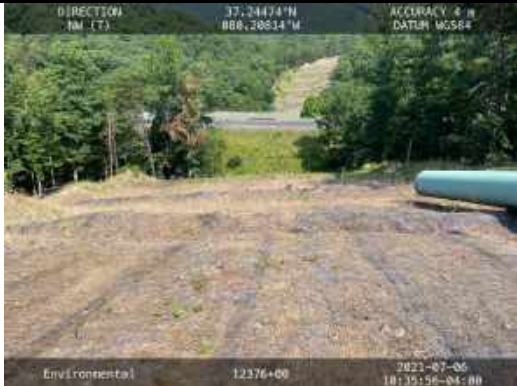
GPS Location	See photo		GPS Location	See photo	
Field Station#	12376+00		Field Station#	12374+16	
Pic 9 Desc.	Stabilized ROW in acceptable condition		Pic 10 Desc.	Stream crossing S-OO16 in acceptable condition

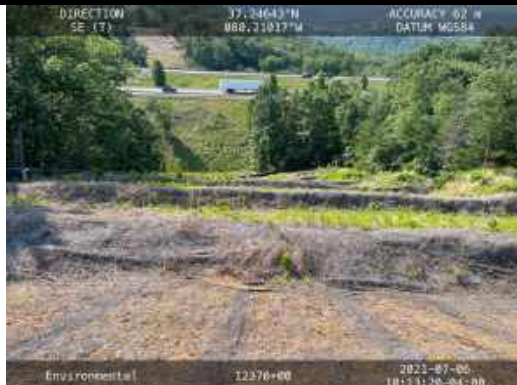
GPS Location	See photo		GPS Location	See photo	
Field Station#	12370+00		Field Station#	12361+02	
Pic 11 Desc.	Stabilized ROW in acceptable condition		Pic 12 Desc.	Stabilized ROW in acceptable condition

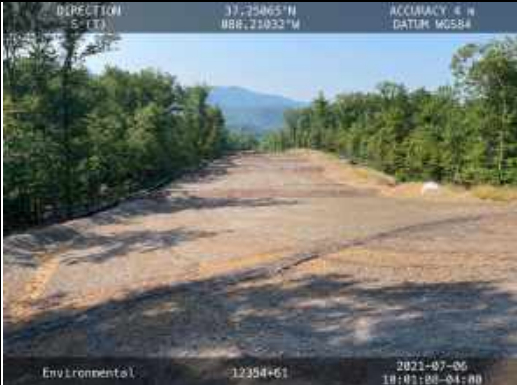
GPS Location	See photo		GPS Location	See photo	
Field Station#	12354+61		Field Station#	12331+50	
Pic 13 Desc.	Stabilized ROW in acceptable condition		Pic 14 Desc.	Fill slope drain pipe in acceptable condition

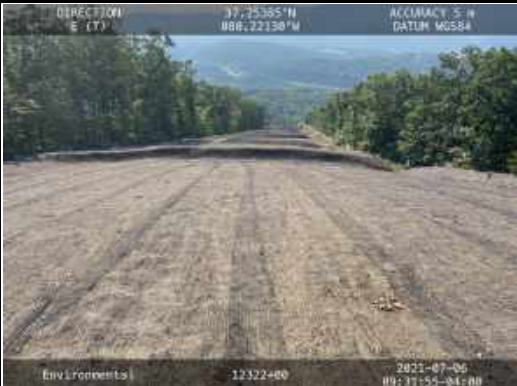
GPS Location	See photo		GPS Location	See photo	
Field Station#	12322+00		Field Station#	12300+00	
Pic 15 Desc.	Stabilized ROW in acceptable condition		Pic 16 Desc.	Stabilized ROW in acceptable condition

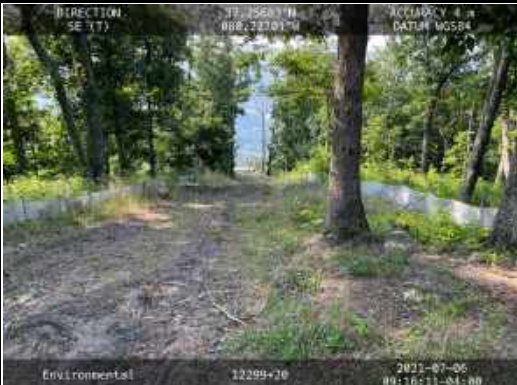
GPS Location	See photo		GPS Location	See photo	
Field Station#	12299+20		Field Station#	12296+00	
Pic 17 Desc.	Stabilized access Road in acceptable condition		Pic 18 Desc.	Stabilized ROW in acceptable condition

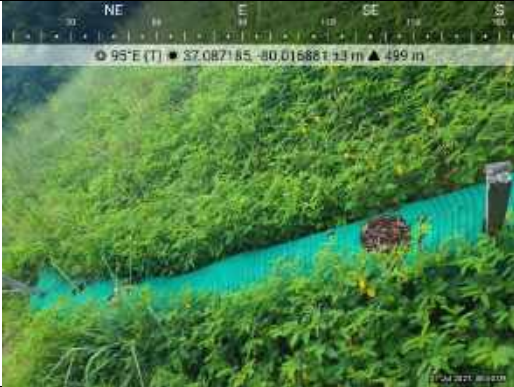
GPS Location	00000	GPS Location	0000		
Field Station#	13454+90	Field Station#	13465+30		
Pic 1 Desc.	CFS requires maintenance due to being weathered and torn. Documented and added to the punch list, contractor on site and making repairs.		Pic 2 Desc.	CFS requires maintenance due to being weathered and torn. Documented and added to the punch list, contractor on site and making repairs.

E&S BMPs	Compliance Level	Corrective Action	Corrective Time Frame	Date Repaired
Compost Filter Sock	Acceptable	Repaired CFS as needed	Immediate	7/7/2021
Rock Construction Entrance	Acceptable			
Vegetative Stabilization (Permanent)	Acceptable			
Equipment Bridge	Acceptable

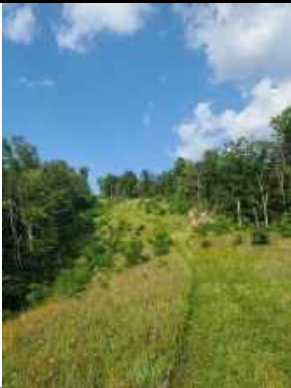
GPS Location	00000	GPS Location	0000		
Field Station#	13465+09	Field Station#	13455+90		
Pic 3 Desc.	CFS requires maintenance due to being weathered and torn. Documented and added to the punch list, contractor on site and making repairs.		Pic 4 Desc.	CFS repaired by the contractor.

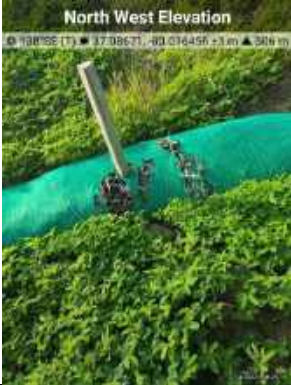
<p>Insert image here</p>		<p>Insert image here</p>	
GPS Location	00000	GPS Location			
Field Station#	13455+90	Field Station#			
Pic 7 Desc.	CFS requires maintenance due to being weathered and torn. Documented and added to the punch list, contractor on site and making	Pic 8 Desc.			
<p>Insert image here</p>		<p>Insert image here</p>			
GPS Location		GPS Location			
Field Station#		Field Station#			
Pic 9 Desc.		Pic 10 Desc.			
<p>Insert image here</p>		<p>Insert image here</p>			
GPS Location		GPS Location			
Field Station#		Field Station#			
Pic 11 Desc.		Pic 12 Desc.

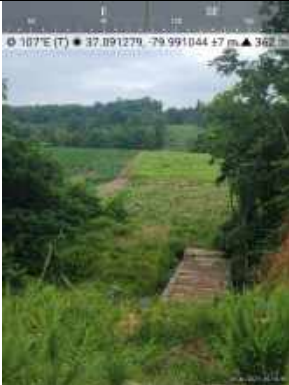
GPS Location	0000	GPS Location	0000		
Field Station#	13541+81	Field Station#	13540+00		
Pic 1 Desc.	Monitored equipment bridge and protection during light rain events today.		Pic 2 Desc.	Row photo showing good vegetation. No environmental issues observed at the time of inspection.

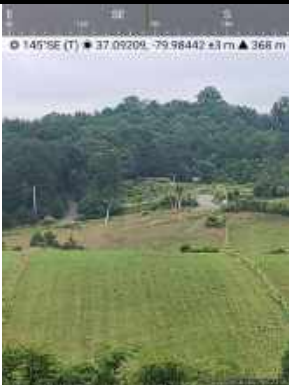
GPS Location	00000	GPS Location	00000		
Field Station#	13563+62	Field Station#	1356+00		
Pic 3 Desc.	Follow up photo taken where a land owner previously cut hay from the row.. good coverage noted with no environmental issues observed.		Pic 4 Desc.	Row photo showing vegetation growth with good coverage.

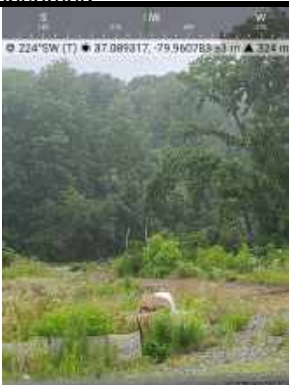
GPS Location	00000	GPS Location	00000		
Field Station#	13643+31	Field Station#	13649+00		
Pic 5 Desc.	Row photo taken at Leaning Oak road crossing during rain events		Pic 6 Desc.	Row photo taken during rain events showing where a land owner has cut hay inside the LOD.

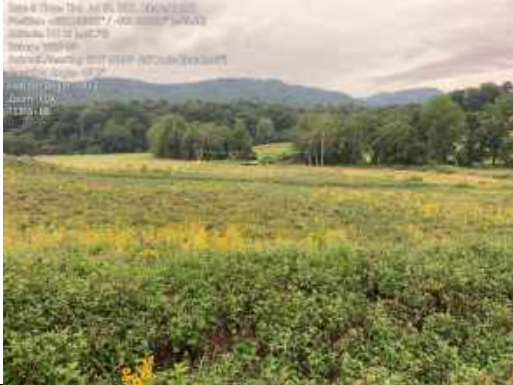
GPS Location	0	GPS Location	0		
Field Station#	13314+00	Field Station#	13309+09		
Pic 1 Desc.	ROW and ECDs in good condition, with good vegetation establishing across LOD.		Pic 2 Desc.	MVP-S-GH7 in good condition

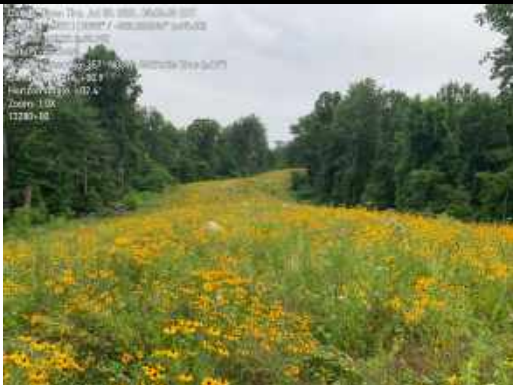
GPS Location	0	GPS Location	0		
Field Station#	13280+00	Field Station#	13262+62		
Pic 3 Desc.	ROW and ECDs in good condition, with good vegetation establishing across LOD.		Pic 4 Desc.	Flanders Road Crossing in good condition

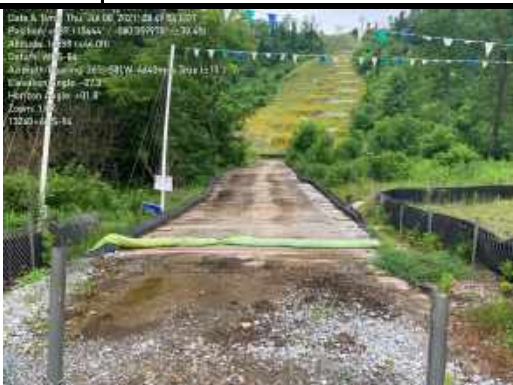
GPS Location	0	GPS Location	0		
Field Station#	13260+66	Field Station#	13259+00		
Pic 5 Desc.	MVP-S-II4 in good condition		Pic 6 Desc.	ROW and ECDs in good condition, with good vegetation establishing across LOD.

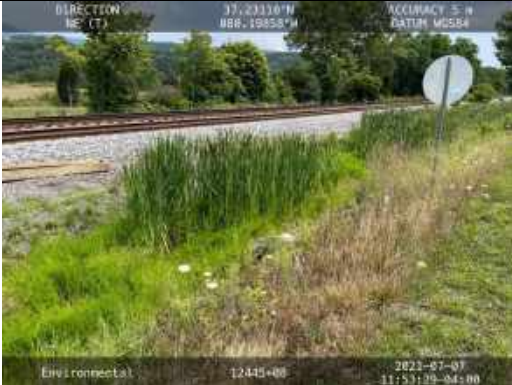
GPS Location	See photo		GPS Location	See photo	
Field Station#	12445+08		Field Station#	12445+86	
Pic 1 Desc.	Stream crossing S-I1		Pic 2 Desc.	Stabilized ATWS in acceptable condition

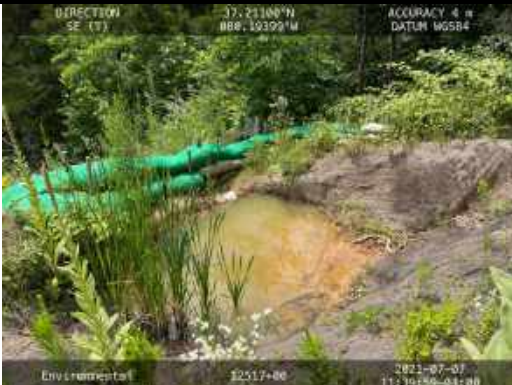
GPS Location	See photo		GPS Location	See photo	
Field Station#	12517+00		Field Station#	12541+00	
Pic 3 Desc.	Sump pit and water bar end treatment in acceptable condition		Pic 4 Desc.	Plastic covered stabilized spoil pile in acceptable condition

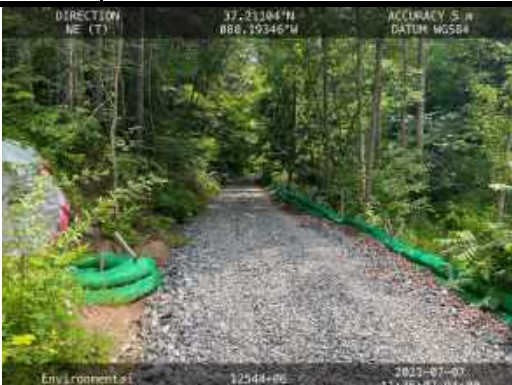
GPS Location	See photo		GPS Location	See photo	
Field Station#	12544+06		Field Station#	12544+15	
Pic 5 Desc.	Access Road MVP-MN-278.01 in acceptable condition		Pic 6 Desc.	Wetland W-EF5 and S-EF20 buffer zones in acceptable condition

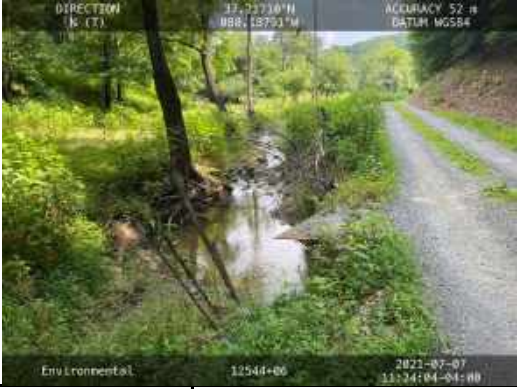
GPS Location	See photo	GPS Location	See photo		
Field Station#	12544+06	Field Station#	12544+06		
Pic 7 Desc.	Stream S-EF20b in acceptable condition	Pic 8 Desc.	Stream S-KL32 in acceptable condition

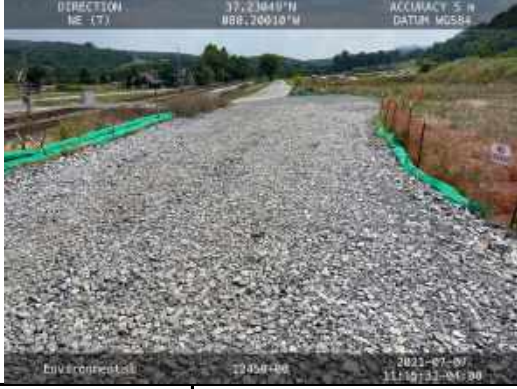
GPS Location	See photo	GPS Location	See photo		
Field Station#	12450+00	Field Station#	12455+21		
Pic 9 Desc.	RCE clean and in acceptable condition	Pic 10 Desc.	Bridge and ECDs at stream crossing S-CD12 in acceptable condition

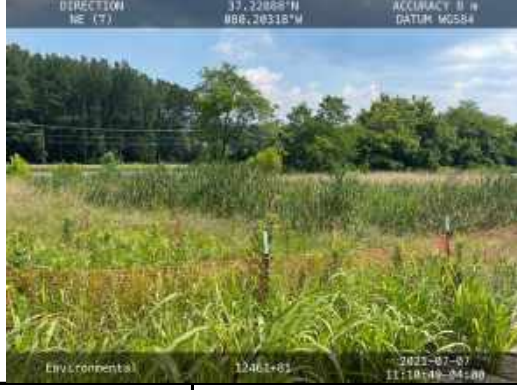
GPS Location	See photo	GPS Location	See photo		
Field Station#	12461+81	Field Station#	12468+00		
Pic 11 Desc.	Wetland W-KL58 in acceptable condition	Pic 12 Desc.	Stabilized ROW in acceptable condition

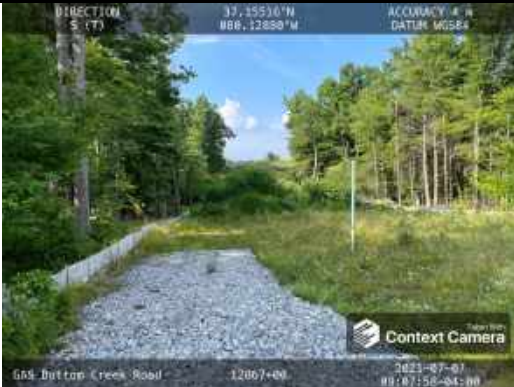
GPS Location	See photo		GPS Location	See photo	
Field Station#	12867+00		Field Station#	12866+00	
Pic 1 Desc.	Current ROW conditions on GAS Bottom Creek Road		Pic 2 Desc.	Current ROW conditions on CIS of Bottom Creek Road

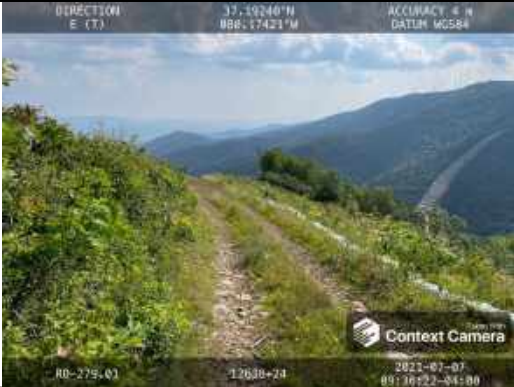
GPS Location	See photo		GPS Location	See photo	
Field Station#	12638+24		Field Station#	12641+00	
Pic 3 Desc.	Access Road RO-279.01		Pic 4 Desc.	Current ROW conditions on GAS of RO-279.01

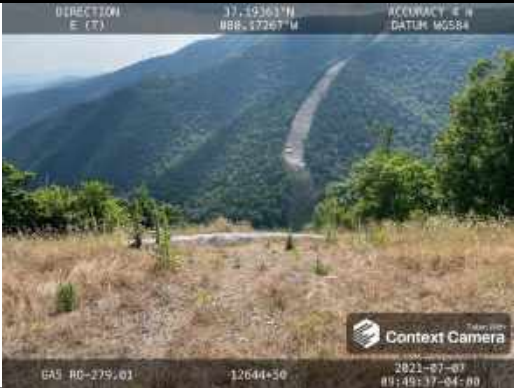
GPS Location	See photo		GPS Location	See photo	
Field Station#	12644+50		Field Station#	12705+00	
Pic 5 Desc.	Current ROW conditions on GAS of RO-279.01		Pic 6 Desc.	Tie In Crew staging pipe in the vicinity of RO-280

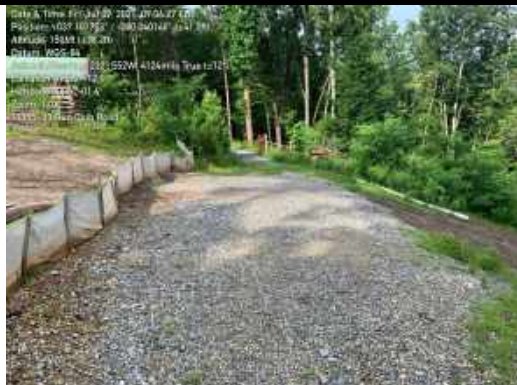
GPS Location	0	GPS Location	0		
Field Station#	13355+33	Field Station#	13358+64		
Pic 11 Desc.	Private road (Gun Club road) in good condition	Pic 12 Desc.	MVP-S-RR11 in good condition

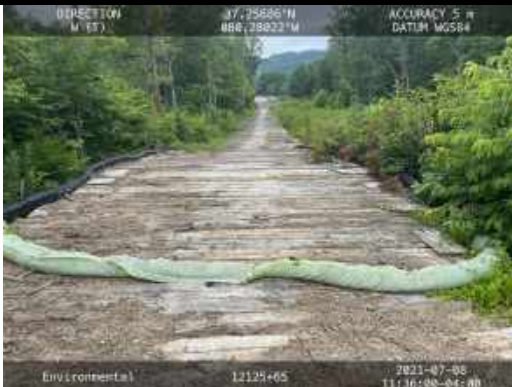
GPS Location	See photo		GPS Location	see photo	
Field Station#	12125+65		Field Station#	12132+73	
Pic 1 Desc.	Bridge and ECDs at stream crossing S-MM31 in acceptable condition		Pic 2 Desc.	Bridge and ECDs at stream crossing S-C29 in acceptable condition

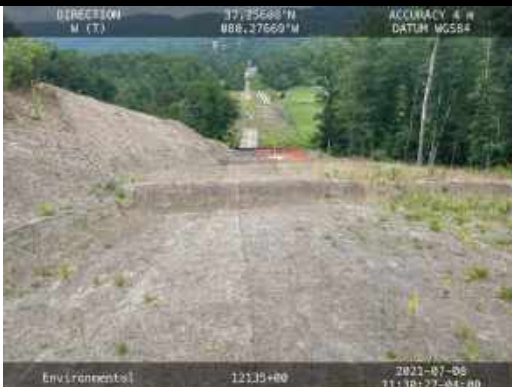
GPS Location	See photo		GPS Location	See photo	
Field Station#	12135+00		Field Station#	12139+91	
Pic 3 Desc.	Stabilized ROW in acceptable condition		Pic 4 Desc.	Wetland crossing W-C6 in acceptable condition

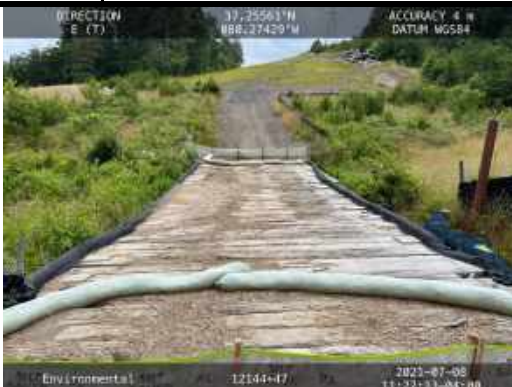
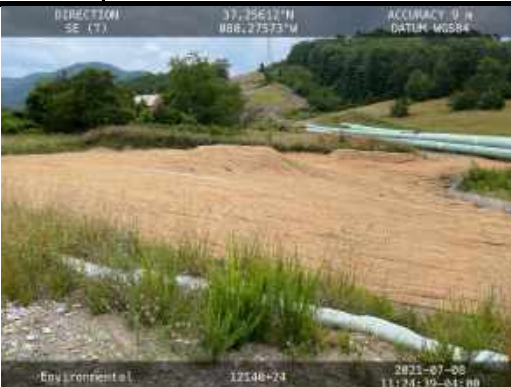
GPS Location	See photo		GPS Location	See photo	
Field Station#	12144+47		Field Station#	12140+24	
Pic 5 Desc.	Bridge and ECDs crossing wetland W-C5 in acceptable condition		Pic 6 Desc.	Stabilized ATWS in acceptable condition

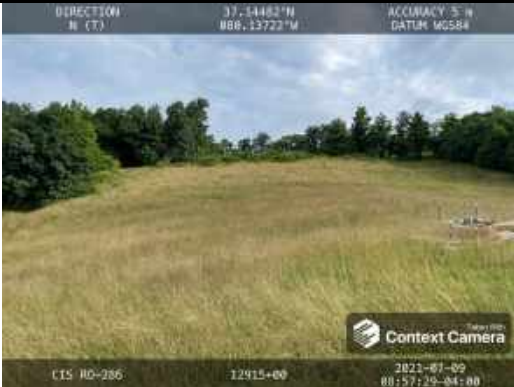
GPS Location	See photo		GPS Location	See photo	
Field Station#	12915+00		Field Station#	12915+50	
Pic 1 Desc.	Current ROW conditions on CIS RO-286.		Pic 2 Desc.	Current ROW conditions on GAS RO-286.

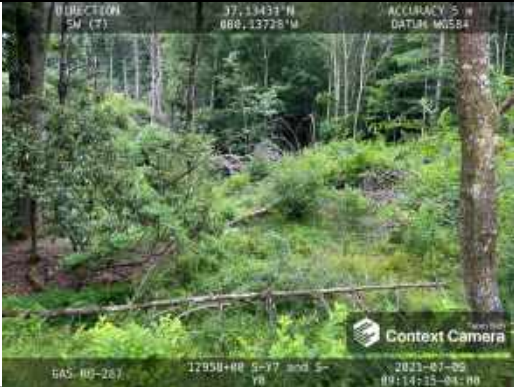
GPS Location	See photo		GPS Location	See photo	
Field Station#	12958+00		Field Station#	12956+93	
Pic 3 Desc.	Streams S-Y7 and S-Y8 on GAS RO-287. No impacts observed.		Pic 4 Desc.	Landowner Spring box at RO-287. Undisturbed

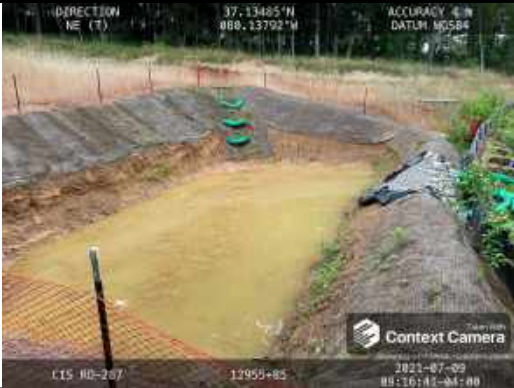
GPS Location	See photo		GPS Location	See photo	
Field Station#	12955+85		Field Station#	12950+00	
Pic 5 Desc.	Sediment Trap functioning as designed on CIS RO-287		Pic 6 Desc.	Vegetation beginning to grow where PPL seeded and Curlexed

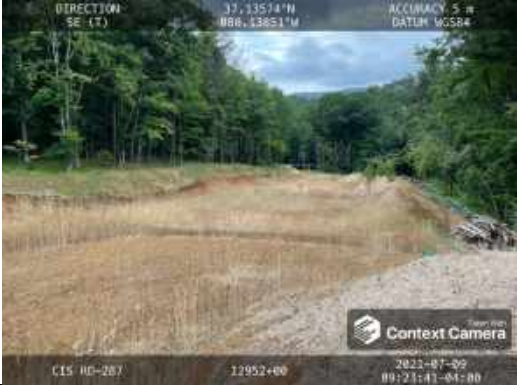
GPS Location	See photo		GPS Location	See photo	
Field Station#	12949+50		Field Station#	12952+00	
Pic 7 Desc.	Vegetation beginning to grow where PPL seeded and Curlexed		Pic 8 Desc.	Area well stabilized on CIS of RO-287

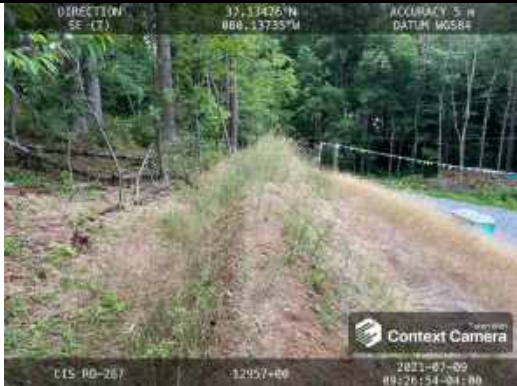
GPS Location	See photo		GPS Location	See photo	
Field Station#	12957+00		Field Station#	12957+38	
Pic 9 Desc.	CWD Berm well stabilized and functional on CIS RO-287		Pic 10 Desc.	Stream S-Z17 on RO-287

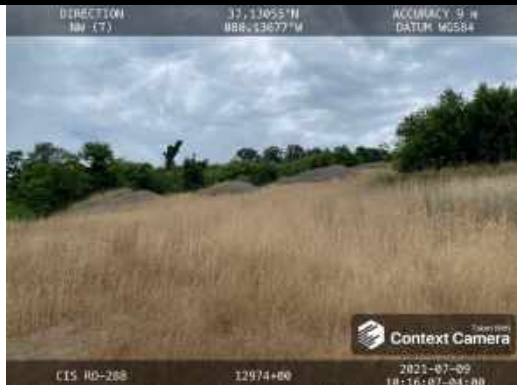
GPS Location	See photo		GPS Location	See photo	
Field Station#	12974+00		Field Station#	12976+00	
Pic 11 Desc.	Current ROW conditions on CIS RO-288. Area well stabilized		Pic 12 Desc.	CWD outlet and plunge pool functional on GAS RO-288

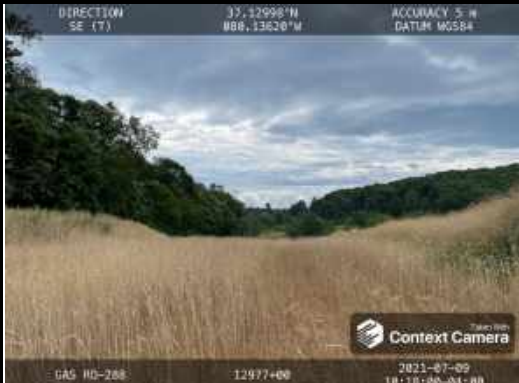
GPS Location	See photo		GPS Location	See photo	
Field Station#	12977+00		Field Station#	12995+00	
Pic 13 Desc.	Current ROW conditions on GAS RO-288. Area well stabilized		Pic 14 Desc.	Current ROW conditions on GAS HWY 221

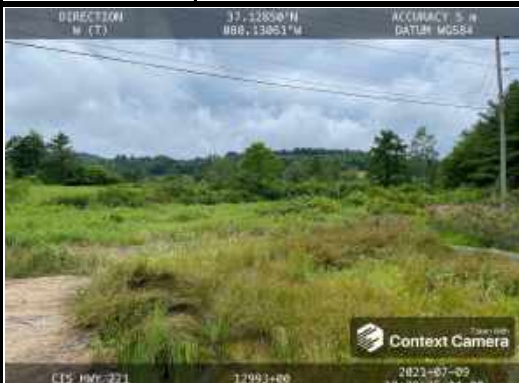
GPS Location	See photo		GPS Location	See photo	
Field Station#	12993+00		Field Station#	13012+00	
Pic 15 Desc.	Current ROW conditions on CIS of HWY 221		Pic 16 Desc.	Current ROW conditions on CIS of BRP. Mature and established vegetation.

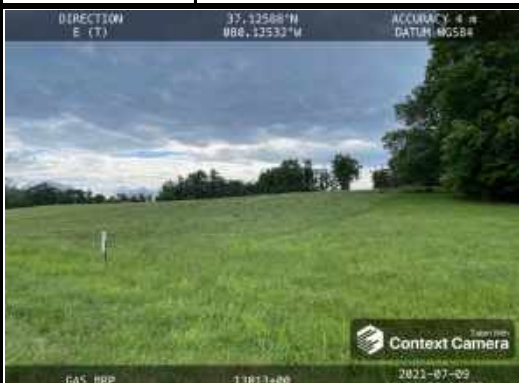
GPS Location	See photo		GPS Location	See photo	
Field Station#	13013+00		Field Station#	13018+00	
Pic 17 Desc.	Current ROW conditions on GAS of BRP. Mature and established vegetation.		Pic 18 Desc.	Current ROW conditions on CIS of FR-289. Permanent Controls in compliance.

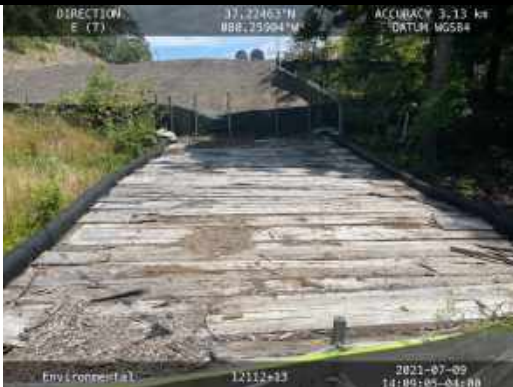
GPS Location	See photo		GPS Location	See photo	
Field Station#	12112+13		Field Station#	12108+41	
Pic 1 Desc.	Bridge and ECDs at stream crossing S-F16A/B in acceptable condition		Pic 2 Desc.	Bridge and ECDs crossing stream S-F15 in acceptable condition

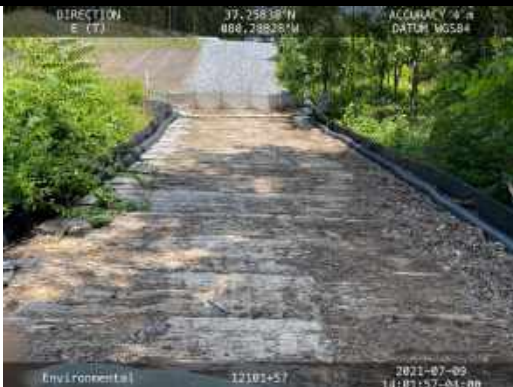
GPS Location	See photo		GPS Location	See photo	
Field Station#	12101+57		Field Station#	12098+44	
Pic 3 Desc.	Bridge and ECDs crossing stream S-MM11 in acceptable condition		Pic 4 Desc.	Bridge and ECDs at stream crossing S-MM13 in acceptable condition

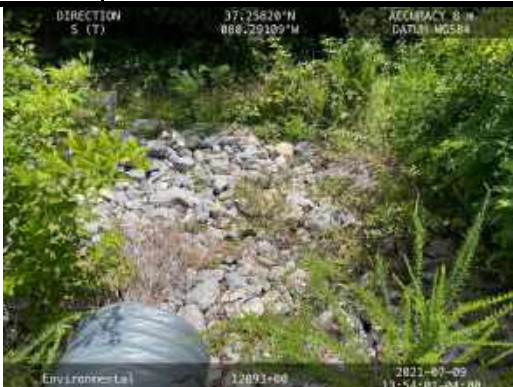
GPS Location	See photo		GPS Location	See photo	
Field Station#	12093+00		Field Station#	12086+56	
Pic 5 Desc.	Clean water crossing pipe outlet in acceptable condition		Pic 6 Desc.	Bridge and ECDs crossing stream S-MM14 in acceptable condition

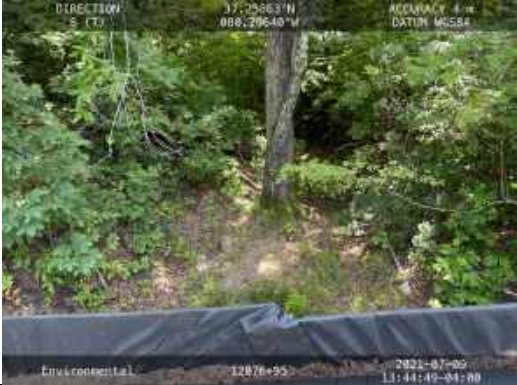
GPS Location	See photo		GPS Location	see photo	
Field Station#	12076+95		Field Station#	12076+95	
Pic 7 Desc.	Down stream of S-MM15 In Acceptable condition		Pic 8 Desc.	Bridge and ECDs crossing stream S-MM15 in acceptable condition

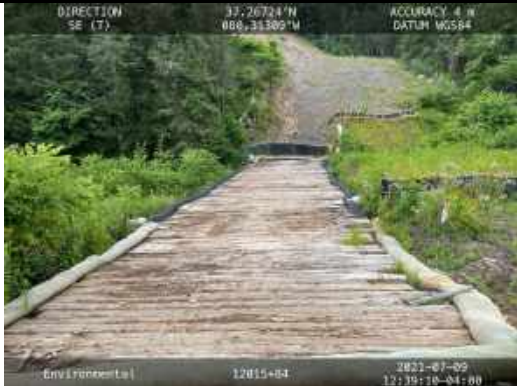
GPS Location	See photo		GPS Location	See photo	
Field Station#	12015+84		Field Station#	12040+00	
Pic 9 Desc.	Bridge and ECDs at stream crossing S-G38 in acceptable condition		Pic 10 Desc.	Stabilized ROW in acceptable condition

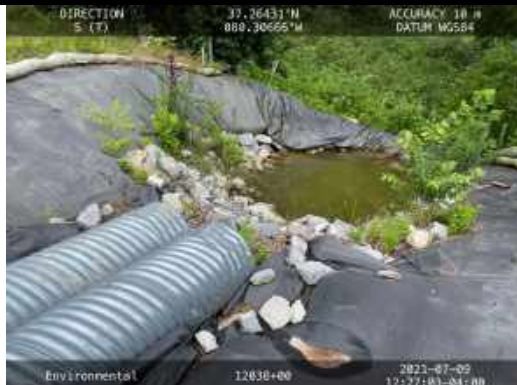
GPS Location	See photo		GPS Location	See photo	
Field Station#	12038+00		Field Station#	12035+75	
Pic 11 Desc.	Clean water crossing pipe outlet in acceptable condition		Pic 12 Desc.	Bridge and ECDs at stream crossing S-PP23 in acceptable condition

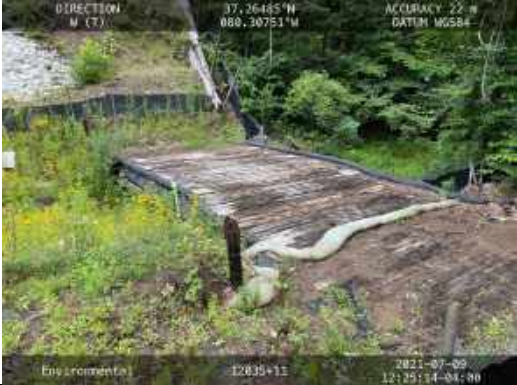
GPS Location	See photo		GPS Location	See photo	
Field Station#	12035+11		Field Station#	12032+51	
Pic 13 Desc.	Bridge and ECDs at stream crossing S-G40 in acceptable condition		Pic 14 Desc.	Bridge and ECDs at stream crossing S-G39 in acceptable condition

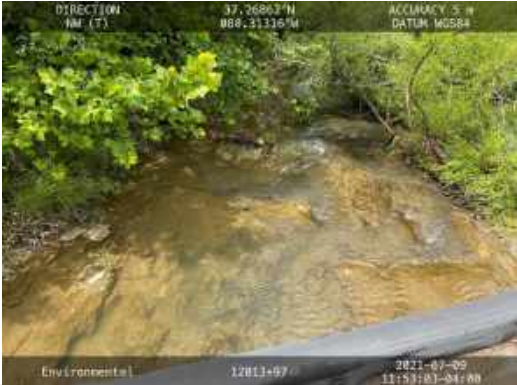
GPS Location	See photo		GPS Location	See photo	
Field Station#	12013+97		Field Station#	12013+97	
Pic 15 Desc.	Down stream of S-G36 in acceptable condition		Pic 16 Desc.	Bridge and ECDs crossing stream S-G36 in acceptable condition

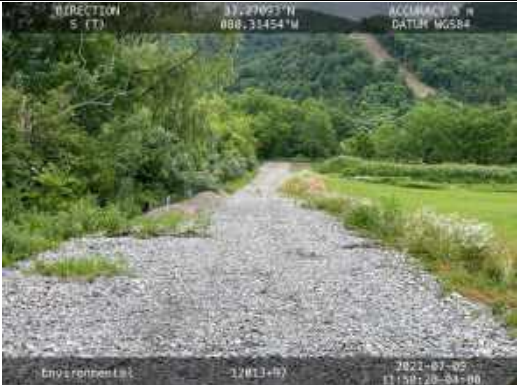
GPS Location	See photo		GPS Location	See photo	
Field Station#	12013+97		Field Station#	12013+97	
Pic 17 Desc.	Access Road MVP-MN-268.01 in acceptable condition		Pic 18 Desc.	Rain gauge totals for Catawba.5"
