Visual Site Inspection Report

Project Name	H-600 Pipeline Spread I	AFE	124300139	Spread	H-600 Pipeline Spread I
Contractor	Precision			Report #	25093
Inspector	Charles Head			Date/Time	6/28/2021 3:38 PM
Permit #	TBD	Inspection Type	VA SWPP	Station Begin	14454+22
State	VA	Inspection Area	Full	Station End	14546+75
County	Franklin	Ground	Dry	Temperature (°F)	92.00
Municipality	N/A	Weather	Sunny	Rain Gauge (in)	0.00
				Rain Accumulation Time (days)	1.00

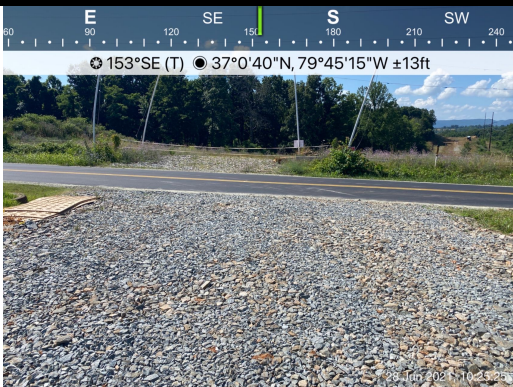
GPS Location	0	GPS Location	0		
Field Station#	14524+50	Field Station#	14518+00		
Pic 3 Desc.	Approximately 14524+50. Overview of road crossing and RCEs.		Pic 4 Desc.	Approximately 14518+00. Overview of ROW.

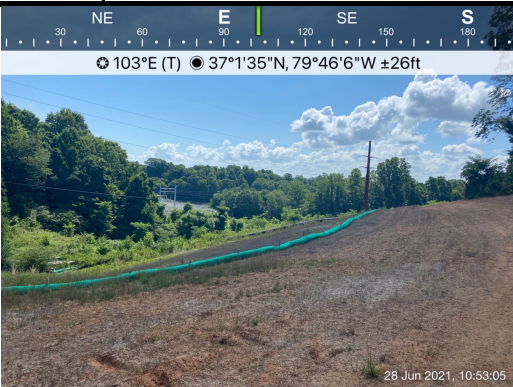
GPS Location	0	GPS Location	0		
Field Station#	14484+50	Field Station#	14457+00		
Pic 5 Desc.	Approximately 14484+50. P-1 requires maintenance. Damaged by livestock.		Pic 6 Desc.	Approximately 14457+00. Overview of ROW.

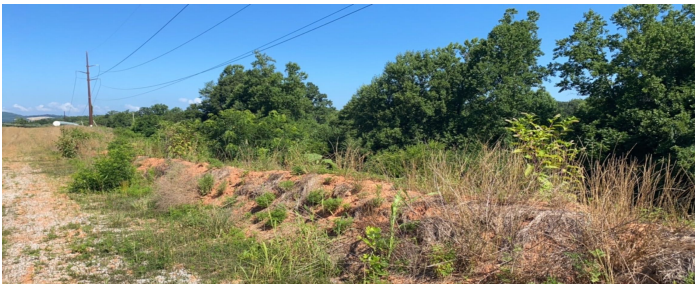
36°58'23" N 79°40'10" W 238°SW COURSE 269' GPS 355 Listening Hill Rd, Penhook, VA 24137, United States 06.28.2021 10:13:18 Accur +/-147.0 Ft ALT 969 Ft			36°58'22" N 79°40'0" W 312°NW COURSE 283' GPS 355 Listening Hill Rd, Penhook, VA 24137, United States 06.28.2021 10:10:21 Accur +/-43.8 Ft ALT 946 Ft		
GPS Location	1	GPS Location	2		
Field Station#	14832+61	Field Station#	14842+00		
Pic 1 Desc.	Equipment bridge and surrounding ECDs in good condition at stream crossing.		Pic 2 Desc.	Temporary diversion berm performing intended function.

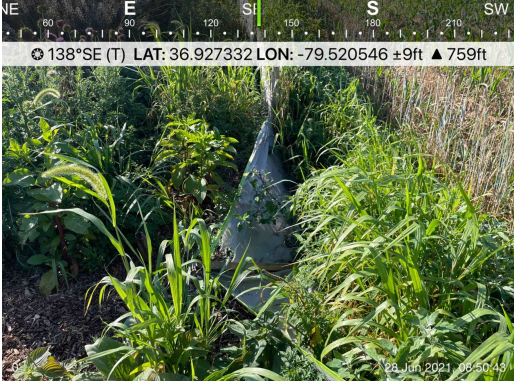
GPS Location	See photo		GPS Location	See photo	
Field Station#	15335+00		Field Station#	15335+00	
Pic 1 Desc.	P1 has been damaged and needs to be replaced.		Pic 2 Desc.	Environmental crew has corrected this issue.

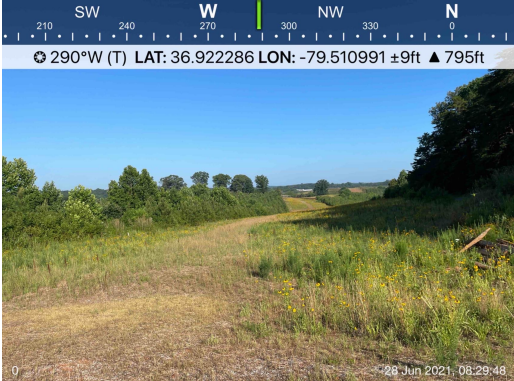
GPS Location	See photo		GPS Location	See photo	
Field Station#	15370+00		Field Station#	15350+00	
Pic 3 Desc.	Vegetation continues to fill in throughout this section.		Pic 4 Desc.	MVP-PI-332 is in good condition with controls in place.

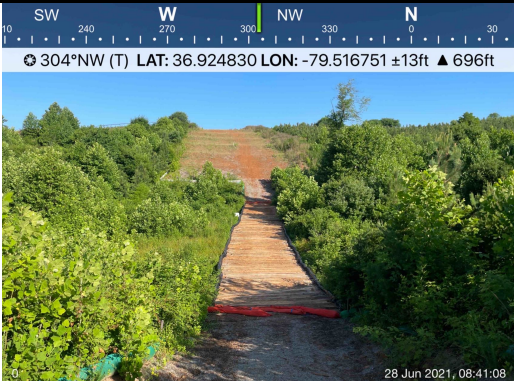
GPS Location	See photo		GPS Location	See photo	
Field Station#	15347+00		Field Station#	15346+20	
Pic 5 Desc.	Equipment bridge ECDs are in good condition.		Pic 6 Desc.	P1 is in good condition at all stream and wetland buffers.

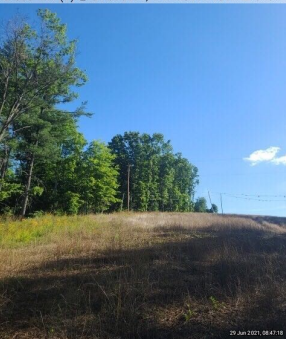
GPS Location	00000	GPS Location	00000		
Field Station#	13743+90	Field Station#	13678+60		
Pic 1 Desc.	Vegetation observation photo showing temporary grass in permanent area. Some new vegetation growing.		Pic 2 Desc.	Row photo showing vegetation, good coverage observed.	
	East Elevation <small>292°W (T) • 37.078716, -79.94112 ±10 m ▲ 331 m</small>

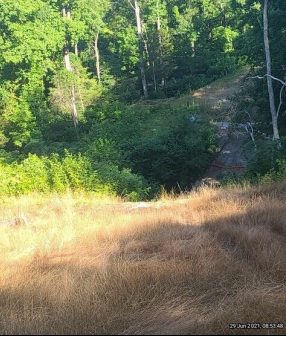
GPS Location	00000	GPS Location	00000		
Field Station#	13728+88	Field Station#	13738+60		
Pic 3 Desc.	Photo showing stabilization on hill side at stream crossing. No issues observed at the time of inspection.		Pic 4 Desc.	Vegetation observation photo. Good coverage noted with some new vegetation growing.

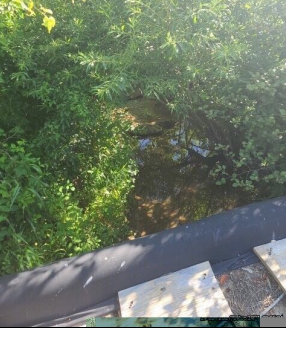
GPS Location	00000	GPS Location	00000		
Field Station#	13678+71	Field Station#	13678+71		
Pic 5 Desc.	Stream observation photo facing upstream during routine inspection today , no environmental issues observed at the time of inspection		Pic 6 Desc.	Stream observation photo facing downstream during routine inspection today. No environmental issues observed at the time of inspection

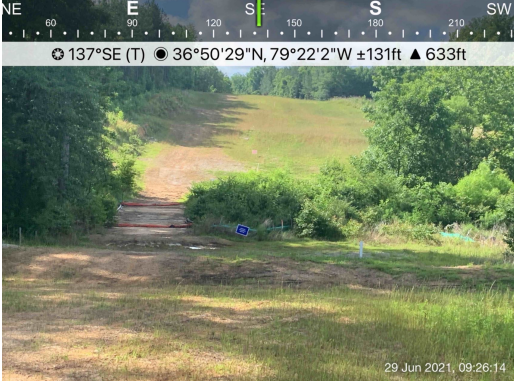
GPS Location	O	GPS Location	O		
Field Station#	15923+49	Field Station#	15878+08		
Pic 1 Desc.	Observing temporary stabilization, signage, buffer, equipment crossing and ECD's	Pic 2 Desc.	Observing temporary stabilization, signage, buffer, equipment crossing and ECD's

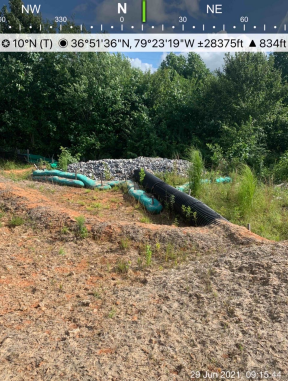
GPS Location	O	GPS Location	O		
Field Station#	15866+00	Field Station#	15825+00		
Pic 3 Desc.	Observing temporary stabilization,CWD outlet and ECD's	Pic 4 Desc.	Observing temporary stabilization,plunge pool and ECD's

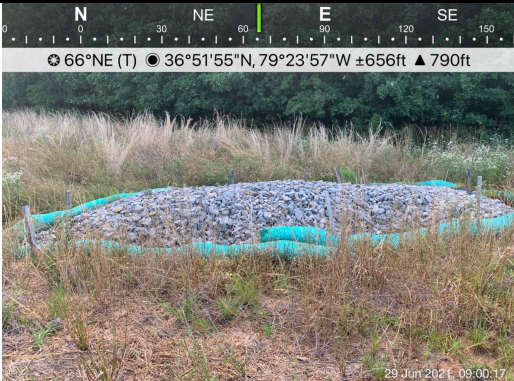
GPS Location	O	GPS Location	O		
Field Station#	15789+00	Field Station#	15794+77		
Pic 5 Desc.	Observing temporary stabilization,CWD outlet and ECD's	Pic 6 Desc.	Observing temporary stabilization, signage, buffer, equipment crossing and ECD's

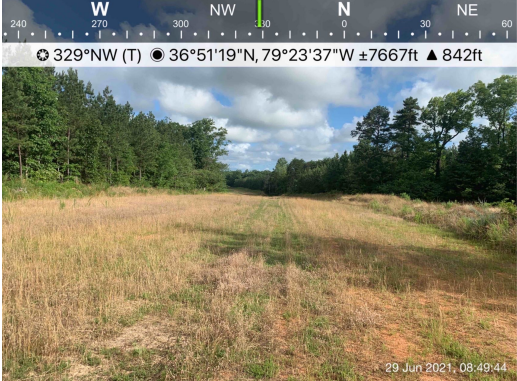
GPS Location	O	GPS Location			
Field Station#	15807+00	Field Station#			
Pic 7 Desc.	Observing temporary stabilization	Pic 8 Desc.			
Insert image here		Insert image here			
GPS Location		GPS Location			
Field Station#		Field Station#			
Pic 9 Desc.		Pic 10 Desc.			
Insert image here		Insert image here			
GPS Location		GPS Location			
Field Station#		Field Station#			
Pic 11 Desc.		Pic 12 Desc.

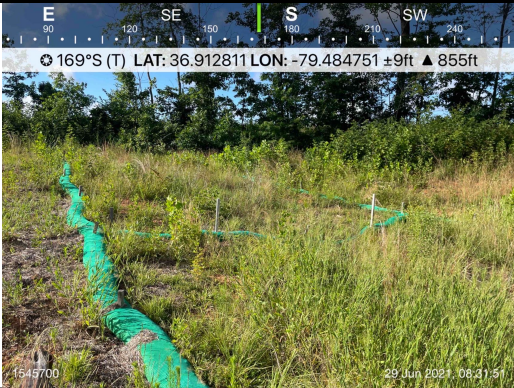
GPS Location	See photo		GPS Location	See photo	
Field Station#	15457+00		Field Station#	15453+00	
Pic 5 Desc.	Drainage ECDs are in good condition with no evidence of sedimentation from 3rd party disturbance.		Pic 6 Desc.	CWD remains in good condition.

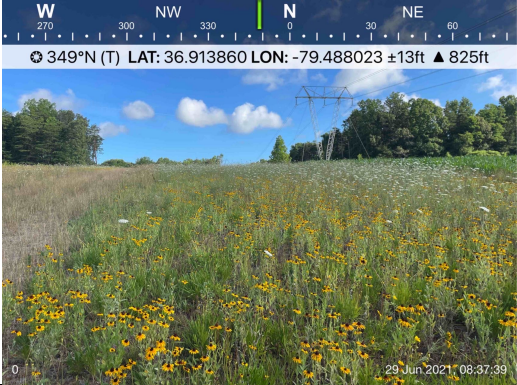
GPS Location	See photo		GPS Location	See photo	
Field Station#	15445+00		Field Station#	15427+43	
Pic 7 Desc.	Vegetation continues to fill in throughout this section.		Pic 8 Desc.	P1 is in good condition at all stream and wetland buffers.

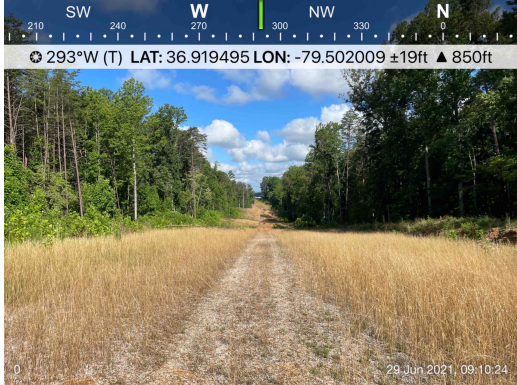
GPS Location	See photo		GPS Location	See photo	
Field Station#	15405+00		Field Station#	15385+00	
Pic 9 Desc.	Vegetation continues to fill in throughout this section.		Pic 10 Desc.	Sensitive resource buffer is in good condition at this location.

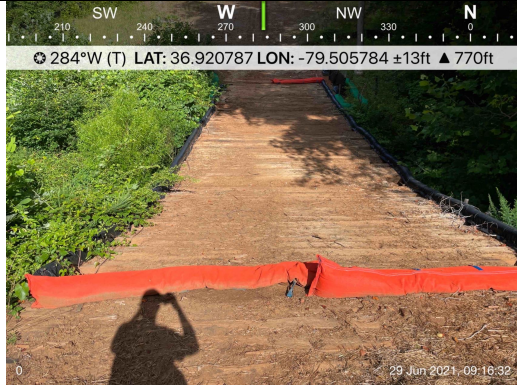
GPS Location	See photo		GPS Location	See photo	
Field Station#	15384+74		Field Station#	15380+00	
Pic 11 Desc.	Equipment bridge ECDs are in place and functioning.		Pic 12 Desc.	Waterbars are functioning as intended.

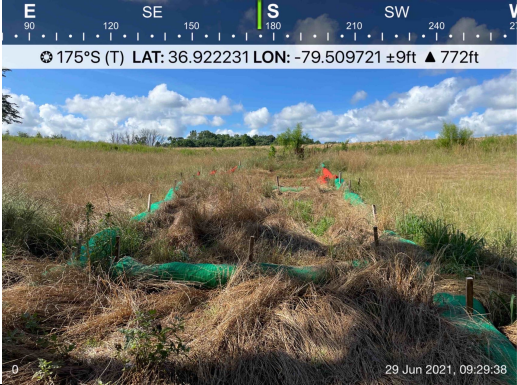
<p>Insert image here</p>			
GPS Location	See photo	GPS Location			
Field Station#	15375+00	Field Station#			
Pic 13 Desc.	Drainage ECDs are in place and functioning.	Pic 14 Desc.			
<p>Insert image here</p>		<p>Insert image here</p>			
GPS Location		GPS Location			
Field Station#		Field Station#			
Pic 15 Desc.		Pic 16 Desc.			
<p>Insert image here</p>		<p>Insert image here</p>			
GPS Location		GPS Location			
Field Station#		Field Station#			
Pic 17 Desc.		Pic 18 Desc.

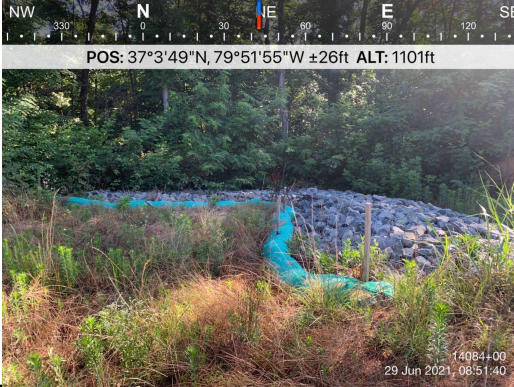
GPS Location	0	GPS Location	0		
Field Station#	14084+00	Field Station#	14105+26		
Pic 3 Desc.	Waterbar end treatment in acceptable condition		Pic 4 Desc.	Equipment bridge in acceptable condition

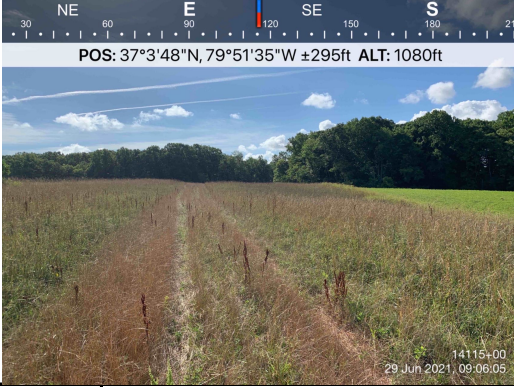
GPS Location	0	GPS Location	0		
Field Station#	14115+00	Field Station#	14157+00		
Pic 5 Desc.	Permanent vegetative stabilization in acceptable condition		Pic 6 Desc.	P1 silt fence in acceptable condition

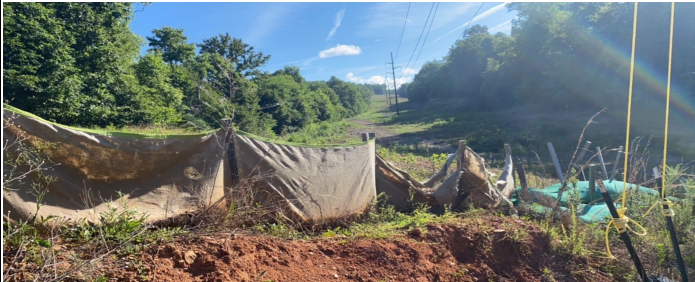
36°58'2" N 79°37'51" W 75°E COURSE 279° GPS Sorry no results found 06.29.2021 08:40:47 Accur +/-46.2 Ft ALT 827 Ft			36°58'4" N 79°38'12" W 65°NE COURSE 174° GPS Sorry no results found 06.29.2021 08:32:02 Accur +/-85.7 Ft ALT 823 Ft		
GPS Location	1		GPS Location	2	
Field Station#	14949+48		Field Station#	14932+00	
Pic 1 Desc.	Routine maintenance. Replace damaged panels of P1 silt fence.		Pic 2 Desc.	P1 silt fence at resource buffer in good condition.

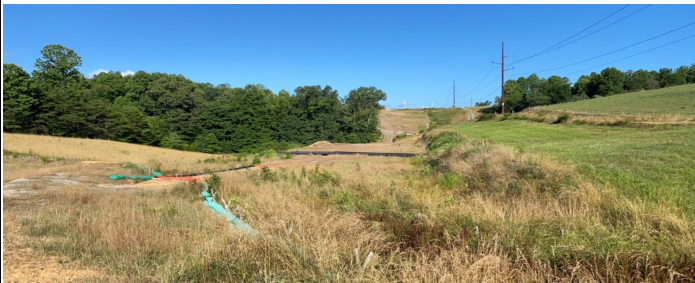
36°58'3" N 79°38'3" W 24°NE COURSE 112° GPS Sorry no results found 06.29.2021 08:35:09 Accur +/-87.8 Ft ALT 827 Ft			36°57'57" N 79°37'21" W 222°SW COURSE 290° GPS Penhook, VA 24137, United States 06.29.2021 09:07:18 Accur +/-25.0 Ft ALT 934 Ft		
GPS Location	3		GPS Location	4	
Field Station#	14938+00		Field Station#	14975+00	
Pic 3 Desc.	Natural drainage area in good condition. Equipment bridge and surrounding ECDs in place and functional.		Pic 4 Desc.	Plunge pool, CFS, and perimeter SSF in good condition and performing intended functions.

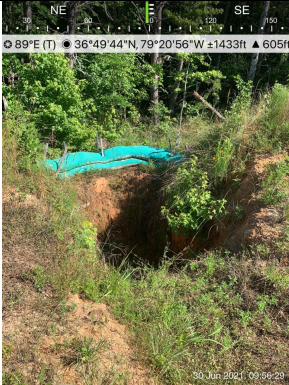
GPS Location	O	GPS Location	O		
Field Station#	16005+00	Field Station#	16007+00		
Pic 1 Desc.	Observing temporary vegetation, sump and end treatment	Pic 2 Desc.	Observing temporary vegetation, water bar, sump and end treatment

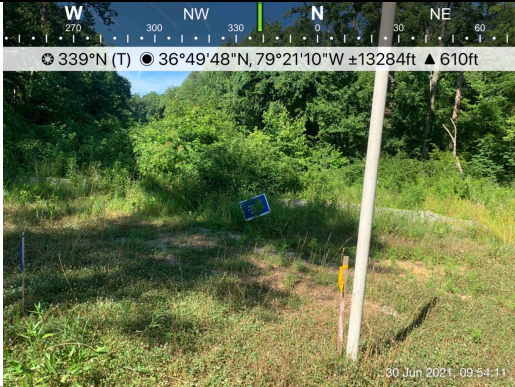
GPS Location	O	GPS Location	O		
Field Station#	16004+00	Field Station#	16010+00		
Pic 3 Desc.	Observing temporary vegetation, signage and buffer	Pic 4 Desc.	Observing temporary vegetation, CWD outlet and ECD's

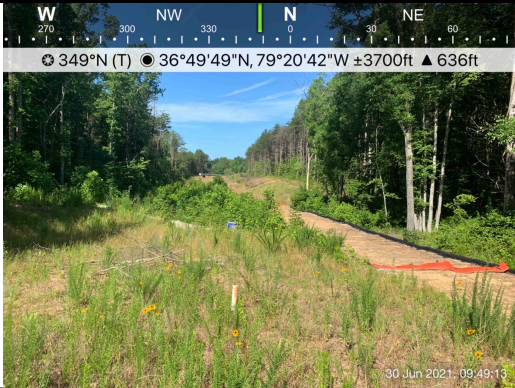
GPS Location	O	GPS Location	O		
Field Station#	16016+36	Field Station#	16022+00		
Pic 5 Desc.	Observing temporary vegetation, signage, buffer, equipment crossing and ECD's	Pic 6 Desc.	Observing temporary stabilization and water bars.

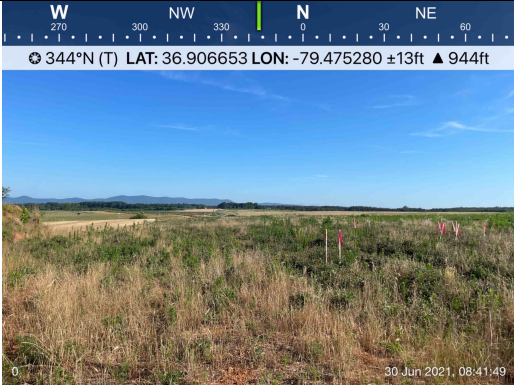
GPS Location	See photo		GPS Location	See photo	
Field Station#	15495+00		Field Station#	15496+70	
Pic 1 Desc.	Vegetation continues to fill in throughout this section.		Pic 2 Desc.	RCEs are in good condition at all road crossings.

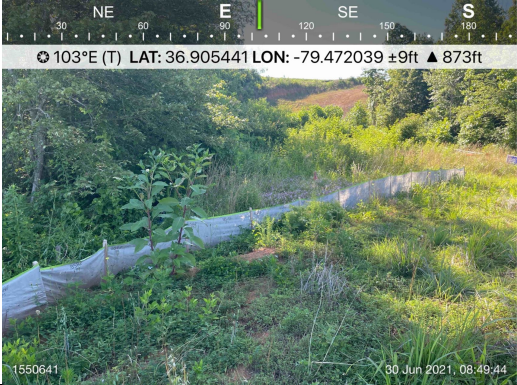
GPS Location	See photo		GPS Location	See photo	
Field Station#	15506+41		Field Station#	15510+00	
Pic 7 Desc.	P1 is in good condition at all stream and wetland buffers.		Pic 8 Desc.	3rd party ECDs appear to be in good condition with no evidence of sedimentation.

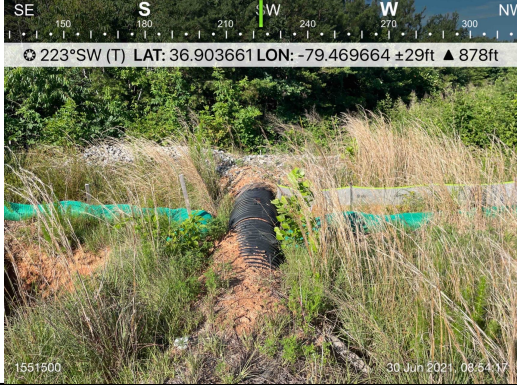
GPS Location	See photo		GPS Location	See photo	
Field Station#	15515+00		Field Station#	15540+00	
Pic 9 Desc.	CWDs are in good condition throughout this section.		Pic 10 Desc.	Equipment bridge ECDs are in place and functioning.

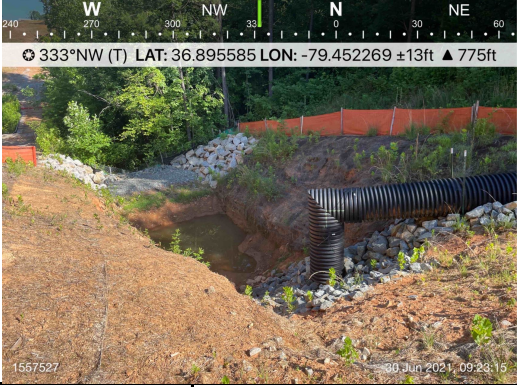
GPS Location	See photo	GPS Location			
Field Station#	15575+27	Field Station#			
Pic 13 Desc.	Slope drain is functioning as intended.	Pic 14 Desc.			
Insert image here		Insert image here			
GPS Location		GPS Location			
Field Station#		Field Station#			
Pic 15 Desc.		Pic 16 Desc.			
Insert image here		Insert image here			
GPS Location		GPS Location			
Field Station#		Field Station#			
Pic 17 Desc.		Pic 18 Desc.

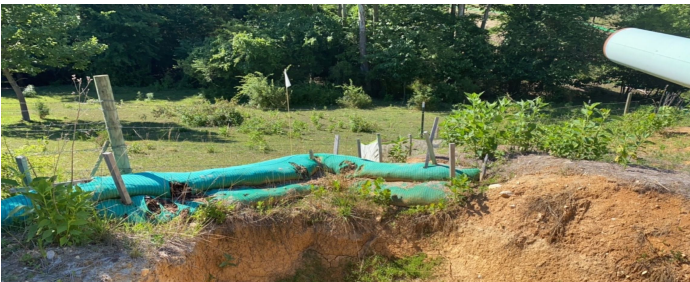
36 57 36" N 79 35 10" W 232°SW COURSE 210° GPS Sandy Level, VA 24161, United States 06.30.2021 09:54:27 Accur +/-15.4 Ft ALT 842 Ft		36 57 35" N 79 35 10" W 121°SE COURSE 171° GPS Sandy Level, VA 24161, United States 06.30.2021 09:55:11 Accur +/-15.4 Ft ALT 842 Ft			
GPS Location	1	GPS Location	2		
Field Station#	14989+00	Field Station#	14992+00		
Pic 1 Desc.	Routine maintenance. Replace damaged/worn perimeter CFS and CFS end treatments on low side of ROW		Pic 2 Desc.	Routine maintenance. Replace damaged/worn perimeter CFS and CFS end treatments on low side of ROW

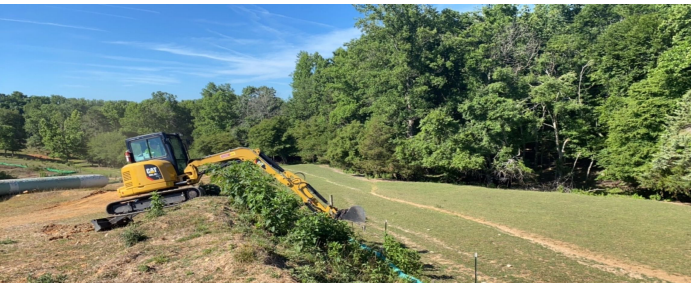
GPS Location	3	GPS Location	4		
Field Station#	14990+00	Field Station#	14993+50		
Pic 3 Desc.	Contractor removing damaged/worn perimeter CFS as needed		Pic 4 Desc.	Contractor replaced perimeter CFS per punch list items

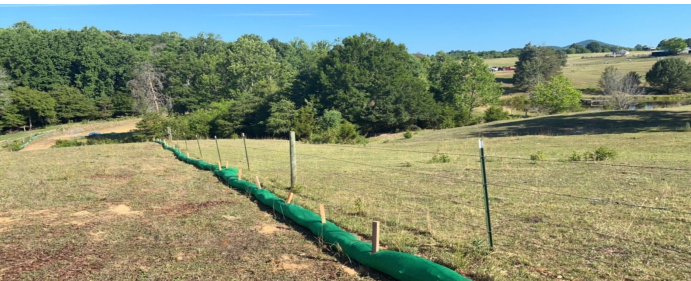
36 57 32" N 79 35 7" W 261°W COURSE 122° GPS Sandy Level, VA 24161, United States 06.30.2021 09:06:22 Accur +/-87.8 Ft ALT 828 Ft		36 57 17" N 79 34 53" W 166°S COURSE 160° GPS 8850-8968 Museville Rd, Sandy Level, VA 24161, United States 06.30.2021 09:20:54 Accur +/-230.8 Ft ALT 928 Ft			
GPS Location	5	GPS Location	6		
Field Station#	14998+00	Field Station#	15117+00		
Pic 5 Desc.	Contractor replaced perimeter CFS per punch list items		Pic 6 Desc.	ROW stabilized and vegetated in temporary area

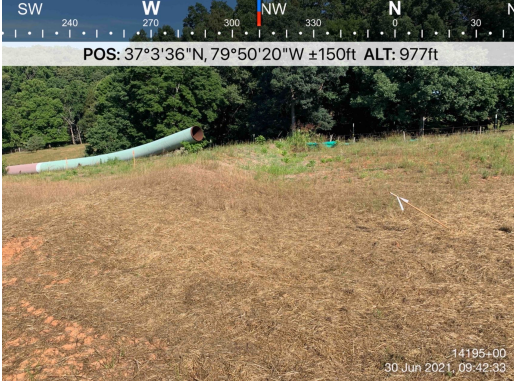
GPS Location	0	GPS Location	0		
Field Station#	14195+00	Field Station#	14195+00		
Pic 1 Desc.	Waterbar in acceptable condition		Pic 2 Desc.	Waterbar end treatment in acceptable condition 1420500

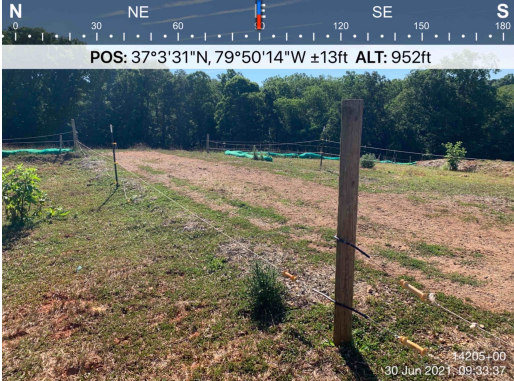
GPS Location	0	GPS Location	0		
Field Station#	14205+00	Field Station#	14251+00		
Pic 3 Desc.	Electric fence damaged by livestock		Pic 4 Desc.	P1 silt fence in acceptable condition

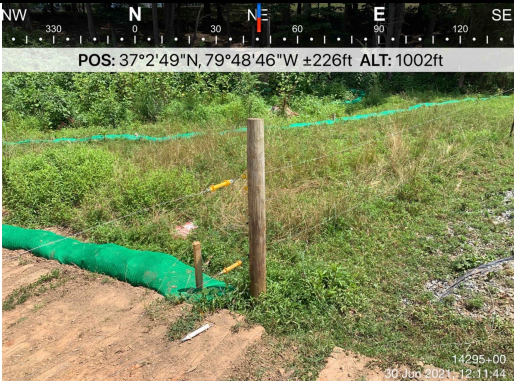
GPS Location	0	GPS Location	0		
Field Station#	14295+00	Field Station#	14301+00		
Pic 5 Desc.	Electric fence damaged by livestock		Pic 6 Desc.	Perimeter CFS in acceptable condition

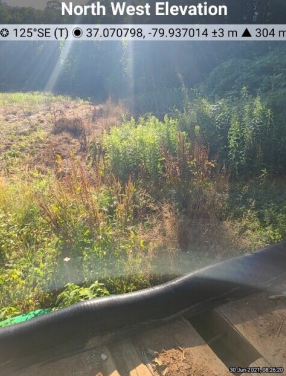
GPS Location	00000	GPS Location	00000		
Field Station#	13770+69	Field Station#	13850+00		
Pic 1 Desc.	Stream observation photo facing downstream during routine inspection today. No issues observed at the time of inspection. Good vegetation noted.		Pic 2 Desc.	Row photo showing stabilization. No issues observed at the time of inspection.	
	West Elevation <small>111°E (T) 37.062363, -79.921224 ±3 m 283 m</small>

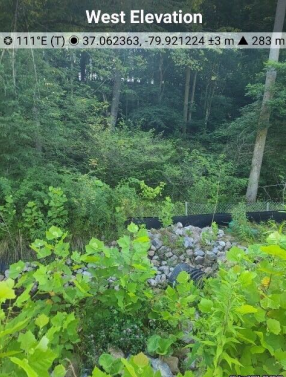
GPS Location	00000	GPS Location	00000		
Field Station#	13840+00	Field Station#	13784+35		
Pic 3 Desc.	Monitored clean water diversion pipe and plunge pool. No environmental issues observed at the time of inspection.		Pic 4 Desc.	Row photo showing stabilization above stream crossing . No environmental issues observed at the time of inspection.

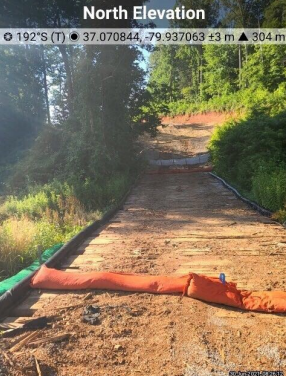
GPS Location	0000	GPS Location	00000		
Field Station#	13770+60	Field Station#	13803+00		
Pic 5 Desc.	Monitored equipment bridge and protection at stream crossing . No issues observed at the time of inspection.		Pic 6 Desc.	Photo showing good stabilization on hill side above stream crossing. ECDs in place and functioning.

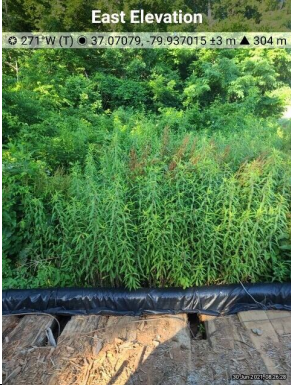
<p>Insert image here</p>		<p>Insert image here</p>	
GPS Location	00000	GPS Location			
Field Station#	13770+69	Field Station#			
Pic 7 Desc.	Stream observation photo facing upstream during routine inspection today. No environmental issues observed at the time of inspection. <i>Q. alba</i> not detected.		Pic 8 Desc.		
<p>Insert image here</p>		<p>Insert image here</p>			
GPS Location		GPS Location			
Field Station#		Field Station#			
Pic 9 Desc.		Pic 10 Desc.			
<p>Insert image here</p>		<p>Insert image here</p>			
GPS Location		GPS Location			
Field Station#		Field Station#			
Pic 11 Desc.		Pic 12 Desc.

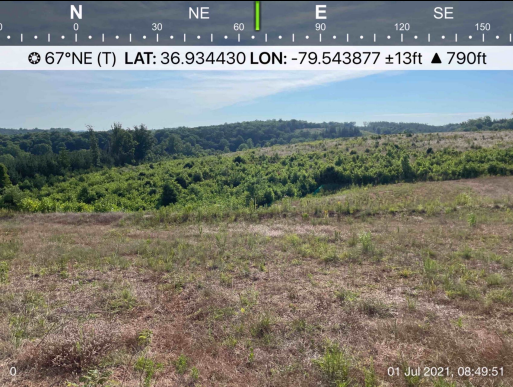
GPS Location	See photo		GPS Location	See photo	
Field Station#	15197+00		Field Station#	15260+00	
Pic 1 Desc.	CFS needs to be restaked at this location.		Pic 2 Desc.	Vegetation continues to fill in throughout this section.

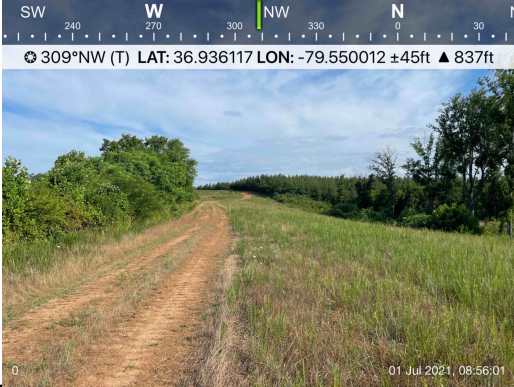
GPS Location	See photo		GPS Location	See photo	
Field Station#	15240+00		Field Station#	15209+00	
Pic 3 Desc.	Vegetation continues to fill in throughout this section.		Pic 4 Desc.	Vegetation continues to fill in throughout this section.

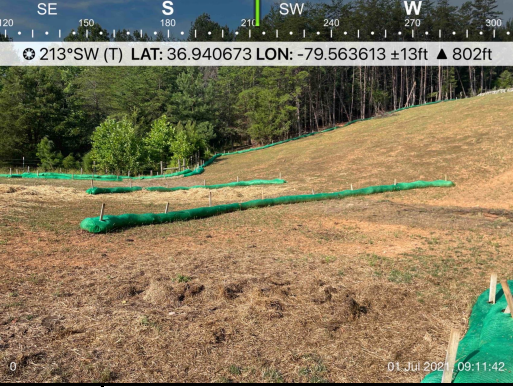
GPS Location	See photo		GPS Location	See photo	
Field Station#	15195+50		Field Station#	15195+00	
Pic 5 Desc.	Fence gap remains open by 3rd party allowing livestock onto ROW.		Pic 6 Desc.	Drainage ECDs are in good condition.

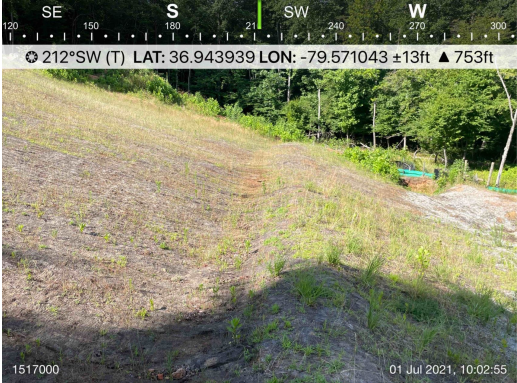
GPS Location	See photo		GPS Location	See photo	
Field Station#	15170+00		Field Station#	15170+00	
Pic 7 Desc.	Waterbars are in good throughout this section.		Pic 8 Desc.	Slope drain is functioning as intended.

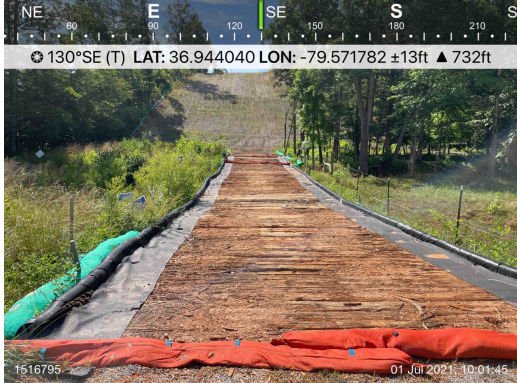
GPS Location	See photo		GPS Location	See photo	
Field Station#	15167+95		Field Station#	15167+95	
Pic 9 Desc.	Equipment bridge ECDs are in place and functioning.		Pic 10 Desc.	P1 is in good condition at this stream crossings.

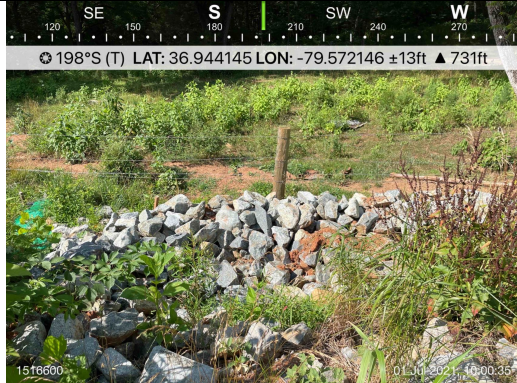
GPS Location	See photo		GPS Location	See photo	
Field Station#	15166+00		Field Station#	15165+57	
Pic 11 Desc.	Rock outlet remains in good condition.		Pic 12 Desc.	Rock inlet remains in good condition.

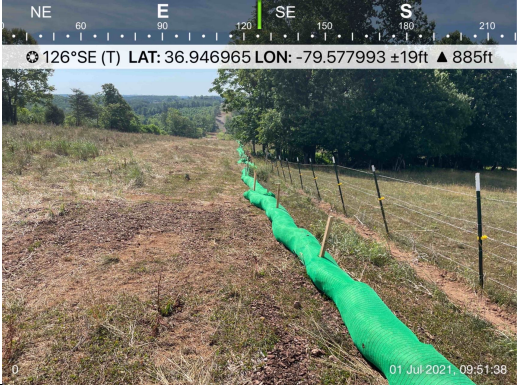
GPS Location	See photo	GPS Location	See photo		
Field Station#	15147+00	Field Station#	15142+66		
Pic 13 Desc.	Previously replaced CFS remains in good condition.	Pic 14 Desc.	RCE is in good condition at Rockcreek Rd.		
Insert image here		Insert image here			
GPS Location		GPS Location			
Field Station#		Field Station#			
Pic 15 Desc.		Pic 16 Desc.			
Insert image here		Insert image here			
GPS Location		GPS Location			
Field Station#		Field Station#			
Pic 17 Desc.		Pic 18 Desc.

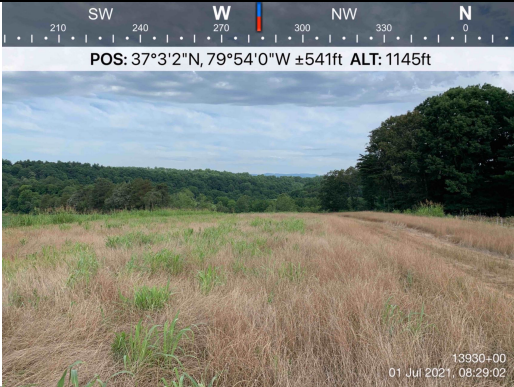
GPS Location	0	GPS Location	0		
Field Station#	13930+00	Field Station#	13878+00		
Pic 3 Desc.	Permanent vegetative stabilization in acceptable condition	Pic 4 Desc.	Temporary vegetative stabilization in acceptable condition

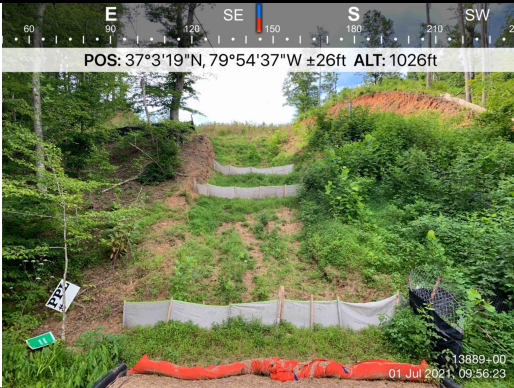
GPS Location	0	GPS Location	0		
Field Station#	13889+00	Field Station#	13862+00		
Pic 5 Desc.	P1 silt fence in acceptable condition	Pic 6 Desc.	Super silt fence in acceptable condition

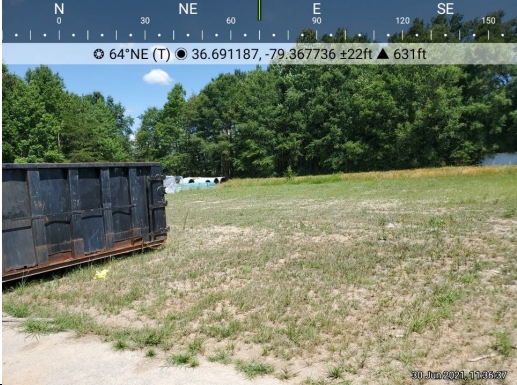
GPS Location	0	GPS Location	0		
Field Station#	0+00	Field Station#	0+00		
Pic 7 Desc.	LY-048 Waste management & temporary stabilization		Pic 8 Desc.	LY-048 North perimeter CFS	
Insert image here		Insert image here			
GPS Location		GPS Location			
Field Station#		Field Station#			
Pic 9 Desc.		Pic 10 Desc.			
Insert image here		Insert image here			
GPS Location		GPS Location			
Field Station#		Field Station#			
Pic 11 Desc.		Pic 12 Desc.

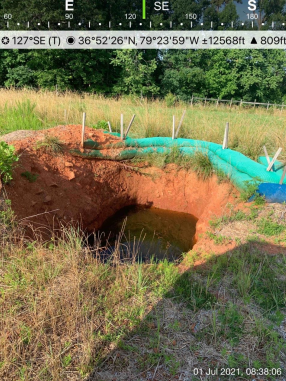
GPS Location	O	GPS Location	O		
Field Station#	15646+00	Field Station#	15636+45		
Pic 1 Desc.	Observing temporary stabilization, sump and end treatment	Pic 2 Desc.	Observing temporary stabilization, signage, buffer, equipment crossing and ECD's

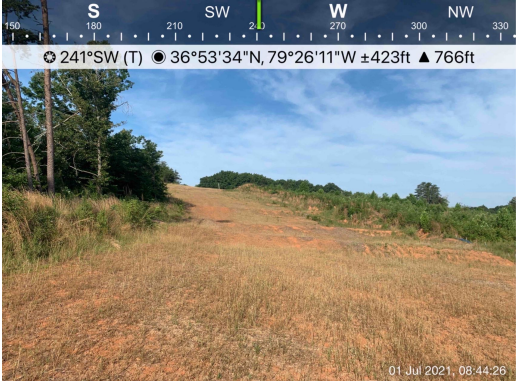
GPS Location	O	GPS Location	O		
Field Station#	15624+00	Field Station#	15619+48		
Pic 3 Desc.	Observing temporary stabilization and water bars	Pic 4 Desc.	Observing road crossing and RCE's

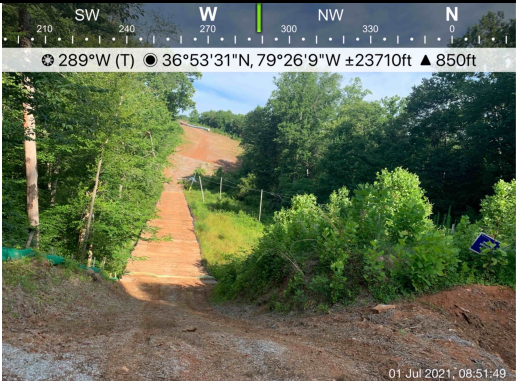
GPS Location	O	GPS Location	O		
Field Station#	15596+79	Field Station#	15590+00		
Pic 5 Desc.	Observing temporary stabilization, signage, buffer, equipment crossing and ECD's	Pic 6 Desc.	Observing temporary stabilization and water bars

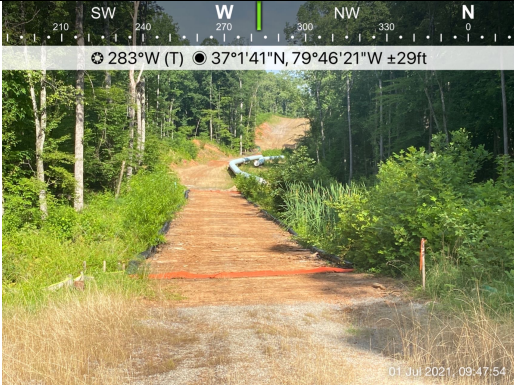
GPS Location	0	GPS Location	0		
Field Station#	14438+49	Field Station#	14430+00		
Pic 1 Desc.	Approximately 14438+49. Overview of stream crossing, equipment bridge and ECDs at stream S-IJ47.		Pic 2 Desc.	Approximately 14430+00. Overview of ROW.

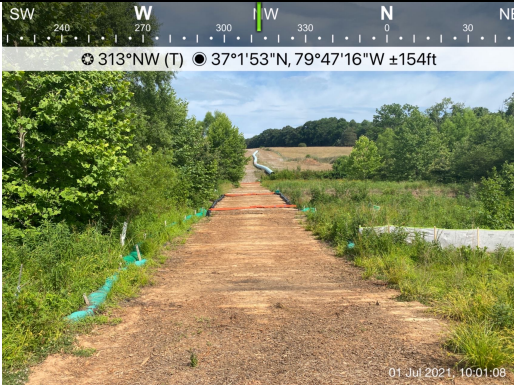
GPS Location	0	GPS Location	0		
Field Station#	14391+50	Field Station#	14353+53		
Pic 3 Desc.	Approximately 14391+50. Overview of stream crossing, equipment bridge and ECDs at stream S-A41.		Pic 4 Desc.	Approximately 14353+53. Overview of stream crossing, equipment bridge and ECDs at stream S-A38.

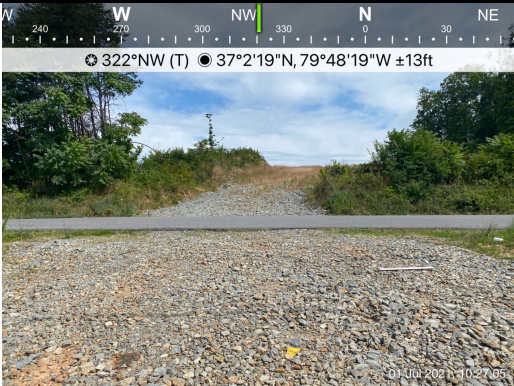
GPS Location	0	GPS Location	0		
Field Station#	14333+20	Field Station#	14318+00		
Pic 5 Desc.	Approximately 14333+20. Overview of road crossing and RCEs.		Pic 6 Desc.	Approximately 14318+00. Overview of ROW.

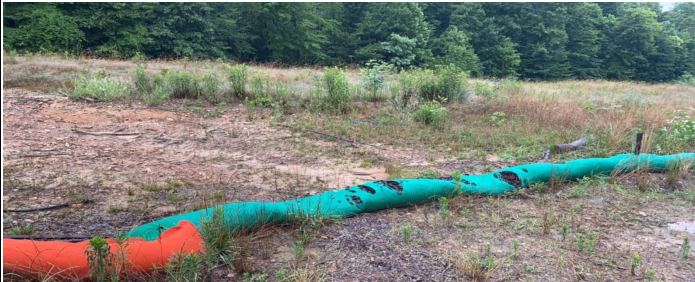
36°58'31" N 79°40'30" W 130°SE COURSE 38' GPS Penhook, VA 24137, United States 07.02.2021 09:18:31 Accur +/-110.5 Ft ALT 965 Ft			36°58'31" N 79°40'30" W 155°SE COURSE 140' GPS Penhook, VA 24137, United States 07.02.2021 09:19:58 Accur +/-1254.6 Ft ALT 947 Ft		
GPS Location	1		GPS Location	2	
Field Station#	14812+00		Field Station#	14816+07	
Pic 1 Desc.	Routine maintenance. Replace damaged perimeter CFS with wattles where landowner is crossing ROW.		Pic 2 Desc.	Routine maintenance. Remove sediment from wattles at equipment bridge. Seed and stabilize denuded area.

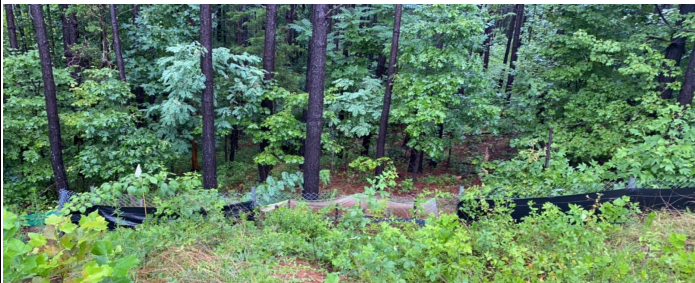
GPS Location	3		GPS Location	4	
Field Station#	14804+00		Field Station#	14893+00	
Pic 3 Desc.	Perimeter P1 silt fence and SSF in good condition.		Pic 4 Desc.	ROW stabilized and limited vegetation observed in temporary area.

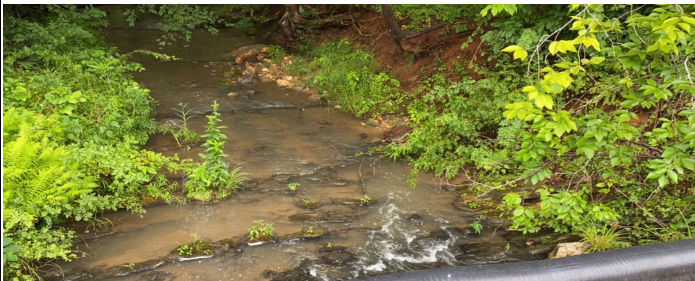
36°58'11" N 79°38'57" W 170°S COURSE 71' GPS Penhook, VA 24137, United States 07.02.2021 10:10:26 Accur +/-304.7 Ft ALT 905 Ft			36°58'5" N 79°38'24" W 131°SE COURSE 142' GPS Sorry no results found 07.02.2021 10:13:18 Accur +/-46.1 Ft ALT 825 Ft		
GPS Location	5		GPS Location	6	
Field Station#	14907+52		Field Station#	14923+00	
Pic 5 Desc.	Stream running clear downstream at ROW crossing.		Pic 6 Desc.	ROW stabilized and vegetated in final cleanup area. Travel lane regrowing where seeded.

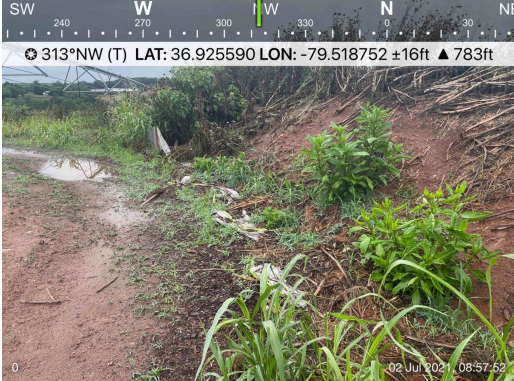
GPS Location	See photo		GPS Location	See photo	
Field Station#	15342+00		Field Station#	15335+00	
Pic 1 Desc.	P1 has been damaged and needs to be replaced.		Pic 2 Desc.	P1 has been damaged and needs to be replaced.

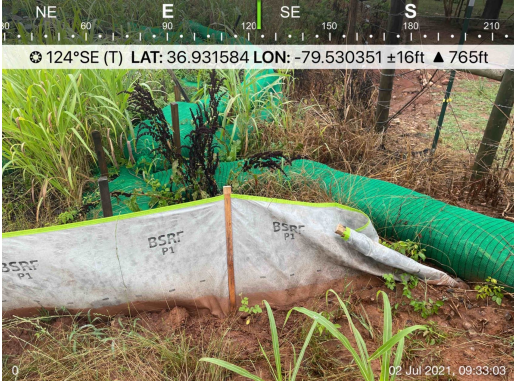
GPS Location	See photo		GPS Location	See photo	
Field Station#	15299+00		Field Station#	15299+00	
Pic 3 Desc.	P1 has been damaged and needs to be restaked.		Pic 4 Desc.	Environmental crew has corrected this issue.

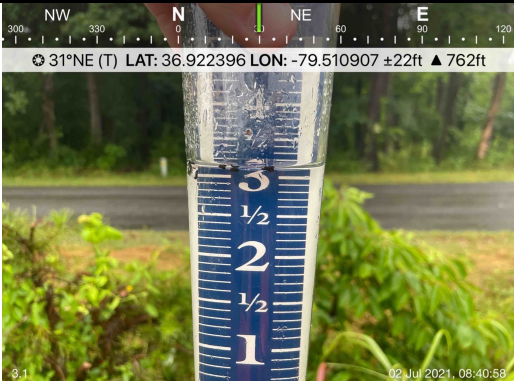
GPS Location	See photo		GPS Location	See photo	
Field Station#	15370+00		Field Station#	15370+00	
Pic 5 Desc.	Rain gauge showing 3.1".		Pic 6 Desc.	Vegetation continues to fill in throughout this section.

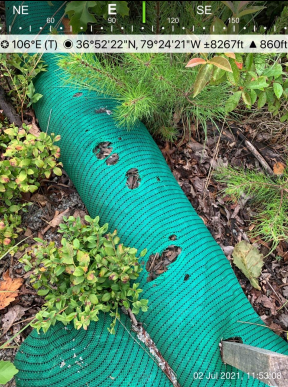
GPS Location	O	GPS Location	O		
Field Station#	15745+00	Field Station#	15745+00		
Pic 1 Desc.	Observing CFS that required maintenance	Pic 2 Desc.	Observing CFS that received maintenance

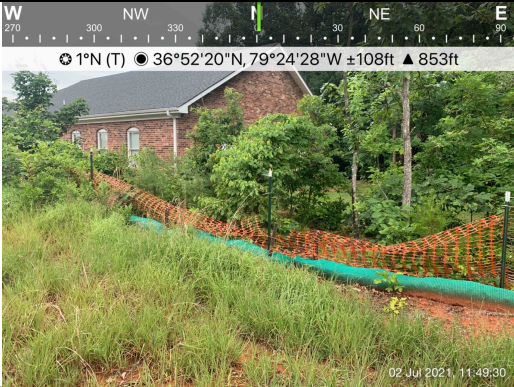
GPS Location	O	GPS Location	O		
Field Station#	15747+00	Field Station#	15747+00		
Pic 3 Desc.	Observing safety fence that required maintenance	Pic 4 Desc.	Observing safety fence that received maintenance

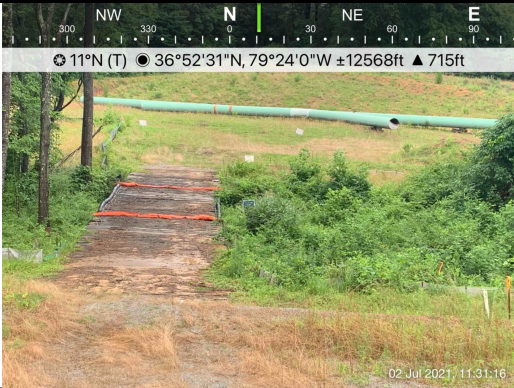
GPS Location	O	GPS Location	O		
Field Station#	15763+80	Field Station#	15665+50		
Pic 5 Desc.	Observing temporary stabilization, signage, buffer, equipment crossing and ECD's	Pic 6 Desc.	Observing signage, buffer equipment crossing and ECD's

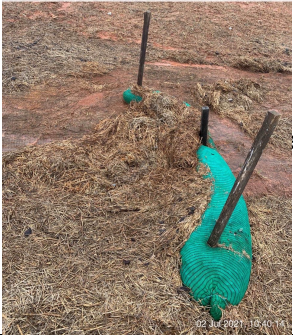
GPS Location	O	GPS Location	O		
Field Station#	15696+00	Field Station#	15696+00		
Pic 7 Desc.	Observing CFS check that required maintenance	Pic 8 Desc.	Observing CFS check that received maintenance

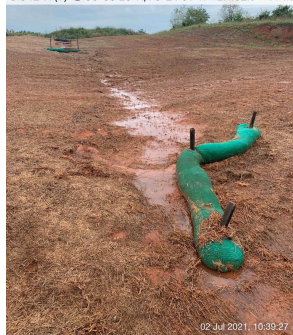
GPS Location	O	GPS Location	O		
Field Station#	15695+59	Field Station#	15690+00		
Pic 11 Desc.	Observing CFS check that required maintenance	Pic 12 Desc.	Observing temporary stabilization, sump and end treatment

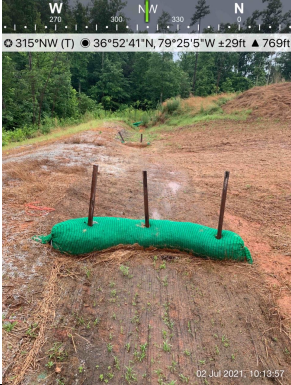
GPS Location	O	GPS Location	O		
Field Station#	15706+00	Field Station#	15720+00		
Pic 13 Desc.	Observing water bar,temporary stabilization,erosion control blanket and CFS checks	Pic 14 Desc.	Observing temporary stabilization,CWD outlet and ECD's

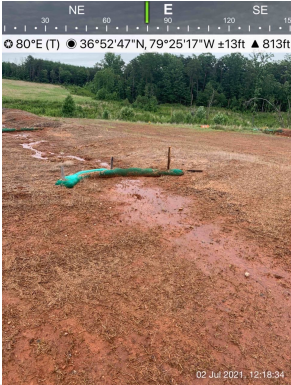
GPS Location	O	GPS Location			
Field Station#	15695+59	Field Station#			
Pic 15 Desc.	Observing CFS check that received maintenance	Pic 16 Desc.

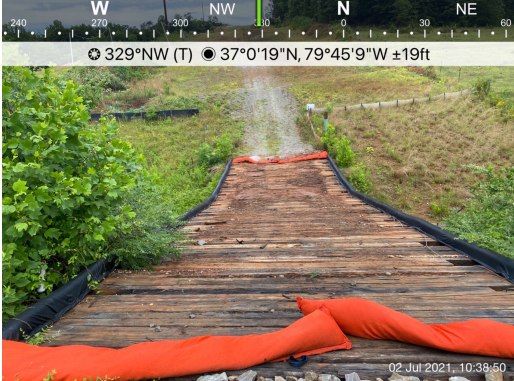
GPS Location	0	GPS Location	0		
Field Station#	14546+33	Field Station#	14496+60		
Pic 1 Desc.	Approximately 14546+33. Overview of stream crossing, equipment bridge and ECDs at stream S-G17.		Pic 2 Desc.	Approximately 14496+60. Overview of stream crossing, equipment bridge and ECDs at stream S-G20.

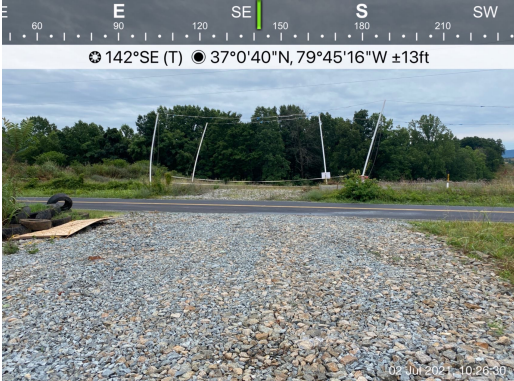
GPS Location	0	GPS Location	0		
Field Station#	14524+50	Field Station#	14486+60		
Pic 3 Desc.	Approximately 14524+50. Overview of road crossing and RCEs.		Pic 4 Desc.	Approximately 14486+60. Overview of stream crossing, equipment bridge and ECDs at stream S-G22.

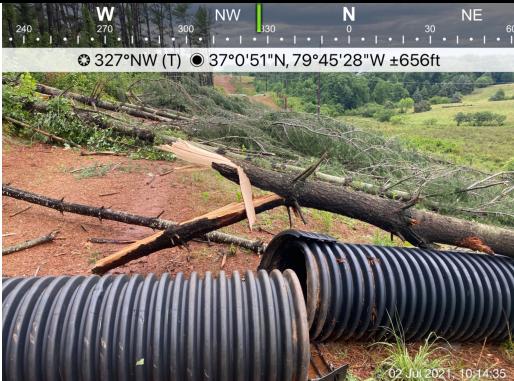
GPS Location	0	GPS Location	0		
Field Station#	14510+00	Field Station#	14473+00		
Pic 5 Desc.	Approximately 14510+00. CWD piping requires maintenance. Damaged by fallen trees during overnight storm's.		Pic 6 Desc.	Approximately 14473+00. SSF requires maintenance.
