Visual Site Inspection Report

Project Name	H-600 Pipeline Spread I	AFE	124300139	Spread	H-600 Pipeline Spread I
Contractor	Precision			Report #	25791
Inspector	Ben Farmer			Date/Time	7/12/2021 6:33 PM
Permit #	TBD	Inspection Type	VA SWPP	Station Begin	15480+67
State	VA	Inspection Area	Partial	Station End	15584+23
County	Pittsylvania	Ground	Dry	Temperature (°F)	82.00
Municipality	Chatham	Weather	Sunny	Rain Gauge (in)	0.10
				Rain Accumulation Time (days)	0.00

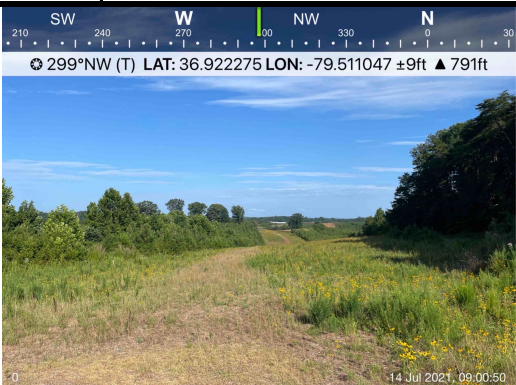
GPS Location	See photo		GPS Location	See photo	
Field Station#	15370+00		Field Station#	15350+00	
Pic 5 Desc.	Vegetation continues to fill in throughout this section.		Pic 6 Desc.	MVP-PI-332 remains in good condition with controls in place.

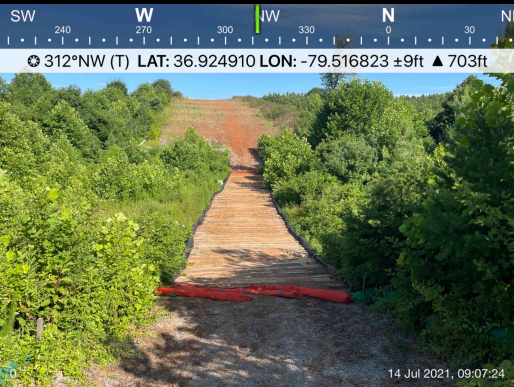
GPS Location	See photo		GPS Location	See photo	
Field Station#	15348+21		Field Station#	15343+34	
Pic 7 Desc.	Equipment bridge ECDs are in good condition and functioning.		Pic 8 Desc.	Waterbars are functioning as intended throughout this section.

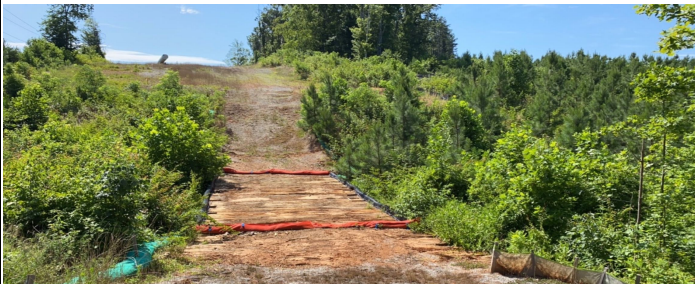
36°58'35" N 79°40'40" W 151°SE COURSE 95° GPS Sorry no results found 07.14.2021 10:50:54 Accur +/-102.9 Ft ALT 880 Ft			36°58'34" N 79°40'38" W 320°NW COURSE 333° GPS Sorry no results found 07.14.2021 10:51:43 Accur +/-15.4 Ft ALT 930 Ft		
GPS Location	1	GPS Location	2		
Field Station#	14804+99	Field Station#	14806+50		
Pic 1 Desc.	Equipment bridge and surrounding ECDs in place and functional at stream crossing and resource buffer.		Pic 2 Desc.	Perimeter CFS triple stacks and SSF in place and functional. No issues observed.

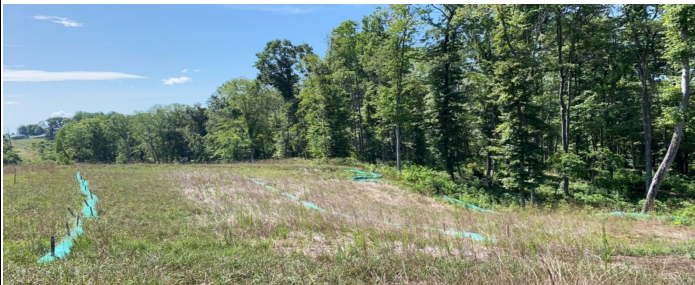
Pic 3 Desc.	Rows of CFS in final cleanup area in good condition. Permanent vegetation growing in area.		Pic 4 Desc.	Perimeter SSF and P1 silt fence behind sump are in good condition.

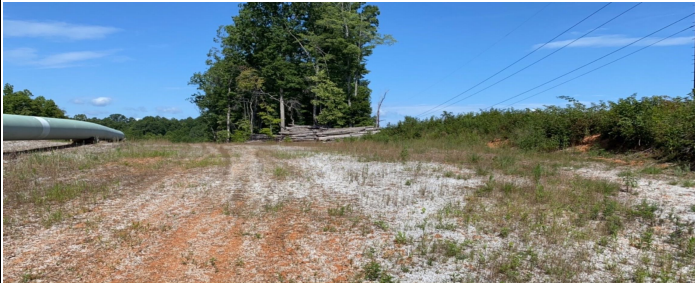
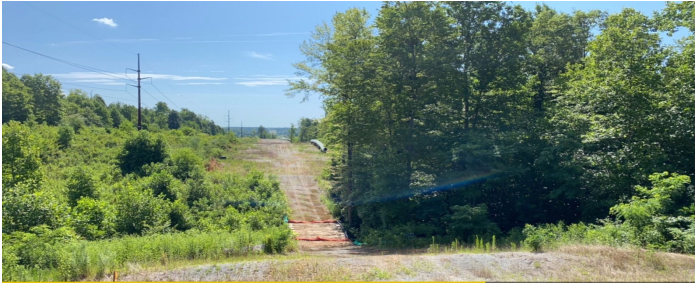
36°58'14" N 79°39'16" W 225°SW COURSE 162° GPS Penhook, VA 24137, United States 07.14.2021 10:35:22 Accur +/-84.0 Ft ALT 883 Ft			36°58'14" N 79°39'15" W 112°E COURSE 93° GPS Penhook, VA 24137, United States 07.14.2021 10:35:56 Accur +/-15.3 Ft ALT 935 Ft		
GPS Location	5	GPS Location	6		
Field Station#	14880+00	Field Station#	14888+69		
Pic 5 Desc.	View of stabilized ground in temporary area. Vegetation is limited or dying out.		Pic 6 Desc.	Equipment bridge and surrounding ECDs in place and functional at stream crossing and resource buffer.

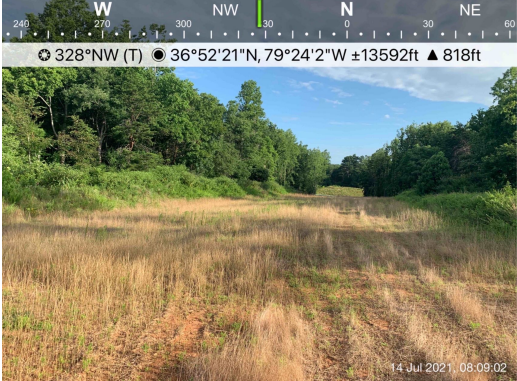
Insert image here			
GPS Location	O	GPS Location			
Field Station#	15768+00	Field Station#			
Pic 7 Desc.	Observing temporary stabilization	Pic 8 Desc.			
Insert image here		Insert image here			
GPS Location		GPS Location			
Field Station#		Field Station#			
Pic 9 Desc.		Pic 10 Desc.			
Insert image here		Insert image here			
GPS Location		GPS Location			
Field Station#		Field Station#			
Pic 11 Desc.		Pic 12 Desc.

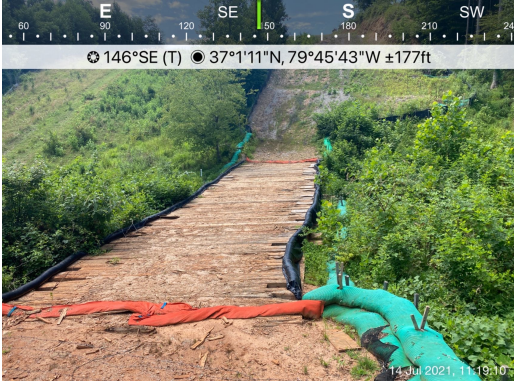
GPS Location	0	GPS Location	0		
Field Station#	14486+60	Field Station#	14510+00		
Pic 3 Desc.	Approximately 14486+60. Overview of stream crossing, equipment bridge and ECDs at stream S-G22.		Pic 4 Desc.	Approximately 14510+00. Overview of ROW.

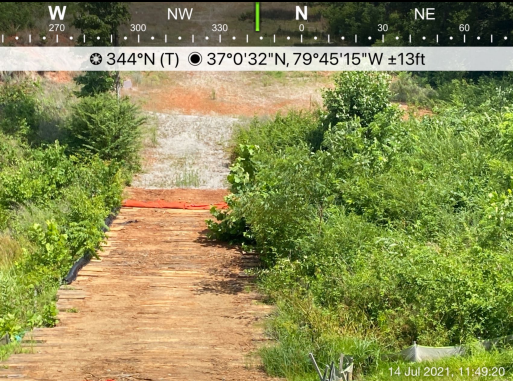
GPS Location	0	GPS Location	0		
Field Station#	14524+50	Field Station#	14531+58		
Pic 5 Desc.	Approximately 14524+50. Overview of road crossing and RCEs.		Pic 6 Desc.	Approximately 14531+58. Overview of stream crossing, equipment bridge and ECDs at stream S-G18.

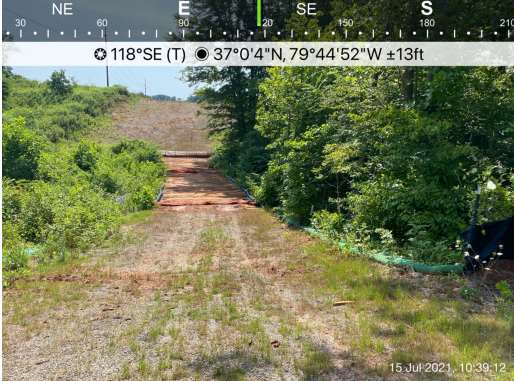
GPS Location	0	GPS Location	0		
Field Station#	14568+10	Field Station#	14548+00		
Pic 1 Desc.	Approximately 14568+10. Overview of stream crossing, equipment bridge and ECDs at stream S-E18.		Pic 2 Desc.	Approximately 14548+00. Overview of ROW.

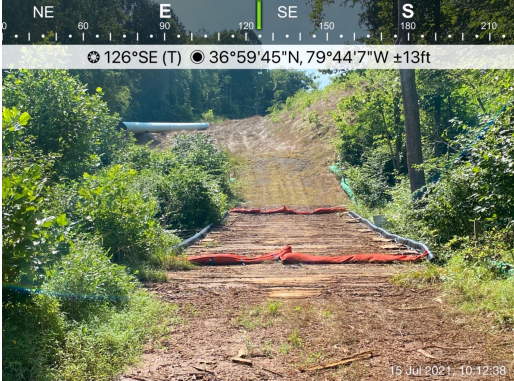
GPS Location	0	GPS Location	0		
Field Station#	14611+27	Field Station#	14599+00		
Pic 3 Desc.	Approximately 14611+27. Overview of stream crossing, equipment bridge and ECDs at stream S-E14.		Pic 4 Desc.	Approximately 14599+00. Overview of road crossing and RCEs.

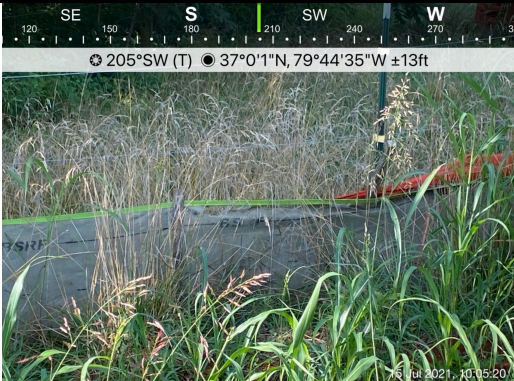
GPS Location	0	GPS Location	0		
Field Station#	14582+25	Field Station#	14575+00		
Pic 5 Desc.	Approximately 14582+25. P-1 requires maintenance.		Pic 6 Desc.	Approximately 14575+00. Overview of ROW.

4. E&S BMPs (List BMPs and note if installed and maintained as per the plan. If corrective action is needed, a picture is required.)					
E&S BMPs	Compliance Level	Corrective Action		Corrective Time Frame	Date Repaired
Compost Filter Sock	Acceptable				
Equipment Bridge	Acceptable				
Rock Construction Entrance	Acceptable				
Sensitive Resource Buffer	Acceptable				
Sensitive Resource Signage	Acceptable				
Silt Fence (Filter Fabric Fence)	Communication	Replace damaged area of fence			
Silt Fence (Reinforce Filter Fence)	Acceptable

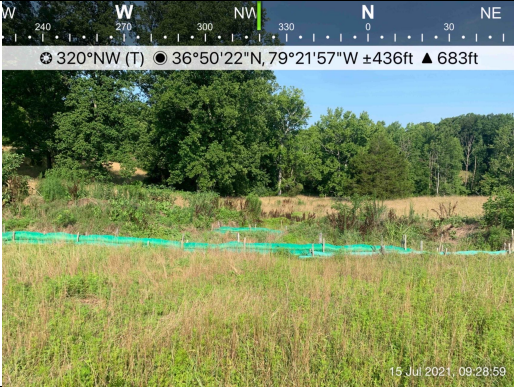
GPS Location	O	GPS Location	O		
Field Station#	15930+00	Field Station#	15934+00		
Pic 1 Desc.	Observing temporary stabilization and ECD's	Pic 2 Desc.	Observing temporary stabilization, CWD outlet and ECD's

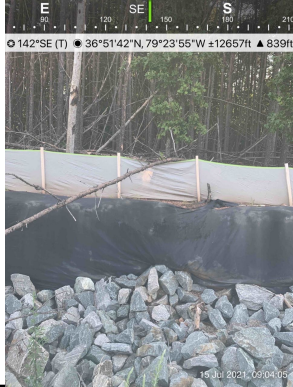
GPS Location	O	GPS Location	O		
Field Station#	15878+08	Field Station#	15836+00		
Pic 3 Desc.	Observing temporary stabilization, signage, buffer, equipment crossing and ECD's	Pic 4 Desc.	Observing limb down on P1.

4. E&S BMPs (List BMPs and note if installed and maintained as per the plan. If corrective action is needed, a picture is required.)					
E&S BMPs	Compliance Level	Corrective Action		Corrective Time Frame	Date Repaired
Cleanwater Diversion Pipe	Acceptable				
Compost Filter Sock	Acceptable				
Equipment Bridge	Acceptable				
Housekeeping	Acceptable				
Plunge Pool	Acceptable				
Rock Filter Outlet	Acceptable				
Sensitive Resource Buffer	Acceptable				
Sensitive Resource Signage	Acceptable				
Silt Fence (Filter Fabric Fence)	Communication	Contractor removed limb from P1			7/15/2021

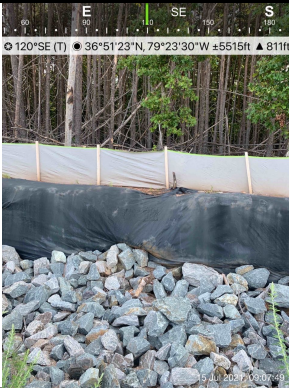
GPS Location	O	GPS Location	O		
Field Station#	15836+00	Field Station#	15825+00		
Pic 5 Desc.	Observing limb removed from P1.	Pic 6 Desc.	Observing temporary stabilization, plunge pool and ECD's

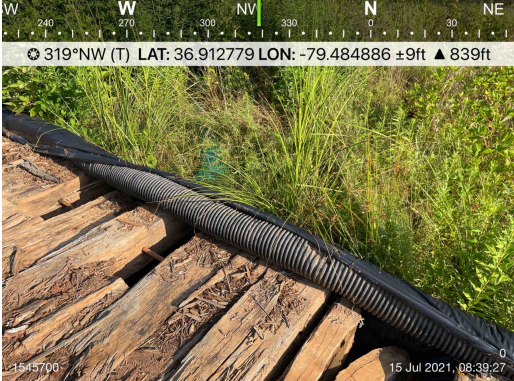
GPS Location	See photo		GPS Location	See photo	
Field Station#	15457+00		Field Station#	15434+52	
Pic 1 Desc.	Equipment bridge fabric needs to be reattached.		Pic 2 Desc.	Equipment bridge fabric and sideboard have been damaged and need to be replaced.

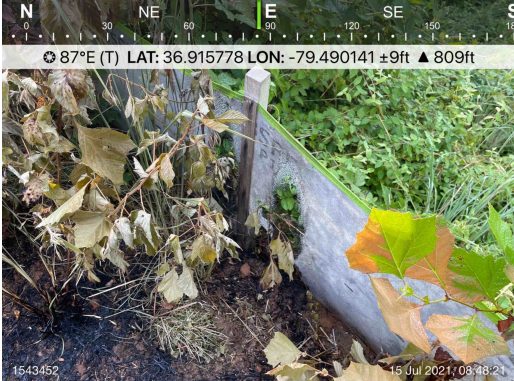
GPS Location	See photo		GPS Location	See photo	
Field Station#	15434+52		Field Station#	15434+52	
Pic 3 Desc.	P1 has been damaged and needs to be replaced.		Pic 4 Desc.	SSF fabric has been damaged and needs to be replaced.

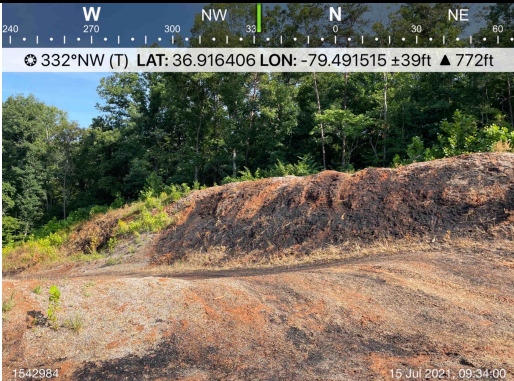
GPS Location	See photo		GPS Location	See photo	
Field Station#	15429+84		Field Station#	15435+09	
Pic 5 Desc.	Area to be stabilized once work is completed.		Pic 6 Desc.	Erosion along equipment bridge needs to be stabilized.

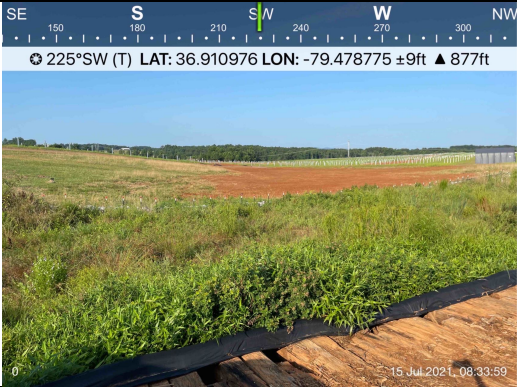
GPS Location	See photo		GPS Location	See photo	
Field Station#	15475+00		Field Station#	15465+00	
Pic 7 Desc.	3rd party rock outlet appears to be in good condition along this drainage.		Pic 8 Desc.	No evidence of sedimentation from 3rd party rock outlet.

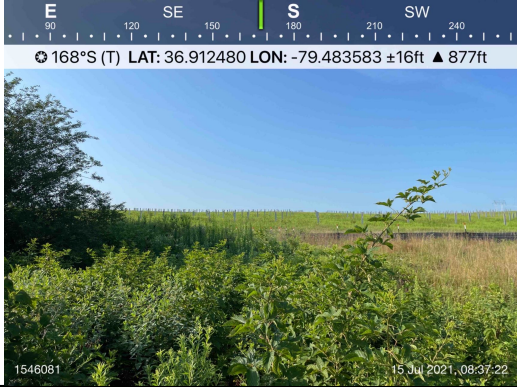
GPS Location	See photo		GPS Location	See photo	
Field Station#	15460+81		Field Station#	15460+81	
Pic 9 Desc.	No evidence of sedimentation from 3rd party rock outlet.		Pic 10 Desc.	CWD remains in good condition.

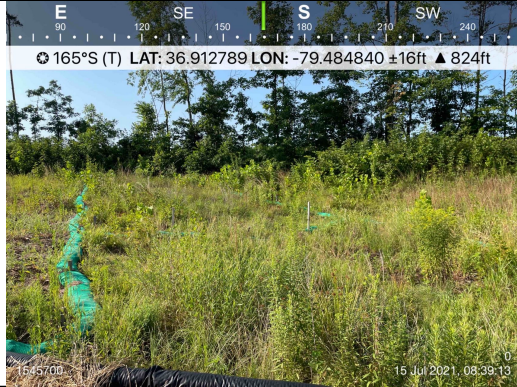
GPS Location	See photo		GPS Location	See photo	
Field Station#	15457+00		Field Station#	15453+00	
Pic 11 Desc.	Drainage ECDs are in good condition with no evidence of sedimentation from 3rd party disturbance.		Pic 12 Desc.	CWD is in good condition with no evidence of sedimentation from 3rd party disturbance.

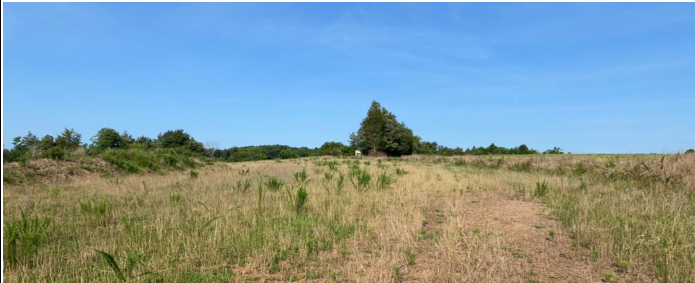
36°57'55" N 79°36'38" W 245°SW COURSE 347° GPS Penhook, VA 24137, United States 07.15.2021 09:30:58 Accur +/-83.4 Ft ALT 815 Ft			36°57'55" N 79°36'26" W 185°S COURSE 100° GPS Penhook, VA 24137, United States 07.15.2021 09:35:05 Accur +/-53.6 Ft ALT 889 Ft		
GPS Location	5		GPS Location	6	
Field Station#	15010+00		Field Station#	15017+00	
Pic 5 Desc.	View of temporary stabilization along ROW. Temporary diversion berm stabilized along perimeter.		Pic 6 Desc.	Water bar performing intended function. ROW stabilized in temporary area.

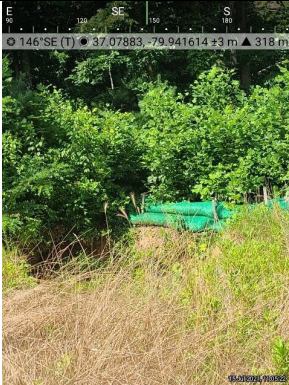
GPS Location	00000	GPS Location	00000		
Field Station#	13729+70	Field Station#	13740+00		
Pic 1 Desc.	Monitored sump pit and end treatment. No environmental issues observed at the time of inspection.		Pic 2 Desc.	Monitored ECDs along row edge. All functioning properly at the time of inspection.

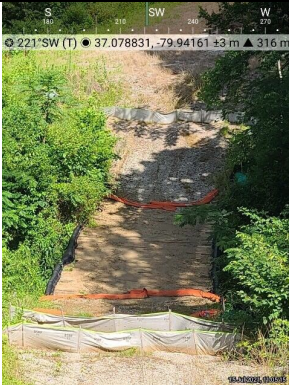
GPS Location	00000	GPS Location	00000		
Field Station#	13728+11	Field Station#	13670+00		
Pic 3 Desc.	Monitored ECDs and equipment bridge. All ECDs functioning. O issues observed at the time of inspection.		Pic 4 Desc.	Vegetation observation photo in permanent area showing good coverage.

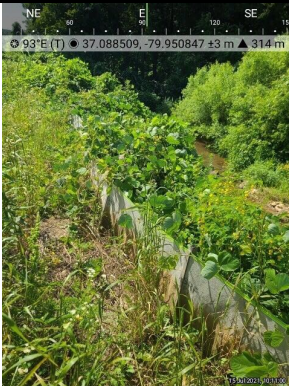
GPS Location	00000	GPS Location	00000		
Field Station#	13677+00	Field Station#	13730+90		
Pic 5 Desc.	Monitored ECDs along stream on edge of row where precious issues have been. No environmental issues observed at the time of inspection.		Pic 6 Desc.	Monitored row stabilization. No issues observed at the time of inspection.

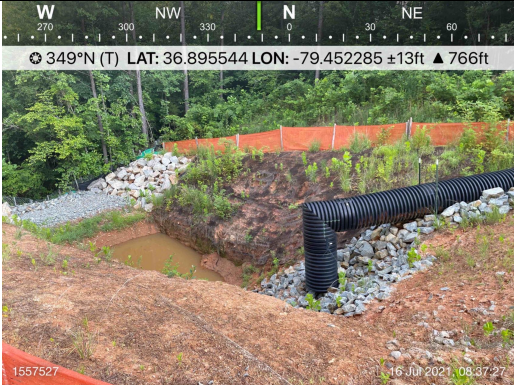
GPS Location	See photo		GPS Location	See photo	
Field Station#	15575+27		Field Station#	15571+67	
Pic 1 Desc.	Slope drain is in good condition and functioning as intended.		Pic 2 Desc.	Waterbars are in good condition throughout this area.

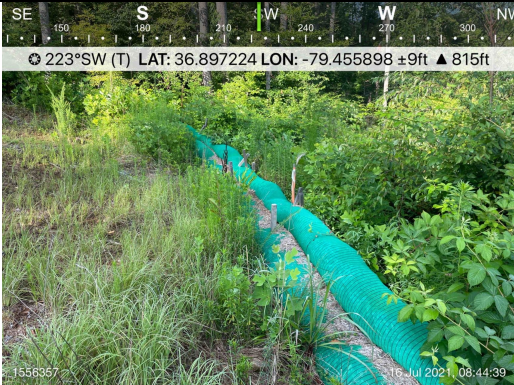
GPS Location	See photo		GPS Location	See photo	
Field Station#	15563+57		Field Station#	15556+83	
Pic 3 Desc.	CFS is in good condition.		Pic 4 Desc.	No evidence of sedimentation from 3rd party disturbance.

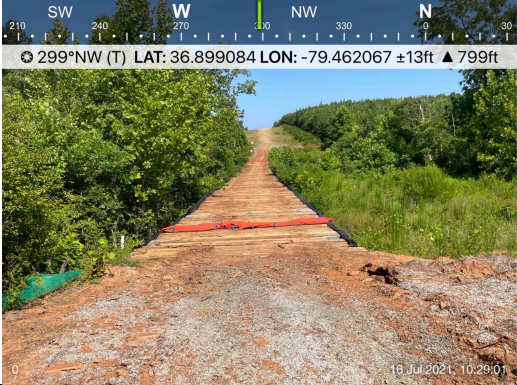
GPS Location	See photo		GPS Location	See photo	
Field Station#	15542+00		Field Station#	15535+00	
Pic 7 Desc.	Equipment bridge ECDs are in place and functioning.		Pic 8 Desc.	Previous dig up area has been stabilized.

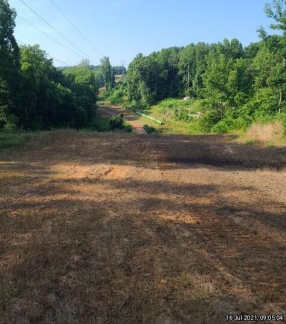
GPS Location	0000	GPS Location	0000		
Field Station#	13832+50	Field Station#	13850+00		
Pic 1 Desc.	Row photo showing stabilization. No environmental issues observed at the time of inspection.		Pic 2 Desc.	Monitored sump pits and end treatment. No environmental issues observed at the time of inspection	
	West Elevation 115°E (T) ● GPS data is unavailable ▲ - m

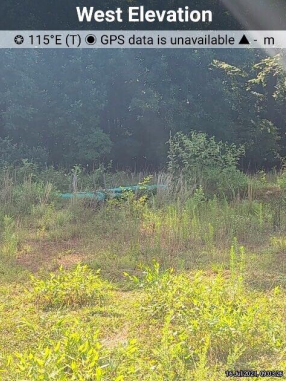
GPS Location	0000	GPS Location	00000		
Field Station#	13849+50	Field Station#	13784+35		
Pic 3 Desc.	Inspected ECDs throughout inspection today.		Pic 4 Desc.	Monitored sump pit and rock lined channel. No environmental issues observed at the time of inspection.

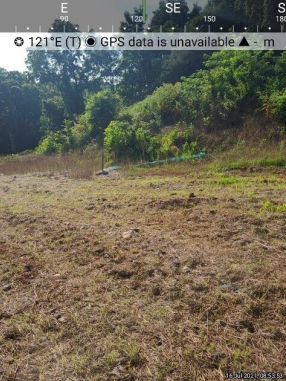
Pic 5 Desc.	Vegetation observation photo, monitored ECDs throughout inspection today. No issues observed at the time of inspection.		Pic 6 Desc.	Monitored ECDs at stream crossing. No issues observed at the time of inspection.

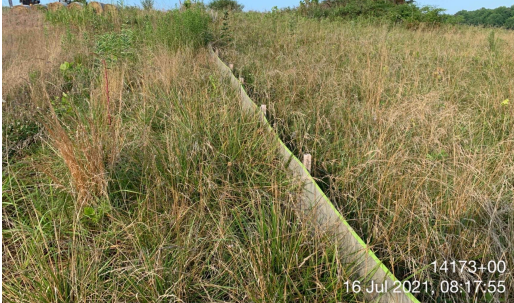
14173+00 16 Jul 2021, 08:17:55

299°NW (T) 37°3'28"N, 79°50'12"W ±577ft ▲921ft 14208+00 16 Jul 2021, 08:40:50	
GPS Location	0	GPS Location	0		
Field Station#	14173+00	Field Station#	14208+00		
Pic 1 Desc.	P1 silt fence in acceptable condition	Pic 2 Desc.	Super silt fence in acceptable condition		
	Glade Hill VA 286°W (T) 37°2'56"N, 79°49'2"W ±91ft ▲941ft

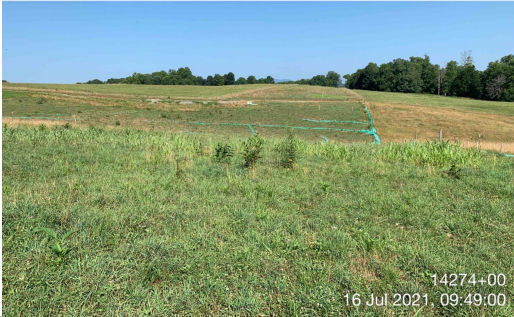
14274+00 16 Jul 2021, 09:49:00

239°SW (T) 37°3'8"N, 79°49'25"W ±95ft ▲983ft 14255+00 16 Jul 2021, 10:00:36	
GPS Location	0	GPS Location	0		
Field Station#	14274+00	Field Station#	14255+00		
Pic 3 Desc.	Permanent vegetative stabilization in acceptable condition	Pic 4 Desc.	Waterbar in acceptable condition		
	Glade Hill VA 222°SW (T) 37°3'7"N, 79°49'26"W ±36ft ▲980ft

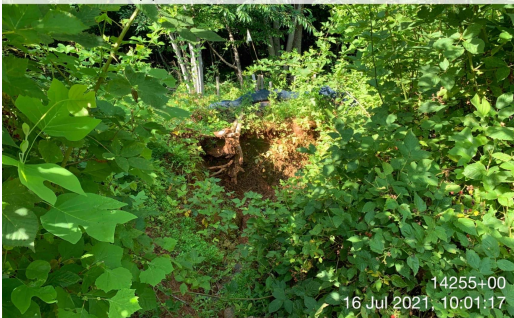
14255+00 16 Jul 2021, 10:01:17

GPS Location	0	GPS Location	0		
Field Station#	14255+00	Field Station#	14250+00		
Pic 5 Desc.	Waterbar end treatment in acceptable condition	Pic 6 Desc.	P1 silt fence in acceptable condition

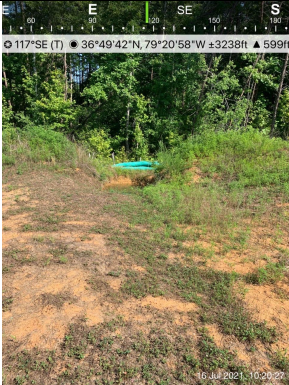
GPS Location	O	GPS Location	O		
Field Station#	16007+00	Field Station#	16004+00		
Pic 1 Desc.	Observing temporary stabilization, sump and end treatment	Pic 2 Desc.	Observing temporary stabilization, signage and buffer

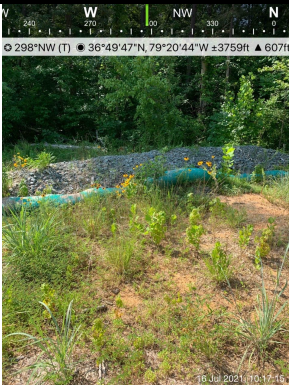
GPS Location	O	GPS Location	O		
Field Station#	16010+00	Field Station#	16016+36		
Pic 3 Desc.	Observing temporary stabilization, CWD outlet and ECD's	Pic 4 Desc.	Observing temporary stabilization, signage, buffer, equipment crossing and ECD's

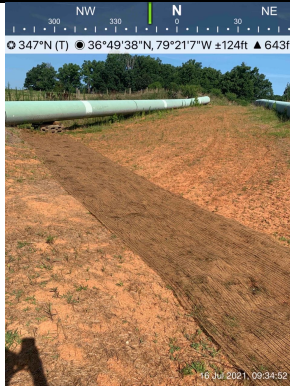
GPS Location	O	GPS Location	O		
Field Station#	15999+00	Field Station#	15996+00		
Pic 5 Desc.	Observing temporary stabilization, signage and buffer	Pic 6 Desc.	Observing erosion that was repaired and erosion control blanket installed

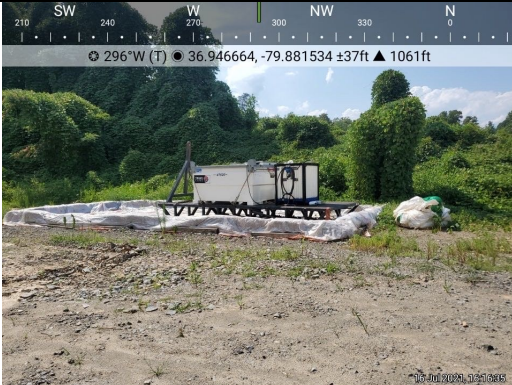
GPS Location	0	GPS Location	0		
Field Station#	0+00	Field Station#	0+00		
Pic 3 Desc.	LY-032 Secondary containment		Pic 4 Desc.	LY-032 Equipment staging

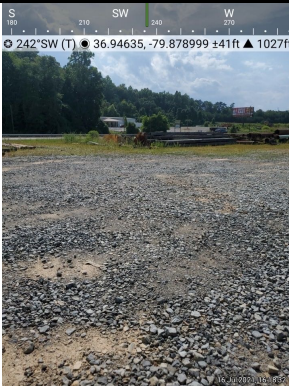
GPS Location	0	GPS Location	0		
Field Station#	0+00	Field Station#	0+00		
Pic 5 Desc.	LY-033 Construction entrance		Pic 6 Desc.	LY-033 Stormwater drain inlet protection

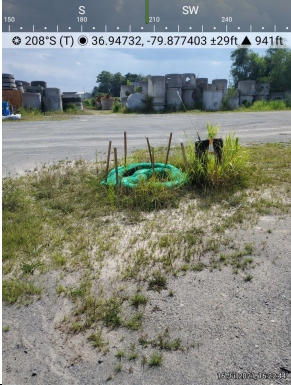
GPS Location	0	GPS Location	0		
Field Station#	0+00	Field Station#	0+00		
Pic 7 Desc.	ANC-006 Stormwater drain inlet protection	Pic 8 Desc.	ANC-006 Secondary containment		
Insert image here		Insert image here			
GPS Location		GPS Location			
Field Station#		Field Station#			
Pic 9 Desc.		Pic 10 Desc.			
Insert image here		Insert image here			
GPS Location		GPS Location			
Field Station#		Field Station#			
Pic 11 Desc.		Pic 12 Desc.
