Visual Site Inspection Report

Project Name	H-600 Pipeline Spread G	AFE	124300137	Spread	H-600 Pipeline Spread G
Contractor	Precision			Report #	31163
Inspector	Chris Burns			Date/Time	11/15/2021 7:49 AM
Permit #	TBD	Inspection Type	VA SWPP	Station Begin	11023+80
State	VA	Inspection Area	Partial	Station End	11098+47
County	Giles	Ground	Wet	Temperature (°F)	43.00
Municipality	N/A	Weather	Cloudy	Rain Gauge (in)	0.00
				Rain Accumulation Time (days)	1.00

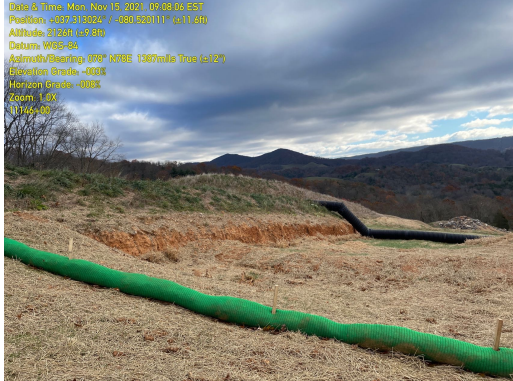
GPS Location	See photo		GPS Location	See photo	
Field Station#	11137+00		Field Station#	11146+00	
Pic 3 Desc.	Permanent waterbars in place		Pic 4 Desc.	Cleanwater diversion berm in place

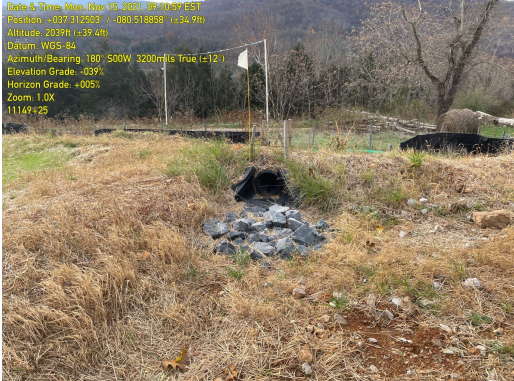
GPS Location	See photo		GPS Location	See photo	
Field Station#	11149+25		Field Station#	11150+00	
Pic 5 Desc.	Stone inlet protection in place		Pic 6 Desc.	Supersilt fence perimeter control in place

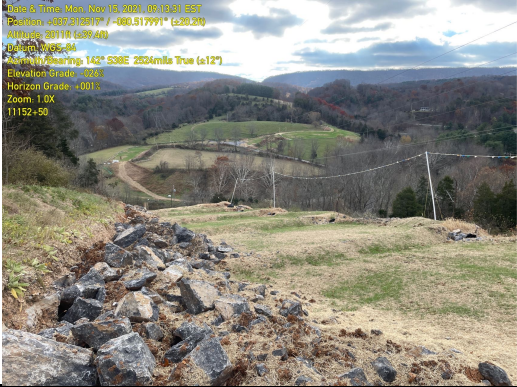
<p>Date & Time: Mon, Nov 15, 2021, 09:23:59 EST Position: +007.210597° / -080.517991° (s19.70) Altitude: 1823ft (s19.70) Datum: WGS-84 Datum/Bearing: 143° S30E 2524mils True (s12°) Elevation Grade: -003% Horizon Grade: -001% Zoom: 1.0X 11152+50</p>

<p>Date & Time: Mon, Nov 15, 2021, 09:23:59 EST Position: +007.210597° / -080.517991° (s19.70) Altitude: 1823ft (s19.70) Datum: WGS-84 Datum/Bearing: 143° S30E 2524mils True (s12°) Elevation Grade: -003% Horizon Grade: -001% Zoom: 1.0X 11165+00</p>			
GPS Location	See photo	GPS Location	See photo		
Field Station#	11152+50	Field Station#	11165+00		
Pic 7 Desc.	Waterbars in place	Pic 8 Desc.	P1 silt fence perimeter control in place

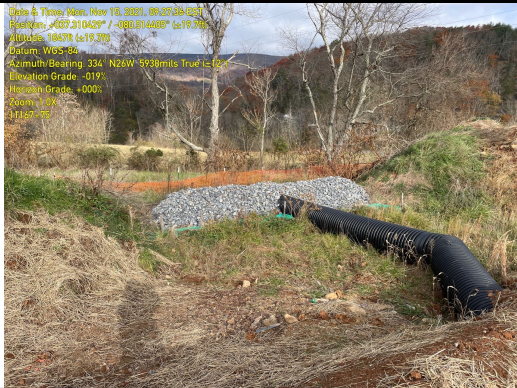
<p>Date & Time: Mon, Nov 15, 2021, 09:23:59 EST Position: +007.210429° / -080.514400° (s19.70) Altitude: 1807ft (s19.70) Datum: WGS-84 Datum/Bearing: 334° N26W 5930mils True (s15°) Elevation Grade: -019% Horizon Grade: -000% Zoom: 1.0X 11167+75</p>

GPS Location	See photo	GPS Location	See photo		
Field Station#	11167+75	Field Station#	11168+15		
Pic 9 Desc.	Cleanwater diversion outlet protection in place	Pic 10 Desc.	RCE in place

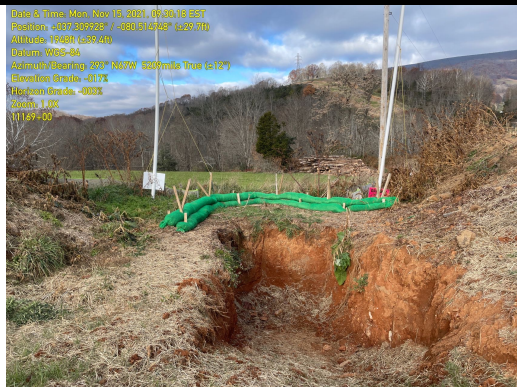
<p>Date & Time: Mon, Nov 15, 2021, 09:24:10 EST Position: +007.209230° / -080.514365° (s19.70) Altitude: 1830ft (s19.70) Datum: WGS-84 Datum/Bearing: 209° N37W 5200mils True (s12°) Elevation Grade: -017% Horizon Grade: -003% Zoom: 1.0X 11169+00</p>

<p>Date & Time: Mon, Nov 15, 2021, 09:24:10 EST Position: +007.209230° / -080.514365° (s19.70) Altitude: 1830ft (s19.70) Datum: WGS-84 Datum/Bearing: 209° N37W 5200mils True (s12°) Elevation Grade: -017% Horizon Grade: -003% Zoom: 1.0X 11176+00</p>			
GPS Location	See photo	GPS Location	See photo		
Field Station#	11169+00	Field Station#	11176+00		
Pic 11 Desc.	End treatment in place	Pic 12 Desc.	Level spreader in place

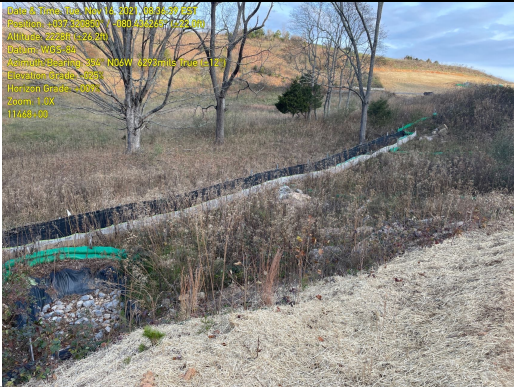
<p>Date & Time: Tue, Nov 16, 2021, 08:40:57 EST Position: +037.232301° / -085.434839° (-11.64N) Altitude: 2245ft (+13.1ft) Datum: WGS-84 Azimuth/Bearing: 232° S32W 453mils True (+13°) Elevation Grade: +00% Horizon Grade: +00% Zoom: 1.0X 11468+00</p>

Field Station#	11468+00	Field Station#	11466+25	GPS Location	See photo
Pic 3 Desc.	ECDs in place at karst feature	Pic 4 Desc.	Stone inlet protection in place

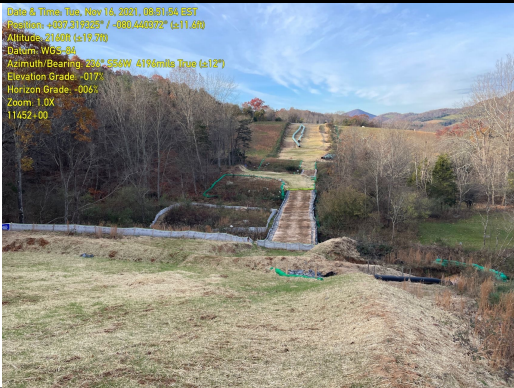
<p>Date & Time: Tue, Nov 16, 2021, 08:40:30 EST Position: +037.216847° / -085.448672° (-11.40N) Altitude: 2140ft (+19.3ft) Datum: WGS-84 Azimuth/Bearing: 232° S32W 419mils True (+12°) Elevation Grade: +01% Horizon Grade: +00% Zoom: 1.0X 11452+00</p>

<p>Date & Time: Tue, Nov 16, 2021, 08:40:30 EST Position: +037.216847° / -085.448672° (-11.40N) Altitude: 2140ft (+19.3ft) Datum: WGS-84 Azimuth/Bearing: 216° S36W 384mils True (+12°) Elevation Grade: +003% Horizon Grade: +002% Zoom: 1.0X 11446+00</p>		GPS Location	See photo
Field Station#	11452+00	Field Station#	11446+00	GPS Location	See photo
Pic 5 Desc.	Stream buffer in place	Pic 6 Desc.	Cleanwater diversion berm in place

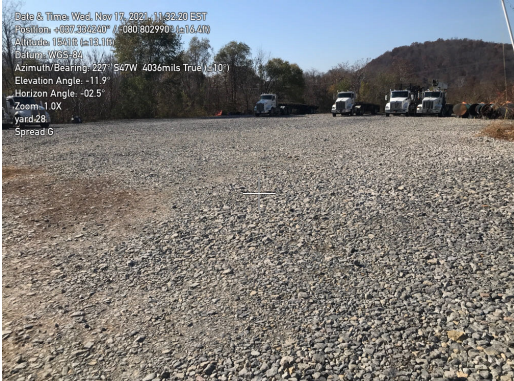
GPS Location	see photo		GPS Location	see photo	
Field Station#	12005+00		Field Station#	12005+00	
Pic 3 Desc.	Yard 28		Pic 4 Desc.	Yard 28

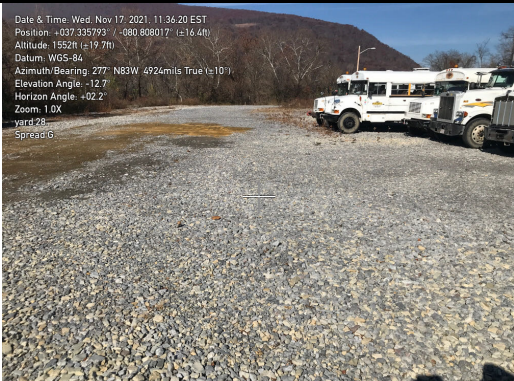
GPS Location	see photo		GPS Location	see photo	
Field Station#	12005+00		Field Station#	122005+00	
Pic 5 Desc.	Yard 28		Pic 6 Desc.	Hwy RCE

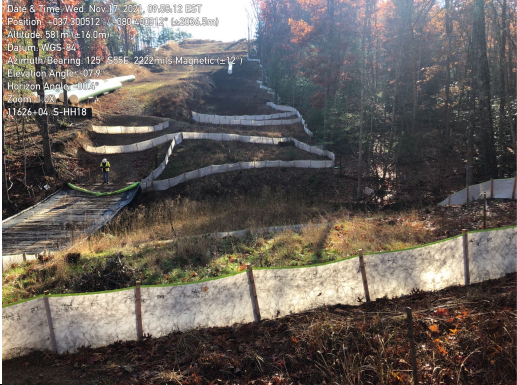
<p><small>Date & Time: Wed Nov 17 2021 11:19:19 AM Position: 437.200512, -89.043811 (a=3004.9m) Altitude: 581m (±16.0m) Datum: WGS-84 Azimuth/Bearing: 129.381° (222mils Magnetic) ±1.7 Elevation Angle: -01.2° Horizon Angle: -01.0° Zoom: 1.0X 11624+04 S-HH18</small></p>

<p><small>Date & Time: Wed Nov 17 2021 11:19:20 AM Position: 437.213917, -89.040215 (a=10.0m) Altitude: 593m (±16.0m) Datum: WGS-84 Azimuth/Bearing: 290.581° (480mils Magnetic) ±1.2 Elevation Angle: -16.0° Horizon Angle: -01.6° Zoom: 1.0X 11614+20 S-RR14</small></p>			
GPS Location	On photo	GPS Location	On photo		
Field Station#	11626+04	Field Station#	11614+20		
Pic 7 Desc.	The S-HH18 crossing is stable.	Pic 8 Desc.	The S-RR14 crossing is stable.

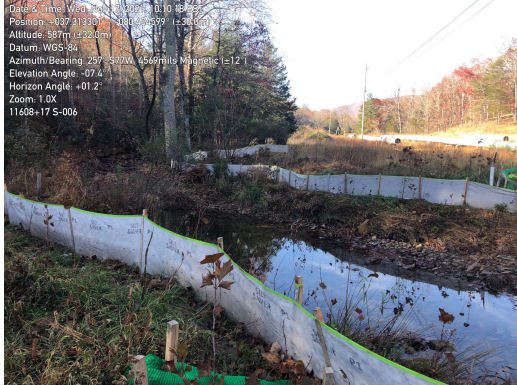
GPS Location	On photo	GPS Location			
Field Station#	11608+17	Field Station#			
Pic 9 Desc.	The S-006 crossing is stable.	Pic 10 Desc.			
<p style="text-align: center;">Insert image here</p>		<p style="text-align: center;">Insert image here</p>			
GPS Location		GPS Location			
Field Station#		Field Station#			
Pic 11 Desc.		Pic 12 Desc.

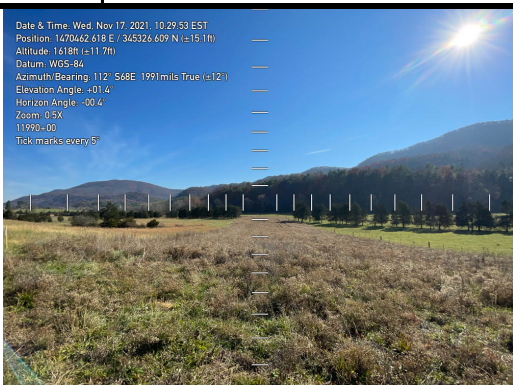
<p>Date & Time: Wed Nov 17, 2021 10:39:01 EST Position: 1471770.806 E / 345648.570 N (±23.8M) Altitude: 192.5M (±25.2M) Datum: WGS-84 Azimuth/Bearing: 232° S32W 4024mils True (±12°) Elevation Angle: -00.6° Horizon Angle: -01.2° Zoom: 0.5X 12005+00 Tick marks every 5°</p>  							
GPS Location				5				GPS Location				6			
Field Station#				11990+00				Field Station#				12005+00			
Pic 5 Desc.				Section of RoW showing conditions and controls.				Pic 6 Desc.				Section of RoW showing conditions and controls.

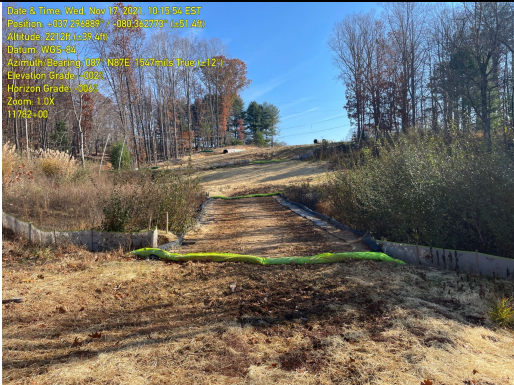
GPS Location	See photo	GPS Location	See photo		
Field Station#	11782+00	Field Station#	11761+00		
Pic 3 Desc.	Sediment filter logs in place	Pic 4 Desc.	Supersilt fence perimeter control in place		
<p>Date & Time Wed, Nov 17, 2021, 10:14:05 EST Position: +37.7231489° / -88.361947° (-88.361947°) Altitude: 210 ft (-194 ft) Datum: WGS-84 Azimuth/Bearing: 101° N39E 3627mils True (+12°) Elevation Grade: -24% Horizon Grade: -09% Zoom: 1.0X 11737+00</p>

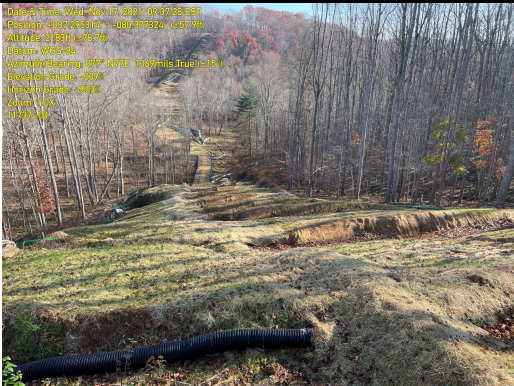
<p>Date & Time Wed, Nov 17, 2021, 10:14:05 EST Position: +37.7231489° / -88.361947° (-88.361947°) Altitude: 210 ft (-194 ft) Datum: WGS-84 Azimuth/Bearing: 101° N39E 3627mils True (+12°) Elevation Grade: -24% Horizon Grade: -09% Zoom: 1.0X 11712+00</p>  			
GPS Location	See photo	GPS Location	See photo		
Field Station#	11737+00	Field Station#	11712+00		
Pic 5 Desc.	Waterbars in place	Pic 6 Desc.	Waterbars in place

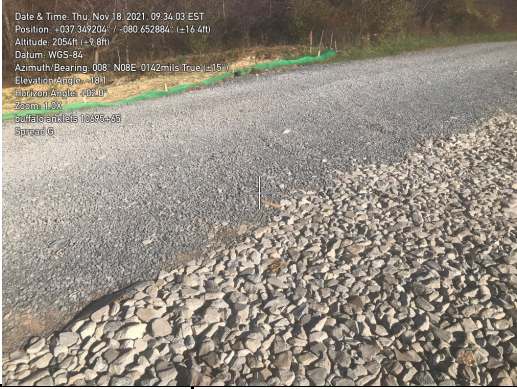
GPS Location	See photo		GPS Location	see photo	
Field Station#	10695+65		Field Station#	10693+00	
Pic 13 Desc.	Buffalo anklets		Pic 14 Desc.	Temporary vegetation	
<p>Date & Time: Thu, Nov 18, 2021, 09:46:29 EST Position: +037.341241° / -080.689143° (±68797.2M) Altitude: 2057M (±32.0M) Datum: WGS-84 Azimuth/Bearing: 110° S08E 204mils True (±12°) Elevation Angle: -20.0° Horizon Angle: -00.0° Zoom: 1.0X Temp veg: 10660+00 Big Stoney RCE 10660+00 Spread: 0</p>

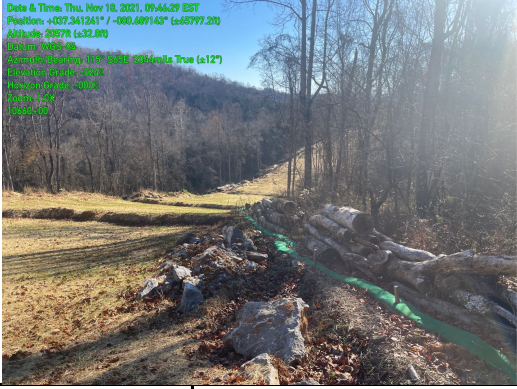
GPS Location	see photo		GPS Location	see photo	
Field Station#	10660+00		Field Station#	10690+00	
Pic 15 Desc.	Water bars		Pic 16 Desc.	Temporary vegetation	
<p>Date & Time: Thu, Nov 18, 2021, 09:52:49 EST Position: +037.352072° / -080.641085° (±16.4M) Altitude: 2220M (±55.3M) Datum: WGS-84 Azimuth/Bearing: 127° N00E 220mils True (±12°) Elevation Angle: -17.0° Horizon Angle: -00.0° Zoom: 1.0X Temp veg: 10667+47 Big Stoney RCE 10667+47 Spread: 0</p>

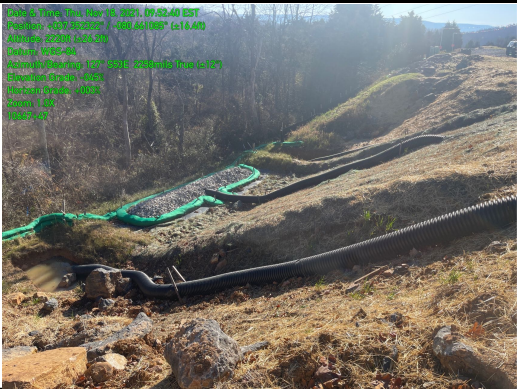
GPS Location	see photo		GPS Location	see photo	
Field Station#	10667+47		Field Station#	10674+75	
Pic 17 Desc.	Level spreader		Pic 18 Desc.	Big Stoney RCE

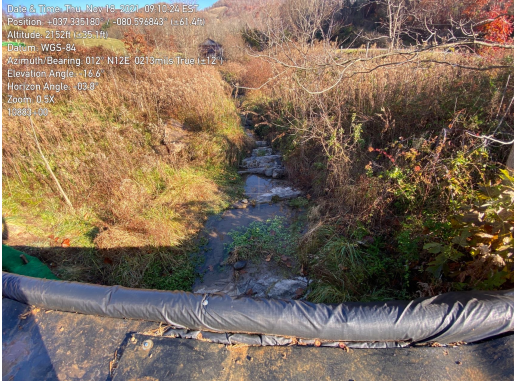
GPS Location		See Photo		GPS Location	
Field Station#		10883+00		Field Station#	
Pic 3 Desc.		Steam		Pic 4 Desc.	
				Photo showing controls and stabilization

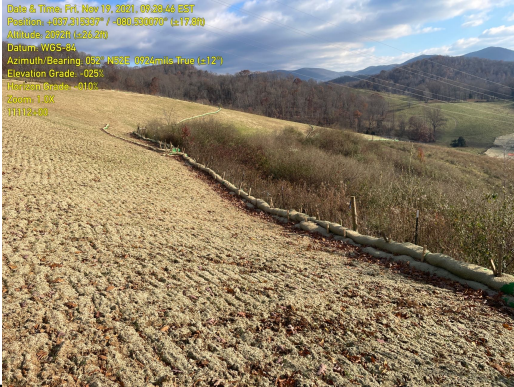
GPS Location	See photo	GPS Location	See photo		
Field Station#	11112+00	Field Station#	11121+00		
Pic 3 Desc.	CFS triple stack perimeter control in place	Pic 4 Desc.	Temporary CFS waterbars in place

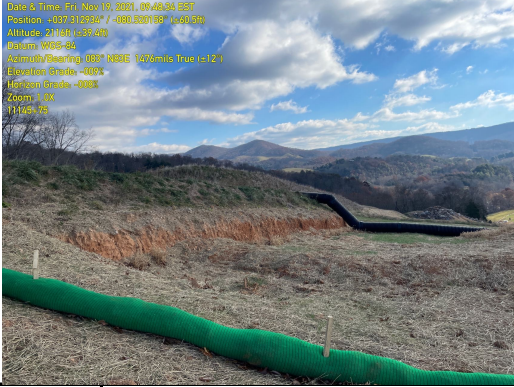
<p>Date & Time: Fri, Nov 19, 2021, 09:51:00 EST Position: +037.31239° / -080.51932° (+17.4N) Altitude: 2050ft (+124.2N) Datum: WGS-84 Azimuth/Bearing: 122.508E 109.8mils True (+12.1) Elevation Grade: -747 Horizon Grade: +003 Zoom: 1.0X 11147+00</p>			
GPS Location	See photo	GPS Location	See photo		
Field Station#	11145+75	Field Station#	11147+00		
Pic 5 Desc.	Cleanwater diversion berm in place	Pic 6 Desc.	Stone inlet protection in place

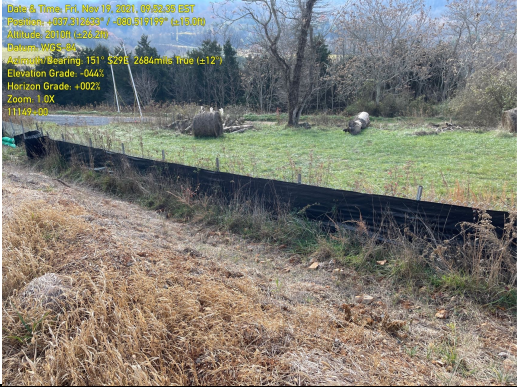
GPS Location		See photo		GPS Location	
Field Station#		11149+00		Field Station#	
Pic 7 Desc.		Supersilt fence perimeter control in place		Pic 8 Desc.	
<p>Date & Time: Fri, Nov 19, 2021, 10:06:15 EST Position: +037.31133° / -060.51262° (s=12.40) Altitude: 199.00 (s=20.20) Datum: WGS-84 Azimuth/Bearing: 119° S61E, 2116mils True (s=12°) Elevation Grade: -003% Horizon Grade: +003% Zoom: 1.0X 11163+50</p>

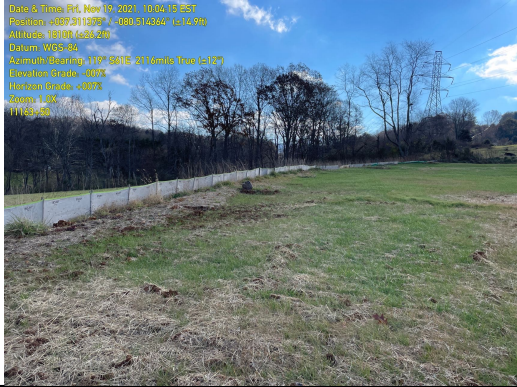
GPS Location		See photo		GPS Location	
Field Station#		11163+50		Field Station#	
Pic 9 Desc.		Silt fence perimeter control in place		Pic 10 Desc.	
<p>Date & Time: Fri, Nov 19, 2021, 11:05:41 EST Position: +037.31050° / -060.51500° (s=15.40) Altitude: 199.00 (s=11.20) Datum: WGS-84 Azimuth/Bearing: 200° S33W, 1656mils True (s=12°) Elevation Grade: -001% Horizon Grade: -003% Zoom: 1.0X 11168+15</p>  		<p>Date & Time: Fri, Nov 19, 2021, 11:17:41 EST Position: +037.30849° / -060.51463° (s=36.30) Altitude: 196.11 (s=78.70) Datum: WGS-84 Azimuth/Bearing: 093° S87E, 1453mils True (s=12°) Elevation Grade: -019% Horizon Grade: -000% Zoom: 1.0X 11178+00</p>  			
GPS Location		See photo		GPS Location	
Field Station#		11168+15		Field Station#	
Pic 11 Desc.		RCE in place		Pic 12 Desc.

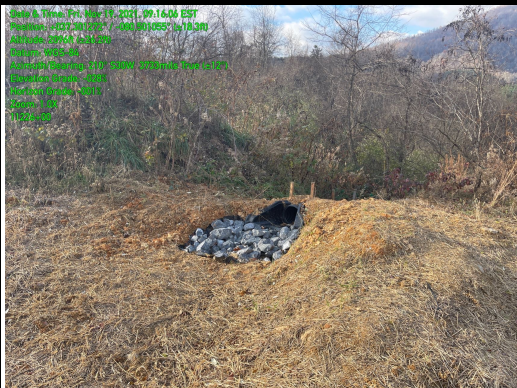
GPS Location	See Photo	GPS Location	See Photo		
Field Station#	11226+00	Field Station#	11226+00		
Pic 9 Desc.	Stone inlet protection conditions.	Pic 10 Desc.	View of slope drain pipe inlet and vegetated sump pit surroundings.

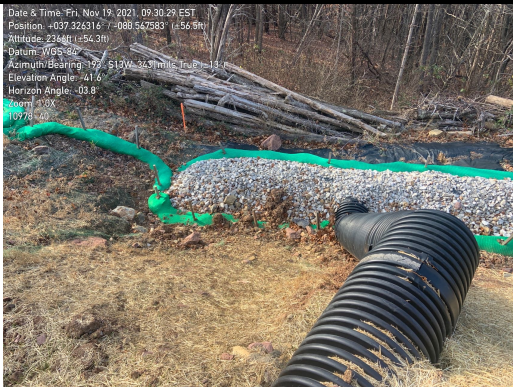
GPS Location	See photo		GPS Location	See photo	
Field Station#	10978+40		Field Station#	10976+00	
Pic 3 Desc.	Level spreader added to the punch list for maintenance		Pic 4 Desc.	Perimeter controls and erosion control blanket are in acceptable condition

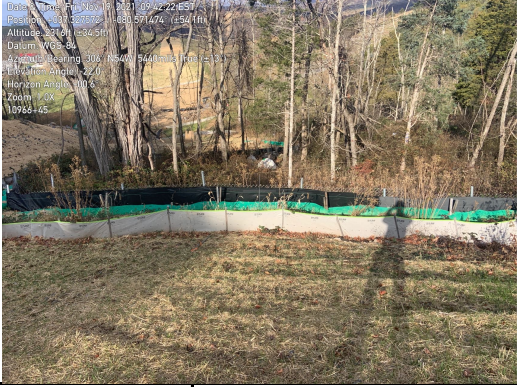
GPS Location	See photo	GPS Location	See photo		
Field Station#	10966+45	Field Station#	10959+00		
Pic 7 Desc.	Karst ECD's are in place	Pic 8 Desc.	CFS water bars are in acceptable condition		
Insert image here		Insert image here			
GPS Location		GPS Location			
Field Station#		Field Station#			
Pic 9 Desc.		Pic 10 Desc.			
Insert image here		Insert image here			
GPS Location		GPS Location			
Field Station#		Field Station#			
Pic 11 Desc.		Pic 12 Desc.
