Visual Site Inspection Report

Project Name	H-600 Pipeline Spread H	AFE	124300138	Spread	H-600 Pipeline Spread H
Contractor	Precision			Report #	29614
Inspector	Jason Nielsen			Date/Time	10/11/2021 6:45 PM
Permit #	TBD	Inspection Type	VA SWPP	Station Begin	12284+75
State	VA	Inspection Area	Partial	Station End	12443+75
County	Montgomery	Ground	Dry	Temperature (°F)	69.00
Municipality	N/A	Weather	Cloudy	Rain Gauge (in)	0.00
				Rain Accumulation Time (days)	0.00

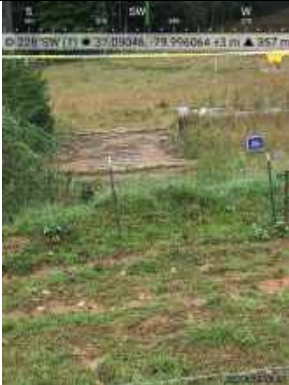
GPS Location	0000		GPS Location	0000	
Field Station#	13525+10		Field Station#	13496+62	
Pic 1 Desc.	Monitored equipment bridge and protection at stream crossing, no environmental issues observed at the time of inspection.		Pic 2 Desc.	Observed rock lined channel on hill side leading to bar ditch at CAHAS#2 rd crossing.

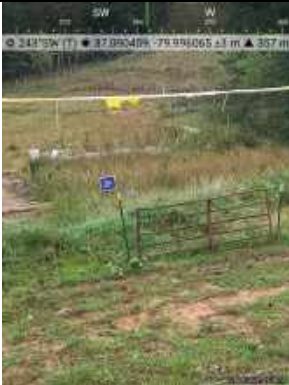
GPS Location	0000		GPS Location	0000	
Field Station#	13525+60		Field Station#	13437+75	
Pic 3 Desc.	Monitored ECDs and vegetation at stream crossing, no environmental issues observed at the time of inspection.		Pic 4 Desc.	Access rd MVP-FR-293.02 requires maintenance due to recent rain events and 3rd party activities, added to the punch list for repair by the contractor.

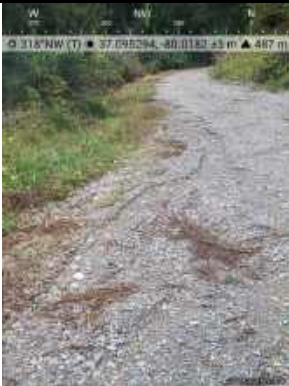
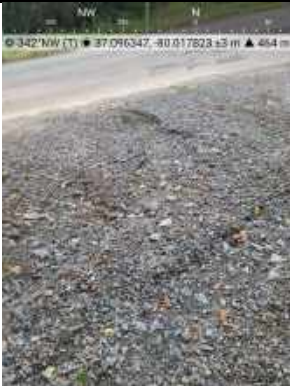
GPS Location	0000		GPS Location	0000	
Field Station#	13437+75		Field Station#	13437+75	
Pic 5 Desc.	Access rd MVP-FR-293.02 requires maintenance due to recent rain events and 3rd party activities, added to the punch list for repair by the contractor.		Pic 6 Desc.	Access rd MVP-FR-293.02 requires maintenance due to recent rain events and 3rd party activities, added to the punch list for repair by the contractor.

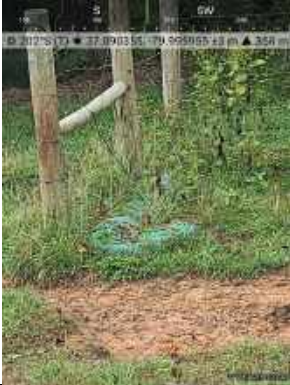
<div>Insert image here</div>		<div>Insert image here</div>	
GPS Location	0000	GPS Location			
Field Station#	13525+70	Field Station#			
Pic 7 Desc.	CFS requires maintenance due to being weathered and torn, documented and sent in to be added to the punch list for repair by the	Pic 8 Desc.			
<div>Insert image here</div>		<div>Insert image here</div>			
GPS Location		GPS Location			
Field Station#		Field Station#			
Pic 9 Desc.		Pic 10 Desc.			
<div>Insert image here</div>		<div>Insert image here</div>			
GPS Location		GPS Location			
Field Station#		Field Station#			
Pic 11 Desc.		Pic 12 Desc.

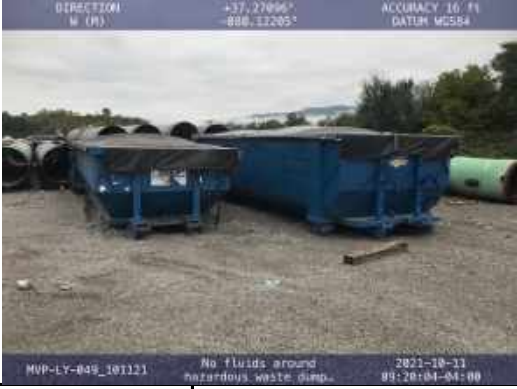
GPS Location	MVP-LY-049 See photo for gps data	GPS Location	MVP-LY-049 See photo for gps data		
Field Station#	+0	Field Station#	+0		
Pic 15 Desc.	No fluids or deposits around hazardous waste dumpsters. Looking W.	Pic 16 Desc.	Containment under light plant free of fluids. Looking NW.

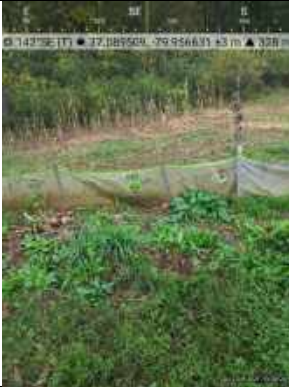
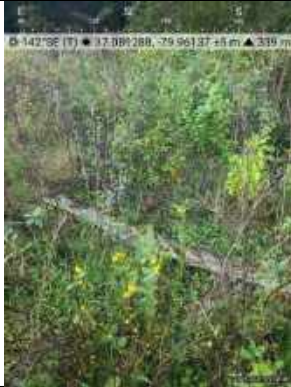
GPS Location	0000	GPS Location	0000		
Field Station#	13656+77	Field Station#	13643+70		
Pic 1 Desc.	P1 requires maintenance due to 3rd party damages , documented and added to the punch list.	Pic 2 Desc.	P1 requires maintenance, added to the punch list for repair.

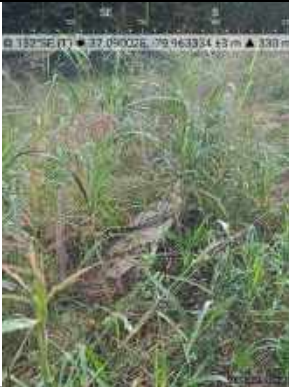
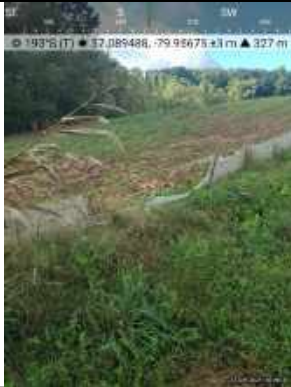
GPS Location	0000	GPS Location	00000		
Field Station#	13640+00	Field Station#	13656+77		
Pic 3 Desc.	P1 requires maintenance, added to the punch list	Pic 4 Desc.	P1 requires maintenance due to 3rd party damages , documented and added to the punch list.

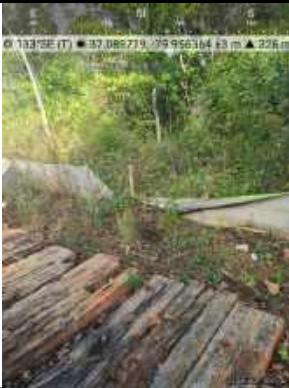
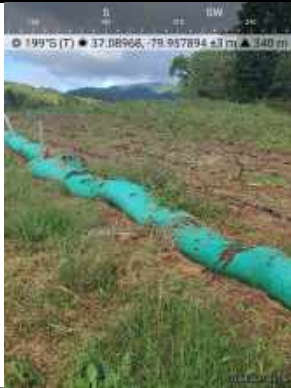
GPS Location	0000	GPS Location	0000		
Field Station#	13657+70	Field Station#	13651+50		
Pic 5 Desc.	P1 requires maintenance, documented and added to the punch list.	Pic 6 Desc.	CFS requires maintenance due to 3rd party damages, documented and added to the punch list.

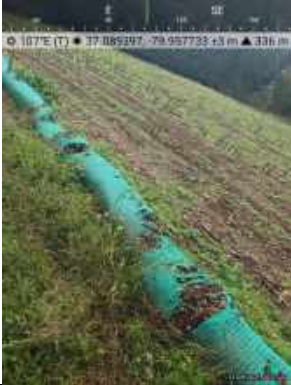
<div style="border: 1px solid black; height: 180px; width: 100%;"></div>		<div style="border: 1px solid black; height: 180px; width: 100%;"></div>	
GPS Location	00000	GPS Location			
Field Station#	13651+50	Field Station#			
Pic 7 Desc.	CFS on both sides of row requires maintenance due to 3rd party damages, recommended adding orange sock to allow	Pic 8 Desc.			
<div style="border: 1px solid black; height: 180px; width: 100%;"></div>		<div style="border: 1px solid black; height: 180px; width: 100%;"></div>			
GPS Location		GPS Location			
Field Station#		Field Station#			
Pic 9 Desc.		Pic 10 Desc.			
<div style="border: 1px solid black; height: 180px; width: 100%;"></div>		<div style="border: 1px solid black; height: 180px; width: 100%;"></div>			
GPS Location		GPS Location			
Field Station#		Field Station#			
Pic 11 Desc.		Pic 12 Desc.

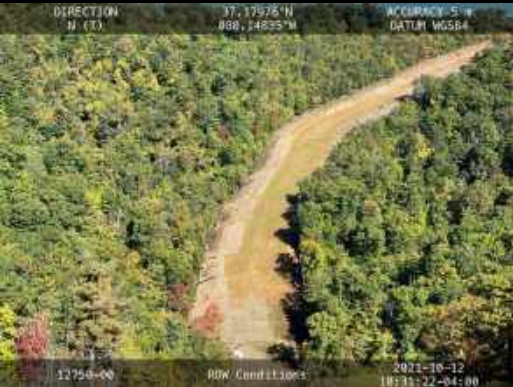
GPS Location	See photo		GPS Location	See photo	
Field Station#	12750+50		Field Station#	12750+00	
Pic 1 Desc.	Current ROW conditions. Waterbars are functional.		Pic 2 Desc.	Current ROW conditions. ROW is stable

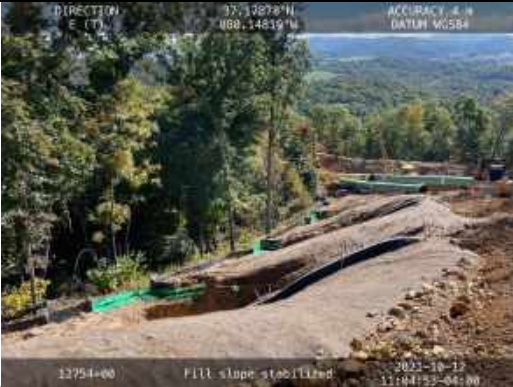
GPS Location	See photo		GPS Location	See photo	
Field Station#	12751+00		Field Station#	12754+00	
Pic 3 Desc.	Stockpiles are well stabilized with curlex		Pic 4 Desc.	Fill slope stabilized and slope drains functional

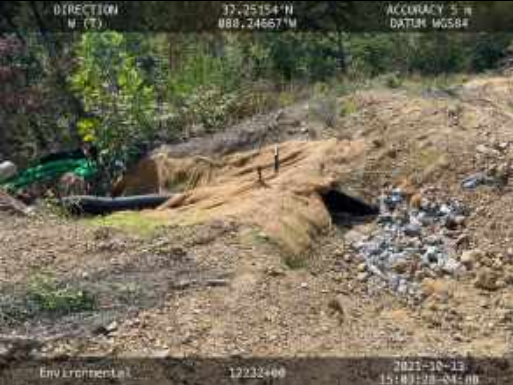
GPS Location	see photo		GPS Location	See photo	
Field Station#	12284+75		Field Station#	12232+00	
Pic 1 Desc.	Access Road MVP-MN-276.03 crossing in acceptable condition		Pic 2 Desc.	Fill slope drain in inlet in acceptable condition

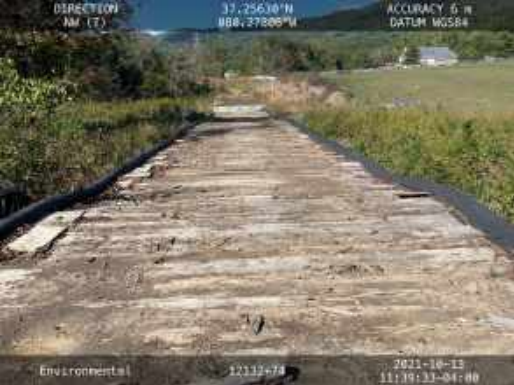
GPS Location	see photo		GPS Location	See photo	
Field Station#	12192+50		Field Station#	12132+74	
Pic 7 Desc.	Bridge and ECDs crossing stream S-C21 in acceptable condition		Pic 8 Desc.	Bridge and ECDs crossing stream S-C29 in acceptable condition

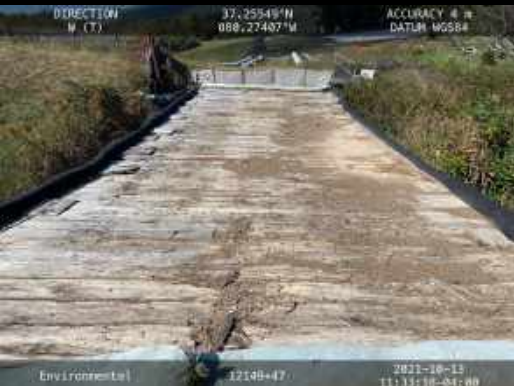
GPS Location	See photo		GPS Location	See photo	
Field Station#	12143+91		Field Station#	12144+47	
Pic 9 Desc.	Wetland W-C6 in acceptable condition		Pic 10 Desc.	Wetland crossing W-C5 in acceptable condition

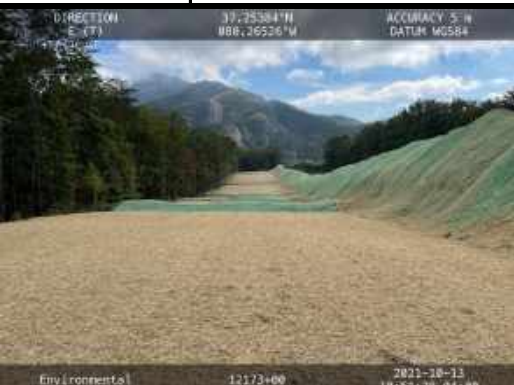
GPS Location	See photo		GPS Location	See photo	
Field Station#	12150+90		Field Station#	12173+00	
Pic 11 Desc.	Stabilized drainage feature in acceptable condition		Pic 12 Desc.	Stabilized ROW conditions acceptable

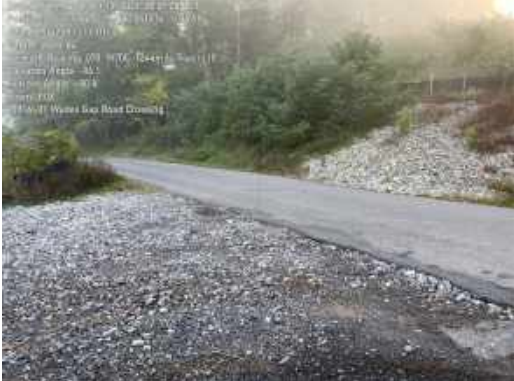
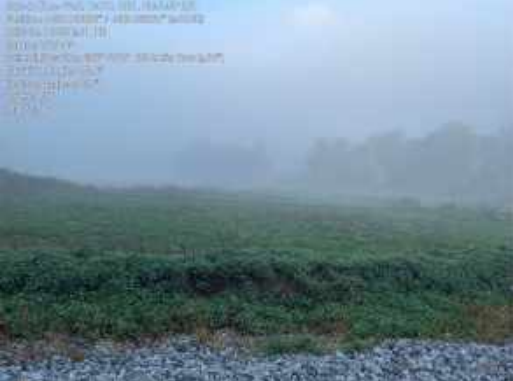
GPS Location	0	GPS Location	0		
Field Station#	13316+21	Field Station#	13314+00		
Pic 1 Desc.	Wades Gap Road Crossing in good condition and RCE in good condition and functioning properly		Pic 2 Desc.	ROW and ECDs in good condition with good vegetation established across ROW

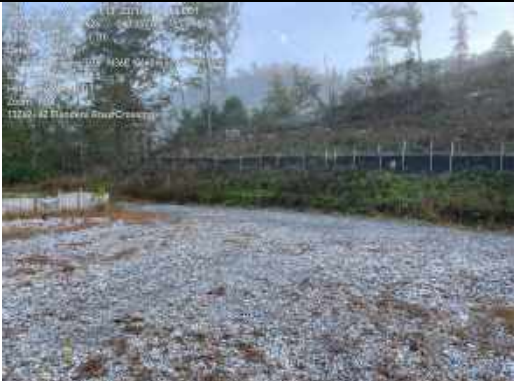
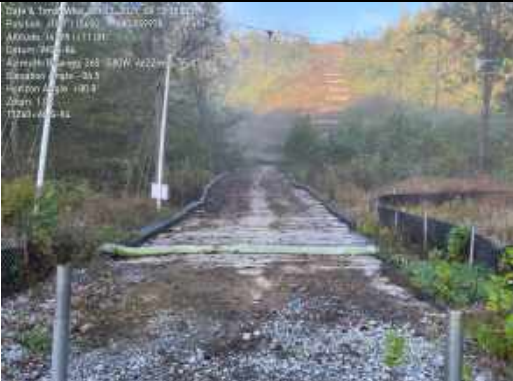
GPS Location	0	GPS Location	0		
Field Station#	13262+62	Field Station#	13260+66		
Pic 3 Desc.	Flanders Road Crossing in good condition and RCE in good condition and functioning properly		Pic 4 Desc.	MVP-S-II4 and Corresponding buffer zone in good condition

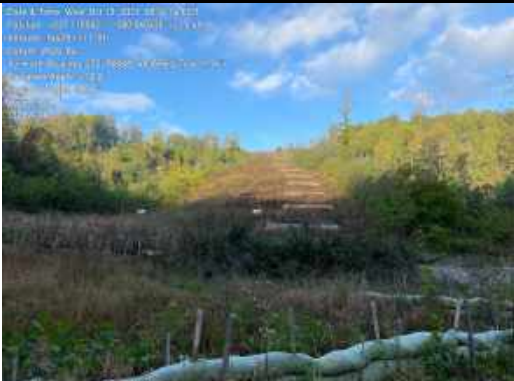
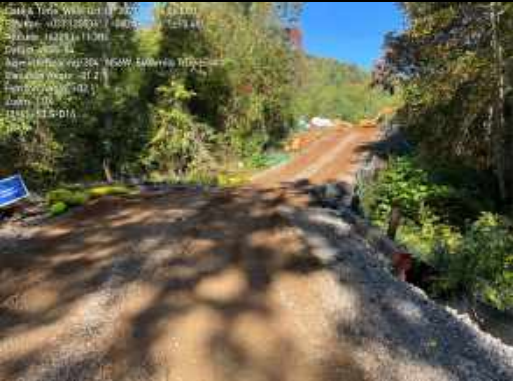
GPS Location	0	GPS Location	0		
Field Station#	13259+00	Field Station#	13141+53		
Pic 5 Desc.	ROW and ECDs in good condition with good vegetation established across ROW		Pic 6 Desc.	MVP-S-D14 and Corresponding buffer zone in good condition

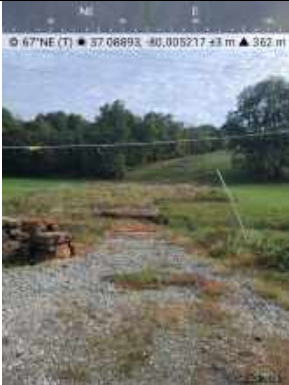
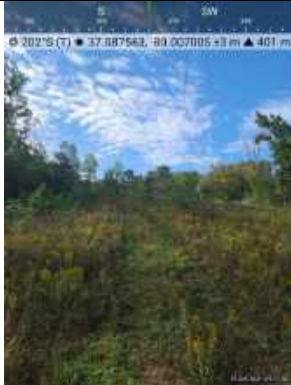
GPS Location	00000	GPS Location	0000		
Field Station#	13497+89	Field Station#	13480+90		
Pic 1 Desc.	Row photo showing stream crossing that was inspected with no environmental issues observed at the time of inspection		Pic 2 Desc.	Permanent vegetation area showing good coverage.

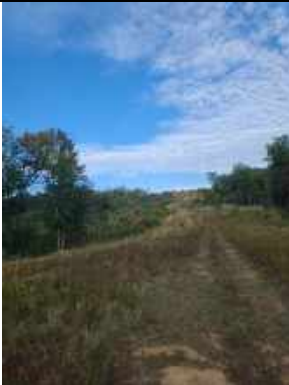
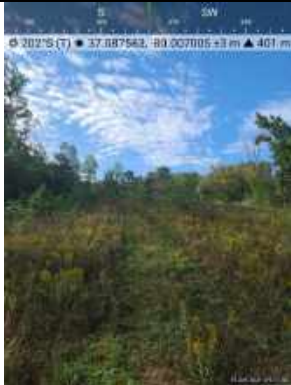
GPS Location	0000	GPS Location	00000		
Field Station#	13470+00	Field Station#	13480+00		
Pic 3 Desc.	Row photo showing travel lane from 3rd party activities, no environmental issues observed at the time of inspection.		Pic 4 Desc.	Permanent vegetation area showing good coverage. Locust trees observed growing inside the LOD.

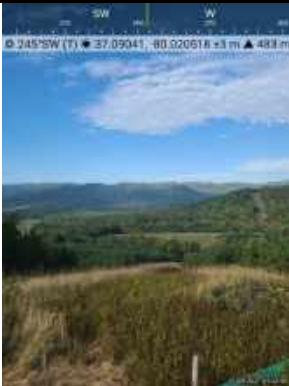
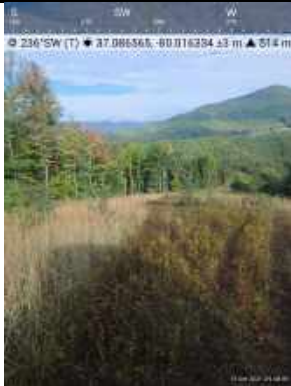
GPS Location	0000	GPS Location	00000		
Field Station#	13436+36	Field Station#	13467+00		
Pic 5 Desc.	Monitored ECDs and vegetation, no environmental issues observed at the time of inspection.		Pic 6 Desc.	Vegetation observation photo showing good coverage in permanent area.

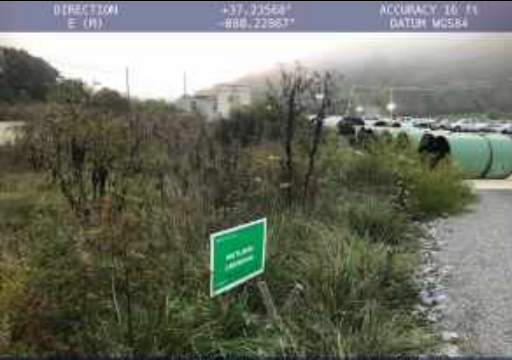
GPS Location	MVP-PY-006 See photo for gps data	GPS Location	MVP-PY-006 See photo for gps data		
Field Station#	+0	Field Station#	+0		
Pic 1 Desc.	Condition of soil pile adjacent to LOD. Not stabilized. Looking SW.	Pic 2 Desc.	Condition of triple stack compost filter sock and signage at feature W-008. Looking E.

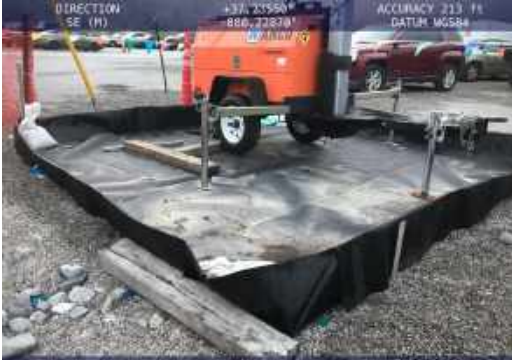
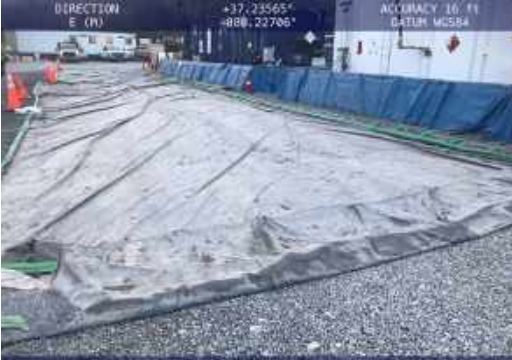
GPS Location	MVP-PY-006 See photo for gps data	GPS Location	MVP-PY-006 See photo for gps data		
Field Station#	+0	Field Station#	+0		
Pic 3 Desc.	Secondary containment under light plant free of fluids and stormwater. Looking SW.	Pic 4 Desc.	Secondary containments in place for tankers offloading fuel. Looking E.

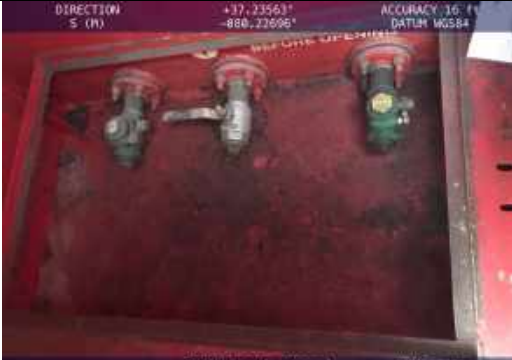
GPS Location	MVP-PY-006 See photo for gps data	GPS Location	MVP-PY-006 See photo for gps data		
Field Station#	+0	Field Station#	+0		
Pic 5 Desc.	Off Road Fuel unit condition of internal drip pan. Free of fluids. Looking SW.	Pic 6 Desc.	Off Road Fuel unit no leaky internal fittings. Looking SW.

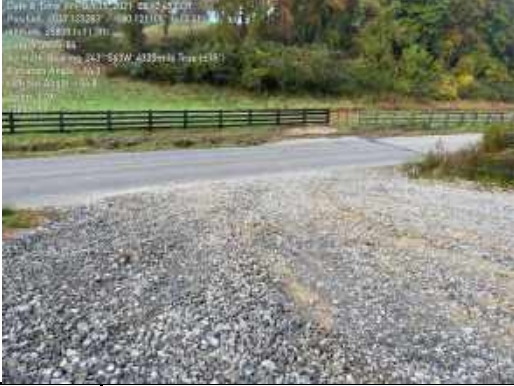
GPS Location	0	GPS Location	0		
Field Station#	13033+59	Field Station#	13061+44		
Pic 1 Desc.	RCE in good condition and functioning properly	Pic 2 Desc.	Equipment bridge in good condition

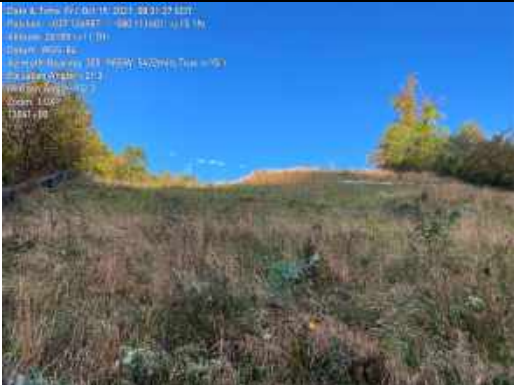
GPS Location	0	GPS Location	0		
Field Station#	13061+00	Field Station#	13061+89		
Pic 3 Desc.	ROW and ECDs in good condition with good vegetation established across ROW	Pic 4 Desc.	MVP-S-G26 and Corresponding buffer zone in good condition

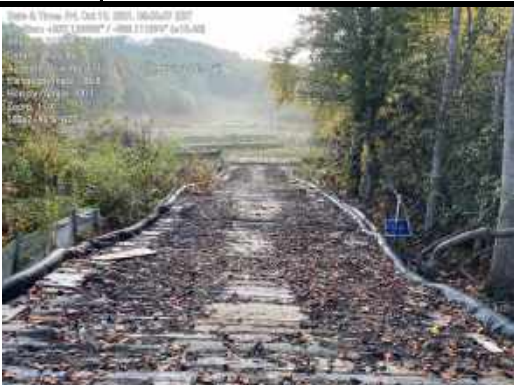
GPS Location	0	GPS Location	0		
Field Station#	13062+96	Field Station#	13064+00		
Pic 5 Desc.	MVP-S-G27 and Corresponding buffer zone in good condition	Pic 6 Desc.	ROW and ECDs in good condition with good vegetation established across ROW
