# Visual Site Inspection Report

<b>Project Name</b> H-600 Pipeline Spread H		<b>AFE</b> 124300138	<b>Spread</b> H-600 Pipeline Spread H
<b>Contractor</b> Precision		<b>Report #</b> 30576	
<b>Inspector</b> Joe Scott		<b>Date/Time</b> 11/1/2021 5:45 PM	
<b>Permit #</b> TBD	<b>Inspection Type</b> VA SWPP	<b>Station Begin</b> 12865+00	
<b>State</b> VA	<b>Inspection Area</b> Partial	<b>Station End</b> 13024+00	
<b>County</b> Roanoke	<b>Ground</b> Damp	<b>Temperature (°F)</b> 56.00	
<b>Municipality</b> N/A	<b>Weather</b> Sunny	<b>Rain Gauge (in)</b> 0.00	
			<b>Rain Accumulation Time (days)</b> 1.00

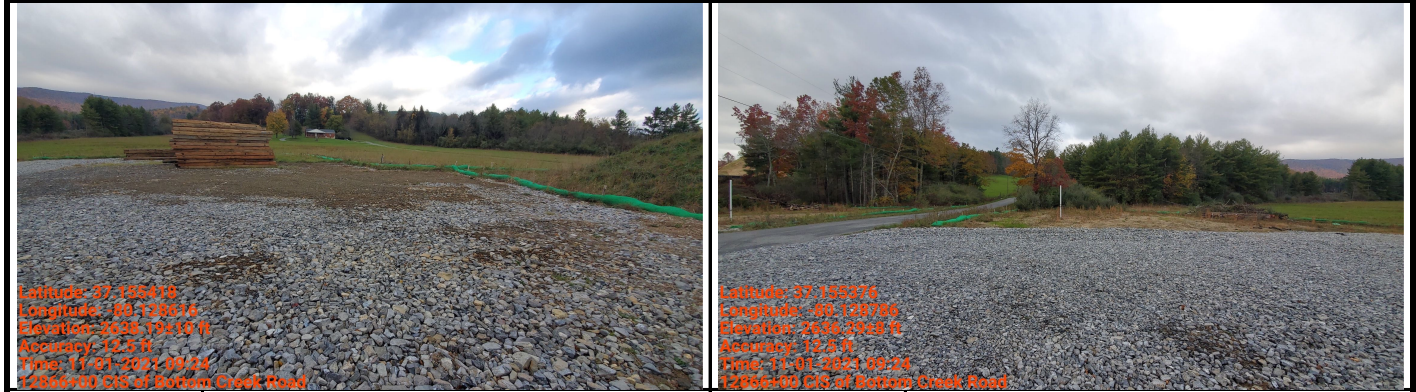
<b>GPS Location</b>	See pic for GPS location.	<b>GPS Location</b>	See pic for GPS location.
<b>Field Station#</b>	12866+00	<b>Field Station#</b>	12866+00
<b>Pic 1 Desc.</b>	No signs of any "water dumping" in the area.	<b>Pic 2 Desc.</b>	No signs of any "water dumping" in the area.

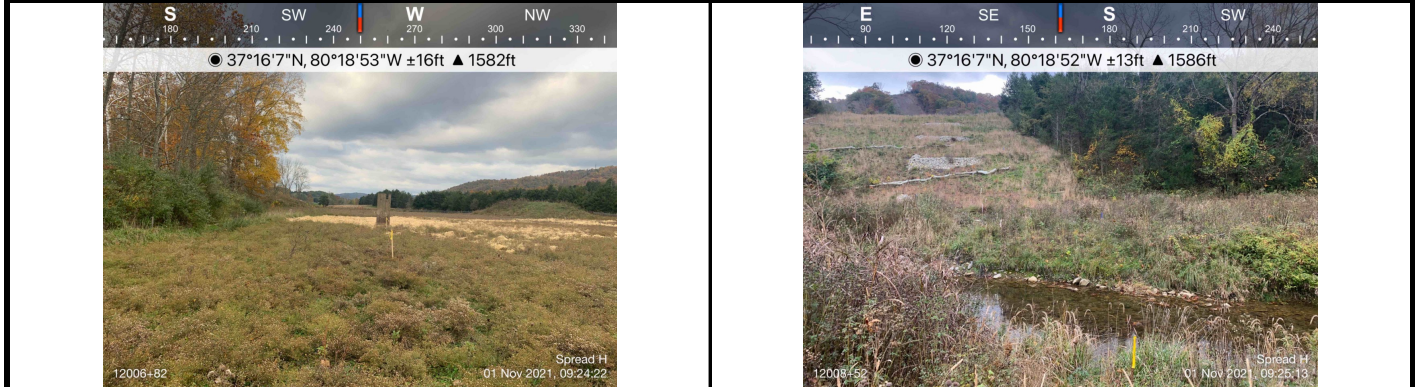
<b>Pic 1 Desc.</b>	ROW is well vegetated and stable.	<b>Pic 2 Desc.</b>	ROW is well vegetated and in acceptable condition.
--------------------	-----------------------------------	--------------------	--

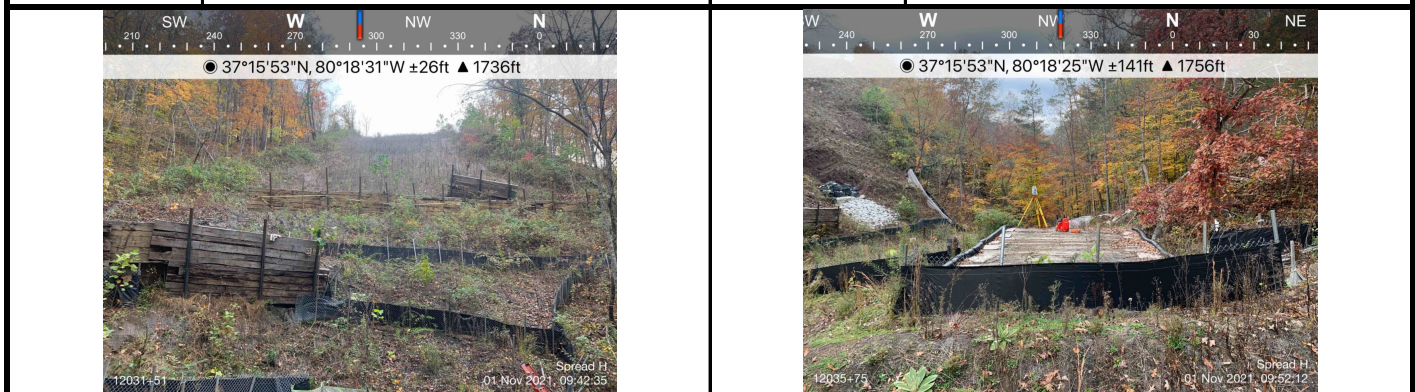
<b>Pic 5 Desc.</b>	Waterbars, end treatments, and sumps are in acceptable condition.	<b>Pic 6 Desc.</b>	Equipment bridge crossings are in acceptable condition.
--------------------	---	--------------------	---

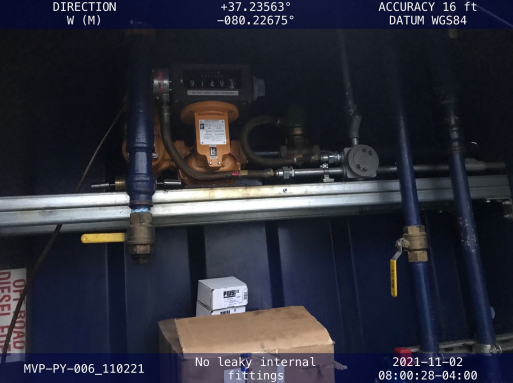
<p>DIRECTION W (M) +37.23563° -080.22675° ACCURACY 16 ft DATUM WGS84</p> <p>MVP-PY-006_110221 No leaky internal fittings 2021-11-02 08:00:26-04:00</p>		
<b>GPS Location</b>	MVP-PY-006 See photo for gps data	<b>GPS Location</b>	MVP-PY-006 See photo for gps data	
<b>Field Station#</b>	+0	<b>Field Station#</b>	+0	
<b>Pic 7 Desc.</b>	Blue Bulk Fuel tanks containment holding stormwater. Sheen observed. Looking N.	<b>Pic 8 Desc.</b>	Blue Bulk Fuel tanks no leaky internal fittings. Looking W.

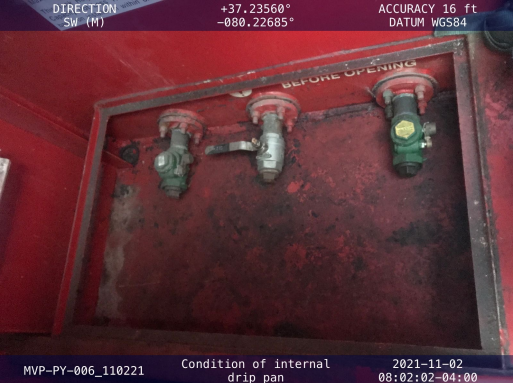
<p>DIRECTION SW (M) +37.23560° -080.22685° ACCURACY 16 ft DATUM WGS84</p> <p>MVP-PY-006_110221 Condition of internal drip pan 2021-11-02 08:02:02-04:00</p>

<b>GPS Location</b>	MVP-PY-006 See photo for gps data	<b>GPS Location</b>	MVP-PY-006 See photo for gps data	
<b>Field Station#</b>	+0	<b>Field Station#</b>	+0	
<b>Pic 9 Desc.</b>	Off Road Fuel unit containment holding some stormwater. Looking W.	<b>Pic 10 Desc.</b>	Off Road Fuel unit condition of internal drip pan. Free of fluids. Looking SW.

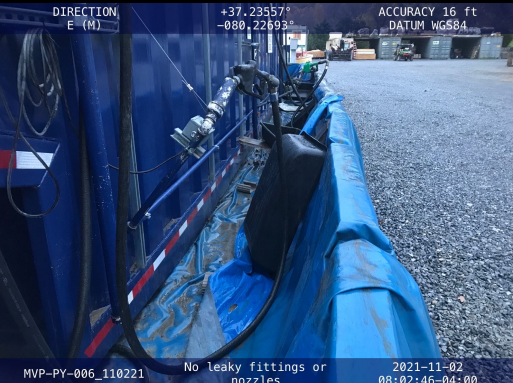
<p>DIRECTION E (M) +37.23557° -080.22693° ACCURACY 16 ft DATUM WGS84</p> <p>MVP-PY-006_110221 No leaky fittings or nozzles 2021-11-02 08:02:46-04:00</p>		
<b>GPS Location</b>	MVP-PY-006 See photo for gps data	<b>GPS Location</b>	MVP-PY-006 See photo for gps data	
<b>Field Station#</b>	+0	<b>Field Station#</b>	+0	
<b>Pic 11 Desc.</b>	Off Road Fuel unit no leaky internal fittings. Looking W.	<b>Pic 12 Desc.</b>	Blue Bulk Fuel tanks no leaky fittings or nozzles, catch pans on site. Looking E.

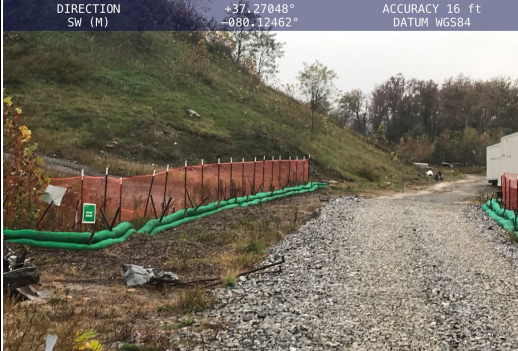
<p>DIRECTION SW (M) +37.27048° -080.12462° ACCURACY 16 ft DATUM WGS84</p> <p>MVP-LY-049_110221 Landowner disturbance west of feature 2021-11-02 09:25:10-04:00</p>

<b>GPS Location</b> MVP-LY-049 See photo for gps data	<b>GPS Location</b> MVP-LY-049 See photo for gps data
<b>Field Station#</b> +0	<b>Field Station#</b> +0
<b>Pic 17 Desc.</b> Landowner soil disturbance west of feature W-CV21B. Both areas not stabilized. Looking SW.	<b>Pic 18 Desc.</b> Landowner disturbance and debris piled along triple compost filter sock and east of feature W-CV21B. Area not stabilized. Looking S.

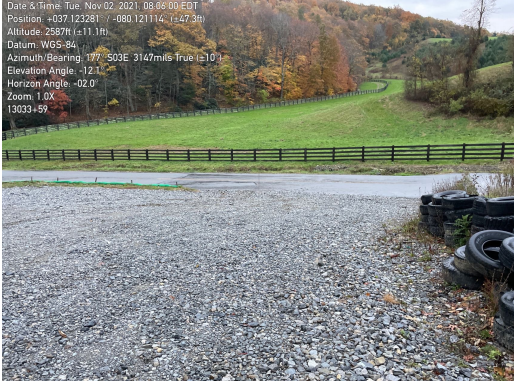
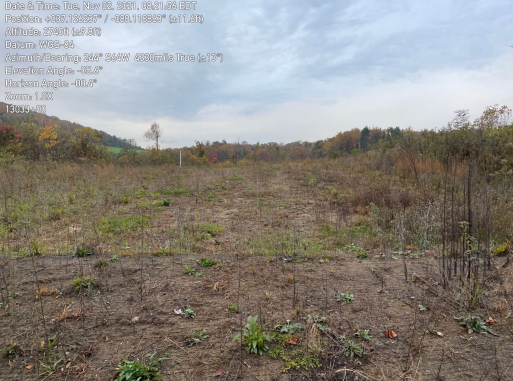
<p>Date &amp; Time: Tue, Nov 02, 2021, 08:07:26 EDT Position: +335.183277° / +680.118337° (+1.57) Altitude: 2590ft (+9.8ft) Datum: WGS-84 Azimuth/Bearing: 336° S47W 4383mils True (+13°) Elevation Angle: -43.2° Horizon Angle: -00.4° Zoom: 1.0X 13033+00</p>			
<b>GPS Location</b>	0	<b>GPS Location</b>	0		
<b>Field Station#</b>	13033+59	<b>Field Station#</b>	13033+00		
<b>Pic 1 Desc.</b>	RCE in good condition and functioning properly		<b>Pic 2 Desc.</b>	ROW and ECDs In good condition with good vegetation established across ROW

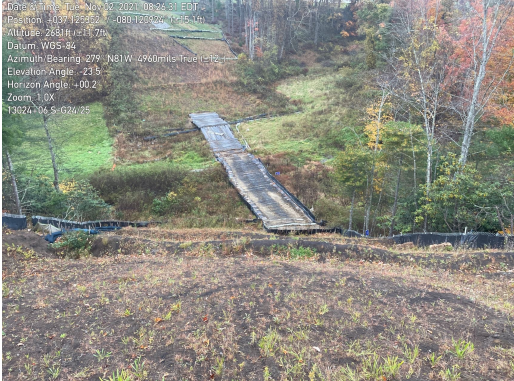
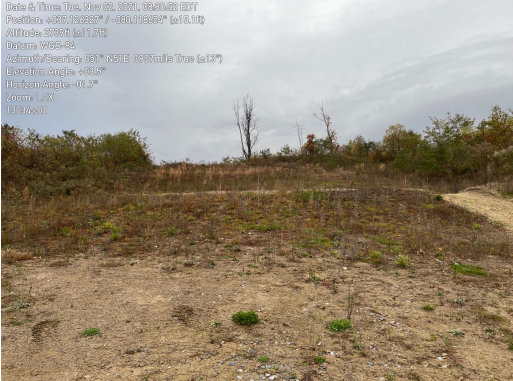
<b>GPS Location</b>	0	<b>GPS Location</b>	0		
<b>Field Station#</b>	13024+06	<b>Field Station#</b>	13034+00		
<b>Pic 3 Desc.</b>	MVP-S-G24/25 and Corresponding buffer zone in good condition		<b>Pic 4 Desc.</b>	ROW and ECDs In good condition with good vegetation established across ROW

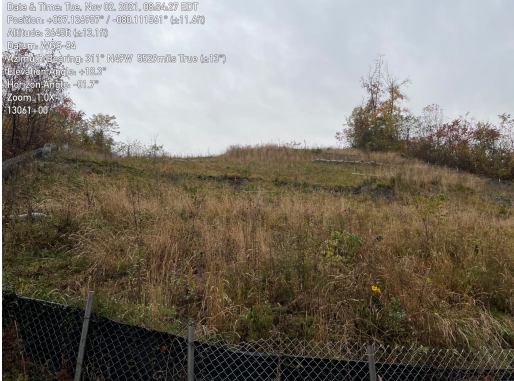
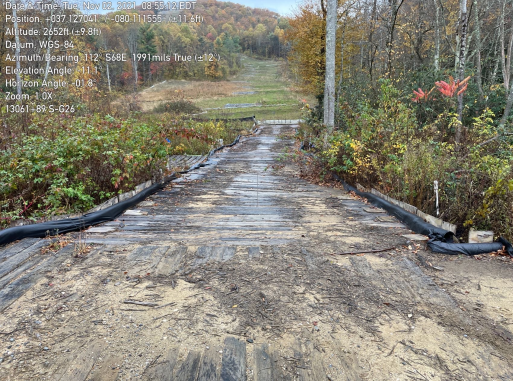
<b>Pic 5 Desc.</b>	ROW and ECDs In good condition with good vegetation established across ROW		<b>Pic 6 Desc.</b>	MVP-S-G26 and Corresponding buffer zone in good condition

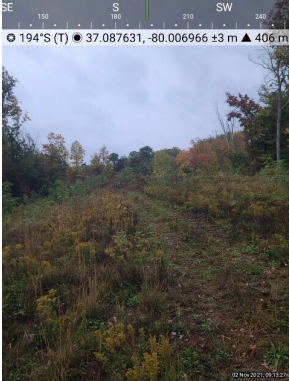
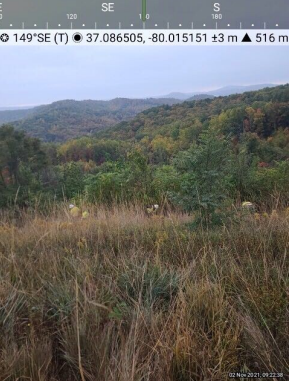
GPS Location	00000
GPS Location	00000	GPS Location	00000	Field Station#	13462+00
Field Station#	13490+00	Field Station#	13462+00	Pic 1 Desc.	Row photo showing vegetation, also showing locust trees continuing to grow inside the LOD area.
Pic 1 Desc.	Row photo showing vegetation, also showing locust trees continuing to grow inside the LOD area.	Pic 2 Desc.	Contractor performing maintenance repairs to damaged P1 on the LOD.		GPS Location

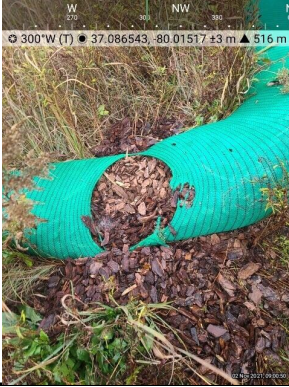
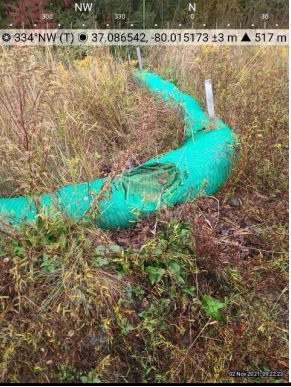
GPS Location	0000
GPS Location	0000	GPS Location	0000	Field Station#	13461+00
Field Station#	13461+00	Field Station#	13461+00	Pic 5 Desc.	CFS requires maintenance due to wildlife damages, contractor on site making repairs.
Pic 5 Desc.	CFS requires maintenance due to wildlife damages, contractor on site making repairs.	Pic 6 Desc.	CFS repaired by the contractor.		GPS Location

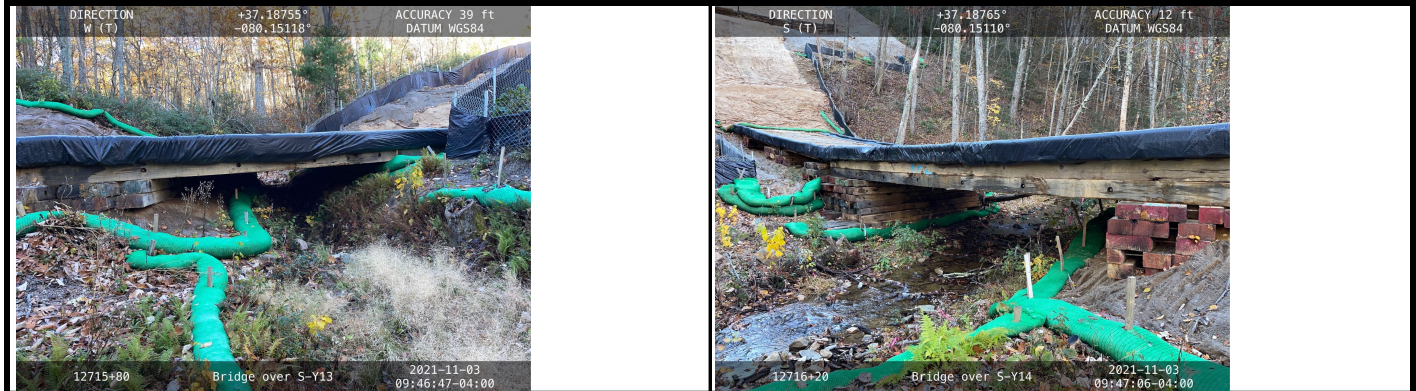
<b>GPS Location</b>	See photo for gps location data	<b>GPS Location</b>	See photo for gps location data
<b>Field Station#</b>	12715+80	<b>Field Station#</b>	12716+20
<b>Pic 11 Desc.</b>	Photo shows the bridge over stream S-Y13.	<b>Pic 12 Desc.</b>	Photo shows the bridge over stream S-Y14

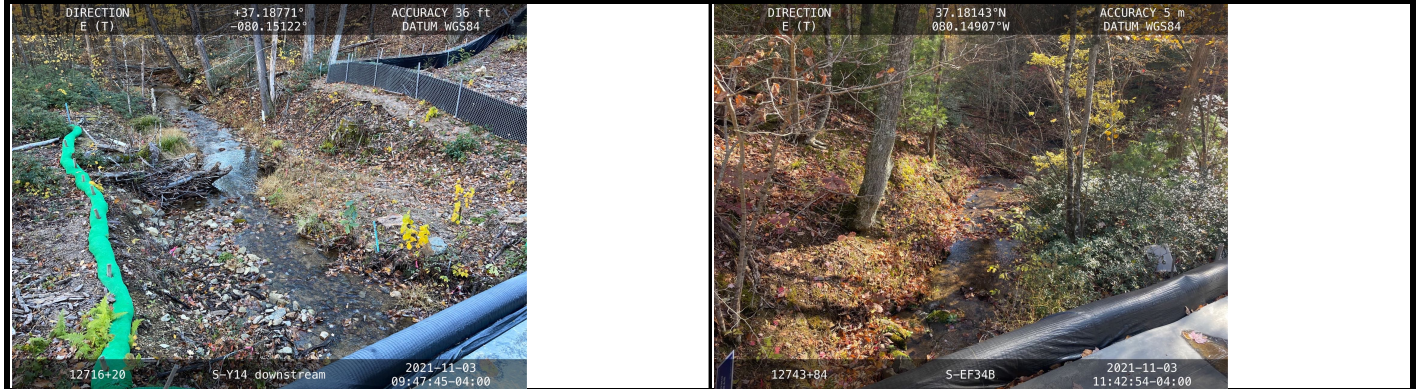
<b>GPS Location</b>	See photo for gps location data	<b>GPS Location</b>	See photo for gps location data
<b>Field Station#</b>	12716+20	<b>Field Station#</b>	12743+84
<b>Pic 13 Desc.</b>	Photo shows stream S-Y14 downstream from the bridge	<b>Pic 14 Desc.</b>	Photo shows S-EF34B downstream from the bridge

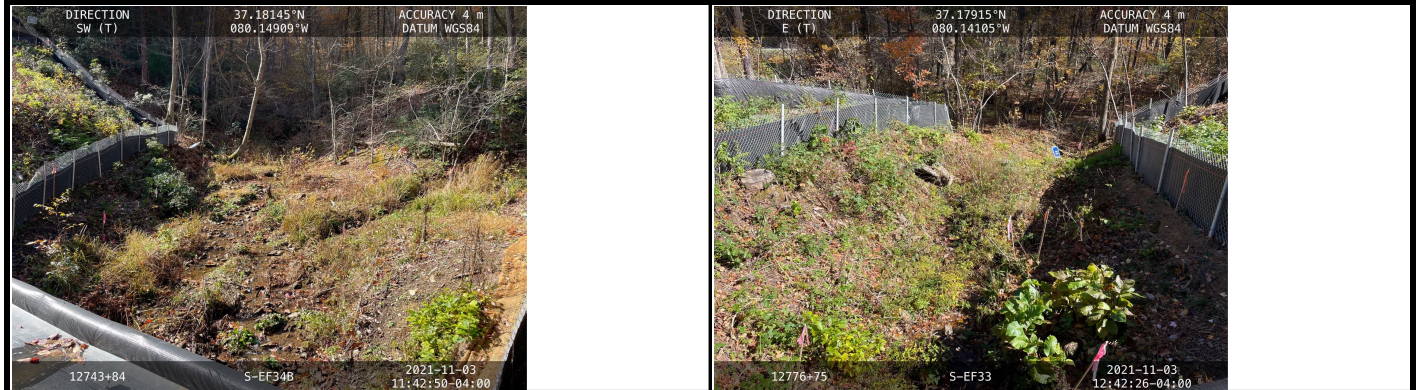
<b>GPS Location</b>	See photo for gps location data	<b>GPS Location</b>	See photo for gps location data
<b>Field Station#</b>	12743+84	<b>Field Station#</b>	12776+75
<b>Pic 15 Desc.</b>	Photo shows S-EF34B upstream from the bridge	<b>Pic 16 Desc.</b>	Photo shows S-EF33 downstream from the bridge

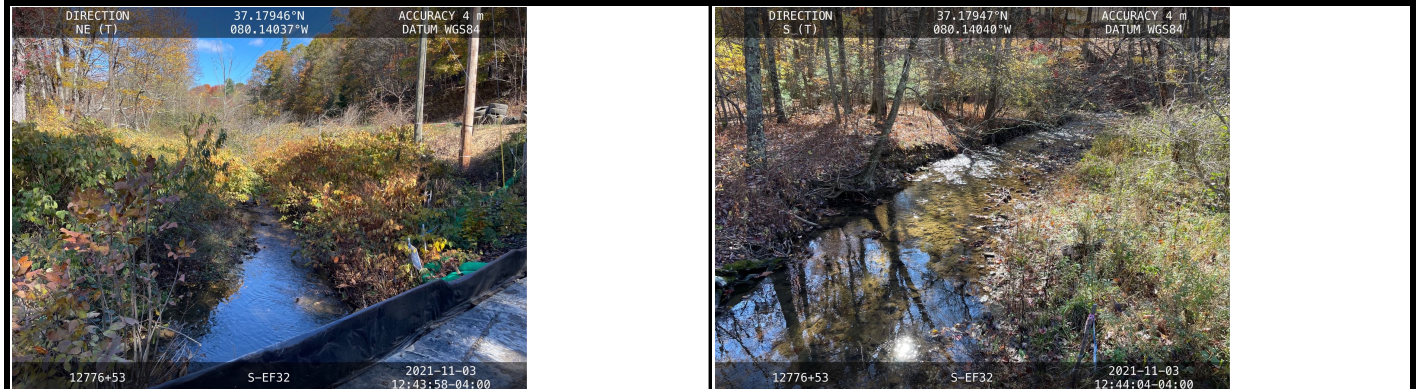
<b>GPS Location</b>	See photo for gps location data	<b>GPS Location</b>	See photo for gps location data
<b>Field Station#</b>	12776+53	<b>Field Station#</b>	12776+53
<b>Pic 17 Desc.</b>	Photo shows S-EF32 upstream from RO-282	<b>Pic 18 Desc.</b>	Photo shows S-EF32 downstream from RO-282

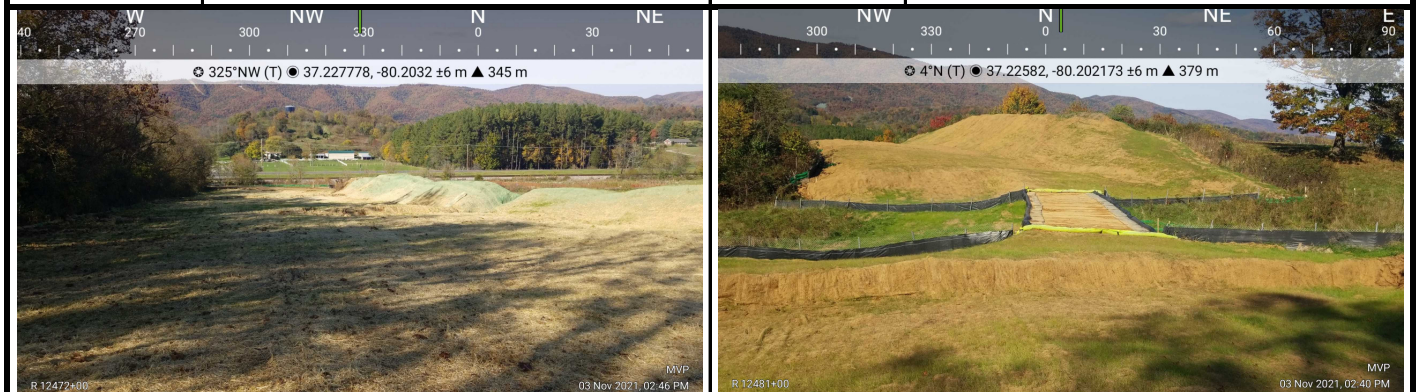
<b>GPS Location</b> See Above	<b>GPS Location</b> See Above
<b>Field Station#</b> 12472+00	<b>Field Station#</b> 12481+00
<b>Pic 5 Desc.</b> (reroute stationing) ROW Overview (temporary stabilization). ECDs are functional and ROW is stable.	<b>Pic 6 Desc.</b> (reroute stationing) ROW Overview (temporary stabilization). ECDs are functional and ROW is stable.

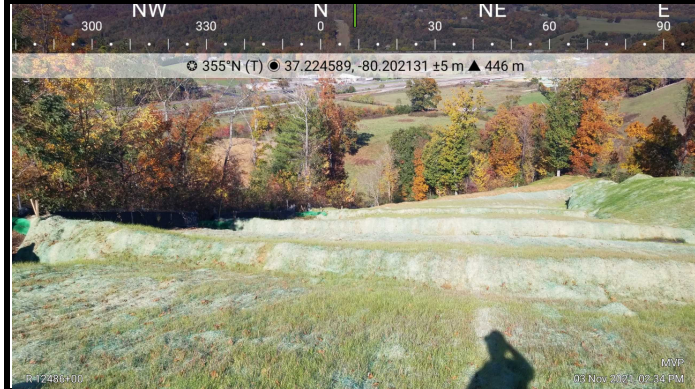
<b>Pic 7 Desc.</b>	(reroute stationing) ROW Overview (temporary stabilization). ECDs are functional and ROW is stable.
--------------------	---

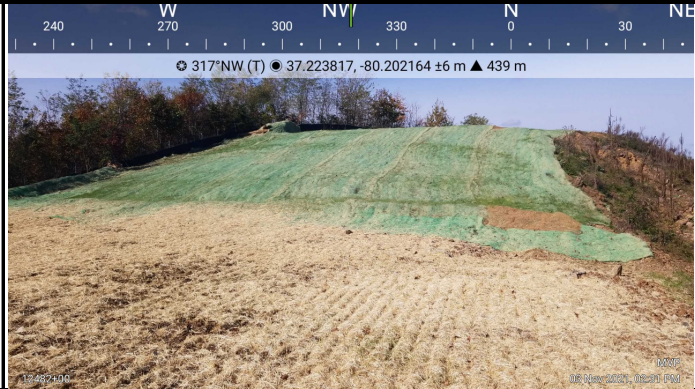
<b>Pic 8 Desc.</b>	ROW Overview. ECDs are functional and ROW is stable.
--------------------	--

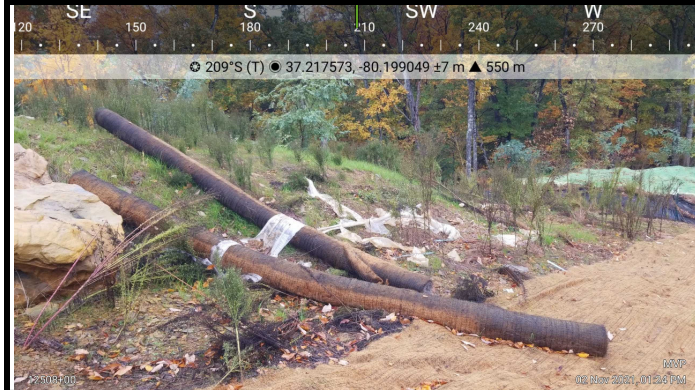
<b>Pic 9 Desc.</b>	Punchlist item from 11/2/21: Remove trash from ROW.
--------------------	---

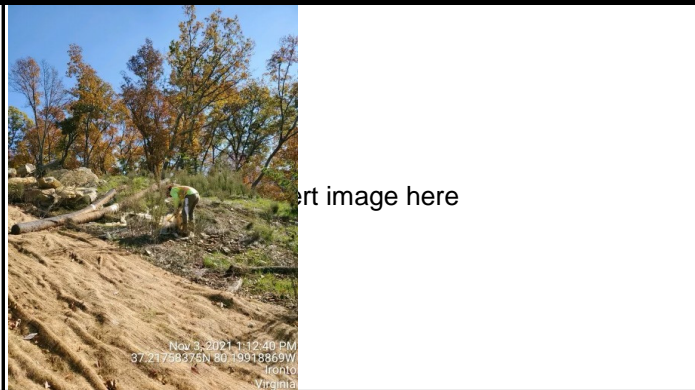
<b>Pic 10 Desc.</b>	Punchlist item from 11/2/21: Trash removed/being removed.
---------------------	---

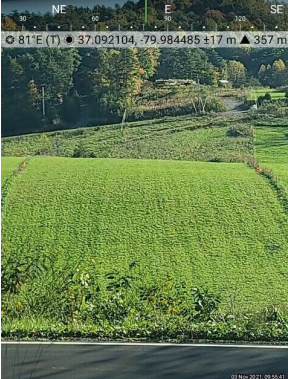
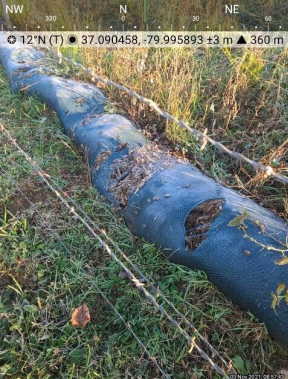
<b>GPS Location</b>	00000	<b>GPS Location</b>	00000		
<b>Field Station#</b>	13565+30	<b>Field Station#</b>	13526+10		
<b>Pic 1 Desc.</b>	Row photo showing area recently mowed by the land owner , good stabilization noted. No environmental issues observed at the time of inspection.		<b>Pic 2 Desc.</b>	CFS requires maintenance due to being weathered and torn, documented and added to the punch list.

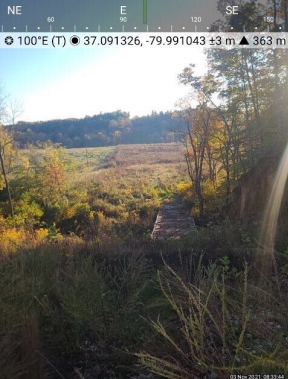
<b>Field Station#</b>	13540+50	<b>Field Station#</b>	13543+40		
<b>Pic 5 Desc.</b>	Monitored permanent vegetation growth, observed ECDs and equipment bridge. No environmental issues observed at the time of inspection.		<b>Pic 6 Desc.</b>	Monitored equipment bridge and protection, observed vegetation growth. No environmental issues observed at the time of inspection.

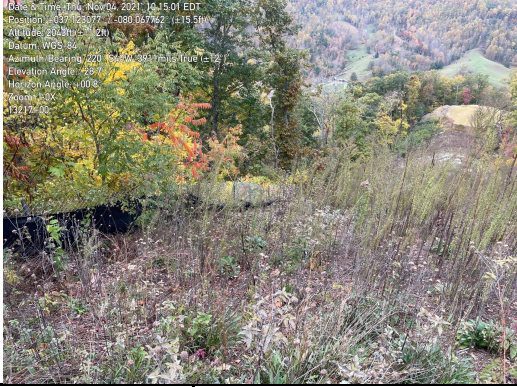
<p> <small>Date &amp; Time Thu, Nov 04, 2021, 10:15:01 EDT            Position: +35.123077° / -80.047162° (±11.81)            Altitude: 3090 ft (±1.10)            Datum: WGS-84            Azimuth/Bearing: 220° 00W 391mils True (±12°)            Elevation Angle: +01°            Horizon Angle: +00°            Zoom: 1.0X            13217+00</small> </p>	
<b>GPS Location</b>	0	<b>GPS Location</b>	0
<b>Field Station#</b>	13221+50	<b>Field Station#</b>	13217+00
<b>Pic 9 Desc.</b>	Triple stack sock needs removed- 72hr maintenance item	<b>Pic 10 Desc.</b>	Filter fabric needs reattached - 72hr maintenance item

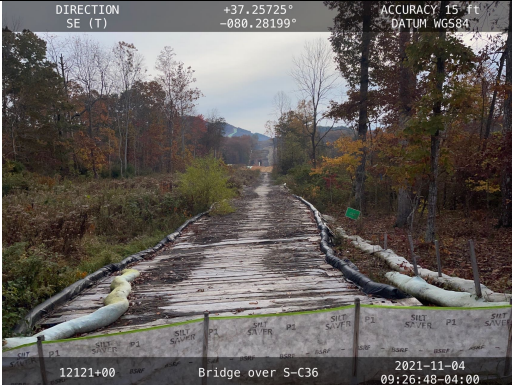
<b>GPS Location</b>	See photo for gps location data		<b>GPS Location</b>	See photo for gps location data	
<b>Field Station#</b>	12121+00		<b>Field Station#</b>	12126+00	
<b>Pic 1 Desc.</b>	Photo shows the bridge over stream S-C36		<b>Pic 2 Desc.</b>	Photo shows the bridge over stream S-MM31

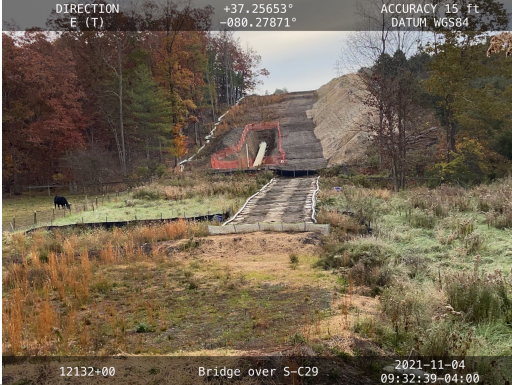
<b>GPS Location</b>	See photo for gps location data		<b>GPS Location</b>	See photo for gps location data	
<b>Field Station#</b>	12132+00		<b>Field Station#</b>	12132+73	
<b>Pic 3 Desc.</b>	Photo shows the bridge over stream S-C29		<b>Pic 4 Desc.</b>	Photo shows stream S-C29 downstream from the bridge

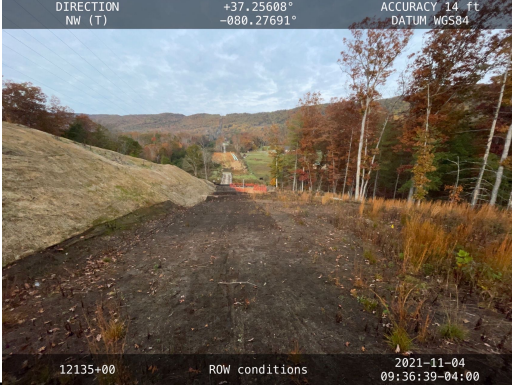
<b>GPS Location</b>	See photo for gps location data		<b>GPS Location</b>	See photo for gps location data	
<b>Field Station#</b>	12135+00		<b>Field Station#</b>	12139+00	
<b>Pic 5 Desc.</b>	Photo shows the ROW condition. ECDs are installed and functioning as designed		<b>Pic 6 Desc.</b>	Photo shows the bridge over wetland W-C6

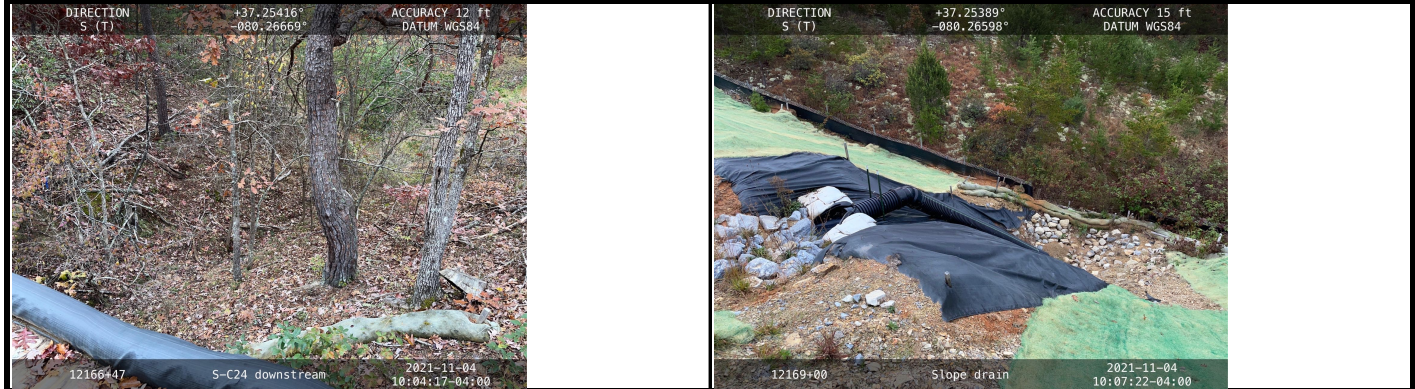
<b>GPS Location</b>	See photo for gps location data	<b>GPS Location</b>	See photo for gps location data
<b>Field Station#</b>	12166+47	<b>Field Station#</b>	12169+00
<b>Pic 13 Desc.</b>	Photo shows stream S-C24 downstream from the bridge	<b>Pic 14 Desc.</b>	Photo shows the slope drain

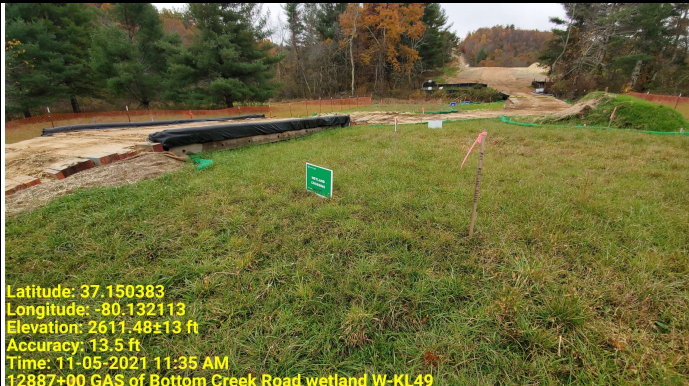
<p>Latitude: 37.150383 Longitude: -80.132113 Elevation: 2611.48±13 ft Accuracy: 13.5 ft Time: 11-05-2021 11:35 AM 12887+00 GAS of Bottom Creek Road wetland W-KL49</p>

<b>GPS Location</b>	See pic for GPS location.	<b>GPS Location</b>	See pic for GPS location.
<b>Field Station#</b>	12887+00	<b>Field Station#</b>	12888+00
<b>Pic 9 Desc.</b>	Wetland crossing W-KL49 from the CIS.	<b>Pic 10 Desc.</b>	Stream crossing S-KL55 from the CIS.

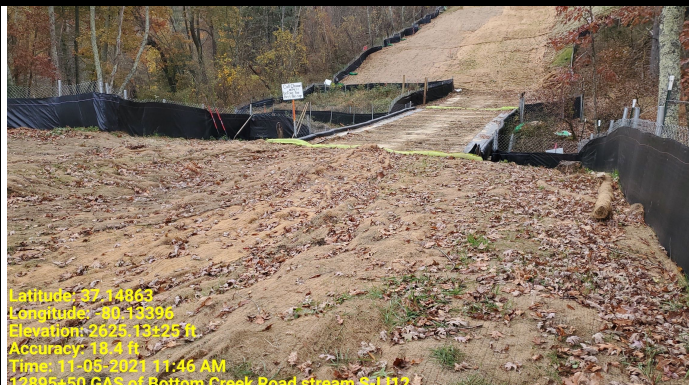
<p>Latitude: 37.14863 Longitude: -80.13396 Elevation: 2625.13±25 ft Accuracy: 18.4 ft Time: 11-05-2021 11:46 AM 12895+50 GAS of Bottom Creek Road stream S-IJ12</p>

<p>Latitude: 37.148564 Longitude: -80.133982 Elevation: 2606.2±21 ft Accuracy: 20.3 ft Time: 11-05-2021 11:48 AM 12896+00 GAS of Bottom Creek Road stream S-IJ12</p>	
<b>GPS Location</b>	See pic for GPS location.	<b>GPS Location</b>	See pic for GPS location.
<b>Field Station#</b>	12895+50	<b>Field Station#</b>	12896+00
<b>Pic 11 Desc.</b>	Stream crossing S-IJ12 from the CIS.	<b>Pic 12 Desc.</b>	Downstream side of stream S-IJ12.

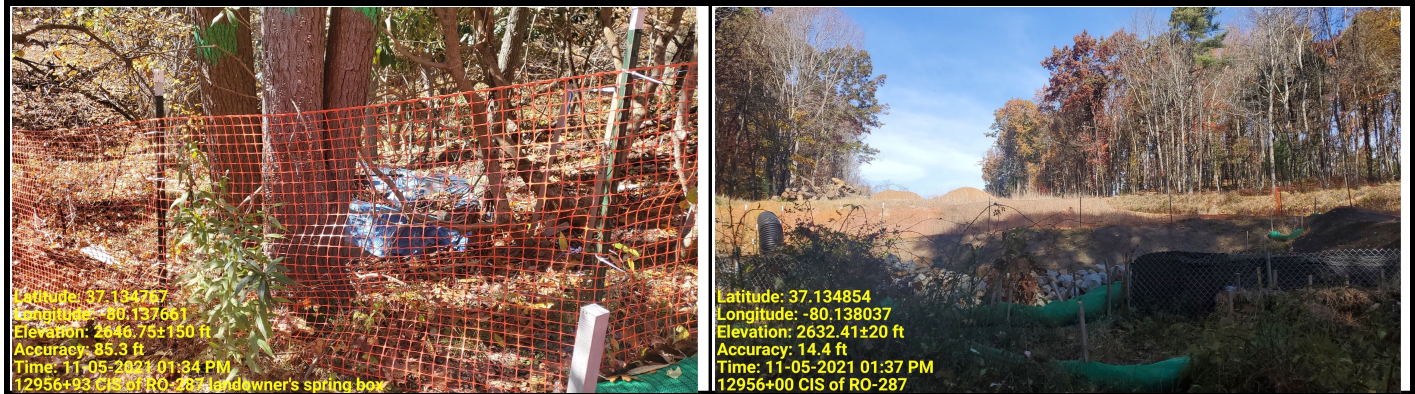
<b>GPS Location</b>	See pic for GPS location.	<b>GPS Location</b>	See pic for GPS location.
<b>Field Station#</b>	12956+93	<b>Field Station#</b>	12956+00
<b>Pic 17 Desc.</b>	Landowner's spring box at RO-287.	<b>Pic 18 Desc.</b>	Sediment trap outlet on the CIS of RO-287.

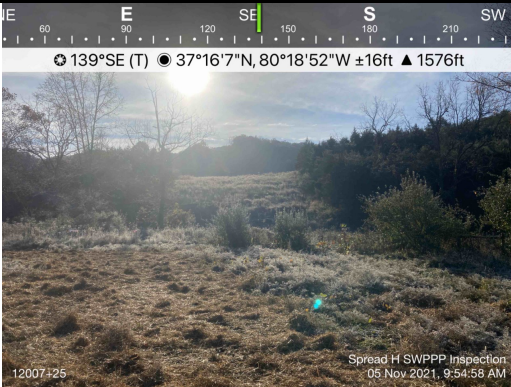
<b>GPS Location</b>	See photo above		<b>GPS Location</b>	See photo above	
<b>Field Station#</b>	12007+25		<b>Field Station#</b>	12005+00	
<b>Pic 1 Desc.</b>	Vegetative controls are in place on inactive section of the ROW. No maintenance is needed.		<b>Pic 2 Desc.</b>	Maintenance crews applying fresh seed and straw to inactive section of ROW.

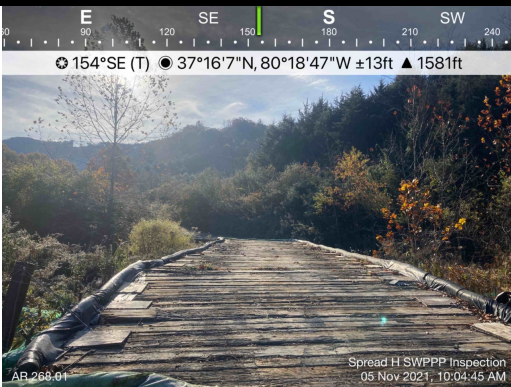
<b>GPS Location</b>	See photo above		<b>GPS Location</b>	See photo above	
<b>Field Station#</b>	12008+50		<b>Field Station#</b>	12009+30	
<b>Pic 3 Desc.</b>	Timber mat stream crossing along AR-268.01 is in good condition.		<b>Pic 4 Desc.</b>	Waterbars and sump pits are functioning properly. No maintenance needed.

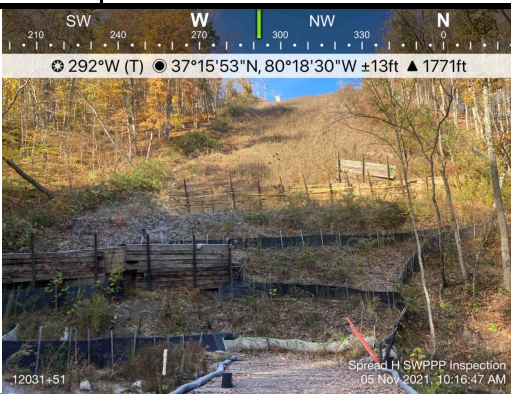
<b>Pic 5 Desc.</b>	Silt fence and compost filter sock is functioning properly along slopes and in good condition.		<b>Pic 6 Desc.</b>	Equipment bridges and erosion controls are in good condition. No maintenance is needed.
