# Visual Site Inspection Report

<b>Project Name</b>	H-600 Pipeline Spread H	<b>AFE</b>	124300138	<b>Spread</b>	H-600 Pipeline Spread H
<b>Contractor</b>	Precision			<b>Report #</b>	30940
<b>Inspector</b>	Jason Nielsen			<b>Date/Time</b>	11/8/2021 7:09 PM
<b>Permit #</b>	TBD	<b>Inspection Type</b>	VA SWPP	<b>Station Begin</b>	12284+75
<b>State</b>	VA	<b>Inspection Area</b>	Partial	<b>Station End</b>	12443+75
<b>County</b>	Montgomery	<b>Ground</b>	Dry	<b>Temperature (°F)</b>	68.00
<b>Municipality</b>	N/A	<b>Weather</b>	Sunny	<b>Rain Gauge (in)</b>	0.00
				<b>Rain Accumulation Time (days)</b>	0.00

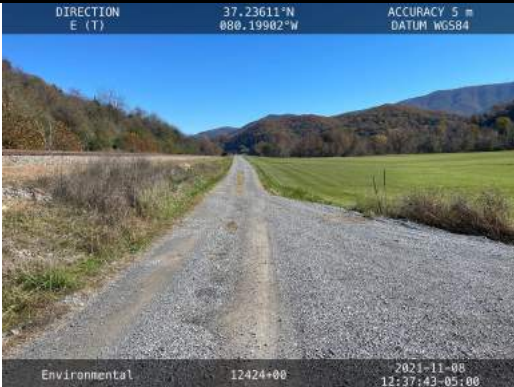
<b>GPS Location</b>	See photo		<b>GPS Location</b>	See photo	
<b>Field Station#</b>	12424+00		<b>Field Station#</b>	12418+00	
<b>Pic 1 Desc.</b>	Access Road MVP-MN-279 In Acceptable condition		<b>Pic 2 Desc.</b>	Stabilized ROW Conditions

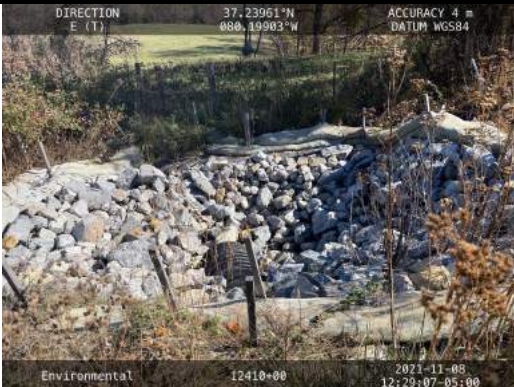
<b>GPS Location</b>	See photo		<b>GPS Location</b>	See photo	
<b>Field Station#</b>	12410+00		<b>Field Station#</b>	12408+80	
<b>Pic 3 Desc.</b>	Clean water crossing pipe outlet		<b>Pic 4 Desc.</b>	Clean water crossing pipe inlet

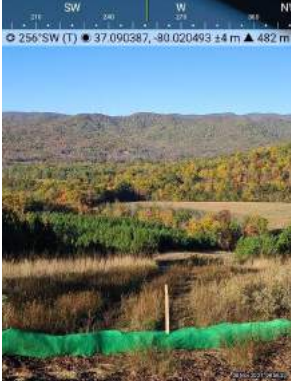
<b>GPS Location</b>	0000	<b>GPS Location</b>	0000		
<b>Field Station#</b>	13436+33	<b>Field Station#</b>	13416+70		
<b>Pic 1 Desc.</b>	Monitored new CFS that was installed during maintenance repairs , no environmental issues observed at the time of inspection.		<b>Pic 2 Desc.</b>	Monitored erosion control blanket on hill side above road crossing , no environmental issues observed at the time of inspection.

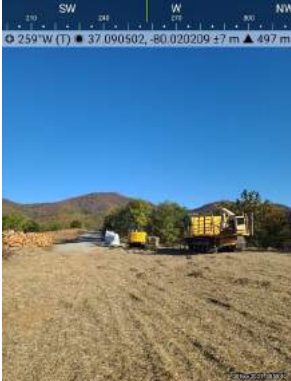
<b>GPS Location</b>	0000	<b>GPS Location</b>	0000		
<b>Field Station#</b>	13437+75	<b>Field Station#</b>	13438+00		
<b>Pic 3 Desc.</b>	Row photo in work space showing stabilization after recent work activities.		<b>Pic 4 Desc.</b>	Observed new CFS and stabilization on row. No environmental issues observed at the time of inspection.

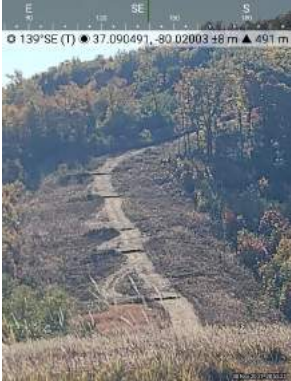
<b>Field Station#</b>	13440+00	<b>Field Station#</b>	13415+80		
<b>Pic 5 Desc.</b>	Row photo showing new stabilization and ECDs installed after recent maintenance repairs.		<b>Pic 6 Desc.</b>	Monitored ECDs at CAHAS#1 road crossing, no environmental issues observed at the time of inspection I

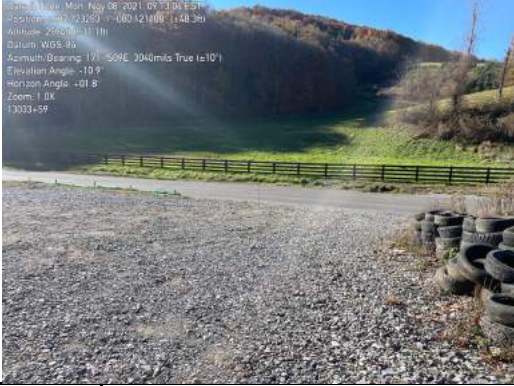
<b>GPS Location</b>	0	<b>GPS Location</b>	0		
<b>Field Station#</b>	13033+59	<b>Field Station#</b>	13033+00		
<b>Pic 1 Desc.</b>	RCE in good condition and functioning properly		<b>Pic 2 Desc.</b>	ROW and ECDs In good condition with good vegetation established across ROW	
<p>Date &amp; Time: Mon, Nov 08, 2021, 09:30:29 EST  Position: +037.125794 / -080.119549 (+11.6m)  Altitude: 27028 (+9.8m)  Datum: WGS-84  Azimuth/Bearing: 240.560W 4267mils True (+12°)  Elevation Angle: -69.1°  Horizon Angle: +08.1°  Zoom: 1.0x  13030+00</p>

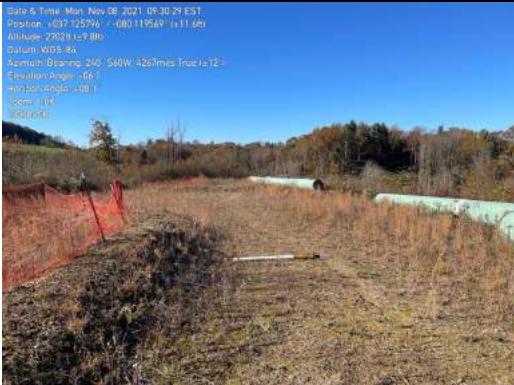
<b>GPS Location</b>	0	<b>GPS Location</b>	0		
<b>Field Station#</b>	13030+00	<b>Field Station#</b>	13024+06		
<b>Pic 3 Desc.</b>	ROW and ECDs In good condition with good vegetation established across ROW		<b>Pic 4 Desc.</b>	MVP-S-G24/25 and Corresponding buffer zone in good condition	
<p>Date &amp; Time: Mon, Nov 08, 2021, 09:36:48 EST  Position: +037.124608 / -080.118572 (+11.6m)  Altitude: 27320 (+9.8m)  Datum: WGS-84  Azimuth/Bearing: 054.044E 0818mils True (+12°)  Elevation Angle: -06.3°  Horizon Angle: +01.2°  Zoom: 1.0x  13034+00</p>

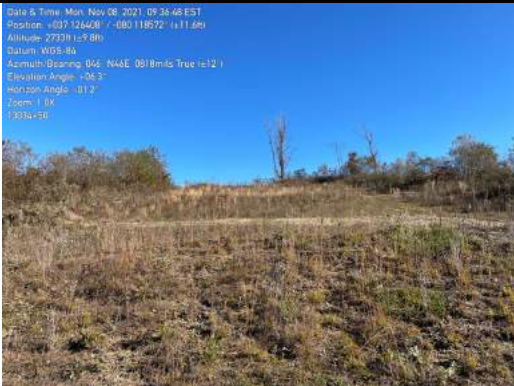
<b>Pic 5 Desc.</b>	ROW and ECDs In good condition with good vegetation established across ROW		<b>Pic 6 Desc.</b>	Access road and ECDs In good condition

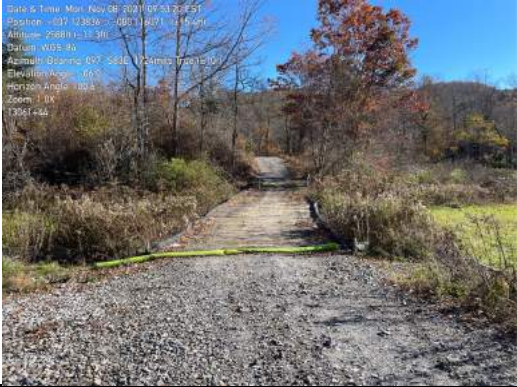
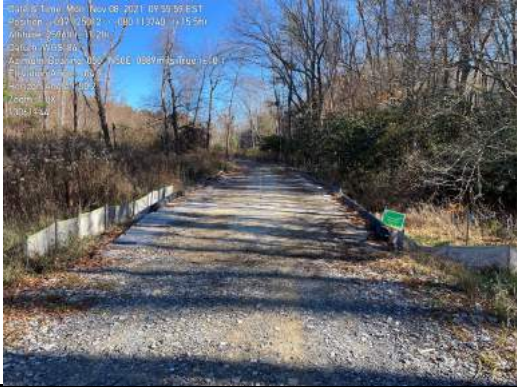
<b>GPS Location</b>	0	<b>GPS Location</b>	0		
<b>Field Station#</b>	13061+44	<b>Field Station#</b>	13061+44		
<b>Pic 7 Desc.</b>	Equipment bridge in good condition		<b>Pic 8 Desc.</b>	Equipment bridge in good condition	
<p>Date &amp; Time: Mon, Nov 08, 2021, 19:00:36 EST  Position: +037.126993 / -080.111647 (s11.6m)  Altitude: 2610ft (s12.1ft)  Datum: WGS-84  Azimuth/Bearing: 312.148W (5547mils True (s13.1))  Elevation Angle: +19.0  Horizon Angle: +02.0  Zoom: 1.0X  13061+00</p>

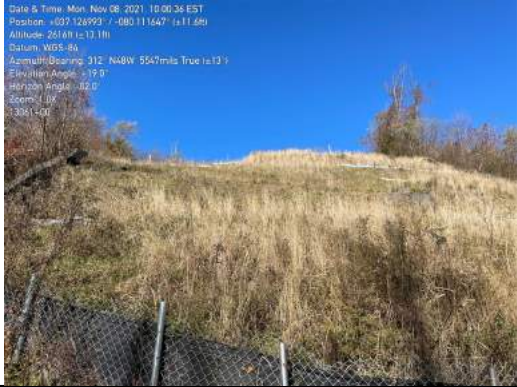
<b>GPS Location</b>	0	<b>GPS Location</b>	0		
<b>Field Station#</b>	13061+00	<b>Field Station#</b>	13064+00		
<b>Pic 9 Desc.</b>	ROW and ECDs In good condition with good vegetation established across ROW		<b>Pic 10 Desc.</b>	ROW and ECDs In good condition with good vegetation established across ROW	
<p>Date &amp; Time: Mon, Nov 08, 2021, 11:09:22 EST  Position: +037.122345 / -080.096812 (s15.4m)  Altitude: 2716ft (s11.2ft)  Datum: WGS-84  Azimuth/Bearing: 315.144W (5610mils True (s12.1))  Elevation Angle: +12.4  Horizon Angle: +02.4  Zoom: 1.0X  13113+00</p>

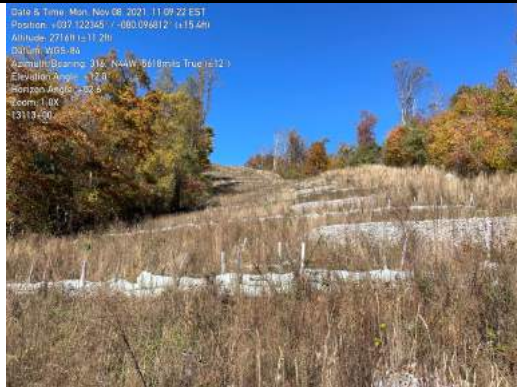
<b>Pic 11 Desc.</b>	ROW and ECDs In good condition with good vegetation established across ROW		<b>Pic 12 Desc.</b>	ROW and ECDs In good condition and stable

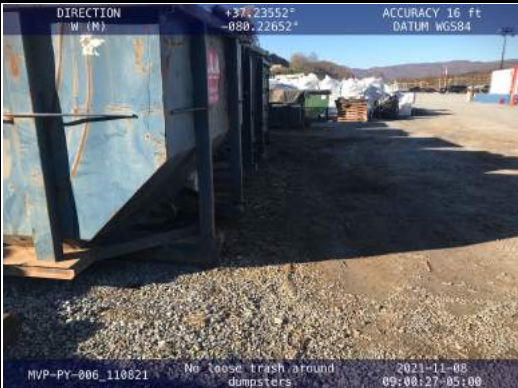
<b>GPS Location</b>	MVP-PY-006 See photo for gps data	<b>GPS Location</b>	MVP-PY-006 See photo for gps data		
<b>Field Station#</b>	+0	<b>Field Station#</b>	+0		
<b>Pic 15 Desc.</b>	No loose trash around dumpsters or in the yard. Looking W.	<b>Pic 16 Desc.</b>	Secondary containment under hazardous waste dumpsters free of fluids. Looking E.

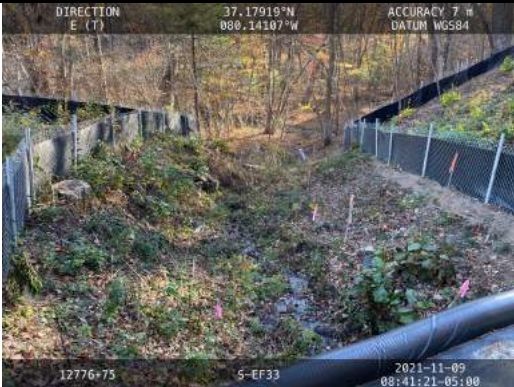
<b>GPS Location</b>	See photo		<b>GPS Location</b>	See photo	
<b>Field Station#</b>	12776+75		<b>Field Station#</b>	12767+00	
<b>Pic 1 Desc.</b>	Downstream of crossing at Stream S-EF33		<b>Pic 2 Desc.</b>	Steep slope area is well stabilized and ECDs are functional.

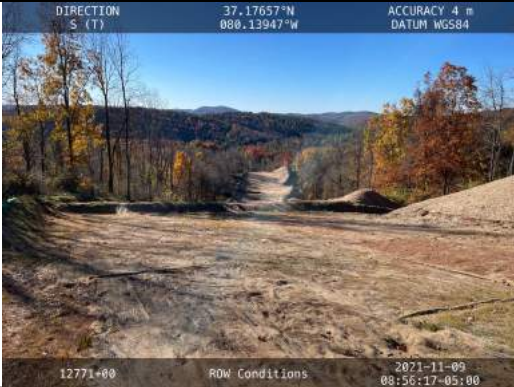
<b>GPS Location</b>	See photo		<b>GPS Location</b>	See photo	
<b>Field Station#</b>	12771+00		<b>Field Station#</b>	12727+00	
<b>Pic 3 Desc.</b>	Current ROW conditions. ROW is stable		<b>Pic 4 Desc.</b>	Current ROW conditions. ROW is stable

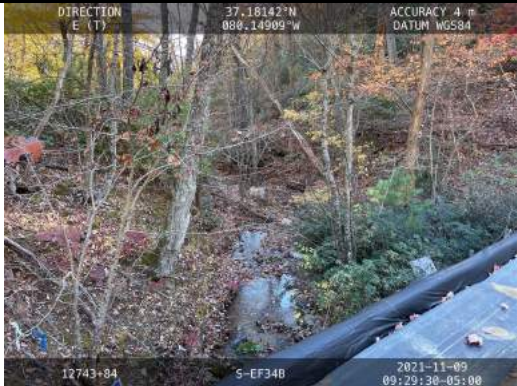
<b>GPS Location</b>	See photo		<b>GPS Location</b>	See photo	
<b>Field Station#</b>	12743+84		<b>Field Station#</b>	12746+50	
<b>Pic 9 Desc.</b>	Downstream of crossing at Stream S-EF34B.		<b>Pic 10 Desc.</b>	Waterbars within steep slope area are functional.

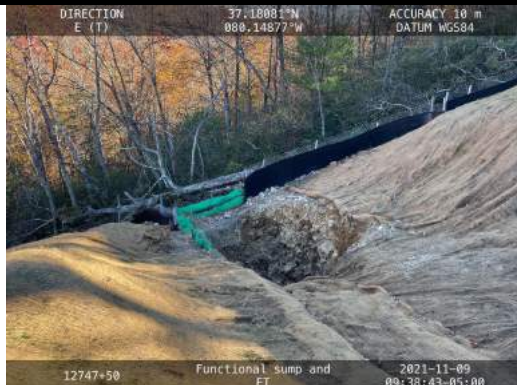
<b>GPS Location</b>	See photo		<b>GPS Location</b>	See photo	
<b>Field Station#</b>	12747+50		<b>Field Station#</b>	12748+00	
<b>Pic 11 Desc.</b>	Sump and End Treatment are functional.		<b>Pic 12 Desc.</b>	ROW is stable. ECDs are functional.

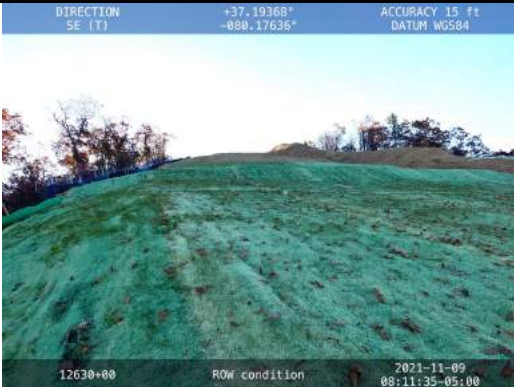
<b>GPS Location</b>	See photo for gps location data		<b>GPS Location</b>	See photo for gps location data	
<b>Field Station#</b>	12630+00		<b>Field Station#</b>	12628+00	
<b>Pic 1 Desc.</b>	Photo shows the ROW condition. ECDs are installed and functioning as designed.		<b>Pic 2 Desc.</b>	Photo shows the ROW condition. ECDs are installed and functioning as designed.

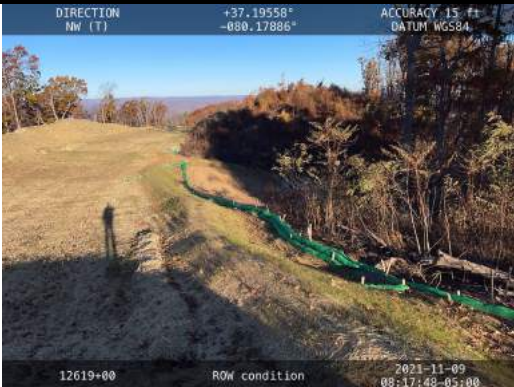
<b>GPS Location</b>	See photo for gps location data		<b>GPS Location</b>	See photo for gps location data	
<b>Field Station#</b>	12619+00		<b>Field Station#</b>	12619+00	
<b>Pic 3 Desc.</b>	Photo shows the ROW condition. ECDs are installed and functioning as designed.		<b>Pic 4 Desc.</b>	Photo shows the stabilized stockpiles

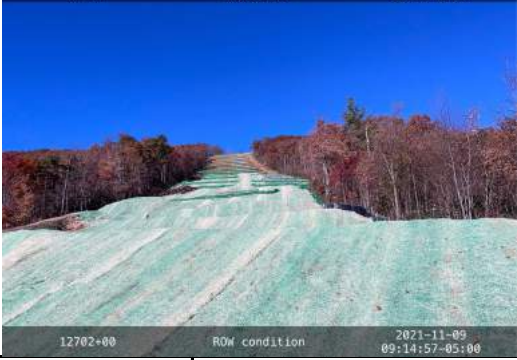
<b>GPS Location</b>	See photo for gps location data		<b>GPS Location</b>	See photo for gps location data	
<b>Field Station#</b>	12702+00		<b>Field Station#</b>	12704+00	
<b>Pic 7 Desc.</b>	Photo shows the ROW condition. Area of permanent restoration.		<b>Pic 8 Desc.</b>	Photo shows the ROW condition. ECDs are installed and functioning as designed.	
DIRECTION SE (T) +37.18960° -080.15229° ACCURACY 14 ft DATUM WGS84

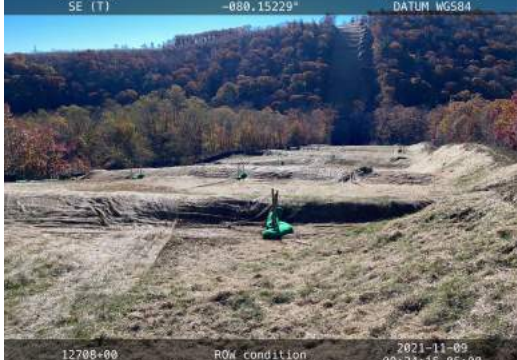
<b>Pic 9 Desc.</b>	Photo shows the ROW condition. ECDs are installed and functioning as designed.		<b>Pic 10 Desc.</b>	Photo shows the ROW condition. ECDs are installed and functioning as designed.	
DIRECTION SE (T) +37.18777° -080.15159° ACCURACY 67 ft DATUM WGS84

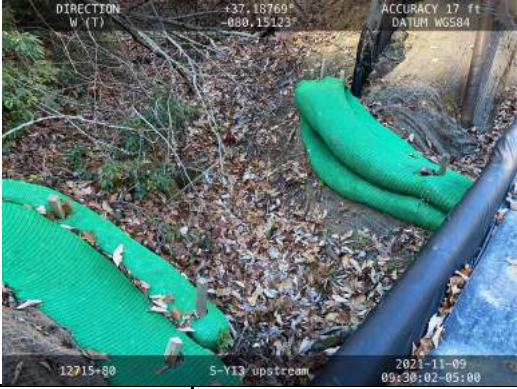
<b>GPS Location</b>	See photo for gps location data		<b>GPS Location</b>	See photo for gps location data	
<b>Field Station#</b>	12715+00		<b>Field Station#</b>	12715+80	
<b>Pic 11 Desc.</b>	Photo shows the bridge over streams S-Y13 and S-Y14.		<b>Pic 12 Desc.</b>	Photo shows stream S-Y13 down stream from the bridge

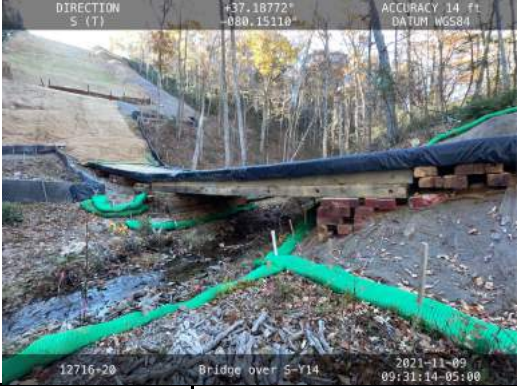
<b>GPS Location</b>	See photo for gps location data		<b>GPS Location</b>	See photo for gps location data	
<b>Field Station#</b>	12715+80		<b>Field Station#</b>	12715+80	
<b>Pic 13 Desc.</b>	Photo shows stream S-Y13 up stream from the bridge		<b>Pic 14 Desc.</b>	Photo shows the bridge over stream S-Y13

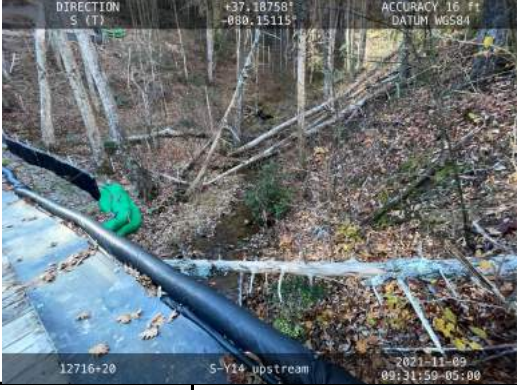
<b>GPS Location</b>	See photo for gps location data		<b>GPS Location</b>	See photo for gps location data	
<b>Field Station#</b>	12716+20		<b>Field Station#</b>	12716+20	
<b>Pic 15 Desc.</b>	Photo shows the bridge over stream S-Y14		<b>Pic 16 Desc.</b>	Photo shows stream S-Y14 down stream from the bridge

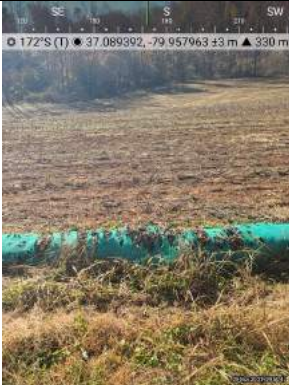
<b>GPS Location</b>	0000	<b>GPS Location</b>	0000		
<b>Field Station#</b>	13651+60	<b>Field Station#</b>	13555+50		
<b>Pic 1 Desc.</b>	CFS requires maintenance due to being weathered and torn, documented and added to the punch list.		<b>Pic 2 Desc.</b>	Row photo showing vegetation, no environmental issues observed at the time of inspection I

<b>A/E</b>	124300138	<b>Date/Time</b>	11/9/2021 2:33 PM	<b>Report #</b>	30946
<b>6. PCSM BMPs</b> (List BMPs and note if installed and maintained as per the plan. If corrective action is needed, a picture is required.)					
<b>PCSM BMPs</b>	<b>Compliance Level</b>	<b>Corrective Action</b>	<b>Corrective Time Frame</b>	<b>Date Repaired</b>	
<b>7. Identify all remedial measures that have been taken since the previous inspection was conducted.</b>					
<b>Comments</b> (Reference above questions as appropriate.)					
<p>The EI Traveled and inspected all ECDs throughout the row, monitored vegetation growth throughout.</p> <p>Inspected all stream and wetland crossings, checked equipment bridges and protection.</p> <p>Monitored RCEs and vegetation stabilization on spoil piles .</p> <p>Throughout today's inspections the EI observed CFS damaged by 3rd party activities as well as some weathered and torn , EI Documented and added to the punch list to be replaced as needed throughout the area.</p>

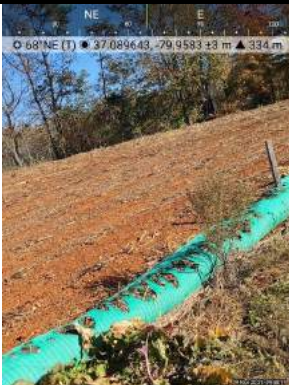
<b>GPS Location</b>	0000	<b>GPS Location</b>	0000		
<b>Field Station#</b>	13651+60	<b>Field Station#</b>	13652+75		
<b>Pic 3 Desc.</b>	CFS requires maintenance due to being weathered and torn, documented and added to the punch list.		<b>Pic 4 Desc.</b>	CFS requires maintenance due to 3rd party damages , documented and added to the punch list .

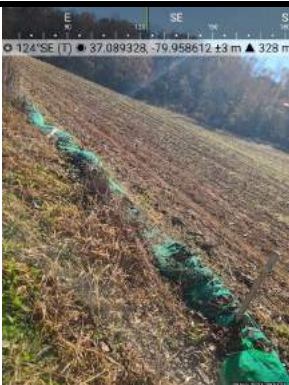
<b>Pic 5 Desc.</b>	CFS requires maintenance due to 3rd party damages , documented and added to the punch list .		<b>Pic 6 Desc.</b>	Row photo showing vegetation, no environmental issues observed at the time of inspection

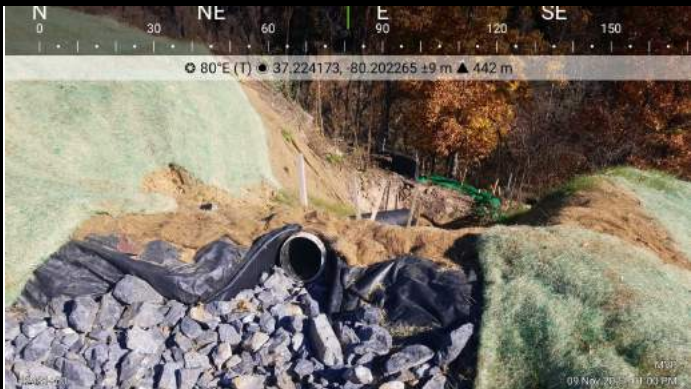
GPS Location	See Above		GPS Location	See Above	
Field Station#	12481+00		Field Station#	12485+00	
Pic 7 Desc.	(reroute stationing) ROW Overview (temporary stabilization). ECDs are functional and ROW is stable.		Pic 8 Desc.	ROW Overview. ECDs are functional and ROW is stable.

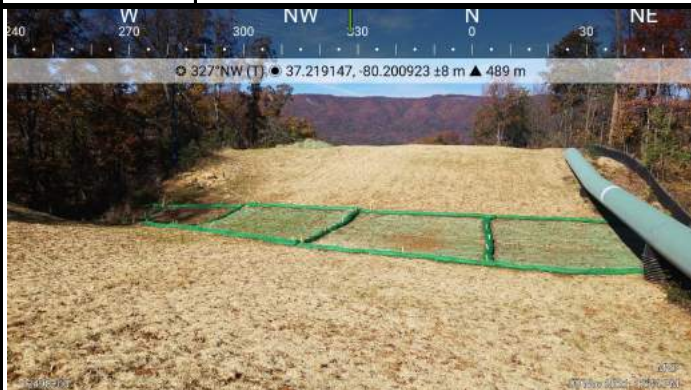
GPS Location	See Above		GPS Location	See Above	
Field Station#	12498+00		Field Station#	12504+00	
Pic 9 Desc.	ROW Overview. ECDs are functional and ROW is stable.		Pic 10 Desc.	ROW Overview. ECDs are functional and ROW is stable.

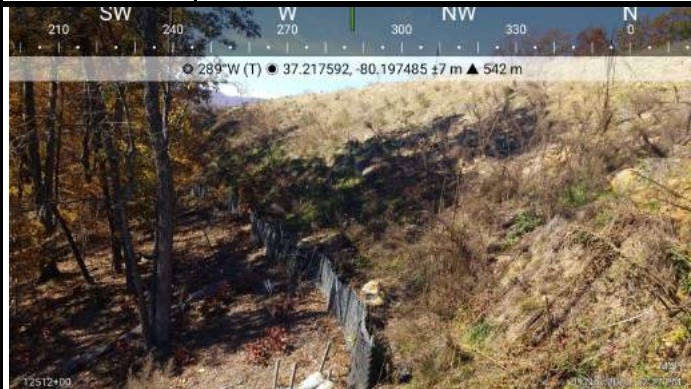
GPS Location	See Above		GPS Location	See Above	
Field Station#	12512+00		Field Station#	12519+00	
Pic 11 Desc.	ROW Overview. ECDs are functional and ROW is stable.		Pic 12 Desc.	ROW Overview. ECDs are functional and ROW is stable.

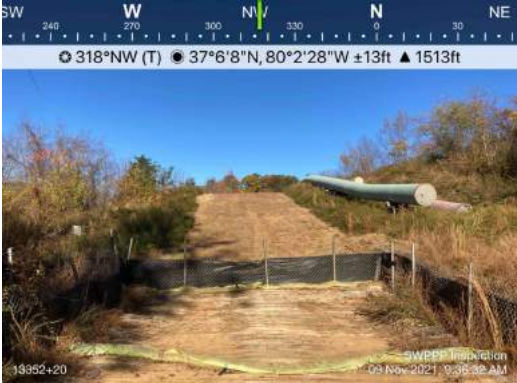
<b>GPS Location</b>	See photo above		<b>GPS Location</b>	See photo above	
<b>Field Station#</b>	13352+20		<b>Field Station#</b>	13354+50	
<b>Pic 7 Desc.</b>	Silt fence and erosion control measures along the ROW are in good condition. No maintenance needed.		<b>Pic 8 Desc.</b>	Landowners gravel driveway and fencing along the ROW are in good condition.

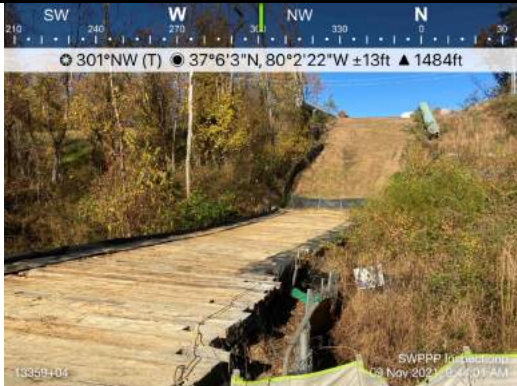
<b>GPS Location</b>	See photo above		<b>GPS Location</b>	See photo above	
<b>Field Station#</b>	13359+04		<b>Field Station#</b>	13362+50	
<b>Pic 9 Desc.</b>	Timber mat stream crossing and buffer zones are in good condition. No maintenance needed.		<b>Pic 10 Desc.</b>	Rock level spreaders and waterbars along slopes are functioning properly.

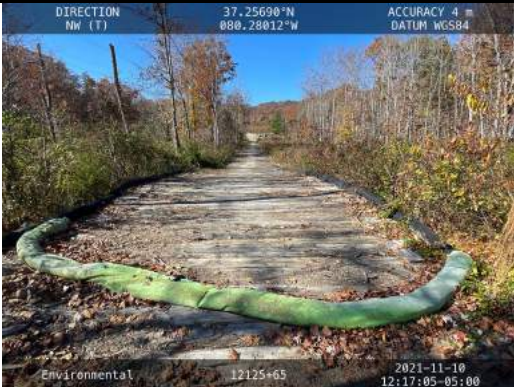
<b>GPS Location</b>	See photo		<b>GPS Location</b>	See photo	
<b>Field Station#</b>	12125+65		<b>Field Station#</b>	12128+00	
<b>Pic 1 Desc.</b>	Bridge and ECDs crossing stream S-MM31 in acceptable condition		<b>Pic 2 Desc.</b>	Stabilized ROW conditions

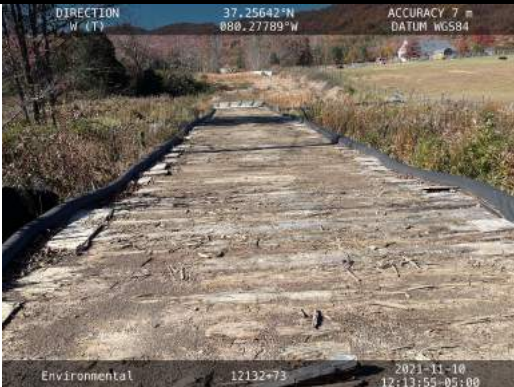
<b>GPS Location</b>	See photo		<b>GPS Location</b>	See photo	
<b>Field Station#</b>	12132+73		<b>Field Station#</b>	12135+00	
<b>Pic 3 Desc.</b>	Bridge and ECDs crossing stream S-C29 in acceptable condition		<b>Pic 4 Desc.</b>	Stabilized ROW conditions

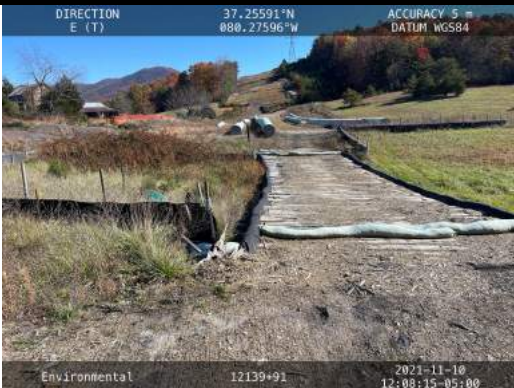
<b>GPS Location</b>	See photo		<b>GPS Location</b>	See photo	
<b>Field Station#</b>	12139+91		<b>Field Station#</b>	12173+00	
<b>Pic 5 Desc.</b>	Wetland crossing W-C6 in acceptable condition		<b>Pic 6 Desc.</b>	Stabilized ROW conditions

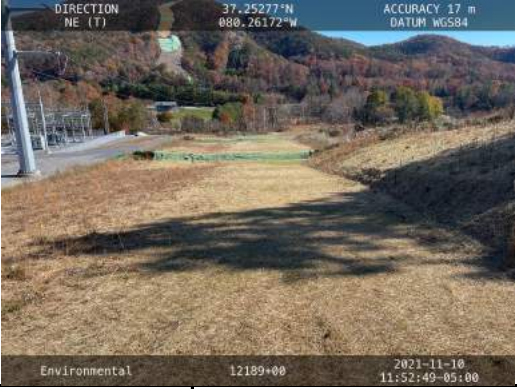
<b>GPS Location</b>	See photo		<b>GPS Location</b>	See photo	
<b>Field Station#</b>	12192+50		<b>Field Station#</b>	12189+00	
<b>Pic 13 Desc.</b>	Down stream of stream crossing S-C21		<b>Pic 14 Desc.</b>	Stabilized ROW conditions

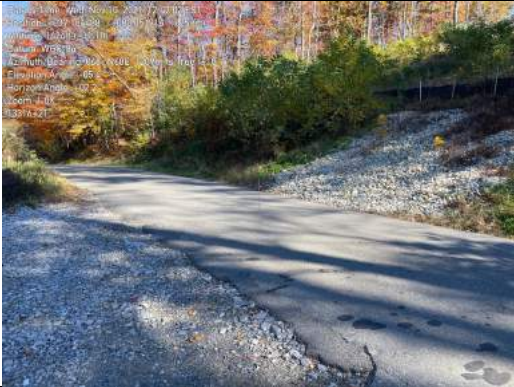
<b>GPS Location</b>	0	<b>GPS Location</b>	0		
<b>Field Station#</b>	13316+21	<b>Field Station#</b>	13314+00		
<b>Pic 1 Desc.</b>	Wades Gap Road Crossing in good condition	<b>Pic 2 Desc.</b>	ROW and ECDs In good condition with good vegetation established across ROW

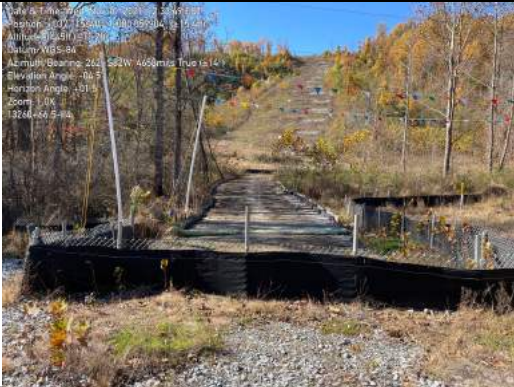
<b>GPS Location</b>	0	<b>GPS Location</b>	0		
<b>Field Station#</b>	13260+66	<b>Field Station#</b>	13259+00		
<b>Pic 3 Desc.</b>	MVP-S-II4 and Corresponding buffer zone in good condition	<b>Pic 4 Desc.</b>	ROW and ECDs In good condition with good vegetation established across ROW

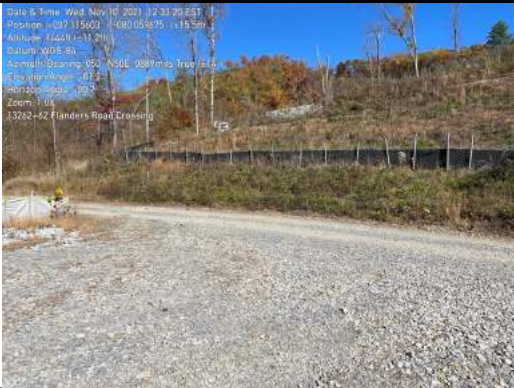
<b>GPS Location</b>	0	<b>GPS Location</b>	0		
<b>Field Station#</b>	13262+62	<b>Field Station#</b>	13197+75		
<b>Pic 5 Desc.</b>	Flanders Road Crossing in good condition	<b>Pic 6 Desc.</b>	ROW and ECDs In good condition and stable

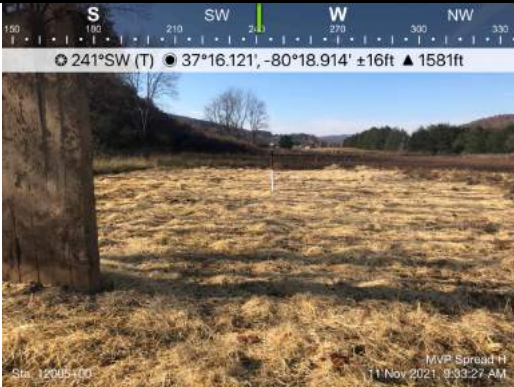
<b>GPS Location</b>	See Photo Watermark		<b>GPS Location</b>	See Photo Watermark	
<b>Field Station#</b>	12005+00		<b>Field Station#</b>	12008+46	
<b>Pic 1 Desc.</b>	Start of inspection. Previously stabilized area remains in good condition.		<b>Pic 2 Desc.</b>	Resource S-G36 is in good condition and remains well vegetated.

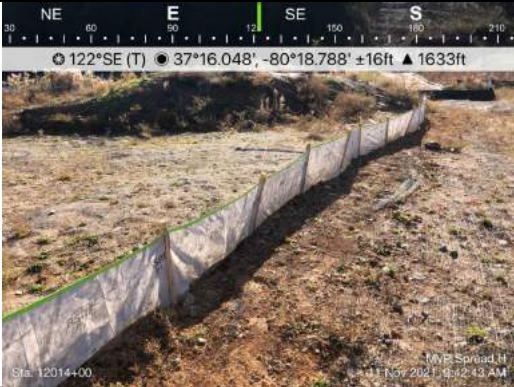
<b>GPS Location</b>	See Photo Watermark		<b>GPS Location</b>	See Photo Watermark	
<b>Field Station#</b>	12014+00		<b>Field Station#</b>	12031+25	
<b>Pic 3 Desc.</b>	Recently installed BSRF and stabilization is in good condition. No maintenance needed.		<b>Pic 4 Desc.</b>	ROW remains in good condition on CIS to S-G39. No maintenance needed.

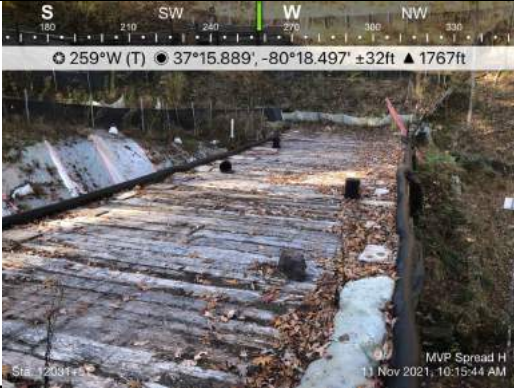
<b>Pic 5 Desc.</b>	Equipment bridge and bank stabilization at S-G39 is in good condition. No maintenance needed.		<b>Pic 6 Desc.</b>	Clean water diversion intermediary plunge pool is in good condition and water is free of sediment/material.

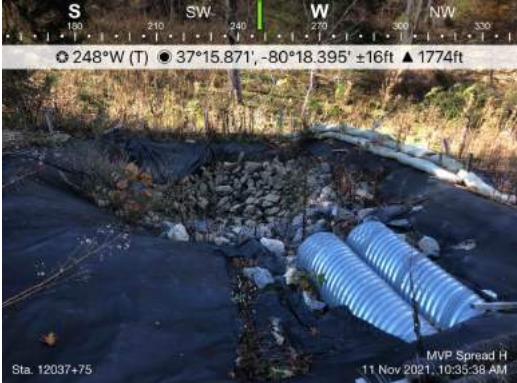
<b>GPS Location</b>	See Photo Watermark		<b>GPS Location</b>	See Photo Watermark	
<b>Field Station#</b>	12037+75		<b>Field Station#</b>	12038+25	
<b>Pic 7 Desc.</b>	Clean water diversion primary plunge pool and level spreader are in good condition. No maintenance needed.		<b>Pic 8 Desc.</b>	Temporary waterbar remains well stabilized with matting, and no maintenance is needed.

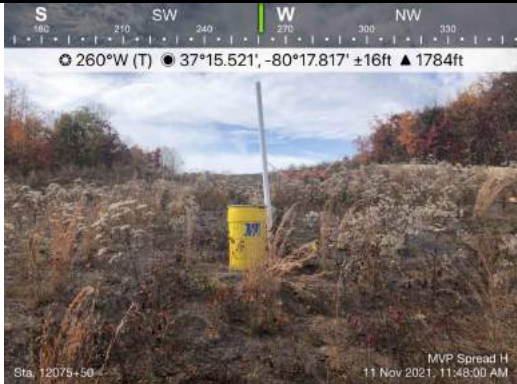
<b>GPS Location</b>	See Photo Watermark		<b>GPS Location</b>	See Photo Watermark	
<b>Field Station#</b>	12075+50		<b>Field Station#</b>	12076+50	
<b>Pic 9 Desc.</b>	Spill kit staged on-site and is well stocked. No maintenance needed.		<b>Pic 10 Desc.</b>	Resource S-MM15 buffer zone remains well vegetated and unimpacted.

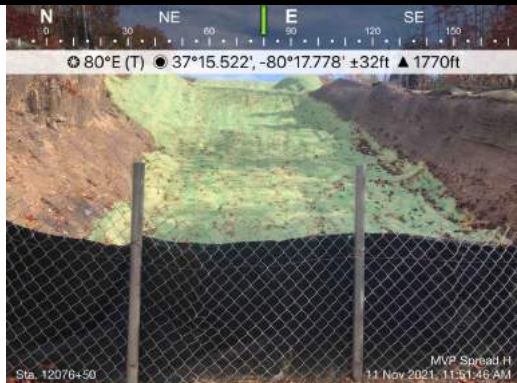
<b>Field Station#</b>	12076+50		<b>Field Station#</b>	12072+50	
<b>Pic 11 Desc.</b>	Erosion control matting and super silt fence on GAS S-MM15 are in good condition. No maintenance needed.		<b>Pic 12 Desc.</b>	MVP-MN-270 and perimeter controls/sump pits remain in good condition.

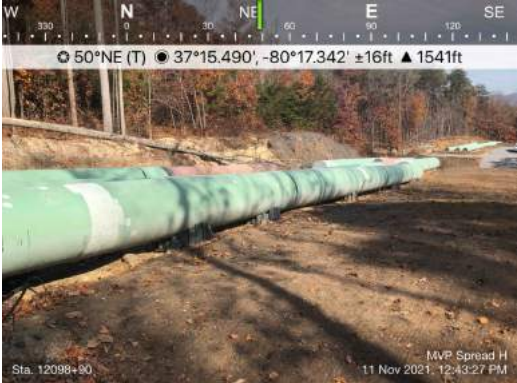
<b>GPS Location</b>	See Photo Watermark		<b>GPS Location</b>	See Photo Watermark	
<b>Field Station#</b>	12098+90		<b>Field Station#</b>	12098+50	
<b>Pic 13 Desc.</b>	Pipe staged along ROW is stable and in good condition. No maintenance needed.		<b>Pic 14 Desc.</b>	Stream resource crossing buffer zone and equipment bridge remain in good condition.

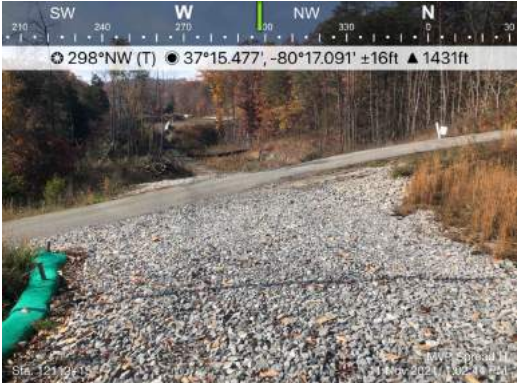
<b>GPS Location</b>	See Photo Watermark		<b>GPS Location</b>	See Photo Watermark	
<b>Field Station#</b>	12112+15		<b>Field Station#</b>	12116+50	
<b>Pic 15 Desc.</b>	Construction entrances remain in good condition, and no tracked material was observed.		<b>Pic 16 Desc.</b>	Permanent waterbar with rock level spreader installations are in good condition. No maintenance needed.

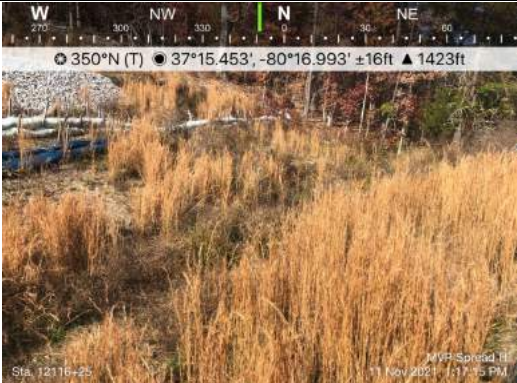
<b>Field Station#</b>	12116+25		<b>Field Station#</b>	12119+00	
<b>Pic 17 Desc.</b>	Drainage channel on CIS Flatwoods Rd remains in good condition and protected with CFS.		<b>Pic 18 Desc.</b>	Flatwoods Rd and associated construction entrances are in good condition and free to accumulated sediment/material.

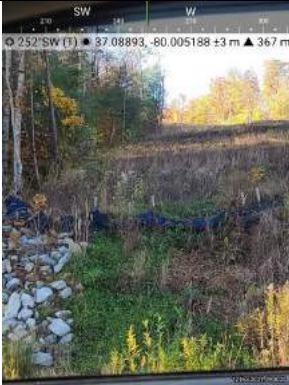
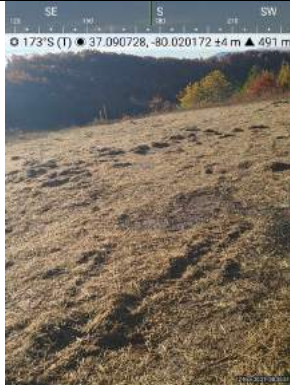
<b>GPS Location</b>	0000	<b>GPS Location</b>	00000		
<b>Field Station#</b>	13496+62	<b>Field Station#</b>	13437+72		
<b>Pic 1 Desc.</b>	Monitored rock lined channel and vegetation at CAHAS#2 road crossing, no environmental issues observed at the time of inspection after overnight rain events.		<b>Pic 2 Desc.</b>	Stabilization photo at CAHAS access road , no environmental issues observed at the time of inspection after overnight rain events.

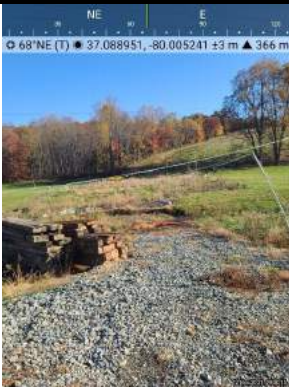
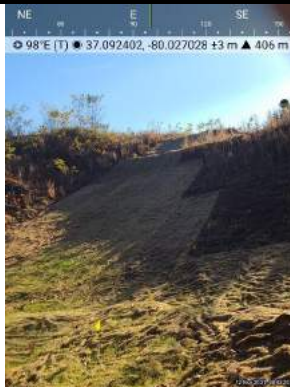
<b>GPS Location</b>	0000	<b>GPS Location</b>	00000		
<b>Field Station#</b>	13497+87	<b>Field Station#</b>	13416+88		
<b>Pic 3 Desc.</b>	Monitored stream crossing where mats were removed during maintenance repairs, no environmental issues observed at the time of inspection.		<b>Pic 4 Desc.</b>	Monitored hill side above road crossing, noticed new vegetation growing on erosion control blanket, no environmental issues observed at the time of inspection.

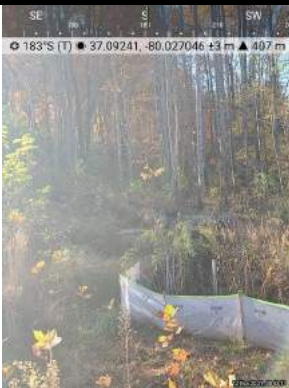
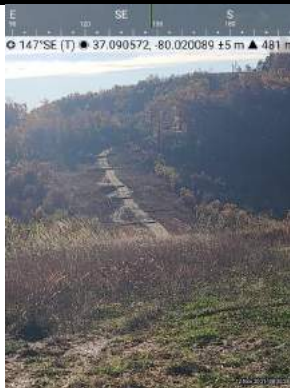
<b>GPS Location</b>	00000	<b>GPS Location</b>	0000		
<b>Field Station#</b>	13415+90	<b>Field Station#</b>	13439+40		
<b>Pic 5 Desc.</b>	Observed ECDs and sump pit after recent overnight rain events. All ECDs functioning properly at the time of inspection.		<b>Pic 6 Desc.</b>	Row photo showing travel lane that was stabilized and seeded recently. No environmental issues observed at the time of inspection.

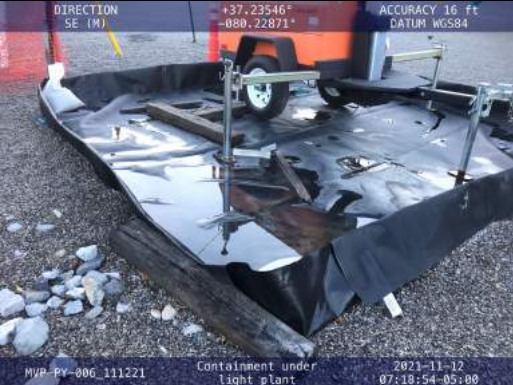
<b>GPS Location</b>	MVP-PY-006 See photo for gps data	<b>GPS Location</b>	MVP-PY-006 See photo for gps data		
<b>Field Station#</b>	+0	<b>Field Station#</b>	+0		
<b>Pic 1 Desc.</b>	Condition of soil pile adjacent to LOD. Not stabilized. Looking S.	<b>Pic 2 Desc.</b>	Secondary containment under light plant. Holding stormwater. Looking SE.

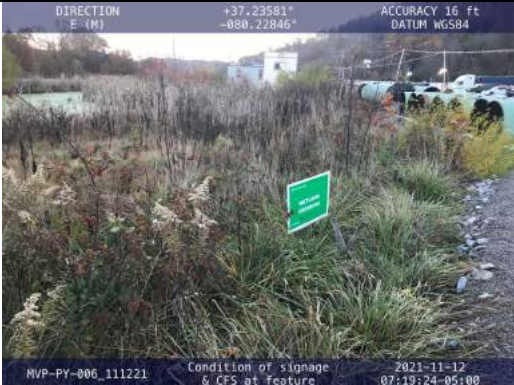
<b>GPS Location</b>	MVP-PY-006 See photo for gps data	<b>GPS Location</b>	MVP-PY-006 See photo for gps data		
<b>Field Station#</b>	+0	<b>Field Station#</b>	+0		
<b>Pic 3 Desc.</b>	Condition of triple stack compost filter sock and signage at feature W-008. Over grown with vegetation. Looking E.	<b>Pic 4 Desc.</b>	Blue Bulk Fuel tanks Secondary containment in place for tankers offloading fuel. Looking E.

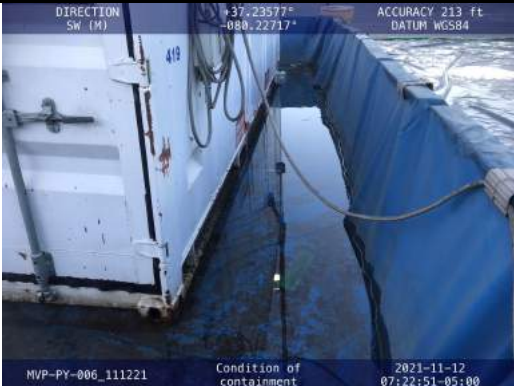
<b>Field Station#</b>	+0	<b>Field Station#</b>	+0		
<b>Pic 5 Desc.</b>	Off Road Fuel unit condition of containment. Holding stormwater, sheen noted. Looking W.	<b>Pic 6 Desc.</b>	Off Road Fuel unit no leaky internal fittings. Looking W.

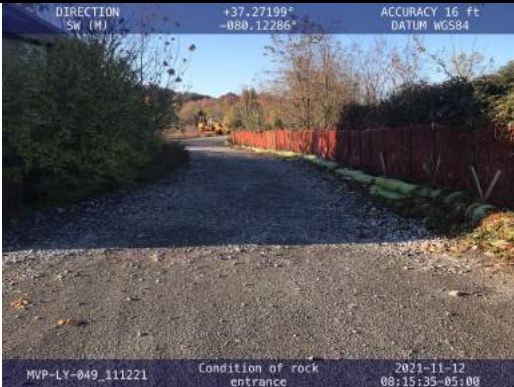
<b>GPS Location</b>	MVP-LY-049 See photo for gps data	<b>GPS Location</b>	MVP-LY-049 See photo for gps data		
<b>Field Station#</b>	+0	<b>Field Station#</b>	+0		
<b>Pic 1 Desc.</b>	Condition of rock entrance. No sediment or debris on stone. Looking SW.	<b>Pic 2 Desc.</b>	Condition of triple stack compost filter sock and safety fence along north LOD. Looking W.

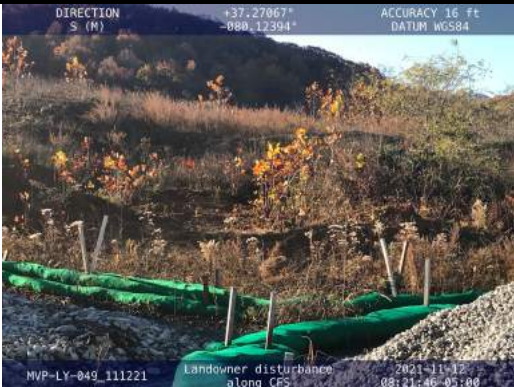
<b>GPS Location</b>	MVP-LY-049 See photo for gps data	<b>GPS Location</b>	MVP-LY-049 See photo for gps data		
<b>Field Station#</b>	+0	<b>Field Station#</b>	+0		
<b>Pic 3 Desc.</b>	Landowner soil disturbance along triple stack compost filter sock. No new damage to installed ECD's. Looking S.	<b>Pic 4 Desc.</b>	Landowner soil disturbance along edge of feature W-CV21A. Area not stabilized. Looking W.

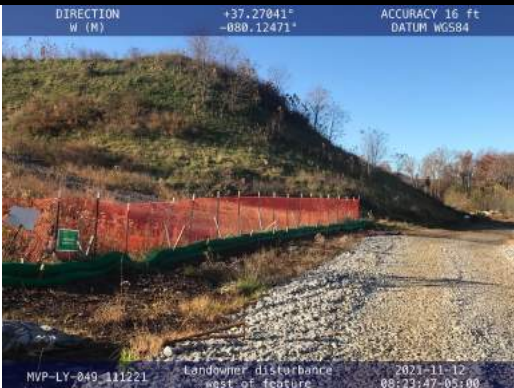
<b>GPS Location</b>	MVP-LY-049 See photo for gps data	<b>GPS Location</b>	MVP-LY-049 See photo for gps data		
<b>Field Station#</b>	+0	<b>Field Station#</b>	+0		
<b>Pic 5 Desc.</b>	Landowner soil disturbance west of feature W-CV21B. Areas not stabilized. Looking W.	<b>Pic 6 Desc.</b>	Landowner soil disturbance and debris piled along triple stack compost filter and feature W-CV21B. Looking S.

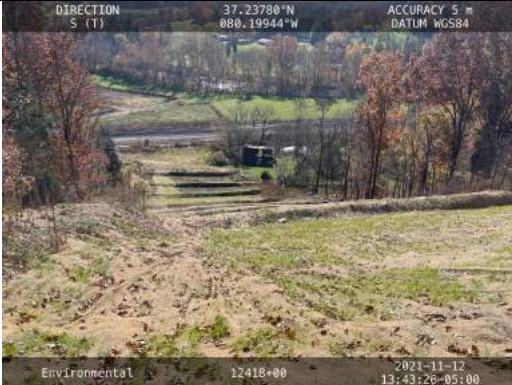
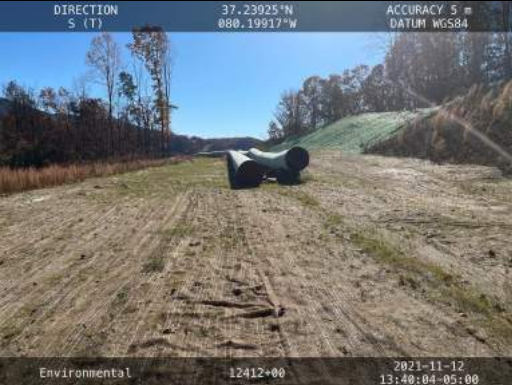
<b>GPS Location</b>	See photo		<b>GPS Location</b>	See photo	
<b>Field Station#</b>	12418+00		<b>Field Station#</b>	12412+00	
<b>Pic 1 Desc.</b>	Stabilized ROW conditions		<b>Pic 2 Desc.</b>	Stabilized ROW conditions

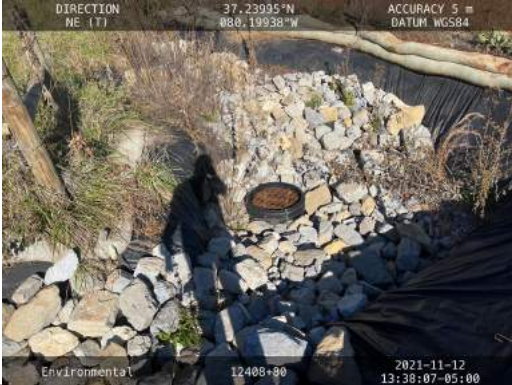
<b>GPS Location</b>	See photo		<b>GPS Location</b>	See photo	
<b>Field Station#</b>	12408+80		<b>Field Station#</b>	12402+00	
<b>Pic 3 Desc.</b>	Clean water crossing pipe inlet in acceptable condition		<b>Pic 4 Desc.</b>	Stabilized ROW conditions

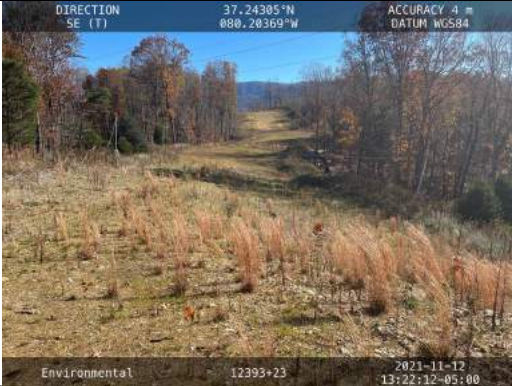
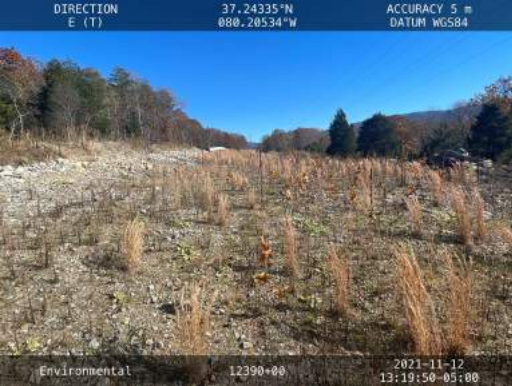
<b>GPS Location</b>	See photo		<b>GPS Location</b>	See photo	
<b>Field Station#</b>	12393+23		<b>Field Station#</b>	12390+00	
<b>Pic 5 Desc.</b>	Stabilized ROW conditions		<b>Pic 6 Desc.</b>	Stabilized ROW conditions

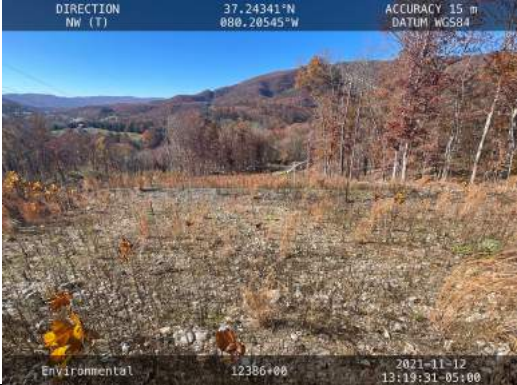
<b>GPS Location</b>	See photo		<b>GPS Location</b>	See photo	
<b>Field Station#</b>	12383+93		<b>Field Station#</b>	12386+00	
<b>Pic 7 Desc.</b>	Clean water crossing in acceptable condition		<b>Pic 8 Desc.</b>	Stabilized ROW conditions

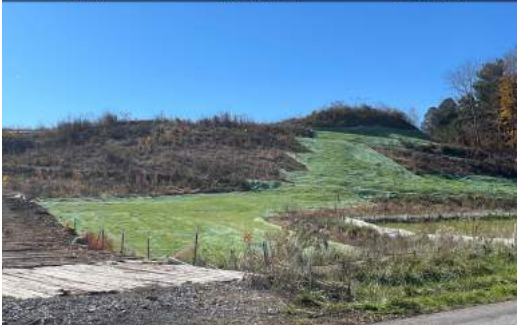
Environmental 12286+00 2021-11-12 12:09:20-05:00			
<b>GPS Location</b>	See photo		<b>GPS Location</b>	See photo	
<b>Field Station#</b>	12437+70		<b>Field Station#</b>	12286+00	
<b>Pic 13 Desc.</b>	Stabilized ROW conditions		<b>Pic 14 Desc.</b>	Stabilized ROW conditions	
DIRECTION SE (T) 37.25581°N 080.22617°W ACCURACY 4 m DATUM WGS84

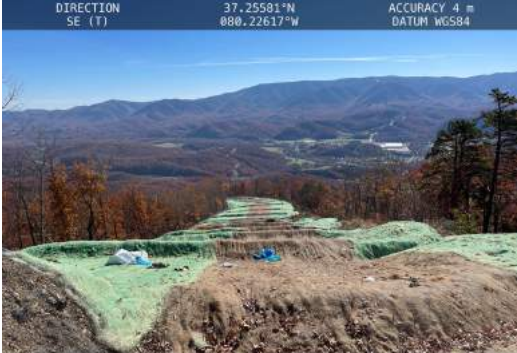
<b>Pic 15 Desc.</b>	Stabilized ROW conditions		<b>Pic 16 Desc.</b>	Stabilized ROW conditions	
DIRECTION NE (T) 37.25679°N 080.22701°W ACCURACY 5 m DATUM WGS84

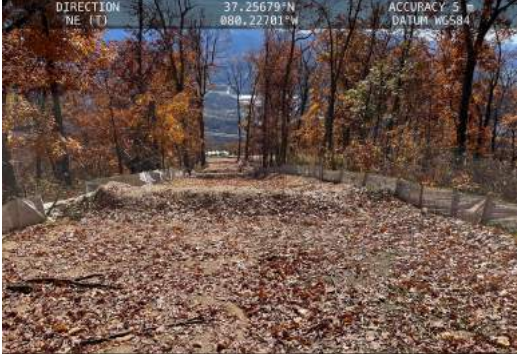
Environmental 12284+75 2021-11-12 10:26:11-05:00			
<b>GPS Location</b>	See photo		<b>GPS Location</b>	See photo	
<b>Field Station#</b>	12209+27		<b>Field Station#</b>	12284+75	
<b>Pic 17 Desc.</b>	Stabilized access Road in acceptable condition		<b>Pic 18 Desc.</b>	Access Road MVP-MN-276.03 crossing

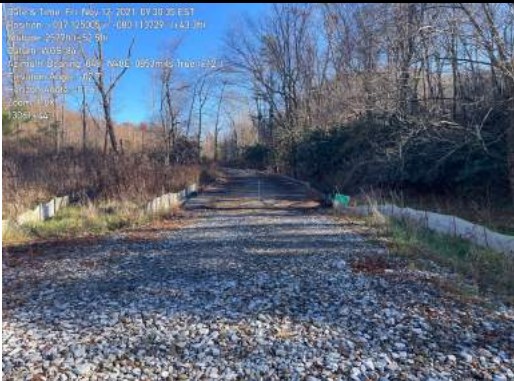
<b>GPS Location</b>	0	<b>GPS Location</b>	0		
<b>Field Station#</b>	13061+44	<b>Field Station#</b>	13061+00		
<b>Pic 5 Desc.</b>	Equipment bridge in good condition		<b>Pic 6 Desc.</b>	ROW and ECDs In good condition with good vegetation established across ROW

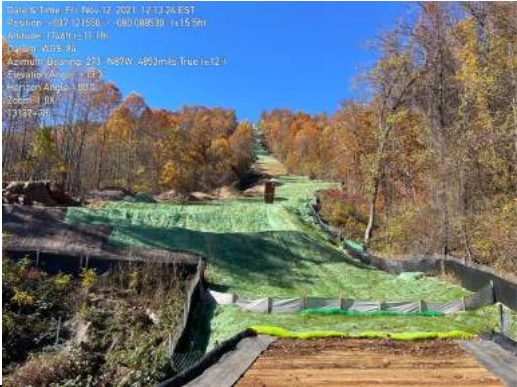
<b>GPS Location</b>	0	<b>GPS Location</b>	0		
<b>Field Station#</b>	13137+78	<b>Field Station#</b>	13137+78		
<b>Pic 15 Desc.</b>	ROW and ECDs In good condition and stable		<b>Pic 16 Desc.</b>	MVP-S-G27 and Corresponding buffer zone in good condition

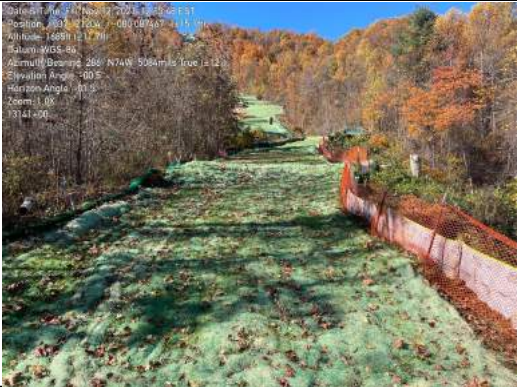
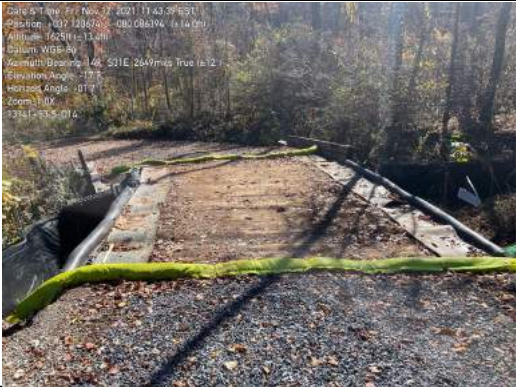
<p>Date &amp; Time: Fri, Nov 12, 2021 01:43:29 EST Position: +037.131410, -080.086396, +13141+ft Altitude: 1625ft (499m) Datum: WGS-84 Azimuth/Bearing: 100° (NOTE: 100° 2m to True is 15°) Elevation/Angle: 03.0° Horizon Angle: 01.9° Zoom: 1.0X 13141+53</p>			
<b>GPS Location</b>	0	<b>GPS Location</b>	0		
<b>Field Station#</b>	13141+00	<b>Field Station#</b>	13141+53		
<b>Pic 17 Desc.</b>	ROW and ECDs In good condition and stable		<b>Pic 18 Desc.</b>	MVP-S-G27 and Corresponding buffer zone in good condition
