Visual Site Inspection Report

Project Name	H-600 Pipeline Spread I	AFE	124300139	Spread	H-600 Pipeline Spread I
Contractor	Precision			Report #	31445
Inspector	John White			Date/Time	11/22/2021 10:22 AM
Permit #	TBD	Inspection Type	VA SWPP	Station Begin	15772+27
State	VA	Inspection Area	Full	Station End	15947+64
County	Pittsylvania	Ground	Dry	Temperature (°F)	50.00
Municipality	Chatham	Weather	Cloudy	Rain Gauge (in)	0.00
				Rain Accumulation Time (days)	6.00

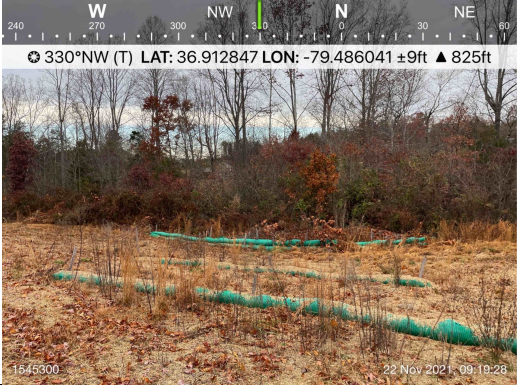
GPS Location	See photo		GPS Location	See photo	
Field Station#	15453+00		Field Station#	15445+00	
Pic 7 Desc.	CWD is in good condition and functioning.		Pic 8 Desc.	Perimeter CFS is in good condition.

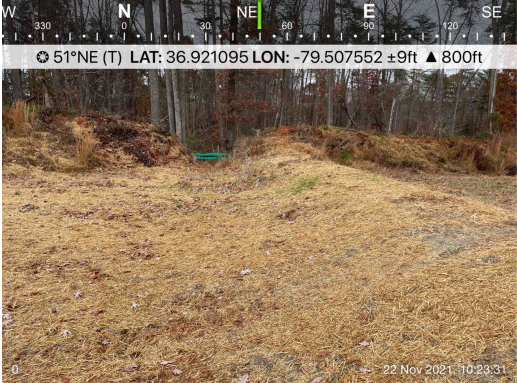
GPS Location	See photo	GPS Location			
Field Station#	15380+00	Field Station#			
Pic 13 Desc.	Waterbars are in good condition throughout this section.	Pic 14 Desc.			
Insert image here		Insert image here			
GPS Location		GPS Location			
Field Station#		Field Station#			
Pic 15 Desc.		Pic 16 Desc.			
Insert image here		Insert image here			
GPS Location		GPS Location			
Field Station#		Field Station#			
Pic 17 Desc.		Pic 18 Desc.

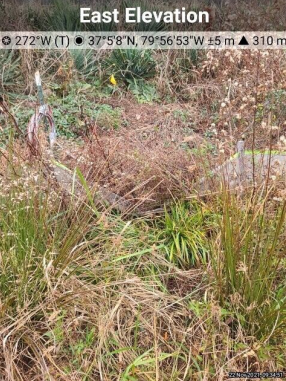
GPS Location	00000	GPS Location	0000		
Field Station#	13691+25	Field Station#	13692+77		
Pic 1 Desc.	P1 requires maintenance due to wildlife damages, documented and added to the punch list for repairs.	Pic 2 Desc.	Stream observation photo facing upstream during routine inspection today, no environmental issues observed at the time of inspection.		
	North Elevation

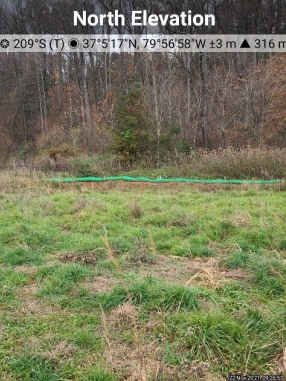
GPS Location	0000	GPS Location	00000		
Field Station#	13680+50	Field Station#	13683+00		
Pic 3 Desc.	Monitored ECDs along the LOD, no environmental issues observed at the time of inspection.	Pic 4 Desc.	Monitored equipment mats and vegetation in temporary area of row. No environmental issues observed at the time of inspection.		
	North West Elevation

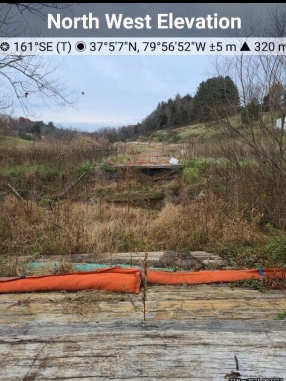
Field Station#	13692+70	Field Station#	13692+77		
Pic 5 Desc.	Observed stream crossing where equipment mats were removed during maintenance repairs, monitored ECDs on stream banks, no environmental issues observed at the time of inspection.	Pic 6 Desc.	Stream observation photo facing downstream during routine inspection, no environmental issues observed at the time of inspection.

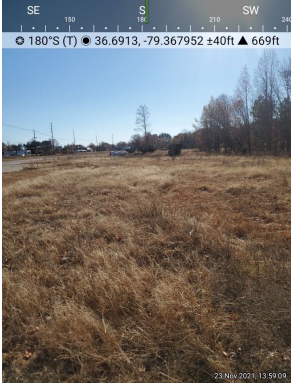
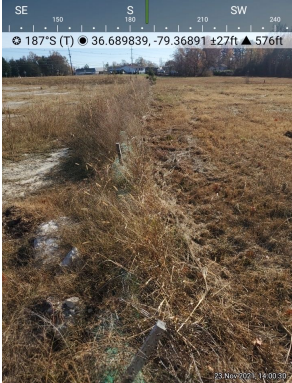
GPS Location	0	GPS Location	0		
Field Station#	0+00	Field Station#	0+00		
Pic 7 Desc.	LY-048 Temporary stabilization	Pic 8 Desc.	LY-048 West perimeter CFS		
Insert image here		Insert image here			
GPS Location		GPS Location			
Field Station#		Field Station#			
Pic 9 Desc.		Pic 10 Desc.			
Insert image here		Insert image here			
GPS Location		GPS Location			
Field Station#		Field Station#			
Pic 11 Desc.		Pic 12 Desc.

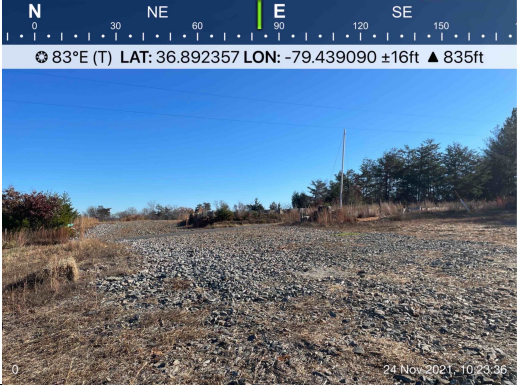
GPS Location	See photo		GPS Location	See photo	
Field Station#	15619+48		Field Station#	15625+00	
Pic 7 Desc.	RCEs are in good condition at all road crossings.		Pic 8 Desc.	End treatments are in good condition and functioning.

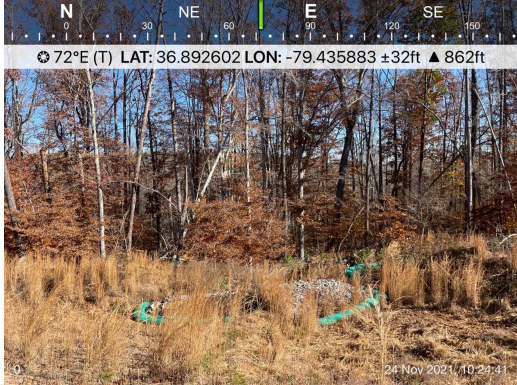
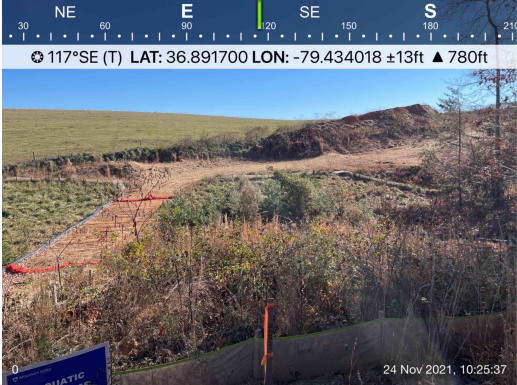
GPS Location	See photo		GPS Location	See photo	
Field Station#	15630+00		Field Station#	15636+45	
Pic 9 Desc.	CWD is in good condition and functioning as intended.		Pic 10 Desc.	Resource buffers remain in good condition	
Insert image here			Insert image here		
GPS Location			GPS Location		
Field Station#			Field Station#		
Pic 11 Desc.			Pic 12 Desc.

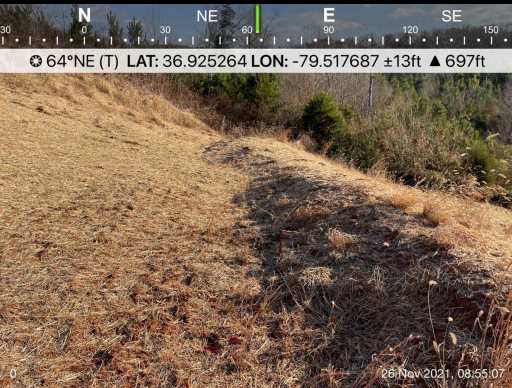
GPS Location	See photo		GPS Location	See photo	
Field Station#	15346+50		Field Station#	15346+00	
Pic 5 Desc.	P1 is in good condition at all stream and wetland buffers.		Pic 6 Desc.	Waterbars are in good condition.

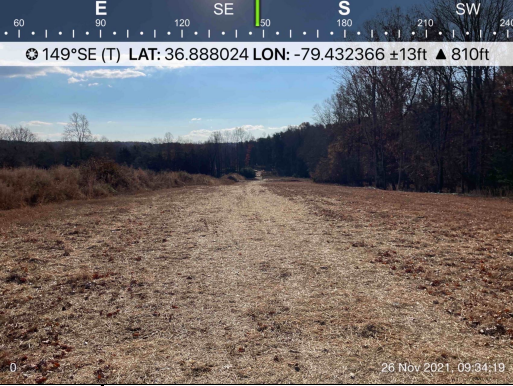
GPS Location	See photo		GPS Location	See photo	
Field Station#	15647+03		Field Station#	15650+00	
Pic 1 Desc.	RCEs are in good condition at all road crossings.		Pic 2 Desc.	This section remains temporarily stabilized

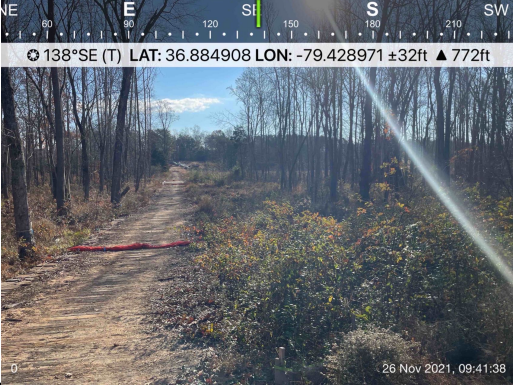
GPS Location	See photo		GPS Location	See photo	
Field Station#	15658+43		Field Station#	15665+50	
Pic 3 Desc.	Equipment bridge ECDs are in place and functioning.		Pic 4 Desc.	Resource buffers remain in good condition.

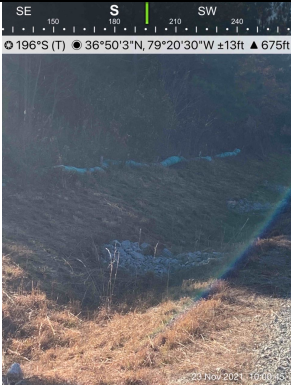
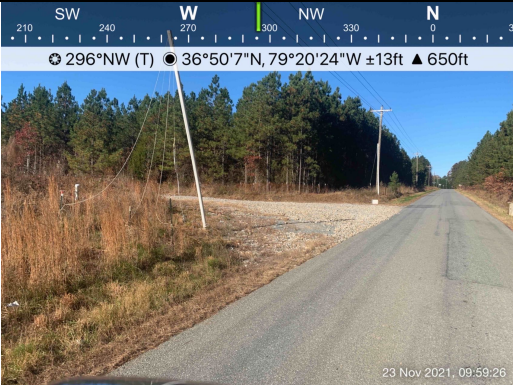
GPS Location	O	GPS Location	O		
Field Station#	00+00	Field Station#	00+00		
Pic 3 Desc.	Observing rock check dams and ECD's		Pic 4 Desc.	Observing RCE	
Insert image here			Insert image here		
GPS Location		GPS Location			
Field Station#		Field Station#			
Pic 5 Desc.		Pic 6 Desc.
