Visual Site Inspection Report

Project Name	H-600 Pipeline Spread G	AFE	124300137	Spread	H-600 Pipeline Spread G
Contractor	Precision			Report #	32462
Inspector	Chris Burns			Date/Time	12/20/2021 11:08 AM
Permit #	TBD	Inspection Type	VA SWPP	Station Begin	11254+99
State	VA	Inspection Area	Partial	Station End	11353+67
County	Giles	Ground	Damp	Temperature (°F)	44.00
Municipality	N/A	Weather	Sunny	Rain Gauge (in)	0.20
				Rain Accumulation Time (days)	1.00

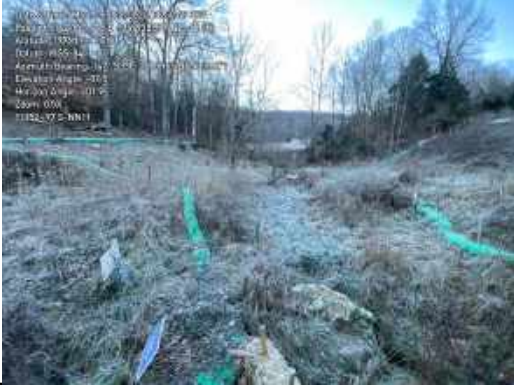
GPS Location	3	GPS Location	4		
Field Station#	11352+97	Field Station#	11263+00		
Pic 3 Desc.	S-NN11.	Pic 4 Desc.	Section of RoW showing conditions and controls.

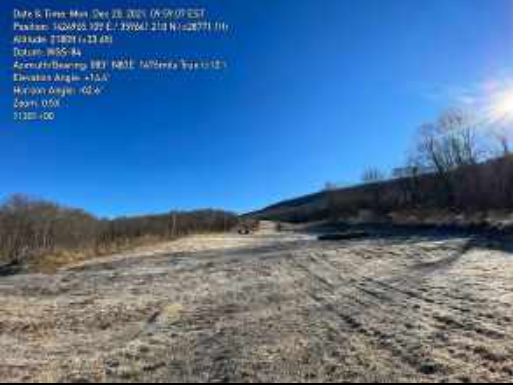
GPS Location	5	GPS Location	6		
Field Station#	11292+50	Field Station#	11301+00		
Pic 5 Desc.	Damaged P-1.	Pic 6 Desc.	Section of RoW showing conditions and controls.

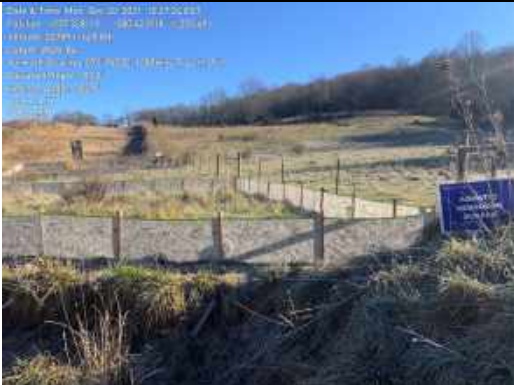
GPS Location	See photo		GPS Location	see photo	
Field Station#	11517+57		Field Station#	11507+05	
Pic 3 Desc.	Aquatic resource signage and buffer zones are in acceptable condition		Pic 4 Desc.	Equipment bridge is maintained in acceptable condition

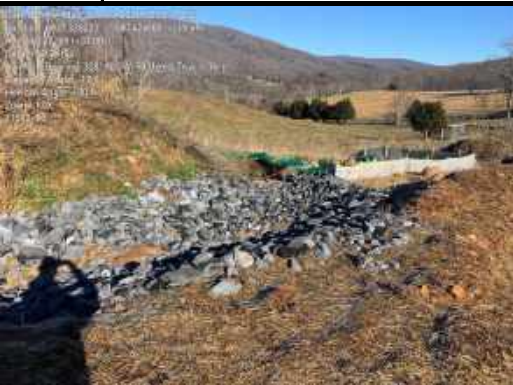
GPS Location	See photo		GPS Location	See photo	
Field Station#	11505+74		Field Station#	11503+80	
Pic 5 Desc.	12" CFS needs replaced		Pic 6 Desc.	Rock lined channel is in acceptable condition

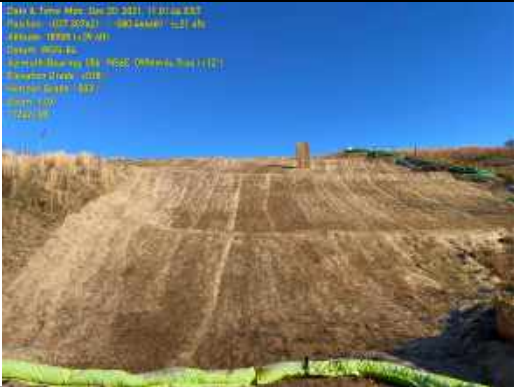
GPS Location	See photo		GPS Location	See photo	
Field Station#	11362+00		Field Station#	11363+00	
Pic 3 Desc.	Erosion control blanket in place		Pic 4 Desc.	End treatments in place

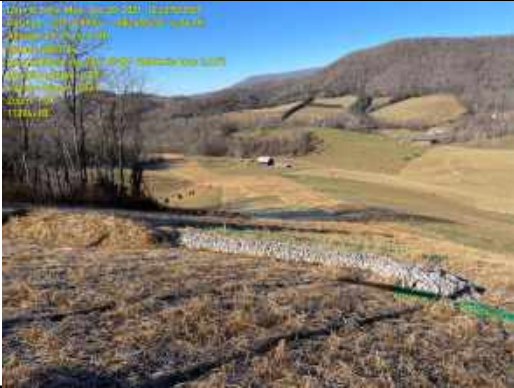
GPS Location	See photo		GPS Location	See photo	
Field Station#	11396+00		Field Station#	11412+00	
Pic 5 Desc.	Level spreader in place		Pic 6 Desc.	CFS temporary waterbars in place

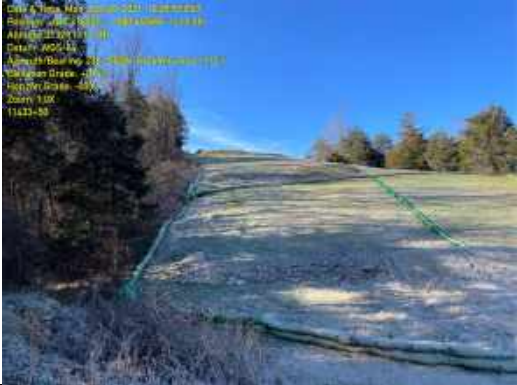
GPS Location	See photo		GPS Location	See photo	
Field Station#	11433+50		Field Station#	11447+00	
Pic 7 Desc.	CFS perimeter control in place		Pic 8 Desc.	Cleanwater diversion berm in place

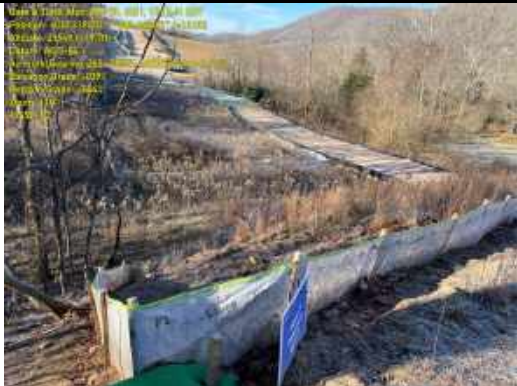
GPS Location	See photo		GPS Location	See photo	
Field Station#	11452+00		Field Station#	11467+00	
Pic 9 Desc.	Steam buffer in place		Pic 10 Desc.	Plunge pool in place

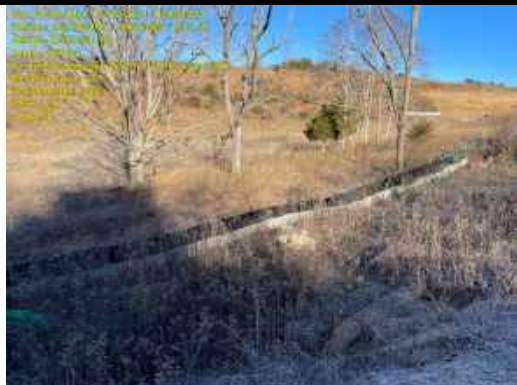
GPS Location	See photo		GPS Location	See photo	
Field Station#	11469+00		Field Station#	11470+00	
Pic 11 Desc.	Triple protection ECDs in place at karst feature		Pic 12 Desc.	Stone inlet protection in place

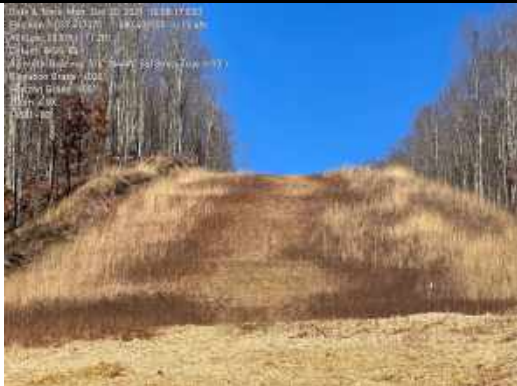
GPS Location	See Photo	GPS Location	See Photo		
Field Station#	11581+00	Field Station#	11584+92		
Pic 9 Desc.	View looking at temporary stabilization. No issues at this time.	Pic 10 Desc.	View of equipment bridge condition over the S-PP20 stream resource

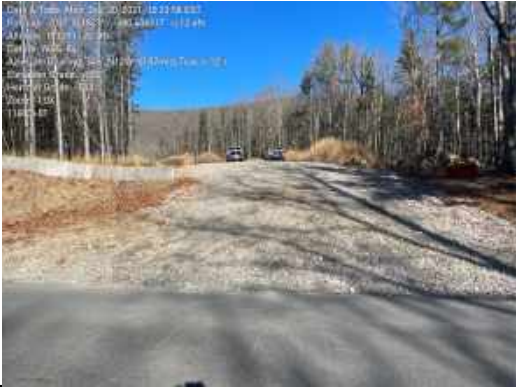
<p style="text-align: center;">Insert image here</p>			
GPS Location	See Photo	GPS Location			
Field Station#	11600+01	Field Station#			
Pic 15 Desc.	RCE current conditions. No issues at this time.	Pic 16 Desc.			
<p style="text-align: center;">Insert image here</p>		<p style="text-align: center;">Insert image here</p>			
GPS Location		GPS Location			
Field Station#		Field Station#			
Pic 17 Desc.		Pic 18 Desc.

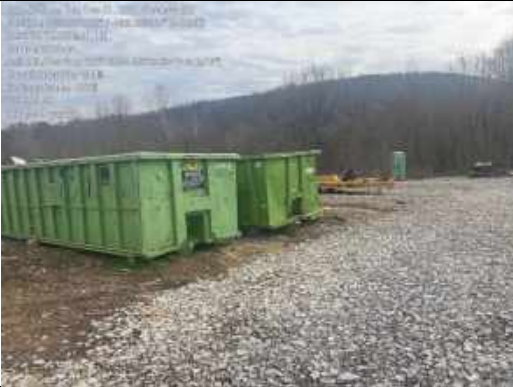
GPS Location	See Photo		GPS Location	See Photo	
Field Station#	12005+00		Field Station#	12005+00	
Pic 1 Desc.	RCE to the eastern yard 28		Pic 2 Desc.	Trash bins at the eastern yard 28

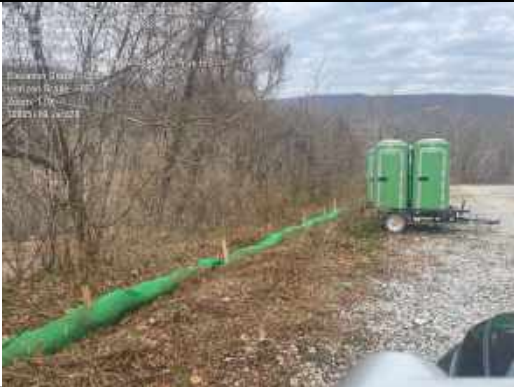
GPS Location	See Photo		GPS Location	See Photo	
Field Station#	12005+00		Field Station#	12005+00	
Pic 3 Desc.	Replaced perimeter CFS at the western portion of yard 28		Pic 4 Desc.	Refreshed RCE at the western portion of yard 28	
Insert image here			Insert image here		
GPS Location			GPS Location		
Field Station#			Field Station#		
Pic 5 Desc.			Pic 6 Desc.

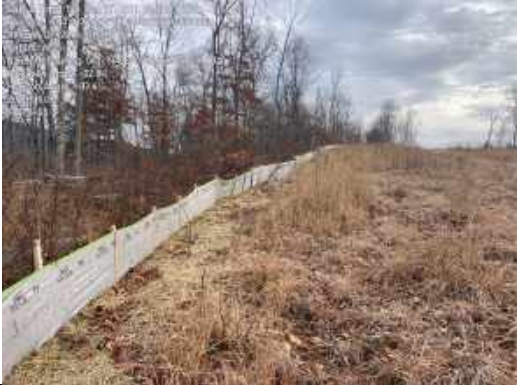
GPS Location	See photo	GPS Location	See photo		
Field Station#	11875+45	Field Station#	11887+00		
Pic 7 Desc.	P1 silt fence is in acceptable condition	Pic 8 Desc.	ECD's have been removed and temporary stabilization is acceptable

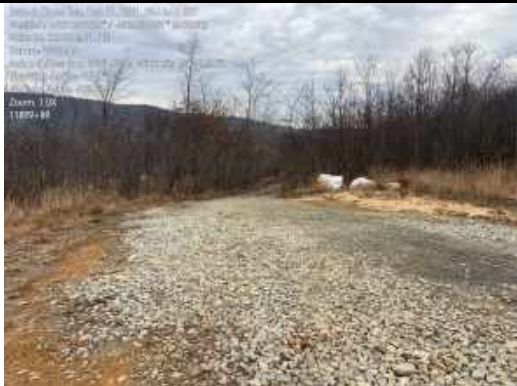
Insert image here			
GPS Location	See photo	GPS Location			
Field Station#	11899+89	Field Station#			
Pic 9 Desc.	AR266.03 is in acceptable condition	Pic 10 Desc.			
Insert image here		Insert image here			
GPS Location		GPS Location			
Field Station#		Field Station#			
Pic 11 Desc.		Pic 12 Desc.

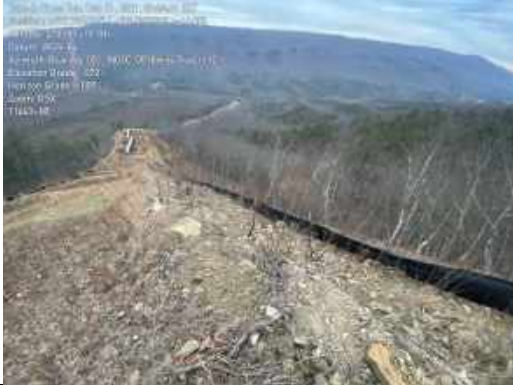
GPS Location	See Photo		GPS Location	See Photo	
Field Station#	11663+00		Field Station#	11663+00	
Pic 1 Desc.	Temporary vegetation and super silt fence functioning as intended		Pic 2 Desc.	Sump pit conditions and water bar end treatment functioning as intended

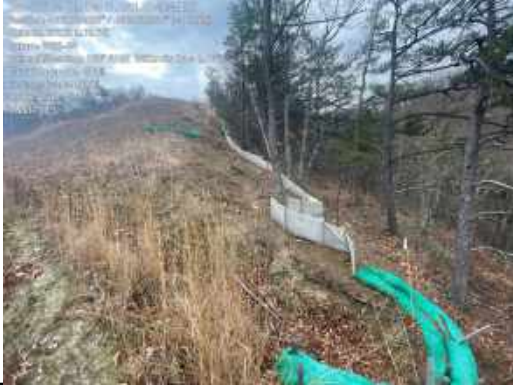
Insert image here			
GPS Location	See Photo		GPS Location		
Field Station#	11661+00		Field Station#		
Pic 3 Desc.	P1 and water bar end treatment along the LOD		Pic 4 Desc.

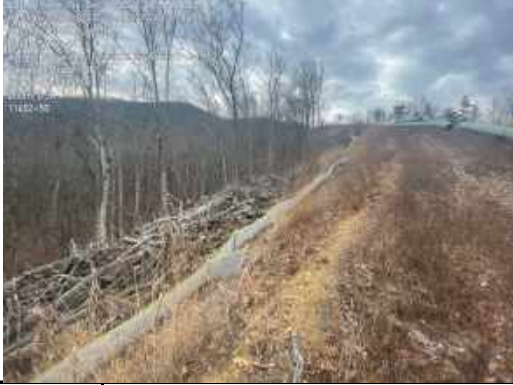
GPS Location	See Photo		GPS Location	See Photo	
Field Station#	11652+50		Field Station#	11630+00	
Pic 5 Desc.	P1 Silt fencing		Pic 6 Desc.	Temporary water bars and stabilization.

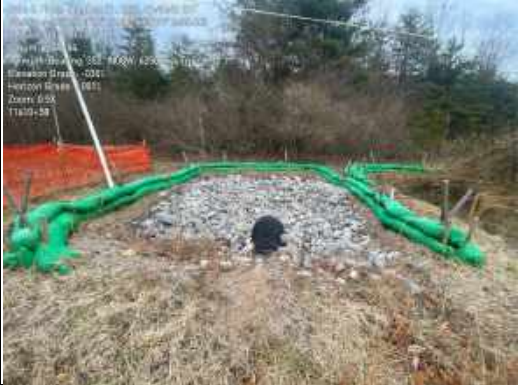
GPS Location	See Photo	GPS Location	See Photo		
Field Station#	11610+58	Field Station#	11607+04		
Pic 13 Desc.	Plunge Pool outlet to geotech lined and stone filled discharge pad. No evidence of water storage at this time	Pic 14 Desc.	Sinking Creek Stream Resource.

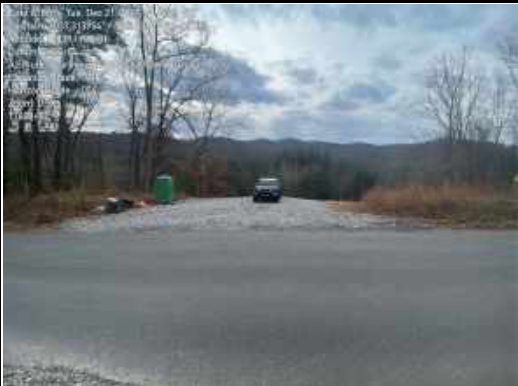
<div style="text-align: center;">Insert image here</div>			
GPS Location	See Photo	GPS Location			
Field Station#	11600+01	Field Station#			
Pic 15 Desc.	RCE and blacktop condition	Pic 16 Desc.			
<div style="text-align: center;">Insert image here</div>		<div style="text-align: center;">Insert image here</div>			
GPS Location		GPS Location			
Field Station#		Field Station#			
Pic 17 Desc.		Pic 18 Desc.

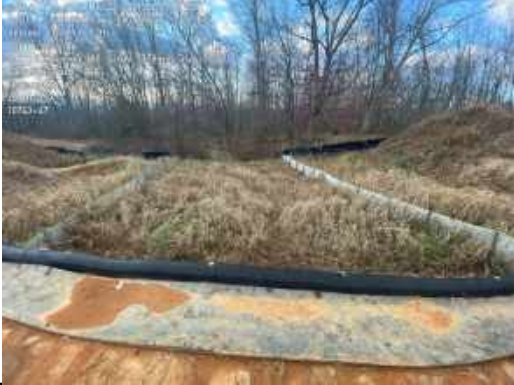
GPS Location	See Photo	GPS Location	See Photo		
Field Station#	10743+47	Field Station#	10743+47		
Pic 3 Desc.	Vegetated Drainage feature down slope. No Issues	Pic 4 Desc.	Equipment bridge over drainage feature. No Issues.

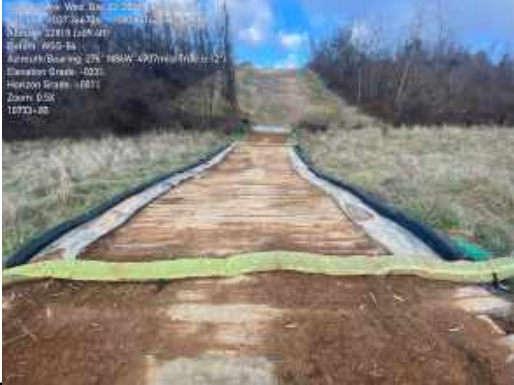
GPS Location	See Photo	GPS Location	See Photo		
Field Station#	10733+00	Field Station#	10733+00		
Pic 5 Desc.	W-Z11 Resource equipment bridge condition. No Issues.	Pic 6 Desc.	Undisturbed W-Z11 wetland vegetation upslope. no Issues.

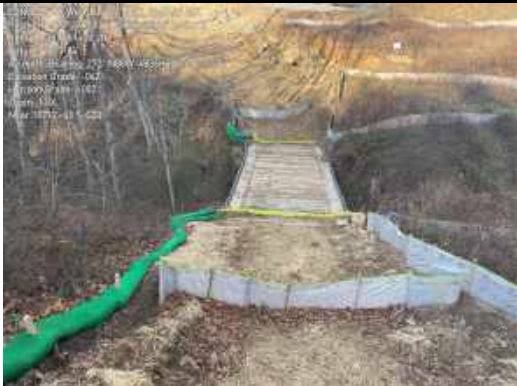
GPS Location	See Photo		GPS Location	See Photo	
Field Station#	10724+00		Field Station#	10712+63	
Pic 9 Desc.	Foam diversion dike installed at L/O access point.		Pic 10 Desc.	Equipment bridge, and vegetated buffer zone condition at the S-G33 stream resource. No Issues.

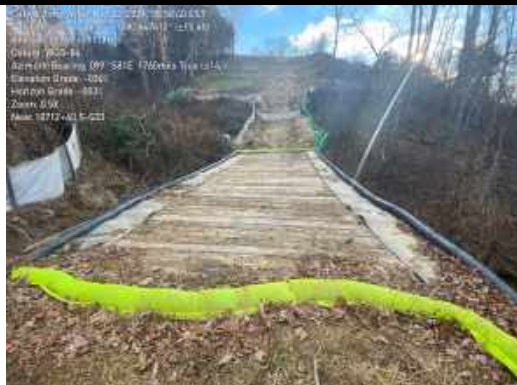
GPS Location	See Photo		GPS Location	See Photo	
Field Station#	10712+63		Field Station#	10709+00	
Pic 11 Desc.	Equipment bridge condition over the S-G33 stream resource. No Issues.		Pic 12 Desc.	Stone inlet protection conditions. No Issues.

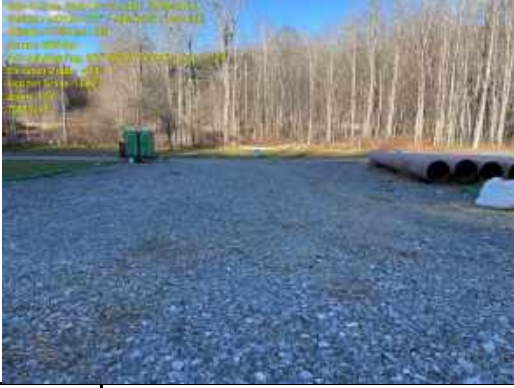
GPS Location	See photo		GPS Location	See photo	
Field Station#	10803+00		Field Station#	10804+00	
Pic 1 Desc.	RCE in place		Pic 2 Desc.	P1 silt fence in place at buffer

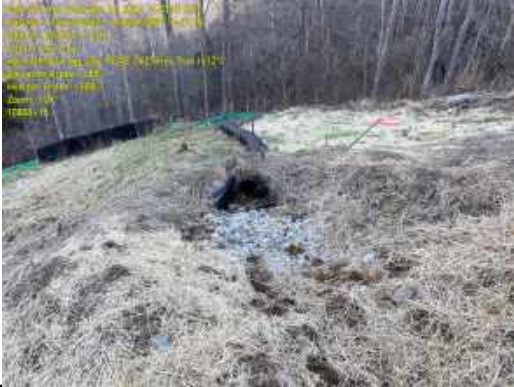
GPS Location	See photo		GPS Location	See photo	
Field Station#	10808+15		Field Station#	10812+50	
Pic 3 Desc.	Stone inlet protection in place		Pic 4 Desc.	Cleanwater diversion outlet protection in place

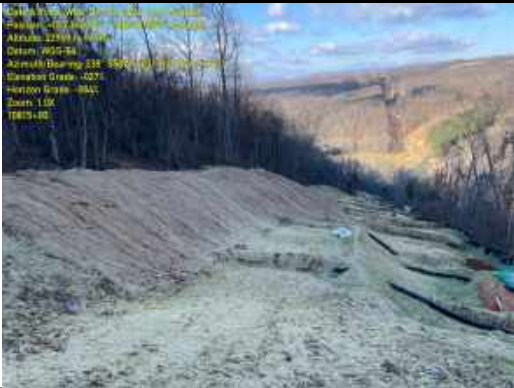
GPS Location	See photo		GPS Location	See photo	
Field Station#	10815+00		Field Station#	10818+75	
Pic 5 Desc.	Erosion control blanket in place		Pic 6 Desc.	Supersilt fence perimeter control in place

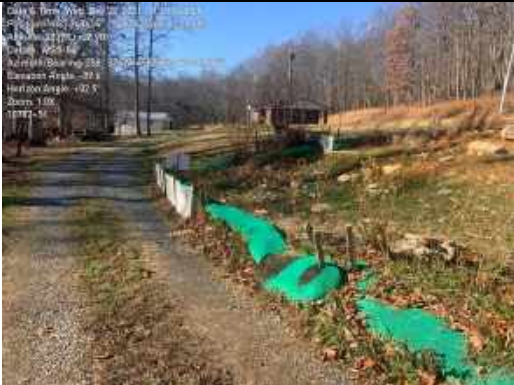
GPS Location	See photo		GPS Location	See photo	
Field Station#	10787+51		Field Station#	10779+85	
Pic 3 Desc.	P1 silt fence and CFS perimeter controls are in acceptable condition		Pic 4 Desc.	Aquatic resource signage and buffer zones are in acceptable condition

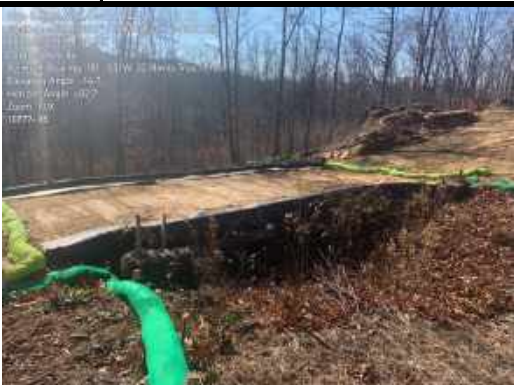
GPS Location	See photo		GPS Location	See photo	
Field Station#	10777+85		Field Station#	10771+35	
Pic 5 Desc.	Equipment bridge is maintained in acceptable condition		Pic 6 Desc.	Slope drain pipe is in acceptable condition

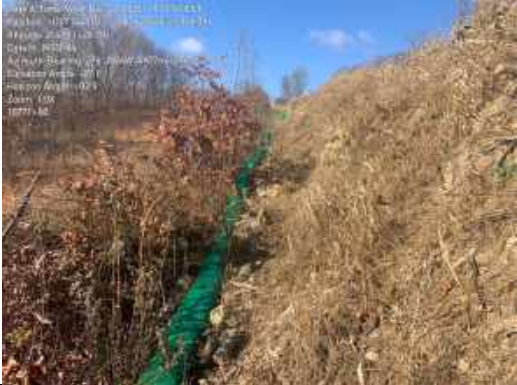
GPS Location	See photo	GPS Location	See photo		
Field Station#	10771+00	Field Station#	10770+00		
Pic 7 Desc.	CFS perimeter controls are in acceptable condition	Pic 8 Desc.	Sump pit is in acceptable condition

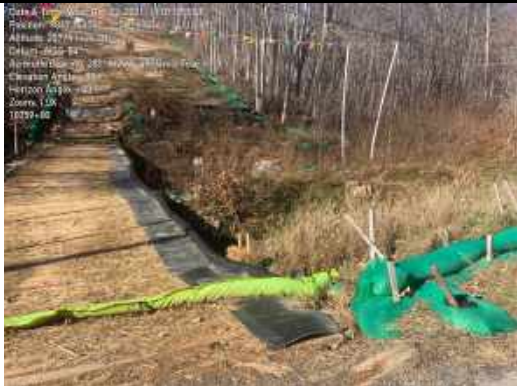
GPS Location	See photo	GPS Location	See photo		
Field Station#	10759+00	Field Station#	10753+35		
Pic 9 Desc.	Aquatic resource areas are in acceptable condition	Pic 10 Desc.	Water bars are in acceptable condition		
Insert image here		Insert image here			
GPS Location		GPS Location			
Field Station#		Field Station#			
Pic 11 Desc.		Pic 12 Desc.

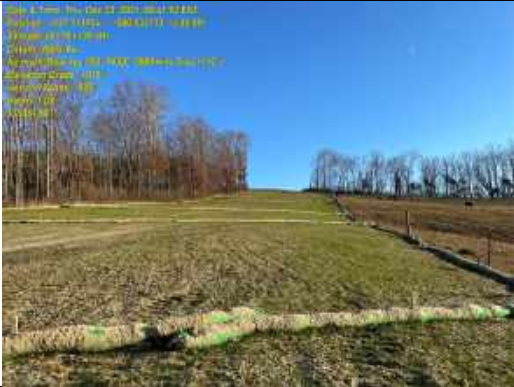
GPS Location	See photos		GPS Location	See photo	
Field Station#	11106+00		Field Station#	11112+00	
Pic 1 Desc.	CFS end treatments in place		Pic 2 Desc.	CFS triple stack perimeter control in place

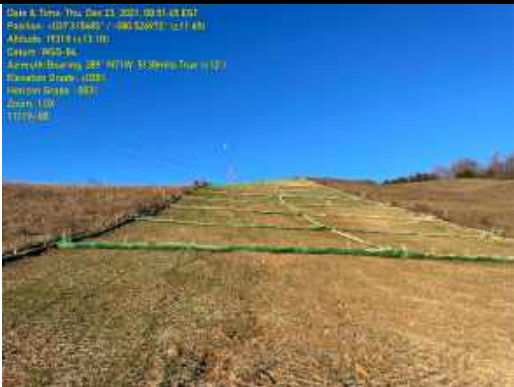
GPS Location	See photo		GPS Location	See photo	
Field Station#	11119+00		Field Station#	11146+00	
Pic 3 Desc.	Temporary CFS waterbars in place		Pic 4 Desc.	Cleanwater diversion pipe in place

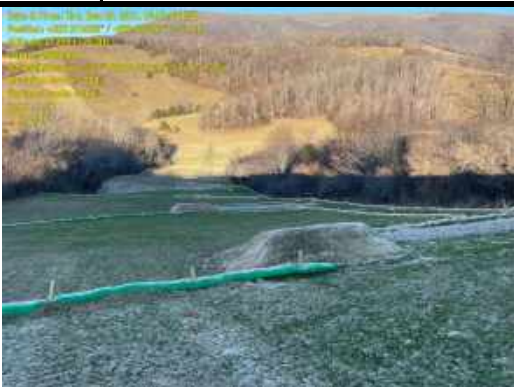
GPS Location	See photo		GPS Location	See photo	
Field Station#	11135+00		Field Station#	11148+50	
Pic 5 Desc.	Permanent waterbars in place		Pic 6 Desc.	Supersilt fence perimeter control in place

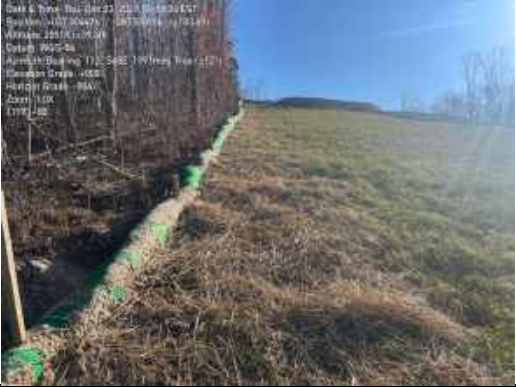
GPS Location	See Photo	GPS Location	See Photo		
Field Station#	11191+00	Field Station#	11193+00		
Pic 13 Desc.	View looking upslope at drainage feature. Limited vegetation growth	Pic 14 Desc.	Additional stabilization along the upslope LOD perimeter.

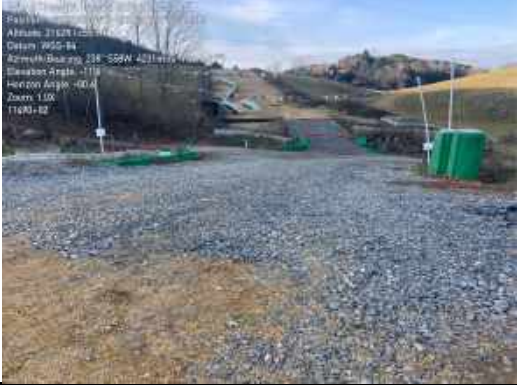
GPS Location	See photo		GPS Location	See photo	
Field Station#	11490+02		Field Station#	115+03	
Pic 7 Desc.	RCE is maintained and in acceptable condition		Pic 8 Desc.	Plunge pool and rock lined channel are in acceptable condition

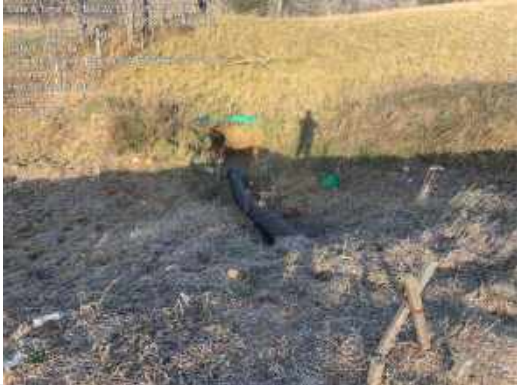
GPS Location	See photo		GPS Location	See photo	
Field Station#	11505+74		Field Station#	11514+00	
Pic 9 Desc.	Perimeter controls have been replaced per punch list from previous day		Pic 10 Desc.	Slope drain pipe is in acceptable condition

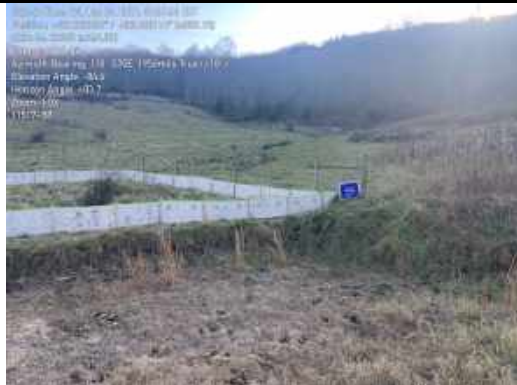
GPS Location	See photo		GPS Location	See photo	
Field Station#	11517+57		Field Station#	11522+00	
Pic 11 Desc.	Sensitive resource signage functional		Pic 12 Desc.	Silt fence is in acceptable condition

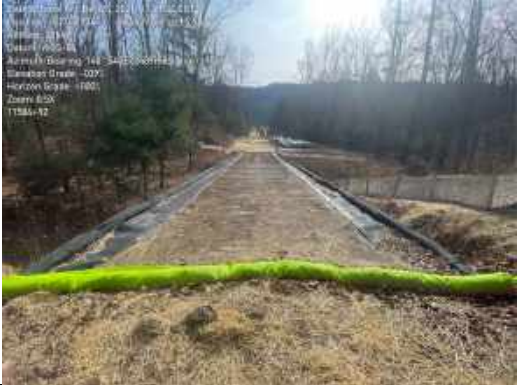
GPS Location	See Photo	GPS Location	See Photo		
Field Station#	11584+92	Field Station#	11583+78		
Pic 13 Desc.	Equipment bridge condition. S-PP21 stream	Pic 14 Desc.	Temporary stabilized water bar prior to the equipment bridge to the S-PP21 stream resource.		
Insert image here		Insert image here			
GPS Location		GPS Location			
Field Station#		Field Station#			
Pic 15 Desc.		Pic 16 Desc.			
Insert image here		Insert image here			
GPS Location		GPS Location			
Field Station#		Field Station#			
Pic 17 Desc.		Pic 18 Desc.

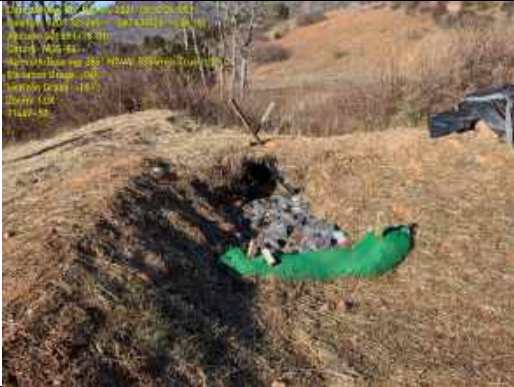
GPS Location	See photo		GPS Location	See photo	
Field Station#	11469+50		Field Station#	11468+00	
Pic 1 Desc.	Stone inlet protection in place		Pic 2 Desc.	Triple protection ECDs in place at karst feature

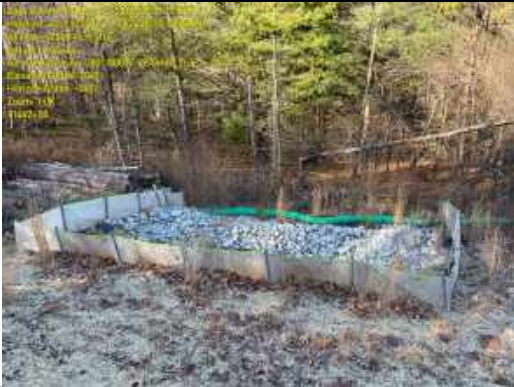
GPS Location	See photo		GPS Location	See photo	
Field Station#	11467+00		Field Station#	11461+00	
Pic 3 Desc.	Plunge pool in place		Pic 4 Desc.	CFS perimeter control in place

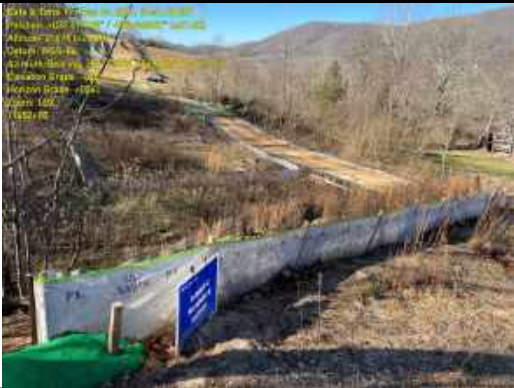
GPS Location	See photo		GPS Location	See photo	
Field Station#	11452+00		Field Station#	11448+00	
Pic 5 Desc.	Stream buffer in place		Pic 6 Desc.	Cleanwater diversion berm in place
