Visual Site Inspection Report

Project Name	H-600 Pipeline Spread G	AFE	124300137	Spread	H-600 Pipeline Spread G
Contractor	Precision			Report #	32662
Inspector	Eric Hanlon			Date/Time	12/27/2021 9:27 AM
Permit #	TBD	Inspection Type	VA SWPP	Station Begin	12005+00
State	VA	Inspection Area	Full	Station End	12005+00
County	Giles	Ground	Dry	Temperature (°F)	48.00
Municipality	N/A	Weather	Cloudy	Rain Gauge (in)	0.00
				Rain Accumulation Time (days)	1.00

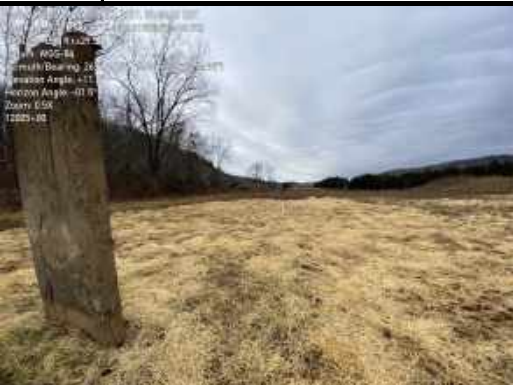
GPS Location	See Photo		GPS Location	See Photo	
Field Station#	11960+00		Field Station#	12005+00	
Pic 5 Desc.	Parameter controls		Pic 6 Desc.	Stabilization

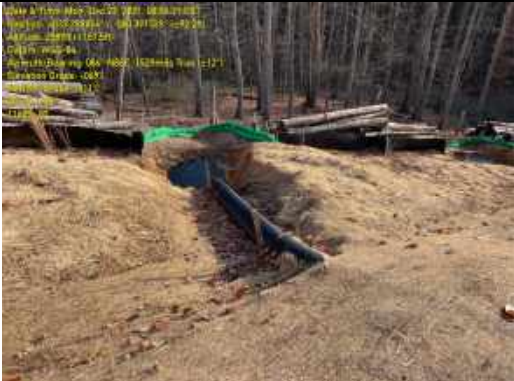
GPS Location	See photo	GPS Location	See photo		
Field Station#	11685+00	Field Station#	11688+50		
Pic 3 Desc.	Slope drain in place	Pic 4 Desc.	Erosion control blanket in place

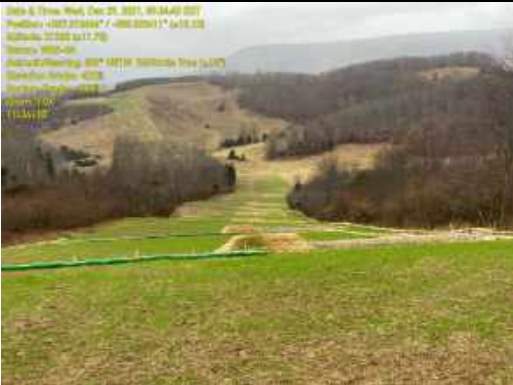
GPS Location	See photo	GPS Location	See photo		
Field Station#	11120+00	Field Station#	11134+00		
Pic 3 Desc.	Temporary CFS waterbars in place	Pic 4 Desc.	Permanent waterbars in place

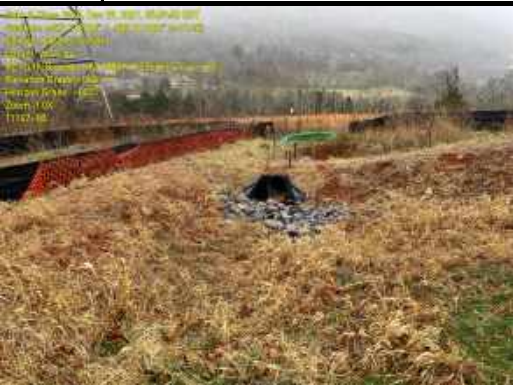
GPS Location	See photo	GPS Location	See photo		
Field Station#	11146+20	Field Station#	11147+00		
Pic 5 Desc.	Cleanwater diversion pipe in place	Pic 6 Desc.	Stone inlet protection in place

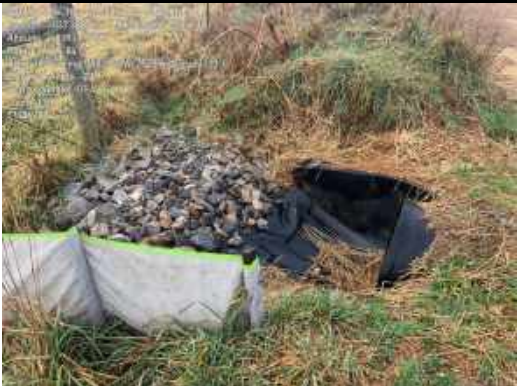
GPS Location	See photo	GPS Location	See photo		
Field Station#	11490+02	Field Station#	11486+87		
Pic 9 Desc.	Rain gage at Stevers Gap with 0.25" inches of rain	Pic 10 Desc.	Inlet to clean water diversion pipe is in acceptable condition		
Insert image here		Insert image here			
GPS Location		GPS Location			
Field Station#		Field Station#			
Pic 11 Desc.		Pic 12 Desc.

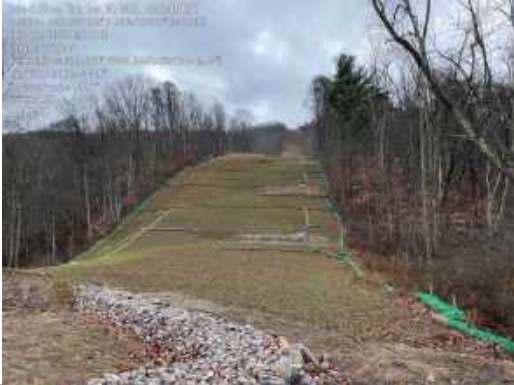
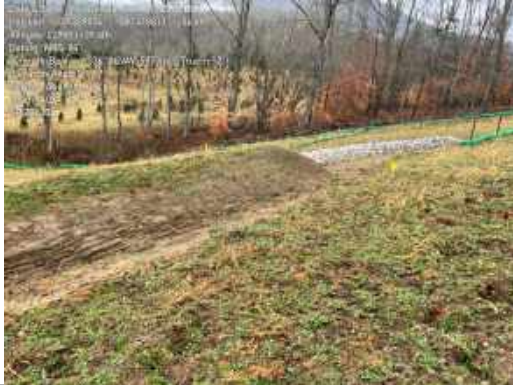
GPS Location	See photo		GPS Location	See photo	
Field Station#	11535+00		Field Station#	11528+33	
Pic 3 Desc.	Water bars in place		Pic 4 Desc.	Erosion control blanket in place

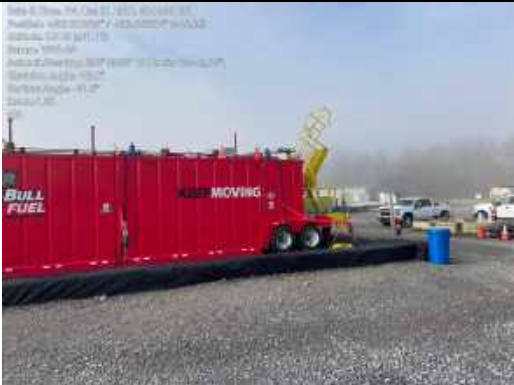
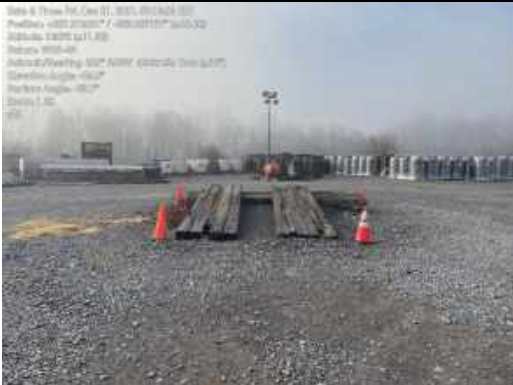
GPS Location	See photo	GPS Location	See photo		
Field Station#	12005+00	Field Station#	12005+00		
Pic 3 Desc.	Secondary containment functional	Pic 4 Desc.	RCE functional

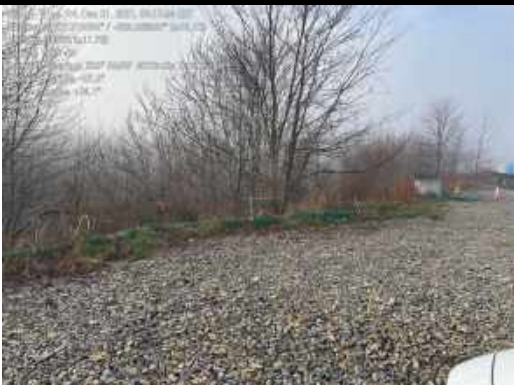
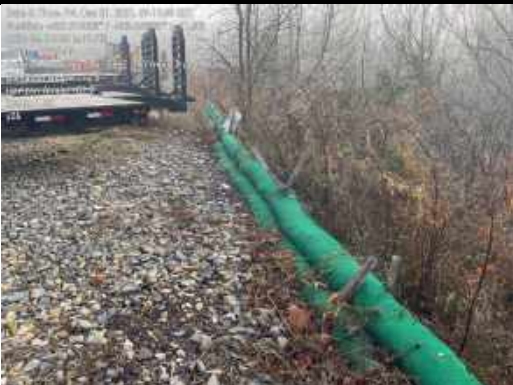
GPS Location	See photo	GPS Location	See photo		
Field Station#	12005+00	Field Station#	12005+00		
Pic 5 Desc.	CFS perimeter controls functional	Pic 6 Desc.	CFS perimeter controls functional
