Visual Site Inspection Report

Project Name	H-600 Pipeline Spread G	AFE	124300137	Spread	H-600 Pipeline Spread G
Contractor	Precision			Report #	34919
Inspector	Eric Hanlon			Date/Time	2/28/2022 7:31 AM
Permit #	TBD	Inspection Type	VA SWPP	Station Begin	12005+00
State	VA	Inspection Area	Full	Station End	12005+00
County	Giles	Ground	Dry	Temperature (°F)	40.00
Municipality	N/A	Weather	Sunny	Rain Gauge (in)	0.00
				Rain Accumulation Time (days)	1.00

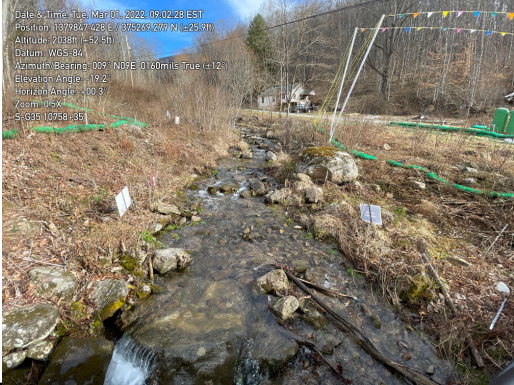
Field Station#	10758+35	GPS Location	4	Field Station#	10763+00
Pic 3 Desc.	S-G35.	Pic 4 Desc.	Punch list items.		
  <p>Date & Time: Tue, Mar 01, 2022, 09:09:48 EST Position: 1380277.066 E, 375245.198 N (+116.9ft) Altitude: 2164ft (+31.2ft) Datum: WGS-84 Azimuth/Bearing: 354.106W, 6293mils/True (+12.1) Elevation Angle: -14.3 Horizon Angle: -02.9 Zoom: 0.5X 10764+95, S-SS4</p>		  <p>Date & Time: Tue, Mar 01, 2022, 09:16:55 EST Position: 1381304.386 E, 374973.001 N (+116.5ft) Altitude: 2107ft (+11.2ft) Datum: WGS-84 Azimuth/Bearing: 006.106E, 0107mils/True (+12.1) Elevation Angle: -17.8 Horizon Angle: -03.6 Zoom: 0.5X 10773+73, S-Z9</p>		GPS Location	5
Field Station#	10764+95	GPS Location	6	Field Station#	10773+73
Pic 5 Desc.	S-SS4.	Pic 6 Desc.	S-Z9.

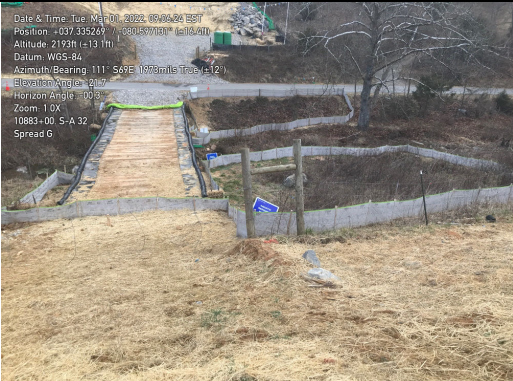
GPS Location	see photo		GPS Location	see photo	
Field Station#	10880+00		Field Station#	10883+00	
Pic 3 Desc.	Added stabilization		Pic 4 Desc.	S-A 32

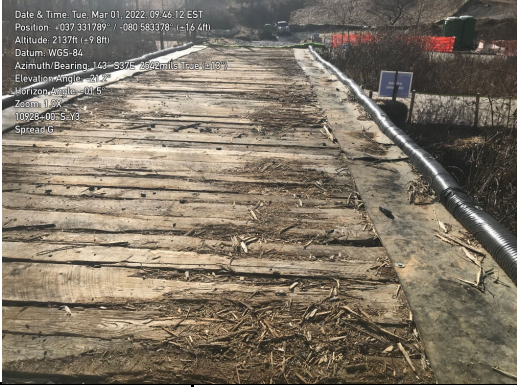
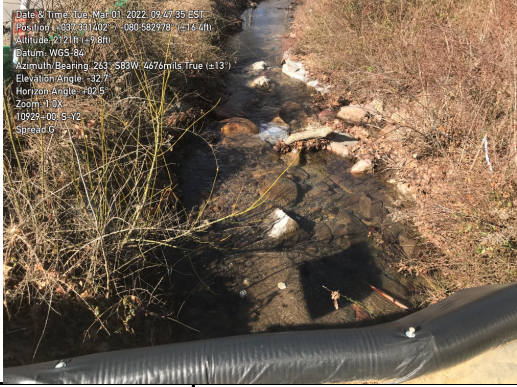
GPS Location	See photo	GPS Location	see photo		
Field Station#	10929+00	Field Station#	10929+00		
Pic 7 Desc.	S-Y 3	Pic 8 Desc.	S-Y 3		
Insert image here		Insert image here			
GPS Location		GPS Location			
Field Station#		Field Station#			
Pic 9 Desc.		Pic 10 Desc.			
Insert image here		Insert image here			
GPS Location		GPS Location			
Field Station#		Field Station#			
Pic 11 Desc.		Pic 12 Desc.

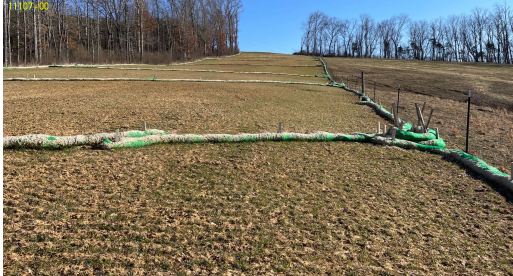
GPS Location		See photo				GPS Location		See photo			
Field Station#		11107+00				Field Station#		11112+00			
Pic 1 Desc.		CFS end treatments in place				Pic 2 Desc.		CFS triple stack perimeter control in place			
<p>Date & Time: Wed Mar 02, 2022, 09:24:01 EST Position: +037.315478° / -080.526837° (+30.6ft) Altitude: 1959ft (+52.5ft) Datum: WGS 84 Azimuth/Bearing: 282° N78W 5013mils True (+12°) Elevation Grade: +019° Horizon Grade: +002° Zoom: 1.0X 11120+00</p>

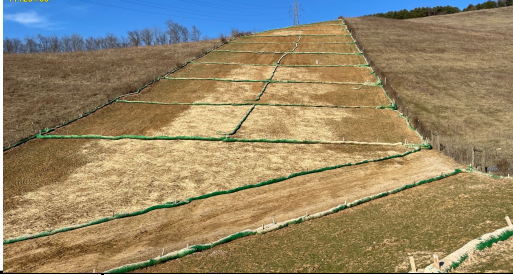
GPS Location		See photo				GPS Location		See photo			
Field Station#		11120+00				Field Station#		11133+00			
Pic 3 Desc.		Temporary CFS waterbars in place				Pic 4 Desc.		Permanent waterbars in place			
<p>Date & Time: Wed Mar 02, 2022, 09:34:00 EST Position: +037.315487° / -080.526837° (+30.6ft) Altitude: 21416 (+35.2ft) Datum: WGS 84 Azimuth/Bearing: 114° N56E 2033mils True (+12°) Elevation Grade: +013° Horizon Grade: +005° Zoom: 1.0X 11141+00</p>

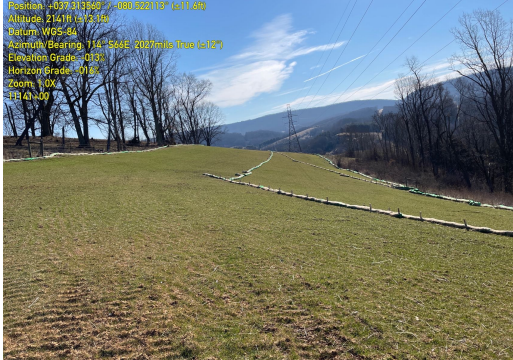
GPS Location		See photo				GPS Location		See photo			
Field Station#		11141+00				Field Station#		11146+40			
Pic 5 Desc.		Permanent vegetation present				Pic 6 Desc.		Cleanwater diversion pipe in place

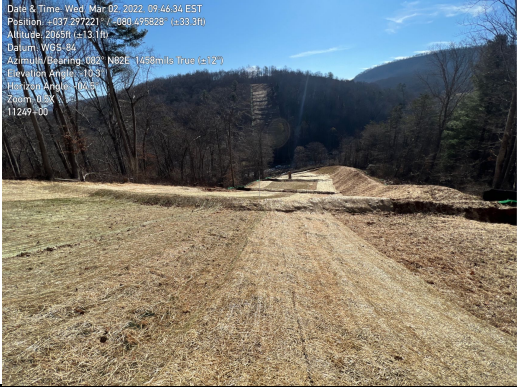
<p><small>Date & Time: Wed Mar 02 2022 09:50:15 EST Position: -037.272524 / -080.495995 / 11251.40 Altitude: 1990ft (+2.2ft) Datum: WGS 84 Azimuth Bearing: 157° N05W 6347mils True (+12.2°) Elevation Angle: -03° Horizon Angle: -03° Zoom: 0.5X 11251+50</small></p>			
GPS Location	See Photo	GPS Location	See Photo		
Field Station#	11249+00	Field Station#	11251+50		
Pic 7 Desc.	Erosion Control Blanket	Pic 8 Desc.	Waterbar and end treatment

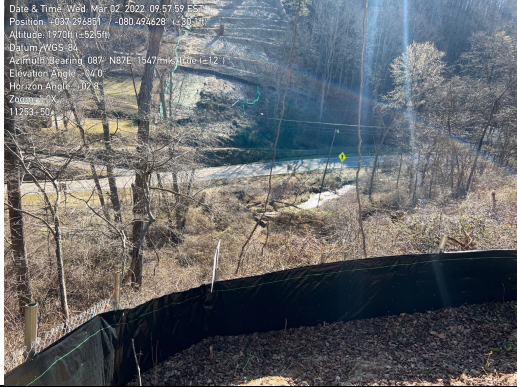
GPS Location	See Photo	GPS Location	See Photo		
Field Station#	11253+50	Field Station#	11254+58		
Pic 9 Desc.	Stream Overview	Pic 10 Desc.	W-RR1B		
Insert image here		Insert image here			
GPS Location		GPS Location			
Field Station#		Field Station#			
Pic 11 Desc.		Pic 12 Desc.

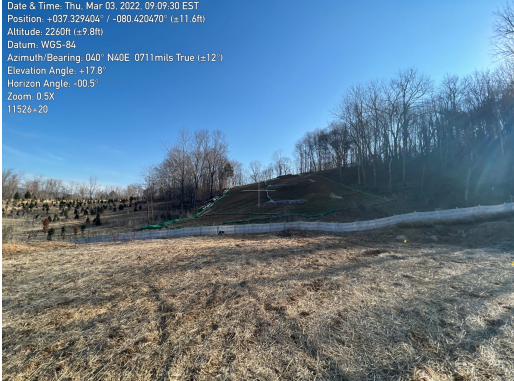
GPS Location	See Photo	GPS Location	See Photo		
Field Station#	11526+20	Field Station#	11528+00		
Pic 1 Desc.	Restoration	Pic 2 Desc.	Level Spreader		
<p>Date & Time: Thu, Mar 03, 2022, 09:12:02 EST Position: +037 329732 / -080 418874 (±16.4ft) Altitude: 2362ft (±11.3ft) Datum: WGS-84 Azimuth/Bearing: 108 S72E 1920mils True (±12.1) Elevation Angle: +00.6 Horizon Angle: +01.0 Zoom: 1.0X 11531+50</p>

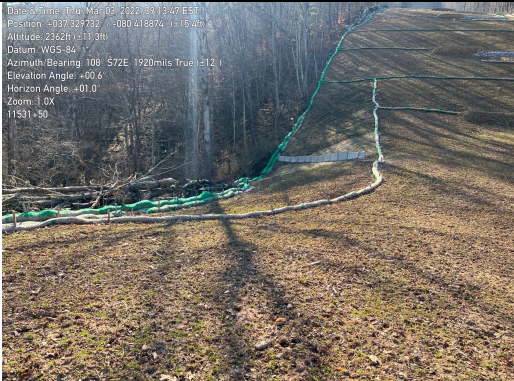
GPS Location	See Photo	GPS Location	See Photo		
Field Station#	11531+50	Field Station#	11582+00		
Pic 3 Desc.	Perimeter controls	Pic 4 Desc.	Section of ROW showing conditions and controls and water bars		
<p>Date & Time: Thu, Mar 03, 2022, 08:47:40 EST Position: +037 317531 / -080 409475 (±15.0ft) Altitude: 1985ft (±8.2ft) Datum: WGS-84 Azimuth/Bearing: 128 S52E 2276mils True (±12.1) Elevation Angle: +01.0 Horizon Angle: +00.6 Zoom: 1.0X 11587+50</p>

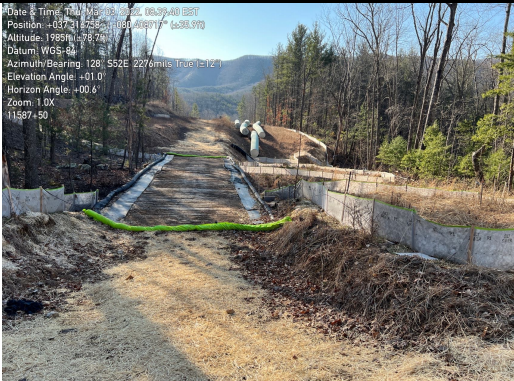
GPS Location	See Photo	GPS Location	See Photo		
Field Station#	11587+50	Field Station#	11600+01		
Pic 5 Desc.	Equipment Bridge and buffers	Pic 6 Desc.	RCE

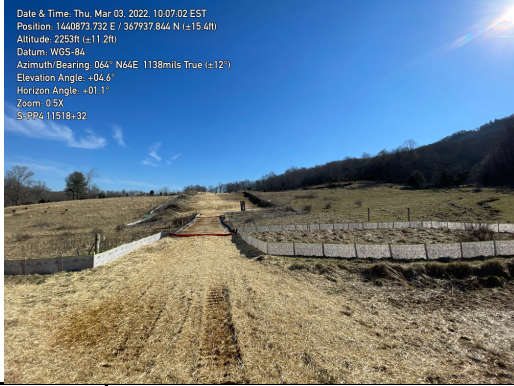
<p>Date & Time: Thu, Mar 03, 2022, 10:07:02 EST Position: 1460873.732 E / 367937.844 N (±15.4m) Altitude: 2253ft (±11.2m) Datum: WGS-84 Azimuth/Bearing: 064° N64E 1138mils True (±12°) Elevation Angle: +04.6° Horizon Angle: +01.1° Zoom: 0.5X SPP4: 11518-32</p>			
GPS Location	1	GPS Location	2		
Field Station#	11524+16	Field Station#	11518+32		
Pic 1 Desc.	AR 268.02.	Pic 2 Desc.	Overview S-PP4.

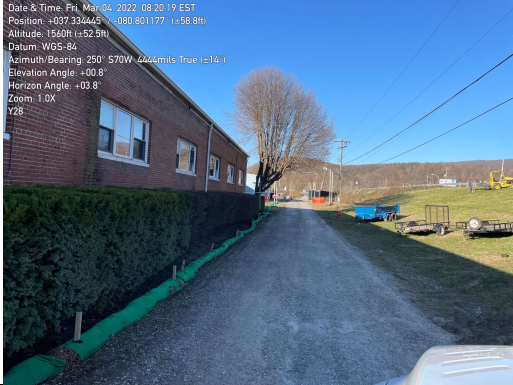
<p>Date & Time: Fri, Mar 04, 2022 08:20:55 EST Position: +037.334445° / -080.801177° (+58.8ft) Altitude: 1560ft (+52.9ft) Datum: WGS-84 Azimuth/Bearing: 179° 51'W 690mils True (+30.0) Elevation Angle: +01.8° Horizon Angle: +02.8° Zoom: 1.0X Y2B</p>					
GPS Location		See photo		GPS Location		See photo	
Field Station#		12005+00		Field Station#		12005+00	
Pic 1 Desc.		Permanent vegetation in good condition		Pic 2 Desc.		RCE functional

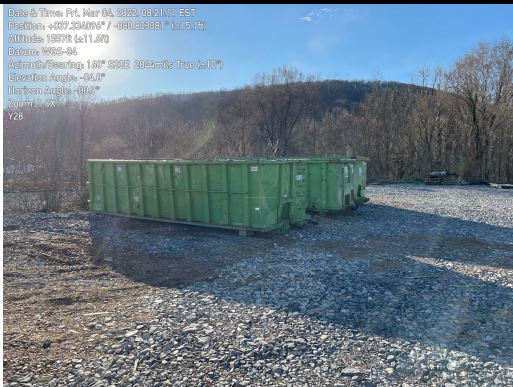
GPS Location		See photo		GPS Location		See photo	
Field Station#		12005+00		Field Station#		12005+00	
Pic 3 Desc.		Housekeeping trash in good condition		Pic 4 Desc.		CFS perimeter controls functional

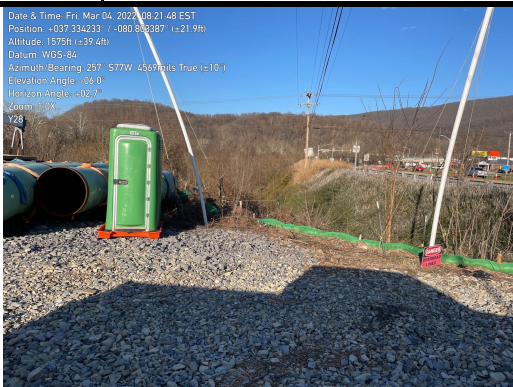
<p>Date & Time: Fri, Mar 04, 2022 08:22:06 EST Position: +037.334280° / -080.803145° (+61.4ft) Altitude: 1560ft (+52.9ft) Datum: WGS-84 Azimuth/Bearing: 029° N29E 051mils True (+10.0) Elevation Angle: -06.1° Horizon Angle: +02.8° Zoom: 1.0X Y2B</p>					
GPS Location		See photo		GPS Location		See photo	
Field Station#		12005+00		Field Station#		12005+00	
Pic 5 Desc.		CFS perimeter controls functional		Pic 6 Desc.		CFS perimeter controls in place

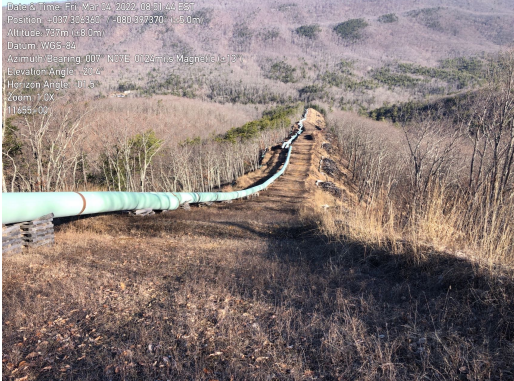
GPS Location	On photo	GPS Location	On photo		
Field Station#	11655+00	Field Station#	11648+00		
Pic 3 Desc.	Slope breakers are functioning as designed.	Pic 4 Desc.	Sump and end treatment acceptable. Maintenance will be completed before any ground disturbance occurs.

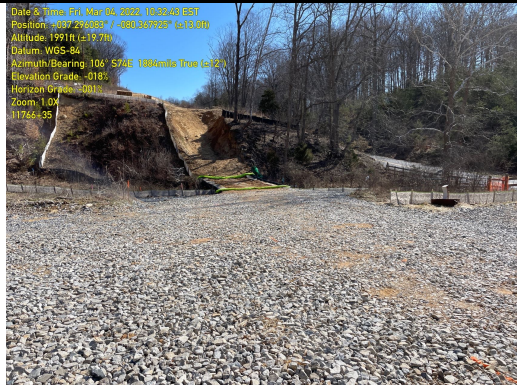
GPS Location	See photo	GPS Location	See photo		
Field Station#	11766+35	Field Station#	11782+50		
Pic 11 Desc.	RCE in place	Pic 12 Desc.	Cleanwater drainage feature in place

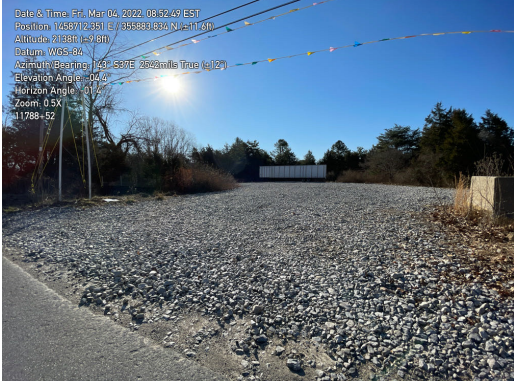
GPS Location 1		GPS Location 2			
Field Station# 11788+52		Field Station# 11792+00			
Pic 1 Desc. RCE off Mt Tabor rd.		Pic 2 Desc. Section of restored RoW showing conditions and controls.

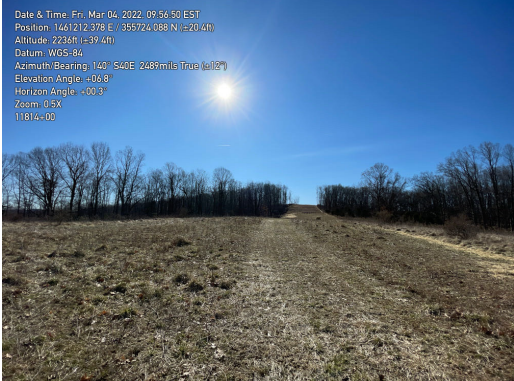
GPS Location 3		GPS Location 4			
Field Station# 11814+00		Field Station# 11826+00			
Pic 3 Desc. Section of restored RoW showing conditions and controls.		Pic 4 Desc. Section of restored RoW showing conditions and controls.

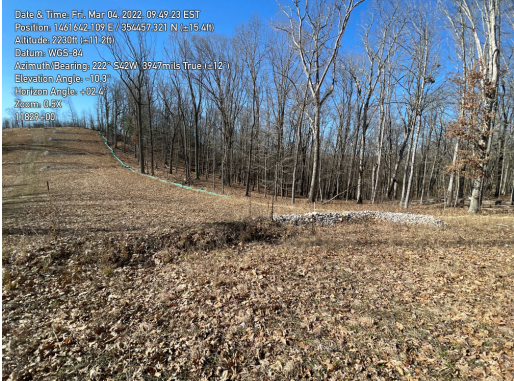
GPS Location 5		GPS Location 6			
Field Station# 11829+00		Field Station# 11840+00			
Pic 5 Desc. Representative photo of permanent waterbars and level spreaders installed.		Pic 6 Desc. Section of restored RoW showing conditions and controls.

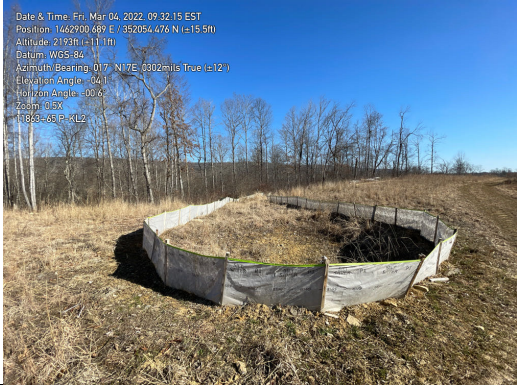
<p><small>Date & Time: Fri, Mar 04, 2022, 09:32:15 EST Position: 1662700.689 E / 352054.476 N (+15.5ft) Altitude: 2193ft (+11.2ft) Datum: WGS-84 Azimuth/Bearing: 017° N17E (3302mils True (+12°)) Elevation Angle: -04° Horizon Angle: -00.6° Zoom: 0.5X 11863+00 P-KL2</small></p>			
GPS Location	7	GPS Location	8		
Field Station#	11850+00	Field Station#	11863+65		
Pic 7 Desc.	Section of restored RoW showing conditions and controls.	Pic 8 Desc.	P-KL2.

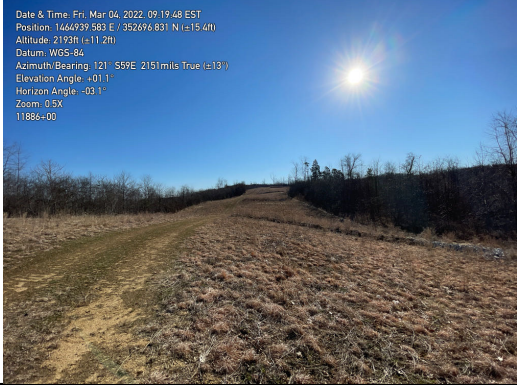
GPS Location	9	GPS Location	10		
Field Station#	11870+00	Field Station#	11886+00		
Pic 9 Desc.	Section of restored RoW showing conditions and controls.	Pic 10 Desc.	Section of restored RoW showing conditions and controls.		
Insert image here		Insert image here			
GPS Location		GPS Location			
Field Station#		Field Station#			
Pic 11 Desc.		Pic 12 Desc.

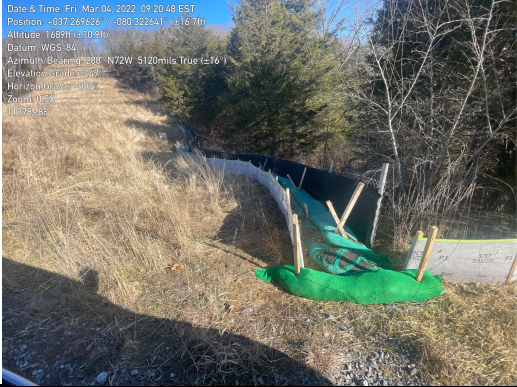
GPS Location	See Photo		GPS Location	See Photo	
Field Station#	11978+86		Field Station#	11900+81	
Pic 13 Desc.	ECD's at perimeter LOD protecting possible Karst areas outside of LOD.		Pic 14 Desc.	Level spreader condition	
<small> Date & Time: Fri, Mar 04, 2022, 10:22:24 EST Position: +037 287785 / -080 334234 (±15.4ft) Altitude: 2232ft (±11.1ft) Datum: WGS-84 Azimuth/Bearing: 109° S71E 1938mils True (±15°) Elevation Grade: +002% Horizon Grade: +002% Zoom: 0.5X 11900+81 </small>

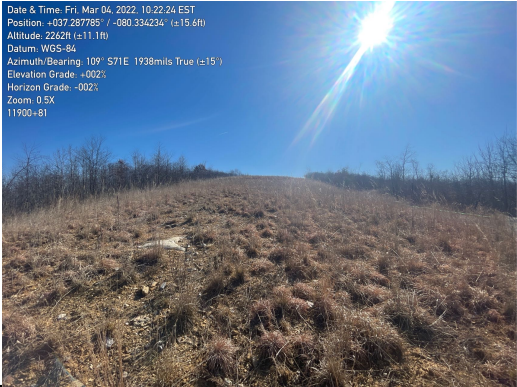
GPS Location	See Photo		GPS Location	See Photo	
Field Station#	11900+81		Field Station#	11917+00	
Pic 15 Desc.	Final Restoration Area		Pic 16 Desc.	Final Restoration Area	
<small> Date & Time: Fri, Mar 04, 2022, 10:41:37 EST Position: +037 284792 / -080 332014 (±33.8ft) Altitude: 2323ft (±39.4ft) Datum: WGS-84 Azimuth/Bearing: 127° S53E 0258mils True (±12°) Elevation Grade: +05% Horizon Grade: +001° Zoom: 0.5X 11922+00 </small>

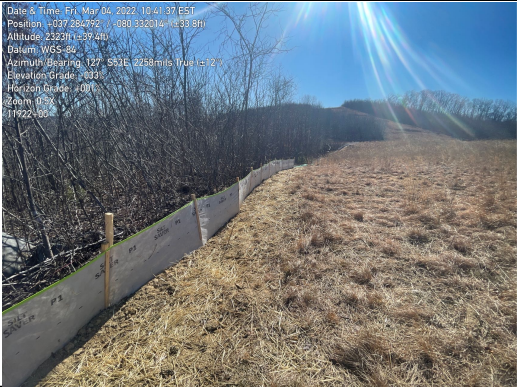
Insert image here	
GPS Location	See Photo		GPS Location		
Field Station#	11922+00		Field Station#		
Pic 17 Desc.	P1 silt fencing conditions at perimeter		Pic 18 Desc.
