# Visual Site Inspection Report

<b>Project Name</b>	H-600 Pipeline Spread H	<b>AFE</b>	124300138	<b>Spread</b>	H-600 Pipeline Spread H
<b>Contractor</b>	Precision			<b>Report #</b>	33107
<b>Inspector</b>	Jonathan Altizer			<b>Date/Time</b>	1/10/2022 4:37 PM
<b>Permit #</b>	TBD	<b>Inspection Type</b>	VA SWPP	<b>Station Begin</b>	12284+75
<b>State</b>	VA	<b>Inspection Area</b>	Partial	<b>Station End</b>	12443+75
<b>County</b>	Montgomery	<b>Ground</b>	Wet	<b>Temperature (°F)</b>	35.00
<b>Municipality</b>	N/A	<b>Weather</b>	Sunny	<b>Rain Gauge (in)</b>	0.20
				<b>Rain Accumulation Time (days)</b>	3.00

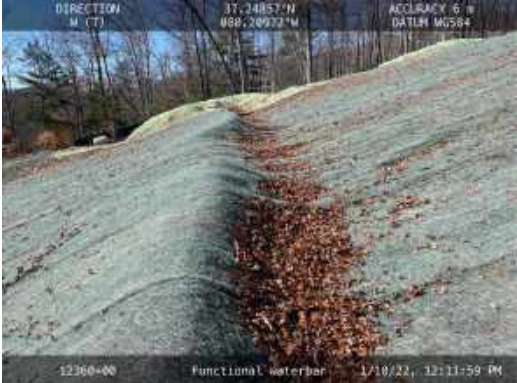
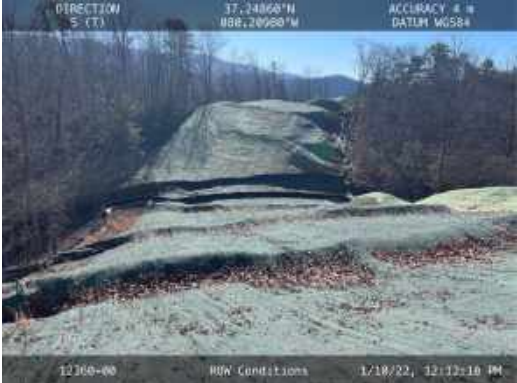
<b>GPS Location</b>	See photo		<b>GPS Location</b>	See photo	
<b>Field Station#</b>	12360+00		<b>Field Station#</b>	12360+00	
<b>Pic 7 Desc.</b>	Waterbar is functional		<b>Pic 8 Desc.</b>	Current ROW conditions. ROW is stable. ECDs are functional.

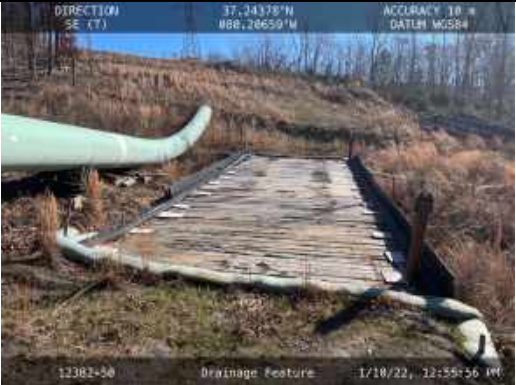
<b>GPS Location</b>	See photo		<b>GPS Location</b>	See photo	
<b>Field Station#</b>	12382+50		<b>Field Station#</b>	12382+50	
<b>Pic 13 Desc.</b>	Drainage Feature is functional		<b>Pic 14 Desc.</b>	Equipment Bridge over drainage feature is functional

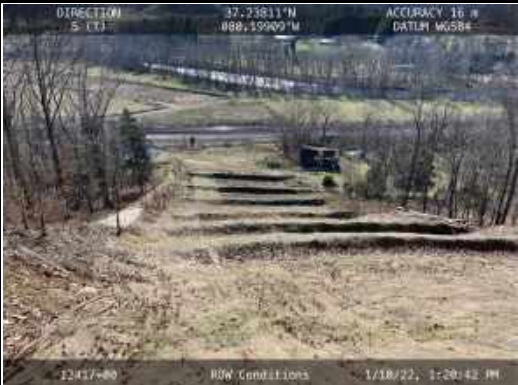
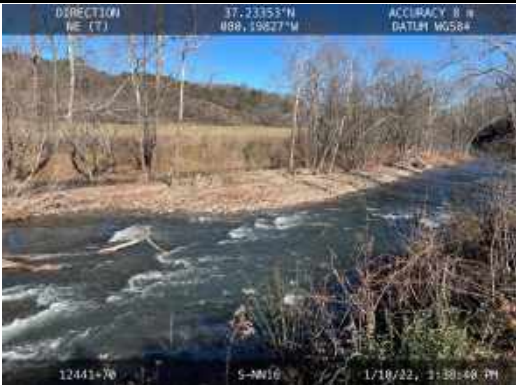
<b>GPS Location</b>	See photo		<b>GPS Location</b>	See photo	
<b>Field Station#</b>	12417+00		<b>Field Station#</b>	12441+70	
<b>Pic 17 Desc.</b>	Current ROW conditions. ROW is stable. ECDs are functional.		<b>Pic 18 Desc.</b>	Overview of Stream S-NN16

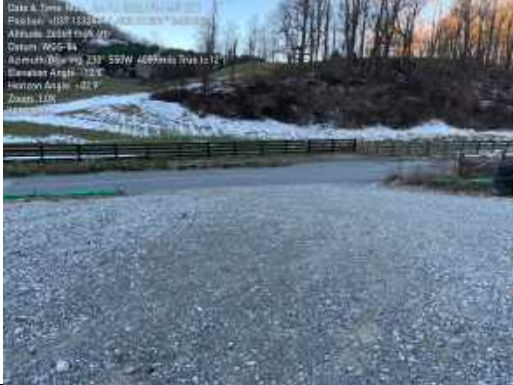
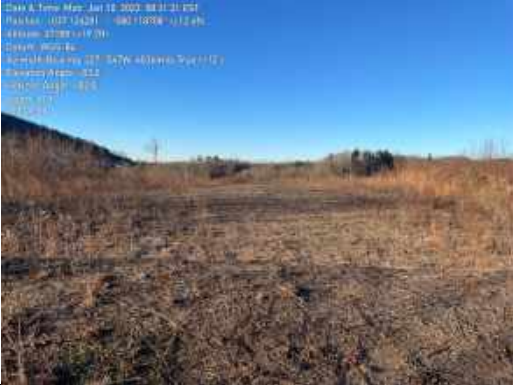
GPS Location	0	GPS Location	0		
Field Station#	13033+59	Field Station#	13033+00		
Pic 1 Desc.	RCE in good condition	Pic 2 Desc.	ROW and ECDs In good condition and stable

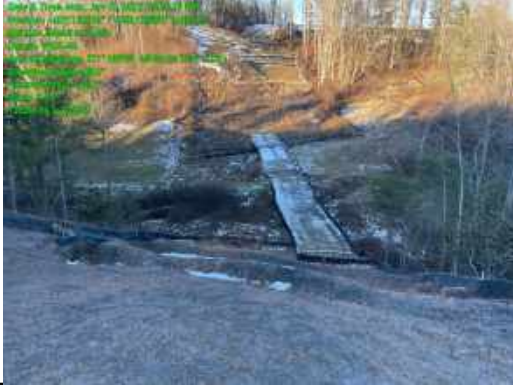
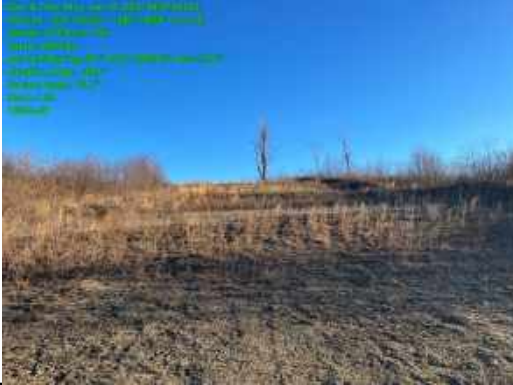
GPS Location	0	GPS Location	0		
Field Station#	13024+06	Field Station#	13034+00		
Pic 3 Desc.	MVP-S-G24/25 and Corresponding buffer zone in good condition	Pic 4 Desc.	ROW and ECDs In good condition and stable

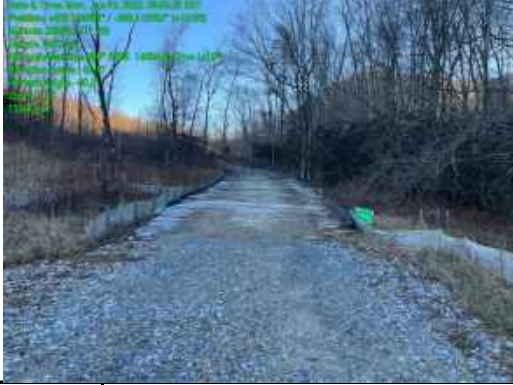
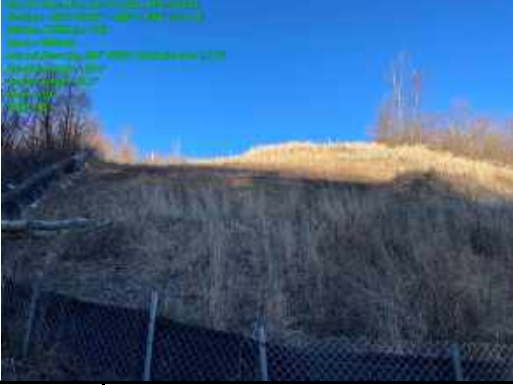
GPS Location	0	GPS Location	0		
Field Station#	13061+44	Field Station#	13061+00		
Pic 5 Desc.	Equipment bridge in good condition	Pic 6 Desc.	ROW and ECDs In good condition and stable

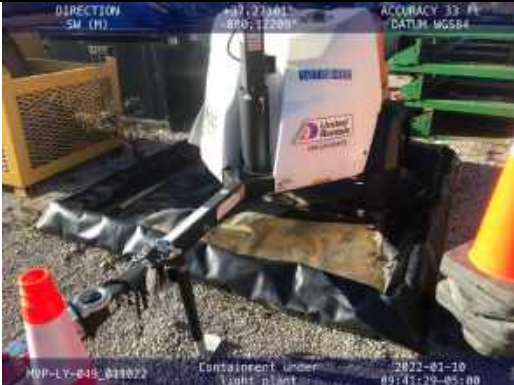
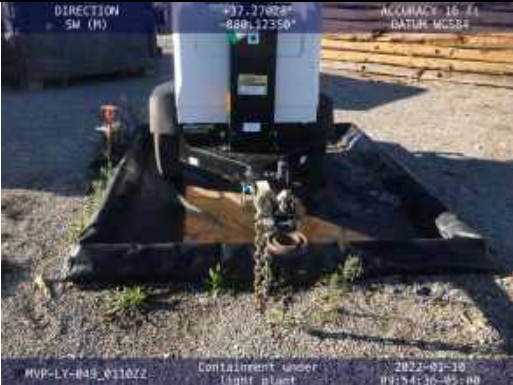
<b>GPS Location</b>	MVP-LY-049 See photo for gps data	<b>GPS Location</b>	MVP-LY-049 See photo for gps data		
<b>Field Station#</b>	+0	<b>Field Station#</b>	+0		
<b>Pic 3 Desc.</b>	Condition of secondary containment under light plant. Holding fluids. Looking SW.	<b>Pic 4 Desc.</b>	Condition of secondary containment under light plant. Holding fluids. Looking SW.

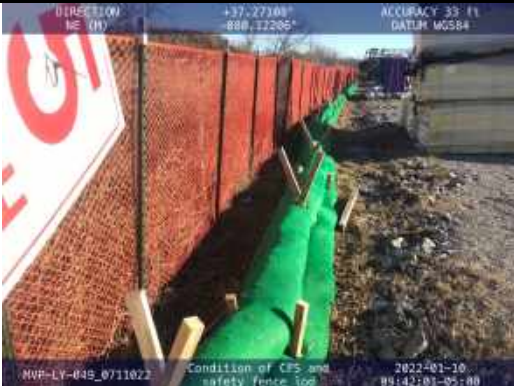
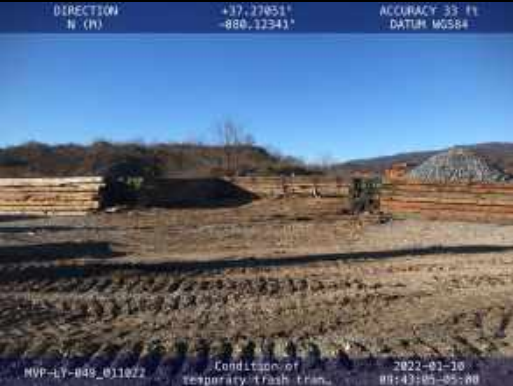
<b>Pic 5 Desc.</b>	Condition of triple stack compost filter sock and safety fence along north LOD. Looking NE.	<b>Pic 6 Desc.</b>	Condition of temporary trash transfer pit. Debris has been placed in dumpsters. Looking N.

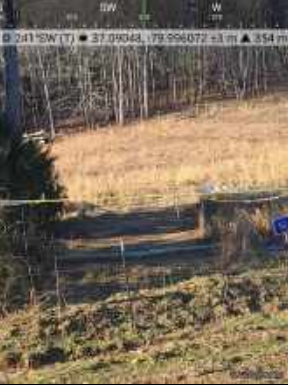
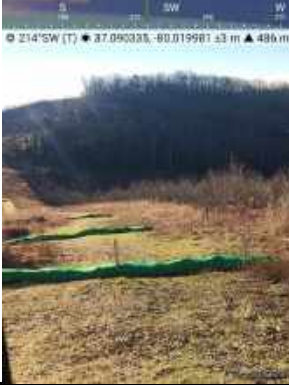
<b>GPS Location</b>	0000	<b>GPS Location</b>	0000		
<b>Field Station#</b>	13525+10	<b>Field Station#</b>	13443+00		
<b>Pic 1 Desc.</b>	Monitored equipment bridge and protection, no environmental issues observed at the time of inspection I		<b>Pic 2 Desc.</b>	Stabilized travel lane with ECDs in place and functioning at the time of inspection I

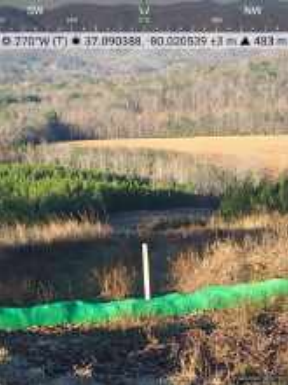
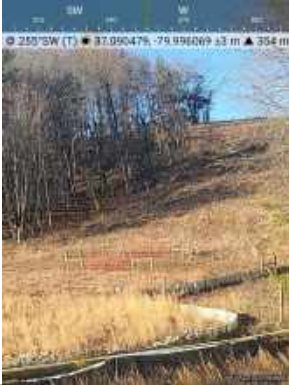
<b>GPS Location</b>	0000	<b>GPS Location</b>	00000		
<b>Field Station#</b>	13436+66	<b>Field Station#</b>	13525+00		
<b>Pic 3 Desc.</b>	Ecds in place and functioning at the time of inspection.		<b>Pic 4 Desc.</b>	Monitored ECDs at stream crossing , good vegetation growth . No environmental issues observed at the time of inspection.

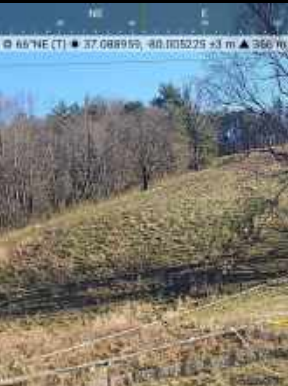
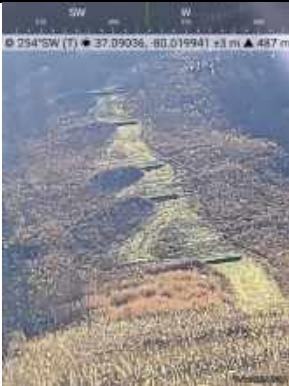
<b>Pic 5 Desc.</b>	Vegetation observation photo up row from stream crossing, good stabilization noted, no environmental issues observed at the time of inspection		<b>Pic 6 Desc.</b>	Row photo showing stabilization on travel lane, ECDs in place, no environmental issues observed at the time of inspection.

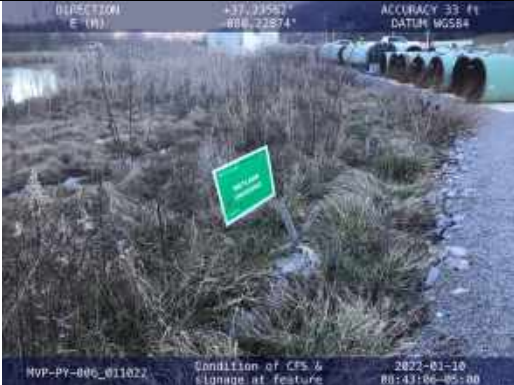
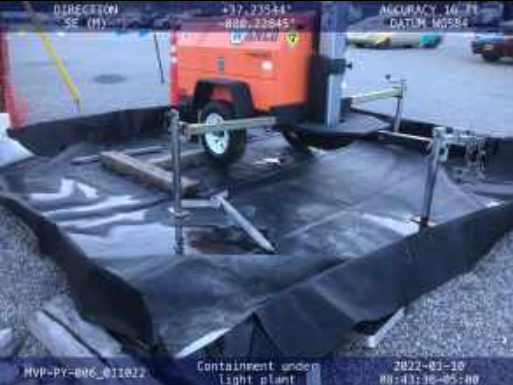
<b>GPS Location</b>	MVP-PY-006 See photo for gps data	<b>GPS Location</b>	MVP-PY-006 See photo for gps data		
<b>Field Station#</b>	+0	<b>Field Station#</b>	+0		
<b>Pic 1 Desc.</b>	Condition of triple stack compost filter sock and signage at feature W-008. Over grown with vegetation. Looking E.		<b>Pic 2 Desc.</b>	Condition of containment under light plant. Holding some fluids. Looking SE.

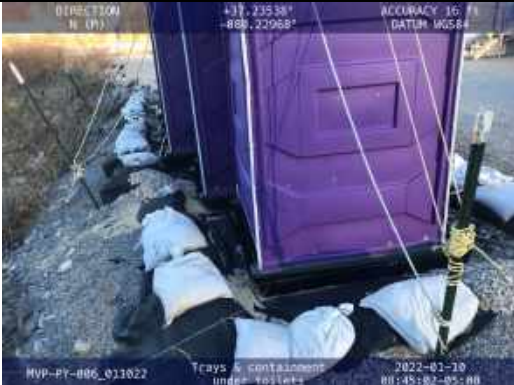
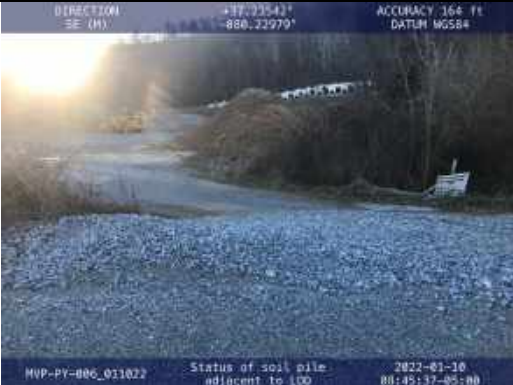
<b>GPS Location</b>	MVP-PY-006 See photo for gps data	<b>GPS Location</b>	MVP-PY-006 See photo for gps data		
<b>Field Station#</b>	+0	<b>Field Station#</b>	+0		
<b>Pic 3 Desc.</b>	Trays and containment under toilets. Trays holding fluids and ice. Looking N.		<b>Pic 4 Desc.</b>	Status of spoil pile adjacent to LOD on VDOT property. Soil pile not stabilized. Looking SE.

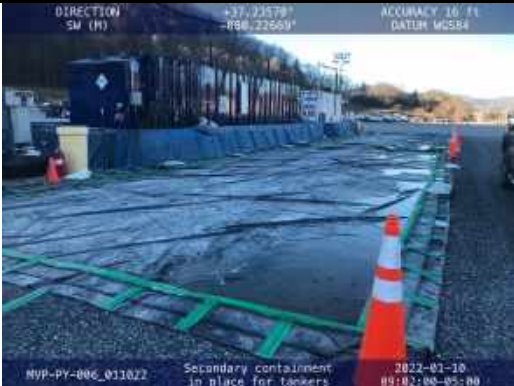
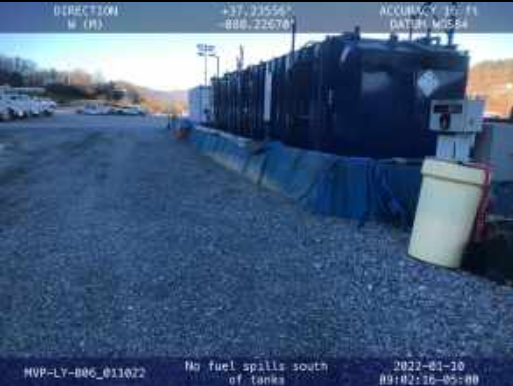
<b>Field Station#</b>	+0	<b>Field Station#</b>	+0		
<b>Pic 5 Desc.</b>	Blue Bulk Fuel tanks secondary containment in place for tankers offloading fuel. Looking SW.		<b>Pic 6 Desc.</b>	Blue Bulk Fuel tanks no fuel spills south of the tanks. Looking W.

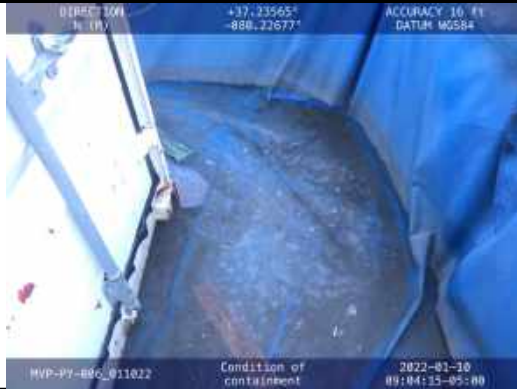
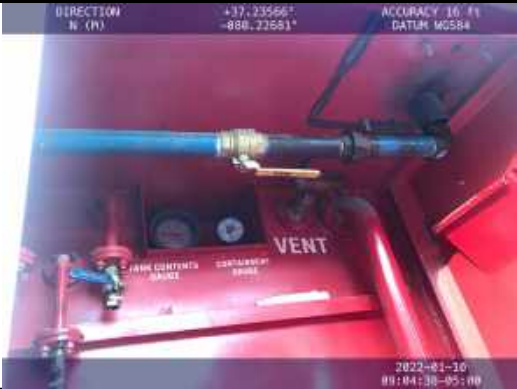
<b>Pic 11 Desc.</b>	Off Road Fuel unit containment holding stormwater and ice. Looking N.		<b>Pic 12 Desc.</b>	Off Road Fuel unit no leaky internal fittings. Looking NW.

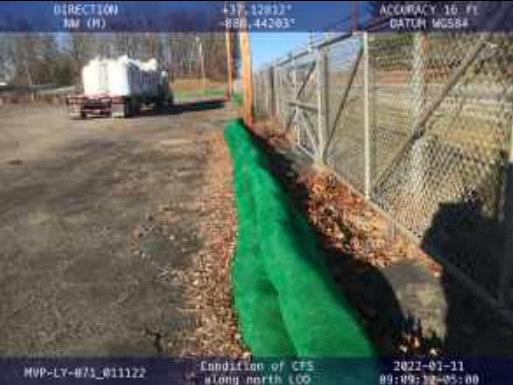
<b>GPS Location</b>	MVP-LY-071 See photo for gps data	<b>GPS Location</b>	MVP-LY-071 See photo for gps data		
<b>Field Station#</b>	+0	<b>Field Station#</b>	+0		
<b>Pic 1 Desc.</b>	Condition of main entrance. No sediment or debris on entrance. Looking NE.	<b>Pic 2 Desc.</b>	Condition of triple stack compost filter sock along north LOD. Looking NW.

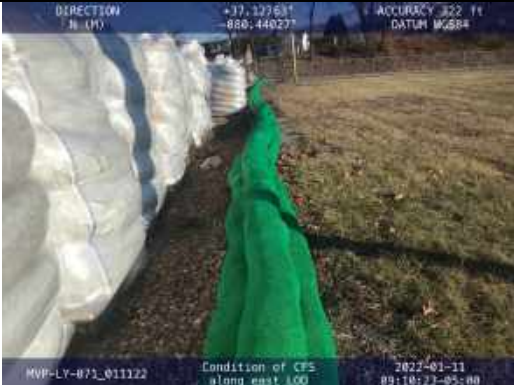
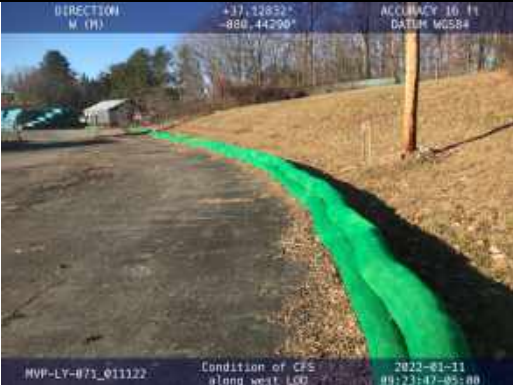
<b>GPS Location</b>	MVP-LY-071 See photo for gps data	<b>GPS Location</b>	MVP-LY-071 See photo for gps data		
<b>Field Station#</b>	+0	<b>Field Station#</b>	+0		
<b>Pic 3 Desc.</b>	Condition of triple stack compost filter sock along east LOD. Looking North.	<b>Pic 4 Desc.</b>	Condition of triple stack compost filter sock along west LOD. Looking SW.

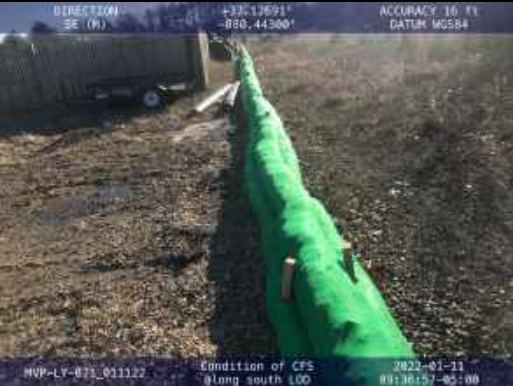
<b>Field Station#</b>	+0	<b>Field Station#</b>	+0		
<b>Pic 5 Desc.</b>	Condition of triple stack compost filter sock along south LOD. Looking W.	<b>Pic 6 Desc.</b>	Condition of triple stack compost filter sock along south LOD. Looking SE.

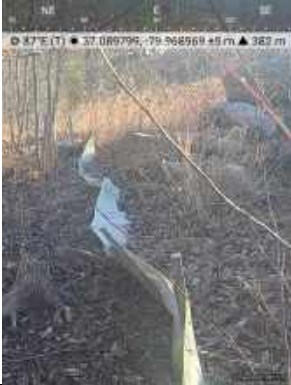
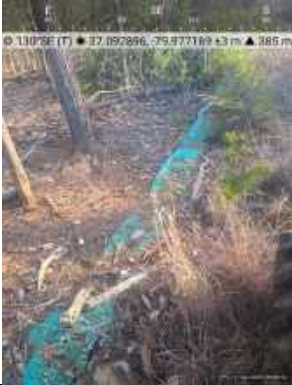
<b>GPS Location</b>	0000	<b>GPS Location</b>	00000		
<b>Field Station#</b>	13620+00	<b>Field Station#</b>	13584+80		
<b>Pic 7 Desc.</b>	P1 requires maintenance due to broken stakes, documented and added to the punch list.		<b>Pic 8 Desc.</b>	CFS requires maintenance due to being weathered and torn, replace as needed

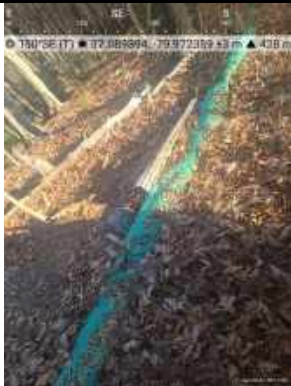
<b>GPS Location</b>	0000	<b>GPS Location</b>			
<b>Field Station#</b>	13583+00	<b>Field Station#</b>			
<b>Pic 9 Desc.</b>	CFS requires maintenance due to being weathered and torn, replace as needed		<b>Pic 10 Desc.</b>

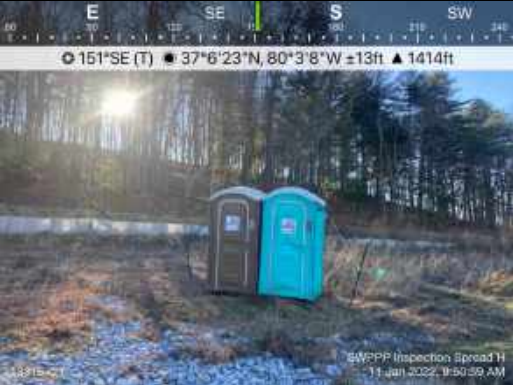
<b>GPS Location</b>	See photo above		<b>GPS Location</b>	See photo above	
<b>Field Station#</b>	13316+21		<b>Field Station#</b>	13316+21	
<b>Pic 1 Desc.</b>	Rock construction entrance off of Wades Gap Rd is in good condition.		<b>Pic 2 Desc.</b>	Portable toilets along the ROW are in acceptable condition. No leaks were observed.

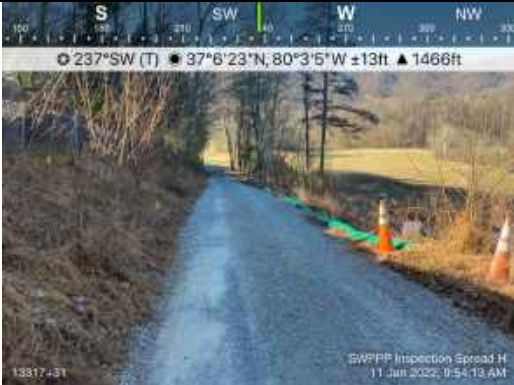
<b>GPS Location</b>	See photo above		<b>GPS Location</b>	See photo above	
<b>Field Station#</b>	13317+31		<b>Field Station#</b>	13342+67	
<b>Pic 3 Desc.</b>	Access road is in good condition and CFS are functioning properly. No maintenance is needed.		<b>Pic 4 Desc.</b>	Construction entrance is well gravelled and needs no maintenance.

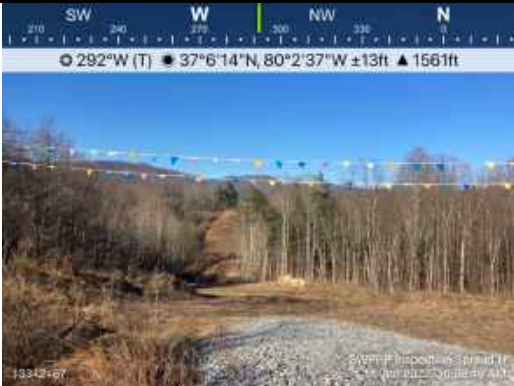
<b>Pic 5 Desc.</b>	ROW is clear and temporary vegetation is functioning properly.		<b>Pic 6 Desc.</b>	Waterbar end treatments are in good condition. No maintenance is needed.

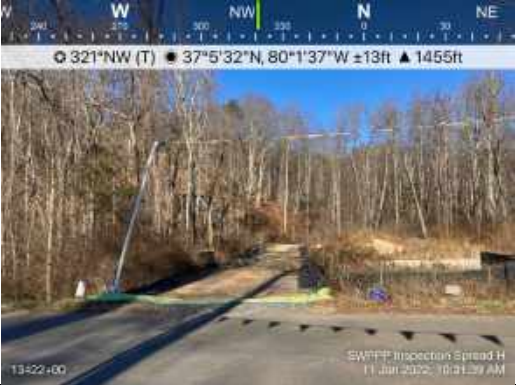
<b>GPS Location</b>	See photo above		<b>GPS Location</b>	See photo above	
<b>Field Station#</b>	13422+00		<b>Field Station#</b>	13422+00	
<b>Pic 13 Desc.</b>	SF and SSF along the ROW perimeters are in acceptable condition.		<b>Pic 14 Desc.</b>	Construction entrance off of Cahas Mountain Rd is cleared of debris and in good condition.

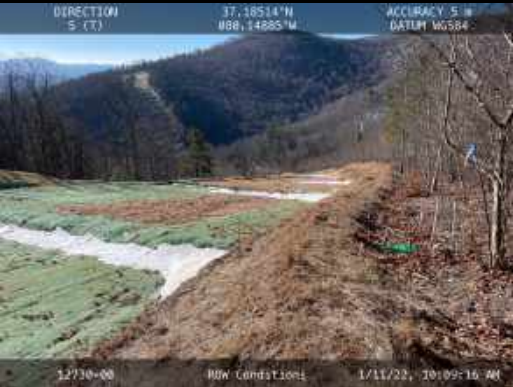
<b>GPS Location</b>	See photo		<b>GPS Location</b>	See photo	
<b>Field Station#</b>	12725+00		<b>Field Station#</b>	12730+00	
<b>Pic 1 Desc.</b>	Current ROW conditions. ROW is stable. ECDs are functional.		<b>Pic 2 Desc.</b>	Current ROW conditions. ROW is stable. ECDs are functional.

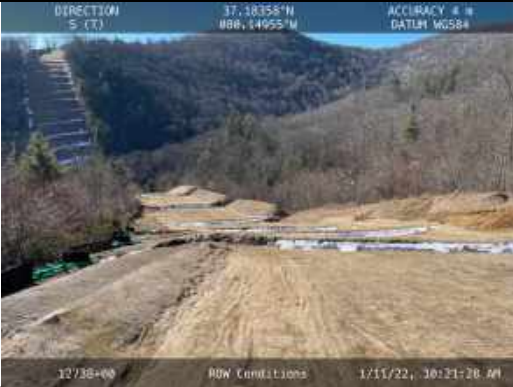
<b>GPS Location</b>	See photo		<b>GPS Location</b>	See photo	
<b>Field Station#</b>	12734+50		<b>Field Station#</b>	12738+00	
<b>Pic 3 Desc.</b>	Slope drain and sump are functional.		<b>Pic 4 Desc.</b>	Current ROW conditions. ROW is stable. ECDs are functional.

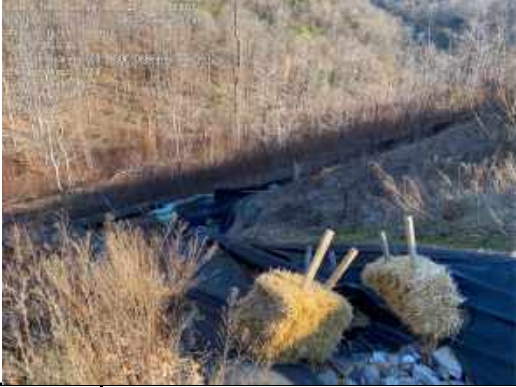
<b>GPS Location</b>	See photo for coordinates.		<b>GPS Location</b>	See photo for coordinates.	
<b>Field Station#</b>	12531+00		<b>Field Station#</b>	12529+00	
<b>Pic 7 Desc.</b>	ROW stabilized.		<b>Pic 8 Desc.</b>	ROW stabilized.

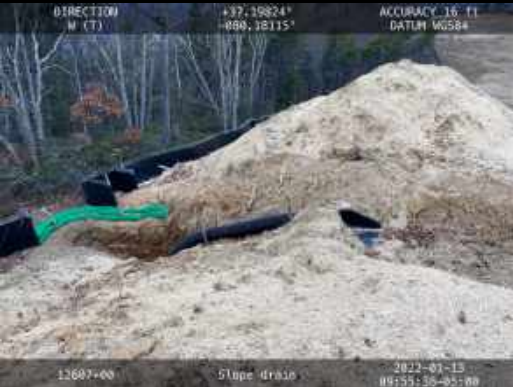
<b>GPS Location</b>	See photo for gps location data.		<b>GPS Location</b>	See photo for gps location data.	
<b>Field Station#</b>	12606+00		<b>Field Station#</b>	12607+00	
<b>Pic 1 Desc.</b>	Photo shows the ROW conditions. ECDs are installed and functioning as designed.		<b>Pic 2 Desc.</b>	Photo shows the slope drain.

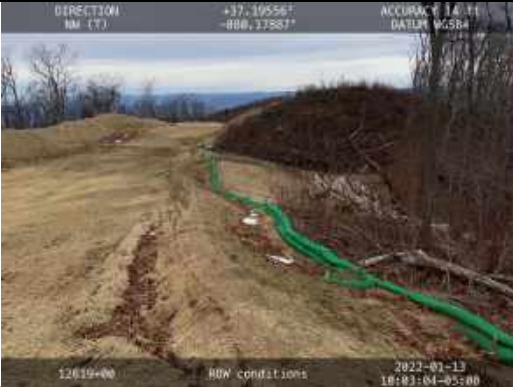
<b>GPS Location</b>	See photo for gps location data.		<b>GPS Location</b>	See photo for gps location data.	
<b>Field Station#</b>	12608+00		<b>Field Station#</b>	12619+00	
<b>Pic 3 Desc.</b>	Photo shows the ROW conditions. ECDs are installed and functioning as designed.		<b>Pic 4 Desc.</b>	Photo shows the ROW conditions. ECDs are installed and functioning as designed.

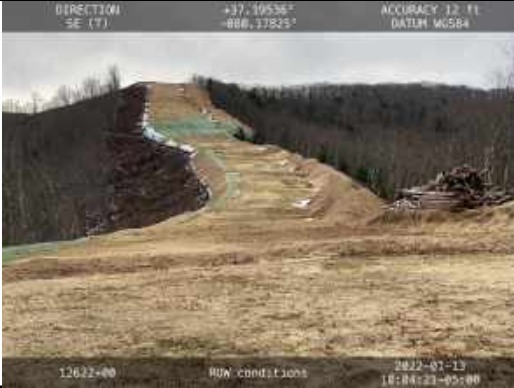
<b>Field Station#</b>	12622+00		<b>Field Station#</b>	12630+00	
<b>Pic 5 Desc.</b>	Photo shows the ROW conditions. ECDs are installed and functioning as designed.		<b>Pic 6 Desc.</b>	Photo shows the ROW conditions. ECDs are installed and functioning as designed.

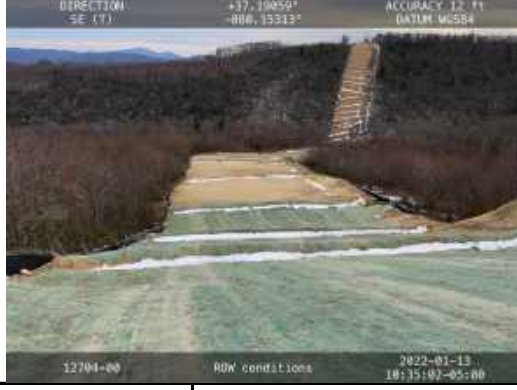
<b>Field Station#</b>	12704+00		<b>Field Station#</b>	12712+00	
<b>Pic 11 Desc.</b>	Photo shows the ROW conditions. ECDs are installed and functioning as designed.		<b>Pic 12 Desc.</b>	Photo shows the ROW conditions. ECDs are installed and functioning as designed.

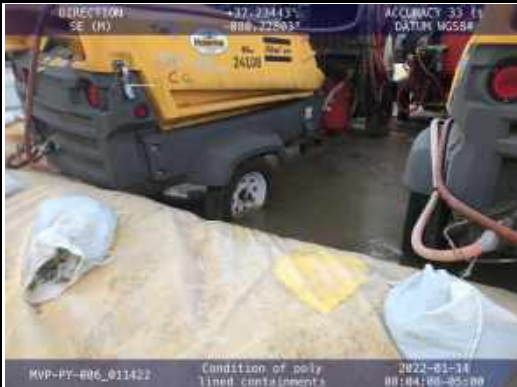
<b>Field Station#</b>	+0	<b>Field Station#</b>	+0		
<b>Pic 17 Desc.</b>	Secondary containment under used oil containers. Free of fluids. Looking E.	<b>Pic 18 Desc.</b>	Condition of poly lined containments. Holding stormwater and ice. Looking SE.

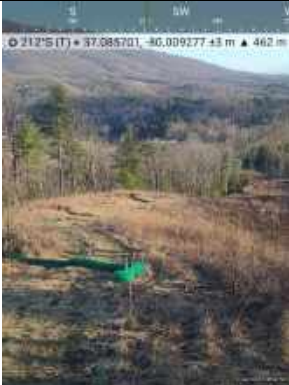
<b>GPS Location</b>	0000	<b>GPS Location</b>	000		
<b>Field Station#</b>	13480+00	<b>Field Station#</b>	13459+30		
<b>Pic 1 Desc.</b>	Row photo showing ECDs and stabilization, no environmental issues observed at the time of inspection .		<b>Pic 2 Desc.</b>	P1 requires maintenance due to being weathered and torn, documented and added to the punch list.

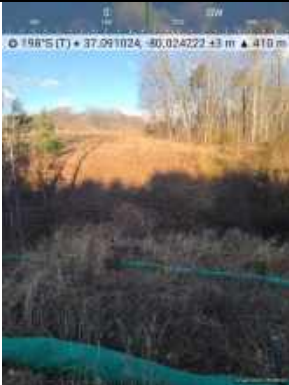
<b>GPS Location</b>	0000	<b>GPS Location</b>	0000		
<b>Field Station#</b>	13425+50	<b>Field Station#</b>	13459+30		
<b>Pic 3 Desc.</b>	Monitored ECDs at str a, crossing , good vegetation on both sides. No environmental issues observed at the time of inspection.		<b>Pic 4 Desc.</b>	P1 requires maintenance due to being weathered and torn, documented and added to the punch list.

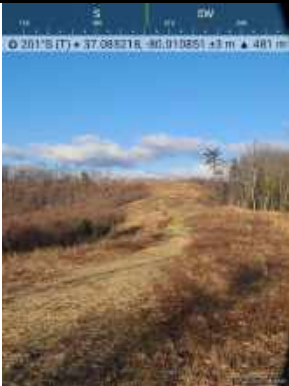
<b>Field Station#</b>	13471+00	<b>Field Station#</b>	13425+15		
<b>Pic 5 Desc.</b>	Row photo showing stabilization and ECDs in place, no environmental issues observed at the time of inspection.		<b>Pic 6 Desc.</b>	Monitored ECDs near stream crossing, all up to date and functioning at the time of inspection I

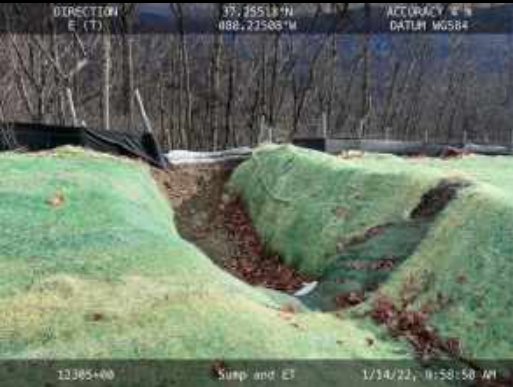
<b>GPS Location</b>	See photo		<b>GPS Location</b>	See photo	
<b>Field Station#</b>	12297+00		<b>Field Station#</b>	12305+00	
<b>Pic 1 Desc.</b>	Current ROW conditions. ROW is stable. ECDs are functional.		<b>Pic 2 Desc.</b>	Sump and End Treatment are functional

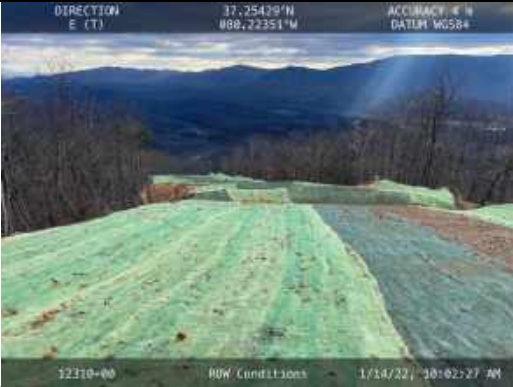
<b>GPS Location</b>	See photo		<b>GPS Location</b>	See photo	
<b>Field Station#</b>	12308+00		<b>Field Station#</b>	12310+00	
<b>Pic 3 Desc.</b>	Perimeter controls are functional		<b>Pic 4 Desc.</b>	Current ROW conditions. ROW is stable. ECDs are functional.

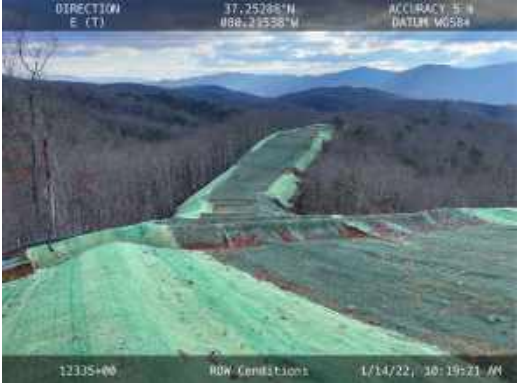
<b>GPS Location</b>	See photo		<b>GPS Location</b>	See photo	
<b>Field Station#</b>	12335+00		<b>Field Station#</b>	12345+00	
<b>Pic 7 Desc.</b>	Current ROW conditions. ROW is stable. ECDs are functional.		<b>Pic 8 Desc.</b>	Current ROW conditions. ROW is stable. ECDs are functional.

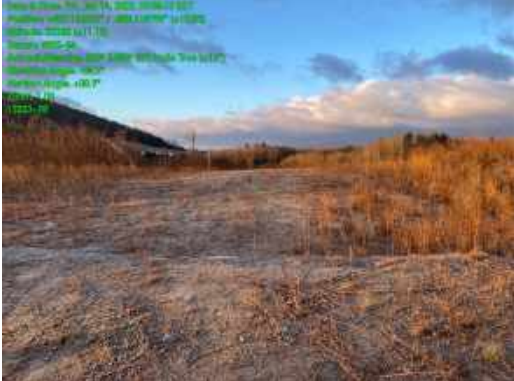
<b>GPS Location</b>	0	<b>GPS Location</b>	0		
<b>Field Station#</b>	13033+00	<b>Field Station#</b>	13024+06		
<b>Pic 1 Desc.</b>	ROW and ECDs In good condition and stable	<b>Pic 2 Desc.</b>	MVP-S-G24/25 and Corresponding buffer zone In good condition

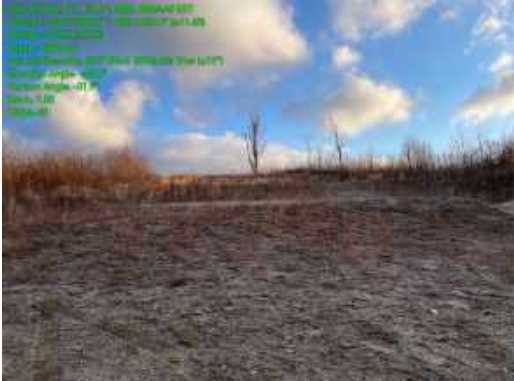
<b>GPS Location</b>	0	<b>GPS Location</b>	0		
<b>Field Station#</b>	13034+00	<b>Field Station#</b>	13033+59		
<b>Pic 3 Desc.</b>	ROW and ECDs In good condition and stable	<b>Pic 4 Desc.</b>	RCE in good condition and functioning properly
