# Visual Site Inspection Report

<b>Project Name</b>	H-600 Pipeline Spread H	<b>AFE</b>	124300138	<b>Spread</b>	H-600 Pipeline Spread H
<b>Contractor</b>	Precision			<b>Report #</b>	32187
<b>Inspector</b>	Pat Davis			<b>Date/Time</b>	12/13/2021 4:00 PM
<b>Permit #</b>	TBD	<b>Inspection Type</b>	VA SWPP	<b>Station Begin</b>	+0
<b>State</b>	VA	<b>Inspection Area</b>	Partial	<b>Station End</b>	+0
<b>County</b>	Montgomery	<b>Ground</b>	Dry	<b>Temperature (°F)</b>	27.00
<b>Municipality</b>	N/A	<b>Weather</b>	Sunny	<b>Rain Gauge (in)</b>	0.20
				<b>Rain Accumulation Time (days)</b>	0.00

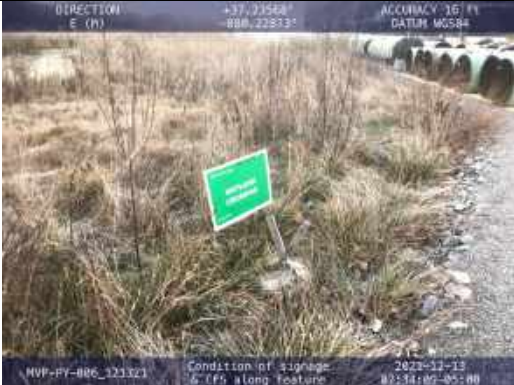
<b>GPS Location</b>	MVP-PY-006 See photo for gps data	<b>GPS Location</b>	MVP-PY-006 See photo for gps data		
<b>Field Station#</b>	+0	<b>Field Station#</b>	+0		
<b>Pic 1 Desc.</b>	Condition of triple stack compost filter sock and signage at feature W-008. Over grown with vegetation. Looking E.	<b>Pic 2 Desc.</b>	Secondary containment under light plant. Holding some stormwater. Looking SE.

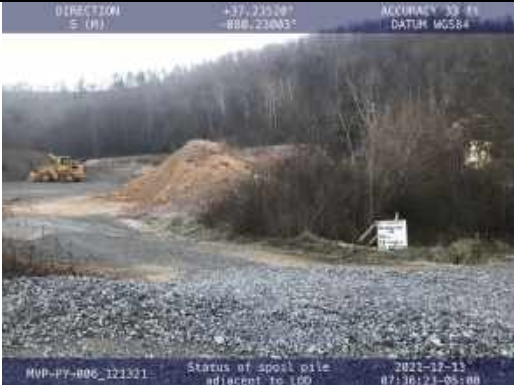
<b>GPS Location</b>	MVP-PY-006 See photo for gps data	<b>GPS Location</b>	MVP-PY-006 See photo for gps data		
<b>Field Station#</b>	+0	<b>Field Station#</b>	+0		
<b>Pic 3 Desc.</b>	Status of spoil pile adjacent to LOD. Soil pile not stabilized. Looking S.	<b>Pic 4 Desc.</b>	Secondary containment under stored equipment. Holding some fluids. Looking S.

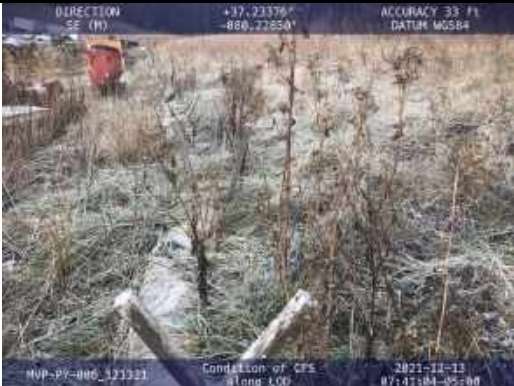
<b>Field Station#</b>	+0	<b>Field Station#</b>	+0		
<b>Pic 5 Desc.</b>	Condition of triple stack compost filter sock along south LOD. Weathered and over grown with vegetation. Looking SE.	<b>Pic 6 Desc.</b>	Condition of triple stack compost filter sock along east LOD. Weathered and over grown with vegetation. Looking S.

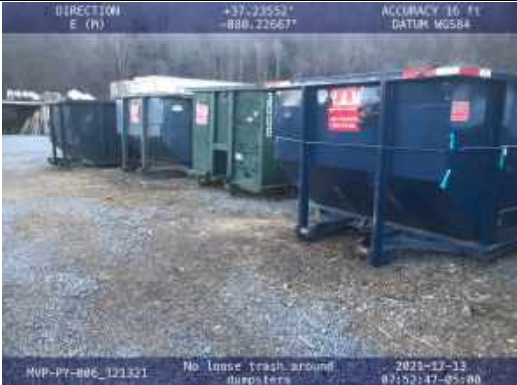
<b>Field Station#</b>	+0	<b>Field Station#</b>	+0		
<b>Pic 17 Desc.</b>	No loose trash around dumpsters or in the yard. Looking E.	<b>Pic 18 Desc.</b>	Condition of posted project documents at the main entrance. Looking W.

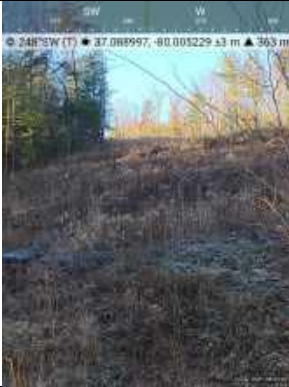
<b>GPS Location</b>	0000	<b>GPS Location</b>	0000		
<b>Field Station#</b>	13496+76	<b>Field Station#</b>	13437+75		
<b>Pic 1 Desc.</b>	Row photo at CAHAS#2 crossing, vegetation observation in permanent area, no environmental issues observed at the time of inspection.		<b>Pic 2 Desc.</b>	Photo showing vegetation growth in work space area recently seeded. No environmental issues observed at the time of inspection.

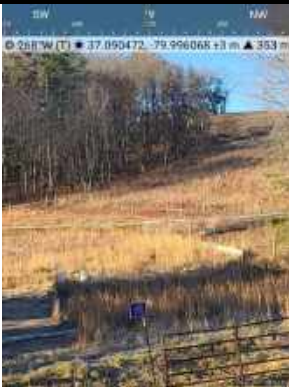
<b>GPS Location</b>	0000	<b>GPS Location</b>	0000		
<b>Field Station#</b>	13525+10	<b>Field Station#</b>	13525+18		
<b>Pic 3 Desc.</b>	Monitored ECDs near stream crossing , no environmental issues observed at the time of inspection.		<b>Pic 4 Desc.</b>	Row photo showing equipment bridge in place as well as ECDs functioning at the time of inspection.

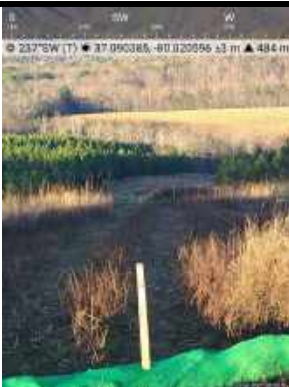
<b>Field Station#</b>	13436+33	<b>Field Station#</b>	13497+20		
<b>Pic 5 Desc.</b>	Monitored ECDs and vegetation in permanent area of row. No environmental issues observed at the time of inspection.		<b>Pic 6 Desc.</b>	Monitored stream crossing and ECDs , no environmental issues observed at the time of inspection.

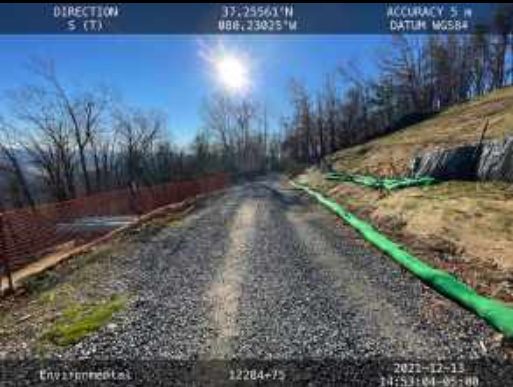
<b>GPS Location</b>	See photo		<b>GPS Location</b>	See photo	
<b>Field Station#</b>	12286+00		<b>Field Station#</b>	12284+75	
<b>Pic 1 Desc.</b>	Stabilized ROW conditions		<b>Pic 2 Desc.</b>	Access Road MVP-MN-276.03 road crossing in acceptable condition

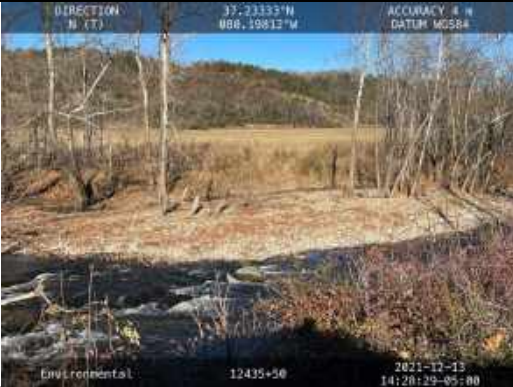
<b>GPS Location</b>	See photo		<b>GPS Location</b>	See photo	
<b>Field Station#</b>	12299+27		<b>Field Station#</b>	12435+50	
<b>Pic 3 Desc.</b>	Stabilized access Road in acceptable condition		<b>Pic 4 Desc.</b>	Stream crossing S-NN16 in acceptable condition

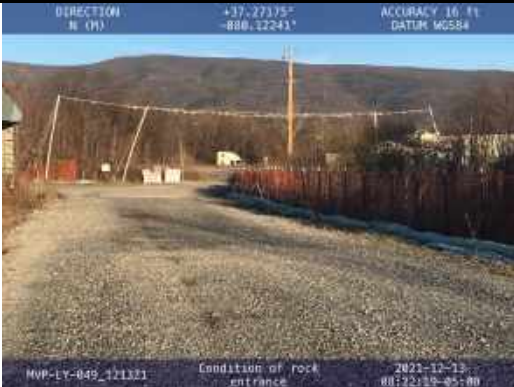
<b>GPS Location</b>	MVP-LY-049 See photo for gps data	<b>GPS Location</b>	MVP-LY-049 See photo for gps data		
<b>Field Station#</b>	+0	<b>Field Station#</b>	+0		
<b>Pic 1 Desc.</b>	Condition of rock entrance. No sediment or debris on stone. Looking N.	<b>Pic 2 Desc.</b>	Secondary containment under light plant. Holding some fluids. Looking SW.

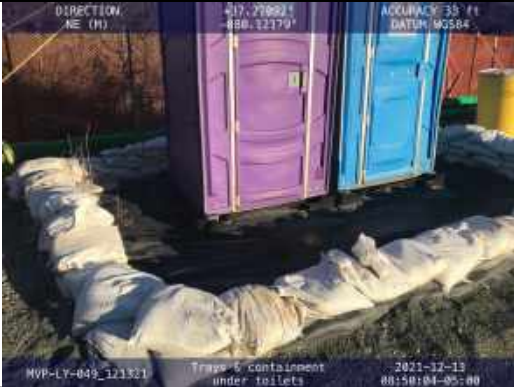
<b>GPS Location</b>	MVP-LY-049 See photo for gps data	<b>GPS Location</b>	MVP-LY-049 See photo for gps data		
<b>Field Station#</b>	+0	<b>Field Station#</b>	+0		
<b>Pic 3 Desc.</b>	Tray and containment under toilets. Trays holding some fluids. Looking NE.	<b>Pic 4 Desc.</b>	Condition of triple stack compost filter sock and safety fence along north LOD. Looking E.

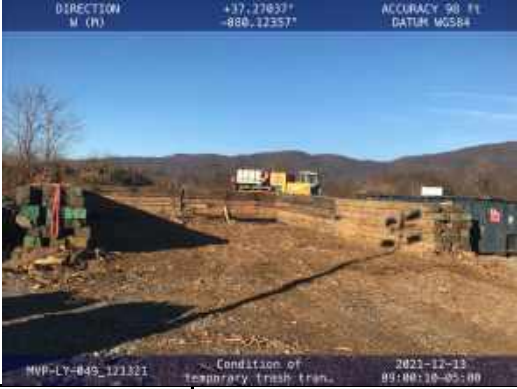
<b>GPS Location</b>	MVP-LY-049 See photo for gps data	<b>GPS Location</b>	MVP-LY-049 See photo for gps data		
<b>Field Station#</b>	+0	<b>Field Station#</b>	+0		
<b>Pic 13 Desc.</b>	Condition of temporary trash transfer pit. Debris has been placed in dumpsters. Looking W.	<b>Pic 14 Desc.</b>	No loose trash around north dumpster or in the yard. Looking SW.

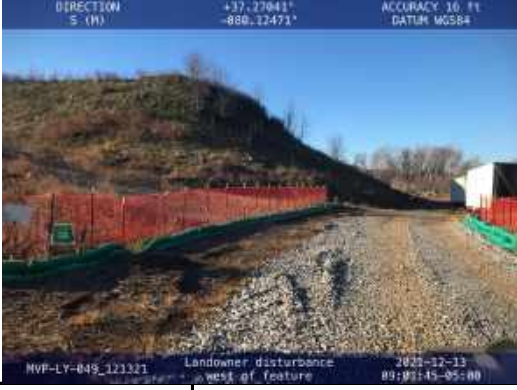
<b>Field Station#</b>	+0	<b>Field Station#</b>	+0		
<b>Pic 17 Desc.</b>	Landowner soil disturbance west of feature W-CV21B. Areas not stabilized. Looking SW.	<b>Pic 18 Desc.</b>	Landowner soil disturbance and debris piled along triple stack compost filter sock and east of feature W-CV21B. Looking SW.

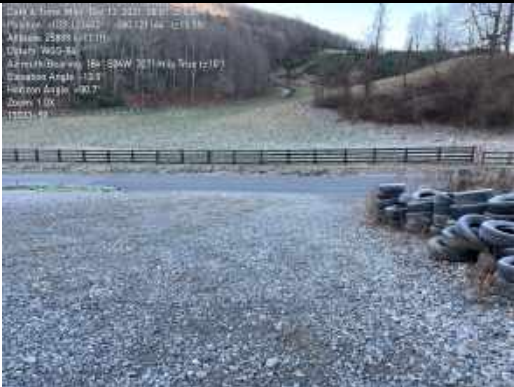
<b>GPS Location</b>		0		<b>GPS Location</b>	
<b>Field Station#</b>		13033+59		<b>Field Station#</b>	
<b>Pic 1 Desc.</b>		RCE in good condition and functioning properly		<b>Pic 2 Desc.</b>

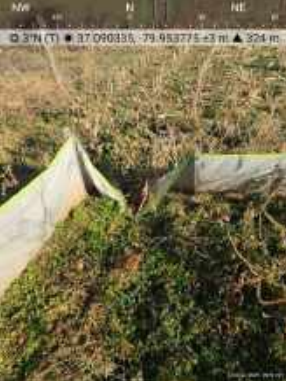
<b>GPS Location</b>	00000	<b>GPS Location</b>	0000		
<b>Field Station#</b>	13666+48	<b>Field Station#</b>	13666+00		
<b>Pic 1 Desc.</b>	P1 requires maintenance due to being weathered and torn, documented and added to the punch list.		<b>Pic 2 Desc.</b>	P1 requires maintenance, documented and added to the punch list.

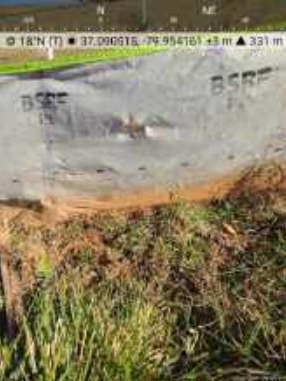
<b>GPS Location</b>	0000	<b>GPS Location</b>	0000		
<b>Field Station#</b>	13666+00	<b>Field Station#</b>	13665+50		
<b>Pic 3 Desc.</b>	P1 requires maintenance documented and added to the punch list for repair.		<b>Pic 4 Desc.</b>	P1 requires maintenance due to being weathered and torn, documented and added to the punch list.

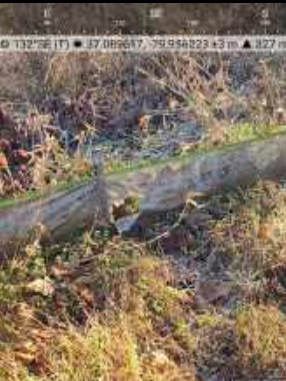
<b>GPS Location</b>	0000	<b>GPS Location</b>	000		
<b>Field Station#</b>	13658+47	<b>Field Station#</b>	13609+70		
<b>Pic 5 Desc.</b>	P1 requires maintenance due to wildlife damages, documented and added to the punch list.		<b>Pic 6 Desc.</b>	Observed completed punch list item, installed CFS after recent 3rd party damages.

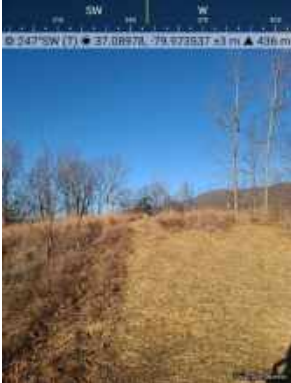
<div>ert image here</div>		<div>Insert image here</div>	
<b>GPS Location</b>	0000	<b>GPS Location</b>			
<b>Field Station#</b>	13612+40	<b>Field Station#</b>			
<b>Pic 7 Desc.</b>	Observed completed punch list item, repaired slope breaker and stabilization.		<b>Pic 8 Desc.</b>		
<div>Insert image here</div>		<div>Insert image here</div>			
<b>GPS Location</b>		<b>GPS Location</b>			
<b>Field Station#</b>		<b>Field Station#</b>			
<b>Pic 9 Desc.</b>		<b>Pic 10 Desc.</b>			
<div>Insert image here</div>		<div>Insert image here</div>			
<b>GPS Location</b>		<b>GPS Location</b>			
<b>Field Station#</b>		<b>Field Station#</b>			
<b>Pic 11 Desc.</b>		<b>Pic 12 Desc.</b>

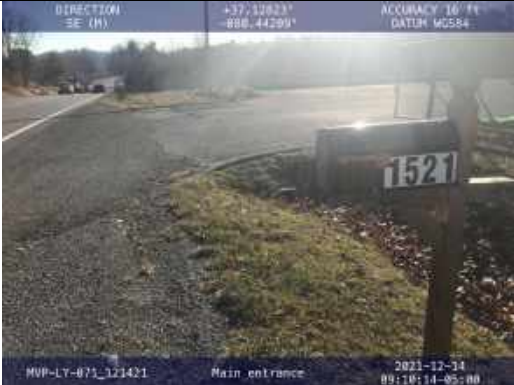
<b>GPS Location</b>	MVP-LY-071 See photo for gps data	<b>GPS Location</b>	MVP-LY-071 See photo for gps data		
<b>Field Station#</b>	+0	<b>Field Station#</b>	+0		
<b>Pic 1 Desc.</b>	Main entrance of of yard MVP-LY-071. Looking SE.	<b>Pic 2 Desc.</b>	Condition of triple stack compost filter sock along north LOD. Looking W.

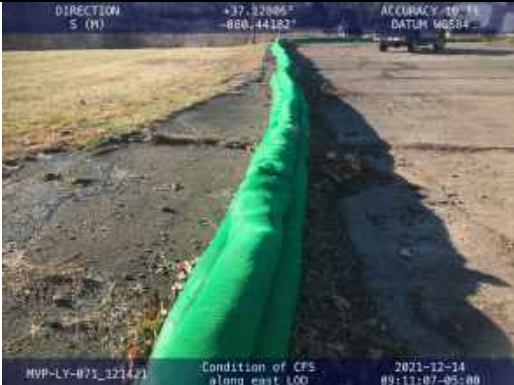
<b>GPS Location</b>	MVP-LY-071 See photo for gps data	<b>GPS Location</b>	MVP-LY-071 See photo for gps data		
<b>Field Station#</b>	+0	<b>Field Station#</b>	+0		
<b>Pic 3 Desc.</b>	Condition of triple stack compost filter sock along east LOD. Looking S.	<b>Pic 4 Desc.</b>	Location of rain gauge. No rainfall. Looking S.

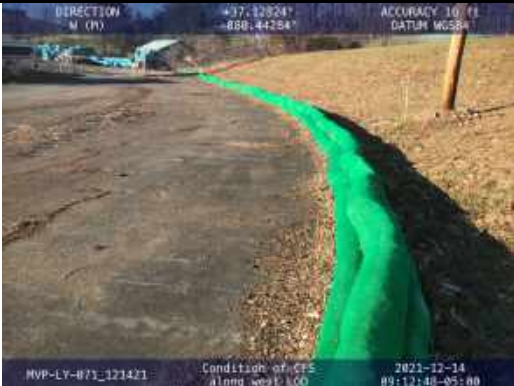
<b>Pic 5 Desc.</b>	Condition of triple stack compost filter sock along west LOD. Looking SW.	<b>Pic 6 Desc.</b>	Condition of triple stack compost filter sock along east LOD. Looking NE.

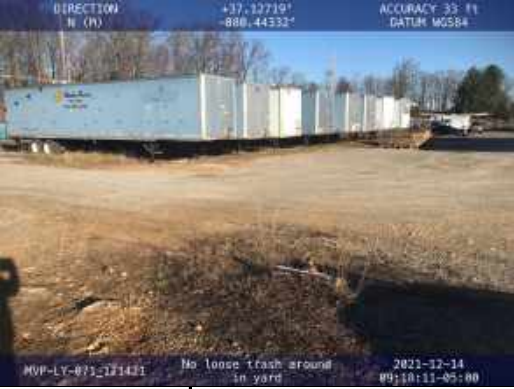
<b>GPS Location</b>	MVP-LY-071 See photo for gps data	<b>GPS Location</b>	MVP-LY-071 See photo for gps data		
<b>Field Station#</b>	+0	<b>Field Station#</b>	+0		
<b>Pic 7 Desc.</b>	Condition of triple stack compost filter sock along south LOD. Looking NW.	<b>Pic 8 Desc.</b>	No loose trash in the yard. Looking N.

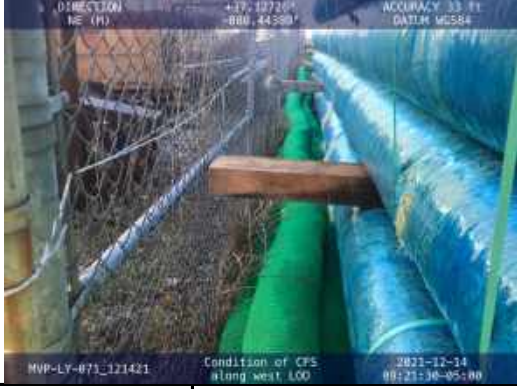
<b>GPS Location</b>	MVP-LY-071 See photo for gps data	<b>GPS Location</b>	MVP-LY-071 See photo for gps data		
<b>Field Station#</b>	+0	<b>Field Station#</b>	+0		
<b>Pic 9 Desc.</b>	Condition of triple stack compost filter sock along west LOD. Looking NE.	<b>Pic 10 Desc.</b>	No debris around straw trailers. Looking S.

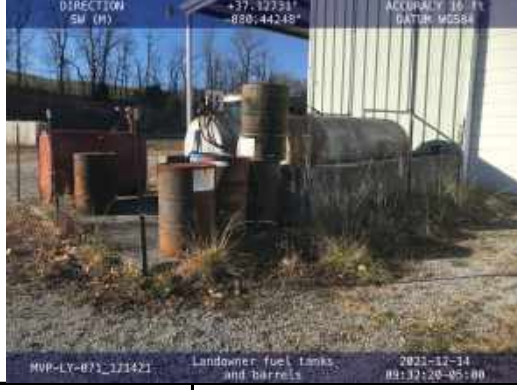
<b>Pic 11 Desc.</b>	Landowner fuel and barrel storage. Not project related. Looking SW.	<b>Pic 12 Desc.</b>	Landowner fuel and barrel storage. Not project related. Looking NW.

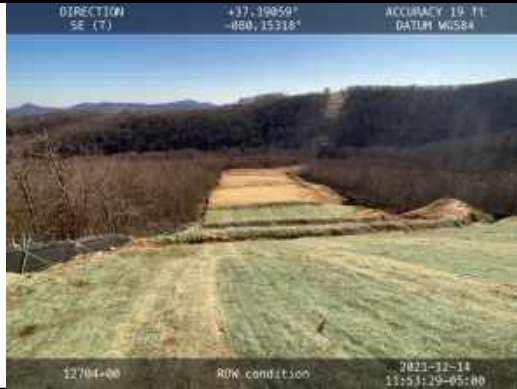
<b>Field Station#</b>	12704+00		<b>Field Station#</b>	12707+00	
<b>Pic 11 Desc.</b>	Photo shows the ROW condition. ECDs are installed and functioning as designed.		<b>Pic 12 Desc.</b>	Photo shows the sump pit and end treatment.

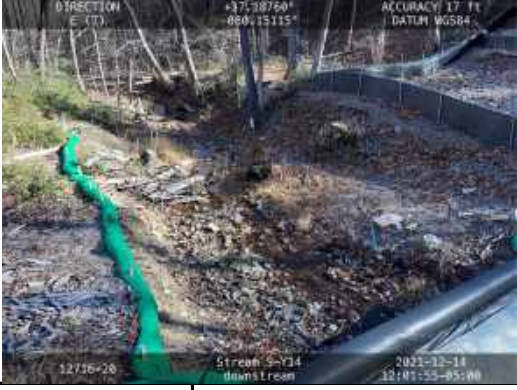
<b>Field Station#</b>	12716+20		<b>Field Station#</b>	12716+50	
<b>Pic 17 Desc.</b>	Photo shows stream S-Y14 downstream from the bridge.		<b>Pic 18 Desc.</b>	Photo shows the ROW condition. ECDs are installed and functioning as designed.

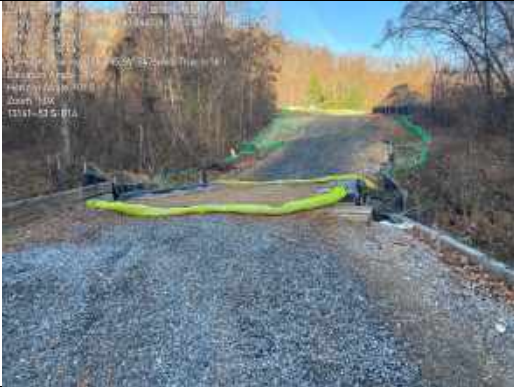
<b>GPS Location</b>	0	<b>GPS Location</b>	0		
<b>Field Station#</b>	13141+53	<b>Field Station#</b>	13144+00		
<b>Pic 1 Desc.</b>	MVP-S-D14 and Corresponding buffer zone in good condition	<b>Pic 2 Desc.</b>	ROW and ECDs in good condition and stable

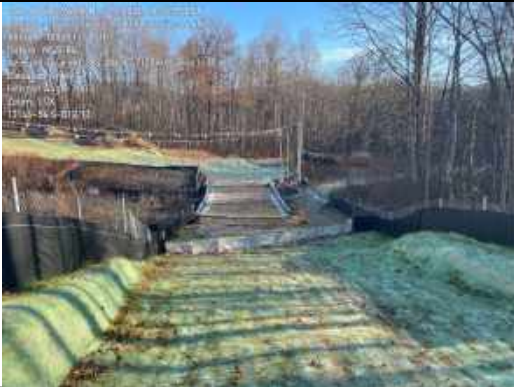
<b>GPS Location</b>	0	<b>GPS Location</b>	0		
<b>Field Station#</b>	13146+56	<b>Field Station#</b>	13147+25		
<b>Pic 3 Desc.</b>	MVP-S-D12/13 and Corresponding buffer zone in good condition	<b>Pic 4 Desc.</b>	ROW and ECDs in good condition and stable

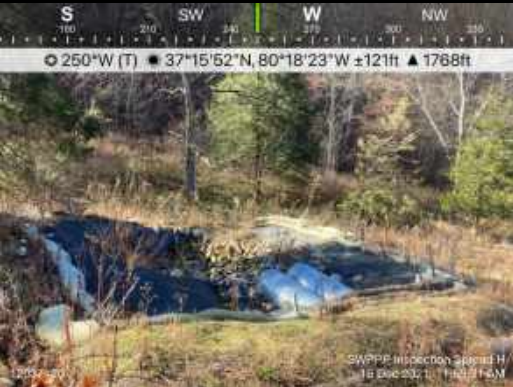
<b>GPS Location</b>	See photo		<b>GPS Location</b>	See photo	
<b>Field Station#</b>	12035+75		<b>Field Station#</b>	12037+20	
<b>Pic 1 Desc.</b>	Controls on the CIS on Catawba in acceptable condition.		<b>Pic 2 Desc.</b>	CWD outlet area in acceptable condition.

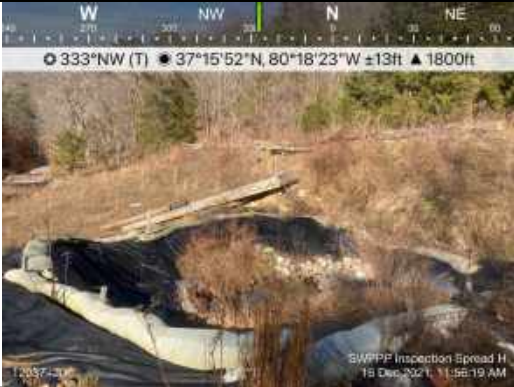
<b>GPS Location</b>	See photo		<b>GPS Location</b>	See photo	
<b>Field Station#</b>	12037+20		<b>Field Station#</b>	12036+20	
<b>Pic 3 Desc.</b>	CWD inlet and berm in acceptable condition.		<b>Pic 4 Desc.</b>	Pipe is staged on the CIS on Catawba and is in acceptable condition.

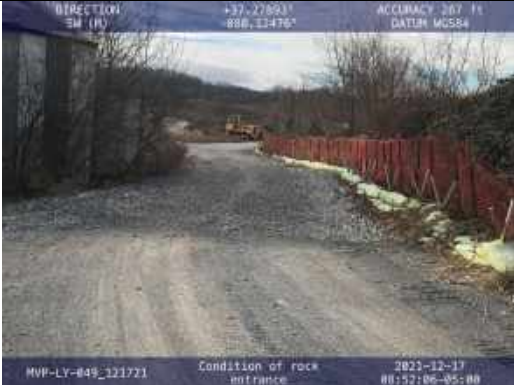
<b>GPS Location</b>	MVP-LY-049 See photo for gps data.	<b>GPS Location</b>	MVP-LY-049 See photo for gps data.		
<b>Field Station#</b>	+0	<b>Field Station#</b>	+0		
<b>Pic 1 Desc.</b>	Condition of rock entrance. No sediment or debris on stone. Looking SW.	<b>Pic 2 Desc.</b>	Landowner soil disturbance along triple stack compost filter sock. No new damage to installed ECD's. Looking SW.

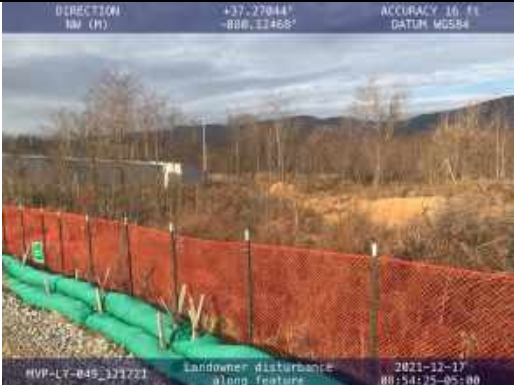
<b>GPS Location</b>	MVP-LY-049 See photo for gps data.	<b>GPS Location</b>	MVP-LY-049 See photo for gps data.		
<b>Field Station#</b>	+0	<b>Field Station#</b>	+0		
<b>Pic 3 Desc.</b>	Landowner soil disturbance along feature W-CV21A. Area not stabilized. Looking NW.	<b>Pic 4 Desc.</b>	Landowner soil disturbance west of feature W-CV21B. Areas not stabilized. Looking SW.

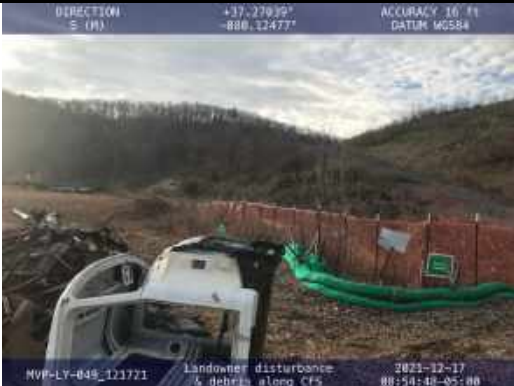
<b>Field Station#</b>	+0	<b>Field Station#</b>	+0		
<b>Pic 5 Desc.</b>	Landowner soil disturbance and debris piled along triple stack compost filter sock and east of feature W-CV21B. Looking S.	<b>Pic 6 Desc.</b>	Secondary containment under stored equipment. Holding fluids. Looking SW.

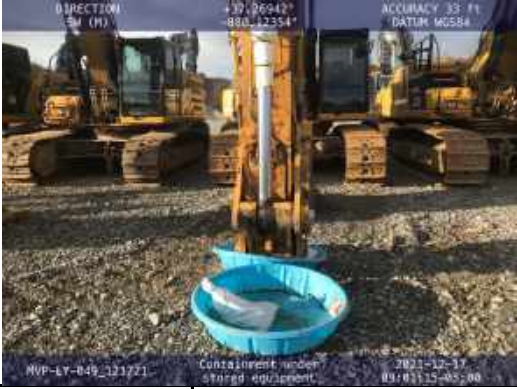
<b>GPS Location</b>	MVP-LY-049 See photo for gps data.	<b>GPS Location</b>	MVP-LY-049 See photo for gps data.		
<b>Field Station#</b>	+0	<b>Field Station#</b>	+0		
<b>Pic 7 Desc.</b>	Secondary containment under stored equipment catching fluids. Looking SW.	<b>Pic 8 Desc.</b>	Secondary containment under stored equipment catching fluids. Looking NE.

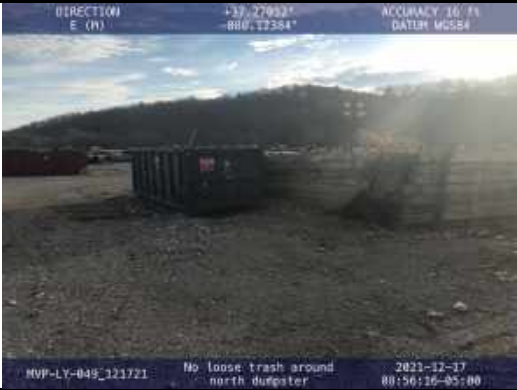
<b>GPS Location</b>	MVP-LY-049 See photo for gps data.	<b>GPS Location</b>	MVP-LY-049 See photo for gps data.		
<b>Field Station#</b>	+0	<b>Field Station#</b>	+0		
<b>Pic 9 Desc.</b>	Secondary containment under stored equipment catching fluids. Looking W.	<b>Pic 10 Desc.</b>	No loose trash around north dumpster or in the yard. Looking SE.

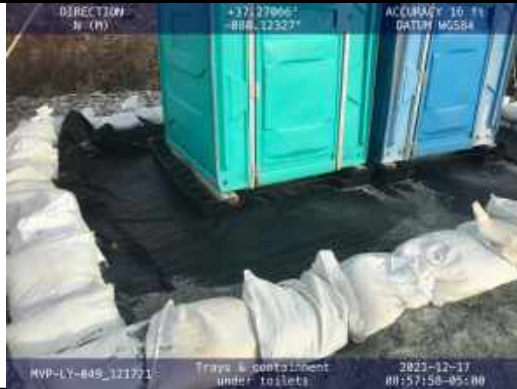
<b>Field Station#</b>	+0	<b>Field Station#</b>	+0		
<b>Pic 11 Desc.</b>	Trays and containment under toilets. Trays free of fluids. Looking N.	<b>Pic 12 Desc.</b>	Condition of temporary trash transfer pit. Debris has been placed in dumpsters. Looking W.

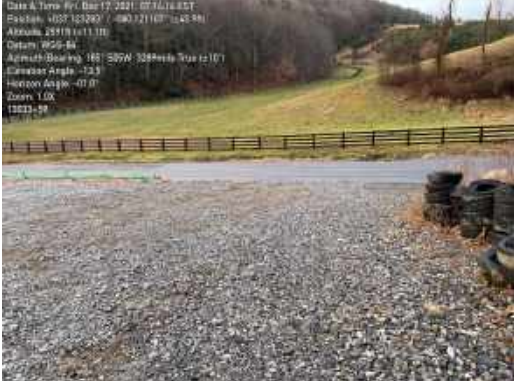
<b>GPS Location</b>	0	<b>GPS Location</b>	0		
<b>Field Station#</b>	13033+59	<b>Field Station#</b>	13033+00		
<b>Pic 1 Desc.</b>	RCE in good condition and functioning properly	<b>Pic 2 Desc.</b>	ROW and ECDs In good condition and stable

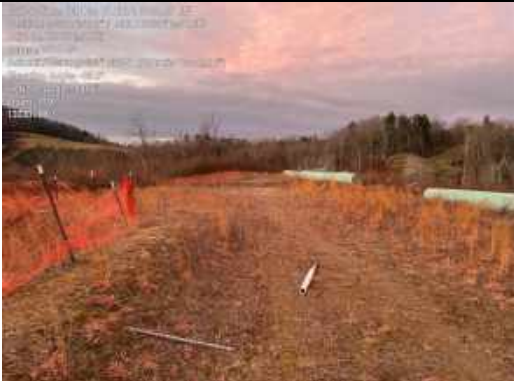
<b>GPS Location</b>	0	<b>GPS Location</b>	0		
<b>Field Station#</b>	13030+00	<b>Field Station#</b>	13024+06		
<b>Pic 3 Desc.</b>	ROW and ECDs In good condition and stable	<b>Pic 4 Desc.</b>	MVP-S-G24/25 and Corresponding buffer zone in good condition

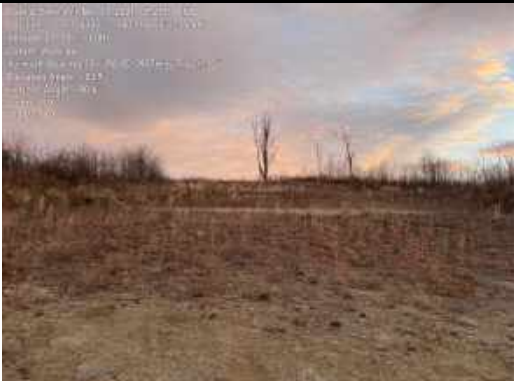
<b>GPS Location</b>	0	<b>GPS Location</b>	0		
<b>Field Station#</b>	13034+00	<b>Field Station#</b>	13061+44		
<b>Pic 5 Desc.</b>	ROW and ECDs In good condition and stable	<b>Pic 6 Desc.</b>	Equipment bridge in good condition

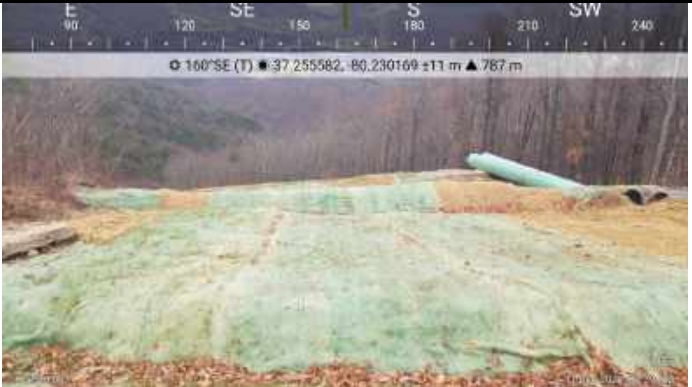
<b>GPS Location</b>	See Above	<b>GPS Location</b>	See Above		
<b>Field Station#</b>	12284+75	<b>Field Station#</b>	12286+00		
<b>Pic 1 Desc.</b>	Overview of Acc. Rd. MN-276.03 ROW crossing. ECDs are functional and ROW is stable.	<b>Pic 2 Desc.</b>	ROW Overview. ECDs are functional and ROW is stable.

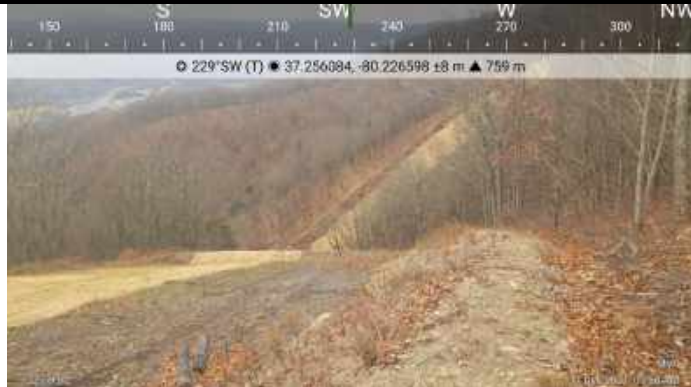
<b>GPS Location</b>	See Above	<b>GPS Location</b>	See Above		
<b>Field Station#</b>	12297+00	<b>Field Station#</b>	12302+00		
<b>Pic 3 Desc.</b>	ROW Overview. ECDs are functional and ROW is stable.	<b>Pic 4 Desc.</b>	ROW Overview. ECDs are functional and ROW is stable.

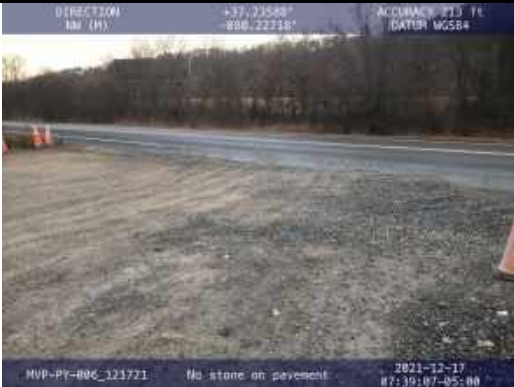
<b>GPS Location</b>	MVP-PY-006 See photo for gps data	<b>GPS Location</b>	MVP-PY-006 See photo for gps data		
<b>Field Station#</b>	+0	<b>Field Station#</b>	+0		
<b>Pic 1 Desc.</b>	No stone on pavement at main entrance. Looking NW.	<b>Pic 2 Desc.</b>	Condition of posted project documents at the main yard entrance. Looking SW

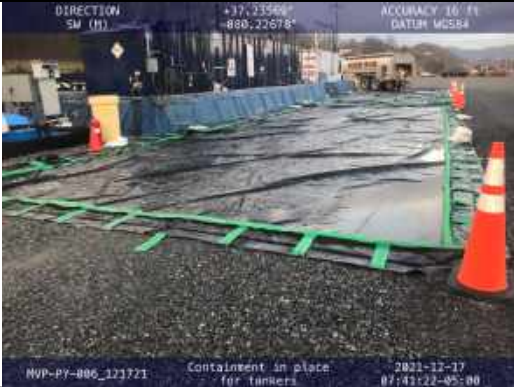
<b>GPS Location</b>	MVP-PY-006 See photo for gps data	<b>GPS Location</b>	MVP-PY-006 See photo for gps data		
<b>Field Station#</b>	+0	<b>Field Station#</b>	+0		
<b>Pic 3 Desc.</b>	Secondary containment in place for tankers offloading fuel. Looking SW.	<b>Pic 4 Desc.</b>	Blue Bulk Fuel tanks no fuel spills south of the tanks. Looking W.

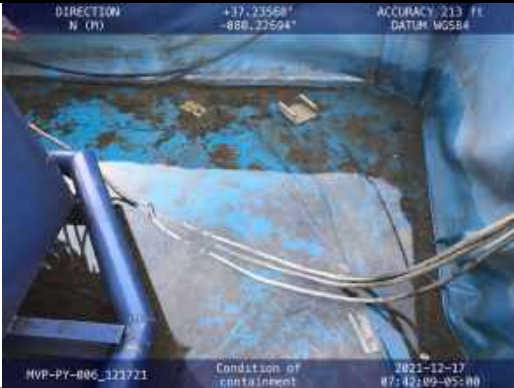
<b>Field Station#</b>	+0	<b>Field Station#</b>	+0		
<b>Pic 5 Desc.</b>	Blue Bulk Fuel tanks containment holding stormwater. Looking N.	<b>Pic 6 Desc.</b>	Blue Bulk Fuel tanks no leaky internal fittings. Looking NW.

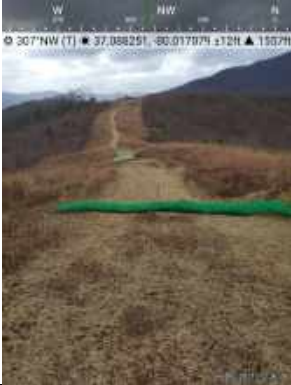
<p>ert image here</p>		<p>Insert image here</p>	
<b>GPS Location</b>	0	<b>GPS Location</b>			
<b>Field Station#</b>	13445+00	<b>Field Station#</b>			
<b>Pic 13 Desc.</b>	CFS Waterbar outlet protection	<b>Pic 14 Desc.</b>			
<p>Insert image here</p>		<p>Insert image here</p>			
<b>GPS Location</b>		<b>GPS Location</b>			
<b>Field Station#</b>		<b>Field Station#</b>			
<b>Pic 15 Desc.</b>		<b>Pic 16 Desc.</b>			
<p>Insert image here</p>		<p>Insert image here</p>			
<b>GPS Location</b>		<b>GPS Location</b>			
<b>Field Station#</b>		<b>Field Station#</b>			
<b>Pic 17 Desc.</b>		<b>Pic 18 Desc.</b>
