# Visual Site Inspection Report

<b>Project Name</b>	H-600 Pipeline Spread H	<b>AFE</b>	124300138	<b>Spread</b>	H-600 Pipeline Spread H
<b>Contractor</b>	Precision			<b>Report #</b>	32678
<b>Inspector</b>	Norm Kitchen			<b>Date/Time</b>	12/27/2021 5:00 PM
<b>Permit #</b>	TBD	<b>Inspection Type</b>	VA SWPP	<b>Station Begin</b>	12119+17
<b>State</b>	VA	<b>Inspection Area</b>	Partial	<b>Station End</b>	12284+75
<b>County</b>	Montgomery	<b>Ground</b>	Dry	<b>Temperature (°F)</b>	52.00
<b>Municipality</b>	N/A	<b>Weather</b>	Cloudy	<b>Rain Gauge (in)</b>	0.00
				<b>Rain Accumulation Time (days)</b>	1.00

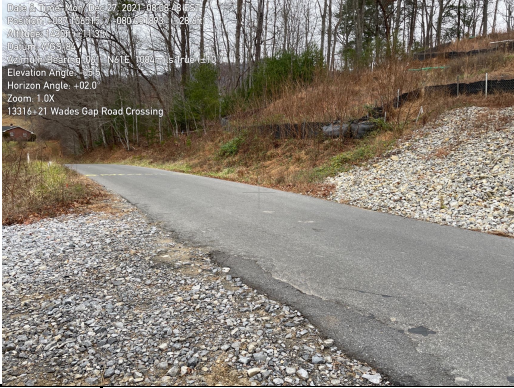
<p>Date &amp; Time: Mon, Dec 27, 2021, 01:53:18 EST Position: +40° 18' 51" N / -82° 02' 57" W (±1.0") Altitude: 1459 (±1.10) Datum: WGS-84 Azimuth/Bearing: 33° 33' 7" 450m True (±1°) Elevation Angle: +10.2° Horizon Angle: +02.0° Zoom: 1.0X 13316+21 Wades Gap Road Crossing</p>

<p>Date &amp; Time: Mon, Dec 27, 2021, 01:53:18 EST Position: +40° 18' 51" N / -82° 02' 57" W (±1.0") Altitude: 1459 (±1.10) Datum: WGS-84 Azimuth/Bearing: 33° 33' 7" 450m True (±1°) Elevation Angle: +10.2° Horizon Angle: +02.0° Zoom: 1.0X 13314+00</p>			
<b>GPS Location</b>	0	<b>GPS Location</b>	0		
<b>Field Station#</b>	13316+21	<b>Field Station#</b>	13314+00		
<b>Pic 1 Desc.</b>	Wades Gap Road Crossing in good condition	<b>Pic 2 Desc.</b>	ROW and ECDs In good condition with good vegetation established across ROW

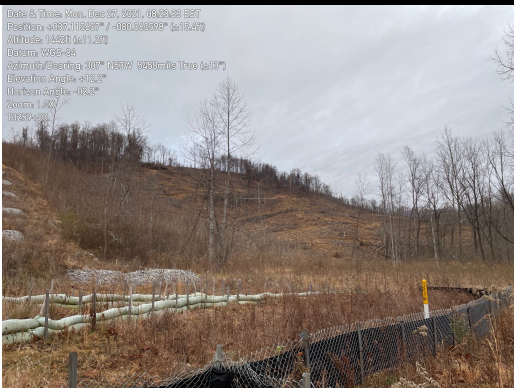
<p>Date &amp; Time: Mon, Dec 27, 2021, 01:53:18 EST Position: +40° 18' 51" N / -82° 02' 57" W (±1.0") Altitude: 1459 (±1.10) Datum: WGS-84 Azimuth/Bearing: 33° 33' 7" 450m True (±1°) Elevation Angle: +10.2° Horizon Angle: +02.0° Zoom: 1.0X 13259+00</p>

<b>Pic 5 Desc.</b>	Continuing to monitor logging activity adjacent to row	<b>Pic 6 Desc.</b>	ROW and ECDs In good condition and stable

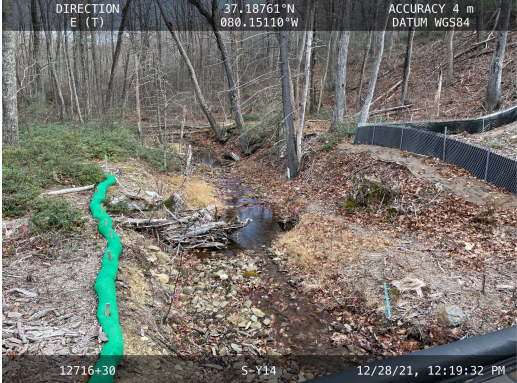
<b>GPS Location</b>	See photo		<b>GPS Location</b>	See photo	
<b>Field Station#</b>	12716+30		<b>Field Station#</b>	12716+30	
<b>Pic 13 Desc.</b>	Downstream of crossing at Stream S-Y14		<b>Pic 14 Desc.</b>	Upstream of crossing at Stream S-Y14

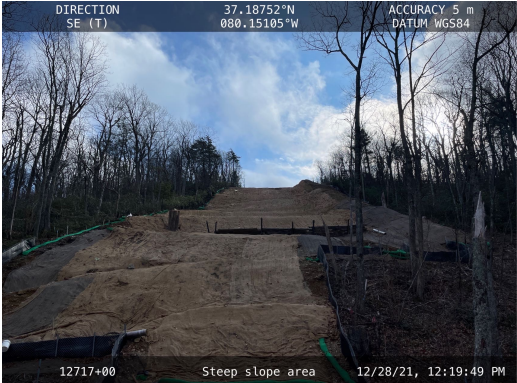
<b>GPS Location</b>	See photo		<b>GPS Location</b>	See photo	
<b>Field Station#</b>	12717+00		<b>Field Station#</b>	12689+00	
<b>Pic 15 Desc.</b>	Steep slope area is stable and ECDs are functional		<b>Pic 16 Desc.</b>	Current ROW conditions. ROW is stable. ECDs are functional.

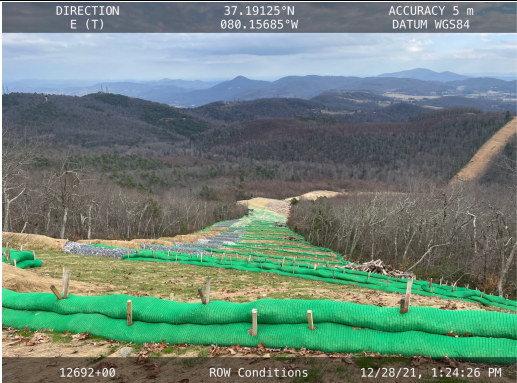
<b>GPS Location</b>	See photo		<b>GPS Location</b>	See photo	
<b>Field Station#</b>	12692+00		<b>Field Station#</b>	12692+00	
<b>Pic 17 Desc.</b>	Current ROW conditions. ROW is stable. ECDs are functional.		<b>Pic 18 Desc.</b>	Permanent Slope Breaker and Level Spreader are functional.

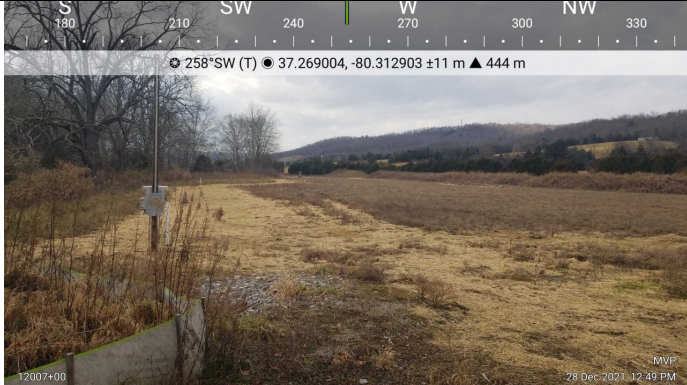
<b>GPS Location</b>	See Above	<b>GPS Location</b>	See Above		
<b>Field Station#</b>	12007+00	<b>Field Station#</b>	12013+97		
<b>Pic 1 Desc.</b>	ROW Overview. ECDs are functional and ROW is stable.	<b>Pic 2 Desc.</b>	Overview of Waterbody S-G36 (Acc Rd 268). ECDs are functional and ROW is stable.

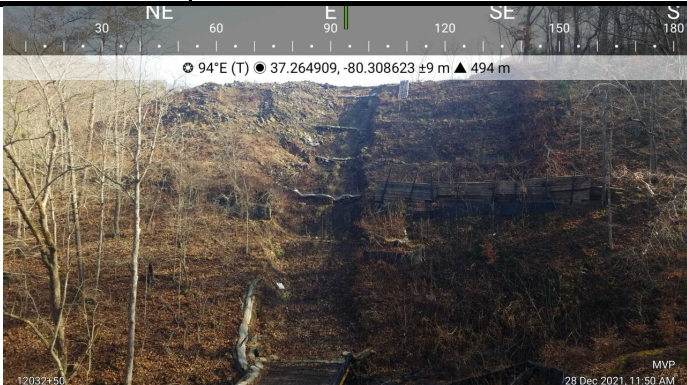
<b>GPS Location</b>	See Above	<b>GPS Location</b>	See Above		
<b>Field Station#</b>	12024+00	<b>Field Station#</b>	12032+50		
<b>Pic 5 Desc.</b>	ROW Overview. ECDs are functional and ROW is stable.	<b>Pic 6 Desc.</b>	ROW Overview. ECDs are functional and ROW is stable.

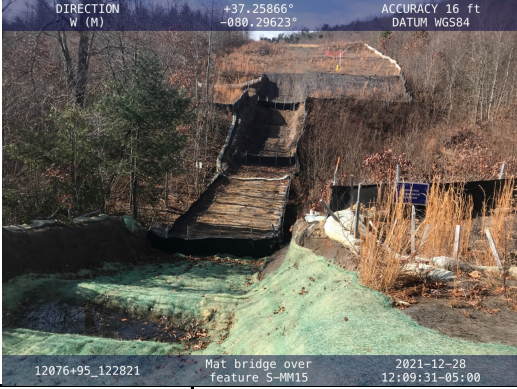
<p>DIRECTION W (M) +37.25866° -080.29623° ACCURACY 16 ft DATUM WGS84</p> <p>12076+95_122821 Mat bridge over feature S-MM15 2021-12-28 12:09:31-05:00</p>

<p>DIRECTION W (M) +37.25851° -080.28916° ACCURACY 98 ft DATUM WGS84</p> <p>12098+44_122821 Mat bridge over feature S-MM13 2021-12-28 11:11:28-05:00</p>			
<b>GPS Location</b>	See Above		<b>GPS Location</b>	See Above	
<b>Field Station#</b>	12076+95		<b>Field Station#</b>	12098+44	
<b>Pic 13 Desc.</b>	Overview of Waterbody S-MM15. ECDs are functional and ROW is stable.		<b>Pic 14 Desc.</b>	Overview of Waterbody S-MM13. ECDs are functional and ROW is stable.

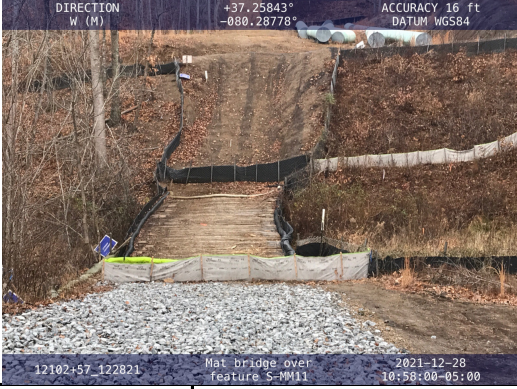
<p>DIRECTION W (M) +37.25843° -080.28778° ACCURACY 16 ft DATUM WGS84</p> <p>12102+57_122821 Mat bridge over feature S-MM11 2021-12-28 10:58:00-05:00</p>

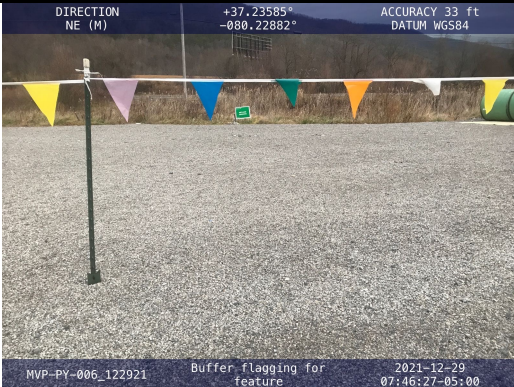
<b>GPS Location</b>	MVP-PY-006 See photo for gps data		<b>GPS Location</b>	MVP-PY-006 See photo for gps data	
<b>Field Station#</b>	+0		<b>Field Station#</b>	+0	
<b>Pic 1 Desc.</b>	Boundary flagging in place for feature W-008. Looking NE		<b>Pic 2 Desc.</b>	Condition of signage and triple stack compost filter sock along feature W-008. Over grown with vegetation. Looking E.

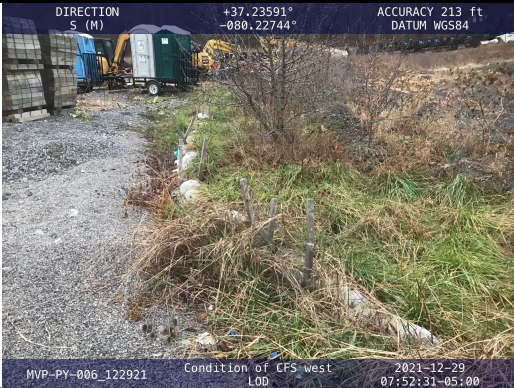
<b>Field Station#</b>	+0		<b>Field Station#</b>	+0	
<b>Pic 5 Desc.</b>	Condition of triple stack compost filter sock along west LOD. Over grown with vegetation. Looking S.		<b>Pic 6 Desc.</b>	Secondary containment under light plant free of stormwater. Looking NE.

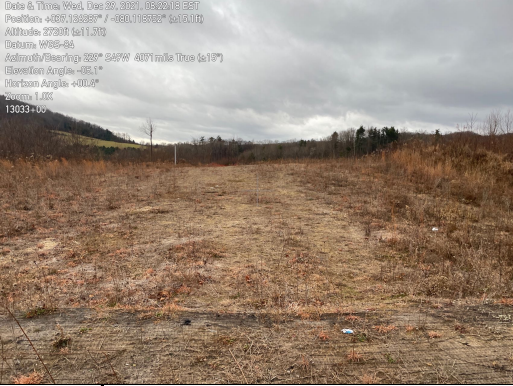
GPS Location		0		GPS Location	
Field Station#		13033+59		Field Station#	
Pic 1 Desc.		RCE in good condition and functioning properly		Pic 2 Desc.	
<p>Date &amp; Time: Wed, Dec 29, 2021, 08:07:23 EST  Position: +037.125619° / -080.125412° (+43.1ft)  Altitude: 2711ft (+5.5ft)  Datum: WGS-84  Azimuth/Bearing: 278° N82W 4942mils True (+12.1°)  Elevation Angle: +21.0°  Horizon Angle: +01.2°  Zoom: 1.0X  13024+06 S-624/25</p>  		<p>Date &amp; Time: Wed, Dec 29, 2021, 08:07:25 EST  Position: +037.12242° / -080.11871° (+40.1ft)  Altitude: 2635ft (+1.5ft)  Datum: WGS-84  Azimuth/Bearing: 351° N31E 3260mils True (+15°)  Elevation Angle: +00.9°  Horizon Angle: +00.8°  Zoom: 1.0X  13034+00</p>

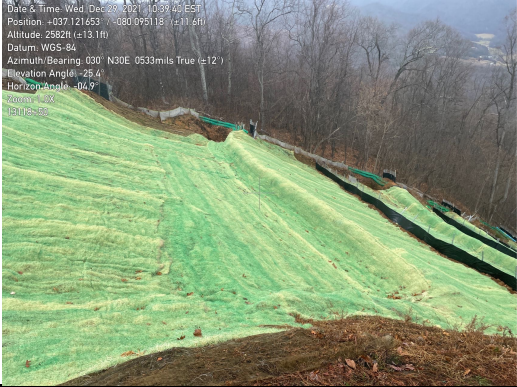
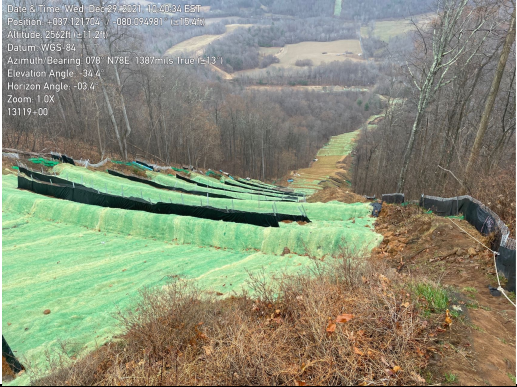
<b>GPS Location</b> 0		<b>GPS Location</b> 0			
<b>Field Station#</b> 13118+50		<b>Field Station#</b> 13119+00			
<b>Pic 13 Desc.</b> ROW and ECDs In good condition and stable		<b>Pic 14 Desc.</b> ROW and ECDs In good condition and stable			
<p>Date &amp; Time: Wed, Dec 29, 2021 10:54:03  Position: +037.115036, -080.097271 (+11.40)  Altitude: 2128ft (+11.0ft)  Datum: WGS-84  Azimuth/Bearing: 143° S43E 3076mils True (+18°)  Elevation Angle: -10.5°  Horizon Angle: +00.1°  Zoom: 1.0X  13115-07</p>

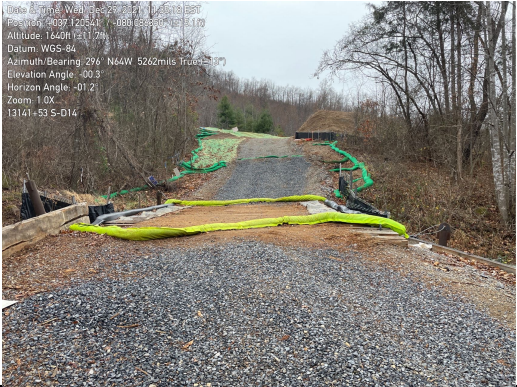
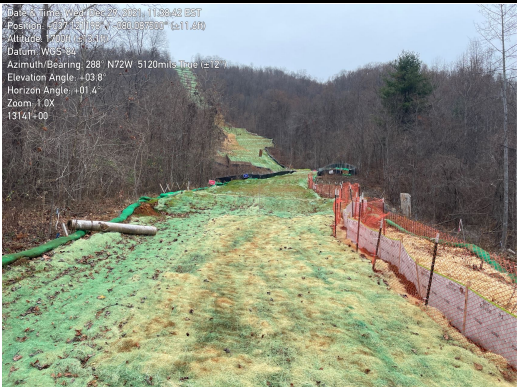
<b>GPS Location</b> 0		<b>GPS Location</b> 0			
<b>Field Station#</b> 13115+97		<b>Field Station#</b> 13141+53			
<b>Pic 15 Desc.</b> RCE in good condition and functioning properly		<b>Pic 16 Desc.</b> MVP-S-D14 and Corresponding buffer zone in good condition			
<p>Date &amp; Time: Wed, Dec 29, 2021 11:28:42  Position: +037.121546, -080.093801 (+11.41)  Altitude: 1759ft (+11.7ft)  Datum: WGS-84  Azimuth/Bearing: 288° N72W 5120mils True (+12°)  Elevation Angle: +03.8°  Horizon Angle: +01.4°  Zoom: 1.0X  13141-00</p>

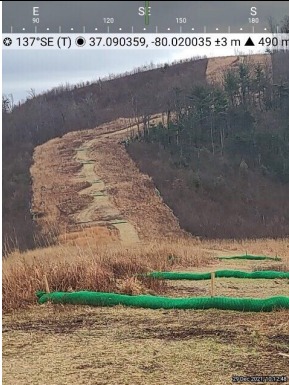
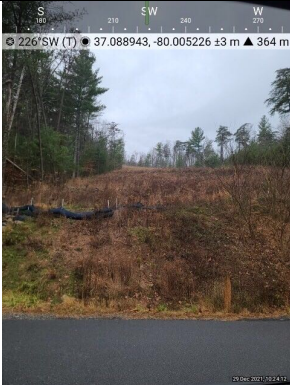
<b>GPS Location</b>	0000	<b>GPS Location</b>	0000		
<b>Field Station#</b>	13440+00	<b>Field Station#</b>	13496+62		
<b>Pic 1 Desc.</b>	Monitored stabilization and ECDs throughout areas in permanently restored row, no environmental issues observed at the time of inspection.		<b>Pic 2 Desc.</b>	Monitored ECDs and vegetation at road crossings during light rain events, no environmental issues observed at the time of inspection.

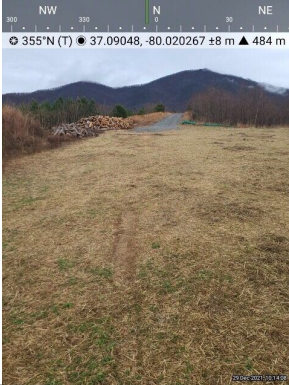
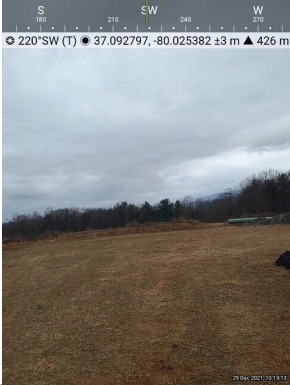
<b>GPS Location</b>	0000	<b>GPS Location</b>	0000		
<b>Field Station#</b>	13437+75	<b>Field Station#</b>	13420+00		
<b>Pic 3 Desc.</b>	Monitored stabilization in work space area, noted temporary vegetation growth coming up. No environmental issues observed at the time of inspection.		<b>Pic 4 Desc.</b>	Monitored stabilization in work space area, noted temporary vegetation growth coming up. No environmental issues observed at the time of inspection.

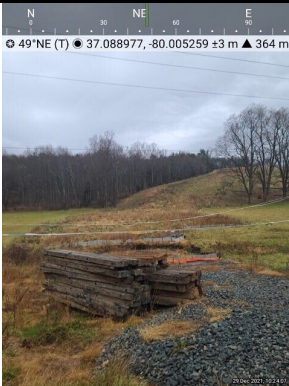
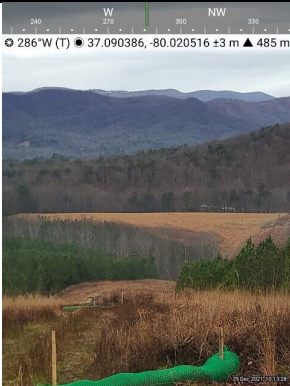
<b>GPS Location</b>	0000	<b>GPS Location</b>	00000		
<b>Field Station#</b>	13497+15	<b>Field Station#</b>	13436+36		
<b>Pic 5 Desc.</b>	Monitored stream crossings and ECDs throughout, no environmental issues observed at the time of inspection.		<b>Pic 6 Desc.</b>	Monitored permanent row area, checked all ECDs and stabilization, no environmental issues observed at the time of inspection.

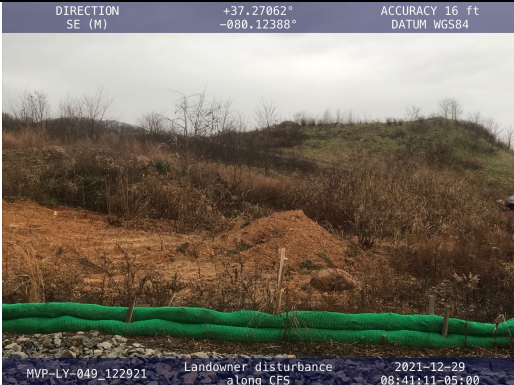
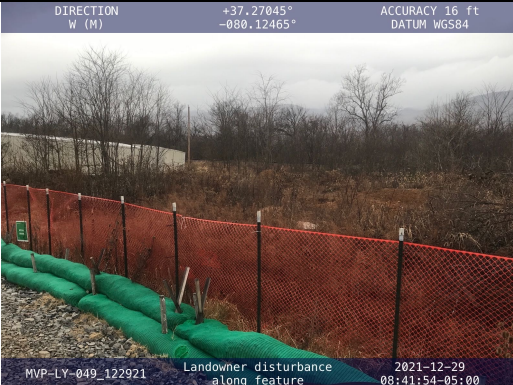
<b>GPS Location</b>	MVP-LY-049 See photo for gps data		<b>GPS Location</b>	MVP-LY-049 See photo for gps data	
<b>Field Station#</b>	+0		<b>Field Station#</b>	+0	
<b>Pic 3 Desc.</b>	Landowner soil disturbance along triple stack compost filter sock. No new damage to installed ECD's. Looking SE.		<b>Pic 4 Desc.</b>	Landowner soil disturbance along feature W-CV21A. Area not stabilized. Looking W.

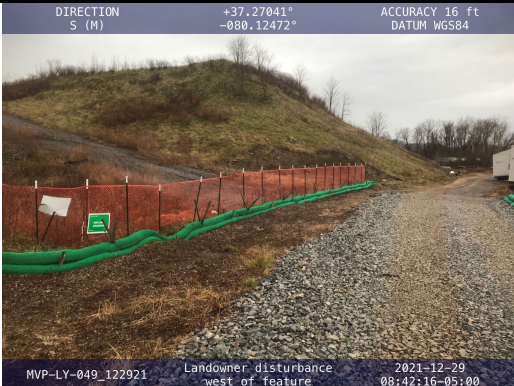
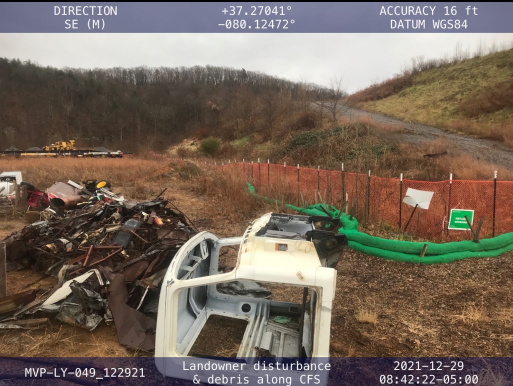
<b>Pic 5 Desc.</b>	Landowner soil disturbance west of feature W-CV21B. Areas not stabilized. Looking S.		<b>Pic 6 Desc.</b>	Landowner soil disturbance and debris piled along triple stack compost filter sock and east of feature W-CV21B. Looking SE.

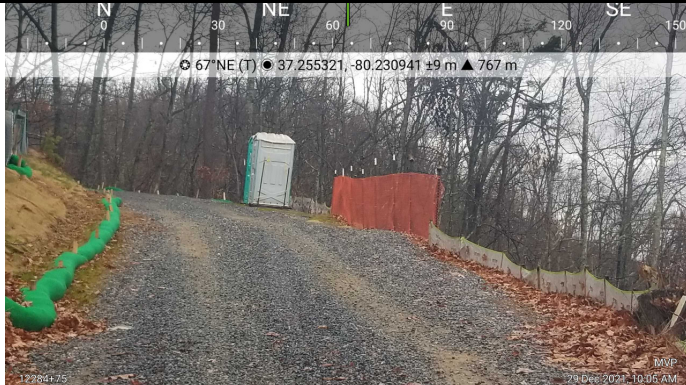
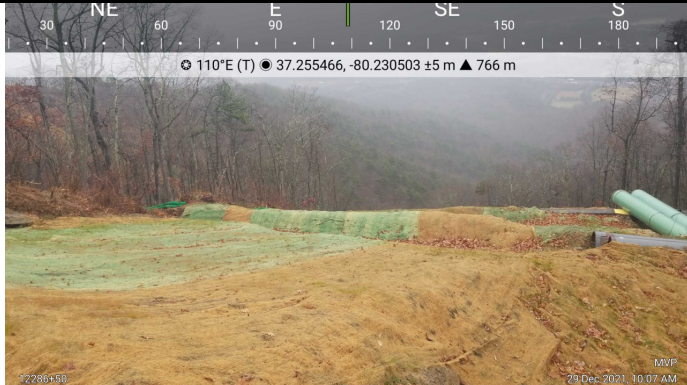
GPS Location	See Above		GPS Location	See Above	
Field Station#	12284+75		Field Station#	12286+50	
Pic 1 Desc.	Overview of Acc. Rd. MN-276.03 ROW crossing. ECDs are functional and ROW is stable.		Pic 2 Desc.	ROW Overview. ECDs are functional and ROW is stable.

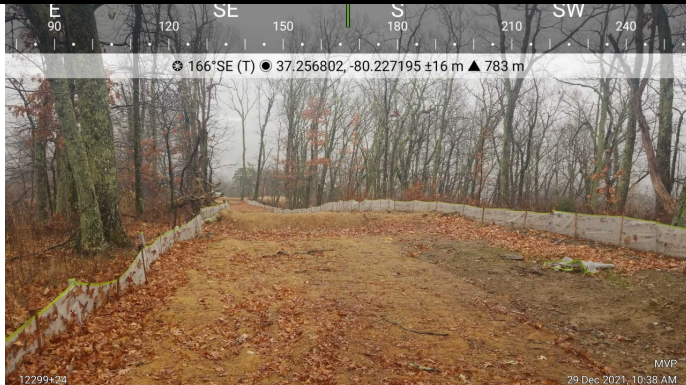
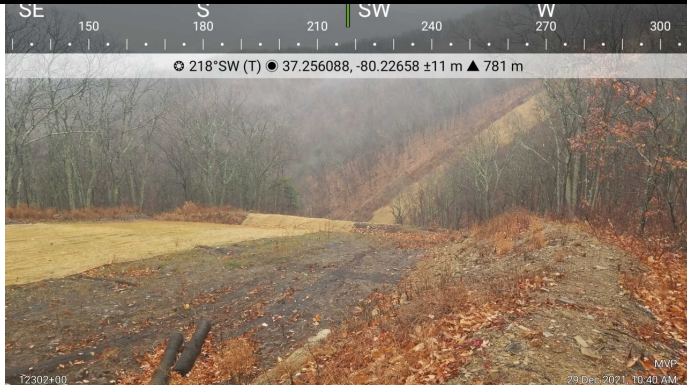
GPS Location	See Above		GPS Location	See Above	
Field Station#	12299+24		Field Station#	12297+00	
Pic 3 Desc.	Overview of Acc. Rd. MN-276.03. ECDs are functional and area is stable.		Pic 4 Desc.	ROW Overview. ECDs are functional and ROW is stable.

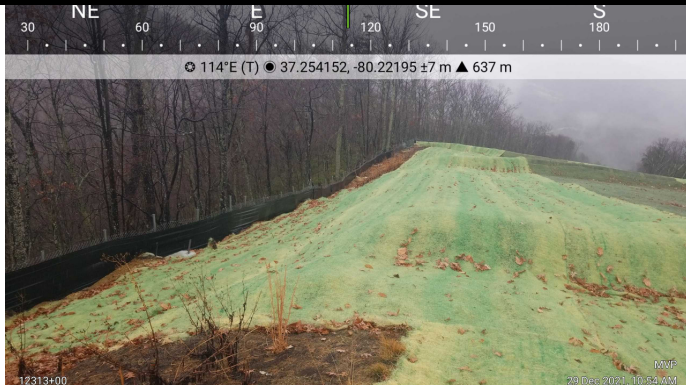
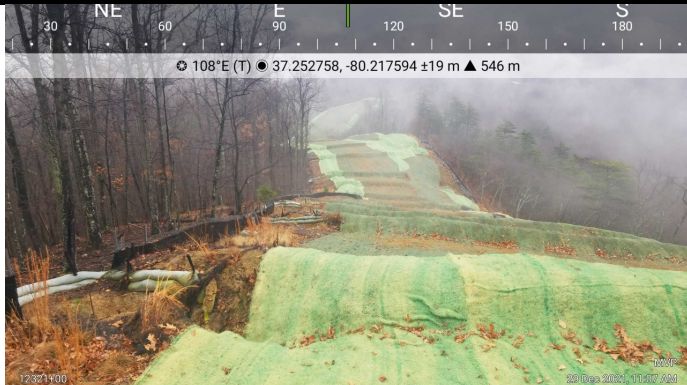
GPS Location	See Above		GPS Location	See Above	
Field Station#	12313+00		Field Station#	12321+00	
Pic 5 Desc.	ROW Overview. ECDs are functional and ROW is stable.		Pic 6 Desc.	ROW Overview. ECDs are functional and ROW is stable.

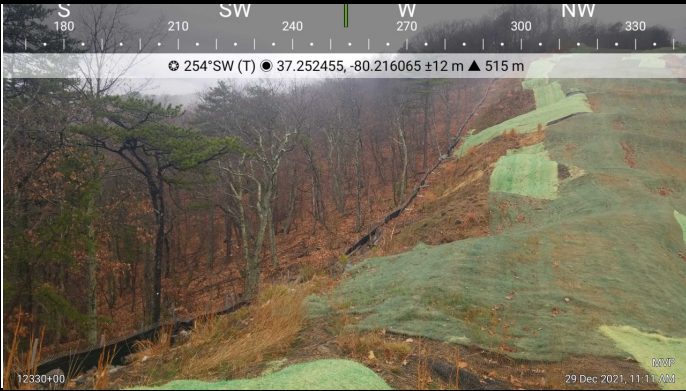
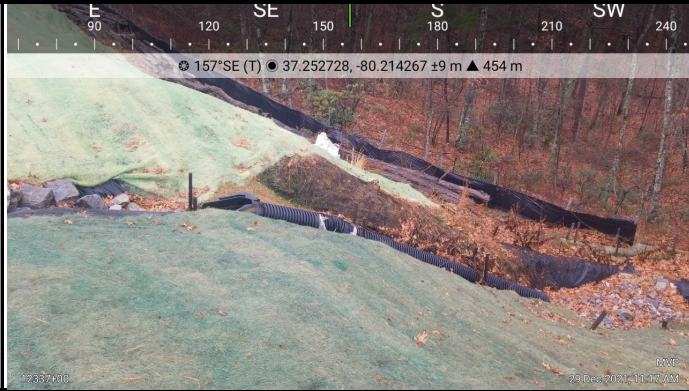
GPS Location	See Above		GPS Location	See Above	
Field Station#	12330+00		Field Station#	12337+00	
Pic 7 Desc.	ROW Overview. ECDs are functional and ROW is stable.		Pic 8 Desc.	ROW Overview. ECDs are functional and ROW is stable.

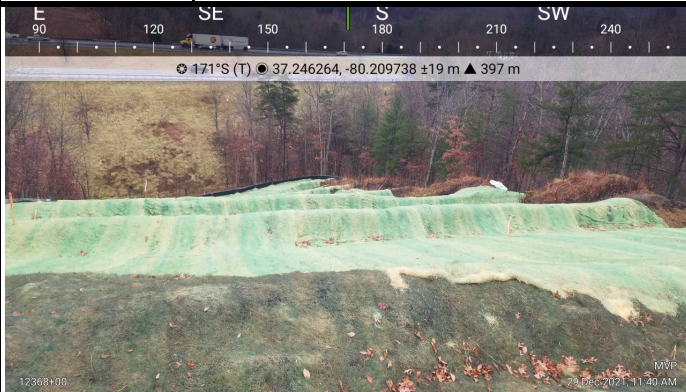
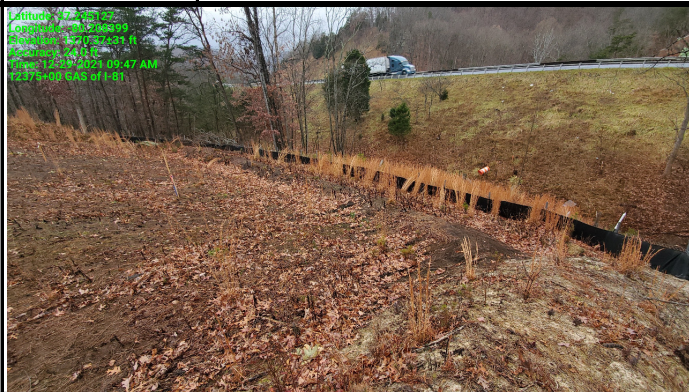
GPS Location	See Above		GPS Location	See Above	
Field Station#	12368+00		Field Station#	12375+00	
Pic 9 Desc.	ROW Overview. ECDs are functional and ROW is stable.		Pic 10 Desc.	Overview of Waterbody S-0016. ECDs are functional and ROW is stable.

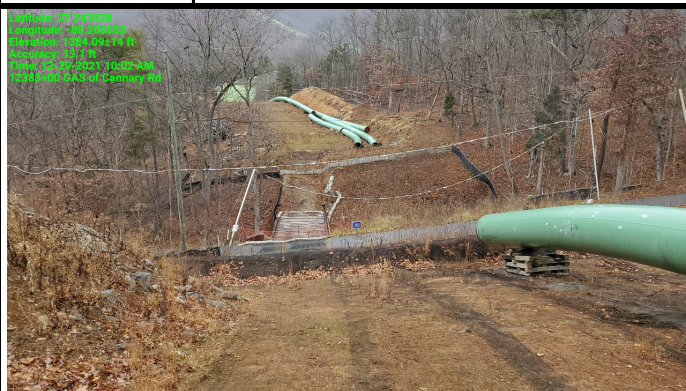
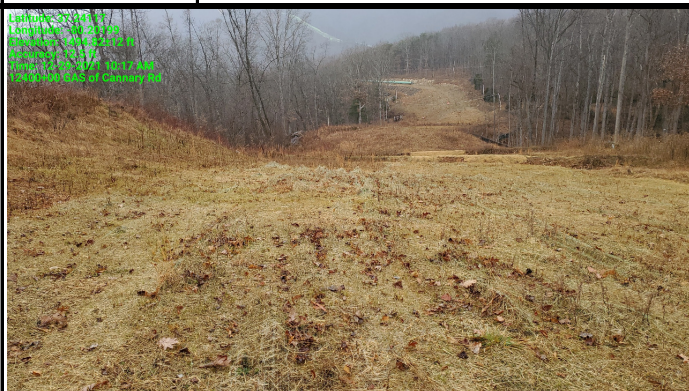
GPS Location	See Above		GPS Location	See Above	
Field Station#	12383+00		Field Station#	12400+00	
Pic 11 Desc.	Overview of Waterbody S-NN19. ECDs are functional and ROW is stable.		Pic 12 Desc.	ROW Overview. ECDs are functional and ROW is stable.

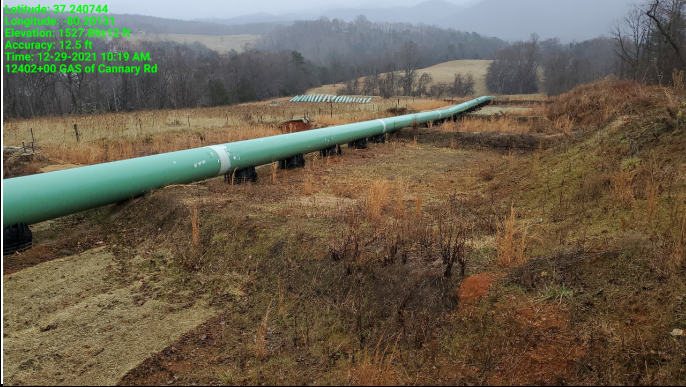
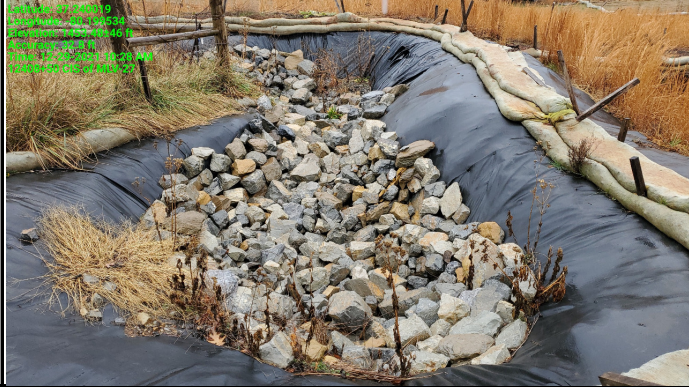
</div>		
<b>GPS Location</b>	See Above		<b>GPS Location</b>	See Above	
<b>Field Station#</b>	12402+00		<b>Field Station#</b>	12408+00	
<b>Pic 13 Desc.</b>	ROW Overview. ECDs are functional and ROW is stable.		<b>Pic 14 Desc.</b>	ROW Overview. ECDs are functional and ROW is stable.	
<div><div>Latitude: 37.234611 Longitude: -80.198364 Elevation: 1163.32±8 ft Accuracy: 12.5 ft Time: 12-29-2021 10:58 AM 12420+00 CIS of Roanoke Riv</div>

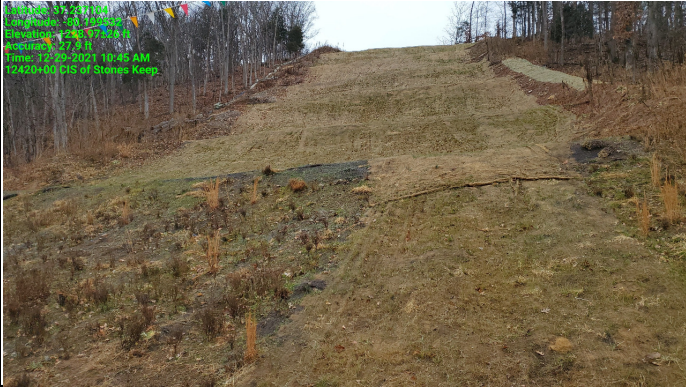
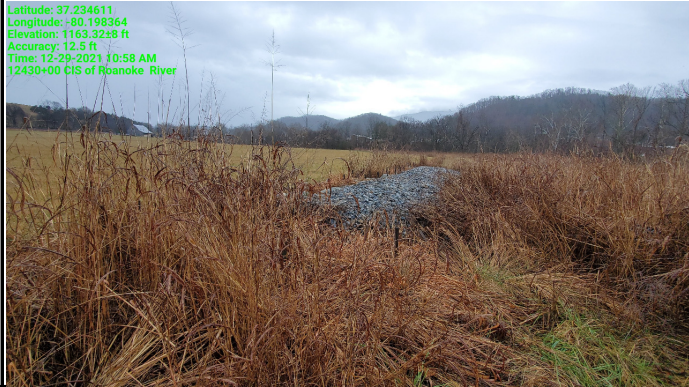
<b>GPS Location</b>	See Above		<b>GPS Location</b>	See Above	
<b>Field Station#</b>	12420+00		<b>Field Station#</b>	12430+00	
<b>Pic 15 Desc.</b>	ROW Overview. ECDs are functional and ROW is stable.		<b>Pic 16 Desc.</b>	ROW Overview. ECDs are functional and ROW is stable.	
<div><div>Latitude: 37.233759 Longitude: -80.197884 Elevation: 1174.15±12 ft Accuracy: 12.8 ft Time: 12-29-2021 10:53 AM 12440+00 CIS of Roanoke Riv</div>

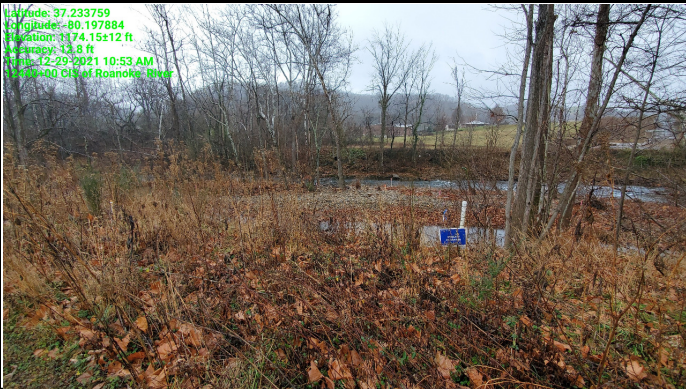
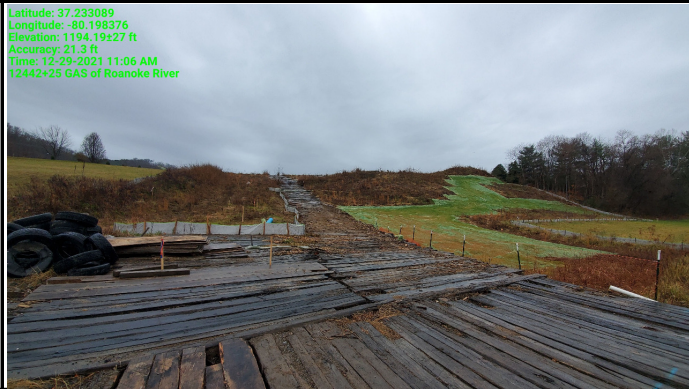
</div>		
<b>GPS Location</b>	See Above		<b>GPS Location</b>	See Above	
<b>Field Station#</b>	12440+00		<b>Field Station#</b>	12442+75	
<b>Pic 17 Desc.</b>	Overview of Waterbody S-NN16. ECDs are functional and ROW is stable.		<b>Pic 18 Desc.</b>	ROW Overview. ECDs are functional and ROW is stable.

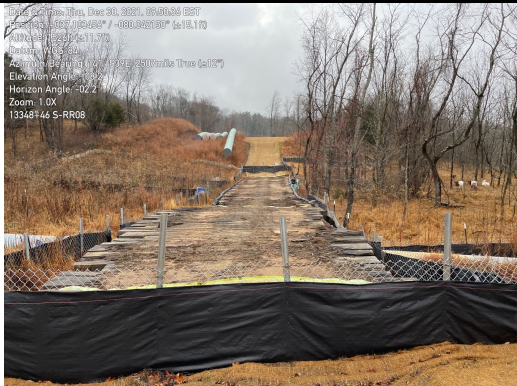
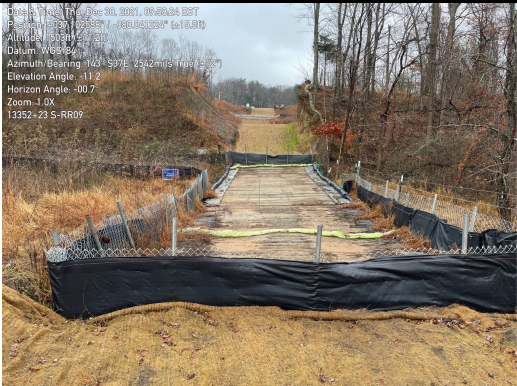
<b>GPS Location</b>	0	<b>GPS Location</b>	0		
<b>Field Station#</b>	13348+46	<b>Field Station#</b>	13352+23		
<b>Pic 9 Desc.</b>	MVP-S-RR08 and Corresponding buffer zone in good condition	<b>Pic 10 Desc.</b>	MVP-S-RR09 and Corresponding buffer zone in good condition

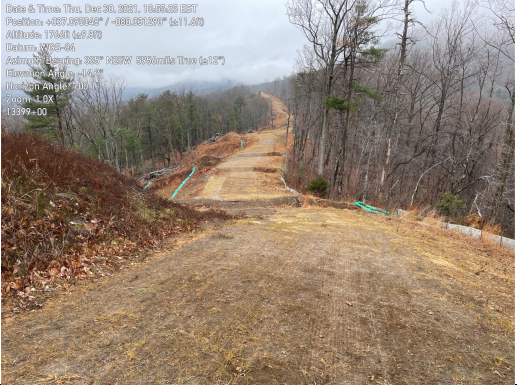
<b>GPS Location</b>	0	<b>GPS Location</b>	0		
<b>Field Station#</b>	13375+50	<b>Field Station#</b>	13399+00		
<b>Pic 13 Desc.</b>	ROW and ECDs In good condition and stable	<b>Pic 14 Desc.</b>	ROW and ECDs In good condition and stable

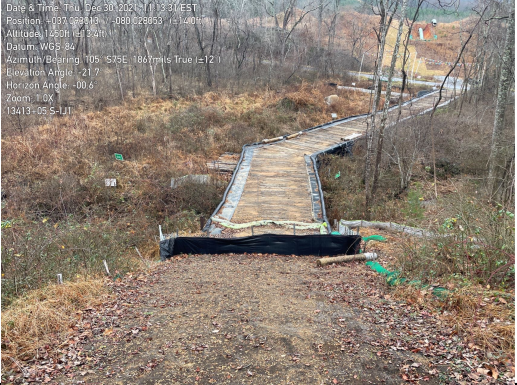
<b>GPS Location</b>	0	<b>GPS Location</b>	0		
<b>Field Station#</b>	13404+50	<b>Field Station#</b>	13413+05		
<b>Pic 15 Desc.</b>	ROW and ECDs In good condition and stable	<b>Pic 16 Desc.</b>	MVP-S-IJ1 and Corresponding buffer zone in good condition

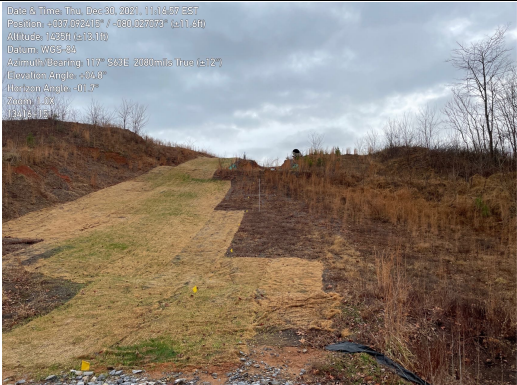
<b>GPS Location</b>	0	<b>GPS Location</b>	0		
<b>Field Station#</b>	13415+51	<b>Field Station#</b>	13416+15		
<b>Pic 17 Desc.</b>	Cahas Mountain Road Crossing in good condition	<b>Pic 18 Desc.</b>	ROW and ECDs In good condition and stable

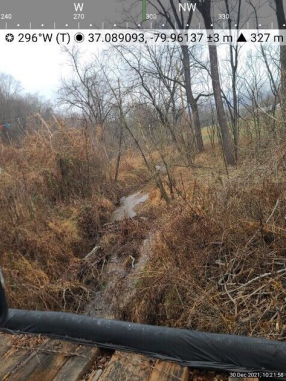
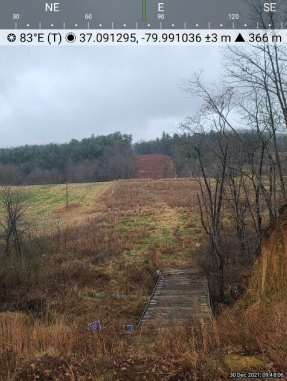
<b>GPS Location</b>	0000	<b>GPS Location</b>	0000		
<b>Field Station#</b>	13643+67	<b>Field Station#</b>	13542+00		
<b>Pic 1 Desc.</b>	Stream observation photo facing upstream during routine inspection today, no environmental issues observed at the time of inspection after overnight showers.		<b>Pic 2 Desc.</b>	Monitored equipment bridge and protection. No environmental issues observed at the time of inspection.

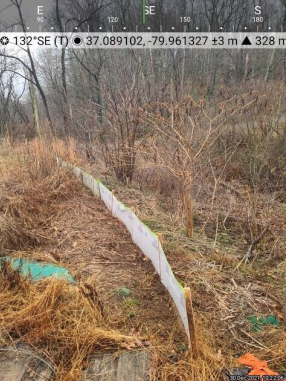
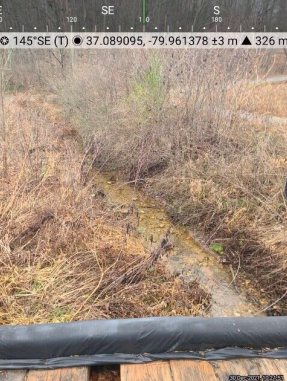
<b>GPS Location</b>	0000	<b>GPS Location</b>	0000		
<b>Field Station#</b>	13643+65	<b>Field Station#</b>	13643+67		
<b>Pic 3 Desc.</b>	Monitored ECDs at stream buffer, all up to date and functioning, no environmental issues observed at the time of inspection.		<b>Pic 4 Desc.</b>	Stream observation photo facing downstream during routine inspection today, no environmental issues observed at the time of inspection after overnight showers.

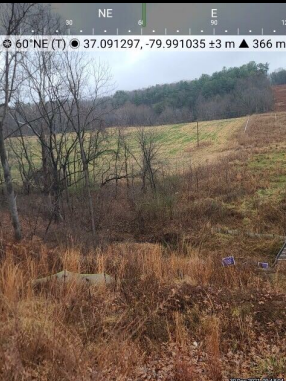
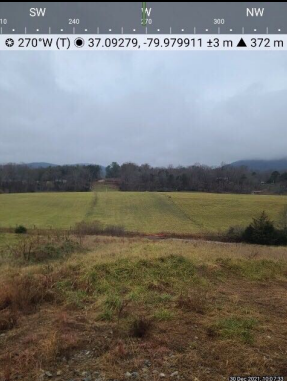
<b>GPS Location</b>	0000	<b>GPS Location</b>	0000		
<b>Field Station#</b>	13541+89	<b>Field Station#</b>	13562+82		
<b>Pic 5 Desc.</b>	Monitored ECDs and vegetation on hill side above stream crossing after overnight rain showers, no environmental issues observed at the time of inspection.		<b>Pic 6 Desc.</b>	Vegetation observation photo showing good permanent vegetation, no environmental issues observed at the time of inspection after overnight showers.

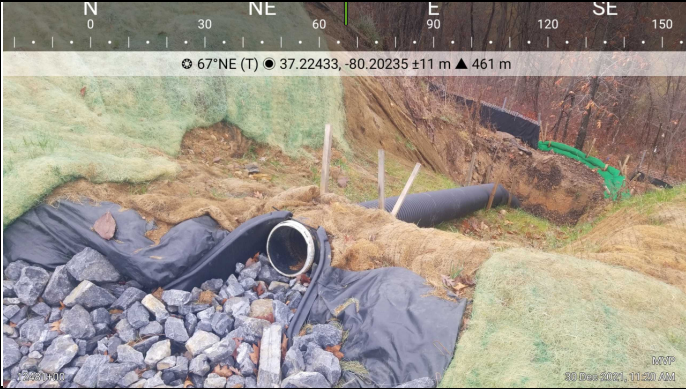
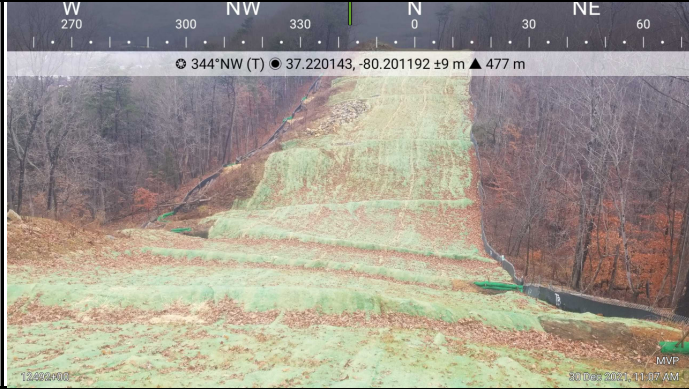
GPS Location	See Above		GPS Location	See Above	
Field Station#	12481+00		Field Station#	12492+00	
Pic 7 Desc.	ROW Overview (temporary stabilization). ECDs are functional and ROW is stable.		Pic 8 Desc.	ROW Overview (temporary stabilization). ECDs are functional and ROW is stable.

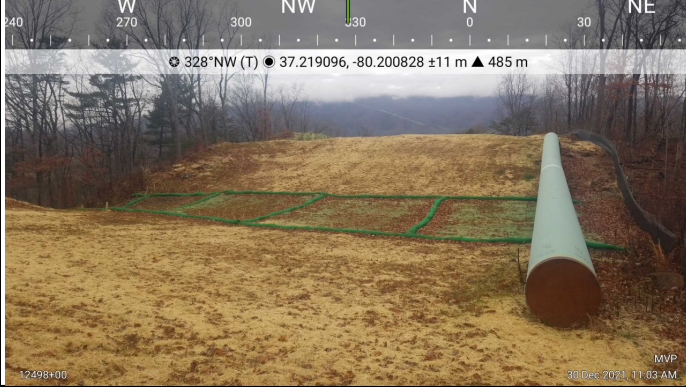
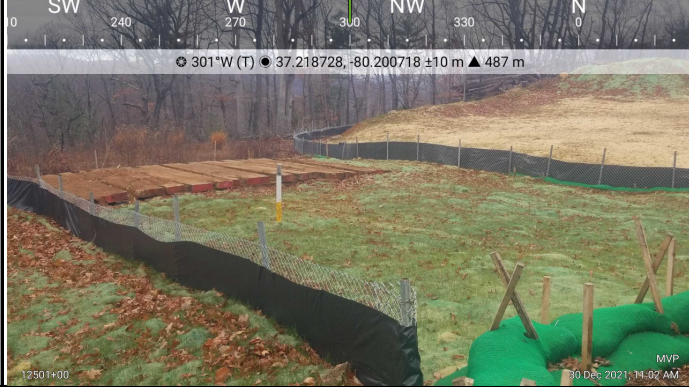
GPS Location	See Above		GPS Location	See Above	
Field Station#	12498+00		Field Station#	12501+00	
Pic 9 Desc.	ROW Overview (temporary stabilization). ECDs are functional and ROW is stable.		Pic 10 Desc.	ROW Overview (temporary stabilization). ECDs are functional and ROW is stable.

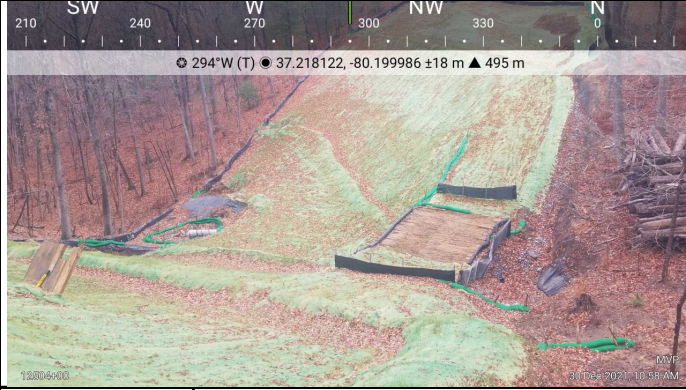
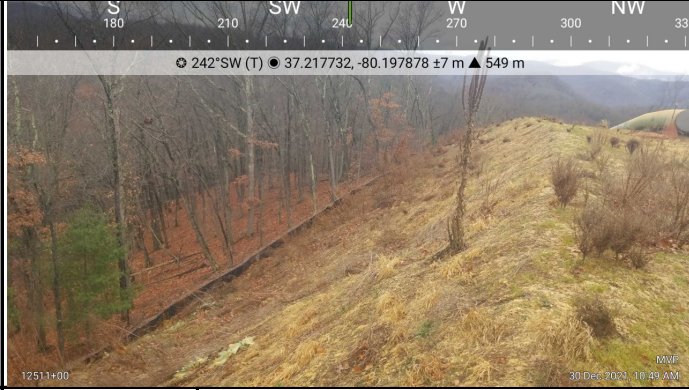
GPS Location	See Above		GPS Location	See Above	
Field Station#	12504+00		Field Station#	12511+00	
Pic 11 Desc.	ROW Overview (temporary stabilization). ECDs are functional and ROW is stable.		Pic 12 Desc.	ROW Overview (temporary stabilization). ECDs are functional and ROW is stable.

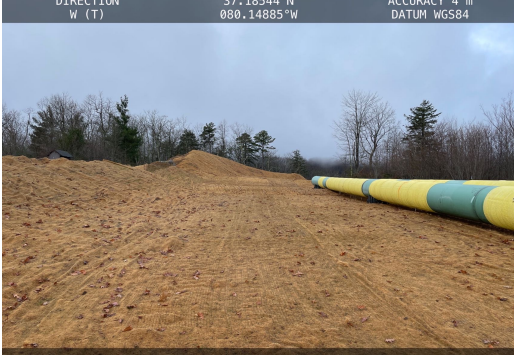
<div>12727+00</div> <div>ROW Conditions</div> <div>12/30/21, 9:04:52 AM</div> </div>		<div> <div>DIRECTION E (T)</div> <div>37.18544°N 080.14866°W</div> <div>ACCURACY 4 m DATUM WGS84</div>

<div>12729+00</div> <div>Stockpiles are stable</div> <div>12/30/21, 9:05:19 AM</div> </div>			
<b>GPS Location</b>	See photo		<b>GPS Location</b>	See photo	
<b>Field Station#</b>	12727+00		<b>Field Station#</b>	12729+00	
<b>Pic 1 Desc.</b>	Current ROW conditions. ROW is stable. ECDs are functional.		<b>Pic 2 Desc.</b>	Stockpiles are sufficiently stabilized	
<div> <div>DIRECTION S (T)</div> <div>37.18506°N 080.14854°W</div> <div>ACCURACY 8 m DATUM WGS84</div>

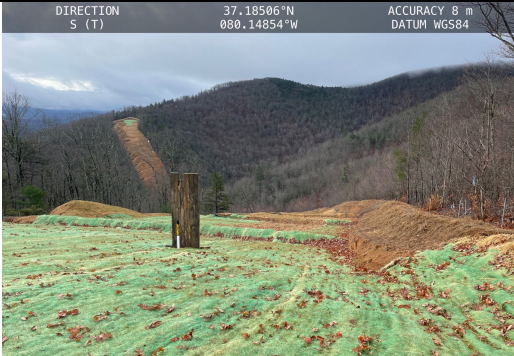
<div>12729+50</div> <div>ROW Conditions</div> <div>12/30/21, 9:05:52 AM</div> </div>		<div> <div>DIRECTION S (T)</div> <div>37.18513°N 080.14843°W</div> <div>ACCURACY 4 m DATUM WGS84</div>

<b>GPS Location</b>	See photo		<b>GPS Location</b>	See photo	
<b>Field Station#</b>	12729+50		<b>Field Station#</b>	12729+50	
<b>Pic 3 Desc.</b>	Current ROW conditions. ROW is stable. ECDs are functional.		<b>Pic 4 Desc.</b>	Perimeter controls are functional.	
<div> <div>DIRECTION S (T)</div> <div>37.18394°N 080.14935°W</div> <div>ACCURACY 5 m DATUM WGS84</div>

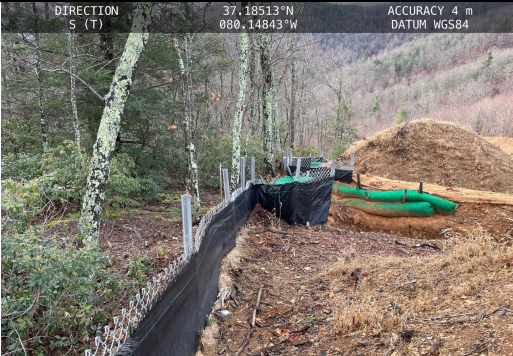
<div>12729+50</div> <div>Perimeter controls are functional</div> <div>12/30/21, 9:13:46 AM</div> </div>

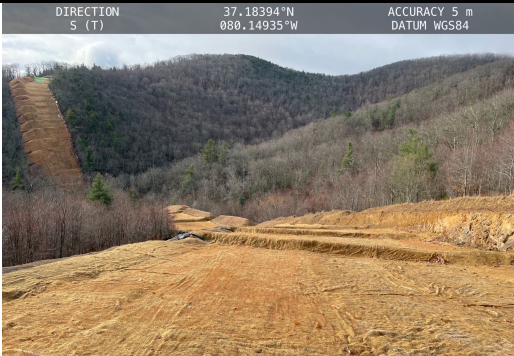
<div>12735+00</div> <div>ROW Conditions</div> <div>12/30/21, 9:17:35 AM</div> </div>		<div> <div>DIRECTION E (T)</div> <div>37.18138°N 080.14902°W</div> <div>ACCURACY 4 m DATUM WGS84</div>

<div>12743+84</div> <div>S-EF34B</div> <div>12/30/21, 9:28:19 AM</div> </div>			
<b>GPS Location</b>	See photo		<b>GPS Location</b>	See photo	
<b>Field Station#</b>	12735+00		<b>Field Station#</b>	12743+84	
<b>Pic 5 Desc.</b>	Current ROW conditions. ROW is stable. ECDs are functional.		<b>Pic 6 Desc.</b>	Downstream of crossing at Stream S-EF34B

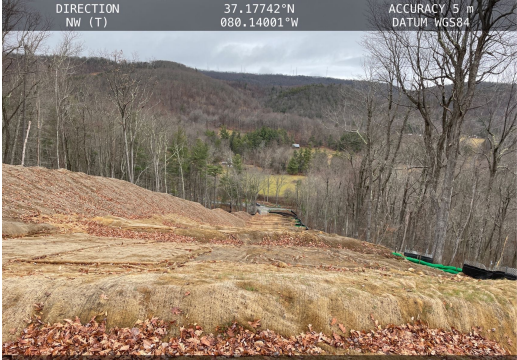
12768+30 Steep slope area 12/30/21, 10:47:36 AM		DIRECTION S (T) 37.17630°N 080.13936°W ACCURACY 4 m DATUM WGS84

12773+00 ROW Conditions 12/30/21, 10:50:16 AM			
<b>GPS Location</b>	See photo		<b>GPS Location</b>	See photo	
<b>Field Station#</b>	12768+30		<b>Field Station#</b>	12773+00	
<b>Pic 13 Desc.</b>	Steep slope area is stable. ECDs are functional		<b>Pic 14 Desc.</b>	Current ROW conditions. ROW is stable. ECDs are functional.	
DIRECTION S (T) 37.17497°N 080.13911°W ACCURACY 4 m DATUM WGS84

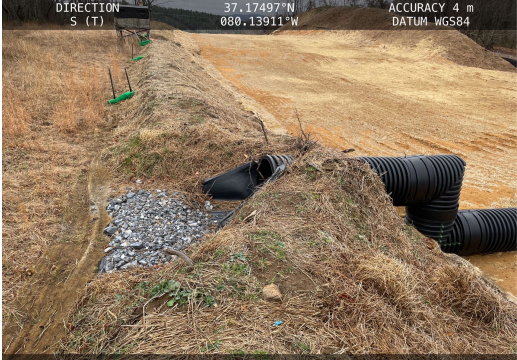
12778+00 CWD Inlet 12/30/21, 10:53:18 AM		DIRECTION S (T) 37.17412°N 080.13917°W ACCURACY 6 m DATUM WGS84

<b>Pic 15 Desc.</b>	CWD Inlet and Inlet Protection		<b>Pic 16 Desc.</b>	Current ROW conditions. ROW is stable. ECDs are functional.	
DIRECTION N (T) 37.17951°N 080.14043°W ACCURACY 5 m DATUM WGS84

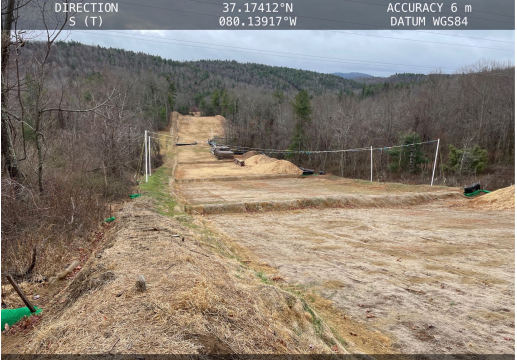
12781+00 ROW Conditions 12/30/21, 10:54:36 AM			
<b>GPS Location</b>	See photo		<b>GPS Location</b>	See photo	
<b>Field Station#</b>	12778+00		<b>Field Station#</b>	12781+00

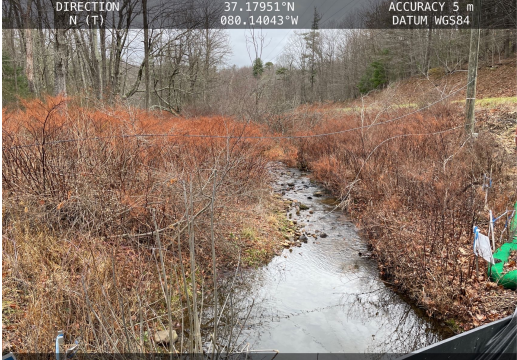
12776+52 S-EF32 12/30/21, 11:54:13 AM		DIRECTION S (T) 37.17951°N 080.14043°W ACCURACY 5 m DATUM WGS84

12776+52 S-EF32 12/30/21, 11:54:19 AM			
<b>GPS Location</b>	See photo		<b>GPS Location</b>	See photo	
<b>Field Station#</b>	12776+52		<b>Field Station#</b>	12776+52	
<b>Pic 17 Desc.</b>	Upstream of crossing at Stream S-EF32		<b>Pic 18 Desc.</b>	Downstream of crossing at Stream S-EF32

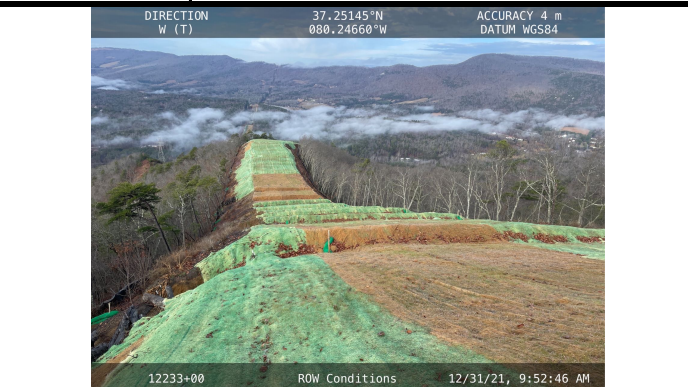
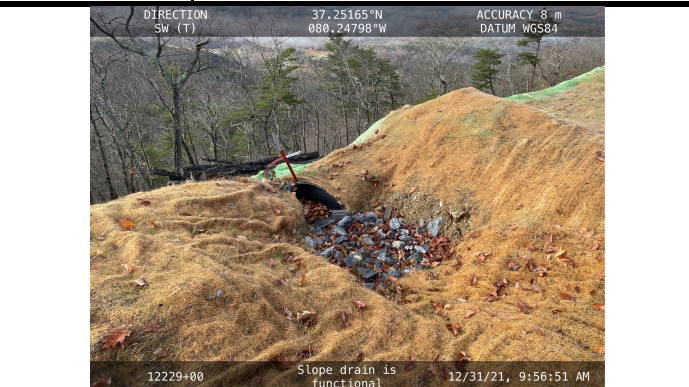
GPS Location	See photo		GPS Location	See photo	
Field Station#	12233+00		Field Station#	12229+00	
Pic 5 Desc.	Current ROW conditions. ROW is stable. ECDs are functional.		Pic 6 Desc.	Slope Drain inlet protection is functional

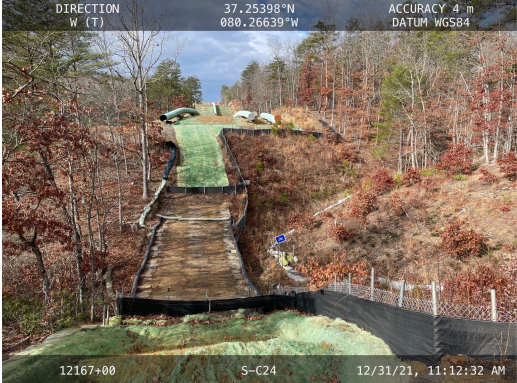
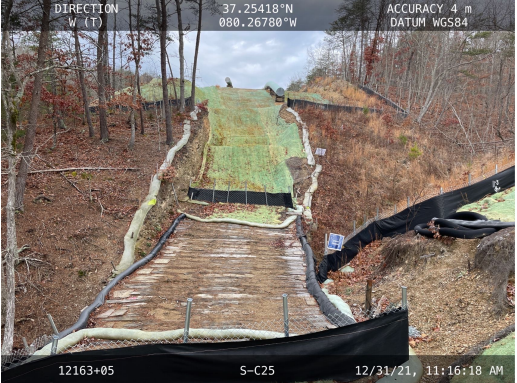
<b>GPS Location</b>	See photo		<b>GPS Location</b>	See photo	
<b>Field Station#</b>	12167+00		<b>Field Station#</b>	12163+00	
<b>Pic 13 Desc.</b>	Equipment Bridge over Stream S-C24		<b>Pic 14 Desc.</b>	Equipment Bridge over Stream S-C5

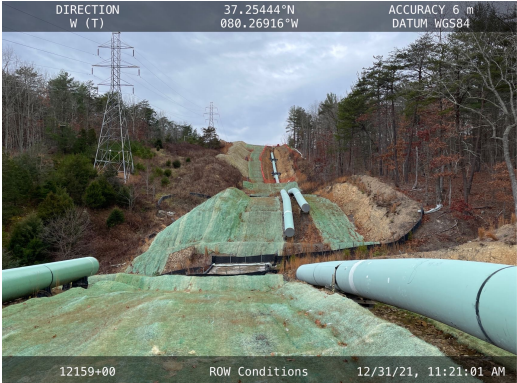
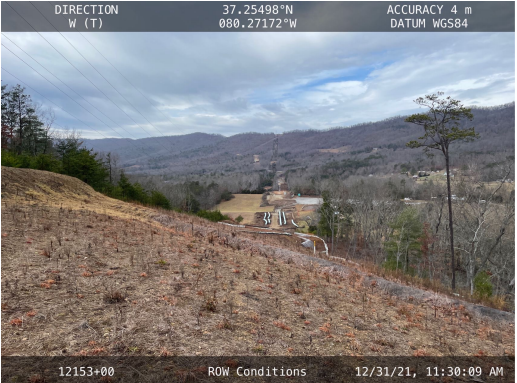
<b>GPS Location</b>	See photo		<b>GPS Location</b>	See photo	
<b>Field Station#</b>	12159+00		<b>Field Station#</b>	12153+00	
<b>Pic 15 Desc.</b>	Current ROW conditions. ROW is stable. ECDs are functional.		<b>Pic 16 Desc.</b>	Current ROW conditions. ROW is stable. ECDs are functional.

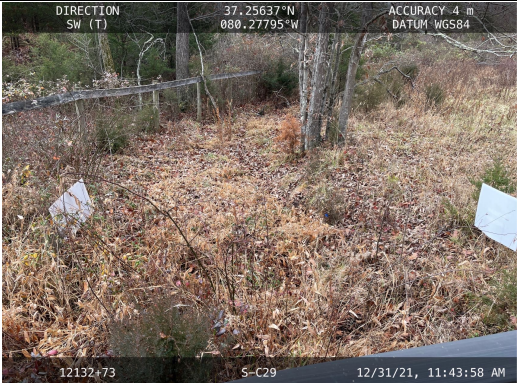
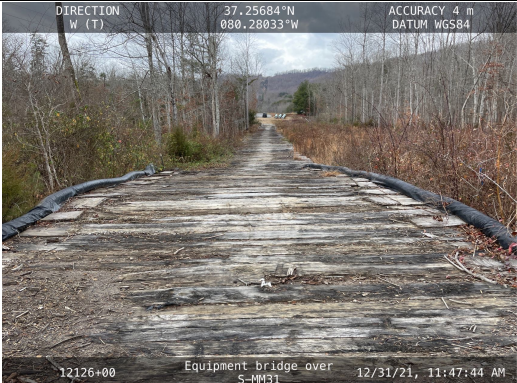
<b>GPS Location</b>	See photo		<b>GPS Location</b>	See photo	
<b>Field Station#</b>	12132+73		<b>Field Station#</b>	12126+00	
<b>Pic 17 Desc.</b>	Downstream of crossing at Stream S-C29		<b>Pic 18 Desc.</b>	Equipment bridge over Stream S-MM31
