Visual Site Inspection Report

Project Name	H-600 Pipeline Spread H	AFE	124300138	Spread	H-600 Pipeline Spread H
Contractor	Precision			Report #	34344
Inspector	Pat Davis			Date/Time	2/14/2022 4:00 PM
Permit #	TBD	Inspection Type	VA SWPP	Station Begin	+0
State	VA	Inspection Area	Partial	Station End	+0
County	Montgomery	Ground	Frozen	Temperature (°F)	23.00
Municipality	N/A	Weather	Cloudy	Rain Gauge (in)	0.00
				Rain Accumulation Time (days)	0.00

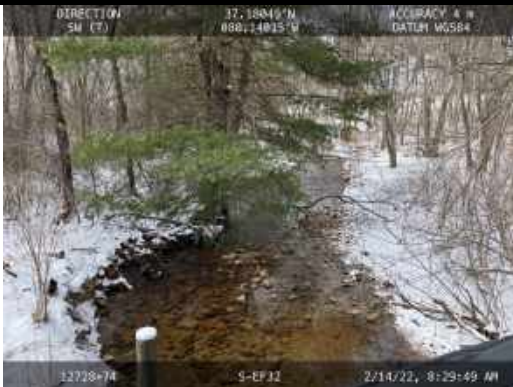
GPS Location	See photo		GPS Location	See photo	
Field Station#	12728+74		Field Station#	12728+74	
Pic 1 Desc.	Downstream of crossing at Stream S-EF32		Pic 2 Desc.	Upstream of crossing at Stream S-EF32

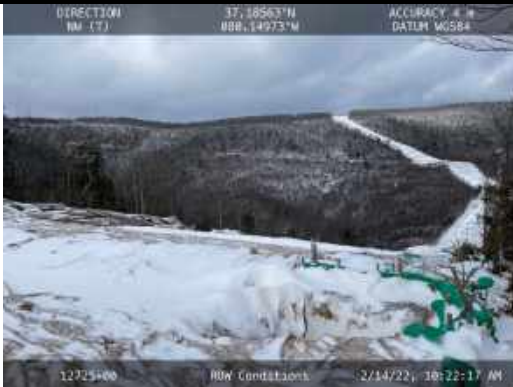
GPS Location	See photo		GPS Location	See photo	
Field Station#	12725+00		Field Station#	12726+00	
Pic 3 Desc.	Current ROW conditions. ROW is stable. ECDs are functional.		Pic 4 Desc.	Stockpile is stabilized

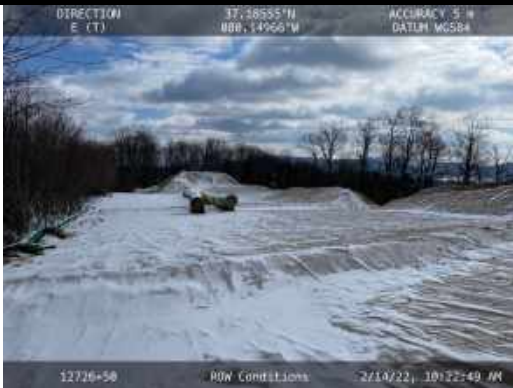
GPS Location	See photo		GPS Location	See photo	
Field Station#	12726+50		Field Station#	12728+00	
Pic 5 Desc.	Current ROW conditions. ROW is stable. ECDs are functional.		Pic 6 Desc.	Sump and End Treatment are functional

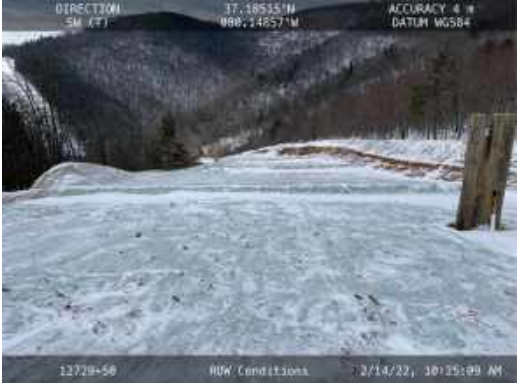
GPS Location	See photo		GPS Location	See photo	
Field Station#	12729+00		Field Station#	12736+00	
Pic 7 Desc.	Current ROW conditions. ROW is stable. ECDs are functional.		Pic 8 Desc.	Slope drain is functional. Fill slope is stable

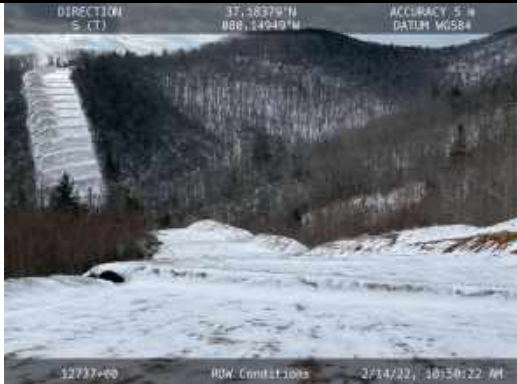
GPS Location	See photo		GPS Location	See photo	
Field Station#	12737+00		Field Station#	12743+00	
Pic 9 Desc.	Current ROW conditions. ROW is stable. ECDs are functional.		Pic 10 Desc.	Current ROW conditions. ROW is stable. ECDs are functional.

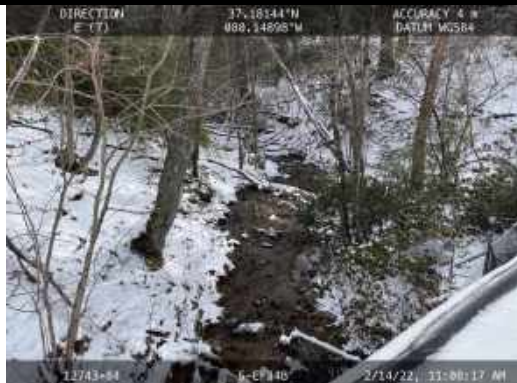
GPS Location	See photo		GPS Location	See photo	
Field Station#	12743+84		Field Station#	12743+84	
Pic 11 Desc.	Downstream of crossing at Stream S-EF34B		Pic 12 Desc.	Equipment bridge over Stream S-EF34B

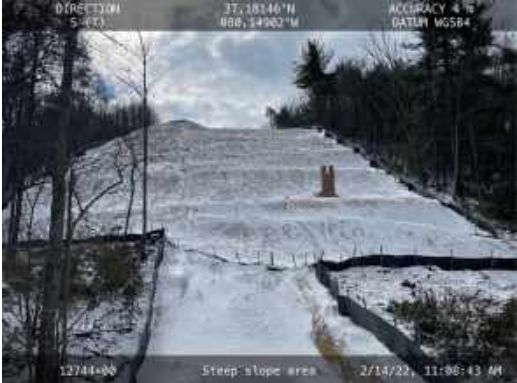
GPS Location	See photo		GPS Location	See photo	
Field Station#	12744+00		Field Station#	12773+00	
Pic 13 Desc.	Current ROW conditions. ROW is stable. ECDs are functional.		Pic 14 Desc.	Current ROW conditions. ROW is stable. ECDs are functional.

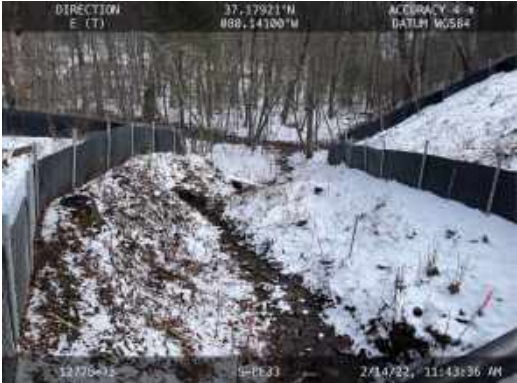
GPS Location	See photo		GPS Location	See photo	
Field Station#	12776+75		Field Station#	12776+75	
Pic 15 Desc.	Downstream of crossing at Stream S-EF33		Pic 16 Desc.	Upstream of crossing at Stream S-EF33

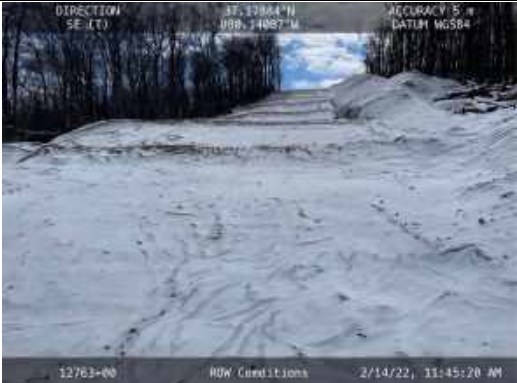
GPS Location	See photo		GPS Location	See photo	
Field Station#	12763+00		Field Station#	12765+00	
Pic 17 Desc.	Current ROW conditions. ROW is stable. ECDs are functional.		Pic 18 Desc.	Sump and End Treatment are functional.

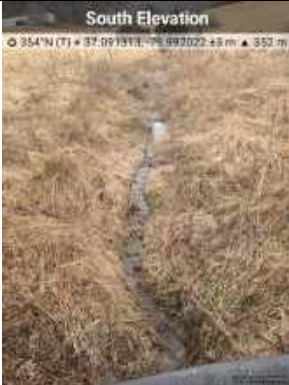
GPS Location	00000	GPS Location	00000		
Field Station#	13539+28	Field Station#	13539+28		
Pic 1 Desc.	Stream observation photo facing upstream during routine inspection today, no environmental issues observed at the time of inspection.		Pic 2 Desc.	Stream observation photo facing downstream during routine inspection today, no environmental issues observed at the time of inspection.

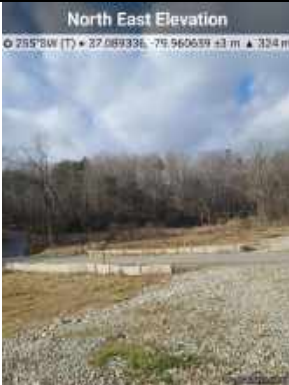
GPS Location	00000	GPS Location	00000		
Field Station#	13644+52	Field Station#	13539+28		
Pic 3 Desc.	Monitored RCEs and ECDs at road crossings, all functioning at the time of inspection.		Pic 4 Desc.	Monitored equipment bridge at stream/wetland crossing, no environmental issues observed at the time of inspection.

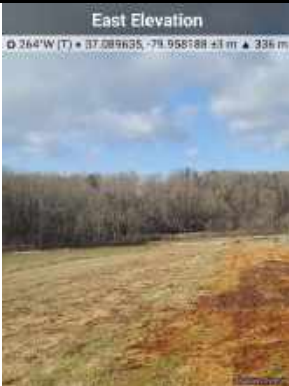
GPS Location	00000	GPS Location	00000		
Field Station#	13650+00	Field Station#	13656+63		
Pic 5 Desc.	Row photo showing vegetation, no environmental issues observed at the time of inspection.		Pic 6 Desc.	Row photo showing vegetation and ECDs along the row edge.

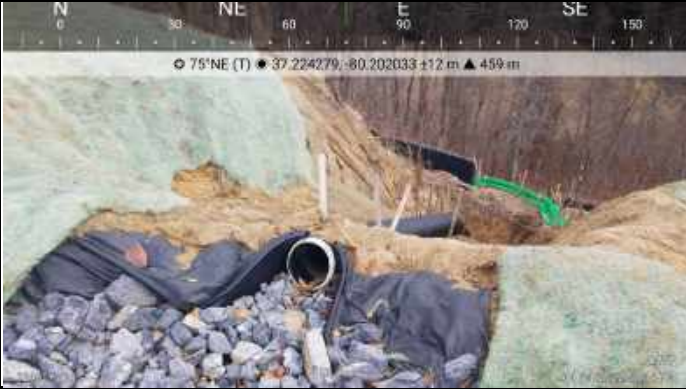
GPS Location	See Above		GPS Location	See Above	
Field Station#	12481+00		Field Station#	12488+00	
Pic 7 Desc.	ROW Overview (temporary stabilization). ECDs are functional and ROW is stable.		Pic 8 Desc.	ROW Overview (temporary stabilization). ECDs are functional and ROW is stable.

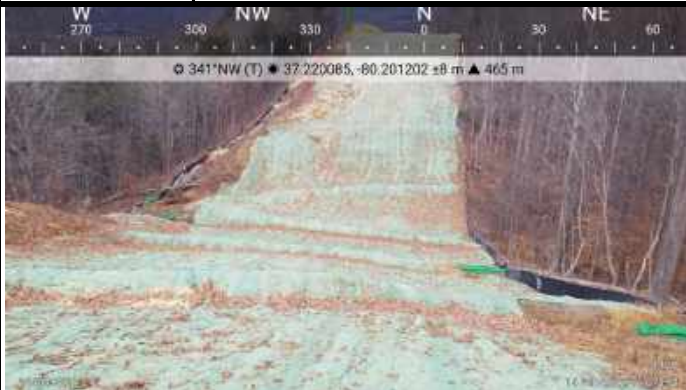
GPS Location	See Above		GPS Location	See Above	
Field Station#	12494+00		Field Station#	12498+00	
Pic 9 Desc.	ROW Overview (temporary stabilization). ECDs are functional and ROW is stable.		Pic 10 Desc.	ROW Overview (temporary stabilization). ECDs are functional and ROW is stable.

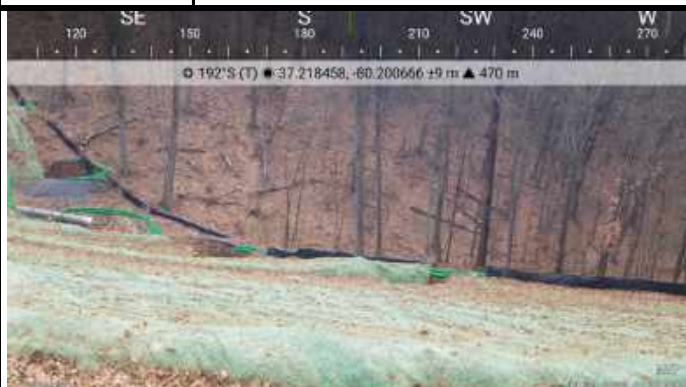
GPS Location	See Above		GPS Location	See Above	
Field Station#	12503+00		Field Station#	12504+00	
Pic 11 Desc.	ROW Overview (temporary stabilization). ECDs are functional and ROW is stable.		Pic 12 Desc.	ROW Overview (temporary stabilization). ECDs are functional and ROW is stable.

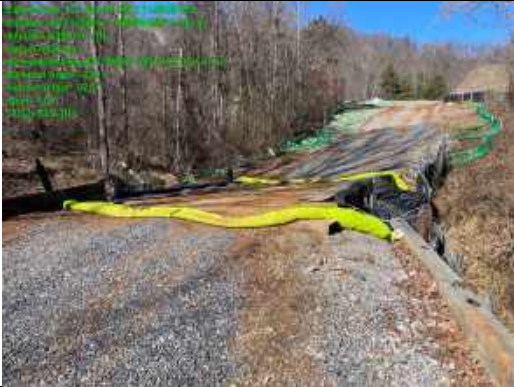
GPS Location	0	GPS Location	0		
Field Station#	13141+53	Field Station#	13144+00		
Pic 1 Desc.	MVP-S-D14 and corresponding buffer zone in good condition	Pic 2 Desc.	ROW and ECDs in good condition and stable

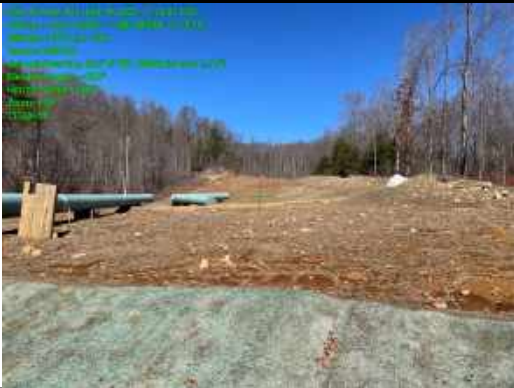
GPS Location	0	GPS Location	0		
Field Station#	13148+50	Field Station#	13154+00		
Pic 5 Desc.	ROW and ECDs in good condition and stable	Pic 6 Desc.	Slope drain pipe in good condition and functioning properly

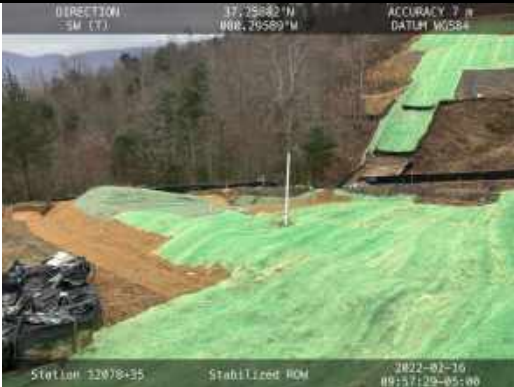
GPS Location	Please see photo for details.		GPS Location	Please see photo for details.	
Field Station#	12078+35		Field Station#	12108+41	
Pic 1 Desc.	Photo shows stabilized ROW conditions with installed water bars going to sump pit equipped with end treatment.		Pic 2 Desc.	Photo shows downstream of Stream S-F15 from equipment bridge.

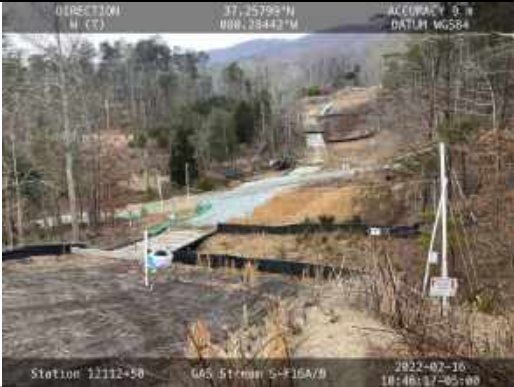
GPS Location	Please see photo for details.		GPS Location	Please see photo for details.	
Field Station#	12112+50		Field Station#	12093+00	
Pic 3 Desc.	Photo shows the stabilized ROW conditions with water bars and that all ECDs are installed and are functioning as designed.		Pic 4 Desc.	Photo shows clean water diversion pipe routed into a plunge pit.

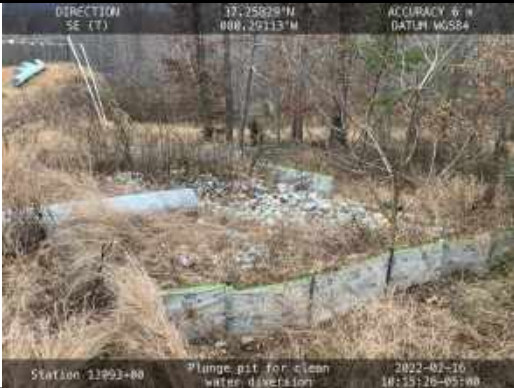
Pic 5 Desc.	Photo shows plunge pit for clean water diversion pipe.		Pic 6 Desc.	Photo shows permanent water bars with level spreaders installed and functioning as designed.

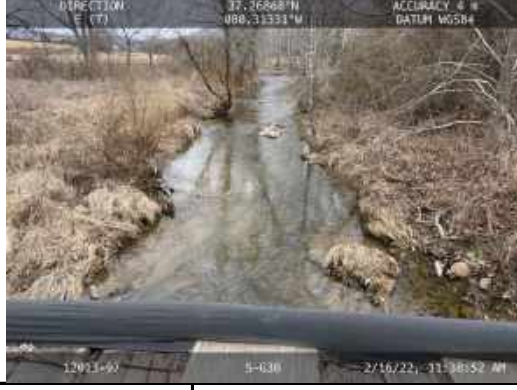
Pic 11 Desc.	Photo shows downstream view of Stream S-G36 from equipment bridge.		Pic 12 Desc.	Photo shows the stabilized ROW conditions with water bars and that all ECDs are installed and are functioning as designed.

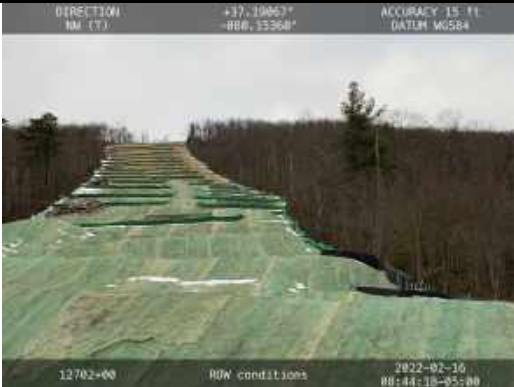
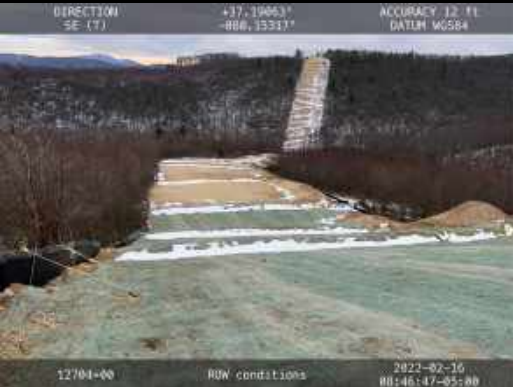
GPS Location	See photo for gps location data.		GPS Location	See photo for gps location data.	
Field Station#	12702+00		Field Station#	12704+00	
Pic 1 Desc.	Photo shows the ROW condition. ECDs are installed and functioning as designed.		Pic 2 Desc.	Photo shows the ROW condition. ECDs are installed and functioning as designed.

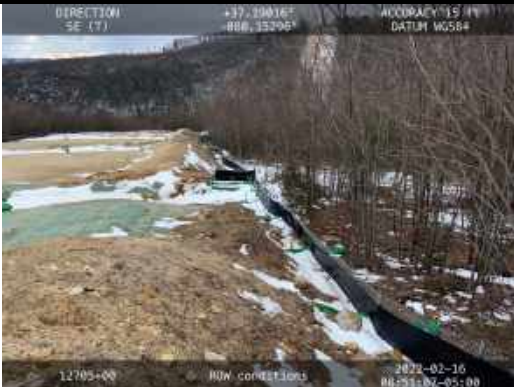
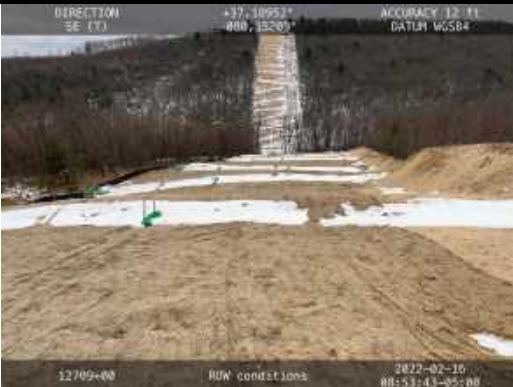
GPS Location	See photo for gps location data.		GPS Location	See photo for gps location data.	
Field Station#	12705+00		Field Station#	12709+00	
Pic 3 Desc.	Photo shows the ROW condition. ECDs are installed and functioning as designed.		Pic 4 Desc.	Photo shows the ROW condition. ECDs are installed and functioning as designed.

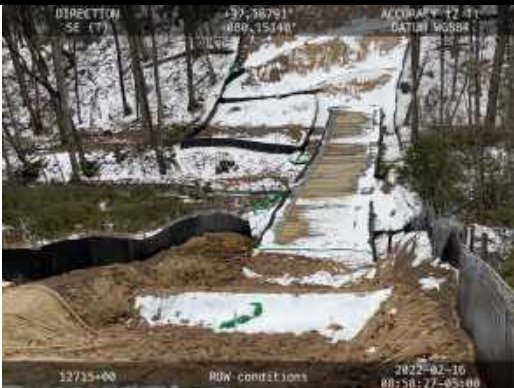
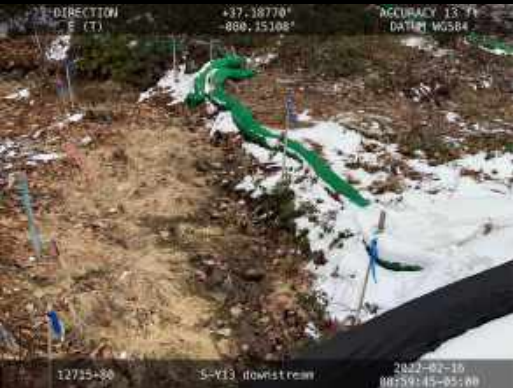
GPS Location	See photo for gps location data.		GPS Location	See photo for gps location data.	
Field Station#	12715+00		Field Station#	12715+80	
Pic 5 Desc.	Photo shows the bridge over stream S-Y13 and S-Y14.		Pic 6 Desc.	Photo shows stream S-Y13 downstream from the bridge.

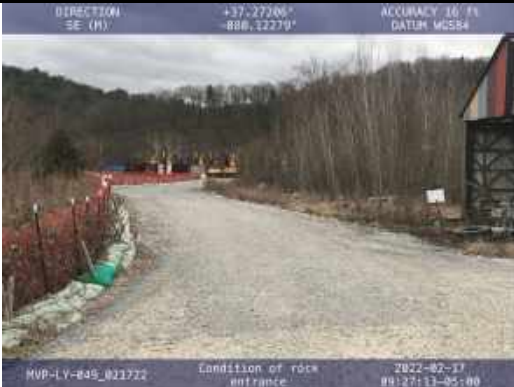
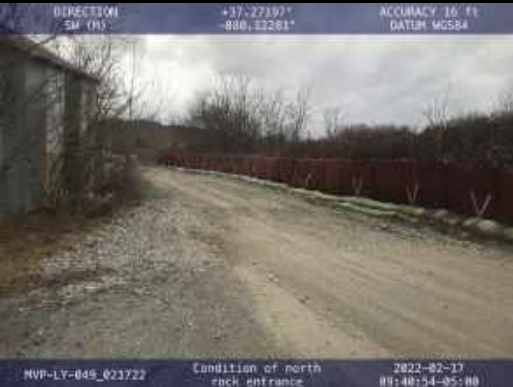
GPS Location	MVP-LY-049 See photo for gps data		GPS Location	MVP-LY-049 See photo for gps data	
Field Station#	+0		Field Station#	+0	
Pic 1 Desc.	Condition of rock entrance on center drive. Looking SE.		Pic 2 Desc.	Condition of rock entrance on north drive. Looking SW.

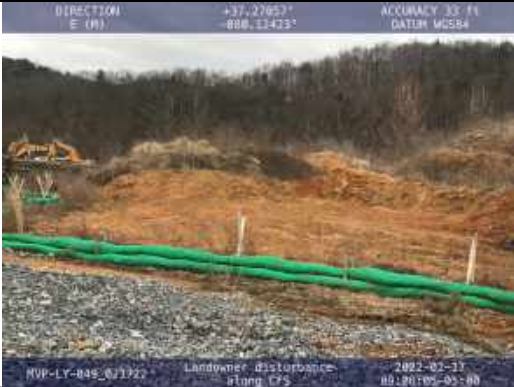
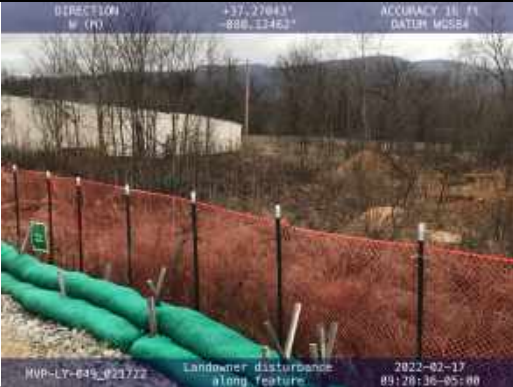
GPS Location	MVP-LY-049 See photo for gps data		GPS Location	MVP-LY-049 See photo for gps data	
Field Station#	+0		Field Station#	+0	
Pic 3 Desc.	Landowner soil disturbance along triple stack compost filter sock. No new damage to installed ECD's. Looking S.		Pic 4 Desc.	Landowner soil disturbance along feature W-CV21A. Area not stabilized. Looking NW.

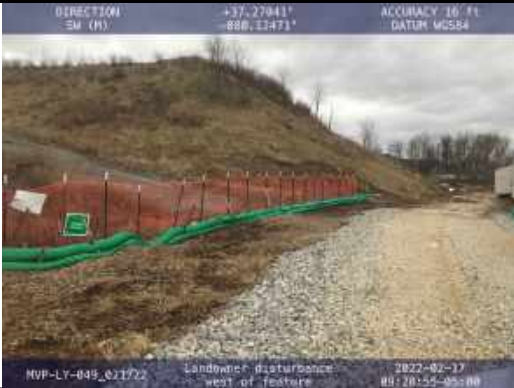
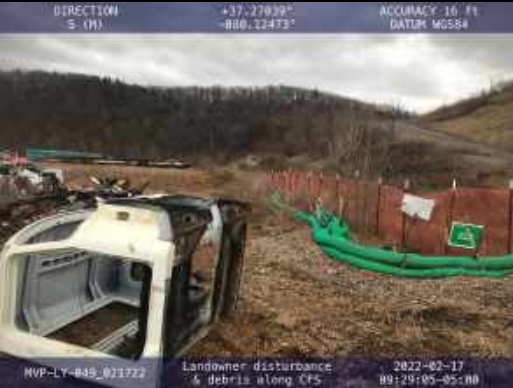
GPS Location	MVP-LY-049 See photo for gps data		GPS Location	MVP-LY-049 See photo for gps data	
Field Station#	+0		Field Station#	+0	
Pic 5 Desc.	Landowner soil disturbance west of feature W-CV21B. Areas not stabilized. Looking SW.		Pic 6 Desc.	Landowner soil disturbance and debris piled along triple stack compost filter sock and east of feature W-CV21B. Looking S.

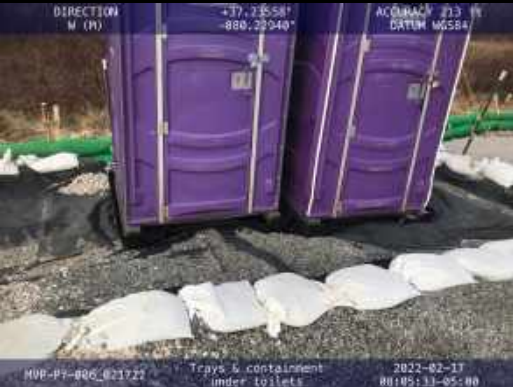
GPS Location	MVP-PY-006 See photo for gps data		GPS Location	MVP-PY-006 See photo for gps data	
Field Station#	+0		Field Station#	+0	
Pic 1 Desc.	Status of spoil pile adjacent to LOD. Soil pile not stabilized. Looking S.		Pic 2 Desc.	Trays and containment under toilets. Trays holding fluids. Looking W.

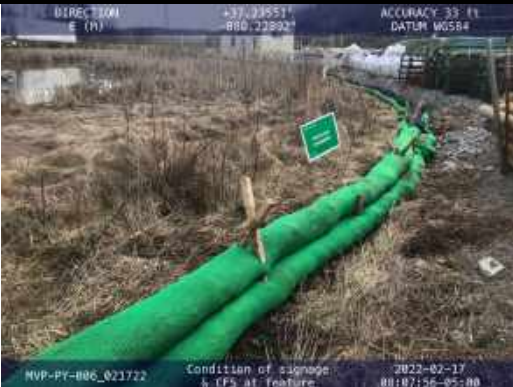
GPS Location	MVP-PY-006 See photo for gps data		GPS Location	MVP-PY-006 See photo for gps data	
Field Station#	+0		Field Station#	+0	
Pic 3 Desc.	Condition of triple stack compost filter sock along north LOD. Looking E.		Pic 4 Desc.	Condition of signage and triple stack compost filter sock along feature W-008. Looking E.

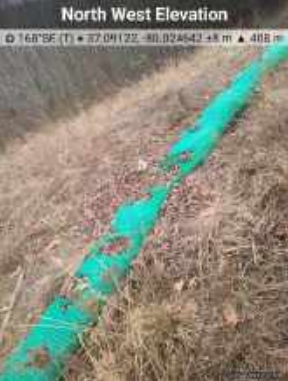
GPS Location	00000	GPS Location	00000		
Field Station#	13423+70	Field Station#	13425+01		
Pic 1 Desc.	CFS requires maintenance due to being weathered and torn, documented and added to the punch list.		Pic 2 Desc.	Observed stream crossing and ECDs , all in place and functioning, no environmental issues observed at the time of inspection.

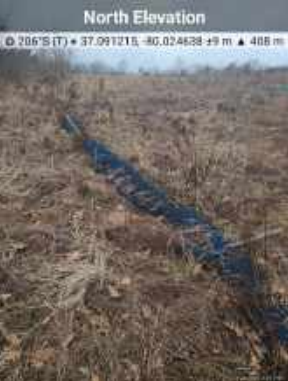
GPS Location	0000	GPS Location	0000		
Field Station#	13424+20	Field Station#	13465+20		
Pic 3 Desc.	CFS requires maintenance due to being weathered and torn, documented and added to the punch list.		Pic 4 Desc.	Monitored ECDs along the edge of the LOD, no environmental issues observed at the time of inspection.

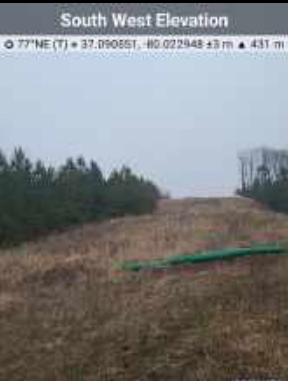
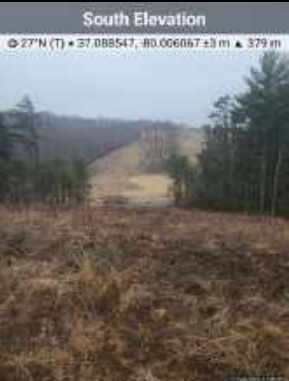
GPS Location	0000	GPS Location	0000		
Field Station#	13430+00	Field Station#	13491+00		
Pic 5 Desc.	Monitored level spreaders and water bars, ECDs in place and functioning at the time of inspection.		Pic 6 Desc.	Row photo showing vegetation above road crossing at CAHAS#2, no environmental issues observed at the time of inspection.

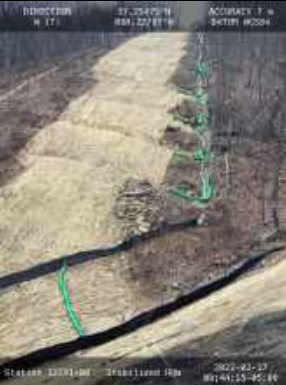
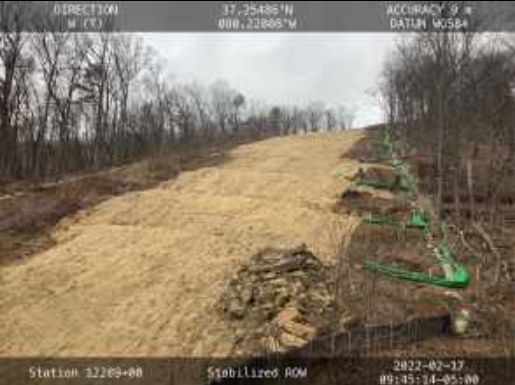
GPS Location	Please see photo for details.		GPS Location	Please see photo for details.	
Field Station#	12291+00		Field Station#	12289+00	
Pic 1 Desc.	Photo shows the stabilized ROW conditions with water bars and that all ECDs are installed and are functioning as designed.		Pic 2 Desc.	Photo shows the stabilized ROW conditions with water bars and that all ECDs are installed and are functioning as designed.

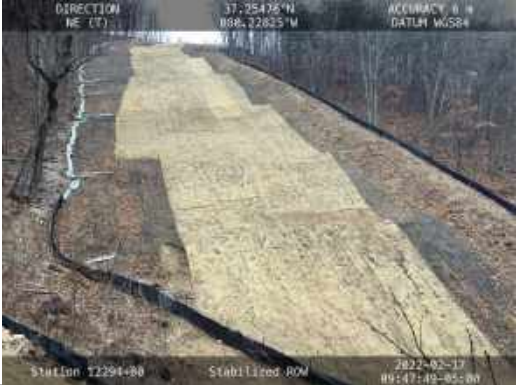
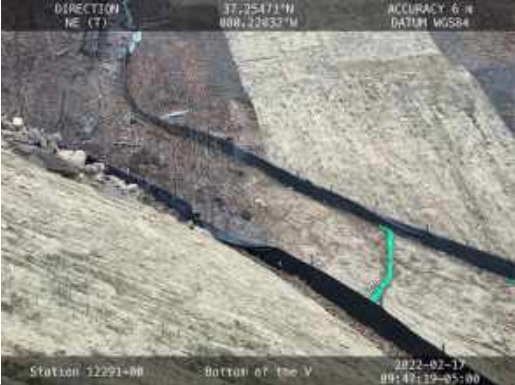
GPS Location	Please see photo for details.		GPS Location	Please see photo for details.	
Field Station#	12994+00		Field Station#	12310+00	
Pic 3 Desc.	Photo shows the stabilized ROW conditions with water bars and that all ECDs are installed and are functioning as designed.		Pic 4 Desc.	Photo shows the stabilized ROW conditions and punch list item of super silt fence down due to windy weather conditions.

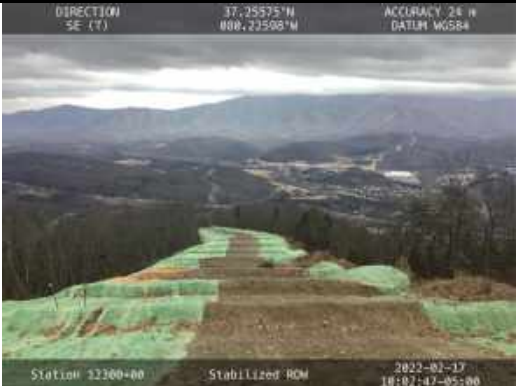
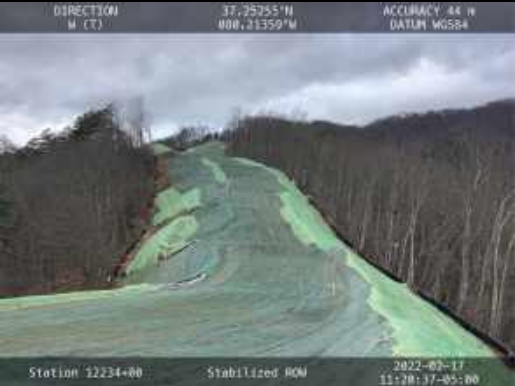
GPS Location	Please see photo for details.		GPS Location	Please see photo for details.	
Field Station#	12300+00		Field Station#	12234+00	
Pic 5 Desc.	Photo shows the stabilized ROW conditions with water bars and that all ECDs are installed and are functioning as designed.		Pic 6 Desc.	Photo shows the stabilized ROW conditions with water bars and that all ECDs are installed and are functioning as designed.

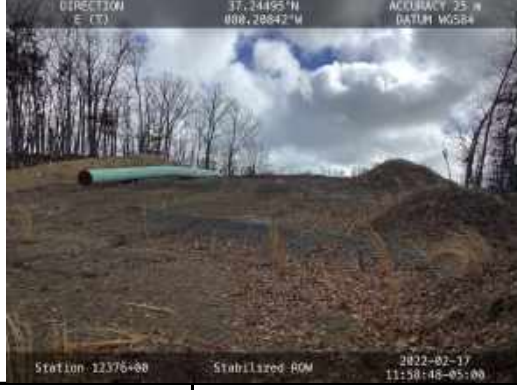
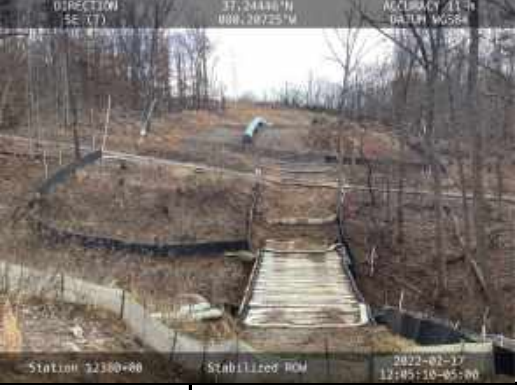
Field Station#	12376+00		Field Station#	12380+00	
Pic 11 Desc.	Photo shows the stabilized ROW conditions with water bars and that all ECDs are installed and are functioning as designed.		Pic 12 Desc.	Photo shows the stabilized ROW conditions with water bars and that all ECDs are installed and are functioning as designed.

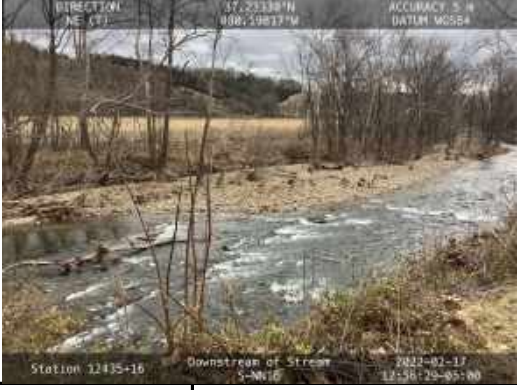
Pic 17 Desc.	Photo shows the stabilized ROW conditions with water bars and that all ECDs are installed and are functioning as designed.		Pic 18 Desc.	Photo shows downstream view of Stream S-NN16 from stream bank.

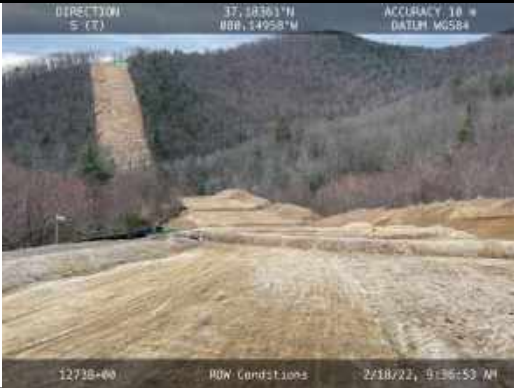
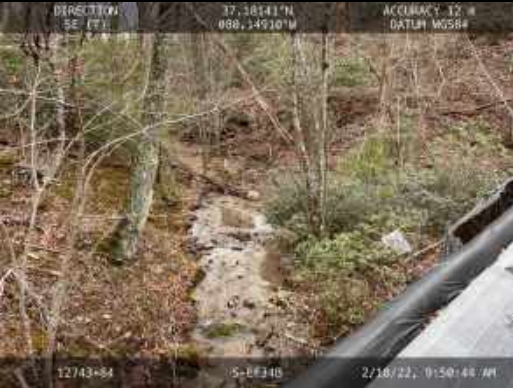
GPS Location	See photo		GPS Location	See photo	
Field Station#	12738+00		Field Station#	12743+84	
Pic 5 Desc.	Current ROW conditions. ROW is stable. ECDs are functional.		Pic 6 Desc.	Downstream of crossing at Stream S-EF34B

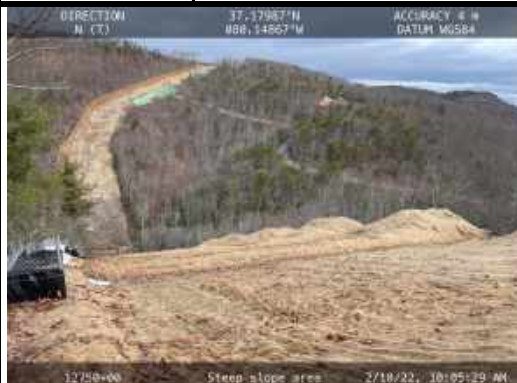
GPS Location	See photo		GPS Location	See photo	
Field Station#	12750+00		Field Station#	12754+00	
Pic 11 Desc.	Current ROW conditions. ROW is stable. ECDs are functional.		Pic 12 Desc.	Slope Drain Stone Inlet Protection is maintained and functional.

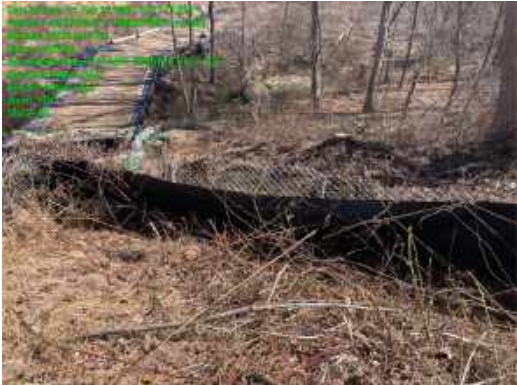
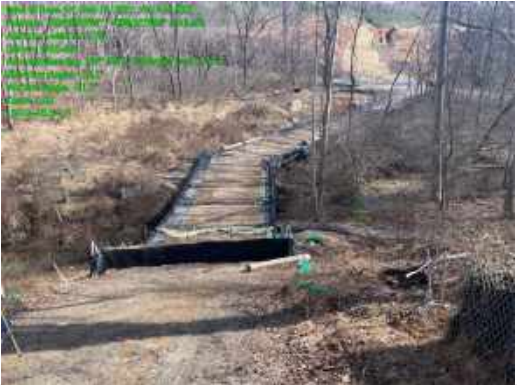
GPS Location	0	GPS Location	0		
Field Station#	13412+50	Field Station#	13413+05		
Pic 15 Desc.	Repair fence fabric - 72 hour maintenance item	Pic 16 Desc.	MVP-S-IJ1 and corresponding buffer zone in good condition

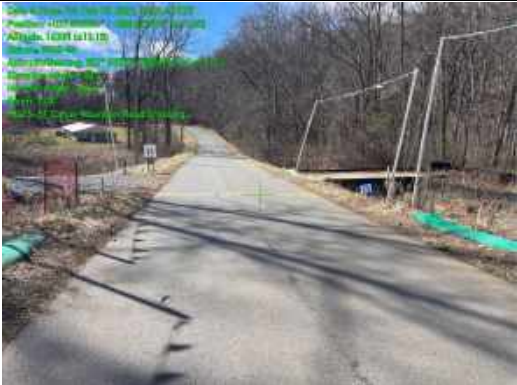
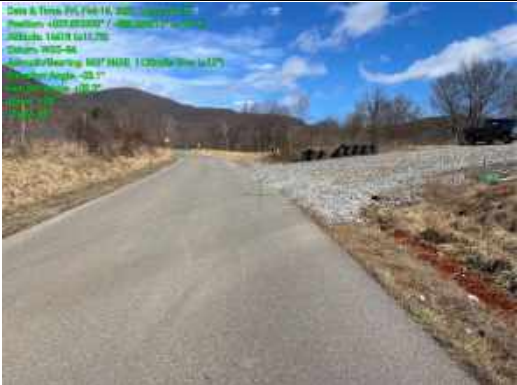
GPS Location	0	GPS Location	0		
Field Station#	13415+51	Field Station#	13422+00		
Pic 17 Desc.	Cahas Mountain Road Crossing in good condition	Pic 18 Desc.	Remove stone from road - 72 hour maintenance item

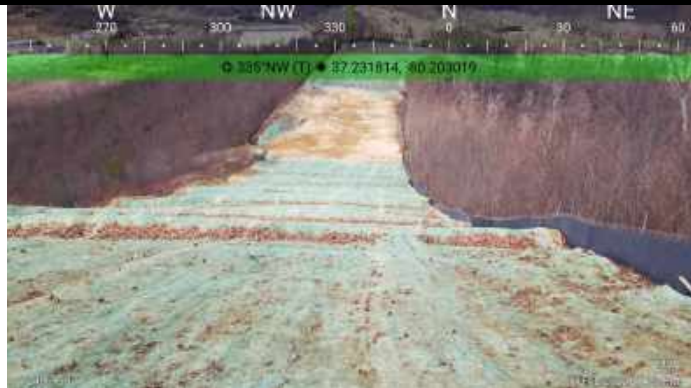
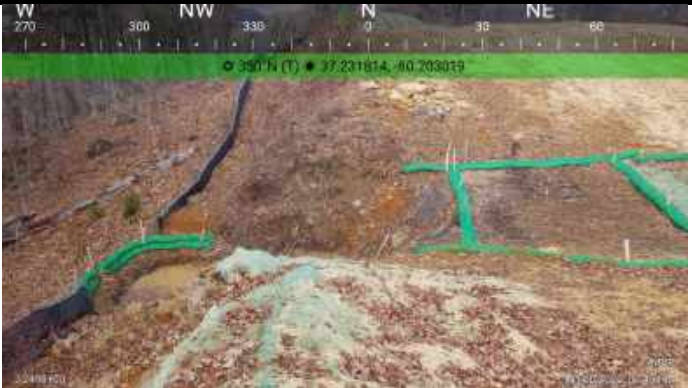
GPS Location	See Above	GPS Location	See Above		
Field Station#	12486+00	Field Station#	12498+00		
Pic 5 Desc.	ROW Overview (temporary stabilization). ECDs are functional and ROW is stable.	Pic 6 Desc.	ROW Overview (temporary stabilization). ECDs are functional and ROW is stable.

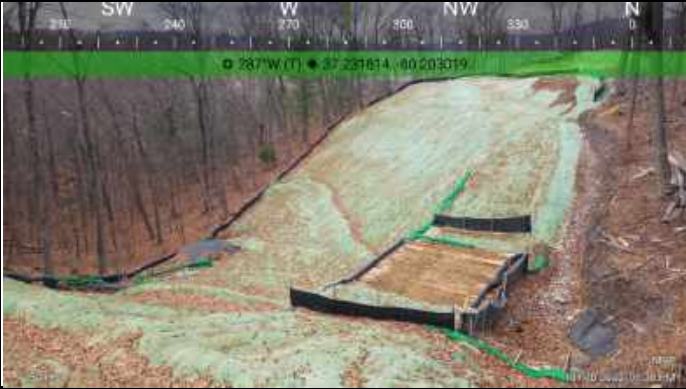
GPS Location	See Above		GPS Location	See Above	
Field Station#	12504+00		Field Station#	12505+00	
Pic 7 Desc.	ROW Overview (temporary stabilization). ECDs are functional and ROW is stable.		Pic 8 Desc.	ROW Overview (temporary stabilization). ECDs are functional and ROW is stable.

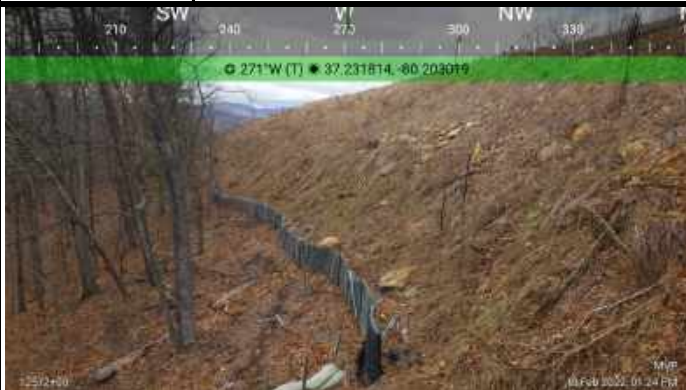
GPS Location	See Above		GPS Location	See Above	
Field Station#	12512+00		Field Station#	12513+00	
Pic 9 Desc.	ROW Overview (temporary stabilization). ECDs are functional and ROW is stable.		Pic 10 Desc.	ROW Overview (temporary stabilization). ECDs are functional and ROW is stable.

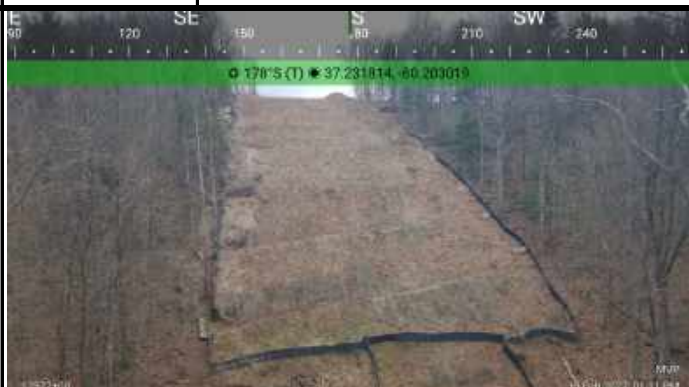
GPS Location	See Above		GPS Location	See Above	
Field Station#	12519+41		Field Station#	12522+00	
Pic 11 Desc.	Overview of Waterbody S-EF19. ECDs are functional and ROW is stable.		Pic 12 Desc.	ROW Overview (temporary stabilization). ECDs are functional and ROW is stable.
