Visual Site Inspection Report

| Project Name | H-600 Pipeline Spread H | AFE | 124300138 | Spread | H-600 Pipeline Spread H |
| Contractor | Precision | | | Report # | 34937 |
| Inspector | Jordan Davis | | | Date/Time | 2/28/2022 3:34 PM |

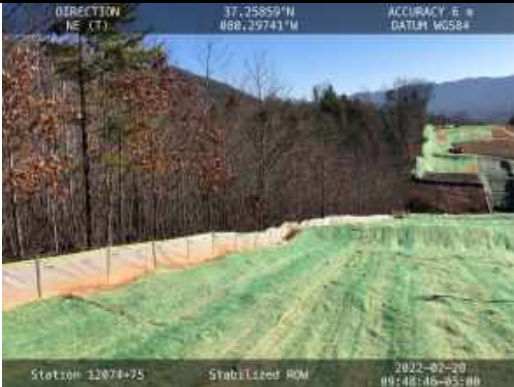
| Field Station# | 12074+75 | | Field Station# | 12080+00 | |

| Pic 1 Desc. | Photo shows the stabilized ROW conditions with water bars and that all ECDs are installed and are functioning as designed. | | Pic 2 Desc. | Photo shows the stabilized ROW conditions with water bars and that all ECDs are installed and are functioning as designed. | |

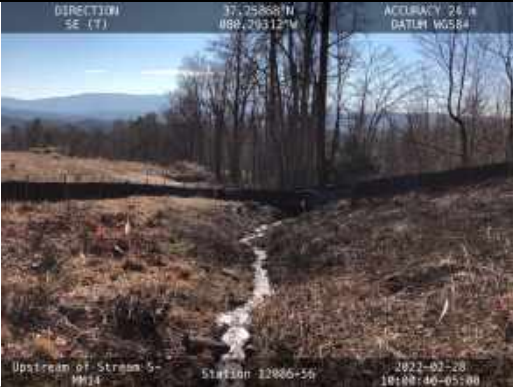
| Field Station# | 12093+00 | | Field Station# | 12086+56 | |

| Pic 3 Desc. | Photo shows clean water diversion pipe leading to plunge pool. | | Pic 4 Desc. | Photo shows upstream of Stream S-MM14 | |

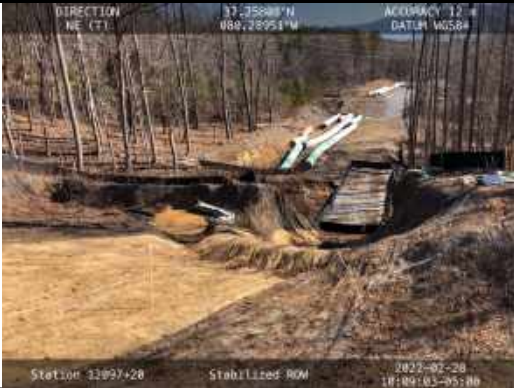
| Field Station# | 12097+20 | | Field Station# | 12110+00 | |

| Pic 5 Desc. | Photo shows the stabilized ROW conditions with water bars and that all ECDs are installed and are functioning as designed. | | Pic 6 Desc. | Photo shows the stabilized ROW conditions with water bars and that all ECDs are installed and are functioning as designed. | |

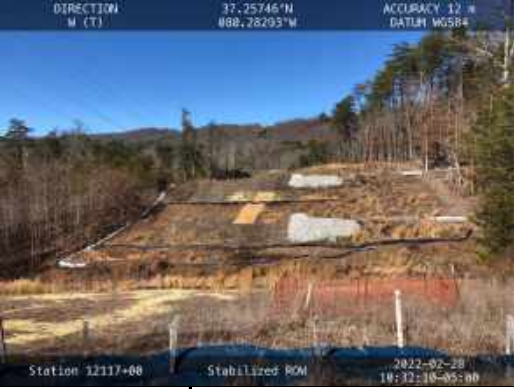
| Field Station# | 12115+00 | | Field Station# | 12117+00 | |

| Pic 7 Desc. | Photo shows the stabilized ROW conditions with water bars and that all ECDs are installed and are functioning as designed. | | Pic 8 Desc. | Photo shows stabilized ROW conditions with permanent water bars and level spreaders installed. | |

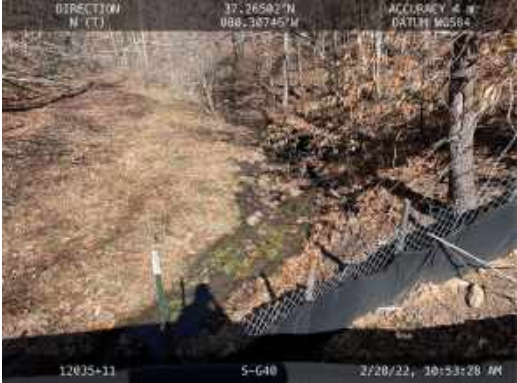
| Field Station# | 12035+11 | | Field Station# | 12031+51 | |

| Pic 13 Desc. | Photo shows downstream of Stream S-G40. | | Pic 14 Desc. | Photo shows downstream of Stream S-G39. | |

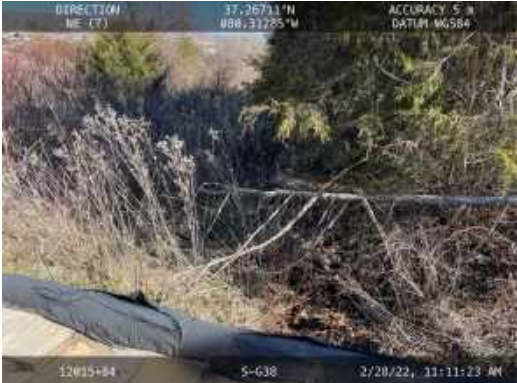
| Field Station# | 12015+84 | | Field Station# | 12012+00 | |

| Pic 15 Desc. | Photo shows downstream of Stream S-G38. | | Pic 16 Desc. | Photo shows stabilized ROW with permanent water bars with level spreaders installed. | |

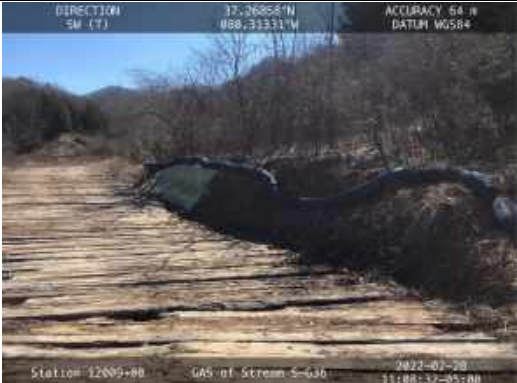
| Field Station# | 12009+00 | | Field Station# | 12112+50 | |

| Pic 17 Desc. | Photo shows punch list item today of compost filter sock rolled out of place and no longer staked properly. | | Pic 18 Desc. | Photo shows punch list item today of super silt fence blown off chain link due to windy weather conditions. | |

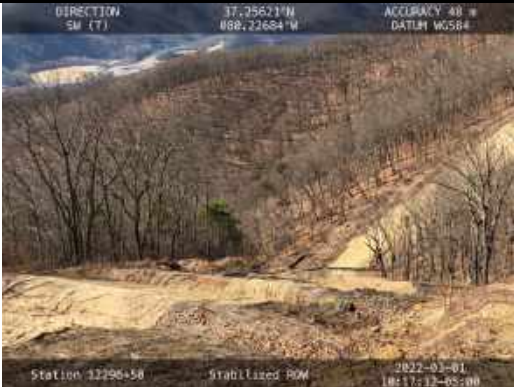
| Field Station# | 12296+50 | | Field Station# | 12315+50 | |

| Pic 1 Desc. | Photo shows the stabilized ROW conditions with water bars and that all ECDs are installed and are functioning as designed. | | Pic 2 Desc. | Photo shows the stabilized ROW conditions with water bars and that all ECDs are installed and are functioning as designed. | |

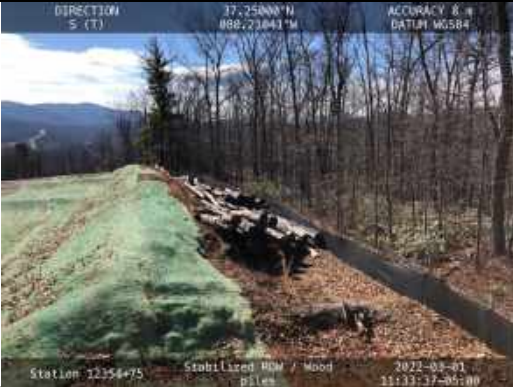
| Field Station# | 12338+50 | | Field Station# | 12354+75 | |

| Pic 3 Desc. | Photo shows the stabilized ROW conditions with water bars and that all ECDs are installed and are functioning as designed. | | Pic 4 Desc. | Photo shows stabilized ROW, timber pile and super silt fence. | |

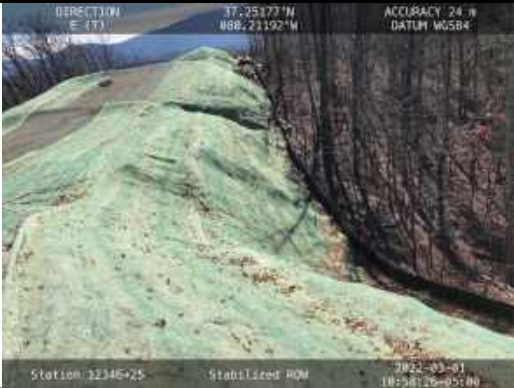
| Field Station# | 12346+25 | | Field Station# | 12361+00 | |

| Pic 5 Desc. | Photo shows the stabilized ROW conditions with water bars and that all ECDs are installed and are functioning as designed. | | Pic 6 Desc. | Photo shows the stabilized ROW conditions with water bars and that all ECDs are installed and are functioning as designed. | |

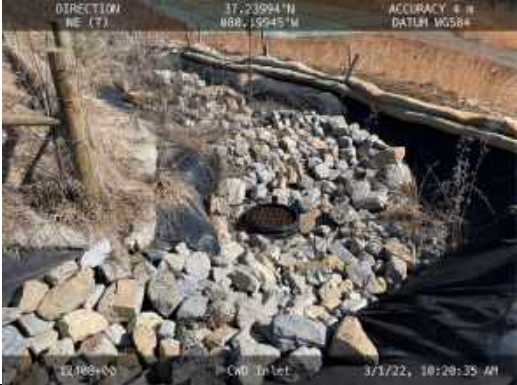
| Field Station# | 12408+00 | | Field Station# | 12410+00 | |

| Pic 13 Desc. | Photo shows clean water diversion inlet with stone inlet protection. | | Pic 14 Desc. | Photo shows plunge pool. | |

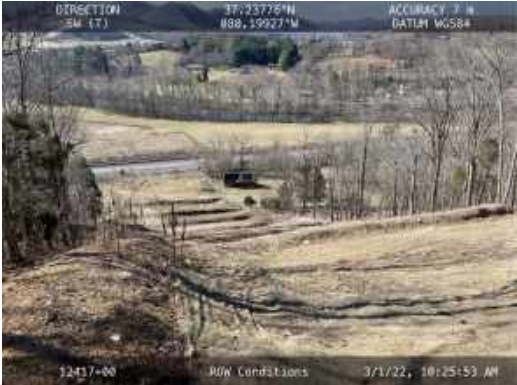
| Field Station# | 12417+00 | | Field Station# | 12441+75 | |

| Pic 15 Desc. | Photo shows the stabilized ROW conditions with water bars and that all ECDs are installed and are functioning as designed. | | Pic 16 Desc. | Photo shows Stream S-NN16 from the going away side. | |

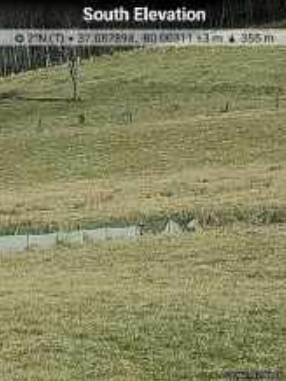
| Field Station# | 13497+15 | Field Station# | 13420+00 | | |

| Pic 1 Desc. | P1 at anode bed location requires maintenance due to being weathered, documented and added to the punch list. | | Pic 2 Desc. | Row photo in work space area showing stabilization and materials stock piled , no environmental issues observed at the time of inspection. | |

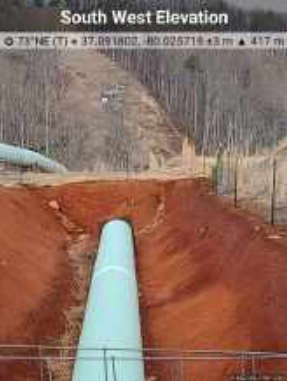
| Field Station# | 13421+30 | Field Station# | 13421+00 | | |

| Pic 3 Desc. | Erosion control blanket in place on water bar, vegetation observation on row, no environmental issues observed at the time of inspection. | | Pic 4 Desc. | Photo showing open ditch , fence around area in place, no environmental issues observed at the time of inspection. | |

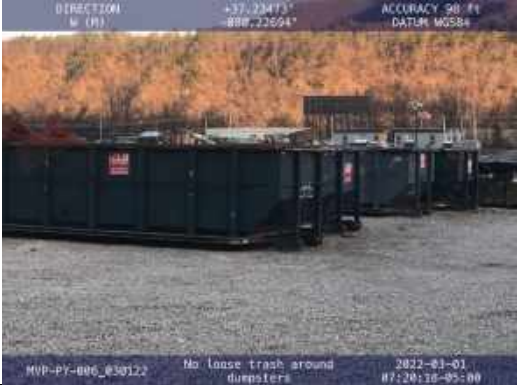
| Pic 7 Desc. | No loose trash around dumpsters or in the yard. Looking W. | | Pic 8 Desc. | No fluids or deposits around hazardous waste dumpsters. Looking SW. | |

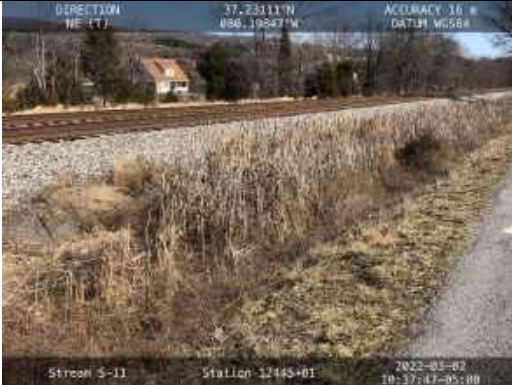
| Field Station# | 12445+01 | | Field Station# | 12455+21 | |

| <p>Stream S-11 Station 12445+01 2022-03-02 10:37:47-05:00</p> | | <p>Upstream of Stream S-11 Station 12455+21 2022-03-02 10:37:57-05:00</p> | | | |

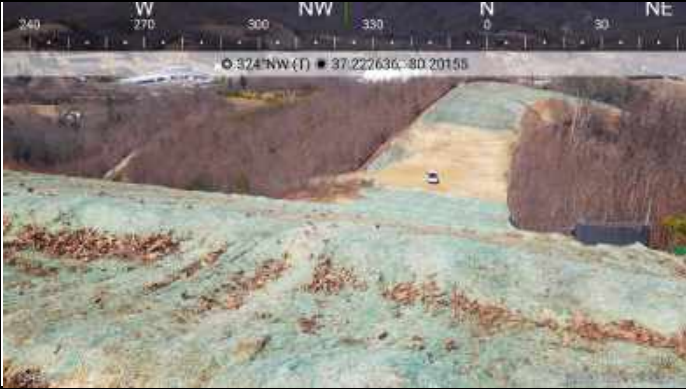
| Pic 7 Desc. | ROW Overview (temporary stabilization). ECDs are functional and ROW is stable. | | Pic 8 Desc. | ROW Overview (temporary stabilization). ECDs are functional and ROW is stable. | |

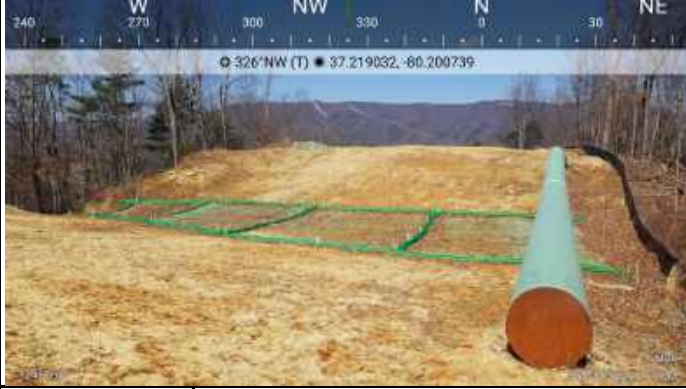
| Pic 9 Desc. | ROW Overview (temporary stabilization). ECDs are functional and ROW is stable. | | Pic 10 Desc. | ROW Overview (temporary stabilization). ECDs are functional and ROW is stable. | |

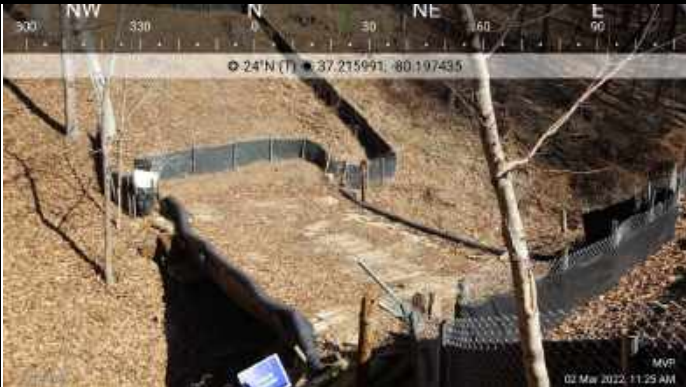
| Pic 13 Desc. | Overview of Waterbody S-EF19. ECDs are functional and ROW is stable. | | Pic 14 Desc. | ROW Overview (temporary stabilization). ECDs are functional and ROW is stable. | |

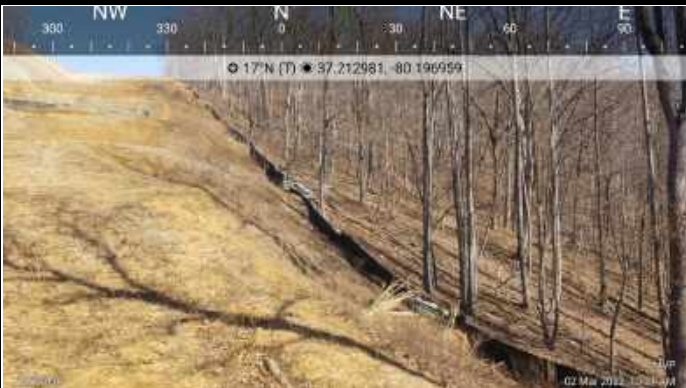
| Pic 15 Desc. | ROW Overview (temporary stabilization). ECDs are functional and ROW is stable. | | Pic 16 Desc. | ROW Overview (temporary stabilization). ECDs are functional and ROW is stable. | |

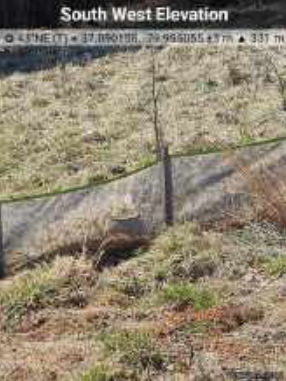
| Pic 1 Desc. | P1 requires maintenance, added to the punch list for repair. | Pic 2 Desc. | P1 requires maintenance, added to the punch list for repair. | | |

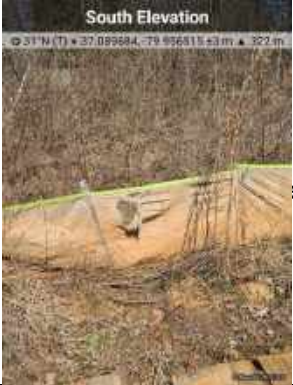
| Pic 7 Desc. | P1 requires maintenance, added to the punch list. | | Pic 8 Desc. | CFS requires maintenance due to being weathered, added to the punch list | |

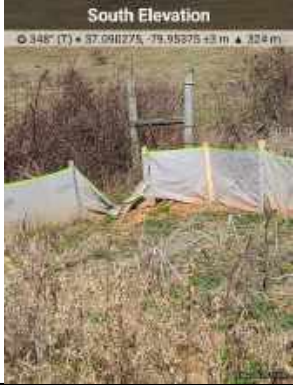
| Pic 9 Desc. | P1 requires maintenance, added to the punch list for repair. | | Pic 10 Desc. | CFS requires maintenance due to being weathered, added to the punch list | |

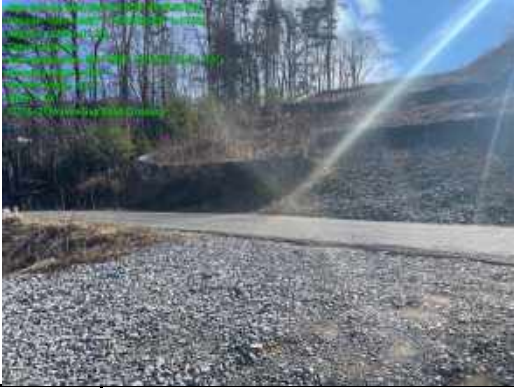
| Pic 1 Desc. | Wades Gap Road Crossing in good condition | Pic 2 Desc. | Private Driveway in good condition | | |

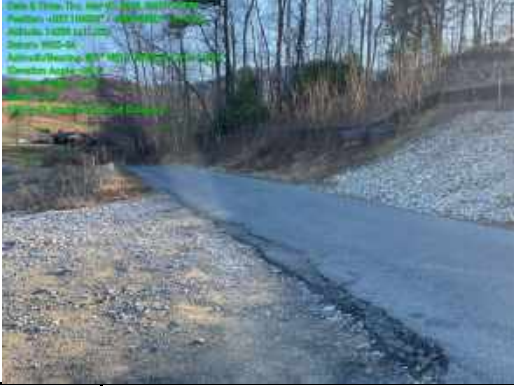
| Pic 1 Desc. | Wades Gap Road Crossing in good condition | Pic 2 Desc. | ROW and ECDs in good condition and stable | | |

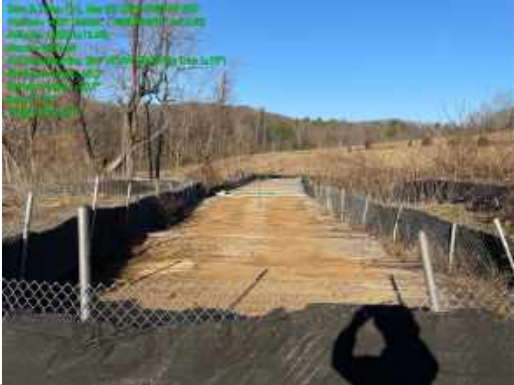
| Pic 3 Desc. | MVP-S-GH7 and corresponding buffer zone in good condition | Pic 4 Desc. | ROW and ECDs in good condition and stable | | |

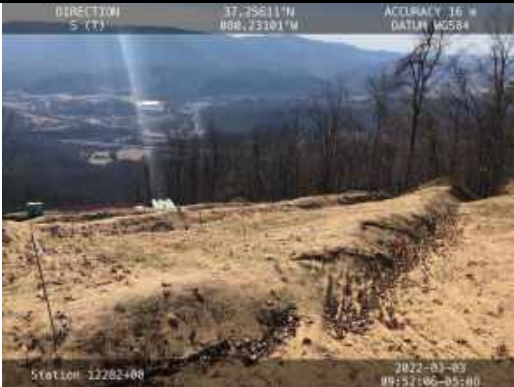
| Pic 1 Desc. | Photo shows the stabilized ROW conditions with water bars and that all ECDs are installed and are functioning as designed. | | Pic 2 Desc. | Photo shows permanent stabilization with permanent water bars with level spreaders. | |

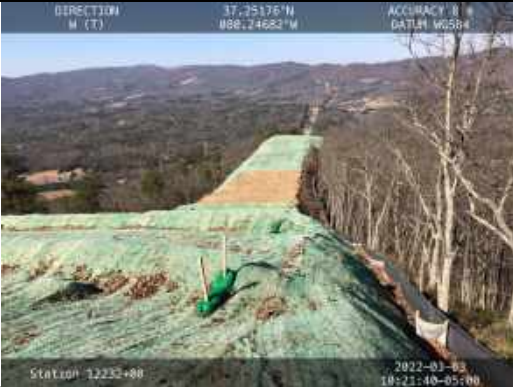
| Pic 3 Desc. | Photo shows permanent stabilization with permanent water bars with level spreaders. | | Pic 4 Desc. | Photo shows the stabilized ROW conditions with water bars and that all ECDs are installed and are functioning as designed. | |

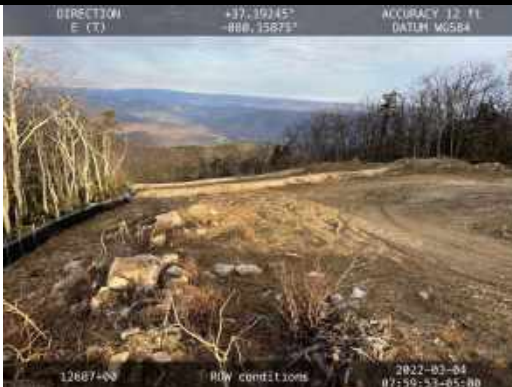
| Pic 1 Desc. | Photo shows the ROW condition. ECDs are in good repair and installed and functioning as designed. | | Pic 2 Desc. | Photo shows the ROW condition. ECDs are in good repair and installed and functioning as designed. | |

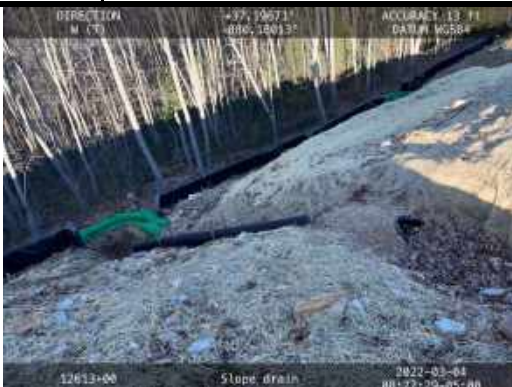
| Pic 5 Desc. | Photo shows the slope drain. | | Pic 6 Desc. | Photo shows the ROW condition. ECDs are in good repair and installed and functioning as designed. | |

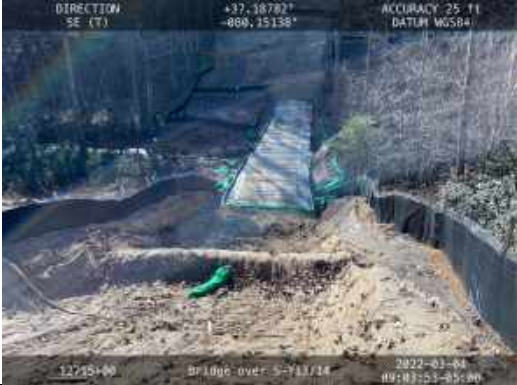
| Field Station# | 12715+00 | | Field Station# | 12715+80 | |

| Pic 13 Desc. | Photo shows the bridge over stream S-Y13 and S-Y14. | | Pic 14 Desc. | Photo shows stream S-Y13 downstream from the bridge. | |

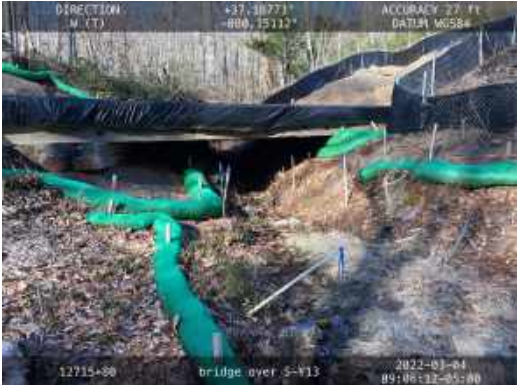
| Field Station# | 12715+80 | | Field Station# | 12716+20 | |

| Pic 15 Desc. | Photo shows the bridge over stream S-Y13. | | Pic 16 Desc. | Photo shows the bridge over stream S-Y14. | |

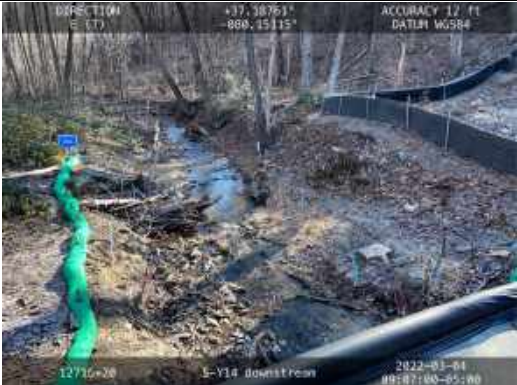
| Field Station# | 12716+20 | | Field Station# | 12716+50 | |

| Pic 17 Desc. | Photo shows stream S-Y14 downstream from the bridge. | | Pic 18 Desc. | Photo shows the ROW condition. ECDs are in good repair and installed and functioning as designed. | |

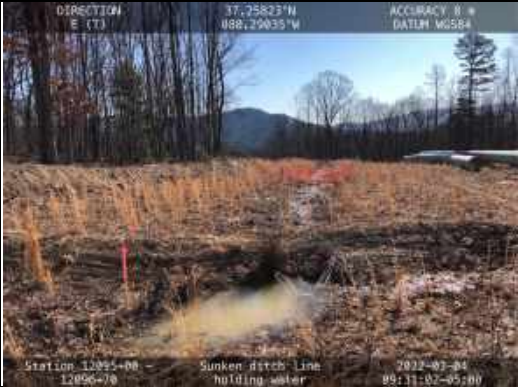
| Field Station# | 12095+00 | | Field Station# | 12097+75 | |

| Pic 13 Desc. | Photo shows sunken ditch line holding water. | | Pic 14 Desc. | Photo shows the stabilized ROW conditions with water bars and that all ECDs are installed and are functioning as designed. | |

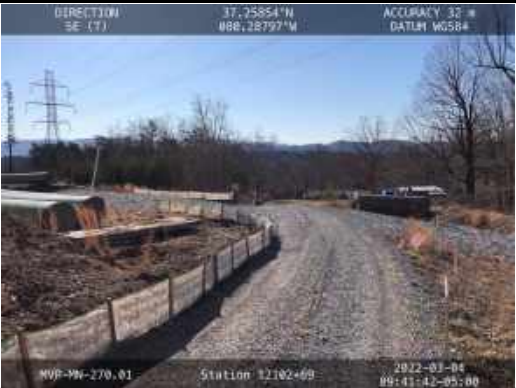
| Field Station# | 12101+57 | | Field Station# | 12102+69 | |

| Pic 15 Desc. | Photo shows upstream of Stream S-MM11. | | Pic 16 Desc. | Photo shows access road MVP-MN-270.01 and installed ECDs functioning as designed. | |

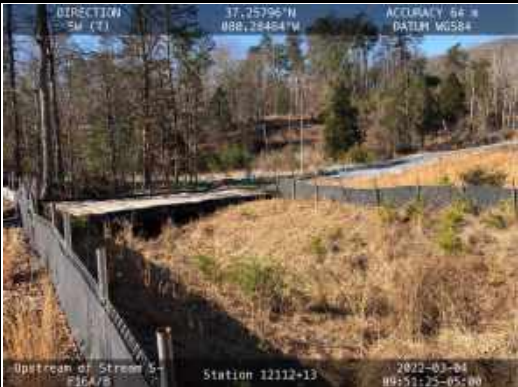
| Field Station# | 12112+13 | | Field Station# | 12117+00 | |

| Pic 17 Desc. | Photo shows upstream of Stream S-F16A/B. | | Pic 18 Desc. | Photo shows the stabilized ROW conditions with permanent water bars with level spreaders. | |
