# Visual Site Inspection Report

<b>Project Name</b>	H-600 Pipeline Spread H	<b>AFE</b>	124300138	<b>Spread</b>	H-600 Pipeline Spread H
<b>Contractor</b>	Precision			<b>Report #</b>	34101
<b>Inspector</b>	Pat Davis			<b>Date/Time</b>	2/7/2022 4:00 PM
<b>Permit #</b>	TBD	<b>Inspection Type</b>	VA SWPP	<b>Station Begin</b>	+0
<b>State</b>	VA	<b>Inspection Area</b>	Partial	<b>Station End</b>	+0
<b>County</b>	Montgomery	<b>Ground</b>	Frozen	<b>Temperature (°F)</b>	18.00
<b>Municipality</b>	N/A	<b>Weather</b>	Cloudy	<b>Rain Gauge (in)</b>	0.00
				<b>Rain Accumulation Time (days)</b>	0.00

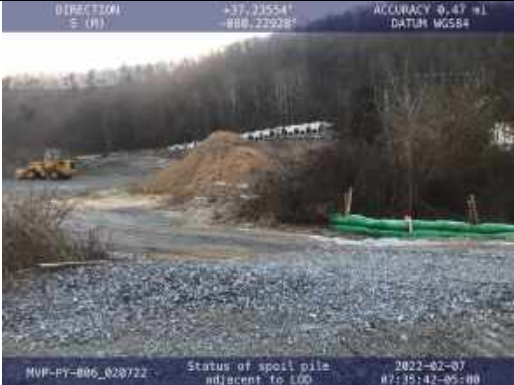
<b>GPS Location</b>	MVP-PY-006 See photo for gps data	<b>GPS Location</b>	MVP-PY-006 See photo for gps data		
<b>Field Station#</b>	+0	<b>Field Station#</b>	+0		
<b>Pic 1 Desc.</b>	Status of spoil pile adjacent to LOD. Soil pile not stabilized. Looking S.	<b>Pic 2 Desc.</b>	Condition of signage and triple stack compost filter sock at feature W-008. Looking NE.

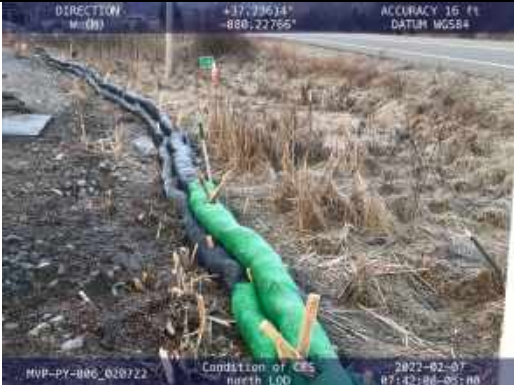
<b>GPS Location</b>	MVP-PY-006 See photo for gps data	<b>GPS Location</b>	MVP-PY-006 See photo for gps data		
<b>Field Station#</b>	+0	<b>Field Station#</b>	+0		
<b>Pic 3 Desc.</b>	Condition of triple stack compost filter sock along north LOD. Looking W.	<b>Pic 4 Desc.</b>	Condition of posted project documents at the main entrance. Looking SW.

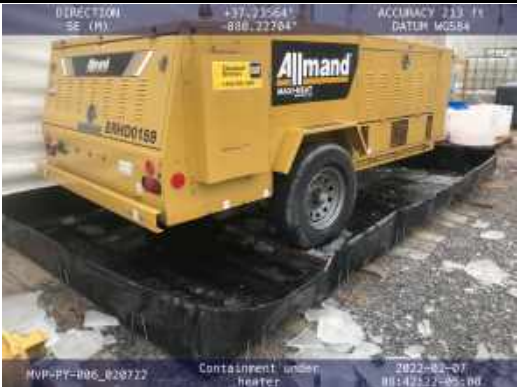
<b>Field Station#</b>	+0		<b>Field Station#</b>	+0	
<b>Pic 17 Desc.</b>	Secondary containment under heater free of stormwater and ice. Looking SE.		<b>Pic 18 Desc.</b>	Secondary containment under used oil containers. Free of stormwater and ice. Looking S.

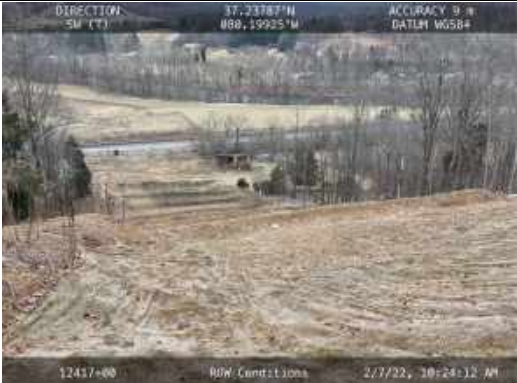
<b>GPS Location</b>	See photo		<b>GPS Location</b>	See photo	
<b>Field Station#</b>	12417+00		<b>Field Station#</b>	12374+16	
<b>Pic 17 Desc.</b>	Current ROW conditions. ROW is stable. ECDs are functional.		<b>Pic 18 Desc.</b>	Looking downstream at Stream S-OO16

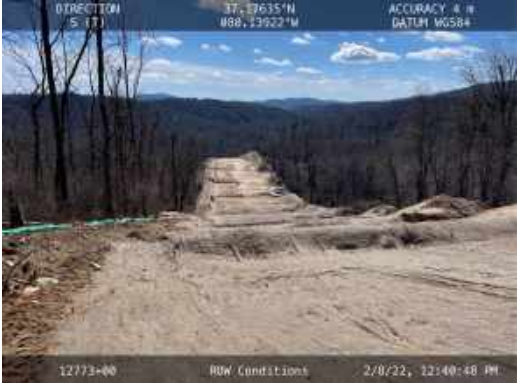
<b>GPS Location</b>	See photo		<b>GPS Location</b>	See photo	
<b>Field Station#</b>	12773+00		<b>Field Station#</b>	12777+50	
<b>Pic 13 Desc.</b>	Current ROW conditions. ROW is stable. ECDs are functional.		<b>Pic 14 Desc.</b>	Level spreader is functional.

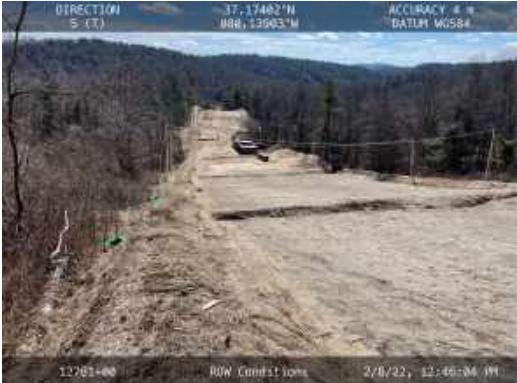
<b>GPS Location</b>	See photo		<b>GPS Location</b>	See photo	
<b>Field Station#</b>	12781+00		<b>Field Station#</b>	12791+00	
<b>Pic 15 Desc.</b>	Current ROW conditions. ROW is stable. ECDs are functional.		<b>Pic 16 Desc.</b>	Slope drain is functional

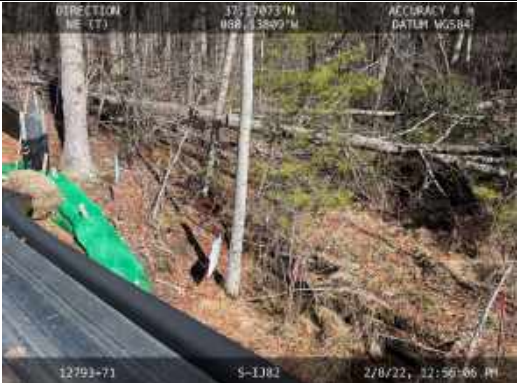
<b>GPS Location</b>	See photo		<b>GPS Location</b>	See photo	
<b>Field Station#</b>	12793+71		<b>Field Station#</b>	12793+71	
<b>Pic 17 Desc.</b>	Upstream of crossing at Stream S-IJ82		<b>Pic 18 Desc.</b>	Downstream of crossing at Stream S-IJ82

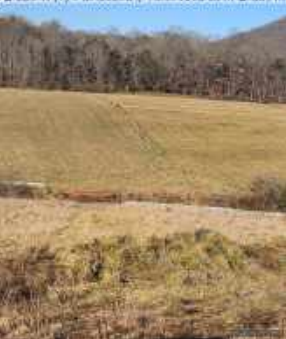
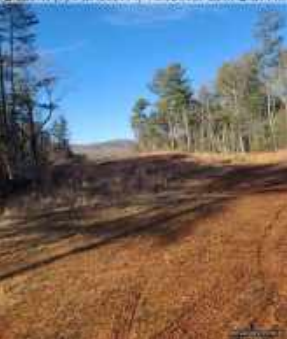
<b>GPS Location</b>	0000	<b>GPS Location</b>	0000		
<b>Field Station#</b>	13574+98	<b>Field Station#</b>	13561+00		
<b>Pic 1 Desc.</b>	Monitored row conditions, observed vegetation and ECDs and equipment bridge crossing.		<b>Pic 2 Desc.</b>	Row photo showing wet conditions, no environmental issues observed at the time of inspection.	
	<b>South West Elevation</b>

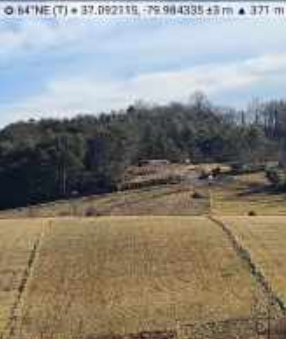
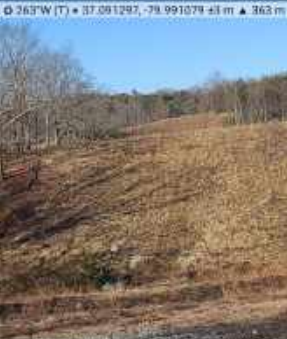
<b>GPS Location</b>	0000	<b>GPS Location</b>	00000		
<b>Field Station#</b>	13564+04	<b>Field Station#</b>	13539+28		
<b>Pic 3 Desc.</b>	Vegetation observation showing good coverage, ECDs in place and functioning at the time of inspection.		<b>Pic 4 Desc.</b>	Row photo showing vegetation and equipment bridge at stream crossing, no environmental issues observed at the time of inspection.

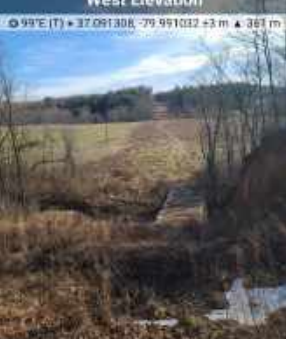
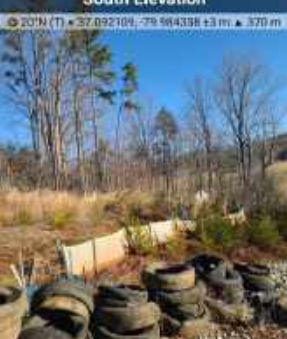
<b>GPS Location</b>	0000	<b>GPS Location</b>	00000		
<b>Field Station#</b>	13543+20	<b>Field Station#</b>	13562+38		
<b>Pic 5 Desc.</b>	Monitored stream crossing, all ECDs functioning at the time of inspection.		<b>Pic 6 Desc.</b>	Observed ECDs at road crossings, all functioning at the time of inspection.

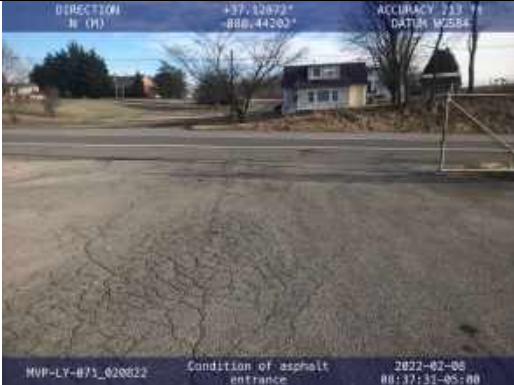
<b>GPS Location</b>	MVP-LY-071 See photo for gps data	<b>GPS Location</b>	MVP-LY-071 See photo for gps data		
<b>Field Station#</b>	+0	<b>Field Station#</b>	+0		
<b>Pic 1 Desc.</b>	Condition of asphalt entrance. Free of sediment and debris. Looking N.	<b>Pic 2 Desc.</b>	Condition of triple stack compost filter sock along north LOD. Looking W.

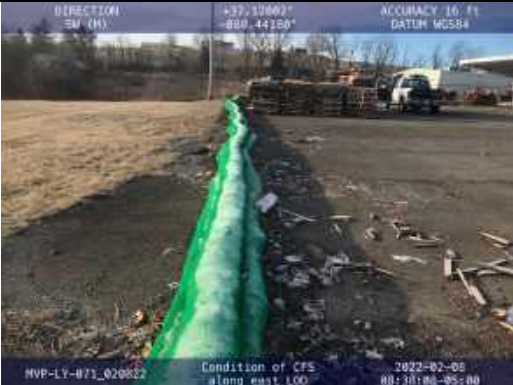
<b>GPS Location</b>	MVP-LY-071 See photo for gps data	<b>GPS Location</b>	MVP-LY-071 See photo for gps data		
<b>Field Station#</b>	+0	<b>Field Station#</b>	+0		
<b>Pic 3 Desc.</b>	No loose trash in the north section of the yard. Looking W.	<b>Pic 4 Desc.</b>	Condition of triple stack compost filter sock along east LOD. Looking SW.

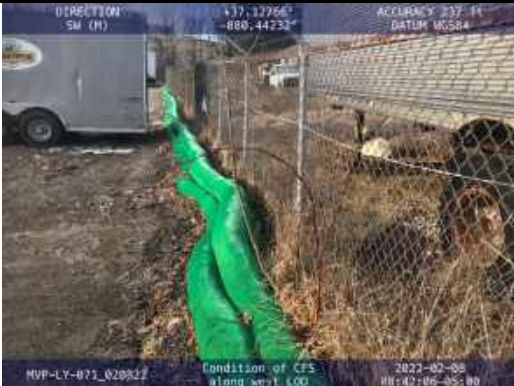
<b>Field Station#</b>	+0	<b>Field Station#</b>	+0		
<b>Pic 5 Desc.</b>	Condition of triple stack compost filter sock along west LOD. Looking SW.	<b>Pic 6 Desc.</b>	No loose trash in the south west section of the yard. Looking S.

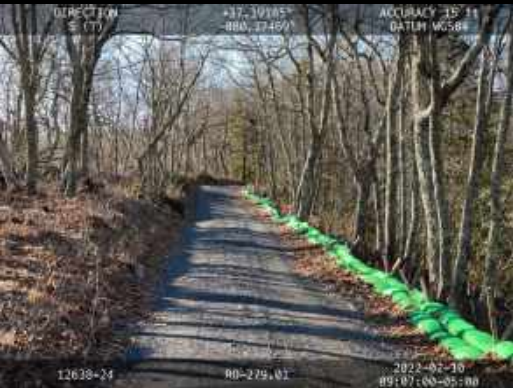
<b>Field Station#</b>	12638+00		<b>Field Station#</b>	12638+24	
<b>Pic 5 Desc.</b>	Photo shows the ROW condition. ECDs are installed and functioning as designed.		<b>Pic 6 Desc.</b>	Photo shows access road RO-279.01. ECDs are installed and functioning as designed.

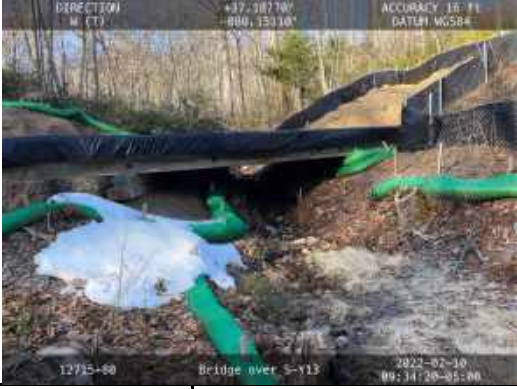
<b>GPS Location</b>	See photo for gps location data.		<b>GPS Location</b>	See photo for gps location data.	
<b>Field Station#</b>	12715+80		<b>Field Station#</b>	12716+20	
<b>Pic 15 Desc.</b>	Photo shows the bridge over stream S-Y13.		<b>Pic 16 Desc.</b>	Photo shows the bridge over stream S-Y14.

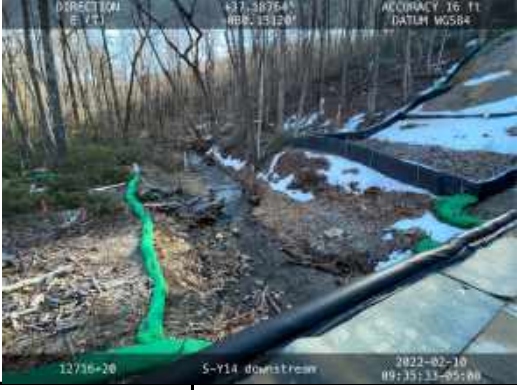
<b>Pic 17 Desc.</b>	Photo shows stream S-Y14 downstream from the bridge.		<b>Pic 18 Desc.</b>	Photo shows the ROW condition. ECDs are installed and functioning as designed.

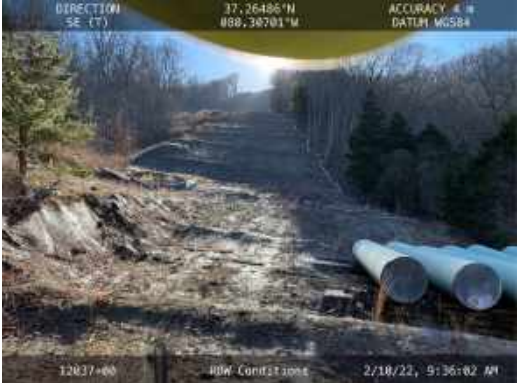
<b>GPS Location</b>	See photo		<b>GPS Location</b>	See photo	
<b>Field Station#</b>	12037+00		<b>Field Station#</b>	12071+80	
<b>Pic 7 Desc.</b>	Current ROW conditions. ROW is stable. ECDs are functional.		<b>Pic 8 Desc.</b>	Current ROW conditions. ROW is stable. ECDs are functional.

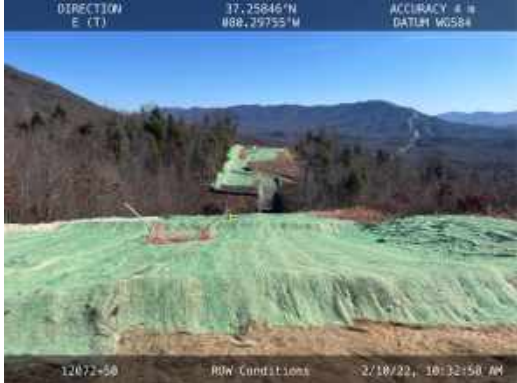
<b>GPS Location</b>	See photo		<b>GPS Location</b>	See photo	
<b>Field Station#</b>	12072+50		<b>Field Station#</b>	12076+95	
<b>Pic 9 Desc.</b>	Current ROW conditions. ROW is stable. ECDs are functional.		<b>Pic 10 Desc.</b>	Downstream of crossing at Stream S-MM15

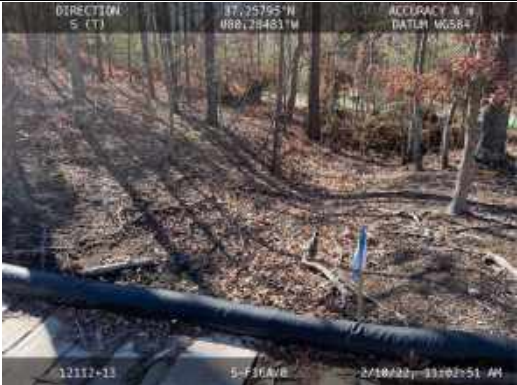
<b>GPS Location</b>	See photo		<b>GPS Location</b>	See photo	
<b>Field Station#</b>	12112+13		<b>Field Station#</b>	12116+00	
<b>Pic 17 Desc.</b>	Downstream of crossing at Stream S-F16A/B		<b>Pic 18 Desc.</b>	Permanent slope breaker and level spreader are functional

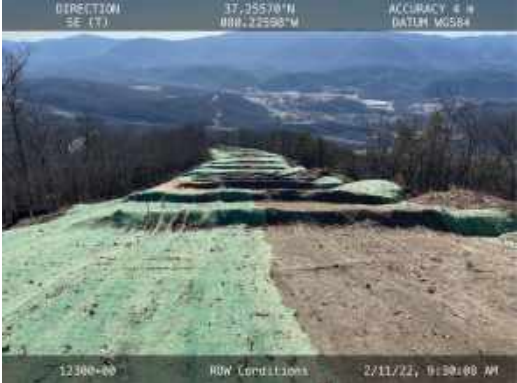
<b>GPS Location</b>	See photo		<b>GPS Location</b>	See photo	
<b>Field Station#</b>	12300+00		<b>Field Station#</b>	12304+00	
<b>Pic 7 Desc.</b>	Current ROW conditions. ROW is stable. ECDs are functional.		<b>Pic 8 Desc.</b>	Sump and End Treatment are functional

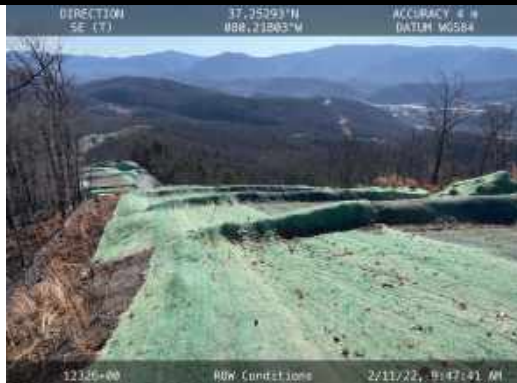
<b>GPS Location</b>	See photo		<b>GPS Location</b>	See photo	
<b>Field Station#</b>	12326+00		<b>Field Station#</b>	12330+00	
<b>Pic 11 Desc.</b>	Current ROW conditions. ROW is stable. ECDs are functional.		<b>Pic 12 Desc.</b>	Slope drain is functional.

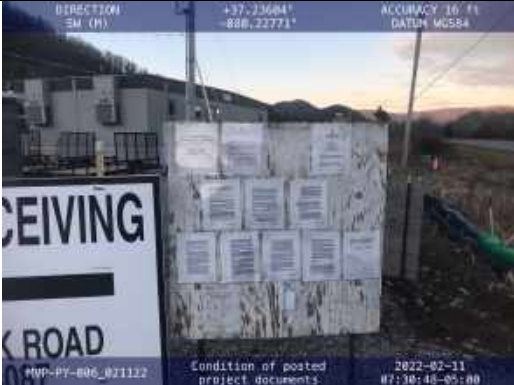
<b>GPS Location</b>	MVP-PY-006 See photo for gps data		<b>GPS Location</b>	MVP-PY-006 See photo for gps data	
<b>Field Station#</b>	+0		<b>Field Station#</b>	+0	
<b>Pic 1 Desc.</b>	Check the condition of the posted project documents at the main entrance. Looking SW.		<b>Pic 2 Desc.</b>	Condition of signage and triple stack compost filter sock at feature W-008. Looking E.

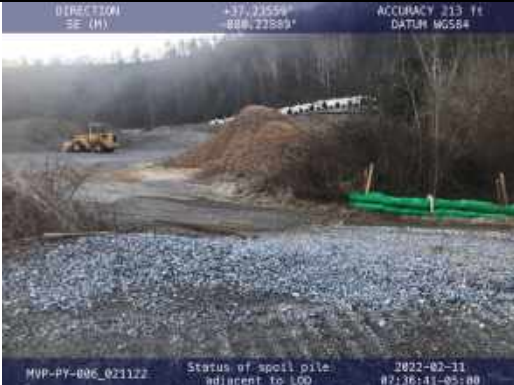
<b>GPS Location</b>	MVP-PY-006 See photo for gps data		<b>GPS Location</b>	MVP-PY-006 See photo for gps data	
<b>Field Station#</b>	+0		<b>Field Station#</b>	+0	
<b>Pic 3 Desc.</b>	Check status of soil pile adjacent to LOD. Soil pile not stabilized. Looking SE.		<b>Pic 4 Desc.</b>	Trays and containment under toilets. Trays holding fluids and ice. Looking E.
