Visual Site Inspection Report

Project Name	H-600 Pipeline Spread I	AFE	124300139	Spread	H-600 Pipeline Spread I
Contractor	Precision			Report #	33331
Inspector	Charles Head			Date/Time	1/18/2022 10:11 AM
Permit #	TBD	Inspection Type	VA SWPP	Station Begin	14454+22
State	VA	Inspection Area	Full	Station End	14546+75
County	Franklin	Ground	Frozen	Temperature (°F)	36.00
Municipality	N/A	Weather	Sunny	Rain Gauge (in)	0.00
				Rain Accumulation Time (days)	1.00

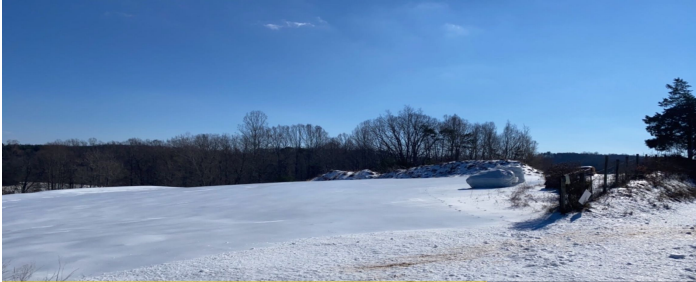
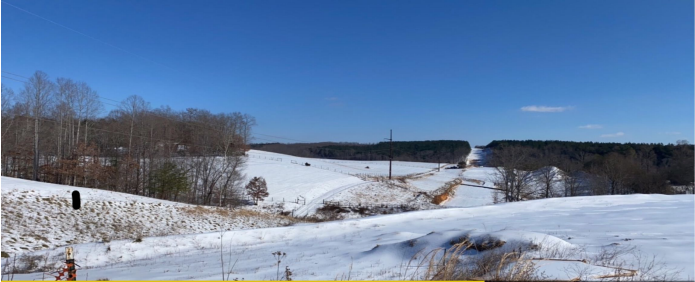
36°58'41" N 79°38'17" W 288°W COURSE 291° GPS 2019 Ramsey Memorial Rd, Penhook, VA 24137, United States 01.18.2022 13:05:08 Accur +/-15.4 Ft ALT 868 Ft			36°58'41" N 79°38'17" W 237°SW COURSE 291° GPS 2019 Ramsey Memorial Rd, Penhook, VA 24137, United States 01.18.2022 13:05:11 Accur +/-15.4 Ft ALT 868 Ft		
GPS Location	1		GPS Location	2	
Field Station#	14928+52		Field Station#	14930+00	
Pic 1 Desc.	ROW covered in snow; no issues observed		Pic 2 Desc.	ROW covered in snow; no issues observed

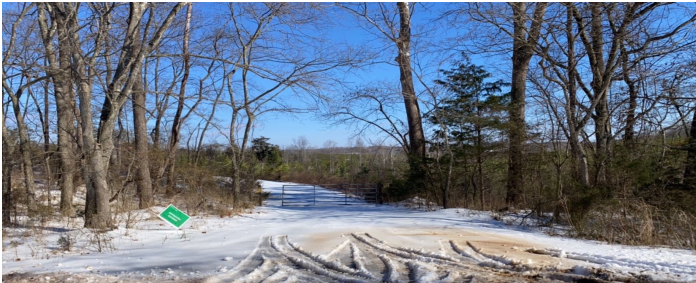
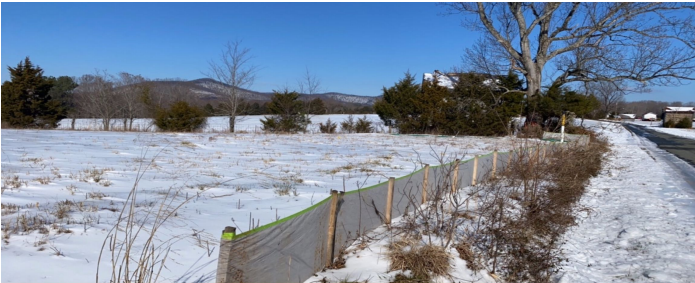
Field Station#	14995+21		Field Station#	15063+85	
Pic 3 Desc.	ROW covered in snow; no issues observed		Pic 4 Desc.	ROW covered in snow; no issues observed

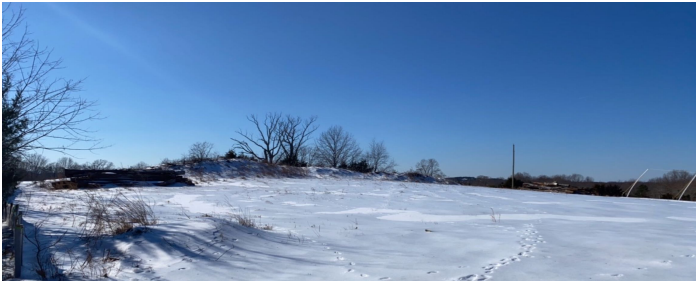
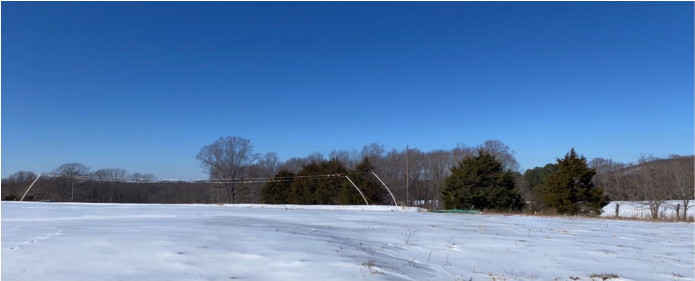
36°57'47" N 79°35'36" W 297°NW COURSE 41° GPS 1918-2164 Armstrong Rd, Penhook, VA 24137, United States 01.18.2022 13:19:58 Accur +/-33.7 Ft ALT 908 Ft			36°57'47" N 79°35'36" W 52°NE COURSE 41° GPS 1918-2164 Armstrong Rd, Penhook, VA 24137, United States 01.18.2022 13:20:01 Accur +/-37.2 Ft ALT 909 Ft		
GPS Location	5		GPS Location	6	
Field Station#	15061+00		Field Station#	15060+00	
Pic 5 Desc.	ROW covered in snow; no issues observed		Pic 6 Desc.	ROW covered in snow; no issues observed

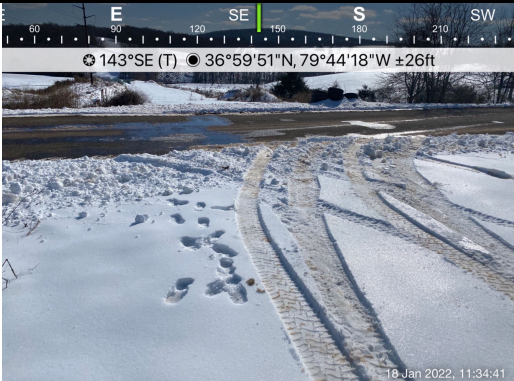
GPS Location	0	GPS Location	0		
Field Station#	14599+00	Field Station#	14604+00		
Pic 5 Desc.	Approximately 14599+00. Overview of road crossing and RCEs.		Pic 6 Desc.	Approximately 14604+00. Overview of ROW.

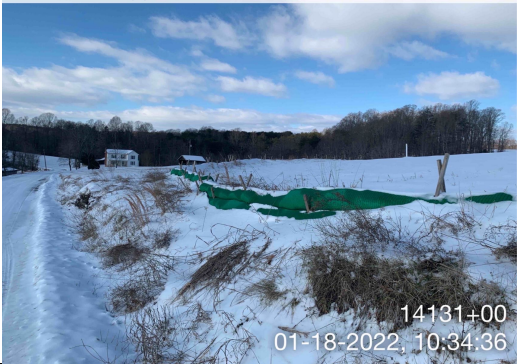
Insert image here	
GPS Location	0	GPS Location			
Field Station#	14131+00	Field Station#			
Pic 7 Desc.	CFS in acceptable condition	Pic 8 Desc.			
Insert image here		Insert image here			
GPS Location		GPS Location			
Field Station#		Field Station#			
Pic 9 Desc.		Pic 10 Desc.			
Insert image here		Insert image here			
GPS Location		GPS Location			
Field Station#		Field Station#			
Pic 11 Desc.		Pic 12 Desc.

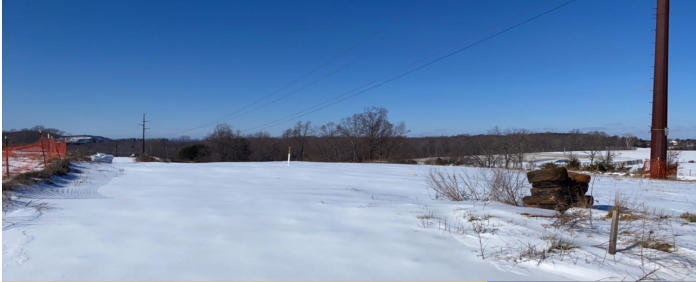
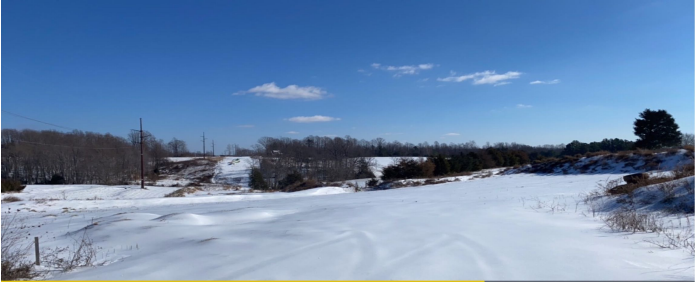
36°58'21" N 79°39'56" W 7°N COURSE -1° GPS 168-344 Listening Hill Rd, Penhook, VA 24137, United States 01.18.2022 12:53:39 Accur +/-15.4 Ft ALT 973 Ft			36°58'20" N 79°39'56" W 186°S COURSE 135° GPS 168-344 Listening Hill Rd, Penhook, VA 24137, United States 01.18.2022 12:53:46 Accur +/-15.4 Ft ALT 972 Ft		
GPS Location	1		GPS Location	2	
Field Station#	14843+00		Field Station#	14847+00	
Pic 1 Desc.	ROW covered in snow; no issues observed		Pic 2 Desc.	ROW covered in snow; no issues observed

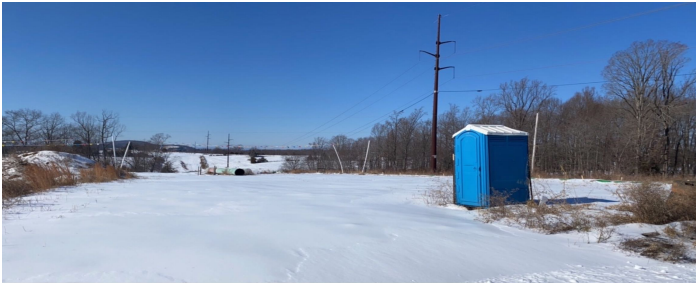
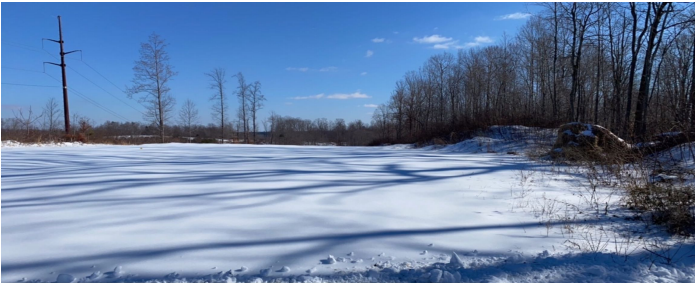
Field Station#	14861+00		Field Station#	14863+00	
Pic 3 Desc.	ROW covered in snow; no issues observed		Pic 4 Desc.	ROW covered in snow; no issues observed

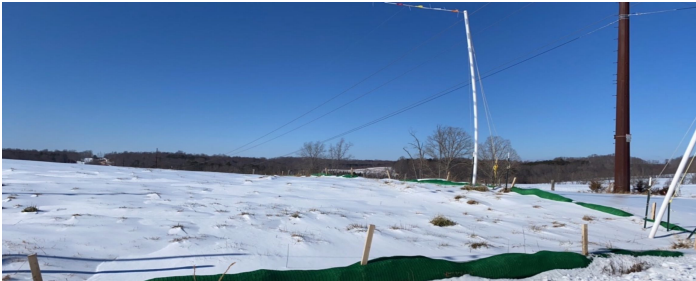
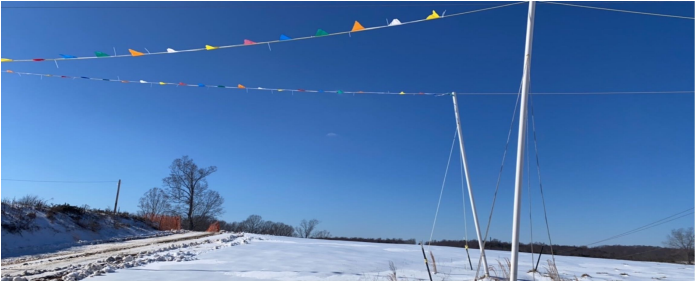
36°58'4" N 79°38'17" W 99°E COURSE 189° GPS 2019 Ramsey Memorial Rd, Penhook, VA 24137, United States 01.18.2022 13:04:52 Accur +/-15.4 Ft ALT 861 Ft			36°58'4" N 79°38'17" W 40°NE COURSE -1° GPS 2019 Ramsey Memorial Rd, Penhook, VA 24137, United States 01.18.2022 13:05:02 Accur +/-15.4 Ft ALT 863 Ft		
GPS Location	5		GPS Location	6	
Field Station#	14927+00		Field Station#	14928+52	
Pic 5 Desc.	ROW covered in snow; no issues observed		Pic 6 Desc.	ROW covered in snow; no issues observed

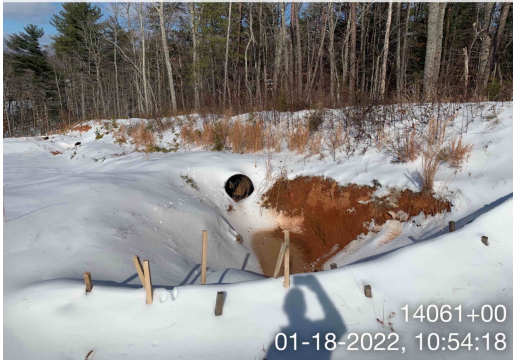
<div>14061+00 01-18-2022, 10:54:18</div>			<div>357°N (T) 37°3'56"N, 79°52'31"W ±272ft ▲1203ft</div>

<div>14061+00 01-18-2022, 10:55:19</div>				
GPS Location		0		GPS Location		0	
Field Station#		14061+00		Field Station#		14061+00	
Pic 1 Desc.		Slope drain and sump pit in acceptable conditions		Pic 2 Desc.		Waterbar in acceptable condition	
<div>76°E (T) 37°3'21"N, 79°52'59"W ±380ft ▲1038ft</div>

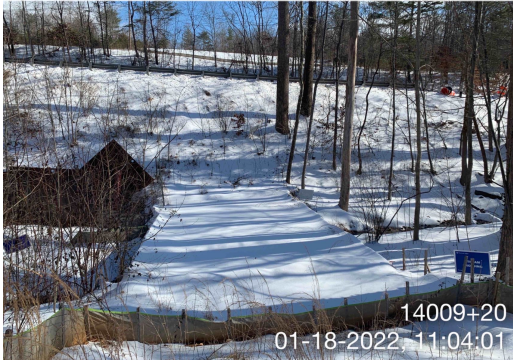
<div>14009+20 01-18-2022, 11:04:01</div>			<div>135°SE (T) 37°3'21"N, 79°52'59"W ±32ft ▲1029ft</div>

<div>14009+20 01-18-2022, 11:04:35</div>				
GPS Location		0		GPS Location		0	
Field Station#		14009+20		Field Station#		14009+20	
Pic 3 Desc.		Equipment bridge and P1 silt fence in acceptable conditions		Pic 4 Desc.		Stream S-KL38 looking downstream in acceptable condition

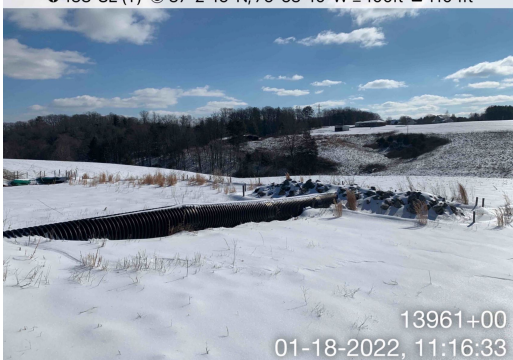
<div>13961+00 01-18-2022, 11:16:33</div>			<div>142°SE (T) 37°2'54"N, 79°53'37"W ±16ft ▲1106ft</div>

<div>13962+00 01-18-2022, 11:17:40</div>				
GPS Location		0		GPS Location		0	
Field Station#		13961+00		Field Station#		13962+00	
Pic 5 Desc.		Clean water diversion pipe in acceptable condition		Pic 6 Desc.		Waterbar end treatment pit in acceptable condition

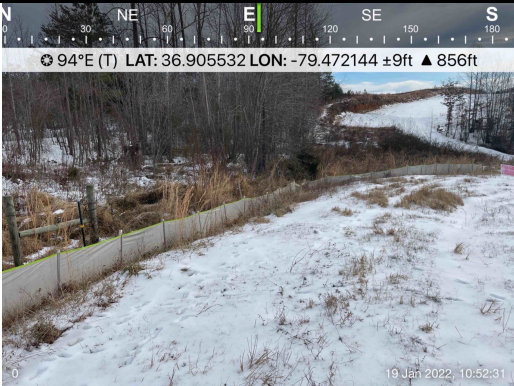
GPS Location	See photo		GPS Location	See photo	
Field Station#	15507+00		Field Station#	15510+00	
Pic 5 Desc.	P1 is in good condition at all stream and wetland buffers.		Pic 6 Desc.	3rd party ECDs appear to be in good condition.

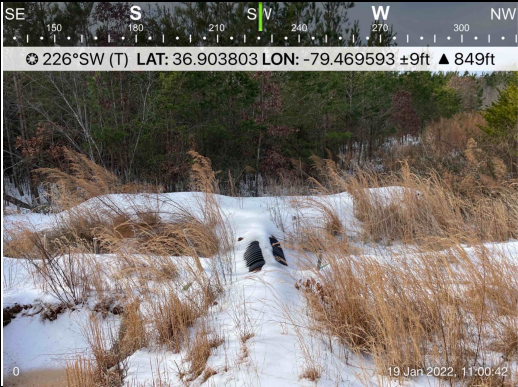
GPS Location	See photo		GPS Location	See photo	
Field Station#	15515+00		Field Station#	15540+00	
Pic 7 Desc.	CWDs are functioning as intended.		Pic 8 Desc.	Equipment bridge ECDs are in place and functioning.

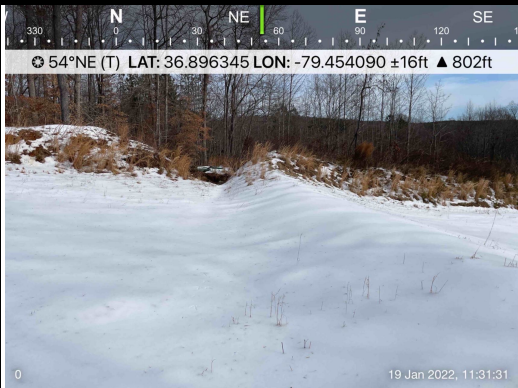
GPS Location	See photo		GPS Location	See photo	
Field Station#	15570+00		Field Station#	15573+54	
Pic 9 Desc.	Waterbars are in good condition.		Pic 10 Desc.	Resource buffers remain in good condition.

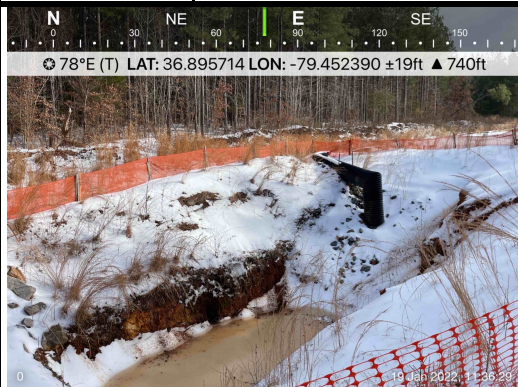
<p>Insert image here</p>	
GPS Location	See photo		GPS Location		
Field Station#	15575+00		Field Station#		
Pic 11 Desc.	Slope drain is in good condition and functioning.		Pic 12 Desc.

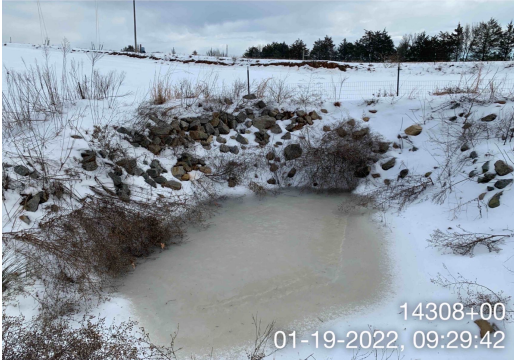
14308+00 01-19-2022, 09:29:42		148°SE (T) 37°2'38"N, 79°48'33"W ±114ft ▲1060ft

14308+00 01-19-2022, 09:31:34			
GPS Location	0	GPS Location	0		
Field Station#	14308+00	Field Station#	14308+00		
Pic 1 Desc.	Plunge pool in acceptable condition	Pic 2 Desc.	Clean water diversion berm in acceptable condition		
67°NE (T) 37°2'55"N, 79°49'2"W ±374ft ▲954ft

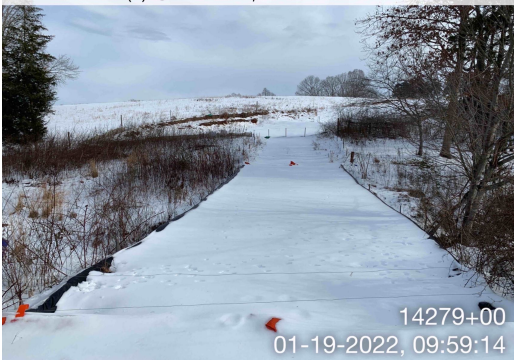
14279+00 01-19-2022, 09:59:14		119°SE (T) 37°3'12"N, 79°49'38"W ±5803ft ▲897ft

14248+50 01-19-2022, 11:18:39			
GPS Location	0	GPS Location	0		
Field Station#	14279+00	Field Station#	14248+50		
Pic 3 Desc.	Equipment bridge in acceptable condition	Pic 4 Desc.	P1 silt fence and super silt fence in acceptable conditions		
331°NW (T) 37°2'58"N, 79°49'7"W ±59ft ▲968ft

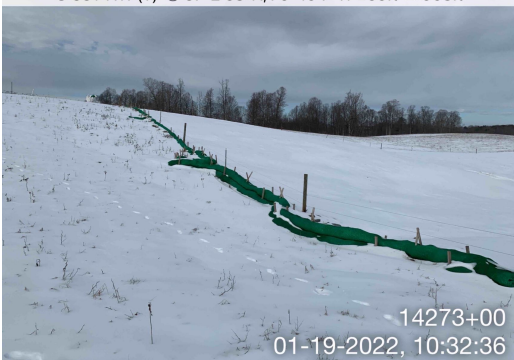
14273+00 01-19-2022, 10:32:36		188°S (T) 37°3'30"N, 79°50'39"W ±39ft ▲976ft

GPS Location	0	GPS Location	0		
Field Station#	14273+00	Field Station#	14177+00		
Pic 5 Desc.	Perimeter CFS in acceptable condition	Pic 6 Desc.	Waterbar in acceptable condition

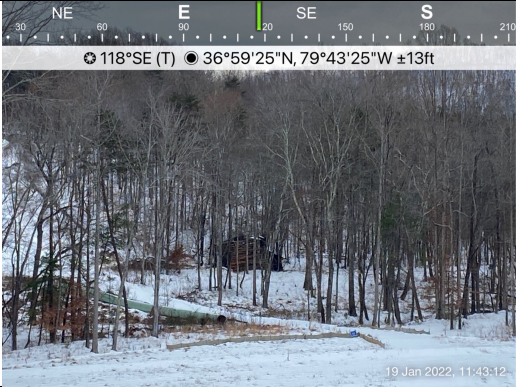
GPS Location	0	GPS Location	0		
Field Station#	14654+00	Field Station#	14680+50		
Pic 1 Desc.	Approximately 14654+00. Overview of ROW.		Pic 2 Desc.	Approximately 14680+50. Overview of stream crossing, equipment bridge and ECDs at stream S-H36.

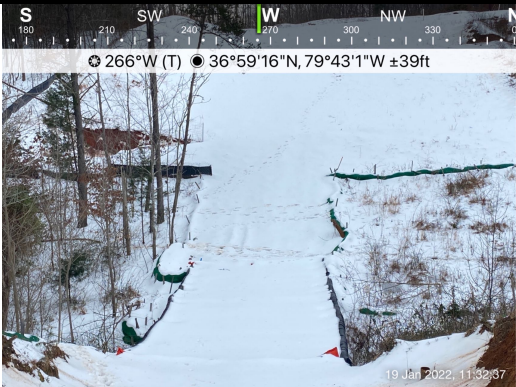
GPS Location	0	GPS Location	0		
Field Station#	14673+10	Field Station#	14689+36		
Pic 3 Desc.	Approximately 14673+10. Overview of stream crossing, equipment bridge and ECDs at stream S-H37.		Pic 4 Desc.	Approximately 14689+36. Overview of stream crossing, equipment bridge and ECDs at stream S-H34.

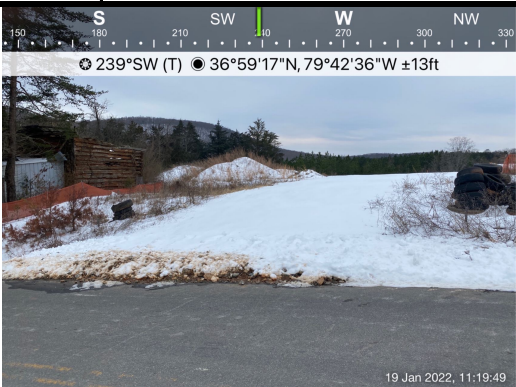
GPS Location	0	GPS Location	0		
Field Station#	14694+50	Field Station#	14670+00		
Pic 5 Desc.	Approximately 14694+50. Overview of road crossing and RCE. VDOT snowplow activity has turned rock and mud up onto approach.		Pic 6 Desc.	Approximately 14670+00. Overview of ROW. Livestock are still active and present in area.

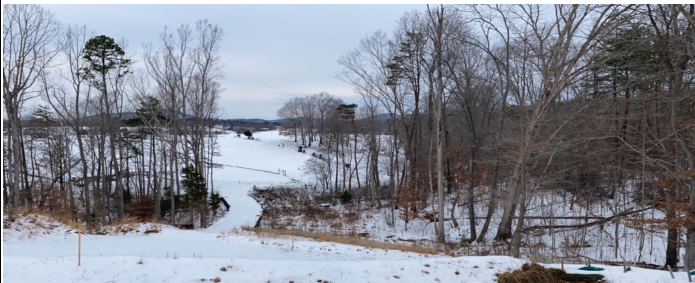
GPS Location	3		GPS Location	4	
Field Station#	15103+45		Field Station#	15126+40	
Pic 3 Desc.	Equipment bridge and surrounding ECDs appear to be in place and functional at stream crossing and resource buffer.		Pic 4 Desc.	Equipment bridge and surrounding ECDs appear to be in place and functional at stream crossing and resource buffer.

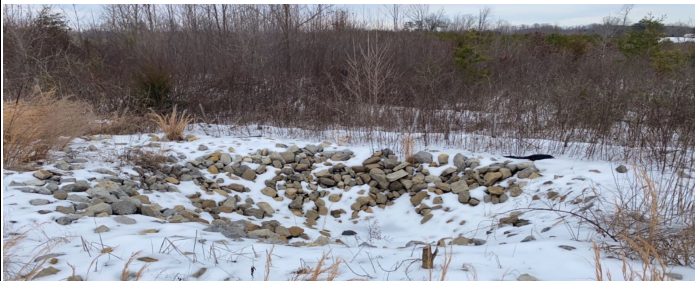
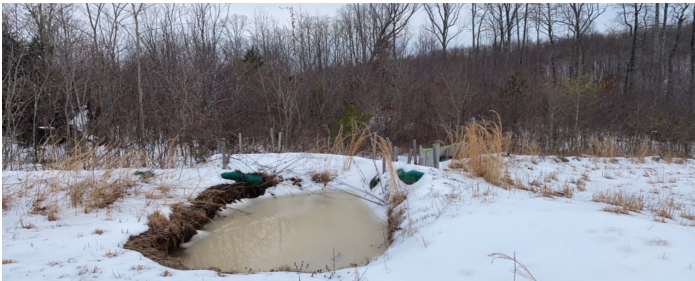
36°57'13" N 79°34'50" W 19°N COURSE 358° GPS Sandy Level, VA 24161, United States 01.19.2022 13:00:13 Accur +/-41.3 Ft ALT 907 Ft			36°57'9" N 79°34'49" W 168°S COURSE 154° GPS Sandy Level, VA 24161, United States 01.19.2022 12:57:38 Accur +/-103.2 Ft ALT 909 Ft		
GPS Location	5		GPS Location	6	
Field Station#	15120+00		Field Station#	15128+00	
Pic 5 Desc.	Plunge pool appears to be performing intended function.		Pic 6 Desc.	Sump pit and CFS end treatment in good condition.

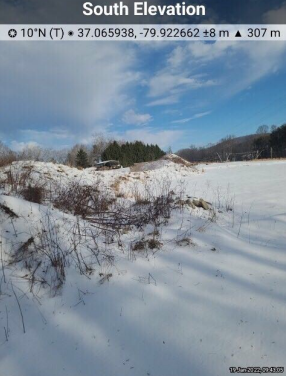
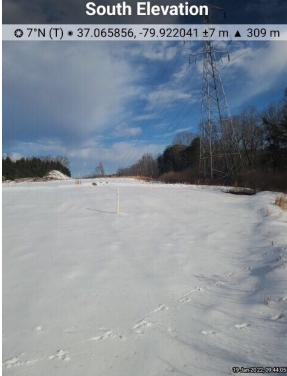
GPS Location	00000	GPS Location	00000		
Field Station#	13826+15	Field Station#	13827+80		
Pic 1 Desc.	Photo showing snow on top soil piles, no environmental issues observed at the time of inspection.		Pic 2 Desc.	Monitored sump pits and ECDs that were visible after recent snow events, row still frozen. No environmental issues observed at the time of inspection.	
	North Elevation <small>177°S (T) • 37.065856, -79.922041 ±7 m ▲ 309 m</small>

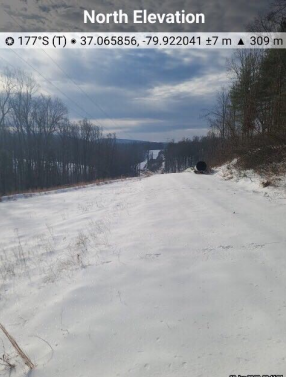
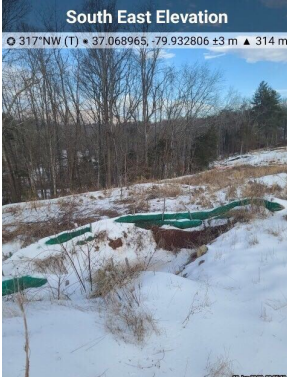
GPS Location	00000	GPS Location	00000		
Field Station#	13830+00	Field Station#	13784+35		
Pic 3 Desc.	Row photo showing snow covered conditions, no environmental issues observed at the time of inspection, row still frozen.		Pic 4 Desc.	Monitored sump pits and end treatment, no environmental issues observed at the time of inspection, row still frozen.

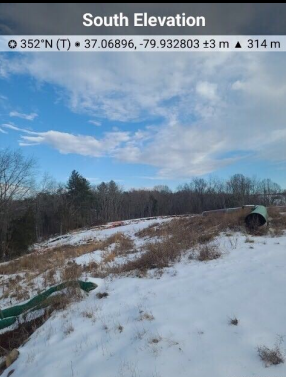
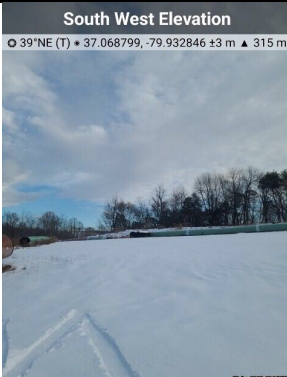
GPS Location	00000	GPS Location	00000		
Field Station#	13784+40	Field Station#	13784+38		
Pic 5 Desc.	Monitored visible vegetation and ECDs, no environmental issues observed at the time of inspection.		Pic 6 Desc.	Row photo showing snow covered conditions, no environmental issues observed at the time of inspection, row still frozen.

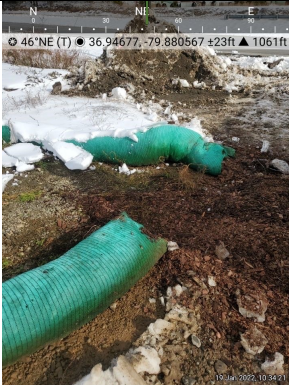
GPS Location	0	GPS Location	0		
Field Station#	0+00	Field Station#	0+00		
Pic 1 Desc.	LY-032 Damaged CFS of secondary containment		Pic 2 Desc.	LY-032 Equipment staging

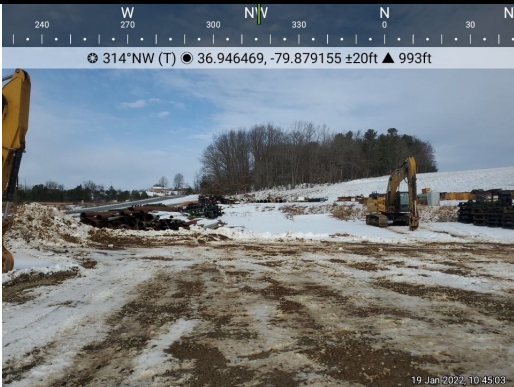
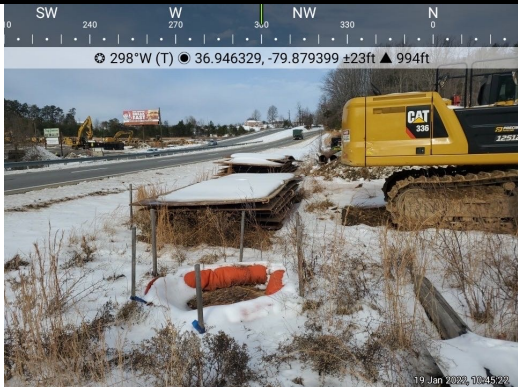
GPS Location	0	GPS Location	0		
Field Station#	0+00	Field Station#	0+00		
Pic 3 Desc.	LY-033 Staging area		Pic 4 Desc.	LY-033 Stormwater drain inlet

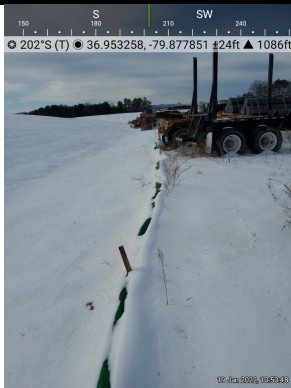
GPS Location	0	GPS Location	0		
Field Station#	0+00	Field Station#	0+00		
Pic 5 Desc.	ANC-006 Snow stockpile with Stormwater drain inlet protection		Pic 6 Desc.	ANC-006 Southeast perimeter CFS

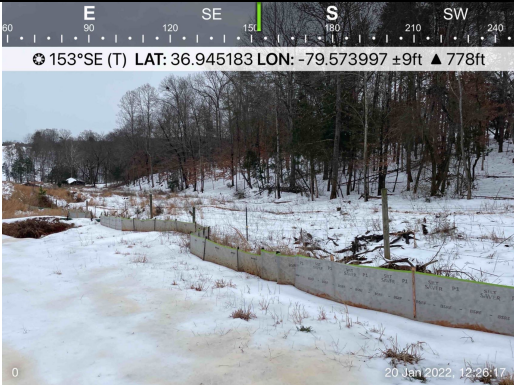
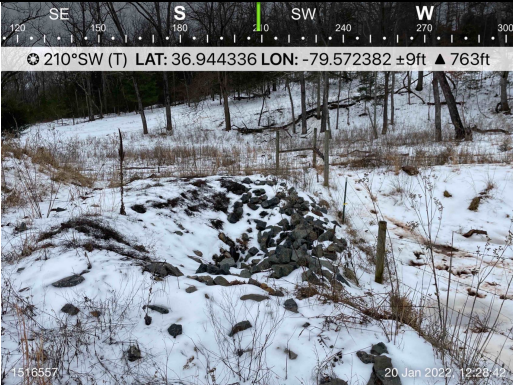
GPS Location	See photo		GPS Location	See photo	
Field Station#	15160+00		Field Station#	15165+57	
Pic 3 Desc.	Perimeter P1 is in good condition.		Pic 4 Desc.	Rock filter inlet remains in good condition.

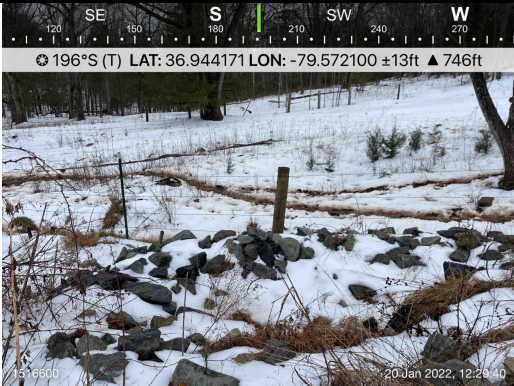
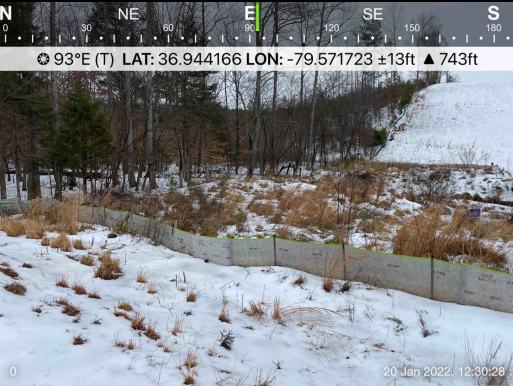
GPS Location	See photo		GPS Location	See photo	
Field Station#	15166+00		Field Station#	15168+00	
Pic 5 Desc.	Rock filter outlet remains in good condition.		Pic 6 Desc.	P1 is in good condition at stream buffer.

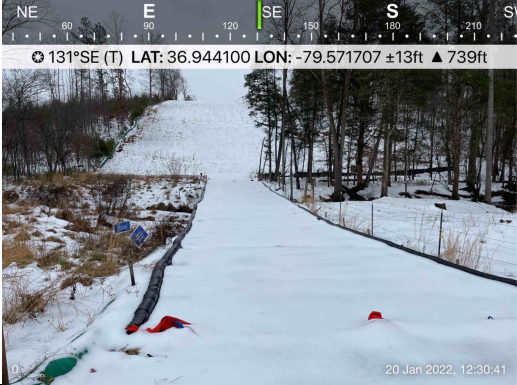
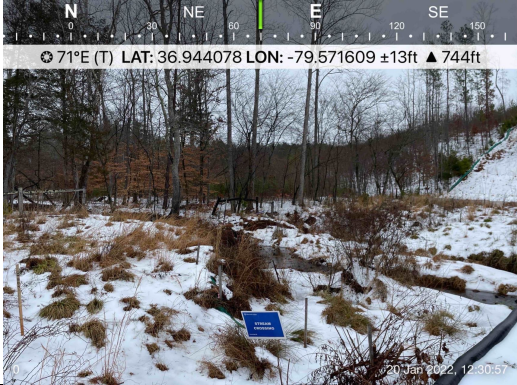
GPS Location	See photo	GPS Location	See photo		
Field Station#	15168+43	Field Station#	15168+43		
Pic 7 Desc.	Equipment bridge ECDs are in place and functioning.	Pic 8 Desc.	Stream buffer is in good condition.

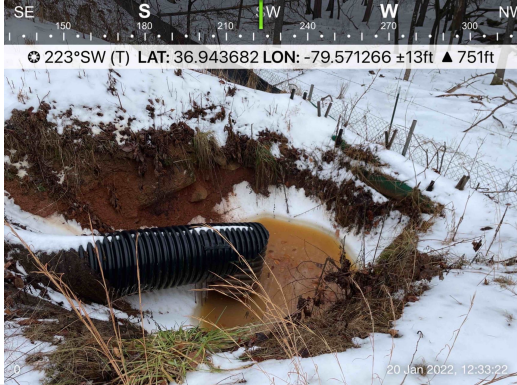
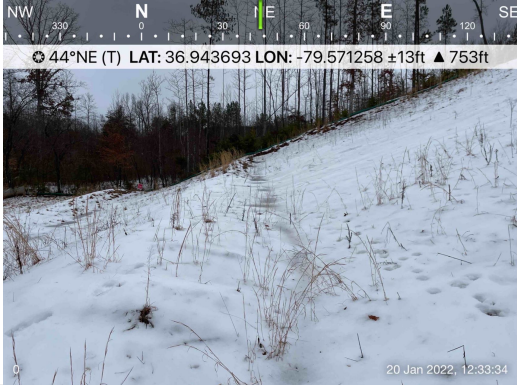
GPS Location	See photo	GPS Location	See photo		
Field Station#	15170+00	Field Station#	15170+00		
Pic 9 Desc.	Slope drain is in good condition and functioning.	Pic 10 Desc.	Waterbars are functioning as intended.

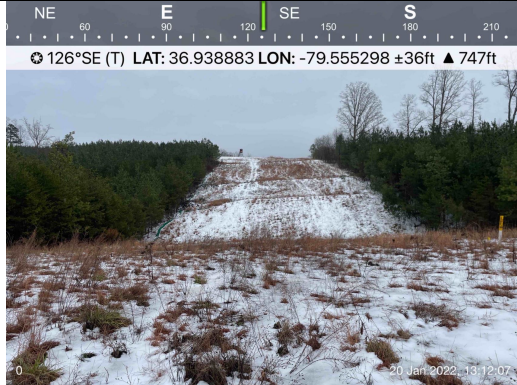
<p style="text-align: center;">Insert image here</p>			
GPS Location	See photo	GPS Location			
Field Station#	15223+00	Field Station#			
Pic 11 Desc.	Permanent vegetation remains in good condition.	Pic 12 Desc.

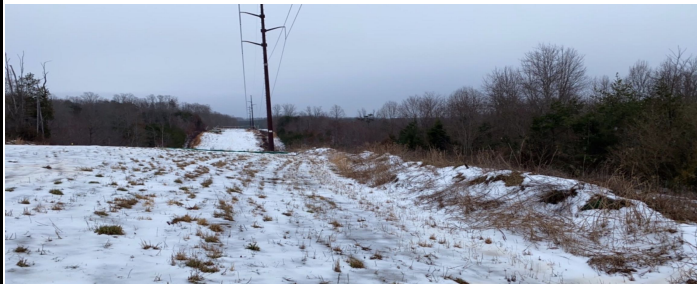
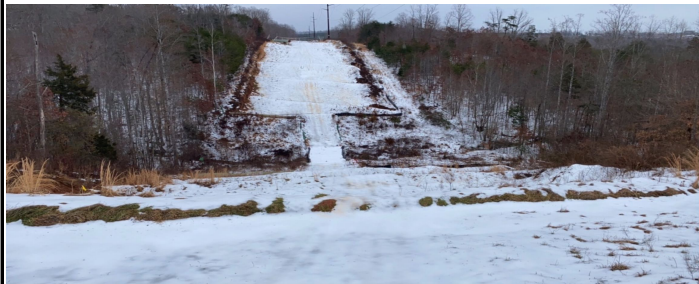
36°59'17" N 79°42'34" W 90°E COURSE 72' GPS 01.20.2022 12:19:25 Accur +/-18.3 Ft ALT 949 Ft			36°59'17" N 79°42'32" W 120°SE COURSE 109' GPS 01.20.2022 12:20:33 1558-2498 Jacks Creek Rd, Union Hall, VA 24176, United States Accur +/-15.4 Ft ALT 950 Ft		
GPS Location	1		GPS Location	2	
Field Station#	14696+00		Field Station#	14700+80	
Pic 1 Desc.	Temporary diversion berm stabilized and vegetated; covered in snow.		Pic 2 Desc.	Equipment bridge and surrounding ECDs appear to be in place and functional at stream crossing and resource buffer; signage visible and intact.

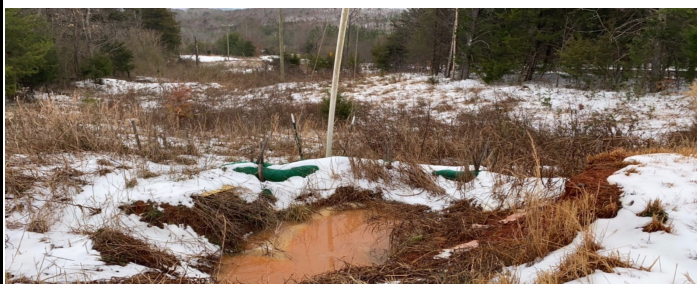
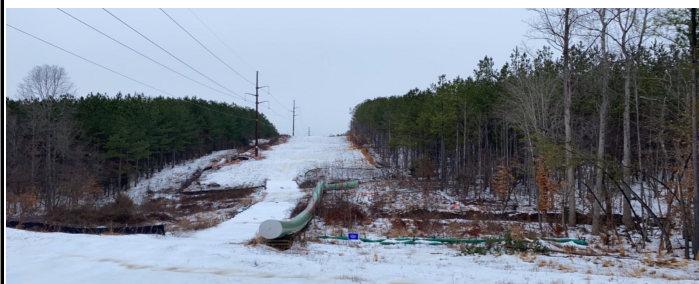
GPS Location	3		GPS Location	4	
Field Station#	14705+00		Field Station#	14749+89	
Pic 3 Desc.	Sump pit and CFS end treatment performing intended functions.		Pic 4 Desc.	Equipment bridge and surrounding ECDs appear to be in place and functional at stream crossing and resource buffer; signage visible and intact.

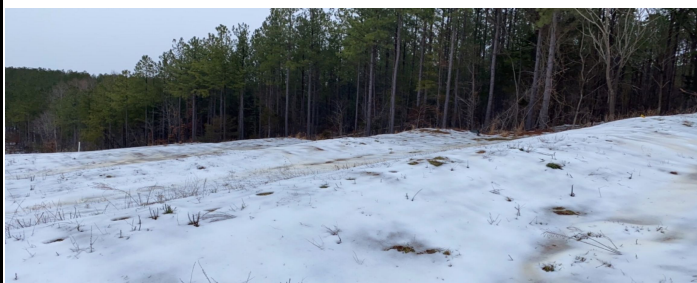
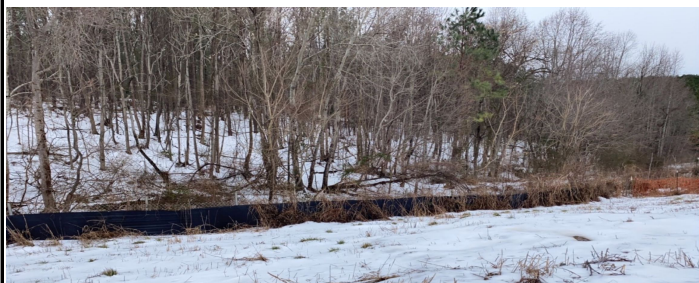
36°59'2" N 79°41'25" W 355°N COURSE 348' GPS 01.20.2022 12:30:57 700-1080 Indian Cave Rd, Union Hall, VA 24176, United States Accur +/-103.5 Ft ALT 950 Ft			36°59'1" N 79°41'24" W 304°NW COURSE 0' GPS 01.20.2022 12:30:01 700-1080 Indian Cave Rd, Union Hall, VA 24176, United States Accur +/-48.6 Ft ALT 0 Ft		
GPS Location	5		GPS Location	6	
Field Station#	14755+00		Field Station#	14757+00	
Pic 5 Desc.	Water bars performing intended functions; ROW stabilized by snow cover.		Pic 6 Desc.	Perimeter SSF in good condition.

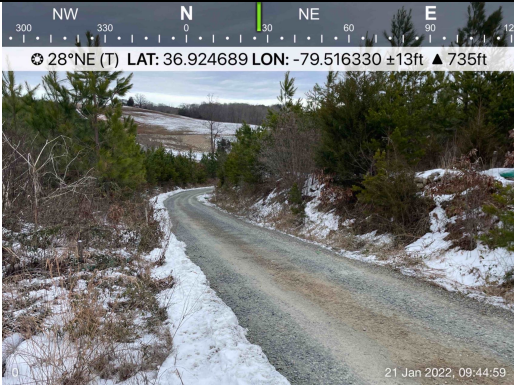
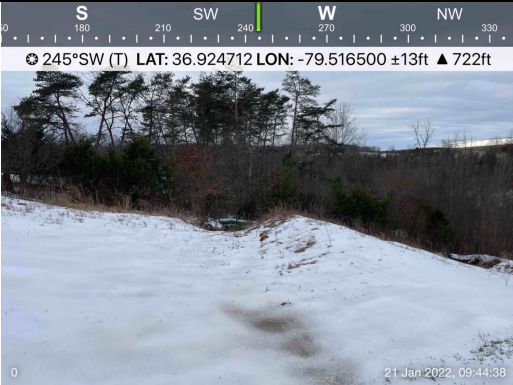
GPS Location	See photo	GPS Location	See photo		
Field Station#	15350+00	Field Station#	15349+00		
Pic 3 Desc.	MVP-PI-332 remains in good condition with controls in place.	Pic 4 Desc.	Waterbars are functioning as intended.

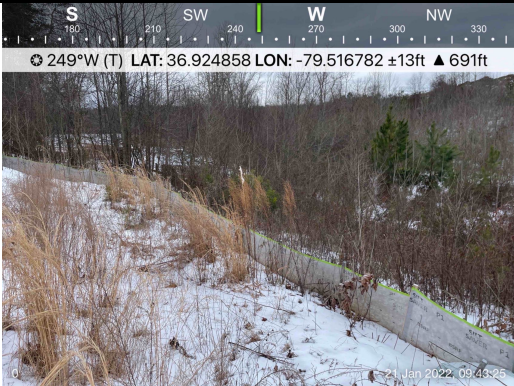
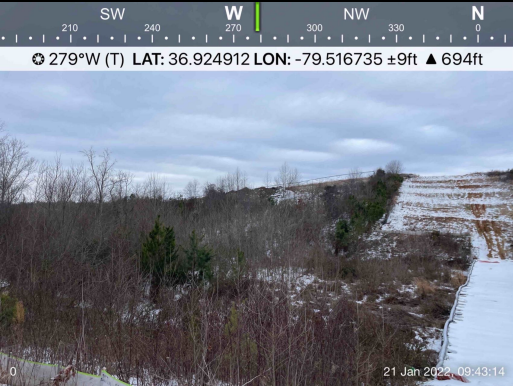
GPS Location	See photo	GPS Location	See photo		
Field Station#	15348+50	Field Station#	15348+21		
Pic 5 Desc.	P1 is in good condition at all stream and wetland buffers.	Pic 6 Desc.	Resource buffers remain in good condition.
