# Visual Site Inspection Report

<b>Project Name</b>	H-600 Pipeline Spread H	<b>AFE</b>	124300138	<b>Spread</b>	H-600 Pipeline Spread H
<b>Contractor</b>	Precision			<b>Report #</b>	35418
<b>Inspector</b>	Pat Davis			<b>Date/Time</b>	3/14/2022 4:00 PM
<b>Permit #</b>	TBD	<b>Inspection Type</b>	VA SWPP	<b>Station Begin</b>	+0
<b>State</b>	VA	<b>Inspection Area</b>	Partial	<b>Station End</b>	+0
<b>County</b>	Montgomery	<b>Ground</b>	Wet	<b>Temperature (°F)</b>	44.00
<b>Municipality</b>	N/A	<b>Weather</b>	Sunny	<b>Rain Gauge (in)</b>	0.50
				<b>Rain Accumulation Time (days)</b>	0.00

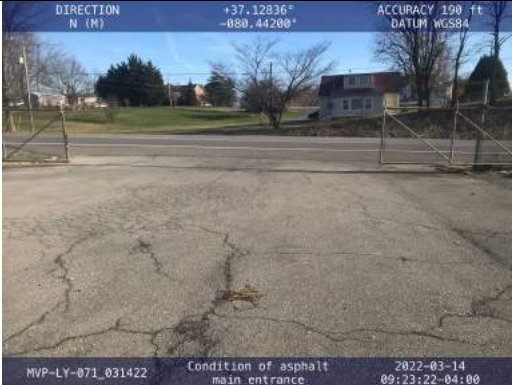
<b>GPS Location</b>	MVP-LY-071 See photo for gps data	<b>GPS Location</b>	MVP-LY-071 See photo for gps data		
<b>Field Station#</b>	+0	<b>Field Station#</b>	+0		
<b>Pic 1 Desc.</b>	Condition of main asphalt entrance. No sediment or debris on asphalt. Looking N.	<b>Pic 2 Desc.</b>	Condition of triple stack compost filter sock along east LOD. Looking N.

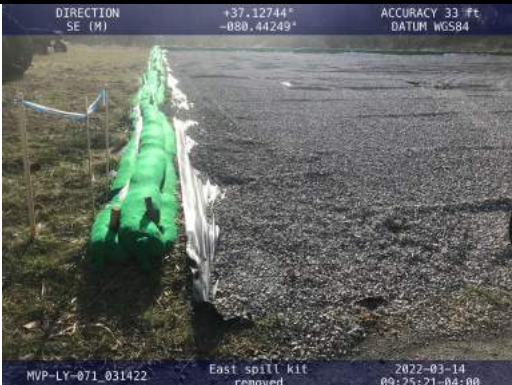
<b>GPS Location</b>	MVP-LY-071 See photo for gps data	<b>GPS Location</b>	MVP-LY-071 See photo for gps data		
<b>Field Station#</b>	+0	<b>Field Station#</b>	+0		
<b>Pic 3 Desc.</b>	East spill kit barrel has been removed. Looking SE.	<b>Pic 4 Desc.</b>	Condition of triple stack compost filter sock along east LOD. Looking N.

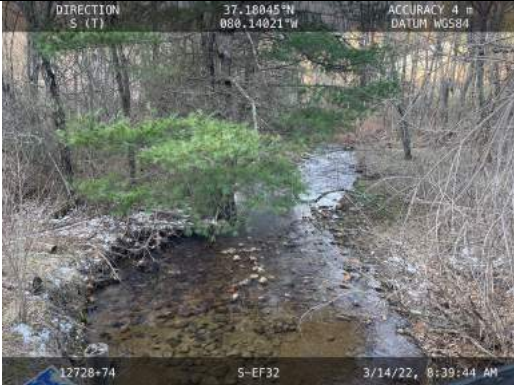
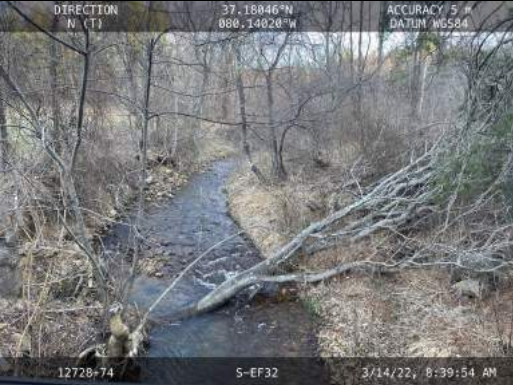
<b>GPS Location</b>	See photo		<b>GPS Location</b>	See photo	
<b>Field Station#</b>	12728+74		<b>Field Station#</b>	12728+74	
<b>Pic 1 Desc.</b>	Downstream of crossing at Stream S-EF32		<b>Pic 2 Desc.</b>	Upstream of crossing at Stream S-EF32

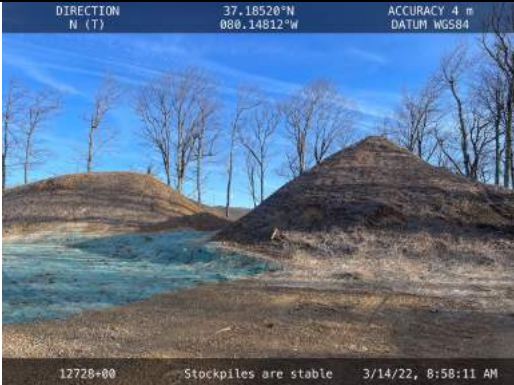
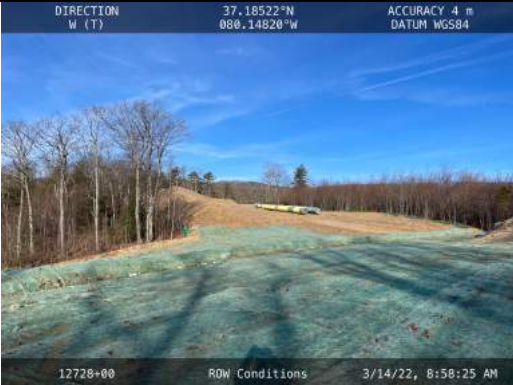
<b>GPS Location</b>	See photo		<b>GPS Location</b>	See photo	
<b>Field Station#</b>	12728+00		<b>Field Station#</b>	12728+00	
<b>Pic 3 Desc.</b>	Stockpiles are stable		<b>Pic 4 Desc.</b>	Current ROW conditions. ROW is stable. ECDs are functional.

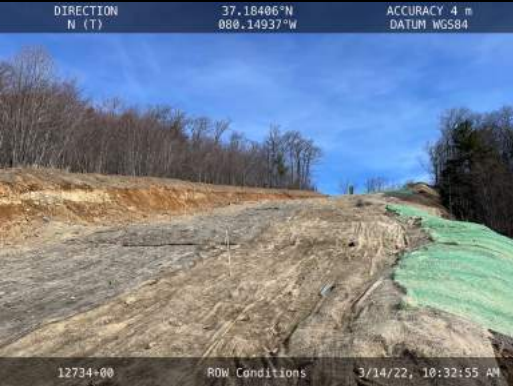
<b>GPS Location</b>	See photo		<b>GPS Location</b>	See photo	
<b>Field Station#</b>	12730+00		<b>Field Station#</b>	12734+00	
<b>Pic 5 Desc.</b>	Current ROW conditions. ROW is stable. ECDs are functional.		<b>Pic 6 Desc.</b>	Current ROW conditions. ROW is stable. ECDs are functional.

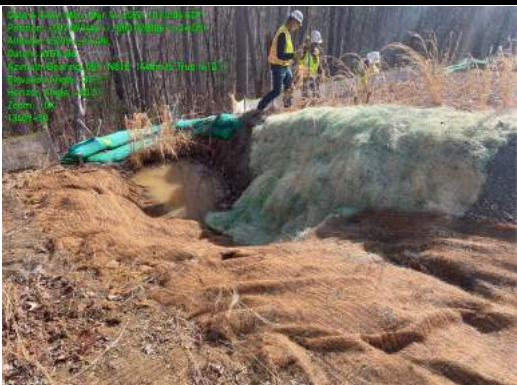
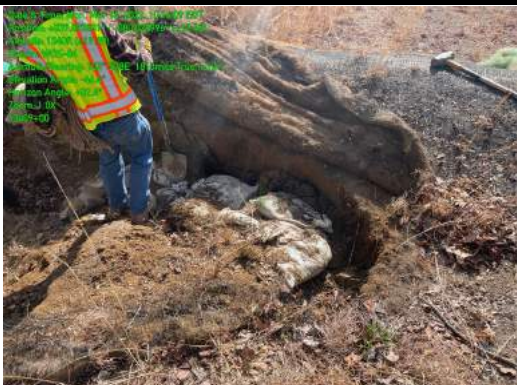
<b>Pic 17 Desc.</b>	PPL performing maintenance on sumps and end treatments.		<b>Pic 18 Desc.</b>	PPL performing maintenance on sumps.

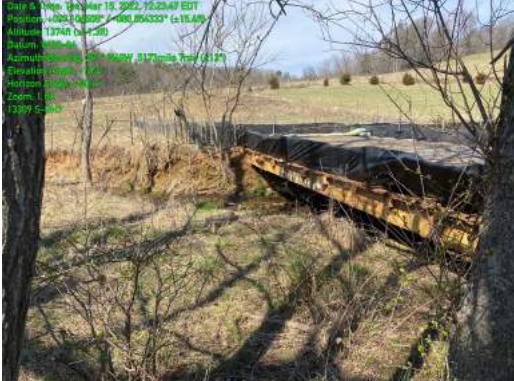
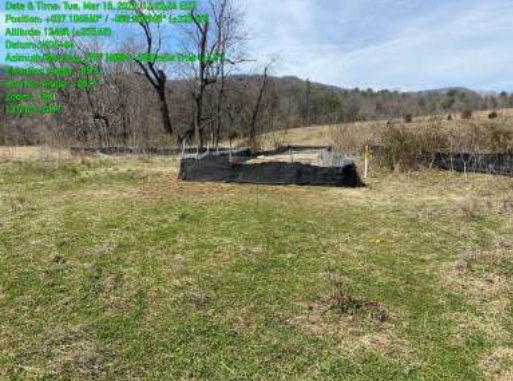
<b>GPS Location</b>	See photo for coordinates.		<b>GPS Location</b>	See photo for coordinates.	
<b>Field Station#</b>	13309+09		<b>Field Station#</b>	13310+00	
<b>Pic 1 Desc.</b>	S-GH7, downstream, no turbidity noted, banks appeared stable.		<b>Pic 2 Desc.</b>	S-GH7, ROW stabilized on CIS and GAS of crossing.

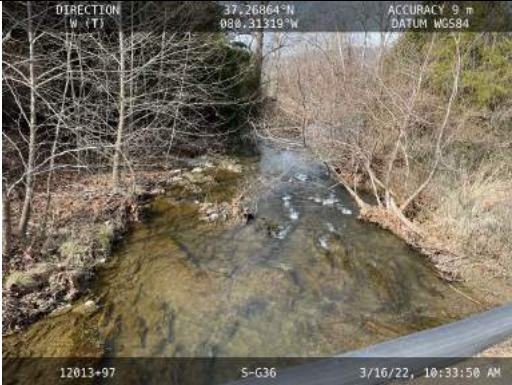
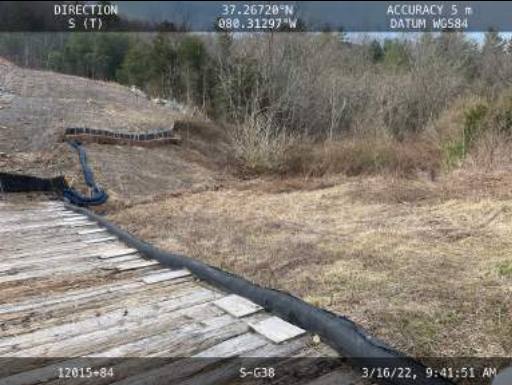
<b>GPS Location</b>	See Above		<b>GPS Location</b>	See Above	
<b>Field Station#</b>	12013+97		<b>Field Station#</b>	12015+84	
<b>Pic 1 Desc.</b>	Overview (downstream) of Waterbody S-G36 (Acc Rd 268). ECDs are functional and ROW is stable.		<b>Pic 2 Desc.</b>	Overview of Waterbody S-G38. ECDs are functional and ROW is stable.

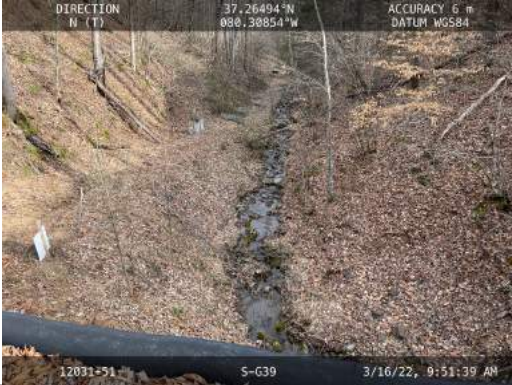
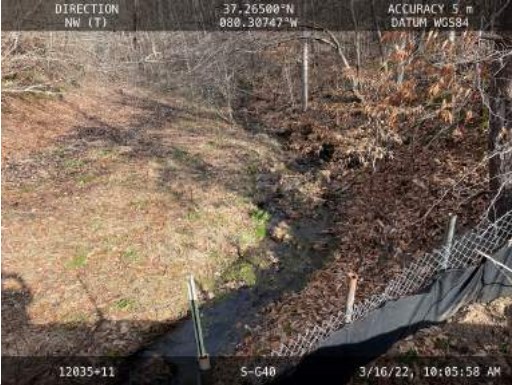
<b>GPS Location</b>	See Above		<b>GPS Location</b>	See Above	
<b>Field Station#</b>	12031+51		<b>Field Station#</b>	12035+11	
<b>Pic 3 Desc.</b>	Overview of Waterbody S-G39. ECDs are functional and ROW is stable.		<b>Pic 4 Desc.</b>	Overview of Waterbody S-G40. ECDs are functional and ROW is stable.

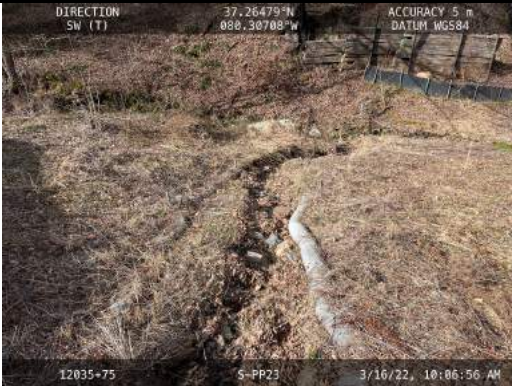
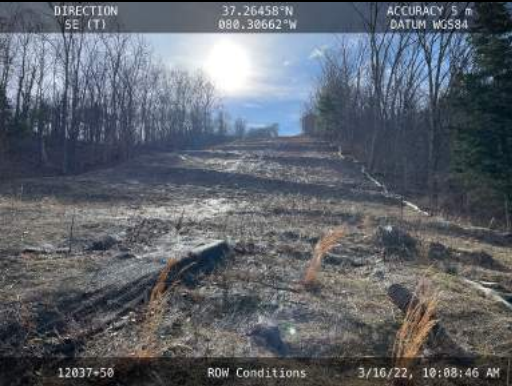
<b>GPS Location</b>	See Above		<b>GPS Location</b>	See Above	
<b>Field Station#</b>	12035+75		<b>Field Station#</b>	12037+50	
<b>Pic 5 Desc.</b>	Overview of Waterbody S-PP23. ECDs are functional and ROW is stable.		<b>Pic 6 Desc.</b>	ROW Overview. ECDs are functional and ROW is stable.

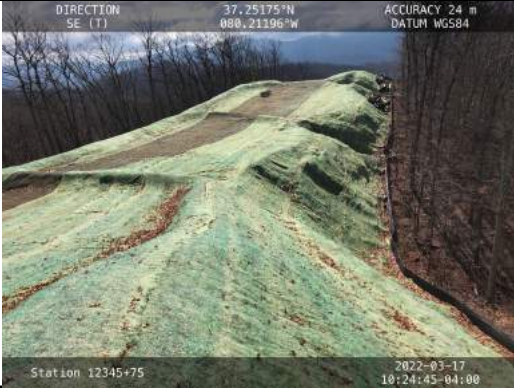
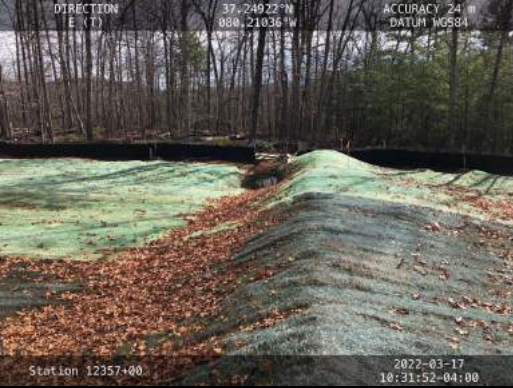
<b>Field Station#</b>	12345+75		<b>Field Station#</b>	12357+00	
<b>Pic 5 Desc.</b>	Photo shows stabilized side slope along with ECDs installed and functioning as designed.		<b>Pic 6 Desc.</b>	Photo shows stabilized ROW with water bar, sump and end treatment functioning as designed.

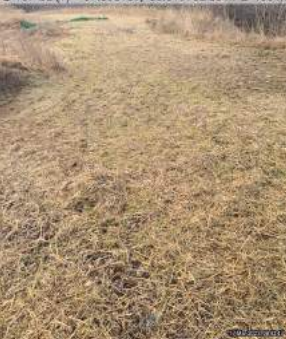
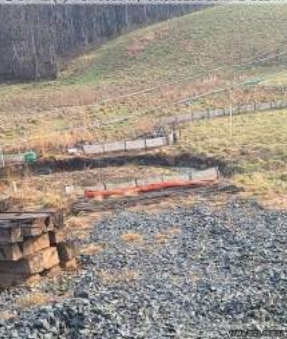
<b>GPS Location</b>	00000	<b>GPS Location</b>	00000		
<b>Field Station#</b>	13446+50	<b>Field Station#</b>	13497+12		
<b>Pic 1 Desc.</b>	Photo showing stabilization after recent seeding activities.		<b>Pic 2 Desc.</b>	Monitored ECDs at stream crossing after recent overnight rain events, no environmental issues observed at the time of inspection.	
	<b>North Elevation</b>

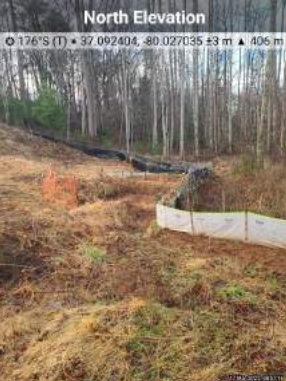
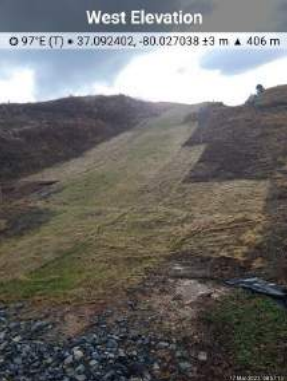
<b>GPS Location</b>	00000	<b>GPS Location</b>	00000		
<b>Field Station#</b>	13416+30	<b>Field Station#</b>	13417+70		
<b>Pic 3 Desc.</b>	Monitored LOD ECDs after recent rain events, no environmental issues observed at the time of inspection.		<b>Pic 4 Desc.</b>	Observed stabilization on hill side above road crossing. No environmental issues observed at the time of inspection.

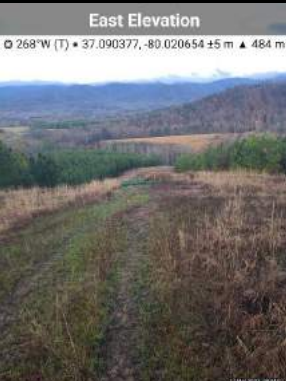
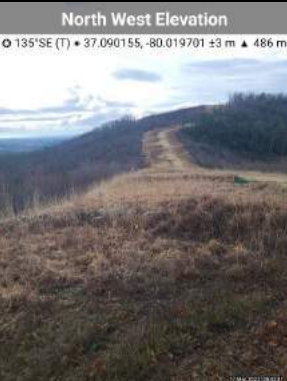
<b>GPS Location</b>	00000	<b>GPS Location</b>	00000		
<b>Field Station#</b>	13432+30	<b>Field Station#</b>	13446+04		
<b>Pic 5 Desc.</b>	Row photo showing vegetation in permanent area of row. No environmental issues observed at the time of inspection.		<b>Pic 6 Desc.</b>	Photo showing water bars and level spreaders , photo taken after recent rain events. No environmental issues observed at the time of inspection.

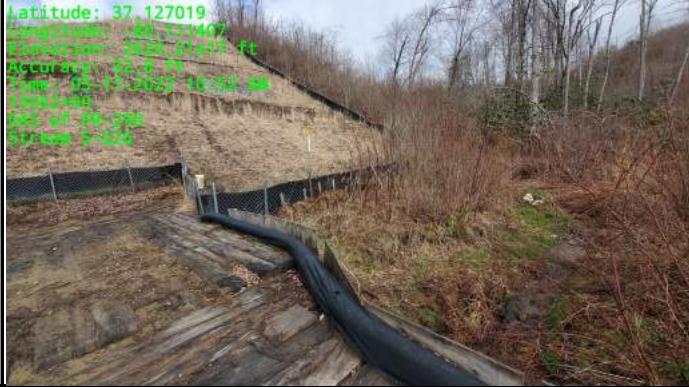
GPS Location	See pic for GPS location.		GPS Location	See pic for GPS location.	
Field Station#	13062+00		Field Station#	13062+00	
Pic 13 Desc.	Downstream side of stream S-G26.		Pic 14 Desc.	Upstream side of stream S-G26.	
<p>Latitude: 37.13063 Longitude: -80.111196 Elevation: 2606.76±15 ft Accuracy: 34.4 ft Time: 03-17-2022 10:53 AM 13063+00 GAS of FR-290 Stream S-G27</p>

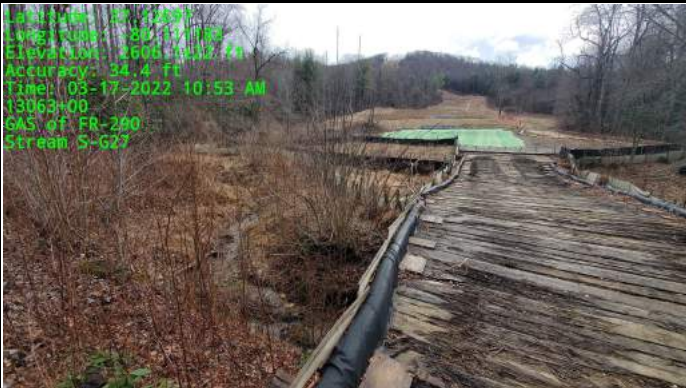
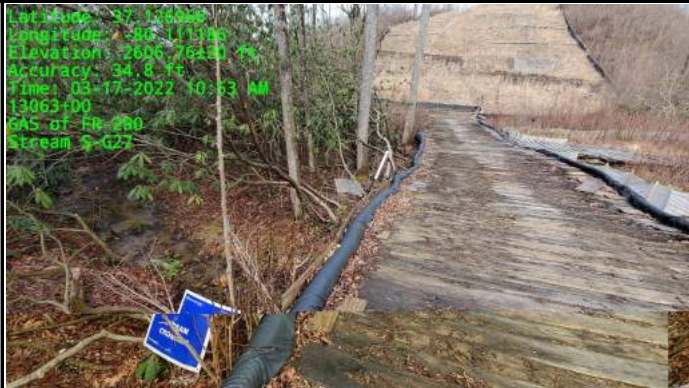
GPS Location	See pic for GPS location.		GPS Location	See pic for GPS location.	
Field Station#	13063+00		Field Station#	13063+00	
Pic 15 Desc.	Upstream side of stream S-G27.		Pic 16 Desc.	Downstream side of stream S-G27.	
<p>Latitude: 37.13061 Longitude: -80.115664 Elevation: 2586.10±15 ft Accuracy: 19.7 ft Time: 03-17-2022 01:01 PM 13061+44 Access Road FR-290 Stream S-RR18</p>

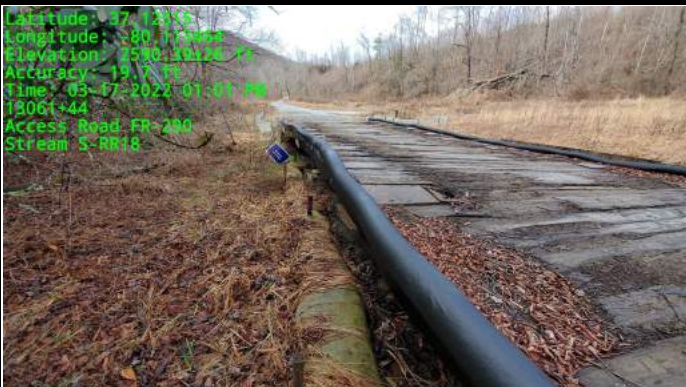
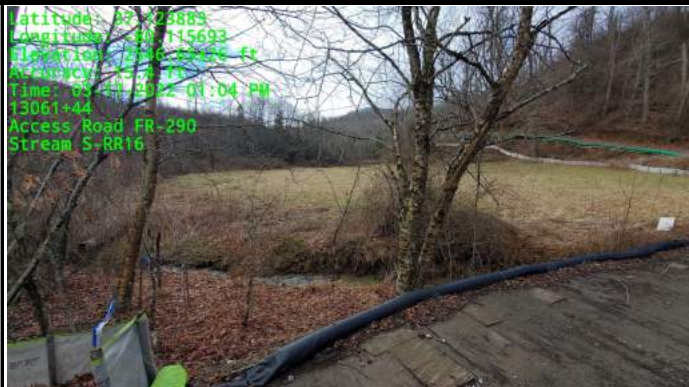
GPS Location	See pic for GPS location.		GPS Location	See pic for GPS location.	
Field Station#	13061+44		Field Station#	13061+44	
Pic 17 Desc.	Downstream side of stream S-RR18 along FR-290.		Pic 18 Desc.	Downstream side of stream S-RR16 along FR-290.

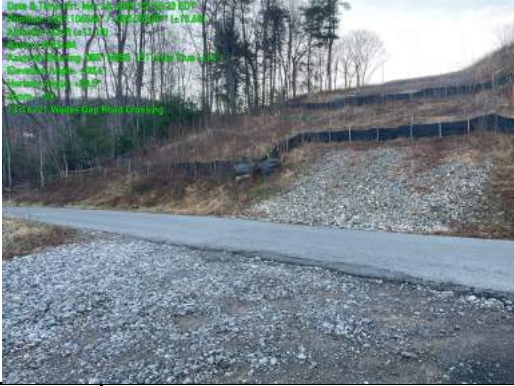
<b>GPS Location</b>	0	<b>GPS Location</b>	0		
<b>Field Station#</b>	13316+21	<b>Field Station#</b>	13317+02		
<b>Pic 1 Desc.</b>	Wades Gap Road Crossing in good condition	<b>Pic 2 Desc.</b>	Private Driveway in good condition

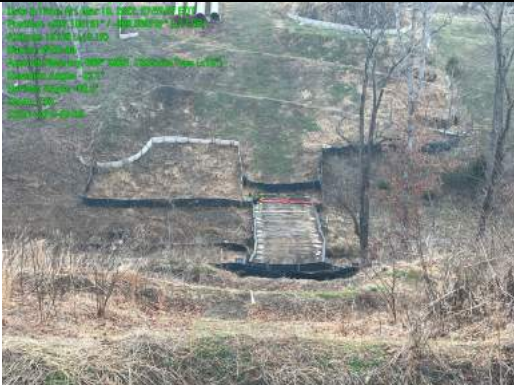
<b>GPS Location</b>	0	<b>GPS Location</b>	0		
<b>Field Station#</b>	13321+47	<b>Field Station#</b>	13334+17		
<b>Pic 3 Desc.</b>	MVP-S-GH15 and corresponding buffer zone in good condition	<b>Pic 4 Desc.</b>	MVP-S-GH11 and corresponding buffer zone in good condition

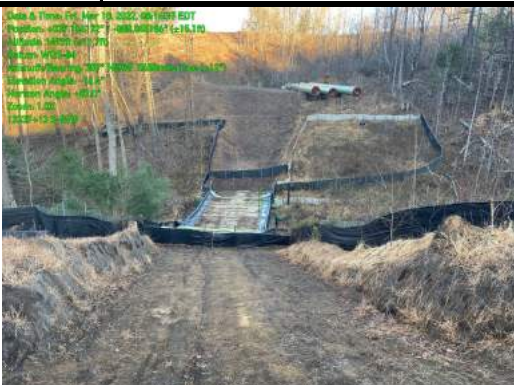
<b>GPS Location</b>	0	<b>GPS Location</b>	0		
<b>Field Station#</b>	13337+13	<b>Field Station#</b>	13342+00		
<b>Pic 5 Desc.</b>	MVP-S-GH9 and corresponding buffer zone in good condition	<b>Pic 6 Desc.</b>	ROW and ECDs In good condition and stable

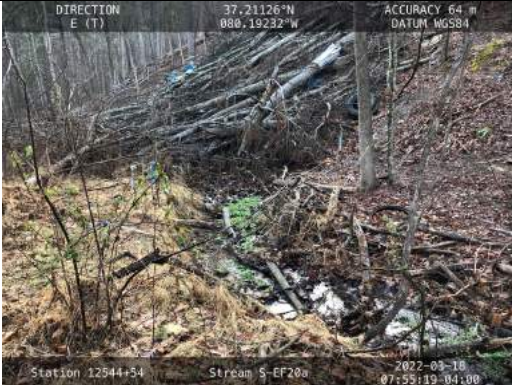
<b>GPS Location</b>	Please see photo for details.		<b>GPS Location</b>	Please see photo for details.	
<b>Field Station#</b>	12544+54		<b>Field Station#</b>	12542+00	
<b>Pic 1 Desc.</b>	Photo shows up stream of Stream S-EC20a		<b>Pic 2 Desc.</b>	Photo shows the stabilized ROW conditions with water bars and that all ECDs are installed and are functioning as designed.

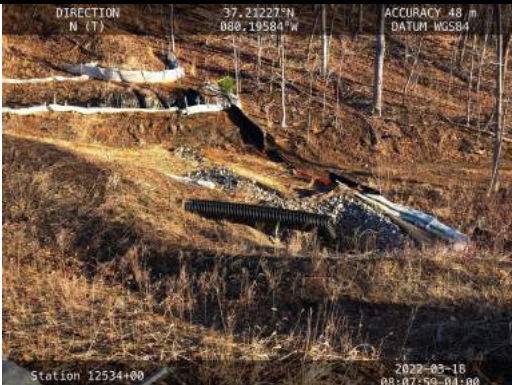
<b>GPS Location</b>	Please see photo for details.		<b>GPS Location</b>	Please see photo for details.	
<b>Field Station#</b>	12534+00		<b>Field Station#</b>	12533+00	
<b>Pic 3 Desc.</b>	Photo shows slope drain and plunge pool.		<b>Pic 4 Desc.</b>	Photo shows the stabilized ROW conditions with water bars and that all ECDs are installed and are functioning as designed.

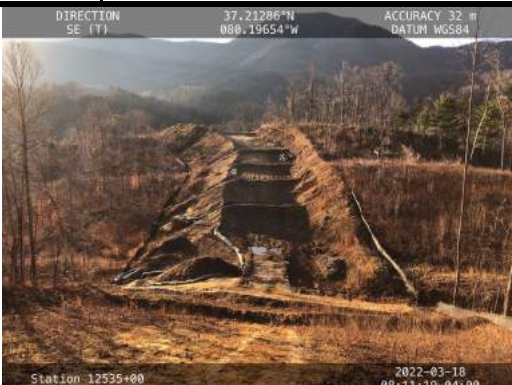
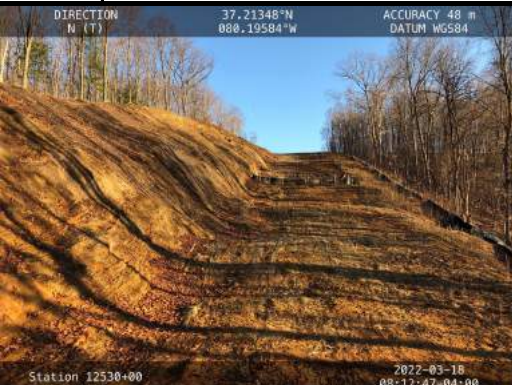
<b>Field Station#</b>	12535+00		<b>Field Station#</b>	12530+00	
<b>Pic 5 Desc.</b>	Photo shows the stabilized ROW conditions with water bars and that all ECDs are installed and are functioning as designed.		<b>Pic 6 Desc.</b>	Photo shows the stabilized ROW conditions with water bars and that all ECDs are installed and are functioning as designed.
