Visual Site Inspection Report

Project Name	H-600 Pipeline Spread H	AFE	124300138	Spread	H-600 Pipeline Spread H
Contractor	Precision			Report #	35203
Inspector	Jordan Davis			Date/Time	3/7/2022 7:55 PM
Permit #	TBD	Inspection Type	VA SWPP	Station Begin	12284+75
State	VA	Inspection Area	Partial	Station End	12443+75
County	Montgomery	Ground	Dry	Temperature (°F)	76.00
Municipality	N/A	Weather	Sunny	Rain Gauge (in)	0.00
				Rain Accumulation Time (days)	0.00

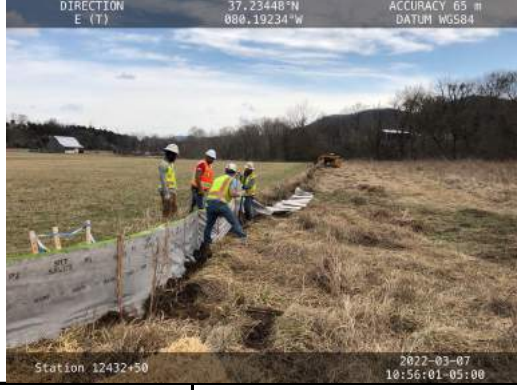
GPS Location	Please see photo for details.		GPS Location	Please see photo for details.	
Field Station#	12432+50		Field Station#	12330+00	
Pic 11 Desc.	Photo shows environmental crew installing P1 silt fence.		Pic 12 Desc.	Photo shows slop drain pipe with with stone inlet protection.

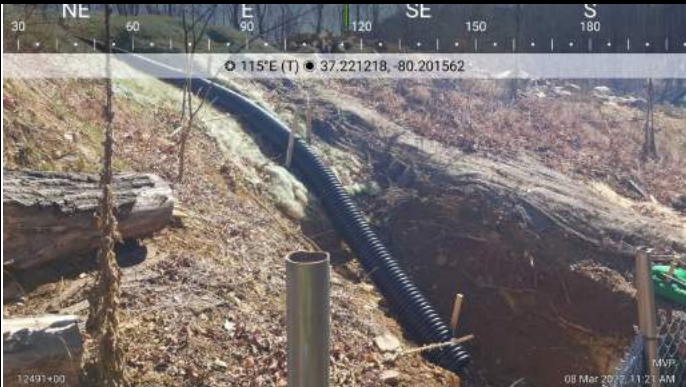
GPS Location	See Above		GPS Location	See Above	
Field Station#	12491+00		Field Station#	12492+00	
Pic 7 Desc.	ROW Overview (temporary stabilization). ECDs are functional and ROW is stable.		Pic 8 Desc.	ROW Overview (temporary stabilization). ECDs are functional and ROW is stable.

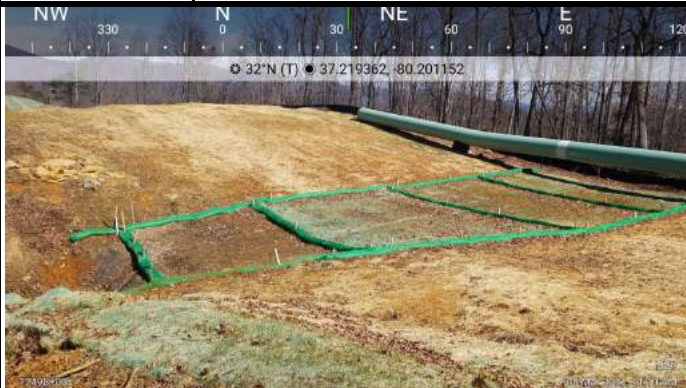
GPS Location	See Above		GPS Location	See Above	
Field Station#	12498+00		Field Station#	12501+00	
Pic 9 Desc.	ROW Overview (temporary stabilization). ECDs are functional and ROW is stable.		Pic 10 Desc.	ROW Overview (temporary stabilization). ECDs are functional and ROW is stable.

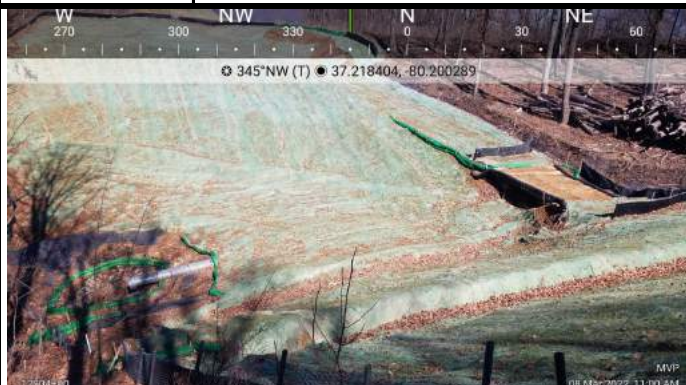
GPS Location	See Above		GPS Location	See Above	
Field Station#	12504+00		Field Station#	12512+50	
Pic 11 Desc.	ROW Overview (temporary stabilization). ECDs are functional and ROW is stable.		Pic 12 Desc.	ROW Overview (temporary stabilization). ECDs are functional and ROW is stable.

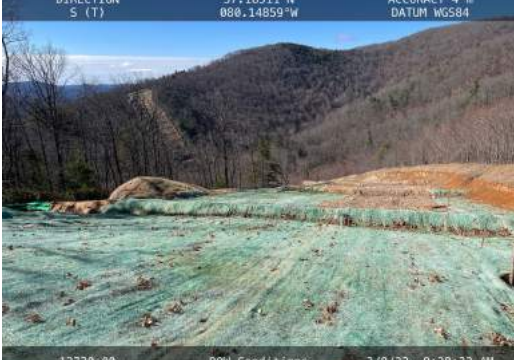
A/E	124300138	Date/Time	3/8/2022 4:02 PM	Report #	
Pictures					
	<div> DIRECTION NW (T) 37.18555°N 880.14981°W ACCURACY 4 m DATUM WGS84 </div>   <div> 12725+00 ROW Conditions 3/8/22, 9:25:50 AM </div>			<div> DIRECTION E (T) 37.18543°N 880.14875°W ACCURACY 4 m DATUM WGS84 </div>   <div> 12728+00 Stockpiles stable 3/8/22, 9:27:32 AM </div>	
GPS Location	See photo		GPS Location	See photo	
Field Station#	12725+00		Field Station#	12728+00	
Pic 1 Desc.	Current ROW conditions. ROW is stable. ECDs are functional.		Pic 2 Desc.	Stockpiles are stable	
	<div> DIRECTION S (T) 37.18511°N 880.14859°W ACCURACY 4 m DATUM WGS84 </div>

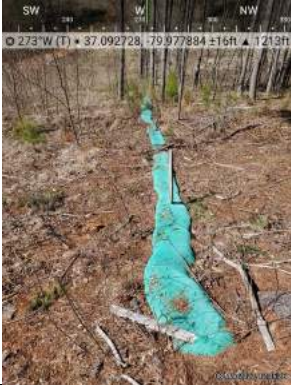
GPS Location	0	GPS Location	0		
Field Station#	13582+00	Field Station#	13595+00		
Pic 7 Desc.	Replace damaged CFS	Pic 8 Desc.	Waterbar outlet and vegetation

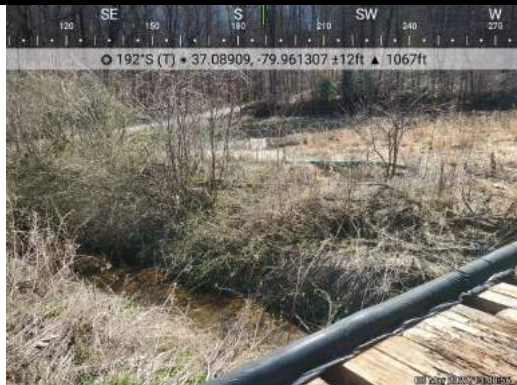
GPS Location	0	GPS Location	0		
Field Station#	13643+60	Field Station#	13657+00		
Pic 11 Desc.	S-EF28 Buffer zone and ECDs	Pic 12 Desc.	CIS S-GH4 Vegetation and ECDs

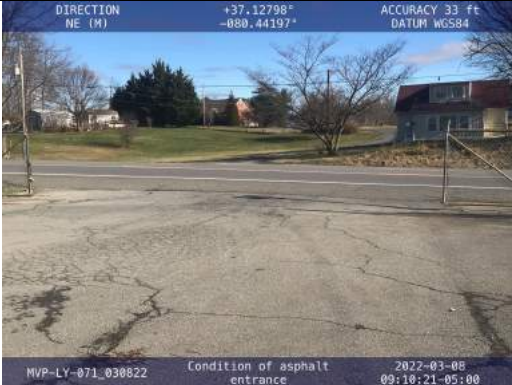
GPS Location	MVP-LY-071 See photo for gps data	GPS Location	MVP-LY-071 See photo for gps data		
Field Station#	+0	Field Station#	+0		
Pic 1 Desc.	Condition of asphalt entrance. No sediment or debris on public roadway. Looking NE.	Pic 2 Desc.	Con of triple stack compost filter sock along north LOD. Looking NW.

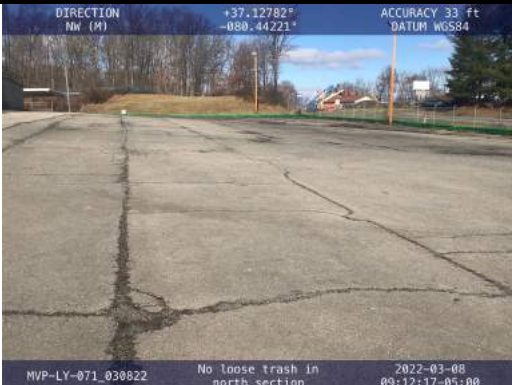
GPS Location	MVP-LY-071 See photo for gps data	GPS Location	MVP-LY-071 See photo for gps data		
Field Station#	+0	Field Station#	+0		
Pic 3 Desc.	No loose trash or debris in north section of the yard. Looking NW.	Pic 4 Desc.	Condition of triple stack compost filter sock along west LOD. Looking SW.

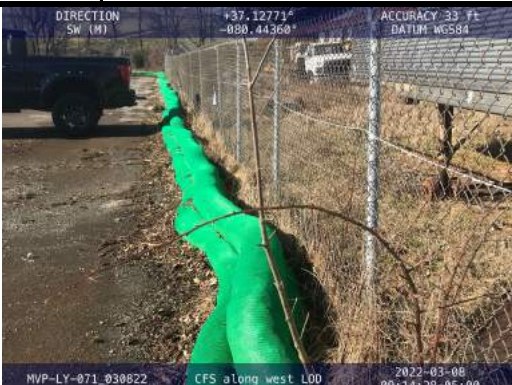
GPS Location	MVP-LY-071 See photo for gps data	GPS Location	MVP-LY-071 See photo for gps data		
Field Station#	+0	Field Station#	+0		
Pic 5 Desc.	Condition of triple stack compost filter sock along west LOD. Looking S.	Pic 6 Desc.	Storage box trailers have been removed from the yard along with any straw debris. Looking SW.

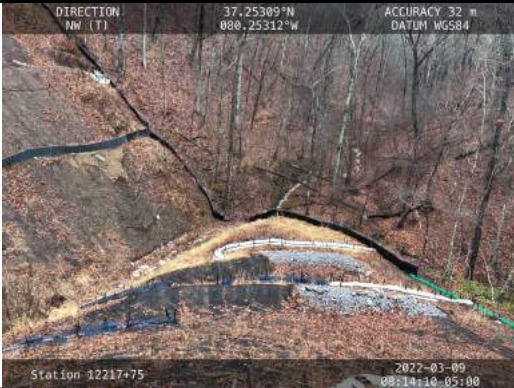
Field Station#	12211+75		Field Station#	12211+00	
Pic 5 Desc.	Photo shows stabilized ROW with permanent water bars and level spreaders installed and functioning as designed.		Pic 6 Desc.	Photo shows water flow after current rain event in channel. (Not a resource).

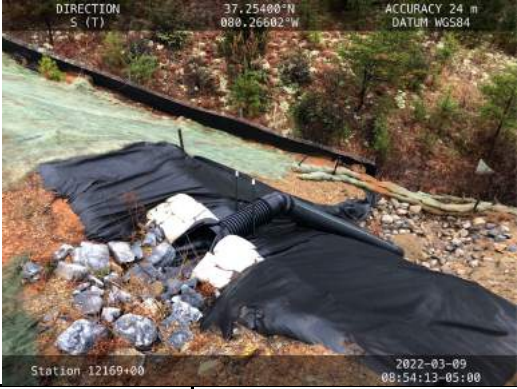
GPS Location	Please see photo for details.		GPS Location	Please see photo for details.	
Field Station#	12169+00		Field Station#	12166+47	
Pic 13 Desc.	Photo shows slope drain pipe with stone inlet protection as well as plunge pool.		Pic 14 Desc.	Photo shows upstream of Stream S-C24 from equipment bridge.

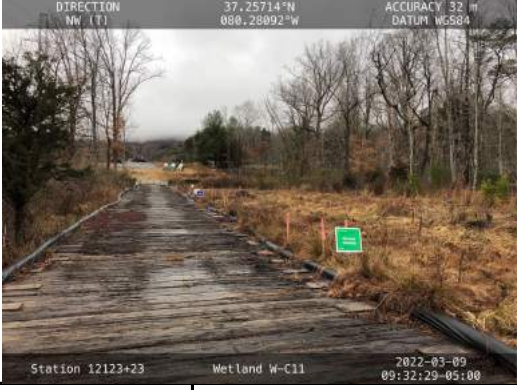
Pic 17 Desc.	Photo shows timber mats with side boards and Wetland W-C11.		Pic 18 Desc.	Photo shows view of Stream S-C33 from equipment bridge.

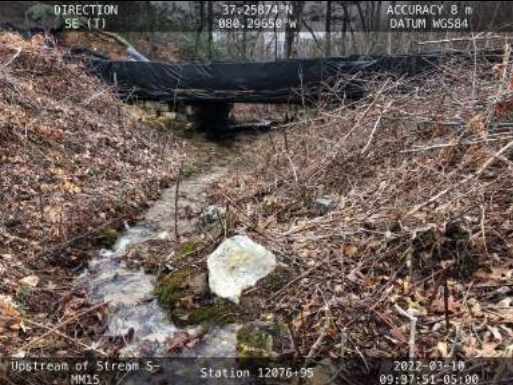
GPS Location	Please see photo for details.		GPS Location	Please see photo for details.	
Field Station#	12079+50		Field Station#	12076+95	
Pic 1 Desc.	Photo shows stabilized ROW with erosion control blanket.		Pic 2 Desc.	Photo shows upstream of Stream S-MM15.

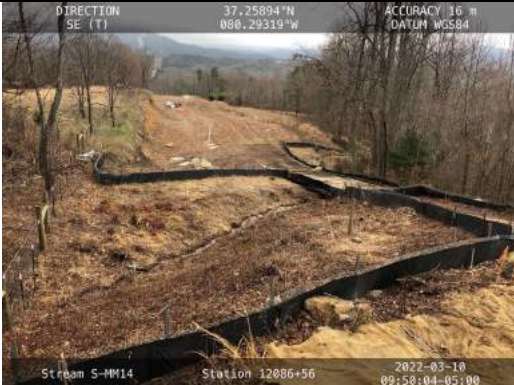
GPS Location	Please see photo for details.		GPS Location	Please see photo for details.	
Field Station#	12086+56		Field Station#	12093+00	
Pic 3 Desc.	Photo shows view of Stream S-MM14 along with its buffer zone.		Pic 4 Desc.	Photo shows clean water diversion pipe leading into plunge pool.

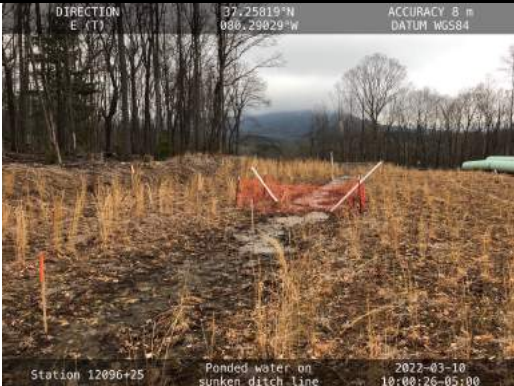
GPS Location	Please see photo for details.		GPS Location	Please see photo for details.	
Field Station#	12096+25		Field Station#	12097+25	
Pic 5 Desc.	Photo shows ponded water over sunken ditch line.		Pic 6 Desc.	Photo shows water bar, sump and end treatment functioning as designed

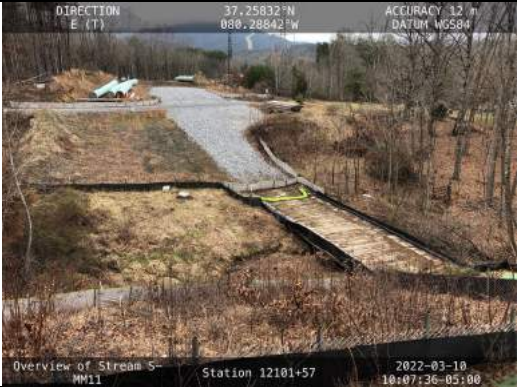
<p>DIRECTION E (T) 37.25832°N 088.28842°W ACCURACY 12 m DATUM WGS84</p> <p>Overview of Stream S-MM11 Station 12101+57 2022-03-10 10:07:36-05:00</p>

<p>DIRECTION S (T) 37.25846°N 088.28816°W ACCURACY 24 m DATUM WGS84</p> <p>Upstream of Stream S-MM11 Station 12101+57 2022-03-10 10:09:24-05:00</p>			
GPS Location	Please see photo for details.		GPS Location	Please see photo for details.	
Field Station#	12101+57		Field Station#	12101+57	
Pic 7 Desc.	Photo shows view of Stream S-MM11 along with its buffer zone.		Pic 8 Desc.	Photo shows upstream of Stream S-MM11.

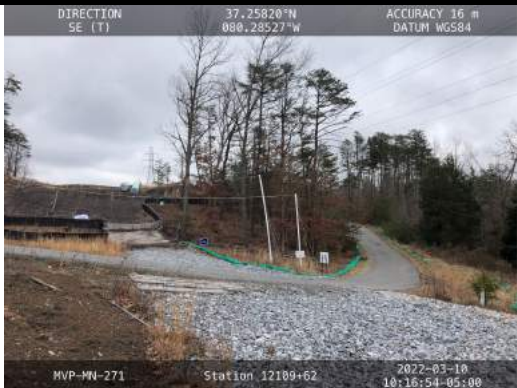
<p>DIRECTION SE (T) 37.25820°N 088.28527°W ACCURACY 16 m DATUM WGS84</p> <p>MVP-MN-271 Station 12109+62 2022-03-10 10:16:54-05:00</p>

GPS Location	Please see photo for details.		GPS Location	Please see photo for details.	
Field Station#	12109+62		Field Station#	12112+13	
Pic 9 Desc.	Photo shows RCE on MVP-MN-271 along with installed ECDs functioning as designed.		Pic 10 Desc.	Photo shows downstream of Stream S-F16A/B.

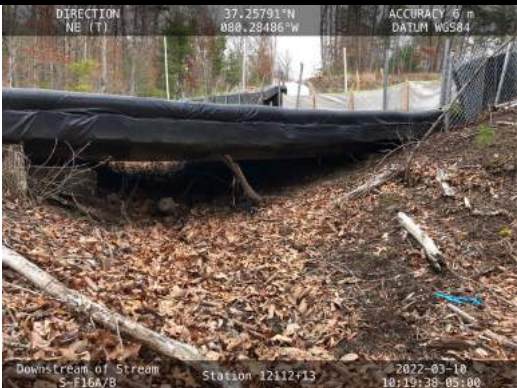
<p>DIRECTION NE (T) 37.25791°N 088.28486°W ACCURACY 6 m DATUM WGS84</p> <p>Downstream of Stream S-F16A/B Station 12112+13 2022-03-10 10:19:38-05:00</p>

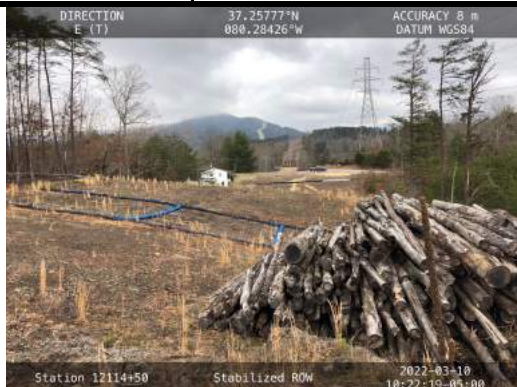
<p>DIRECTION E (T) 37.25777°N 088.28426°W ACCURACY 8 m DATUM WGS84</p> <p>Station 12114+50 Stabilized ROW 2022-03-10 10:22:19-05:00</p>

<p>DIRECTION SE (T) 37.25778°N 088.28334°W ACCURACY 6 m DATUM WGS84</p> <p>Station 12116+75 Stabilized ROW 2022-03-10 10:27:35-05:00</p>			
GPS Location	Please see photo for details.		GPS Location	Please see photo for details.	
Field Station#	12114+50		Field Station#	12116+75	
Pic 11 Desc.	Photo shows stabilized ROW, stacked timber pile and that installed ECDs are functioning as designed.		Pic 12 Desc.	Photo shows stabilized ROW, installed permanent water bars with level spreaders as well as properly installed ECDs.

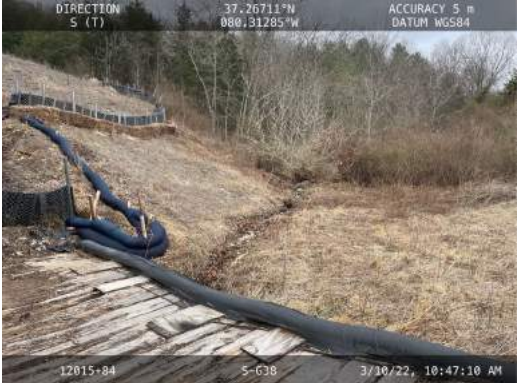
GPS Location	Please see photo for details.		GPS Location	Please see photo for details.	
Field Station#	12015+84		Field Station#	12013+97	
Pic 13 Desc.	Photo shows view of Stream S-G38 fro, equipment bridge.		Pic 14 Desc.	Photo shows downstream view of Stream S-G38 from equipment bridge.

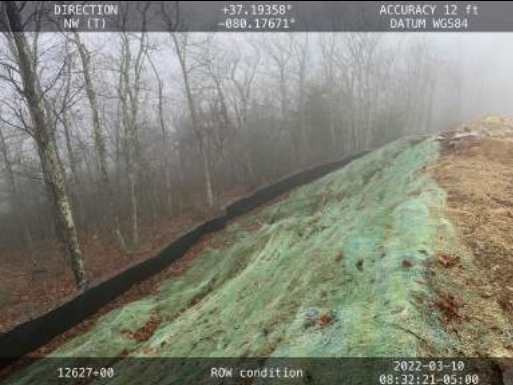
GPS Location	See photo for gps location data.		GPS Location	See photo for gps location data.	
Field Station#	12628+00		Field Station#	12627+00	
Pic 1 Desc.	Photo shows the ROW condition. ECDs are installed and functioning as designed.		Pic 2 Desc.	Photo shows the ROW condition. ECDs are installed and functioning as designed.

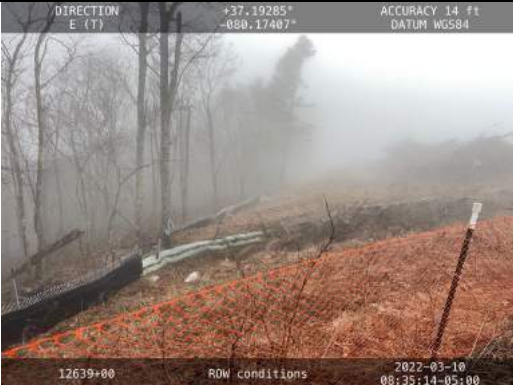
GPS Location	See photo for gps location data.		GPS Location	See photo for gps location data.	
Field Station#	12630+00		Field Station#	12639+00	
Pic 3 Desc.	Photo shows the sump pit and end treatment. ECDs are installed and functioning as designed.		Pic 4 Desc.	Photo shows the ROW condition. ECDs are installed and functioning as designed.

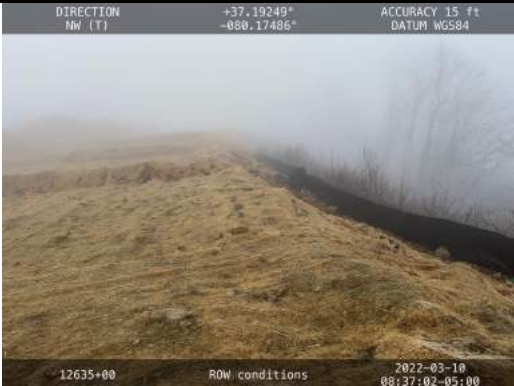
GPS Location	See photo for gps location data.		GPS Location	See photo for gps location data.	
Field Station#	12635+00		Field Station#	12634+00

Pic 5 Desc.	Photo shows the ROW condition. ECDs are installed and functioning as designed.		Pic 6 Desc.	Photo shows the slope drain. ECDs are installed and functioning as designed.

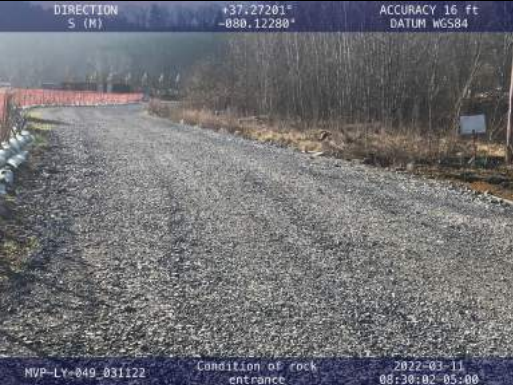
GPS Location	MVP-LY-049 See photo for gps data	GPS Location	MVP-LY-049 See photo for gps data		
Field Station#	+0	Field Station#	+0		
Pic 1 Desc.	Condition of rock entrance. No sediment or debris on stone. Looking SW.	Pic 2 Desc.	Condition of rock entrance. Small stone applied over larger stone. Looking S.

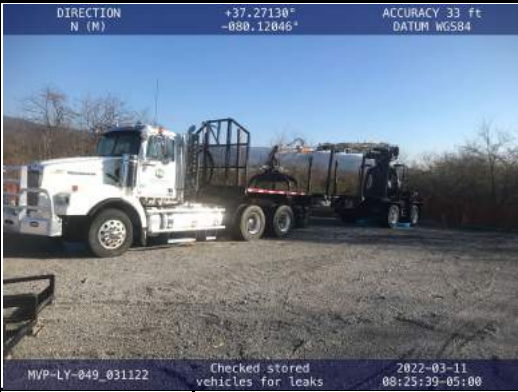
Pic 17 Desc.	Checked under stored vehicles for new leaks. No new leaks found. Looking N.	Pic 18 Desc.	Checked under stored equipment for new leaks. No new leaks found. Looking W.

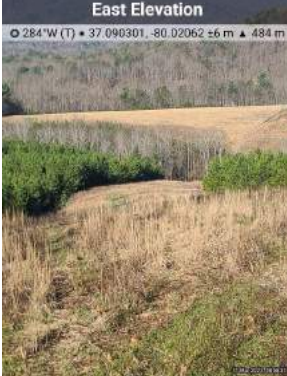
GPS Location	0000	GPS Location	0000		
Field Station#	13436+15	Field Station#	13436+00		
Pic 1 Desc.	CFS throughout the row monitored with no issues observed at the time of inspection.		Pic 2 Desc.	Row photo showing vegetation in permanent area of row, no environmental issues observed at the time of inspection.	
	North Elevation  			North West Elevation

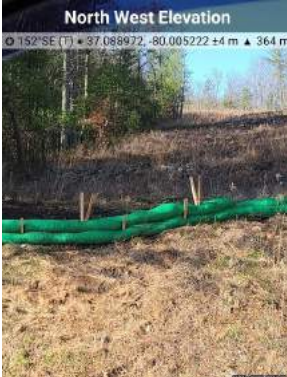
GPS Location	0000	GPS Location	0000		
Field Station#	13416+12	Field Station#	13496+62		
Pic 3 Desc.	Monitored sump pit and ECDs , no environmental issues observed at the time of inspection.		Pic 4 Desc.	Observed newly installed ECDs at CAHAS#2 rd crossing, no environmental issues observed at the time of inspection.	
	North West Elevation

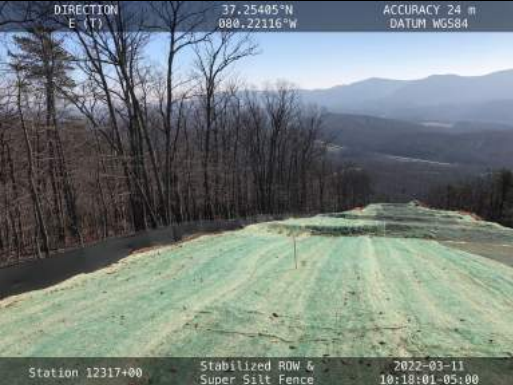
GPS Location	Please see photo for details.		GPS Location	Please see photo for details.	
Field Station#	12296+00		Field Station#	12317+00	
Pic 1 Desc.	Photo shows the stabilized ROW conditions with water bars and that all ECDs are installed and are functioning as designed.		Pic 2 Desc.	Photo shows the stabilized ROW conditions with water bars and that all ECDs are installed and are functioning as designed.

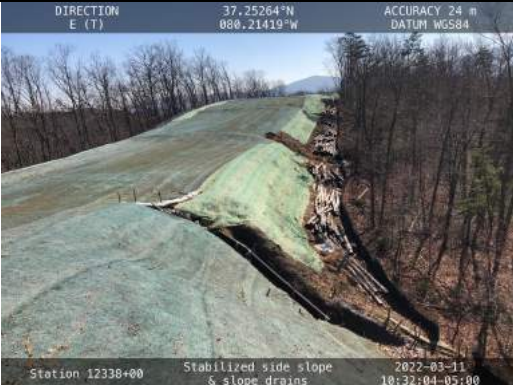
GPS Location	Please see photo for details.		GPS Location	Please see photo for details.	
Field Station#	12332+85		Field Station#	12338+00	
Pic 3 Desc.	Photo shows stabilized ROW with water bar, sump, and end treatment functioning as designed.		Pic 4 Desc.	Photo shows stabilized side slope with slope drains and plunge pool functioning as designed.

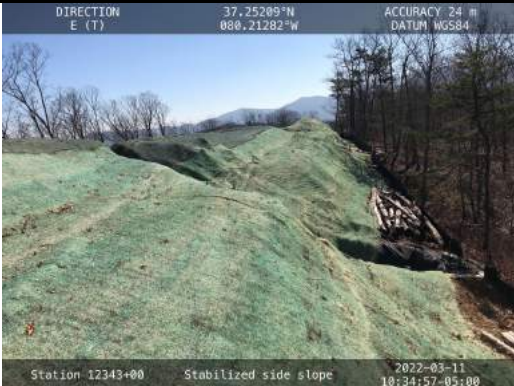
Field Station#	12343+00		Field Station#	12346+50	
Pic 5 Desc.	Photo shows stabilized side slope and installed ECDs functioning as designed.		Pic 6 Desc.	Photo shows stabilized side slope and installed ECDs functioning as designed.

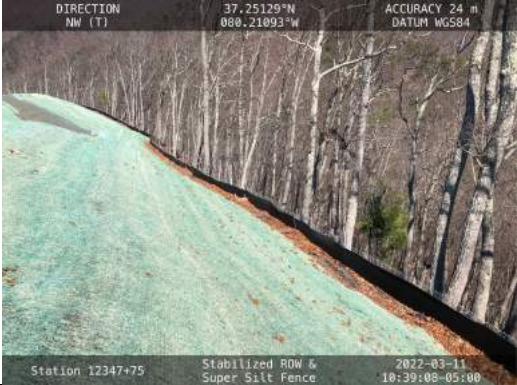
GPS Location	Please see photo for details.		GPS Location	Please see photo for details.	
Field Station#	12347+75		Field Station#	12360+85	
Pic 7 Desc.	Photo shows stabilized side slope and installed ECDs functioning as designed.		Pic 8 Desc.	Photo shows stabilized ROW, installed water bars, sump, end treatment and ECDs functioning as designed.

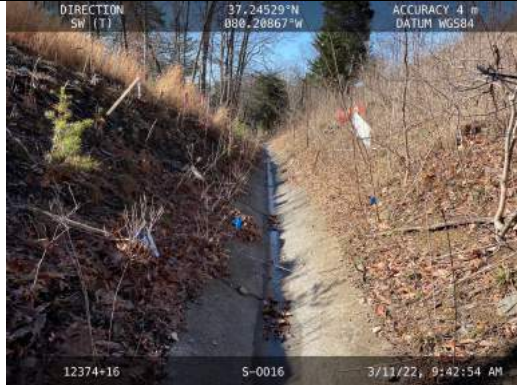
Pic 11 Desc.	Photo shows view from upstream of Stream S-0016.		Pic 12 Desc.	Photo shows the stabilized ROW conditions with water bars and that all ECDs are installed and are functioning as designed.
