# Visual Site Inspection Report

| <b>Project Name</b> | H-600 Pipeline Spread H | <b>AFE</b> | 124300138 | <b>Spread</b> | H-600 Pipeline Spread H |
| <b>Inspector</b> | Norm Kitchen | | | <b>Date/Time</b> | 4/11/2022 3:00 PM |

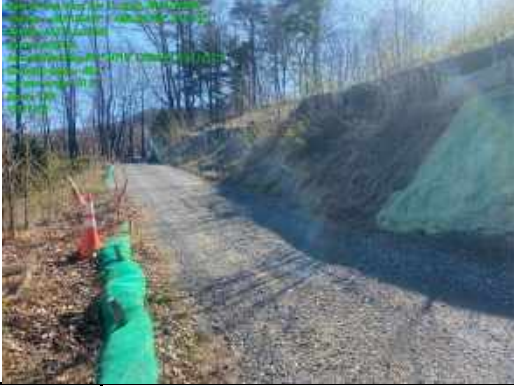
| <b>Field Station#</b> | 13317+02 | <b>Field Station#</b> | 13321+47 | | |

| <b>Pic 1 Desc.</b> | Private drive in good condition | <b>Pic 2 Desc.</b> | MVP-S-GH15 and Corresponding buffer zone in good condition | | |

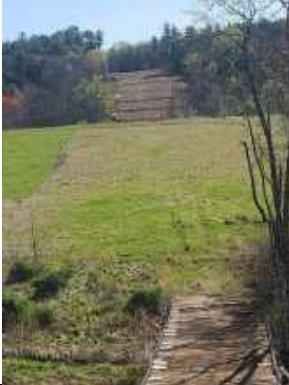
| <b>Field Station#</b> | 13544+00 | <b>Field Station#</b> | 13643+67 | | |

| <b>Pic 1 Desc.</b> | Photo showing area of permanent row that has been mowed by a land owner, documented as non project related activities. | | <b>Pic 2 Desc.</b> | Debris needs removed from flume pipes at stream crossing, added to the punch list. | |

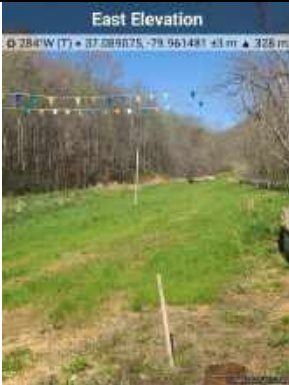
| <b>Field Station#</b> | 13643+00 | <b>Field Station#</b> | 13644+73 | | |

| <b>Pic 3 Desc.</b> | Vegetation observation photo showing stabilization. No environmental issues observed at the time of inspection. | | <b>Pic 4 Desc.</b> | Additional photo showing P1 that requires maintenance. | |

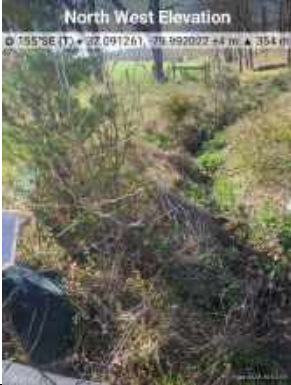
| <b>Field Station#</b> | 13539+14 | <b>Field Station#</b> | | | |

| <b>Pic 7 Desc.</b> | Stream observation photo facing downstream during routine inspection today, no environmental issues observed at the time of inspection | | <b>Pic 8 Desc.</b> | | |

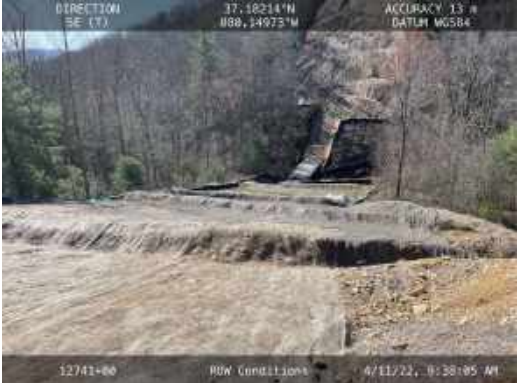
| <b>Field Station#</b> | 12741+00 | | <b>Field Station#</b> | 12743+84 | |

| <b>Pic 7 Desc.</b> | Current ROW Conditions. ROW is stable. ECDs are functional. | | <b>Pic 8 Desc.</b> | Equipment Bridge over Stream S-EF34B | |

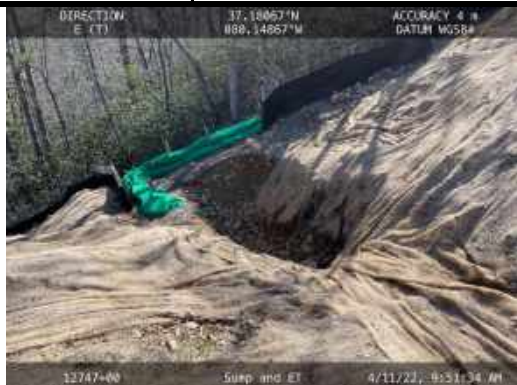
| <b>Field Station#</b> | 12747+00 | | <b>Field Station#</b> | 12747+00 | |

| <b>Pic 11 Desc.</b> | Sump and End Treatment are functional | | <b>Pic 12 Desc.</b> | Current ROW Conditions. ROW is stable. ECDs are functional. | |

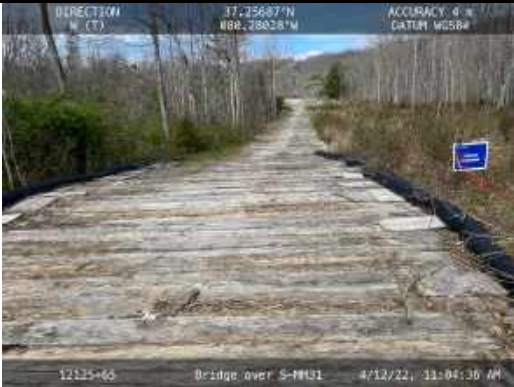
| <b>Field Station#</b> | 12125+65 | <b>Field Station#</b> | 12132+73 | | |

| <b>Pic 1 Desc.</b> | Overview of Waterbody S-MM31. ECDs functional and in good condition. | <b>Pic 2 Desc.</b> | Overview of Waterbody S-C29 (downstream). ECDs functional and in good condition. | | |

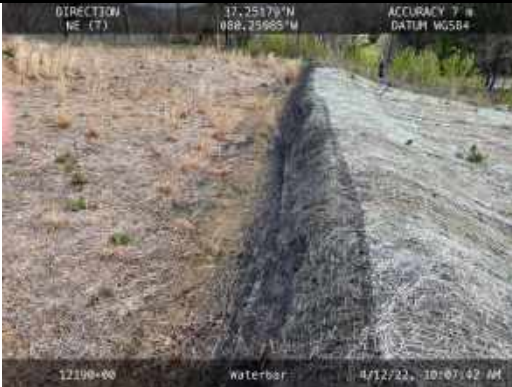
| <b>Field Station#</b> | 12190+00 | | <b>Field Station#</b> | 12180+00 | |

| <b>Pic 1 Desc.</b> | Waterbar is functional | | <b>Pic 2 Desc.</b> | Current ROW conditions. ROW is stable. ECDs are functional. | |

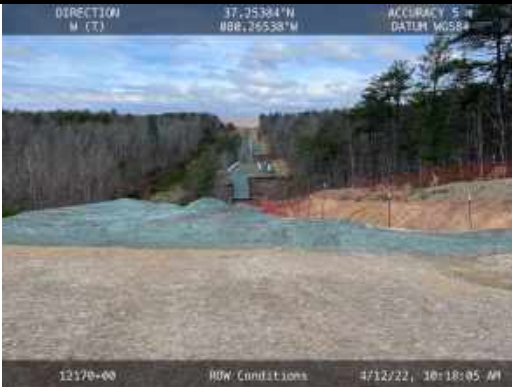
| <b>Field Station#</b> | 12170+00 | | <b>Field Station#</b> | 12166+47 | |

| <b>Pic 3 Desc.</b> | Current ROW conditions. ROW is stable. ECDs are functional. | | <b>Pic 4 Desc.</b> | Overview of Stream S-C24 | |

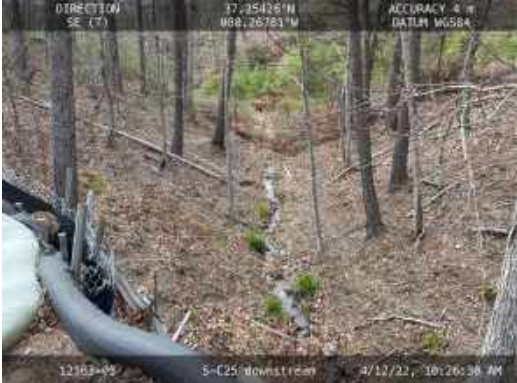
| <b>Field Station#</b> | 12163+05 | | <b>Field Station#</b> | 12160+00 | |

| <b>Pic 7 Desc.</b> | Downstream of crossing at Stream S-C25 | | <b>Pic 8 Desc.</b> | Current ROW conditions. ROW is stable. ECDs are functional. | |

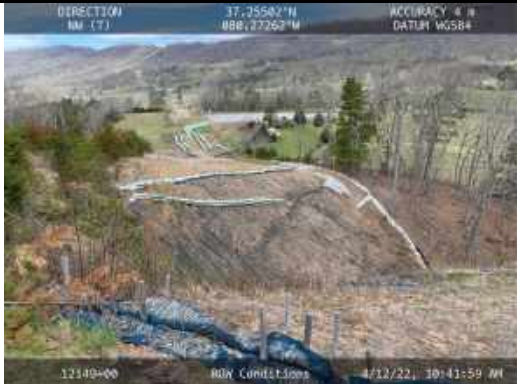
| <b>Field Station#</b> | 12149+00 | | <b>Field Station#</b> | 12146+00 | |

| <b>Pic 9 Desc.</b> | Current ROW conditions. ROW is stable. ECDs are functional. | | <b>Pic 10 Desc.</b> | Current ROW conditions. ROW is stable. ECDs are functional. | |

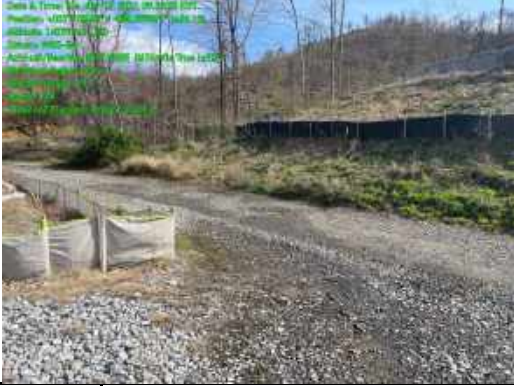
| <b>Field Station#</b> | 13262+62 | | <b>Field Station#</b> | 13260+66 | |

| <b>Pic 1 Desc.</b> | Flanders Road crossing in acceptable condition. | | <b>Pic 2 Desc.</b> | S-II4, perimeter ECDs in acceptable condition. | |

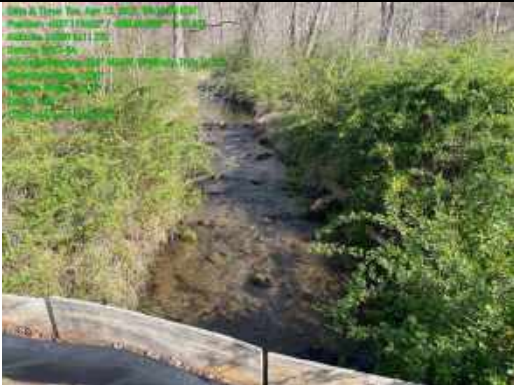
| <b>Field Station#</b> | 13260+66 | | <b>Field Station#</b> | 13259+00 | |

| <b>Pic 3 Desc.</b> | S-II4, upstream, no ROW impacts observed. | | <b>Pic 4 Desc.</b> | ROW stable with good vegetative cover. | |

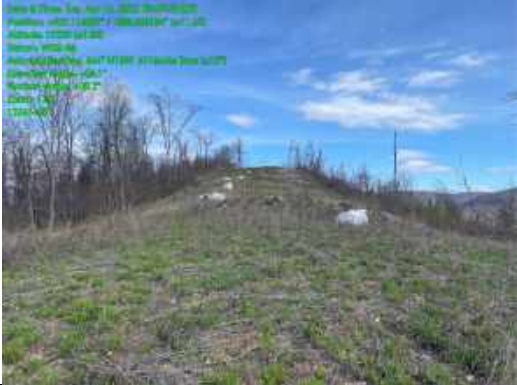
| <b>Field Station#</b> | 13247+00 | | <b>Field Station#</b> | 13231+00 | |

| <b>Pic 7 Desc.</b> | Good vegetative cover noted, ROW stable. | | <b>Pic 8 Desc.</b> | Good vegetative cover noted, ROW stable. | |

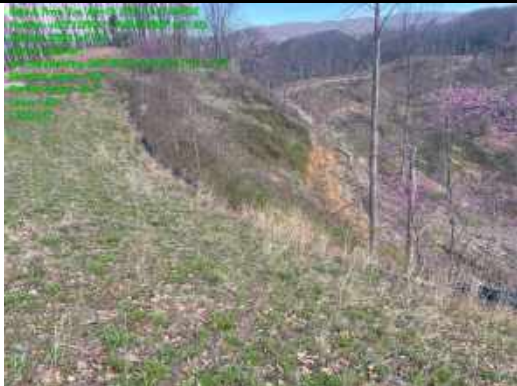
| <b>Field Station#</b> | 13222+00 | | <b>Field Station#</b> | 13112+00 | |

| <b>Pic 9 Desc.</b> | No changes noted at off ROW slip. | | <b>Pic 10 Desc.</b> | Adequate vegetative cover noted, ROW stable. | |

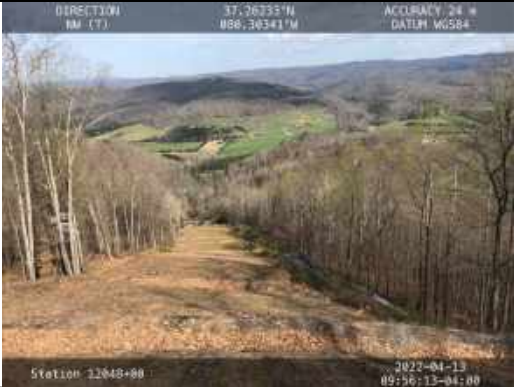
| <b>Pic 1 Desc.</b> | Photo shows the stabilized ROW conditions with water bars and that all ECDs are installed and are functioning as designed. | | <b>Pic 2 Desc.</b> | Photo shows the stabilized ROW conditions with water bars and that all ECDs are installed and are functioning as designed. | |

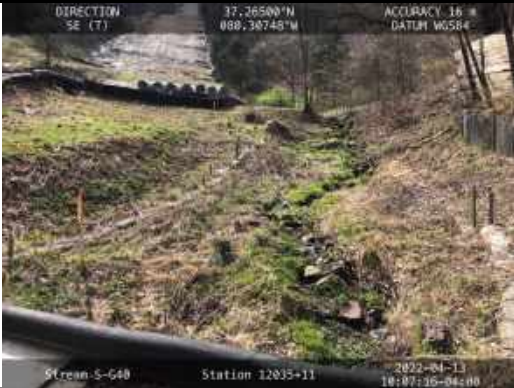
| <b>Pic 3 Desc.</b> | Photo shows the stabilized ROW conditions with water bars and that all ECDs are installed and are functioning as designed. | | <b>Pic 4 Desc.</b> | Photo shows upstream view of Stream S-PP23 from equipment bridge spanning stream channel. | |

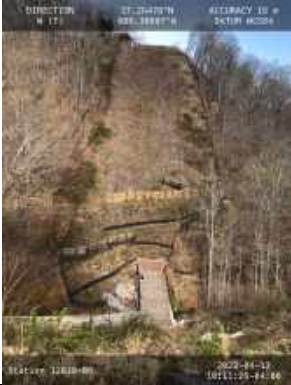
| <b>Pic 5 Desc.</b> | Photo shows upstream view of Stream S-G40 from equipment bridge spanning stream channel. | | <b>Pic 6 Desc.</b> | Photo shows the stabilized ROW conditions with water bars and that all ECDs are installed and are functioning as designed. | |

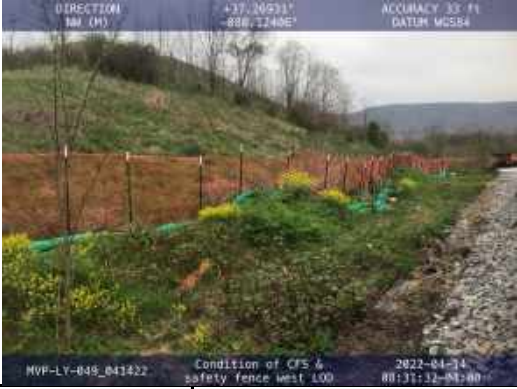
| <b>Pic 7 Desc.</b> | Condition of safety fence and triple stack compost filter sock along west LOD. Looking NW. | | <b>Pic 8 Desc.</b> | Check stored vehicles for new leaks. No new leaks noted. Looking NE. | |

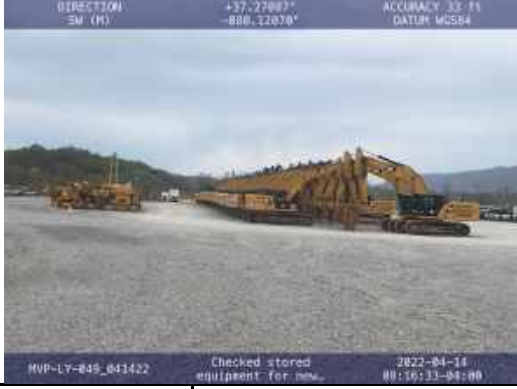
| <b>Pic 9 Desc.</b> | Checked stored equipment for new leaks. No new leaks noted. Looking SW. | | <b>Pic 10 Desc.</b> | Compost filter sock in place and functioning around sand pile. Looking W. | |

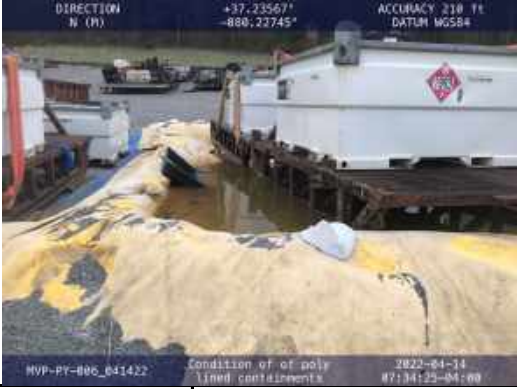
| <b>Pic 13 Desc.</b> | Condition of poly lined rock berm containments. Holding stormwater. Looking N. | <b>Pic 14 Desc.</b> | No fluids or deposits around hazardous waste dumpsters. Looking NE. | | |

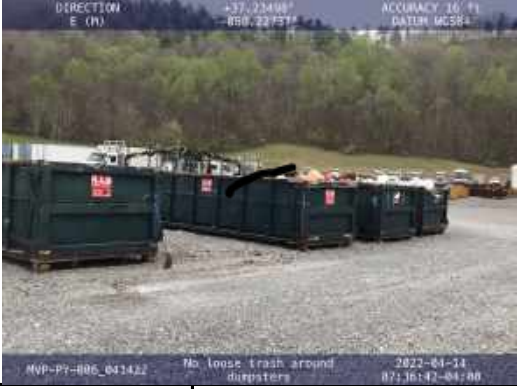
| <b>Pic 15 Desc.</b> | No loose trash around dumpsters or in the yard. Looking E. | <b>Pic 16 Desc.</b> | Condition of north rock entrance. No stone on public roadway. Looking NE. | | |

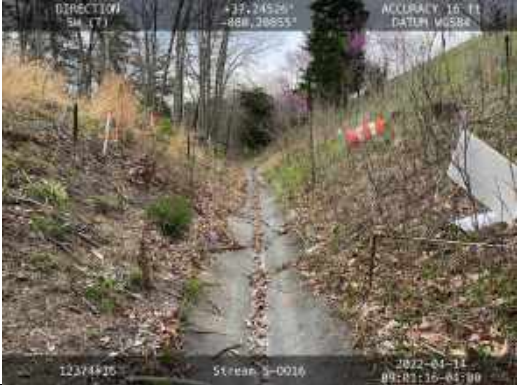
| <b>Pic 13 Desc.</b> | Overview of Waterbody S-0016. ECDs are functional and ROW is stable. | | <b>Pic 14 Desc.</b> | Overview of Waterbody S-NN19. ECDs are functional and ROW is stable. | |

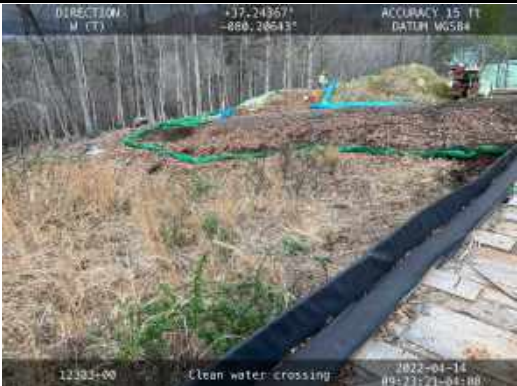
| <b>Pic 15 Desc.</b> | Environmental crew working on routine ECD maintenance. | | <b>Pic 16 Desc.</b> | ROW Overview. ECDs are functional and ROW is stable. | |

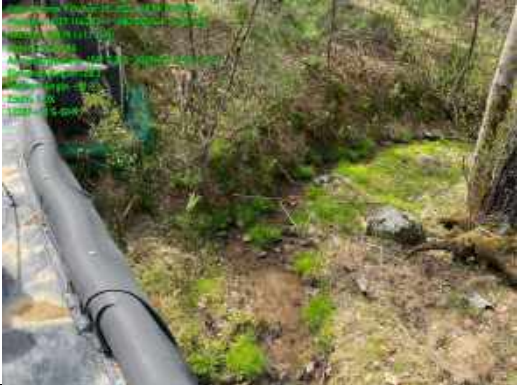
| <b>Field Station#</b> | 13337+13 | | <b>Field Station#</b> | 13334+17 | |

| <b>Pic 7 Desc.</b> | S-GH9, downstream, no ROW impacts observed. | | <b>Pic 8 Desc.</b> | S-GH11, downstream, no chances noted, no ROW impacts observed. | |

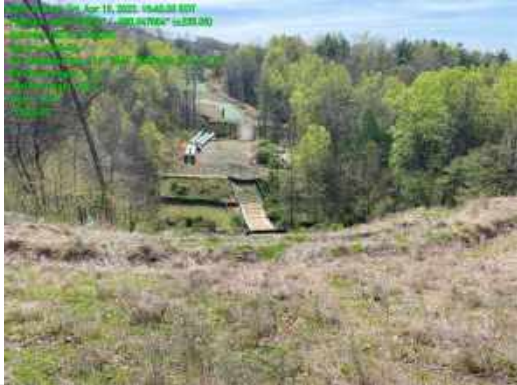
| <b>Field Station#</b> | 13330+00 | | <b>Field Station#</b> | 13325+30 | |

| <b>Pic 9 Desc.</b> | ROW stabilized, ECDs in acceptable condition. | | <b>Pic 10 Desc.</b> | S-GH14, upstream of equipment bridge. | |

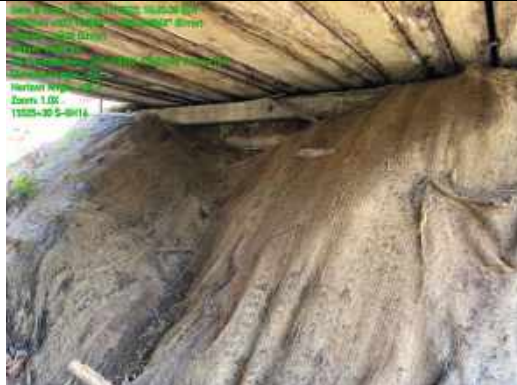
| <b>Field Station#</b> | 13325+30 | | <b>Field Station#</b> | 13325+30 | |

| <b>Pic 11 Desc.</b> | S-GH14, coming in side of equipment bridge. | | <b>Pic 12 Desc.</b> | S-GH14, no notable changes observed of stakes and curlex on bank. | |

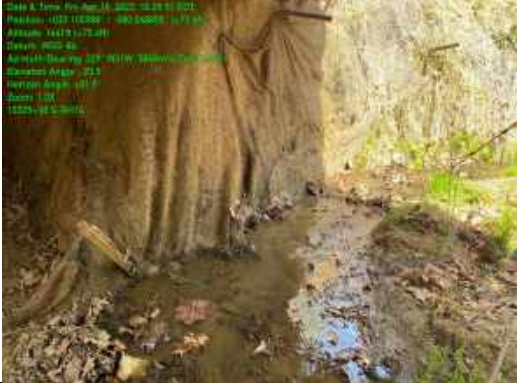
| <b>Field Station#</b> | 13325+30 | | <b>Field Station#</b> | 13325+30 | |

| <b>Pic 13 Desc.</b> | S-GH14, no notable changes observed of stakes and curlex on bank. | | <b>Pic 14 Desc.</b> | S-GH14, sediment accumulation noted upstream side of equipment bridge. | |

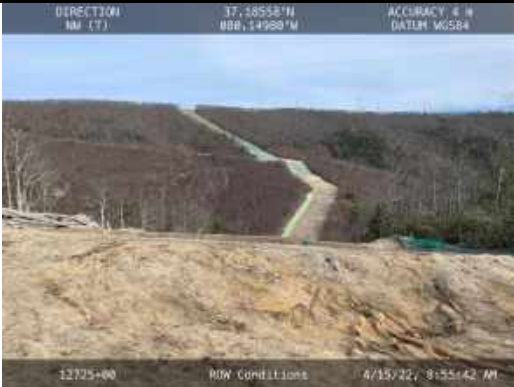
| <b>Field Station#</b> | 12725+00 | | <b>Field Station#</b> | 12729+00 | |

| <b>Pic 1 Desc.</b> | Current ROW conditions. ROW is stable. ECDs are functional. | | <b>Pic 2 Desc.</b> | Spoil piles are stable | |

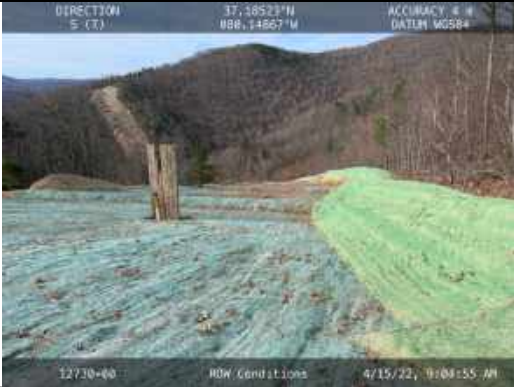
| <b>Field Station#</b> | 12730+00 | | <b>Field Station#</b> | 12735+00 | |

| <b>Pic 3 Desc.</b> | Current ROW conditions. ROW is stable. ECDs are functional. | | <b>Pic 4 Desc.</b> | Current ROW conditions. ROW is stable. ECDs are functional. | |

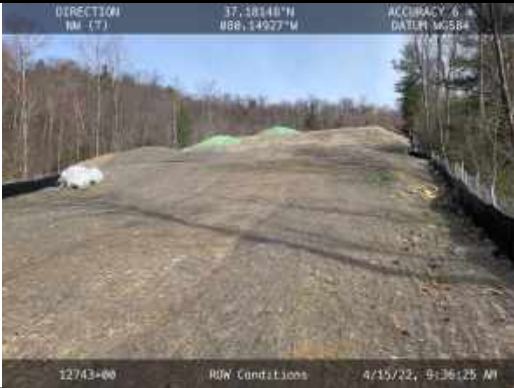
| <b>Field Station#</b> | 12743+84 | | <b>Field Station#</b> | 12743+84 | |

| <b>Pic 5 Desc.</b> | Current ROW conditions. ROW is stable. ECDs are functional. | | <b>Pic 6 Desc.</b> | Upstream of crossing at Stream S-EF34B | |
