Visual Site Inspection Report

Project Name	H-600 Pipeline Spread H	AFE	124300138	Spread	H-600 Pipeline Spread H
Contractor	Precision			Report #	36973
Inspector	Norm Kitchen			Date/Time	4/25/2022 3:00 PM
Permit #	TBD	Inspection Type	VA SWPP	Station Begin	12005+00
State	VA	Inspection Area	Partial	Station End	12119+17
County	Montgomery	Ground	Dry	Temperature (°F)	75.00
Municipality	N/A	Weather	Sunny	Rain Gauge (in)	0.00
				Rain Accumulation Time (days)	1.00

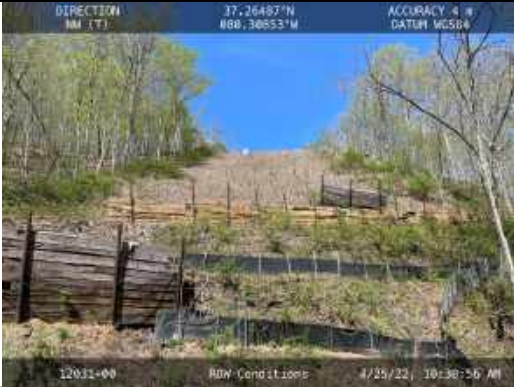
GPS Location	See Above		GPS Location	See Above	
Field Station#	12031+00		Field Station#	12031+51	
Pic 3 Desc.	ROW Overview. ECDs are functional and ROW is stable.		Pic 4 Desc.	Overview of Waterbody S-G39. ECDs are functional and ROW is stable.

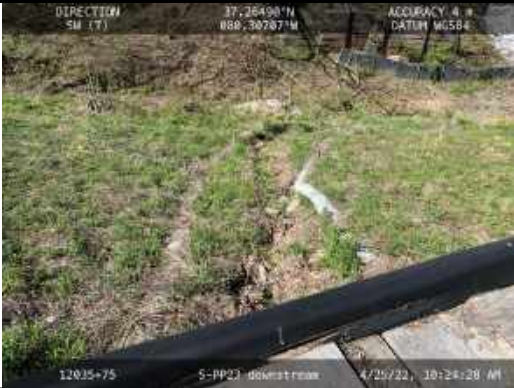
GPS Location	See Above		GPS Location	See Above	
Field Station#	12035+75		Field Station#	12038+00	
Pic 5 Desc.	Overview of Waterbody S-PP23. ECDs are functional and ROW is stable.		Pic 6 Desc.	ROW Overview. ECDs are functional and ROW is stable.

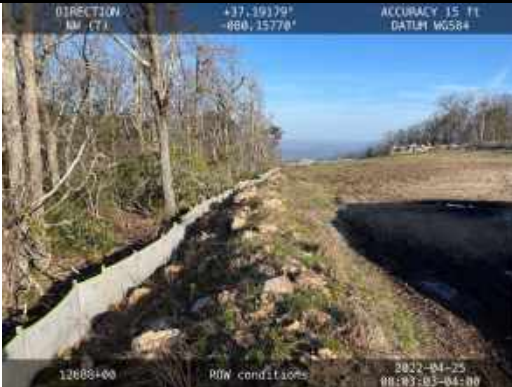
GPS Location	See photo for gps location data.		GPS Location	See photo for gps location data.	
Field Station#	12688+00		Field Station#	12691+00	
Pic 1 Desc.	Photo shows the ROW condition. ECDs are installed and functioning as designed.		Pic 2 Desc.	Photo shows the ROW condition. ECDs are installed and functioning as designed.

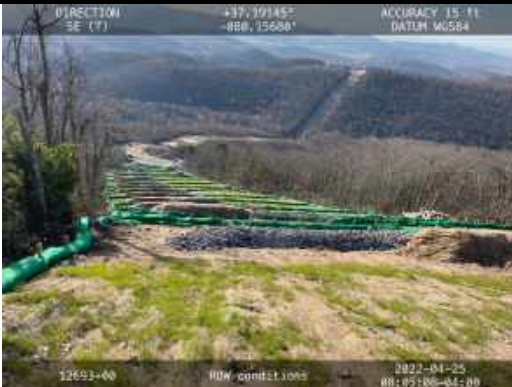
GPS Location	See photo for gps location data.		GPS Location	See photo for gps location data.	
Field Station#	12693+00		Field Station#	12702+00	
Pic 3 Desc.	Photo shows the ROW condition. ECDs are installed and functioning as designed.		Pic 4 Desc.	Photo shows the ROW condition. ECDs are installed and functioning as designed.

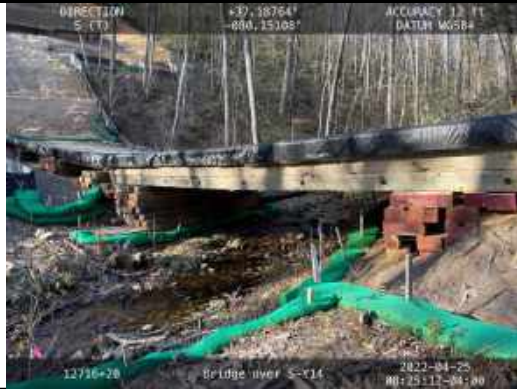
GPS Location	See photo for gps location data.		GPS Location	See photo for gps location data.	
Field Station#	12716+20		Field Station#	12716+20	
Pic 11 Desc.	Photo shows the bridge over stream S-Y14.		Pic 12 Desc.	Photo shows stream S-Y14 downstream from the bridge.

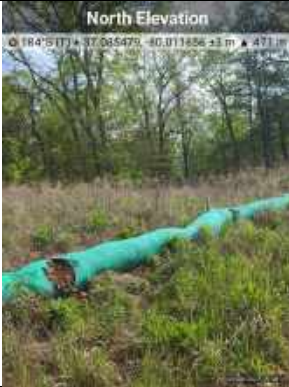
<p>South West Elevation 144°NE (T) + 37.086479 - 80.006375 +3 m ▲ 390 m</p>	
GPS Location	00000	GPS Location	00000		
Field Station#	13471+15	Field Station#	13493+00		
Pic 1 Desc.	CFS requires maintenance due to wildlife damages, documented and added to the punch list.	Pic 2 Desc.	CFS requires maintenance due to wildlife damages, documented and added to the punch list.

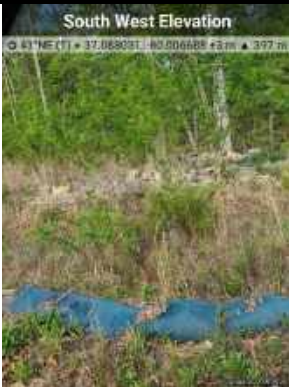
<p>South West Elevation 137°NE (T) + 37.067801 - 80.006935 +3 m ▲ 399 m</p>	
GPS Location	00000	GPS Location	00000		
Field Station#	13491+30	Field Station#	13490+40		
Pic 3 Desc.	CFS requires maintenance due to wildlife damages, documented and added to the punch list.	Pic 4 Desc.	CFS requires maintenance due to wildlife damages, documented and added to the punch list.

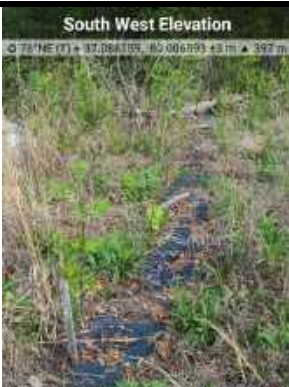
<p>South West Elevation 152°NE (T) + 37.087269 - 80.007104 +3 m ▲ 406 m</p>	
GPS Location	00000	GPS Location	00000		
Field Station#	13491+80	Field Station#	13488+00		
Pic 5 Desc.	CFS requires maintenance due to wildlife damages, documented and added to the punch list.	Pic 6 Desc.	CFS requires maintenance due to wildlife damages, documented and added to the punch list.

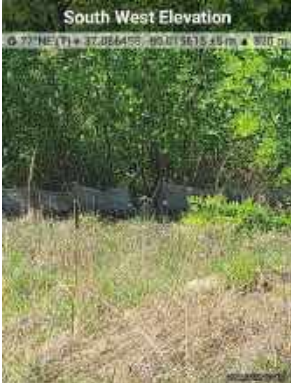
GPS Location	00000	GPS Location	0000		
Field Station#	13460+00	Field Station#	13463+20		
Pic 7 Desc.	P1 requires maintenance due to wildlife damage, added to the punch list for repair.		Pic 8 Desc.	Monitored water bars and level spreaders during routine inspection today. No environmental issues observed at the time of inspection.

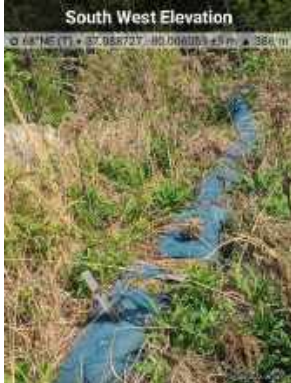
<p style="text-align: center;">Insert image here</p>	
GPS Location	0000	GPS Location			
Field Station#	13494+50	Field Station#			
Pic 9 Desc.	CFS requires maintenance due to wildlife damages, documented and added to the punch list.		Pic 10 Desc.		
<p style="text-align: center;">Insert image here</p>		<p style="text-align: center;">Insert image here</p>			
GPS Location		GPS Location			
Field Station#		Field Station#			
Pic 11 Desc.			Pic 12 Desc.

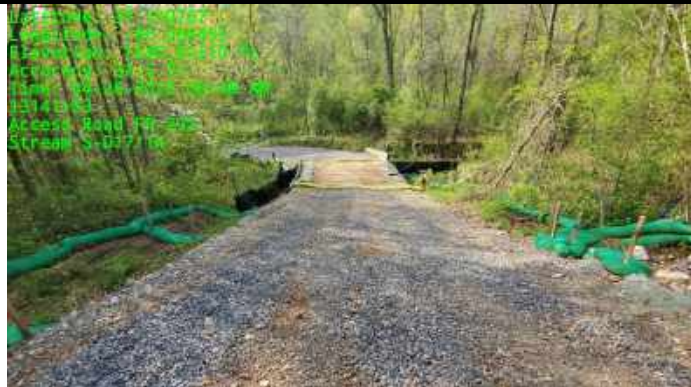
GPS Location	See pic for GPS location.		GPS Location	See pic for GPS location.	
Field Station#	13141+53		Field Station#	13139+00	
Pic 3 Desc.	Stream S-D17/14 where it crosses access road FR-292.		Pic 4 Desc.	Downstream side of stream crossing S-D17/14.

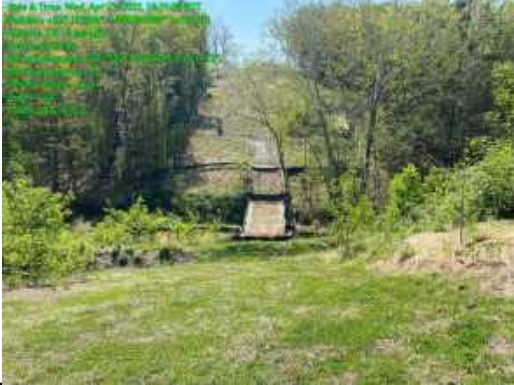
GPS Location	0	GPS Location	0		
Field Station#	13323+43	Field Station#	13334+17		
Pic 3 Desc.	MVP-S-GH14 and corresponding buffer zone in good condition	Pic 4 Desc.	MVP-S-GH11 and corresponding buffer zone in good condition

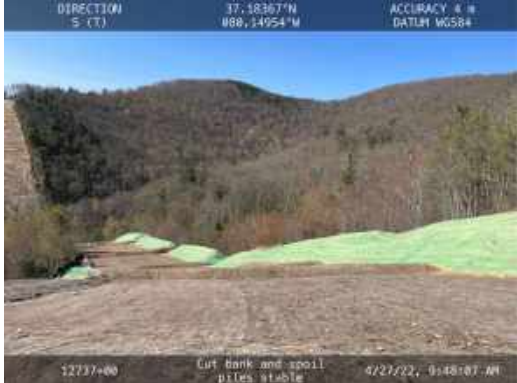
GPS Location	See photo		GPS Location	See photo	
Field Station#	12737+00		Field Station#	12743+00	
Pic 9 Desc.	Current ROW conditions. ROW is stable. ECDs are functional.		Pic 10 Desc.	Current ROW conditions. ROW is stable. ECDs are functional.

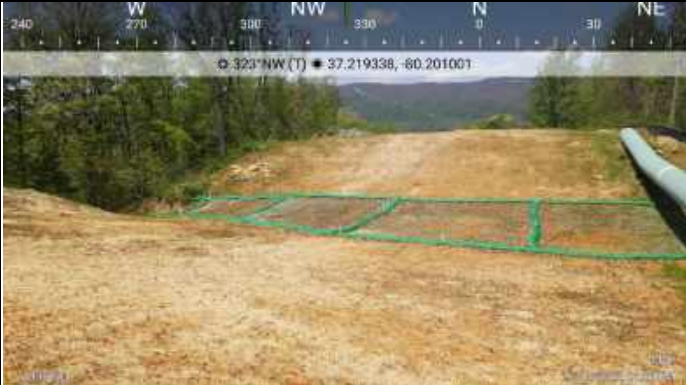
GPS Location	See Above		GPS Location	See Above	
Field Station#	12498+00		Field Station#	12504+00	
Pic 7 Desc.	ROW Overview (temporary stabilization). ECDs are functional and ROW is stable.		Pic 8 Desc.	ROW Overview (temporary stabilization). ECDs are functional and ROW is stable.

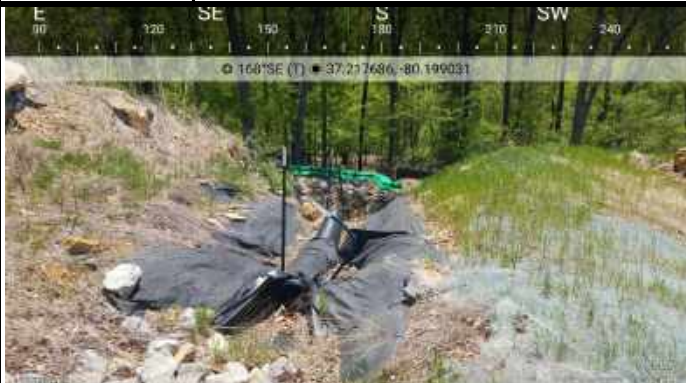
GPS Location	See Above		GPS Location	See Above	
Field Station#	12508+75		Field Station#	12512+00	
Pic 9 Desc.	ROW Overview (temporary stabilization). ECDs are functional and ROW is stable.		Pic 10 Desc.	ROW Overview (temporary stabilization). ECDs are functional and ROW is stable.

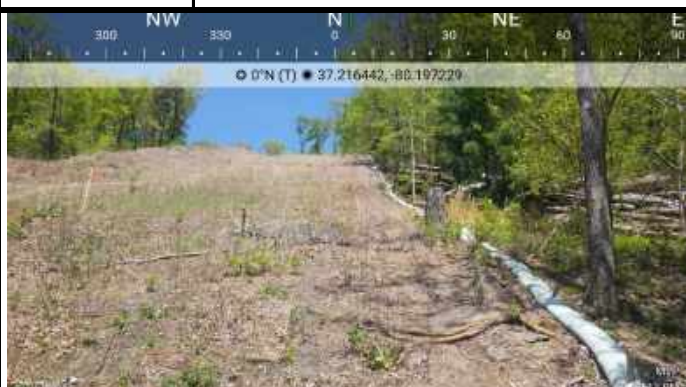
GPS Location	See Above		GPS Location	See Above	
Field Station#	12518+00		Field Station#	12519+41	
Pic 11 Desc.	ROW Overview (temporary stabilization). ECDs are functional and ROW is stable.		Pic 12 Desc.	Overview of Waterbody S-EF19. ECDs are functional and ROW is stable.

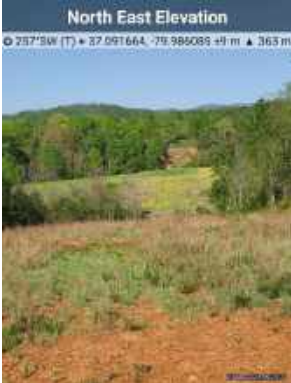
GPS Location	0000	GPS Location	0000		
Field Station#	13553+24	Field Station#	13560+80		
Pic 7 Desc.	Row photo showing stabilization in permanent area of row. No environmental issues observed at the time of inspection.	Pic 8 Desc.	Monitored CFS along the edge of the row during routine inspection today, no issues observed.		
Insert image here		Insert image here			
GPS Location		GPS Location			
Field Station#		Field Station#			
Pic 9 Desc.		Pic 10 Desc.			
Insert image here		Insert image here			
GPS Location		GPS Location			
Field Station#		Field Station#			
Pic 11 Desc.		Pic 12 Desc.

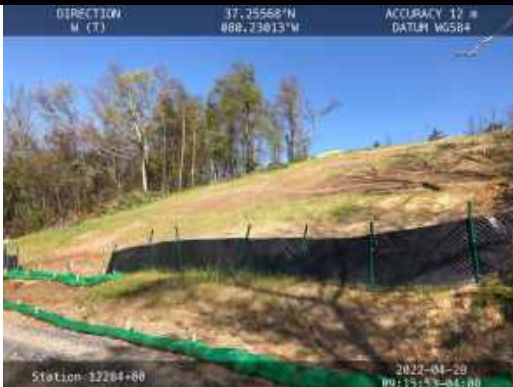
GPS Location	Please see photo for details.		GPS Location	Please see photo for details.	
Field Station#	12284+00		Field Station#	12236+00	
Pic 1 Desc.	Photo shows the stabilized ROW conditions with water bars and that all ECDs are installed and are functioning as designed.		Pic 2 Desc.	Photo shows the stabilized ROW conditions in permanent restoration area with permanent water bars equipped with level spreaders.

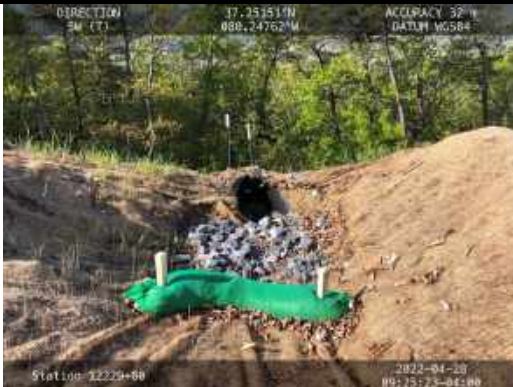
GPS Location	Please see photo for details.		GPS Location	Please see photo for details.	
Field Station#	12229+00		Field Station#	12229+00	
Pic 3 Desc.	Photo shows slope drain inlet with stone inlet protection.		Pic 4 Desc.	Photo shows slope drain pipe along with plunge pool.

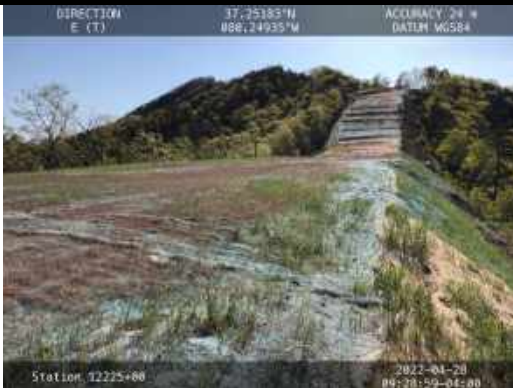
Pic 5 Desc.	Photo shows the stabilized ROW conditions with water bars and that all ECDs are installed and are functioning as designed.		Pic 6 Desc.	Photo shows stabilized side slope along with super silt fence installed and functioning as designed.

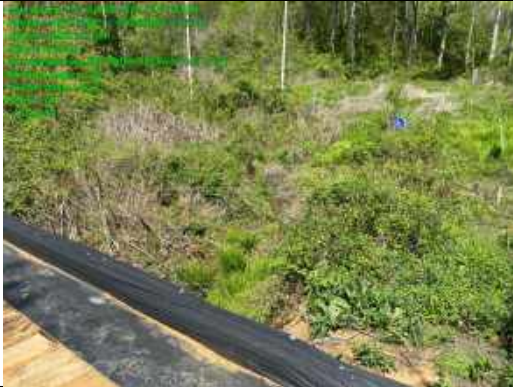
GPS Location	See photo for coordinates.		GPS Location	See photo for coordinates.	
Field Station#	13143+50		Field Station#	13146+50	
Pic 1 Desc.	ROW stabilized.		Pic 2 Desc.	S-D12 and S-D13 upstream of equipment bridge.

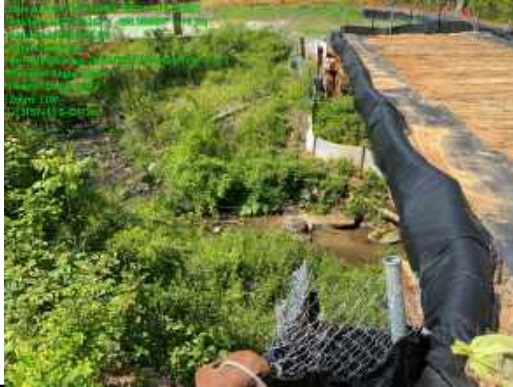
GPS Location	See photo for coordinates.		GPS Location	See photo for coordinates.	
Field Station#	13147+25		Field Station#	13157+13	
Pic 3 Desc.	ROW stabilized.		Pic 4 Desc.	S-D11, downstream, no ROW impacts observed.

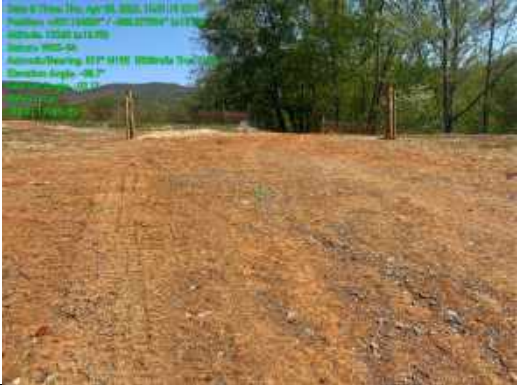
GPS Location	See photo for coordinates.		GPS Location	See photo for coordinates.	
Field Station#	13185+50		Field Station#	13185+50	
Pic 7 Desc.	Farm road crossing ROW, added as maintenance to Punch List for re-stabilization.		Pic 8 Desc.	Sump along MVP-FR-292, added to Punch List as maintenance item.

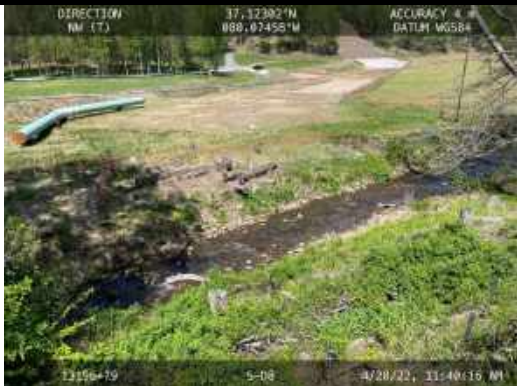
GPS Location	See photo for coordinates.		GPS Location	See photo for coordinates.	
Field Station#	13196+79		Field Station#	13207+00	
Pic 9 Desc.	S-D8 crossing, ROW stabilized.		Pic 10 Desc.	ROW stabilized.

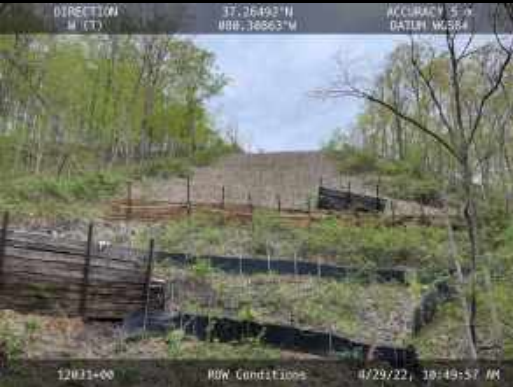
GPS Location	Please see photo for details.		GPS Location	Please see photo for details.	
Field Station#	12013+96		Field Station#	12031+00	
Pic 1 Desc.	Photo shows downstream view of Stream S-G36 from equipment bridge spanning the stream channel.		Pic 2 Desc.	Photo shows the stabilized ROW conditions with water bars and that all ECDs are installed and are functioning as designed.

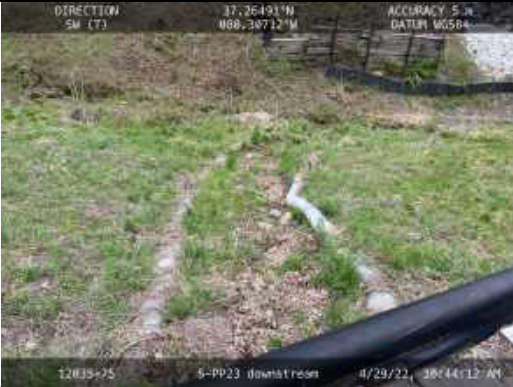
GPS Location	Please see photo for details.		GPS Location	Please see photo for details.	
Field Station#	12031+51		Field Station#	12035+75	
Pic 3 Desc.	Photo shows downstream view of Stream S-G39.		Pic 4 Desc.	Photo shows downstream view of Stream S-PP23 from equipment bridge spanning the stream channel.

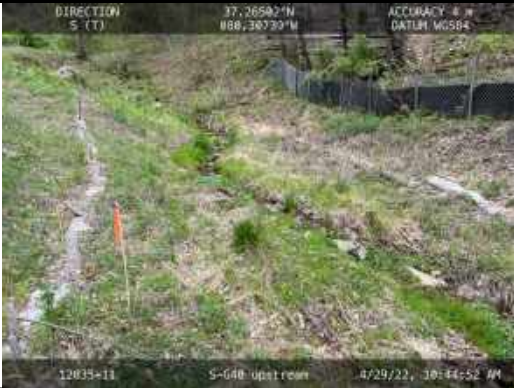
Pic 5 Desc.	Photo shows upstream view of Stream S-G40 from equipment bridge spanning the stream channel.		Pic 6 Desc.	Photo shows the stabilized ROW conditions with water bars and that all ECDs are installed and are functioning as designed.

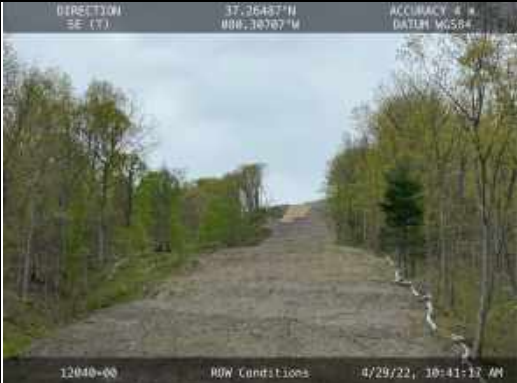
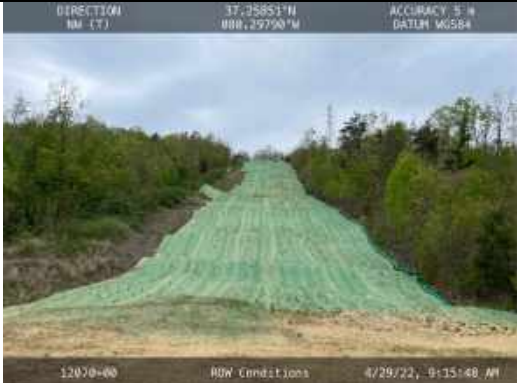
GPS Location	Please see photo for details.		GPS Location	Please see photo for details.	
Field Station#	12040+00		Field Station#	12070+00	
Pic 7 Desc.	Photo shows the stabilized ROW conditions with water bars and that all ECDs are installed and are functioning as designed.		Pic 8 Desc.	Photo shows the stabilized ROW conditions with water bars and that all ECDs are installed and are functioning as designed.

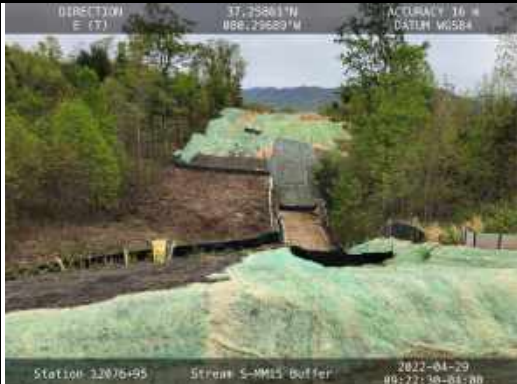
GPS Location	Please see photo for details.		GPS Location	Please see photo for details.	
Field Station#	12076+95		Field Station#	12084+50	
Pic 9 Desc.	Photo shows Stream S-MM15 buffer zone from the coming in side with all ECDs installed and functioning as designed.		Pic 10 Desc.	Photo shows the stabilized ROW conditions with water bars and that all ECDs are installed and are functioning as designed.

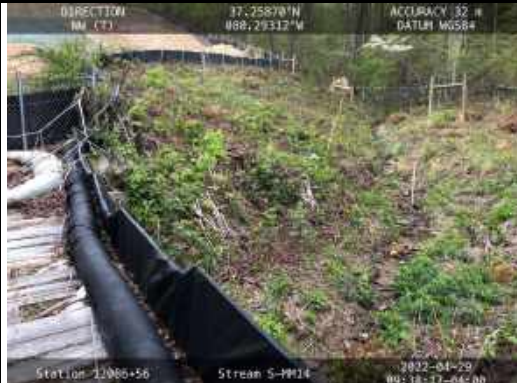
GPS Location	Please see photo for details.		GPS Location	Please see photo for details.	
Field Station#	12086+56		Field Station#	12097+00	
Pic 11 Desc.	Photo shows upstream view of Stream S-G36 from equipment bridge spanning the stream channel.		Pic 12 Desc.	Photo shows the stabilized ROW conditions with water bars and that all ECDs are installed and are functioning as designed.

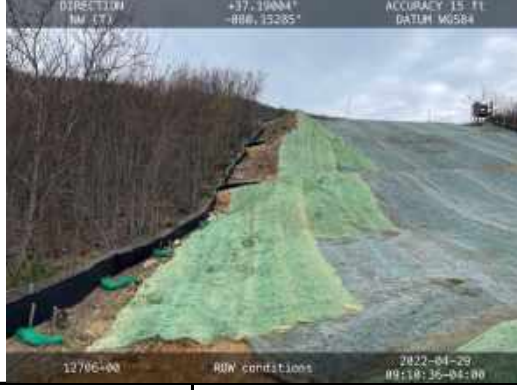
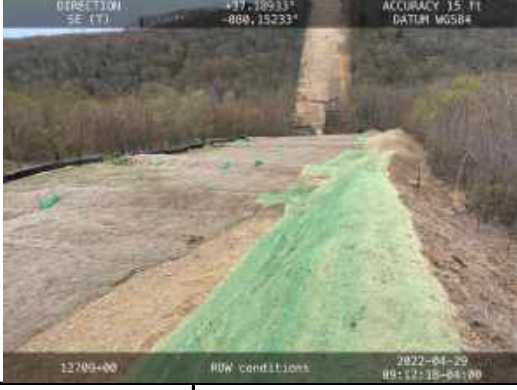
Pic 11 Desc.	Photo shows the ROW condition. ECDs are installed and functioning as designed.		Pic 12 Desc.	Photo shows the ROW condition. ECDs are installed and functioning as designed.
