# Visual Site Inspection Report

| <b>Project Name</b> | H-600 Pipeline Spread H | <b>AFE</b> | 124300138 | <b>Spread</b> | H-600 Pipeline Spread H |
| <b>Contractor</b> | Precision | | | <b>Report #</b> | 36201 |
| <b>Inspector</b> | Joe Scott | | | <b>Date/Time</b> | 4/4/2022 5:41 PM |

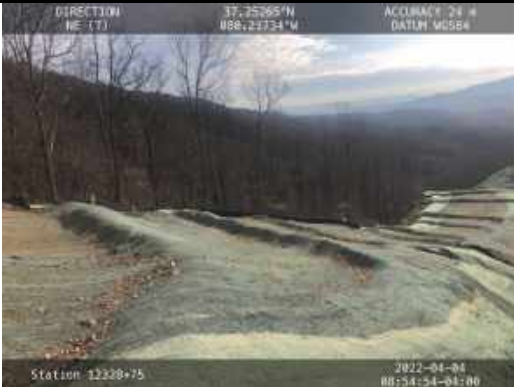
| <b>Pic 1 Desc.</b> | Photo shows the stabilized ROW conditions with water bars and that all ECDs are installed and are functioning as designed. | | <b>Pic 2 Desc.</b> | Photo shows the stabilized ROW conditions with water bars and that all ECDs are installed and are functioning as designed. | |

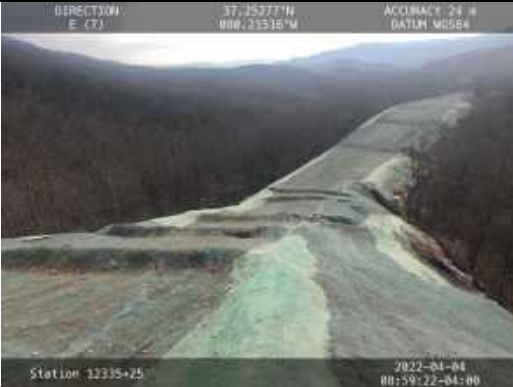
| <b>Pic 3 Desc.</b> | Photo shows stabilized ROW with water bar, sump and end treatment functioning as designed. | | <b>Pic 4 Desc.</b> | Photo shows the stabilized ROW conditions with water bars and that all ECDs are installed and are functioning as designed. | |

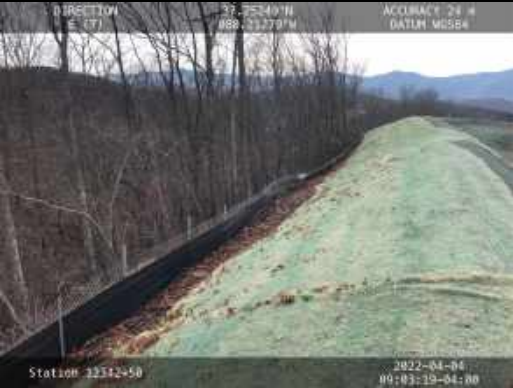
| <b>Pic 5 Desc.</b> | Photo shows punch list item fixed. (Reconnection of slope drain pipe). | | <b>Pic 6 Desc.</b> | Photo shows the stabilized ROW conditions with water bars and that all ECDs are installed and are functioning as designed. | |

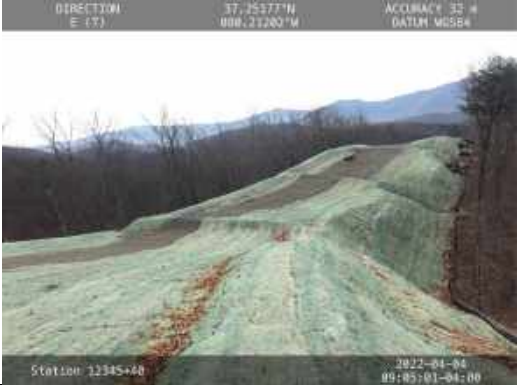
| <b>Pic 7 Desc.</b> | Photo shows the stabilized ROW conditions with water bars and that all ECDs are installed and are functioning as designed. | | <b>Pic 8 Desc.</b> | Photo shows the stabilized ROW conditions with water bars and that all ECDs are installed and are functioning as designed. | |

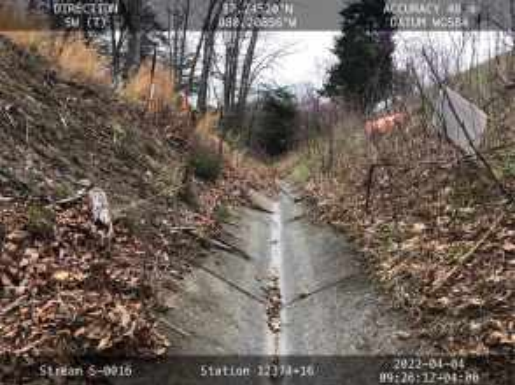
| <b>Pic 9 Desc.</b> | Photo shows the stabilized ROW conditions with water bars and that all ECDs are installed and are functioning as designed. | | <b>Pic 10 Desc.</b> | Photo shows upstream view of Stream S-0016. | |

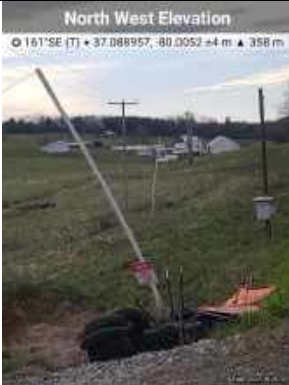
| <b>Pic 1 Desc.</b> | Vegetation observation photo at anode bed location, good growth noted, no environmental issues observed at the time of inspection. | | <b>Pic 2 Desc.</b> | Row photo showing stabilization, ECDs in place, water bars and level spreaders functioning, no environmental issues observed at the time of inspection. | |

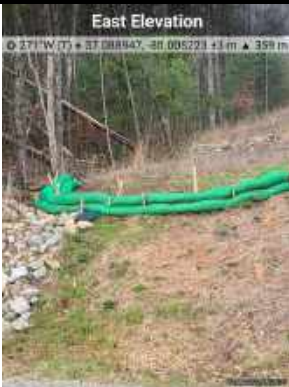
| <b>Pic 3 Desc.</b> | Monitored rock lined channel and ECDs at road crossing, no environmental issues observed at the time of inspection. | | <b>Pic 4 Desc.</b> | Monitored ECDs at stream location, all functioning properly at the time of inspection. | |

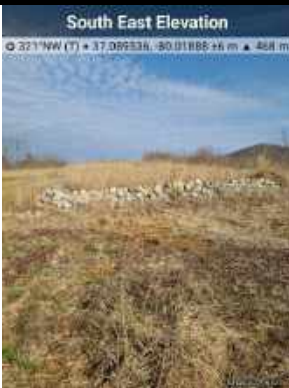
| <b>Pic 5 Desc.</b> | Observed water bars and level spreaders during routine row inspection today, no environmental issues observed at the time of inspection. | | <b>Pic 6 Desc.</b> | Conducted routine inspection of stream and wetland crossings, all ECDs in place and functioning. No issues observed at the time of inspection. | |

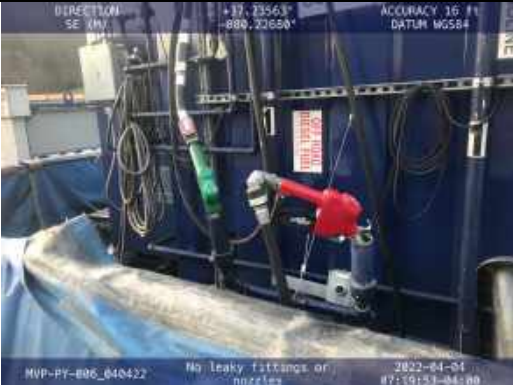
| <b>Pic 3 Desc.</b> | Blue Bulk Fuel tanks no leaky internal fittings. Looking NW. | <b>Pic 4 Desc.</b> | Blue Bulk Fuel tanks no leaky fittings or nozzles. Looking SE. | | |

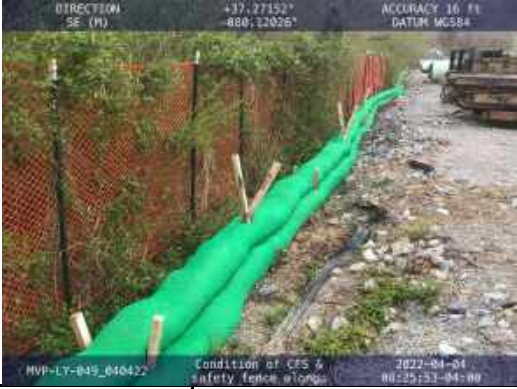
| <b>Pic 7 Desc.</b> | Condition of triple stack compost filter sock and safety fence along east LOD. Looking SE. | <b>Pic 8 Desc.</b> | Condition of triple stack compost filter sock and safety fence along south LOD. Looking SW. | | |

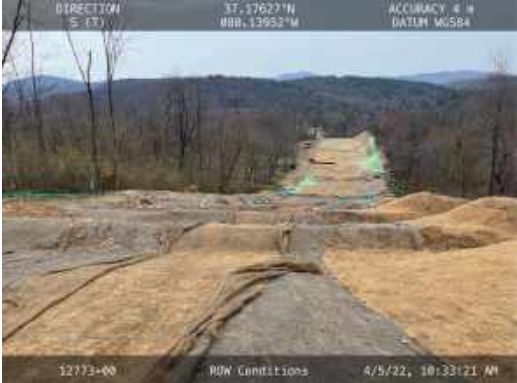
| <b>Pic 13 Desc.</b> | Curlex removed from travel lane to allow ATV access to haul curlex | | <b>Pic 14 Desc.</b> | Current ROW conditions. ROW is stable. ECDs are functional. | |

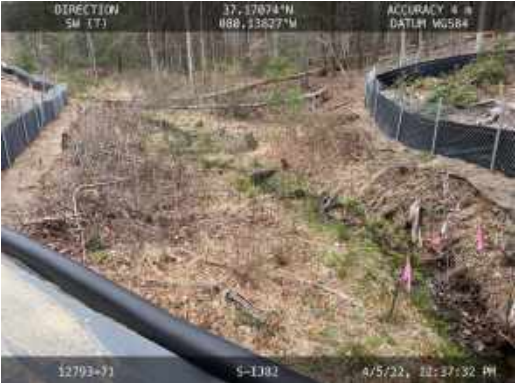
| <b>Pic 15 Desc.</b> | Overseeing CWD Berm | | <b>Pic 16 Desc.</b> | Downstream of crossing at Stream S-IJ82 | |

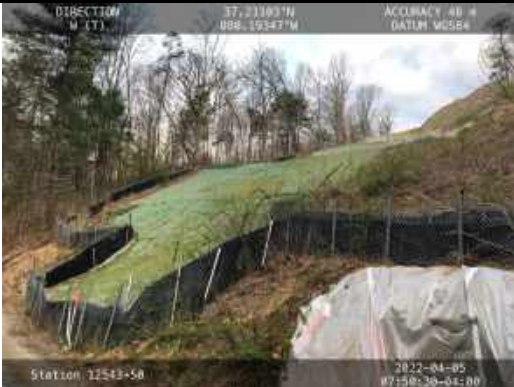
| <b>Pic 1 Desc.</b> | Photo shows the stabilized ROW conditions with water bars and that all ECDs are installed and are functioning as designed. | | <b>Pic 2 Desc.</b> | Photo shows the stabilized ROW conditions with water bars and that all ECDs are installed and are functioning as designed. | |

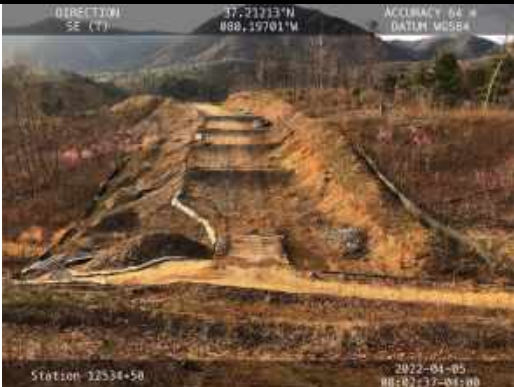
| <b>Pic 3 Desc.</b> | Photo shows the stabilized ROW conditions with water bars and that all ECDs are installed and are functioning as designed. | | <b>Pic 4 Desc.</b> | Photo shows the stabilized ROW conditions with water bars and that all ECDs are installed and are functioning as designed. | |

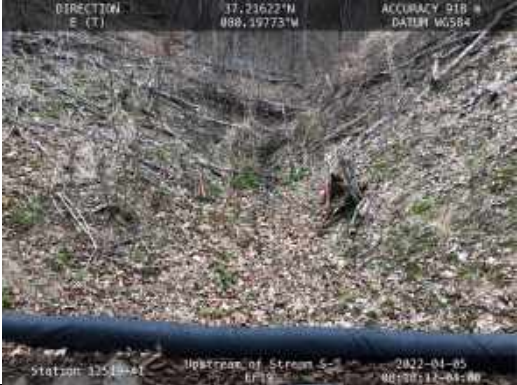
| <b>Pic 7 Desc.</b> | Photo shows upstream view of Stream S-EF19 from equipment bridge spanning stream channel. | | <b>Pic 8 Desc.</b> | Photo shows downstream view of Stream S-EF19 from equipment bridge spanning stream channel. | |

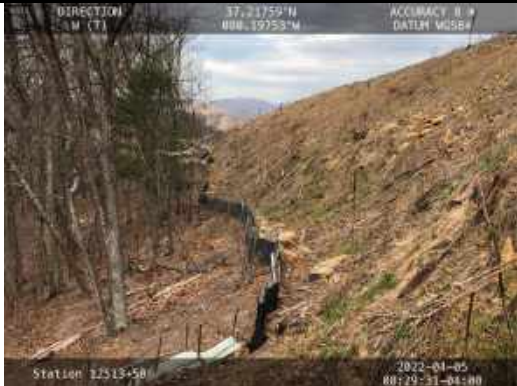
| <b>Pic 9 Desc.</b> | Photo shows stabilized bank along the ROW perimeter with installed ECDs functioning as designed. | | <b>Pic 10 Desc.</b> | Photo shows stabilized ROW conditions with installed water bars leading to sumps equipped with functioning end treatments. | |

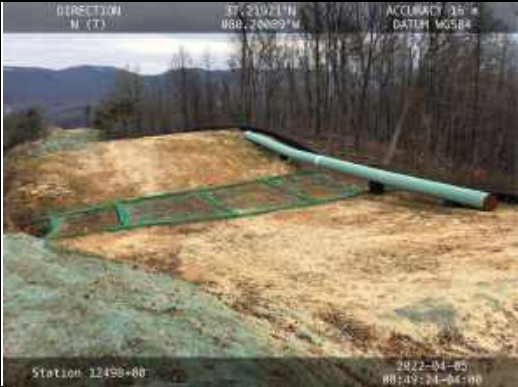
| <b>Pic 13 Desc.</b> | Photo shows the stabilized ROW conditions with water bars and that all ECDs are installed and are functioning as designed. | | <b>Pic 14 Desc.</b> | Photo shows the stabilized ROW conditions with water bars and that all ECDs are installed and are functioning as designed. | |

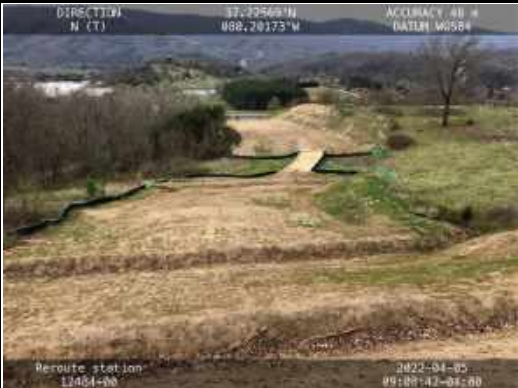
| <b>Pic 15 Desc.</b> | Photo shows overview of stabilized ROW conditions. (Reroute station number). | | <b>Pic 16 Desc.</b> | Photo shows overview of buffer zone for Wetland W-KL58. | |

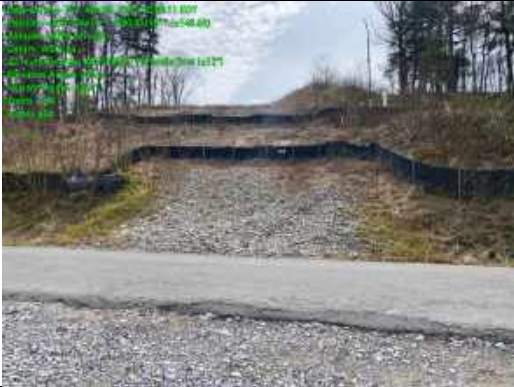
| <b>Field Station#</b> | 13316+13 | | <b>Field Station#</b> | 13317+02 | |

| <b>Pic 1 Desc.</b> | Wades Gap road crossing. | | <b>Pic 2 Desc.</b> | Private drive, going away side of Wades Gap road. | |

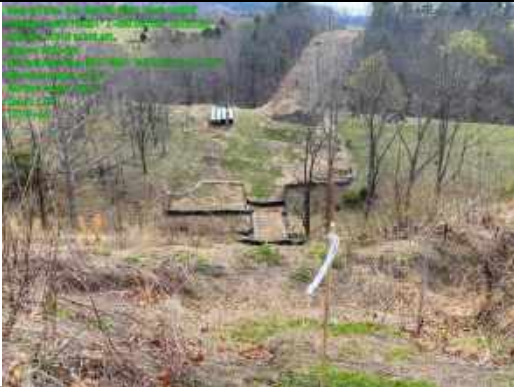
| <b>Pic 3 Desc.</b> | S-GH15, ROW stabilized. | | <b>Pic 4 Desc.</b> | S-GH15, downstream, no ROW impacts observed in stream crossing. | |

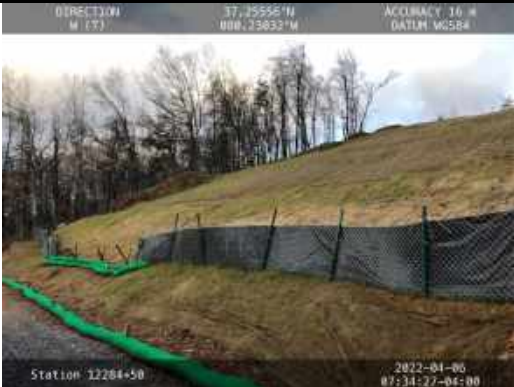
| <b>Pic 1 Desc.</b> | Photo shows the stabilized ROW conditions with water bars and that all ECDs are installed and are functioning as designed. | | <b>Pic 2 Desc.</b> | Photo shows punch list item today of stock pile needing erosion control blanket for stabilization. (Item resolved). | |

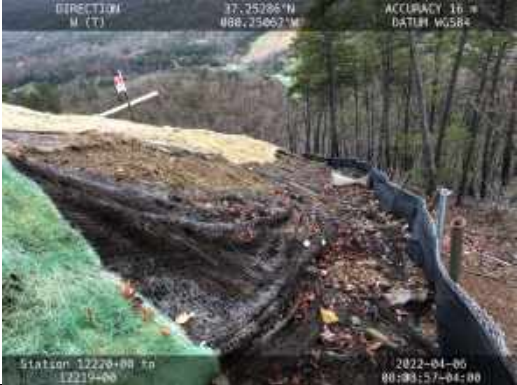
| <b>Pic 7 Desc.</b> | Photo shows punch list item for today of replacing damaged erosion control blanket. | | <b>Pic 8 Desc.</b> | Photo shows the stabilized ROW conditions with water bars and that all ECDs are installed and are functioning as designed. | |

| E&S BMPs | Compliance Level | Corrective Action | Corrective Time Frame | Date Repaired |
|---|---|---|---|---|
| Erosion Control Blanket | Communication | Replace damaged erosion control bl | | 4/7/2022 |

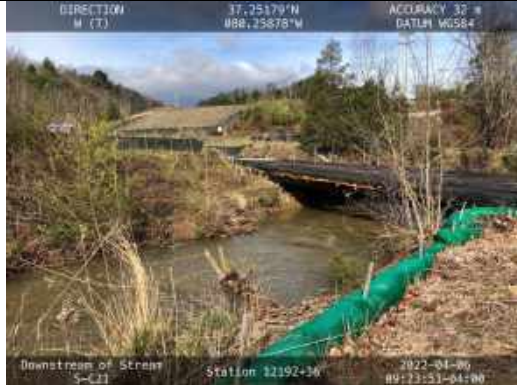
| <b>Pic 11 Desc.</b> | Photo shows downstream view of Stream S-C21 from ROW. | | <b>Pic 12 Desc.</b> | Photo shows the stabilized ROW conditions with water bars and that all ECDs are installed and are functioning as designed. | |

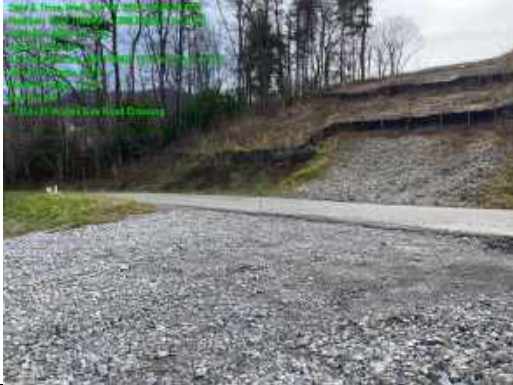
| Pic 1 Desc. | Wades Gap Road Crossing in good condition | | Pic 2 Desc. | ROW and ECDs In good condition and stable | |

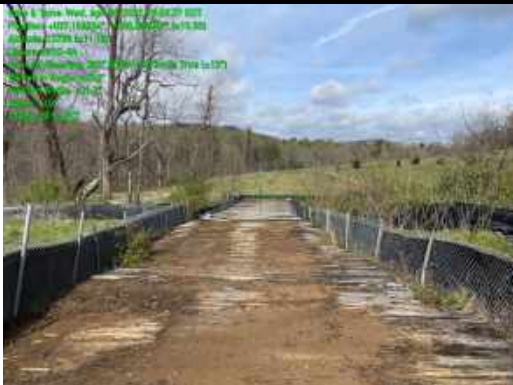
| Pic 3 Desc. | MVP-S-GH7 and corresponding buffer zone in good condition | | Pic 4 Desc. | Flanders Road Crossing in good condition | |

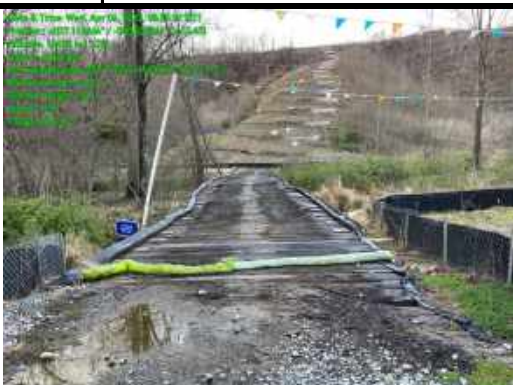
| Pic 5 Desc. | MVP-S-II4 and corresponding buffer zone in good condition | | Pic 6 Desc. | ROW and ECDs In good condition and stable | |

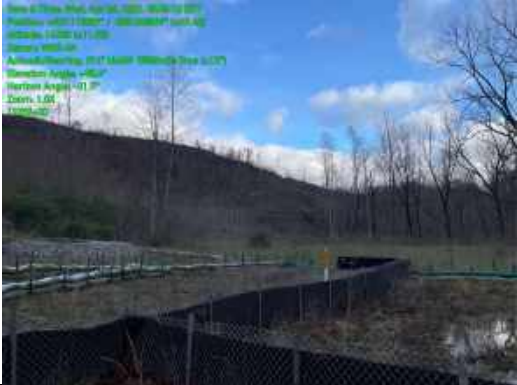
| <b>Pic 7 Desc.</b> | Continuing to monitor logging activity adjacent to row | <b>Pic 8 Desc.</b> | ROW and ECDs In good condition and stable | | |

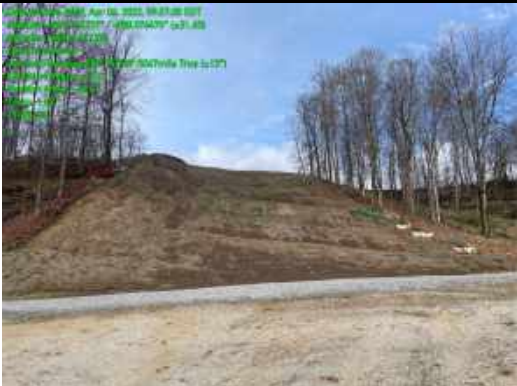
| <b>Pic 9 Desc.</b> | MVP-S-D8 and corresponding buffer zone in good condition | <b>Pic 10 Desc.</b> | ROW and ECDs In good condition and stable | | |

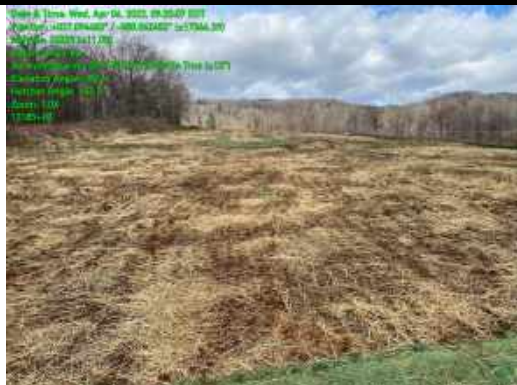
| <b>Pic 11 Desc.</b> | ROW and ECDs In good condition and stable | <b>Pic 12 Desc.</b> | ROW and ECDs In good condition and stable | | |

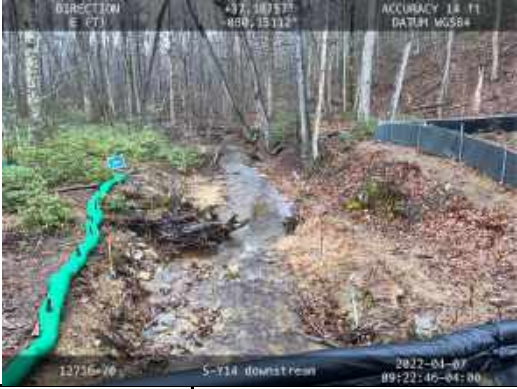
| <b>Pic 13 Desc.</b> | Photo shows S-Y14 downstream from the bridge. | | <b>Pic 14 Desc.</b> | Photo shows the bridge over stream S-Y14. | |

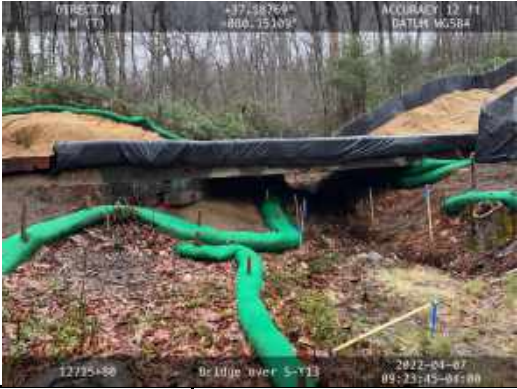
| <b>Pic 15 Desc.</b> | Photo shows the bridge over stream S-Y13. | | <b>Pic 16 Desc.</b> | Photo shows S-Y13 downstream from the bridge. | |

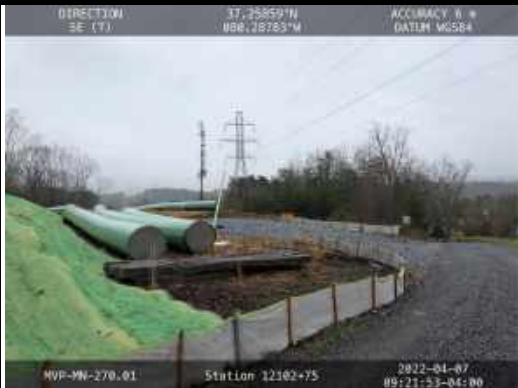
| <b>Pic 9 Desc.</b> | Photo shows access road MVP-MN-270.01 with installed ECDs functioning as designed. | | <b>Pic 10 Desc.</b> | Photo shows RCE and Stream S-F16A/B buffer zone. | |

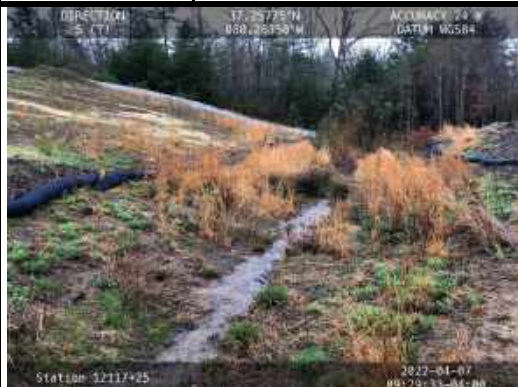
| <b>Pic 11 Desc.</b> | Photo shows drainage feature along with installed ECDs functioning as designed. | | <b>Pic 12 Desc.</b> | Photo shows the stabilized ROW conditions with water bars and that all ECDs are installed and are functioning as designed. | |

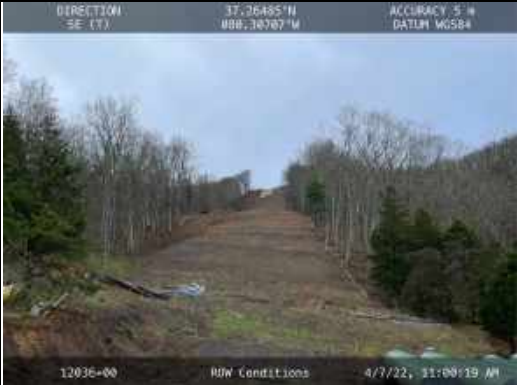
| <b>Pic 13 Desc.</b> | Photo shows the stabilized ROW conditions with water bars and that all ECDs are installed and are functioning as designed. | | <b>Pic 14 Desc.</b> | Photo shows downstream view of Stream S-G40 from equipment bridge spanning the stream channel. | |

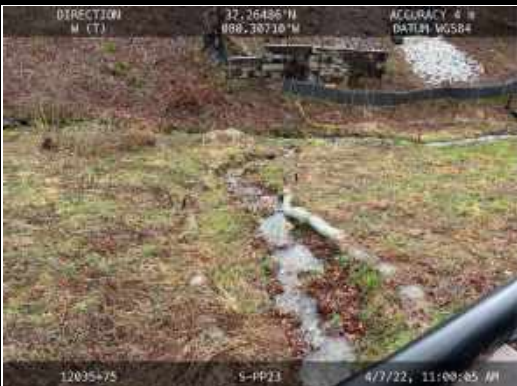
| <b>Pic 15 Desc.</b> | Photo shows downstream view of Stream S-PP23 from equipment bridge spanning the stream channel. | | <b>Pic 16 Desc.</b> | Photo shows environmental crew completing punch list item of seeding and installing erosion control blanket for stabilization. | |

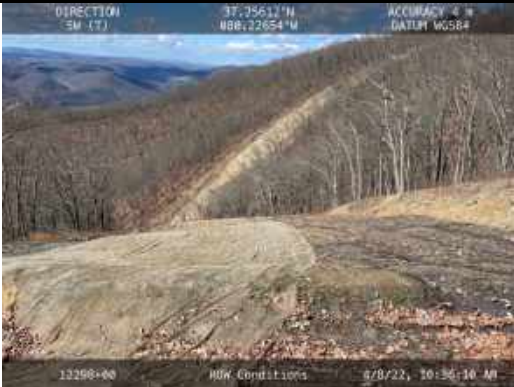
| <b>Pic 1 Desc.</b> | Photo shows the stabilized ROW conditions with water bars and that all ECDs are installed and are functioning as designed. | | <b>Pic 2 Desc.</b> | Photo shows the stabilized ROW conditions with water bars and that all ECDs are installed and are functioning as designed. | |

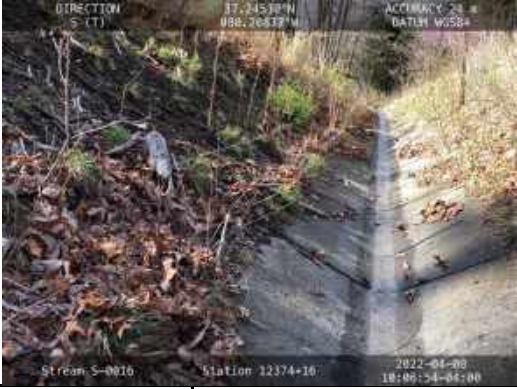
| <b>Pic 7 Desc.</b> | Photo shows upstream view of Stream S-0016. | | <b>Pic 8 Desc.</b> | Photo shows new erosion control blanket installed to maintain stabilization. | |

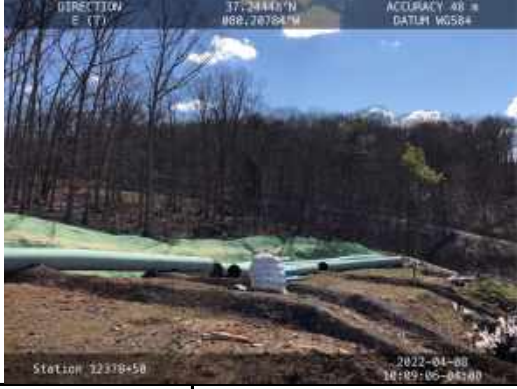
| <b>Pic 9 Desc.</b> | Photo shows environmental crew installing erosion control blanket to maintain stabilization. | | <b>Pic 10 Desc.</b> | Photo shows upstream view of Stream S-NN19 from equipment bridge spanning stream channel. | |

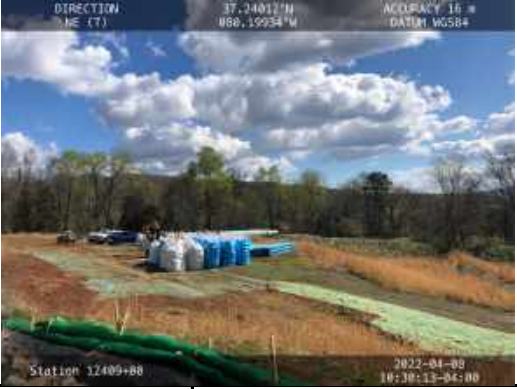
| <b>Pic 13 Desc.</b> | Photo shows the stabilized ROW conditions with water bars and that all ECDs are installed and are functioning as designed. | | <b>Pic 14 Desc.</b> | Photo shows materials staged at MVP-ATWS-724 for environmental crews maintaining stabilization in the area. | |

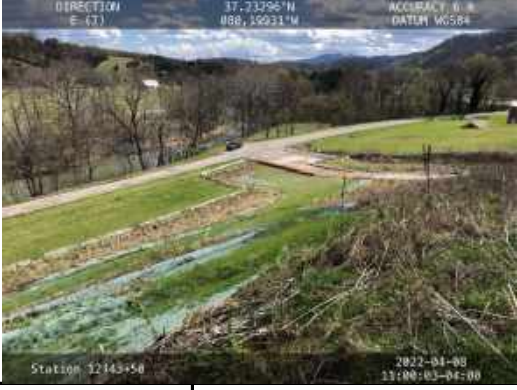
| <b>Pic 17 Desc.</b> | Photo shows view of Stream S-NN16 from the going away side. | | <b>Pic 18 Desc.</b> | Photo shows the stabilized ROW conditions with water bars and that all ECDs are installed and are functioning as designed. | |

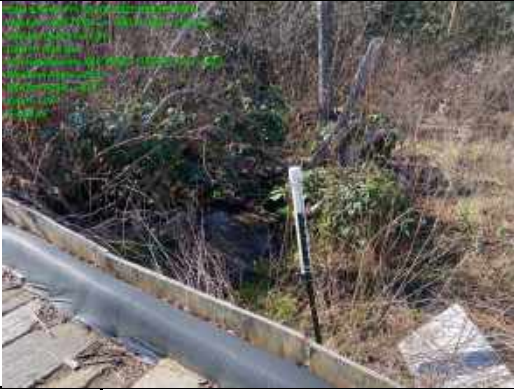
| <b>Pic 1 Desc.</b> | Downstream side of stream S-G26. | | <b>Pic 2 Desc.</b> | Downstream side of stream S-G27. | |

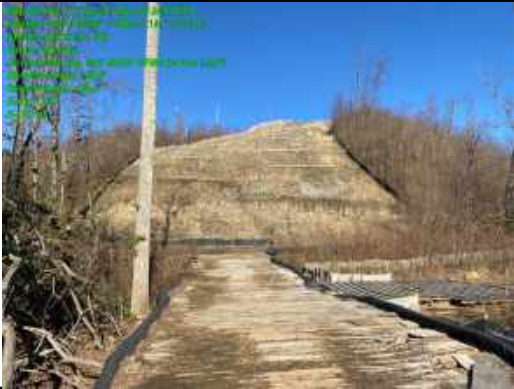
| <b>Pic 3 Desc.</b> | CIS of FR-290. | | <b>Pic 4 Desc.</b> | GAS of FR-290. | |

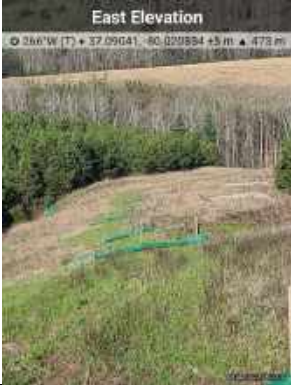
| <b>Pic 7 Desc.</b> | Observed ECDs and water bars throughout inspection today, new vegetation growth in travel lane area. | | <b>Pic 8 Desc.</b> | | |

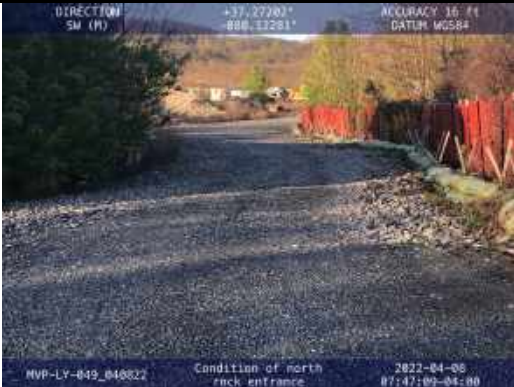
| <b>Pic 1 Desc.</b> | Condition of rock entrance on north drive. No sediment or debris on stone. Looking SW. | | <b>Pic 2 Desc.</b> | Condition of rock entrance on center drive. Smaller stone applied over large stone. Looking SE. | |

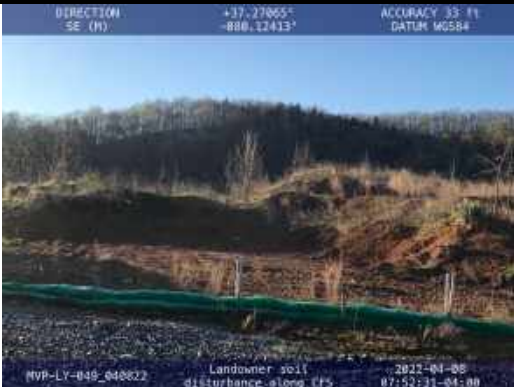
| <b>Pic 3 Desc.</b> | Landowner soil disturbance along triple stack compost filter sock. No new damage to installed ECD's. Looking SE. | | <b>Pic 4 Desc.</b> | Landowner soil disturbance along feature W-CV21A. Area not stabilized. Looking NW. | |

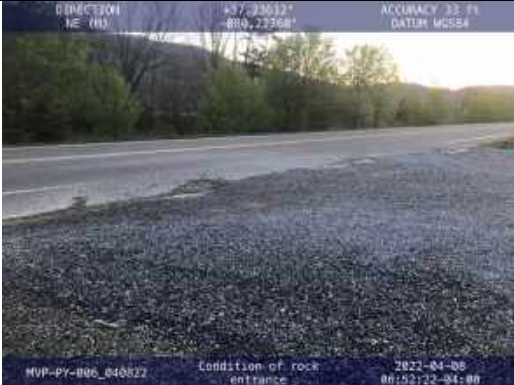
| <b>Pic 1 Desc.</b> | Condition of north rock entrance. No stone on public roadway. Looking NE. | <b>Pic 2 Desc.</b> | Condition of posted project documents at main entrance. Looking SW. | | |

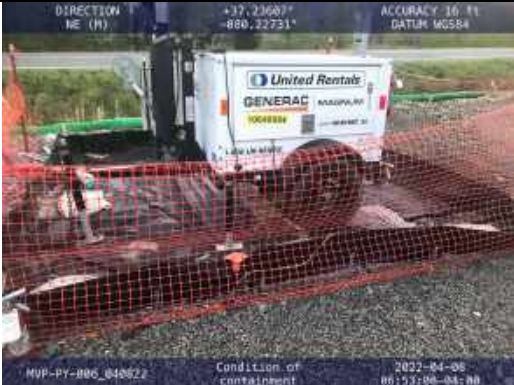
| <b>Pic 3 Desc.</b> | Secondary containment under light plant holding some stormwater. Looking NE. | <b>Pic 4 Desc.</b> | Condition of triple stack compost filter sock and signage at feature W-008. Looking E. | | |
