## Visual Site Inspection Report

| <b>Project Name</b> | H-600 Pipeline Spread H | <b>AFE</b> | 124300138 | <b>Spread</b> | H-600 Pipeline Spread H |

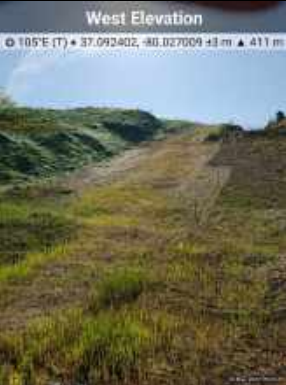
| <b>Pic 1 Desc.</b> | Photo showing stabilization on hill side above road crossing. | | <b>Pic 2 Desc.</b> | Monitored ECDs and sump pit , all functioning at the time of inspection. | |

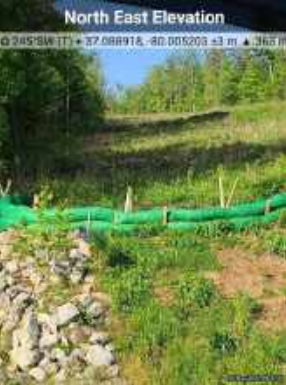
| <b>Pic 3 Desc.</b> | Monitored ECDs and rock lined channel at CAHAS rd crossing. No environmental issues observed at the time of inspection. | | <b>Pic 4 Desc.</b> | Observed water bars and level spreaders in permanent areas of row during routine inspection, no environmental issues observed at the time of inspection. | |

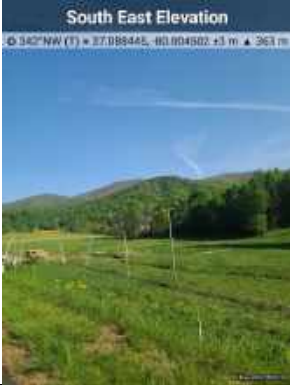
| <b>Pic 7 Desc.</b> | Monitored ECDs and vegetation in anode bed location. No environmental issues observed at the time of inspection. | | <b>Pic 8 Desc.</b> | Monitored perimeter ECDs around work space, no issues observed at the time of inspection. | |

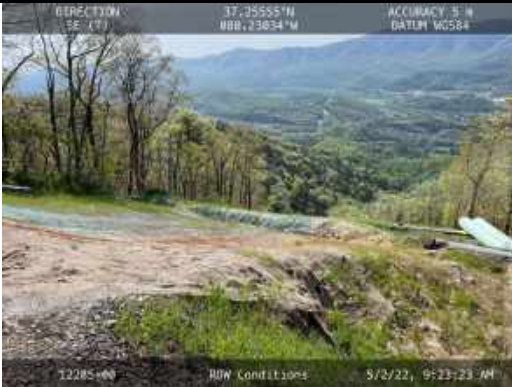
| <b>Pic 1 Desc.</b> | Photo shows the stabilized ROW conditions with water bars and that all ECDs are installed and are functioning as designed. | | <b>Pic 2 Desc.</b> | Photo shows the stabilized ROW conditions with water bars and that all ECDs are installed and are functioning as designed. | |

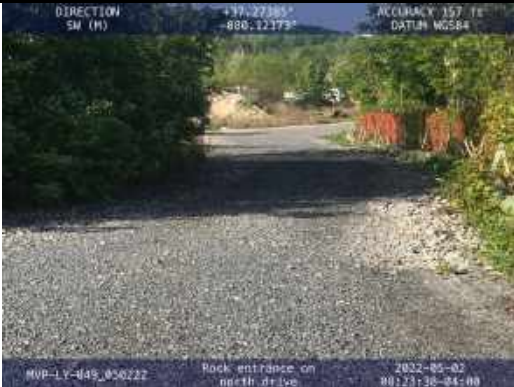
| <b>Pic 1 Desc.</b> | Condition of rock entrance on north drive. No sediment or debris on stone. Looking SW. | | <b>Pic 2 Desc.</b> | Condition of rock entrance on center drive. Large stone applied over larger stone. Looking SE. | |

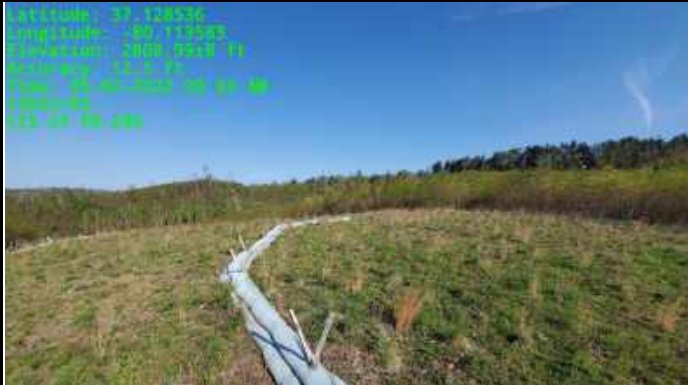
| <b>Pic 7 Desc.</b> | Current ROW conditions. | | <b>Pic 8 Desc.</b> | Current ROW conditions. | |

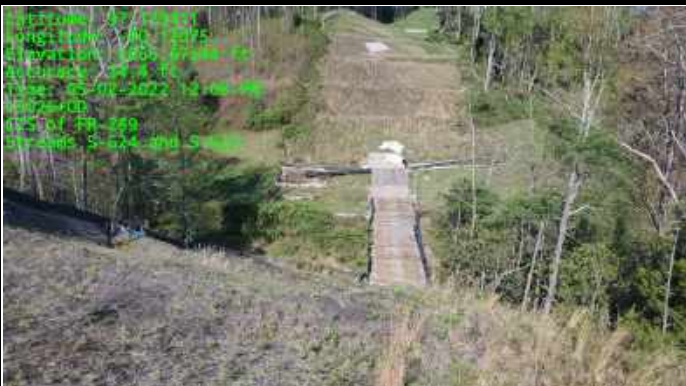
| Pic 15 Desc. | Streams S-G24 and S-G25 from the GAS. | | Pic 16 Desc. | Upstream side of streams S-G24 and S-G25. | |

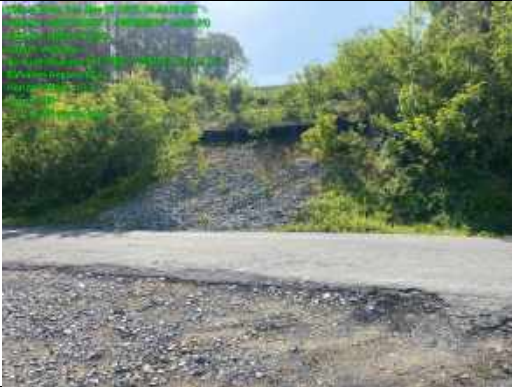
| <b>Pic 1 Desc.</b> | Wade's Gap Road crossing. | | <b>Pic 2 Desc.</b> | Private driveway. | |

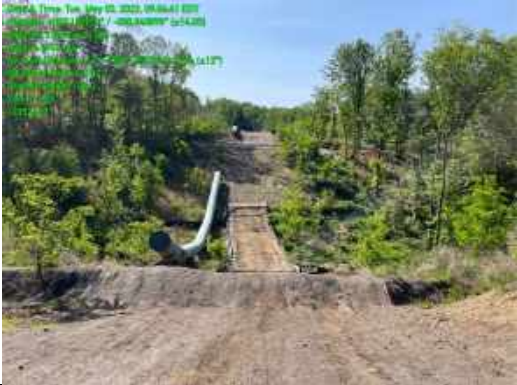
| <b>Pic 13 Desc.</b> | ROW stabilized. | | <b>Pic 14 Desc.</b> | S-RR11, ROW stabilized. | |

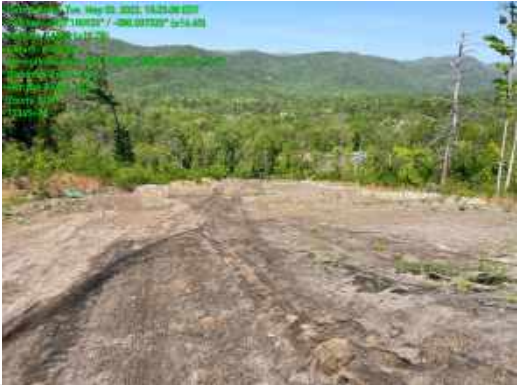
| <b>Pic 15 Desc.</b> | ROW stabilized. | | <b>Pic 16 Desc.</b> | ROW stabilized. | |

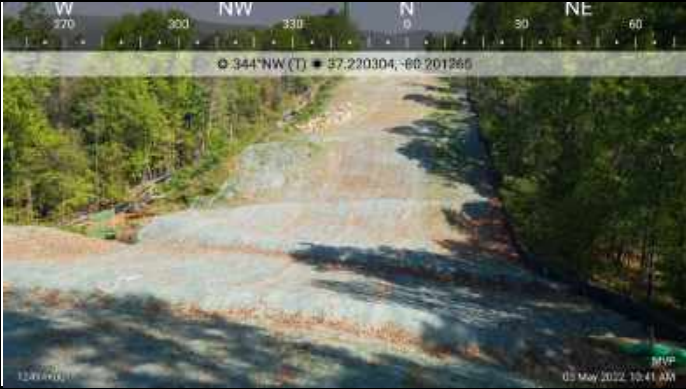
| Pic 7 Desc. | ROW Overview (temporary stabilization). ECDs are functional and ROW is stable. | | Pic 8 Desc. | ROW Overview (temporary stabilization). ECDs are functional and ROW is stable. | |

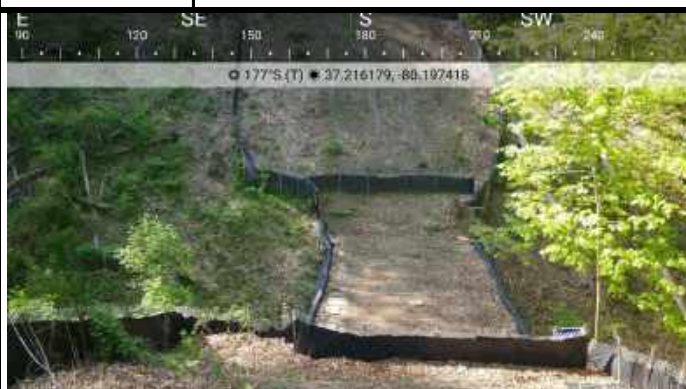
| Pic 9 Desc. | ROW Overview (temporary stabilization). ECDs are functional and ROW is stable. | | Pic 10 Desc. | ROW Overview (temporary stabilization). ECDs are functional and ROW is stable. | |

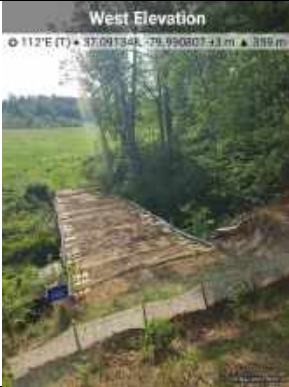
| <b>Field Station#</b> | 13543+11 | <b>Field Station#</b> | 13543+00 | | |

| <b>Pic 1 Desc.</b> | Observed equipment bridge and protection during routine inspection of stream crossings, no environmental issues observed at the time of inspection. | | <b>Pic 2 Desc.</b> | Monitored ECDs and stabilization on stream banks during routine inspection of stream crossings. No environmental issues observed at the time of inspection. | |

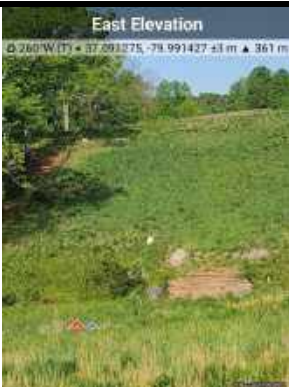
| <b>Field Station#</b> | 13539+28 | <b>Field Station#</b> | 13630+00 | | |

| <b>Pic 5 Desc.</b> | Observed vegetation on both sides of stream/wetland crossing during routine inspection today. No issues were observed at the time of inspection. | | <b>Pic 6 Desc.</b> | Row photo showing stabilization in permanent area. Photo showing growth of locust trees inside the LOD. | |

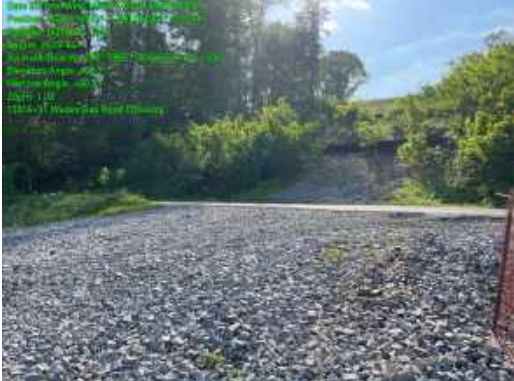
| <b>Field Station#</b> | 13316+21 | <b>Field Station#</b> | 13309+09 | | |

| <b>Pic 1 Desc.</b> | Wades Gap Road Crossing in good condition | <b>Pic 2 Desc.</b> | MVP-S-GH7 and corresponding buffer zone in good condition | | |

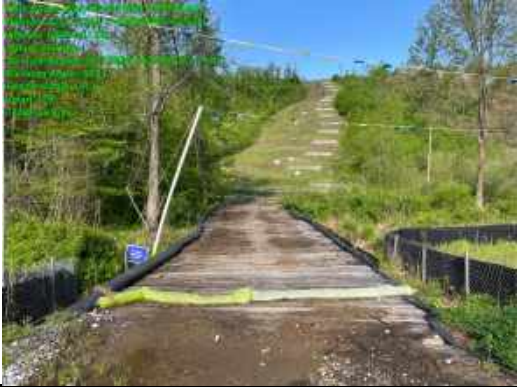
| <b>Field Station#</b> | 13260+66 | <b>Field Station#</b> | 13259+00 | | |

| <b>Pic 7 Desc.</b> | MVP-S-II4 and corresponding buffer zone in good condition | <b>Pic 8 Desc.</b> | ROW and ECDs In good condition and stable | | |

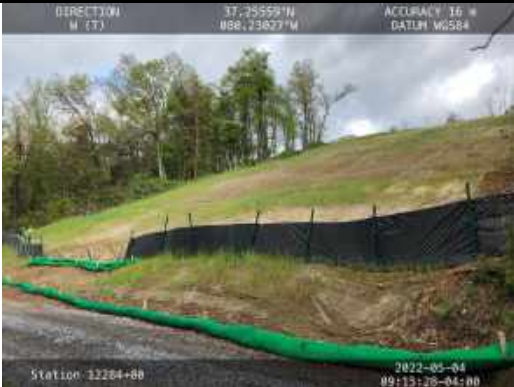
| <b>Field Station#</b> | 12284+00 | | <b>Field Station#</b> | 12227+00 | |

| <b>Pic 1 Desc.</b> | Photo shows the stabilized ROW conditions with water bars and that all ECDs are installed and are functioning as designed. | | <b>Pic 2 Desc.</b> | Photo shows vegetation on side slope and super silt fence installed and functioning as designed. | |

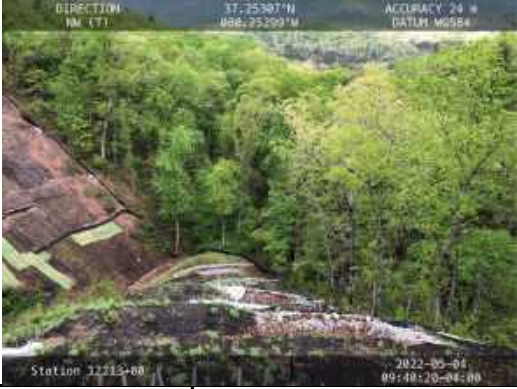
| <b>Field Station#</b> | 12213+00 | | <b>Field Station#</b> | 12210+00 | |

| <b>Pic 7 Desc.</b> | Photo shows permanent restoration section of ROW with permanent water bars installed equipped with level spreaders. | | <b>Pic 8 Desc.</b> | Photo shows the stabilized ROW conditions with water bars and that all ECDs are installed and are functioning as designed. | |

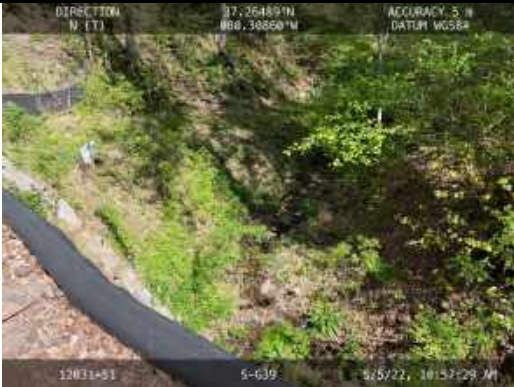
| <b>Field Station#</b> | 12031+51 | | <b>Field Station#</b> | 12035+11 | |

| <b>Pic 1 Desc.</b> | Photo shows downstream view of Stream S-G39 from equipment bridge spanning the stream channel. | | <b>Pic 2 Desc.</b> | Photo shows downstream view of Stream S-PP23 from equipment bridge spanning the stream channel. | |

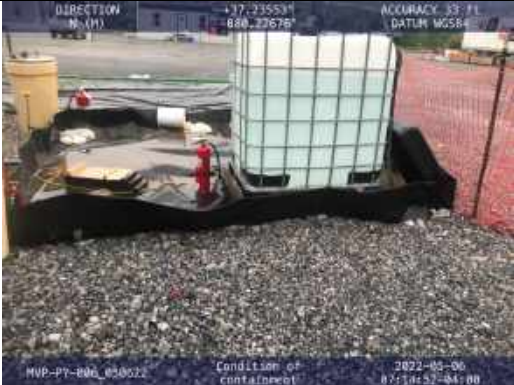
| <b>Field Station#</b> | +0 | <b>Field Station#</b> | +0 | | |

| <b>Pic 1 Desc.</b> | Secondary containment under DEF container holding stormwater. Looking N. | <b>Pic 2 Desc.</b> | Blue Bulk Fuel tanks no fluid spills south of the tanks. Looking W. | | |

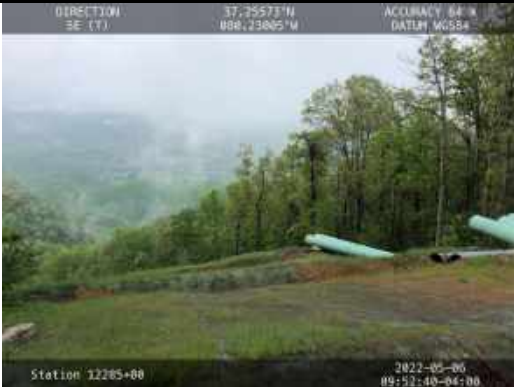
| <b>Field Station#</b> | 12285+00 | | <b>Field Station#</b> | 12301+00 | |

| <b>Pic 1 Desc.</b> | Photo shows the stabilized ROW conditions with water bars and that all ECDs are installed and are functioning as designed. | | <b>Pic 2 Desc.</b> | Photo shows the stabilized ROW conditions with water bars and that all ECDs are installed and are functioning as designed. | |

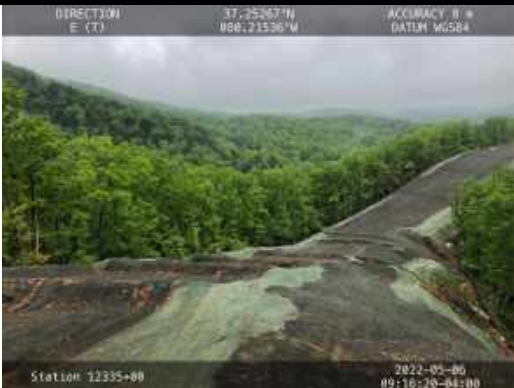
| <b>Field Station#</b> | 12335+00 | | <b>Field Station#</b> | 12336+50 | |

| <b>Pic 5 Desc.</b> | Photo shows the stabilized ROW conditions with water bars and that all ECDs are installed and are functioning as designed. | | <b>Pic 6 Desc.</b> | Photo shows the stabilized ROW conditions with water bars and that all ECDs are installed and are functioning as designed. | |

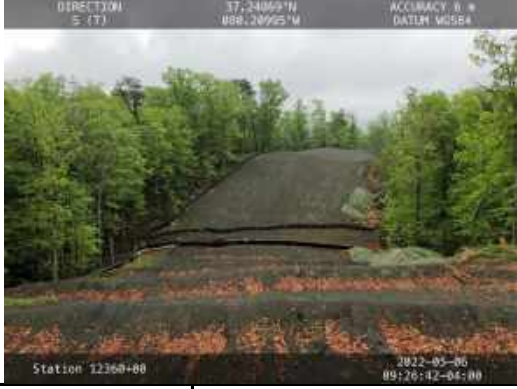
| <b>Field Station#</b> | 12360+00 | | <b>Field Station#</b> | 12362+00 | |

| <b>Pic 9 Desc.</b> | Photo shows the stabilized ROW conditions with water bars and that all ECDs are installed and are functioning as designed. | | <b>Pic 10 Desc.</b> | Photo shows the stabilized ROW conditions with water bars and that all ECDs are installed and are functioning as designed. | |

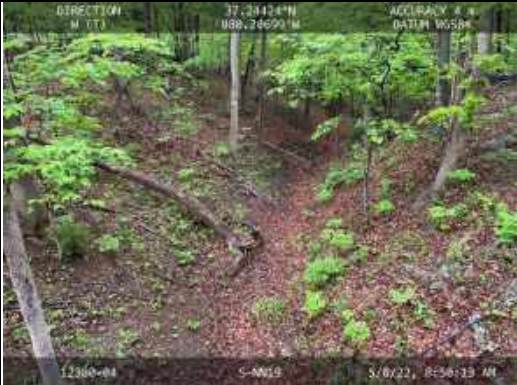
| <b>Field Station#</b> | 12380+04 | | <b>Field Station#</b> | 12374+16 | |

| <b>Pic 13 Desc.</b> | Photo shows downstream view of stream S-NN19 from equipment bridge spanning the stream channel. | | <b>Pic 14 Desc.</b> | Photo shows upstream view of stream S-0016. | |

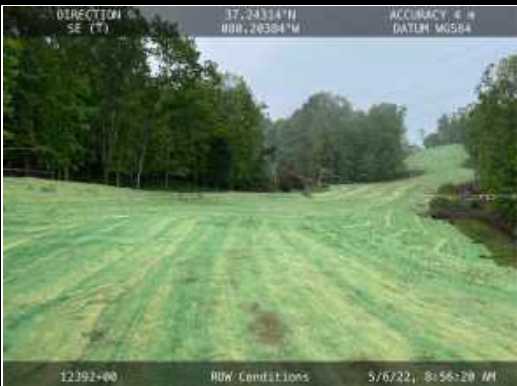
| <b>Field Station#</b> | 12392+00 | | <b>Field Station#</b> | 12377+00 | |

| <b>Pic 15 Desc.</b> | Photo shows the stabilized ROW conditions with water bars and that all ECDs are installed and are functioning as designed. | | <b>Pic 16 Desc.</b> | Photo shows the stabilized ROW conditions with water bars and that all ECDs are installed and are functioning as designed. | |

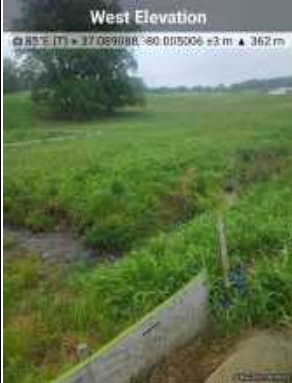
| <b>Field Station#</b> | 13497+89 | <b>Field Station#</b> | 13497+89 | | |

| <b>Pic 7 Desc.</b> | Stream observation photo facing downstream during routine inspection today. Light rain events throughout the morning. | | <b>Pic 8 Desc.</b> | Photo showing stream/wetland area with ECDs in place and functioning at the time of inspection. | |
