Visual Site Inspection Report

Project Name	H-600 Pipeline Spread I	AFE	124300139	Spread	H-600 Pipeline Spread I
Contractor	Precision			Report #	36182
Inspector	Justin Burch			Date/Time	4/4/2022 10:28 AM
Permit #	TBD	Inspection Type	VA SWPP	Station Begin	15142+66
State	VA	Inspection Area	Full	Station End	15260+00
County	Pittsylvania	Ground	Damp	Temperature (°F)	67.00
Municipality	Chatham	Weather	Cloudy	Rain Gauge (in)	0.30
				Rain Accumulation Time (days)	6.00

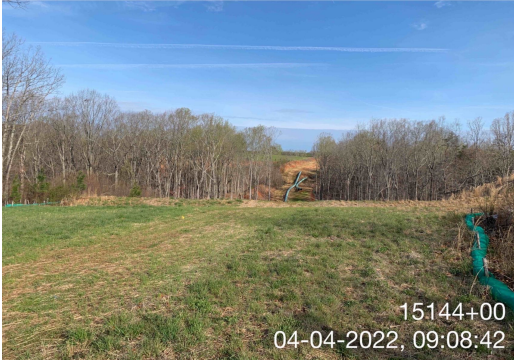
15154+00 04-04-2022, 09:12:11			
GPS Location	0	GPS Location	0		
Field Station#	15144+00	Field Station#	15154+00		
Pic 1 Desc.	Permanent vegetative stabilization and perimeter CFS in acceptable conditions	Pic 2 Desc.	Temporary vegetative stabilization and waterbar in acceptable conditions		
182°S (T) 36°56'45"N, 79°34'33"W ±16ft ▲ 835ft

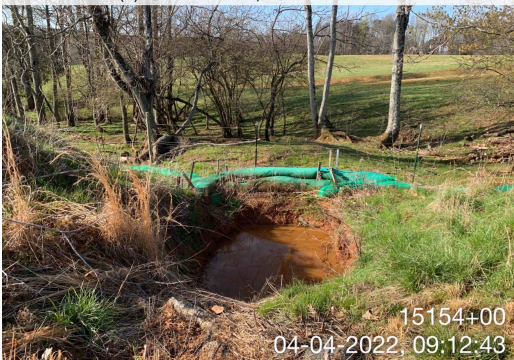
15169+00 04-04-2022, 09:22:40			
GPS Location	0	GPS Location	0		
Field Station#	15154+00	Field Station#	15169+00		
Pic 3 Desc.	Waterbar end treatment in acceptable condition	Pic 4 Desc.	Sensitive resource buffer in acceptable condition		
238°SW (T) 36°56'37"N, 79°34'16"W ±29ft ▲ 741ft

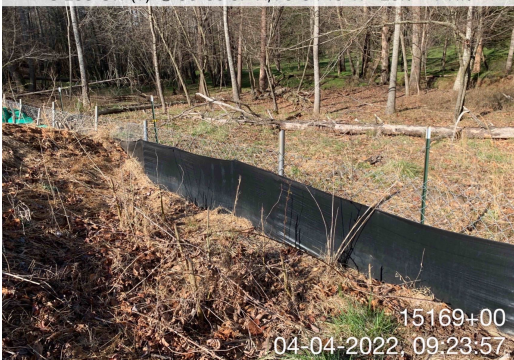
GPS Location	0	GPS Location	0		
Field Station#	15169+00	Field Station#	15169+00		
Pic 5 Desc.	Super silt fence in acceptable condition	Pic 6 Desc.	Slope drain pipe and sump pit in acceptable conditions

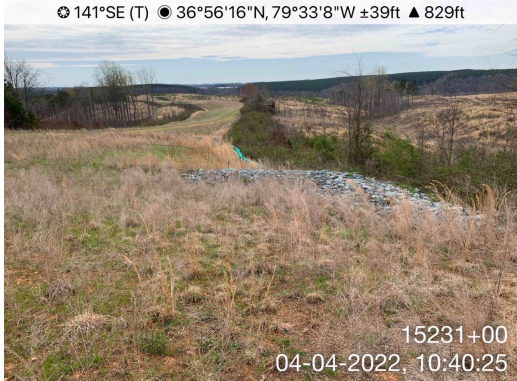
<p>15231+00 04-04-2022, 10:40:25</p>		<div style="text-align: center;">Insert image here</div>			
GPS Location	0	GPS Location			
Field Station#	15231+00	Field Station#			
Pic 9 Desc.	Waterbar end treatment in acceptable condition		Pic 10 Desc.		
<div style="text-align: center;">Insert image here</div>			<div style="text-align: center;">Insert image here</div>		
GPS Location		GPS Location			
Field Station#		Field Station#			
Pic 11 Desc.			Pic 12 Desc.

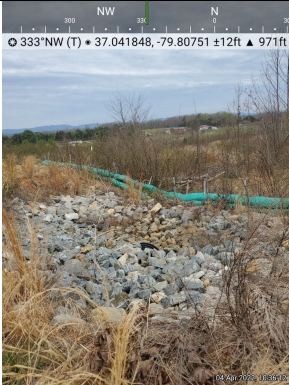
GPS Location	0	GPS Location	0		
Field Station#	14320+00	Field Station#	14323+00		
Pic 1 Desc.	Plunge pool	Pic 2 Desc.	Temporary vegetation

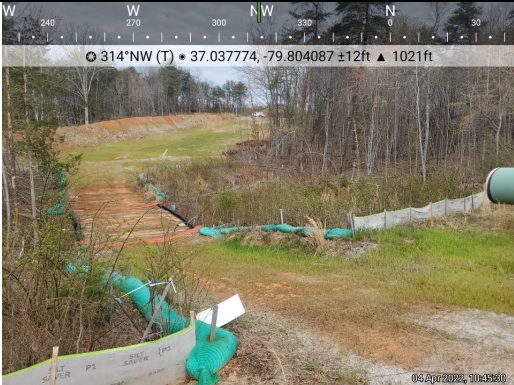
GPS Location	0	GPS Location	0		
Field Station#	14339+00	Field Station#	14361+00		
Pic 3 Desc.	GAS S-A36 Perimeter ECDs and buffer zone	Pic 4 Desc.	Plunge pool

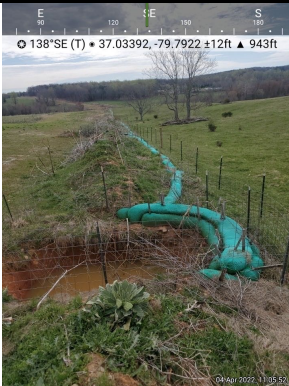
GPS Location	0	GPS Location	0		
Field Station#	14380+00	Field Station#	14389+00		
Pic 5 Desc.	Perimeter CFS and sump	Pic 6 Desc.	CIS W-DD1 Perimeter CFS and buffer

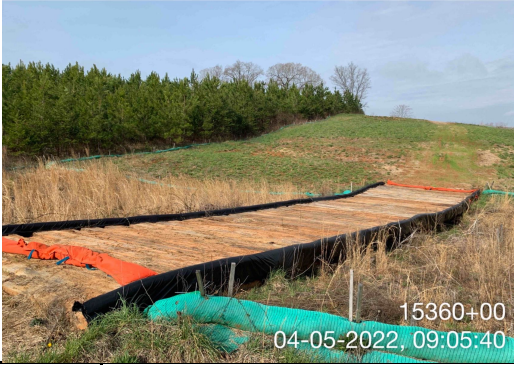
15323+00 04-05-2022, 10:32:47			
GPS Location	0	GPS Location	0		
Field Station#	15360+00	Field Station#	15323+00		
Pic 1 Desc.	Equipment bridge and CFS in acceptable conditions	Pic 2 Desc.	Rock construction entrance in acceptable condition		
☉ 210°SW (T) ● 36°55'45"N, 79°31'25"W ±13ft ▲ 704ft

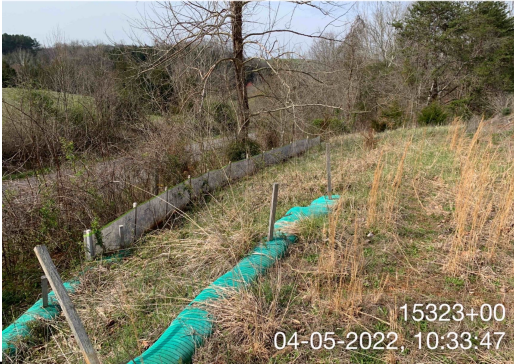
15315+00 04-05-2022, 10:46:20			
GPS Location	0	GPS Location	0		
Field Station#	15323+00	Field Station#	15315+00		
Pic 3 Desc.	Perimeter P1 silt fence and CFS in acceptable conditions	Pic 4 Desc.	Sensitive resource buffer and P1 silt fence in acceptable conditions		
☉ 349°N (T) ● 36°55'51"N, 79°31'53"W ±114ft ▲ 777ft

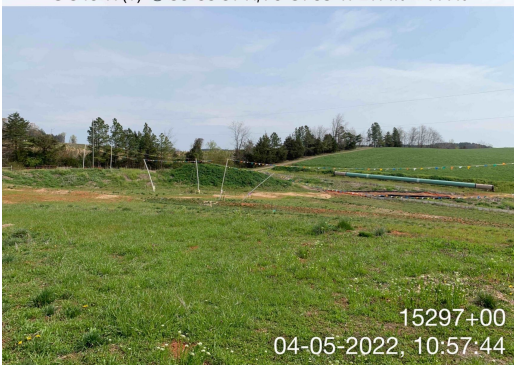
GPS Location	0	GPS Location	0		
Field Station#	15297+00	Field Station#	15301+00		
Pic 5 Desc.	Temporary vegetative stabilization in acceptable condition	Pic 6 Desc.	Clean water diversion berm and temporary vegetative stabilization in acceptable conditions

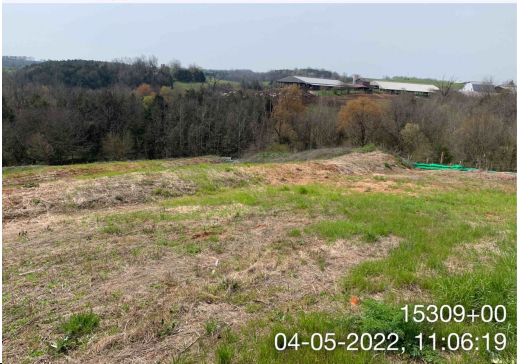
GPS Location	0	GPS Location	0		
Field Station#	15309+00	Field Station#	15309+00		
Pic 7 Desc.	Waterbar in acceptable condition	Pic 8 Desc.	Waterbar end treatment in acceptable condition		
Insert image here		Insert image here			
GPS Location		GPS Location			
Field Station#		Field Station#			
Pic 9 Desc.		Pic 10 Desc.			
Insert image here		Insert image here			
GPS Location		GPS Location			
Field Station#		Field Station#			
Pic 11 Desc.		Pic 12 Desc.

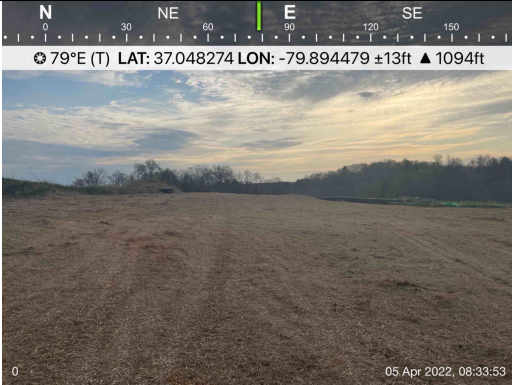
GPS Location	See photo		GPS Location	See photo	
Field Station#	13959+00		Field Station#	13960+00	
Pic 1 Desc.	ROW has been stabilized in this area.		Pic 2 Desc.	CWD is functioning as intended

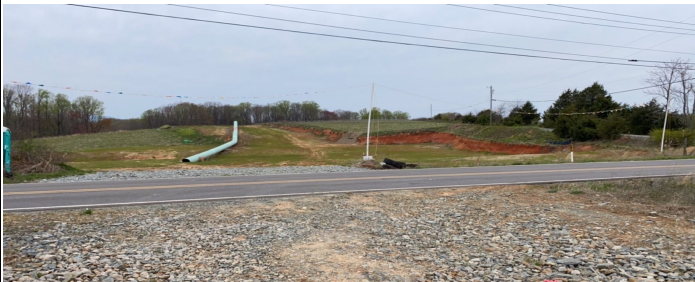
37°1'35" N 79°46'6" W 47°NE COURSE 244' GPS 2750 Webster Rd, Glade Hill, VA 24092, United States 04.05.2022 11:22:09 Accur +/-21.8 Ft ALT 1102 Ft			37°1'34" N 79°46'4" W 96°E COURSE 119' GPS 2750 Webster Rd, Glade Hill, VA 24092, United States 04.05.2022 11:23:06 Accur +/-15.5 Ft ALT 1087 Ft		
GPS Location	1	GPS Location	2		
Field Station#	14454+22	Field Station#	14458+00		
Pic 1 Desc.	RCE at Webster Rd in good condition.		Pic 2 Desc.	Slope drain tile in place and functional.

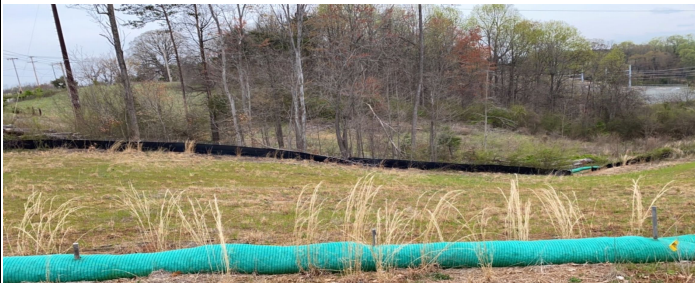
Pic 3 Desc.	Perimeter SSF and CFS in good condition.		Pic 4 Desc.	Sump pit and CFS end treatment performing intended functions.

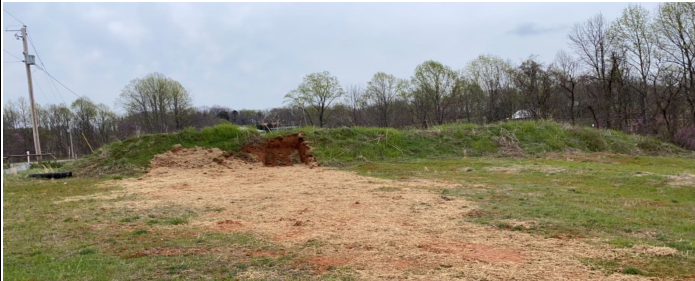
37°0'39" N 79°45'14" W 192°S COURSE 115' GPS 1760 SR-674, Glade Hill, VA 24092, United States 04.05.2022 13:47:06 Accur +/-81.1 Ft ALT 1047 Ft			37°0'38" N 79°45'17" W 194°S COURSE -1' GPS 1760 SR-674, Glade Hill, VA 24092, United States 04.05.2022 13:47:41 Accur +/-197.1 Ft ALT 1078 Ft		
GPS Location	5	GPS Location	6		
Field Station#	14525+25	Field Station#	14530+00		
Pic 5 Desc.	Updated picture of temporary stabilization where spoil pile was disturbed.		Pic 6 Desc.	ROW stabilized and vegetated in temporary area.

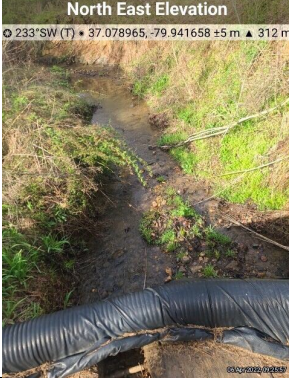
GPS Location	00000	GPS Location	00000		
Field Station#	136728+15	Field Station#	13732+00		
Pic 1 Desc.	Stream observation photo facing downstream during routine inspection today after overnight rain events, no environmental issues observed at the time of inspection.		Pic 2 Desc.	Monitored sump pits and end treatment during routine inspection today. No environmental issues observed at the time of inspection.	
	South Elevation <small>27°N (T) • 37.078974, -79.94169 ±5 m ▲ 314 m</small>

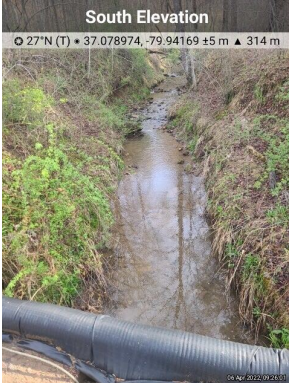
Pic 3 Desc.	Stream observation photo facing upstream during routine inspection today. No issues were observed at the time of inspection.		Pic 4 Desc.	During the EI's travel of the row today the EI noticed new vegetation on the hill sides above stream crossing S-EF4.	
	South East Elevation <small>325°NW (T) • 37.084246, -79.947295 ±4 m ▲ 307 m</small>

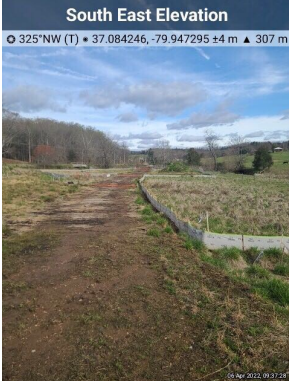
GPS Location	0000	GPS Location	00000		
Field Station#	13696+70	Field Station#	13705+07		
Pic 5 Desc.	During routine inspection today the EI monitored ECDs throughout row travel. No issues were observed at the time of inspection.		Pic 6 Desc.	Stream observation photo facing downstream after recent overnight rain events, no environmental issues observed at the time of inspection.

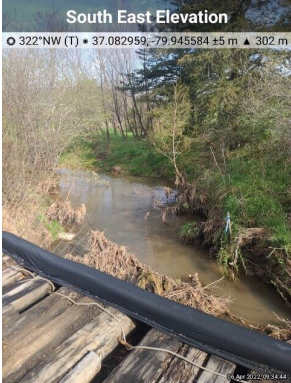
<p>Insert image here</p>		<p>Insert image here</p>	
GPS Location	0000	GPS Location			
Field Station#	13705+07	Field Station#			
Pic 7 Desc.	Stream observation photo facing upstream during routine inspection today, no environmental issues observed at the time of inspection		Pic 8 Desc.		
<p>Insert image here</p>		<p>Insert image here</p>			
GPS Location		GPS Location			
Field Station#		Field Station#			
Pic 9 Desc.		Pic 10 Desc.			
<p>Insert image here</p>		<p>Insert image here</p>			
GPS Location		GPS Location			
Field Station#		Field Station#			
Pic 11 Desc.		Pic 12 Desc.

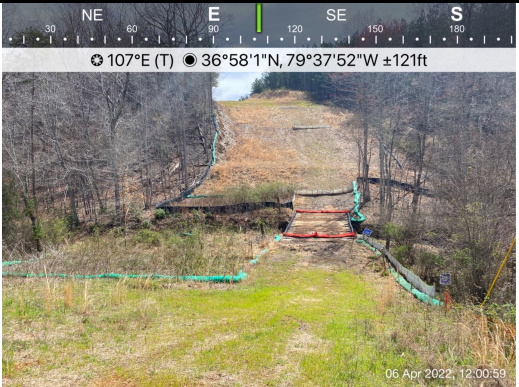
GPS Location	0	GPS Location	0		
Field Station#	14950+47	Field Station#	14940+00		
Pic 1 Desc.	Approximately 14950+47. Overview of stream crossing, equipment bridge and ECDs at stream S-G13.		Pic 2 Desc.	Approximately 14940+00. Overview of ROW.

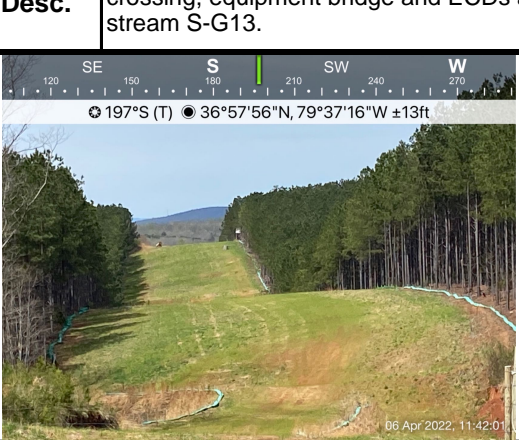
GPS Location	0	GPS Location	0		
Field Station#	14969+00	Field Station#	14981+55		
Pic 3 Desc.	Approximately 14969+00. Overview of ROW. Permanent vegetation.		Pic 4 Desc.	Approximately 14981+55. Overview of road crossing and RCEs.

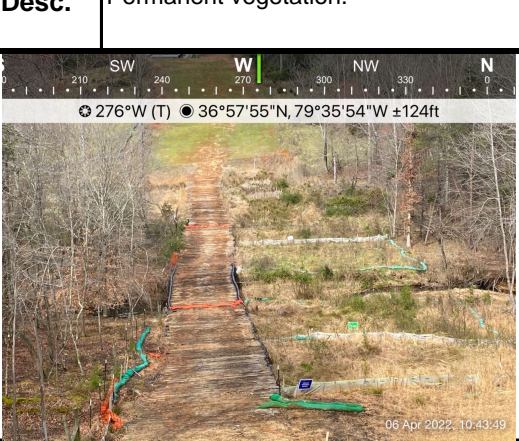
GPS Location	0	GPS Location	0		
Field Station#	14044+90	Field Station#	15053+00		
Pic 5 Desc.	Approximately 14044+90. Overview of stream crossing, equipment bridge and ECDs at stream S-D2.		Pic 6 Desc.	Approximately 15053+00. Overview of ROW.

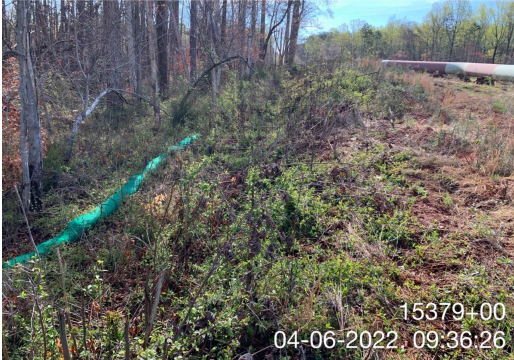
GPS Location	0		GPS Location	0	
Field Station#	15379+00		Field Station#	15384+00	
Pic 1 Desc.	Perimeter CFS and temporary vegetative stabilization in acceptable conditions		Pic 2 Desc.	P1 silt fence in acceptable conditions

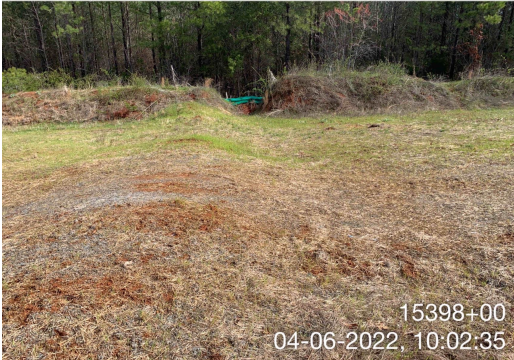
GPS Location	0		GPS Location	0	
Field Station#	15398+00		Field Station#	15398+00	
Pic 3 Desc.	Waterbar in acceptable condition		Pic 4 Desc.	Waterbar end treatment in acceptable condition

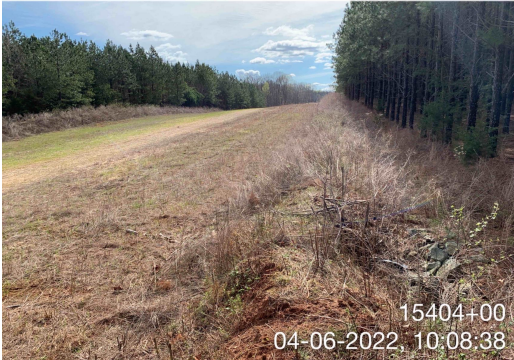
GPS Location	0		GPS Location	0	
Field Station#	15404+00		Field Station#	15413+00	
Pic 5 Desc.	Clean water diversion berm and temporary vegetative stabilization in acceptable conditions		Pic 6 Desc.	Super silt fence in acceptable condition

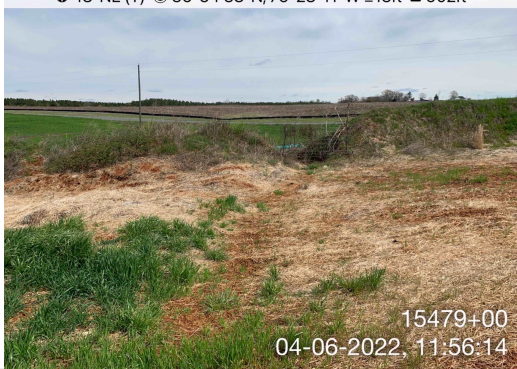
GPS Location	0	GPS Location	0		
Field Station#	15479+00	Field Station#	15479+00		
Pic 9 Desc.	Waterbar in acceptable condition		Pic 10 Desc.	Waterbar end treatment in acceptable condition	
Insert image here			Insert image here		
GPS Location		GPS Location			
Field Station#		Field Station#			
Pic 11 Desc.		Pic 12 Desc.

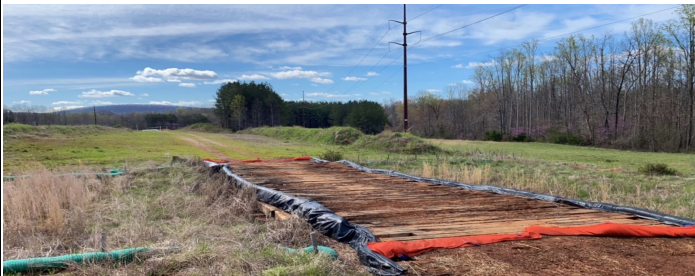
37°0'15" N 79°45'6" W 218°SW COURSE 154' GPS 594 Tobacco Rd, Glade Hill, VA 24092, United States 04.06.2022 10:00:36 Accur +/-171.8 Ft ALT 937 Ft			37°0'15" N 79°45'6" W 211°SW COURSE 183' GPS 594 Tobacco Rd, Glade Hill, VA 24092, United States 04.06.2022 09:59:56 Accur +/-80.5 Ft ALT 937 Ft		
GPS Location	1	GPS Location	2		
Field Station#	14557+00	Field Station#	14559+00		
Pic 1 Desc.	Equipment bridge and surrounding ECDs in place and functional at natural drainage area.		Pic 2 Desc.	Temporary diversion berm stabilized and vegetated.

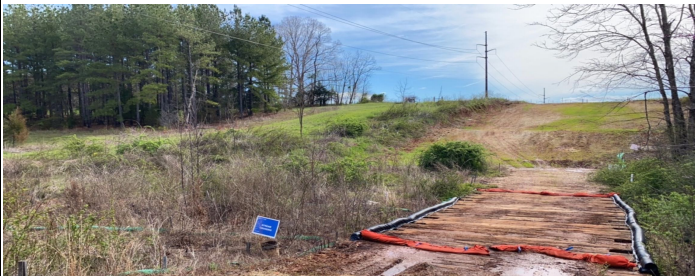
GPS Location	3	GPS Location	4		
Field Station#	14568+10	Field Station#	14578+00		
Pic 3 Desc.	Equipment bridge and surrounding ECDs in place and functional at stream crossing and resource buffer.		Pic 4 Desc.	ROW stabilized and vegetated in temporary area.

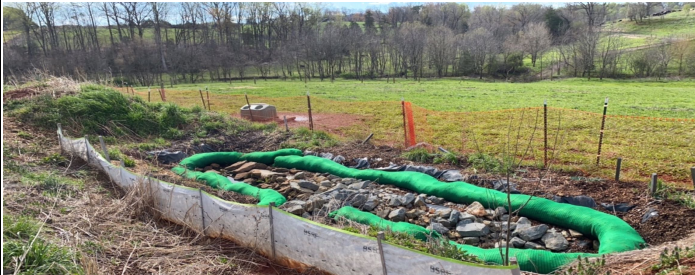
37°0'2" N 79°44'41" W 183°S COURSE 103' GPS Glade Hill, VA 24092, United States 04.06.2022 10:11:25 Accur +/-92.2 Ft ALT 888 Ft			37°0'4" N 79°44'53" W 103°E COURSE -1' GPS 594 Tobacco Rd, Glade Hill, VA 24092, United States 04.06.2022 10:16:31 Accur +/-96.6 Ft ALT 878 Ft		
GPS Location	5	GPS Location	6		
Field Station#	14576+00	Field Station#	14587+00		
Pic 5 Desc.	ECDs replaced by contractor per punch list item.		Pic 6 Desc.	Sump pit and CFS end treatment performing intended functions.

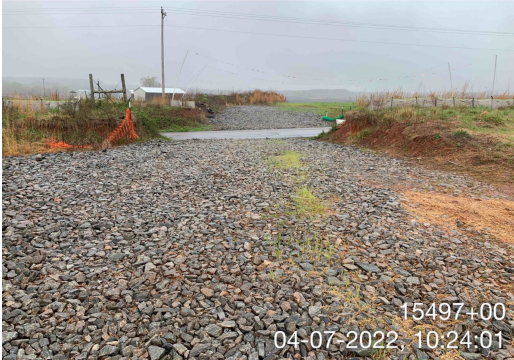
15497+00 04-07-2022, 10:24:01		97°E (T) 36°54'28"N, 79°24'34"W ±57460ft ▲892ft

15506+00 04-07-2022, 10:41:30			
GPS Location	0	GPS Location	0		
Field Station#	15497+00	Field Station#	15506+00		
Pic 1 Desc.	Rock construction entrance in acceptable condition	Pic 2 Desc.	Perimeter P1 silt fence and temporary vegetative stabilization in acceptable conditions		
214°SW (T) 36°54'18"N, 79°28'16"W ±52ft ▲858ft

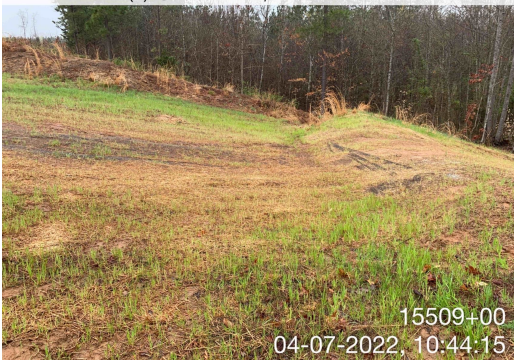
15509+00 04-07-2022, 10:44:15		256°W (T) 36°54'18"N, 79°28'16"W ±22ft ▲856ft

15509+00 04-07-2022, 10:44:31			
GPS Location	0	GPS Location	0		
Field Station#	15509+00	Field Station#	15509+00		
Pic 3 Desc.	Waterbar and temporary vegetative stabilization in acceptable condition	Pic 4 Desc.	Waterbar end treatment in acceptable condition		
121°SE (T) 36°54'11"N, 79°28'6"W ±26ft ▲832ft

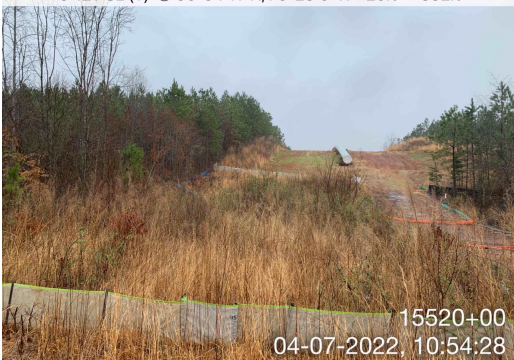
15520+00 04-07-2022, 10:54:28		305°NW (T) 36°54'10"N, 79°28'5"W ±344ft ▲831ft

GPS Location	0	GPS Location	0		
Field Station#	15520+00	Field Station#	15521+00		
Pic 5 Desc.	Sensitive resource buffer and P1 silt fence in acceptable conditions	Pic 6 Desc.	Equipment bridge in acceptable condition

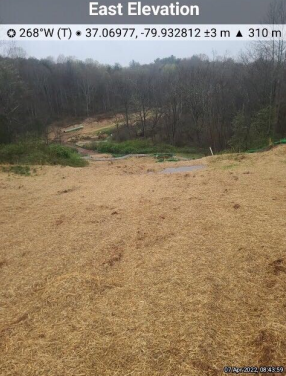
GPS Location	00000	GPS Location	0000		
Field Station#	13783+40	Field Station#	13784+35		
Pic 1 Desc.	Stabilization photo taken on hill side above stream crossing. No environmental issues observed at the time of inspection during light rain events.		Pic 2 Desc.	Monitored sump pit and ECDs , no issues were observed at the time of inspection during light rain events.	
	East Elevation

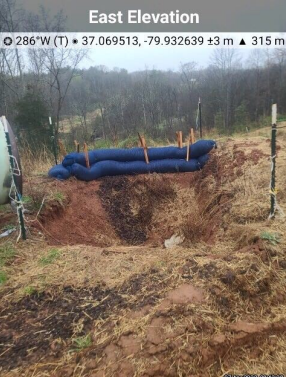
GPS Location	0000	GPS Location	0000		
Field Station#	13784+42	Field Station#	13811+70		
Pic 3 Desc.	Monitored sump pits and end treatments, all functioning at the time of inspection.		Pic 4 Desc.	Monitored RCEs during light rain events today, no environmental issues observed at the time of inspection.	
	South East Elevation

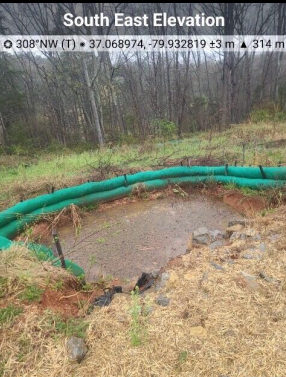
Field Station#	13784+49	Field Station#	13826+95		
Pic 5 Desc.	Monitored sump pits and end treatments, all functioning at the time of inspection.		Pic 6 Desc.	Row photo showing stabilization, no environmental issues observed at the time of inspection.

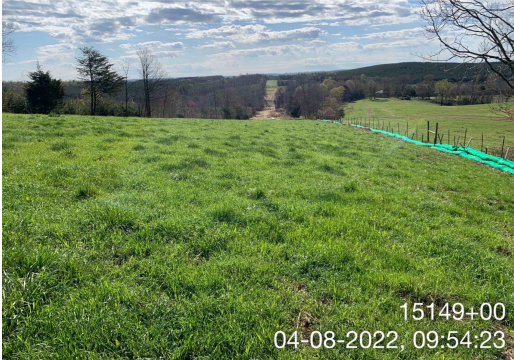
GPS Location	0	GPS Location	0		
Field Station#	15149+00	Field Station#	15157+00		
Pic 1 Desc.	Permanent vegetative stabilization and perimeter CFS in acceptable conditions	Pic 2 Desc.	Perimeter CFS and temporary vegetative stabilization in acceptable condition

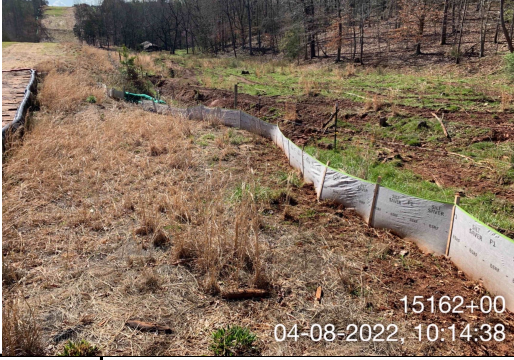
GPS Location	0	GPS Location	0		
Field Station#	15162+00	Field Station#	15166+00		
Pic 3 Desc.	P1 silt fence in acceptable condition	Pic 4 Desc.	Slope drain pipes in acceptable condition

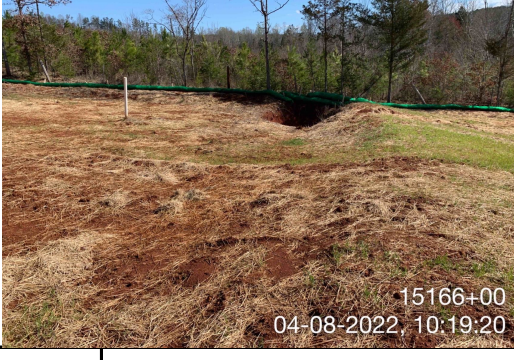
GPS Location	0	GPS Location	0		
Field Station#	15166+00	Field Station#	15166+00		
Pic 5 Desc.	Waterbar in acceptable condition	Pic 6 Desc.	Waterbar end treatment in acceptable condition

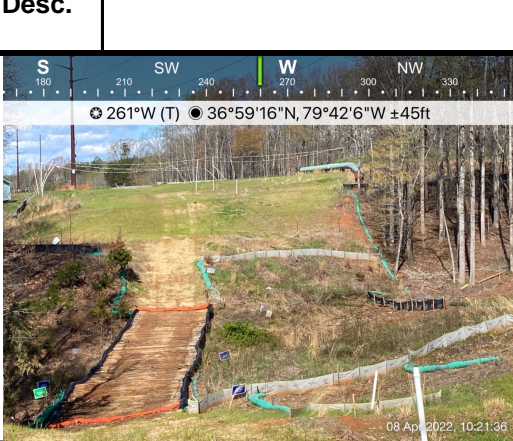
GPS Location	0		GPS Location	0	
Field Station#	14716+50		Field Station#	14697+00	
Pic 5 Desc.	Approximately 14716+50. Overview of wetland crossing, equipment bridge and ECDs at wetland W-H11. Third party disturbance north and uphill of wetland beyond LOD.		Pic 6 Desc.	Approximately 14697+00. Overview of ROW.

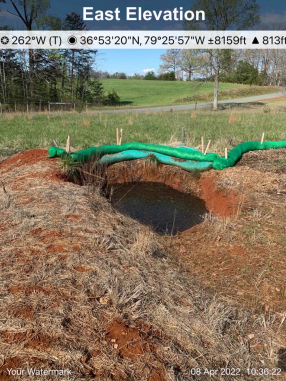
GPS Location	O	GPS Location	O		
Field Station#	15646+00	Field Station#	15636+45		
Pic 1 Desc.	Observing temporary stabilization, sump and end treatment		Pic 2 Desc.	Observing temporary stabilization, signage, buffer, equipment crossing and ECD's	
		South Elevation 338°N (T) 36°53'37"N, 79°26'14"W ±577ft ▲ 779ft

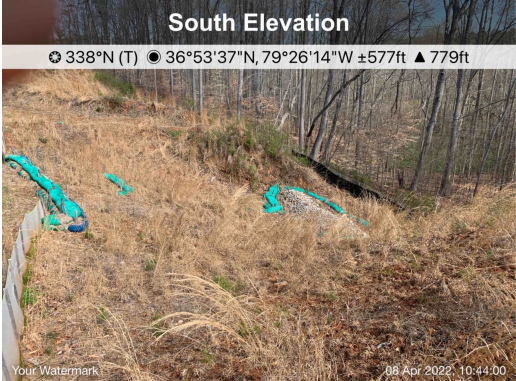
GPS Location	O	GPS Location	O		
Field Station#	15632+00	Field Station#	15619+48		
Pic 3 Desc.	Observing temporary stabilization, CWD outlet and ECD's		Pic 4 Desc.	Observing road crossing and RCE's	
		North West Elevation 150°SE (T) 36°53'32"N, 79°26'21"W ±42ft ▲ 832ft

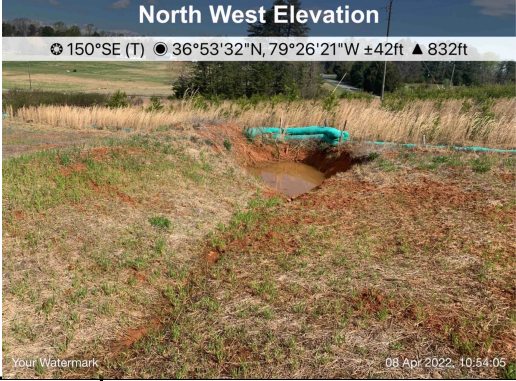
GPS Location	O	GPS Location	O		
Field Station#	15617+00	Field Station#	15614+94		
Pic 5 Desc.	Observing temporary stabilization, water bar, sump and end treatment		Pic 6 Desc.	Observing temporary stabilization, signage, buffer, equipment crossing and ECD's
