Visual Site Inspection Report

Project Name	H-600 Pipeline Spread I	AFE	124300139	Spread	H-600 Pipeline Spread I
Contractor	Precision			Report #	37459
Inspector	Charles Head			Date/Time	5/9/2022 9:10 AM
Permit #	TBD	Inspection Type	VA SWPP	Station Begin	14802+19
State	VA	Inspection Area	Full	Station End	14928+52
County	Franklin	Ground	Wet	Temperature (°F)	66.00
Municipality	N/A	Weather	Sunny	Rain Gauge (in)	1.00
				Rain Accumulation Time (days)	2.00

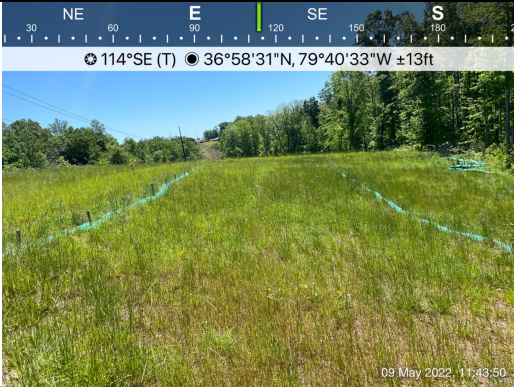
GPS Location	0	GPS Location	0		
Field Station#	14812+00	Field Station#	14804+99		
Pic 3 Desc.	Approximately 14812+00. Overview of ROW. Permanent vegetation.		Pic 4 Desc.	Approximately 14804+99. Overview of stream crossing, equipment bridge and ECDs at stream S-H23.

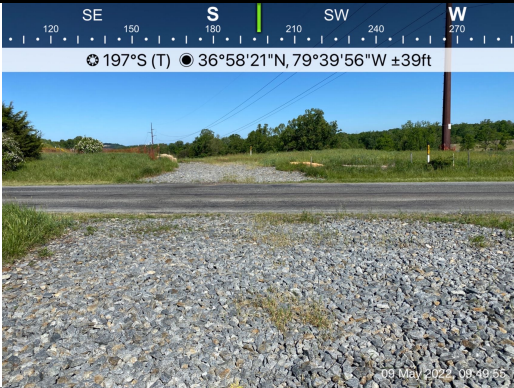
GPS Location	0	GPS Location	0		
Field Station#	14845+00	Field Station#	14870+00		
Pic 5 Desc.	Approximately 14845+00. Overview of road crossing and RCEs.		Pic 6 Desc.	Approximately 14870+00. Overview of ROW.

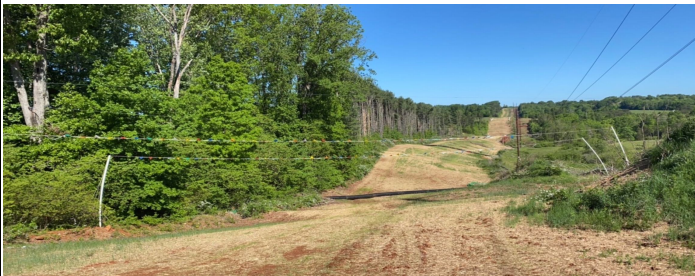
37°046' N 79°45'21" W 313°NW COURSE -1' GPS Glade Hill, VA 24092, United States 05.09.2022 09:56:18 Accur +/-15.4 Ft ALT 993 Ft			37°047' N 79°45'22" W 322°NW COURSE 357' GPS 1979 SR-674, Glade Hill, VA 24092, United States 05.09.2022 09:56:54 Accur +/-15.4 Ft ALT 971 Ft		
GPS Location	1		GPS Location	2	
Field Station#	14481+00		Field Station#	14502+00	
Pic 1 Desc.	ROW stabilized and vegetated in temporary area.		Pic 2 Desc.	Perimeter SSF and CFS in good condition.

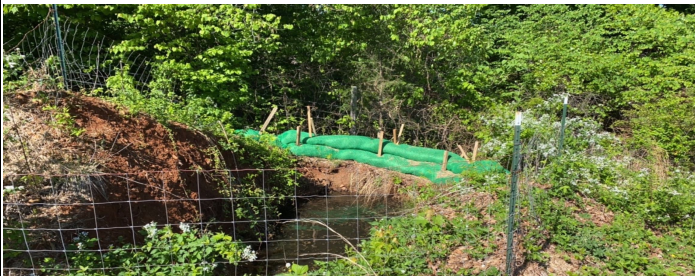
Pic 3 Desc.	Sump pit and CFS end treatment performing intended functions.		Pic 4 Desc.	Equipment bridge blocked off by contractor for equipment to cross it; ECDs in place and functional at stream crossing and resource buffer.

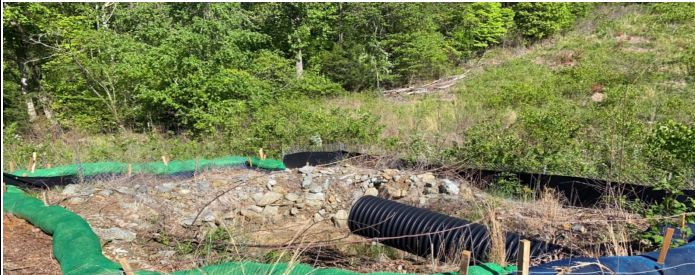
37°031' N 79°45'16" W 22°N COURSE 164' GPS Glade Hill, VA 24092, United States 05.09.2022 10:08:32 Accur +/-90.4 Ft ALT 1006 Ft			37°028' N 79°45'15" W 210°SW COURSE 190' GPS 1864 SR-674, Glade Hill, VA 24092, United States 05.09.2022 10:10:20 Accur +/-34.3 Ft ALT 1047 Ft		
GPS Location	5		GPS Location	6	
Field Station#	14533+00		Field Station#	14542+00	
Pic 5 Desc.	Plunge pool and surrounding ECDs performing intended functions.		Pic 6 Desc.	ROW stabilized and vegetated in temporary area.

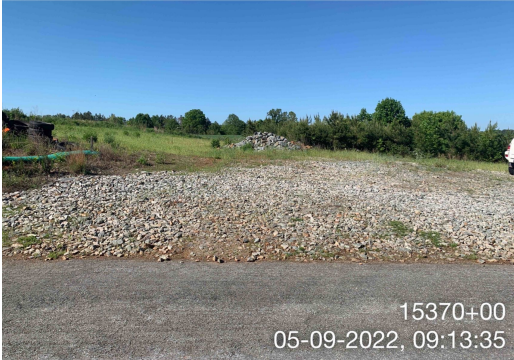
15370+00 05-09-2022, 09:14:32			
GPS Location	0	GPS Location	0		
Field Station#	15370+00	Field Station#	15370+00		
Pic 1 Desc.	Rock construction entrance in acceptable condition	Pic 2 Desc.	Perimeter CFS in acceptable condition		
360°N (T) 36°55'23"N, 79°30'51"W ±36ft ▲757ft

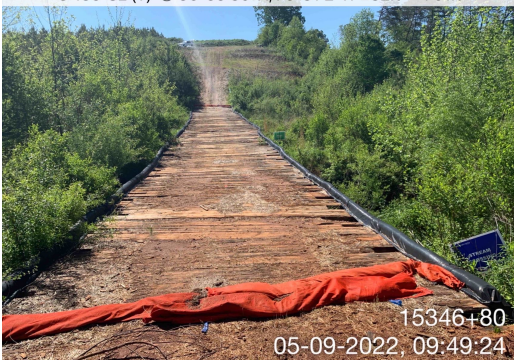
GPS Location	0	GPS Location	0		
Field Station#	15346+80	Field Station#	15328+00		
Pic 5 Desc.	Equipment bridge in acceptable condition	Pic 6 Desc.	Clean water diversion berm and temporary vegetative stabilization in acceptable conditions

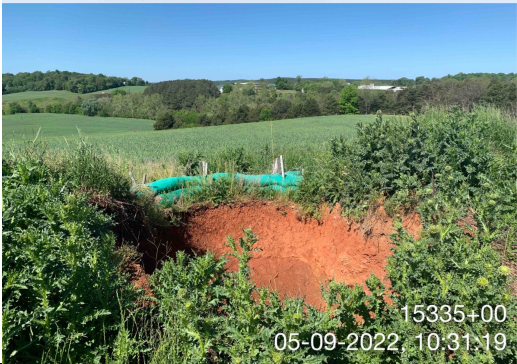
<p>15317+00 05-09-2022 10:53:16</p>			
GPS Location	0	GPS Location	0		
Field Station#	15335+00	Field Station#	15317+00		
Pic 7 Desc.	Sump pit in acceptable condition	Pic 8 Desc.	Waterbar in acceptable condition

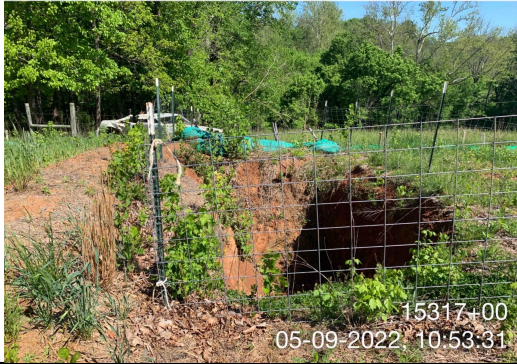
<p>15299+00 05-09-2022 11:40:20</p>			
GPS Location	0	GPS Location	0		
Field Station#	15317+00	Field Station#	15299+00		
Pic 9 Desc.	Waterbar end treatment in acceptable condition	Pic 10 Desc.	Temporary vegetative stabilization in acceptable condition		
Insert image here			Insert image here		
GPS Location		GPS Location			
Field Station#		Field Station#			
Pic 11 Desc.		Pic 12 Desc.

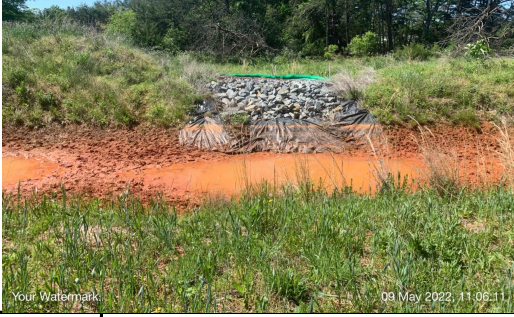
<small>Your Watermark 09 May 2022, 11:08:36</small>			
GPS Location	O	GPS Location	O		
Field Station#	15740+00	Field Station#	15735+00		
Pic 3 Desc.	Observing temporary stabilization, sump and end treatment	Pic 4 Desc.	Observing temporary stabilization, CWD outlet, sump, end treatment and ECD's

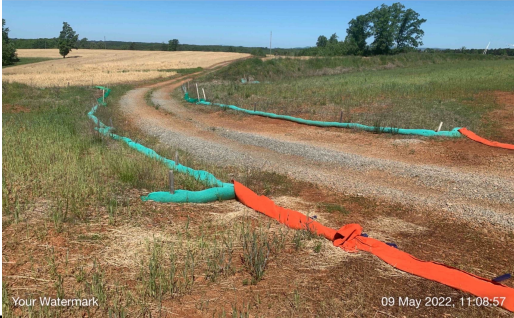
<small>Your Watermark 09 May 2022, 11:18:59</small>			
GPS Location	O	GPS Location	O		
Field Station#	15734+40	Field Station#	15693+89		
Pic 5 Desc.	Observing temporary stabilization, access road and ECD's	Pic 6 Desc.	Observing road crossing and RCE's

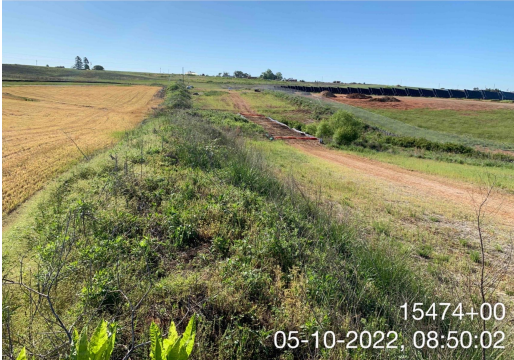
GPS Location	0	GPS Location	0		
Field Station#	15474+00	Field Station#	15458+00		
Pic 1 Desc.	Clean water diversion berm and temporary vegetative stabilization in acceptable conditions	Pic 2 Desc.	Waterbar in acceptable condition

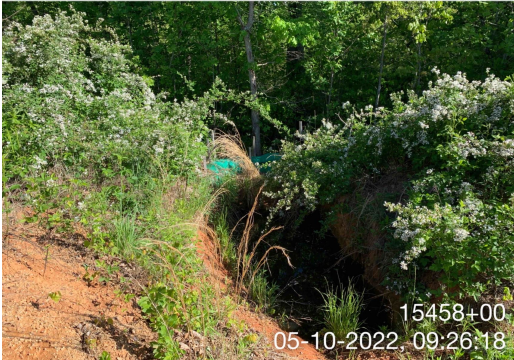
GPS Location	0	GPS Location	0		
Field Station#	15458+00	Field Station#	15447+67		
Pic 3 Desc.	Waterbar end treatment in acceptable condition	Pic 4 Desc.	Equipment bridge in acceptable condition

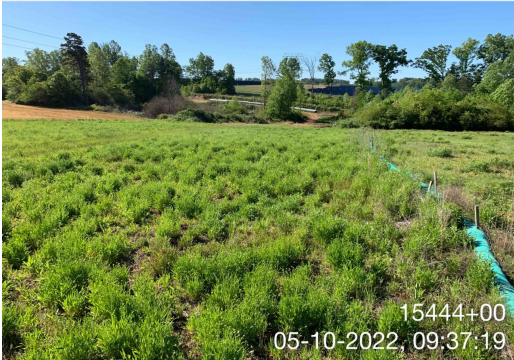
GPS Location	0	GPS Location	0		
Field Station#	15444+00	Field Station#	15442+00		
Pic 5 Desc.	Permanent vegetative stabilization and perimeter CFS in acceptable conditions	Pic 6 Desc.	Waterbar in acceptable condition

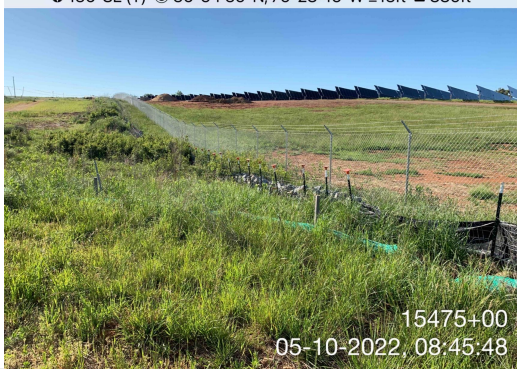
<div style="text-align: center;">Insert image here</div>			
GPS Location	0	GPS Location			
Field Station#	15475+00	Field Station#			
Pic 9 Desc.	Solar farm perimeter ECDs appear to be in acceptable conditions		Pic 10 Desc.		
<div style="text-align: center;">Insert image here</div>			<div style="text-align: center;">Insert image here</div>		
GPS Location		GPS Location			
Field Station#		Field Station#			
Pic 11 Desc.			Pic 12 Desc.

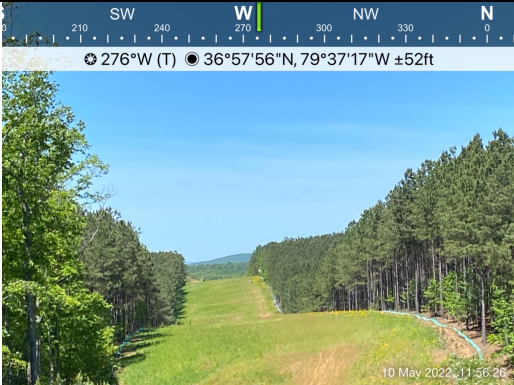
GPS Location	0	GPS Location	0		
Field Station#	14968+00	Field Station#	14981+50		
Pic 3 Desc.	Approximately 14968+00. Overview of ROW. Permanent vegetation.		Pic 4 Desc.	Approximately 14981+50. Overview of road crossing and RCEs.

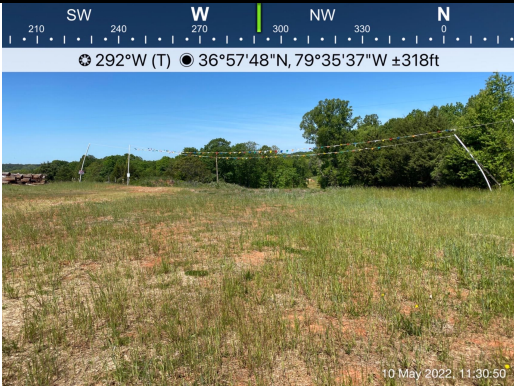
GPS Location	0	GPS Location	0		
Field Station#	15060+00	Field Station#	15052+00		
Pic 5 Desc.	Approximately 15060+00. Overview of ROW.		Pic 6 Desc.	Approximately 15052+00. Overview of ROW.

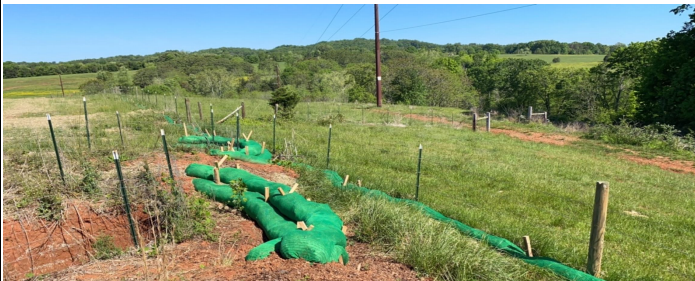
36°59'54" N 79°44'22" W 346°N COURSE 340° GPS 753 Simmons Creek Rd, Union Hall, VA 24176, United States 05.10.2022 10:16:38 Accur +/-656.2 Ft ALT 946 Ft			36°59'49" N 79°44'16" W 216°SW COURSE 271° GPS 05.10.2022 10:04:00 Accur +/-21.3 Ft ALT 917 Ft		
GPS Location	5	GPS Location	6		
Field Station#	14595+00	Field Station#	14506+00		
Pic 5 Desc.	CFS end treatment ps and perimeter CFS in good condition.		Pic 6 Desc.	Plunge pool performing intended function.

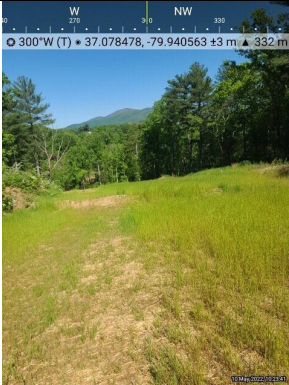
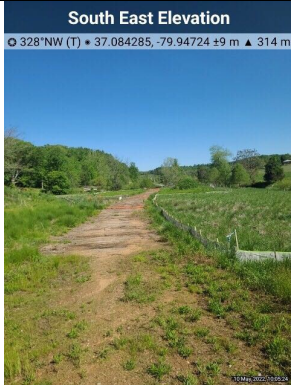
GPS Location	0000	GPS Location	0000		
Field Station#	13737+90	Field Station#	13696+89		
Pic 1 Desc.	Stabilization photo showing good temporary coverage. No environmental issues observed at the time of inspection.		Pic 2 Desc.	Monitored ECDs during row inspection today. No issues were observed at the time of inspection.

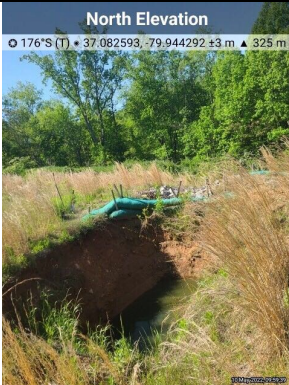
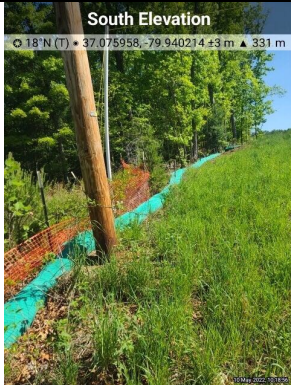
GPS Location	0000	GPS Location	0000		
Field Station#	13708+00	Field Station#	13742+40		
Pic 3 Desc.	Monitored sump pits and end treatments throughout. No environmental issues observed at the time of inspection.		Pic 4 Desc.	Observed CFS along the row perimeter during routine inspection today. No environmental issues observed at the time of inspection.

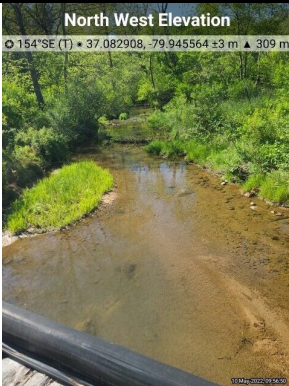
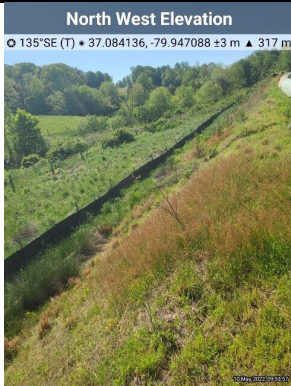
GPS Location	0000	GPS Location	0000		
Field Station#	13705+00	Field Station#	13698+10		
Pic 5 Desc.	Stream observation photo facing downstream. No environmental issues observed at the time of inspection.		Pic 6 Desc.	Observed reinforced silt fence during row inspection , all functioning at the time of inspection.

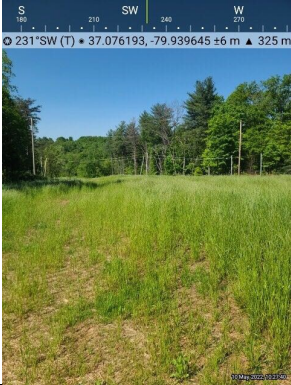
<p>GPS data: 231°SW (T) • 37.076193, -79.939645 ±6 m ▲ 325 m</p>		<p>Insert image here</p>			
GPS Location	0000	GPS Location			
Field Station#	13742+00	Field Station#			
Pic 7 Desc.	Vegetation observation photo in permanent area of row, no issues were observed at the time of inspection.		Pic 8 Desc.		
<p>Insert image here</p>		<p>Insert image here</p>			
GPS Location		GPS Location			
Field Station#		Field Station#			
Pic 9 Desc.		Pic 10 Desc.			
<p>Insert image here</p>		<p>Insert image here</p>			
GPS Location		GPS Location			
Field Station#		Field Station#			
Pic 11 Desc.		Pic 12 Desc.

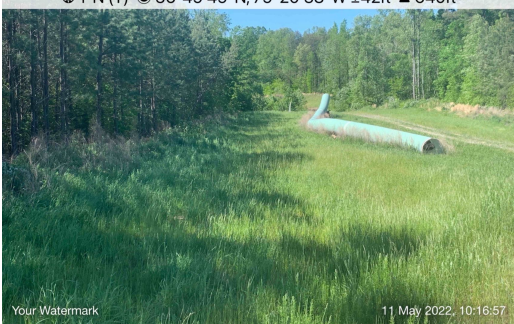
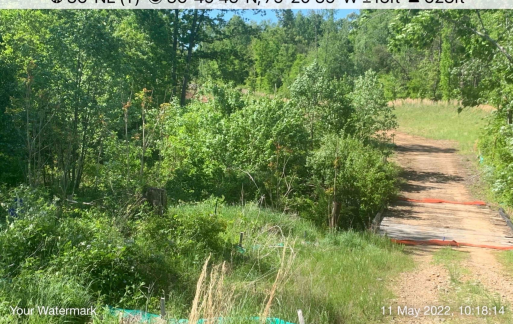
Your Watermark 11 May 2022, 10:18:14		
GPS Location	O		GPS Location	O	
Field Station#	6+00		Field Station#	12+65	
Pic 1 Desc.	Observing temporary stabilization		Pic 2 Desc.	Observing temporary stabilization, signage, buffer, equipment crossing and ECD's	
East Elevation 287°W (T) 36°49'43"N, 79°20'40"W ±13ft ▲625ft

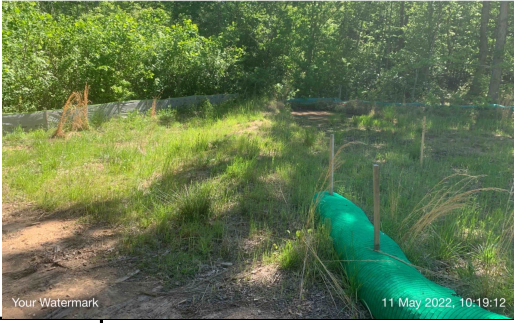
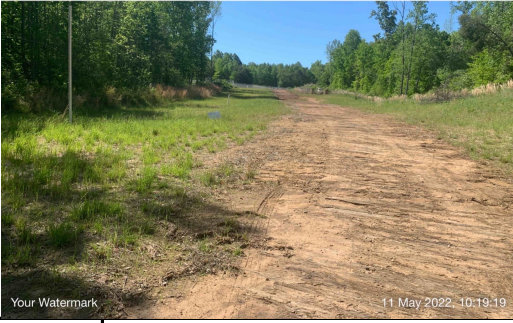
Your Watermark 11 May 2022, 10:19:19		
GPS Location	O		GPS Location	O	
Field Station#	13+50		Field Station#	15+00	
Pic 3 Desc.	Observing temporary stabilization, water bar, sump, end treatment and ECD's		Pic 4 Desc.	Observing temporary stabilization

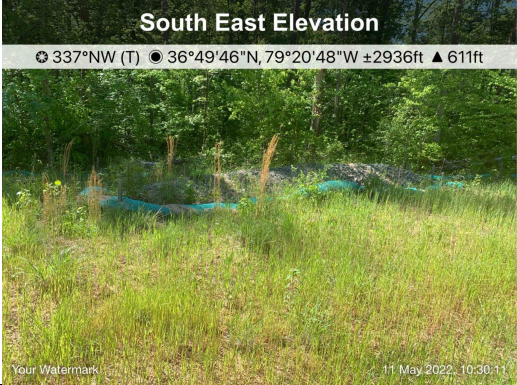
GPS Location	O	GPS Location			
Field Station#	16010+00	Field Station#			
Pic 7 Desc.	Observing temporary stabilization,CWD outlet and ECD's	Pic 8 Desc.			
Insert image here		Insert image here			
GPS Location		GPS Location			
Field Station#		Field Station#			
Pic 9 Desc.		Pic 10 Desc.			
Insert image here		Insert image here			
GPS Location		GPS Location			
Field Station#		Field Station#			
Pic 11 Desc.		Pic 12 Desc.

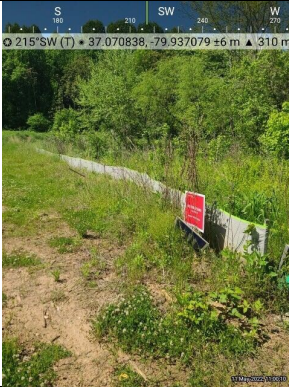
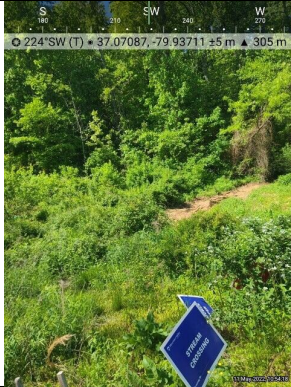
GPS Location	0000	GPS Location	0000		
Field Station#	13755+71	Field Station#	13770+69		
Pic 1 Desc.	Monitored stream buffer P1 during routine inspection today. No issues were observed at the time of inspection.		Pic 2 Desc.	Stream observation photo facing upstream, erosion control blanket in place and functioning at the time of inspection.

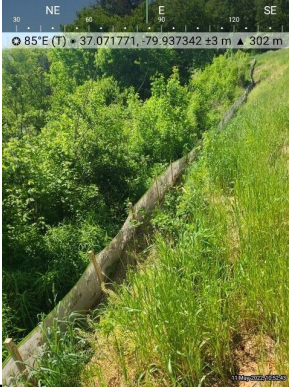
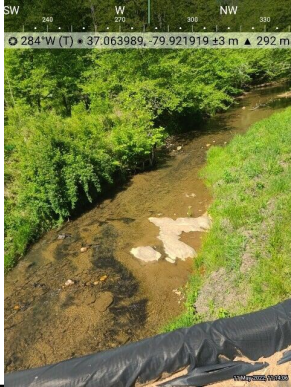
GPS Location	0000	GPS Location	00000		
Field Station#	13768+04	Field Station#	13834+04		
Pic 3 Desc.	Inspected P1 perimeter silt fence during inspection today, all in place and functioning at the time of inspection.		Pic 4 Desc.	Stream observation photo facing upstream during routine inspection today. No environmental issues observed at the time of inspection.

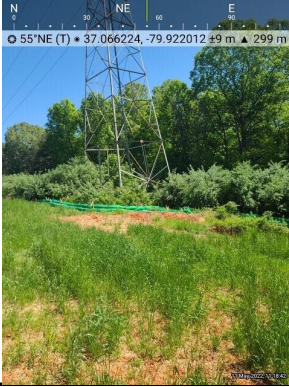
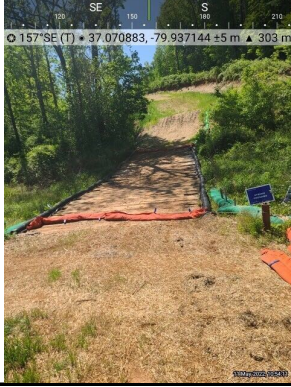
GPS Location	00000	GPS Location	00000		
Field Station#	13826+95	Field Station#	13770+60		
Pic 5 Desc.	Monitored CFS along the row perimeter during routine inspection, no issues observed at the time of inspection.		Pic 6 Desc.	Monitored equipment bridges and protection during routine row inspection today. No environmental issues observed at the time of inspection.

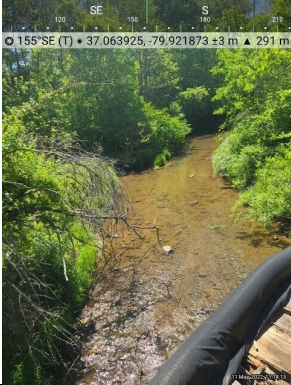
<p>Insert image here</p>		<p>Insert image here</p>	
GPS Location	0000	GPS Location			
Field Station#	13834+04	Field Station#			
Pic 7 Desc.	Stream observation photo facing downstream during routine inspection today. No environmental issues observed at the time of inspection.	Pic 8 Desc.			
<p>Insert image here</p>		<p>Insert image here</p>			
GPS Location		GPS Location			
Field Station#		Field Station#			
Pic 9 Desc.		Pic 10 Desc.			
<p>Insert image here</p>		<p>Insert image here</p>			
GPS Location		GPS Location			
Field Station#		Field Station#			
Pic 11 Desc.		Pic 12 Desc.

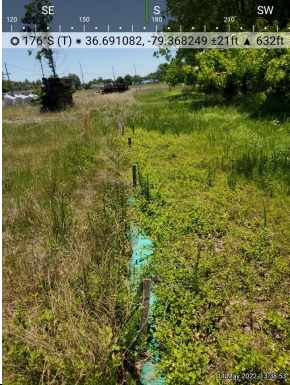
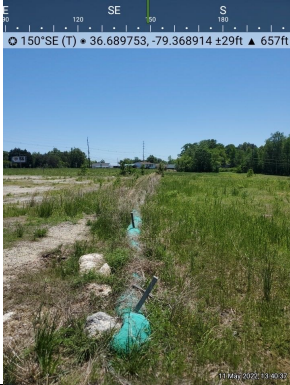
GPS Location	0	GPS Location	0		
Field Station#	0+00	Field Station#	0+00		
Pic 7 Desc.	LY-048 West perimeter CFS	Pic 8 Desc.	LY-048 West perimeter CFS		
Insert image here		Insert image here			
GPS Location		GPS Location			
Field Station#		Field Station#			
Pic 9 Desc.		Pic 10 Desc.			
Insert image here		Insert image here			
GPS Location		GPS Location			
Field Station#		Field Station#			
Pic 11 Desc.		Pic 12 Desc.

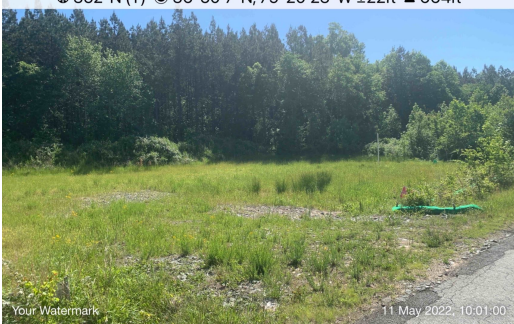
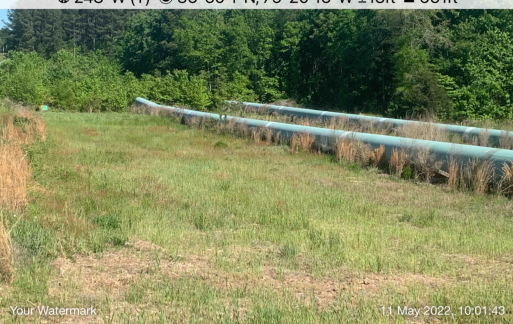
GPS Location	O	GPS Location	O		
Field Station#	14+00	Field Station#	22+00		
Pic 1 Desc.	Observing temporary stabilization,RCE, signage and buffer	Pic 2 Desc.	Observing temporary stabilization, signage and buffer		
North East Elevation 217°SW (T) 36°50'5"N, 79°20'31"W ±164ft ▲ 655ft

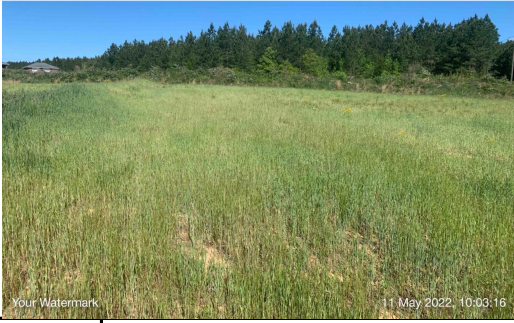
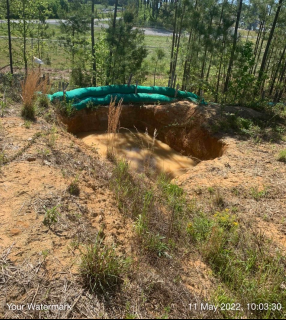
GPS Location	O	GPS Location	O		
Field Station#	13+00	Field Station#	12+00		
Pic 3 Desc.	Observing temporary stabilization	Pic 4 Desc.	Observing temporary stabilization,water bar, sump and end treatment		
Insert image here			Insert image here		
GPS Location		GPS Location			
Field Station#		Field Station#			
Pic 5 Desc.		Pic 6 Desc.

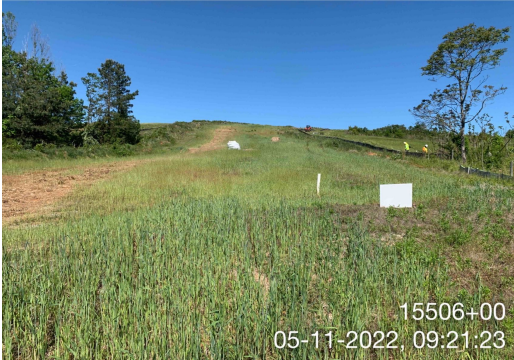
15506+00 05-11-2022, 09:21:23		⚓ 307°NW (T) ● 36°54'18"N, 79°28'16"W ±36ft ▲ 856ft

15508+50 05-11-2022, 09:23:55			
GPS Location	0	GPS Location	0		
Field Station#	15506+00	Field Station#	15508+50		
Pic 1 Desc.	Temporary vegetative stabilization in acceptable condition and solar farm workers installing ECDS adjacent to the ROW	Pic 2 Desc.	P1 silt fence and sensitive resource buffer in acceptable conditions		
⚓ 127°SE (T) ● 36°54'10"N, 79°28'6"W ±118ft ▲ 834ft

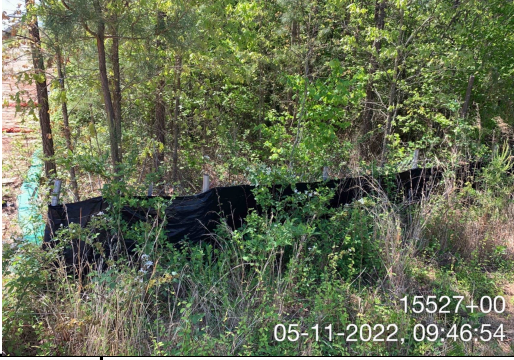
15527+00 05-11-2022, 09:46:54		⚓ 352°N (T) ● 36°53'55"N, 79°27'44"W ±541ft ▲ 775ft

15544+00 05-11-2022, 10:58:04			
GPS Location	0	GPS Location	0		
Field Station#	15527+00	Field Station#	15544+00		
Pic 3 Desc.	Super silt fence in acceptable condition	Pic 4 Desc.	Waterbar in acceptable condition		
⚓ 358°N (T) ● 36°53'57"N, 79°27'43"W ±19ft ▲ 785ft

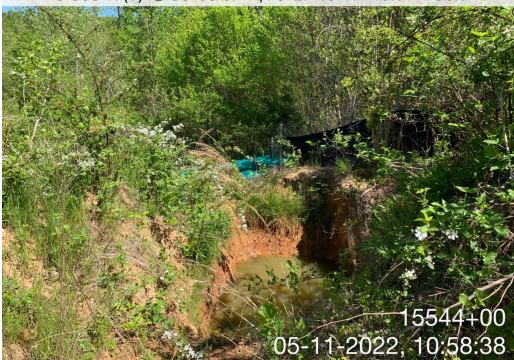
15544+00 05-11-2022, 10:58:38		⚓ 297°NW (T) ● 36°53'54"N, 79°27'39"W ±213ft ▲ 845ft

GPS Location	0	GPS Location	0		
Field Station#	15544+00	Field Station#	15548+00		
Pic 5 Desc.	Waterbar end treatment in acceptable condition	Pic 6 Desc.	Clean water diversion berm and temporary vegetative stabilization in acceptable conditions

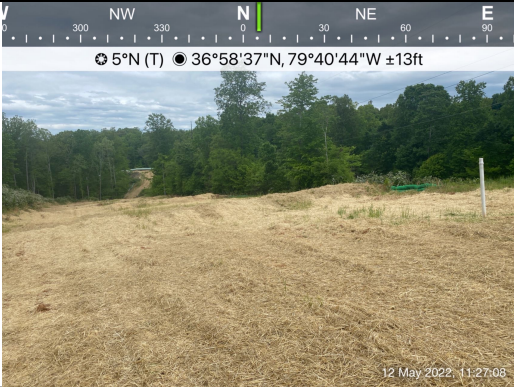
GPS Location	0	GPS Location	0		
Field Station#	14800+00	Field Station#	14766+11		
Pic 3 Desc.	Approximately 14800+00. Overview of ROW.		Pic 4 Desc.	Approximately 14766+11. Overview of stream crossing, equipment bridge and ECDs at stream S-MM44.

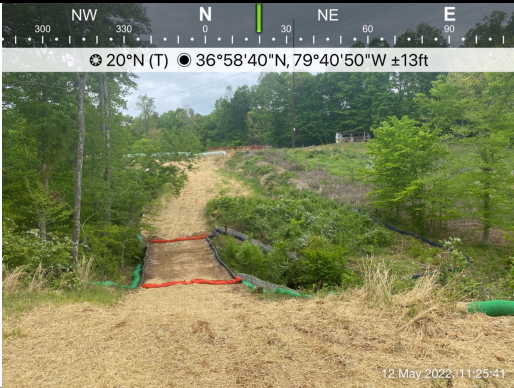
GPS Location	0	GPS Location	0		
Field Station#	14794+00	Field Station#	14697+00		
Pic 5 Desc.	Approximately 14794+00. Overview of stream crossing, equipment bridge and ECDs at stream S-H24.		Pic 6 Desc.	Approximately 14697+00. Overview of ROW.

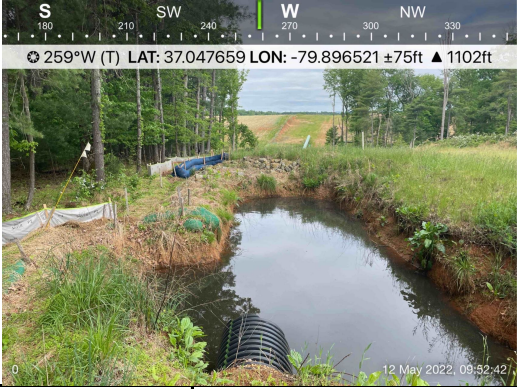
GPS Location	See photo	GPS Location			
Field Station#	13955+00	Field Station#			
Pic 13 Desc.	Slope drain is functioning as intended	Pic 14 Desc.			
Insert image here		Insert image here			
GPS Location		GPS Location			
Field Station#		Field Station#			
Pic 15 Desc.		Pic 16 Desc.			
Insert image here		Insert image here			
GPS Location		GPS Location			
Field Station#		Field Station#			
Pic 17 Desc.		Pic 18 Desc.

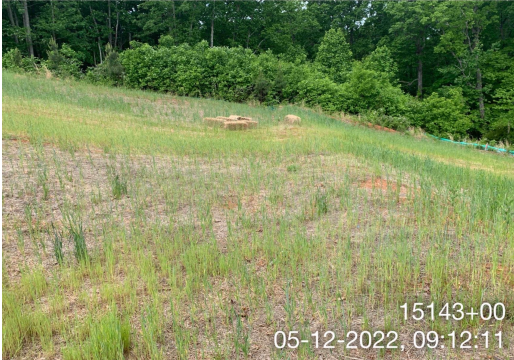
15143+00 05-12-2022, 09:12:11		280°W (T) 36°56'52"N, 79°34'42"W ±26ft ▲900ft

15143+00 05-12-2022, 09:12:48			
GPS Location	0	GPS Location	0		
Field Station#	15143+00	Field Station#	15143+00		
Pic 1 Desc.	Waterbar in acceptable condition	Pic 2 Desc.	Waterbar end treatment in acceptable condition		
99°E (T) 36°56'45"N, 79°34'32"W ±42ft ▲824ft

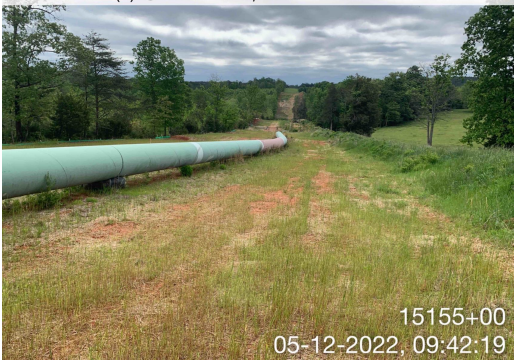
15155+00 05-12-2022, 09:42:19		263°W (T) 36°56'42"N, 79°34'23"W ±452ft ▲745ft

15162+00 05-12-2022, 09:56:55			
GPS Location	0	GPS Location	0		
Field Station#	15155+00	Field Station#	15162+00		
Pic 3 Desc.	Temporary vegetative stabilization in acceptable condition	Pic 4 Desc.	P1 silt fence and equipment bridge in acceptable conditions		
222°SW (T) 36°58'0"N, 79°35'15"W ±24645ft ▲762ft

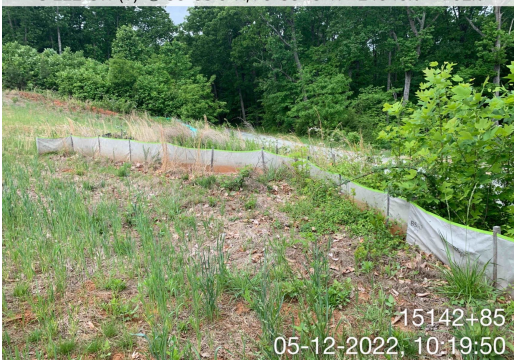
15142+85 05-12-2022, 10:19:50		88°E (T) 36°56'15"N, 79°33'15"W ±13ft ▲837ft

GPS Location	0	GPS Location	0		
Field Station#	15142+85	Field Station#	15230+26		
Pic 5 Desc.	P1 silt fence in acceptable condition	Pic 6 Desc.	CFS and Rock construction entrance in acceptable conditions

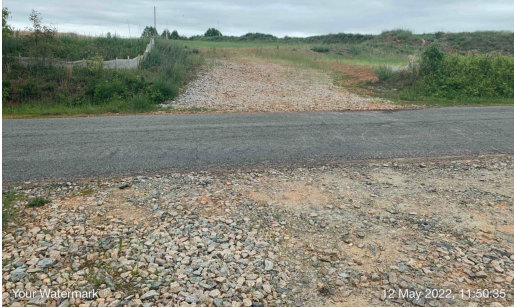
GPS Location	O	GPS Location	O		
Field Station#	15584+23	Field Station#	15595+60		
Pic 1 Desc.	Observing road crossing and RCE's	Pic 2 Desc.	Observing temporary stabilization, water bars, signage, buffer, equipment crossing and ECD's		
East Elevation 280°W (T) 36°53'40"N, 79°26'50"W ±3559ft ▲ 775ft

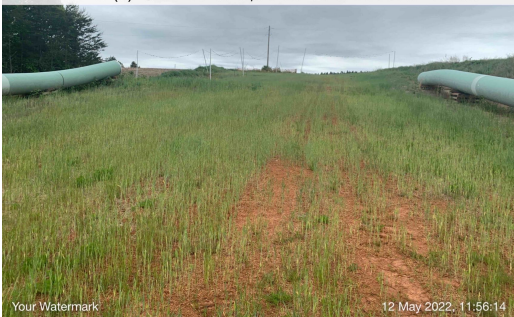
GPS Location	O	GPS Location	O		
Field Station#	15590+00	Field Station#	15616+00		
Pic 3 Desc.	Observing temporary stabilization and water bars	Pic 4 Desc.	Observing temporary stabilization, sump and end treatment		
South West Elevation 46°NE (T) 36°53'34"N, 79°25'34"W ±14235ft ▲ 827ft  		West Elevation 79°E (T) 36°53'34"N, 79°26'8"W ±29ft ▲ 808ft

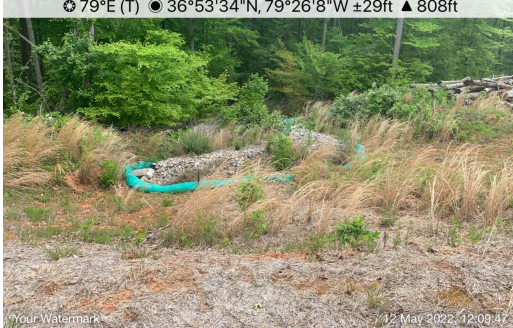
GPS Location	O	GPS Location	O		
Field Station#	15623+00	Field Station#	15630+00		
Pic 5 Desc.	Observing temporary stabilization and water bars	Pic 6 Desc.	Observing temporary stabilization, CWD outlet and ECD's

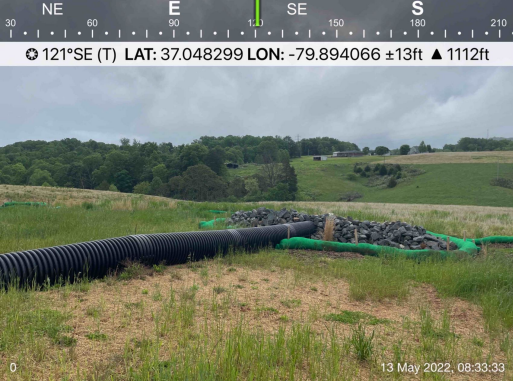
GPS Location	See photo		GPS Location	See photo	
Field Station#	13958+31		Field Station#	13960+00	
Pic 1 Desc.	RCEs are in good condition at all road crossings		Pic 2 Desc.	CWDs are functioning as intended

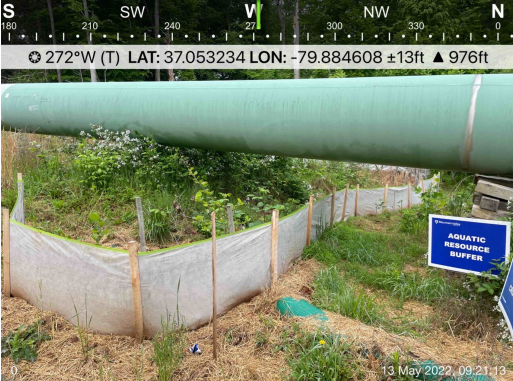
GPS Location	See photo		GPS Location	See photo	
Field Station#	13970+00		Field Station#	13998+00	
Pic 3 Desc.	Vegetation continues to fill in throughout this section		Pic 4 Desc.	P1 is in good condition at all stream and wetland buffers

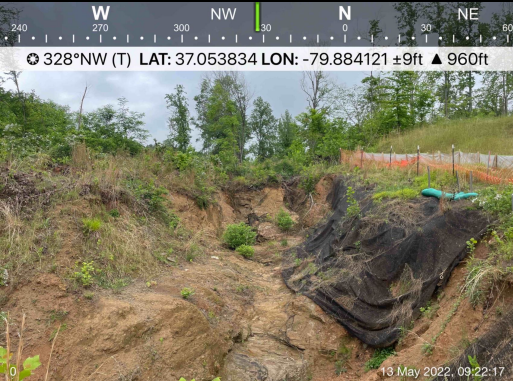
GPS Location	See photo		GPS Location	See photo	
Field Station#	13998+15		Field Station#	14000+00	
Pic 5 Desc.	Equipment bridge ECDs are in good condition and functioning		Pic 6 Desc.	No evidence of 3rd party pond discharging onto ROW

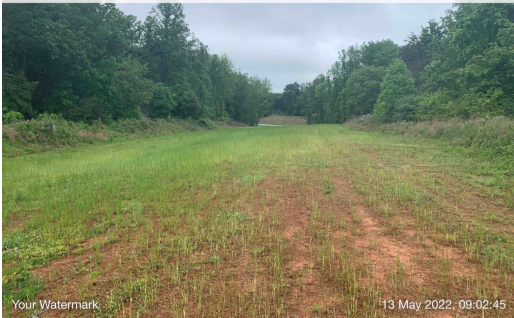
Your Watermark 13 May 2022, 09:04:58		
GPS Location	O		GPS Location	O	
Field Station#	15770+00		Field Station#	15763+80	
Pic 1 Desc.	Observing temporary stabilization		Pic 2 Desc.	Observing temporary stabilization, water bar, signage, buffer, equipment crossing and ECD's	
East Elevation 263°W (T) 36°53'19"N, 79°23'51"W ±56440ft ▲ 824ft

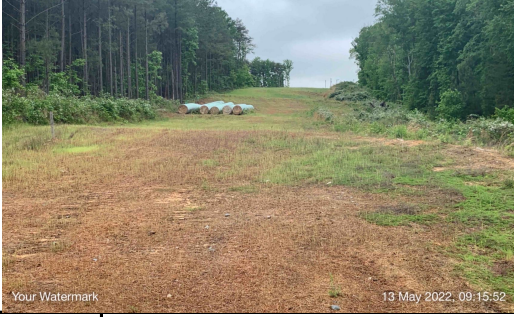
Your Watermark 13 May 2022, 09:27:09		
GPS Location	O		GPS Location	O	
Field Station#	15753+00		Field Station#	15735+00	
Pic 3 Desc.	Observing temporary stabilization and water bars		Pic 4 Desc.	Observing temporary stabilization, CWD outlet and ECD's

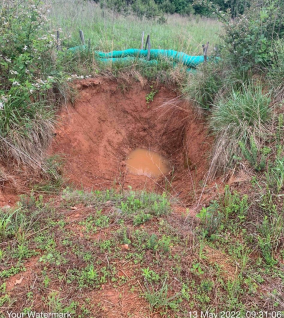
Your Watermark 13 May 2022, 09:31:15		
GPS Location	O		GPS Location	O	
Field Station#	15728+00		Field Station#	15726+00	
Pic 5 Desc.	Observing temporary stabilization, sump and end treatment		Pic 6 Desc.	Observing temporary stabilization and water bars

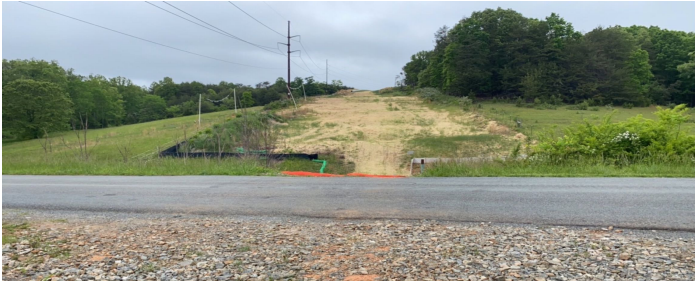
37°0'20" N 79°45'10" W 144°SE COURSE -1' GPS 05.13.2022 10:08:38 Accur +/-47.6 Ft ALT 956 Ft			37°0'19" N 79°45'9" W 42°NE COURSE 240' GPS 594 Tobacco Rd, Glade Hill, VA 24092, United States 05.13.2022 11:08:14 Accur +/-49.1 Ft ALT 948 Ft		
GPS Location	5	GPS Location	6		
Field Station#	14545+83	Field Station#	14546+75		
Pic 5 Desc.	Sensitive resource buffer and signage visible and intact. Perimeter P1 silt fence in good condition.		Pic 6 Desc.	RCE in good condition.

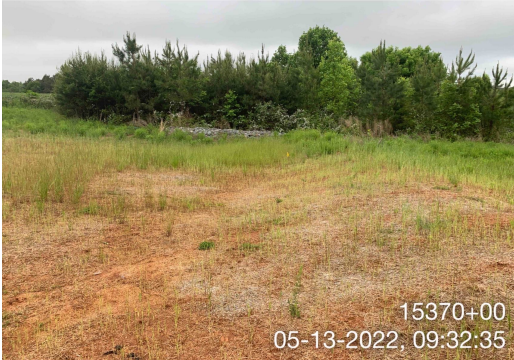
15370+00 05-13-2022, 09:32:35		☼ 281°W (T) ● 36°55'19"N, 79°30'39"W ±26ft ▲ 789ft

15370+00 05-13-2022, 09:33:12			
GPS Location	0	GPS Location	0		
Field Station#	15370+00	Field Station#	15370+00		
Pic 1 Desc.	Waterbar in acceptable condition	Pic 2 Desc.	Perimeter CFS and waterbar end treatment in acceptable conditions		
☼ 18°N (T) ● 36°55'21"N, 79°30'43"W ±45ft ▲ 766ft

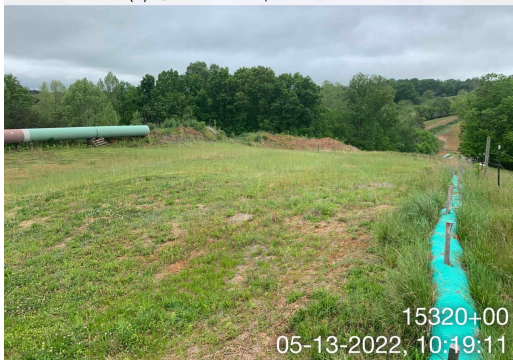
15320+00 05-13-2022, 10:49:11			
GPS Location	0	GPS Location	0		
Field Station#	15366+00	Field Station#	15320+00		
Pic 3 Desc.	Permanent vegetative stabilization in acceptable condition	Pic 4 Desc.	Perimeter CFS and temporary vegetative stabilization in acceptable conditions		
☼ 297°NW (T) ● 36°55'50"N, 79°31'53"W ±2572ft ▲ 775ft

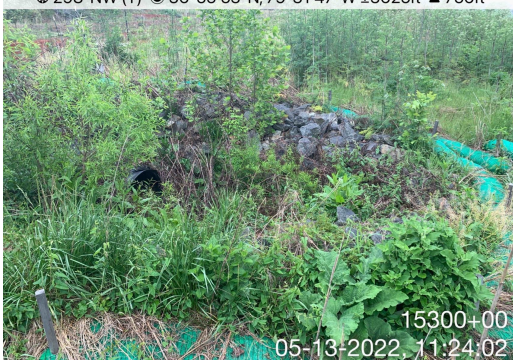
GPS Location	0	GPS Location	0		
Field Station#	15300+00	Field Station#	15300+00		
Pic 5 Desc.	P1 silt fence and temporary vegetative stabilization in acceptable conditions	Pic 6 Desc.	Clean water diversion pipe and plunge pool in acceptable conditions

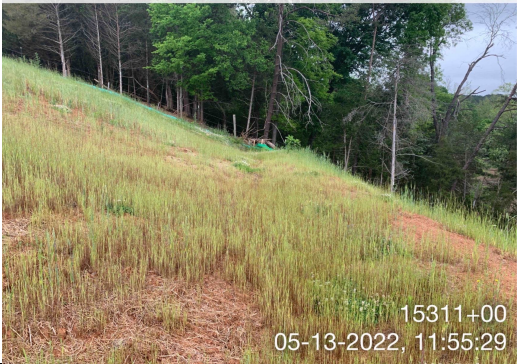
GPS Location	0	GPS Location	0		
Field Station#	15311+00	Field Station#	15311+00		
Pic 7 Desc.	Waterbar in acceptable condition		Pic 8 Desc.	Waterbar end treatment in acceptable condition	
Insert image here			Insert image here		
GPS Location		GPS Location			
Field Station#		Field Station#			
Pic 9 Desc.			Pic 10 Desc.		
Insert image here			Insert image here		
GPS Location		GPS Location			
Field Station#		Field Station#			
Pic 11 Desc.			Pic 12 Desc.

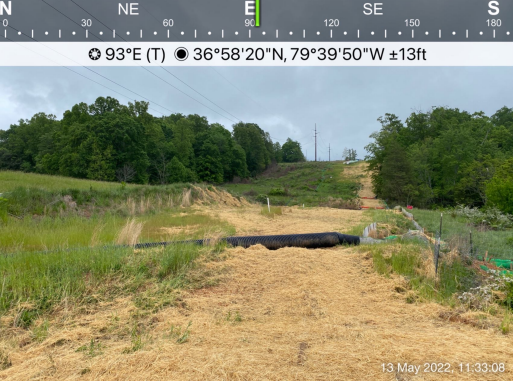
GPS Location	0	GPS Location	0		
Field Station#	14806+00	Field Station#	14851+00		
Pic 1 Desc.	Approximately 14806+00. Overview of ROW.	Pic 2 Desc.	Approximately 14851+00. Overview of ROW.

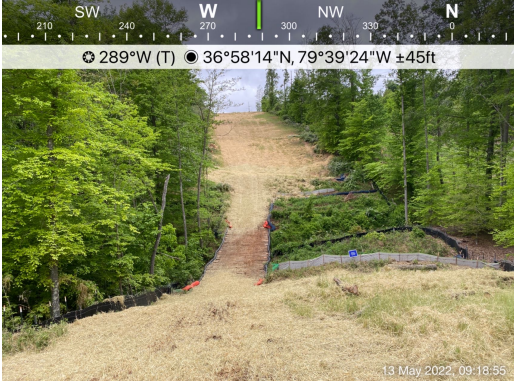
GPS Location	0	GPS Location	0		
Field Station#	14870+43	Field Station#	14907+60		
Pic 3 Desc.	Approximately 14870+43. Overview of stream crossing, equipment bridge and ECDs at stream S-SS8.	Pic 4 Desc.	Approximately 14907+60. Overview of stream crossing, equipment bridge and ECDs at stream S-DD3.

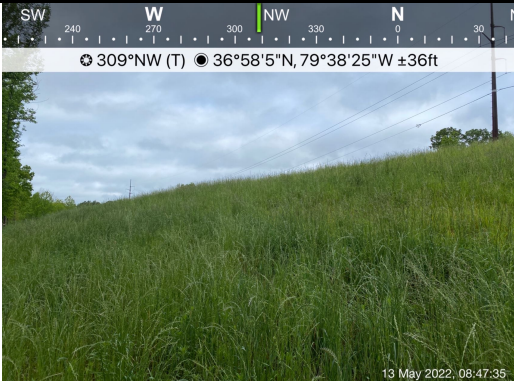
GPS Location	0	GPS Location	0		
Field Station#	14923+50	Field Station#	14907+00		
Pic 5 Desc.	Approximately 14923+50. Overview of ROW. Permanent vegetation.	Pic 6 Desc.	Approximately 14907+00. CFS requires maintenance. Weathered and torn.
