Visual Site Inspection Report

Project Name	H-600 Pipeline Spread G	AFE	124300137	Spread	H-600 Pipeline Spread G
Contractor	Precision			Report #	37689
Inspector	Eric Hanlon			Date/Time	5/16/2022 7:26 AM
Permit #	TBD	Inspection Type	VA SWPP	Station Begin	11524+16
State	VA	Inspection Area	Full	Station End	11600+01
County	Giles	Ground	Wet	Temperature (°F)	67.00
Municipality	N/A	Weather	Cloudy	Rain Gauge (in)	0.00
				Rain Accumulation Time (days)	1.00

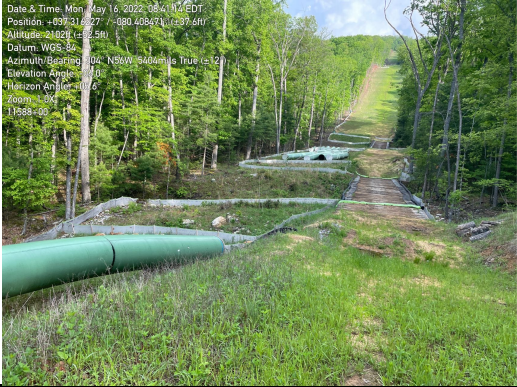
GPS Location	See photo	GPS Location	See photo		
Field Station#	11588+00	Field Station#	11596+00		
Pic 7 Desc.	Equipment bridge functional	Pic 8 Desc.	Perimeter controls in place		
<small>Date & Time: Mon, May 16, 2022 08:36:56 EDT Position: +037.31456° / -080.40632° (r:15.0m) Altitude: 1920ft (r:13.0m) Datum: WGS-84 Azimuth/Bearing: 076° R76E 1351mils True (r:13) Elevation Angle: -04.7 Horizon Angle: -01.6 Zoom: 1.0X 11597+00</small>

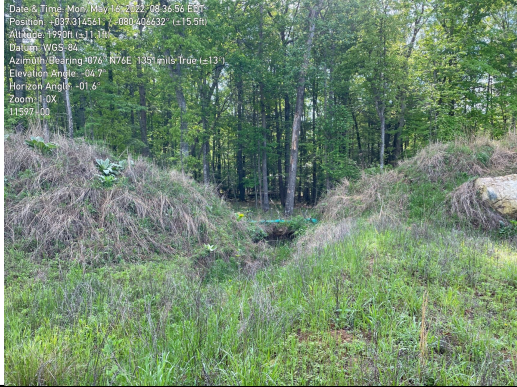
GPS Location	See photo	GPS Location	See photo		
Field Station#	11597+00	Field Station#	11600+01		
Pic 9 Desc.	ET in place	Pic 10 Desc.	RCE functional		
Insert image here		Insert image here			
GPS Location		GPS Location			
Field Station#		Field Station#			
Pic 11 Desc.		Pic 12 Desc.

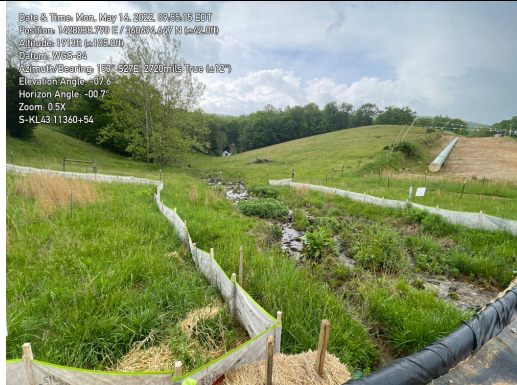
Insert image here	
GPS Location	11	GPS Location			
Field Station#	11360+54	Field Station#			
Pic 11 Desc.	S-KL43.		Pic 12 Desc.

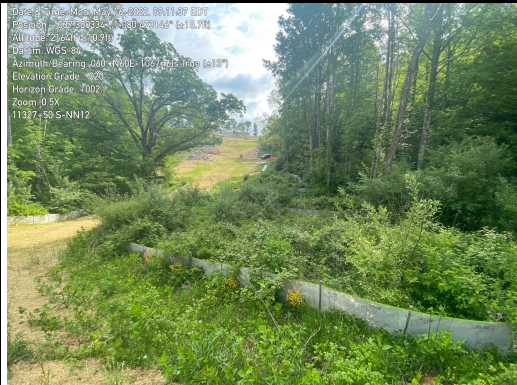
Field Station#	11327+50	Field Station#			
Pic 11 Desc.	View of heavily vegetated buffer zone to the S-NN12 stream	Pic 12 Desc.

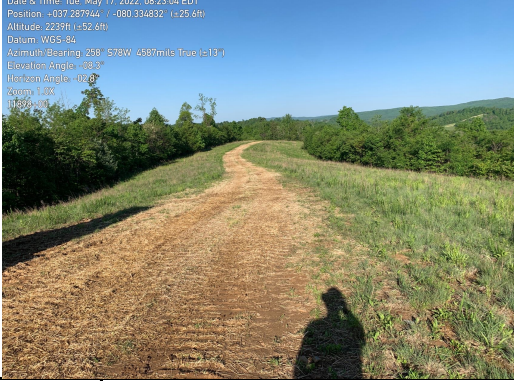
GPS Location	See photo for GPS location.		GPS Location	See photo for GPS location.	
Field Station#	11898+00		Field Station#	11883+00	
Pic 1 Desc.	ROW permanently restored.		Pic 2 Desc.	Permanent waterbar and level spreader in place.	
<p>Date & Time: Tue May 17, 2022 08:35:15 EDT Position: -037.28685° / -080.34392° (+15.2ft) Altitude: 2128ft (+11.5ft) Datum: WGS-84 Azimuth/Bearing: 210.530W 3733mils True (+13.1) Elevation Angle: -04.2° Horizon Angle: -01.0° Zoom: 1.0X 11872+00</p>

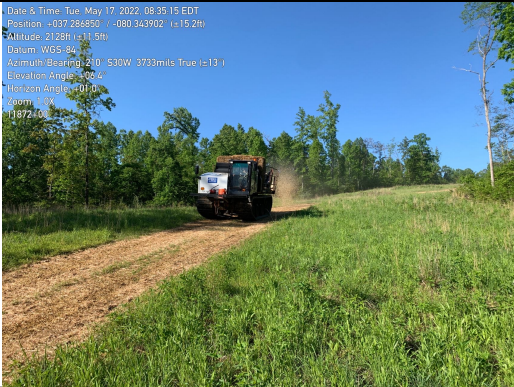
GPS Location	See photo for GPS location.		GPS Location	See photo for GPS location.	
Field Station#	11872+00		Field Station#	11864+00	
Pic 3 Desc.	Travel lane being stabilized with seed and mulch.		Pic 4 Desc.	Priority one silt fence in place around P-KL2.	
<p>Date & Time: Tue May 17, 2022 08:57:47 EDT Position: -037.33019° / -080.32269° (+775.6ft) Altitude: 2243ft (+106.8ft) Datum: WGS-84 Azimuth/Bearing: 024° N24E 0662mils True (+13.1) Elevation Angle: -14.7° Horizon Angle: -03.3° Zoom: 1.0X 11830+00</p>

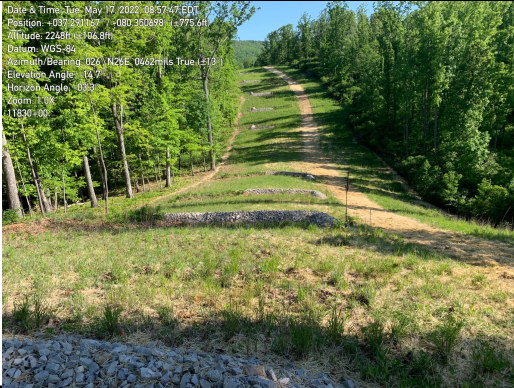
Pic 5 Desc.	Waterbars and level spreaders in place.		Pic 6 Desc.	RCE in place at Mount Tabor Road.

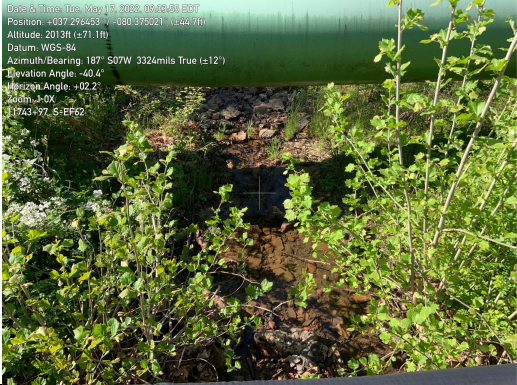
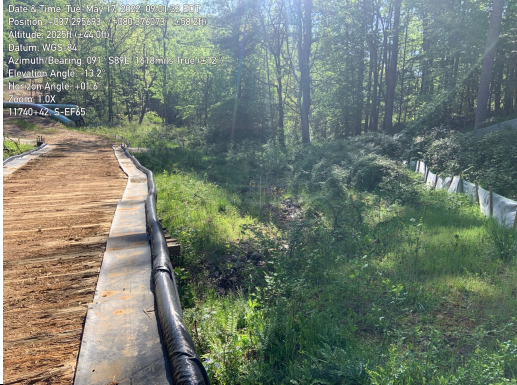
GPS Location	See photo	GPS Location	See photo		
Field Station#	11743+97	Field Station#	11740+42		
Pic 7 Desc.	S-EF62	Pic 8 Desc.	S-EF65

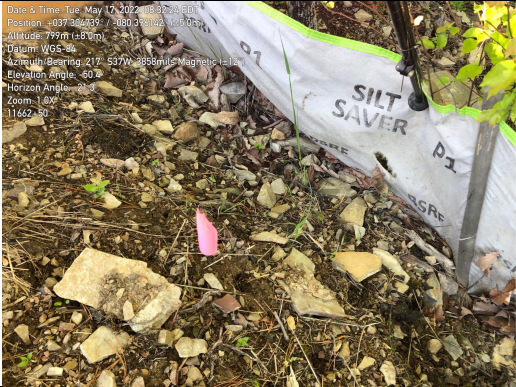
<p>Date & Time: Tue, May 17, 2022 08:17:12 EDT Position: +037.393703, -080.374684 (+30.0m) Altitude: 808m (+32.0m) Datum: WGS-84 Azimuth/Bearing: 308.120W, 540mils Magnetic (+15.1) Elevation Angle: -0.0 Horizon Angle: -0.0 Zoom: 1.0x 11669+00</p>			
GPS Location	On photo	GPS Location	On photo		
Field Station#	11662+50	Field Station#	11669+00		
Pic 1 Desc.	Communication; repair P1 silt fence.	Pic 2 Desc.	ROW stable.

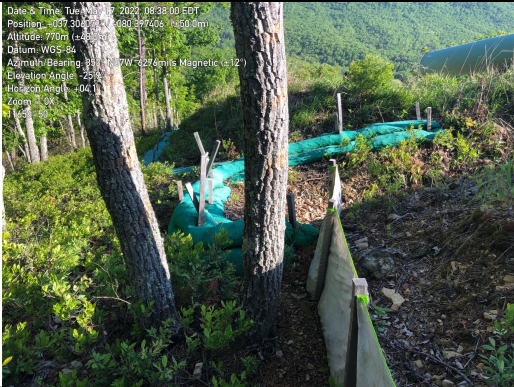
GPS Location	On photo	GPS Location	On photo		
Field Station#	11663+00	Field Station#	11656+50		
Pic 3 Desc.	ECDs in place at edge of LOD.	Pic 4 Desc.	ECDs in place and functional.

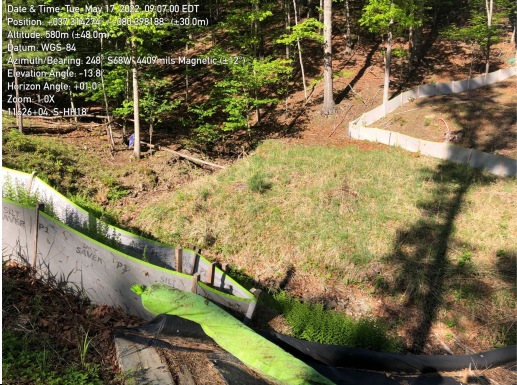
GPS Location	On photo	GPS Location	On photo		
Field Station#	11629+00	Field Station#	11626+04		
Pic 7 Desc.	Perimeter ECDs are in place.	Pic 8 Desc.	The S-HH18 crossing is stable.

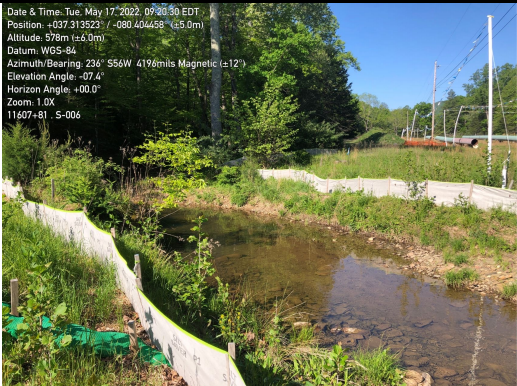
GPS Location	On photo	GPS Location	On photo		
Field Station#	11614+20	Field Station#	11607+81		
Pic 9 Desc.	The S-RR14 crossing is currently stable.	Pic 10 Desc.	The S-006 crossing is stable.		
Insert image here		Insert image here			
GPS Location		GPS Location			
Field Station#		Field Station#			
Pic 11 Desc.		Pic 12 Desc.

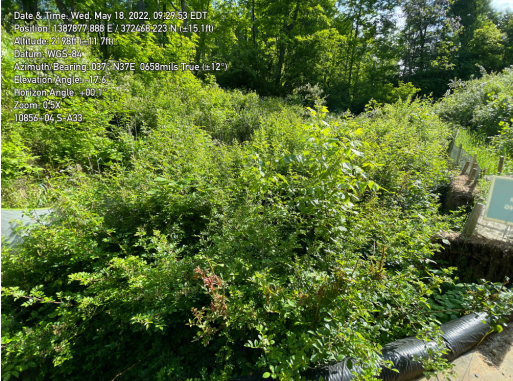
<p>Date & Time: Wed, May 18, 2022, 09:27:40 EDT Position: 1388141.097 E / 372351.845 N (+26.9M) Altitude: 2335ft (+26.9M) Datum: WGS-84 Azimuth/Bearing: 324° S65W 040mils True (+15°) Elevation Angle: +031° Horizon Angle: +022° Zoom: 0.5X 10859+25</p>

<p>Date & Time: Wed, May 18, 2022, 09:29:53 EDT Position: 1387877.888 E / 372468.223 N (+15.1M) Altitude: 2136ft (+11.7M) Datum: WGS-84 Azimuth/Bearing: 027° N37E 045mils True (+12°) Elevation Angle: +12.6° Horizon Angle: +00° Zoom: 0.5X 10856+04</p>			
GPS Location		1		GPS Location	
Field Station#		10859+25		2	
Field Station#		10856+04		Pic 1 Desc.	
Pic 1 Desc.		Section of RoW showing conditions and controls.		Pic 2 Desc.	
				S-A33.

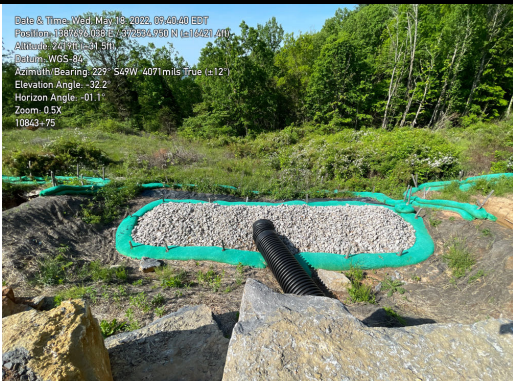
<p>Date & Time: Wed, May 18, 2022, 09:40:49 EDT Position: 1387777.231 E / 372353.951 N (+15.1M) Altitude: 2131ft (+11.7M) Datum: WGS-84 Azimuth/Bearing: 229° S49W 407mils True (+12°) Elevation Angle: +32.2° Horizon Angle: +01.1° Zoom: 0.5X 10843+75</p>

GPS Location		3		GPS Location	
Field Station#		10854+70		4	
Field Station#		10843+75		Pic 3 Desc.	
Pic 3 Desc.		S-A34.		Pic 4 Desc.	
				CWDP outlet protection functional.

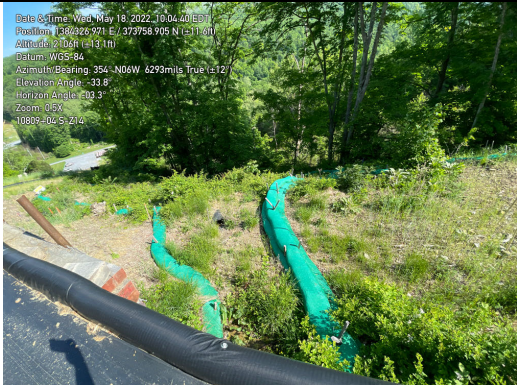
GPS Location	7	GPS Location	8		
Field Station#	10818+50	Field Station#	10809+04		
Pic 7 Desc.	Section of RoW showing conditions and controls.		Pic 8 Desc.	S-Z14.

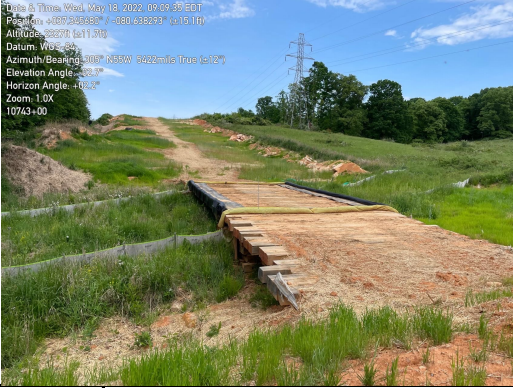
<p>Date & Time: Wed, May 18, 2022, 09:43:45 EDT Position: +037.348587° / -080.649437° (+13.11ft) Altitude: 2327ft (+11.70ft) Datum: WGS-84 Azimuth/Bearing: 100° N44W 3620mils True (+13°) Elevation Angle: -13.2° Horizon Angle: +05.4° Zoom: 1.0X 10743+00</p>		GPS Location	See Photo
GPS Location		GPS Location		Field Station#	See Photo
Field Station#		Field Station#		Pic 1 Desc.	RCE
Pic 1 Desc.		Pic 2 Desc.		Field Station#	10743+00
Field Station#		Field Station#		Pic 2 Desc.	Equipment Bridge

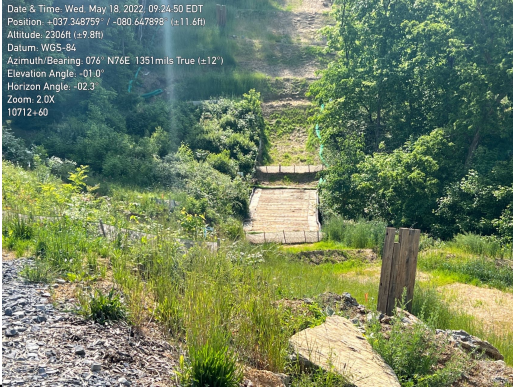
GPS Location		GPS Location		Field Station#	See Photo
Field Station#		Field Station#		Pic 3 Desc.	Section of ROW showing conditions and controls
Pic 3 Desc.		Pic 4 Desc.		Field Station#	10712+60
Field Station#		Field Station#		Pic 4 Desc.	Stream Overview

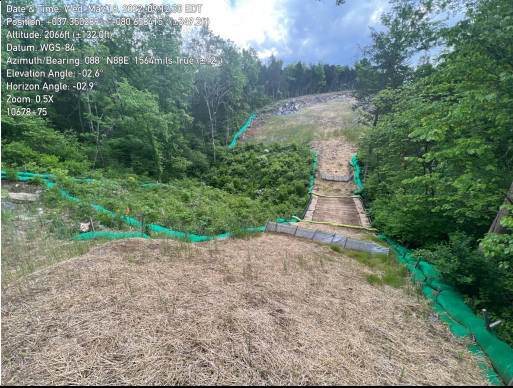
<p>Date & Time: Wed, May 18, 2022, 09:16:39 EDT Position: +037.348334° / -080.658613° (+13.11ft) Altitude: 2066ft (+12.3ft) Datum: WGS-84 Azimuth/Bearing: 088° N88E 1500mils True (+13°) Elevation Angle: -02.6° Horizon Angle: -02.9° Zoom: 0.5X 10678+75</p>		GPS Location	See Photo
GPS Location		GPS Location		Field Station#	See photo
Field Station#		Field Station#		Pic 5 Desc.	Stone Outlet

Pic 5 Desc.		Pic 6 Desc.		Field Station#	10678+75
Field Station#		Field Station#		Pic 6 Desc.	Section of ROW showing conditions and controls

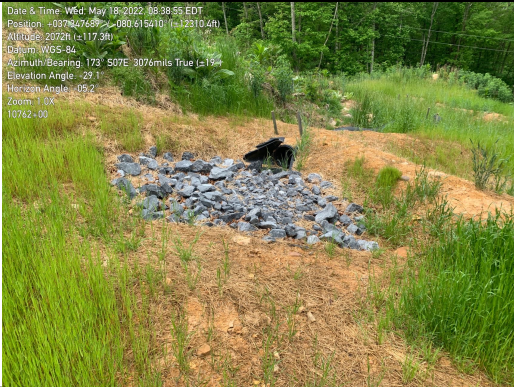
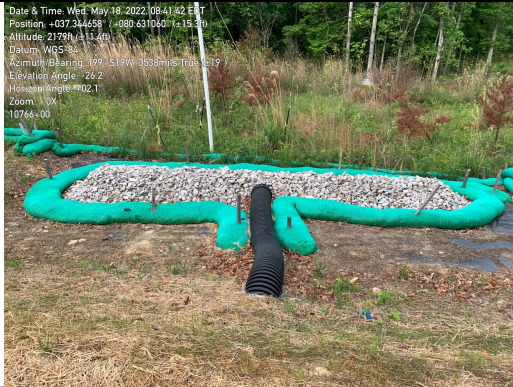
GPS Location	See photo for GPS location.		GPS Location	See photo for GPS location.	
Field Station#	10762+00		Field Station#	10766+00	
Pic 3 Desc.	Rock inlet in place at slope drain.		Pic 4 Desc.	Clean water diversion pipe and level spreader in place.

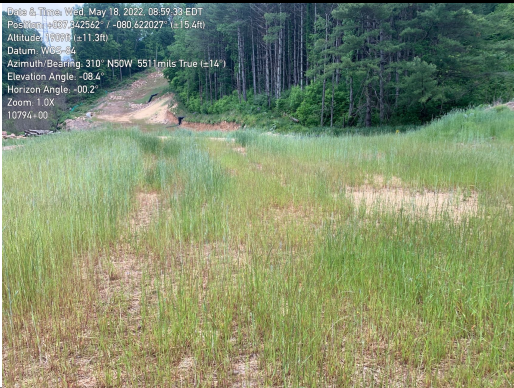
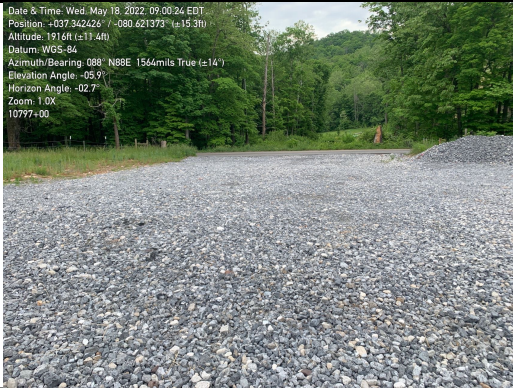
GPS Location	See photo for GPS location.		GPS Location	See photo for GPS location.	
Field Station#	10794+00		Field Station#	10797+00	
Pic 5 Desc.	ROW temporarily stabilized.		Pic 6 Desc.	RCE in place at Cascade Road.

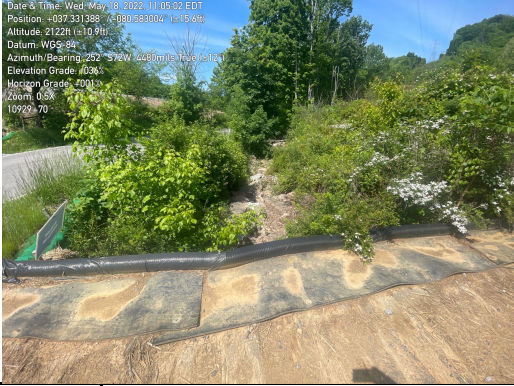
<p>Date & Time: Wed May 18 2022 10:42:31 EDT Position: -697.331382, -680.593007, 10927.77 Altitude: 2100ft (±11.1ft) Datum: WGS-84 Azimuth/Bearing: 338° N22W 4009mils True (±1°) Elevation Grade: -019° Horizon Grade: -003° Zoom: 0.5X 10927+77</p>			
GPS Location	See Photo	GPS Location	See Photo		
Field Station#	10929+70	Field Station#	10927+77		
Pic 1 Desc.	S-Y2 stream bed condition. No Issues at this time.	Pic 2 Desc.	S-Y3 equipment bridge condition.

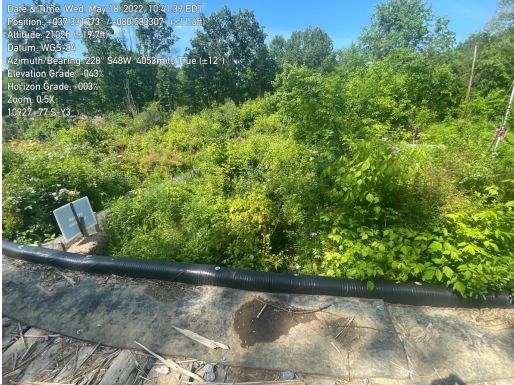
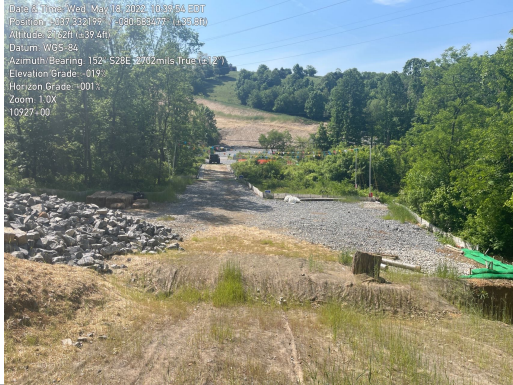
GPS Location	See Photo	GPS Location	See Photo		
Field Station#	10927+77	Field Station#	10927+00		
Pic 3 Desc.	S-Y3 vegetated stream bed.	Pic 4 Desc.	Over view of the RCE adjacent to the S-Y3 team resource area.

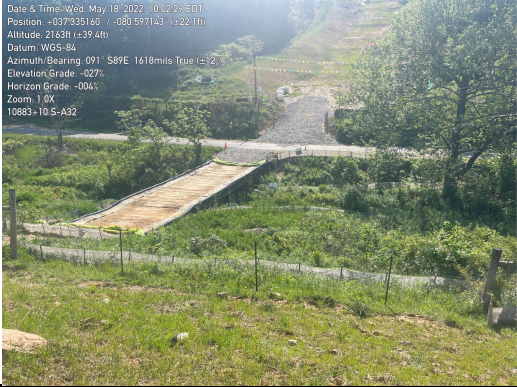
GPS Location		See Photo		GPS Location	
Field Station#		10883+10		Field Station#	
Pic 7 Desc.		S-A32 stream resource area. Vegetated buffer zones and functional equipment bridge crossing.		Pic 8 Desc.	
<p>Date & Time: Wed May 18 2022 09:58:41 EDT Position: +037°33'52.11" / -080°59'77.78" (+15.24ft) Altitude: 2324ft (+22.24ft) Datum: WGS-84 Azimuth/Bearing: 108° S08W 332mils True (+12.1°) Elevation Grade: +013% Horizon Grade: +002% Zoom: 0.5X 10880+00</p>

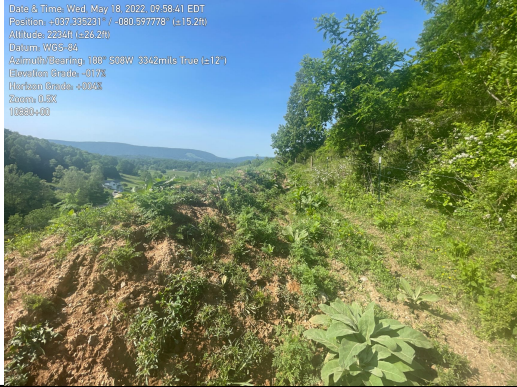
GPS Location		See Photo		GPS Location	
Field Station#		10880+00		Field Station#	
Pic 9 Desc.		Temporary vegetation of top soil pile at the ATWS		Pic 10 Desc.	
<p>Date & Time: Wed May 18 2022 10:54:09 EDT Position: +037°33'52.61" / -080°59'07.75" (+19.01ft) Altitude: 2443ft (+11.4ft) Datum: WGS-84 Azimuth/Bearing: 069° N67E 1191mils True (+12.1°) Elevation Grade: +058% Horizon Grade: +002% Zoom: 0.5X 10871+00</p>

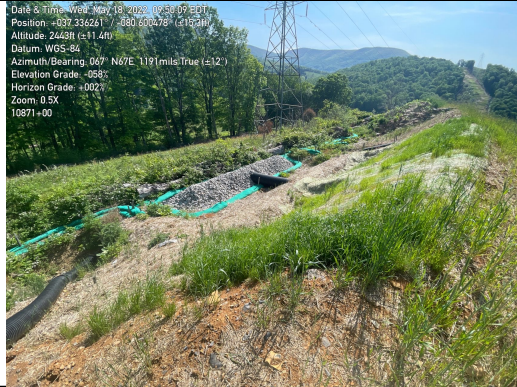
GPS Location		See Photo		GPS Location	
Field Station#		10871+00		Field Station#	
Pic 11 Desc.		View of TLS, slope drain pipe, and adjacent sump pit conditions. No Issues at this time.		Pic 12 Desc.	
				Temporary stabilization of row

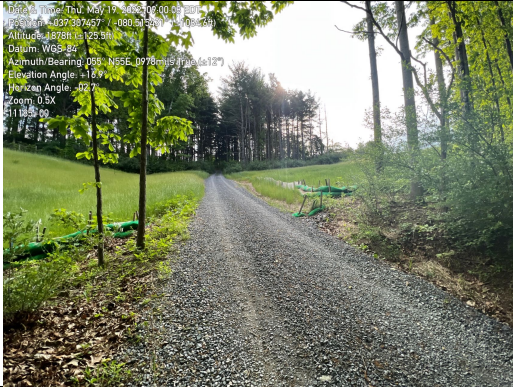
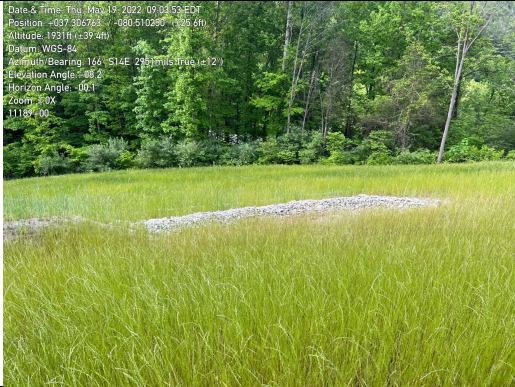
<p>Date & Time: Thu May 19 2022 09:03:50 EDT Position: +337.304227 / -080.510250 / 1931.610 Altitude: 1931ft (+39.4ft) Datum: WGS-84 Azimuth/Bearing: 166° S14E 235mils True (+12°) Elevation Angle: +26.2° Horizon Angle: -00.1° Zoom: 0.7X 11189+00</p>		
GPS Location	See Photo		GPS Location	See Photo	
Field Station#	11185+00		Field Station#	11189+00	
Pic 1 Desc.	Access Road		Pic 2 Desc.	Level Spreader

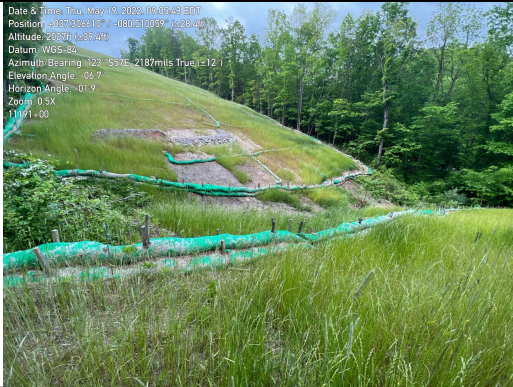
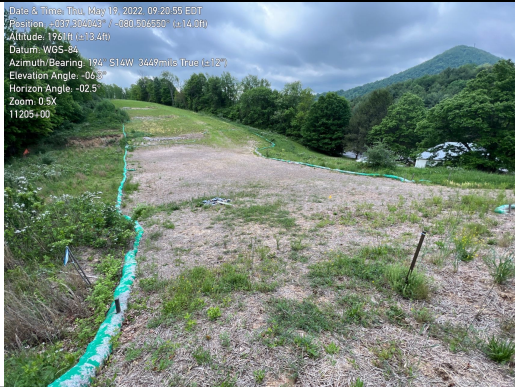
GPS Location	See Photo		GPS Location	See Photo	
Field Station#	11191+00		Field Station#	11205+00	
Pic 3 Desc.	Drainage Feature		Pic 4 Desc.	Monitoring growth was over-seeded approx 5 weeks ago

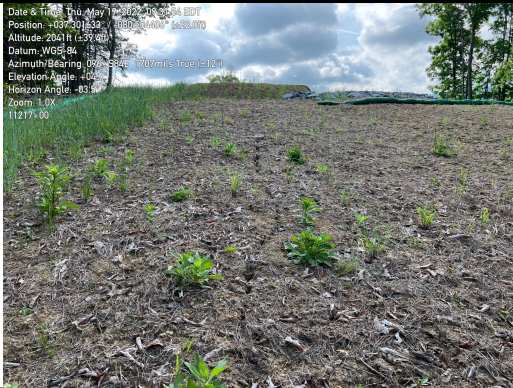
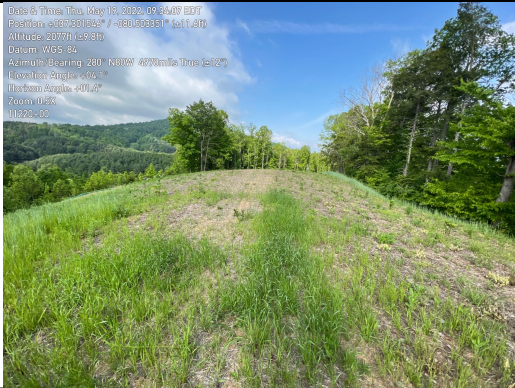
<p>Date & Time: Thu May 19 2022 09:44:09 EDT Position: +337.304227 / -080.506550 / 1914.51ft Altitude: 1914ft (+33.4ft) Datum: WGS-84 Azimuth/Bearing: 280° N04W 690mils True (+12°) Elevation Angle: +00.0° Horizon Angle: +01.4° Zoom: 0.5X 11220+00</p>		
GPS Location	See Photo		GPS Location	See Photo	
Field Station#	1217+00		Field Station#	11220+00	
Pic 5 Desc.	Ditch Subsidence being monitored		Pic 6 Desc.	Section of ROW showing conditions

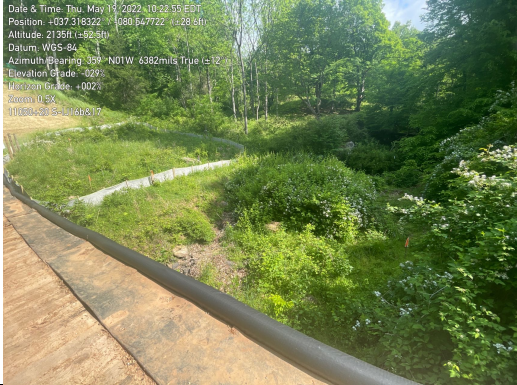
GPS Location	See Photo	GPS Location	See Photo		
Field Station#	11052+00	Field Station#	11050+20		
Pic 7 Desc.	Perimeter P1 silt fencing	Pic 8 Desc.	S-IJ16b&17 Heavily vegetated banks and buffer zones.		
<p><small>Date & Time: Thu, May 19, 2022, 10:50:49 EDT Position: +037.318427 / -080.545556 (+14.0ft) Altitude: 2224ft (+68.0m) Datum: WGS-84 Azimuth/Bearing: 099° S88E 1704mils True (+12°) Elevation Grade: -01% Horizon Grade: -00% Zoom: 0.5X 11049+96</small></p>

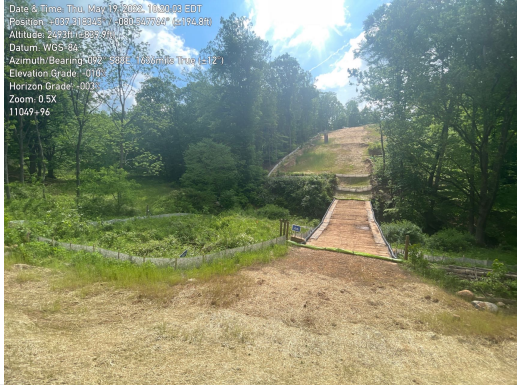
GPS Location	See Photo	GPS Location	See Photo		
Field Station#	11049+96	Field Station#	11046+15		
Pic 9 Desc.	Over view of the S-IJ16b&17 vegetated buffer zones.	Pic 10 Desc.	Steep slope stabilization with curled and CC4 wrapped water bars. New temporary vegetation visible. No Issues at this time.		
<p><small>Date & Time: Thu, May 19, 2022, 10:10:01 EDT Position: +037.319909 / -080.550575 (+11.5ft) Altitude: 2260ft (+69.7ft) Datum: WGS-84 Azimuth/Bearing: 263° S63W 4320mils True (+1°) Elevation Grade: -23% Horizon Grade: -00% Zoom: 0.5X 11038+00</small></p>

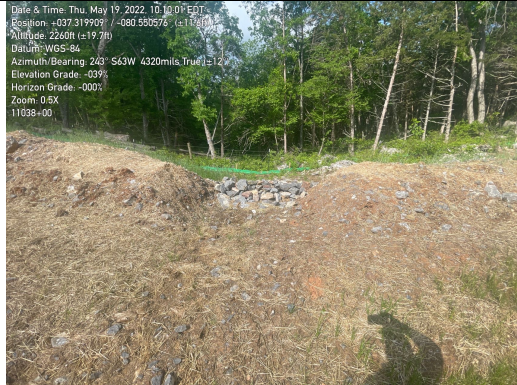
Pic 11 Desc.	Rock filter outlet prior to perimeter CFS perimeter controls.	Pic 12 Desc.	Temporary stabilization of row and functional water bars.

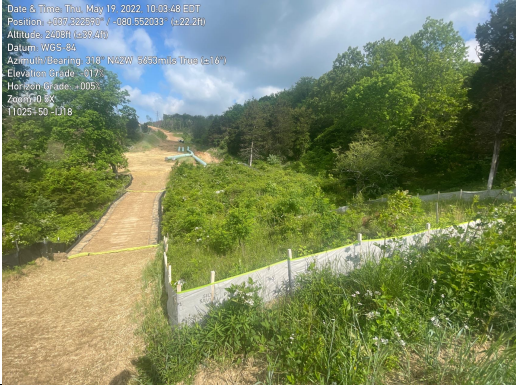
GPS Location	See Photo	GPS Location	See Photo		
Field Station#	11025+50	Field Station#	11025+50		
Pic 13 Desc.	S-IJ18 Heavily vegetated buffer zones	Pic 14 Desc.	S-IJ18 heavily vegetated stream channel.		
Insert image here		Insert image here			
GPS Location		GPS Location			
Field Station#		Field Station#			
Pic 15 Desc.		Pic 16 Desc.			
Insert image here		Insert image here			
GPS Location		GPS Location			
Field Station#		Field Station#			
Pic 17 Desc.		Pic 18 Desc.

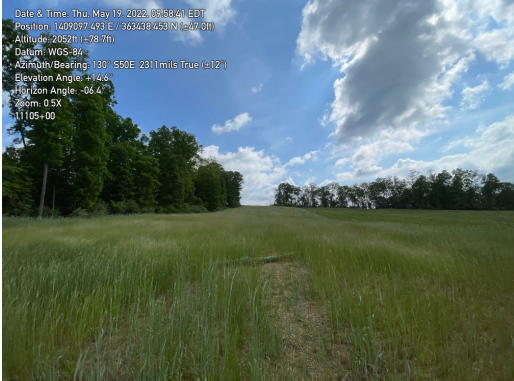
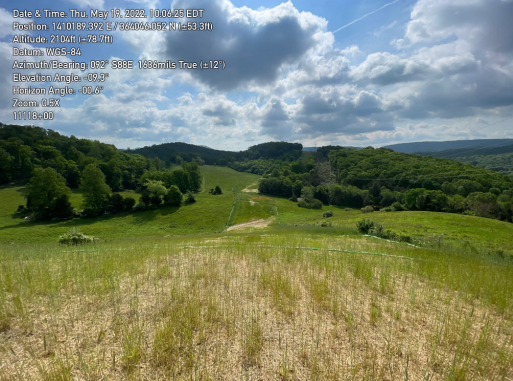
<p>Date & Time: Thu May 19, 2022, 10:00:25 EDT Position: 1410189.392 E / 366004.059 N (+53.31) Altitude: 2104ft (+787m) Datum: WGS-84 Azimuth/Bearing: 089° S88E 1288mils True (+12°) Elevation Angle: -09.3° Horizon Angle: -09.4° Zoom: 0.5X 11118+00</p>			
GPS Location	1	GPS Location	2		
Field Station#	11105+00	Field Station#	11118+00		
Pic 1 Desc.	Section of restored RoW showing conditions and controls.		Pic 2 Desc.	Section of restored RoW showing conditions and controls.

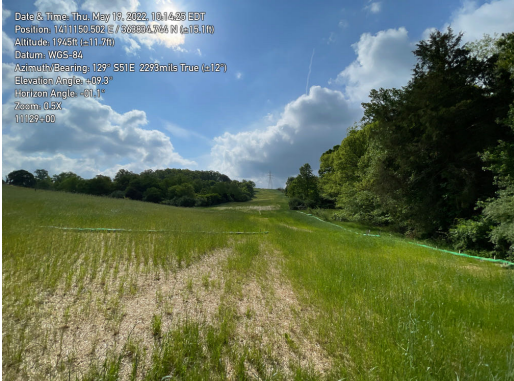
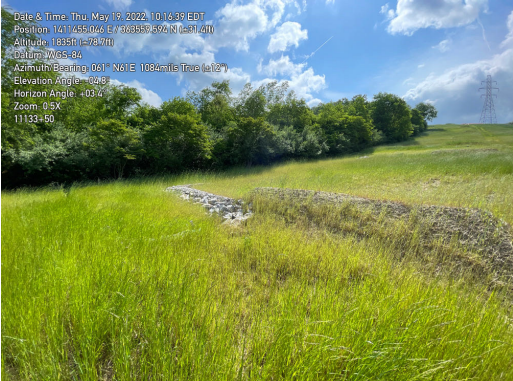
GPS Location	3	GPS Location	4		
Field Station#	11129+00	Field Station#	11133+50		
Pic 3 Desc.	Section of restored RoW showing conditions and controls.		Pic 4 Desc.	Representative photo of permanent waterbar and level spreaders installed.

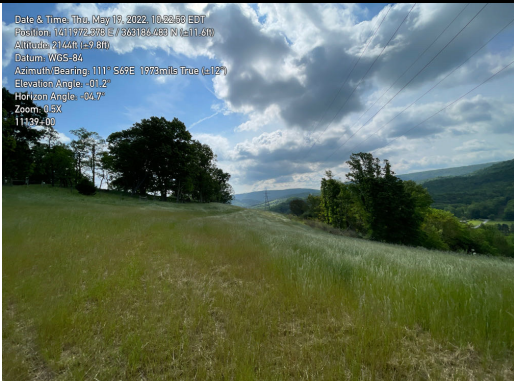
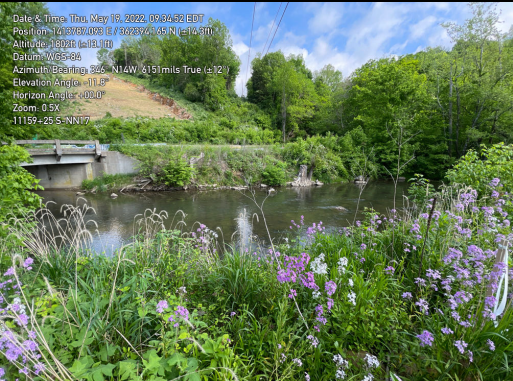
<p>Date & Time: Thu May 19, 2022, 09:54:58 EDT Position: 1413367.098 E / 362374.45 N (+16.51) Altitude: 1938ft (+591m) Datum: WGS-84 Azimuth/Bearing: 326° N14W 6151mils True (+12°) Elevation Angle: -11.6° Horizon Angle: -020.0° Zoom: 0.5X 11159+25 S-NN17</p>			
GPS Location	5	GPS Location	6		
Field Station#	11139+00	Field Station#	11159+25		
Pic 5 Desc.	Section of restored RoW showing conditions and controls.		Pic 6 Desc.	S-NN17.

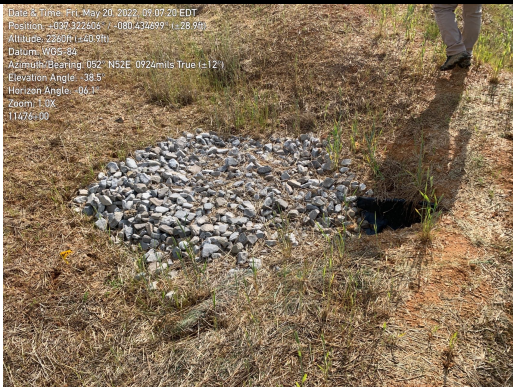
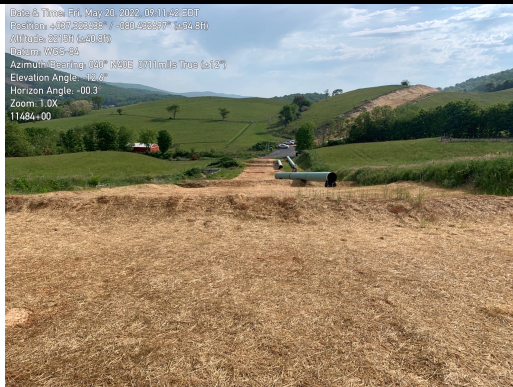
<p>Date & Time: Fri, May 20, 2022 09:02:20 EDT Position: +037.322626 / -080.420899 / 1726.95ft Altitude: 2280ft (+20.9m) Datum: WGS 84 Azimuth/Bearing: 052° N52E 092mils True (+12°) Elevation Angle: -38.5° Horizon Angle: -06.1° Zoom: 1.0X 11476+00</p>				<p>Date & Time: Fri, May 20, 2022 09:11:05 EDT Position: +037.233436 / -080.526477 / 1974.31ft Altitude: 2210ft (+68.6m) Datum: WGS 84 Azimuth/Bearing: 087° N86E 150mils True (+13°) Elevation Angle: -12.0° Horizon Angle: -00.3° Zoom: 1.0X 11484+00</p>											
GPS Location				See photo for GPS location.				GPS Location				See photo for GPS location.			
Field Station#				11476+00				Field Station#				11484+00			
Pic 3 Desc.				Rock inlet in place at slope drain.				Pic 4 Desc.				Waterbars in place. ROW temporarily stabilized with seed and mulch.

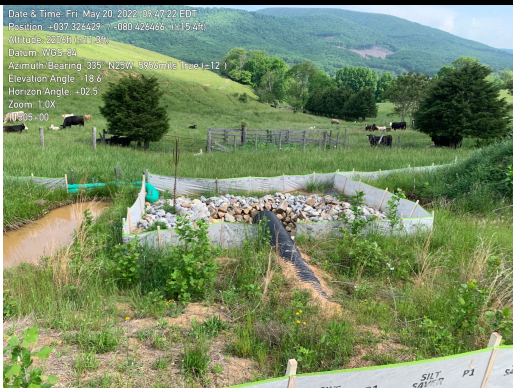
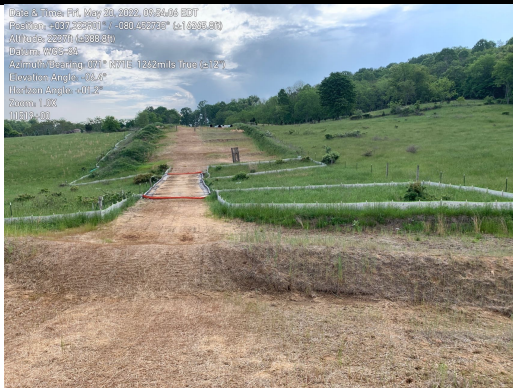
GPS Location				See photo for GPS location.				GPS Location				See photo for GPS location.			
Field Station#				11505+00				Field Station#				11519+00			
Pic 5 Desc.				Plunge pool and clean water diversion pipe in place.				Pic 6 Desc.				sensitive resource buffer in place at stream S-PP4.

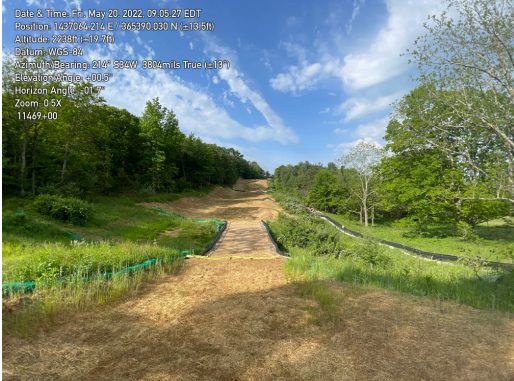
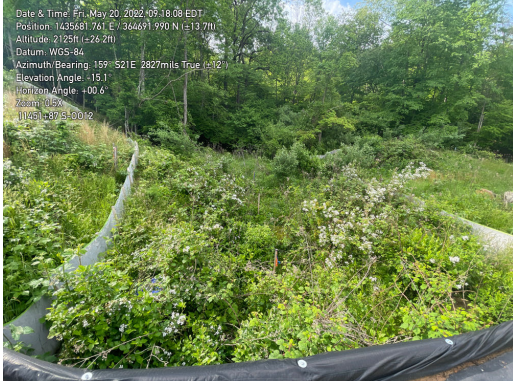
GPS Location	1	GPS Location	2		
Field Station#	11469+00	Field Station#	11451+87		
Pic 1 Desc.	Section of RoW showing conditions and controls.	Pic 2 Desc.	S-0012.

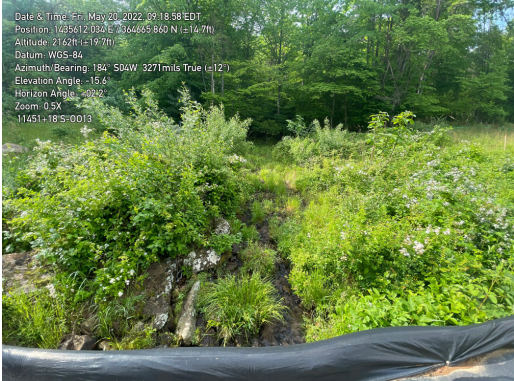
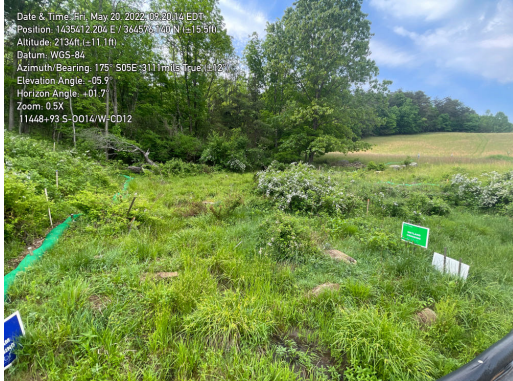
GPS Location	3	GPS Location	4		
Field Station#	1145+18	Field Station#	11448+93		
Pic 3 Desc.	S-0013.	Pic 4 Desc.	S-0014/W-CD12.

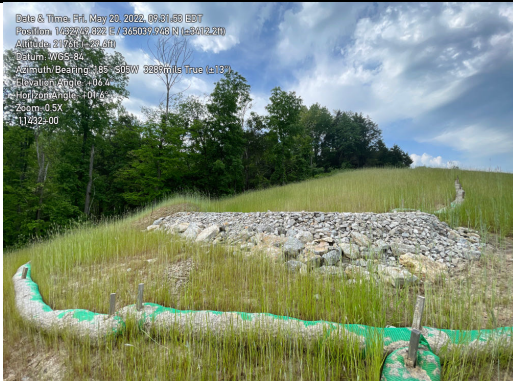
GPS Location	5	GPS Location	6		
Field Station#	11439+00	Field Station#	11342+00		
Pic 5 Desc.	Section of restored RoW showing conditions and controls.	Pic 6 Desc.	Representative photo of permanent waterbar and level spreaders installed.

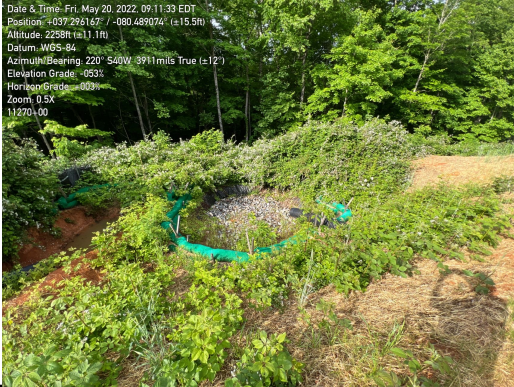
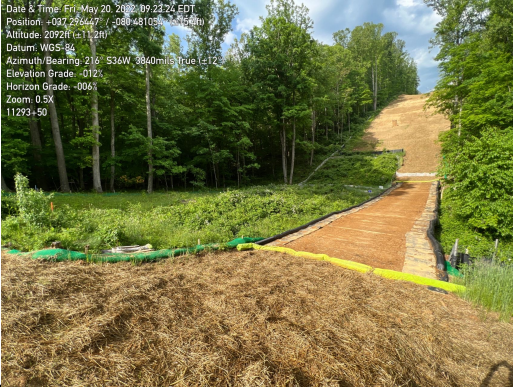
GPS Location	See Photo	GPS Location	See Photo		
Field Station#	11270+00	Field Station#	11293+50		
Pic 3 Desc.	Plunge Pool with CFS perimeter protection.	Pic 4 Desc.	Over view of the S-MM18 stream resource area.

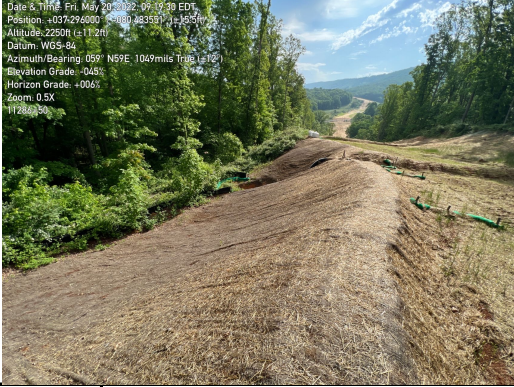
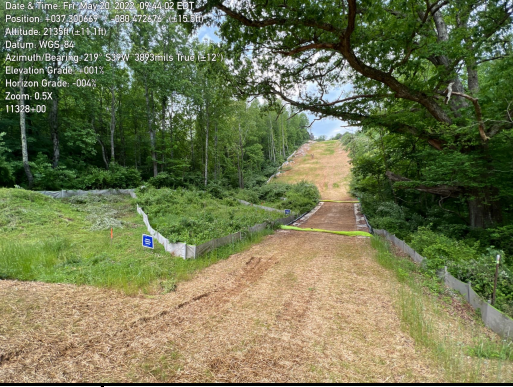
GPS Location	See Photo	GPS Location	See Photo		
Field Station#	11286+50	Field Station#	11328+00		
Pic 5 Desc.	CC4 ECB on steep side slope.	Pic 6 Desc.	S-NN12 Stream resource area. Heavily vegetated buffer zones.

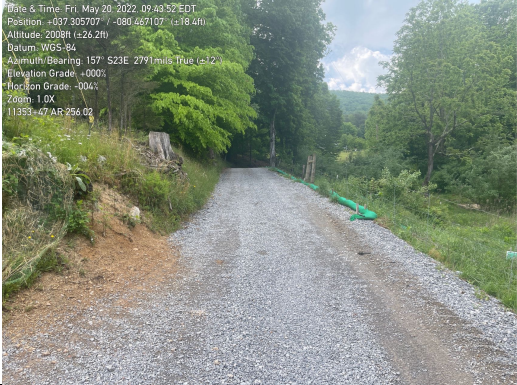
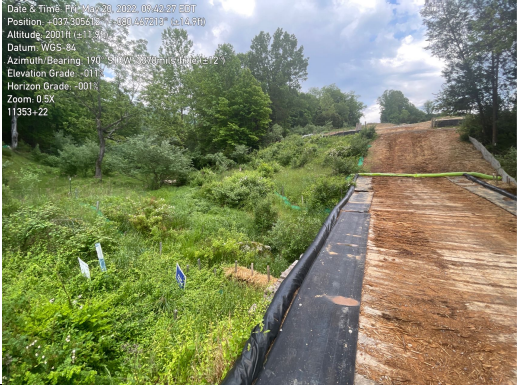
GPS Location	See Photo	GPS Location	See Photo		
Field Station#	11353+47	Field Station#	11353+22		
Pic 7 Desc.	AR 256.02	Pic 8 Desc.	S-NN11 Stream resource area. No issues at this time.		
Insert image here		Insert image here			
GPS Location		GPS Location			
Field Station#		Field Station#			
Pic 9 Desc.		Pic 10 Desc.
