Visual Site Inspection Report

Project Name	H-600 Pipeline Spread H	AFE	124300138	Spread	H-600 Pipeline Spread H
Contractor	Precision			Report #	37956
Inspector	Jonathan Altizer			Date/Time	5/23/2022 3:47 PM
Permit #	TBD	Inspection Type	VA SWPP	Station Begin	12865+00
State	VA	Inspection Area	Partial	Station End	13024+00
County	Roanoke	Ground	Wet	Temperature (°F)	65.00
Municipality	N/A	Weather	Light Rain	Rain Gauge (in)	0.60
				Rain Accumulation Time (days)	1.00

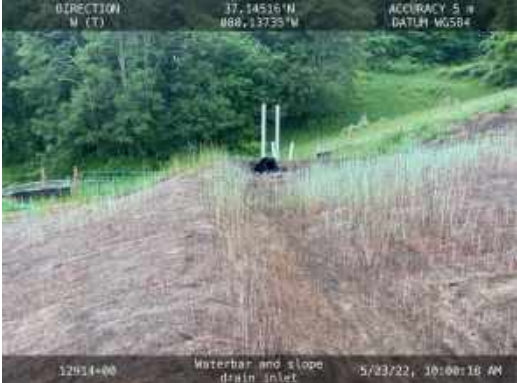
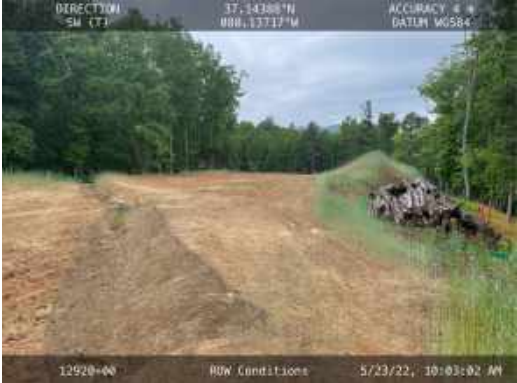
GPS Location	See photo		GPS Location	See photo	
Field Station#	12914+00		Field Station#	12920+00	
Pic 7 Desc.	Waterbar and slope drain are functional		Pic 8 Desc.	Current ROW conditions. ROW is stable. ECDs are functional.

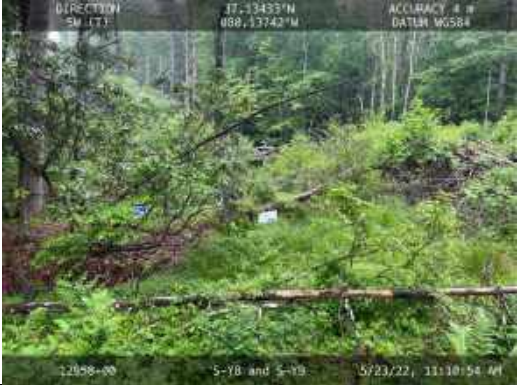
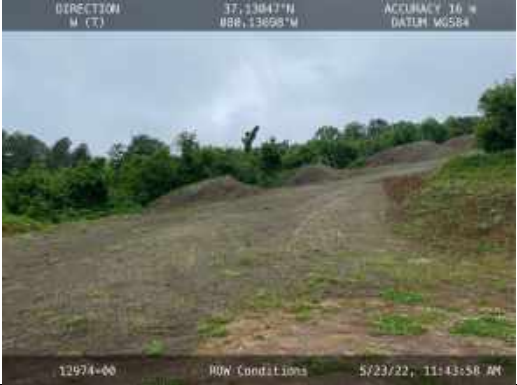
GPS Location	See photo		GPS Location	See photo	
Field Station#	12958+00		Field Station#	12974+00	
Pic 13 Desc.	Overview of Streams S-Y8/Y9		Pic 14 Desc.	Current ROW conditions. ROW is stable. ECDs are functional.

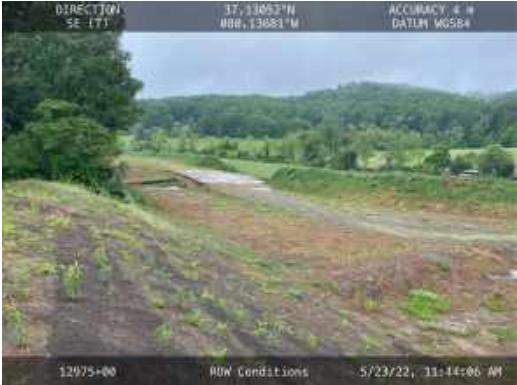
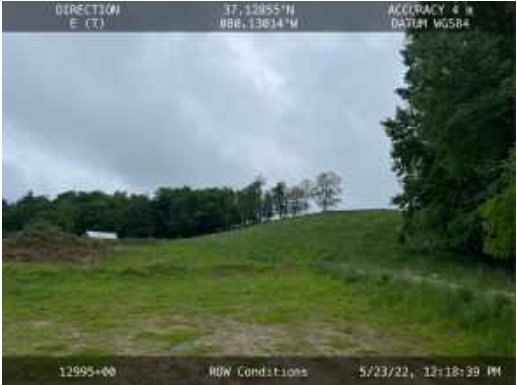
GPS Location	See photo		GPS Location	See photo	
Field Station#	12975+00		Field Station#	12995+00	
Pic 15 Desc.	Current ROW conditions. ROW is stable. ECDs are functional.		Pic 16 Desc.	Current ROW conditions. ROW is stable. ECDs are functional.

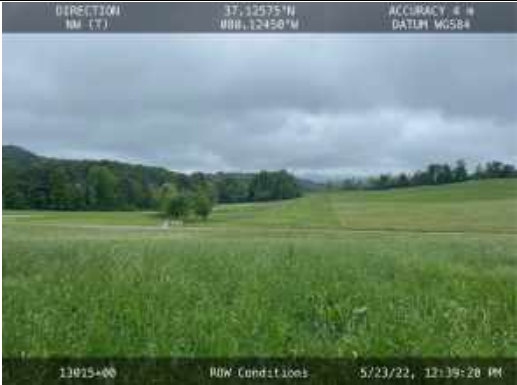
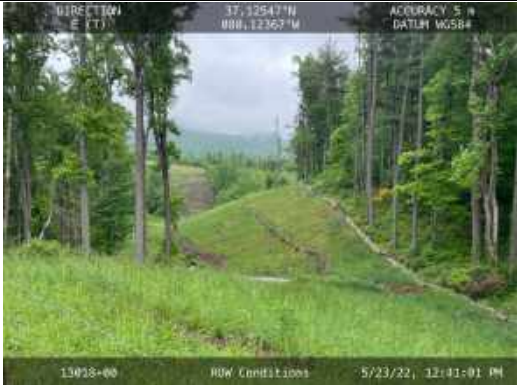
GPS Location	See photo		GPS Location	See photo	
Field Station#	13015+00		Field Station#	13018+00	
Pic 17 Desc.	Permanent vegetation is well established		Pic 18 Desc.	Permanent vegetation is well established.

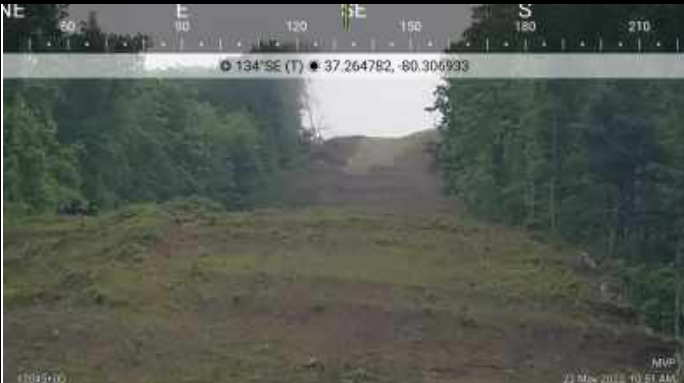
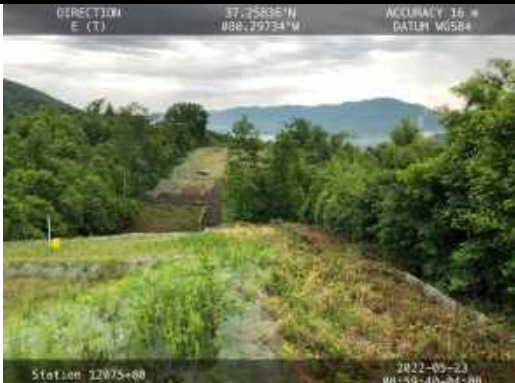
GPS Location	Please see photo for details.		GPS Location	Please see photo for details.	
Field Station#	12045+00		Field Station#	12075+00	
Pic 7 Desc.	Photo shows the stabilized ROW conditions with water bars and that all ECDs are installed and are functioning as designed.		Pic 8 Desc.	Photo shows stabilized ROW conditions, ECDs installed and functioning as designed within recent vegetative maintenance area.

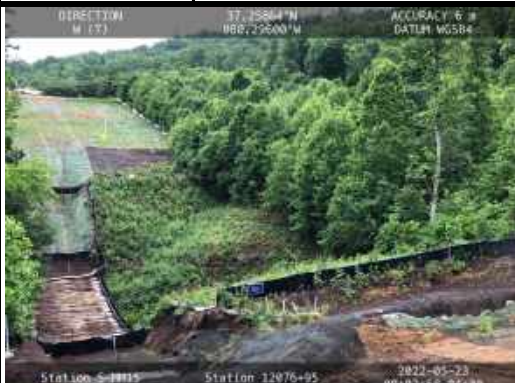
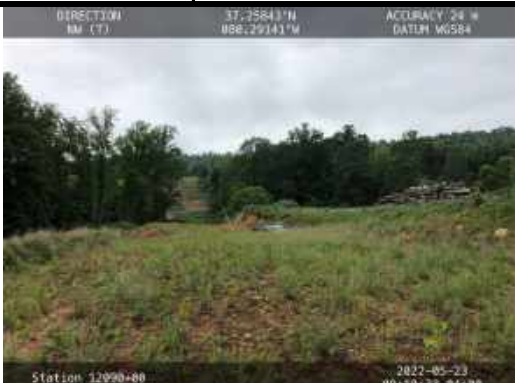
GPS Location	Please see photo for details.		GPS Location	Please see photo for details.	
Field Station#	12076+95		Field Station#	12090+00	
Pic 9 Desc.	Photo shows overview of Stream S-MM15 and its buffer zone from the going away side.		Pic 10 Desc.	Photo shows the stabilized ROW conditions with water bars and that all ECDs are installed and are functioning as designed.

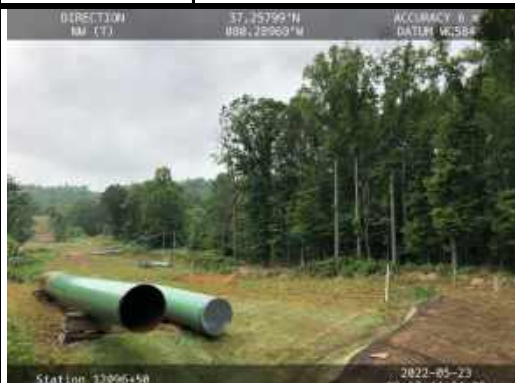
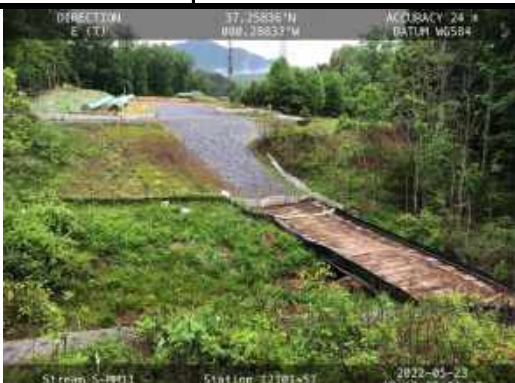
Field Station#	12096+50		Field Station#	12101+57	
Pic 11 Desc.	Photo shows the stabilized ROW conditions with water bars and that all ECDs are installed and are functioning as designed.		Pic 12 Desc.	Photo shows overview of Stream S-MM11 and its buffer zone from the coming in side.

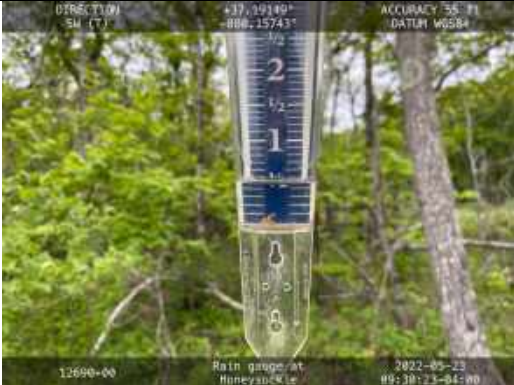
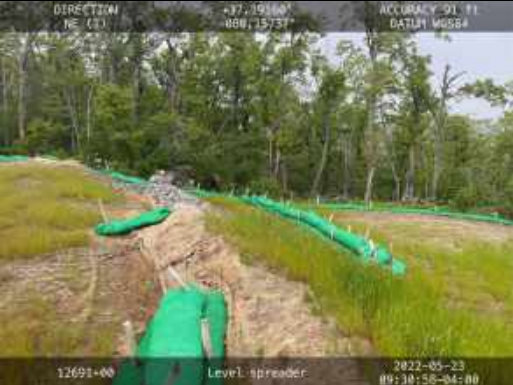
GPS Location	See photo for gps location data.		GPS Location	See photo for gps location data.	
Field Station#	12690+00		Field Station#	12691+00	
Pic 1 Desc.	Photo shows the rain gauge at Honeysuckle Road. 0.5" of rainfall within the last 72 hours.		Pic 2 Desc.	Photo shows the level spreader.

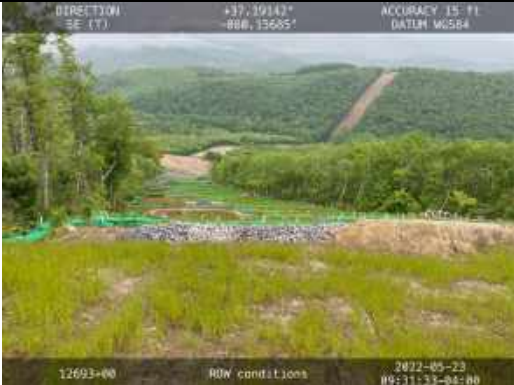
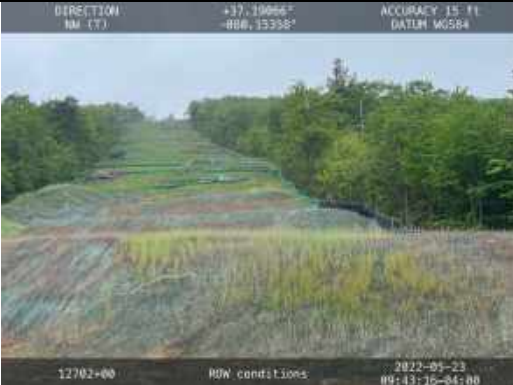
GPS Location	See photo for gps location data.		GPS Location	See photo for gps location data.	
Field Station#	12693+00		Field Station#	12702+00	
Pic 3 Desc.	Photo shows the ROW condition. ECDs are installed and functioning as designed.		Pic 4 Desc.	Photo shows the ROW condition. ECDs are installed and functioning as designed.

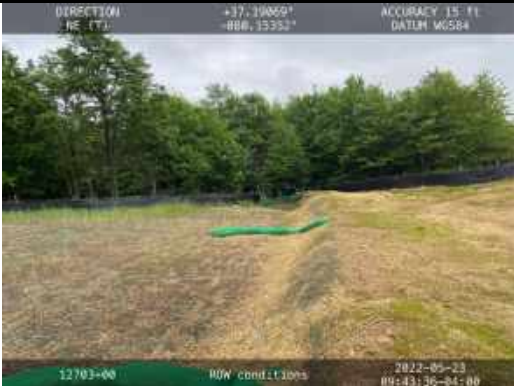
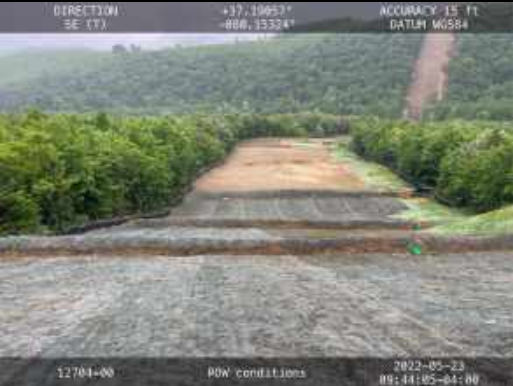
GPS Location	See photo for gps location data.		GPS Location	See photo for gps location data.	
Field Station#	12703+00		Field Station#	12704+00	
Pic 5 Desc.	Photo shows the ROW condition. ECDs are installed and functioning as designed.		Pic 6 Desc.	Photo shows the ROW condition. ECDs are installed and functioning as designed.

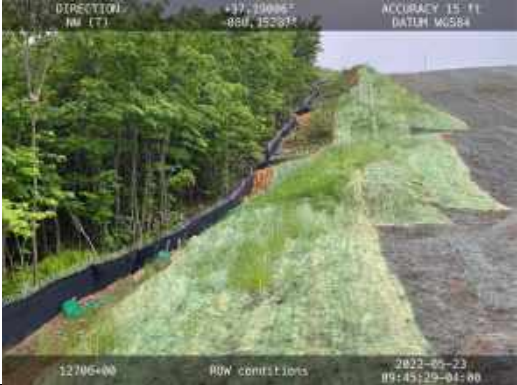
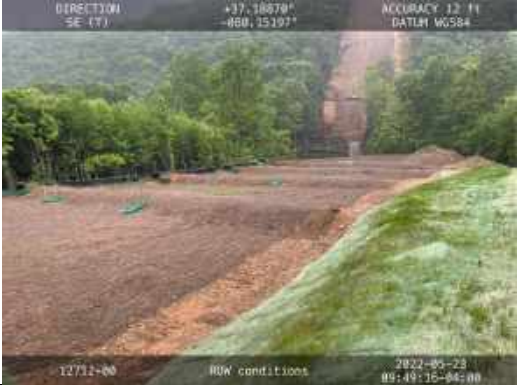
GPS Location	See photo for gps location data.		GPS Location	See photo for gps location data.	
Field Station#	12706+00		Field Station#	12712+00	
Pic 7 Desc.	Photo shows the ROW condition. ECDs are installed and functioning as designed.		Pic 8 Desc.	Photo shows the ROW condition. ECDs are installed and functioning as designed.

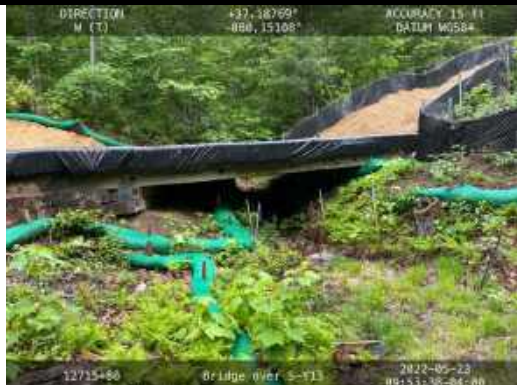
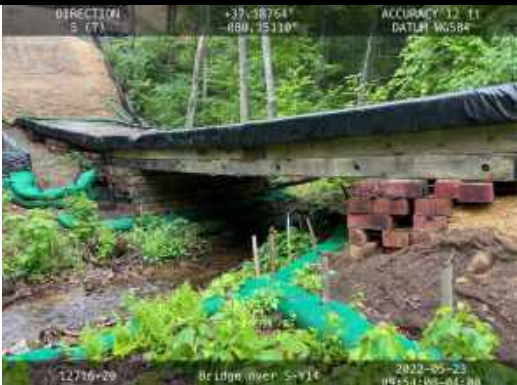
GPS Location	See photo for gps location data.		GPS Location	See photo for gps location data.	
Field Station#	12715+80		Field Station#	12716+20	
Pic 11 Desc.	Photo shows the bridge over stream S-Y13.		Pic 12 Desc.	Photo shows the bridge over stream S-Y14.

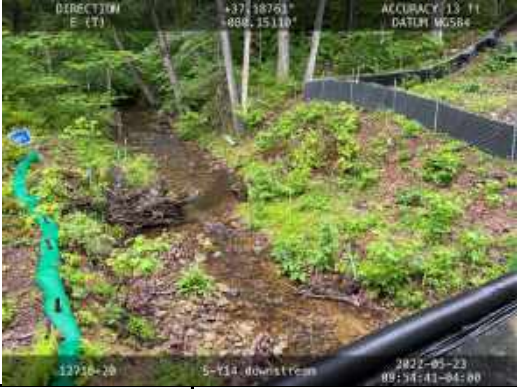
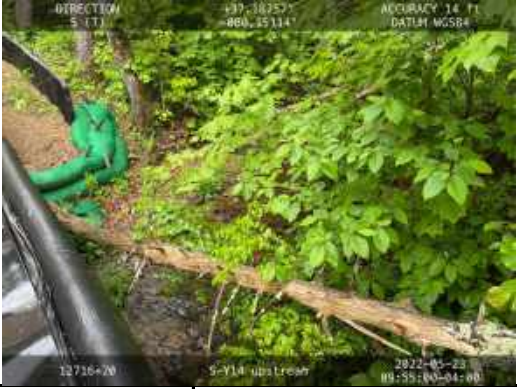
GPS Location	See photo for gps location data.		GPS Location	See photo for gps location data.	
Field Station#	12716+20		Field Station#	12715+80	
Pic 13 Desc.	Photo shows S-Y14 downstream from the bridge.		Pic 14 Desc.	Photo shows stream S-Y14 upstream from the bridge.

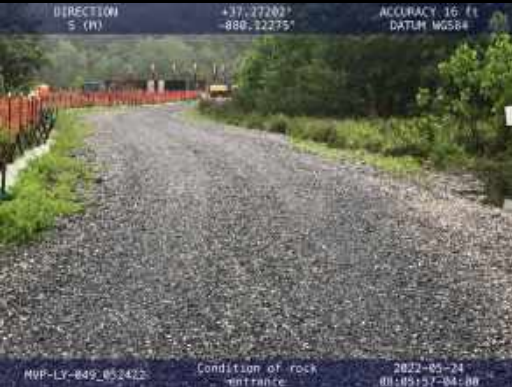
GPS Location	MVP-LY-049 See photo for gps data	GPS Location	MVP-LY-049 See photo for gps data		
Field Station#	+0	Field Station#	+0		
Pic 1 Desc.	Condition of rock entrance on north drive. No sediment or debris on stone. Looking SW.	Pic 2 Desc.	Condition of rock entrance on center drive. Smaller stone applied over larger stone. Looking S.

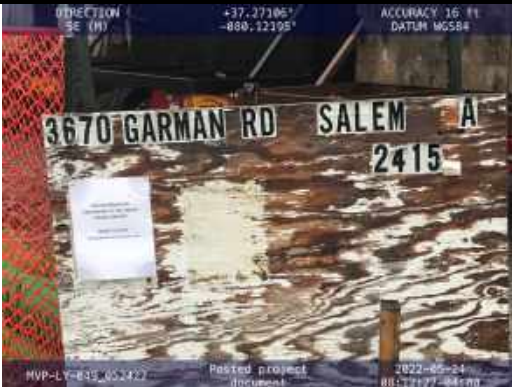
GPS Location	MVP-LY-049 See photo for gps data	GPS Location	MVP-LY-049 See photo for gps data		
Field Station#	+0	Field Station#	+0		
Pic 3 Desc.	Posted project document at main entrance on center drive. Looking SE.	Pic 4 Desc.	Landowner soil disturbance along triple stack compost filter sock. Area not stabilized. Looking SE.

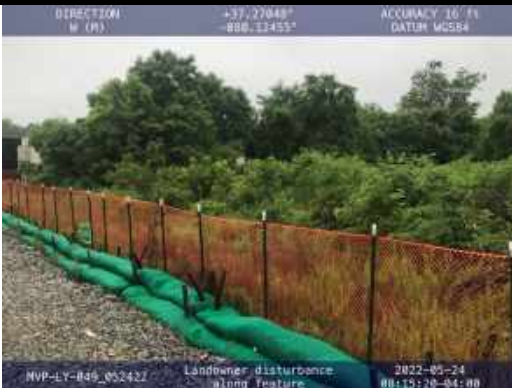
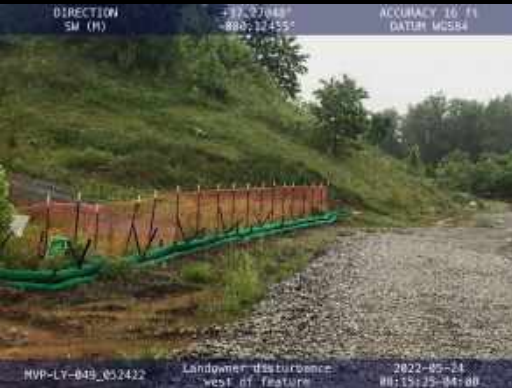
GPS Location	MVP-LY-049 See photo for gps data	GPS Location	MVP-LY-049 See photo for gps data		
Field Station#	+0	Field Station#	+0		
Pic 5 Desc.	Landowner soil disturbance along feature W-CV21A. Area not stabilized. Looking W.	Pic 6 Desc.	Landowner soil disturbance west of feature W-CV21B. Areas not stabilized. Looking SW.

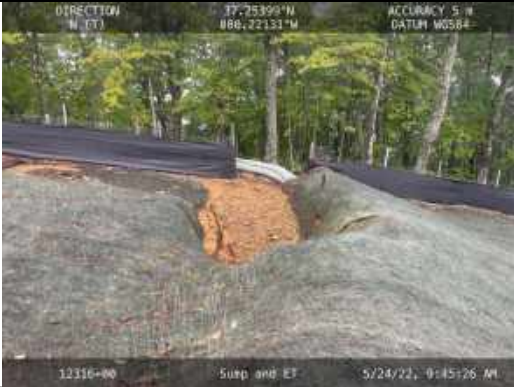
GPS Location	See photo		GPS Location	See photo	
Field Station#	12316+00		Field Station#	12326+00	
Pic 3 Desc.	Sump and End Treatment are functional		Pic 4 Desc.	Current ROW conditions. ROW is stable. ECDs are functional.

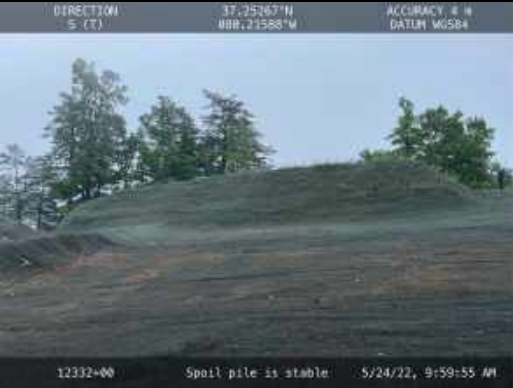
GPS Location	See photo		GPS Location	See photo	
Field Station#	12330+00		Field Station#	12332+00	
Pic 5 Desc.	Slope drain is functional		Pic 6 Desc.	Spoil pile is stable

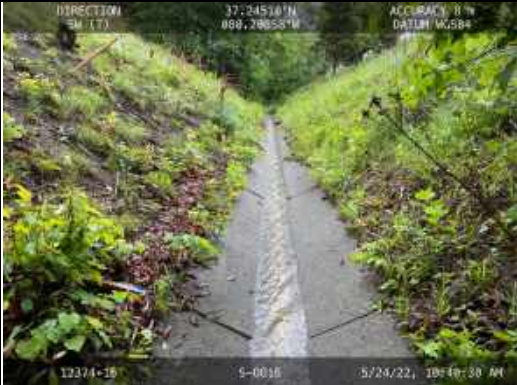
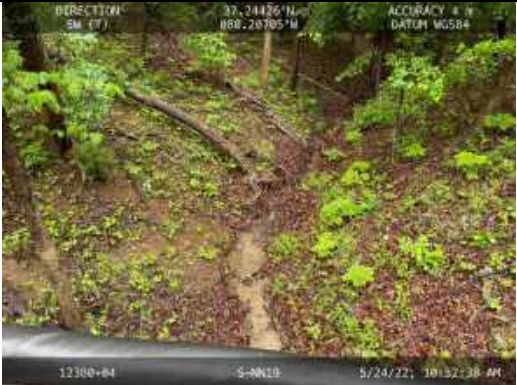
GPS Location	See photo		GPS Location	See photo	
Field Station#	12374+16		Field Station#	12380+04	
Pic 13 Desc.	Looking downstream at Stream S-OO16		Pic 14 Desc.	Downstream of crossing at Stream S-NN19

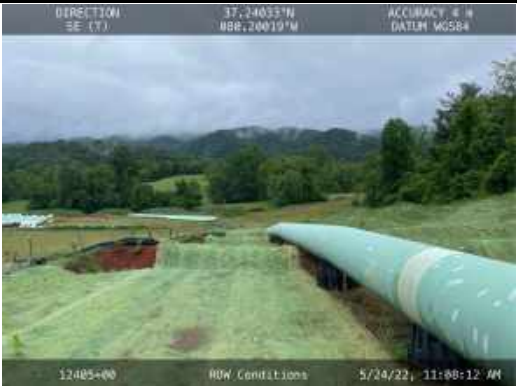
GPS Location	See photo		GPS Location	See photo	
Field Station#	12382+00		Field Station#	12405+00	
Pic 15 Desc.	Drainage feature is functional		Pic 16 Desc.	Current ROW conditions. ROW is stable. ECDs are functional.

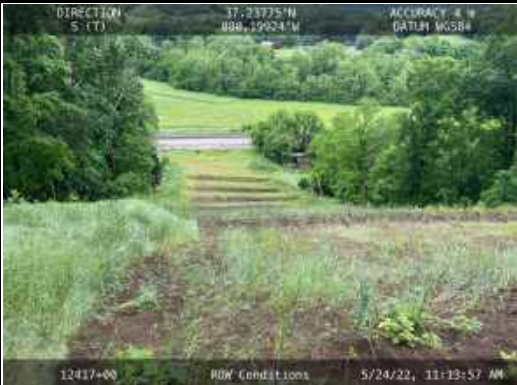
<p>Insert image here</p>			
GPS Location	See photo		GPS Location	See photo	
Field Station#	12417+00		Field Station#		
Pic 17 Desc.	Current ROW conditions. ROW is stable. ECDs are functional.		Pic 18 Desc.

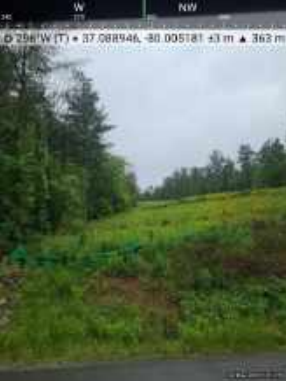
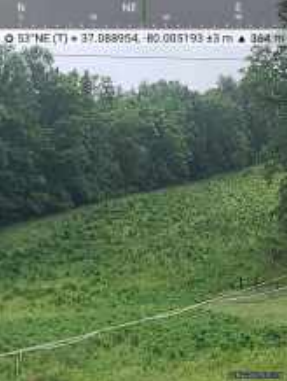
GPS Location	0000	GPS Location	0000		
Field Station#	13496+62	Field Station#	13500+88		
Pic 1 Desc.	Observed rock lined channel and ECDs at road crossing as light rain events continued. No environmental issues observed at the time of inspection.		Pic 2 Desc.	Permanent area of row showing vegetation, photo taken during rain events. No environmental issues observed at the time of inspection.

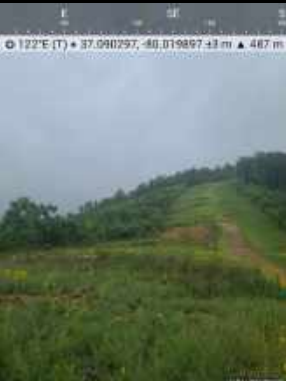
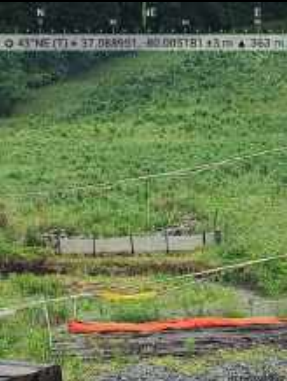
GPS Location	0000	GPS Location	0000		
Field Station#	13431+10	Field Station#	13423+40		
Pic 3 Desc.	Vegetation observation photo during light rain events. Good vegetation noted in permanent area of row.		Pic 4 Desc.	Monitored ECDs and stabilization above stream crossing, good vegetation noted in permanent area during light rain events.

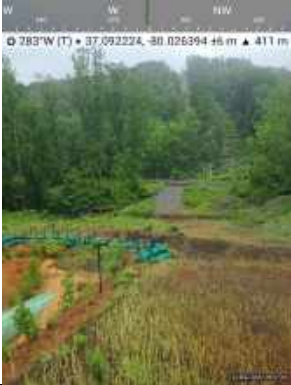
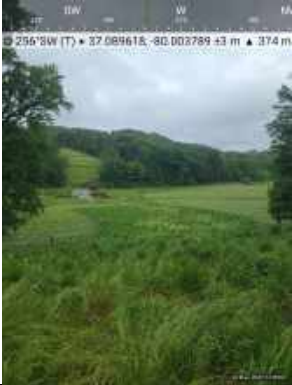
GPS Location	0000	GPS Location	0000		
Field Station#	13418+00	Field Station#	13503+00		
Pic 7 Desc.	Observed stabilization on hill side during continued rain events. Row conditions were saturated. ECDs in place and functioning at the time of inspection.		Pic 8 Desc.	Row photo up hill from road crossing showing good vegetation growth in permanent area.

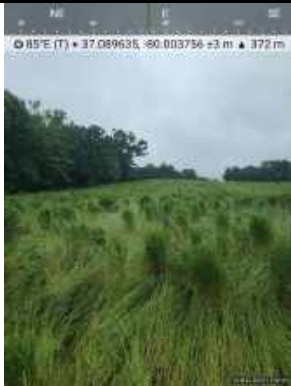
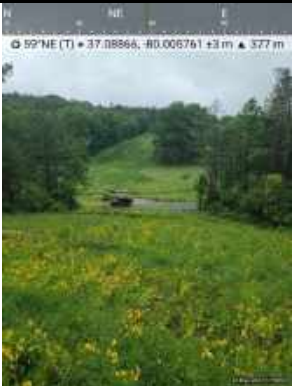
GPS Location	0000	GPS Location	0000		
Field Station#	13505+00	Field Station#	13492+50		
Pic 9 Desc.	Permanent vegetation observation on problem land owner area. Good coverage noted.		Pic 10 Desc.	Vegetation observation photo up hill from road crossing, good stabilization noted in permanent area.	
<div style="text-align: center;">Insert image here</div>		<div style="text-align: center;">Insert image here</div>			
GPS Location		GPS Location			
Field Station#		Field Station#

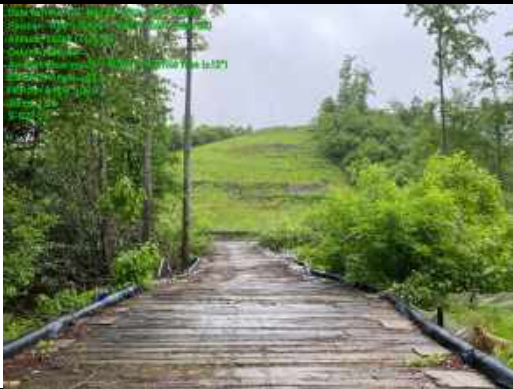
GPS Location		See photo for coordinates.			GPS Location		See photo for coordinates.		
Field Station#		13042+58			Field Station#		13062+96		
Pic 7 Desc.		Right of way stabilized.			Pic 8 Desc.		Right of way stabilized.

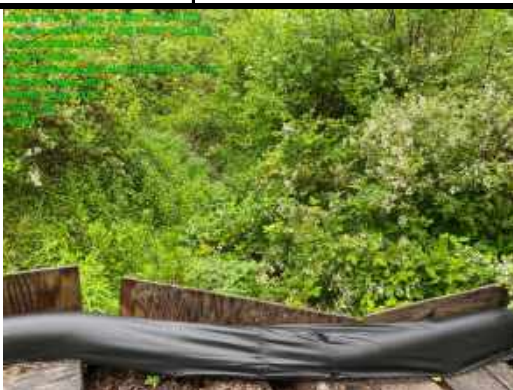
GPS Location		See photo for coordinates.			GPS Location		See photo for coordinates.		
Field Station#		13061+89			Field Station#		13061+89		
Pic 9 Desc.		S-G26, downstream, no turbidity noted.			Pic 10 Desc.		S-G26, upstream, no turbidity noted.

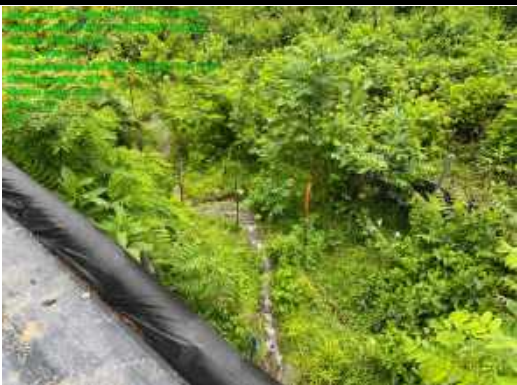
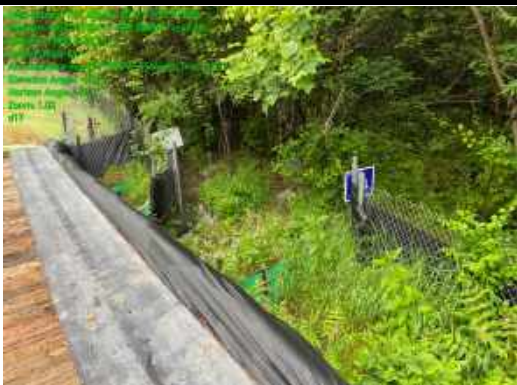
GPS Location	See photo for coordinates.		GPS Location	See photo for coordinates.	
Field Station#	13137+78		Field Station#	13137+78	
Pic 17 Desc.	S-D17/14, downstream, high flow from rain event, low turbidity.		Pic 18 Desc.	S-D17/14, upstream, high flow from rain event, low turbidity.

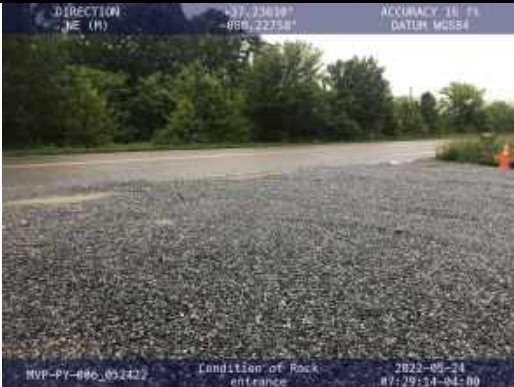
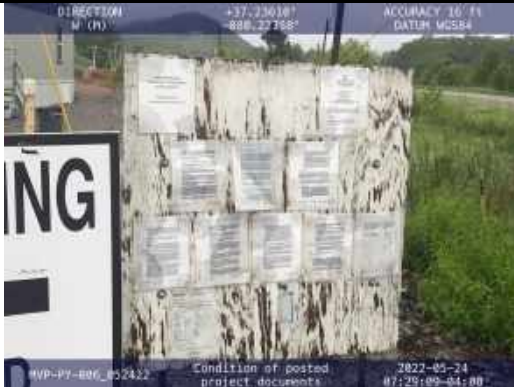
GPS Location	MVP-PY-006 See photo for gps data	GPS Location	MVP-PY-006 See photo for gps data		
Field Station#	+0	Field Station#	+0		
Pic 1 Desc.	Condition of rock entrance. No debris or sediment on public roadway. Looking NE.	Pic 2 Desc.	Condition of posted project documents at main entrance. Looking W.

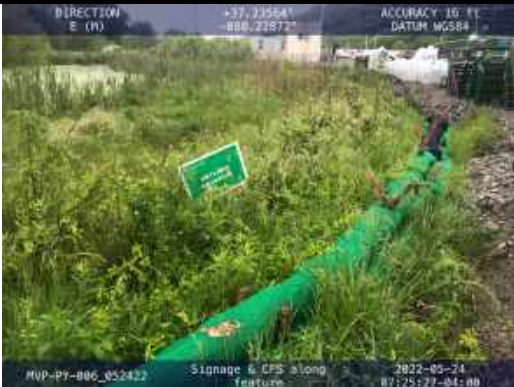
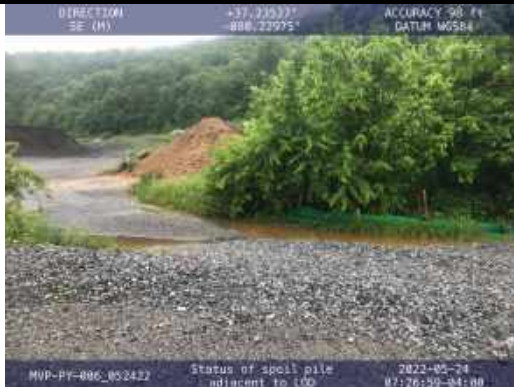
GPS Location	MVP-PY-006 See photo for gps data	GPS Location	MVP-PY-006 See photo for gps data		
Field Station#	+0	Field Station#	+0		
Pic 3 Desc.	Signage and triple stack compost filter sock at feature W-008. Looking E.	Pic 4 Desc.	Status of spoil pile adjacent to LOD on VDOT property. Soil pile not stabilized. Looking SE.

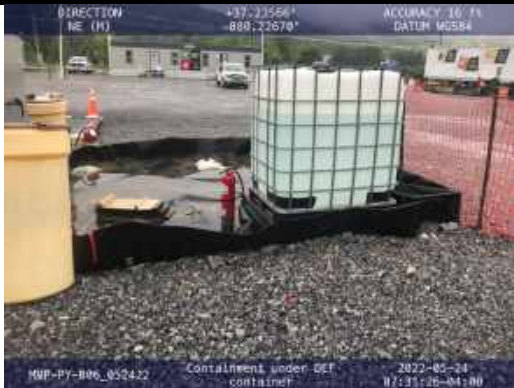
GPS Location	MVP-PY-006 See photo for gps data	GPS Location	MVP-PY-006 See photo for gps data		
Field Station#	+0	Field Station#	+0		
Pic 5 Desc.	Secondary containment under light plant holding some fluids. Looking SW.	Pic 6 Desc.	Secondary containment under DEF container holding stormwater. Looking NE.

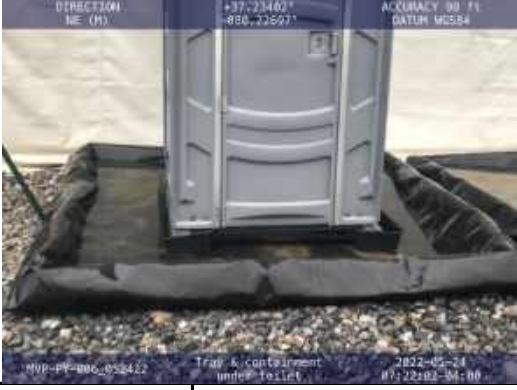
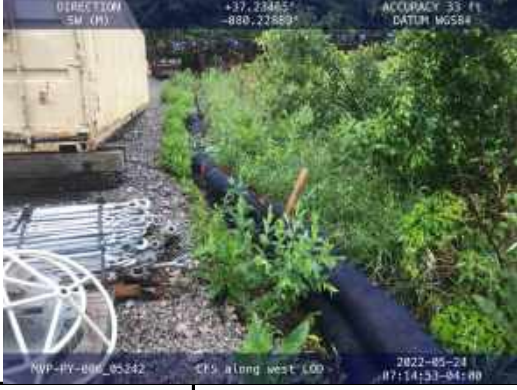
GPS Location	MVP-PY-006 See photo for gps data	GPS Location	MVP-PY-006 See photo for gps data		
Field Station#	+0	Field Station#	+0		
Pic 17 Desc.	Tray and containment under toilet. Both holding stormwater. Looking NE.	Pic 18 Desc.	Triple stack compost filter sock along west LOD, becoming over grown with vegetation. Looking SW.

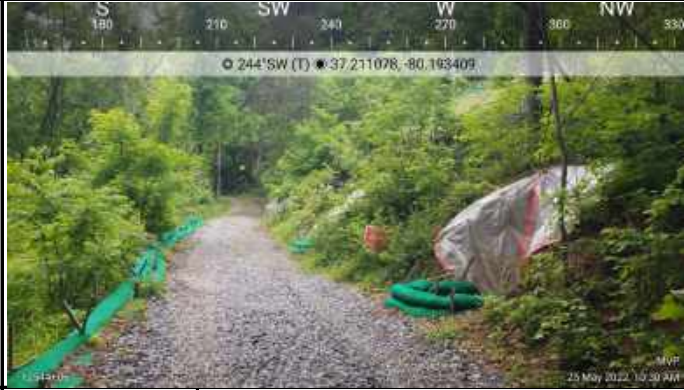
GPS Location	See Above		GPS Location	See Above	
Field Station#	12535+00		Field Station#	12544+06	
Pic 17 Desc.	ROW Overview (temporary stabilization). ECDs are functional and ROW is stable.		Pic 18 Desc.	ECDs are functional and Access road MN-278.01 (Yellow Finch Lane) area is stable.

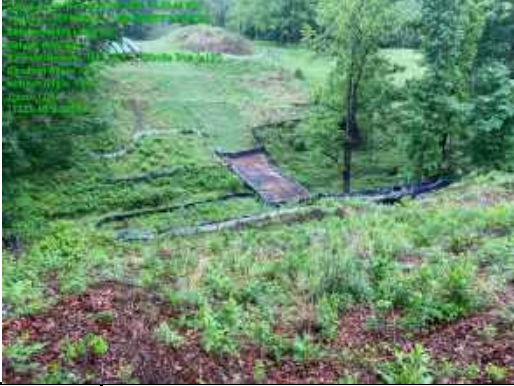
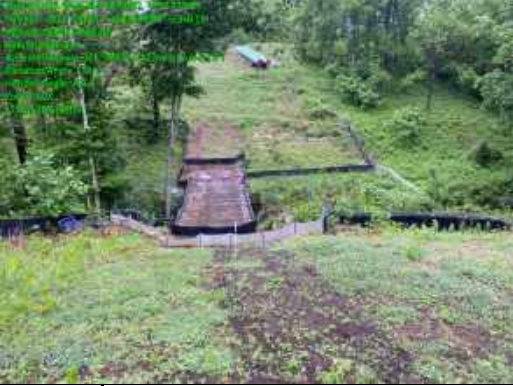
GPS Location	0	GPS Location	0		
Field Station#	13320+00	Field Station#	13325+30		
Pic 1 Desc.	MVP-S-GH15 and corresponding buffer zone in good condition		Pic 2 Desc.	MVP-S-GH14 and corresponding buffer zone in good condition

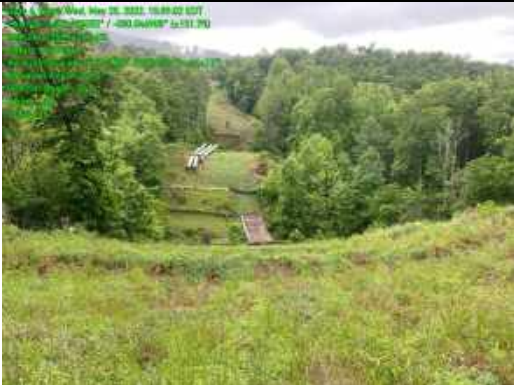
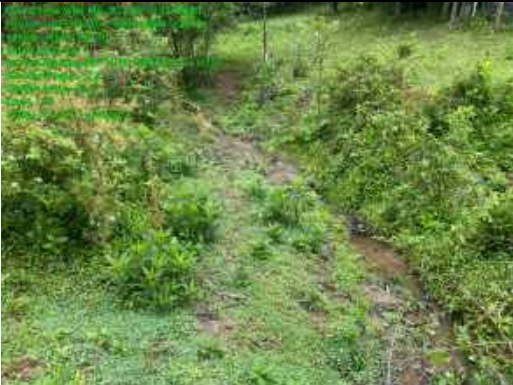
GPS Location	0	GPS Location	0		
Field Station#	13332+25	Field Station#	13334+17		
Pic 3 Desc.	ROW and ECDs In good condition and stable		Pic 4 Desc.	Some sediment deposits upstream of MVP-S-GH11, sediment coming from pasture field adjacent to row, from livestock disturbance

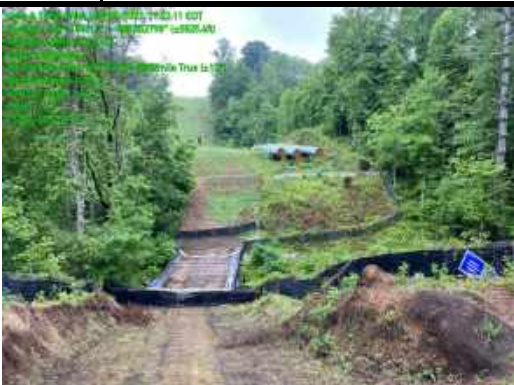
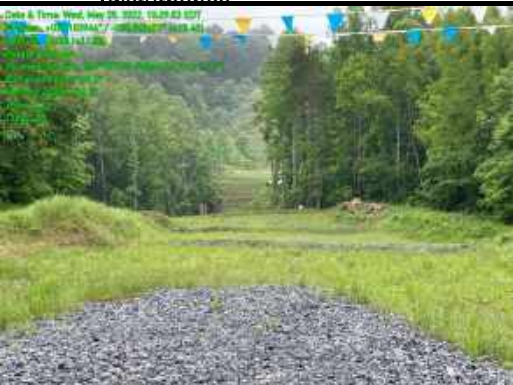
GPS Location	0	GPS Location	0		
Field Station#	13338+00	Field Station#	13342+00		
Pic 5 Desc.	MVP-S-GH9 and corresponding buffer zone in good condition		Pic 6 Desc.	ROW and ECDs In good condition and stable

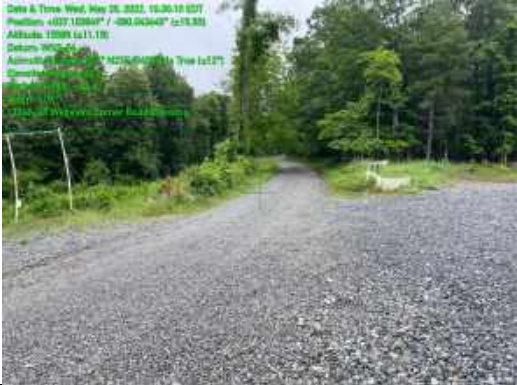
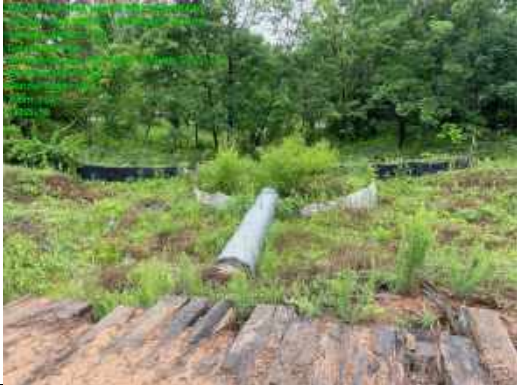
GPS Location	0	GPS Location	0		
Field Station#	13342+67	Field Station#	13345+50		
Pic 7 Desc.	Websters Corner Road Crossing in good condition	Pic 8 Desc.	Clean water diversion pipe and outlet in good condition

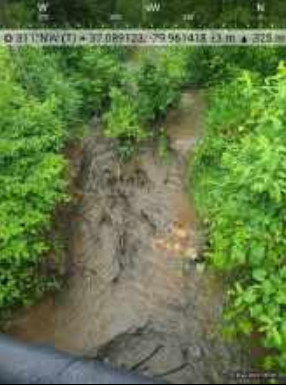
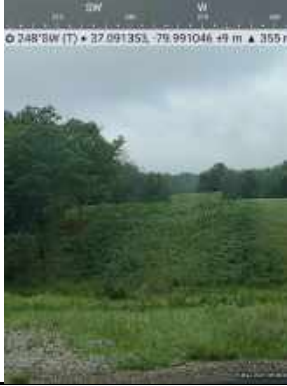
GPS Location	0000	GPS Location	0000		
Field Station#	13643+54	Field Station#	13541+50		
Pic 1 Desc.	Stream observation photo facing upstream during routine inspection. No issues were observed at the time of inspection.		Pic 2 Desc.	Row photo taken in permanent area of row showing vegetation. No issues were observed at the time of inspection.

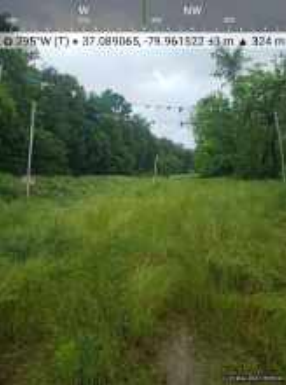
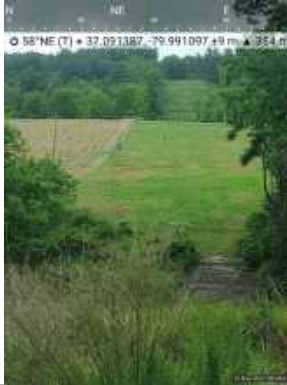
GPS Location	0000	GPS Location	0000		
Field Station#	13643+00	Field Station#	13541+83		
Pic 3 Desc.	Vegetation observation photo up row from stream crossing. Good coverage noted.		Pic 4 Desc.	Monitored equipment bridge and protection. Good stabilization noted on hill side. Photo showing permanent area down row from stream crossing.

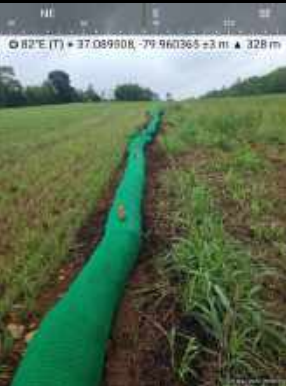
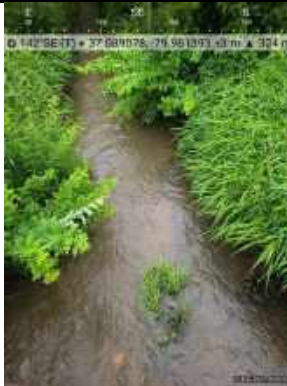
GPS Location	0000	GPS Location	00000		
Field Station#	13649+00	Field Station#	13643+54		
Pic 5 Desc.	Observed recent replaced CFS along the perimeter of the row. All in place and functioning at the time of inspection.		Pic 6 Desc.	Stream observation photo facing downstream during routine inspection today. No environmental issues observed at the time of inspection after recent rain events.

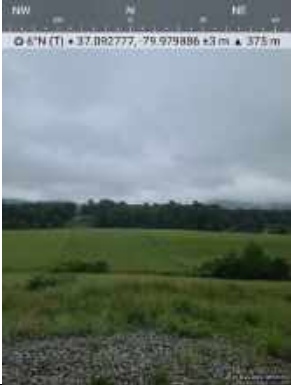
<div>Insert image here</div>		<div>Insert image here</div>	
GPS Location	0000	GPS Location			
Field Station#	13574+98	Field Station#			
Pic 7 Desc.	Monitored RCEs and vegetation in permanent areas of row. No environmental issues observed at the time of inspection.		Pic 8 Desc.		
<div>Insert image here</div>		<div>Insert image here</div>			
GPS Location		GPS Location			
Field Station#		Field Station#			
Pic 9 Desc.		Pic 10 Desc.			
<div>Insert image here</div>		<div>Insert image here</div>			
GPS Location		GPS Location			
Field Station#		Field Station#			
Pic 11 Desc.		Pic 12 Desc.

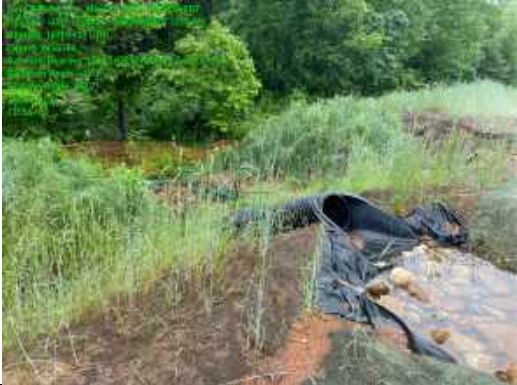
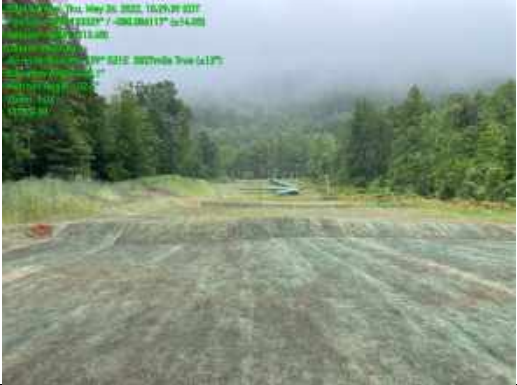
GPS Location	0	GPS Location	0		
Field Station#	13154+00	Field Station#	13153+00		
Pic 13 Desc.	Slope drain pipe in good condition	Pic 14 Desc.	ROW and ECDs In good condition and stable

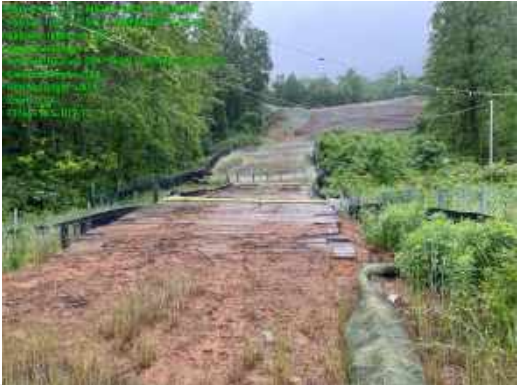
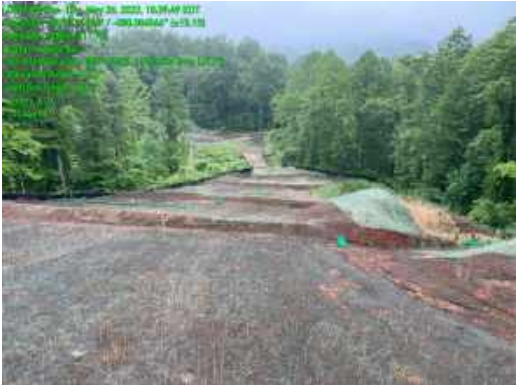
GPS Location	0	GPS Location	0		
Field Station#	13146+56	Field Station#	13144+00		
Pic 15 Desc.	MVP-S-D12/13 and corresponding buffer zone in good condition	Pic 16 Desc.	ROW and ECDs In good condition and stable

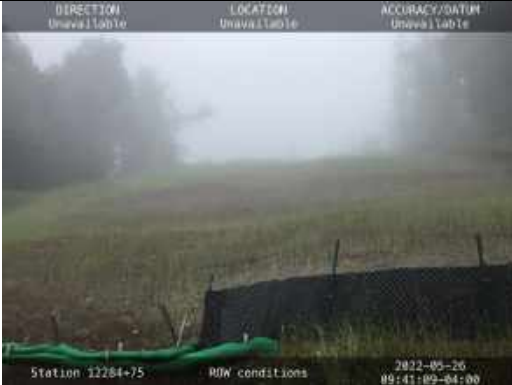
GPS Location	Please see photo for details.		GPS Location	Please see photo for details.	
Field Station#	12284+75		Field Station#	12231+00	
Pic 1 Desc.	Photo shows the stabilized ROW conditions with waterbars and that all ECDs are installed and are functioning as designed.		Pic 2 Desc.	Photo shows the stabilized ROW conditions with waterbars and that all ECDs are installed and are functioning as designed.

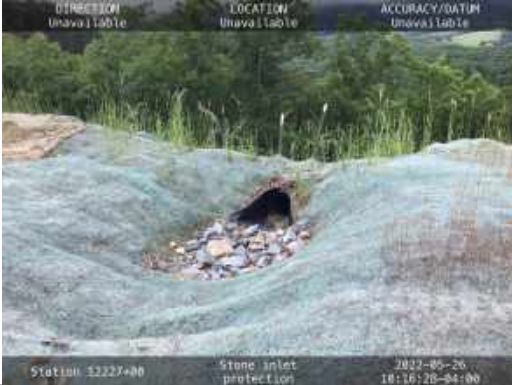
GPS Location	Please see photo for details.		GPS Location	Please see photo for details.	
Field Station#	12227+00		Field Station#	12216+00	
Pic 3 Desc.	Photo shows stone inlet protection for slope drain inlet.		Pic 4 Desc.	Photo shows stabilized permanent restoration area of the ROW with installed ECDs, permanent waterbars and level spreaders.

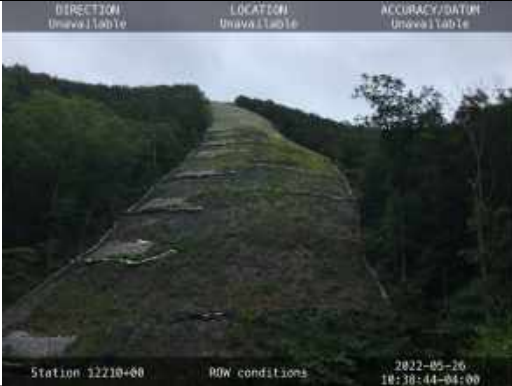
Field Station#	12212+00		Field Station#	12210+00	
Pic 5 Desc.	Photo shows stabilized permanent restoration area of the ROW with installed ECDs, permanent waterbars and level spreaders.		Pic 6 Desc.	Photo shows the stabilized ROW conditions with waterbars and that all ECDs are installed and are functioning as designed.

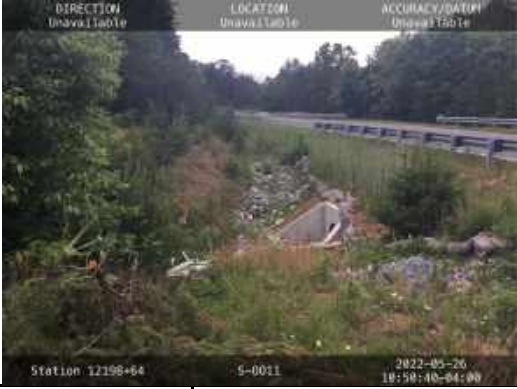
<p>Station 12198+64 S-0011 2022-05-26 10:50:40-04:00</p>

<p>Station 12192+66 S-C21 2022-05-26 10:53:10-04:00</p>			
GPS Location	Please see photo for details.		GPS Location	Please see photo for details.	
Field Station#	12198+64		Field Station#	12192+66	
Pic 7 Desc.	Photo shows overview of upstream of Stream S-0011.		Pic 8 Desc.	Photo shows downstream view of Stream S-C21 from the equipment bridge spanning the stream channel.

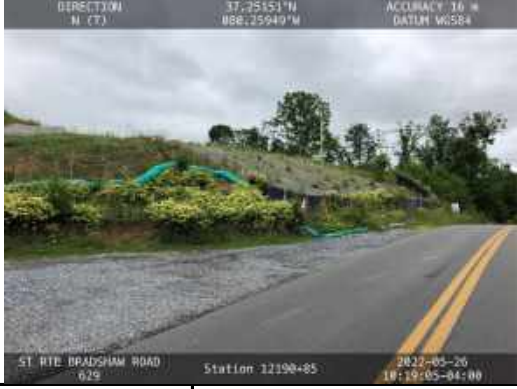
<p>ST RTE BRADSHAW ROAD 629 Station 12190+85 2022-05-26 10:19:05-04:00</p>

<p>Station 12175+00 2022-05-26 10:24:31-04:00</p>			
GPS Location	Please see photo for details.		GPS Location	Please see photo for details.	
Field Station#	12190+85		Field Station#	12175+00	
Pic 9 Desc.	Photo shows the coming in side of ST RTE BRADSHAW ROAD 629.		Pic 10 Desc.	Photo shows the stabilized ROW conditions with waterbars and that all ECDs are installed and are functioning as designed.

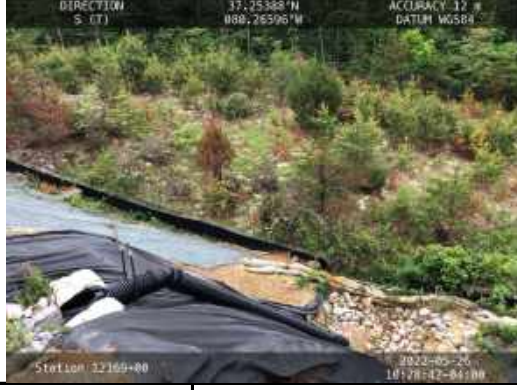
<p>Station 12169+00 2022-05-26 10:19:42-04:00</p>

<p>Stream S-C24 Station 12166+47 2022-05-26 10:30:20-04:00</p>			
GPS Location	Please see photo for details.		GPS Location	Please see photo for details.	
Field Station#	12169+00		Field Station#	12166+47	
Pic 11 Desc.	Photo shows slope drain pipe, stone inlet protection for slope drain inlet and plunge pool.		Pic 12 Desc.	Photo shows upstream view of Stream S-C24 from the equipment bridge spanning the stream channel.

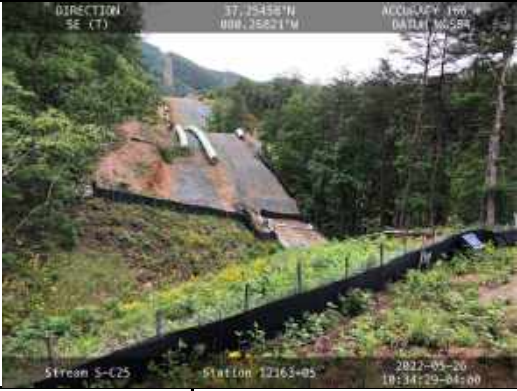
<p>Stream S-C25</p>

<p>Station 12148+50</p>			
GPS Location	Please see photo for details.		GPS Location	Please see photo for details.	
Field Station#	12163+05		Field Station#	12148+50	
Pic 13 Desc.	Photo shows overview of Stream S-C25 and its buffer zone from the coming in side.		Pic 14 Desc.	Photo shows stabilized permanent restoration area of the ROW with installed ECDs, permanent waterbars and level spreaders.

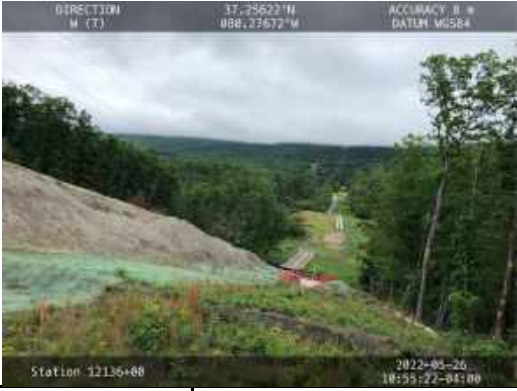
<p>Station 12136+00</p>

<p>Station 12135+00</p>			
GPS Location	Please see photo for details.		GPS Location	Please see photo for details.	
Field Station#	12136+00		Field Station#	12135+00	
Pic 15 Desc.	Photo shows the stabilized ROW conditions with waterbars and that all ECDs are installed and are functioning as designed.		Pic 16 Desc.	Photo shows the stabilized ROW conditions with waterbars and that all ECDs are installed and are functioning as designed.

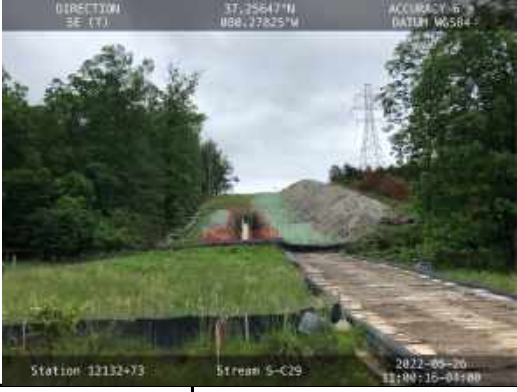
<p>Stream S-C29</p>

<p>Wetland W-C11</p>			
GPS Location	Please see photo for details.		GPS Location	Please see photo for details.	
Field Station#	12132+73		Field Station#	12123+23	
Pic 17 Desc.	Photo shows overview of Stream S-C29 and its buffer zone from the coming in side.		Pic 18 Desc.	Photo shows over of Wetland W-C11 from the going away side while standing on timber mats.

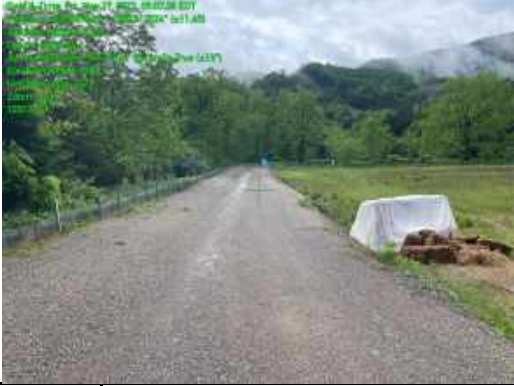
GPS Location	Please see photo for details.		GPS Location	Please see photo for details.	
Field Station#	12013+97		Field Station#	12013+97	
Pic 1 Desc.	Photo shows condition of MVP-MN-268.01.		Pic 2 Desc.	Photo shows upstream view of Stream S-G36 from equipment bridge spanning the stream channel.

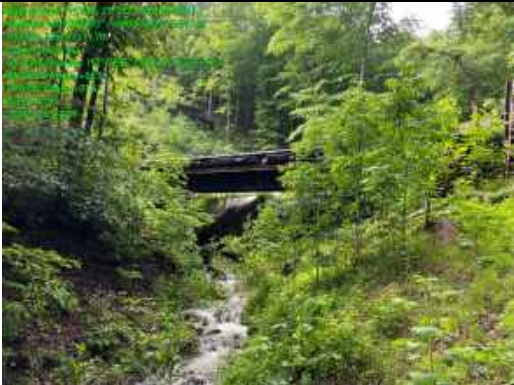
GPS Location	Please see photo for details.		GPS Location	Please see photo for details.	
Field Station#	12031+51		Field Station#	12031+51	
Pic 3 Desc.	Photo shows downstream view of Stream S-G39 and equipment bridge spanning the Stream channel.		Pic 4 Desc.	Photo shows stabilized ROW conditions on the going away side of S-G39 buffer zone.

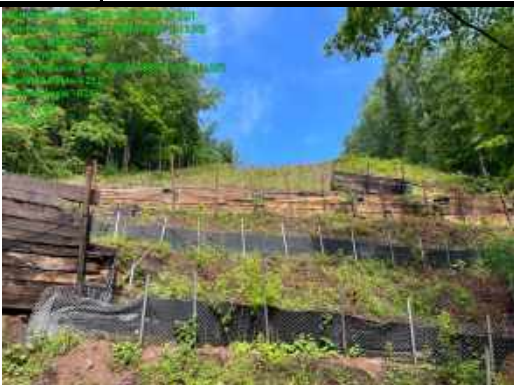
GPS Location	Please see photo for details.		GPS Location	Please see photo for details.	
Field Station#	12031+51		Field Station#	12035+11	
Pic 5 Desc.	Photo shows stabilized ROW conditions on the coming in side of S-G39 buffer zone.		Pic 6 Desc.	Photo shows downstream view of S-G40 and equipment bridge spanning the Stream channel.

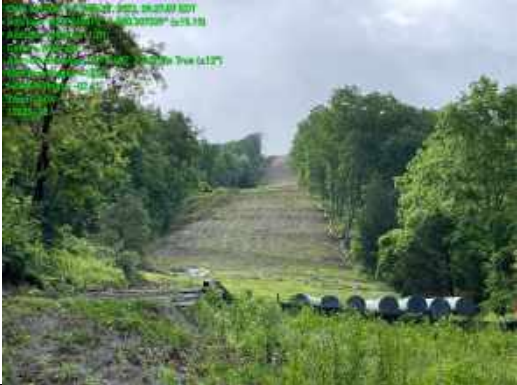
GPS Location	Please see photo for details.	GPS Location	Please see photo for details.		
Field Station#	12035+20	Field Station#	12078+50		
Pic 7 Desc.	Photo shows the stabilized ROW conditions with waterbars and that all ECDs are installed and are functioning as designed.	Pic 8 Desc.	Photo shows stabilized ROW conditions. Sumps are full, functioning as designed. No sediment off ROW.

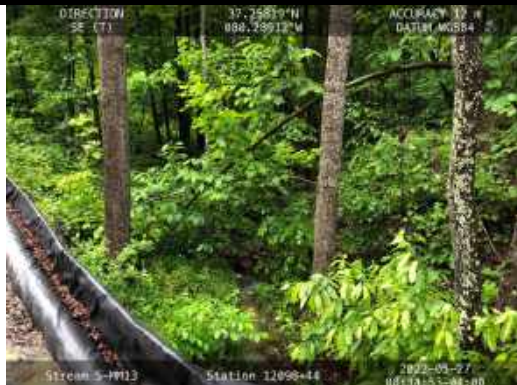
Pic 11 Desc.	Photo shows downstream view of Stream S-MM13 from equipment bridge spanning the stream channel.	Pic 12 Desc.	Photo shows over view of Stream S-MM11 and its buffer zone from the going away side.

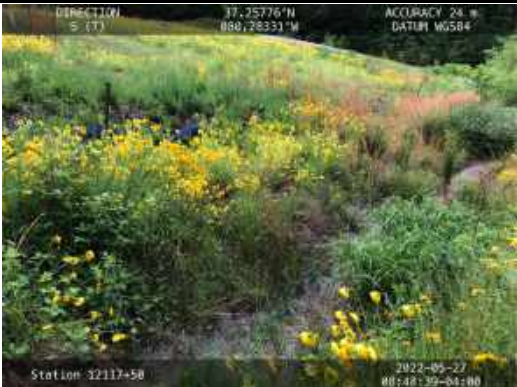
Pic 17 Desc.	Photo shows drainage feature running across the ROW in low lying area.		Pic 18 Desc.	Photo shows stabilized ROW conditions and permanent restoration area with permanent slope breakers equipped with level spreaders.

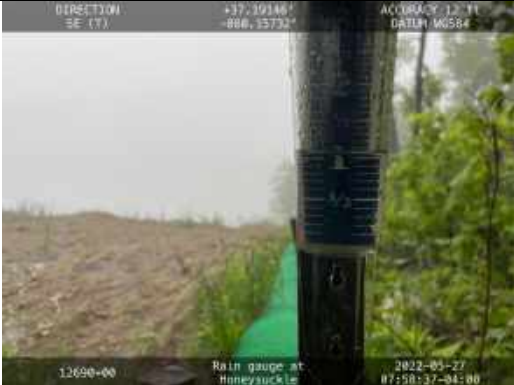
<p>12690+00 Rain gauge at Honeysuckle 2022-05-27 07:50:37-04:00</p>

<p>12691+00 Level spreader 2022-05-27 07:59:29-04:00</p>			
GPS Location	See photo for gps location data.		GPS Location	See photo for gps location data.	
Field Station#	12690+00		Field Station#	12691+00	
Pic 1 Desc.	Photo shows the rain gauge at Honeysuckle. 1.1" of rainfall.		Pic 2 Desc.	Photo shows the level spreader.

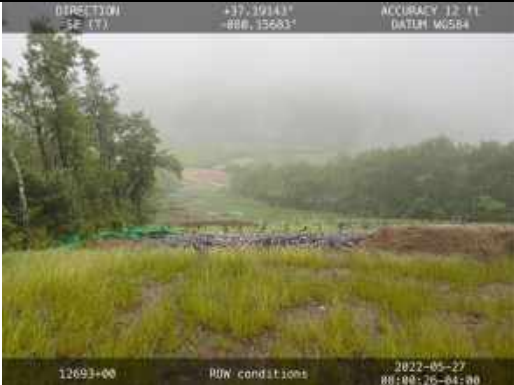
<p>12693+00 ROW conditions 2022-05-27 08:00:26-04:00</p>

<p>12702+00 ROW conditions 2022-05-27 08:11:41-04:00</p>			
GPS Location	See photo for gps location data.		GPS Location	See photo for gps location data.	
Field Station#	12693+00		Field Station#	12702+00	
Pic 3 Desc.	Photo shows the ROW condition. ECDs are installed and functioning as designed.		Pic 4 Desc.	Photo shows the ROW condition. ECDs are installed and functioning as designed.
