Visual Site Inspection Report

Project Name	H-600 Pipeline Spread H	AFE	124300138	Spread	H-600 Pipeline Spread H
Contractor	Precision			Report #	37956
Inspector	Jonathan Altizer			Date/Time	5/23/2022 3:47 PM
Permit #	TBD	Inspection Type	VA SWPP	Station Begin	12865+00
State	VA	Inspection Area	Partial	Station End	13024+00
County	Roanoke	Ground	Wet	Temperature (°F)	65.00
Municipality	N/A	Weather	Light Rain	Rain Gauge (in)	0.60
				Rain Accumulation Time (days)	1.00

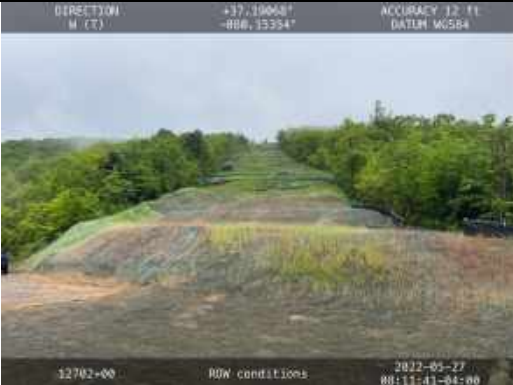
<p>12702+00 ROW conditions 2022-05-27 08:11:41-04:00</p>			
GPS Location	See photo for gps location data.		GPS Location	See photo for gps location data.	
Field Station#	12693+00		Field Station#	12702+00	
Pic 3 Desc.	Photo shows the ROW condition. ECDs are installed and functioning as designed.		Pic 4 Desc.	Photo shows the ROW condition. ECDs are installed and functioning as designed.

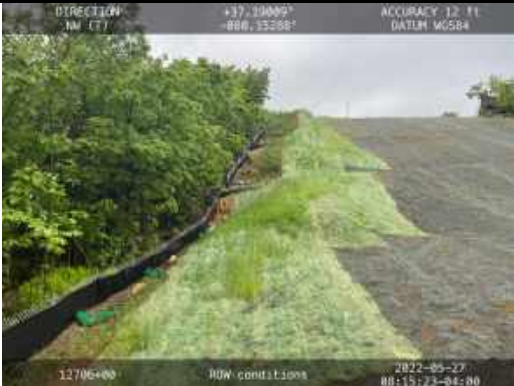
<p>12706+00 ROW conditions 2022-05-27 08:15:23-04:00</p>

<p>12709+00 ROW conditions 2022-05-27 08:19:32-04:00</p>			
GPS Location	See photo for gps location data.		GPS Location	See photo for gps location data.	
Field Station#	12706+00		Field Station#	12709+00	
Pic 5 Desc.	Photo shows the ROW condition. ECDs are installed and functioning as designed.		Pic 6 Desc.	Photo shows the ROW condition. ECDs are installed and functioning as designed.

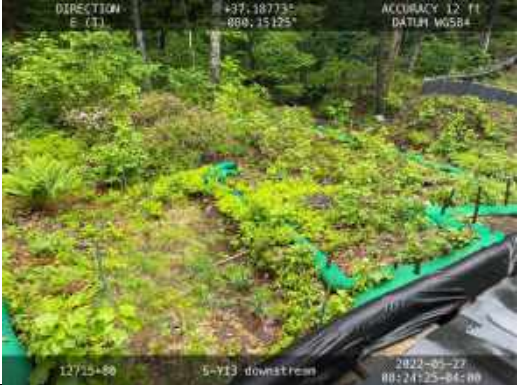
GPS Location	See photo for gps location data.		GPS Location	See photo for gps location data.	
Field Station#	12715+00		Field Station#	12715+80	
Pic 7 Desc.	Photo shows the bridge over streams S-Y13 and S-Y14.		Pic 8 Desc.	Photo shows stream S-Y13 downstream from the bridge.
