Visual Site Inspection Report

Project Name	H-600 Pipeline Spread H	AFE	124300138	Spread	H-600 Pipeline Spread H
Contractor	Precision			Report #	38179
Inspector	Logan Box			Date/Time	5/30/2022 4:48 PM
Permit #	TBD	Inspection Type	VA SWPP	Station Begin	13415+51
State	VA	Inspection Area	Partial	Station End	13525+99
County	Franklin	Ground	Damp	Temperature (°F)	81.00
Municipality	N/A	Weather	Sunny	Rain Gauge (in)	0.00
				Rain Accumulation Time (days)	0.00

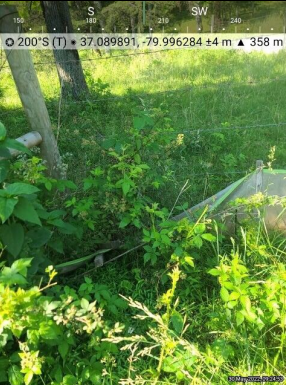
GPS Location	0000	GPS Location	0000		
Field Station#	13523+50	Field Station#	13522+49		
Pic 1 Desc.	P1 requires maintenance due to broken stakes, added to the punch list.	Pic 2 Desc.	CFS requires maintenance. Added to the punch list.

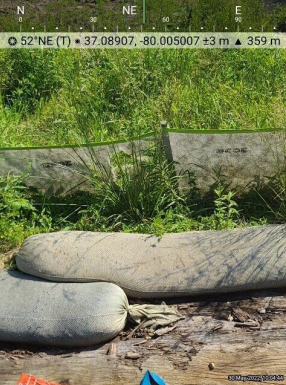
GPS Location	0000	GPS Location	00000		
Field Station#	13497+98	Field Station#	13525+08		
Pic 3 Desc.	P1 requires maintenance due to being weathered and torn. Documented and added to the punch list.	Pic 4 Desc.	P1 requires maintenance due to broken stakes, added to the punch list.

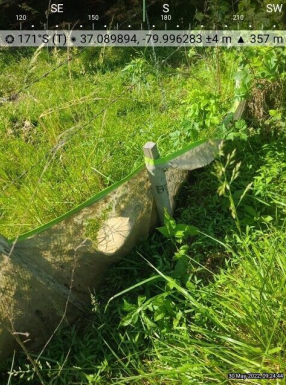
GPS Location	0000	GPS Location	0000		
Field Station#	13523+70	Field Station#	13522+00		
Pic 5 Desc.	Perimeter P1 requires maintenance. Added to the punch list for repair.	Pic 6 Desc.	Additional photo showing CFS that requires maintenance repairs. Added to the punch list.

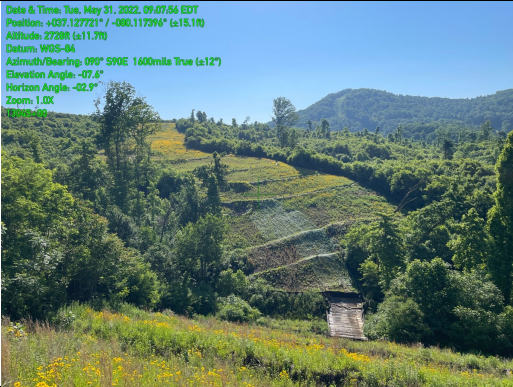
GPS Location	See photo for coordinates.		GPS Location	See photo for coordinates.	
Field Station#	13024+06		Field Station#	13045+00	
Pic 1 Desc.	S-G24 and S-G25; S-G24 flowing in UTV disturbance upstream of bridge.		Pic 2 Desc.	S-H1, ROW stable with vegetation establishing across the ROW.

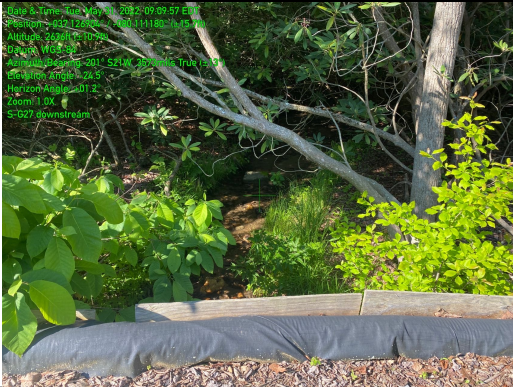
GPS Location	See photo for coordinates.		GPS Location	See photo for coordinates.	
Field Station#	13061+89		Field Station#	13062+96	
Pic 3 Desc.	S-G26, downstream, no turbidity noted in stream, banks well vegetated.		Pic 4 Desc.	S-G27, downstream, no turbidity noted.

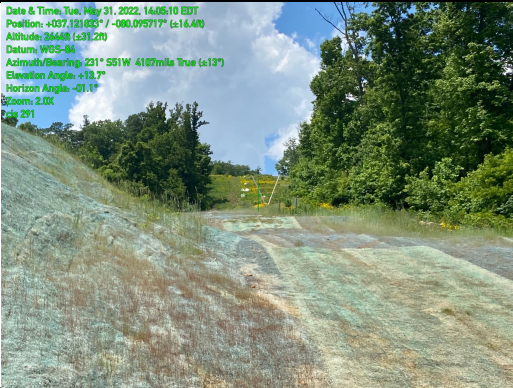
GPS Location	See photo for coordinates.		GPS Location	See photo for coordinates.	
Field Station#	13062+96		Field Station#	13116+00	
Pic 5 Desc.	GAS of S-G27, ROW stable, vegetative cover noted across LOD.		Pic 6 Desc.	ROW stabilized.

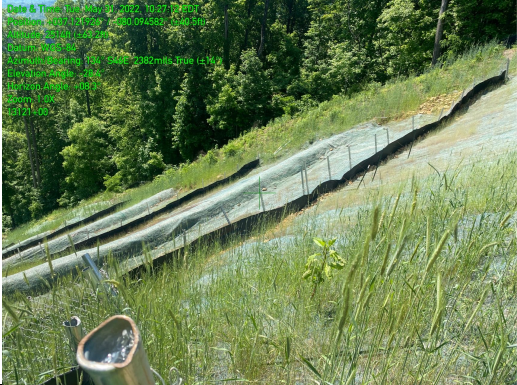
GPS Location	See photo for coordinates.		GPS Location	See photo for coordinates.	
Field Station#	13120+50		Field Station#	13121+00	
Pic 7 Desc.	ROW stabilized, some substrate accumulation noted in SSF across ROW.		Pic 8 Desc.	ROW stabilized, some substrate accumulation noted in SSF across ROW.

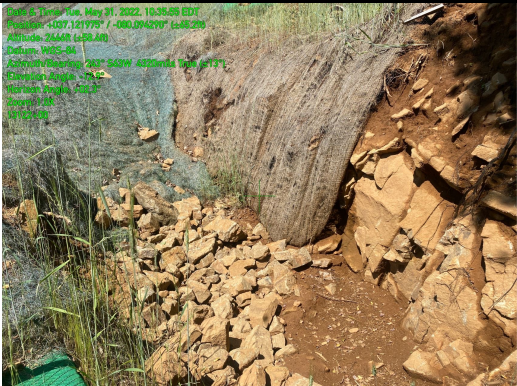
GPS Location	See photo for coordinates.		GPS Location	See photo for coordinates.	
Field Station#	13121+50		Field Station#	13122+00	
Pic 9 Desc.	SSF failure, denuded soil, CFS checks filled with fallen material; added to daily Punch List as maintenance items.		Pic 10 Desc.	Sump filled with material from SSF failure upslope; added to daily Punch List as maintenance item.

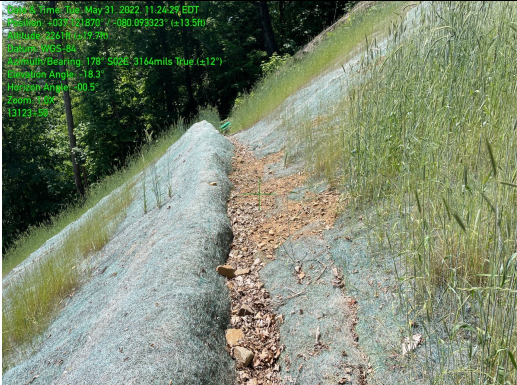
GPS Location	See photo for coordinates.		GPS Location	See photo for coordinates.	
Field Station#	13123+00		Field Station#	13123+50	
Pic 11 Desc.	Super silt fence failed downslope of sump, denuded soil present erosion; added to daily Punch List as maintenance item.		Pic 12 Desc.	Sediment and rock accumulated in waterbar throat from cut bank; added to daily Punch List as maintenance item.

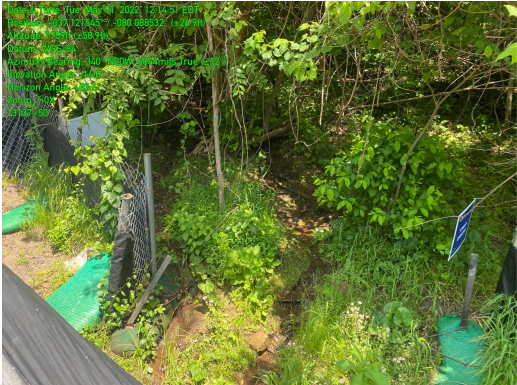
GPS Location	See photo for coordinates.		GPS Location	See photo for coordinates.	
Field Station#	13137+78		Field Station#	13121+50	
Pic 15 Desc.	S-D17/14, upstream, water level elevated, flow in both channels, no turbidity observed.		Pic 16 Desc.	Punch list items completed: repair SSF, stabilize, clean sump.

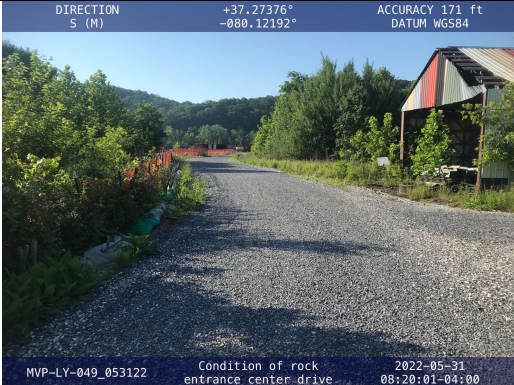
GPS Location	MVP-LY-049 See photo for gps data	GPS Location	MVP-LY-049 See photo for gps data		
Field Station#	+0	Field Station#	+0		
Pic 1 Desc.	Condition of rock entrance on center drive. Smaller stone applied over larger stone. Looking S.	Pic 2 Desc.	Condition of rock entrance on the north drive. No sediment or debris on stone. Looking SW.

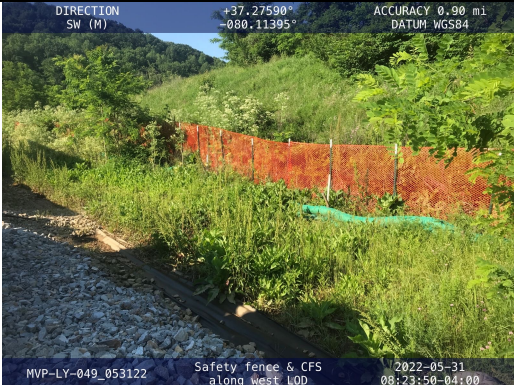
GPS Location	MVP-LY-049 See photo for gps data	GPS Location	MVP-LY-049 See photo for gps data		
Field Station#	+0	Field Station#	+0		
Pic 3 Desc.	Condition of safety fence and triple stack compost filter sock along west LOD, overgrown with vegetation. Looking SW.	Pic 4 Desc.	Condition of safety fence and triple stack compost filter sock along south LOD, overgrown with vegetation. Looking S.

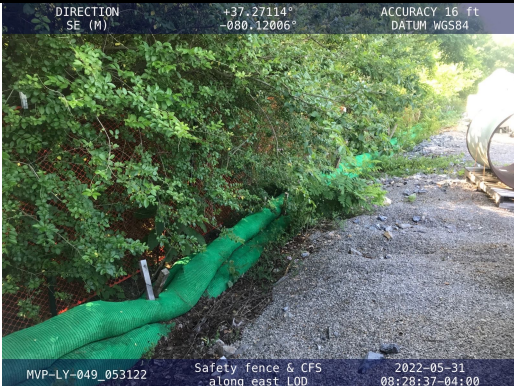
Field Station#	+0	Field Station#	+0		
Pic 5 Desc.	Condition of safety fence and triple stack compost filter sock along west LOD, overgrown with vegetation. Looking SE.	Pic 6 Desc.	Condition of safety fence and triple stack compost filter sock along north LOD. Looking W.

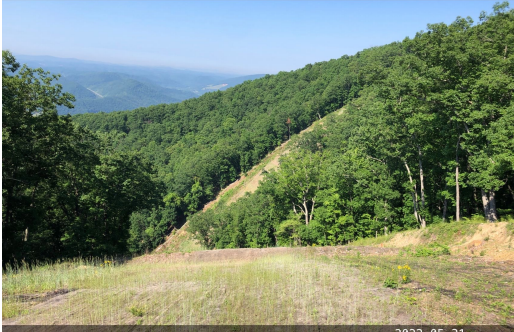
<div>Station 12298+00</div> <div>2022-05-31 09:55:34-04:00</div> </div>		<div> <div>DIRECTION NW (T)</div> <div>37.25431°N 080.22400°W</div> <div>ACCURACY 16 m DATUM WGS84</div>

<div>12306+00</div> <div>2022-05-31 10:00:38-04:00</div> </div>			
GPS Location	Please see photo for details.		GPS Location	Please see photo for details.	
Field Station#	12298+00		Field Station#	12306+00	
Pic 1 Desc.	Photo shows the stabilized ROW conditions with waterbars and that all ECDs are installed and are functioning as designed.		Pic 2 Desc.	Photo shows the stabilized ROW conditions with waterbars and that all ECDs are installed and are functioning as designed.	
<div> <div>DIRECTION S (T)</div> <div>37.25307°N 080.21832°W</div> <div>ACCURACY 4 m DATUM WGS84</div>

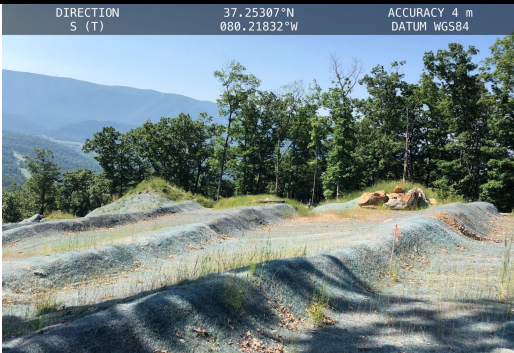
<div>Station 12325+50</div> <div>2022-05-31 10:09:25-04:00</div> </div>		<div> <div>DIRECTION E (T)</div> <div>37.25248°N 080.21742°W</div> <div>ACCURACY 16 m DATUM WGS84</div>

GPS Location	Please see photo for details.		GPS Location	Please see photo for details.	
Field Station#	12325+50		Field Station#	12328+50	
Pic 3 Desc.	Photo shows the stabilized ROW conditions with waterbars and that all ECDs are installed and are functioning as designed.		Pic 4 Desc.	Photo shows the stabilized ROW conditions with waterbars and that all ECDs are installed and are functioning as designed.	
<div> <div>DIRECTION SE (T)</div> <div>37.25258°N 080.21560°W</div> <div>ACCURACY 200 m DATUM WGS84</div>

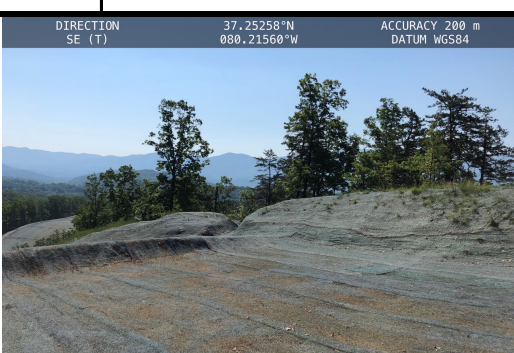
<div>Station 12333+00</div> <div>2022-05-31 10:14:46-04:00</div> </div>		<div> <div>DIRECTION E (T)</div> <div>37.25266°N 080.21468°W</div> <div>ACCURACY 24 m DATUM WGS84</div>

Pic 5 Desc.	Photo shows the stabilized ROW conditions with waterbars and that all ECDs are installed and are functioning as designed.		Pic 6 Desc.	Photo shows stabilized side slope on ROW along with slope drain pipes equipped with stone inlet protection & plunge pools.

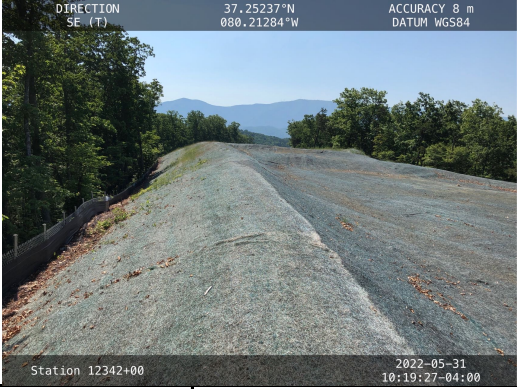
<p>DIRECTION SE (T) 37.25237°N 080.21284°W ACCURACY 8 m DATUM WGS84</p> <p>Station 12342+00 2022-05-31 10:19:27-04:00</p>

<p>DIRECTION S (T) 37.24816°N 080.20962°W ACCURACY 24 m DATUM WGS84</p> <p>Station 12362+00 2022-05-31 10:32:03-04:00</p>			
GPS Location	Please see photo for details.		GPS Location	Please see photo for details.	
Field Station#	12342+00		Field Station#	12362+00	
Pic 7 Desc.	Photo shows the stabilized ROW conditions with waterbars and that all ECDs are installed and are functioning as designed.		Pic 8 Desc.	Photo shows the stabilized ROW conditions with waterbars and that all ECDs are installed and are functioning as designed.

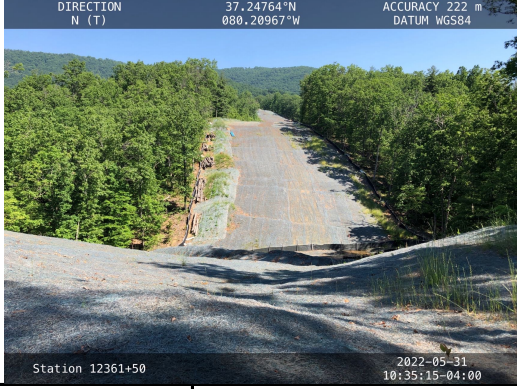
<p>DIRECTION N (T) 37.24764°N 080.20967°W ACCURACY 222 m DATUM WGS84</p> <p>Station 12361+50 2022-05-31 10:35:15-04:00</p>

GPS Location	Please see photo for details.		GPS Location	Please see photo for details.	
Field Station#	12361+50		Field Station#	12368+00	
Pic 9 Desc.	Photo shows the stabilized ROW conditions with waterbars and that all ECDs are installed and are functioning as designed.		Pic 10 Desc.	Photo shows the stabilized ROW conditions with waterbars and that all ECDs are installed and are functioning as designed.

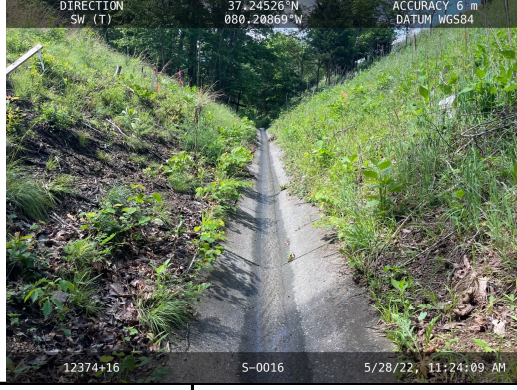
<p>DIRECTION SW (T) 37.24526°N 080.20869°W ACCURACY 6 m DATUM WGS84</p> <p>12374+16 S-0016 5/28/22, 11:24:09 AM</p>

<p>DIRECTION SW (T) 37.24434°N 080.20700°W ACCURACY 4 m DATUM WGS84</p> <p>12380+04 S-NN19 5/31/22, 9:25:50 AM</p>			
GPS Location	Please see photo for details.		GPS Location	Please see photo for details.	
Field Station#	12374+16		Field Station#	12380+04	
Pic 11 Desc.	Photo shows upstream view of Stream S-0016.		Pic 12 Desc.	Photo shows downstream view of Stream S-NN19 from equipment bridge spanning the stream channel.

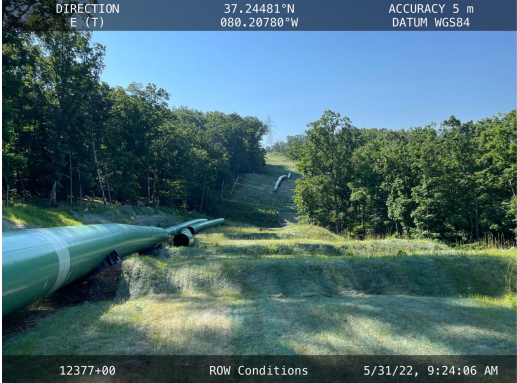
GPS Location	Please see photo for details.		GPS Location	Please see photo for details.	
Field Station#	12377+00		Field Station#	12382+50	
Pic 13 Desc.	Photo shows the stabilized ROW conditions with waterbars and that all ECDs are installed and are functioning as designed.		Pic 14 Desc.	Photo shows drainage feature that runs across ROW in low lying area.

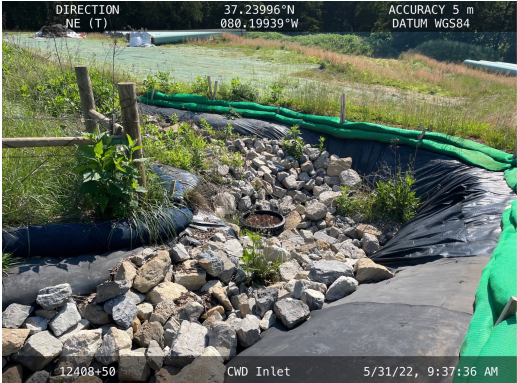
GPS Location	Please see photo for details.		GPS Location	Please see photo for details.	
Field Station#	12408+50		Field Station#	12392+00	
Pic 15 Desc.	Photo shows clean water diversion inlet with stone inlet protection.		Pic 16 Desc.	Photo shows the stabilized ROW conditions with waterbars and that all ECDs are installed and are functioning as designed.

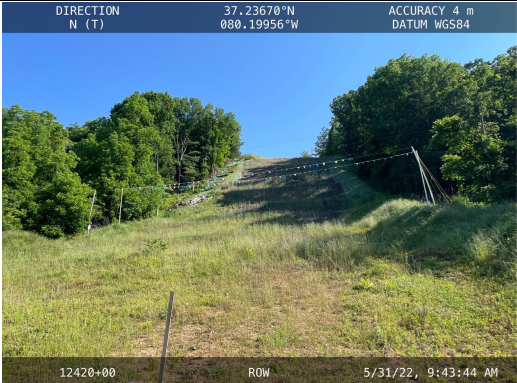
Pic 17 Desc.	Photo shows the stabilized ROW conditions with waterbars and that all ECDs are installed and are functioning as designed.		Pic 18 Desc.	Photo shows the stabilized ROW conditions with waterbars and that all ECDs are installed and are functioning as designed.

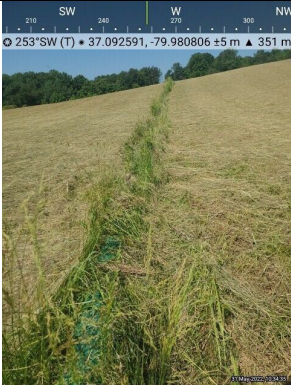
GPS Location	00000	GPS Location	0000		
Field Station#	13570+30	Field Station#	13645+00		
Pic 1 Desc.	Observed ECDs in the area where 3rd party mowing activities were done inside the LOD . No environmental issues observed at the time of inspection.		Pic 2 Desc.	Monitored CFS along the row in permanent area. No issues observed at the time of inspection.

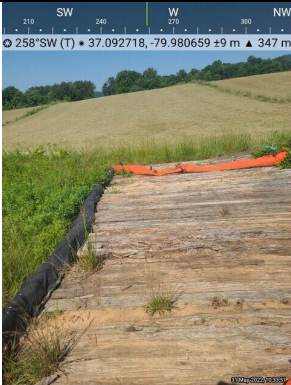
GPS Location	0000	GPS Location	00000		
Field Station#	13572+83	Field Station#	13525+08		
Pic 3 Desc.	Equipment bridge in place with functioning ECDs over natural drain area. No environmental issues observed at the time of inspection.		Pic 4 Desc.	Monitored CFS along the row in permanent area. No issues observed at the time of inspection.

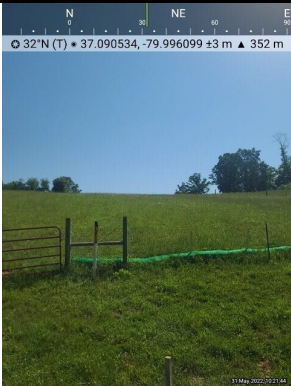
GPS Location	0000	GPS Location	0000		
Field Station#	13526+08	Field Station#	13562+83		
Pic 5 Desc.	Row photo showing vegetation and ECDs in place in a permanent area of row. No issues were observed at the time of inspection.		Pic 6 Desc.	Row photo showing where a land owner has started cutting hay from inside the row. No environmental issues observed at the time of inspection.

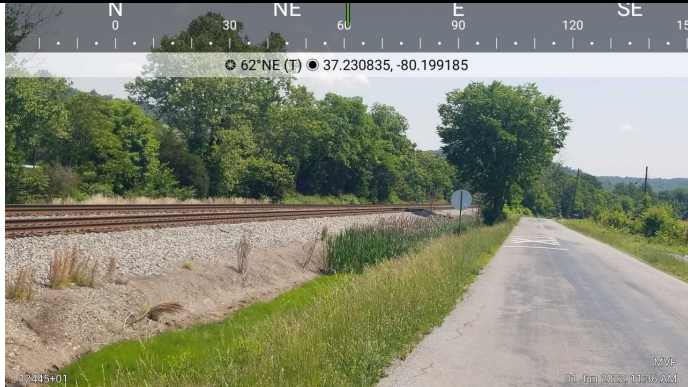
GPS Location	See Above		GPS Location	See Above	
Field Station#	12445+01		Field Station#	12455+21	
Pic 1 Desc.	Overview of Waterbody S-I1. ROW is stable. No erosion or sedimentation concerns noted.		Pic 2 Desc.	Overview of Waterbody S-CD12b. ECDs are functional and ROW is stable.

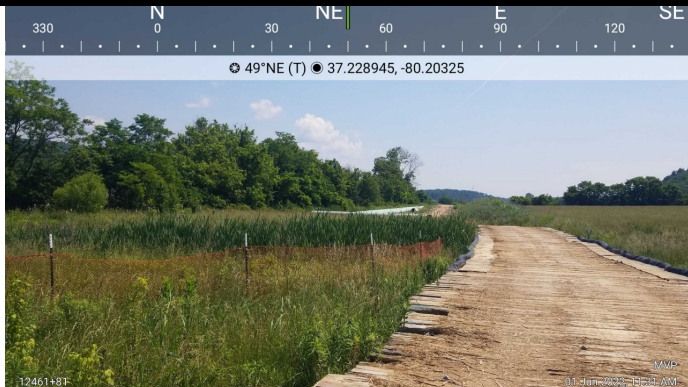
GPS Location	See Above		GPS Location	See Above	
Field Station#	12461+81		Field Station#	12481+00	
Pic 3 Desc.	Overview of Wetland W-KL58. ECDs are functional and ROW is stable.		Pic 4 Desc.	(reroute stationing) ROW Overview (temporary stabilization). ECDs are functional and ROW is stable.

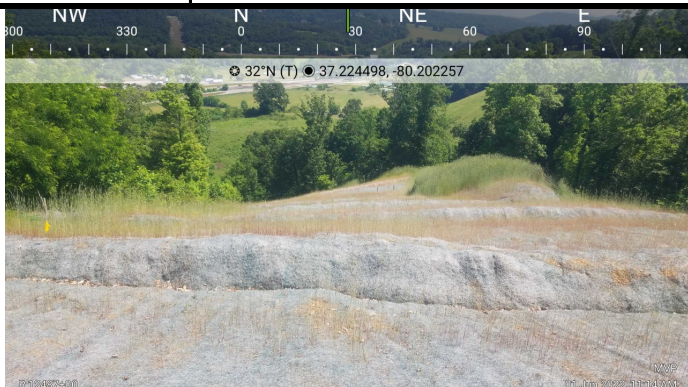
GPS Location	See Above		GPS Location	See Above	
Field Station#	12487+00		Field Station#	12481+00	
Pic 5 Desc.	(reroute stationing) ROW Overview (temporary stabilization). ECDs are functional and ROW is stable.		Pic 6 Desc.	ROW Overview (temporary stabilization). ECDs are functional and ROW is stable.

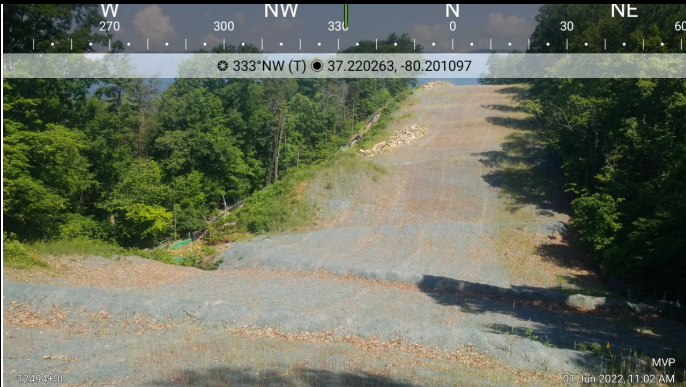
GPS Location	See Above		GPS Location	See Above	
Field Station#	12494+00		Field Station#	12498+00	
Pic 7 Desc.	ROW Overview (temporary stabilization). ECDs are functional and ROW is stable.		Pic 8 Desc.	ROW Overview (temporary stabilization). ECDs are functional and ROW is stable.

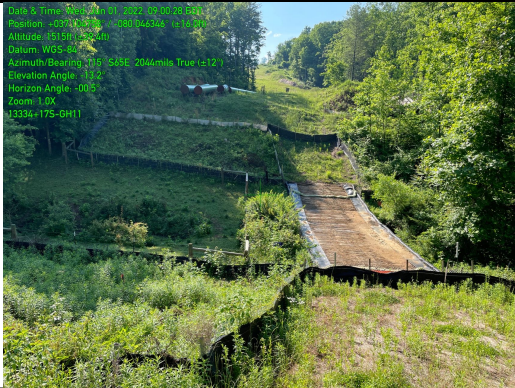
<p> Date & Time: Wed, Jun 01, 2022, 08:45:00 EDT Position: +037.104012° / -060.049269° (±15.4m) Altitude: 1463ft (±11.2ft) Datum: WGS-84 Azimuth/Bearing: 118° S42E 200ft/mile True (±12°) Elevation Angle: -13.1° Horizon Angle: -01.0° Zoom: 1.0X 13334+17 S-GH11 </p>		GPS Location 0	
Field Station# 13332+00		Field Station# 13334+17			
Pic 5 Desc. ROW and ECDs in good condition and stable		Pic 6 Desc. MVP-S-GH11 and corresponding buffer zone in good condition

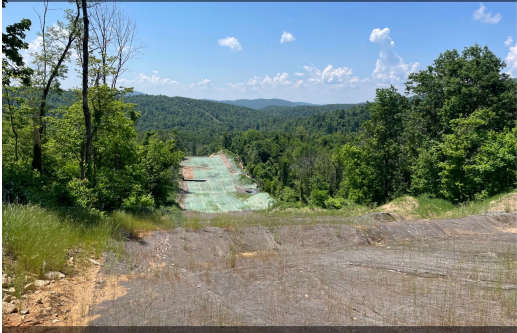
12773+00 ROW 6/1/22, 11:54:23 AM		DIRECTION SW (T) 37.17490°N 080.13948°W ACCURACY 4 m DATUM WGS84

12779+50 Level spreader 6/1/22, 11:57:56 AM			
GPS Location	See photo		GPS Location	See photo	
Field Station#	12773+00		Field Station#	12779+50	
Pic 13 Desc.	Current ROW conditions. ROW is stable. ECDs are functional.		Pic 14 Desc.	Level spreader is functional	
DIRECTION S (T) 37.17414°N 080.13920°W ACCURACY 4 m DATUM WGS84

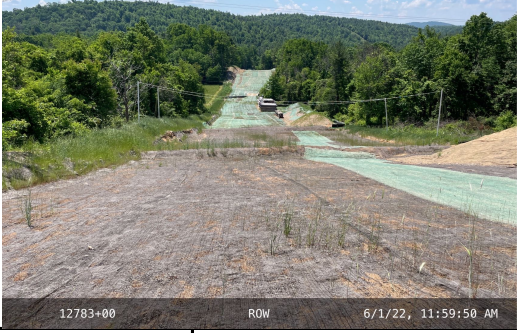
12783+00 ROW 6/1/22, 11:59:50 AM		DIRECTION SW (T) 37.17250°N 080.13875°W ACCURACY 5 m DATUM WGS84

12786+75 Level spreader 6/1/22, 12:03:16 PM			
GPS Location	See photo		GPS Location	See photo	
Field Station#	12783+00		Field Station#	12786+75	
Pic 15 Desc.	Current ROW conditions. ROW is stable. ECDs are functional.		Pic 16 Desc.	Level spreader is functional

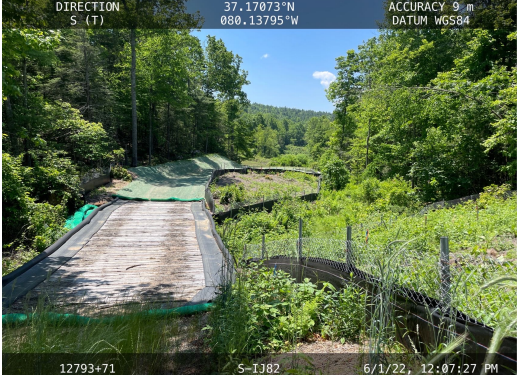
12793+71 S-IJ82 6/1/22, 12:07:27 PM		DIRECTION SW (T) 37.17071°N 080.13810°W ACCURACY 5 m DATUM WGS84

12793+71 S-IJ82 6/1/22, 12:07:40 PM			
GPS Location	See photo		GPS Location	See photo	
Field Station#	12793+71		Field Station#	12793+71	
Pic 17 Desc.	Overview of Stream S-IJ82		Pic 18 Desc.	Downstream of crossing at Stream S-IJ82

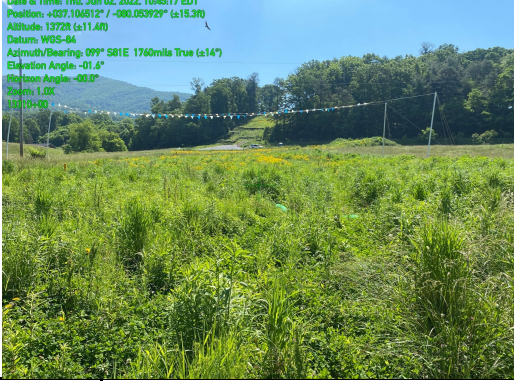
GPS Location	0	GPS Location	0		
Field Station#	13310+00	Field Station#	13309+09		
Pic 1 Desc.	ROW and ECDs In good condition and stable		Pic 2 Desc.	MVP-S-GH7 and corresponding buffer zone in good condition	
<p>Date & Time: Thu, Jun 02, 2022, 10:45:58 EDT Position: +037.104779° / -080.053200° (±15.410) Altitude: 13608 (±11.310) Datum: WGS-84 Azimuth/Bearing: 303° N57W 5387mils True (±14°) Elevation Angle: +05.0° Horizon Angle: -00.9° Zoom: 1.0X 13306+00</p>

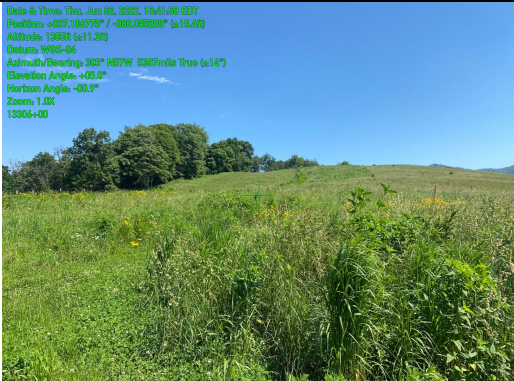
GPS Location	0	GPS Location	0		
Field Station#	13306+00	Field Station#	13262+62		
Pic 3 Desc.	ROW and ECDs In good condition and stable		Pic 4 Desc.	Flanders Road Crossing in good condition	
<p>Date & Time: Thu, Jun 02, 2022, 10:45:36 EDT Position: +037.104512° / -080.052929° (±15.310) Altitude: 13728 (±11.40) Datum: WGS-84 Azimuth/Bearing: 254° S64W 4338mils True (±14°) Elevation Angle: +05.3° Horizon Angle: -00.7° Zoom: 1.0X 13261+50</p>

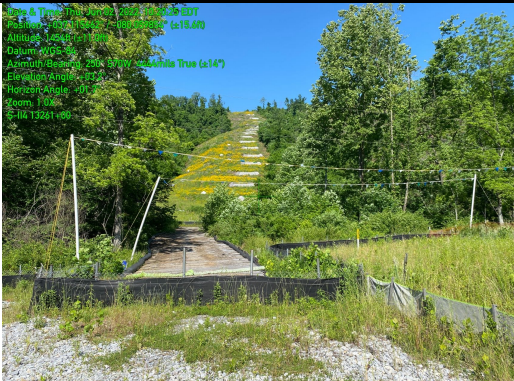
GPS Location	0	GPS Location	0		
Field Station#	13260+66	Field Station#	13260+50		
Pic 5 Desc.	MVP-S-II4 and corresponding buffer zone in good condition		Pic 6 Desc.	ROW and ECDs In good condition and stable

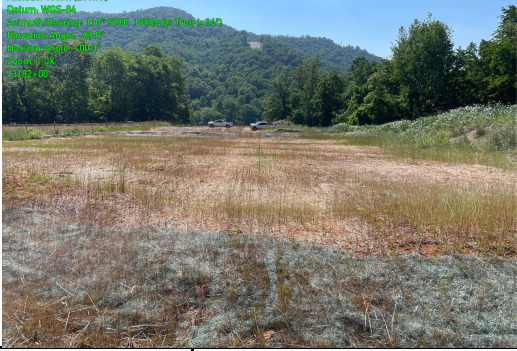
GPS Location	0	GPS Location	0		
Field Station#	13182+00	Field Station#	13175+00		
Pic 7 Desc.	ROW and ECDs In good condition and stable	Pic 8 Desc.	ROW and ECDs In good condition and stable		
<p>Date & Time: Thu, Jun 02, 2022, 10:16:28 EDT Position: +037.125240° / -080.082940° (s14.28) Altitude: 1611ft (s11.70) Datum: WGS-84 Azimuth/Bearing: 265° S60W 4371mils True (s12°) Elevation Angle: -03.0° Horizontal Angle: -05.0° Zoom: 1.0X 13169+00</p>

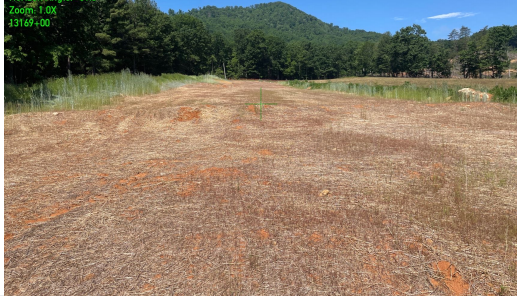
GPS Location	0	GPS Location	0		
Field Station#	13169+00	Field Station#	13161+50		
Pic 9 Desc.	ROW and ECDs In good condition and stable	Pic 10 Desc.	Slope drain pipe in good condition and functioning properly		
<p>Date & Time: Thu, Jun 02, 2022, 10:16:59 EDT Position: +037.124440° / -080.083117° (s14.98) Altitude: 1729ft (s13.10) Datum: WGS-84 Azimuth/Bearing: 195° S13W 3431mils True (s12°) Elevation Angle: -22.0° Horizontal Angle: +03.1° Zoom: 1.0X 13161+50</p>

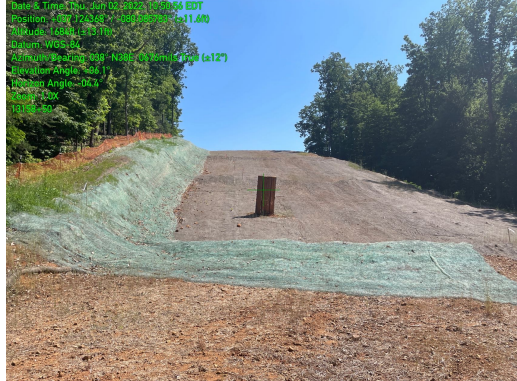
GPS Location	0	GPS Location	0		
Field Station#	13158+50	Field Station#	13157+22		
Pic 11 Desc.	ROW and ECDs In good condition and stable	Pic 12 Desc.	MVP-S-D11 and corresponding buffer zone in good condition

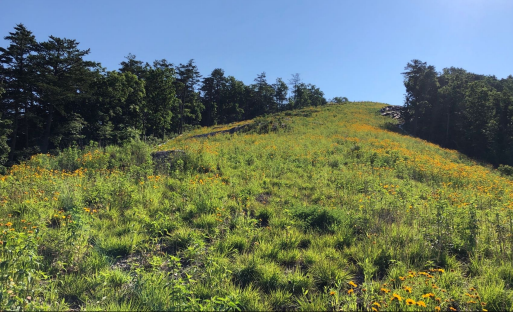
<div>Station 12284+75</div> <div>2022-06-02 09:10:01-04:00</div> </div>		<div> <div>DIRECTION NE (T)</div> <div>37.25174°N 080.24558°W</div> <div>ACCURACY 24 m DATUM WGS84</div>

<div>Station 12236+00</div> <div>2022-06-02 09:16:29-04:00</div> </div>			
GPS Location	Please see photo for details.		GPS Location	Please see photo for details.	
Field Station#	12284+75		Field Station#	12236+00	
Pic 1 Desc.	Photo shows the stabilized ROW conditions with water bars and that all ECDs are installed and are functioning as designed.		Pic 2 Desc.	Photo shows stabilized permanent restoration section of ROW with permanent slope breakers and level spreaders.	
<div> <div>DIRECTION S (T)</div> <div>37.25165°N 080.24776°W</div> <div>ACCURACY 6 m DATUM WGS84</div>

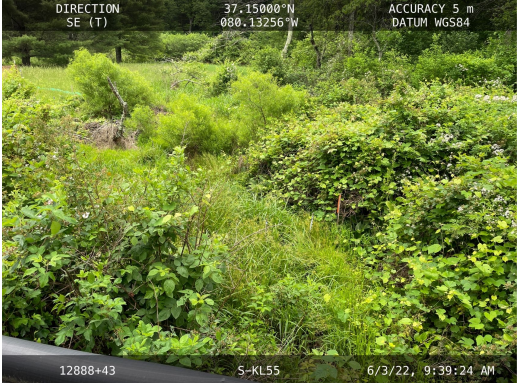
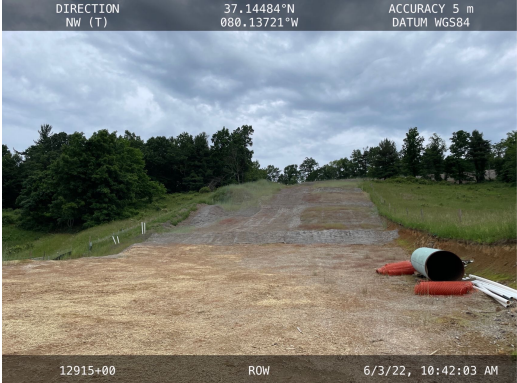
GPS Location	See photo		GPS Location	See photo	
Field Station#	12888+43		Field Station#	12915+00	
Pic 7 Desc.	Downstream of crossing at Stream S-KL55		Pic 8 Desc.	Current ROW conditions. ROW is stable. ECDs are functional.

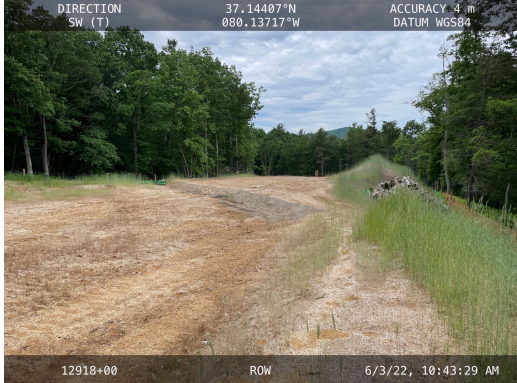
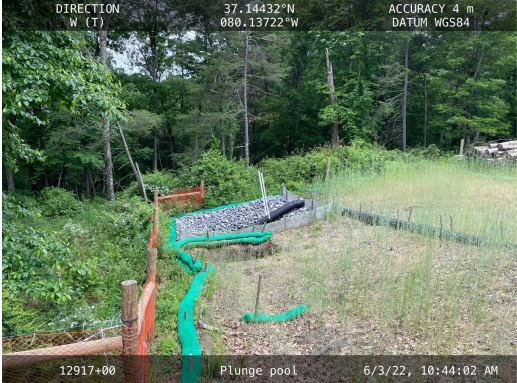
GPS Location	See photo		GPS Location	See photo	
Field Station#	12918+00		Field Station#	12917+00	
Pic 9 Desc.	Current ROW conditions. ROW is stable. ECDs are functional.		Pic 10 Desc.	Plunge pool is functional

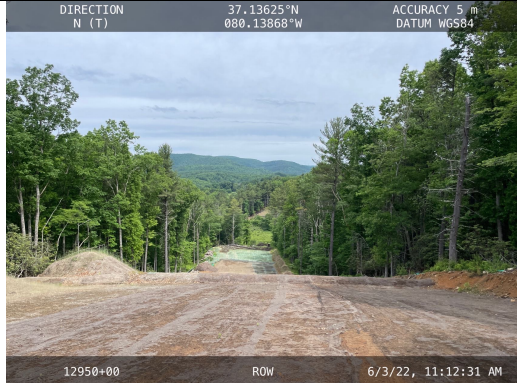
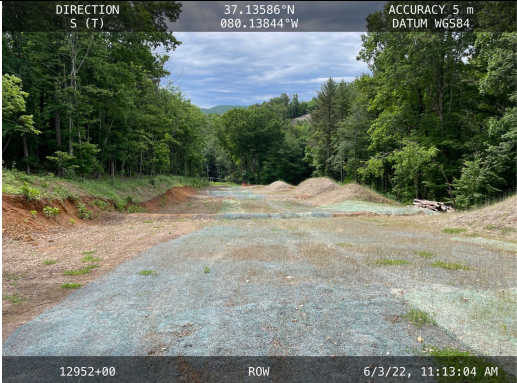
GPS Location	See photo		GPS Location	See photo	
Field Station#	12950+00		Field Station#	12952+00	
Pic 11 Desc.	Current ROW conditions. ROW is stable. ECDs are functional.		Pic 12 Desc.	Current ROW conditions. ROW is stable. ECDs are functional.

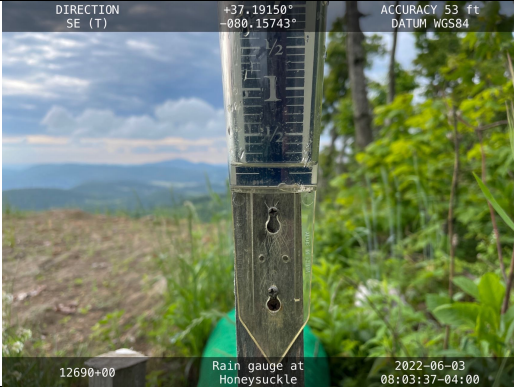
<p>DIRECTION SE (T) +37.19150° -080.15743° ACCURACY 53 ft DATUM WGS84</p> <p>12690+00 Rain gauge at Honeysuckle 2022-06-03 08:03:37-04:00</p>

<p>DIRECTION SE (T) +37.19142° -080.15683° ACCURACY 15 ft DATUM WGS84</p> <p>12693+00 ROW conditions 2022-06-03 08:04:57-04:00</p>			
GPS Location	See photo for gps location data.		GPS Location	See photo for gps location data.	
Field Station#	12690+00		Field Station#	12693+00	
Pic 1 Desc.	Photo shows the rain gauge at Honeysuckle. 0.2" of rainfall within the last 24 hours.		Pic 2 Desc.	Photo shows the ROW condition. ECDs are installed and functioning as designed.

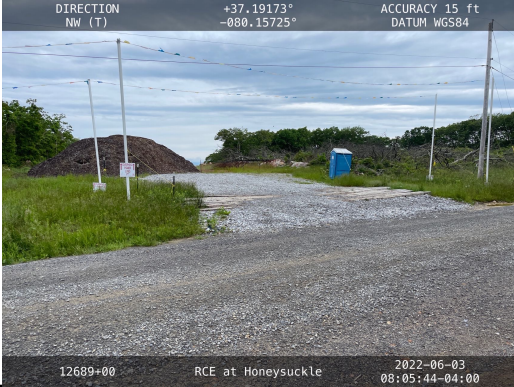
GPS Location	See photo for gps location data.		GPS Location	See photo for gps location data.	
Field Station#	12689+00		Field Station#	12638+00	
Pic 3 Desc.	Photo shows the RCE at Honeysuckle.		Pic 4 Desc.	Photo shows the ROW condition. ECDs are installed and functioning as designed.

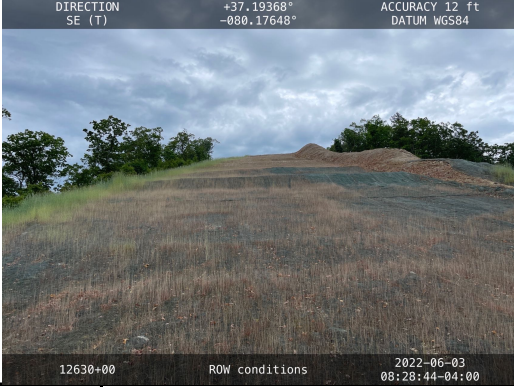
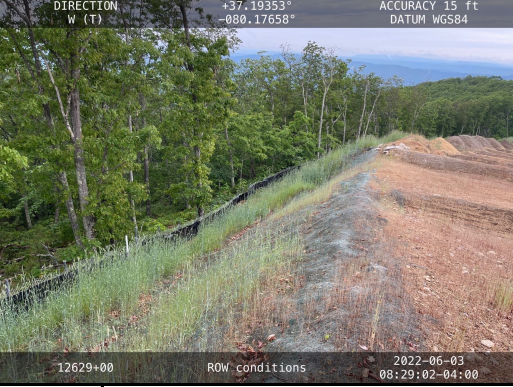
<p>DIRECTION W (T) +37.19353° -080.17658° ACCURACY 15 ft DATUM WGS84</p> <p>12629+00 ROW conditions 2022-06-03 08:29:02-04:00</p>			
GPS Location	See photo for gps location data.		GPS Location	See photo for gps location data.	
Field Station#	12630+00		Field Station#	12629+00	
Pic 5 Desc.	Photo shows the ROW condition. ECDs are installed and functioning as designed.		Pic 6 Desc.	Photo shows the ROW condition. ECDs are installed and functioning as designed.

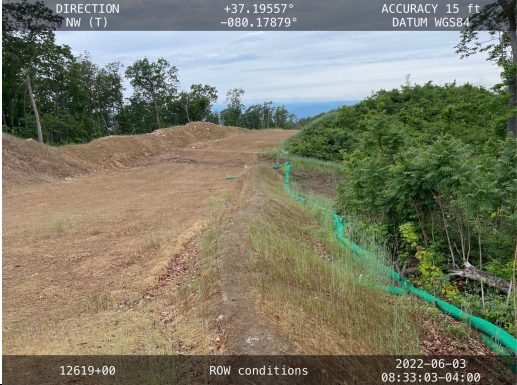
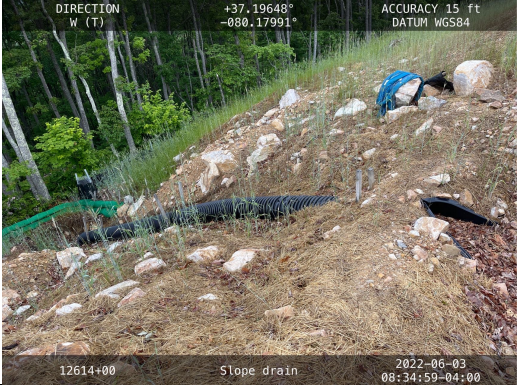
GPS Location	See photo for gps location data.		GPS Location	See photo for gps location data.	
Field Station#	12619+00		Field Station#	12614+00	
Pic 7 Desc.	Photo shows the ROW condition. ECDs are installed and functioning as designed.		Pic 8 Desc.	Photo shows the ROW condition. ECDs are installed and functioning as designed.

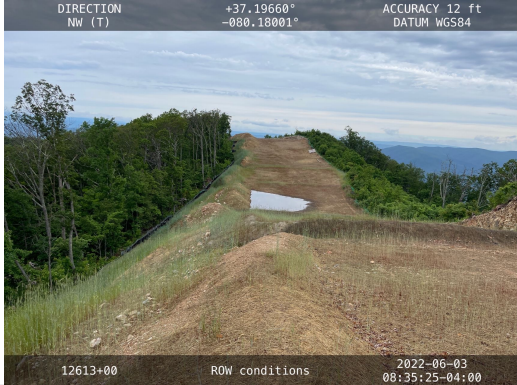
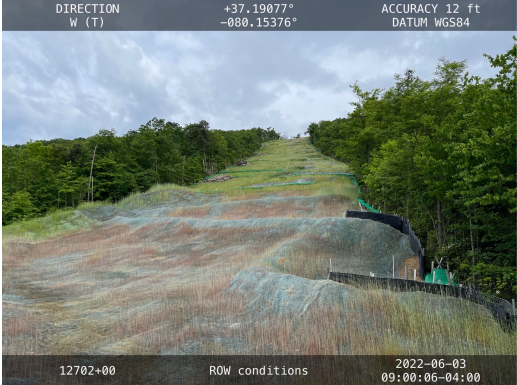
GPS Location	See photo for gps location data.		GPS Location	See photo for gps location data.	
Field Station#	12613+00		Field Station#	12702+00	
Pic 9 Desc.	Photo shows the ROW condition. ECDs are installed and functioning as designed.		Pic 10 Desc.	Photo shows the ROW condition. ECDs are installed and functioning as designed.

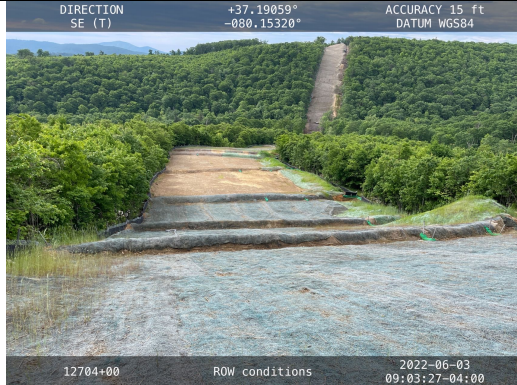
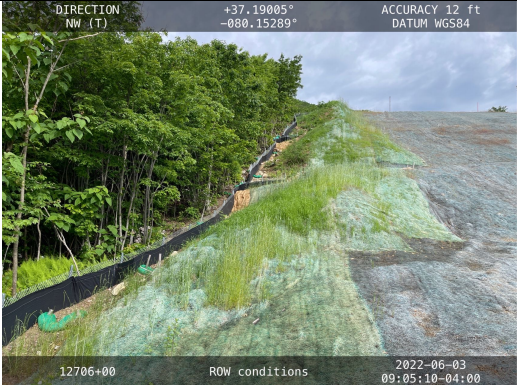
GPS Location	See photo for gps location data.		GPS Location	See photo for gps location data.	
Field Station#	12704+00		Field Station#	12706+00

Pic 11 Desc.	Photo shows the ROW condition. ECDs are installed and functioning as designed.		Pic 12 Desc.	Photo shows the ROW condition. ECDs are installed and functioning as designed.

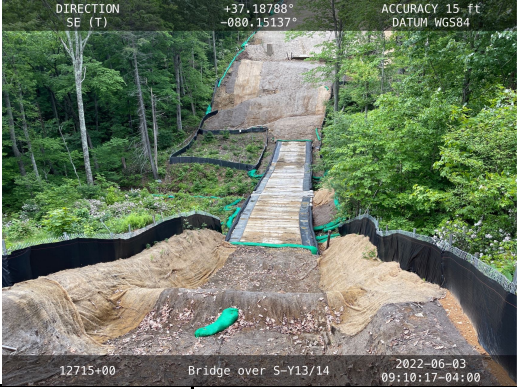
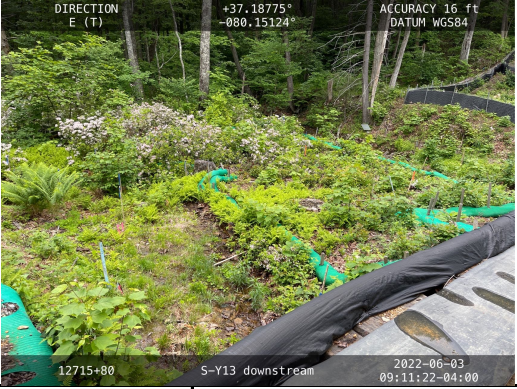
<p>DIRECTION E (T) +37.18775° -080.15124° ACCURACY 16 ft DATUM WGS84</p> <p>12715+80 S-Y13 downstream 2022-06-03 09:11:22-04:00</p>			
GPS Location	See photo for gps location data.		GPS Location	See photo for gps location data.	
Field Station#	12715+00		Field Station#	12715+80	
Pic 13 Desc.	Photo shows the bridge over streams S-Y13 and S-Y14.		Pic 14 Desc.	Photo shows S-Y13 downstream from the bridge.

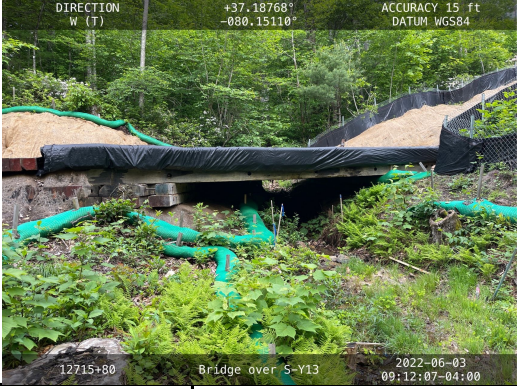
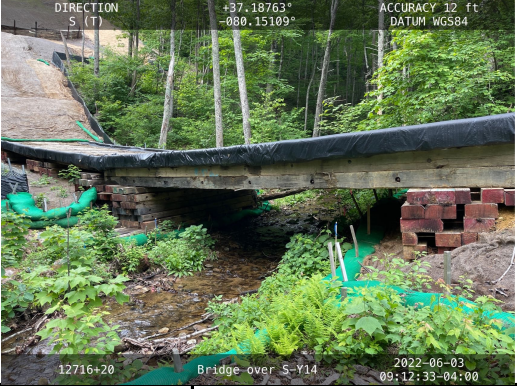
Field Station#	12715+80		Field Station#	12716+20	
Pic 15 Desc.	Photo shows the bridge over stream S-Y13.		Pic 16 Desc.	Photo shows the bridge over stream S-Y14.

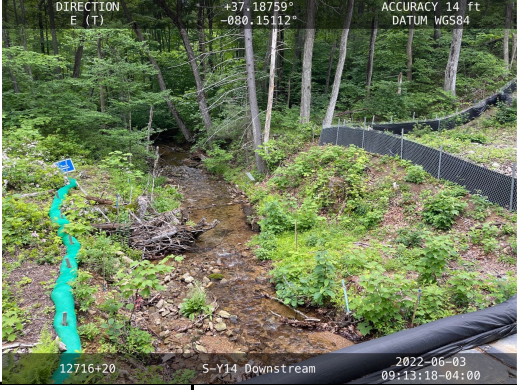
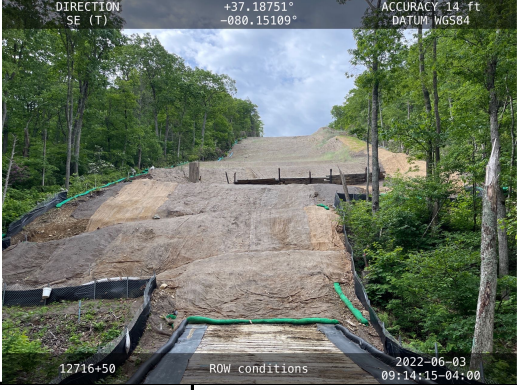
<p>DIRECTION SE (T) +37.18751° -080.15109° ACCURACY 14 ft DATUM WGS84</p> <p>12716+50 ROW conditions 2022-06-03 09:14:15-04:00</p>			
GPS Location	See photo for gps location data.		GPS Location	See photo for gps location data.	
Field Station#	12716+20		Field Station#	12716+50	
Pic 17 Desc.	Photo shows stream S-Y14 downstream from the bridge.		Pic 18 Desc.	Photo shows the ROW condition. ECDs are installed and functioning as designed.

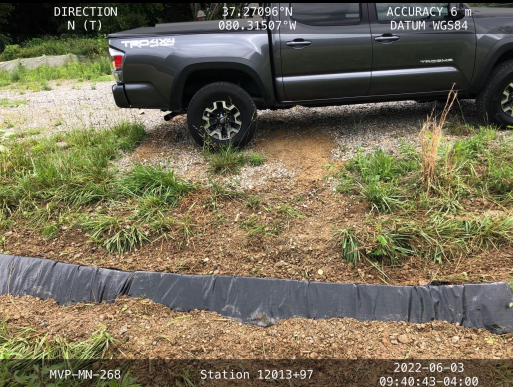
E&S BMPs	Compliance Level	Corrective Action	Corrective Time Frame	Date Repaired
Cleanwater Diversion Berm	Acceptable			
Compost Filter Sock	Acceptable			
Other - Explain in Comments	Communication	Replace flattened triangle diversion	24 Hours	6/3/2022
Erosion Control Blanket	Acceptable			
Silt Fence (Reinforce Filter Fence)	Acceptable			
Vegetative Stabilization (Permanent)	Acceptable			
Vegetative Stabilization (Temporary)	Acceptable			
Sensitive Resource Buffer	Acceptable			
Waterbar	Acceptable

GPS Location	Please see photo for details.		GPS Location	Please see photo for details.	
Field Station#	12013+97		Field Station#	12013+97	
Pic 1 Desc.	Photo shows todays punch list item. Replace flattened triangle diversion and fix rills above.		Pic 2 Desc.	Photo shows resolved punch list item.

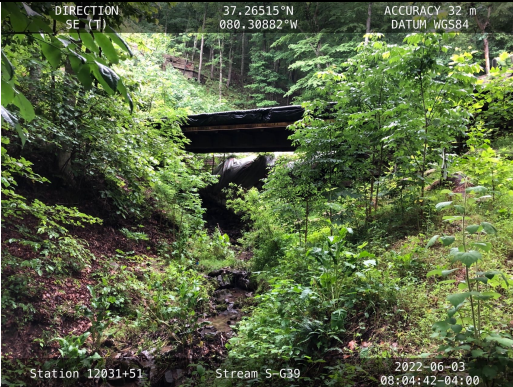
GPS Location	Please see photo for details.		GPS Location	Please see photo for details.	
Field Station#	12013+97		Field Station#	12031+51	
Pic 3 Desc.	Photo shows tree stuck under equipment bridge spanning the stream channel of Stream S-G36.		Pic 4 Desc.	Photo shows downstream view of Stream S-S-G39.

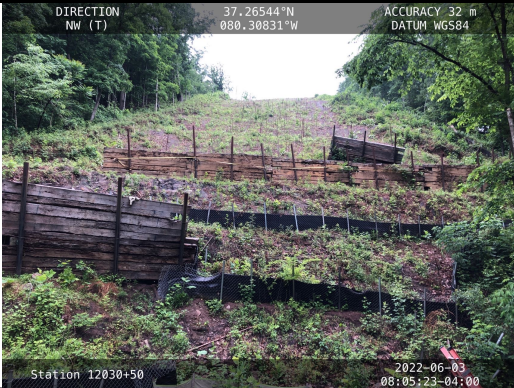
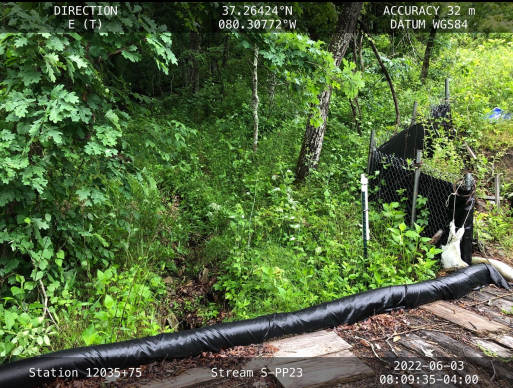
GPS Location	Please see photo for details.		GPS Location	Please see photo for details.	
Field Station#	12030+50		Field Station#	12035+75	
Pic 5 Desc.	Photo shows stabilized ROW conditions.		Pic 6 Desc.	Photo shows upstream view of Stream S-PP23 from equipment bridge spanning the stream channel.

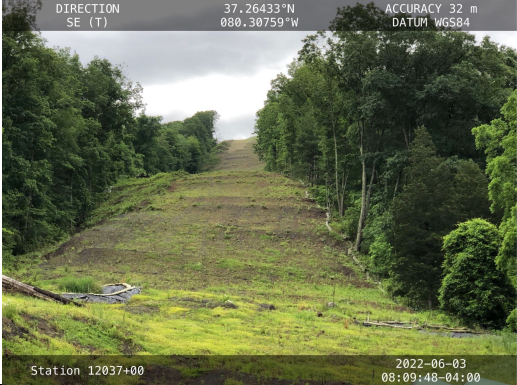
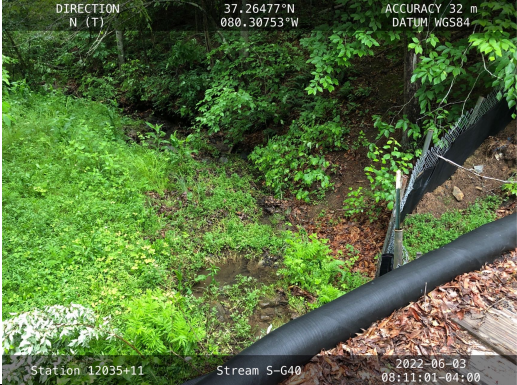
GPS Location	Please see photo for details.		GPS Location	Please see photo for details.	
Field Station#	12037+00		Field Station#	12035+11	
Pic 7 Desc.	Photo shows stabilized ROW conditions.		Pic 8 Desc.	Photo shows downstream view of Stream S-G40 from the equipment bridge spanning the stream channel.

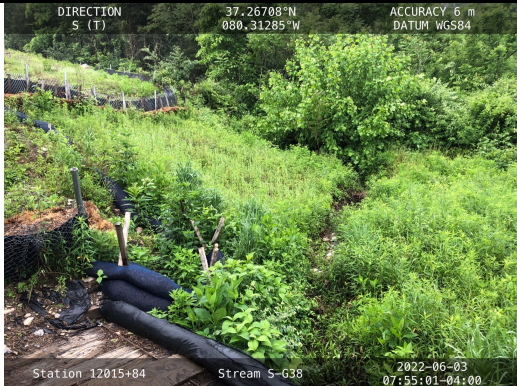
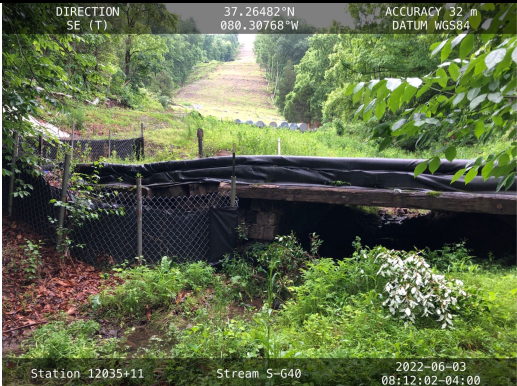
GPS Location	Please see photo for details.		GPS Location	Please see photo for details.	
Field Station#	12015+84		Field Station#	12035+11	
Pic 9 Desc.	Photo shows upstream view of Stream S-38 from the equipment bridge spanning the stream channel.		Pic 10 Desc.	Photo shows downstream view of Stream S-G40 along with equipment bridge spanning the stream channel.

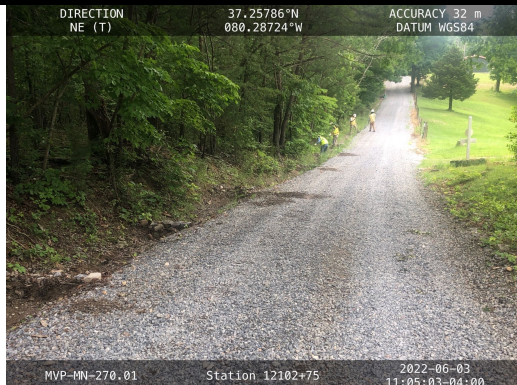
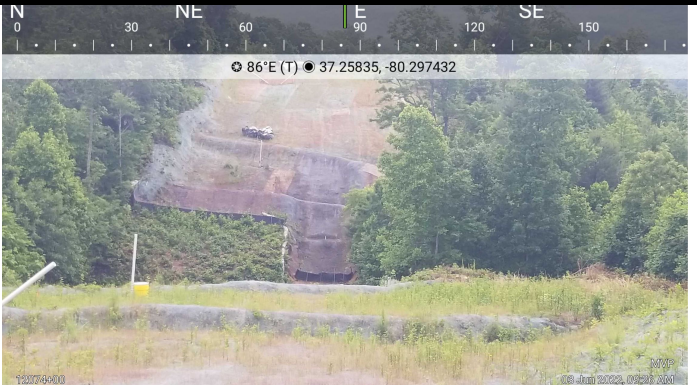
GPS Location	Please see photo for details.		GPS Location	Please see photo for details.	
Field Station#	12102+75		Field Station#	12074+00

Pic 11 Desc.	Photo shows environmental crew cleaning rock checks out sling MVP-MN-270.01.		Pic 12 Desc.	Photo shows stabilized ROW conditions.

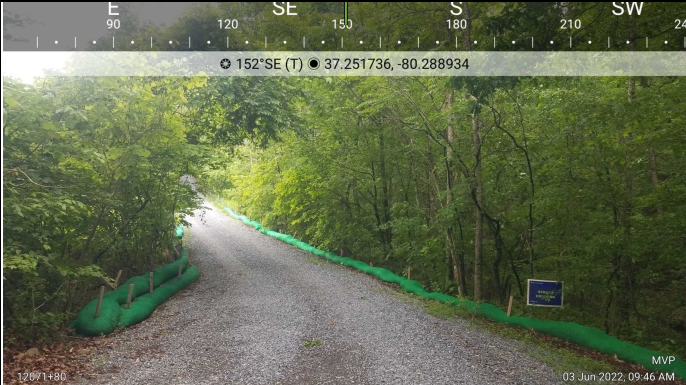
GPS Location	Please see photo for details.		GPS Location	Please see photo for details.	
Field Station#	12071+80		Field Station#	12106+00	
Pic 13 Desc.	Photo shows MVP-MN-270.		Pic 14 Desc.	Photo shows stabilized ROW conditions.

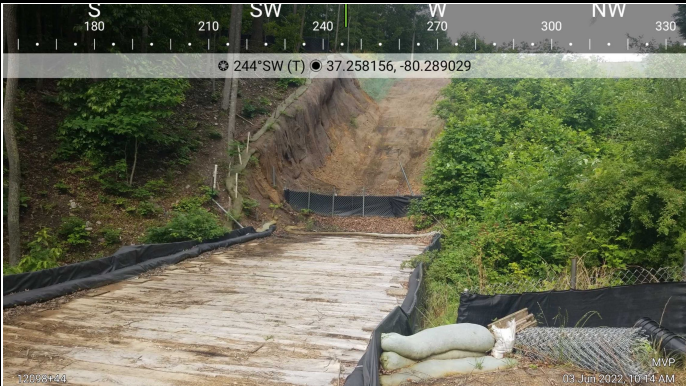
GPS Location	Please see photo for details.		GPS Location	Please see photo for details.	
Field Station#	12098+44		Field Station#	12108+41	
Pic 15 Desc.	Photo shows Stream S-MM13 and its buffer zone from the going away side.		Pic 16 Desc.	Photo shows Stream S-F15 and its buffer zone from the going away side.

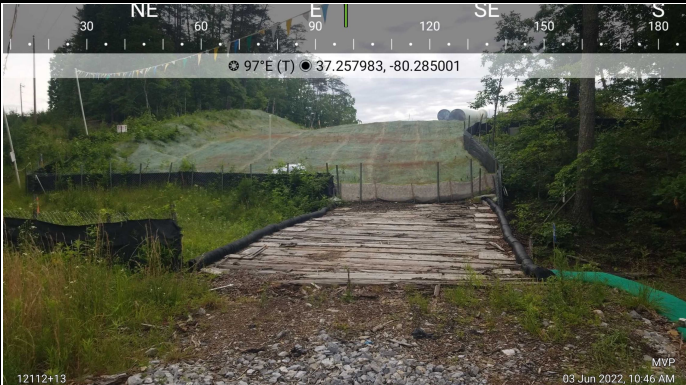
GPS Location	Please see photo for details.		GPS Location	Please see photo for details.	
Field Station#	12112+13		Field Station#	12117+00	
Pic 17 Desc.	Photo shows Stream S-F16A/B and its buffer zone from the coming in side.		Pic 18 Desc.	Photo shows stabilized permanent restoration area of the ROW with permanent slope breakers equipped with level spreaders.
