# Visual Site Inspection Report

<b>Project Name</b>	H-600 Pipeline Spread H	<b>AFE</b>	124300138	<b>Spread</b>	H-600 Pipeline Spread H
<b>Contractor</b>	Precision			<b>Report #</b>	38706
<b>Inspector</b>	Jonathan Altizer			<b>Date/Time</b>	6/13/2022 3:48 PM
<b>Permit #</b>	TBD	<b>Inspection Type</b>	VA SWPP	<b>Station Begin</b>	12725+00
<b>State</b>	VA	<b>Inspection Area</b>	Partial	<b>Station End</b>	12865+00
<b>County</b>	Roanoke	<b>Ground</b>	Dry	<b>Temperature (°F)</b>	82.00
<b>Municipality</b>	N/A	<b>Weather</b>	Sunny	<b>Rain Gauge (in)</b>	0.00
				<b>Rain Accumulation Time (days)</b>	3.00

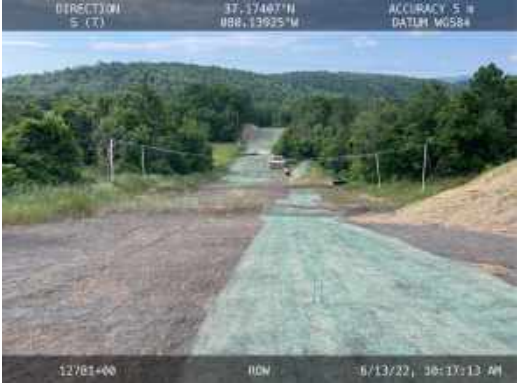
<b>GPS Location</b>	See photo		<b>GPS Location</b>	See photo	
<b>Field Station#</b>	12781+00		<b>Field Station#</b>	12786+75	
<b>Pic 7 Desc.</b>	Current ROW conditions. ROW is stable. ECDs are functional.		<b>Pic 8 Desc.</b>	Level spreader is functional

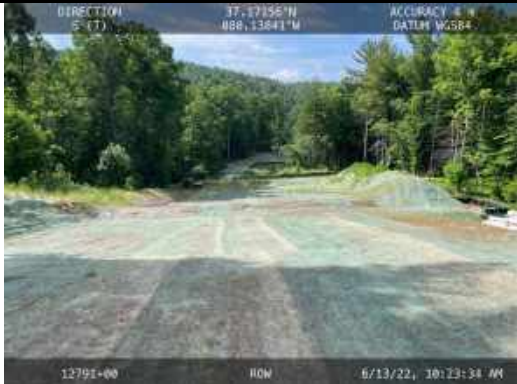
<b>GPS Location</b>	See photo		<b>GPS Location</b>	See photo	
<b>Field Station#</b>	12791+00		<b>Field Station#</b>	12793+71	
<b>Pic 9 Desc.</b>	Current ROW conditions. ROW is stable. ECDs are functional.		<b>Pic 10 Desc.</b>	Overview of Stream S-IJ82

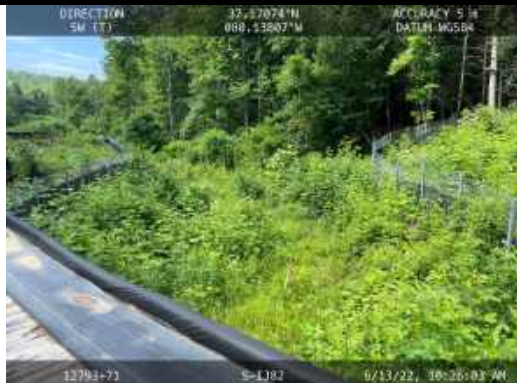
<b>GPS Location</b>	See photo		<b>GPS Location</b>	See photo	
<b>Field Station#</b>	12793+71		<b>Field Station#</b>	12728+74	
<b>Pic 11 Desc.</b>	Downstream of crossing at Stream S-IJ82		<b>Pic 12 Desc.</b>	Downstream of crossing at Stream S-EF32

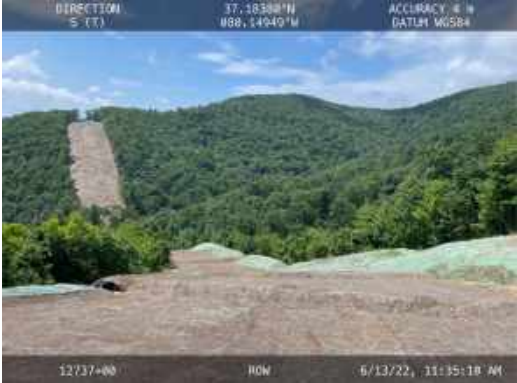
<b>GPS Location</b>	See photo		<b>GPS Location</b>	See photo	
<b>Field Station#</b>	12737+00		<b>Field Station#</b>	12736+00	
<b>Pic 13 Desc.</b>	Current ROW conditions. ROW is stable. ECDs are functional.		<b>Pic 14 Desc.</b>	Slope drain is functional

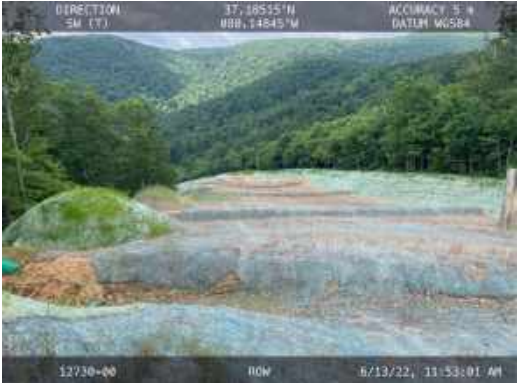
<b>GPS Location</b>	See photo		<b>GPS Location</b>	See photo	
<b>Field Station#</b>	12730+00		<b>Field Station#</b>	12730+00	
<b>Pic 15 Desc.</b>	Current ROW conditions. ROW is stable. ECDs are functional.		<b>Pic 16 Desc.</b>	CWD Berm is stable

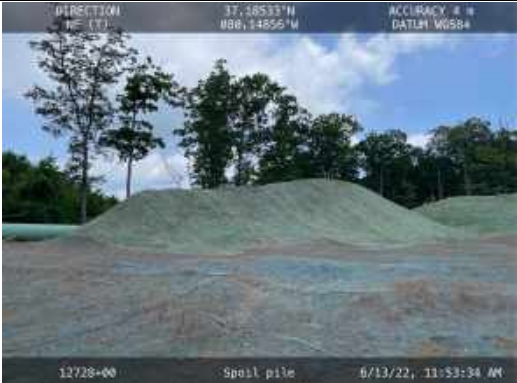
<b>GPS Location</b>	See photo		<b>GPS Location</b>	See photo	
<b>Field Station#</b>	12728+00		<b>Field Station#</b>	12727+00	
<b>Pic 17 Desc.</b>	Stockpiles are stable		<b>Pic 18 Desc.</b>	Current ROW conditions. ROW is stable. ECDs are functional.

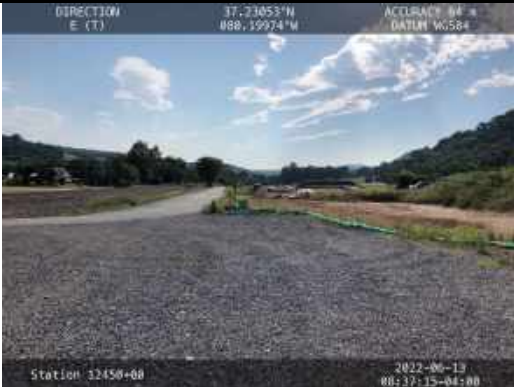
<b>GPS Location</b>	Please see photo for details.		<b>GPS Location</b>	Please see photo for details.	
<b>Field Station#</b>	12450+00		<b>Field Station#</b>	12460+76	
<b>Pic 1 Desc.</b>	Photo shows RCE condition and installed ECDs functioning as designed.		<b>Pic 2 Desc.</b>	Photo shows Wetland W-KL58 and its buffer zone from the coming in side.

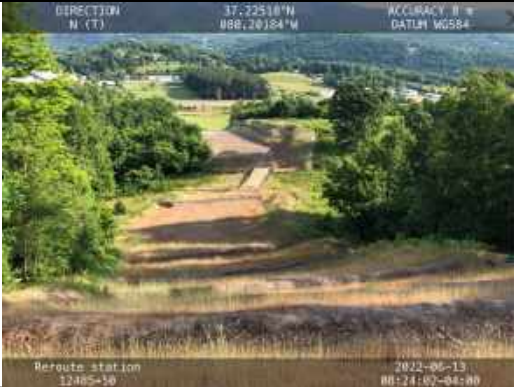
<b>GPS Location</b>	Please see photo for details.		<b>GPS Location</b>	Please see photo for details.	
<b>Field Station#</b>	12485+50		<b>Field Station#</b>	12484+00	
<b>Pic 3 Desc.</b>	Photo shows the stabilized ROW conditions with water bars and that all ECDs are installed and are functioning as designed.		<b>Pic 4 Desc.</b>	Photo shows the stabilized ROW conditions with water bars and that all ECDs are installed and are functioning as designed.

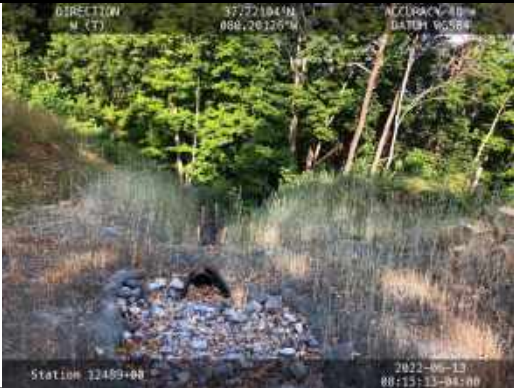
<b>GPS Location</b>	Please see photo for details.		<b>GPS Location</b>	Please see photo for details.	
<b>Field Station#</b>	12489+00		<b>Field Station#</b>	12490+00	
<b>Pic 5 Desc.</b>	Photo shows stone inlet protection for slope drain pipe inlet.		<b>Pic 6 Desc.</b>	Photo shows the stabilized ROW conditions with water bars and that all ECDs are installed and are functioning as designed.

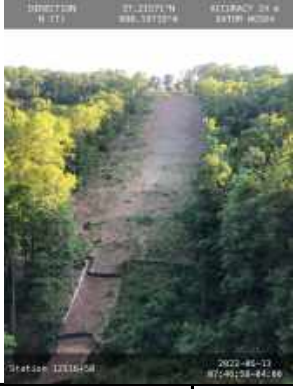
<b>GPS Location</b>	Please see photo for details.		<b>GPS Location</b>	Please see photo for details.	
<b>Field Station#</b>	12516+50		<b>Field Station#</b>	12520+00	
<b>Pic 9 Desc.</b>	Photo shows the stabilized ROW conditions with water bars and that all ECDs are installed and are functioning as designed.		<b>Pic 10 Desc.</b>	Photo shows the buffer zone on the going away side for Stream S-EF19.

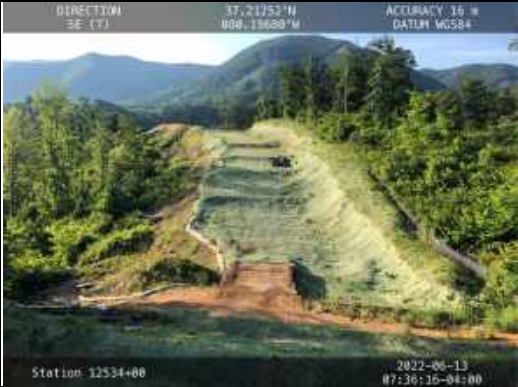
<b>GPS Location</b>	Please see photo for details.		<b>GPS Location</b>	Please see photo for details.	
<b>Field Station#</b>	12534+00		<b>Field Station#</b>	12533+50	
<b>Pic 13 Desc.</b>	Photo shows the stabilized ROW conditions with water bars and that all ECDs are installed and are functioning as designed.		<b>Pic 14 Desc.</b>	Photo shows the stabilized ROW conditions with water bars and that all ECDs are installed and are functioning as designed.

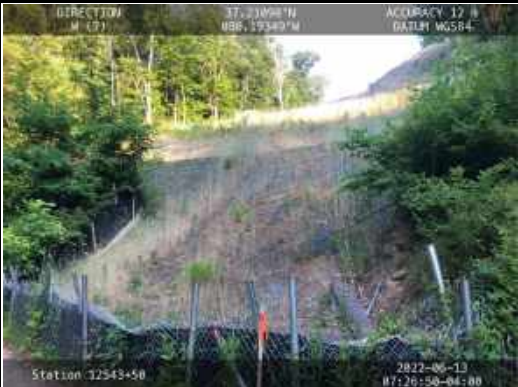
<b>GPS Location</b>	Please see photo for details.		<b>GPS Location</b>	Please see photo for details.	
<b>Field Station#</b>	12543+50		<b>Field Station#</b>	12519+41	
<b>Pic 17 Desc.</b>	Photo shows the stabilized ROW conditions with water bars and that all ECDs are installed and are functioning as designed.		<b>Pic 18 Desc.</b>	Photo shows downstream view of Stream S-EF-19 from equipment bridge spanning the stream channel.

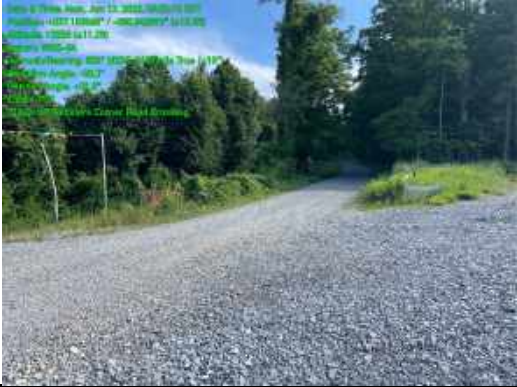
<b>GPS Location</b>	0	<b>GPS Location</b>	0		
<b>Field Station#</b>	13342+67	<b>Field Station#</b>	13345+50		
<b>Pic 7 Desc.</b>	Websters Corner Road Crossing in good condition	<b>Pic 8 Desc.</b>	Clean water diversion pipe and outlet in good condition

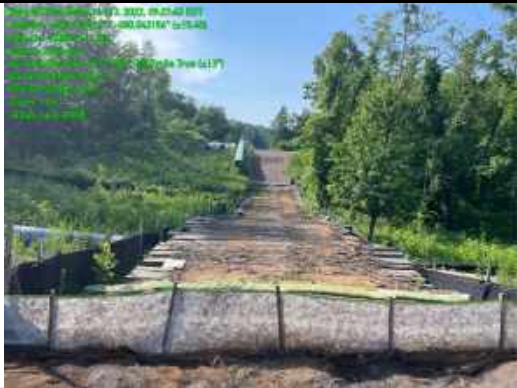
<b>GPS Location</b>	0	<b>GPS Location</b>	0		
<b>Field Station#</b>	13348+46	<b>Field Station#</b>	13352+23		
<b>Pic 9 Desc.</b>	MVP-S-RR08 and corresponding buffer zone in good condition	<b>Pic 10 Desc.</b>	MVP-S-RR09 and corresponding buffer zone in good condition

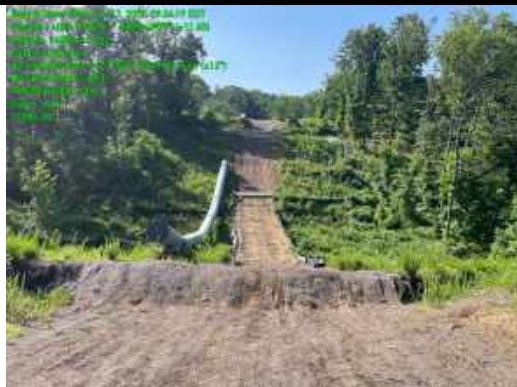
<b>GPS Location</b>	0	<b>GPS Location</b>	0		
<b>Field Station#</b>	13353+00	<b>Field Station#</b>	13358+64		
<b>Pic 11 Desc.</b>	ROW and ECDs in good condition and stable	<b>Pic 12 Desc.</b>	MVP-S-RR11 and corresponding buffer zone in good condition

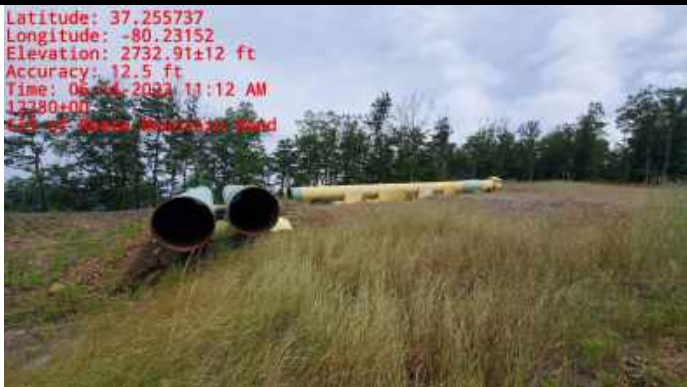
<b>GPS Location</b>	See photo		<b>GPS Location</b>	See photo	
<b>Field Station#</b>	12280+00		<b>Field Station#</b>	12231+00	
<b>Pic 1 Desc.</b>	Current ROW conditions. ROW is stable. ECDs are functional.		<b>Pic 2 Desc.</b>	Current ROW conditions. ROW is stable. ECDs are functional.

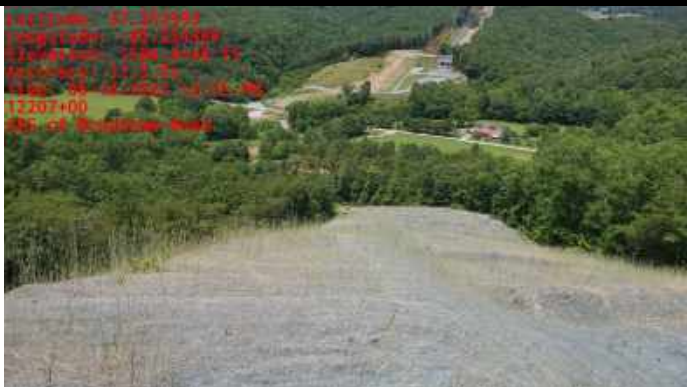
<b>GPS Location</b>	See photo		<b>GPS Location</b>	See photo	
<b>Field Station#</b>	12207+00		<b>Field Station#</b>	12208+00	
<b>Pic 3 Desc.</b>	Current ROW conditions. ROW is stable. ECDs are functional.		<b>Pic 4 Desc.</b>	Current ROW conditions. ROW is stable. ECDs are functional.

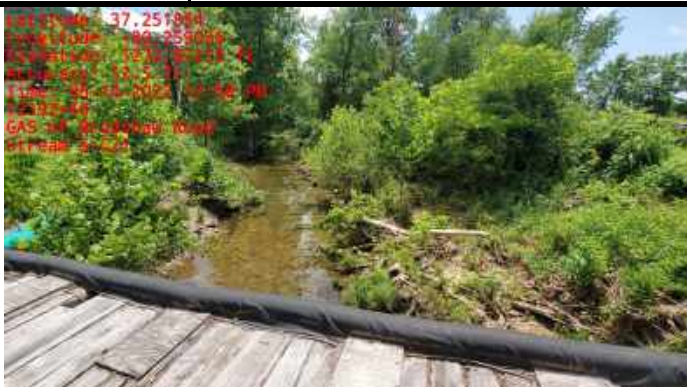
<b>GPS Location</b>	See photo		<b>GPS Location</b>	See photo	
<b>Field Station#</b>	12192+50		<b>Field Station#</b>	12151+00	
<b>Pic 5 Desc.</b>	Downstream of crossing at Stream S-C21		<b>Pic 6 Desc.</b>	Current ROW conditions. ROW is stable. ECDs are functional.

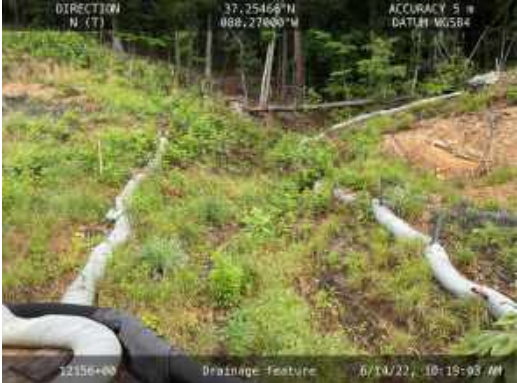
<b>GPS Location</b>	See photo		<b>GPS Location</b>	See photo	
<b>Field Station#</b>	12156+00		<b>Field Station#</b>	12150+50	
<b>Pic 7 Desc.</b>	Drainage feature is functional		<b>Pic 8 Desc.</b>	Drainage feature is functional

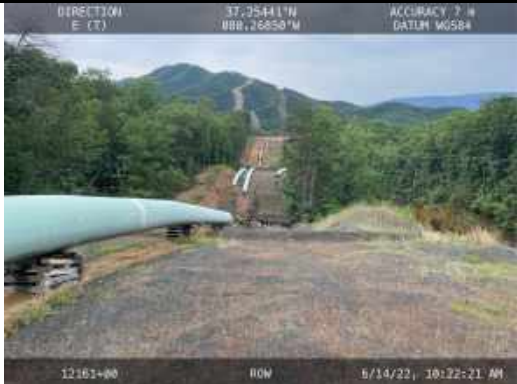
<b>GPS Location</b>	See photo		<b>GPS Location</b>	See photo	
<b>Field Station#</b>	12161+00		<b>Field Station#</b>	12163+04	
<b>Pic 9 Desc.</b>	Current ROW conditions. ROW is stable. ECDs are functional.		<b>Pic 10 Desc.</b>	Overview of Stream S-C25

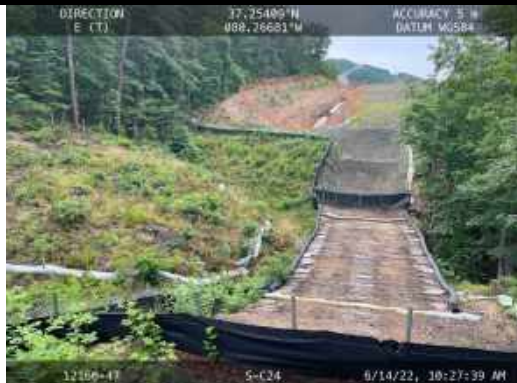
<b>GPS Location</b>	See photo		<b>GPS Location</b>	See photo	
<b>Field Station#</b>	12166+47		<b>Field Station#</b>	12166+47	
<b>Pic 11 Desc.</b>	Overview of Stream S-C24		<b>Pic 12 Desc.</b>	Upstream of crossing at Stream S-C24

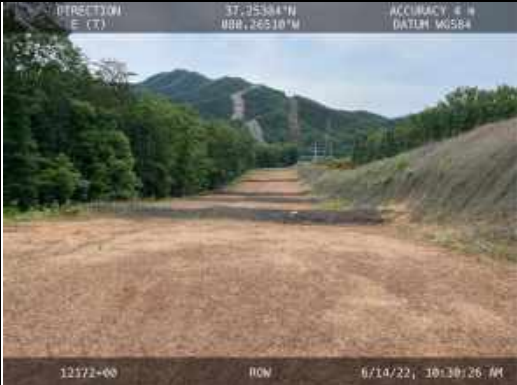
<b>GPS Location</b>	See photo		<b>GPS Location</b>	See photo	
<b>Field Station#</b>	12172+00		<b>Field Station#</b>	12179+00	
<b>Pic 13 Desc.</b>	Current ROW conditions. ROW is stable. ECDs are functional.		<b>Pic 14 Desc.</b>	Stockpiles are stable

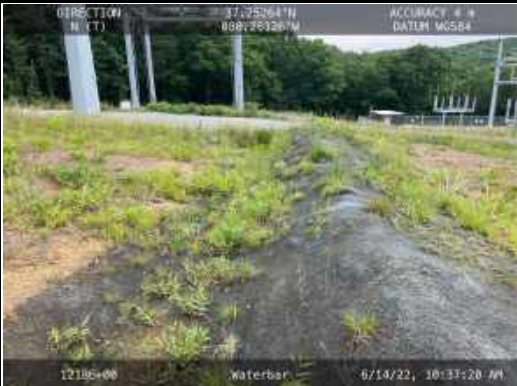
<b>GPS Location</b>	See photo		<b>GPS Location</b>	See photo	
<b>Field Station#</b>	12186+00		<b>Field Station#</b>	12141+00	
<b>Pic 15 Desc.</b>	Waterbar is functional		<b>Pic 16 Desc.</b>	Current ROW conditions. ROW is stable. ECDs are functional.

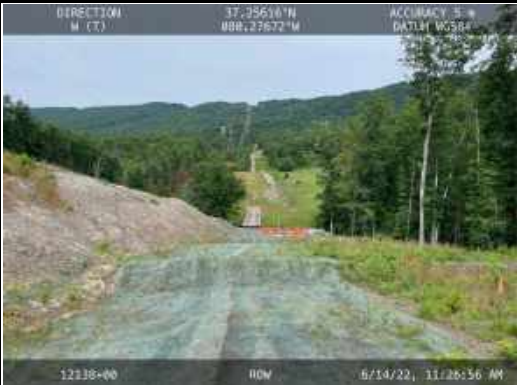
<b>GPS Location</b>	See photo		<b>GPS Location</b>	See photo	
<b>Field Station#</b>	12138+00		<b>Field Station#</b>	12120+00	
<b>Pic 17 Desc.</b>	Current ROW conditions. ROW is stable. ECDs are functional.		<b>Pic 18 Desc.</b>	Timber mat crossings over Streams and Wetlands are functional

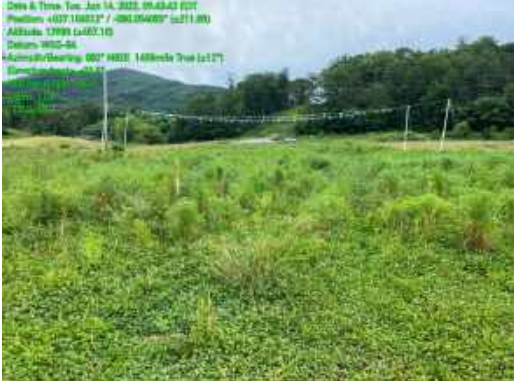
<b>GPS Location</b>	See photo for coordinates.		<b>GPS Location</b>	See photo for coordinates.	
<b>Field Station#</b>	13310+00		<b>Field Station#</b>	13309+09	
<b>Pic 1 Desc.</b>	Right of way stabilized, good vegetative cover.		<b>Pic 2 Desc.</b>	S-GH7, upstream, no right of way impacts observed; stream slightly turbid.

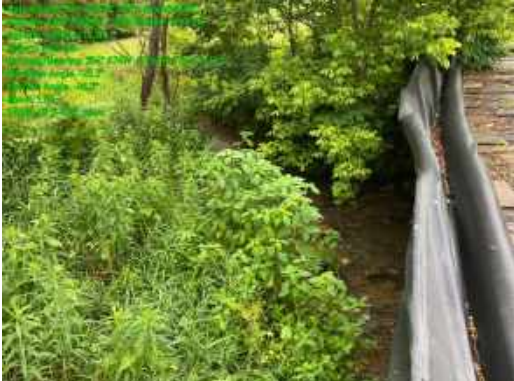
<b>GPS Location</b>	See photo for coordinates.		<b>GPS Location</b>	See photo for coordinates.	
<b>Field Station#</b>	13309+09		<b>Field Station#</b>	13306+00	
<b>Pic 3 Desc.</b>	S-GH7, downstream, no right of way impacted noted.		<b>Pic 4 Desc.</b>	Right of way restore, good vegetative cover observed.

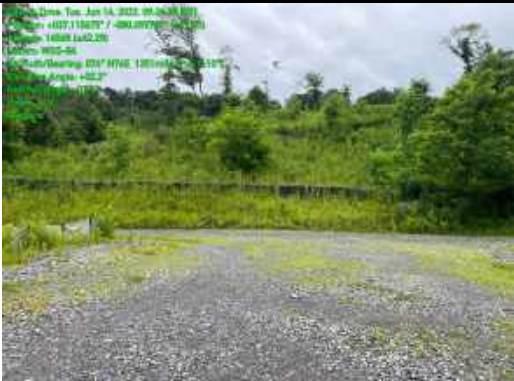
<b>Pic 5 Desc.</b>	Right of way well vegetated, Flanders Road crossing.		<b>Pic 6 Desc.</b>	S-II4, perimeter controls in acceptable condition.

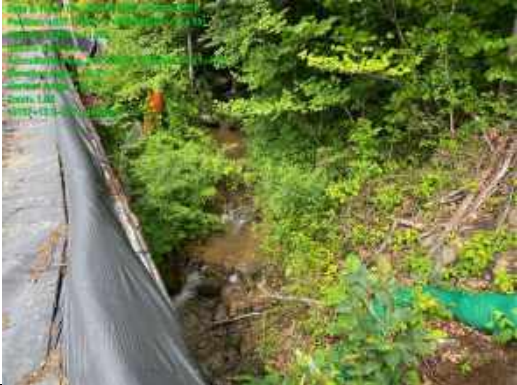
<b>GPS Location</b>	See photo for coordinates.		<b>GPS Location</b>	See photo for coordinates.	
<b>Field Station#</b>	13157+13		<b>Field Station#</b>	13157+13	
<b>Pic 13 Desc.</b>	S-D11, upstream, no right of way impacts noted; slight turbidity noted.		<b>Pic 14 Desc.</b>	S-D11, downstream, no right of way impacts noted.

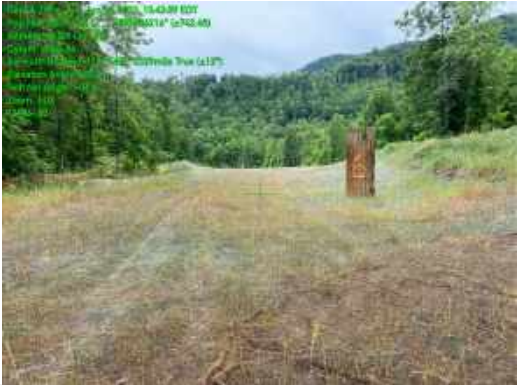
<b>GPS Location</b>	See photo for coordinates.		<b>GPS Location</b>	See photo for coordinates.	
<b>Field Station#</b>	13156+00		<b>Field Station#</b>	13146+50	
<b>Pic 15 Desc.</b>	Right of way stabilized.		<b>Pic 16 Desc.</b>	S-D12 and S-D13, upstream, streams flowing with no right of way impacts observed.

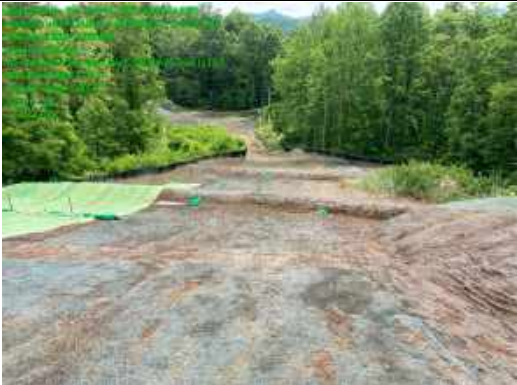
<b>Pic 17 Desc.</b>	Right of way stabilized.		<b>Pic 18 Desc.</b>	MVP-FR-292, S-D14, no flow present in stream channel.

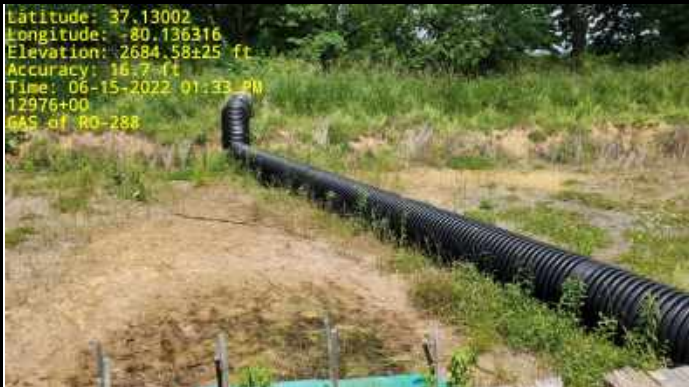
GPS Location	See pic for GPS location.		GPS Location	See pic for GPS location.	
Field Station#	12976+00		Field Station#	12976+00	
Pic 13 Desc.	CWDB and CWDP on the GAS of RO-288.		Pic 14 Desc.	Plunge Pool and CWDP on the GAS of RO-288.

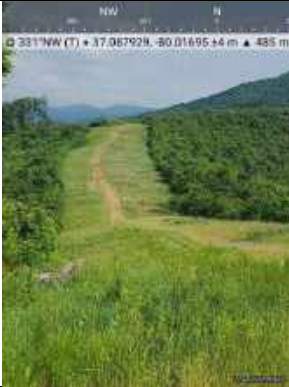
<b>GPS Location</b>	00000	<b>GPS Location</b>	0000		
<b>Field Station#</b>	13450+12	<b>Field Station#</b>	13449+00		
<b>Pic 1 Desc.</b>	Monitored water bars and level spreaders during routine inspection. No issues observed at the time of inspection.		<b>Pic 2 Desc.</b>	Observed CFS perimeter ECDs throughout. No environmental issues observed at the time of inspection.

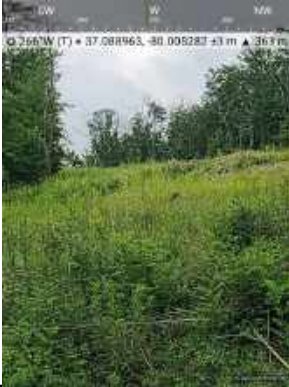
<b>GPS Location</b>	0000	<b>GPS Location</b>	0000		
<b>Field Station#</b>	12494+90	<b>Field Station#</b>	13416+00		
<b>Pic 3 Desc.</b>	Row photo showing vegetation in permanent area. No issues observed at the time of inspection.		<b>Pic 4 Desc.</b>	Monitored ECDs along the row perimeter. No environmental issues observed at the time of inspection.

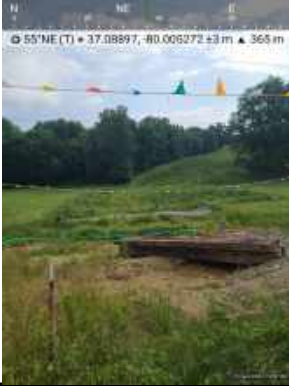
<b>Pic 5 Desc.</b>	Monitored newly installed ECDs at stream crossing at CAHAS#1 . All in place and functioning at the time of inspection.		<b>Pic 6 Desc.</b>	Monitored CFS along the row during routine inspection of permanent area of the row. No issues were observed at the time of inspection.

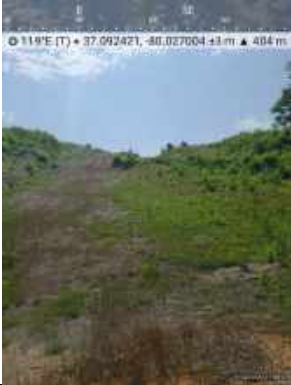
<p>GPS data: 119°E (T) + 37.042421, -88.027604 +3 m ▲ 484 m</p>		<p>Insert image here</p>		<p>Insert image here</p>	
<b>GPS Location</b>	0000	<b>GPS Location</b>			
<b>Field Station#</b>	13417+00	<b>Field Station#</b>			
<b>Pic 7 Desc.</b>	Observed erosion control blanket and stabilization on hill side above road crossing. No issues observed at the time of inspection.		<b>Pic 8 Desc.</b>		
<p>Insert image here</p>			<p>Insert image here</p>		
<b>GPS Location</b>		<b>GPS Location</b>			
<b>Field Station#</b>		<b>Field Station#</b>			
<b>Pic 9 Desc.</b>			<b>Pic 10 Desc.</b>		
<p>Insert image here</p>			<p>Insert image here</p>		
<b>GPS Location</b>		<b>GPS Location</b>			
<b>Field Station#</b>		<b>Field Station#</b>			
<b>Pic 11 Desc.</b>			<b>Pic 12 Desc.</b>

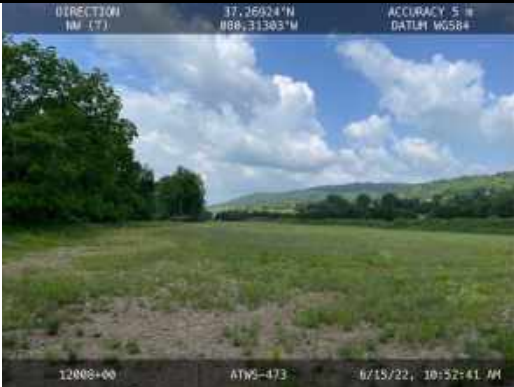
<b>GPS Location</b>	Please see photo for details.		<b>GPS Location</b>	Please see photo for details.	
<b>Field Station#</b>	12008+00		<b>Field Station#</b>	12013+97	
<b>Pic 1 Desc.</b>	Photo shows stabilized ROW conditions in MVP-ATWS-473.		<b>Pic 2 Desc.</b>	Photo shows downstream view of Stream S-G36 from equipment bridge spanning the stream channel.

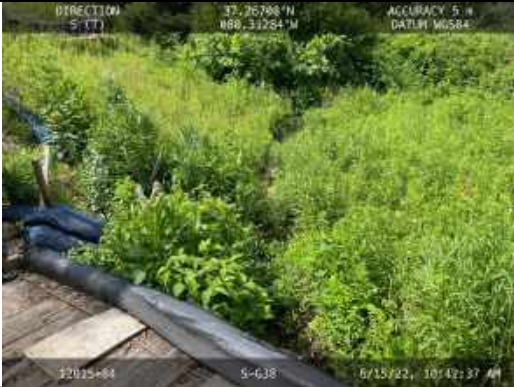
<b>GPS Location</b>	Please see photo for details.		<b>GPS Location</b>	Please see photo for details.	
<b>Field Station#</b>	12015+84		<b>Field Station#</b>	12031+00	
<b>Pic 3 Desc.</b>	Photo shows upstream view of Stream S-G38 from equipment bridge spanning the stream channel.		<b>Pic 4 Desc.</b>	Photo shows the stabilized ROW conditions with water bars and that all ECDs are installed and are functioning as designed.

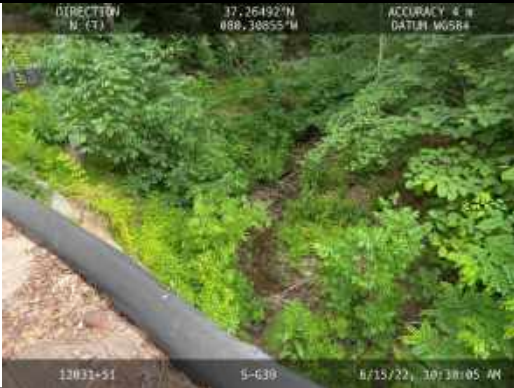
<b>GPS Location</b>	Please see photo for details.		<b>GPS Location</b>	Please see photo for details.	
<b>Field Station#</b>	12031+51		<b>Field Station#</b>	12035+11	
<b>Pic 5 Desc.</b>	Photo shows downstream view of Stream S-G39 from equipment bridge spanning the stream channel.		<b>Pic 6 Desc.</b>	Photo shows downstream view of Stream S-G40 from equipment bridge spanning the stream channel.

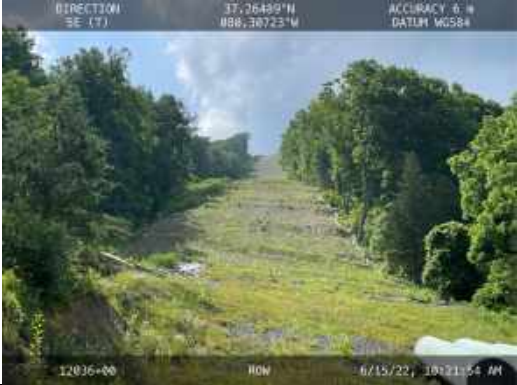
<b>GPS Location</b>	Please see photo for details.		<b>GPS Location</b>	Please see photo for details.	
<b>Field Station#</b>	12036+00		<b>Field Station#</b>	12070+00	
<b>Pic 7 Desc.</b>	Photo shows the stabilized ROW conditions with water bars and that all ECDs are installed and are functioning as designed.		<b>Pic 8 Desc.</b>	Photo shows the stabilized ROW conditions with water bars and that all ECDs are installed and are functioning as designed.

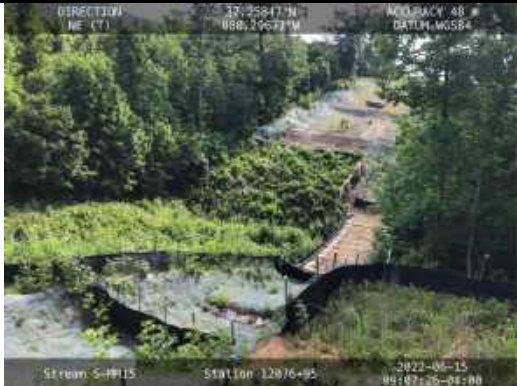
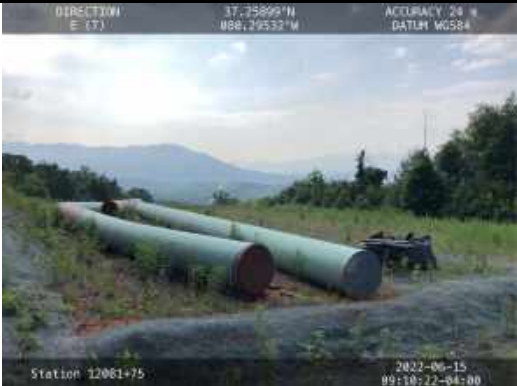
<b>GPS Location</b>	Please see photo for details.		<b>GPS Location</b>	Please see photo for details.	
<b>Field Station#</b>	12076+95		<b>Field Station#</b>	12081+75	
<b>Pic 9 Desc.</b>	Photo shows overview of Stream S-MM15 and its buffer zone from the coming in side.		<b>Pic 10 Desc.</b>	Photo shows the stabilized ROW conditions with water bars and that all ECDs are installed and are functioning as designed.

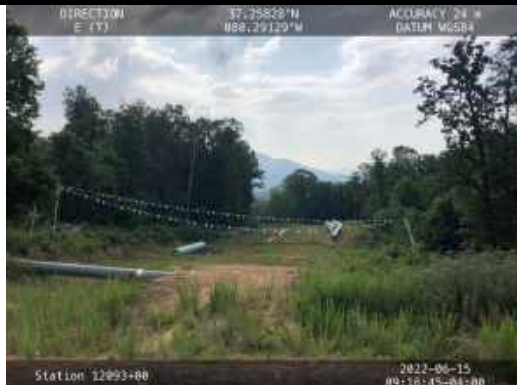
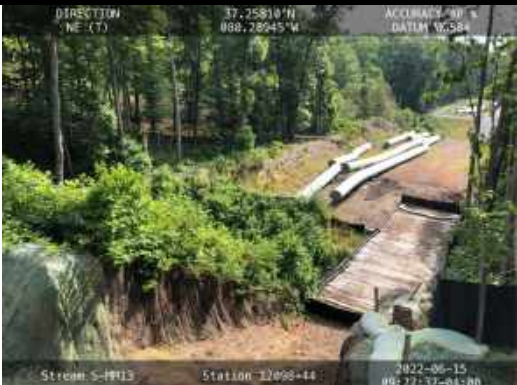
<b>GPS Location</b>	Please see photo for details.		<b>GPS Location</b>	Please see photo for details.	
<b>Field Station#</b>	12093+00		<b>Field Station#</b>	12098+44	
<b>Pic 11 Desc.</b>	Photo shows the stabilized ROW conditions with water bars and that all ECDs are installed and are functioning as designed.		<b>Pic 12 Desc.</b>	Photo shows overview of Stream S-MM13 and its buffer zone from the coming in side.

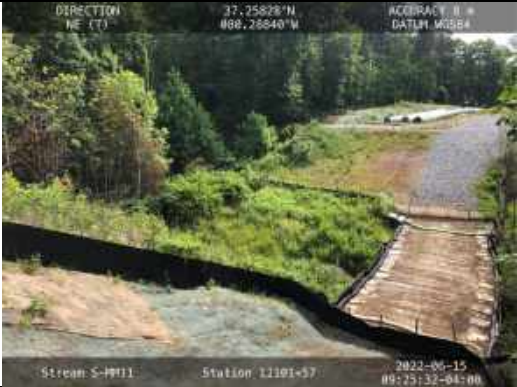
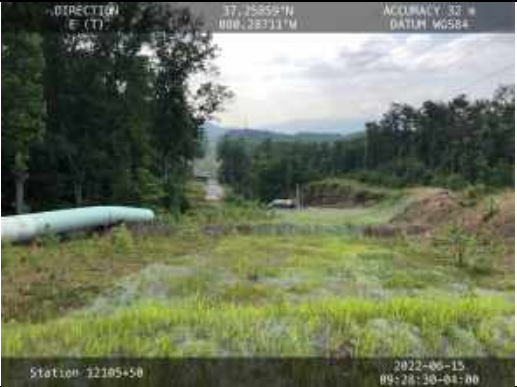
<b>GPS Location</b>	Please see photo for details.		<b>GPS Location</b>	Please see photo for details.	
<b>Field Station#</b>	12101+57		<b>Field Station#</b>	12105+50	
<b>Pic 13 Desc.</b>	Photo shows overview of Stream S-MM11 and its buffer zone from the coming in side.		<b>Pic 14 Desc.</b>	Photo shows the stabilized ROW conditions with water bars and that all ECDs are installed and are functioning as designed.

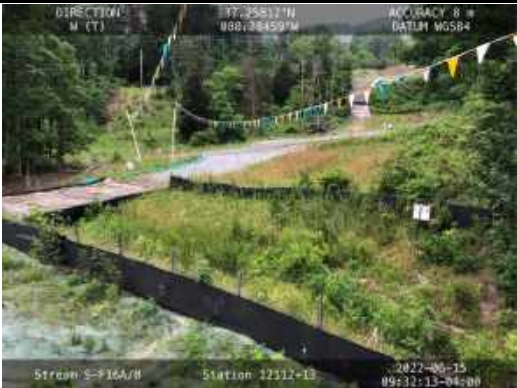
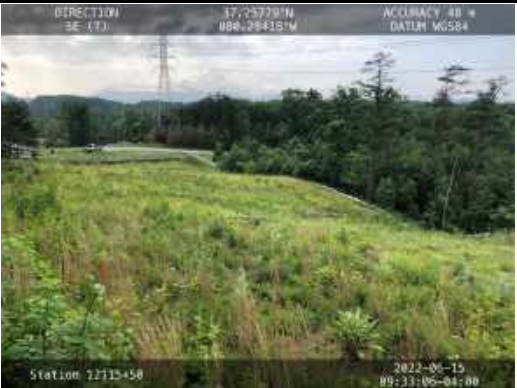
<b>GPS Location</b>	Please see photo for details.		<b>GPS Location</b>	Please see photo for details.	
<b>Field Station#</b>	12112+13		<b>Field Station#</b>	12115+50	
<b>Pic 15 Desc.</b>	Photo shows overview of Stream S-F16A/B and its buffer zone from the going away side.		<b>Pic 16 Desc.</b>	Photo shows the stabilized ROW conditions with water bars and that all ECDs are installed and are functioning as designed.

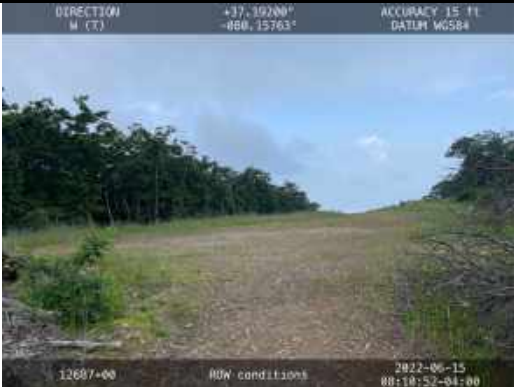
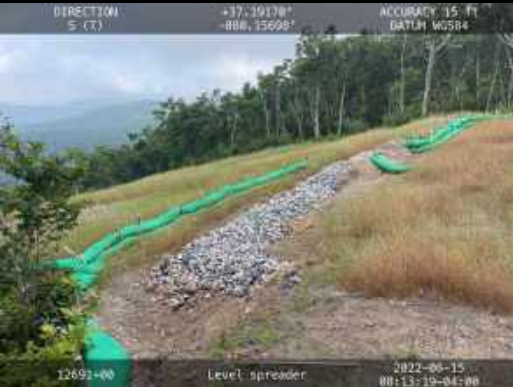
<b>GPS Location</b>	See photo for gps location data.		<b>GPS Location</b>	See photo for gps location data.	
<b>Field Station#</b>	12687+00		<b>Field Station#</b>	12691+00	
<b>Pic 1 Desc.</b>	Photo shows the ROW condition. ECDs are installed and functioning as designed.		<b>Pic 2 Desc.</b>	Photo shows the level spreader.

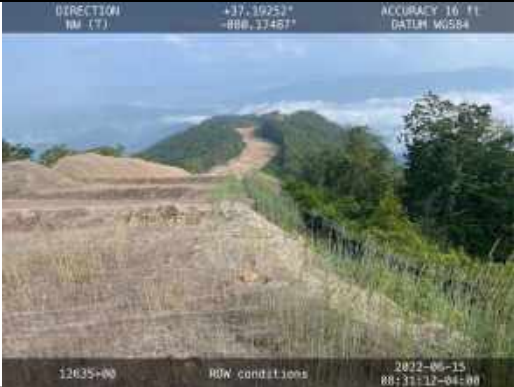
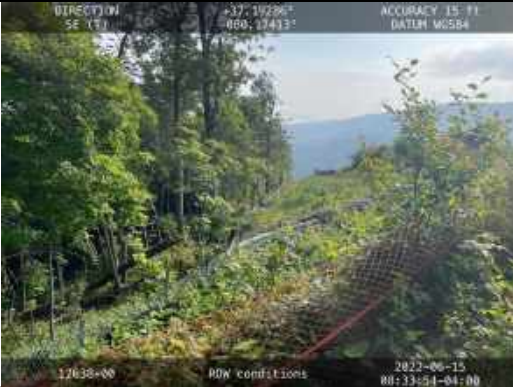
<b>GPS Location</b>	See photo for gps location data.		<b>GPS Location</b>	See photo for gps location data.	
<b>Field Station#</b>	12635+00		<b>Field Station#</b>	12638+00	
<b>Pic 3 Desc.</b>	Photo shows the ROW condition. ECDs are installed and functioning as designed.		<b>Pic 4 Desc.</b>	Photo shows the ROW condition. ECDs are installed and functioning as designed.

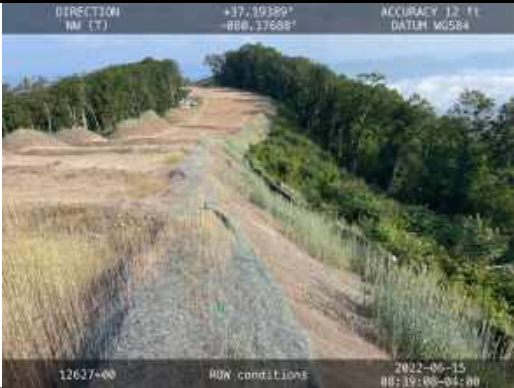
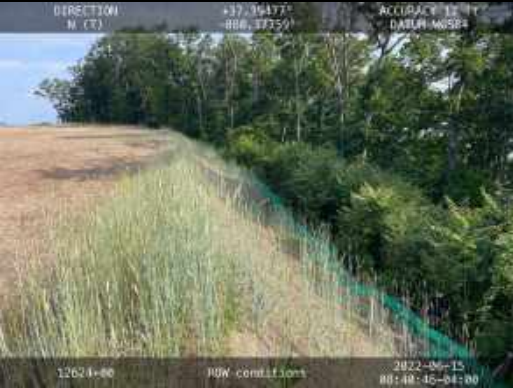
<b>Field Station#</b>	12627+00		<b>Field Station#</b>	12624+00	
<b>Pic 5 Desc.</b>	Photo shows the ROW condition. ECDs are installed and functioning as designed.		<b>Pic 6 Desc.</b>	Photo shows the ROW condition. ECDs are installed and functioning as designed.

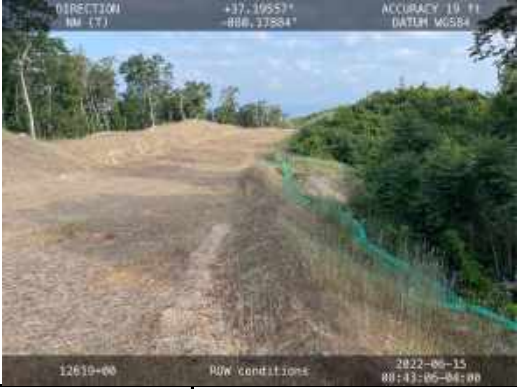
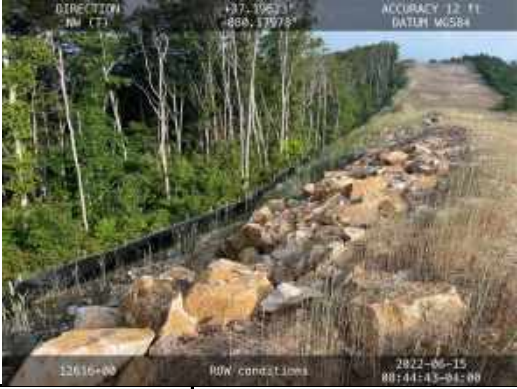
<b>GPS Location</b>	See photo for gps location data.		<b>GPS Location</b>	See photo for gps location data.	
<b>Field Station#</b>	12619+00		<b>Field Station#</b>	12616+00	
<b>Pic 7 Desc.</b>	Photo shows the ROW condition. ECDs are installed and functioning as designed.		<b>Pic 8 Desc.</b>	Photo shows the ROW condition. ECDs are installed and functioning as designed.

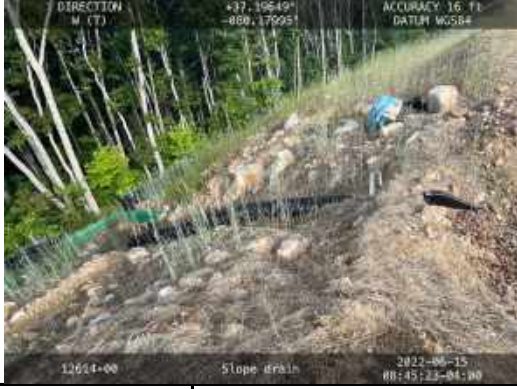
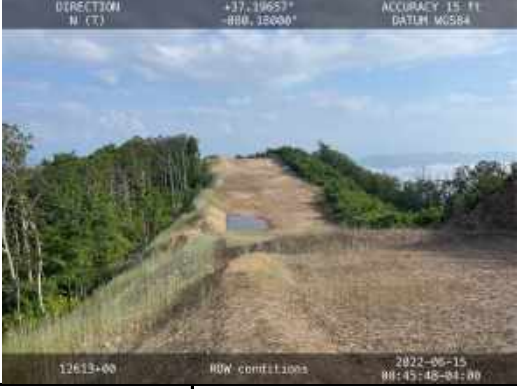
<b>GPS Location</b>	See photo for gps location data.		<b>GPS Location</b>	See photo for gps location data.	
<b>Field Station#</b>	12614+00		<b>Field Station#</b>	12613+00	
<b>Pic 9 Desc.</b>	Photo shows the slope drain.		<b>Pic 10 Desc.</b>	Photo shows the ROW condition. ECDs are installed and functioning as designed.

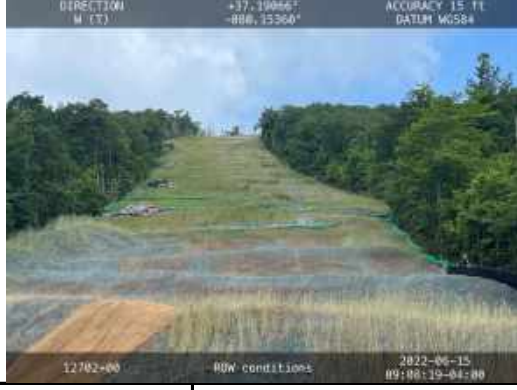
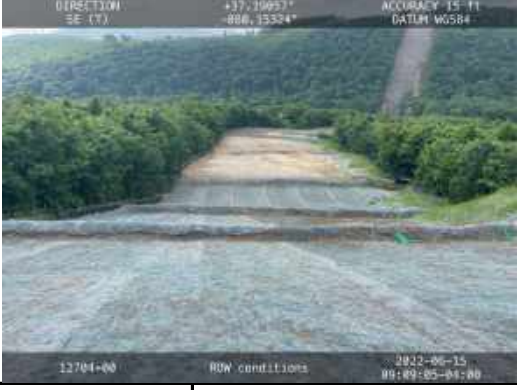
<b>Field Station#</b>	12702+00		<b>Field Station#</b>	12704+00	
<b>Pic 11 Desc.</b>	Photo shows the ROW condition. ECDs are installed and functioning as designed.		<b>Pic 12 Desc.</b>	Photo shows the ROW condition. ECDs are installed and functioning as designed.

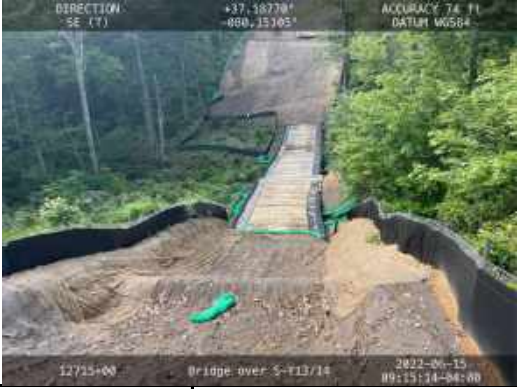
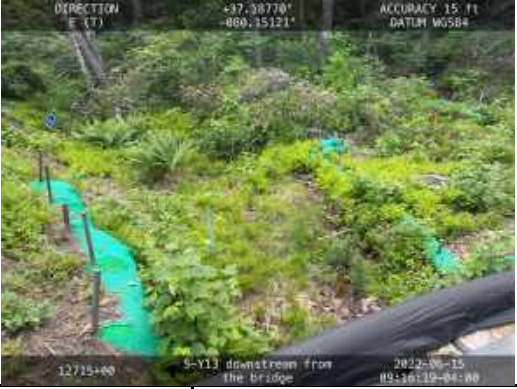
<b>GPS Location</b>	See photo for gps location data.		<b>GPS Location</b>	See photo for gps location data.	
<b>Field Station#</b>	12715+00		<b>Field Station#</b>	12715+80	
<b>Pic 13 Desc.</b>	Photo shows the bridge over streams S-Y13 and S-Y14.		<b>Pic 14 Desc.</b>	Photo shows S-Y13 downstream from the bridge.

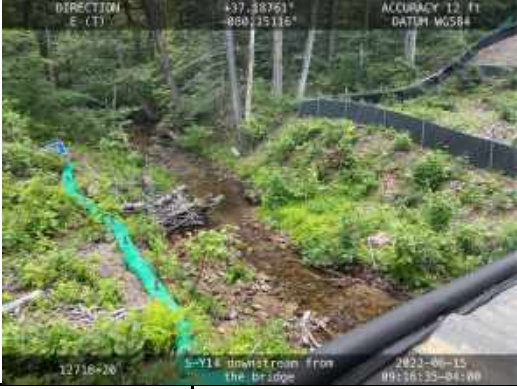
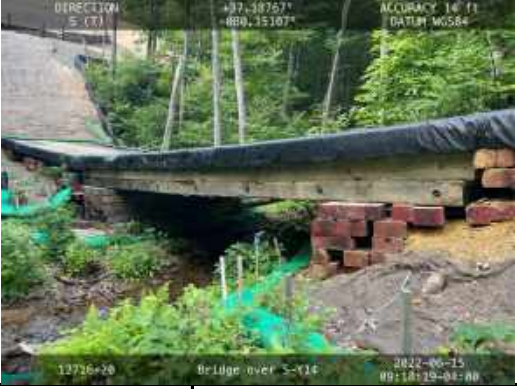
<b>GPS Location</b>	See photo for gps location data.		<b>GPS Location</b>	See photo for gps location data.	
<b>Field Station#</b>	12716+20		<b>Field Station#</b>	12716+20	
<b>Pic 15 Desc.</b>	Photo shows S-Y14 downstream from the bridge.		<b>Pic 16 Desc.</b>	Photo shows the bridge over stream S-Y14.

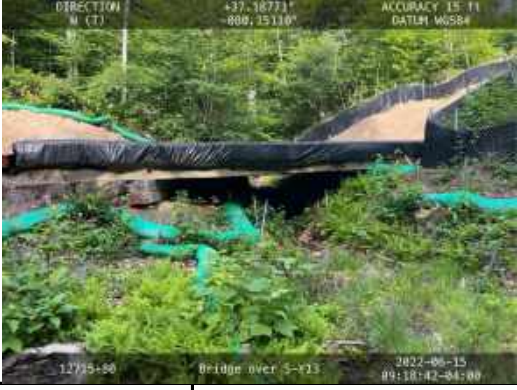
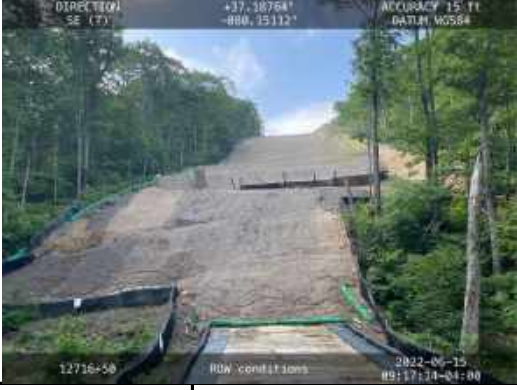
<b>Pic 17 Desc.</b>	Photo shows the bridge over stream S-Y13.		<b>Pic 18 Desc.</b>	Photo shows the ROW condition. ECDs are installed and functioning as designed.

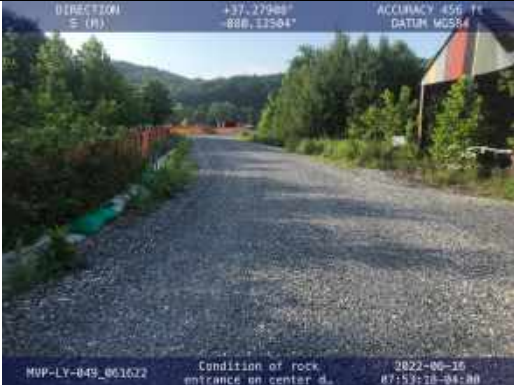
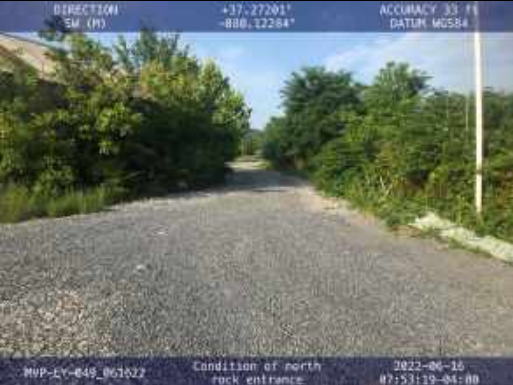
<b>GPS Location</b>	MVP-LY-049 See photo for gps data	<b>GPS Location</b>	MVP-LY-049 See photo for gps data		
<b>Field Station#</b>	+0	<b>Field Station#</b>	+0		
<b>Pic 1 Desc.</b>	Rock entrance no center drive. Larger stone has been covered with smaller stone. Looking S.	<b>Pic 2 Desc.</b>	Rock entrance on north drive. No sediment or debris on stone. Looking SW.

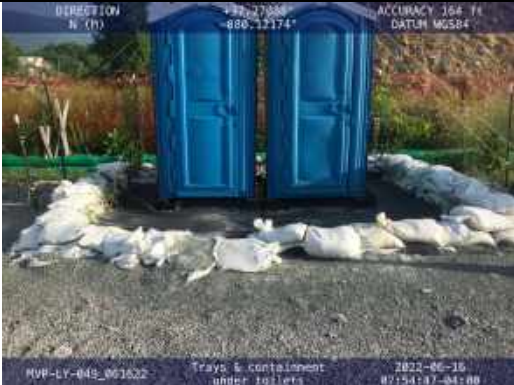
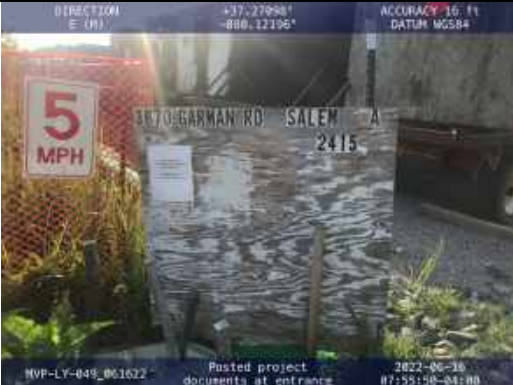
<b>GPS Location</b>	MVP-LY-049 See photo for gps data	<b>GPS Location</b>	MVP-LY-049 See photo for gps data		
<b>Field Station#</b>	+0	<b>Field Station#</b>	+0		
<b>Pic 3 Desc.</b>	Trays and containment under toilets. Trays holding fluids. Looking N.	<b>Pic 4 Desc.</b>	Posted project documents at the main entrance. Looking E.

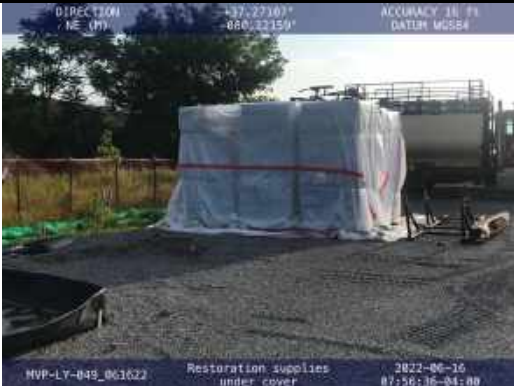
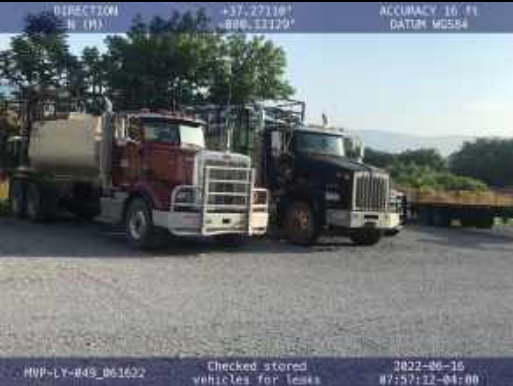
<b>Field Station#</b>	+0	<b>Field Station#</b>	+0		
<b>Pic 5 Desc.</b>	Restoration supplies under cover. Looking NE.	<b>Pic 6 Desc.</b>	Checked stored vehicles for new leaks. No new leaks noted. Looking N.

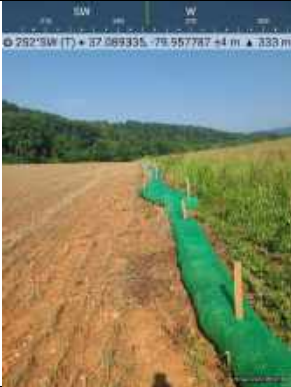
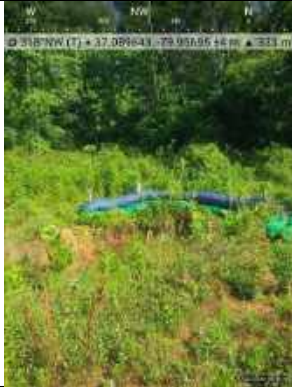
<b>GPS Location</b>	0000	<b>GPS Location</b>	000		
<b>Field Station#</b>	13651+00	<b>Field Station#</b>	13657+20		
<b>Pic 1 Desc.</b>	Observed perimeter CFS along the row where farming activities have been done adjacent to the row. All in place and functioning at the time of inspection.		<b>Pic 2 Desc.</b>	Monitored sump pit and end treatment during routine inspection today. All functioning at the time of inspection.

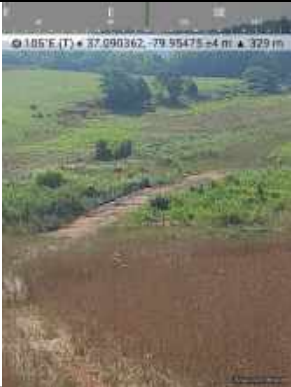
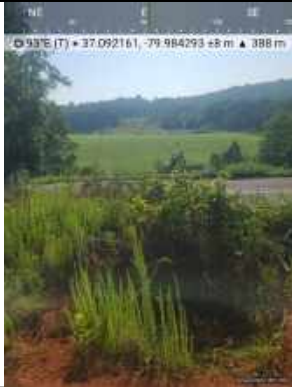
<b>GPS Location</b>	0000	<b>GPS Location</b>	0000		
<b>Field Station#</b>	13664+90	<b>Field Station#</b>	13562+48		
<b>Pic 3 Desc.</b>	Monitored equipment bridge and ECDs at stream crossing , photo showing stabilization up row from crossing.		<b>Pic 4 Desc.</b>	Monitored sump pit and end treatment. No issues observed at the time of inspection.

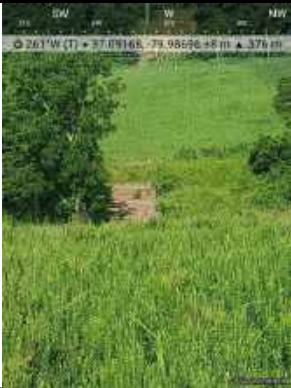
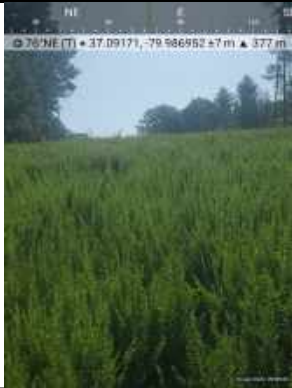
<b>Field Station#</b>	13552+88	<b>Field Station#</b>	13558+00		
<b>Pic 5 Desc.</b>	Additional photo showing permanent vegetation area with equipment bridge in place and ECDs functioning.		<b>Pic 6 Desc.</b>	Vegetation observation photo showing good coverage in permanent area of row.

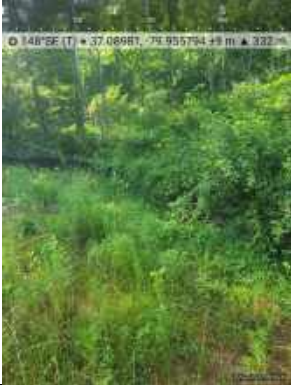
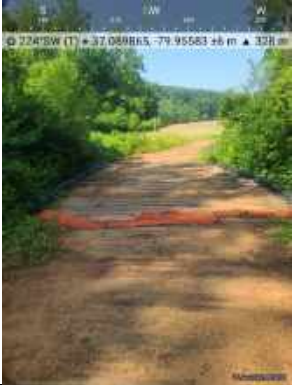
<b>GPS Location</b>	0000	<b>GPS Location</b>	0000		
<b>Field Station#</b>	13659+55	<b>Field Station#</b>	13659+10		
<b>Pic 7 Desc.</b>	Monitored reinforced silt fence along the row . No environmental issues observed at the time of inspection.		<b>Pic 8 Desc.</b>	Observed equipment bridges over stream crossing during row inspections today. No issues were observed with the bridge or	
Insert image here		Insert image here			
<b>GPS Location</b>		<b>GPS Location</b>			
<b>Field Station#</b>		<b>Field Station#</b>			
<b>Pic 9 Desc.</b>			<b>Pic 10 Desc.</b>		
Insert image here		Insert image here			
<b>GPS Location</b>		<b>GPS Location</b>			
<b>Field Station#</b>		<b>Field Station#</b>			
<b>Pic 11 Desc.</b>			<b>Pic 12 Desc.</b>

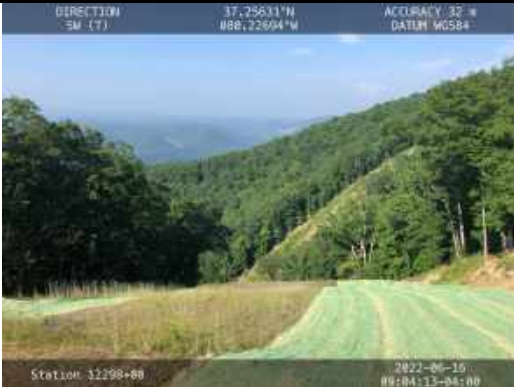
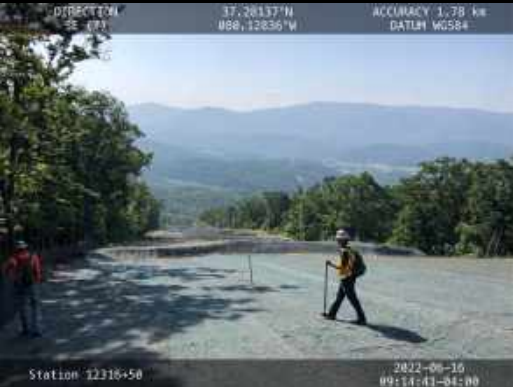
<b>GPS Location</b>	Please see photo for details.		<b>GPS Location</b>	Please see photo for details.	
<b>Field Station#</b>	12298+00		<b>Field Station#</b>	12316+50	
<b>Pic 1 Desc.</b>	Photo shows the stabilized ROW conditions with water bars and that all ECDs are installed and are functioning as designed.		<b>Pic 2 Desc.</b>	Photo shows the stabilized ROW conditions with water bars and that all ECDs are installed and are functioning as designed.

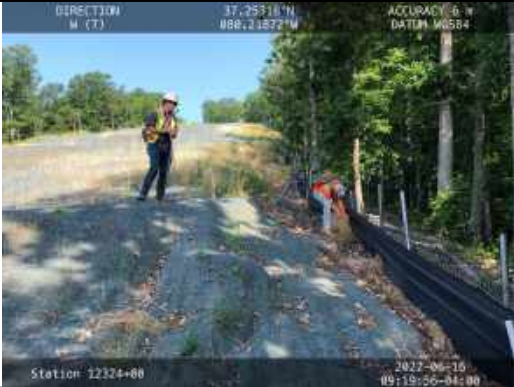
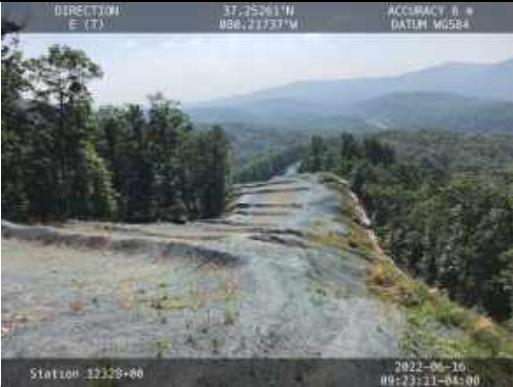
<b>GPS Location</b>	Please see photo for details.		<b>GPS Location</b>	Please see photo for details.	
<b>Field Station#</b>	12324+00		<b>Field Station#</b>	12328+00	
<b>Pic 3 Desc.</b>	Photo shows stabilized ROW conditions and environmental employees tightening SSF fabric on chain link.		<b>Pic 4 Desc.</b>	Photo shows the stabilized ROW conditions with water bars and that all ECDs are installed and are functioning as designed.

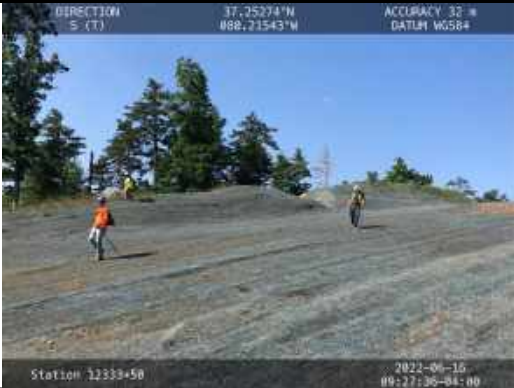
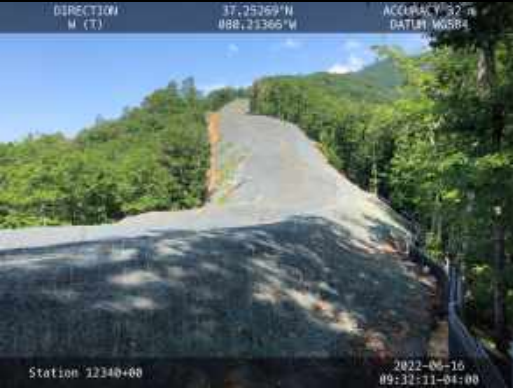
<b>GPS Location</b>	Please see photo for details.		<b>GPS Location</b>	Please see photo for details.	
<b>Field Station#</b>	12333+50		<b>Field Station#</b>	12340+00	
<b>Pic 5 Desc.</b>	Photo shows the stabilized ROW conditions with water bars and that all ECDs are installed and are functioning as designed.		<b>Pic 6 Desc.</b>	Photo shows the stabilized ROW conditions with water bars and that all ECDs are installed and are functioning as designed.

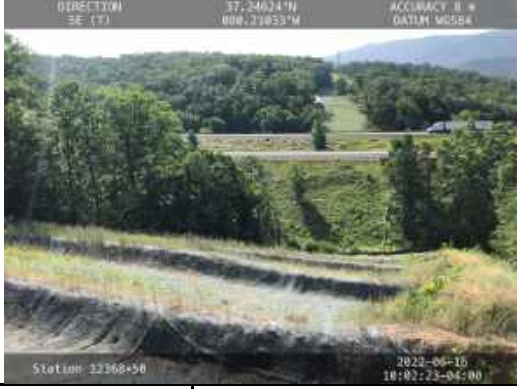
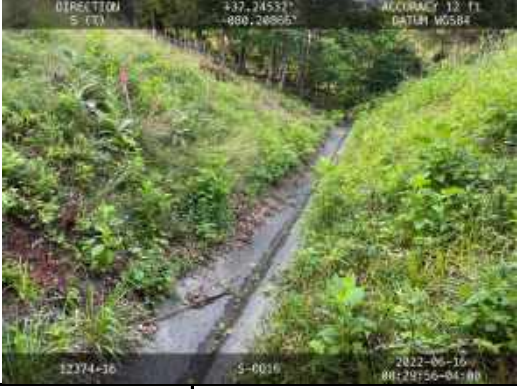
<b>GPS Location</b>	Please see photo for details.		<b>GPS Location</b>	Please see photo for details.	
<b>Field Station#</b>	12368+50		<b>Field Station#</b>	12374+16	
<b>Pic 9 Desc.</b>	Photo shows the stabilized ROW conditions with water bars and that all ECDs are installed and are functioning as designed.		<b>Pic 10 Desc.</b>	Photo shows view of Stream S-0016 standing on the upstream side.
