# Visual Site Inspection Report

<b>Project Name</b>	H-600 Pipeline Spread H	<b>AFE</b>	124300138	<b>Spread</b>	H-600 Pipeline Spread H
<b>Contractor</b>	Precision			<b>Report #</b>	38706
<b>Inspector</b>	Jonathan Altizer			<b>Date/Time</b>	6/13/2022 3:48 PM
<b>Permit #</b>	TBD	<b>Inspection Type</b>	VA SWPP	<b>Station Begin</b>	12725+00
<b>State</b>	VA	<b>Inspection Area</b>	Partial	<b>Station End</b>	12865+00
<b>County</b>	Roanoke	<b>Ground</b>	Dry	<b>Temperature (°F)</b>	82.00
<b>Municipality</b>	N/A	<b>Weather</b>	Sunny	<b>Rain Gauge (in)</b>	0.00
				<b>Rain Accumulation Time (days)</b>	3.00

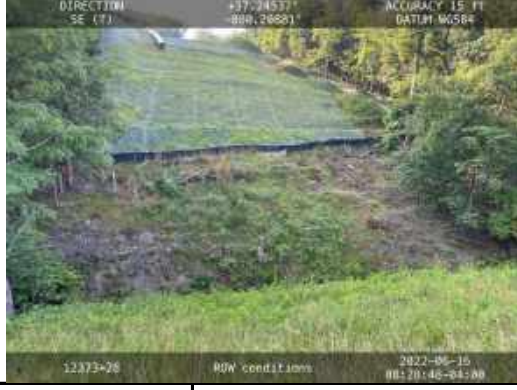
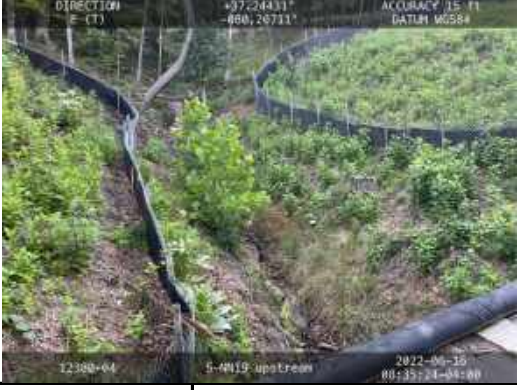
<b>GPS Location</b>	Please see photo for details.		<b>GPS Location</b>	Please see photo for details.	
<b>Field Station#</b>	12373+28		<b>Field Station#</b>	12380+04	
<b>Pic 11 Desc.</b>	Photo shows the stabilized ROW conditions with water bars and that all ECDs are installed and are functioning as designed.		<b>Pic 12 Desc.</b>	Photo shows upstream view of Stream S-NN19 from equipment bridge spanning the stream channel.

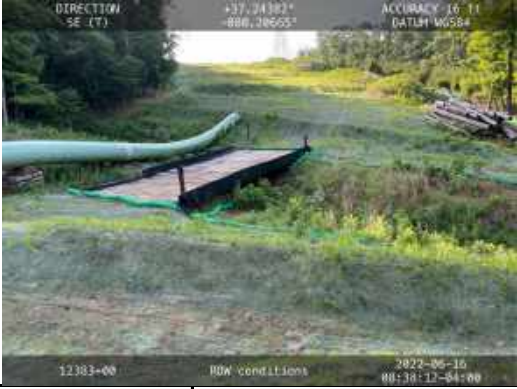
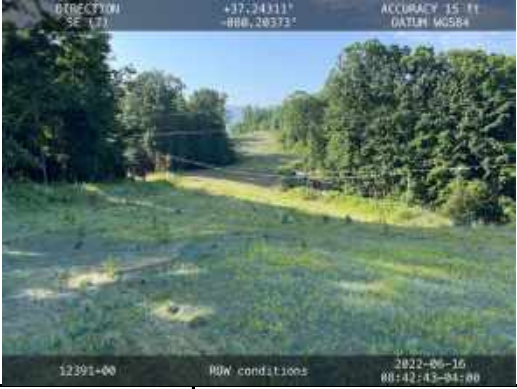
<b>GPS Location</b>	Please see photo for details.		<b>GPS Location</b>	Please see photo for details.	
<b>Field Station#</b>	12383+00		<b>Field Station#</b>	12391+00	
<b>Pic 13 Desc.</b>	Photo shows the stabilized ROW conditions with water bars and that all ECDs are installed and are functioning as designed.		<b>Pic 14 Desc.</b>	Photo shows the stabilized ROW conditions with water bars and that all ECDs are installed and are functioning as designed.

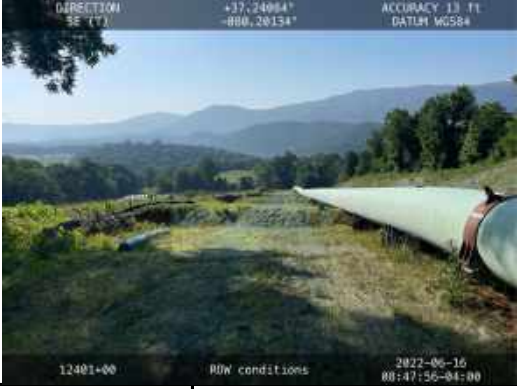
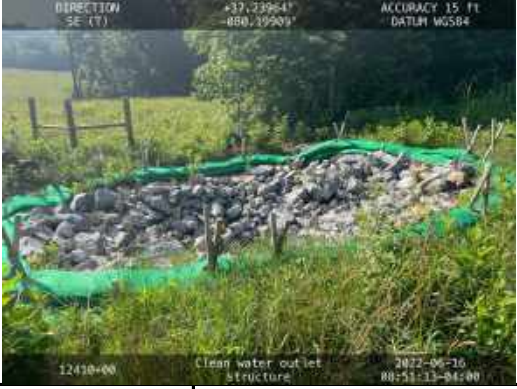
<b>GPS Location</b>	Please see photo for details.		<b>GPS Location</b>	Please see photo for details.	
<b>Field Station#</b>	12401+00		<b>Field Station#</b>	12410+00	
<b>Pic 15 Desc.</b>	Photo shows the stabilized ROW conditions with water bars and that all ECDs are installed and are functioning as designed.		<b>Pic 16 Desc.</b>	Photo shows plunge pool for clean water diversion outlet.

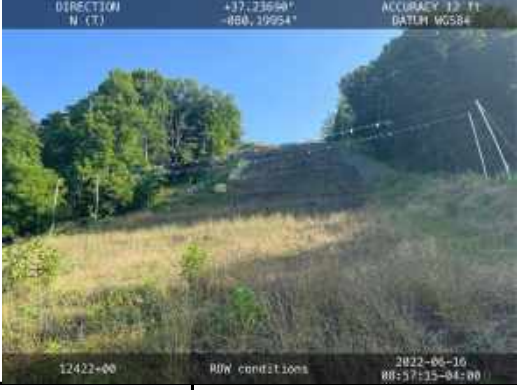
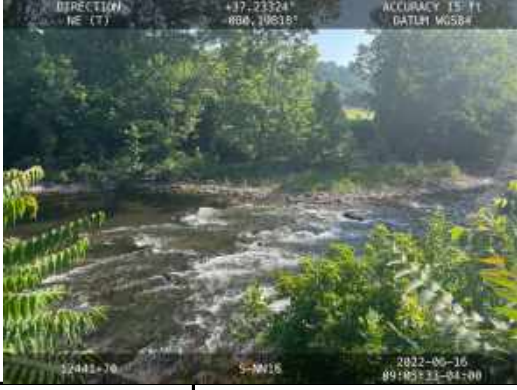
<b>GPS Location</b>	Please see photo for details.		<b>GPS Location</b>	Please see photo for details.	
<b>Field Station#</b>	12422+00		<b>Field Station#</b>	12441+70	
<b>Pic 17 Desc.</b>	Photo shows the stabilized ROW conditions with water bars and that all ECDs are installed and are functioning as designed.		<b>Pic 18 Desc.</b>	Photo shows overview of Stream S-NN16 from the going away side.

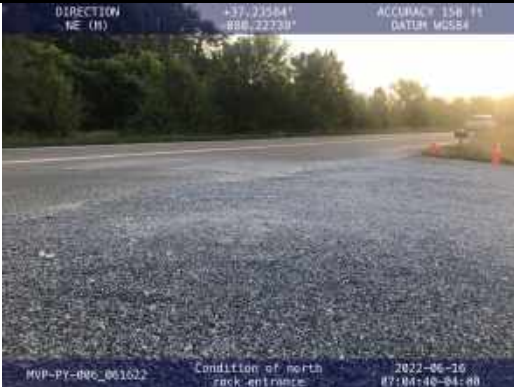
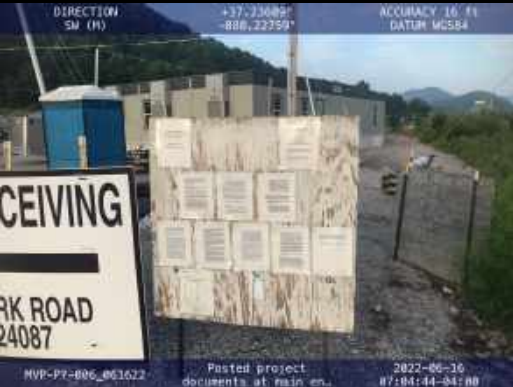
<b>GPS Location</b>	MVP-PY-006 See photo for gps data	<b>GPS Location</b>	MVP-PY-006 See photo for gps data		
<b>Field Station#</b>	+0	<b>Field Station#</b>	+0		
<b>Pic 1 Desc.</b>	Condition of rock entrance on north drive. No sediment or debris on stone. No stone on public roadway. Looking NE.		<b>Pic 2 Desc.</b>	Condition of posted project documents at the main entrance. Looking SW.

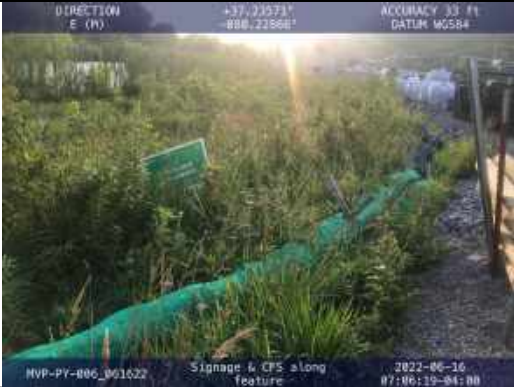
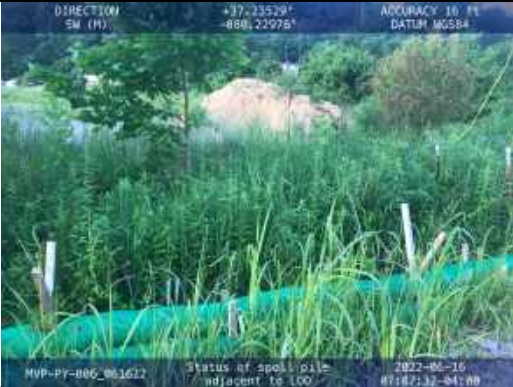
<b>GPS Location</b>	MVP-PY-006 See photo for gps data	<b>GPS Location</b>	MVP-PY-006 See photo for gps data		
<b>Field Station#</b>	+0	<b>Field Station#</b>	+0		
<b>Pic 3 Desc.</b>	Signage and triple stack compost filter sock at feature W-008. Looking E.		<b>Pic 4 Desc.</b>	Status of spoil pile adjacent to LOD on VDOT property. Looking SW.

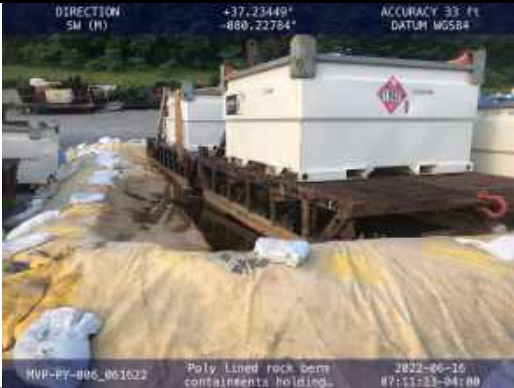
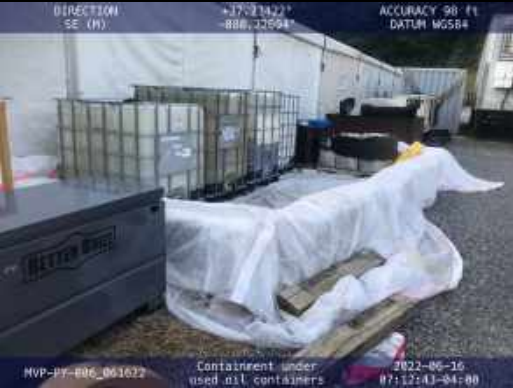
<b>Field Station#</b>	+0	<b>Field Station#</b>	+0		
<b>Pic 5 Desc.</b>	Poly lined rock berm containments holding stormwater. Looking SW.		<b>Pic 6 Desc.</b>	Secondary containment under used oil containers free of fluids. Looking SE.

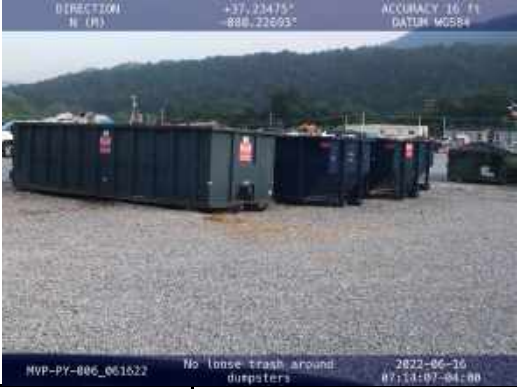
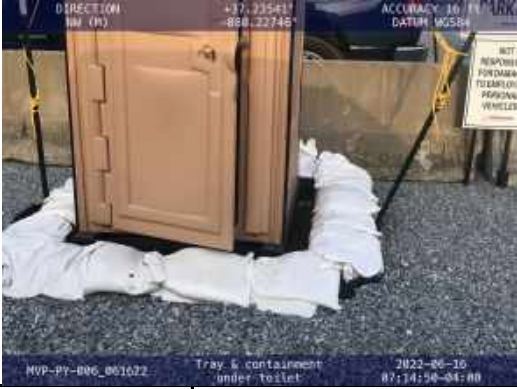
<b>GPS Location</b>	MVP-PY-006 See photo for gps data	<b>GPS Location</b>	MVP-PY-006 See photo for gps data		
<b>Field Station#</b>	+0	<b>Field Station#</b>	+0		
<b>Pic 7 Desc.</b>	No loose trash around dumpsters or in the yard. Looking N.	<b>Pic 8 Desc.</b>	Tray and containment under toilet. Tray holding fluids. Looking NW.

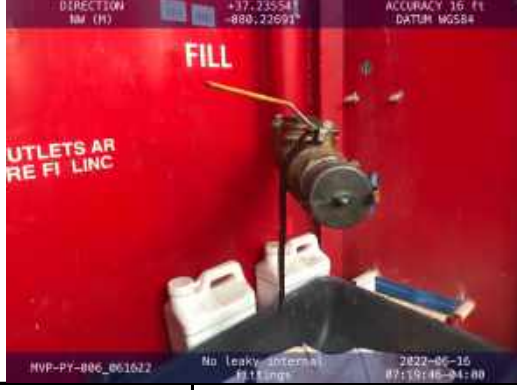
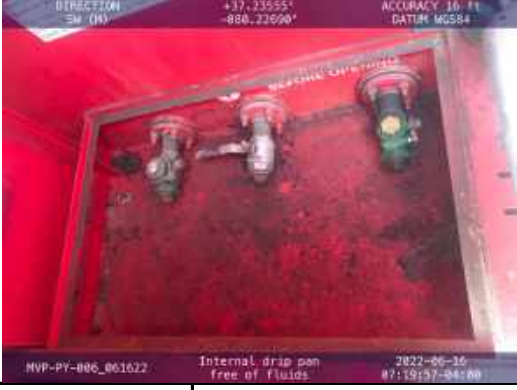
<b>Field Station#</b>	+0	<b>Field Station#</b>	+0		
<b>Pic 11 Desc.</b>	Off Road Fuel unit no leaky internal fittings. Looking NW.	<b>Pic 12 Desc.</b>	Off Road Fuel unit internal drip pan free of fluids. Looking SW.

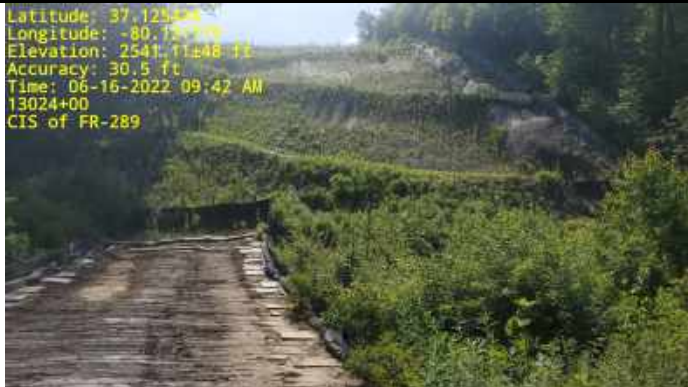
AFE	124300138	Date/Time	6/16/2022 8:04 PM	Report #	
Pictures					
<div>Latitude: 37.125144 Longitude: -80.121149 Elevation: 2541.11±48 ft Accuracy: 30.5 ft Time: 06-16-2022 09:42 AM 13024+00 CIS of FR-289</div>

GPS Location	See pic		GPS Location	See pic	
Field Station#	13024+00		Field Station#	13025+50	
Pic 1 Desc.	GAS of streams S-G24 and S-G25.		Pic 2 Desc.	Streams S-G24 and S-G25 from the GAS.	
<div>Latitude: 37.127407 Longitude: -80.117996 Elevation: 2752.23±15 ft Accuracy: 12.5 ft Time: 06-16-2022 09:56 AM 13039+00 GAS of FR-289 replace damaged P1</div>

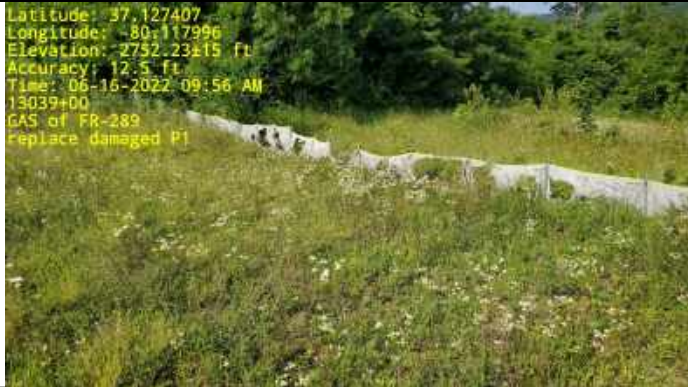
GPS Location	See pic.		GPS Location	See pic	
Field Station#	13039+00		Field Station#	13043+75	
Pic 3 Desc.	Multiple signs of bear activity damaging P1 silt fence on GAS of FR-289. Added to the Punch List.		Pic 4 Desc.	Stream S-H1 from the GAS.	
<div>Latitude: 37.128583 Longitude: -80.113974 Elevation: 2810.79±10 ft Accuracy: 12.5 ft Time: 06-16-2022 10:18 AM 13052+00 GAS of FR-289 landowner utv activities</div>

<b>GPS Location</b>	See pic	<b>GPS Location</b>	See pic		
<b>Field Station#</b>	13100+00	<b>Field Station#</b>	13039+00		
<b>Pic 17 Desc.</b>	Current ROW conditions	<b>Pic 18 Desc.</b>	P1 silt fence replaced where damaged.

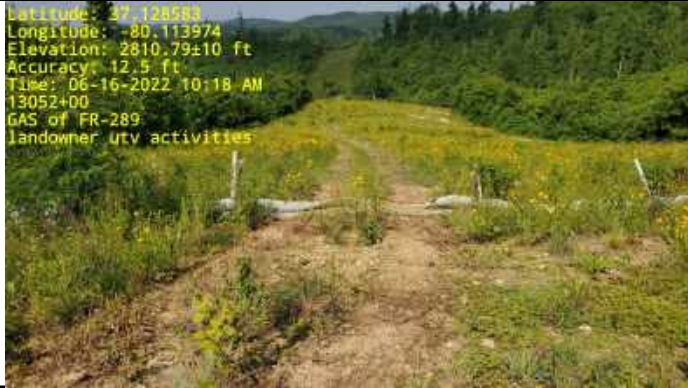
GPS Location	See pic		GPS Location	See pic	
Field Station#	13052+00		Field Station#	13060+00	
Pic 5 Desc.	Landowner UTV activities inside the ROW. No signs of sedimentation or erosion at this time. Significant vegetation in throughout the area.		Pic 6 Desc.	Streams S-G26 and S-G27 from the CIS slope.

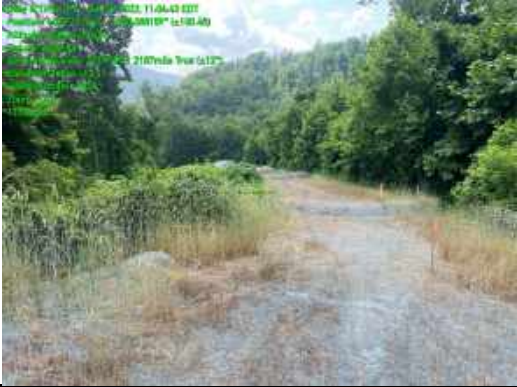
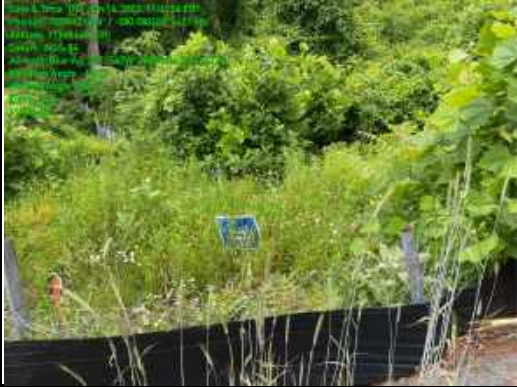
<b>GPS Location</b>	See pic	<b>GPS Location</b>	See pic		
<b>Field Station#</b>	13179+00	<b>Field Station#</b>	13179+00		
<b>Pic 13 Desc.</b>	Current ROW conditions	<b>Pic 14 Desc.</b>	Downstream side of stream S-D17/14

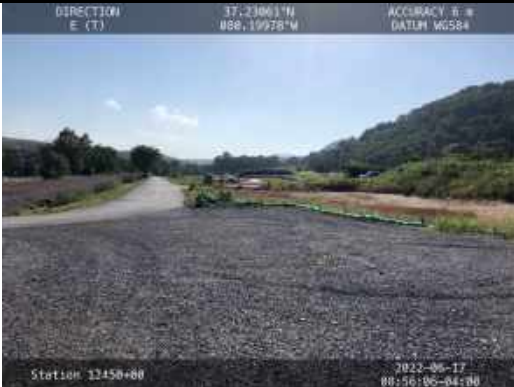
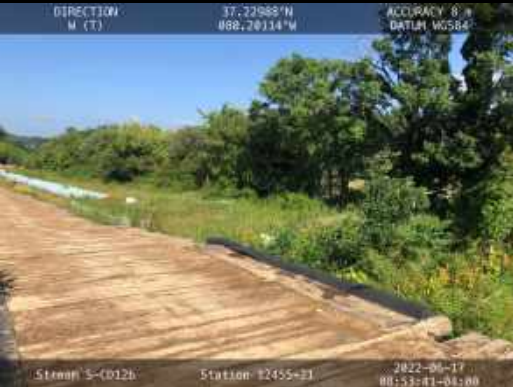
<b>GPS Location</b>	Please see photo for details.		<b>GPS Location</b>	Please see photo for details.	
<b>Field Station#</b>	12450+00		<b>Field Station#</b>	12455+21	
<b>Pic 1 Desc.</b>	Photo shows RCE condition where ST RTE 603 Cove Hollow road meets ROW.		<b>Pic 2 Desc.</b>	Photo shows overview of Stream and equipment bridge spanning the stream channel for Stream S-CS12b.

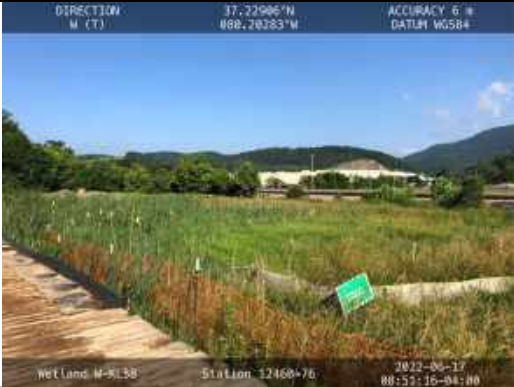
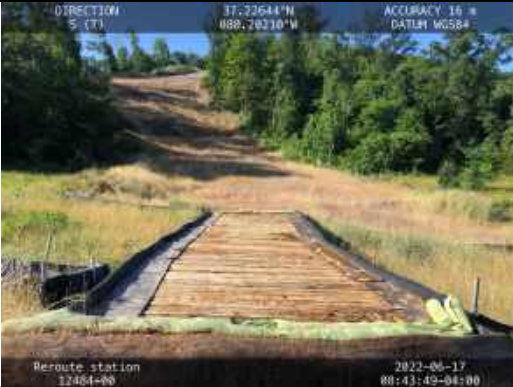
<b>GPS Location</b>	Please see photo for details.		<b>GPS Location</b>	Please see photo for details.	
<b>Field Station#</b>	12460+76		<b>Field Station#</b>	12484+00	
<b>Pic 3 Desc.</b>	Photo shows overview of Wetland W-KL58 and its buffer zone from the coming in side.		<b>Pic 4 Desc.</b>	Photo shows equipment bridge spanning clean water diversion and stabilized ROW conditions.

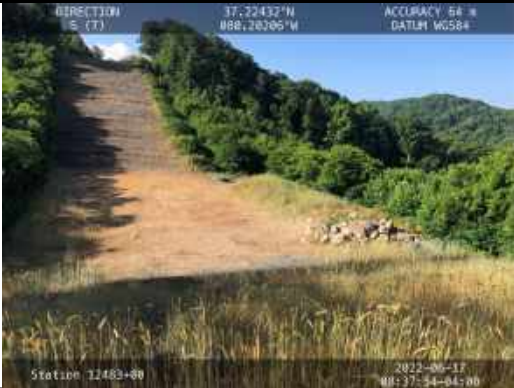
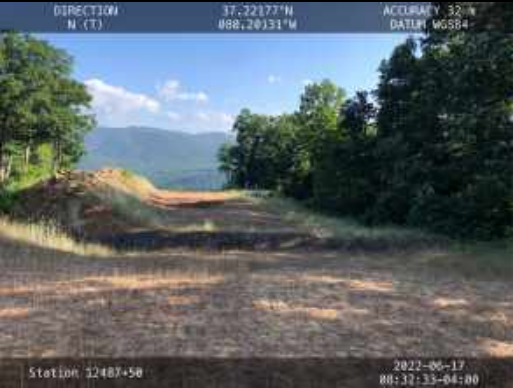
<b>Field Station#</b>	12483+00		<b>Field Station#</b>	12487+50	
<b>Pic 5 Desc.</b>	Photo shows the stabilized ROW conditions with water bars and that all ECDs are installed and are functioning as designed.		<b>Pic 6 Desc.</b>	Photo shows the stabilized ROW conditions with water bars and that all ECDs are installed and are functioning as designed.

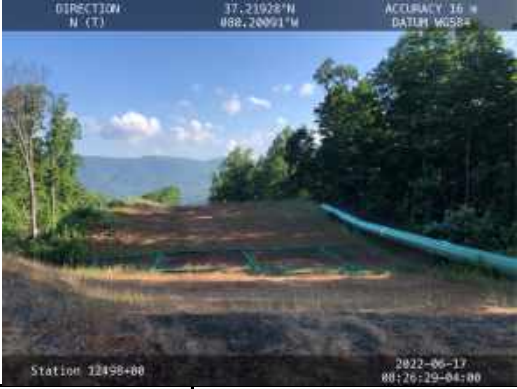
<b>GPS Location</b>	Please see photo for details.		<b>GPS Location</b>	Please see photo for details.	
<b>Field Station#</b>	12498+00		<b>Field Station#</b>	12504+00	
<b>Pic 7 Desc.</b>	Photo shows the stabilized ROW conditions with water bars and that all ECDs are installed and are functioning as designed.		<b>Pic 8 Desc.</b>	Photo shows the stabilized ROW conditions along with clean water diversion berm, clean water diversion pipe and plunge pool.

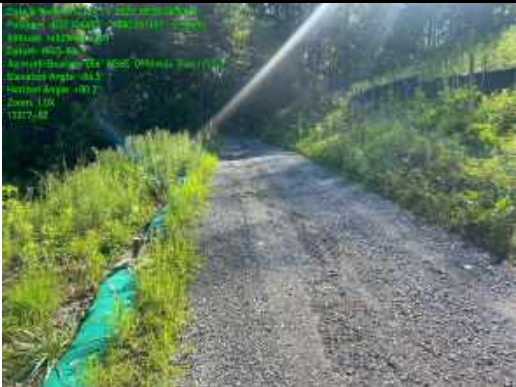
GPS Location	See photo for coordinates.		GPS Location	See photo for coordinates.	
Field Station#	13317+02		Field Station#	13316+55	
Pic 1 Desc.	Erosional channel noted along private drive; added to Punch List.		Pic 2 Desc.	CFS full of sediment and gravel from private drive; added to Punch List.

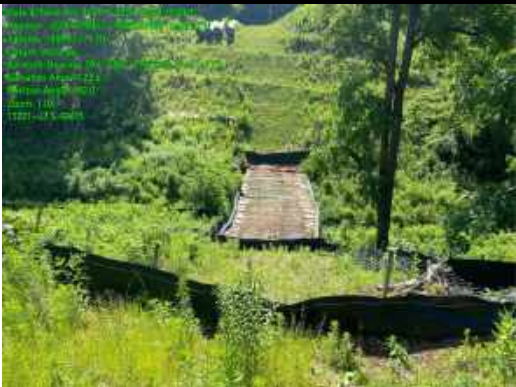
GPS Location	See photo for coordinates.		GPS Location	See photo for coordinates.	
Field Station#	13321+47		Field Station#	13321+47	
Pic 3 Desc.	S-GH15, silt fence perimeter controls in acceptable condition.		Pic 4 Desc.	S-GH15, upstream, no right of way impacts observed.

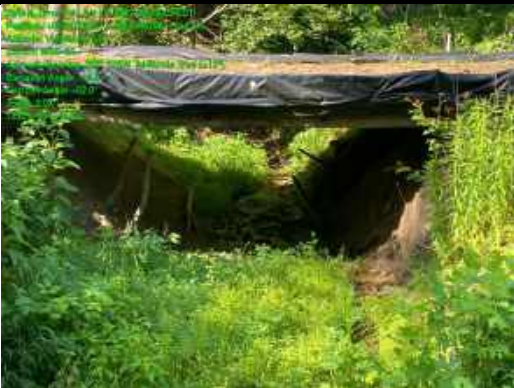
GPS Location	See photo for coordinates.		GPS Location	See photo for coordinates.	
Field Station#	13323+43		Field Station#	13325+30	
Pic 5 Desc.	S-GH14, silt fence perimeter controls were in acceptable condition.		Pic 6 Desc.	S-GH14, upstream looking downstream, long term bank erosion along right descending bank present.

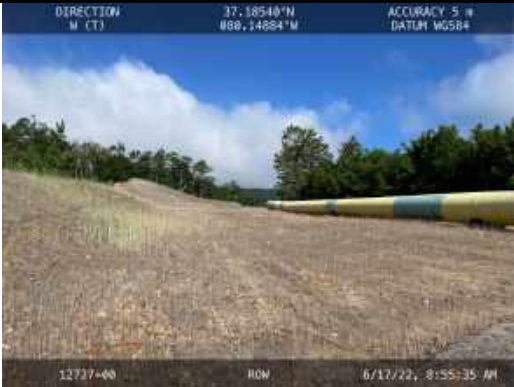
<b>GPS Location</b>	See photo		<b>GPS Location</b>	See photo	
<b>Field Station#</b>	12727+00		<b>Field Station#</b>	12727+00	
<b>Pic 1 Desc.</b>	Current ROW conditions. ROW is stable and ECDs are functional.		<b>Pic 2 Desc.</b>	Sump and End Treatment are functional

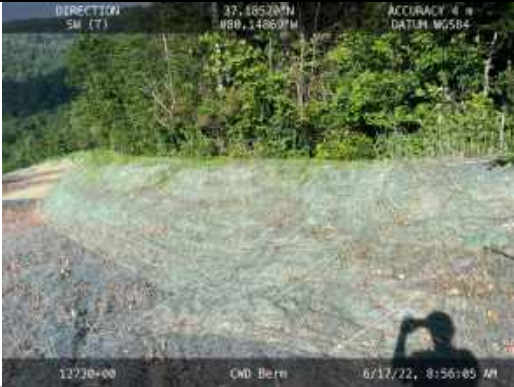
<b>GPS Location</b>	See photo		<b>GPS Location</b>	See photo	
<b>Field Station#</b>	12730+00		<b>Field Station#</b>	12730+00	
<b>Pic 3 Desc.</b>	CWD Berm is stable and functional		<b>Pic 4 Desc.</b>	Current ROW conditions. ROW is stable and ECDs are functional.

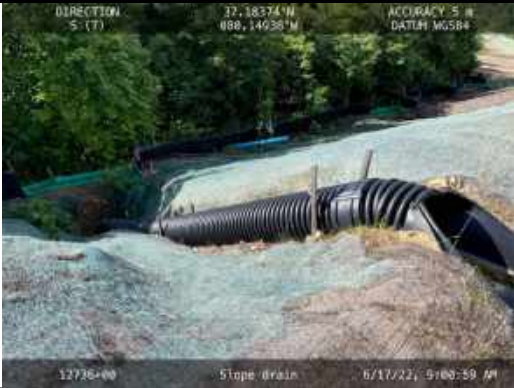
<b>GPS Location</b>	See photo		<b>GPS Location</b>	See photo	
<b>Field Station#</b>	12736+00		<b>Field Station#</b>	12737+00	
<b>Pic 5 Desc.</b>	Slope drain is functional		<b>Pic 6 Desc.</b>	Current ROW conditions. ROW is stable and ECDs are functional.

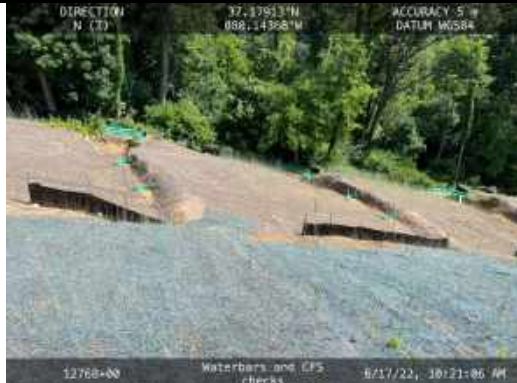
<b>GPS Location</b>	See photo		<b>GPS Location</b>	See photo	
<b>Field Station#</b>	12768+00		<b>Field Station#</b>	12773+00	
<b>Pic 11 Desc.</b>	Waterbars and CFS checks are functional. SSF is maintained		<b>Pic 12 Desc.</b>	Current ROW conditions. ROW is stable and ECDs are functional.
