Visual Site Inspection Report

Project Name	H-600 Pipeline Spread H	AFE	124300138	Spread	H-600 Pipeline Spread H
Contractor	Precision			Report #	38947
Inspector	Jordan Davis			Date/Time	6/20/2022 3:00 PM
Permit #	TBD	Inspection Type	VA SWPP	Station Begin	12119+17
State	VA	Inspection Area	Partial	Station End	12284+75
County	Montgomery	Ground	Dry	Temperature (°F)	75.00
Municipality	N/A	Weather	Cloudy	Rain Gauge (in)	0.00
				Rain Accumulation Time (days)	0.00

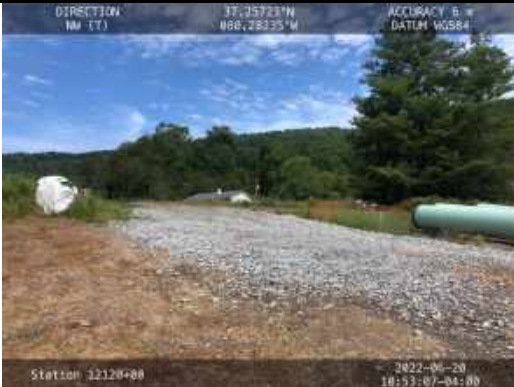
GPS Location	Please see photo for details.		GPS Location	Please see photo for details.	
Field Station#	12120+00		Field Station#	12121+83	
Pic 1 Desc.	Photo shows RCE condition on the going away side of ST RTE 622 FLATWOODS ROAD.		Pic 2 Desc.	Photo shows overview of Stream S-C36 along with current vegetative growth in resource area.

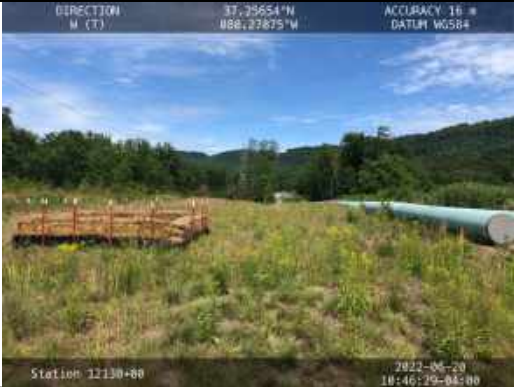
GPS Location	Please see photo for details.		GPS Location	Please see photo for details.	
Field Station#	12130+00		Field Station#	12132+73	
Pic 3 Desc.	Photo shows stabilized ROW conditions along with dewatering containment location. (Not in use).		Pic 4 Desc.	Photo shows overview of Stream S-C29 and its buffer zone from the equipment spanning the stream channel.

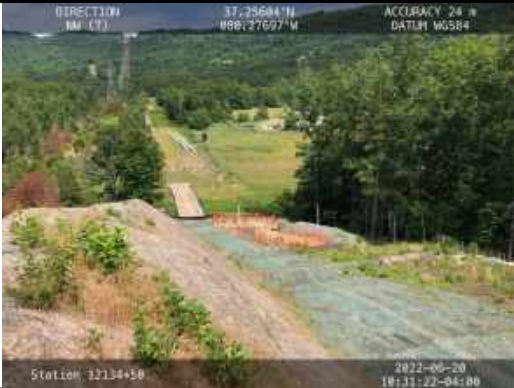
Pic 5 Desc.	Photo shows the stabilized ROW conditions with water bars and that all ECDs are installed and are functioning as designed.		Pic 6 Desc.	Photo shows overview of Wetland W-C6 from the coming in side.

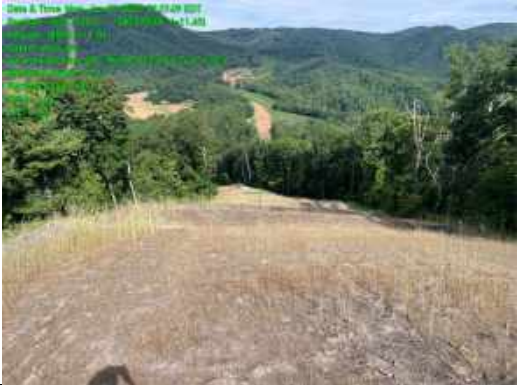
GPS Location	0	GPS Location	0		
Field Station#	13211+00	Field Station#	13211+00		
Pic 7 Desc.	ROW and ECDs In good condition and stable	Pic 8 Desc.	Slope drain pipe in good condition and functioning properly

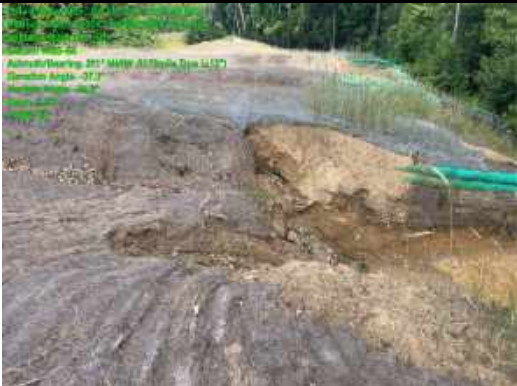
GPS Location	0	GPS Location	0		
Field Station#	13209+50	Field Station#	13209+50		
Pic 9 Desc.	Repair SSF fabric - 72hr maintenance item	Pic 10 Desc.	Repair rilling and stabilize sump and waterbar - 72hr maintenance item

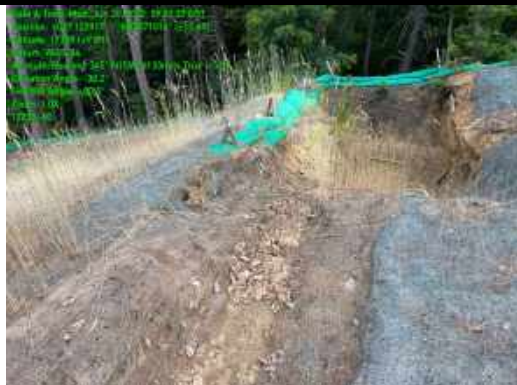
GPS Location	0	GPS Location	0		
Field Station#	13208+00	Field Station#	13197+55		
Pic 11 Desc.	Repair rilling and stabilize sump and waterbar - 72hr maintenance item	Pic 12 Desc.	Dillions Mill Road Crossing in good condition

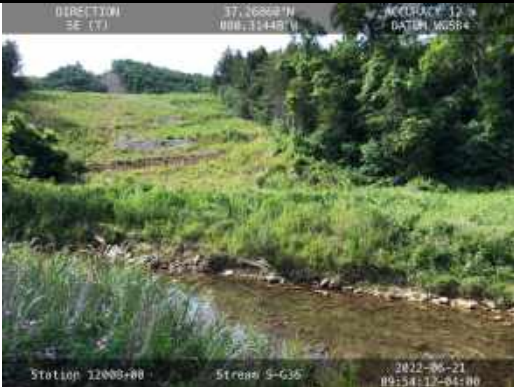
GPS Location	Please see photo for details.		GPS Location	Please see photo for details.	
Field Station#	12008+00		Field Station#	12013+97	
Pic 1 Desc.	Photo shows overview of Stream S-G36 from the coming in side along with permanently restoration area of ROW.		Pic 2 Desc.	Photo shows one of three punch list items today. Replace damaged wattle.

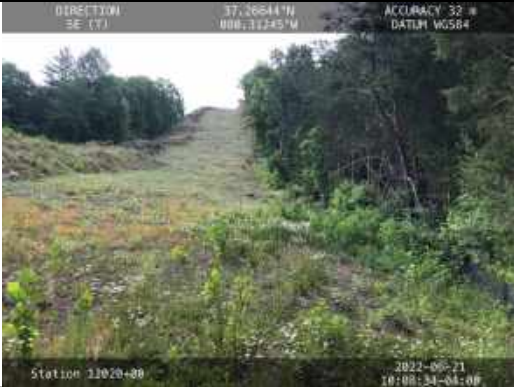
GPS Location	Please see photo for details.		GPS Location	Please see photo for details.	
Field Station#	12020+00		Field Station#	12031+51	
Pic 3 Desc.	Photo shows the stabilized ROW conditions with water bars and that all ECDs are installed and are functioning as designed.		Pic 4 Desc.	Photo shows downstream view of Stream S-G39 with the equipment bridge spanning the stream channel.

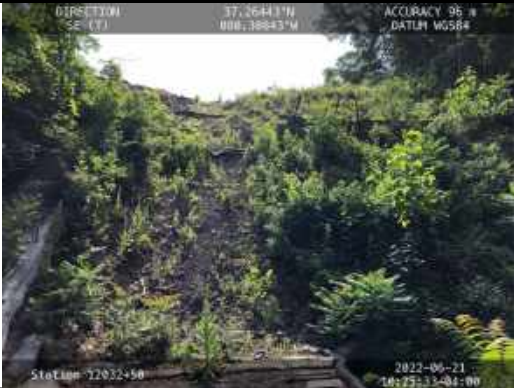
Field Station#	12032+50		Field Station#	12034+00	
Pic 5 Desc.	Photo shows the stabilized ROW conditions with water bars and that all ECDs are installed and are functioning as designed.		Pic 6 Desc.	Photo shows the stabilized ROW conditions with water bars and that all ECDs are installed and are functioning as designed.

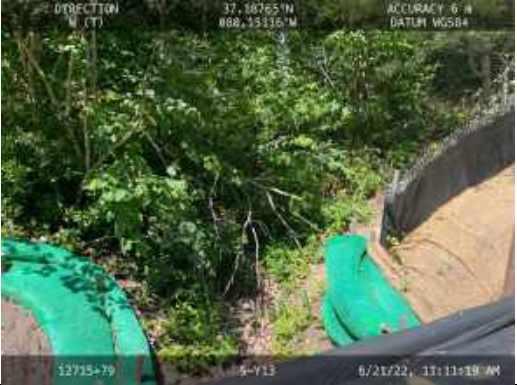
GPS Location	See photo		GPS Location	See photo	
Field Station#	12714+00		Field Station#	12715+79	
Pic 13 Desc.	Steep slope adjacent to S-Y13/14 is stable and ECDs are functional		Pic 14 Desc.	Upstream of crossing at Stream S-Y13

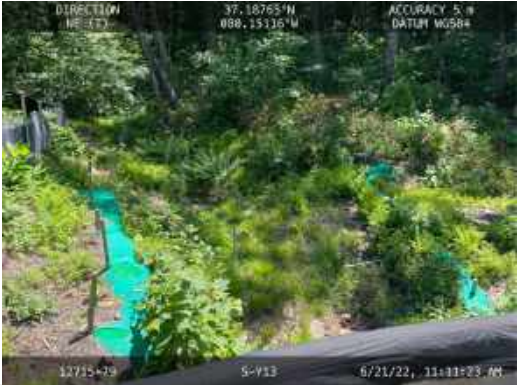
GPS Location	See photo		GPS Location	See photo	
Field Station#	12715+79		Field Station#	12716+30	
Pic 15 Desc.	Downstream of crossing at Stream S-Y13		Pic 16 Desc.	Upstream of crossing at stream S-Y14

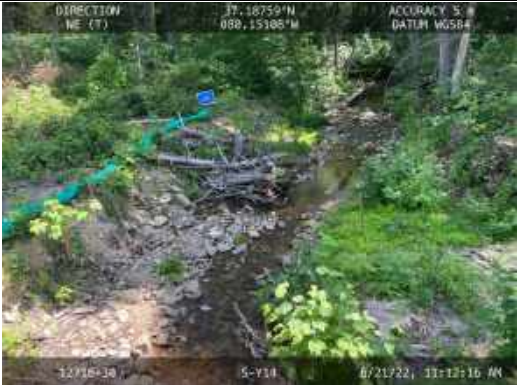
GPS Location	See photo		GPS Location	See photo	
Field Station#	12716+30		Field Station#	12685+00	
Pic 17 Desc.	Downstream of crossing at Stream S-Y14		Pic 18 Desc.	Current ROW conditions. ROW is stable and ECDs are functional.

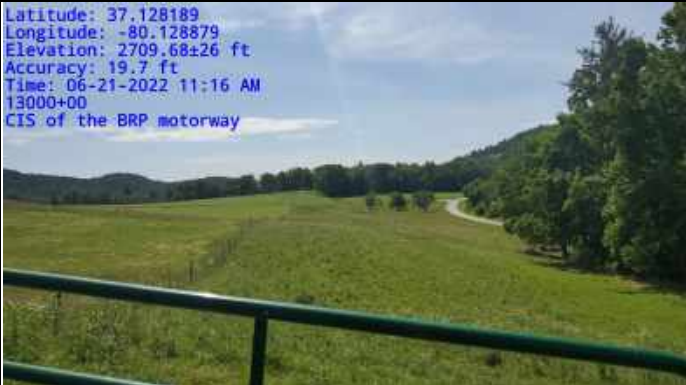
AFE	124300138	Date/Time	6/21/2022 2:57 PM	Report #	
Pictures					
<div>Latitude: 37.128189 Longitude: -80.128879 Elevation: 2709.68±26 ft Accuracy: 19.7 ft Time: 06-21-2022 11:16 AM 13000+00 CIS of the BRP motorway</div>

GPS Location	See pic.		GPS Location	See pic.	
Field Station#	13000+00		Field Station#	12999+00	
Pic 7 Desc.	Current ROW conditions.		Pic 8 Desc.	Current ROW conditions.	
<div>Latitude: 37.128535 Longitude: -80.13047 Elevation: 2633.99±9 ft Accuracy: 12.5 ft Time: 06-21-2022 11:19 AM 12993+00 GAS of RD-288</div>

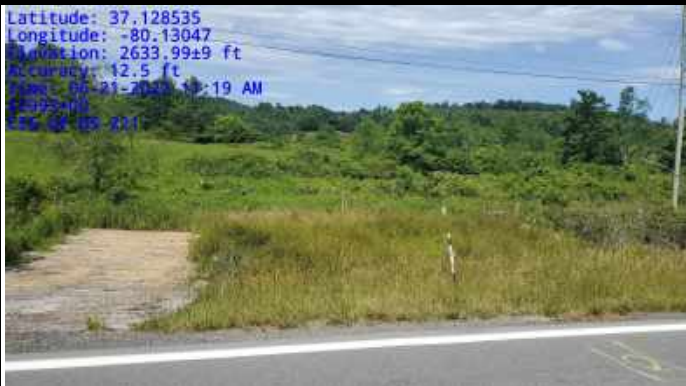
Pic 9 Desc.	Current ROW conditions.		Pic 10 Desc.	Current ROW conditions.	
<div>Latitude: 37.130009 Longitude: -80.130299 Elevation: 2646.23±34 ft Accuracy: 25.3 ft Time: 06-21-2022 11:30 AM 12976+00 GAS of RD-288</div>

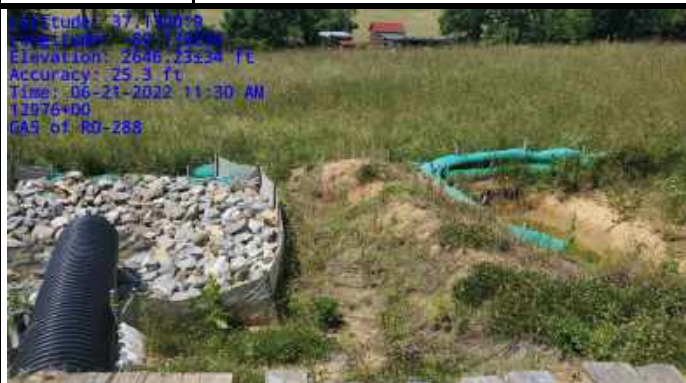
GPS Location	See pic.		GPS Location	See pic.	
Field Station#	12976+00		Field Station#	12958+00	
Pic 11 Desc.	CWDP and plunge pool on the GAS of RD-288.		Pic 12 Desc.	Streams S-Y7 and S-Y8 from the CIS.

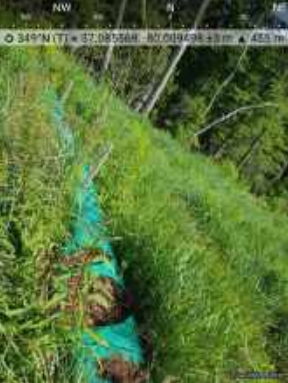
GPS Location	00000		GPS Location	00000	
Field Station#	13480+00		Field Station#	13482+10	
Pic 1 Desc.	CFS requires maintenance due to wildlife damages, added to the punch list for repair.		Pic 2 Desc.	CFS requires maintenance due to being weathered and torn, documented and added to the punch list for repair.

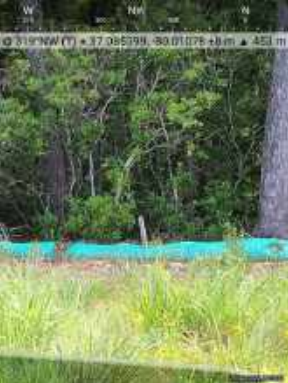
GPS Location	00000		GPS Location	00000	
Field Station#	13472+60		Field Station#	13482+10	
Pic 3 Desc.	CFS requires maintenance due to wildlife damages, added to the punch list for repair.		Pic 4 Desc.	CFS requires maintenance due to wildlife damages, added to the punch list for repair.

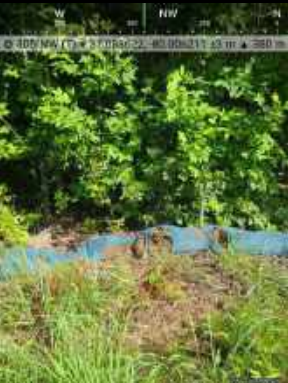
GPS Location	00000		GPS Location	00000	
Field Station#	13493+25		Field Station#	13456+00	
Pic 5 Desc.	CFS requires maintenance due to wildlife damages, added to the punch list for repair.		Pic 6 Desc.	CFS requires maintenance due to wildlife damages, added to the punch list for repair.

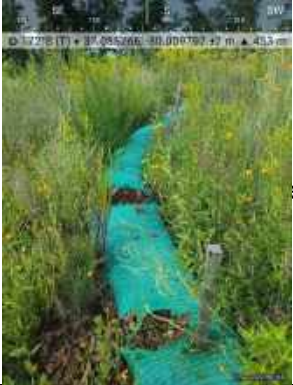
GPS Location	0000	GPS Location	0000		
Field Station#	13476+35	Field Station#	13450+00		
Pic 7 Desc.	CFS requires maintenance due to wildlife damages, added to the punch list for repair.	Pic 8 Desc.	CFS requires maintenance due to wildlife damages, added to the punch list for repair.

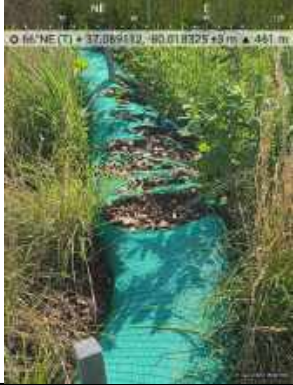
GPS Location	00000	GPS Location	0000		
Field Station#	13445+43	Field Station#	13476+35		
Pic 9 Desc.	CFS requires maintenance due to wildlife damages, added to the punch list for repair.	Pic 10 Desc.	CFS requires maintenance due to wildlife damages, added to the punch list for repair.

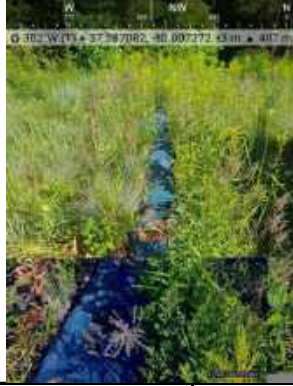
GPS Location	0000	GPS Location	0000		
Field Station#	13490+00	Field Station#	13470+00		
Pic 11 Desc.	CFS requires maintenance due to wildlife damages, added to the punch list for repair.	Pic 12 Desc.	CFS requires maintenance due to wildlife damages, added to the punch list for repair.

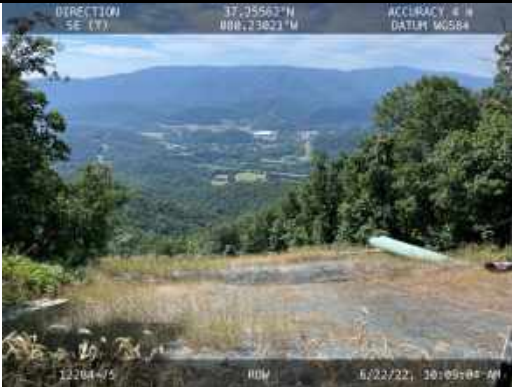
GPS Location	Please see photo for details.		GPS Location	Please see photo for details.	
Field Station#	12284+75		Field Station#	12298+00	
Pic 1 Desc.	Photo shows the stabilized ROW conditions with water bars and that all ECDs are installed and are functioning as designed.		Pic 2 Desc.	Photo shows the stabilized ROW conditions with water bars and that all ECDs are installed and are functioning as designed.

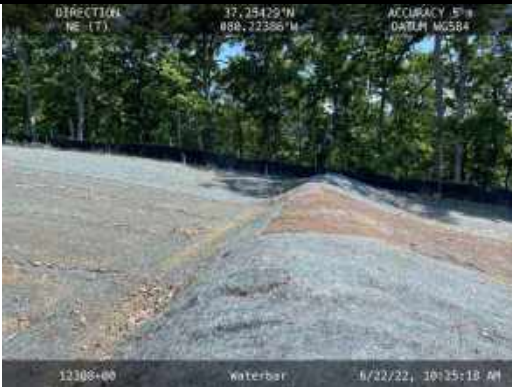
GPS Location	Please see photo for details.		GPS Location	Please see photo for details.	
Field Station#	12308+00		Field Station#	12330+00	
Pic 3 Desc.	Photo shows the stabilized ROW conditions with water bars and that all ECDs are installed and are functioning as designed.		Pic 4 Desc.	Photo shows the stabilized ROW conditions with water bars and that all ECDs are installed and are functioning as designed.

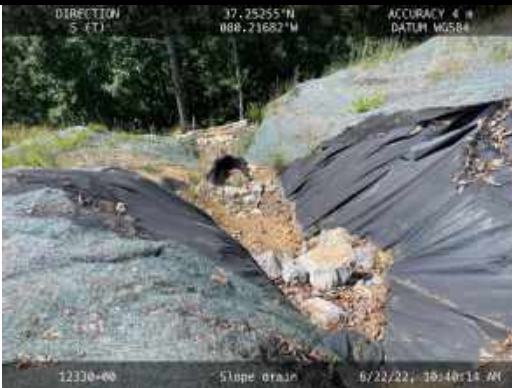
GPS Location	Please see photo for details.		GPS Location	Please see photo for details.	
Field Station#	12330+00		Field Station#	12338+00	
Pic 5 Desc.	Photo shows slope drain with stone inlet protection.		Pic 6 Desc.	Photo shows the stabilized ROW conditions with water bars and that all ECDs are installed and are functioning as designed.

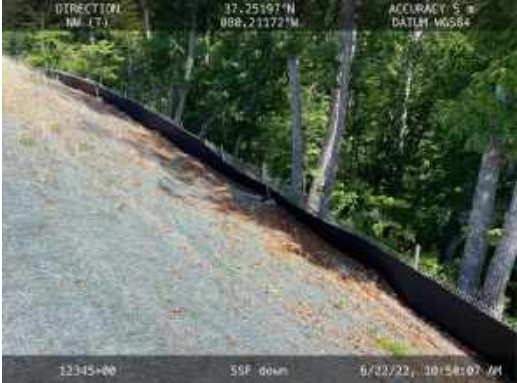
GPS Location	Please see photo for details.		GPS Location	Please see photo for details.	
Field Station#	12345+00		Field Station#	12346+00	
Pic 7 Desc.	Photo shows a punch list item from today that consists of reattaching SFF fabric to chain link.		Pic 8 Desc.	Photo shows a punch list item from today that consists of reattaching SFF fabric to chain link.

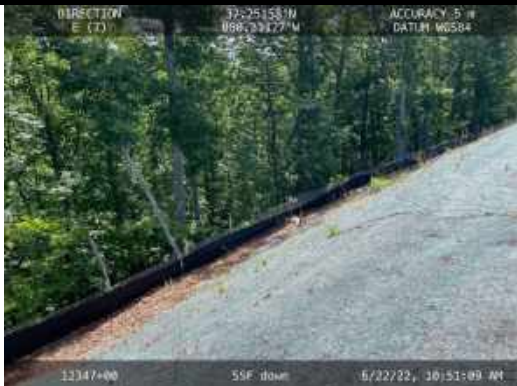
GPS Location	Please see photo for details.		GPS Location	Please see photo for details.	
Field Station#	12347+00		Field Station#	12353+00	
Pic 9 Desc.	Photo shows a punch list item from today that consists of reattaching SFF fabric to chain link.		Pic 10 Desc.	Photo shows a punch list item from today that consists of reattaching SFF fabric to chain link.

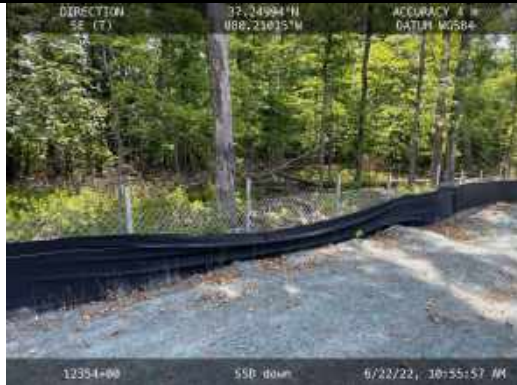
GPS Location	Please see photo for details.		GPS Location	Please see photo for details.	
Field Station#	12354+00		Field Station#	12362+00

Pic 11 Desc.	Photo shows a punch list item from today that consists of reattaching SFF fabric to chain link.		Pic 12 Desc.	Photo shows the stabilized ROW conditions with water bars and that all ECDs are installed and are functioning as designed.

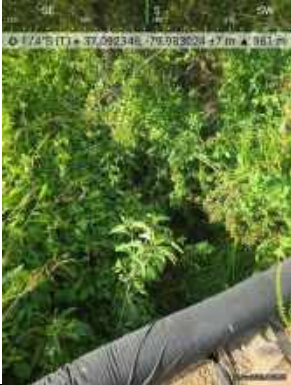
<div>Insert image here</div>		<div>Insert image here</div>	
GPS Location	0000	GPS Location	0000		
Field Station#	13565+30	Field Station#			
Pic 7 Desc.	Stream observation photo facing upstream during routine inspection. No issues were observed at the time of inspection.		Pic 8 Desc.		
<div>Insert image here</div>		<div>Insert image here</div>		<div>Insert image here</div>	
GPS Location		GPS Location			
Field Station#		Field Station#			
Pic 9 Desc.			Pic 10 Desc.		
<div>Insert image here</div>		<div>Insert image here</div>		<div>Insert image here</div>	
GPS Location		GPS Location			
Field Station#		Field Station#			
Pic 11 Desc.			Pic 12 Desc.

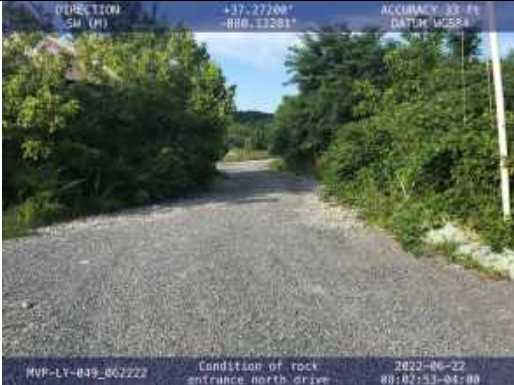
GPS Location	MVP-LY-049 See photo for gps data	GPS Location	MVP-LY-049 See photo for gps data		
Field Station#	+0	Field Station#	+0		
Pic 1 Desc.	Rock entrance on north drive. No sediment or debris on stone. Looking SW.	Pic 2 Desc.	Rock entrance on center drive. Small stone has been applied over larger stone. Looking S.

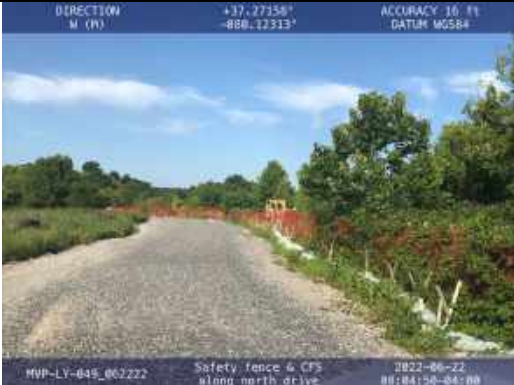
GPS Location	MVP-LY-049 See photo for gps data	GPS Location	MVP-LY-049 See photo for gps data		
Field Station#	+0	Field Station#	+0		
Pic 3 Desc.	Safety fence and triple stack compost filter sock along north LOD. Looking W.	Pic 4 Desc.	Landowner soil disturbance along triple stack compost filter sock. Area not stabilized. Looking S.

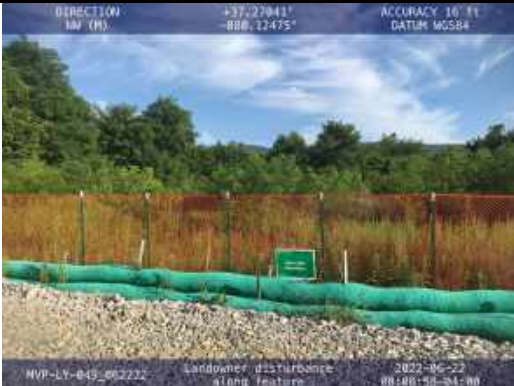
GPS Location	MVP-LY-049 See photo for gps data	GPS Location	MVP-LY-049 See photo for gps data		
Field Station#	+0	Field Station#	+0		
Pic 5 Desc.	Landowner soil disturbance along feature W-CV21A. Area not stabilized. Looking NW.	Pic 6 Desc.	Landowner soil disturbance west of feature W-CV21B. Areas not stabilized. Looking SW.

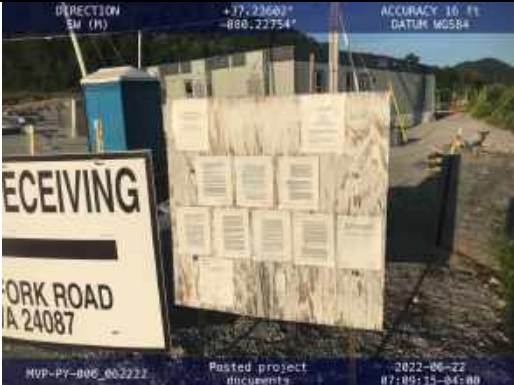
GPS Location	MVP-PY-006 See photo for gps data		GPS Location	MVP-PY-006 See photo for gps data	
Field Station#	+0		Field Station#	+0	
Pic 3 Desc.	Posted project documents at main entrance. Looking SW.		Pic 4 Desc.	Status of spoil pile adjacent to LOD on VDOT property. Soil pile not stabilized. Looking S.

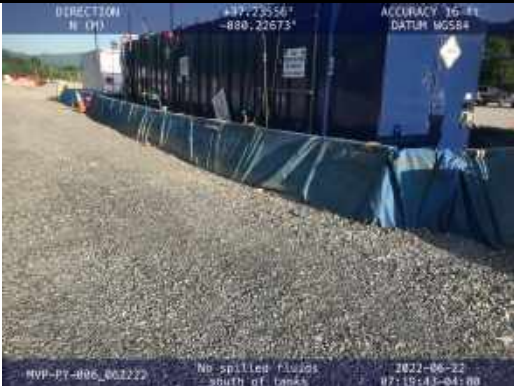
GPS Location	MVP-PY-006 See photo for gps data		GPS Location	MVP-PY-006 See photo for gps data	
Field Station#	+0		Field Station#	+0	
Pic 5 Desc.	Blue Bulk Fuel tanks no fuel spills south of tanks. Looking N.		Pic 6 Desc.	Secondary containment under DEF container free of fluids. Looking N.

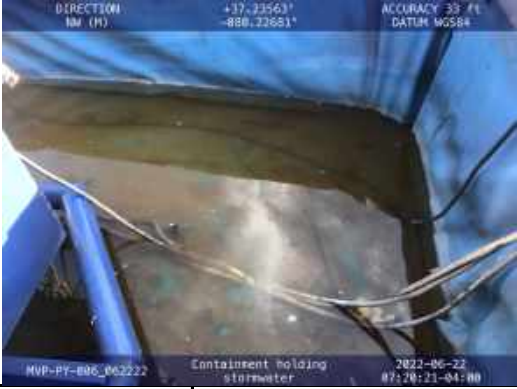
GPS Location	MVP-PY-006 See photo for gps data	GPS Location	MVP-PY-006 See photo for gps data		
Field Station#	+0	Field Station#	+0		
Pic 7 Desc.	Blue Bulk Fuel tanks holding stormwater. Looking NW.	Pic 8 Desc.	Blue Bulk Fuel tanks no leaky internal fittings. Looking NW.

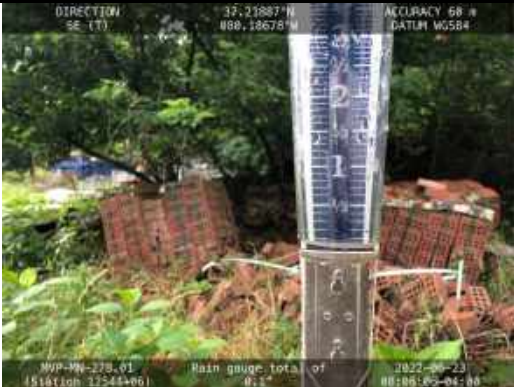
GPS Location	Please see photo for details.		GPS Location	Please see photo for details.	
Field Station#	12544+06		Field Station#	12538+00	
Pic 1 Desc.	Photo shows rain gauge total for the last 24hrs of 0.1"		Pic 2 Desc.	Photo shows the stabilized ROW conditions with water bars and that all ECDs are installed and are functioning as designed.

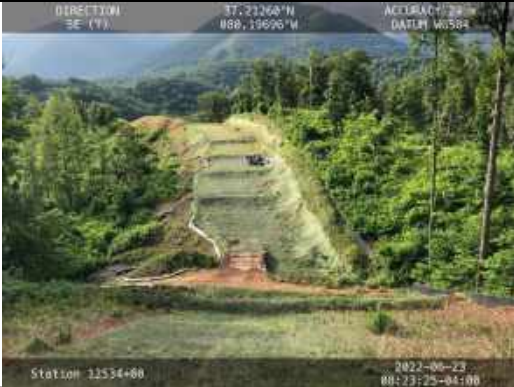
GPS Location	Please see photo for details.		GPS Location	Please see photo for details.	
Field Station#	12534+00		Field Station#	12527+00	
Pic 3 Desc.	Photo shows the stabilized ROW conditions with water bars and that all ECDs are installed and are functioning as designed.		Pic 4 Desc.	Photo shows the stabilized ROW conditions with water bars and that all ECDs are installed and are functioning as designed.

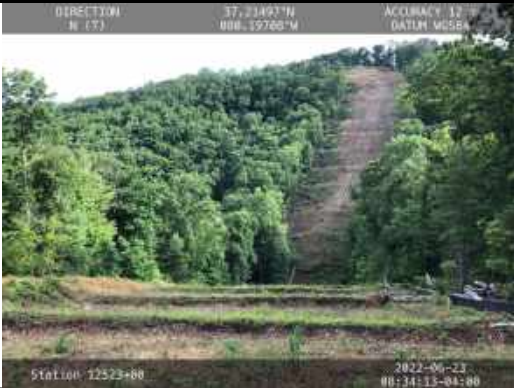
GPS Location	Please see photo for details.		GPS Location	Please see photo for details.

Field Station#	12523+00		Field Station#	12521+00	
Pic 5 Desc.	Photo shows the stabilized ROW conditions with water bars and that all ECDs are installed and are functioning as designed.		Pic 6 Desc.	Photo shows the stabilized ROW conditions with water bars and that all ECDs are installed and are functioning as designed.

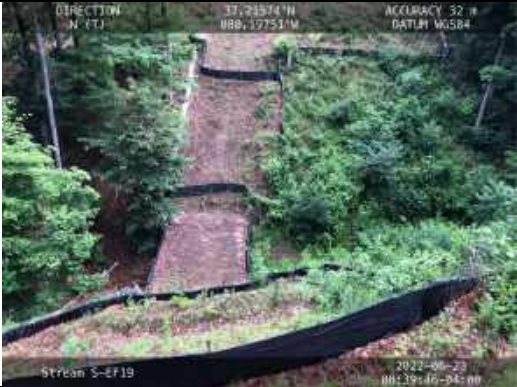
GPS Location	Please see photo for details.		GPS Location	Please see photo for details.	
Field Station#	12519+41		Field Station#	12519+41	
Pic 7 Desc.	Photo shows overview of Stream S-EF19 and its buffer zone from the going away side.		Pic 8 Desc.	Photo shows upstream view of Stream S-EF19 from the equipment bridge spanning the stream channel.

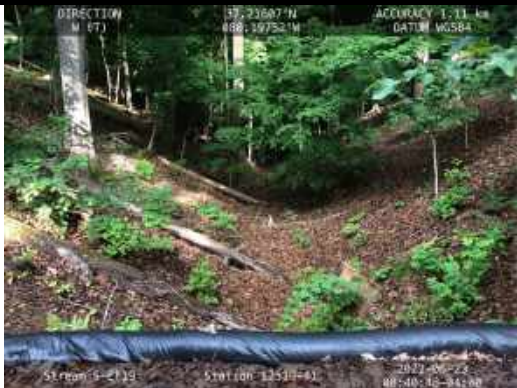
GPS Location	Please see photo for details.		GPS Location	Please see photo for details.	
Field Station#	12519+41		Field Station#	12517+00	
Pic 9 Desc.	Photo shows downstream view of Stream S-EF19 from the equipment bridge spanning the stream channel.		Pic 10 Desc.	Photo shows the stabilized ROW conditions with water bars and that all ECDs are installed and are functioning as designed.

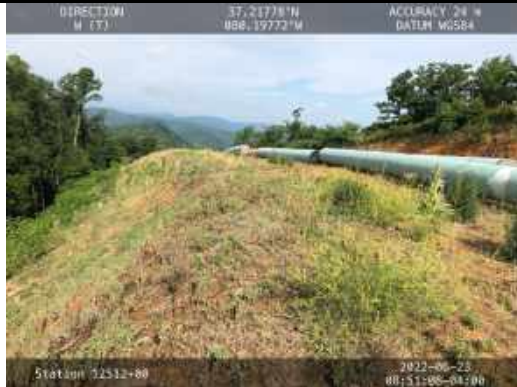
GPS Location	Please see photo for details.		GPS Location	Please see photo for details.

Field Station#	12512+00		Field Station#	12509+00	
Pic 11 Desc.	Photo shows the stabilized ROW conditions with water bars and that all ECDs are installed and are functioning as designed.		Pic 12 Desc.	Photo shows slope drain pipe with stone inlet protection.

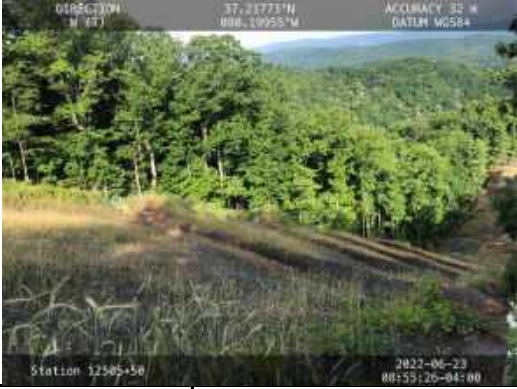
GPS Location	Please see photo for details.		GPS Location	Please see photo for details.	
Field Station#	12505+50		Field Station#	12504+00	
Pic 13 Desc.	Photo shows the stabilized ROW conditions with water bars and that all ECDs are installed and are functioning as designed.		Pic 14 Desc.	Photo shows stabilized ROW conditions along with clean water diversion pipe draining into plunge pool.

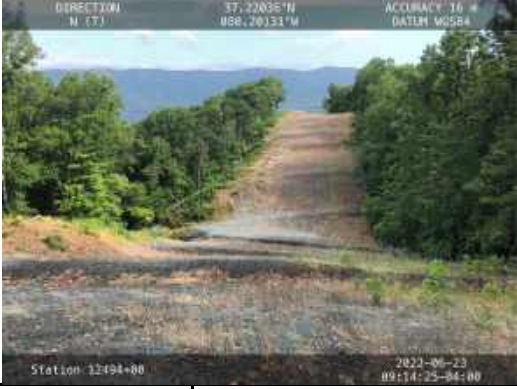
GPS Location	Please see photo for details.		GPS Location	Please see photo for details.	
Field Station#	12494+00		Field Station#	12470+00	
Pic 15 Desc.	Photo shows the stabilized ROW conditions with water bars and that all ECDs are installed and are functioning as designed.		Pic 16 Desc.	Photo shows the stabilized ROW conditions with water bars and that all ECDs are installed and are functioning as designed.

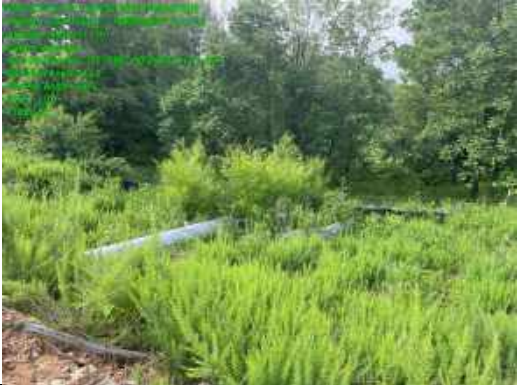
GPS Location	0	GPS Location	0		
Field Station#	13345+50	Field Station#	13348+46		
Pic 7 Desc.	Clean water diversion pipe and outlet in good condition	Pic 8 Desc.	MVP-S-RR08 and corresponding buffer zone in good condition

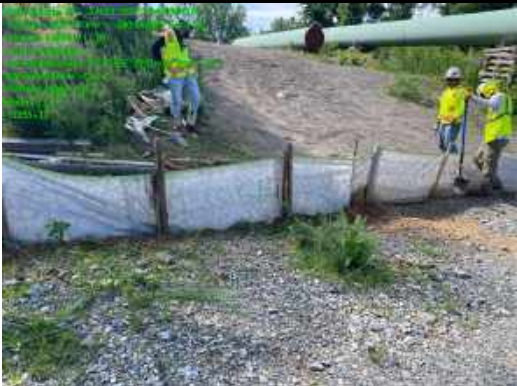
GPS Location	0	GPS Location	0		
Field Station#	13352+23	Field Station#	13355+33		
Pic 9 Desc.	MVP-S-RR09 and corresponding buffer zone in good condition	Pic 10 Desc.	72 hour maintenance item identified and repaired, repair holes in P1

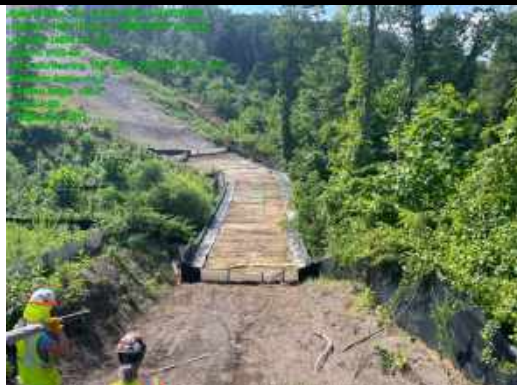
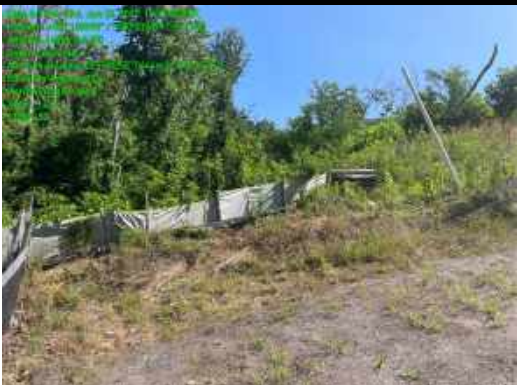
GPS Location	0	GPS Location	0		
Field Station#	13358+64	Field Station#	13359+50		
Pic 11 Desc.	MVP-S-RR11 and corresponding buffer zone in good condition	Pic 12 Desc.	72 hour maintenance item identified and repaired, repair holes in P1

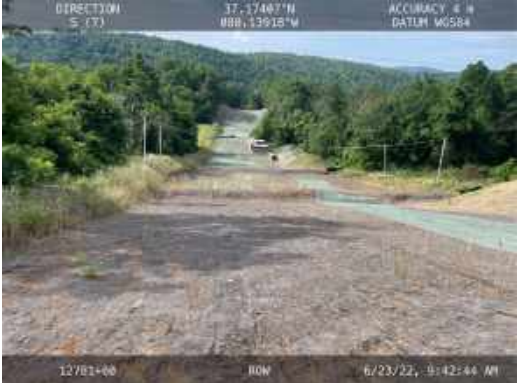
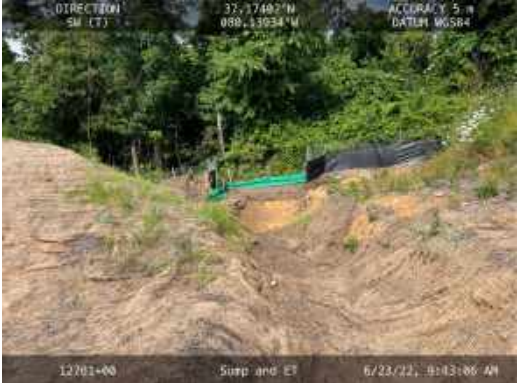
GPS Location	See photo		GPS Location	See photo	
Field Station#	12781+00		Field Station#	12781+00	
Pic 7 Desc.	Current ROW conditions. ROW is stable. ECDs are functional.		Pic 8 Desc.	Sump and End Treatment are functional

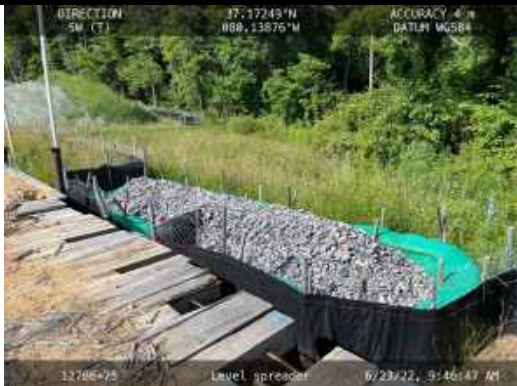
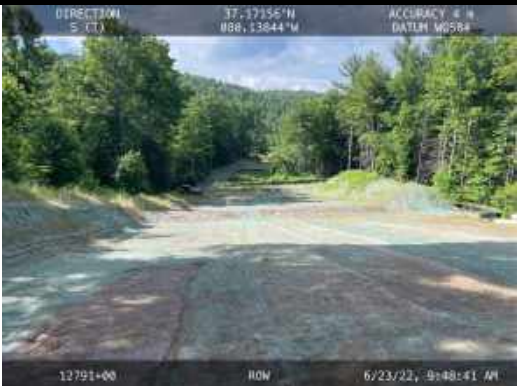
GPS Location	See photo		GPS Location	See photo	
Field Station#	12786+75		Field Station#	12791+00	
Pic 9 Desc.	Level spreader is functional		Pic 10 Desc.	Current ROW conditions. ROW is stable. ECDs are functional.

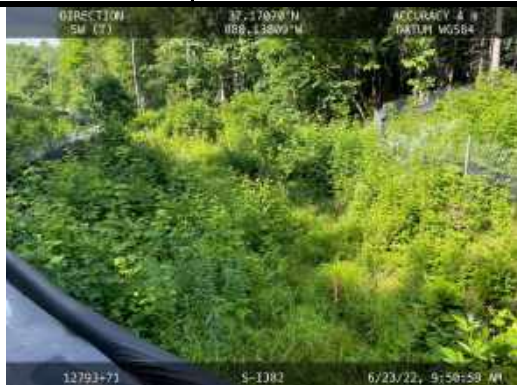
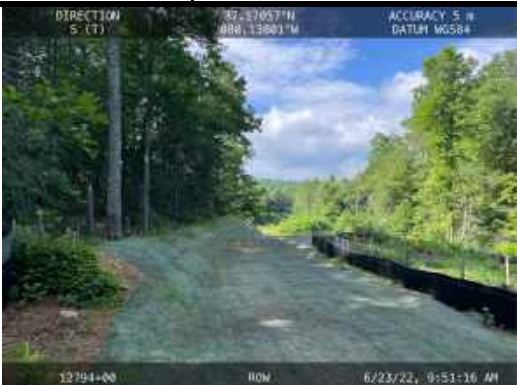
GPS Location	See photo		GPS Location	See photo	
Field Station#	12793+71		Field Station#	12794+00	
Pic 11 Desc.	Downstream of crossing at Stream S-IJ82		Pic 12 Desc.	Current ROW conditions. ROW is stable. ECDs are functional.

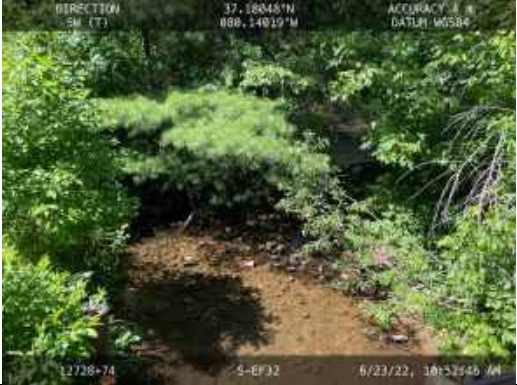
GPS Location	See photo		GPS Location	See photo	
Field Station#	12774+00		Field Station#	12728+74	
Pic 13 Desc.	Current ROW conditions. ROW is stable. ECDs are functional.		Pic 14 Desc.	Downstream of crossing at Stream S-EF32

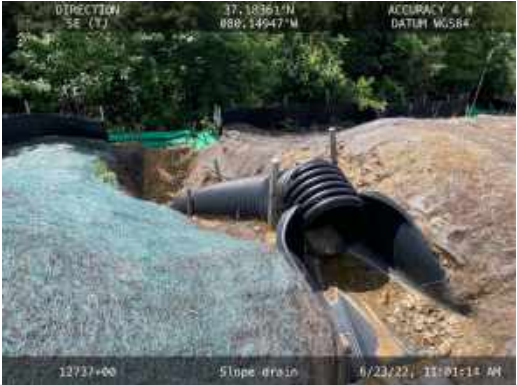
GPS Location	See photo		GPS Location	See photo	
Field Station#	12738+00		Field Station#	12737+00	
Pic 15 Desc.	Current ROW conditions. ROW is stable. ECDs are functional.		Pic 16 Desc.	Slope drain is functional

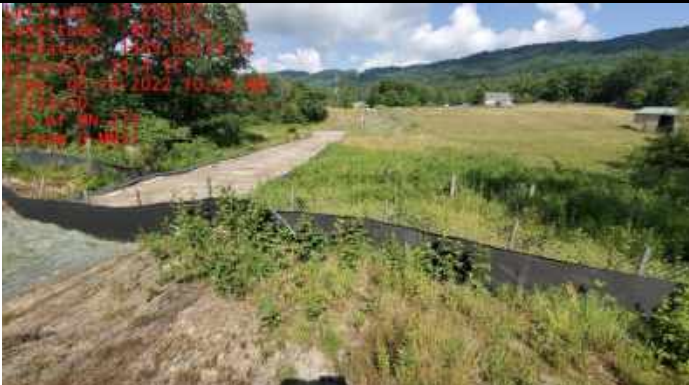
GPS Location		Please see photo for details.		GPS Location		Please see photo for details.	
Field Station#		12123+23		Field Station#		12132+73	
Pic 1 Desc.		Photo shows overview of Wetland W-C11 from the going away side.		Pic 2 Desc.		Photo shows overview of Stream S-C29 and its buffer zone from the going away side.

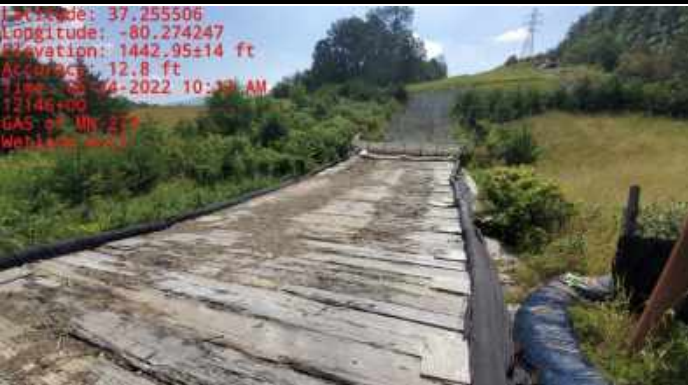
GPS Location		Please see photo for details.		GPS Location		Please see photo for details.	
Field Station#		12144+50		Field Station#		12145+00	
Pic 3 Desc.		Photo shows overview of Wetland W-C5 from the coming in side.		Pic 4 Desc.		Photo shows the stabilized ROW conditions with water bars and that all ECDs are installed and are functioning as designed.

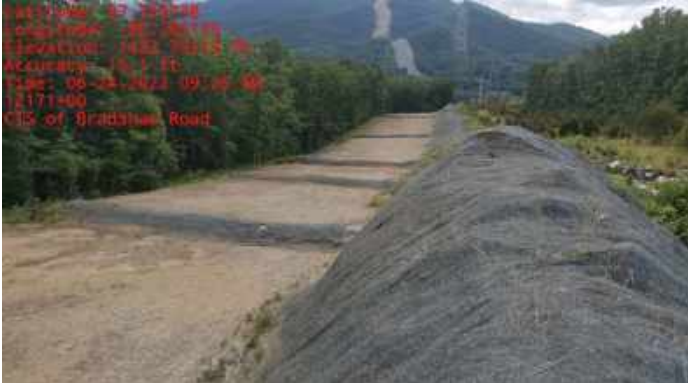
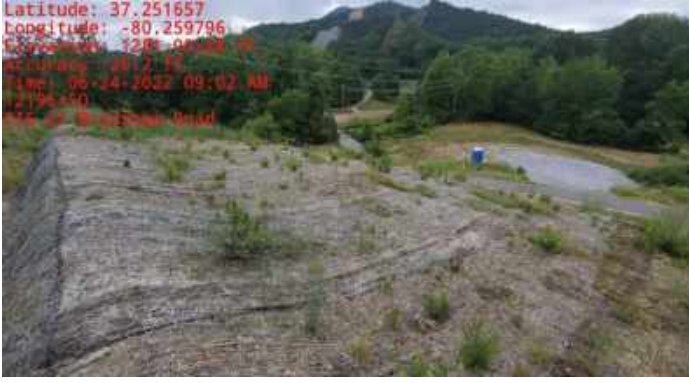
GPS Location	Please see photo for details.		GPS Location	Please see photo for details.	
Field Station#	12171+00		Field Station#	12196+50	
Pic 7 Desc.	Photo shows the stabilized ROW conditions with water bars and that all ECDs are installed and are functioning as designed.		Pic 8 Desc.	Photo shows the stabilized ROW conditions with water bars and that all ECDs are installed and are functioning as designed.

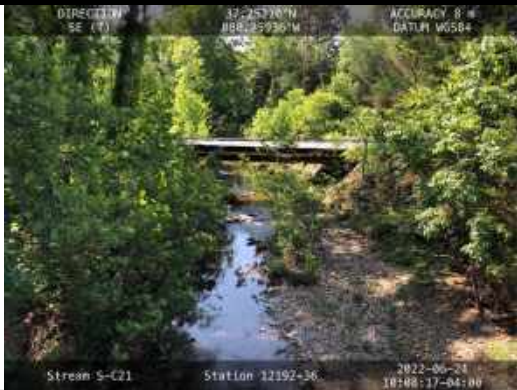
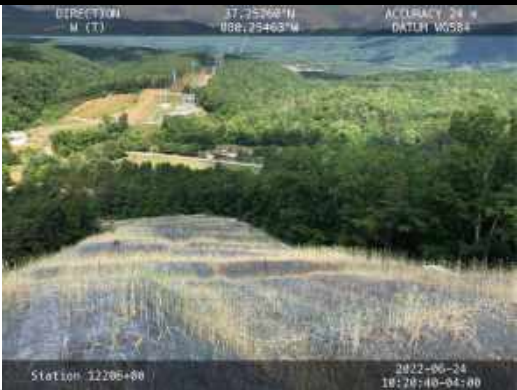
GPS Location	Please see photo for details.		GPS Location	Please see photo for details.	
Field Station#	12192+36		Field Station#	12206+00	
Pic 9 Desc.	Photo shows upstream overview of Stream S-C21 and the equipment bridge spanning the stream channel.		Pic 10 Desc.	Photo shows the stabilized ROW conditions with water bars and that all ECDs are installed and are functioning as designed.

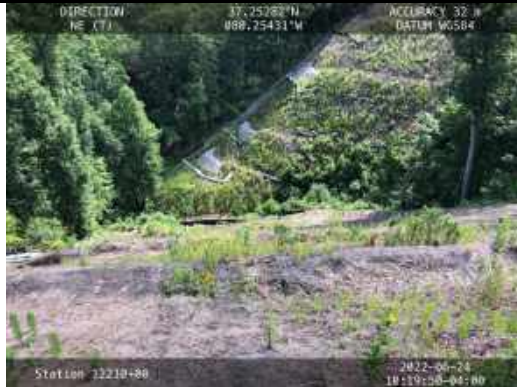
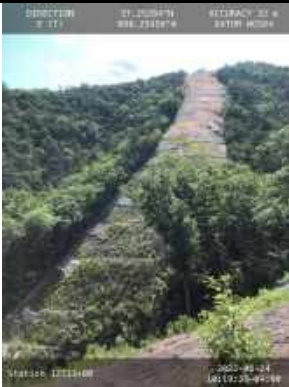
GPS Location	Please see photo for details.		GPS Location	Please see photo for details.	
Field Station#	12210+00		Field Station#	12213+00	
Pic 11 Desc.	Photo shows the stabilized ROW conditions with water bars and that all ECDs are installed and are functioning as designed.		Pic 12 Desc.	Photo shows the stabilized ROW conditions with water bars and that all ECDs are installed and are functioning as designed.

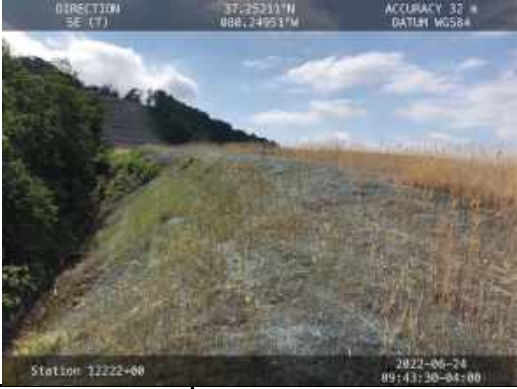
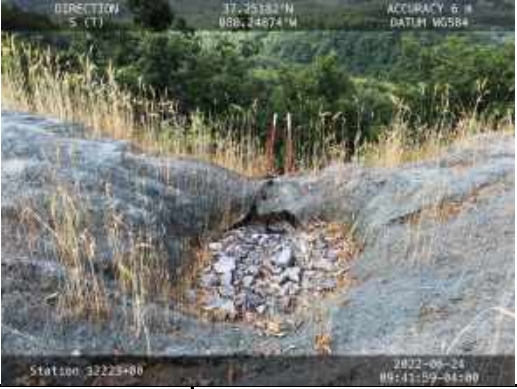
GPS Location	Please see photo for details.		GPS Location	Please see photo for details.	
Field Station#	12222+00		Field Station#	12223+00	
Pic 13 Desc.	Photo shows the stabilized ROW conditions with water bars and that all ECDs are installed and are functioning as designed.		Pic 14 Desc.	Photo shows slope drain inlet with stone inlet protection.

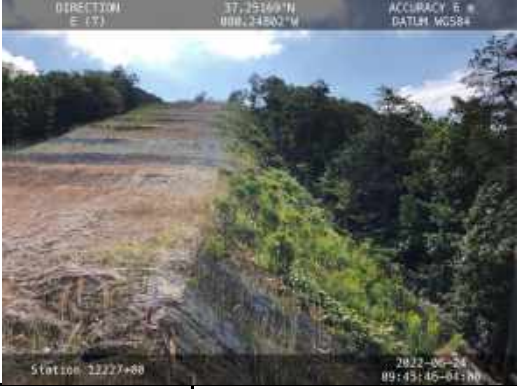
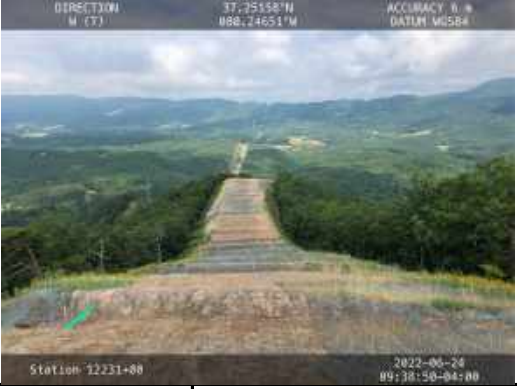
GPS Location	Please see photo for details.		GPS Location	Please see photo for details.	
Field Station#	12227+00		Field Station#	12231+00	
Pic 15 Desc.	Photo shows the stabilized ROW conditions with water bars and that all ECDs are installed and are functioning as designed.		Pic 16 Desc.	Photo shows the stabilized ROW conditions with water bars and that all ECDs are installed and are functioning as designed.

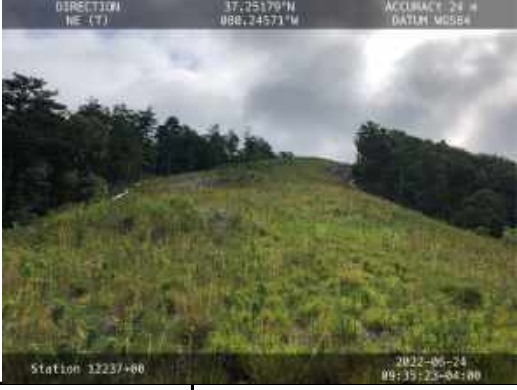
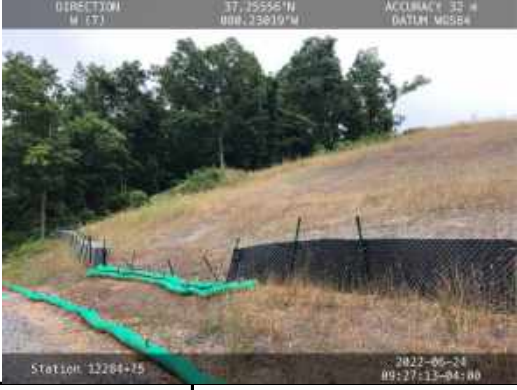
Field Station#	12237+00		Field Station#	12284+75	
Pic 17 Desc.	Photo shows the stabilized ROW conditions with water bars and that all ECDs are installed and are functioning as designed.		Pic 18 Desc.	Photo shows the stabilized ROW conditions with water bars and that all ECDs are installed and are functioning as designed.

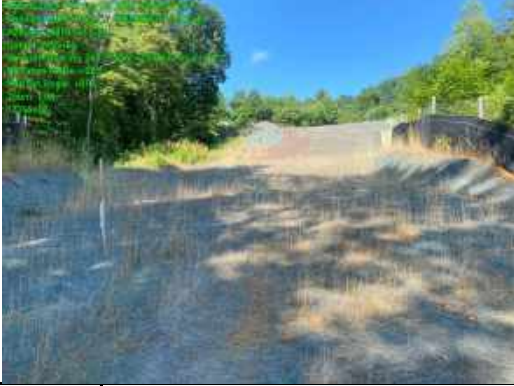
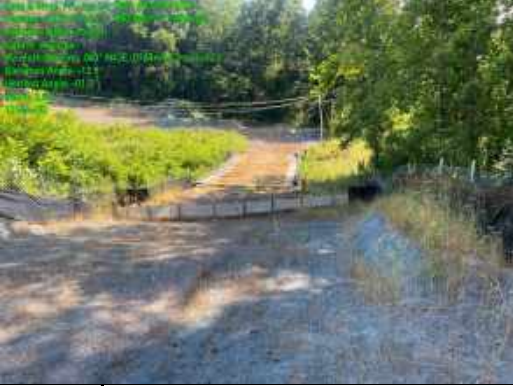
GPS Location	0	GPS Location	0		
Field Station#	13146+00	Field Station#	13146+00		
Pic 1 Desc.	ROW and ECDs In good condition and stable	Pic 2 Desc.	MVP-S-D12/13 and corresponding buffer zone in good condition

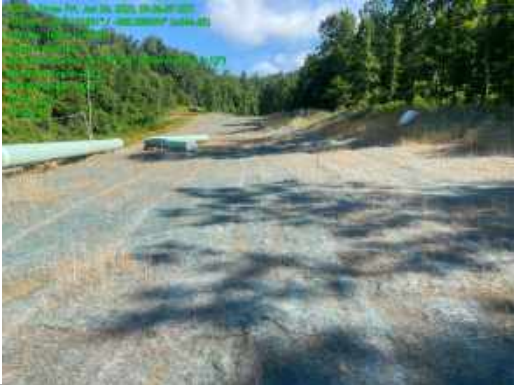
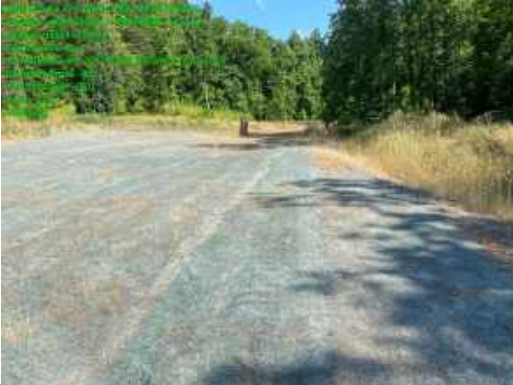
GPS Location	0	GPS Location	0		
Field Station#	13148+00	Field Station#	13154+00		
Pic 3 Desc.	ROW and ECDs In good condition and stable	Pic 4 Desc.	ROW and ECDs In good condition and stable

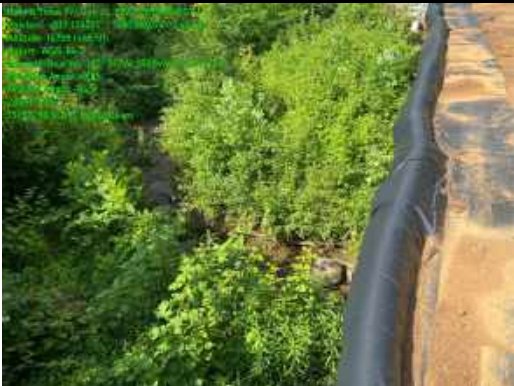
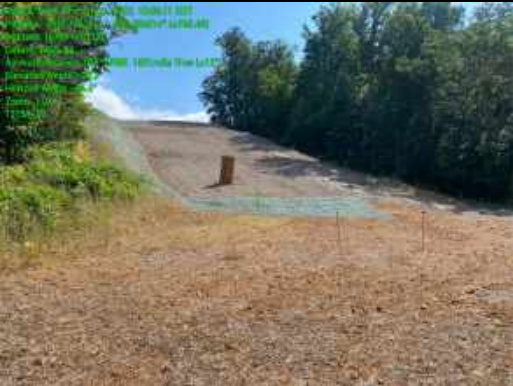
GPS Location	0	GPS Location	0		
Field Station#	13157+50	Field Station#	13158+00		
Pic 5 Desc.	MVP-S-D11 Downstream and corresponding buffer zone in good condition	Pic 6 Desc.	ROW and ECDs In good condition and stable
