Visual Site Inspection Report

Project Name	H-600 Pipeline Spread H	AFE	124300138	Spread	H-600 Pipeline Spread H
Contractor	Precision			Report #	39213
Inspector	Jordan Davis			Date/Time	6/27/2022 3:52 PM
Permit #	TBD	Inspection Type	VA SWPP	Station Begin	12005+00
State	VA	Inspection Area	Partial	Station End	12119+17
County	Montgomery	Ground	Dry	Temperature (°F)	83.00
Municipality	N/A	Weather	Cloudy	Rain Gauge (in)	0.00
				Rain Accumulation Time (days)	0.00

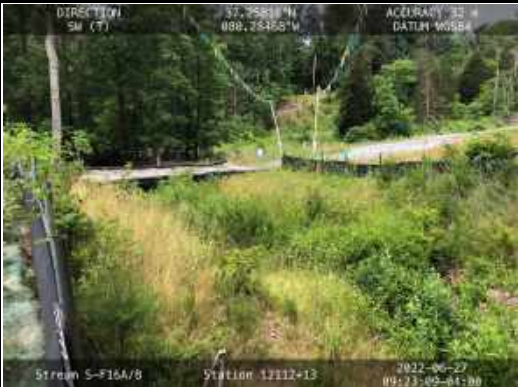
Field Station#	12112+13		Field Station#	12116+50	
Pic 17 Desc.	Photo shows overview of Stream S-F16A/B and its buffer zone from the upstream side.		Pic 18 Desc.	Today's punch list item consisting of fixing hole on bottom of CFS.

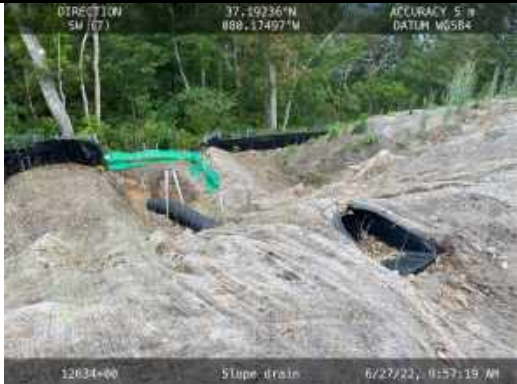
GPS Location	See photo		GPS Location	See photo	
Field Station#	12634+00		Field Station#	12684+00	
Pic 9 Desc.	Slope drain is functional		Pic 10 Desc.	Current ROW conditions. ROW is stable and ECDs are functional

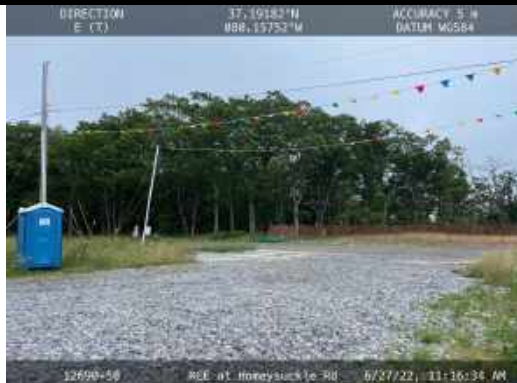
GPS Location	See photo		GPS Location	See photo	
Field Station#	12690+50		Field Station#	12692+00	
Pic 11 Desc.	RCE is well maintained		Pic 12 Desc.	Current ROW conditions. ROW is stable and ECDs are functional

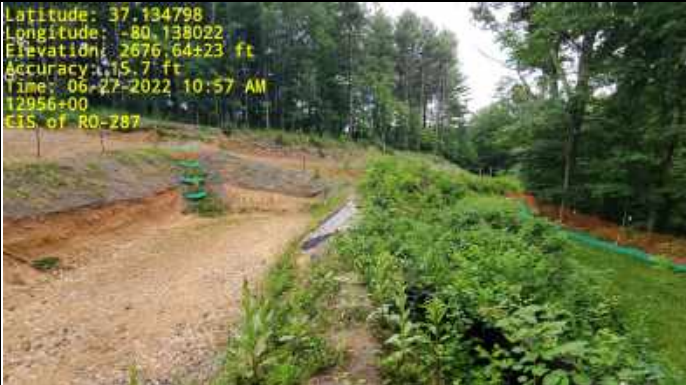
<div>Latitude: 37.13484 Longitude: -80.138067 Elevation: 2648.79±34 ft Accuracy: 24.3 ft Time: 06-27-2022 10:59 AM 12955+00 CIS of RO-287</div>  		
GPS Location	See pic.		GPS Location	See pic.	
Field Station#	12956+00		Field Station#	12955+00	
Pic 13 Desc.	Large sediment trap on the CIS of RO-287.		Pic 14 Desc.	Current ROW conditions.	
<div>Latitude: 37.134674 Longitude: -80.137458 Elevation: 2654.3±20 ft Accuracy: 14.4 ft Time: 06-27-2022 11:01 AM 12958+00 GAS of RO-287 Streams S-Y7 and S-Y8</div>

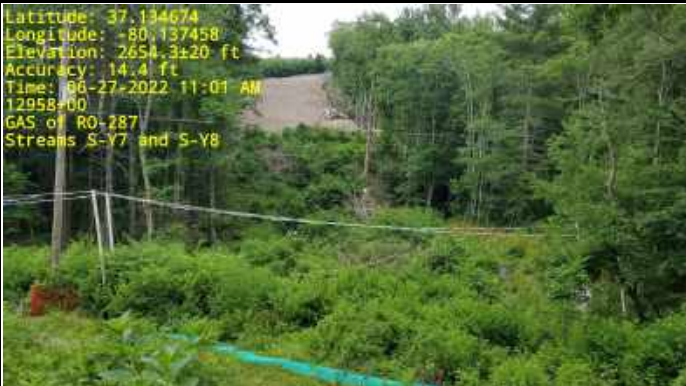
Field Station#	12958+00		Field Station#	12914+00	
Pic 15 Desc.	Streams S-Y7 and S-Y8 from the CIS.		Pic 16 Desc.	Current ROW conditions.	
<div>Latitude: 37.144665 Longitude: -80.137246 Elevation: 2711.32±10 ft Accuracy: 32.5 ft Time: 06-27-2022 11:30 AM 12916+00 GAS of RO-286</div>

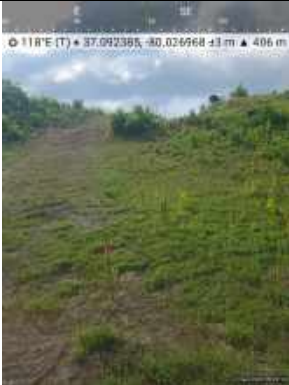
GPS Location	0000	GPS Location	0000		
Field Station#	13417+60	Field Station#	13416+00		
Pic 1 Desc.	Photo showing stabilization on hill side above road crossing. No environmental issues observed at the time of inspection.		Pic 2 Desc.	Monitored sump pit and ECDs , all in place and functioning. Good stabilization noted at the time of inspection.

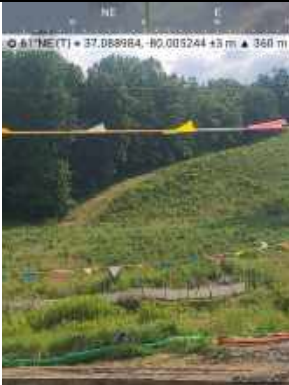
GPS Location	0000	GPS Location	0000		
Field Station#	13497+55	Field Station#	13421+00		
Pic 3 Desc.	Monitored stream crossing and ECDs . All in place and functioning. Photo showing area adjacent to the row where the land owner has moved. No environmental issues observed at		Pic 4 Desc.	Additional work space photo showing stabilization. No issues observed at the time of inspection.

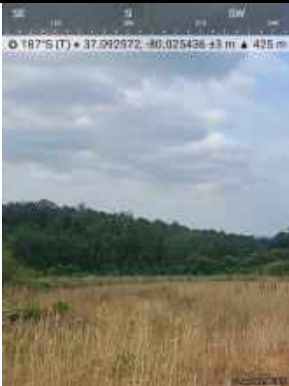
Pic 5 Desc.	Work space photo showing stabilization. No issues observed at the time of inspection.		Pic 6 Desc.	Monitored water bars and level spreaders throughout. No environmental issues observed at the time of inspection.

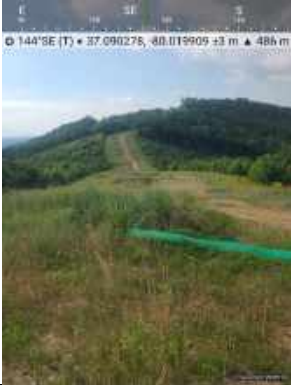
GPS Location	0000	GPS Location	0000	GPS Location	0000
Field Station#	13442+12	Field Station#	13497+12	Field Station#	13497+12
Pic 7 Desc.	Monitored ECDs and stabilization, photo showing travel lane where recent punch list items were completed. Travel lane stabilized.		Pic 8 Desc.	Vegetation observation photo in anode bed location. ECDs in place and functioning at the time of inspection.	
<div style="text-align: center;">Insert image here</div>			<div style="text-align: center;">Insert image here</div>		
GPS Location		GPS Location		GPS Location	
Field Station#		Field Station#		Field Station#	
Pic 9 Desc.			Pic 10 Desc.		
<div style="text-align: center;">Insert image here</div>			<div style="text-align: center;">Insert image here</div>		
GPS Location		GPS Location		GPS Location	
Field Station#		Field Station#		Field Station#

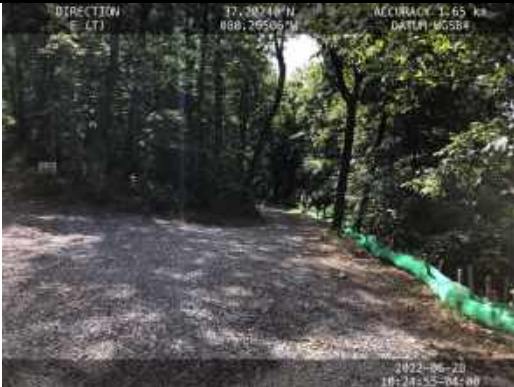
GPS Location	Please see photo for details.		GPS Location	Please see photo for details.	
Field Station#	12284+75		Field Station#	12296+00	
Pic 1 Desc.	Photo shows MVP-MN-276.03 RCE.		Pic 2 Desc.	Photo shows the stabilized ROW conditions with water bars and that all ECDs are installed and are functioning as designed.

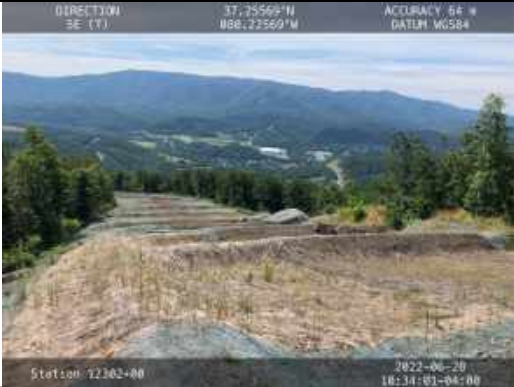
GPS Location	Please see photo for details.		GPS Location	Please see photo for details.	
Field Station#	12302+00		Field Station#	12310+00	
Pic 3 Desc.	Photo shows the stabilized ROW conditions with water bars and that all ECDs are installed and are functioning as designed.		Pic 4 Desc.	Photo shows punch list item of SSF that needs to be reattached to chain link.

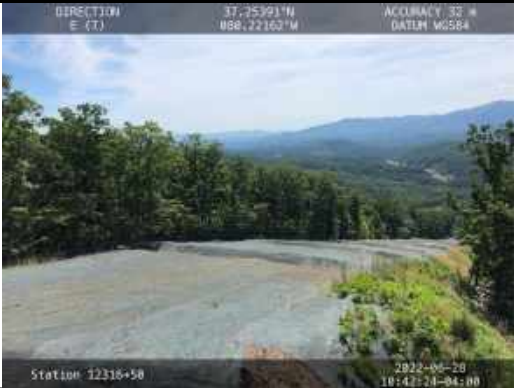
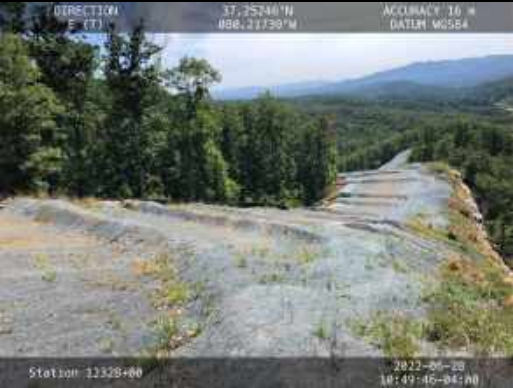
Pic 5 Desc.	Photo shows the stabilized ROW conditions with water bars and that all ECDs are installed and are functioning as designed.		Pic 6 Desc.	Photo shows the stabilized ROW conditions with water bars and that all ECDs are installed and are functioning as designed.

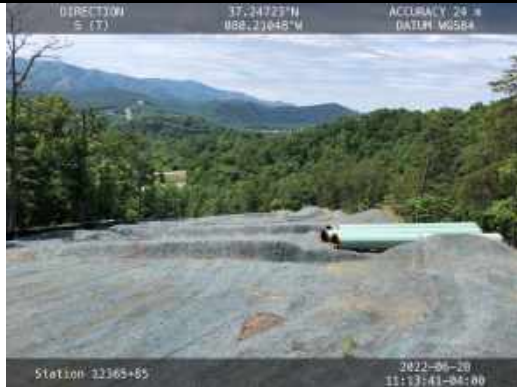
Field Station#	12365+85		Field Station#	12374+16	
Pic 11 Desc.	Photo shows the stabilized ROW conditions with water bars and that all ECDs are installed and are functioning as designed.		Pic 12 Desc.	Photo shows upstream view of Stream S-0016.

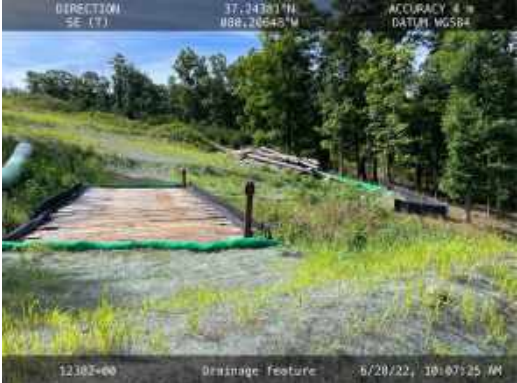
GPS Location	Please see photo for details.		GPS Location	Please see photo for details.	
Field Station#	12383+00		Field Station#	12380+04	
Pic 13 Desc.	Photo shows stabilized ROW conditions along with equipment bridge spanning drainage feature with ECDs installed.		Pic 14 Desc.	Photo shows overview of Stream S-NN19 and its buffer zone from the coming in side.

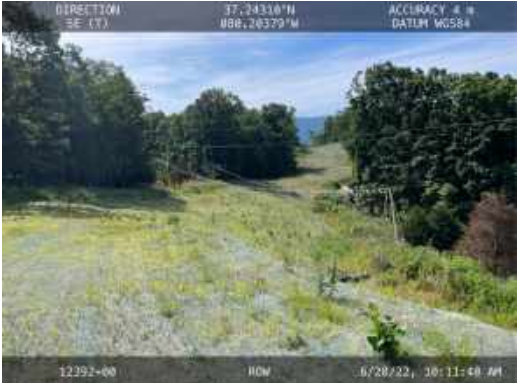
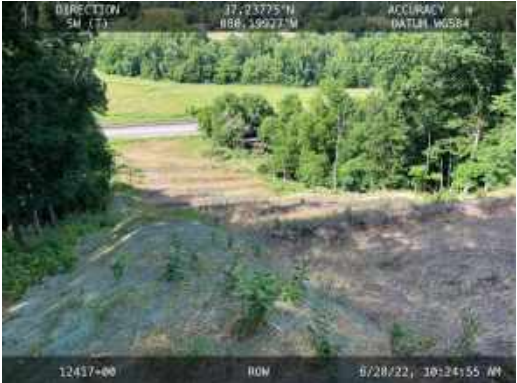
GPS Location	Please see photo for details.		GPS Location	Please see photo for details.	
Field Station#	12392+00		Field Station#	12417+00	
Pic 15 Desc.	Photo shows the stabilized ROW conditions with water bars and that all ECDs are installed and are functioning as designed.		Pic 16 Desc.	Photo shows the stabilized ROW conditions with water bars and that all ECDs are installed and are functioning as designed.

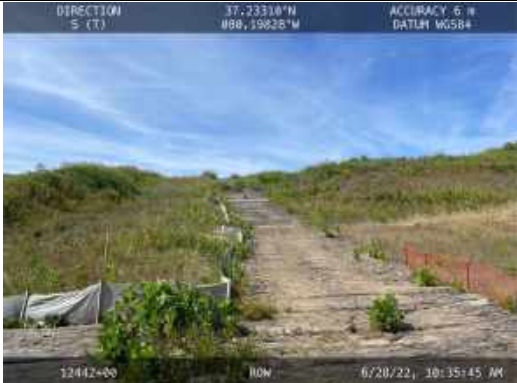
Field Station#	12441+77		Field Station#	12442+00	
Pic 17 Desc.	Photo shows overview of Stream S-NN16 from the going away side.		Pic 18 Desc.	Photo shows stabilized ROW conditions with timber mat road as well as ECDs installed and functioning as designed.

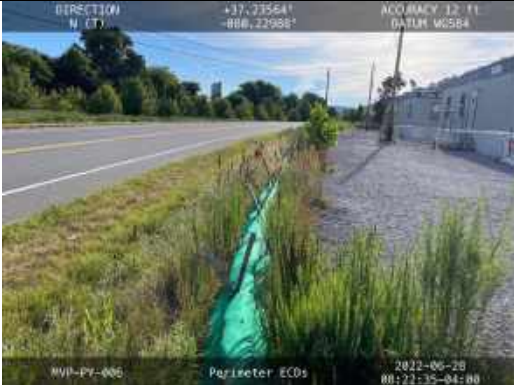
GPS Location	See photo for gps location data		GPS Location	See photo for gps location data	
Field Station#	+0		Field Station#	+0	
Pic 1 Desc.	Photo shows the perimeter ECDs along PY-006. ECDs are installed and functioning as designed.		Pic 2 Desc.	Photo shows the perimeter ECDs along PY-006 and W-008. ECDs are installed and functioning as designed.

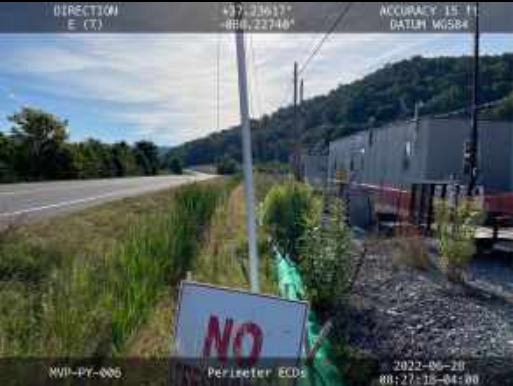
GPS Location	See photo for gps location data		GPS Location	See photo for gps location data	
Field Station#	+0		Field Station#	+0	
Pic 5 Desc.	Photo shows the RCE at Northfork Road.		Pic 6 Desc.	Photo shows the perimeter ECDs along PY-006. ECDs are installed and functioning as designed.

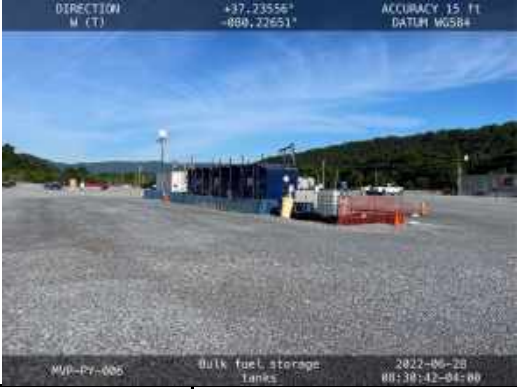
GPS Location	See photo for gps location data		GPS Location	See photo for gps location data	
Field Station#	+0		Field Station#	+0	
Pic 7 Desc.	Photo shows the bulk fuel storage tanks with secondary containment.		Pic 8 Desc.	Photo shows the refueling area on the north side of the tanks.

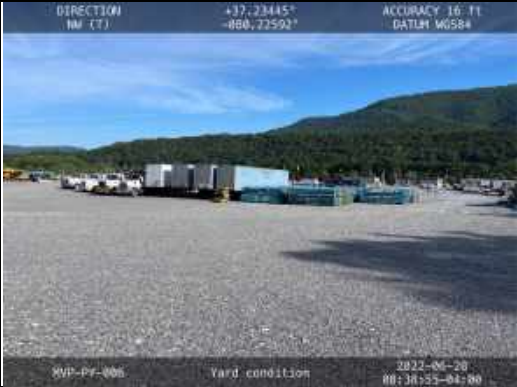
GPS Location	See photo for gps location data		GPS Location	See photo for gps location data	
Field Station#	+0		Field Station#	+0	
Pic 13 Desc.	Photo shows the general condition of the yard.		Pic 14 Desc.	Photo shows the perimeter ECDs. ECDs are installed and functioning as designed.

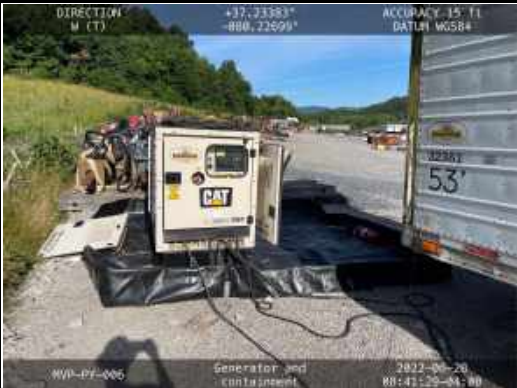
GPS Location	See photo for gps location data		GPS Location	See photo for gps location data	
Field Station#	+0		Field Station#	+0	
Pic 15 Desc.	Photo shows a generator and secondary containment.		Pic 16 Desc.	Photo shows mobile fuel cells and secondary containment.

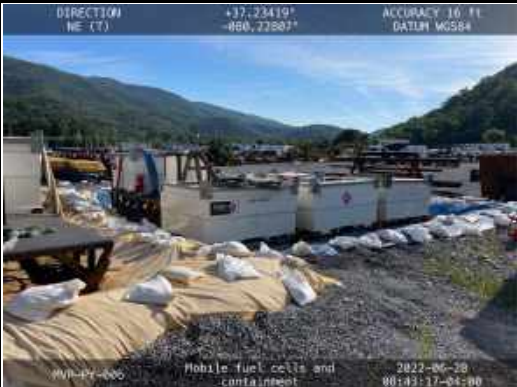
GPS Location	See photo for gps location data		GPS Location	See photo for gps location data	
Field Station#	+0		Field Station#	+0	
Pic 17 Desc.	Photo shows mobile fuel cells and secondary containment.		Pic 18 Desc.	Photo shows mobile equipment and secondary containment.

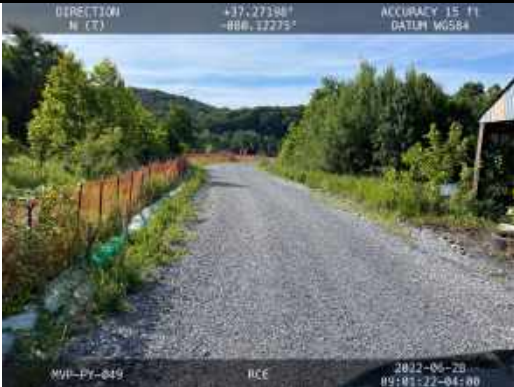
GPS Location	See photo for gps location data.		GPS Location	See photo for gps location data.	
Field Station#	+0		Field Station#	+0	
Pic 1 Desc.	Photo shows the RCE at PY-049.		Pic 2 Desc.	Photo shows the general yard condition.

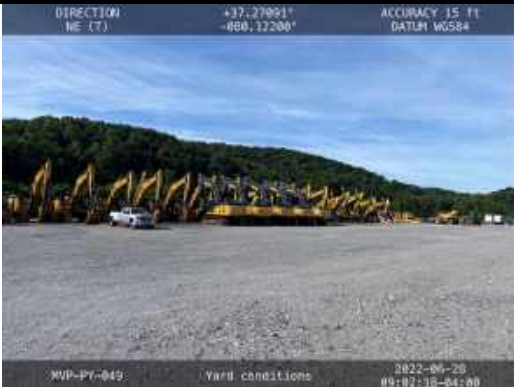
GPS Location	See photo for gps location data.		GPS Location	See photo for gps location data.	
Field Station#	+0		Field Station#	+0	
Pic 3 Desc.	Photo shows the general yard condition and parked equipment. No leaks observed.		Pic 4 Desc.	Photo shows the general yard condition and parked equipment. No leaks observed.

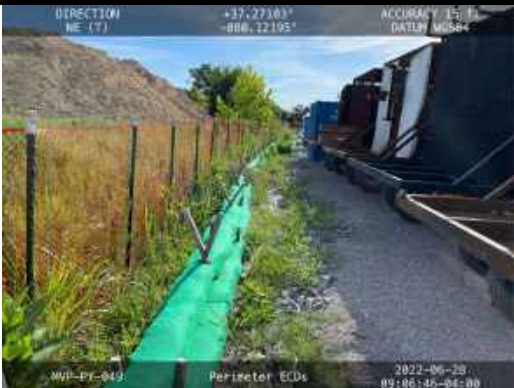
GPS Location	See photo for gps location data.		GPS Location	See photo for gps location data.	
Field Station#	+0		Field Station#	+0	
Pic 5 Desc.	Photo shows the perimeter ECDs. ECDs are installed and functioning as designed.		Pic 6 Desc.	Photo shows the perimeter ECDs. ECDs are installed and functioning as designed.

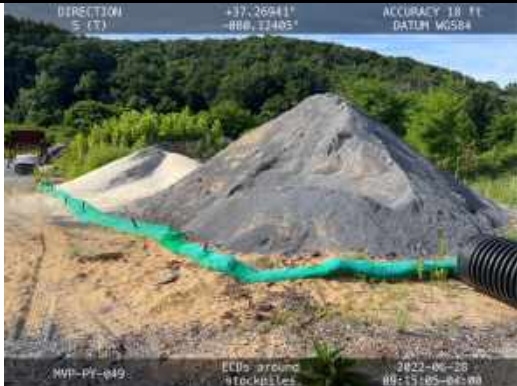
GPS Location	See photo for gps location data.		GPS Location	See photo for gps location data.	
Field Station#	+0		Field Station#	+0	
Pic 9 Desc.	Photo shows the ECDs around the sand stockpiles.		Pic 10 Desc.	Photo shows the perimeter ECDs. ECDs are installed and functioning as designed.

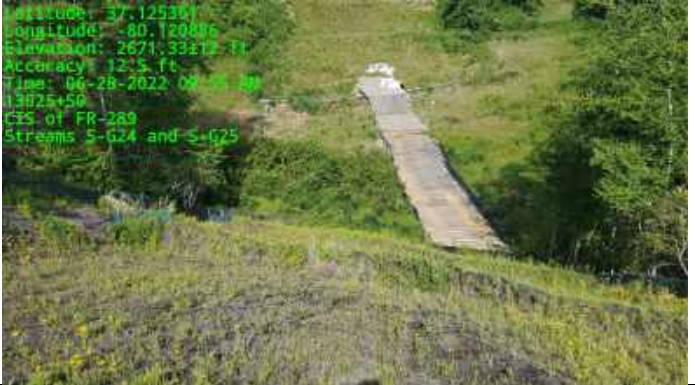
GPS Location	See pic.	GPS Location	See pic.		
Field Station#	13118+00	Field Station#	13025+50		
Pic 7 Desc.	Current ROW conditions.	Pic 8 Desc.	Streams S-G24 and S-G25 from the GAS.

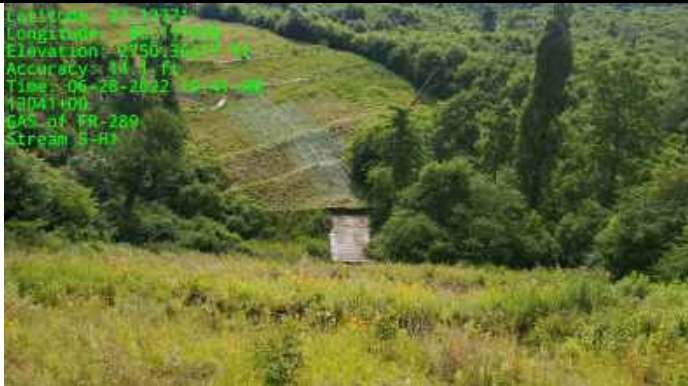
GPS Location	See pic.	GPS Location	See pic.		
Field Station#	13041+00	Field Station#	13133+00		
Pic 9 Desc.	Stream crossing S-H1 from the CIS.	Pic 10 Desc.	Current ROW conditions.

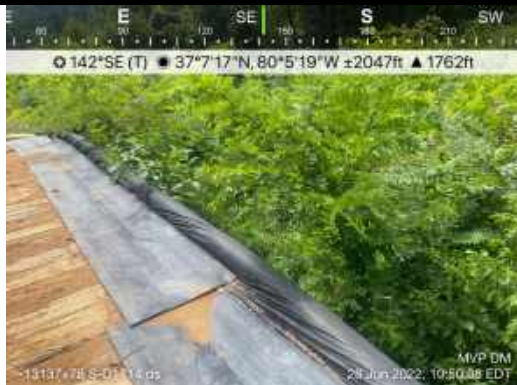
GPS Location	See pic.	GPS Location	See pic.		
Field Station#	13137+78	Field Station#	13064+00		
Pic 11 Desc.	Downstream side of stream S-D17/14.	Pic 12 Desc.	Current ROW conditions.

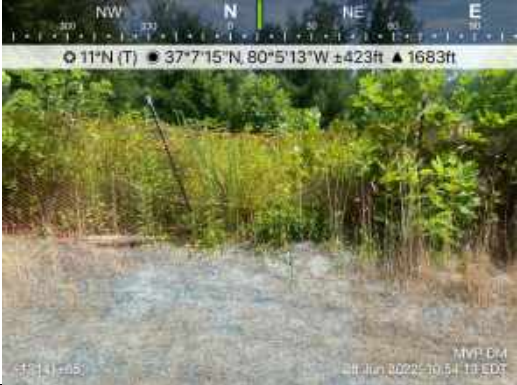
GPS Location	See pic.	GPS Location	See pic.		
Field Station#	13141+65	Field Station#	13141+65		
Pic 13 Desc.	P1 silt fence in need of maintenance.	Pic 14 Desc.	Maintenance performed to P1 silt fence.

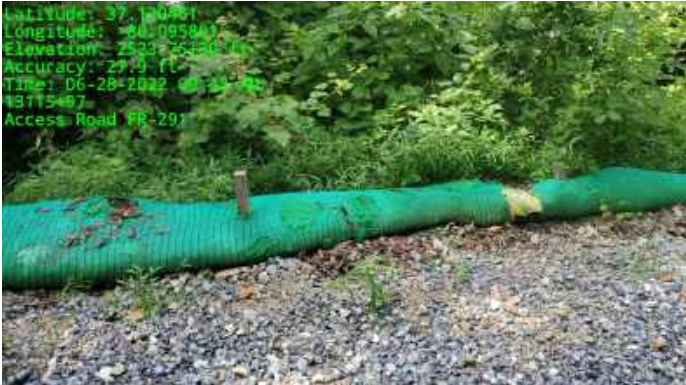
GPS Location	See pic.	GPS Location	See pic.		
Field Station#	13115+97	Field Station#	13115+97		
Pic 15 Desc.	Holes in CFS along access road FR-291.	Pic 16 Desc.	Maintenance performed to CFS along FR-291.

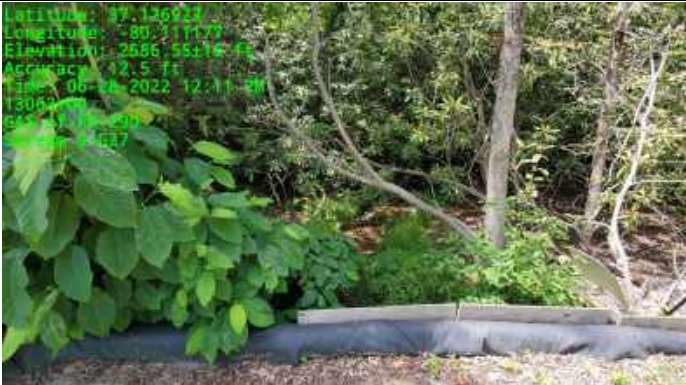
GPS Location	See pic.	GPS Location	See pic.		
Field Station#	13063+00	Field Station#	13062+00		
Pic 17 Desc.	Downstream side of stream S-G27.	Pic 18 Desc.	Downstream side of stream S-G26.

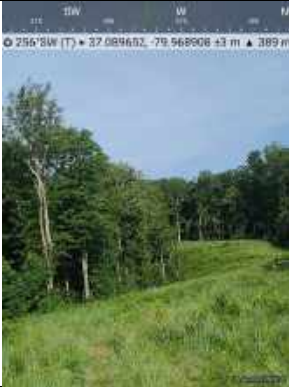
GPS Location	0000	GPS Location	0000		
Field Station#	13610+00	Field Station#	13574+98		
Pic 1 Desc.	Row photo showing stabilization through permanent areas of row. Perimeter ECDs in place and functioning at the time of inspection.		Pic 2 Desc.	Row photo showing vegetation. No environmental issues observed at the time of inspection.

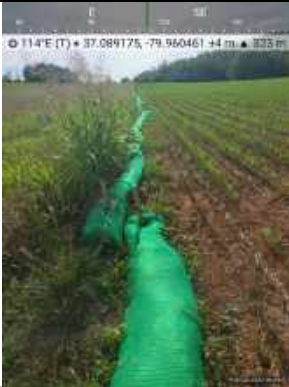
GPS Location	0000	GPS Location	0000		
Field Station#	13648+00	Field Station#	13562+38		
Pic 3 Desc.	Monitored perimeter ECDs during routine inspection today. All in place and functioning at the time of inspection.		Pic 4 Desc.	Monitored ECDs at road crossings during routine inspection. No issues were observed at the time of inspection.

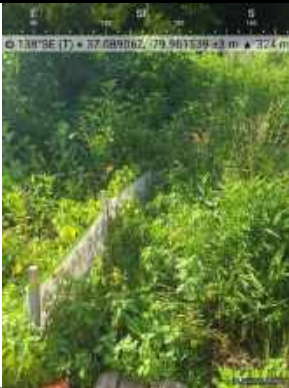
GPS Location	0000	GPS Location	0000		
Field Station#	13643+03	Field Station#	13562+85		
Pic 5 Desc.	Monitored ECDs at stream crossing. No environmental issues observed at the time of inspection. Good vegetation noted.		Pic 6 Desc.	P1 requires maintenance due to being weathered and torn. Added to the punch list for repair.

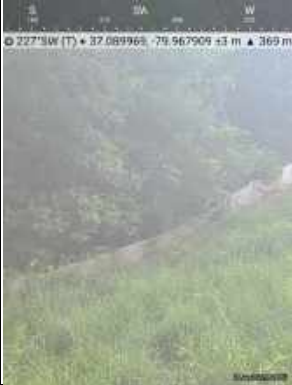
GPS Location	0000	GPS Location	0000		
Field Station#	13620+50	Field Station#	13581+00		
Pic 7 Desc.	Monitored ECDs throughout the row inspection today. No environmental issues observed at the time of inspection.		Pic 8 Desc.	Row photo showing stabilization throughout permanent areas of row. Good coverage noted.	
Insert image here		Insert image here			
GPS Location		GPS Location			
Field Station#		Field Station#			
Pic 9 Desc.		Pic 10 Desc.			
Insert image here		Insert image here			
GPS Location		GPS Location			
Field Station#		Field Station#			
Pic 11 Desc.		Pic 12 Desc.

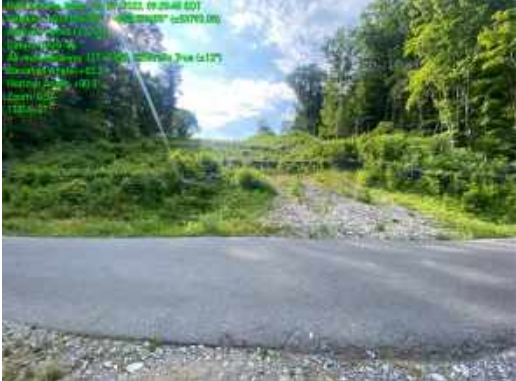
GPS Location	See photo for coordinates.		GPS Location	See photo for coordinates.	
Field Station#	13316+21		Field Station#	13317+02	
Pic 1 Desc.	Wade's Gap road crossing, ROW of way was stabilized.		Pic 2 Desc.	Private driveway, bank well vegetated.

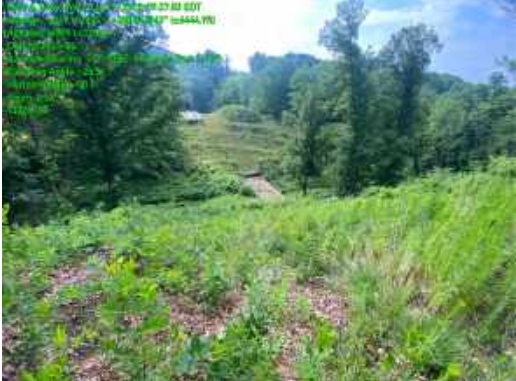
GPS Location	See photo for coordinates.		GPS Location	See photo for coordinates.	
Field Station#	13320+00		Field Station#	13321+47	
Pic 3 Desc.	ROW stabilized, looking toward S-GH15.		Pic 4 Desc.	S-GH15, downstream, no ROW impacts noted.

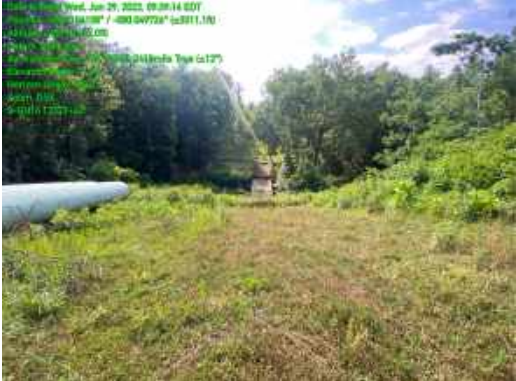
GPS Location	See photo for coordinates.		GPS Location	See photo for coordinates.	
Field Station#	13323+43		Field Station#	13323+43	
Pic 5 Desc.	ROW stabilized, looking toward S-GH14.		Pic 6 Desc.	S-GH14, upstream of equipment bridge, no notable changes observed along stream banks.

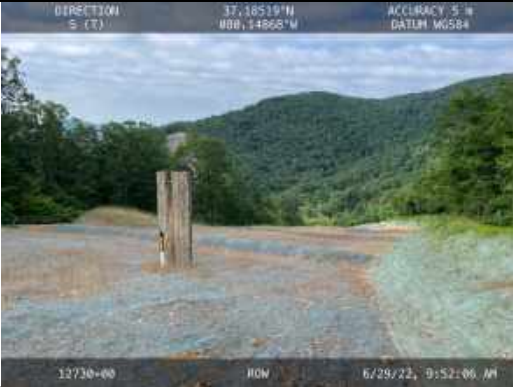
GPS Location	See photo		GPS Location	See photo	
Field Station#	12730+00		Field Station#	12730+00	
Pic 3 Desc.	CWD Berm is stable and functional		Pic 4 Desc.	Current ROW conditions. ROW is stable and ECDs are functional

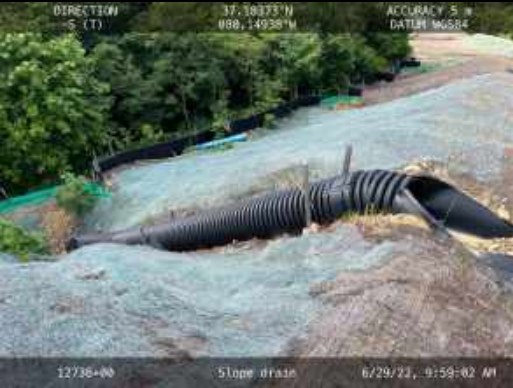
GPS Location	See photo		GPS Location	See photo	
Field Station#	12734+00		Field Station#	12736+00	
Pic 5 Desc.	Current ROW conditions. ROW is stable and ECDs are functional		Pic 6 Desc.	Slope drain is functional

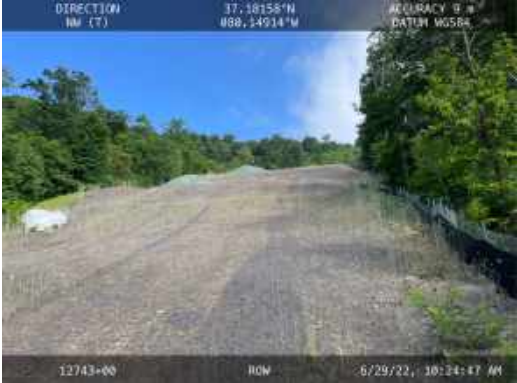
GPS Location	See photo		GPS Location	See photo	
Field Station#	12737+00		Field Station#	12743+00	
Pic 7 Desc.	Current ROW conditions. ROW is stable and ECDs are functional		Pic 8 Desc.	Current ROW conditions. ROW is stable and ECDs are functional

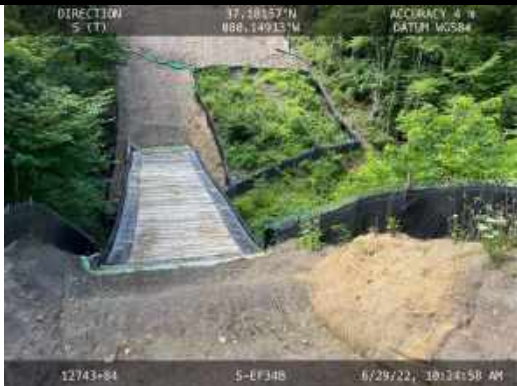
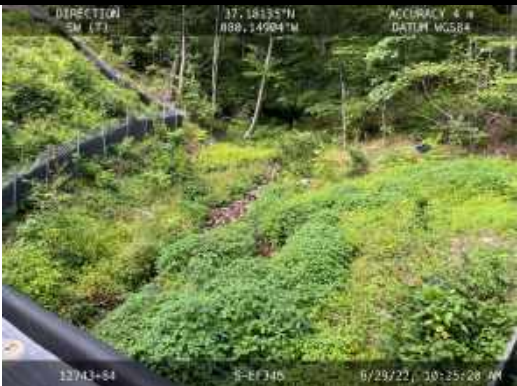
GPS Location	See photo		GPS Location	See photo	
Field Station#	12743+84		Field Station#	12743+84	
Pic 9 Desc.	Overview of Stream S-EF34B		Pic 10 Desc.	Upstream of crossing at Stream S-EF34B

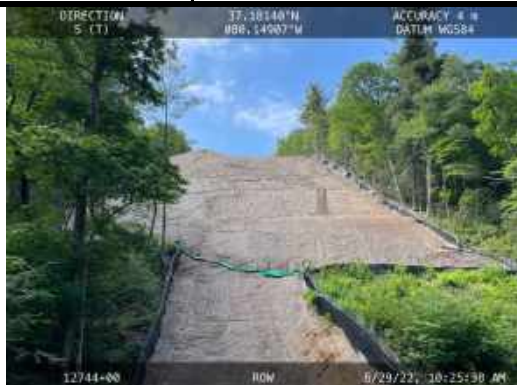
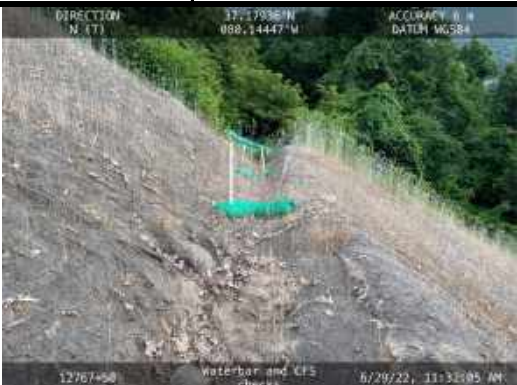
GPS Location	See photo		GPS Location	See photo	
Field Station#	12744+00		Field Station#	12767+50	
Pic 11 Desc.	Current ROW conditions. ROW is stable and ECDs are functional		Pic 12 Desc.	Waterbar and CFS checks are functional

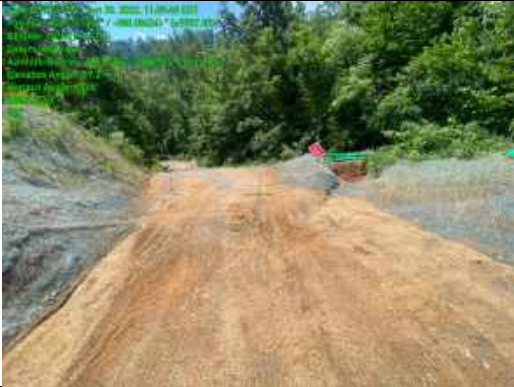
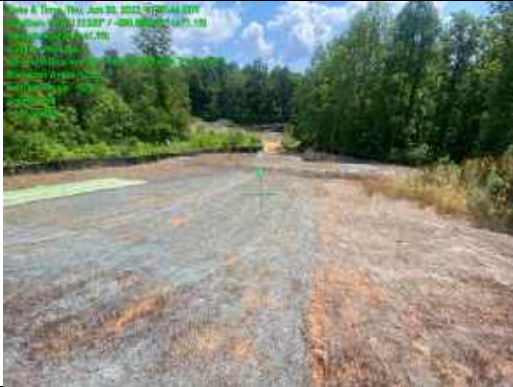
GPS Location	See photo for coordinates.		GPS Location	See photo for coordinates.	
Field Station#	13141+53		Field Station#	13144+00	
Pic 1 Desc.	ROW stabilized, access road MVP-FR-292 and equipment bridge crossing S-D14 in acceptable condition.		Pic 2 Desc.	ROW stabilized with erosion control blanket.

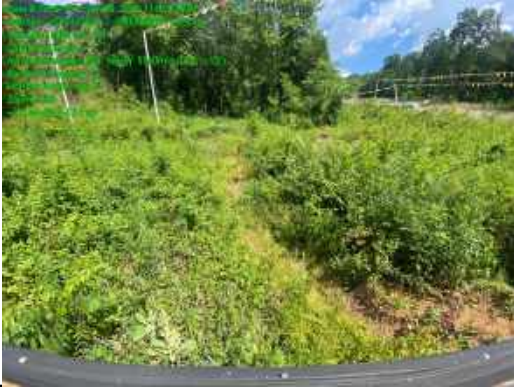
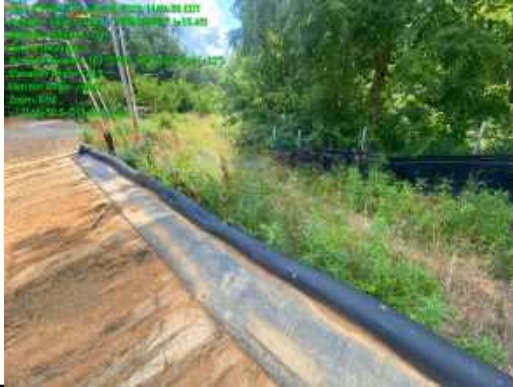
GPS Location	See photo for coordinates.		GPS Location	See photo for coordinates.	
Field Station#	13146+50		Field Station#	13146+50	
Pic 3 Desc.	S-D12, upstream, no ROW impacts noted; no turbidity noted.		Pic 4 Desc.	Downstream (culvert) of equipment bridge crossing S-D12 and S-D13.

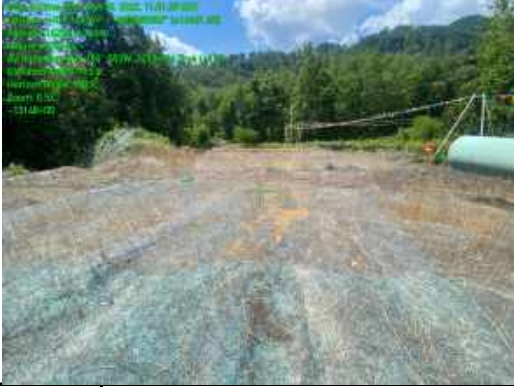
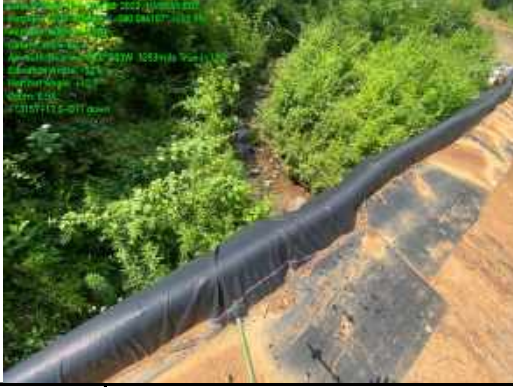
GPS Location	See photo for coordinates.		GPS Location	See photo for coordinates.	
Field Station#	13148+00		Field Station#	13157+13	
Pic 5 Desc.	ROW stabilized with erosion control blanket, sparse vegetation noted.		Pic 6 Desc.	S-D11, downstream, no ROW impacts noted; no turbidity observed.

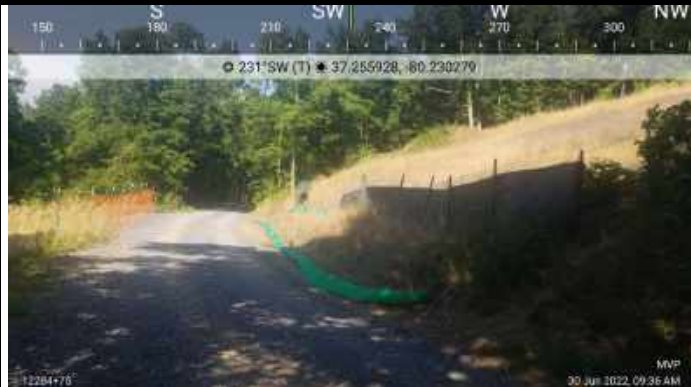
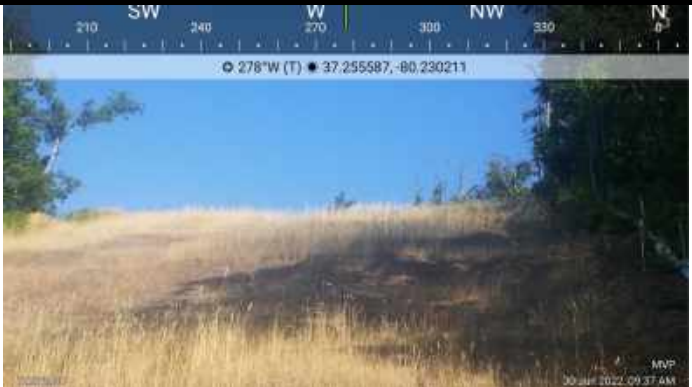
GPS Location	Please see photo for details.		GPS Location	Please see photo for details.	
Field Station#	12284+75		Field Station#	12282+00	
Pic 1 Desc.	Photo shows the stabilized ROW conditions with water bars and that all ECDs are installed and are functioning as designed.		Pic 2 Desc.	Photo shows the stabilized ROW conditions with water bars and that all ECDs are installed and are functioning as designed.

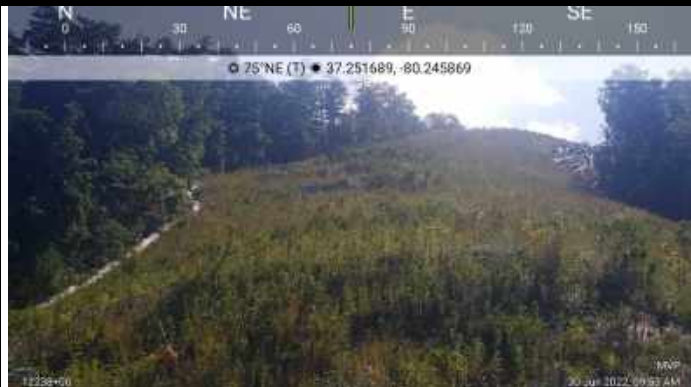
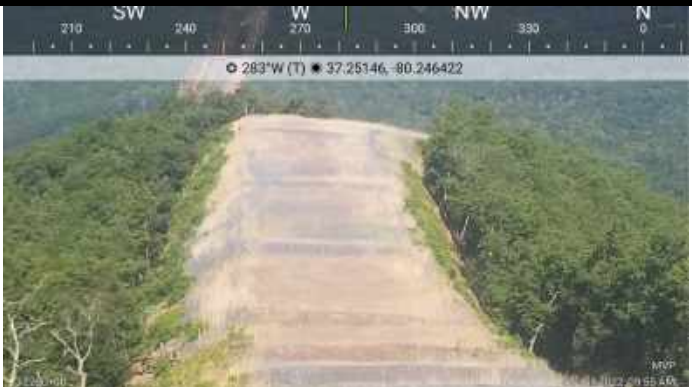
GPS Location	Please see photo for details.		GPS Location	Please see photo for details.	
Field Station#	12238+00		Field Station#	12230+00	
Pic 3 Desc.	Photo shows stabilized ROW conditions and permanent water bars equipped with level spreaders installed.		Pic 4 Desc.	Photo shows the stabilized ROW conditions with water bars and that all ECDs are installed and are functioning as designed.

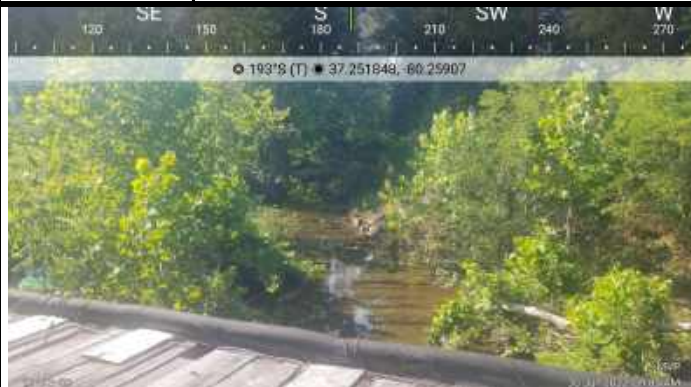
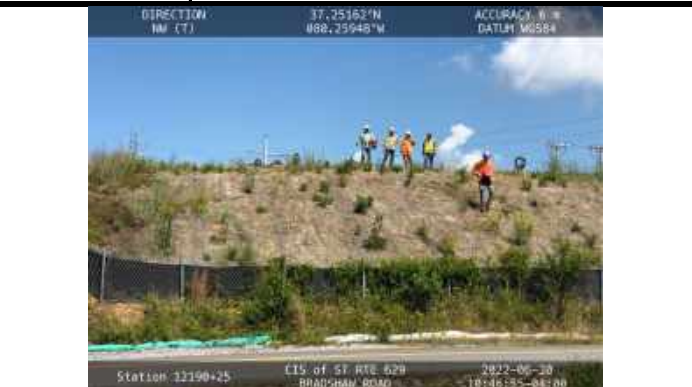
GPS Location	Please see photo for details.		GPS Location	Please see photo for details.	
Field Station#	12192+50		Field Station#	12190+25	
Pic 5 Desc.	Photo shows downstream view of Stream S-C21 from the equipment bridge spanning the stream channel.		Pic 6 Desc.	Photo shows today's punch list item of area needing to be re-stabilized using applied seed and erosion control blanket.

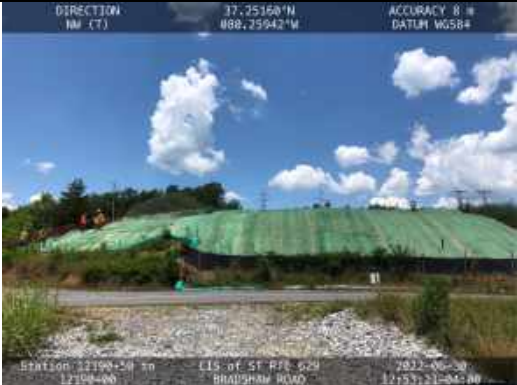
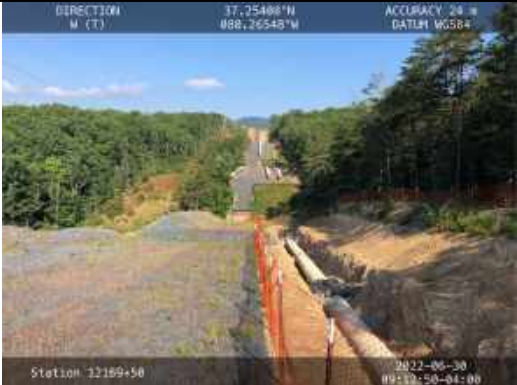
GPS Location	Please see photo for details.		GPS Location	Please see photo for details.	
Field Station#	12190+25		Field Station#	12169+50	
Pic 7 Desc.	Photo shows area re-stabilized to be in compliance with adequate temporary stabilization.		Pic 8 Desc.	Photo shows the stabilized ROW conditions with water bars and that all ECDs are installed and are functioning as designed.

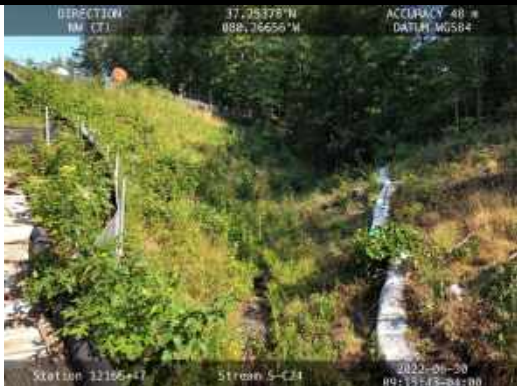
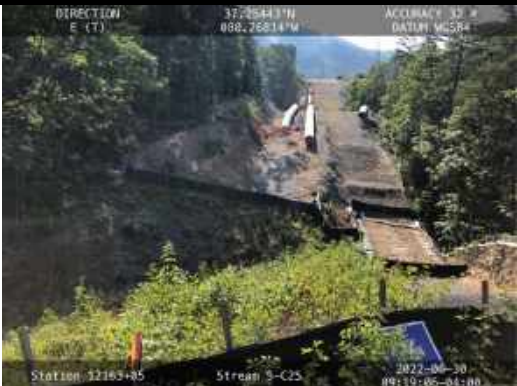
GPS Location	Please see photo for details.		GPS Location	Please see photo for details.	
Field Station#	12166+47		Field Station#	12163+05	
Pic 9 Desc.	Photo shows upstream view of Stream S-C24 from the equipment bridge spanning the stream channel.		Pic 10 Desc.	Photo shows overview of Stream S-C25 and its buffer zone from the coming in side.

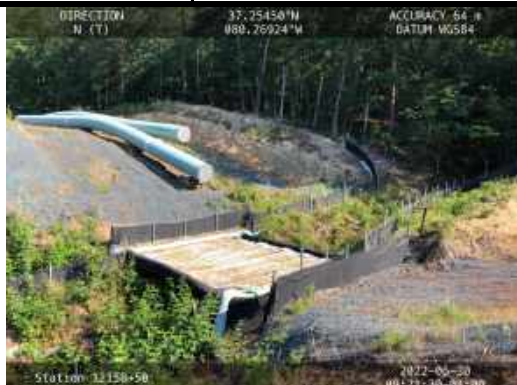
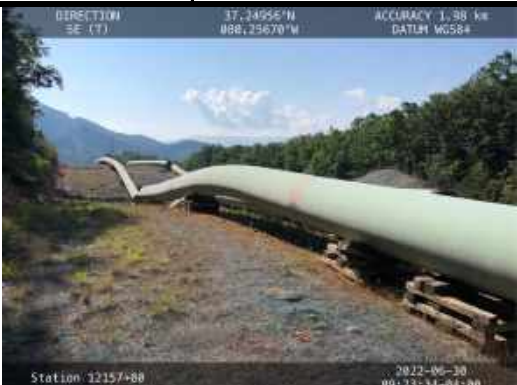
Field Station#	12158+50		Field Station#	12157+00	
Pic 11 Desc.	Photo shows equipment bridge spanning low lying drainage feature crossing the ROW.		Pic 12 Desc.	Photo shows the stabilized ROW conditions with water bars and that all ECDs are installed and are functioning as designed.

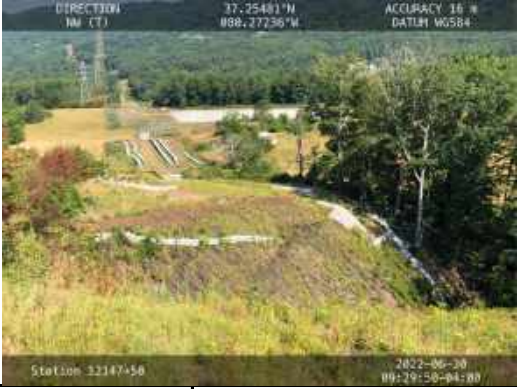
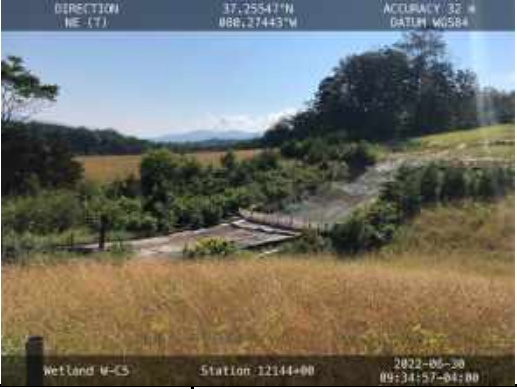
GPS Location	Please see photo for details.		GPS Location	Please see photo for details.	
Field Station#	12147+50		Field Station#	12144+00	
Pic 13 Desc.	Photo shows the stabilized ROW conditions with water bars and that all ECDs are installed and are functioning as designed.		Pic 14 Desc.	Photo shows overview of Wetland W-C5 and its buffer zone from the coming in side.

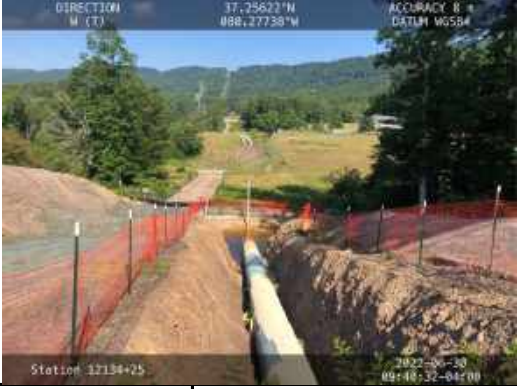
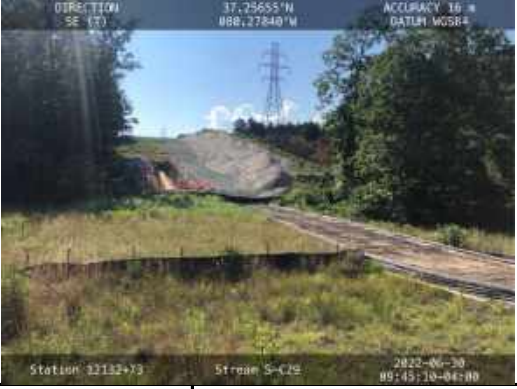
GPS Location	Please see photo for details.		GPS Location	Please see photo for details.	
Field Station#	12134+25		Field Station#	12132+73	
Pic 15 Desc.	Photo shows the stabilized ROW conditions with water bars and that all ECDs are installed and are functioning as designed.		Pic 16 Desc.	Photo shows overview of Stream S-C29 and its buffer zone from the coming in side

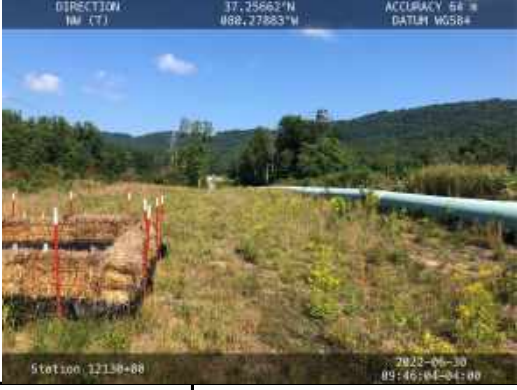
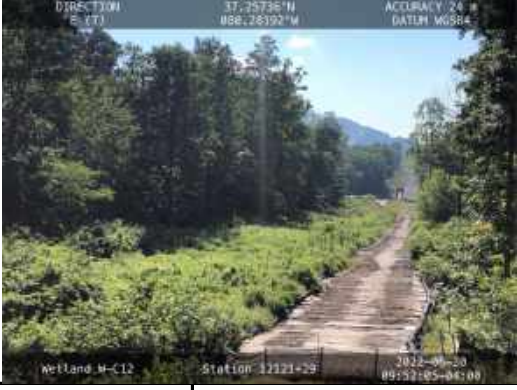
Field Station#	12130+00		Field Station#	12121+29	
Pic 17 Desc.	Photo shows the stabilized ROW conditions with water bars and that all ECDs are installed and are functioning as designed.		Pic 18 Desc.	Photo shows overview of the coming in side of Wetland W-C12.

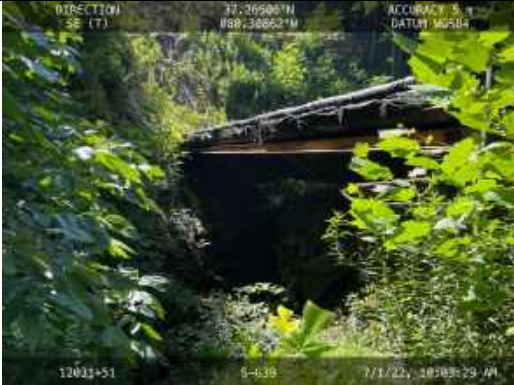
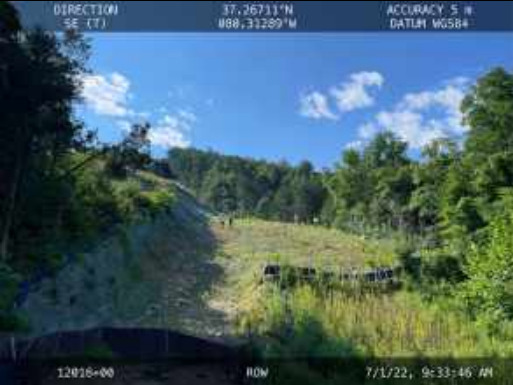
GPS Location	Please see photo for details.		GPS Location	Please see photo for details.	
Field Station#	12031+51		Field Station#	12016+00	
Pic 1 Desc.	Photo shows downstream view of Stream S-G39 and the equipment bridge spanning the Stream channel.		Pic 2 Desc.	Photo shows current stabilized ROW conditions.

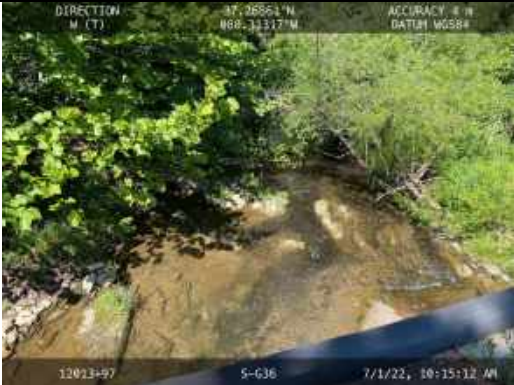
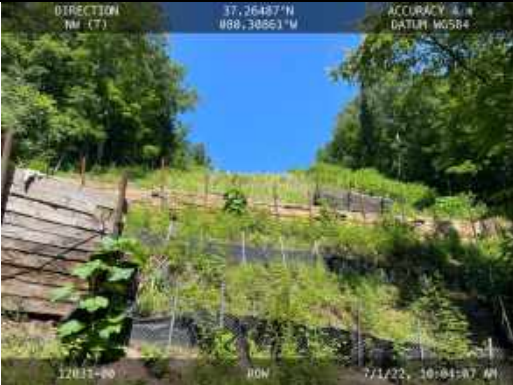
GPS Location	Please see photo for details.		GPS Location	Please see photo for details.	
Field Station#	12013+97		Field Station#	12031+00	
Pic 3 Desc.	Photo shows downstream view of Stream S-G36 from the equipment bridge spanning the Stream channel on MVP-MN-268.01.		Pic 4 Desc.	Photo shows current stabilized ROW conditions.

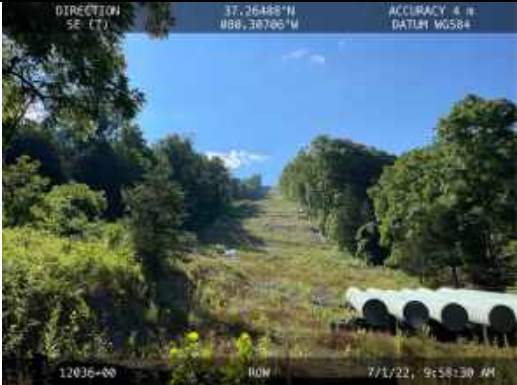
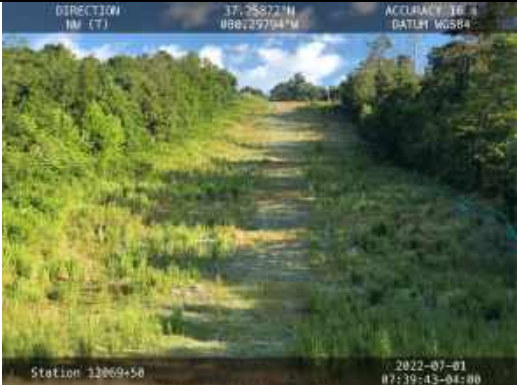
GPS Location	Please see photo for details.		GPS Location	Please see photo for details.	
Field Station#	12036+00		Field Station#	12069+50	
Pic 7 Desc.	Photo shows current stabilized ROW conditions.		Pic 8 Desc.	Photo shows current stabilized ROW conditions.

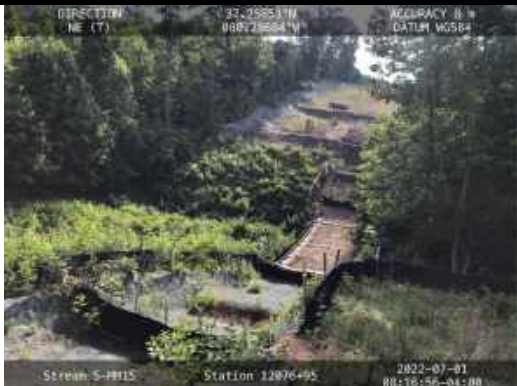
GPS Location	Please see photo for details.		GPS Location	Please see photo for details.	
Field Station#	12076+95		Field Station#	12098+44	
Pic 9 Desc.	Photo shows overview of Stream S-MM15 and its buffer zone from the coming in side.		Pic 10 Desc.	Photo show overview of Stream S-MM13 and its buffer zone from the going away side.

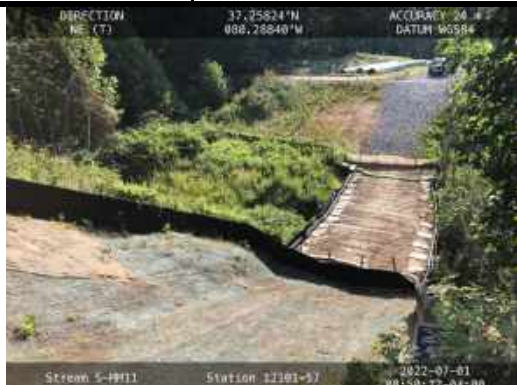
GPS Location	Please see photo for details.		GPS Location	Please see photo for details.	
Field Station#	12101+57		Field Station#	12101+57	
Pic 11 Desc.	Photo shows overview of Stream S-MM11 and its buffer zone from the coming in side.		Pic 12 Desc.	Photo shows upstream view of Stream S-MM11.

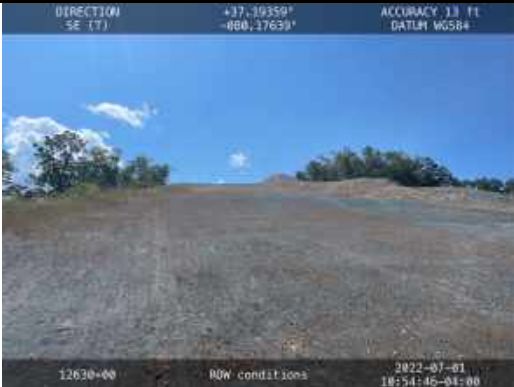
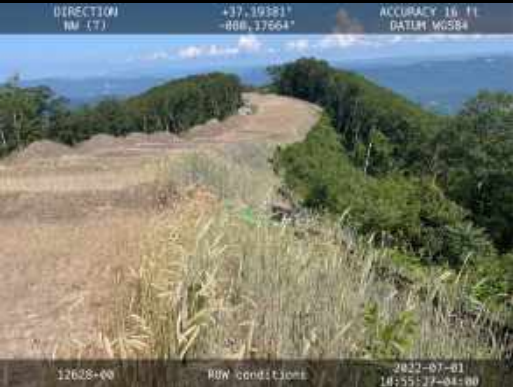
GPS Location	See photo for gps location data.		GPS Location	See photo for gps location data.	
Field Station#	12630+00		Field Station#	12628+00	
Pic 1 Desc.	Photo shows the ROW condition. ECDs are installed and functioning as designed.		Pic 2 Desc.	Photo shows the ROW condition. ECDs are installed and functioning as designed.

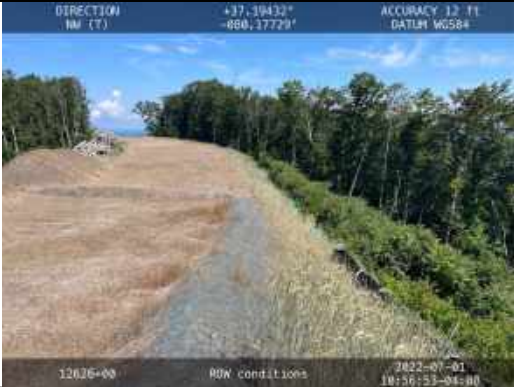
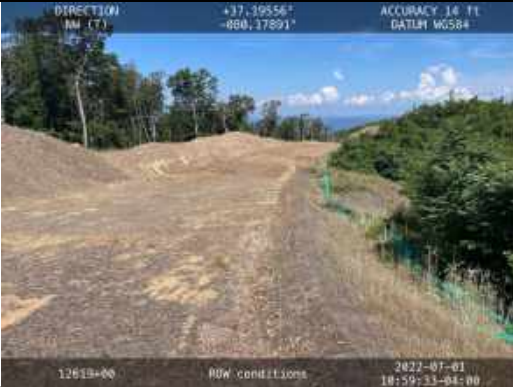
GPS Location	See photo for gps location data.		GPS Location	See photo for gps location data.	
Field Station#	12626+00		Field Station#	12619+00	
Pic 3 Desc.	Photo shows the ROW condition. ECDs are installed and functioning as designed.		Pic 4 Desc.	Photo shows the ROW condition. ECDs are installed and functioning as designed.

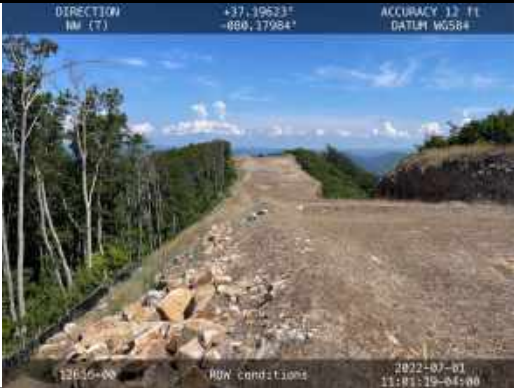
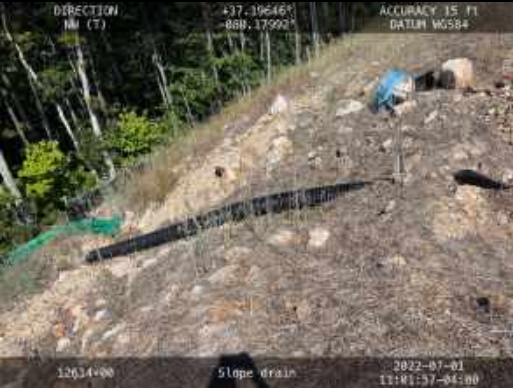
GPS Location	See photo for gps location data.		GPS Location	See photo for gps location data.	
Field Station#	12616+00		Field Station#	12614+00	
Pic 5 Desc.	Photo shows the ROW condition. ECDs are installed and functioning as designed.		Pic 6 Desc.	Photo shows the slope drain.
