Visual Site Inspection Report

Project Name	H-600 Pipeline Spread H	AFE	124300138	Spread	H-600 Pipeline Spread H
Contractor	Precision			Report #	39213
Inspector	Jordan Davis			Date/Time	6/27/2022 3:52 PM
Permit #	TBD	Inspection Type	VA SWPP	Station Begin	12005+00
State	VA	Inspection Area	Partial	Station End	12119+17
County	Montgomery	Ground	Dry	Temperature (°F)	83.00
Municipality	N/A	Weather	Cloudy	Rain Gauge (in)	0.00
				Rain Accumulation Time (days)	0.00

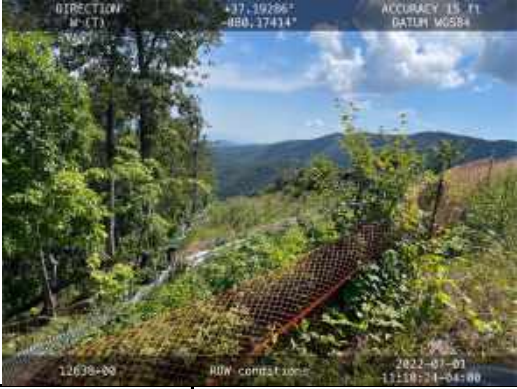
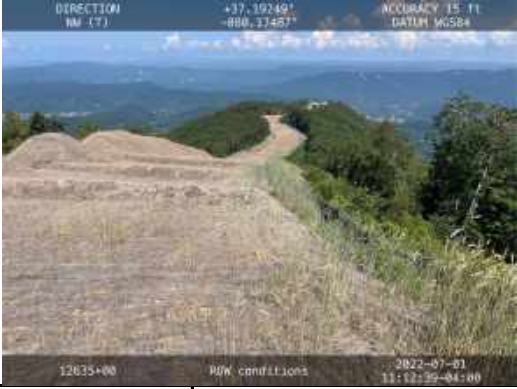
GPS Location	See photo for gps location data.		GPS Location	See photo for gps location data.	
Field Station#	12638+00		Field Station#	12635+00	
Pic 7 Desc.	Photo shows the ROW condition. ECDs are installed and functioning as designed.		Pic 8 Desc.	Photo shows the ROW condition. ECDs are installed and functioning as designed.

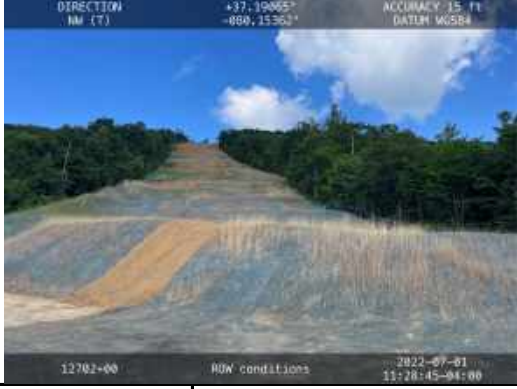
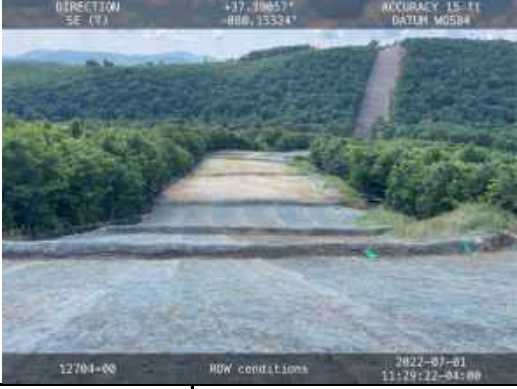
GPS Location	See photo for gps location data.		GPS Location	See photo for gps location data.	
Field Station#	12702+00		Field Station#	12704+00	
Pic 9 Desc.	Photo shows the ROW condition. ECDs are installed and functioning as designed.		Pic 10 Desc.	Photo shows the ROW condition. ECDs are installed and functioning as designed.

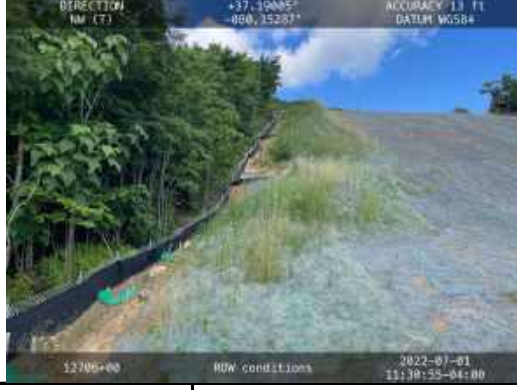
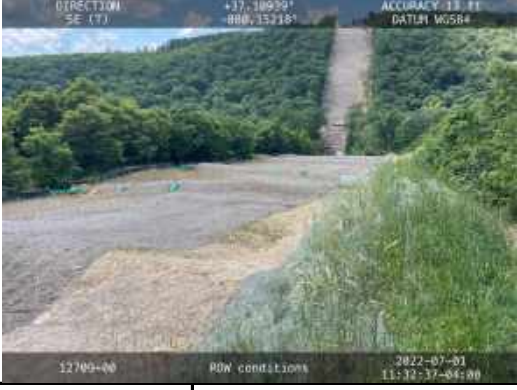
GPS Location	See photo for gps location data.		GPS Location	See photo for gps location data.	
Field Station#	12706+00		Field Station#	12709+00

Pic 11 Desc.	Photo shows the ROW condition. ECDs are installed and functioning as designed.		Pic 12 Desc.	Photo shows the ROW condition. ECDs are installed and functioning as designed.

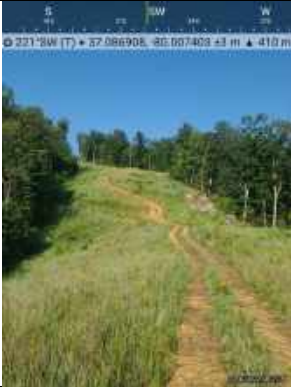
GPS Location	0000	GPS Location	0000		
Field Station#	13490+12	Field Station#	13494+00		
Pic 1 Desc.	Additional photo showing travel lane after recent punch list activities. Area stabilized and seeded. No environmental issues observed at the time of inspection.		Pic 2 Desc.	Row photo showing vegetation. No environmental issues observed at the time of inspection.

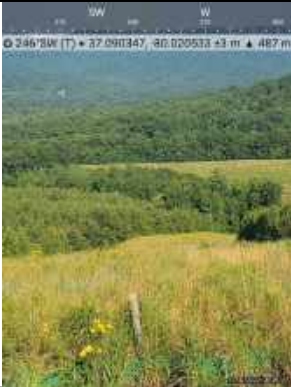
GPS Location	0000	GPS Location	0000		
Field Station#	13436+21	Field Station#	13471+00		
Pic 3 Desc.	Row photo showing vegetation in permanent area of row. Good coverage noted.		Pic 4 Desc.	Monitored row ECDs throughout the inspection area. No environmental issues observed at the time of inspection.

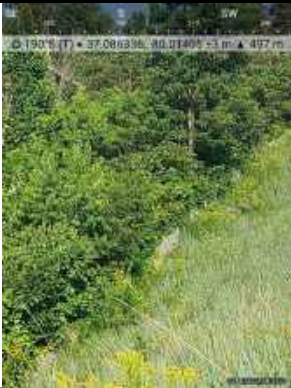
GPS Location	0000	GPS Location	0000		
Field Station#	13462+10	Field Station#	13457+00		
Pic 5 Desc.	Observed perimeter P1 all for the row edge during routine inspection. No issues were observed at the time of inspection.		Pic 6 Desc.	Row photo showing stabilization where recent punch list work activities were completed. Travel lane stabilized after completed work by the contractor.

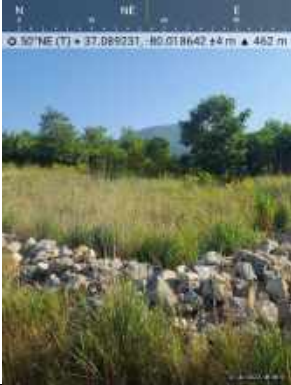
<div style="text-align: center;">Insert image here</div>			
GPS Location	00000	GPS Location			
Field Station#	13444+59	Field Station#			
Pic 7 Desc.	Monitored water bars and level spreaders during routine inspection today. No issues were observed at the time of inspection.		Pic 8 Desc.		
<div style="text-align: center;">Insert image here</div>		<div style="text-align: center;">Insert image here</div>			
GPS Location		GPS Location			
Field Station#		Field Station#			
Pic 9 Desc.		Pic 10 Desc.			
<div style="text-align: center;">Insert image here</div>		<div style="text-align: center;">Insert image here</div>			
GPS Location		GPS Location			
Field Station#		Field Station#			
Pic 11 Desc.		Pic 12 Desc.
