Visual Site Inspection Report

Project Name	H-600 Pipeline Spread G	AFE	124300137	Spread	H-600 Pipeline Spread G
Contractor	Precision			Report #	39668
Inspector	Daniel Fortune			Date/Time	7/11/2022 1:29 PM
Permit #	TBD	Inspection Type	VA SWPP	Station Begin	11254+99
State	VA	Inspection Area	Partial	Station End	11353+67
County	Giles	Ground	Wet	Temperature (°F)	74.00
Municipality	N/A	Weather	Cloudy	Rain Gauge (in)	1.50
				Rain Accumulation Time (days)	1.00

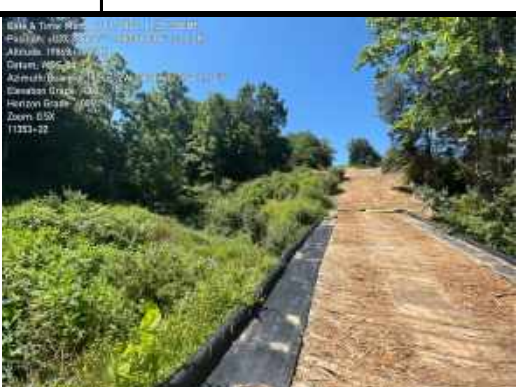
GPS Location	See photo		GPS Location	See photo	
Field Station#	11347+00		Field Station#	11290+00	
Pic 3 Desc.	Improper installation of P1 silt fencing.		Pic 4 Desc.	ECB requires re-installation maintenance.

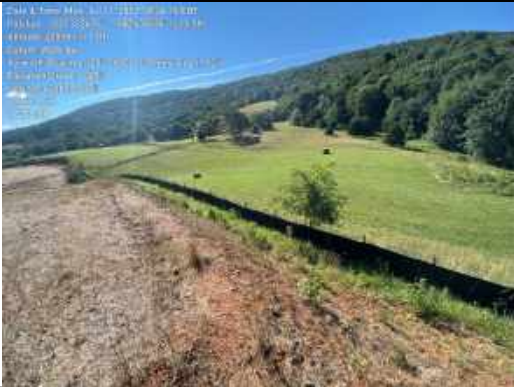
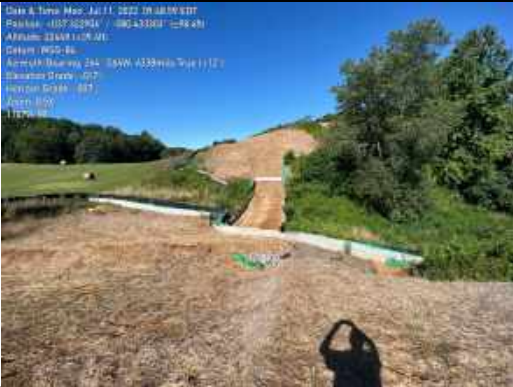
GPS Location	See photo		GPS Location	See photo	
Field Station#	11477+00		Field Station#	11479+00	
Pic 3 Desc.	Supersilt fence perimeter control in place		Pic 4 Desc.	Cleanwater drainage feature in place

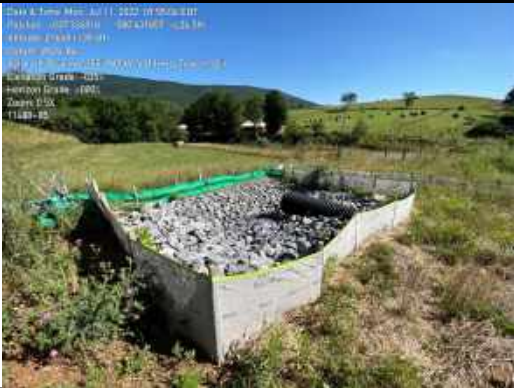
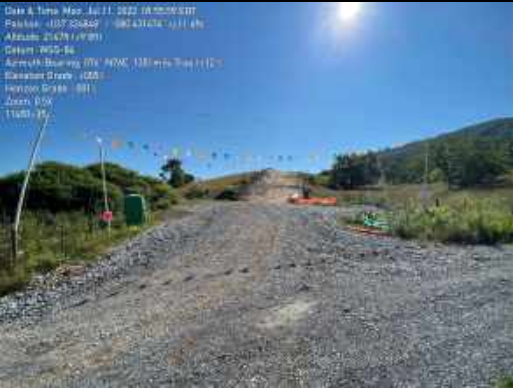
GPS Location	See photo		GPS Location	See photo	
Field Station#	11488+85		Field Station#	11490+25	
Pic 5 Desc.	Plunge pool in place		Pic 6 Desc.	RCE in place

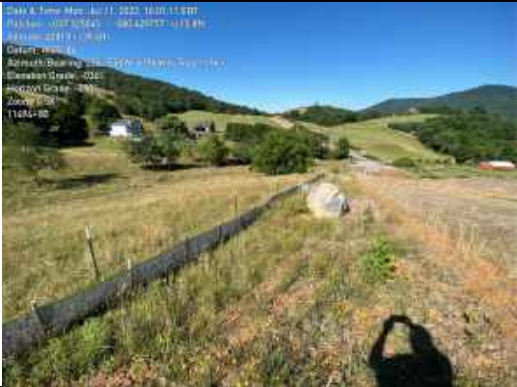
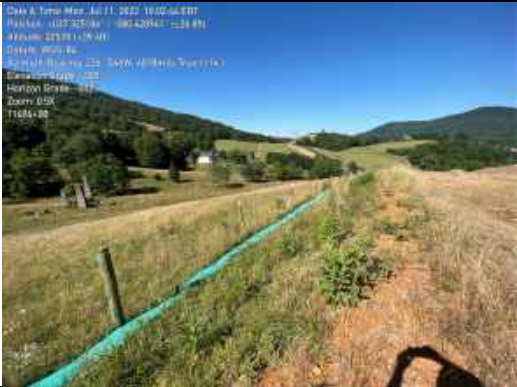
GPS Location	See photo	GPS Location	See photo		
Field Station#	11494+00	Field Station#	11496+00		
Pic 7 Desc.	P1 silt fence perimeter control in place	Pic 8 Desc.	CFS perimeter control in place

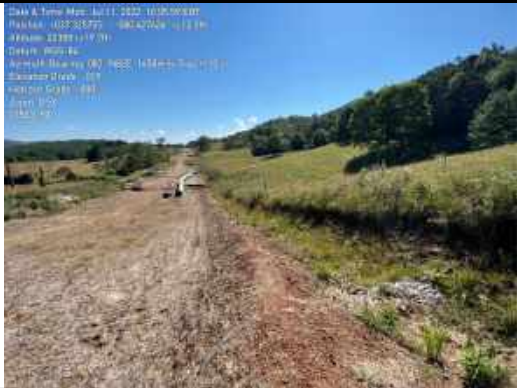
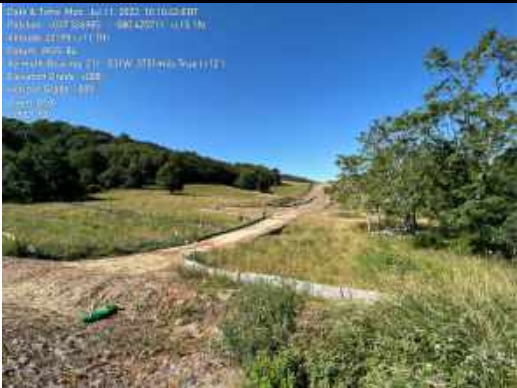
GPS Location	See photo	GPS Location	See photo		
Field Station#	11503+50	Field Station#	11507+50		
Pic 9 Desc.	Cleanwater diversion berm in place	Pic 10 Desc.	Stream buffer in place

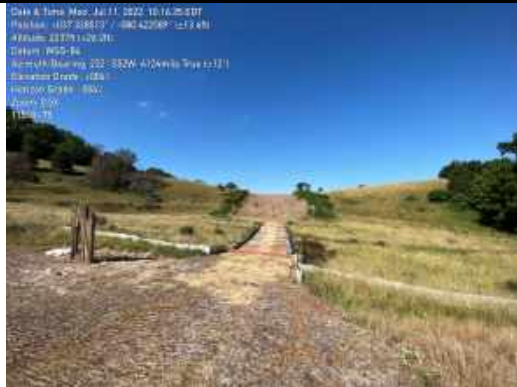
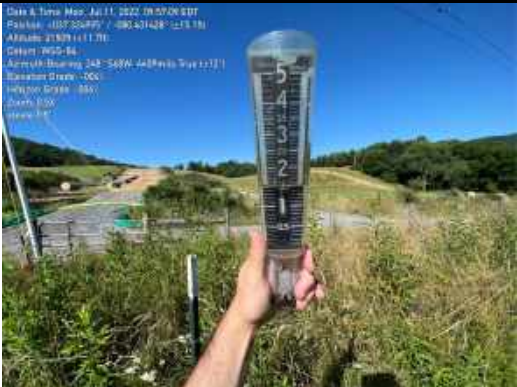
GPS Location	See photo	GPS Location	See photo		
Field Station#	11518+75	Field Station#	11471+56		
Pic 11 Desc.	Stream buffer in place	Pic 12 Desc.	Rain gauge measured 1.5" of rainfall

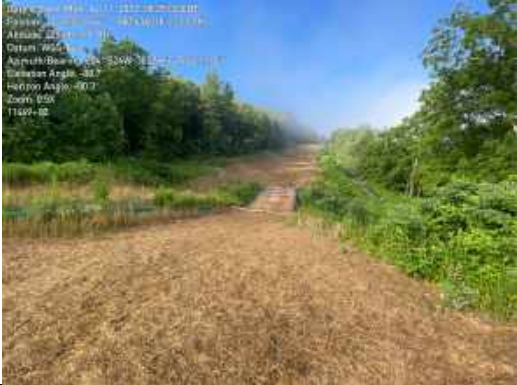
Insert image here			
GPS Location	See photo	GPS Location			
Field Station#	11469+00	Field Station#			
Pic 13 Desc.	Resource buffers in place	Pic 14 Desc.			
Insert image here		Insert image here			
GPS Location		GPS Location			
Field Station#		Field Station#			
Pic 15 Desc.		Pic 16 Desc.			
Insert image here		Insert image here			
GPS Location		GPS Location			
Field Station#		Field Station#			
Pic 17 Desc.		Pic 18 Desc.

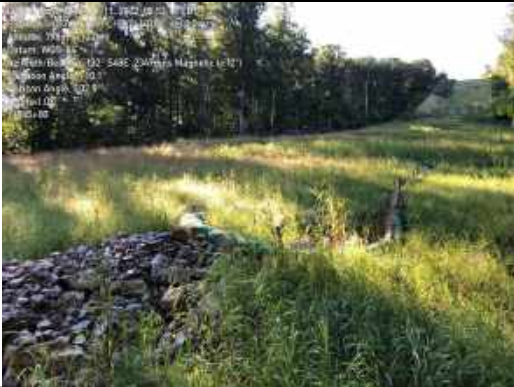
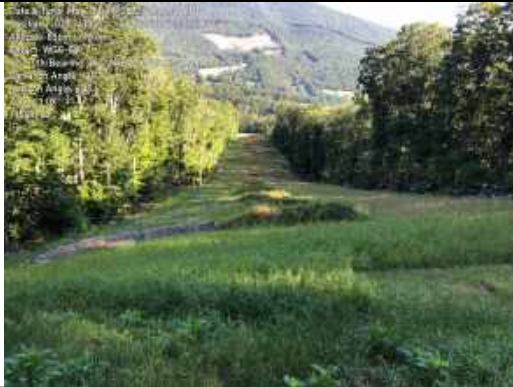
GPS Location	On photo		GPS Location	On photo	
Field Station#	11545+00		Field Station#	11548+00	
Pic 3 Desc.	ROW stable.		Pic 4 Desc.	ROW surface stable with permanent slope breakers and level spreaders in place.

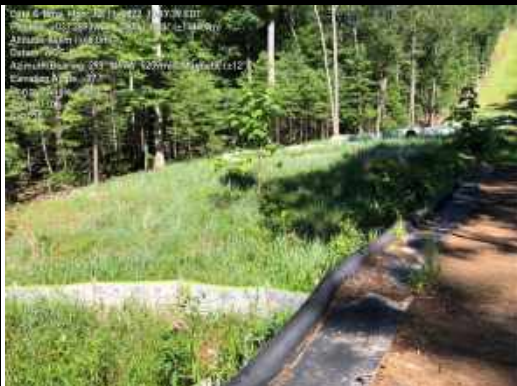
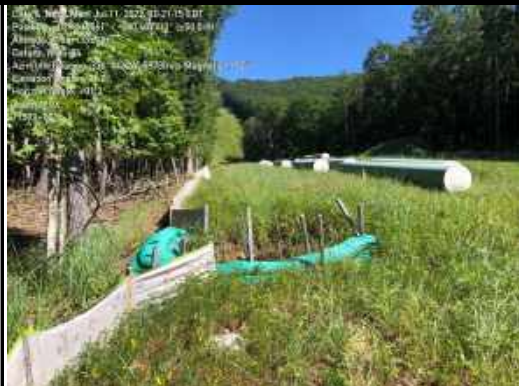
GPS Location	On photo		GPS Location	On photo	
Field Station#	11588+41		Field Station#	11593+00	
Pic 9 Desc.	The S-PP20 crossing is stable.		Pic 10 Desc.	ROW well vegetated. ECDs are in place.

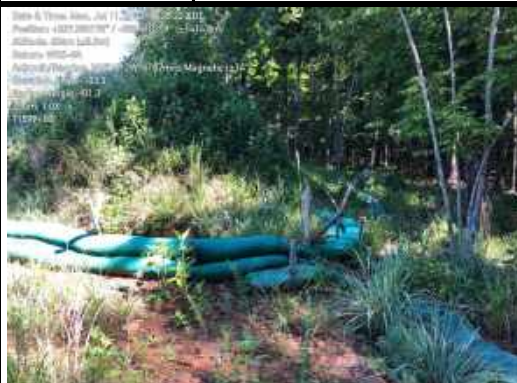
<p>Insert image here</p>			
GPS Location	On photo		GPS Location		
Field Station#	11599+00		Field Station#		
Pic 11 Desc.	No erosion being caused by stormwater runoff.		Pic 12 Desc.

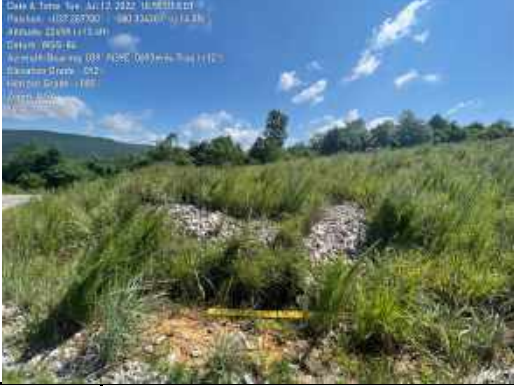
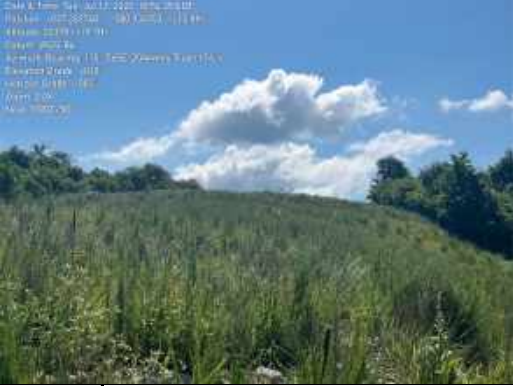
GPS Location	See photo		GPS Location	See photo	
Field Station#	11900+81		Field Station#	11902+00	
Pic 1 Desc.	Permanent level spreader surrounded by heavy vegetation.		Pic 2 Desc.	Final restoration area

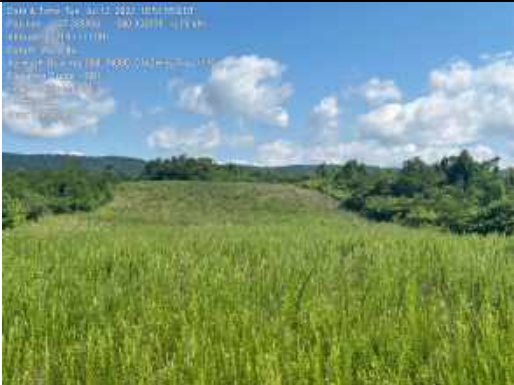
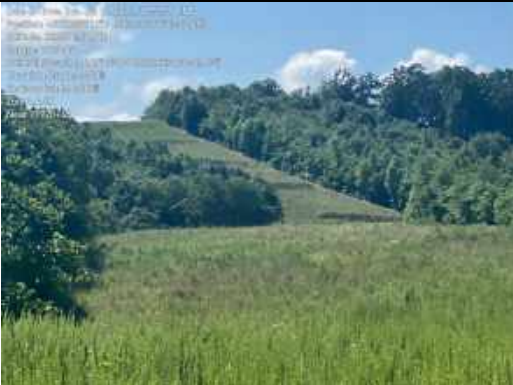
GPS Location	See photo		GPS Location	See photo	
Field Station#	11909+00		Field Station#	11920+45	
Pic 3 Desc.	Final Restoration area		Pic 4 Desc.	Final restoration area with distant view of staggered permanent water bars.

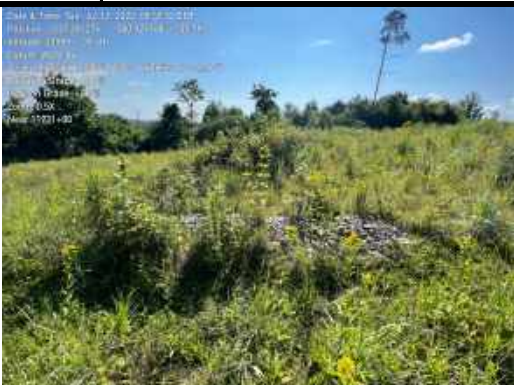
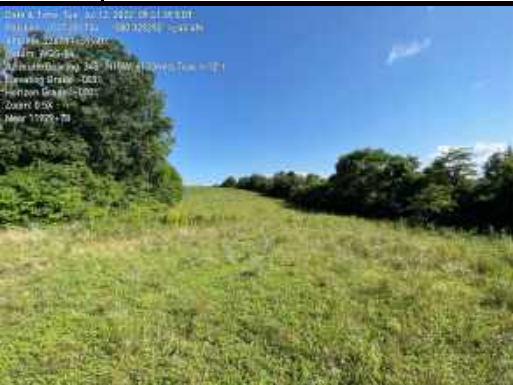
GPS Location	See photo		GPS Location	See photo	
Field Station#	11931+00		Field Station#	11929+78	
Pic 5 Desc.	Permanent level spreader condition.		Pic 6 Desc.	Final restoration area prior to AR 266.

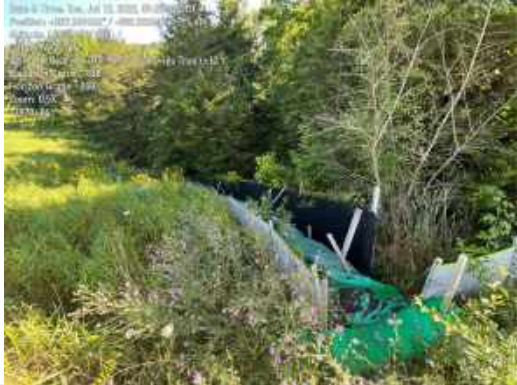
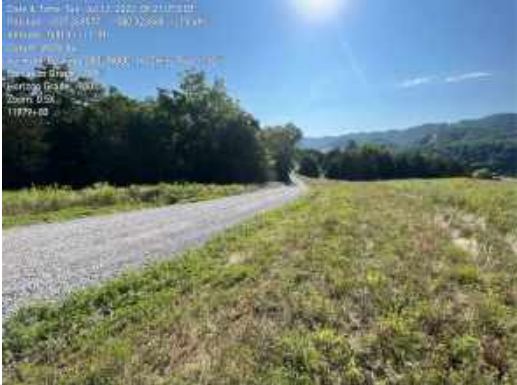
GPS Location	See photo		GPS Location	See photo	
Field Station#	11978+86		Field Station#	11979+00	
Pic 9 Desc.	Adequate karst feature protection		Pic 10 Desc.	Gravel AR 266

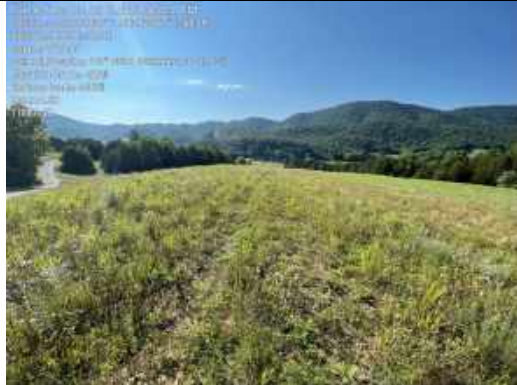
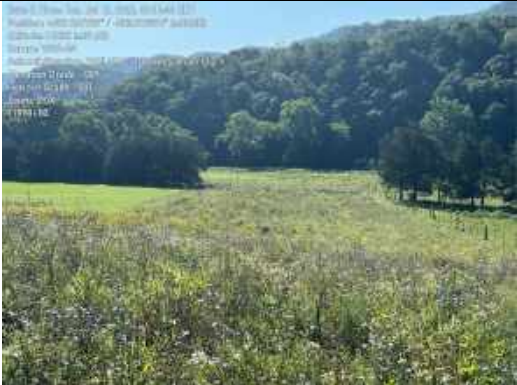
GPS Location	See photo		GPS Location	See photo	
Field Station#	11980+40		Field Station#	11998+00	
Pic 11 Desc.	Final Restoration area		Pic 12 Desc.	Final restoration near spread break.

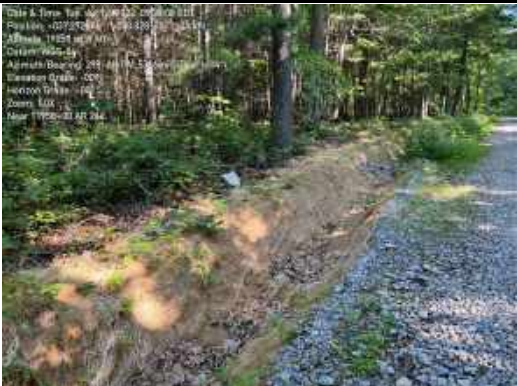
<p style="text-align: center;">Insert image here</p>			
GPS Location	See photo	GPS Location			
Field Station#	11958+00	Field Station#			
Pic 15 Desc.	AR 266 road side ditch stabilization.	Pic 16 Desc.			
<p style="text-align: center;">Insert image here</p>		<p style="text-align: center;">Insert image here</p>			
GPS Location		GPS Location			
Field Station#		Field Station#			
Pic 17 Desc.		Pic 18 Desc.

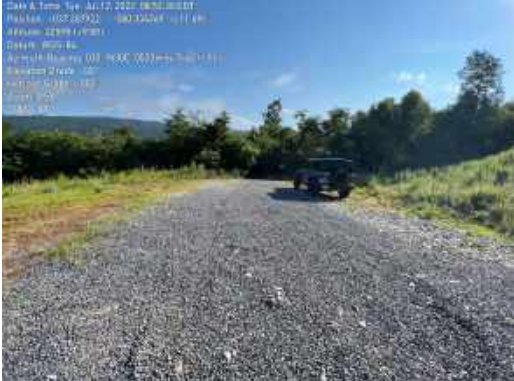
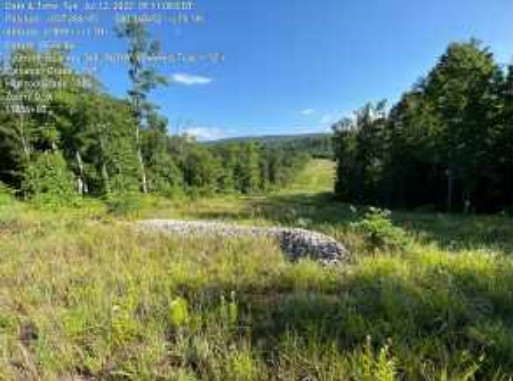
GPS Location	See photo		GPS Location	See photo	
Field Station#	11899+89		Field Station#	11854+00	
Pic 1 Desc.	RCE in place		Pic 2 Desc.	Level spreader in place

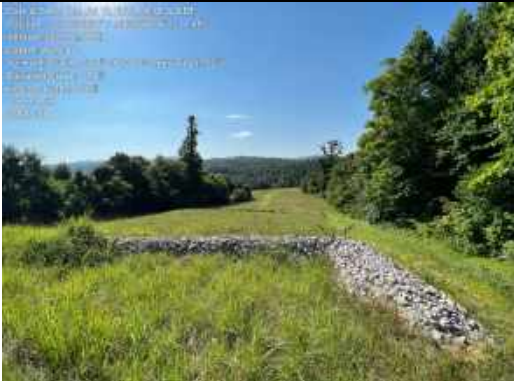
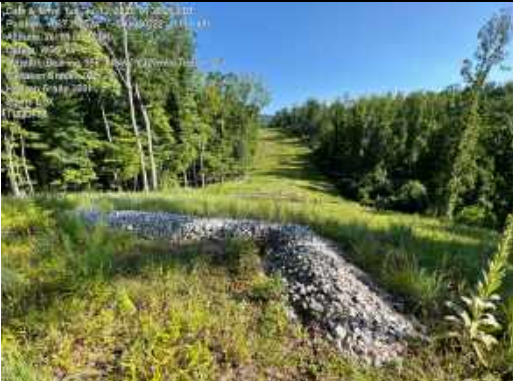
GPS Location	See photo		GPS Location	See photo	
Field Station#	11839+00		Field Station#	11830+50	
Pic 3 Desc.	Permanent waterbar in place		Pic 4 Desc.	Permanent waterbar with level spreader in place

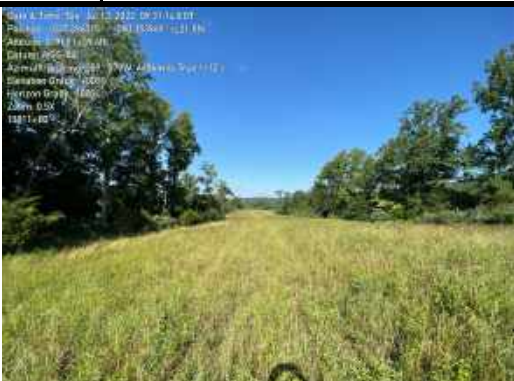
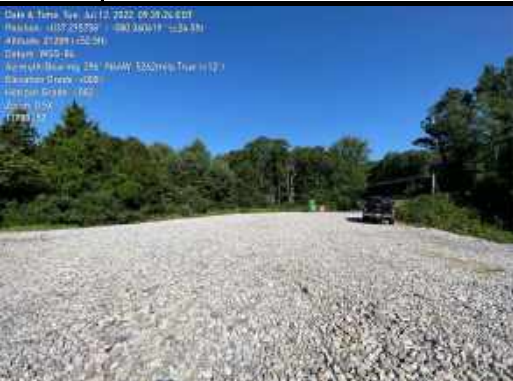
GPS Location	See photo		GPS Location	See photo	
Field Station#	11811+00		Field Station#	11788+52	
Pic 5 Desc.	Permanent vegetation present		Pic 6 Desc.	RCE in place

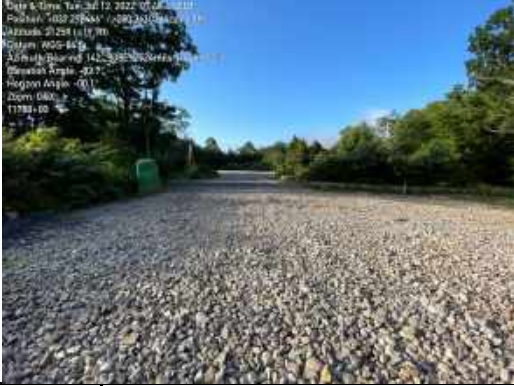
GPS Location	See photo	GPS Location	See photo		
Field Station#	11788+00	Field Station#	11783+50		
Pic 1 Desc.	RCE functional	Pic 2 Desc.	Equipment bridge functional

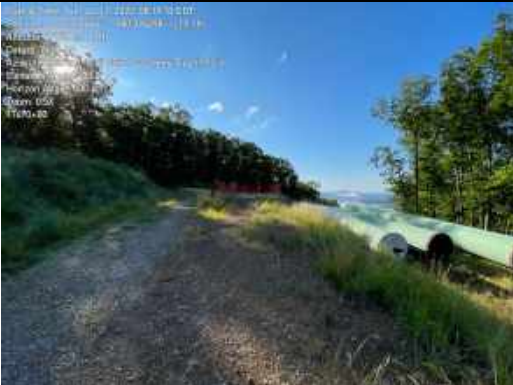
GPS Location	See photo	GPS Location	See photo		
Field Station#	11767+21	Field Station#	11670+00		
Pic 3 Desc.	Wattles in place	Pic 4 Desc.	Wash station in place

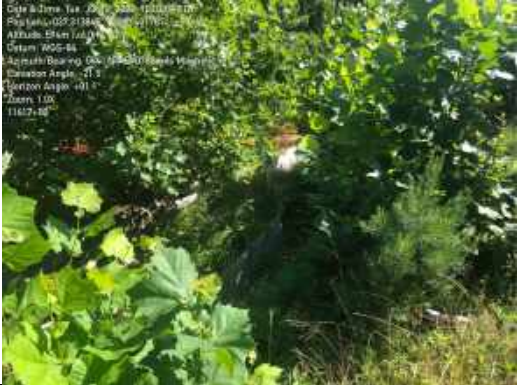
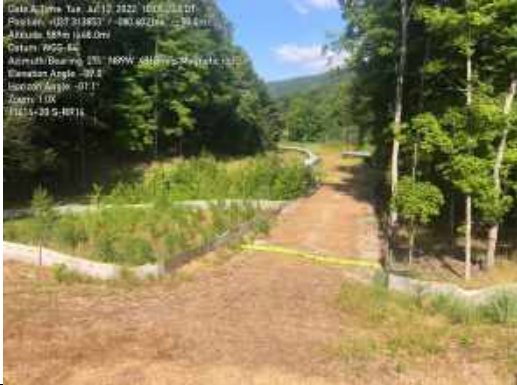
GPS Location	On photo	GPS Location	On photo		
Field Station#	11617+00	Field Station#	11614+20		
Pic 7 Desc.	The ROW is currently stable with ECDs in place.	Pic 8 Desc.	The S-RR14 crossing is stable with ECDs in place.

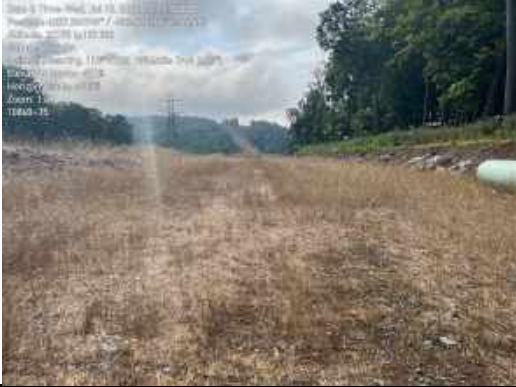
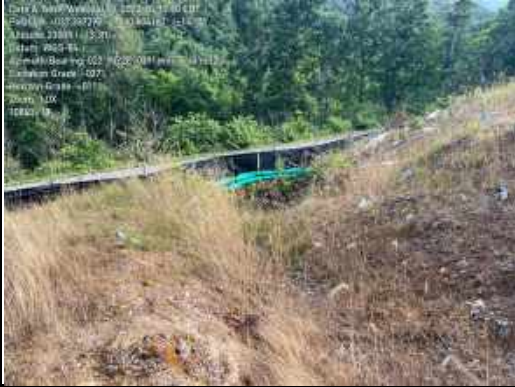
GPS Location	See photo		GPS Location	See photo	
Field Station#	10868+35		Field Station#	10860+18	
Pic 13 Desc.	Temporary stabilization of row.		Pic 14 Desc.	Water bar end treatment, road side perimeter super silt fence, and temporary vegetation. No issues at this time.	
Insert image here			Insert image here		
GPS Location			GPS Location		
Field Station#			Field Station#		
Pic 15 Desc.			Pic 16 Desc.		
Insert image here			Insert image here		
GPS Location			GPS Location		
Field Station#			Field Station#		
Pic 17 Desc.			Pic 18 Desc.

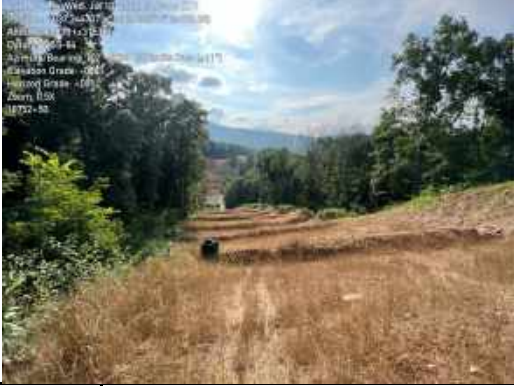
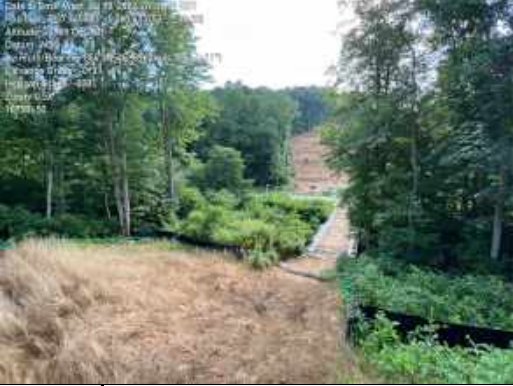
GPS Location	See photo	GPS Location	See photo		
Field Station#	10752+50	Field Station#	10758+50		
Pic 1 Desc.	Waterbars in place	Pic 2 Desc.	Stream buffer in place

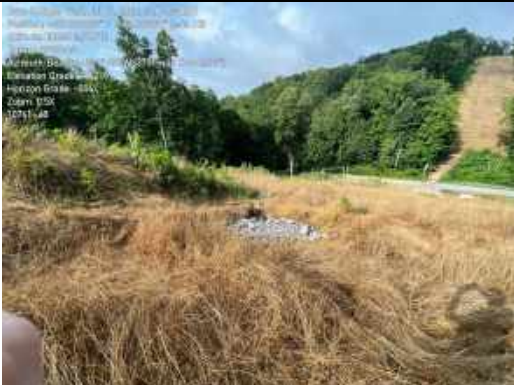
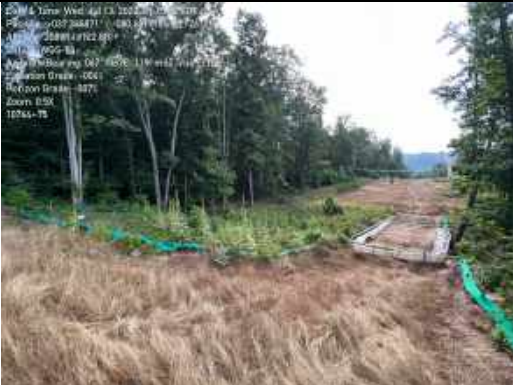
GPS Location	See photo	GPS Location	See photo		
Field Station#	10761+60	Field Station#	10764+75		
Pic 3 Desc.	Stone inlet protection in place	Pic 4 Desc.	Stream buffer in place

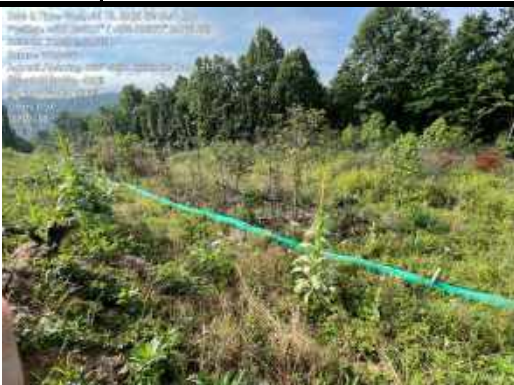
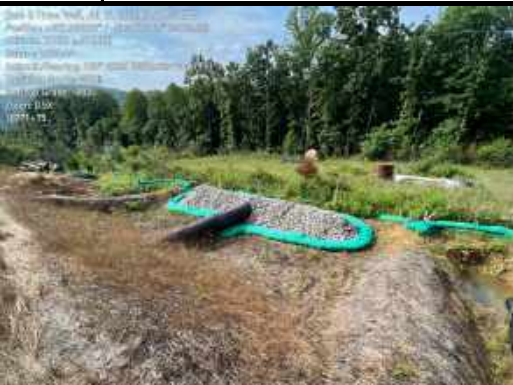
GPS Location	See photo	GPS Location	See photo		
Field Station#	10769+00	Field Station#	10771+75		
Pic 5 Desc.	CFS perimeter control in place	Pic 6 Desc.	Cleanwater diversion outlet protection in place

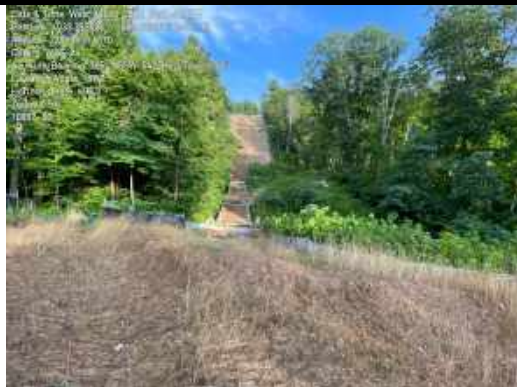
GPS Location	See photo	GPS Location	See photo		
Field Station#	10857+00	Field Station#	10859+00		
Pic 11 Desc.	Resource buffers in place	Pic 12 Desc.	RCE functional

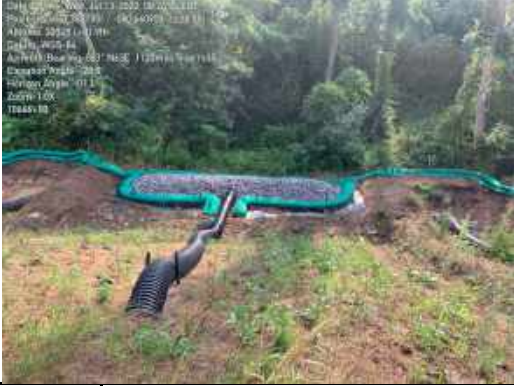
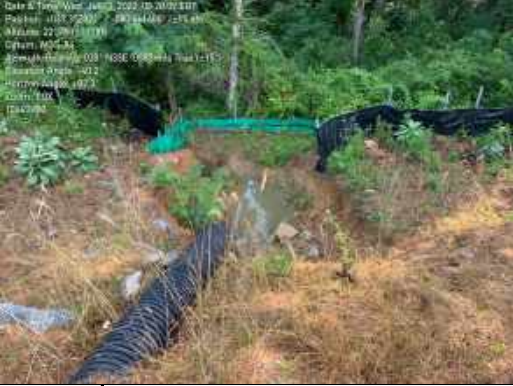
GPS Location	See photo for GPS location.		GPS Location	See photo for GPS location.	
Field Station#	10666+00		Field Station#	10663+00	
Pic 1 Desc.	Clean water diversion pipe and level spreader in place.		Pic 2 Desc.	Slope drain in place over fill slope. sump pit and end treatment in place.

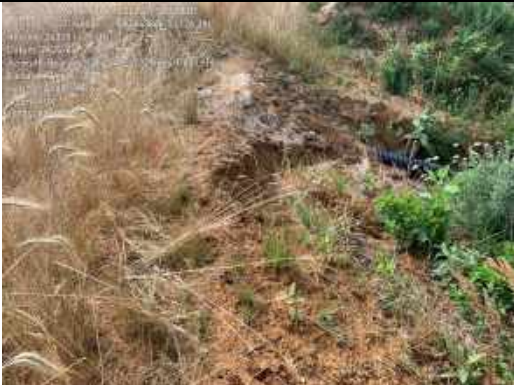
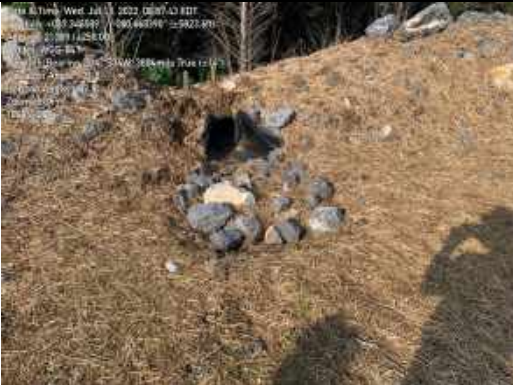
GPS Location	See photo for GPS location.		GPS Location	See photo for GPS location.	
Field Station#	10724+00		Field Station#	10684+00	
Pic 3 Desc.	Sloughing fill slope added to the punchlist.		Pic 4 Desc.	Rock inlet in place at slope drain pipe.

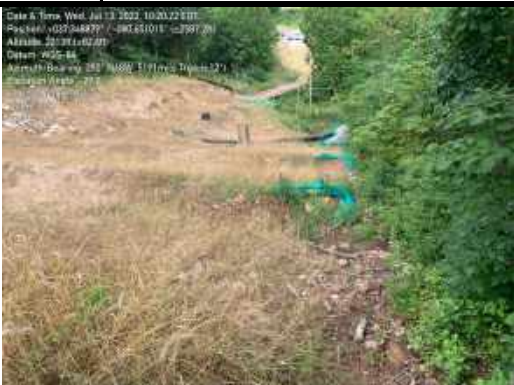
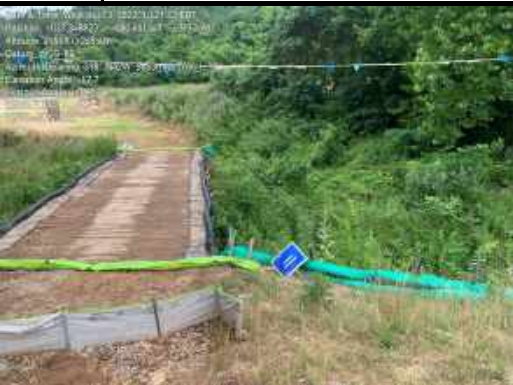
GPS Location	See photo for GPS location.		GPS Location	See photo for GPS location.	
Field Station#	10701+00		Field Station#	10698+00	
Pic 5 Desc.	Waterbar, sump pit, and end treatment in place.		Pic 6 Desc.	Sensitive resource buffer in place at stream S-G32.

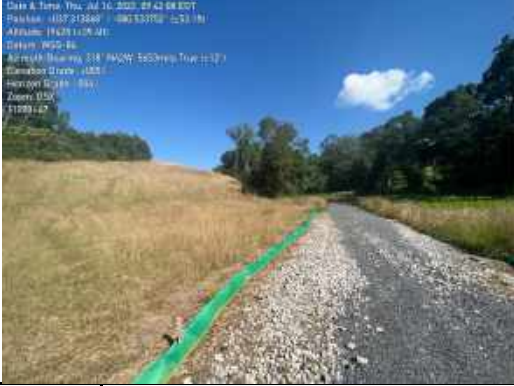
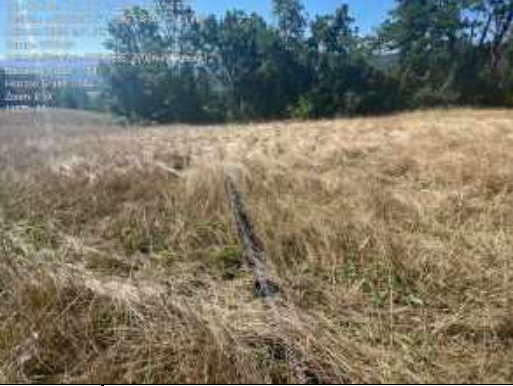
GPS Location	See photo	GPS Location	See photo		
Field Station#	11098+47	Field Station#	11075+80		
Pic 1 Desc.	Final Restoration area and current AR 245.02 conditions.	Pic 2 Desc.	Over flow drain pipe from water well. No Issues at this time.

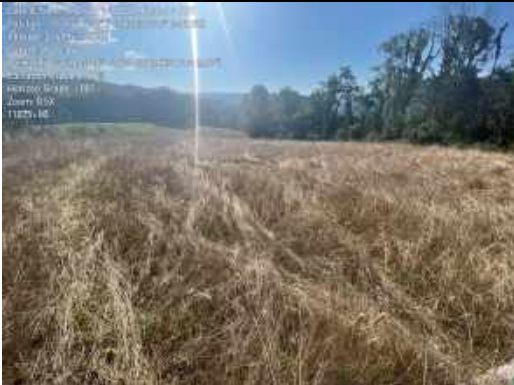
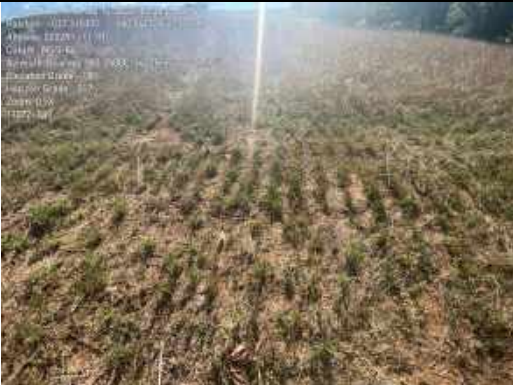
GPS Location	See photo	GPS Location	See photo		
Field Station#	11075+00	Field Station#	11072+04		
Pic 3 Desc.	Heavy annual grasses in final restoration area	Pic 4 Desc.	View of current clover vegetation in final restoration.

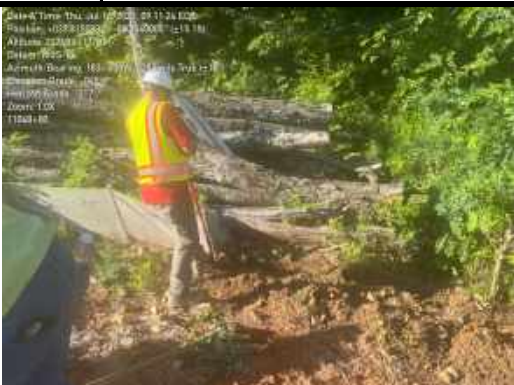
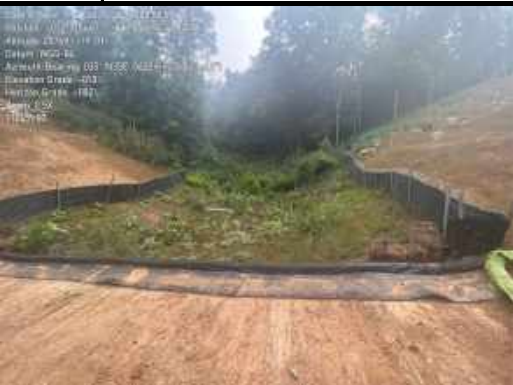
GPS Location	See photo	GPS Location	See photo		
Field Station#	11068+00	Field Station#	11065+80		
Pic 5 Desc.	View of current repairs to P1 silt fence.	Pic 6 Desc.	View of drainage feature conditions.

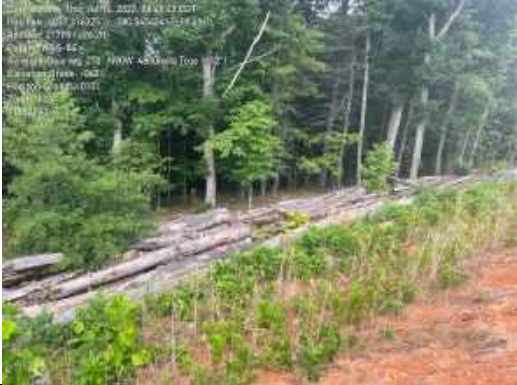
GPS Location	See photo		GPS Location	See photo	
Field Station#	11059+60		Field Station#	11049+96	
Pic 7 Desc.	Perimeter P1 silt fencing and vegetated side slope conditions.		Pic 8 Desc.	S-IJ16b and 17 stream resources and current vegetative conditions.

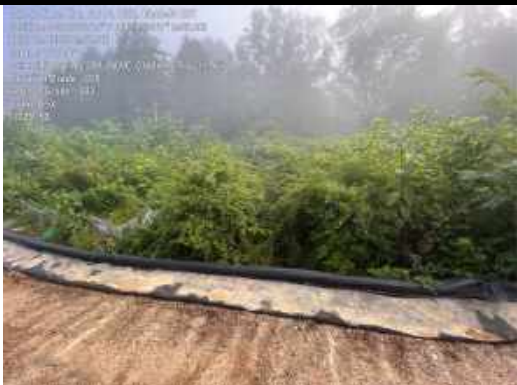
GPS Location	See photo		GPS Location	See photo	
Field Station#	11025+50		Field Station#	11025+50	
Pic 11 Desc.	Over view of the vegetated buffer zones of the S-IJ 18 stream resource.		Pic 12 Desc.	S-IJ18 stream resource conditions. Functional equipment bridge and perimeter ECDs.

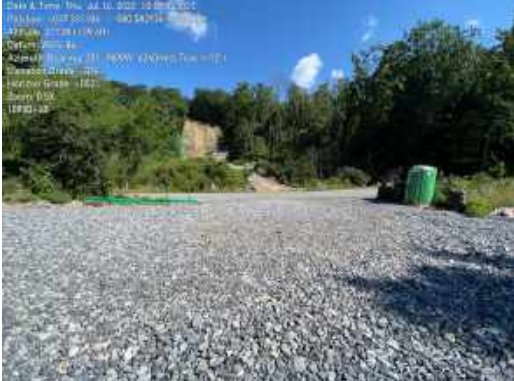
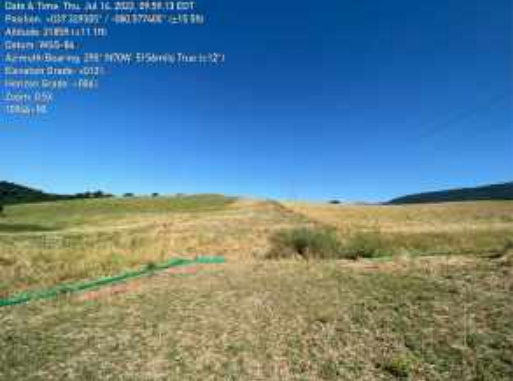
GPS Location	See photo	GPS Location	See photo		
Field Station#	10930+40	Field Station#	10946+00		
Pic 1 Desc.	RCE in place	Pic 2 Desc.	Permanent vegetation present

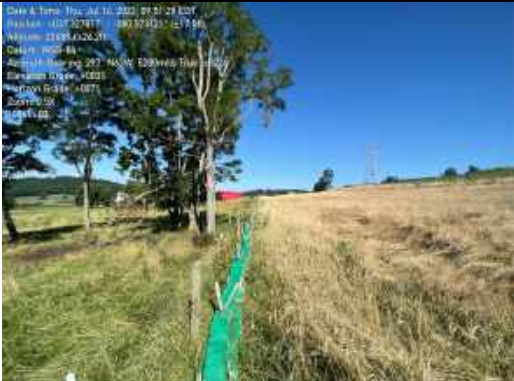
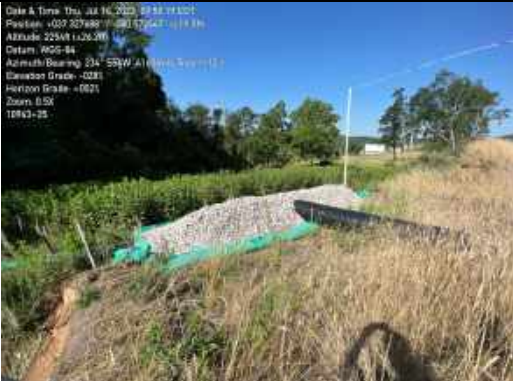
GPS Location	See photo	GPS Location	See photo		
Field Station#	10961+00	Field Station#	10963+25		
Pic 3 Desc.	Triple stack CFS perimeter control in place	Pic 4 Desc.	Cleanwater diversion outlet protection in place

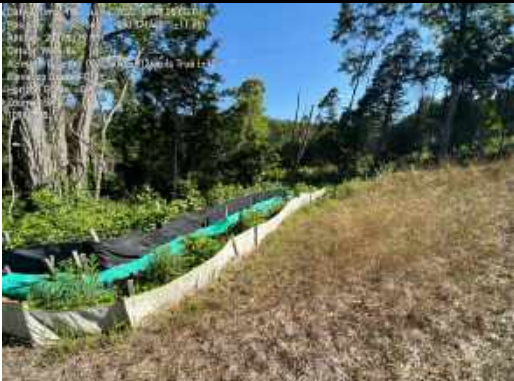
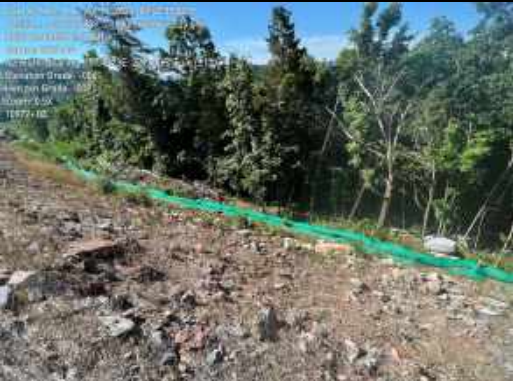
GPS Location	See photo	GPS Location	See photo		
Field Station#	10966+85	Field Station#	10972+00		
Pic 5 Desc.	Triple protection ECDs in place at karst feature	Pic 6 Desc.	Triple stack CFS perimeter control in place

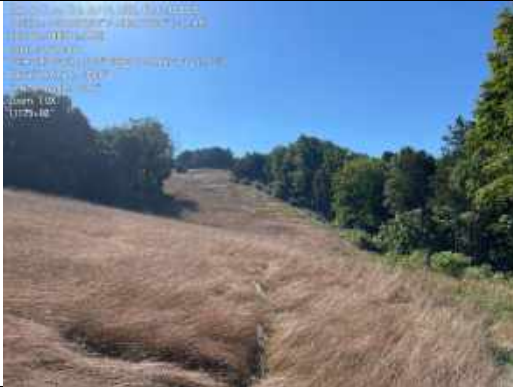
GPS Location	See photo	GPS Location	See photo		
Field Station#	11183+00	Field Station#	11175+00		
Pic 1 Desc.	Stabilization functional	Pic 2 Desc.	Perimeter controls in place

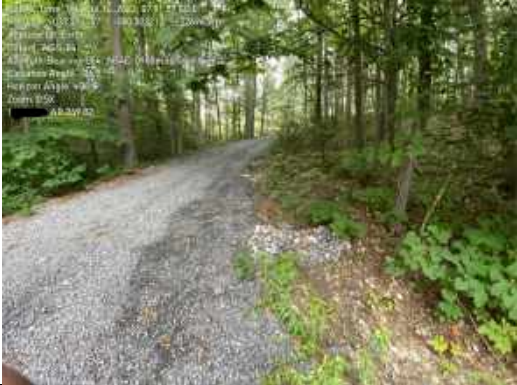
GPS Location	See photo	GPS Location	See photo		
Field Station#	11118+00	Field Station#	11184+85		
Pic 7 Desc.	Perimeter controls in place	Pic 8 Desc.	Rock check dams in place

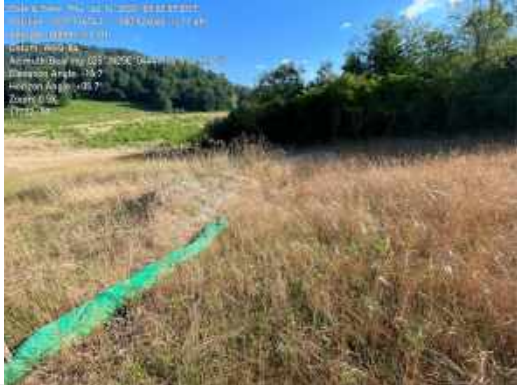
<p style="text-align: center;">Insert image here</p>			
GPS Location	See photo	GPS Location			
Field Station#	11132+00	Field Station#			
Pic 9 Desc.	Permanent water bars and level spreader	Pic 10 Desc.			
<p style="text-align: center;">Insert image here</p>		<p style="text-align: center;">Insert image here</p>			
GPS Location		GPS Location			
Field Station#		Field Station#			
Pic 11 Desc.		Pic 12 Desc.

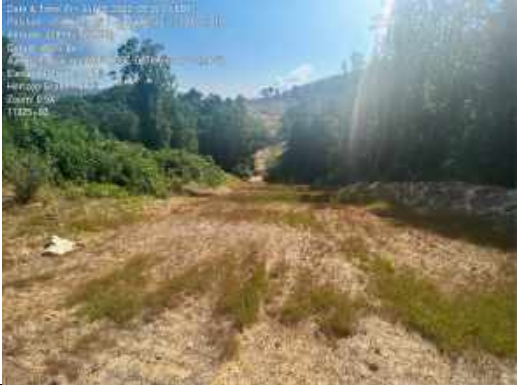
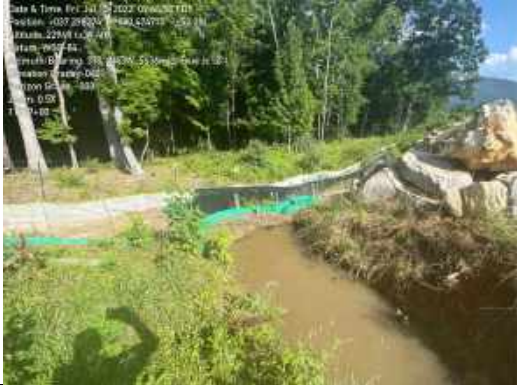
GPS Location	See photo	GPS Location	See photo		
Field Station#	11325+00	Field Station#	11317+00		
Pic 7 Desc.	Steep slope stabilization. No Issues.	Pic 8 Desc.	Adequately protected Karst feature area.

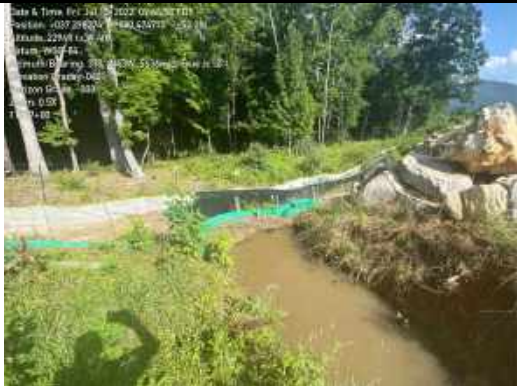
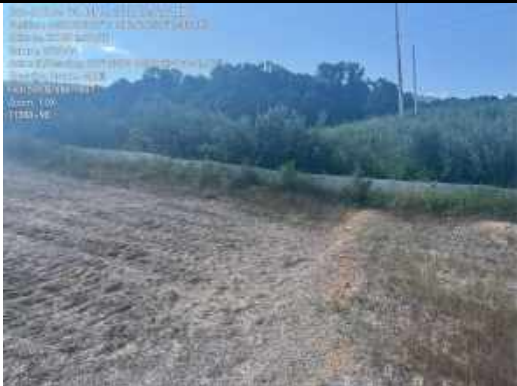
GPS Location	See photo	GPS Location	See photo		
Field Station#	11317+00	Field Station#	11308+90		
Pic 9 Desc.	Adequately protected karst feature area with functional ECDs.	Pic 10 Desc.	Temporary stabilization of water bar and functional perimeter P1 silt fencing.

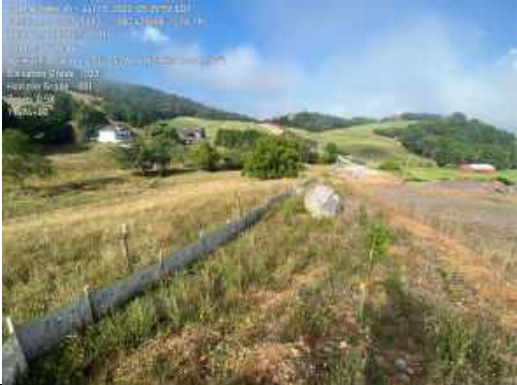
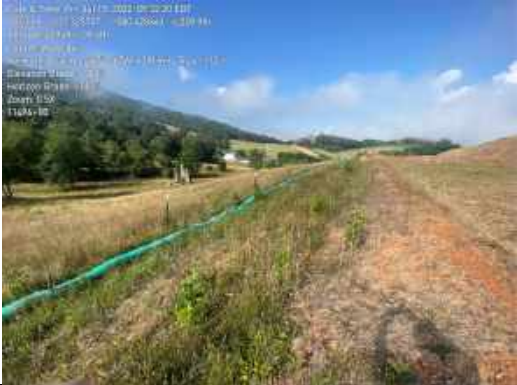
GPS Location	See photo		GPS Location	See photo	
Field Station#	11494+00		Field Station#	11496+00	
Pic 7 Desc.	P1 silt fence perimeter control in place		Pic 8 Desc.	CFS perimeter control in place

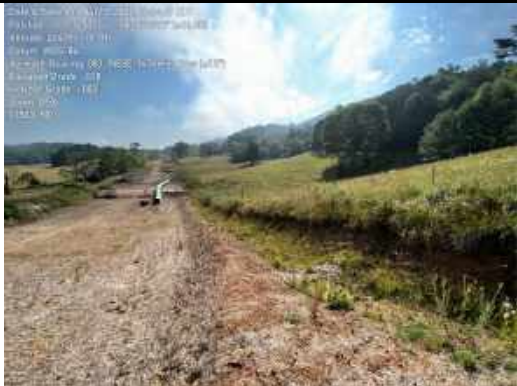
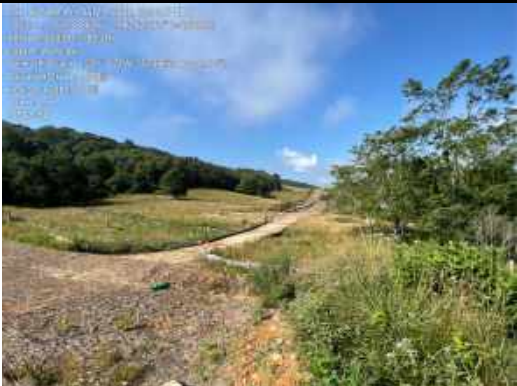
GPS Location	See photo		GPS Location	See photo	
Field Station#	11503+50		Field Station#	11507+50	
Pic 9 Desc.	Cleanwater diversion berm in place		Pic 10 Desc.	Stream buffer in place

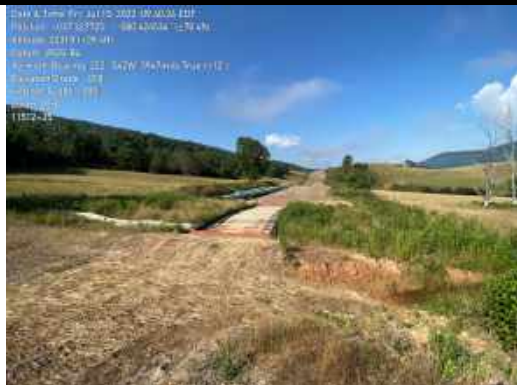
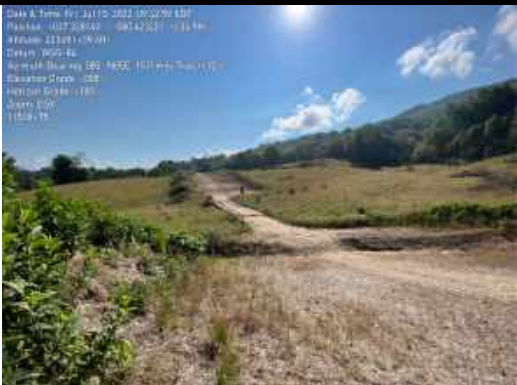
GPS Location	See photo		GPS Location	See photo	
Field Station#	11512+25		Field Station#	11518+75	
Pic 11 Desc.	Cleanwater drainage feature in place		Pic 12 Desc.	Stream buffer in place

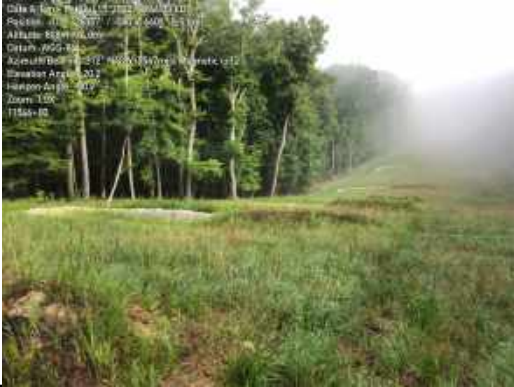
GPS Location	On photo		GPS Location	On photo	
Field Station#	11546+00		Field Station#	11550+00	
Pic 3 Desc.	Permanently restored area stable.		Pic 4 Desc.	ROW stable. New vegetation sprouting under erosion control blanket.

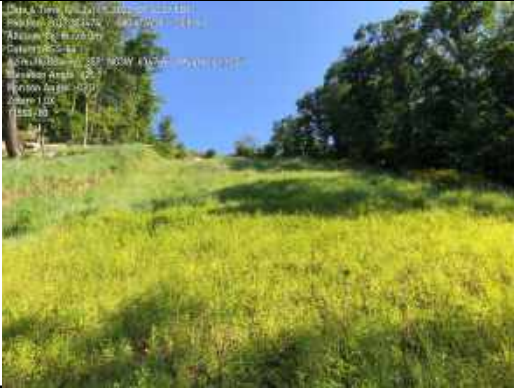
GPS Location	On photo		GPS Location	On photo	
Field Station#	11558+00		Field Station#	11567+42	
Pic 5 Desc.	ROW stable. Slope breakers in place and functional.		Pic 6 Desc.	The S-PP22 crossing is stable.

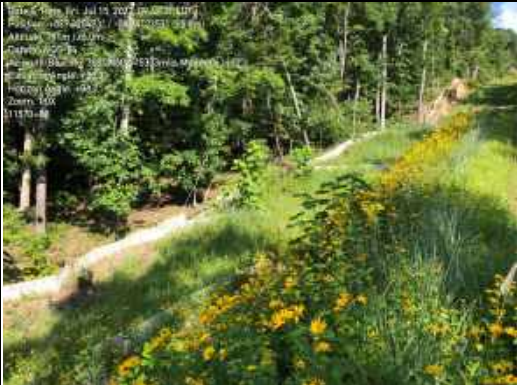
GPS Location	On photo	GPS Location	On photo		
Field Station#	11570+50	Field Station#	11584+00		
Pic 7 Desc.	Good vegetation. Stable ROW. ECDs are in place.	Pic 8 Desc.	Sumps and end treatments are effective.

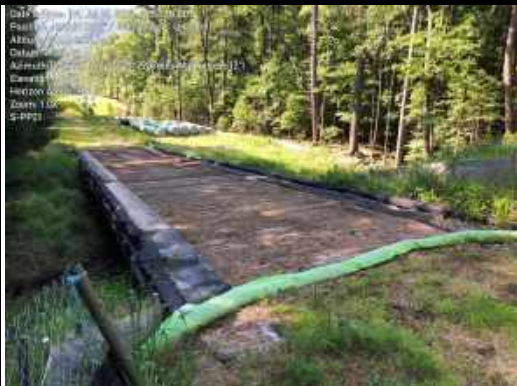
GPS Location	On photo	GPS Location	On photo		
Field Station#	11585+48	Field Station#	11588+41		
Pic 9 Desc.	The S-PP21 crossing is stable.	Pic 10 Desc.	The S-PP20 crossing is stable.

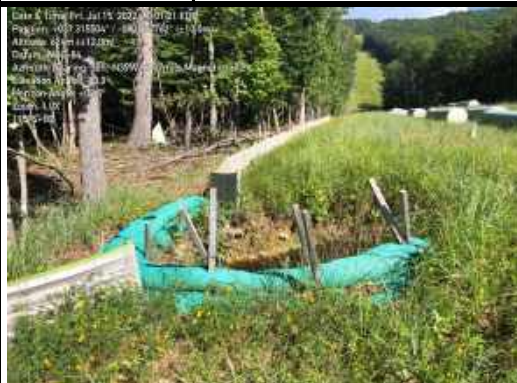
Insert image here			
GPS Location	On photo	GPS Location			
Field Station#	11594+00	Field Station#			
Pic 11 Desc.	Stable ROW with ECDs in place.	Pic 12 Desc.
