Visual Site Inspection Report

Project Name	H-600 Pipeline Spread G	AFE	124300137	Spread	H-600 Pipeline Spread G
Contractor	Precision			Report #	39962
Inspector	Daniel Fortune			Date/Time	7/18/2022 3:10 PM
Permit #	TBD	Inspection Type	VA SWPP	Station Begin	12005+00
State	VA	Inspection Area	Partial	Station End	12005+00
County	Giles	Ground	Dry	Temperature (°F)	78.00
Municipality	N/A	Weather	Cloudy	Rain Gauge (in)	0.00
				Rain Accumulation Time (days)	0.00

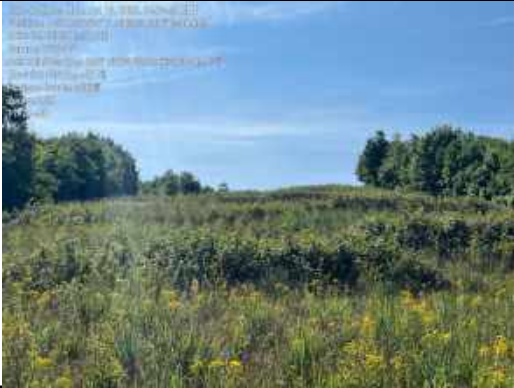
GPS Location	See photo		GPS Location	See photo	
Field Station#	11921+00		Field Station#	11935+00	
Pic 5 Desc.	Vegetated staggered water bars. (Final restoration area).		Pic 6 Desc.	Perineal vegetation visible throughout the final restoration area.

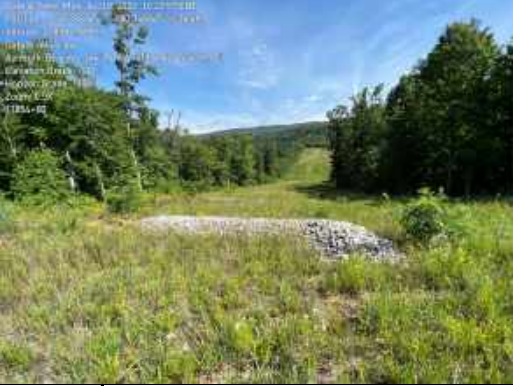
GPS Location	See photo	GPS Location	See photo		
Field Station#	11899+89	Field Station#	11854+00		
Pic 1 Desc.	RCE in place	Pic 2 Desc.	Permanent waterbar in place

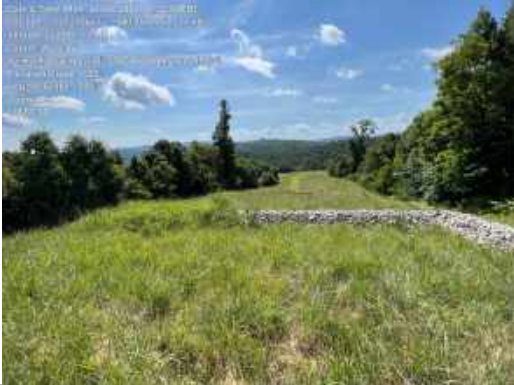
GPS Location	See photo	GPS Location	See photo		
Field Station#	11839+00	Field Station#	11830+50		
Pic 3 Desc.	Waterbar with level spreader in place	Pic 4 Desc.	Level spreader in place

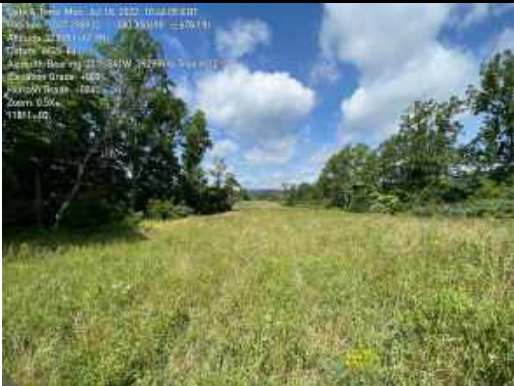
GPS Location	See photo	GPS Location	See photo		
Field Station#	11811+00	Field Station#	11788+52		
Pic 5 Desc.	Permanent vegetation present	Pic 6 Desc.	RCE in place

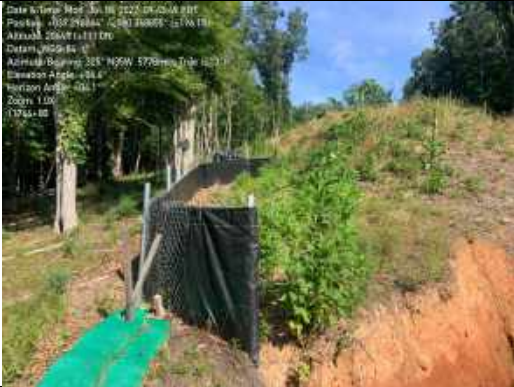
<p>Date & Time: Mon, Jul 18, 2022, 01:45:00 PM Position: 35° 29' 26.84" N, 83° 00' 00.00" W Altitude: 2049 ft (625 m) Datum: WGS84 Azimuth Bearing: 325° N 55W 57° 30m True (102.1°) Elevation Angle: +08.6° Horizontal Angle: -04.1° Slope: 12% 11764+00</p>

<p>Date & Time: Mon, Jul 18, 2022, 01:45:00 PM Position: 35° 29' 26.84" N, 83° 00' 00.00" W Altitude: 2140 ft (652 m) Datum: WGS84 Azimuth Bearing: 325° N 55W 57° 30m True (102.1°) Elevation Angle: +17.2° Horizontal Angle: -02.1° Slope: 10% 11751+00</p>		GPS Location	See photo
Field Station#	11764+00	Field Station#	11751+00	GPS Location	see photo
Pic 1 Desc.	Perimeter controls are in place	Pic 2 Desc.	Section of Row showing conditions and controls

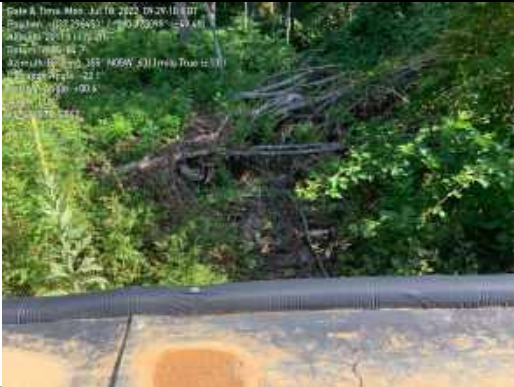
<p>Date & Time: Mon, Jul 18, 2022, 01:46:00 PM Position: 35° 29' 26.84" N, 83° 00' 00.00" W Altitude: 2213 ft (674 m) Datum: WGS84 Azimuth Bearing: 325° N 55W 57° 30m True (102.1°) Elevation Angle: +22.1° Horizontal Angle: -02.1° Slope: 10% 11743+97</p>

Field Station#	11743+97	Field Station#	11740+72	GPS Location	See photo
Pic 3 Desc.	S-EF62 looking upstream	Pic 4 Desc.	S-EF65 looking downstream

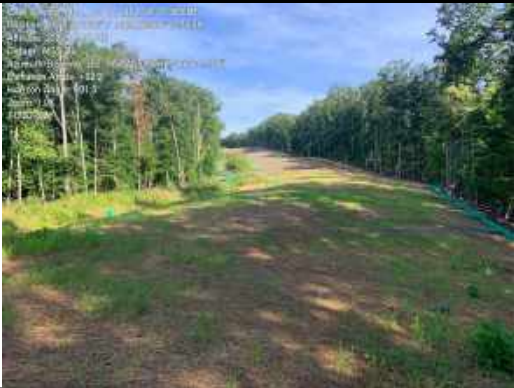
<p>Date & Time: Mon, Jul 18, 2022, 01:47:00 PM Position: 35° 29' 26.84" N, 83° 00' 00.00" W Altitude: 2213 ft (674 m) Datum: WGS84 Azimuth Bearing: 325° N 55W 57° 30m True (102.1°) Elevation Angle: +22.1° Horizontal Angle: -02.1° Slope: 10% 11720+00</p>

<p>Date & Time: Mon, Jul 18, 2022, 01:47:00 PM Position: 35° 29' 26.84" N, 83° 00' 00.00" W Altitude: 2213 ft (674 m) Datum: WGS84 Azimuth Bearing: 325° N 55W 57° 30m True (102.1°) Elevation Angle: +22.1° Horizontal Angle: -02.1° Slope: 10% 11709+50</p>		GPS Location	See photo
Field Station#	11720+00	Field Station#	11709+50	GPS Location	See photo
Pic 5 Desc.	Section of Row showing conditions and controls	Pic 6 Desc.	CFS perimeter controls are in place

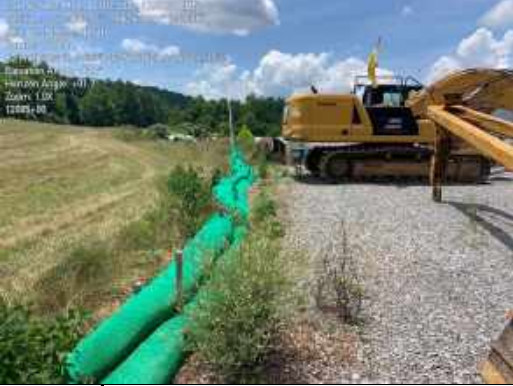
GPS Location	See photo	GPS Location	See photo		
Field Station#	12005+00	Field Station#	12005+00		
Pic 1 Desc.	Culvert is in place	Pic 2 Desc.	CFS perimeter controls are in place

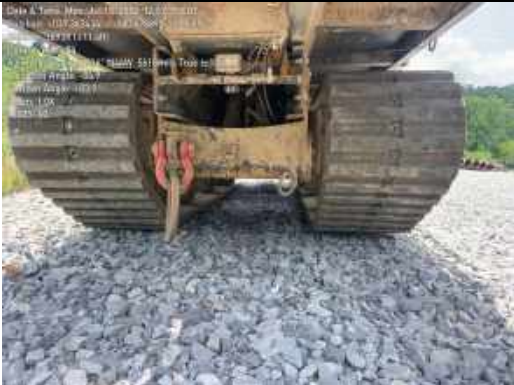
GPS Location	See photo	GPS Location	See photo		
Field Station#	12005+00	Field Station#	12005+00		
Pic 3 Desc.	No visible leaks or spills	Pic 4 Desc.	Rock surface of RCE is maintained in acceptable condition

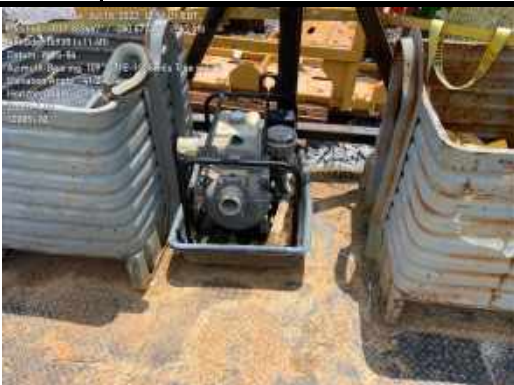
GPS Location	See photo	GPS Location	See photo		
Field Station#	12005+00	Field Station#	12005+00		
Pic 5 Desc.	Secondary containment is in place	Pic 6 Desc.	Dumpsters are in place

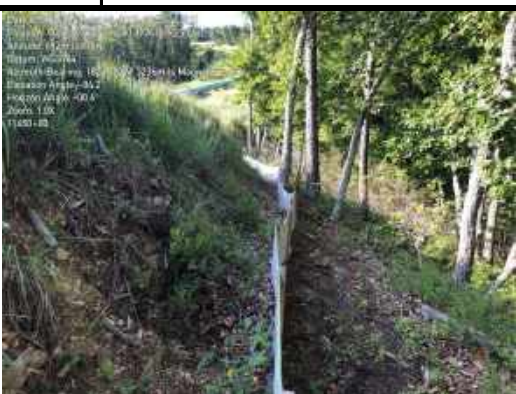
GPS Location	On photo		GPS Location	On photo	
Field Station#	11650+00		Field Station#	11634+00	
Pic 5 Desc.	ECDs are in place and functional.		Pic 6 Desc.	ROW surface stable. ECDs in place.

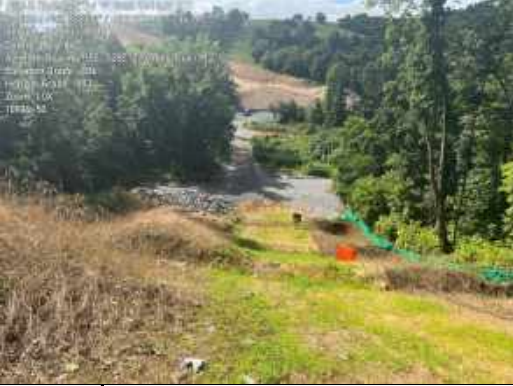
GPS Location	See photo	GPS Location	See photo		
Field Station#	10927+77	Field Station#	10924+50		
Pic 1 Desc.	S-Y3 vegetated stream bed conditions. Buffer zones heavily vegetated.	Pic 2 Desc.	Steep slope stabilization and new emerging temporary vegetation. Perimeter controls functional.

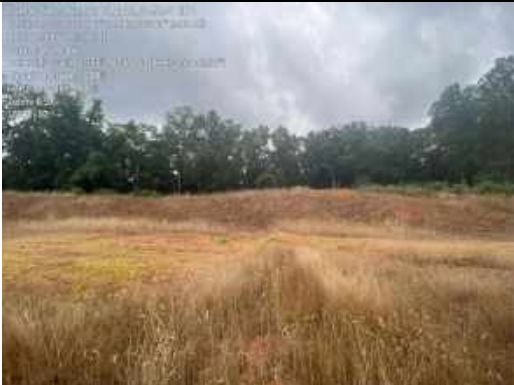
GPS Location	See photo	GPS Location	See photo		
Field Station#	10902+00	Field Station#	10895+00		
Pic 3 Desc.	Spoil pile lacking vegetative cover. This has been added to the punch list.	Pic 4 Desc.	Stone inlet protection condition.

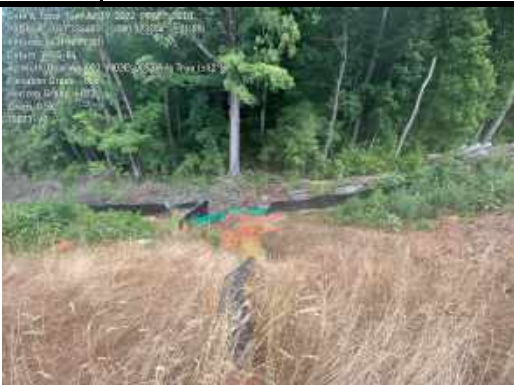
GPS Location	See photo	GPS Location	See photo		
Field Station#	10893+60	Field Station#	10891+00		
Pic 5 Desc.	Fill slope stabilization with functional perimeter super silt fence and water bar end treatment.	Pic 6 Desc.	Recent ECB stabilization of water runoff area prior to water bar end treatment.

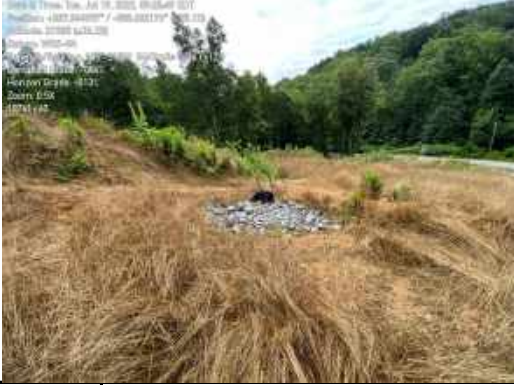
GPS Location	See photo		GPS Location	See photo	
Field Station#	10761+60		Field Station#	10764+75	
Pic 3 Desc.	Stone inlet protection in place		Pic 4 Desc.	Stream buffer in place

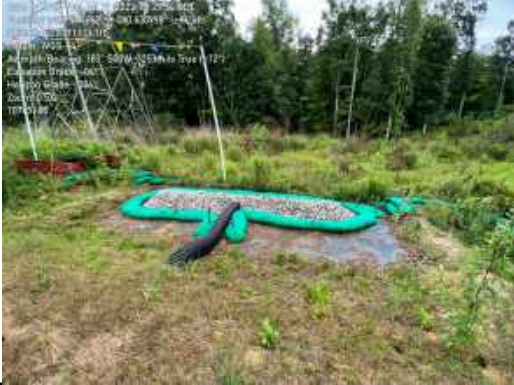
GPS Location	See photo		GPS Location	See photo	
Field Station#	10765+85		Field Station#	10769+00	
Pic 5 Desc.	Cleanwater diversion outlet protection in place		Pic 6 Desc.	CFS perimeter control in place

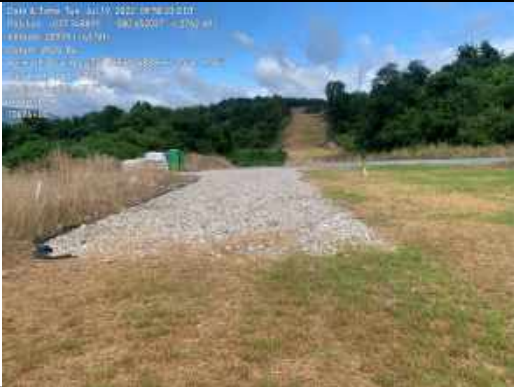
GPS Location	See photo for GPS location.		GPS Location	See photo for GPS location.	
Field Station#	10696+00		Field Station#	10729+66	
Pic 3 Desc.	RCE in place at Buffalo Anklets Road crossing.		Pic 4 Desc.	Sump pit wall sloughing. Item added to punchlist.

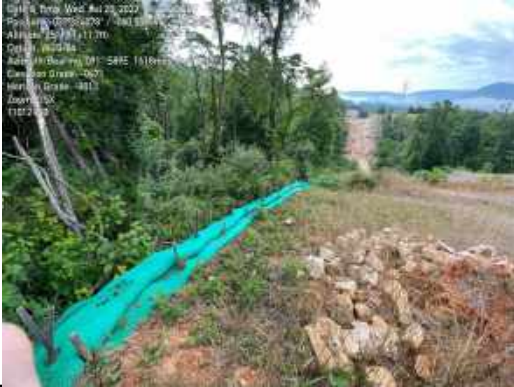
GPS Location	See photo		GPS Location	See photo	
Field Station#	11012+50		Field Station#	11004+00	
Pic 3 Desc.	CFS triple stack perimeter control in place		Pic 4 Desc.	Cleanwater diversion berm in place

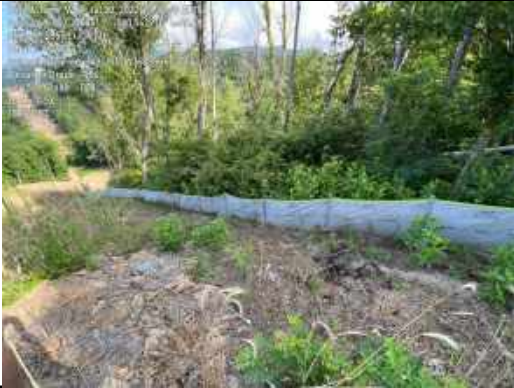
GPS Location	See photo		GPS Location	See photo	
Field Station#	10994+00		Field Station#	10986+25	
Pic 5 Desc.	P1 silt fence perimeter control in place		Pic 6 Desc.	Stream buffer in place

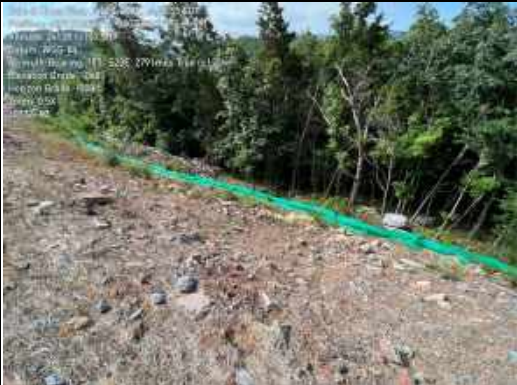
GPS Location	See photo		GPS Location	See photo	
Field Station#	10972+00		Field Station#	10976+75	
Pic 7 Desc.	CFS triple stack perimeter control in place		Pic 8 Desc.	Cleanwater drainage feature in place

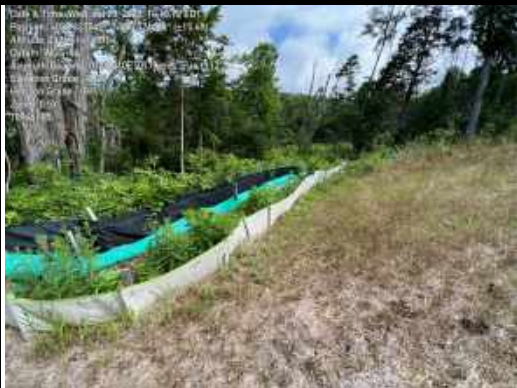
GPS Location	See photo		GPS Location	See photo	
Field Station#	10966+85		Field Station#	10963+25	
Pic 9 Desc.	Triple protection ECDs in place at karst feature		Pic 10 Desc.	Cleanwater diversion outlet protection in place

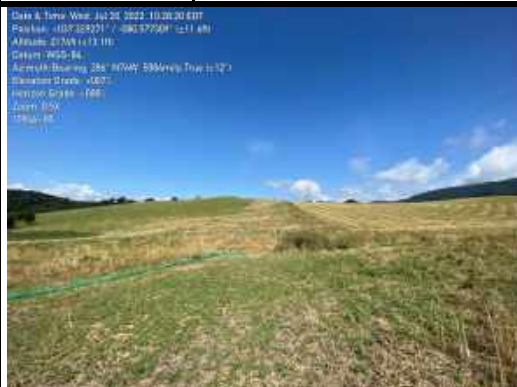
GPS Location	See photo		GPS Location	See photo	
Field Station#	10946+00		Field Station#	10930+40	
Pic 11 Desc.	Permanent vegetation present		Pic 12 Desc.	RCE in place

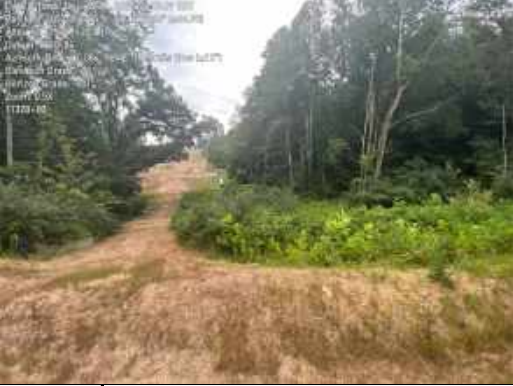
GPS Location	See photo		GPS Location	See photo	
Field Station#	11353+22		Field Station#	11328+00	
Pic 1 Desc.	S-NN11 Stream resource area and well vegetated undisturbed buffer zones		Pic 2 Desc.	S-NN 12 Stream resource area and well vegetated undisturbed buffer zones

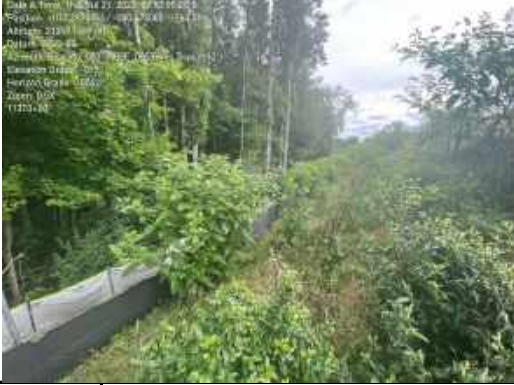
GPS Location	See photo		GPS Location	See photo	
Field Station#	11313+00		Field Station#	11312+00	
Pic 3 Desc.	Perimeter Karst feature controls found functional.		Pic 4 Desc.	Temporary water bar conditions and ongoing water flow from private well. No additional erosion issues at this time.

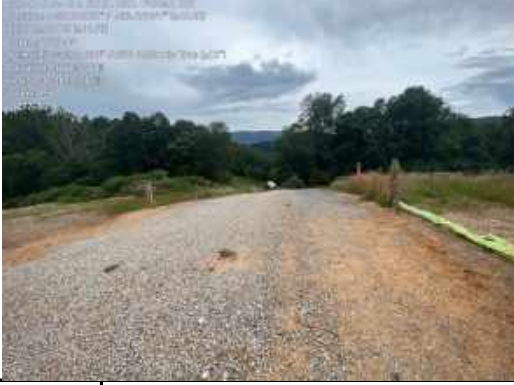
GPS Location	See photo		GPS Location	See photo	
Field Station#	11297+00		Field Station#	11293+66	
Pic 5 Desc.	Seven Oaks access road conditions. No issues at this time.		Pic 6 Desc.	S-MM18 Stream resource area and well vegetated undisturbed buffer zones

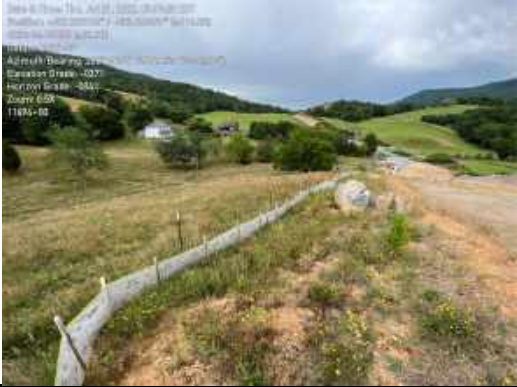
GPS Location	See photo		GPS Location	See photo	
Field Station#	11494+00		Field Station#	11496+00	
Pic 7 Desc.	P1 silt fence perimeter control in place		Pic 8 Desc.	CFS perimeter control in place

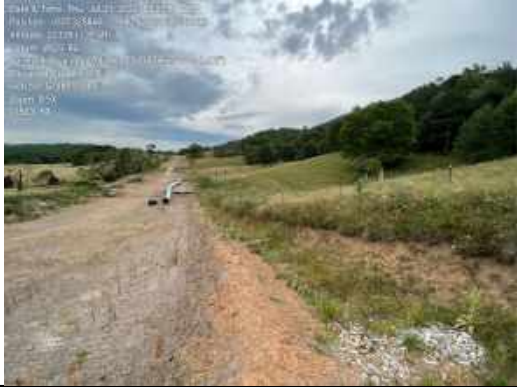
GPS Location	See photo		GPS Location	See photo	
Field Station#	11503+50		Field Station#	11507+50	
Pic 9 Desc.	Cleanwater diversion berm in place		Pic 10 Desc.	Stream buffer in place

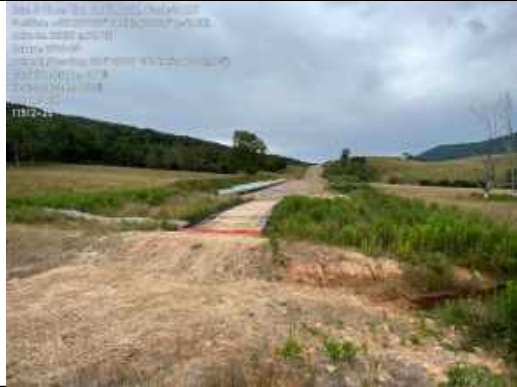
GPS Location	See photo		GPS Location	See photo	
Field Station#	11512+25		Field Station#	11518+75	
Pic 11 Desc.	Cleanwater drainage feature in place		Pic 12 Desc.	Stream buffer in place

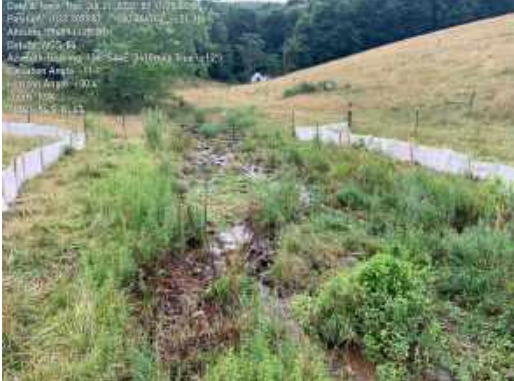
GPS Location	See photo		GPS Location	See photo	
Field Station#	11360+54		Field Station#	11362+00	
Pic 1 Desc.	Section of Row showing conditions and controls at S-KL43		Pic 2 Desc.	Section of Row showing conditions and controls

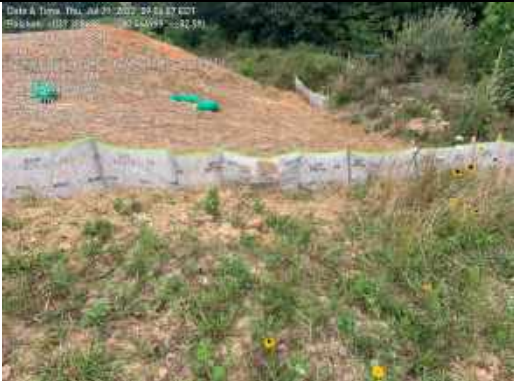
GPS Location	See photo		GPS Location	See photo	
Field Station#	11367+00		Field Station#	11378+00	
Pic 3 Desc.	Damaged P1 due to livestock		Pic 4 Desc.	Section of Row showing conditions and controls

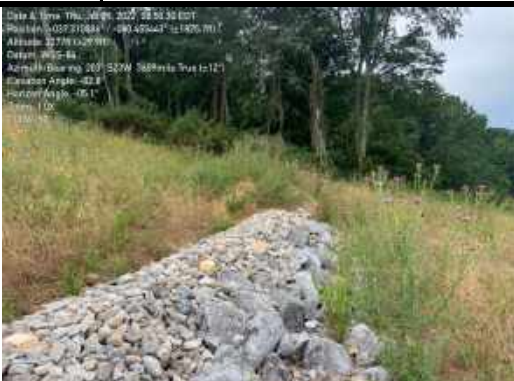
GPS Location	See photo		GPS Location	See photo	
Field Station#	11396+00		Field Station#	11407+00	
Pic 5 Desc.	Representational photo of water bar and level spreader		Pic 6 Desc.	Section of Row showing conditions and controls

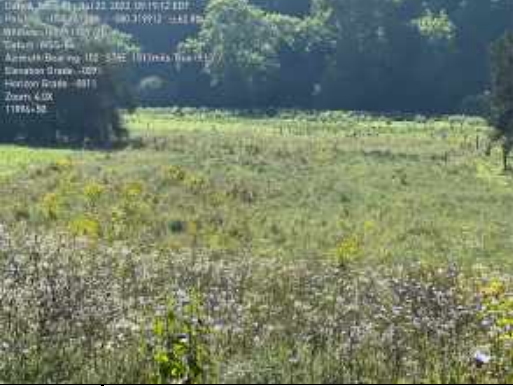
GPS Location	See photo	GPS Location	See photo		
Field Station#	12005+00	Field Station#	11994+50		
Pic 1 Desc.	Final Restoration at the spread break G/H	Pic 2 Desc.	Final Restoration near the spread break./

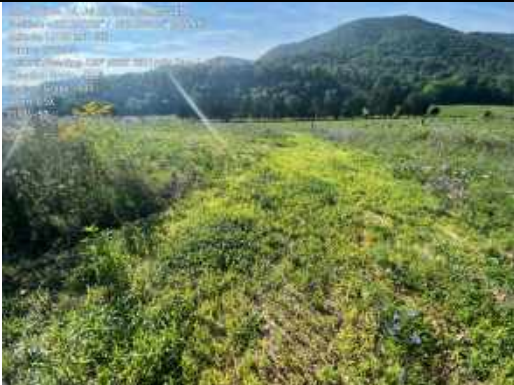
GPS Location	See photo	GPS Location	See photo		
Field Station#	11994+50	Field Station#	11990+50		
Pic 3 Desc.	Recently removed ECDs and re-emerging vegetation.	Pic 4 Desc.	Road crossing at Catawba.

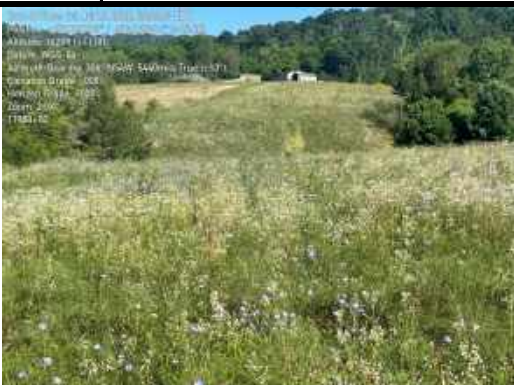
GPS Location	See photo	GPS Location	See photo		
Field Station#	11988+00	Field Station#	11988+00		
Pic 5 Desc.	Permanent vegetation in the final restoration area.	Pic 6 Desc.	Final restoration area upslope from Catawba Rd. ECDs have been removed. Vegetation thriving.

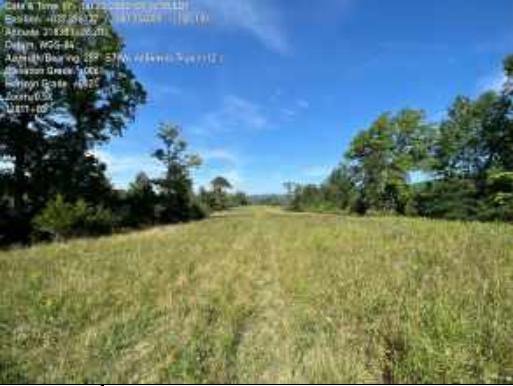
GPS Location	See photo	GPS Location	See photo		
Field Station#	11788+52	Field Station#	11811+00		
Pic 1 Desc.	RCE in place	Pic 2 Desc.	Permanent vegetation present

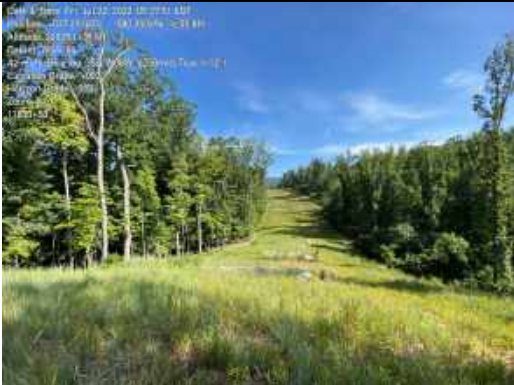
GPS Location	See photo	GPS Location	See photo		
Field Station#	11830+50	Field Station#	11839+00		
Pic 3 Desc.	Permanent waterbars in place	Pic 4 Desc.	Permanent waterbar with level spreader in place

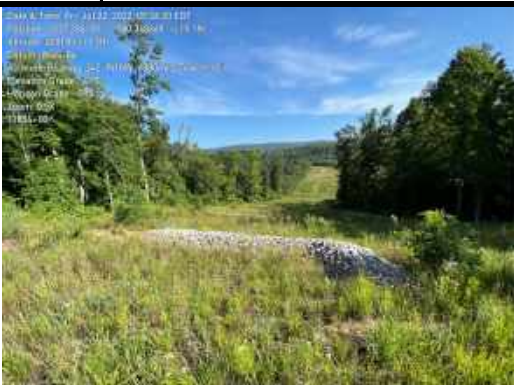
GPS Location	See photo	GPS Location	See photo		
Field Station#	11854+00	Field Station#	11899+89		
Pic 5 Desc.	Level spreaders in place	Pic 6 Desc.	RCE in place

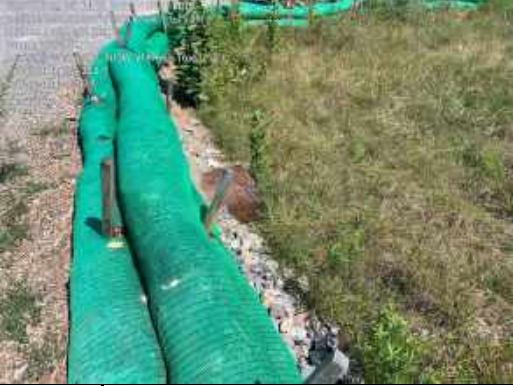
GPS Location	See photo	GPS Location	See photo		
Field Station#	12005+00	Field Station#	12005+00		
Pic 1 Desc.	CFS perimeter controls are in acceptable condition	Pic 2 Desc.	Culvert in place

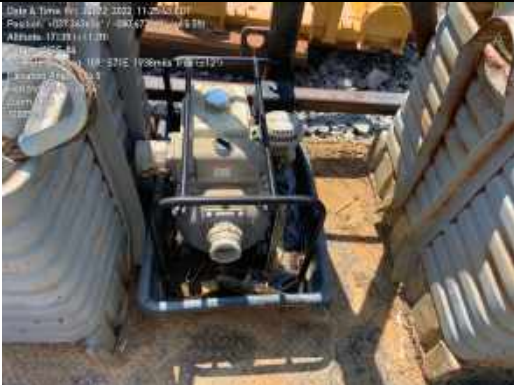
GPS Location	See photo	GPS Location	See photo		
Field Station#	12005+00	Field Station#	12005+00		
Pic 3 Desc.	Secondary containment in place	Pic 4 Desc.	Rock surface of Rce is in acceptable condition

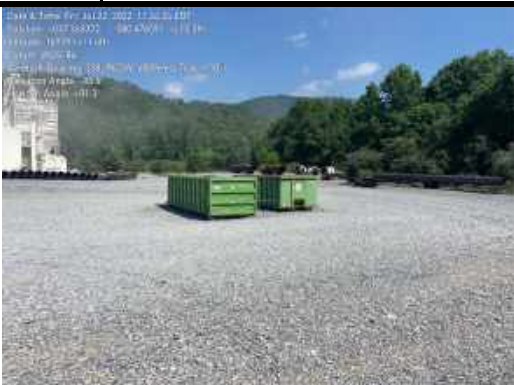
GPS Location	See photo	GPS Location	See photo		
Field Station#	12005+00	Field Station#	12005+00		
Pic 5 Desc.	Dumpsters in place	Pic 6 Desc.	No visible spills or leaks

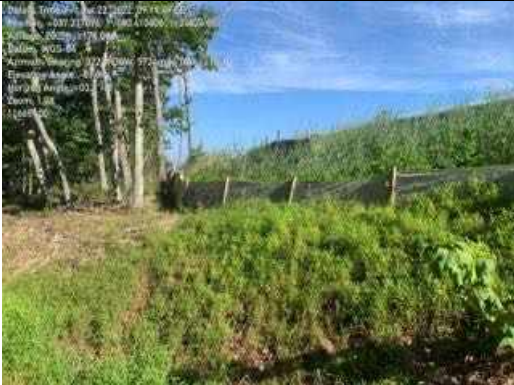
GPS Location	On photo	GPS Location	On photo		
Field Station#	11669+00	Field Station#	11667+00		
Pic 1 Desc.	ECDs are in place at top of Brush Mountain. ROW is stable.		Pic 2 Desc.	ECDs are in place with no sediment migration or erosion from runoff.

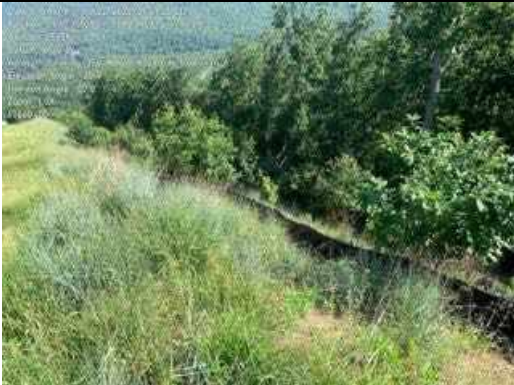
GPS Location	On photo	GPS Location	On photo		
Field Station#	11660+00	Field Station#	11662+00		
Pic 3 Desc.	ROW is stable with ECDs in place.		Pic 4 Desc.	ROW stable. Slope breakers in place and working properly.

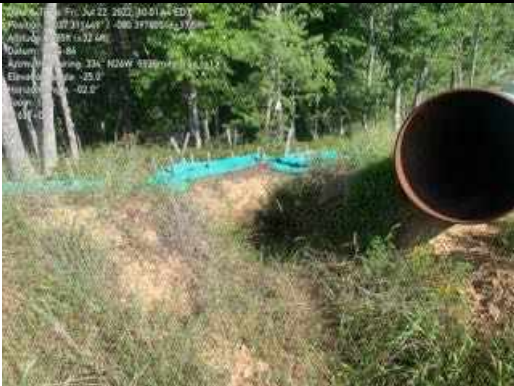
GPS Location	On photo	GPS Location	On photo		
Field Station#	11631+00	Field Station#	11626+04		
Pic 5 Desc.	No erosion resulting from stormwater runoff.		Pic 6 Desc.	The S-HH18 crossing is stable with no impact at resource.

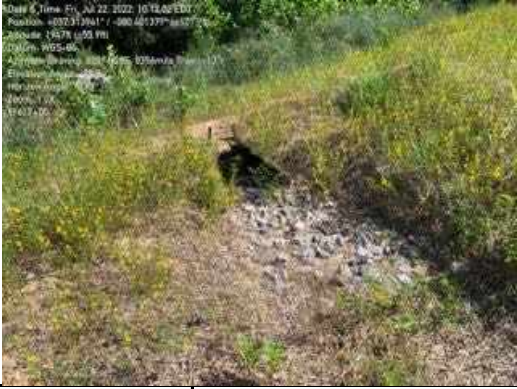
GPS Location	On photo	GPS Location	On photo		
Field Station#	11617+00	Field Station#	11614+20		
Pic 7 Desc.	Slope pipe in place and effective.		Pic 8 Desc.	The S-RR14 crossing is stable with heavy vegetation in buffer.

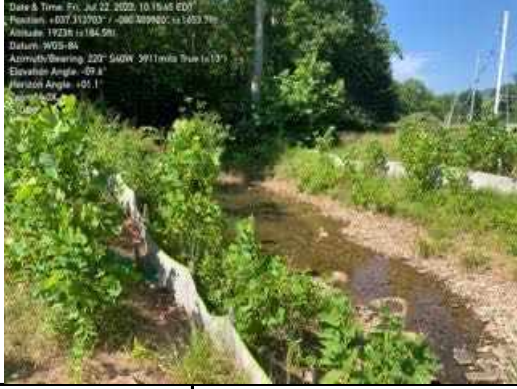
Insert image here	
GPS Location	On photo	GPS Location			
Field Station#	11607+81	Field Station#			
Pic 9 Desc.	The S+006 crossing is stable with no impact apparent.		Pic 10 Desc.		
Insert image here		Insert image here			
GPS Location		GPS Location			
Field Station#		Field Station#			
Pic 11 Desc.		Pic 12 Desc.
