Visual Site Inspection Report

Project Name	H-600 Pipeline Spread H	AFE	124300138	Spread	H-600 Pipeline Spread H
Contractor	Precision			Report #	39667
Inspector	Jordan Davis			Date/Time	7/11/2022 3:00 PM
Permit #	TBD	Inspection Type	VA SWPP	Station Begin	12284+75
State	VA	Inspection Area	Partial	Station End	12443+75
County	Montgomery	Ground	Damp	Temperature (°F)	80.00
Municipality	N/A	Weather	Cloudy	Rain Gauge (in)	0.20
				Rain Accumulation Time (days)	1.00

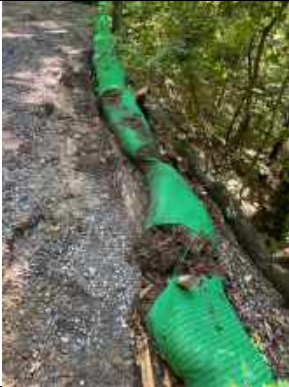
GPS Location	Please see photo for details.		GPS Location	Please see photo for details.	
Field Station#	12284+75		Field Station#	12284+75	
Pic 1 Desc.	Photo shows punch list item of CFS needing to be repaired on MVP-MN-276.03 due to third party damage.		Pic 2 Desc.	Photo shows punch list item resolved of repairing CFS on MVP-MN-276.03 due to third party damage.

E&S BMPs	Compliance Level	Corrective Action	Corrective Time Frame	Date Repaired
Compost Filter Sock	Communication	Repair 3rd party damaged CFS	24 Hours	7/11/2022
Silt Fence (Reinforce Filter Fence)	Communication	Reattach SSF to chain link		7/12/2022
Waterbar End Treatment	Communication	Refresh CFS on waterbar end treatr		7/12/2022
Silt Fence (Filter Fabric Fence)	Communication	Repair detached P1 & sagging P1	24 Hours	7/11/2022
Vegetative Stabilization (Temporary)	Communication	Apply seed & straw mulch to bare ar		7/12/2022
Erosion Control Blanket	Acceptable			
Slope Drain Pipe	Acceptable			
Stone Inlet Protection	Acceptable			
Plunge Pool	Acceptable

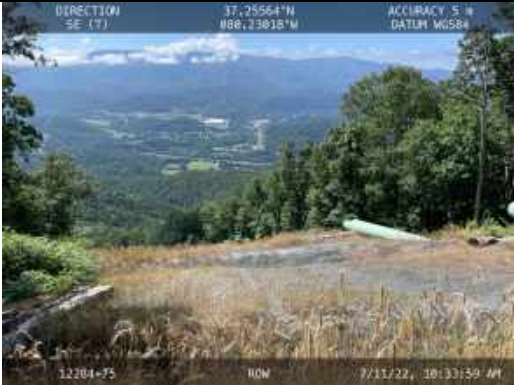
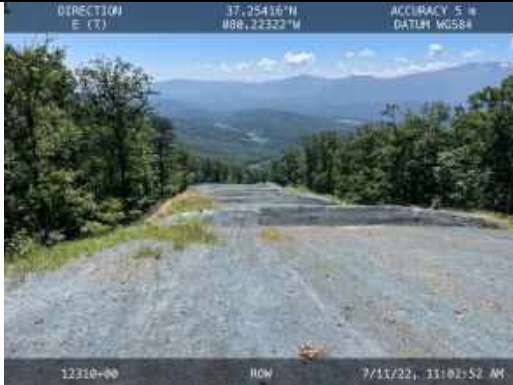
GPS Location	Please see photo for details.		GPS Location	Please see photo for details.	
Field Station#	12284+75		Field Station#	12310+00	
Pic 3 Desc.	Photo shows the stabilized ROW conditions with water bars and that all ECDs are installed and are functioning as designed.		Pic 4 Desc.	Photo shows the stabilized ROW conditions with water bars and that all ECDs are installed and are functioning as designed.

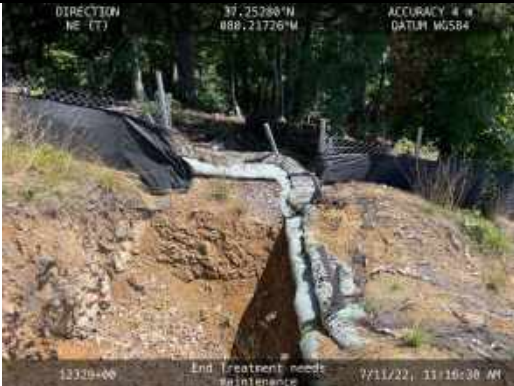
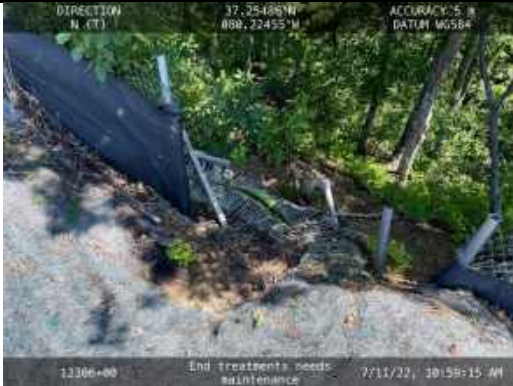
Field Station#	12329+00		Field Station#	12306+00	
Pic 5 Desc.	Photo shows punch list item of CFS on CFS waterbar end treatment needing to be refreshed.		Pic 6 Desc.	Photo shows punch list item of CFS on CFS waterbar end treatment needing to be refreshed.

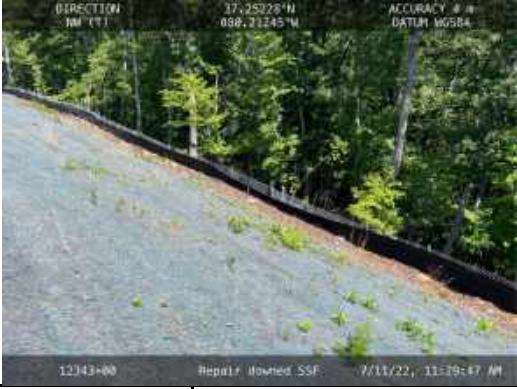
GPS Location	Please see photo for details.		GPS Location	Please see photo for details.	
Field Station#	12343+00		Field Station#	12374+16	
Pic 7 Desc.	Photo shows punch list item of SSF needing to be reattached to chain link.		Pic 8 Desc.	Photo shows view of Stream S-0011 from upstream.

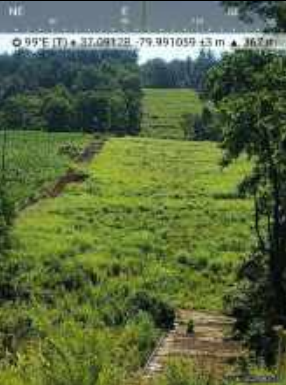
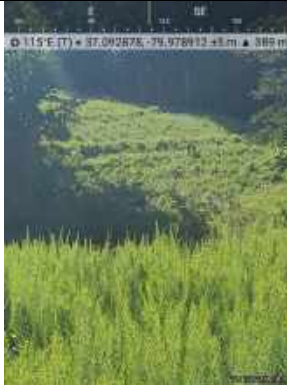
GPS Location	00000	GPS Location	0000		
Field Station#	13542+00	Field Station#	13577+22		
Pic 1 Desc.	Monitored equipment bridge and ECDs at stream crossing. No environmental issues observed at the time of inspection.		Pic 2 Desc.	Vegetation observation photo both sides of stream crossing. No issues were observed at the time of inspection.

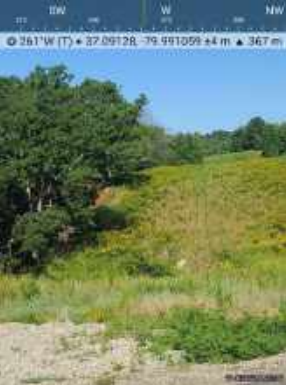
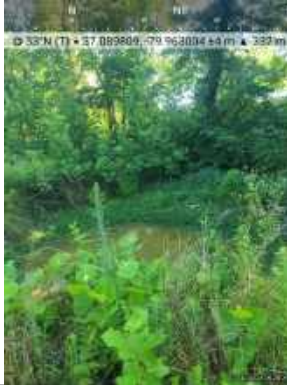
GPS Location	0000	GPS Location	0000		
Field Station#	13541+60	Field Station#	13639+00		
Pic 3 Desc.	Row photo showing RCE and vegetation in permanent area. No environmental issues observed at the time of inspection.		Pic 4 Desc.	Monitored clean water diversion and plunge pool during routine inspection today. No environmental issues observed at the time of inspection.

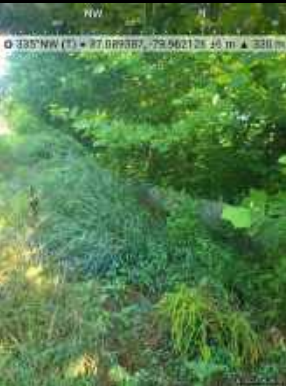
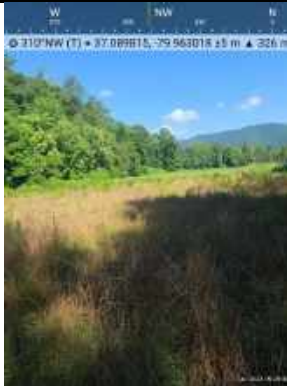
GPS Location	00000	GPS Location	0000		
Field Station#	13643+78	Field Station#	13637+20		
Pic 5 Desc.	Monitored perimeter P1 along adjacent stream. All in place and functioning at the time of inspection.		Pic 6 Desc.	Row photo showing vegetation. No issues observed at the time of inspection.

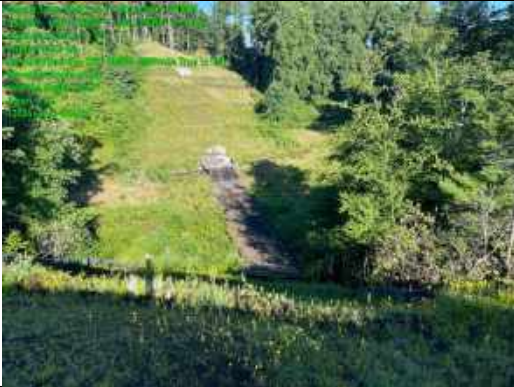
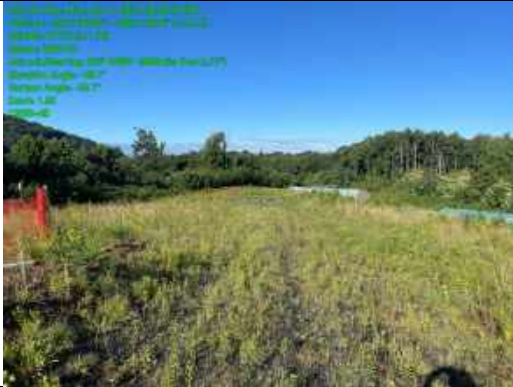
GPS Location	See photo for coordinates.		GPS Location	See photo for coordinates.	
Field Station#	13024+06		Field Station#	13030+00	
Pic 1 Desc.	S-G24, S-G25, and W-ST2, ROW stable, perimeter controls in acceptable condition.		Pic 2 Desc.	ROW stabilized.

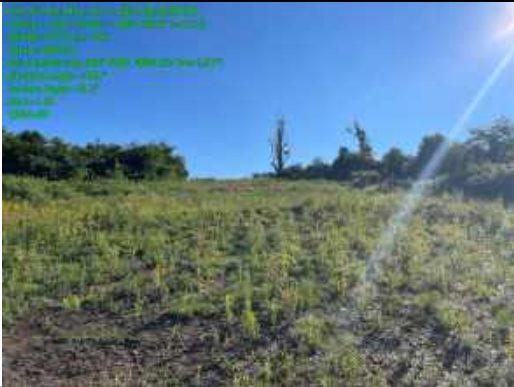
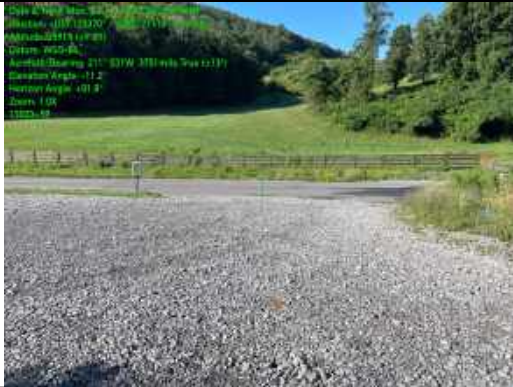
GPS Location	See photo for coordinates.		GPS Location	See photo for coordinates.	
Field Station#	13034+00		Field Station#	13033+59	
Pic 3 Desc.	ROW stabilized.		Pic 4 Desc.	MVP-FR-289 and MVP-FR-290 entrance, RCE in acceptable condition.

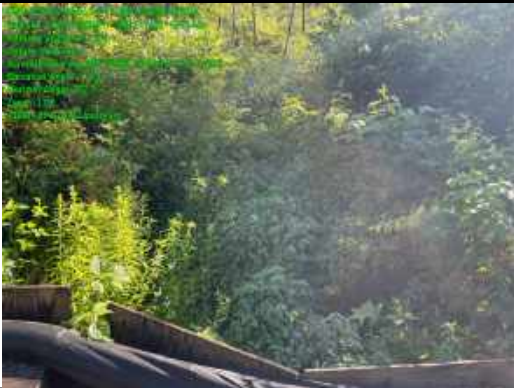
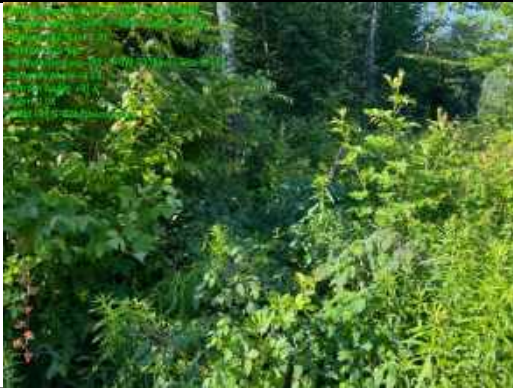
GPS Location	See photo for coordinates.		GPS Location	See photo for coordinates.	
Field Station#	13061+89		Field Station#	13061+89	
Pic 5 Desc.	S-G26, upstream, no impacts observed.		Pic 6 Desc.	S-G26, downstream, no impacts observed.

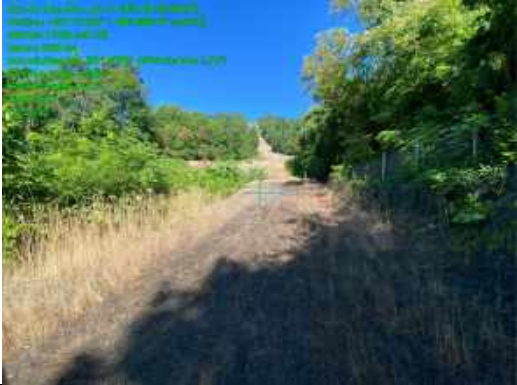
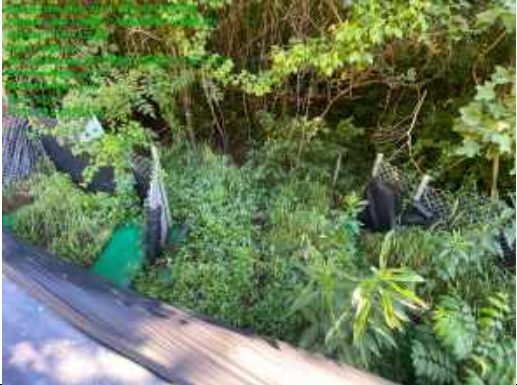
GPS Location	See photo for coordinates.		GPS Location	See photo for coordinates.	
Field Station#	13138+00		Field Station#	13137+78	
Pic 13 Desc.	S-D17/14, ROW stabilized on the coming in and going away sides of the stream crossing.		Pic 14 Desc.	S-D17/14, upstream, flow noted off ROW, standing water observed in stream banks on ROW.

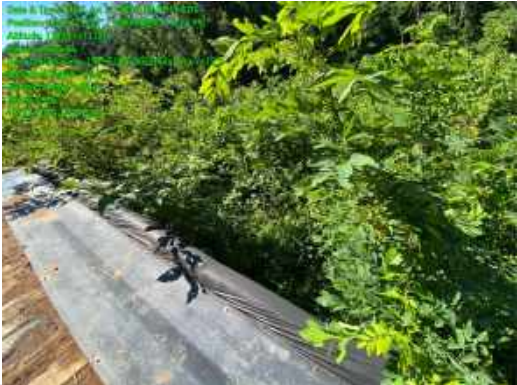
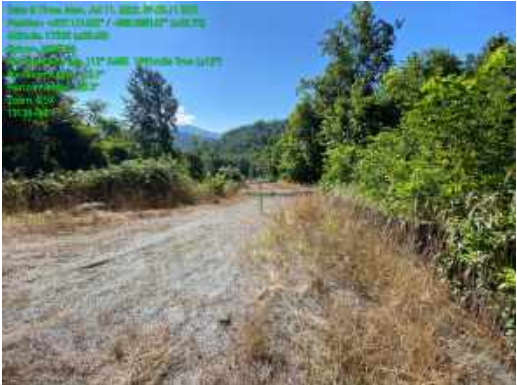
GPS Location	See photo for coordinates.		GPS Location	See photo for coordinates.	
Field Station#	13137+78		Field Station#	13138+50	
Pic 15 Desc.	S-D17/14, downstream, no flow noted.		Pic 16 Desc.	ROW stabilized, perimeter controls in acceptable condition.

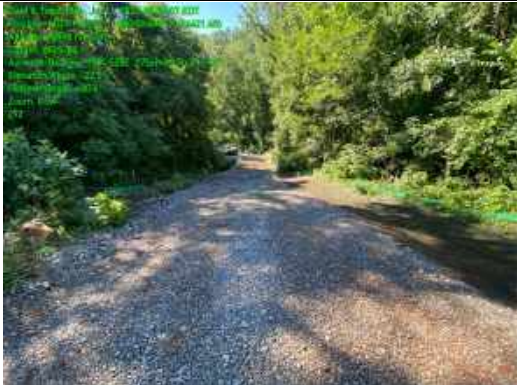
GPS Location	See photo for coordinates.		GPS Location	See photo for coordinates.	
Field Station#	13138+50		Field Station#	13141+53	
Pic 17 Desc.	Habitat log appeared stable and well vegetated.		Pic 18 Desc.	MVP-FR-292, access road in acceptable condition, small amount of sediment accumulation noted on road.

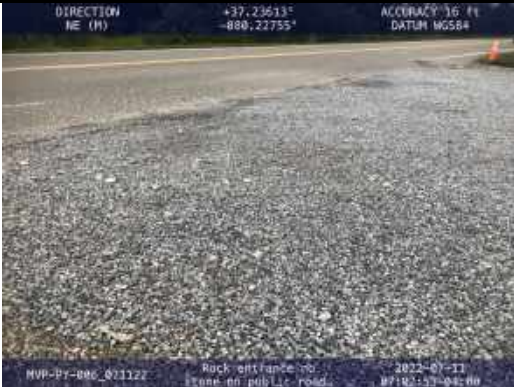
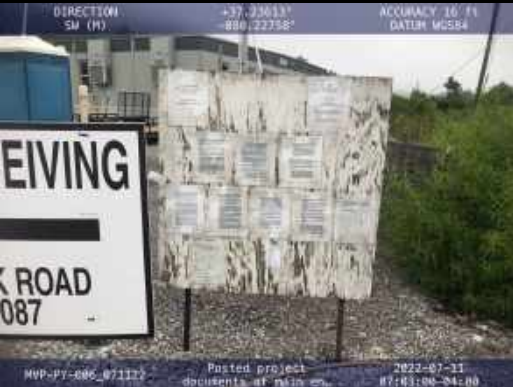
GPS Location	MVP-PY-006 See photo for gps data		GPS Location	MVP-PY-006 See photo for gps data	
Field Station#	+0		Field Station#	+0	
Pic 1 Desc.	Rock entrance no stone on public roadway. Looking NE.		Pic 2 Desc.	Posted project documents at the main north entrance. Looking SW.

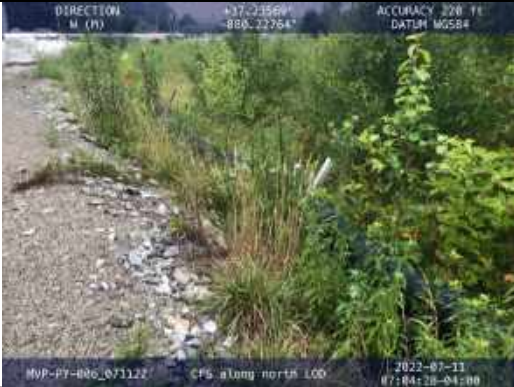
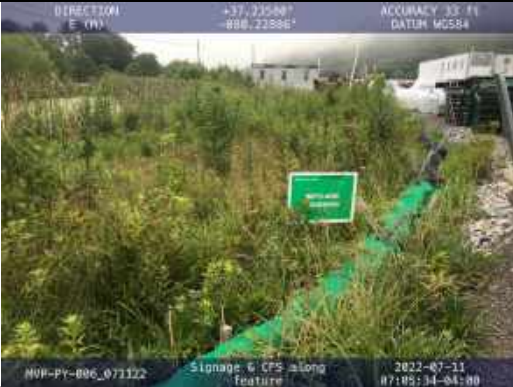
GPS Location	MVP-PY-006 See photo for gps data		GPS Location	MVP-PY-006 See photo for gps data	
Field Station#	+0		Field Station#	+0	
Pic 3 Desc.	Triple stack compost filter sock along north LOD overgrown with vegetation. Looking W.		Pic 4 Desc.	Signage and triple stack compost filter sock at feature W-008 overgrown with vegetation. Looking E.

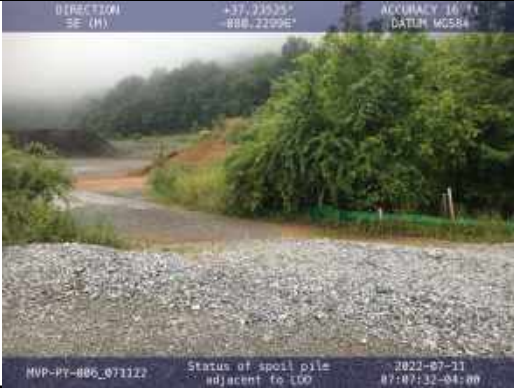
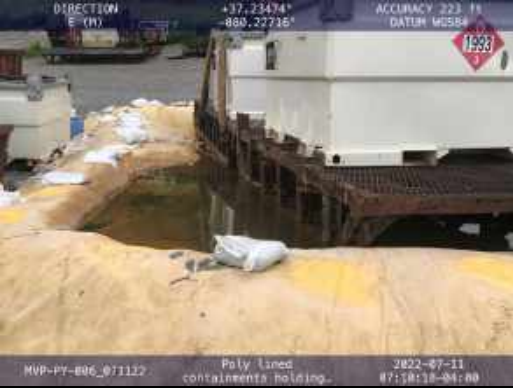
GPS Location	MVP-PY-006 See photo for gps data		GPS Location	MVP-PY-006 See photo for gps data	
Field Station#	+0		Field Station#	+0	
Pic 5 Desc.	Status of spoil pile adjacent to LOD on VDOT property. Soil pile not stabilized. Looking SE.		Pic 6 Desc.	Poly lined rock berm containments holding stormwater. Looking E.

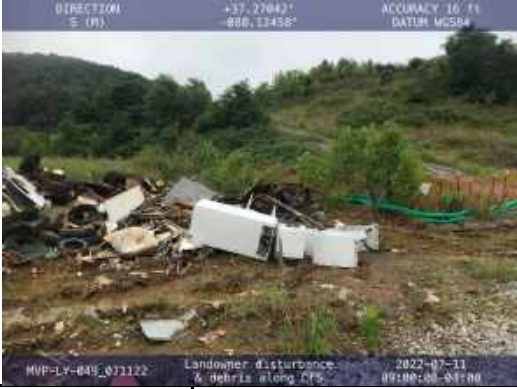
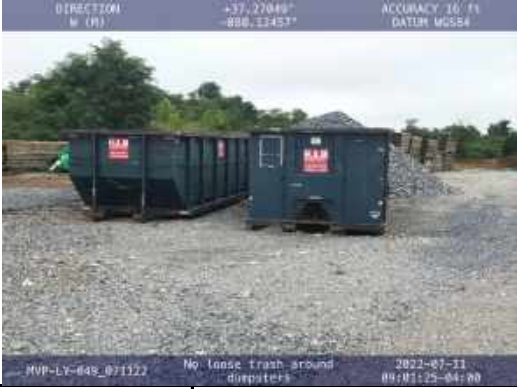
GPS Location	MVP-LY-049 See photo for gps data	GPS Location	MVP-LY-049 See photo for gps data		
Field Station#	+0	Field Station#	+0		
Pic 7 Desc.	Landowner soil disturbance and debris piled along triple stack compost filter sock and east of feature W-CV21B. Looking S.	Pic 8 Desc.	No loose trash around dumpsters or in the yard. Looking W.

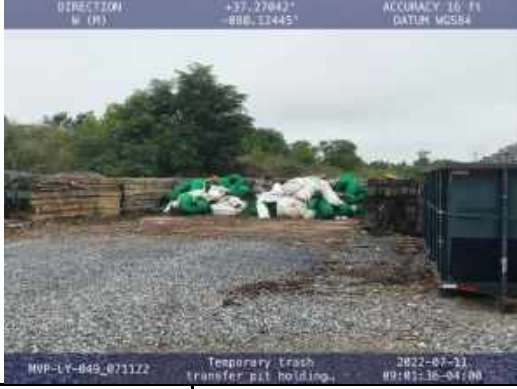
GPS Location	MVP-LY-049 See photo for gps data	GPS Location	MVP-LY-049 See photo for gps data		
Field Station#	+0	Field Station#	+0		
Pic 9 Desc.	Temporary trash transfer pit holding debris. Looking W.	Pic 10 Desc.	No fluids or deposits around hazardous waste dumpsters. Looking E.

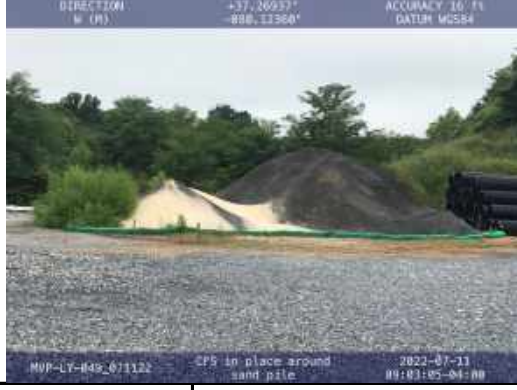
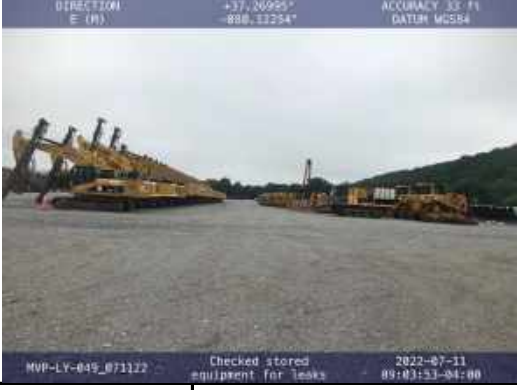
GPS Location	MVP-LY-049 See photo for gps data	GPS Location	MVP-LY-049 See photo for gps data		
Field Station#	+0	Field Station#	+0		
Pic 11 Desc.	Compost filter sock in place and functioning around sand pile. Looking W.	Pic 12 Desc.	Checked stored equipment for new leaks. No new leaks noted. Looking E.

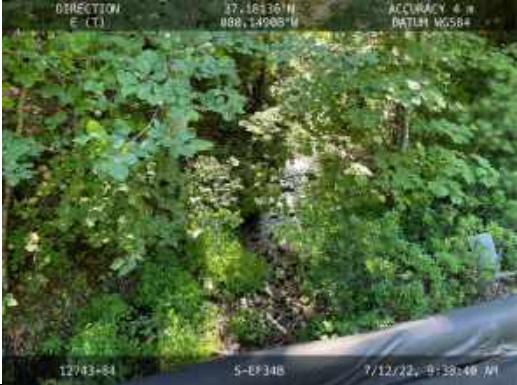
GPS Location	See photo		GPS Location	See photo	
Field Station#	12743+84		Field Station#	12743+84	
Pic 7 Desc.	Upstream of crossing at Stream S-EF34B		Pic 8 Desc.	Downstream of crossing at Stream S-EF34B

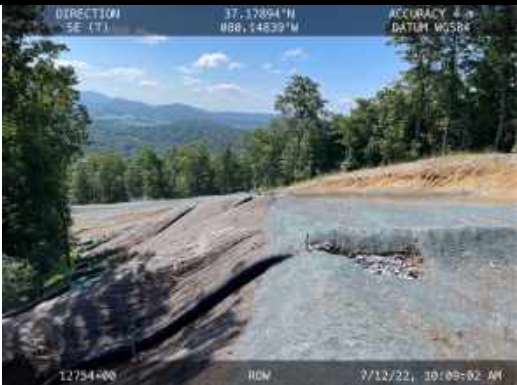
GPS Location	See photo		GPS Location	See photo	
Field Station#	12747+50		Field Station#	12754+00	
Pic 11 Desc.	Current ROW conditions. ROW is stable and ECDs are functional.		Pic 12 Desc.	Current ROW conditions. ROW is stable and ECDs are functional.

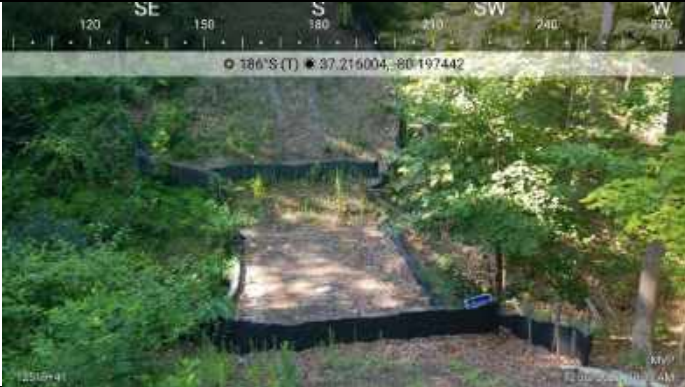
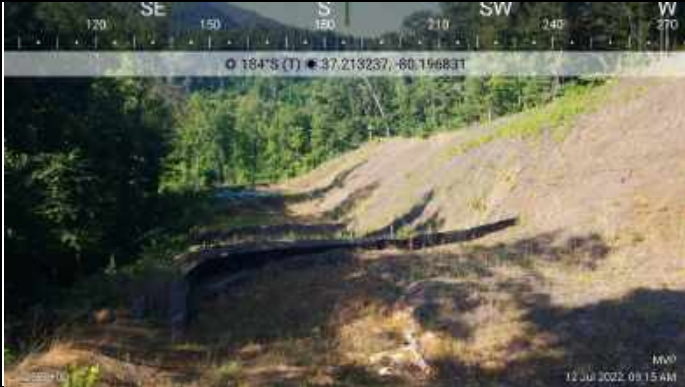
GPS Location	See Above		GPS Location	See Above	
Field Station#	12519+41		Field Station#	12528+00	
Pic 13 Desc.	Overview of Waterbody S-EF19. ECDs are functional and ROW is stable.		Pic 14 Desc.	ROW Overview (temporary stabilization). ECDs are functional and ROW is stable.

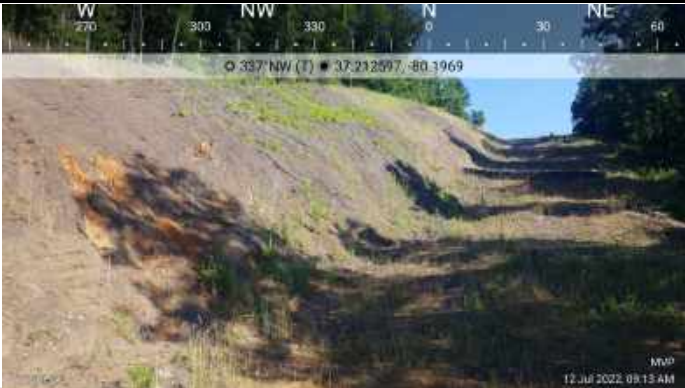
GPS Location	See Above		GPS Location	See Above	
Field Station#	12531+00		Field Station#	12533+00	
Pic 15 Desc.	ROW Overview (temporary stabilization). ECDs are functional and ROW is stable.		Pic 16 Desc.	ROW Overview (temporary stabilization). ECDs are functional and ROW is stable.

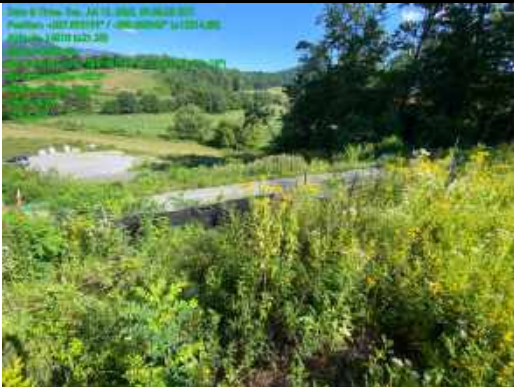
GPS Location	See photo for coordinates.		GPS Location	See photo for coordinates.	
Field Station#	13316+20		Field Station#	13320+00	
Pic 1 Desc.	Private driveway in acceptable condition.		Pic 2 Desc.	S-GH15, perimeter controls in acceptable condition at stream crossing.

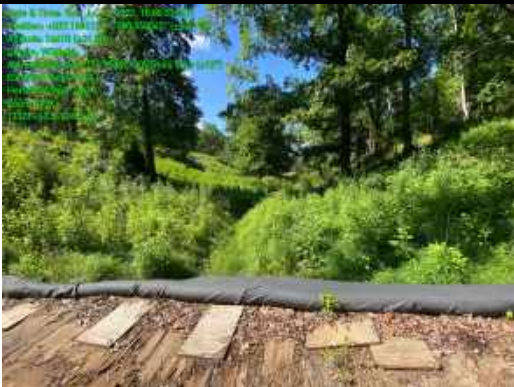
GPS Location	See photo for coordinates.		GPS Location	See photo for coordinates.	
Field Station#	13321+47		Field Station#	13325+20	
Pic 3 Desc.	S-GH15, downstream, no impacts noted.		Pic 4 Desc.	S-GH14, perimeter controls in acceptable condition at stream crossing.

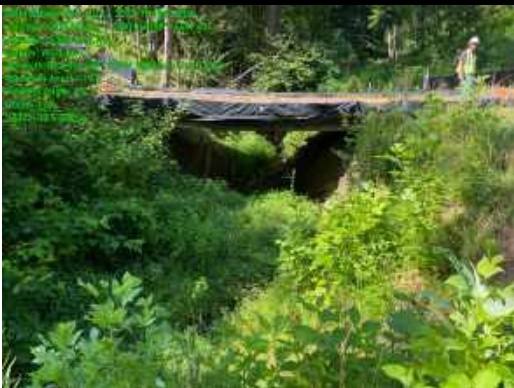
GPS Location	See photo for coordinates.		GPS Location	See photo for coordinates.	
Field Station#	13325+30		Field Station#	13334+17	
Pic 5 Desc.	Upstream of S-GH14, looking downstream, no changes noted.		Pic 6 Desc.	S-GH11, perimeter controls in acceptable condition at stream crossing.

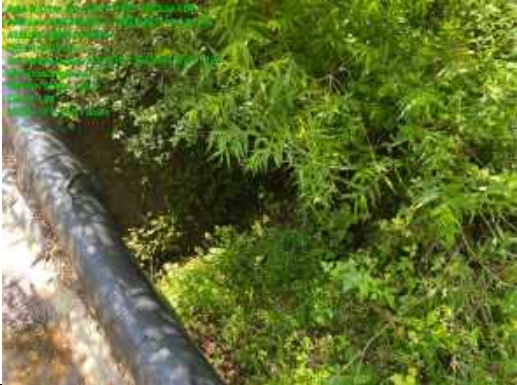
GPS Location	See photo for coordinates.		GPS Location	See photo for coordinates.	
Field Station#	13334+17		Field Station#	13337+13	
Pic 7 Desc.	S-GH11, downstream, no impacts noted.		Pic 8 Desc.	S-GH9, perimeter controls in acceptable condition at stream crossing.

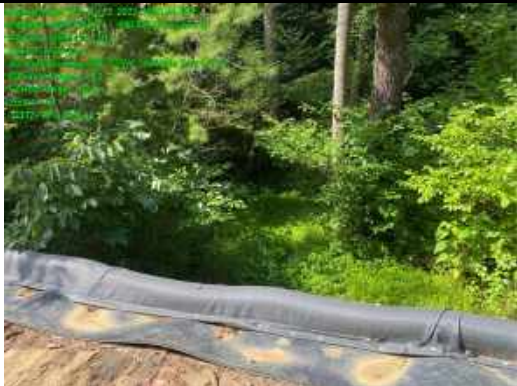
GPS Location	See photo for coordinates.		GPS Location	See photo for coordinates.	
Field Station#	13337+13		Field Station#	13342+73	
Pic 9 Desc.	S-GH9, downstream, no impacts observed.		Pic 10 Desc.	Websters Corner road crossing and rock construction entrances in acceptable.

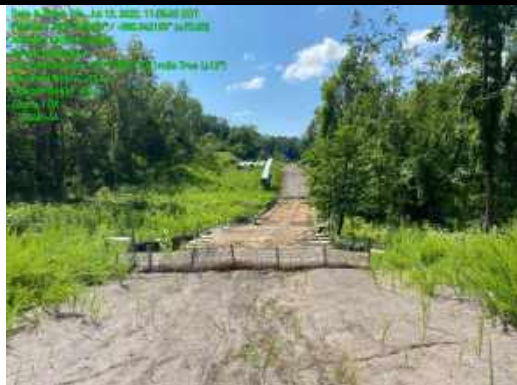
GPS Location	See photo for coordinates.		GPS Location	See photo for coordinates.	
Field Station#	13348+46		Field Station#	13348+46	
Pic 11 Desc.	S-RR08, perimeter controls in acceptable condition along stream crossing.		Pic 12 Desc.	S-RR08, downstream, no impacts noted.

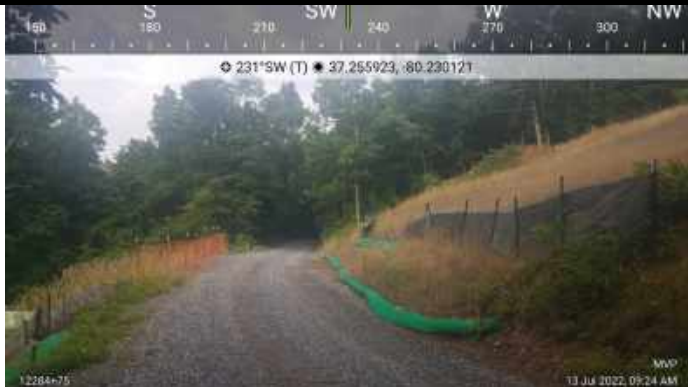
GPS Location	Please see photo for details.		GPS Location	Please see photo for details.	
Field Station#	12284+75		Field Station#	12237+00	
Pic 1 Desc.	Photo shows stabilized ROW conditions with all ECDs installed and functioning as designed along with MVP-MN-276.03.		Pic 2 Desc.	Photo shows stabilized ROW conditions and permanent water bars equipped with level spreaders installed.

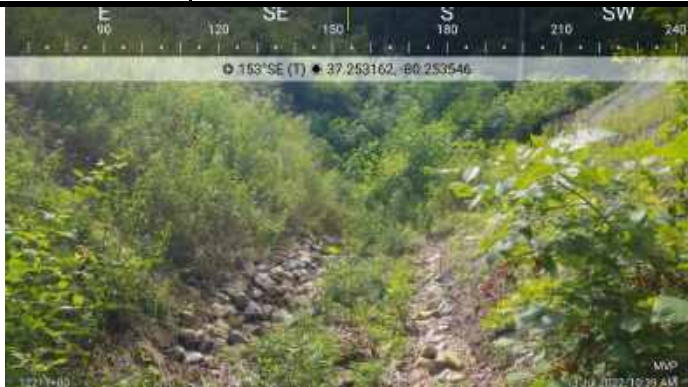
Field Station#	12211+00		Field Station#	12198+64	
Pic 5 Desc.	Photo shows low lying drainage area that runs across the ROW. (Not a resource).		Pic 6 Desc.	Photo shows overview of Stream S-0011.

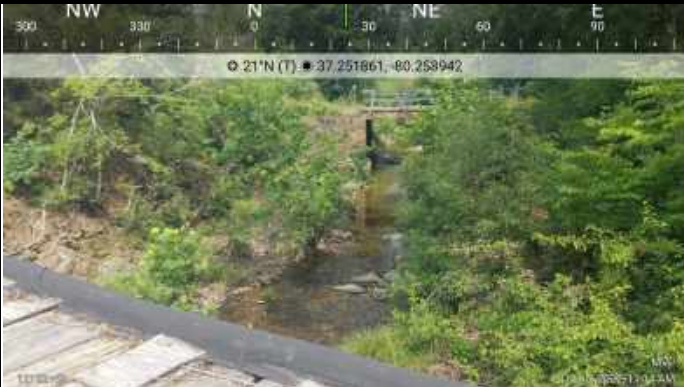
GPS Location	Please see photo for details.		GPS Location	Please see photo for details.	
Field Station#	12192+50		Field Station#	12190+85	
Pic 7 Desc.	Photo shows upstream view of Stream S-C21 from the equipment bridge spanning the stream channel.		Pic 8 Desc.	Photo shows stabilized ROW conditions on the coming in side of ST RTE 629 BRADSHAW ROAD crossing.

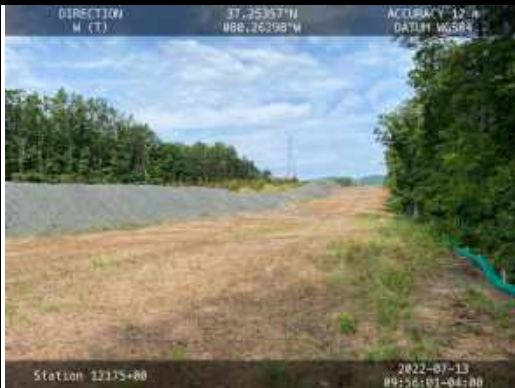
GPS Location	Please see photo for details.		GPS Location	Please see photo for details.	
Field Station#	12175+00		Field Station#	12166+47	
Pic 9 Desc.	Photo shows the stabilized ROW conditions with water bars and that all ECDs are installed and are functioning as designed.		Pic 10 Desc.	Photo shows overview of Stream S-C24 and its buffer zone from the going away side.

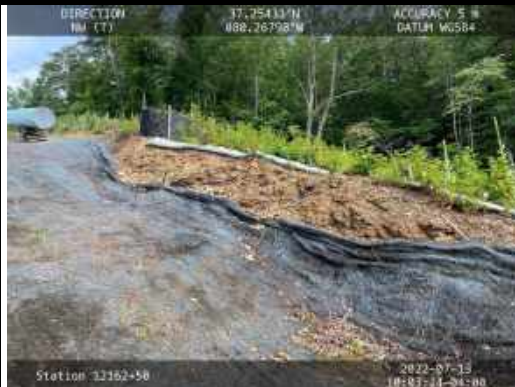
Field Station#	12162+50		Field Station#	12162+43	
Pic 11 Desc.	Photo shows punch list item today of ECB needing to be pulled back into place and repined.		Pic 12 Desc.	Photo shows punch list item of today of ground level hole in SSF fabric needing to be repaired.

E&S BMPs	Compliance Level	Corrective Action	Corrective Time Frame	Date Repaired
Erosion Control Blanket	Communication	Pull back into place and repin		7/13/2022
Silt Fence (Filter Fabric Fence)	Communication	Repair holes in P1 around topsoil		7/13/2022
Silt Fence (Reinforced Filter Fabric Fence)	Communication	Repair ground level holes in SSF		7/13/2022
Sensitive Resource Buffer	Acceptable			
Vegetative Stabilization (Permanent)	Acceptable			
Waterbar	Acceptable			
Slope Drain Pipe	Acceptable			
Stone Inlet Protection	Acceptable			
Plunge Pool	Acceptable

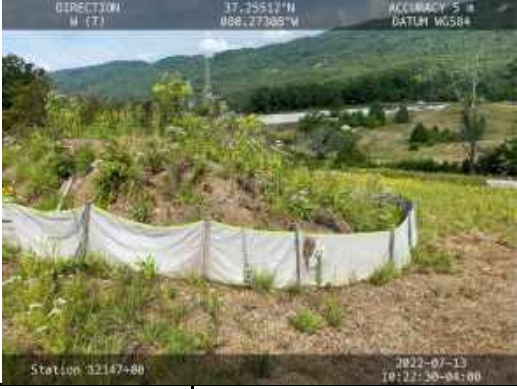
GPS Location	Please see photo for details.		GPS Location	Please see photo for details.	
Field Station#	12147+00		Field Station#	12139+36	
Pic 15 Desc.	Photo shows today's punch list item of holes in P1 silt fence that need to be repaired.		Pic 16 Desc.	Photo shows overview of Wetland W-C6 and its buffer zone from the coming in side.

7. Identify all remedial measures that have been taken since the previous inspection was conducted.					
Two remedial measure was preformed since the last VA DEQ SWPPP inspection. This consisted of repairing CFS along MVP-MN-276.03 due to third party damage and cleaning sediment off of CFS at station 12197+25.					
Comments (Reference above questions as appropriate.)					
<p> Attended the virtual inspection meeting this morning at 6:30am then traveled to MVP-MN-276.03. Here, on this date the VA DEQ SWPPP inspection was done. From station 12284+75 to station 12119+17 the ROW was walked to evaluate that all ECDs are installed and functioning as designed along with the ROW that had been previously disturbed and is now inactive has been properly stabilized with either straw mulch, erosion control blanket or temporary or permanent vegetation. Located within todays assisted section of the SWPPP inspection area are the following resources that were evaluated and observed along with multiple access roads. </p> <p> Stream S-0011 located at station number 12196+24, Stream S-SC-21 located at station number 12192+36, Stream S-C24 located at station number 12166+47, Stream S-C25 located at station number 12163+05, Stream S-C29 located at station number 12133+12, Stream S-MM31 located at station number 12125+65, Stream S-C36 located at station number 12121+83, Stream S-C33 located at station number 12121+33, Wetland W-C5 from station 12143+59 to station 12144+47, Wetland W-C6 from station 12139+36 to station 12139+91, Wetland W-C11 from station 12122+02 to station 12123+23 and Wetland W-C12 from station 12121+29 to station 12122+14. MVP-MN-272 and MVP-MN-273. </p> <p> - All areas observed and evaluated in todays inspection were found to have no environmental issues, no off ROW sediment as well as no stream or wetland impacts. </p> <p> - The ECDs observed today appeared to be installed and functioning as designed. Some of the ECDs are showing some wear but are still functioning. </p> <p> * Three punch list items found during todays VA DEQ SWPPP inspection. They are as follows: (1) Pull ECB back into place and repin from station 12162+50 to station 12162+75. (2) Fix ground level holes in SFF fabric station at 12162+43. (3) Fix holes in P1 silt fence from station from 12146+75 to station 12147+00. All items were resolved. (07/13/2022) </p>

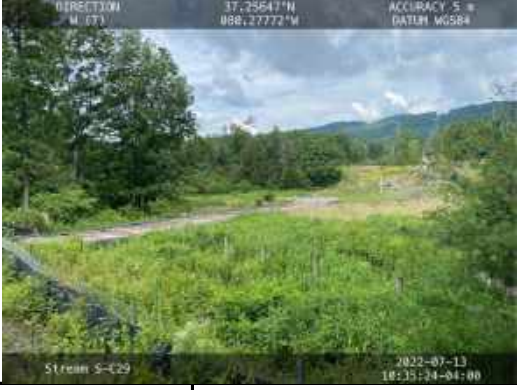
Pic 17 Desc.	Photo shows overview of Stream S-C29 from the upstream side of the ROW along with its buffer zone.		Pic 18 Desc.	Photo shows overview of Wetland W-C11 while standing on the timber mats on the working side of the ROW.

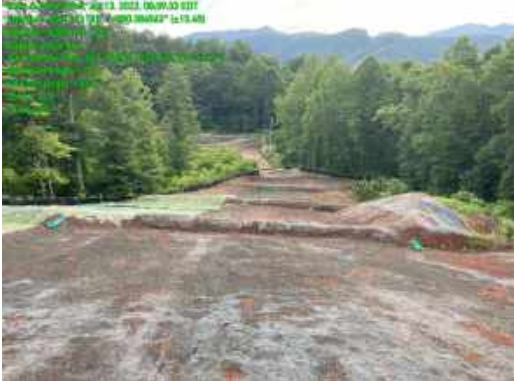
GPS Location	See photo for coordinates.		GPS Location	See photo for coordinates.	
Field Station#	13144+00		Field Station#	13146+56	
Pic 1 Desc.	ROW stabilized.		Pic 2 Desc.	S-D12 and S-D13 stream crossing, perimeter controls in acceptable condition.

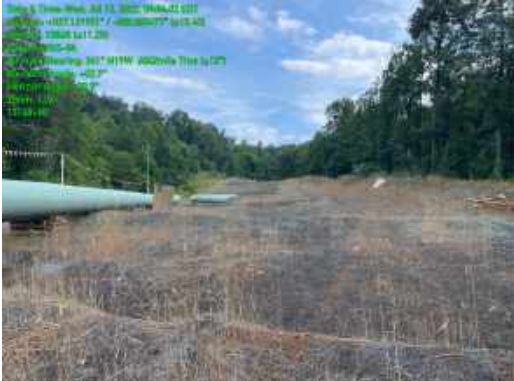
GPS Location	See photo for coordinates.		GPS Location	See photo for coordinates.	
Field Station#	13148+00		Field Station#	13148+00	
Pic 3 Desc.	ROW stabilized.		Pic 4 Desc.	Waterbar, sump, and end treatment functioning acceptably.

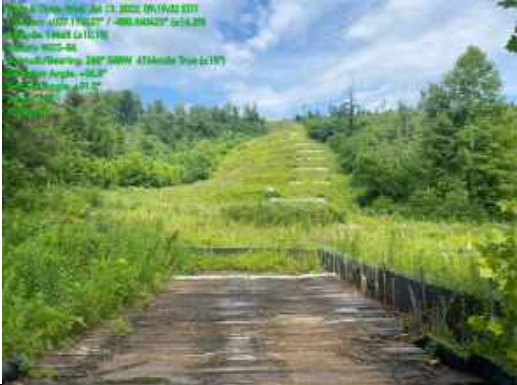
GPS Location	See photo for coordinates.		GPS Location	See photo for coordinates.	
Field Station#	13260+00		Field Station#	13260+60	
Pic 13 Desc.	ROW stabilized on the CIS of S-II4; restored upslope of stabilized area.		Pic 14 Desc.	S-II4, downstream, no ROW impacts noted.

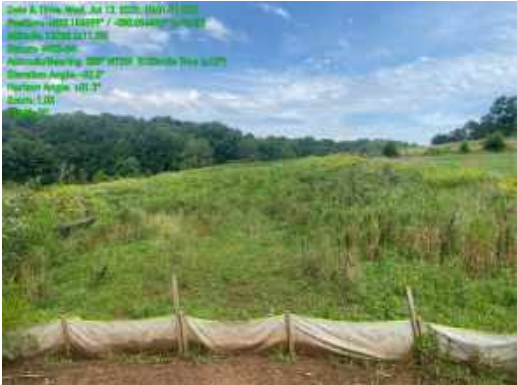
GPS Location	See photo for coordinates.		GPS Location	See photo for coordinates.	
Field Station#	13308+00		Field Station#	13309+09	
Pic 15 Desc.	ROW restored with temporary stabilization measures at stream crossing.		Pic 16 Desc.	S-GH7, downstream, no ROW impacts noted.

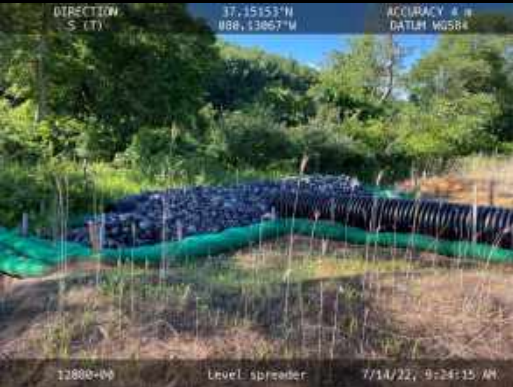
GPS Location	See photo		GPS Location	See photo	
Field Station#	12876+00		Field Station#	12880+00	
Pic 1 Desc.	Sump and End Treatment are functional		Pic 2 Desc.	Level spreader is functional

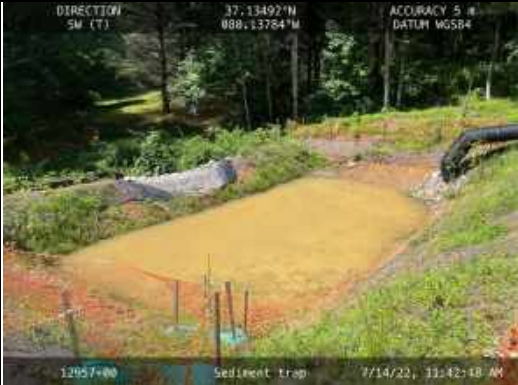
<p>12957+00 Sediment trap 7/14/22, 11:42:18 AM</p>

<p>12974+00 ROW 7/14/22, 12:34:22 PM</p>			
GPS Location	See photo		GPS Location	See photo	
Field Station#	12957+00		Field Station#	12974+00	
Pic 13 Desc.	Sediment trap is functional		Pic 14 Desc.	Current ROW conditions. ROW is stable and ECDs are functional.

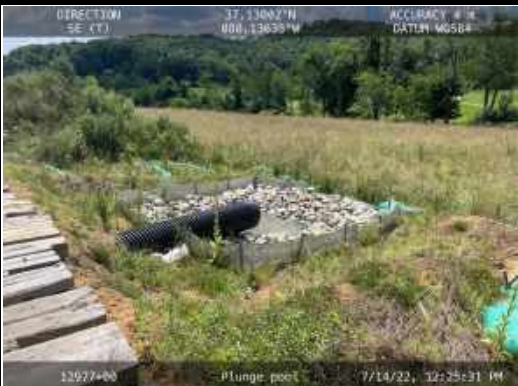
<p>12977+00 Plunge pool 7/14/22, 12:25:31 PM</p>

<p>12995+00 ROW 7/14/22, 12:34:49 PM</p>			
GPS Location	See photo		GPS Location	See photo	
Field Station#	12977+00		Field Station#	12995+00	
Pic 15 Desc.	Plunge pool is functional		Pic 16 Desc.	Current ROW conditions. ROW is stable and ECDs are functional.

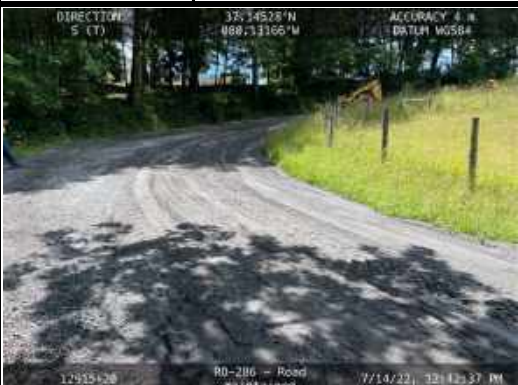
<p>12915+20 RD-210 - Road maintained 7/14/22, 12:42:37 PM</p>

Pic 17 Desc.	Rilling has been raked out and road tracked in		Pic 18 Desc.	CFS Checks have been cleaned out

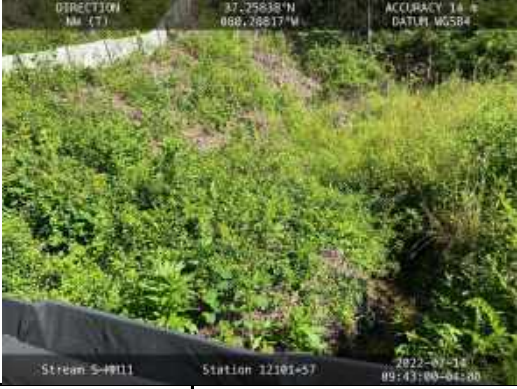
GPS Location	Please see photo for details.		GPS Location	Please see photo for details.	
Field Station#	12101+57		Field Station#	12105+50	
Pic 15 Desc.	Photo shows upstream view of Stream S-MM11 from the equipment bridge spanning the stream channel.		Pic 16 Desc.	Photo shows the stabilized ROW conditions with water bars and that all ECDs are installed and are functioning as designed.

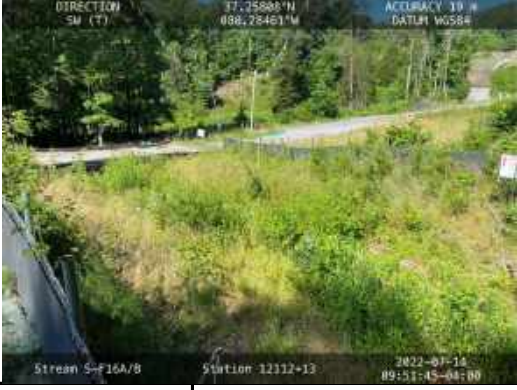
Field Station#	12112+13		Field Station#	12117+00	
Pic 17 Desc.	Photo shows upstream view of Stream S-F16A/B from the going away side while standing at the buffer zone SSF.		Pic 18 Desc.	Photo shows permanent restoration portion of the ROW, where permanent waterbars were installed and equipped with level spreaders.

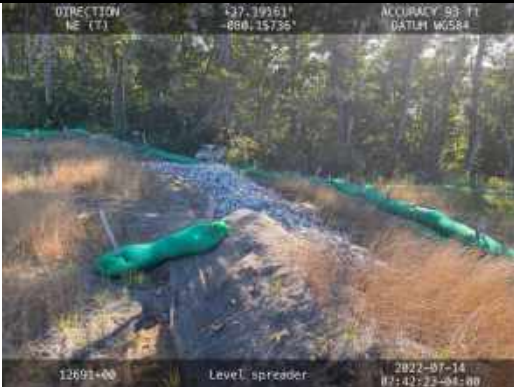
GPS Location	See photo for gps location data.		GPS Location	See photo for gps location data.	
Field Station#	12691+00		Field Station#	12693+00	
Pic 1 Desc.	Photo shows the level spreader.		Pic 2 Desc.	Photo shows the ROW condition. ECDs are See photo for gps location data.

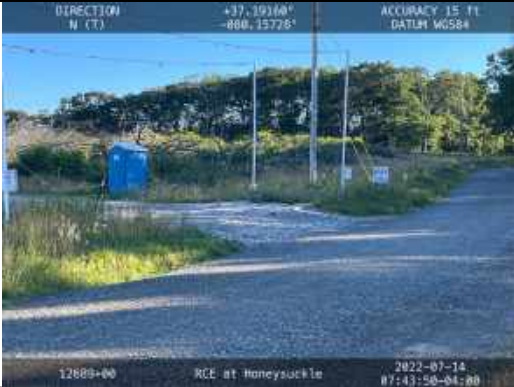
GPS Location	See photo for gps location data.		GPS Location	See photo for gps location data.	
Field Station#	12689+00		Field Station#	12638+00	
Pic 3 Desc.	Photo shows the RCE at Honeysuckle Road.		Pic 4 Desc.	Photo shows the ROW condition. ECDs are See photo for gps location data.

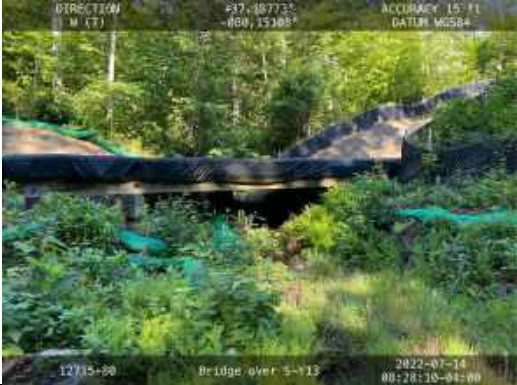
GPS Location	See photo for gps location data.		GPS Location	See photo for gps location data.	
Field Station#	12715+80		Field Station#	12716+20	
Pic 13 Desc.	Photo shows the bridge over stream S-Y13.		Pic 14 Desc.	Photo shows the bridge over stream S-Y14.

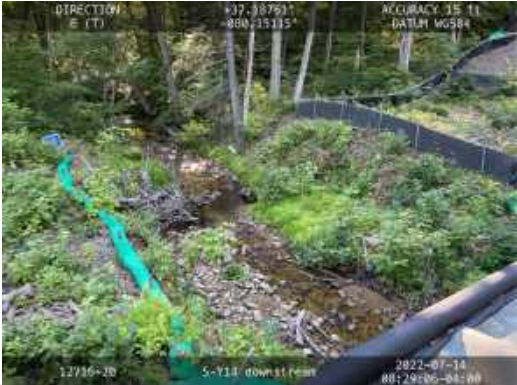
GPS Location	See photo for gps location data.		GPS Location	See photo for gps location data.	
Field Station#	12716+20		Field Station#	12716+50	
Pic 15 Desc.	Photo shows S-Y14 downstream from the bridge.		Pic 16 Desc.	Photo shows the ROW condition. ECDs are See photo for gps location data.

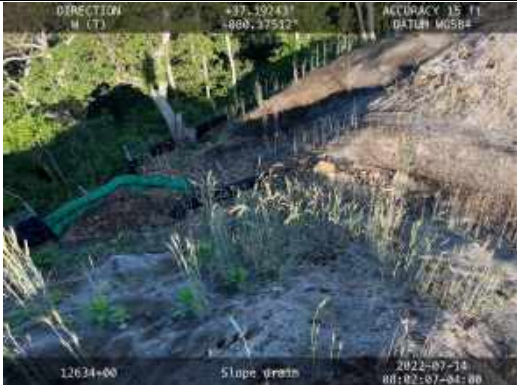
GPS Location	See photo for gps location data.		GPS Location	See photo for gps location data.	
Field Station#	12635+00		Field Station#	12634+00	
Pic 17 Desc.	Photo shows the ROW condition. ECDs are See photo for gps location data.		Pic 18 Desc.	Photo shows the slope drain.

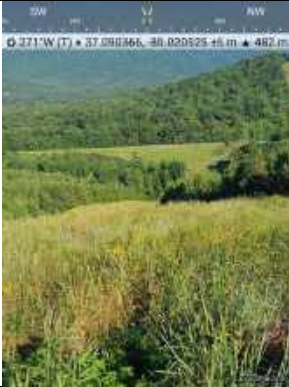
GPS Location	00000	GPS Location	00000		
Field Station#	13436+36	Field Station#	13498+00		
Pic 1 Desc.	Row photo showing vegetation in permanent area of row. No issues observed at the time of inspection.		Pic 2 Desc.	Stream observation photo facing upstream during routine inspection. ECDs in place at the stream crossing. No environmental issues observed at the time of inspection.

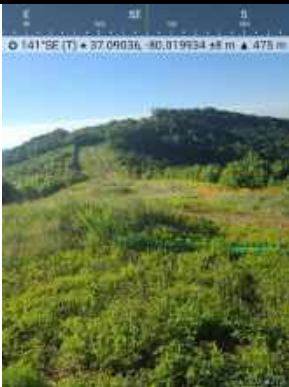
GPS Location	00000	GPS Location	00000		
Field Station#	13439+76	Field Station#	13498+00		
Pic 3 Desc.	Monitored water bars and level spreaders, ECDs in place and functioning at the time of inspection.		Pic 4 Desc.	Stream observation photo facing downstream during routine inspection. No environmental issues observed at the time of inspection.

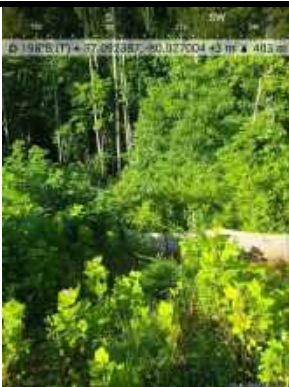
Pic 5 Desc.	Observed ECDs along the row perimeter, good stabilization noted in the area. No environmental issues observed at the time of inspection.		Pic 6 Desc.	Monitored rock lined channel and ECDs at road crossings. No issues were observed at the time of inspection.

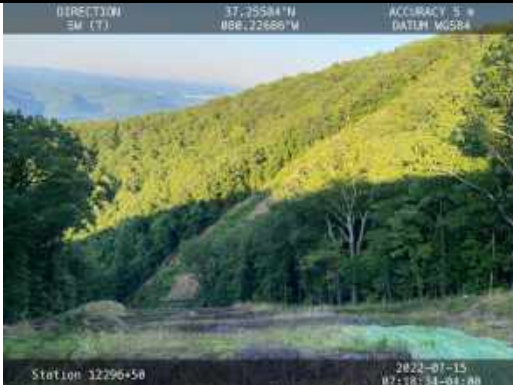
GPS Location	Please see photo for details.		GPS Location	Please see photo for details.	
Field Station#	12296+50		Field Station#	12302+00	
Pic 1 Desc.	Photo shows the stabilized ROW conditions with water bars and that all ECDs are installed and are functioning as designed.		Pic 2 Desc.	Photo shows today's punch list item that consists of a ground level in SSF fabric.

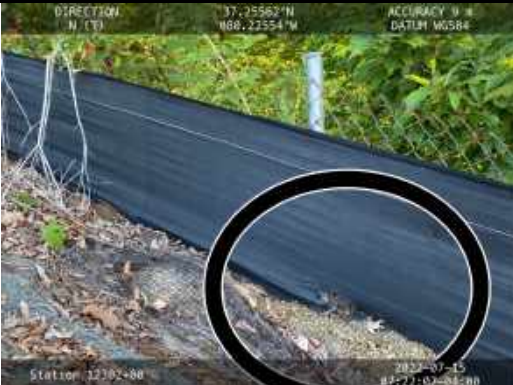
E&S BMPs	Compliance Level	Corrective Action	Corrective Time Frame	Date Repaired
Silt Fence (Reinforced Filter Fabric Fence)	Communication	Fix ground level hole in SSF fabric	24 Hours	7/15/2022
Cleanwater Diversion Berm	Acceptable			
Silt Fence (Filter Fabric Fence)	Acceptable			
Slope Drain Pipe	Acceptable			
Stone Inlet Protection	Acceptable			
Plunge Pool	Acceptable			
Waterbar	Acceptable			
Sump Pit	Acceptable			
Sensitive Resource Buffer	Acceptable

7. Identify all remedial measures that have been taken since the previous inspection was conducted. During today's VA DEQ SWPPP inspection total of (6) remedial measures from past punch list items were found to be completed as the ROW was observed and evaluated. These items consisted of the following: (1) Repair CFS in MVP-MN-276.03 due to third party damage. (2) Refresh CFS on CFS water end treatment at station 12306+00. (3) Refresh CFS on CFS water end treatment at station 12329+00. (4) Reattach SSF to chain link at station 12343+00. (5) Reattach P1 fabric to stake that is no longer attached / tighten another sagging panel of P1 at 12392+00. (6) Apply seed and straw mulch on bare area of the ROW to be in compliance with temporary stabilization at station 12438+00 to station 12438+50.					
Comments (Reference above questions as appropriate.) Attended morning virtual conference call for inspection at 6:30am then traveled to MVP-MN-276.03. Here, the VA DEQ SWPPP inspection was performed on this date. From station 12284+75 to station 12443+75 the ROW was walked to evaluate that all ECDs are installed and functioning as designed along with the ROW that had been previously disturbed and is now inactive has been properly stabilized with either straw mulch, erosion control blanket or temporary or permanent vegetation. In which appeared to be adequate. - Final result of all areas observed and evaluated in today's inspection were found to be in compliance and have no environmental issues, no off ROW sediment as well as no stream or wetland impacts. - The ECDs observed today appeared to be installed and functioning as designed. Some of the ECDs are showing some wear but are still functioning. - Located within today's SWPPP inspection area are the following resources and other access roads that were evaluated and observed. Stream S-0016 located at station 12374+16 - Stream S-NN19 located at 12380+04 - Stream S-NN16 located at station 12435+16. Wetland W-NN8 located from station 12434+55 to station 12435+46. MVP-MN-276.03 - MVP-MN-277.0 * A total of (1) punch list item was found during today's VA DEQ SWPPP inspection. (1) Repair ground level hole in SSF fabric at station 12302+00. (Resolved 07/15/2022).

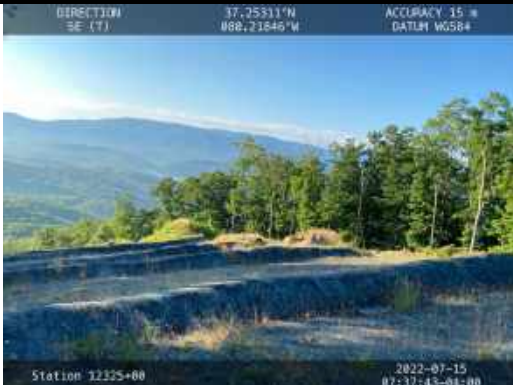
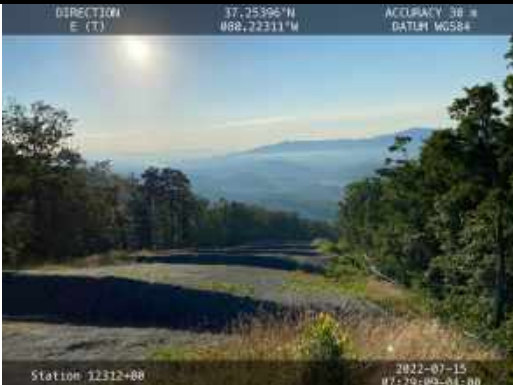
GPS Location	Please see photo for details.		GPS Location	Please see photo for details.	
Field Station#	12325+00		Field Station#	12312+00	
Pic 3 Desc.	Photo shows the stabilized ROW conditions with water bars and that all ECDs are installed and are functioning as designed.		Pic 4 Desc.	Photo shows the stabilized ROW conditions with water bars and that all ECDs are installed and are functioning as designed.

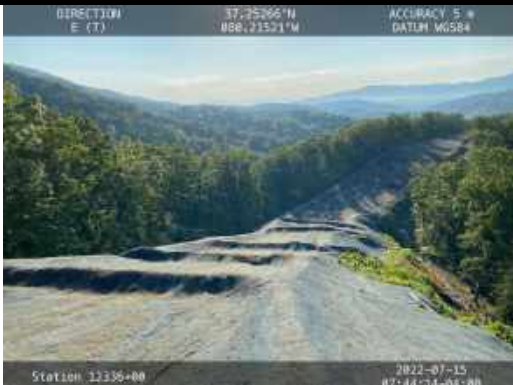
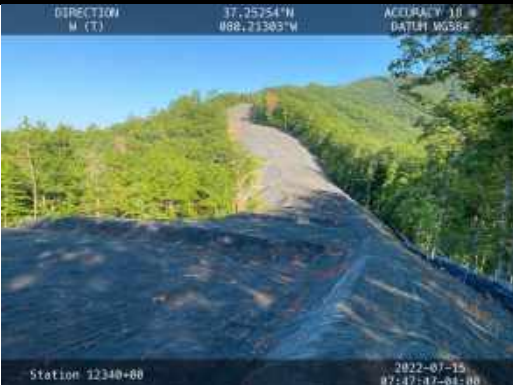
Field Station#	12336+00		Field Station#	12340+00	
Pic 5 Desc.	Photo shows the stabilized ROW conditions with water bars and that all ECDs are installed and are functioning as designed.		Pic 6 Desc.	Photo shows the stabilized ROW conditions with water bars and that all ECDs are installed and are functioning as designed.

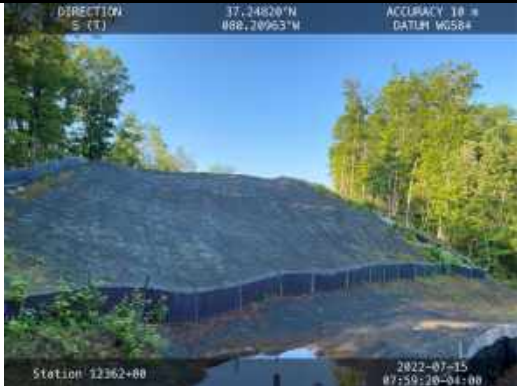
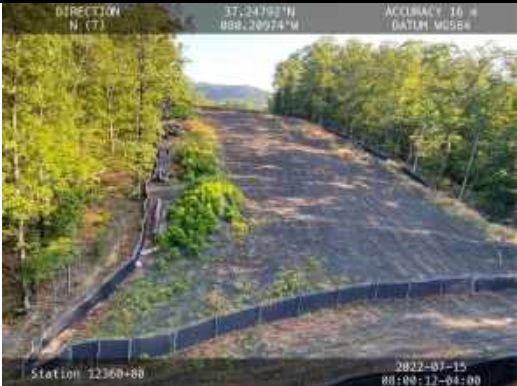
GPS Location	Please see photo for details.		GPS Location	Please see photo for details.	
Field Station#	12362+00		Field Station#	12360+00	
Pic 9 Desc.	Photo shows the stabilized ROW conditions with water bars and that all ECDs are installed and are functioning as designed.		Pic 10 Desc.	Photo shows the stabilized ROW conditions with water bars and that all ECDs are installed and are functioning as designed.

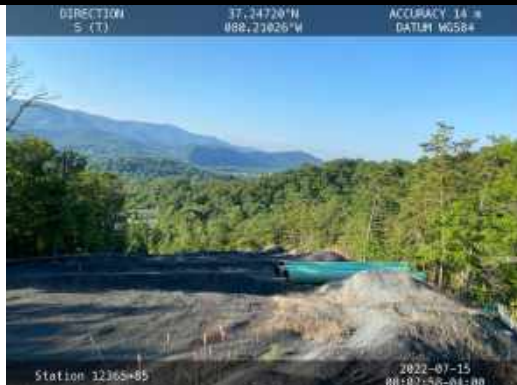
GPS Location	Please see photo for details.		GPS Location	Please see photo for details.	
Field Station#	12365+85		Field Station#	12368+00	
Pic 11 Desc.	Photo shows the stabilized ROW conditions with water bars and that all ECDs are installed and are functioning as designed.		Pic 12 Desc.	Photo shows the stabilized ROW conditions with water bars and that all ECDs are installed and are functioning as designed.

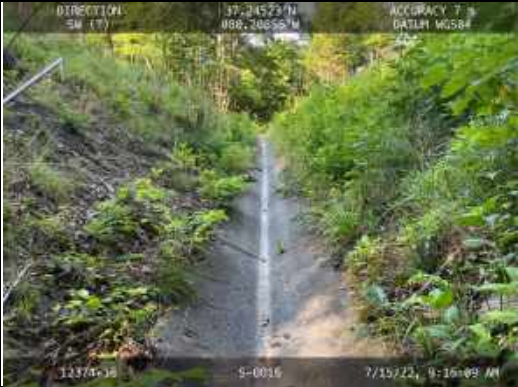
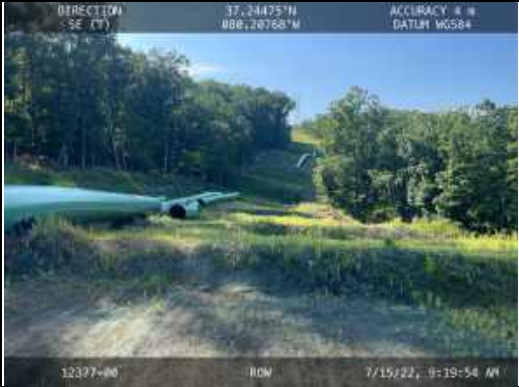
GPS Location	Please see photo for details.		GPS Location	Please see photo for details.	
Field Station#	12347+16		Field Station#	12377+00	
Pic 13 Desc.	Photo shows upstream view of Stream S-0011 standing on the upstream side.		Pic 14 Desc.	Photo shows the stabilized ROW conditions with water bars and that all ECDs are installed and are functioning as designed.
