Visual Site Inspection Report

Project Name	H-600 Pipeline Spread H	AFE	124300138	Spread	H-600 Pipeline Spread H
Contractor	Precision			Report #	39667
Inspector	Jordan Davis			Date/Time	7/11/2022 3:00 PM
Permit #	TBD	Inspection Type	VA SWPP	Station Begin	12284+75
State	VA	Inspection Area	Partial	Station End	12443+75
County	Montgomery	Ground	Damp	Temperature (°F)	80.00
Municipality	N/A	Weather	Cloudy	Rain Gauge (in)	0.20
				Rain Accumulation Time (days)	1.00

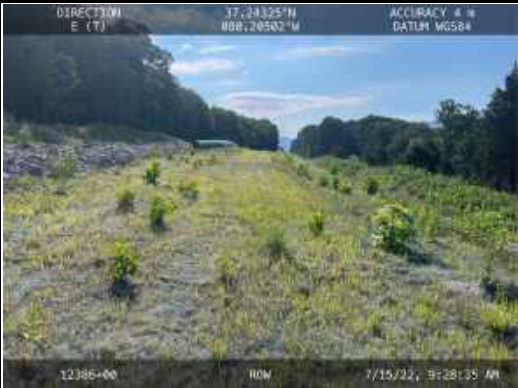
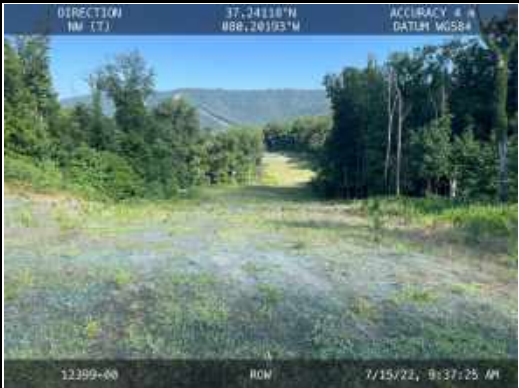
GPS Location	Please see photo for details.		GPS Location	Please see photo for details.	
Field Station#	12386+00		Field Station#	12399+00	
Pic 15 Desc.	Photo shows the stabilized ROW conditions with water bars and that all ECDs are installed and are functioning as designed.		Pic 16 Desc.	Photo shows the stabilized ROW conditions with water bars and that all ECDs are installed and are functioning as designed.

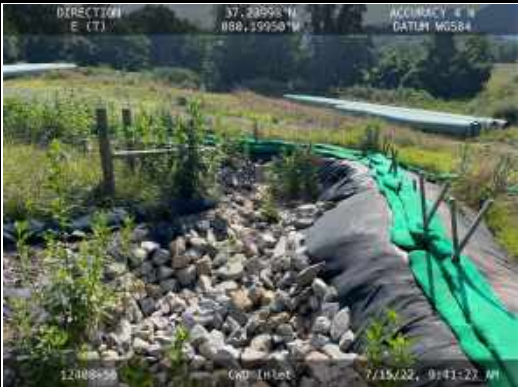
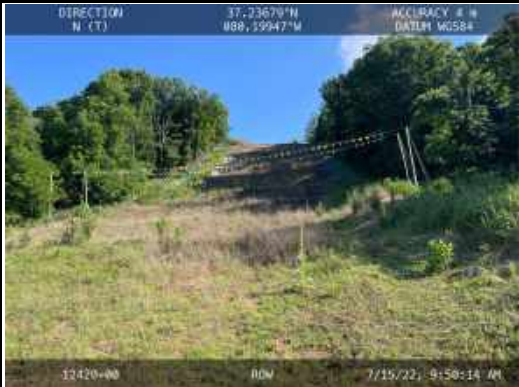
Field Station#	12408+50		Field Station#	12420+00	
Pic 17 Desc.	Photo shows clean water diversion inlet with stone inlet protection.		Pic 18 Desc.	Photo shows the stabilized ROW conditions with water bars and that all ECDs are installed and are functioning as designed.

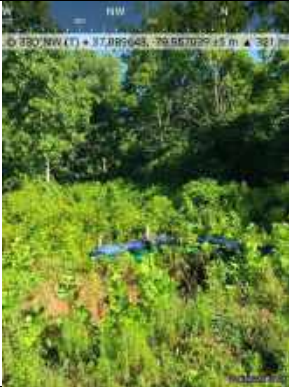
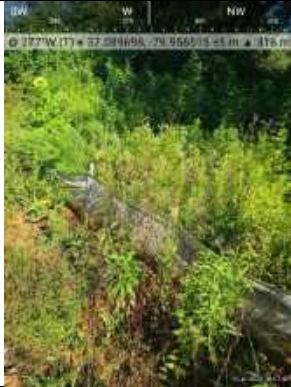
GPS Location	0000	GPS Location	0000		
Field Station#	13656+00	Field Station#	13657+80		
Pic 1 Desc.	Monitored sump pit and end treatment throughout the inspection area. No issues were observed at the time of inspection.		Pic 2 Desc.	Monitored ECDs along the perimeter of row. All in place and functioning at the time of inspection.

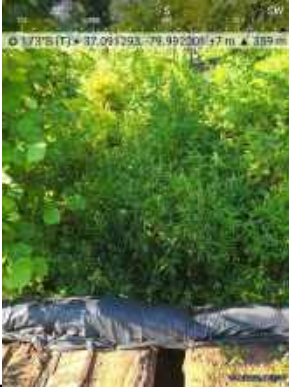
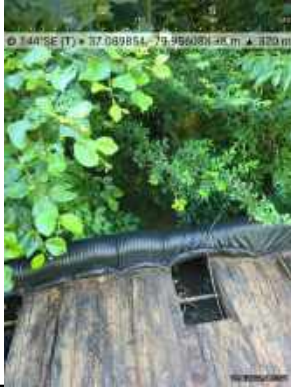
GPS Location	0000	GPS Location	00000		
Field Station#	13539+53	Field Station#	13659+04		
Pic 3 Desc.	Stream observation photo facing downstream during routine inspection. No environmental issues observed at the time of inspection.		Pic 4 Desc.	Stream observation photo facing downstream during routine inspection today. No issues were observed at the time of inspection.

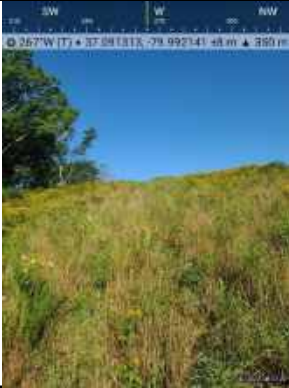
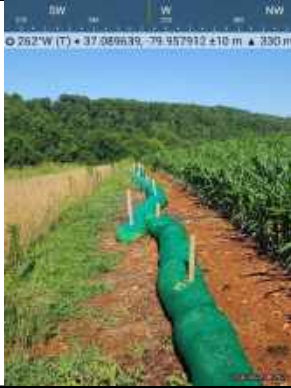
GPS Location	0000	GPS Location	0000		
Field Station#	13539+00	Field Station#	13650+00		
Pic 5 Desc.	Row photo showing vegetation in a permanent area. No issues were observed at the time of inspection.		Pic 6 Desc.	Monitored perimeter CFS along the row. All in place and functioning at the time of inspection.

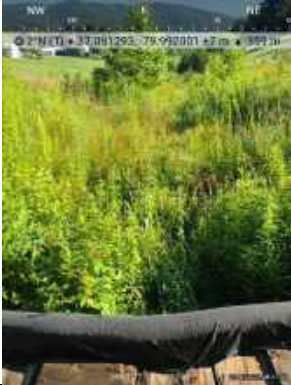
<p>Insert image here</p>		<p>Insert image here</p>	
GPS Location	0000	GPS Location	0000		
Field Station#	13539+04	Field Station#			
Pic 7 Desc.	Stream observation photo facing upstream during routine inspection. No environmental issues observed at the time of inspection.		Pic 8 Desc.		
<p>Insert image here</p>		<p>Insert image here</p>			
GPS Location		GPS Location			
Field Station#		Field Station#			
Pic 9 Desc.			Pic 10 Desc.		
<p>Insert image here</p>		<p>Insert image here</p>			
GPS Location		GPS Location			
Field Station#		Field Station#			
Pic 11 Desc.			Pic 12 Desc.

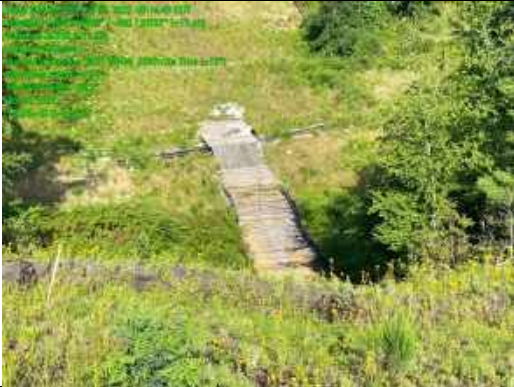
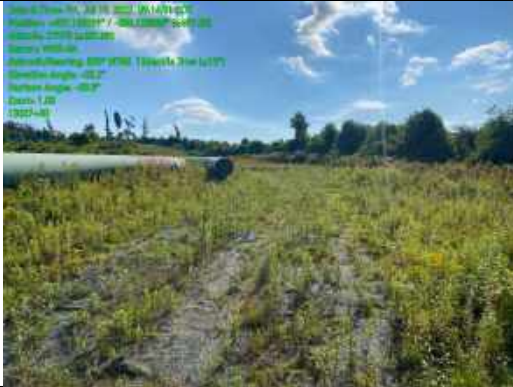
GPS Location	See photo for coordinates.		GPS Location	See photo for coordinates.	
Field Station#	13025+00		Field Station#	13027+00	
Pic 1 Desc.	S-G24 and S-G25 crossing, right of way stable; no changes observed.		Pic 2 Desc.	Right of way stabilized, ECDs functioning acceptably.

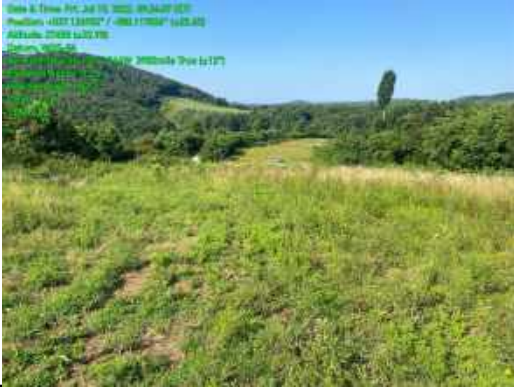
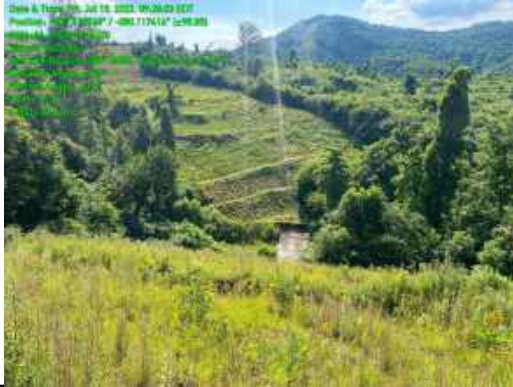
GPS Location	See photo for coordinates.		GPS Location	See photo for coordinates.	
Field Station#	13037+00		Field Station#	13041+00	
Pic 3 Desc.	Right of way stabilized, ECDs functioning acceptably.		Pic 4 Desc.	S-H1, right of way stable.

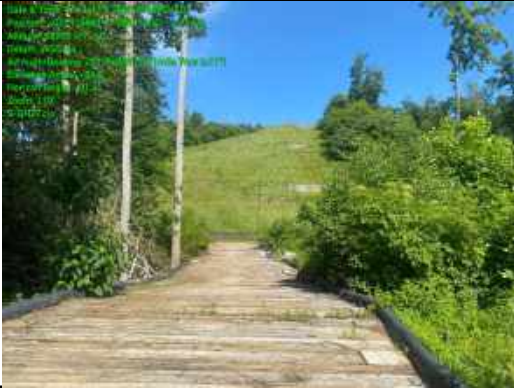
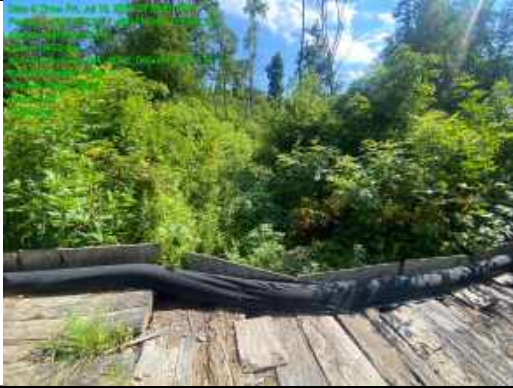
GPS Location	See photo for coordinates.		GPS Location	See photo for coordinates.	
Field Station#	13062+00		Field Station#	13061+89	
Pic 5 Desc.	Right of way stabilized at stream crossing and restored upslope.		Pic 6 Desc.	S-G26, upstream, no impacts noted.

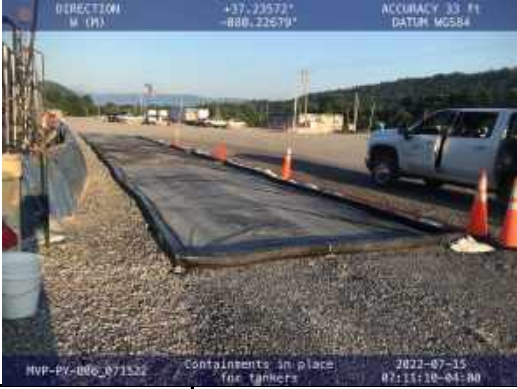
GPS Location	MVP-PY-006 See photo for gps data	GPS Location	MVP-PY-006 See photo for gps data		
Field Station#	+0	Field Station#	+0		
Pic 7 Desc.	Blue Bulk Fuel tanks no leaky internal fittings. Looking NW.	Pic 8 Desc.	Secondary containments in place for tankers offloading fuel. Looking W.

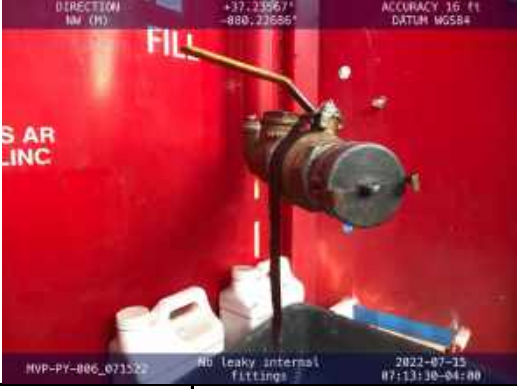
GPS Location	MVP-PY-006 See photo for gps data	GPS Location	MVP-PY-006 See photo for gps data		
Field Station#	+0	Field Station#	+0		
Pic 9 Desc.	Off Road Fuel unit secondary containment holding stormwater. Looking N.	Pic 10 Desc.	Off Road Fuel unit no leaky internal fittings. Looking NW.

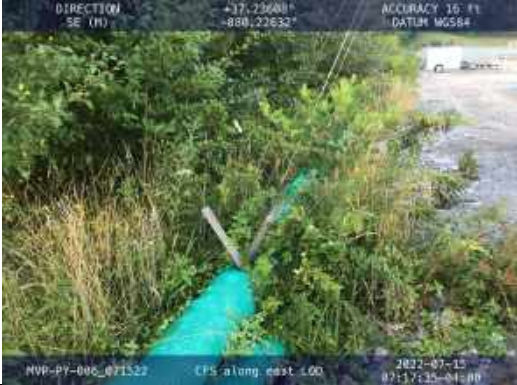
GPS Location	MVP-PY-006 See photo for gps data	GPS Location	MVP-PY-006 See photo for gps data		
Field Station#	+0	Field Station#	+0		
Pic 13 Desc.	Triple stack compost filter sock along east LOD overgrown with vegetation. Looking SE.	Pic 14 Desc.	Tray and secondary containment under toilet. Trays holding fluids. Looking S.

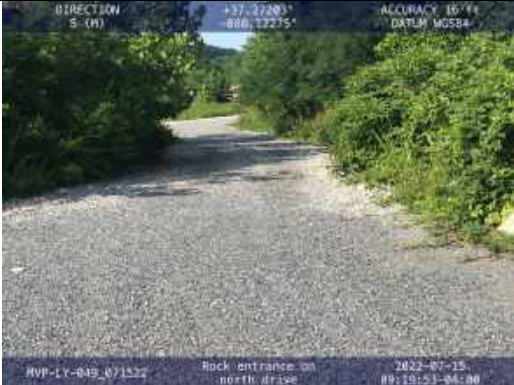
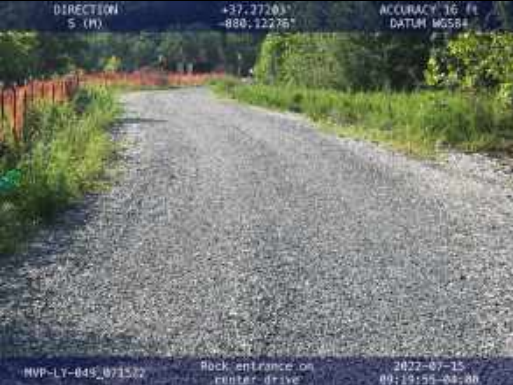
GPS Location	MVP-LY-049 See photos for gps data		GPS Location	MVP-LY-049 See photos for gps data	
Field Station#	+0		Field Station#	+0	
Pic 1 Desc.	Rock entrance on north drive. No sediment or debris on stone. Looking SW.		Pic 2 Desc.	Rock entrance on center drive. Smaller stone applied over larger stone. No sediment or debris on stone. Looking S.

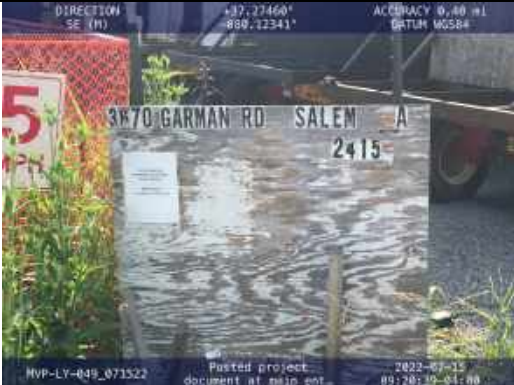
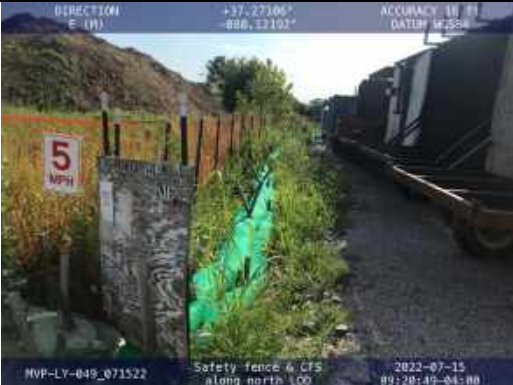
GPS Location	MVP-LY-049 See photos for gps data		GPS Location	MVP-LY-049 See photos for gps data	
Field Station#	+0		Field Station#	+0	
Pic 3 Desc.	Posted project document at main entrance. Looking SE.		Pic 4 Desc.	Safety fence and triple stack compost filter sock along north LOD. Looking E.

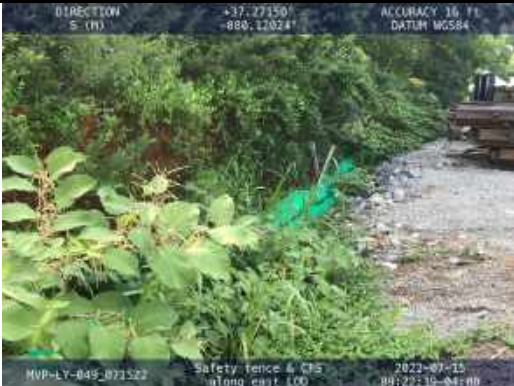
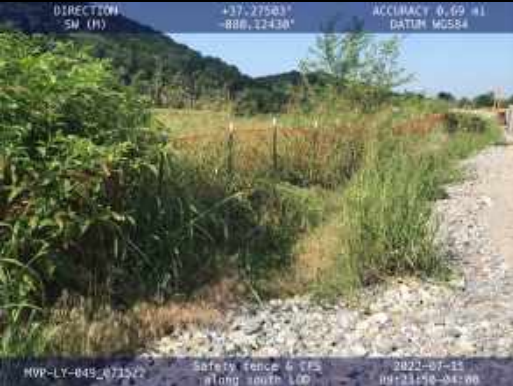
GPS Location	MVP-LY-049 See photos for gps data		GPS Location	MVP-LY-049 See photos for gps data	
Field Station#	+0		Field Station#	+0	
Pic 5 Desc.	Safety fence and triple stack compost filter sock along east LOD overgrown with vegetation. Looking S.		Pic 6 Desc.	Safety fence and triple stack compost filter sock along south LOD overgrown with vegetation. Looking SW.

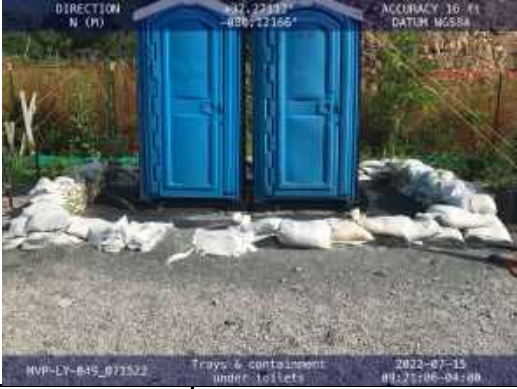
GPS Location	MVP-LY-049 See photos for gps data	GPS Location	MVP-LY-049 See photos for gps data		
Field Station#	+0	Field Station#	+0		
Pic 7 Desc.	Trays and containment under toilets. Trays holding fluids. Looking N.	Pic 8 Desc.	Restoration supplies under cover and cover secured. Looking E.

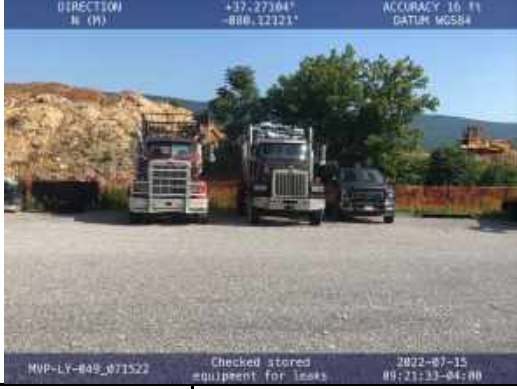
GPS Location	MVP-LY-049 See photos for gps data	GPS Location	MVP-LY-049 See photos for gps data		
Field Station#	+0	Field Station#	+0		
Pic 9 Desc.	Checked stored vehicles for new leaks. No new leaks located. Looking N.	Pic 10 Desc.	Checked stored equipment for new leaks. No new leaks located. Looking SW.

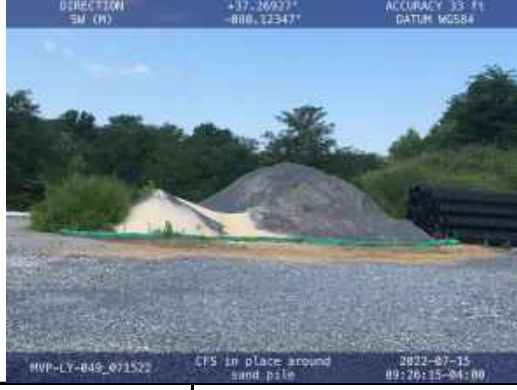
GPS Location	MVP-LY-049 See photos for gps data	GPS Location	MVP-LY-049 See photos for gps data		
Field Station#	+0	Field Station#	+0		
Pic 11 Desc.	Compost filter sock in place and functioning around sand pile. Looking SW.	Pic 12 Desc.	No fluids or deposits around hazardous waste dumpster. Looking NE.
