Visual Site Inspection Report

| Project Name | H-600 Pipeline Spread H | AFE | 124300138 | Spread | H-600 Pipeline Spread H |
| Inspector | Bryan Cole | | | Date/Time | 7/18/2022 1:42 PM |

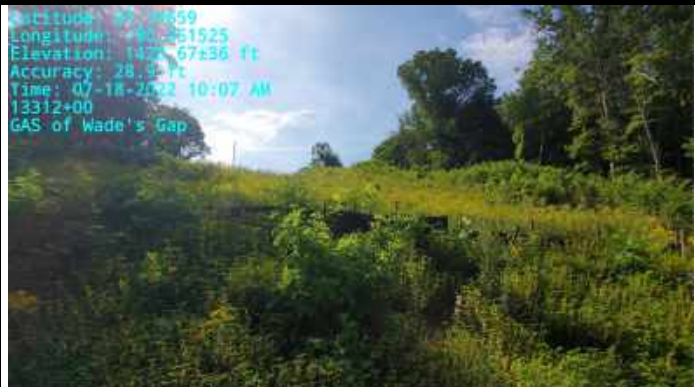
| Field Station# | 13312+00 | | Field Station# | 13322+00 | |

| Pic 1 Desc. | ROW and ECDs In good condition and stable | | Pic 2 Desc. | MVP-S-GH15 and corresponding buffer zone in good condition | |

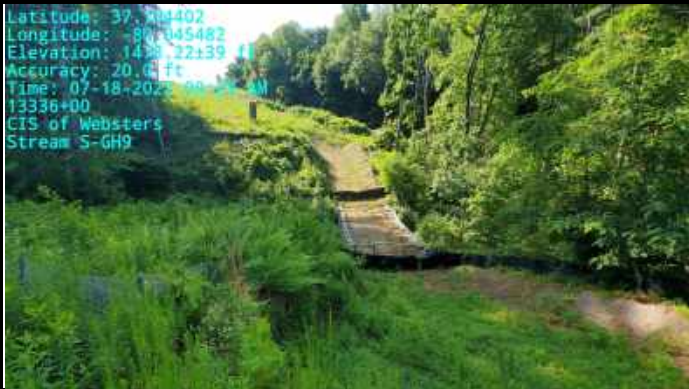
| Field Station# | 13336+00 | | Field Station# | 13330+00 | |

| Pic 7 Desc. | MVP-S-GH9 and corresponding buffer zone in good condition | | Pic 8 Desc. | ROW and ECDs In good condition and stable | |

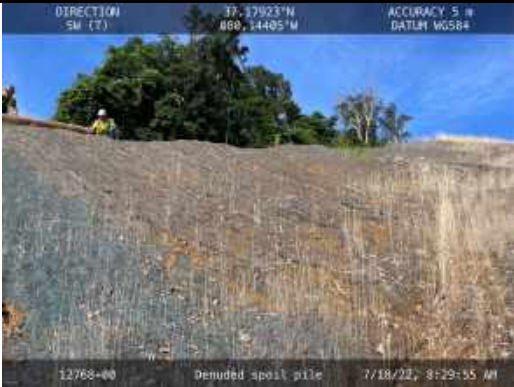
| Field Station# | 12768+00 | | Field Station# | 12767+50 | |

| Pic 1 Desc. | Denuded area on spoil pile needs to be stabilized | | Pic 2 Desc. | Crew Curlexing denuded area on spoil pile | |

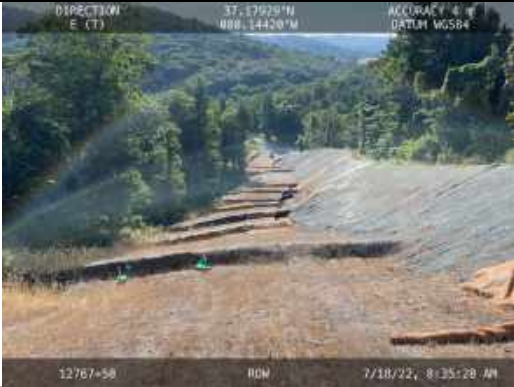
| Field Station# | 12767+50 | | Field Station# | 12767+50 | |

| Pic 3 Desc. | Waterbars are functional | | Pic 4 Desc. | Spoil pile has been stabilized | |

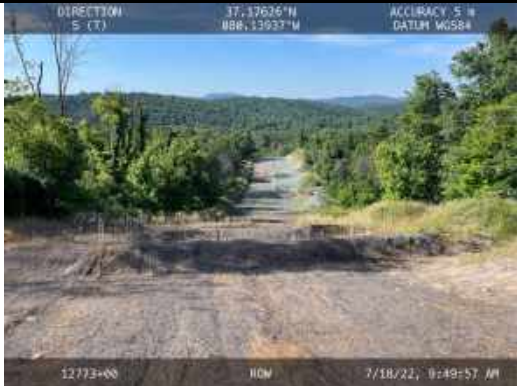
| Field Station# | 12773+00 | | Field Station# | 12779+50 | |

| Pic 9 Desc. | Current ROW conditions. ROW is stable and ECDs are functional. | | Pic 10 Desc. | Level spreader is functional. | |

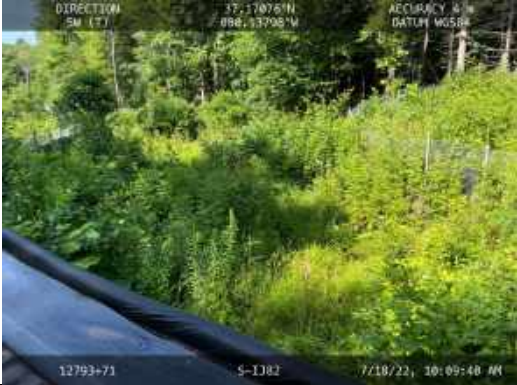
| Field Station# | 12793+71 | | Field Station# | 127950+00 | |

| Pic 13 Desc. | Downstream of crossing at Stream S-IJ82 | | Pic 14 Desc. | Current ROW conditions. ROW is stable and ECDs are functional. | |

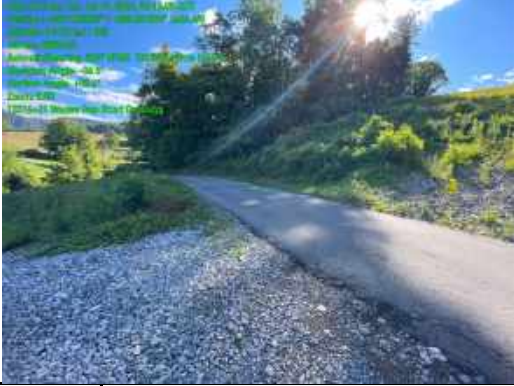
| Field Station# | 13316+21 | Field Station# | 13314+00 | | |

| Pic 1 Desc. | Wades Gap Road Crossing in good condition | Pic 2 Desc. | ROW and ECDs In good condition and stable | | |

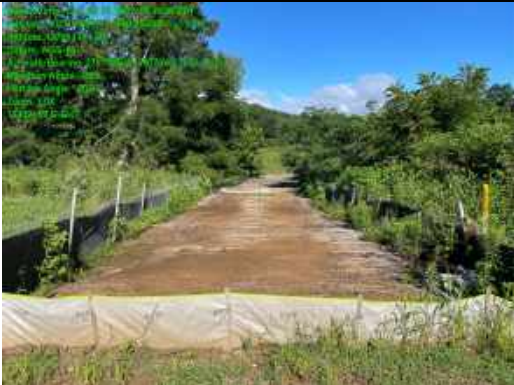
| Field Station# | 13309+09 | Field Station# | 13308+50 | | |

| Pic 3 Desc. | MVP-S-GH7 and corresponding buffer zone in good condition | Pic 4 Desc. | ROW and ECDs In good condition and stable | | |

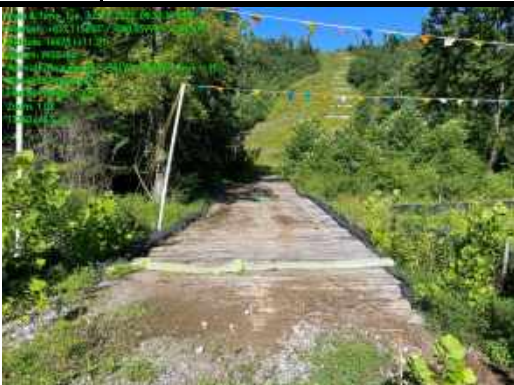
| Field Station# | 13360+66 | Field Station# | 13259+00 | | |

| Pic 5 Desc. | MVP-S-II4 and corresponding buffer zone in good condition | Pic 6 Desc. | ROW and ECDs In good condition and stable | | |

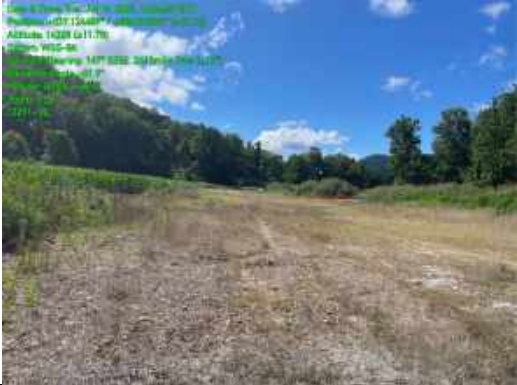
| Field Station# | 13191+00 | Field Station# | 13189+00 | | |

| Pic 7 Desc. | ROW and ECDs In good condition and stable | Pic 8 Desc. | ROW and ECDs In good condition and stable | | |

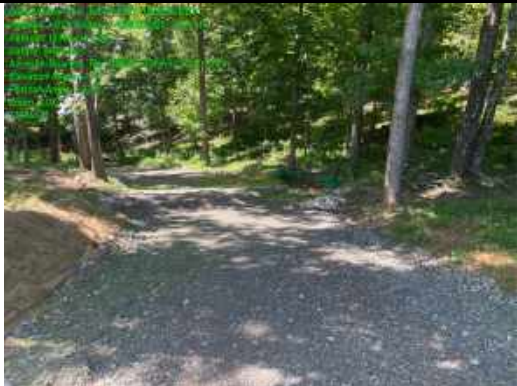
| Field Station# | 13196+31 | Field Station# | 13185+00 | | |

| Pic 9 Desc. | Access road and ECDs In good condition | Pic 10 Desc. | ROW and ECDs In good condition and stable | | |

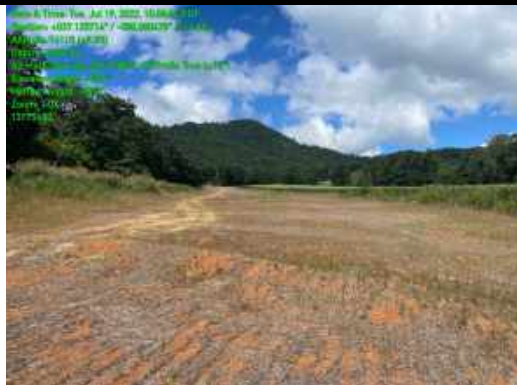
| Field Station# | 13175+00 | Field Station# | 13169+00 | | |

| Pic 11 Desc. | ROW and ECDs In good condition and stable | Pic 12 Desc. | ROW and ECDs In good condition and stable | | |

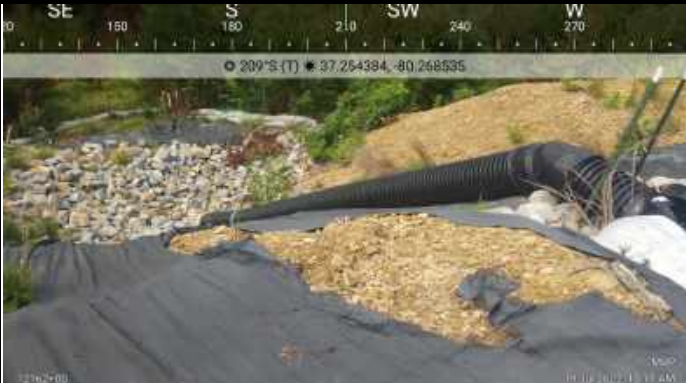
| Field Station# | 12162+00 | | Field Station# | 12163+05 | |

| Pic 7 Desc. | Photo shows a punch list item for today that consists of Geotextile fabric needing to be pulled back into place and repined. | | Pic 8 Desc. | Photo shows overview of Stream S-C25 and its buffer zone from the coming in side. | |

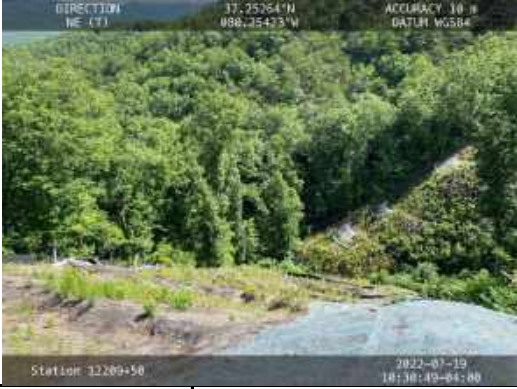
| Field Station# | 12209+50 | | Field Station# | 12211+00 | |

| Pic 13 Desc. | Photo shows the stabilized ROW conditions with water bars and that all ECDs are installed and are functioning as designed. | | Pic 14 Desc. | Photo shows low lying drainage area that runs across the ROW. (Not a resource). | |

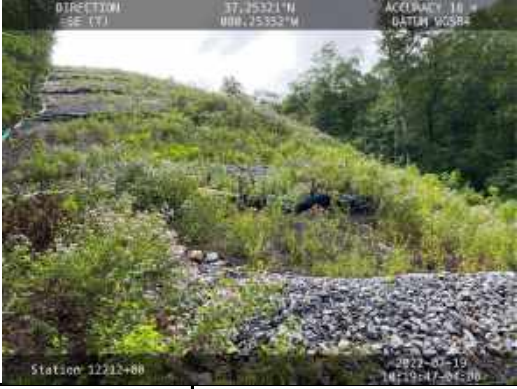
| Field Station# | 12212+00 | | Field Station# | 12245+00 | |

| Pic 15 Desc. | Photo shows stabilized ROW conditions in permanent restoration area. Permanent waterbars with level spreaders installed. | | Pic 16 Desc. | Photo shows stabilized ROW conditions in permanent restoration area. Permanent waterbars with level spreaders installed. | |

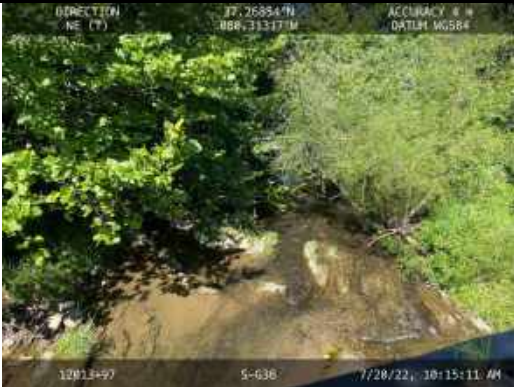
| Field Station# | 12013+97 | | Field Station# | 12037+00 | |

| Pic 1 Desc. | Photo shows downstream view of Stream S-G36 from the equipment bridge spanning stream channel on MVP-MN-268.01. | | Pic 2 Desc. | Photo shows the stabilized ROW conditions with water bars and that all ECDs are installed and are functioning as designed. | |

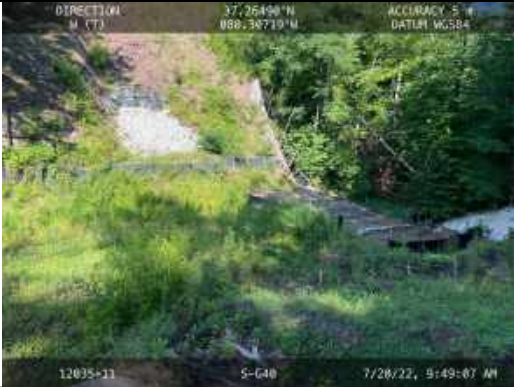
| Pic 3 Desc. | Photo shows overview of Stream S-G40 from the going away side. | | Pic 4 Desc. | Photo shows the stabilized ROW conditions with water bars and that all ECDs are installed and are functioning as designed. | |

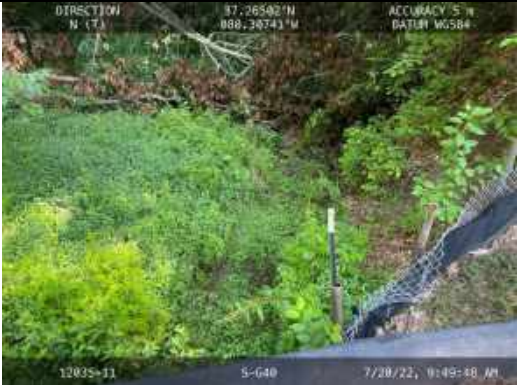
| Pic 7 Desc. | Photo shows downstream view of Stream S-G40 from the equipment bridge spanning the stream channel. | | Pic 8 Desc. | Photo shows punch list item from today of repairing or replacing down P1. (Resolved 07/20/22). | |

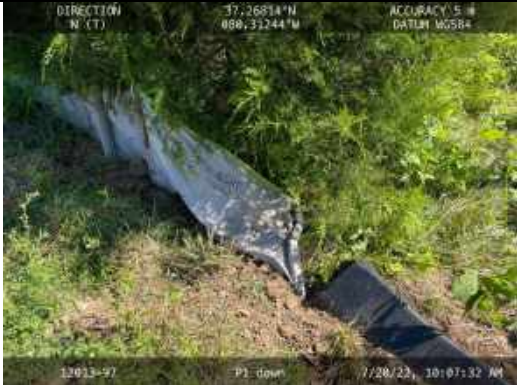
| E&S BMPs | Compliance Level | Corrective Action | Corrective Time Frame | Date Repaired |
|---|---|---|---|---|
| Silt Fence (Filter Fabric Fence) | Communication | Repair or replace down panel P1 | | 7/20/2022 |

| <p>Attended morning virtual conference call for inspection at 6:30am then traveled to MVP-MN-268.01. Here, the VA DEQ SWPPP inspection was performed on this date. From station 12005+00 to station 12119+17 the ROW was walked to evaluate that all ECDs are installed and functioning as designed along with the ROW that had been previously disturbed and is now inactive has been properly stabilized with either straw mulch, erosion control blanket or temporary or permanent vegetation. In which appeared to be adequate.</p> <p>- Final result of all areas observed and evaluated in todays inspection were found to be in compliance and have no environmental issues, no off ROW sediment as well as no stream or wetland impacts.</p> <p>- The ECDs observed today appeared to be installed and functioning as designed. Some of the ECDs are showing some wear but are still functioning.</p> <p>- Located within todays SWPPP inspection area are the following resources that were evaluated and observed. Stream S-SG36 located at station number 12008+53. Stream S-G38 located at station number 12015+84. Stream S-G39 located at station number 12031+51. Stream S-G40 located at station number 12035+11. Stream S-PP23 located at station number 12035+75. Stream S-MM15 located at station number 12076+95. Stream S-MM14 located at station number 12086+56. Stream S-MM13 located at station number 12098+44. Stream S-MM11 located at station number 12101+57. Stream S-F15 located at station number 12108+41. Stream S-F16A/B located at station number 12112+23. Wetland W-F9-PFO located from station number 12108+40 to station number 12109+05.</p> <p>* One punch list item during todays VA DEQ SWPPP inspection. Repair or replace panel of P1 at 12013+97. (MVP-MN-268.01).</p> | | | | | |

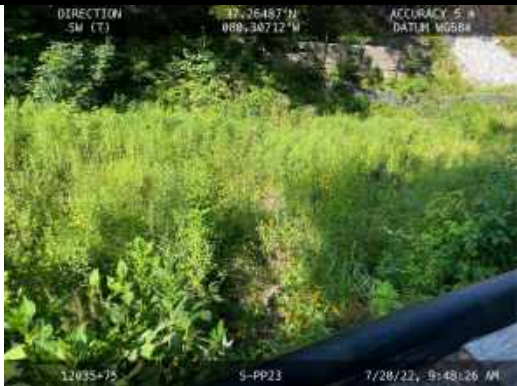
| Pic 9 Desc. | Photo shows downstream view of Stream S-PP23 from the equipment bridge spanning the stream channel. | | Pic 10 Desc. | Photo shows the stabilized ROW conditions with water bars and that all ECDs are installed and are functioning as designed. | |

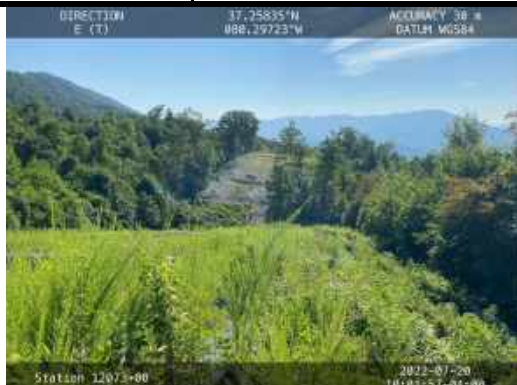
| Pic 11 Desc. | Photo shows the stabilized ROW conditions with water bars and that all ECDs are installed and are functioning as designed. | | Pic 12 Desc. | Photo shows overview of Stream S-MM11 and its buffer zone from the coming in side. | |

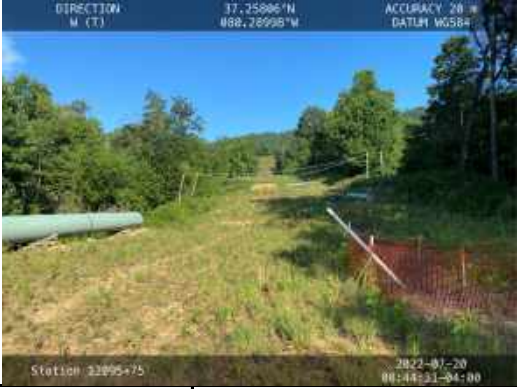
| Pic 13 Desc. | Photo shows the stabilized ROW conditions with water bars and that all ECDs are installed and are functioning as designed. | | Pic 14 Desc. | Photo shows overview of Stream S-MM14 from the equipment bridge and the buffer zone on the coming in side. | |

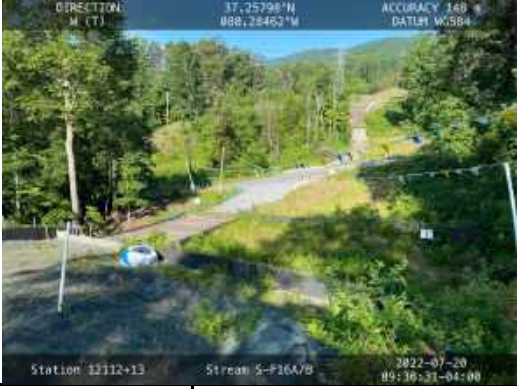
| Pic 15 Desc. | Photo shows overview of Stream S-F16A/B and its buffer zone from the going away side. | | Pic 16 Desc. | Photo shows a permanent waterbar and level spreader within a section of permanent restoration. | |

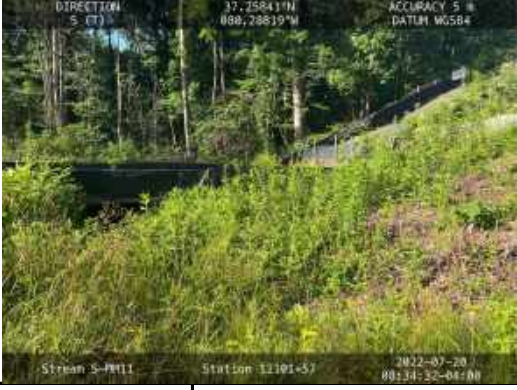
| Pic 17 Desc. | Photo shows upstream view of Stream S-MM11 and the equipment bridge spanning the stream channel. | | Pic 18 Desc. | Photo shows the stabilized ROW conditions with water bars and that all ECDs are installed and are functioning as designed. | |

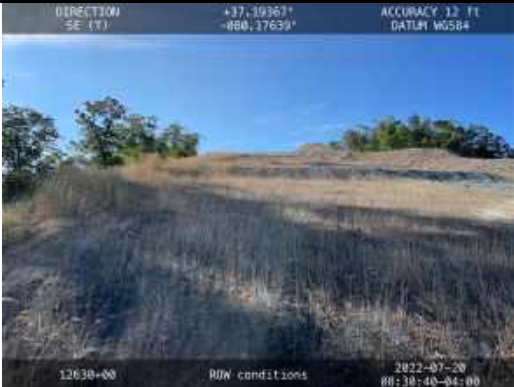
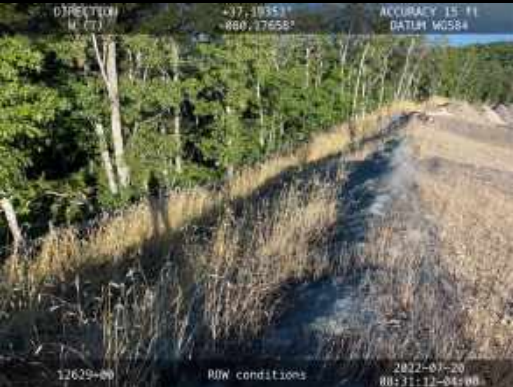
| Pic 1 Desc. | Photo shows the ROW condition. ECDs are installed and functioning as designed. | | Pic 2 Desc. | Photo shows the ROW condition. ECDs are installed and functioning as designed. | |

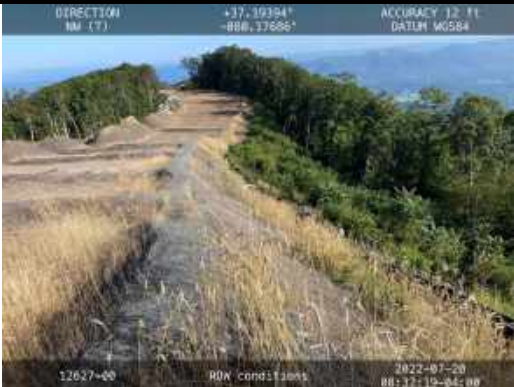
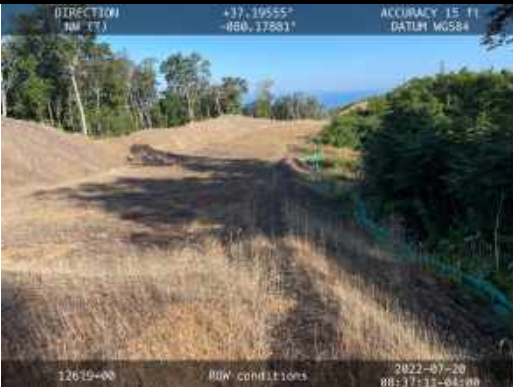
| Pic 3 Desc. | Photo shows the ROW condition. ECDs are installed and functioning as designed. | | Pic 4 Desc. | Photo shows the ROW condition. ECDs are installed and functioning as designed. | |

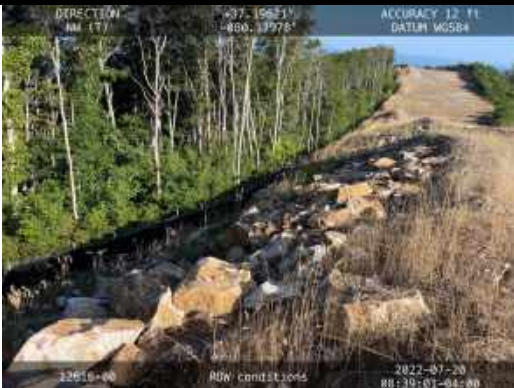
| Pic 5 Desc. | Photo shows the ROW condition. ECDs are installed and functioning as designed. | | Pic 6 Desc. | Photo shows the slope drain. | |

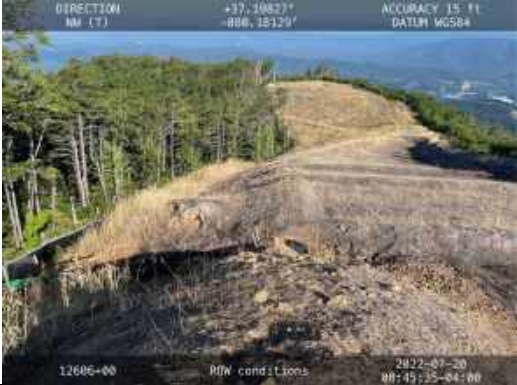
| Pic 7 Desc. | Photo shows the ROW condition. ECDs are installed and functioning as designed. | | Pic 8 Desc. | Photo shows the ROW condition. ECDs are installed and functioning as designed. | |

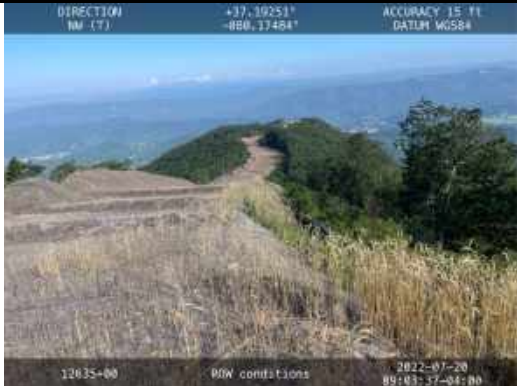
| Pic 9 Desc. | Photo shows the ROW condition. ECDs are installed and functioning as designed. | | Pic 10 Desc. | Photo shows the ROW condition. ECDs are installed and functioning as designed. | |

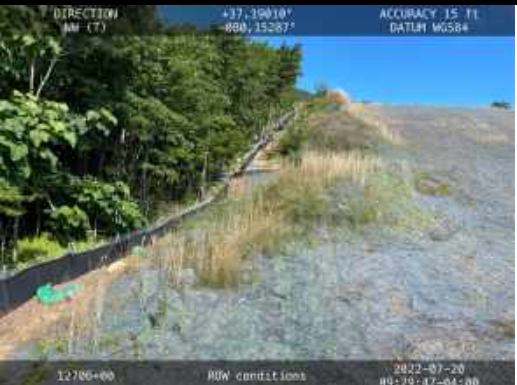
| Pic 11 Desc. | Photo shows the ROW condition. ECDs are installed and functioning as designed. | | Pic 12 Desc. | Photo shows the ROW condition. ECDs are installed and functioning as designed. | |

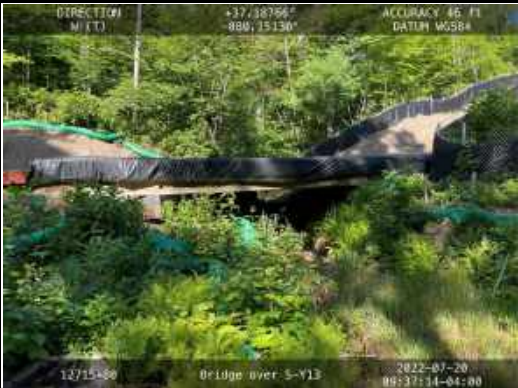
| Pic 15 Desc. | Photo shows the bridge over stream S-Y13. | | Pic 16 Desc. | Photo shows the bridge over stream S-Y14. | |

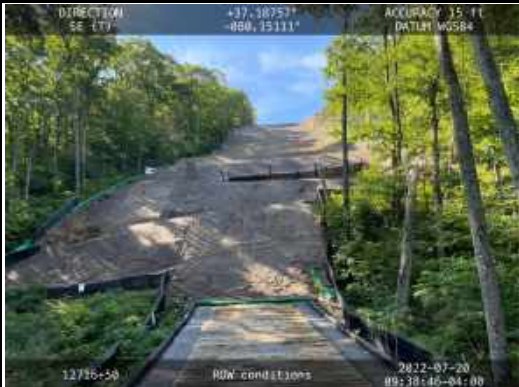
| Pic 17 Desc. | Photo shows S-Y14 downstream from the bridge. | | Pic 18 Desc. | Photo shows the ROW condition. ECDs are installed and functioning as designed. | |

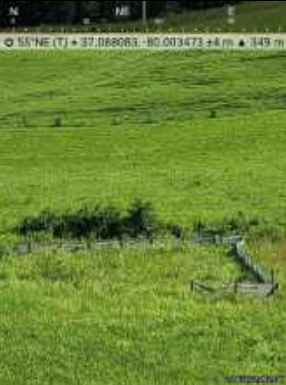
| Pic 1 Desc. | Monitored ECDs around the anode bed location, all in place and functioning at the time of inspection. | | Pic 2 Desc. | Monitored water bars and level spreaders throughout the permanent area of row. No issues were observed at the time of inspection. | |

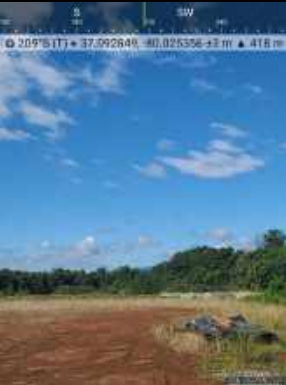
| Pic 3 Desc. | Work space photo showing materials stored. Good stabilization noted at the time of inspection. | | Pic 4 Desc. | Monitored rock lined channel and ECDs at CAHAS#2 road crossing. No environmental issues observed at the time of inspection. | |

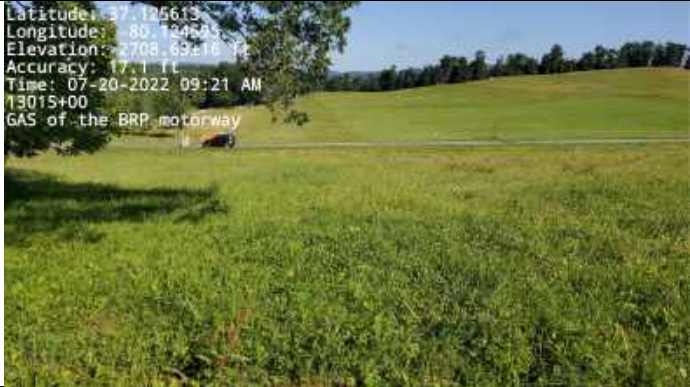
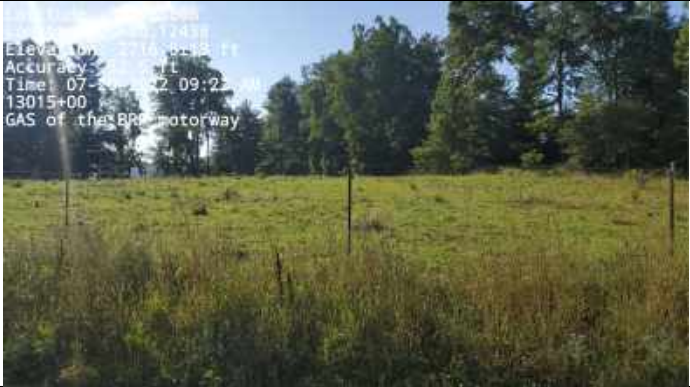
| Pic 1 Desc. | Current ROW conditions. | | Pic 2 Desc. | Current ROW conditions. | |

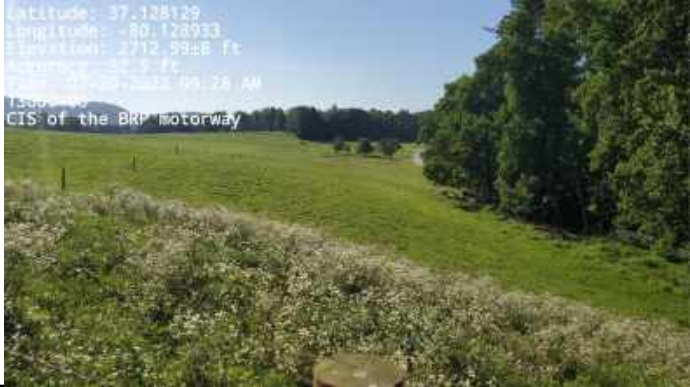
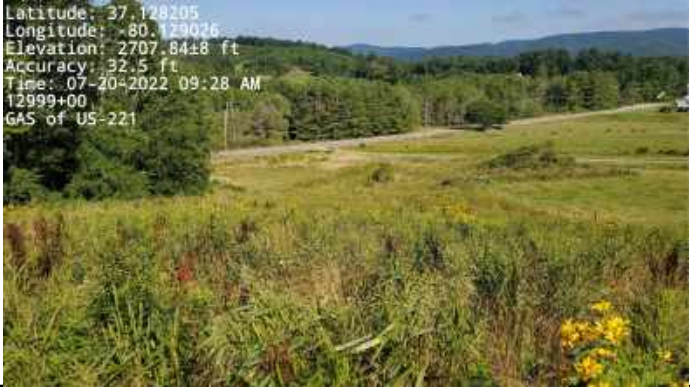
| Pic 3 Desc. | Current ROW conditions. | | Pic 4 Desc. | Current ROW conditions. | |

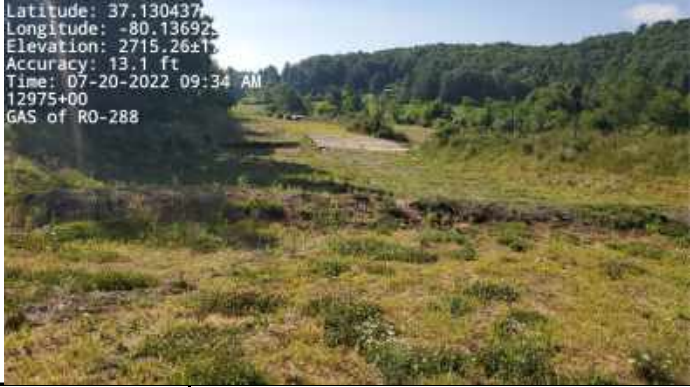
| Field Station# | 12975+00 | | Field Station# | 12973+00 | |

| Pic 5 Desc. | Current ROW conditions. | | Pic 6 Desc. | Current ROW conditions. | |

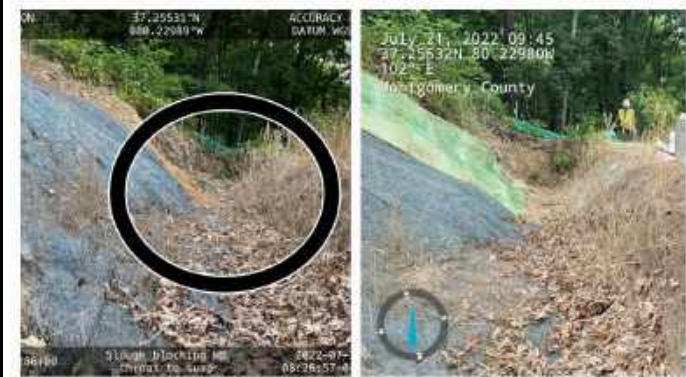
| Field Station# | 12286+00 | | Field Station# | 12290+00 | |

| Pic 1 Desc. | Photo shows before and after of punch list item consisting of cleaning sediment out of throat of waterbar and re-stabilizing with ECB. | | Pic 2 Desc. | Photo shows before and after of punch list item consisting of cleaning sediment out of throat of waterbar and re-stabilizing with ECB. | |

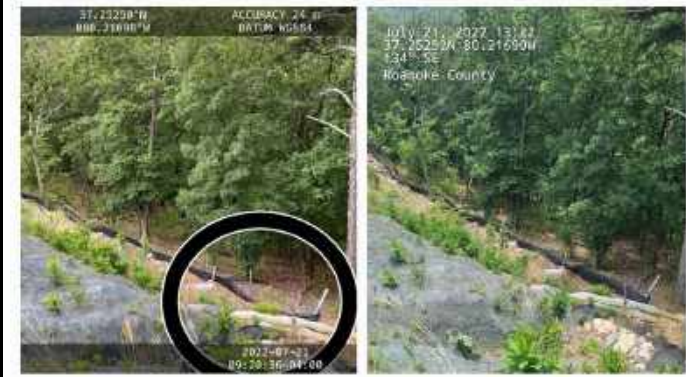
| Field Station# | 12330+00 | | Field Station# | 12293+00 | |

| Pic 3 Desc. | Photo shows before and after of punch list item consisting of reattaching SSF fabric to chain link. | | Pic 4 Desc. | Photo shows the stabilized ROW conditions with water bars and that all ECDs are installed and are functioning as designed. | |

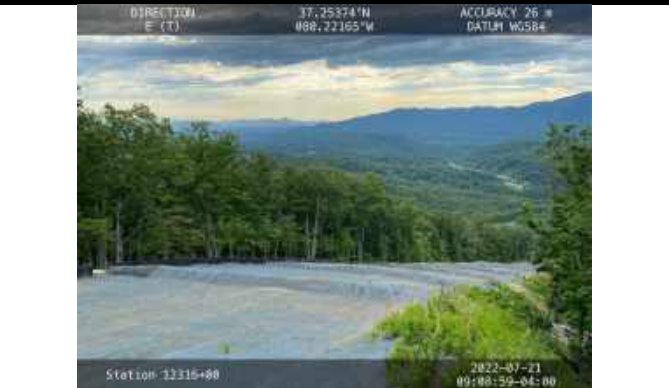
| Field Station# | 12300+00 | | Field Station# | 12316+00 | |

| Pic 5 Desc. | Photo shows the stabilized ROW conditions with water bars and that all ECDs are installed and are functioning as designed. | | Pic 6 Desc. | Photo shows the stabilized ROW conditions with water bars and that all ECDs are installed and are functioning as designed. | |

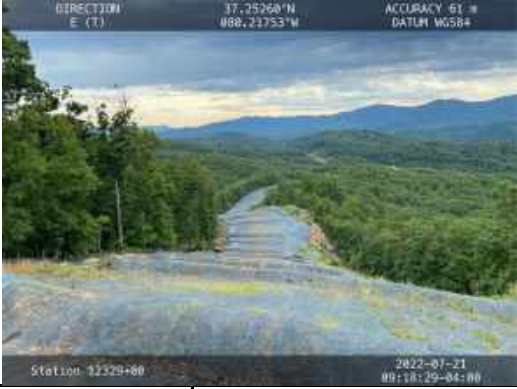
| Field Station# | 12329+00 | | Field Station# | 12332+85 | |

| Pic 7 Desc. | Photo shows the stabilized ROW conditions with water bars and that all ECDs are installed and are functioning as designed. | | Pic 8 Desc. | Photo shows stabilized ROW conditions with waterbar, sump and CFS end treatment. | |

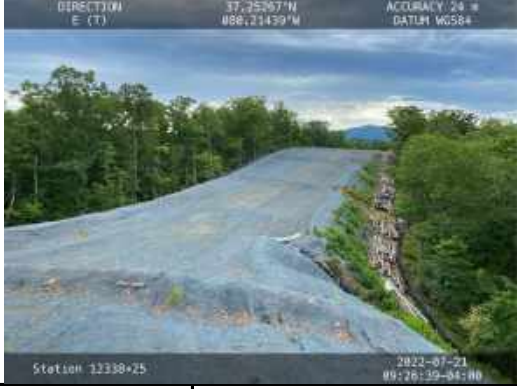
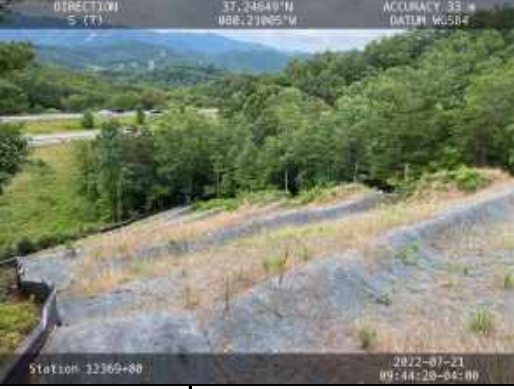
| Field Station# | 12338+25 | | Field Station# | 12369+00 | |

| Pic 9 Desc. | Photo shows the stabilized ROW conditions with water bars and that all ECDs are installed and are functioning as designed. | | Pic 10 Desc. | Photo shows the stabilized ROW conditions with water bars and that all ECDs are installed and are functioning as designed. | |

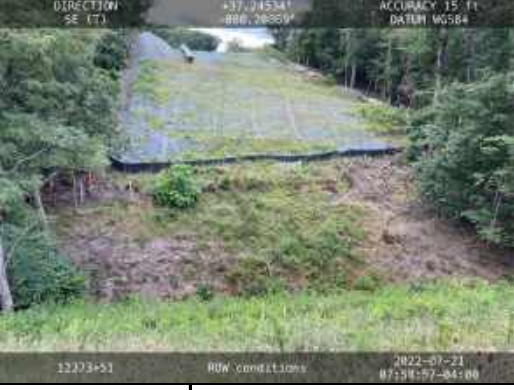
| Field Station# | 12374+16 | | Field Station# | 12373+51 | |

| Pic 11 Desc. | Photo shows upstream view of Stream S-0016. | | Pic 12 Desc. | Photo shows the stabilized ROW conditions with water bars and that all ECDs are installed and are functioning as designed. | |

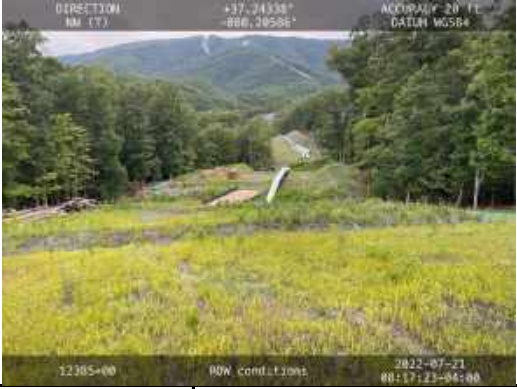
| Field Station# | 12380+04 | | Field Station# | 12385+00 | |

| Pic 13 Desc. | Photo shows upstream view of Stream S-NN19 from the equipment bridge spanning the stream channel. | | Pic 14 Desc. | Photo shows the stabilized ROW conditions with water bars and that all ECDs are installed and are functioning as designed. | |

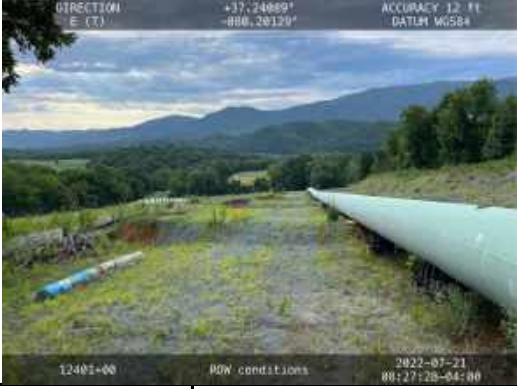
| Field Station# | 12401+00 | | Field Station# | 12411+00 | |

| Pic 15 Desc. | Photo shows the stabilized ROW conditions with water bars and that all ECDs are installed and are functioning as designed. | | Pic 16 Desc. | Photo shows clean water diversion outlet for clean water diversion pipe that runs under the ROW. | |

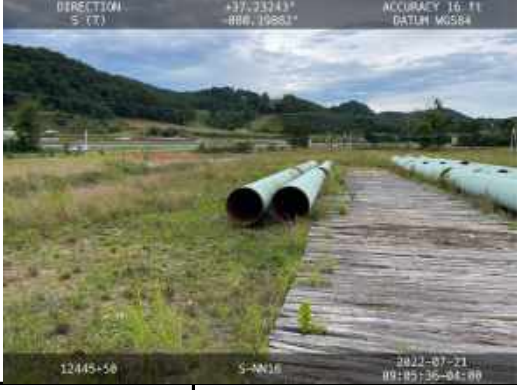
| Field Station# | 12435+50 | | Field Station# | 12442+00 | |

| Pic 17 Desc. | Photo shows overview of Stream S-NN16 from the going away side. | | Pic 18 Desc. | Photo shows the stabilized ROW conditions with water bars and that all ECDs are installed and are functioning as designed. | |

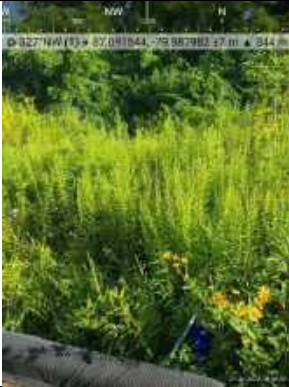
| Field Station# | 13551+34 | Field Station# | 13643+54 | | |

| Pic 1 Desc. | Stream observation photo facing upstream during routine inspection. Good stabilization on stream banks. | | Pic 2 Desc. | Stream observation photo facing upstream during routine inspection today. No issues were observed at the time of inspection. | |

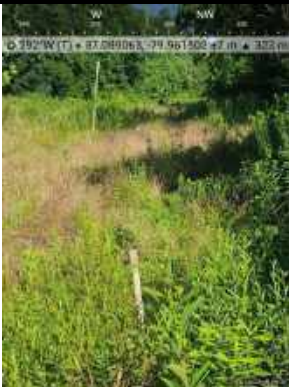
| Field Station# | 13643+00 | Field Station# | 13550+72 | | |

| Pic 3 Desc. | Vegetation observation photo up row from stream crossing. No environmental issues observed at the time of inspection. | | Pic 4 Desc. | Stream observation photo facing downstream during routine inspection today. No issues were observed at the time of inspection. | |

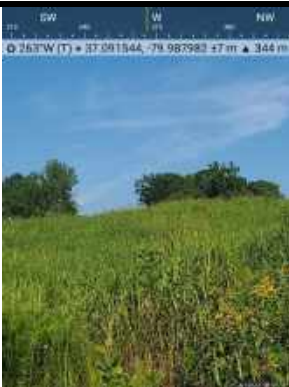
| Field Station# | 13549+72 | Field Station# | 13626+40 | | |

| Pic 5 Desc. | Vegetation observation photo showing good coverage in permanent area of row. | | Pic 6 Desc. | Row photo showing stabilization on hill side. No environmental issues observed at the time of inspection. | |

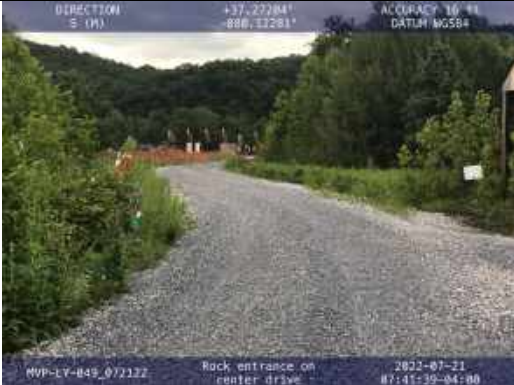
| Pic 1 Desc. | Rock entrance on center drive. Smaller stone applied over larger stone. No sediment or debris on stone. Looking S. | | Pic 2 Desc. | Rock entrance on north drive. No sediment or debris on stone. Looking SW. | |

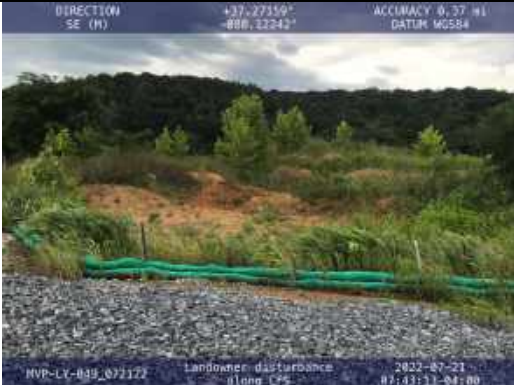
| Pic 3 Desc. | Landowner soil disturbance along triple stack compost filter sock. No new damage to installed ECD's. Area not stabilized. Looking S | | Pic 4 Desc. | Landowner soil disturbance along feature W-CV21A. Area not stabilized. Looking W. | |

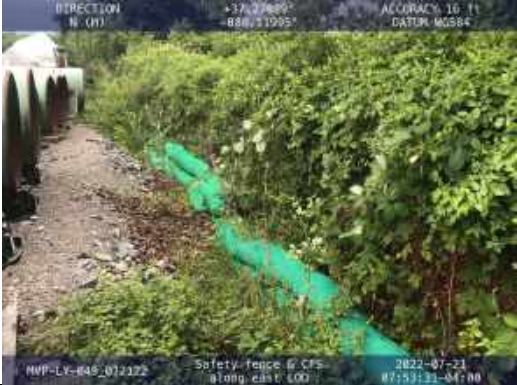
| Pic 13 Desc. | Safety fence and triple stack compost filter sock along east LOD. Looking N. | Pic 14 Desc. | Safety fence and triple stack compost filter sock along north LOD. Looking W. | | |

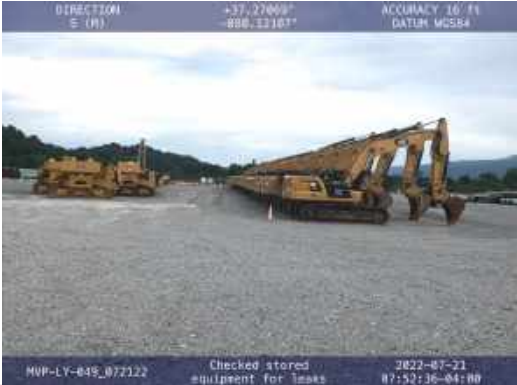
| Pic 15 Desc. | Checked stored equipment for new leaks. No new leaks noted. Looking SW. | Pic 16 Desc. | Trays and containment under toilets. Trays holding fluids. Looking N. | | |

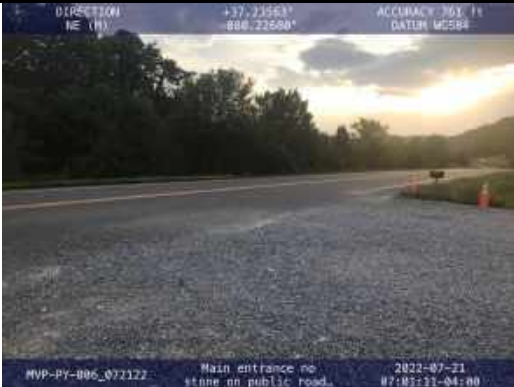
| Pic 1 Desc. | Main entrance no stone on public roadway. Looking NE. | Pic 2 Desc. | Posted project documents at the main entrance. Looking SW. | | |

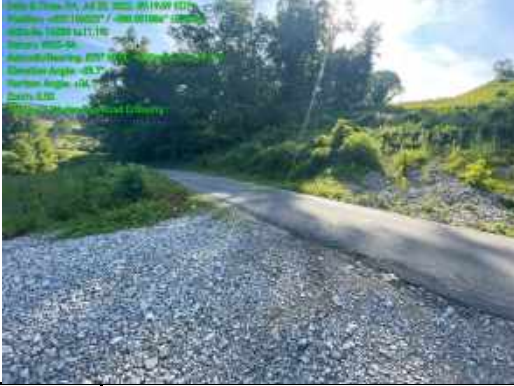
| Field Station# | 13316+21 | Field Station# | 13317+02 | | |

| Pic 1 Desc. | Wades Gap Road Crossing in good condition | Pic 2 Desc. | Private drive in good condition | | |

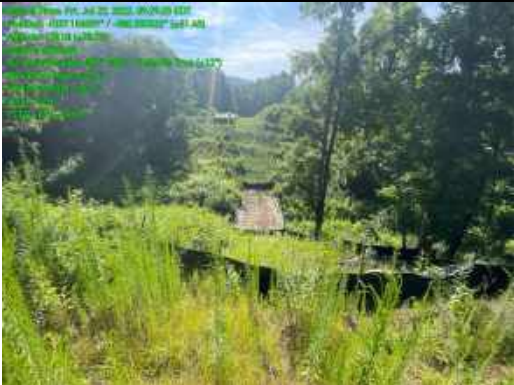
| Field Station# | 13421+47 | Field Station# | 13325+30 | | |

| Pic 3 Desc. | MVP-S-GH15 and corresponding buffer zone in good condition | Pic 4 Desc. | MVP-S-GH14 and corresponding buffer zone in good condition | | |

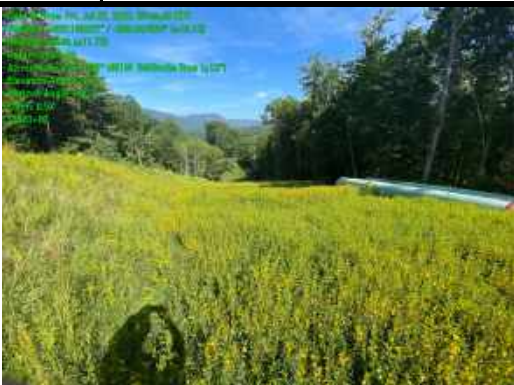
| Field Station# | 13320+00 | Field Station# | 13337+13 | | |

| Pic 5 Desc. | ROW and ECDs In good condition and stable | Pic 6 Desc. | MVP-S-GH9 and corresponding buffer zone in good condition | | |

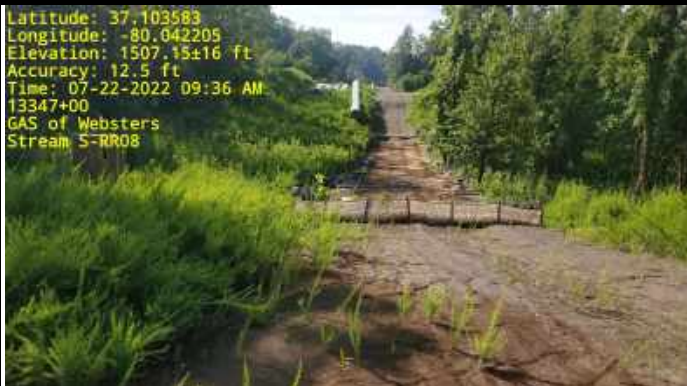
| Field Station# | 13347+00 | | Field Station# | 13353+00 | |

| Pic 9 Desc. | MVP-S-RR08 and corresponding buffer zone in good condition | | Pic 10 Desc. | MVP-S-RR09 and corresponding buffer zone in good condition | |

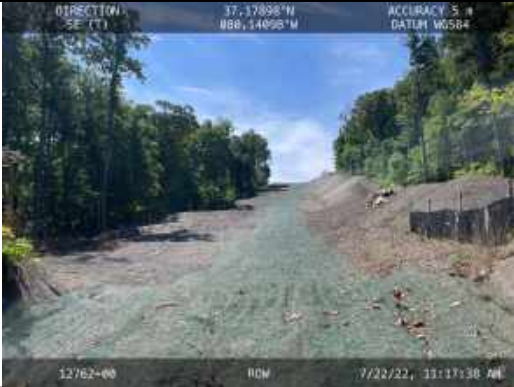
| Field Station# | 12762+00 | | Field Station# | 12776+75 | |

| Pic 3 Desc. | Current ROW conditions. ROW is stable and ECDs are functional. | | Pic 4 Desc. | Downstream of crossing at Stream S-EF33 | |

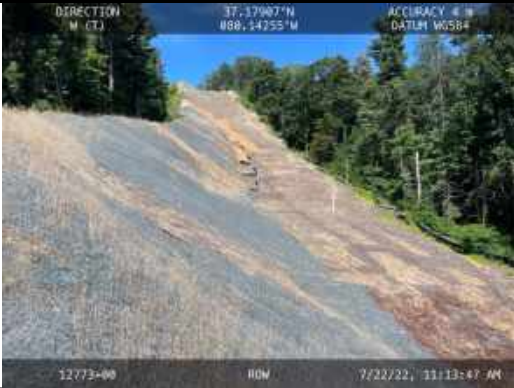
| Field Station# | 12773+00 | | Field Station# | 12768+00 | |

| Pic 5 Desc. | Current ROW conditions. ROW is stable and ECDs are functional. | | Pic 6 Desc. | Area has been stabilized with new curlex | |
