Visual Site Inspection Report

Project Name	H-600 Pipeline Spread H	AFE	124300138	Spread	H-600 Pipeline Spread H
Contractor	Precision			Report #	39499
Inspector	Jordan Davis			Date/Time	7/5/2022 3:00 PM
Permit #	TBD	Inspection Type	VA SWPP	Station Begin	12284+75
State	VA	Inspection Area	Partial	Station End	12443+75
County	Montgomery	Ground	Dry	Temperature (°F)	87.00
Municipality	N/A	Weather	Sunny	Rain Gauge (in)	0.00
				Rain Accumulation Time (days)	0.00

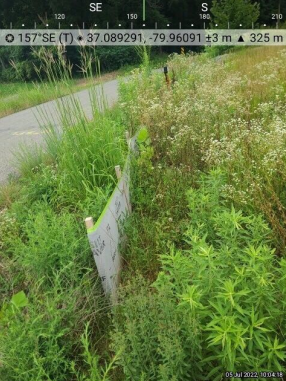
GPS Location	0000	GPS Location	0000		
Field Station#	13644+75	Field Station#	13574+24		
Pic 1 Desc.	Monitored ECDs at road crossings. All in place and functioning at the time of inspection.		Pic 2 Desc.	Row photo showing vegetation in permanent and temporary area at RCE. Equipment bridge in place and functioning.

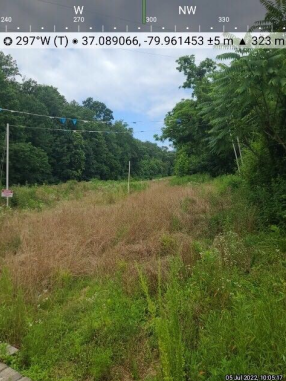
GPS Location	00000	GPS Location	00000		
Field Station#	13643+00	Field Station#	13643+54		
Pic 3 Desc.	Vegetation observation photo up row from stream crossing. Good stabilization noted.		Pic 4 Desc.	Stream observation photo facing upstream during routine inspection. No issues were observed at the time of inspection.

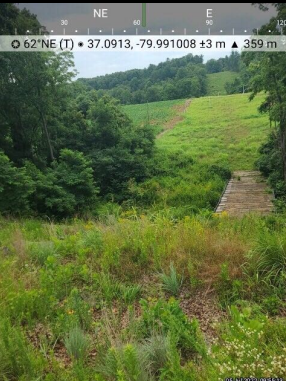
GPS Location	0000	GPS Location	00000		
Field Station#	13541+82	Field Station#	13643+54		
Pic 5 Desc.	Monitored equipment bridge and protection. ECDs in place above stream crossing. No issues observed at the time of inspection.		Pic 6 Desc.	Stream observation photo facing downstream during routine inspection today. No environmental issues observed at the time of inspection.

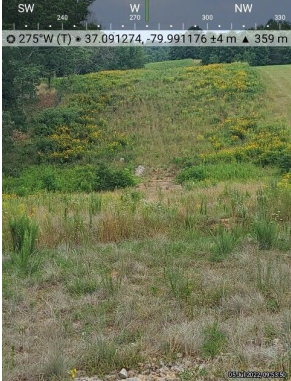
<div>ert image here</div> <div>Insert image here</div>			
GPS Location	0000	GPS Location			
Field Station#	13538+67	Field Station#			
Pic 7 Desc.	Row photo showing vegetation in permanent area of row. No environmental issues observed at the time of inspection.	Pic 8 Desc.			
<div>Insert image here</div>		<div>Insert image here</div>			
GPS Location		GPS Location			
Field Station#		Field Station#			
Pic 9 Desc.		Pic 10 Desc.			
<div>Insert image here</div>		<div>Insert image here</div>			
GPS Location		GPS Location			
Field Station#		Field Station#			
Pic 11 Desc.		Pic 12 Desc.

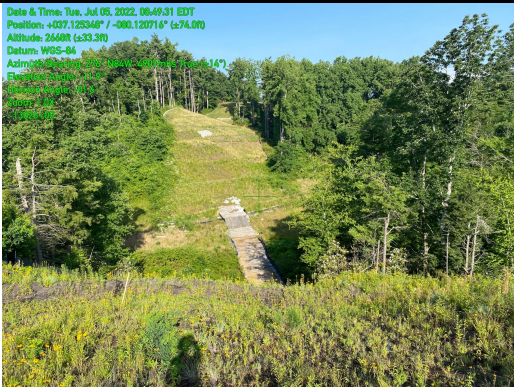
GPS Location		See pic.				GPS Location		See pic.			
Field Station#		13026+00				Field Station#		13042+00			
Pic 1 Desc.		Streams S-G24 and S-G25 from the GAS.				Pic 2 Desc.		Stream S-H1 from the CIS.

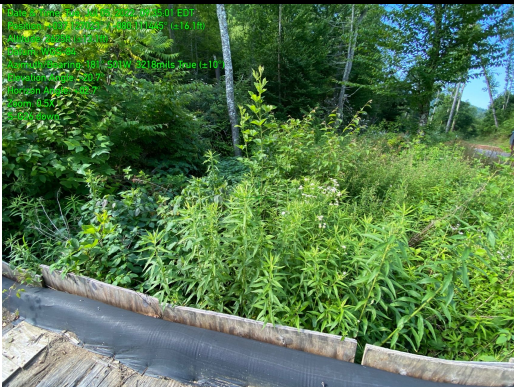
GPS Location		See pic.				GPS Location		See pic.			
Field Station#		13062+00				Field Station#		13063+00			
Pic 3 Desc.		Downstream side of stream S-G26.				Pic 4 Desc.		Downstream side of stream S-G27.

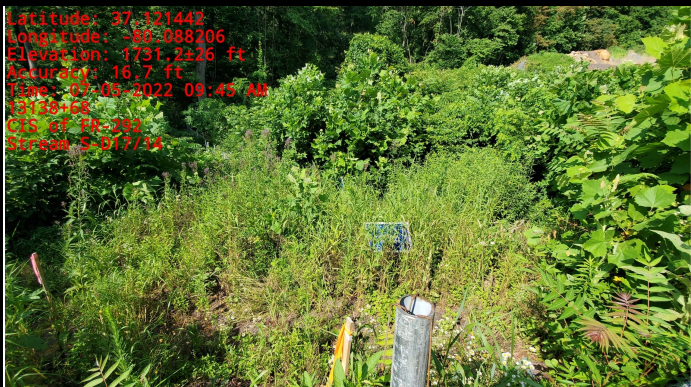
AFE	124300138	Date/Time	7/5/2022 4:18 PM	Report #	
Pictures					
<div>Latitude: 37.121442 Longitude: -80.088206 Elevation: 1731.2±26 ft Accuracy: 16.7 ft Time: 07-05-2022 09:45 AM 13138+68 CIS of FR-292 Stream S-D17/14</div>

GPS Location	See pic.		GPS Location	See pic.	
Field Station#	13138+68		Field Station#	13137+50	
Pic 7 Desc.	Downstream side of stream S-D17/14.		Pic 8 Desc.	Upstream side of stream S-D17/14.	
<div>Latitude: 37.121559 Longitude: -80.088556 Elevation: 1765.35±17 ft Accuracy: 13.5 ft Time: 07-05-2022 09:47 AM 13137+50 CIS of FR-292 Stream S-D17/14</div>

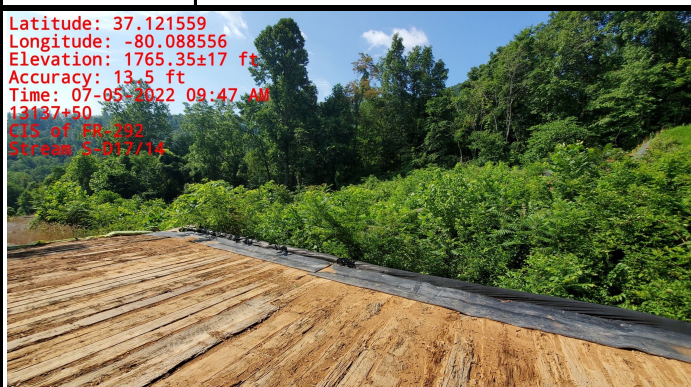
GPS Location	See pic.		GPS Location	See pic.	
Field Station#	13137+50		Field Station#	13135+00	
Pic 9 Desc.	Downstream side of stream S-D17/14.		Pic 10 Desc.	Current ROW conditions.	
<div>Latitude: 37.120119 Longitude: -80.086543 Elevation: 1838.2±14 ft Accuracy: 24.3 ft Time: 07-05-2022 09:57 AM 13141+53 Access Road FR-292 Stream S-D17/14</div>

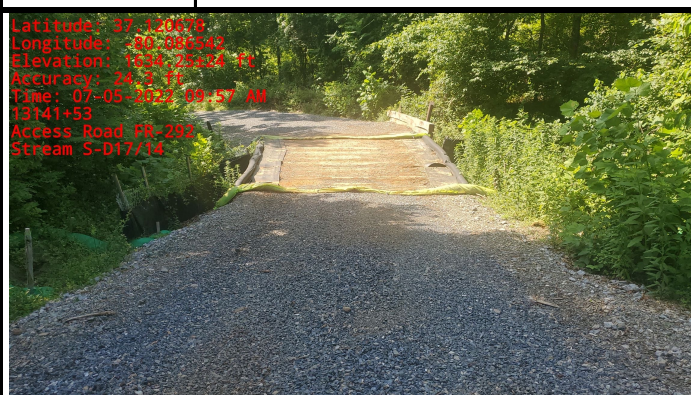
GPS Location	See pic.		GPS Location	See pic.	
Field Station#	13141+53		Field Station#	13119+00	
Pic 11 Desc.	Stream crossing S-D17/14 on access road FR-292.		Pic 12 Desc.	Current ROW conditions.

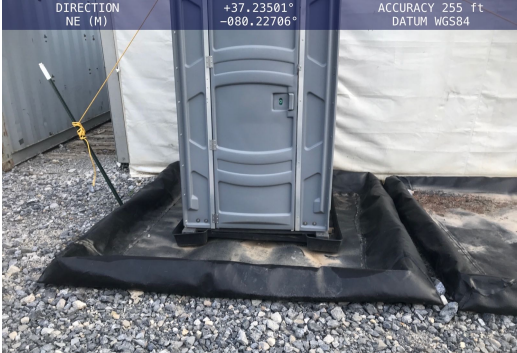
GPS Location	MVP-PY-006 See photo for gps data	GPS Location	MVP-PY-006 See photo for gps data		
Field Station#	+0	Field Station#	+0		
Pic 15 Desc.	Tray and secondary containment under toilet. Tray free of fluids. Looking NE.	Pic 16 Desc.	Secondary containment liner secured and functioning around full DEF containers. Looking NE.

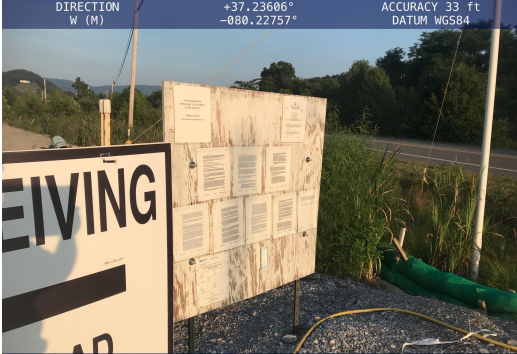
GPS Location	MVP-PY-006 See photo for gps data	GPS Location	MVP-PY-006 See photo for gps data		
Field Station#	+0	Field Station#	+0		
Pic 17 Desc.	Signage and triple stack compost filter sock along feature W-008. Overgrown with vegetation. Looking E.	Pic 18 Desc.	Posted project documents at main entrance. Looking W.

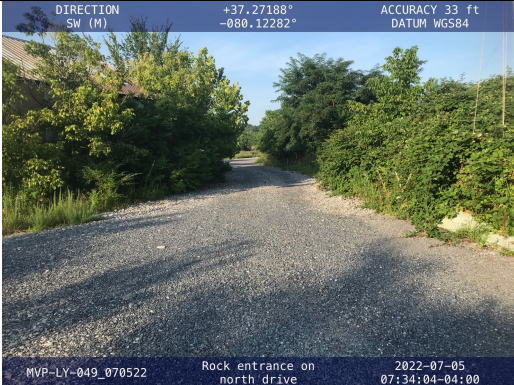
GPS Location	MVP-LY-049 See photo for gps data	GPS Location	MVP-LY-049 See photo for gps data		
Field Station#	+0	Field Station#	+0		
Pic 1 Desc.	Rock entrance on north drive. No sediment or debris on stone. Looking SW.	Pic 2 Desc.	Rock entrance on center drive. Smaller stone applied over larger stone. No sediment or debris on stone. Looking SE.

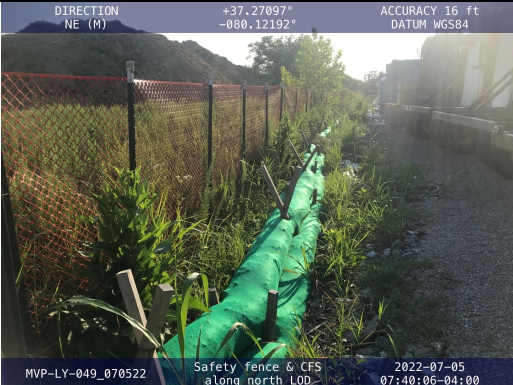
GPS Location	MVP-LY-049 See photo for gps data	GPS Location	MVP-LY-049 See photo for gps data		
Field Station#	+0	Field Station#	+0		
Pic 3 Desc.	Posted project documents at main entrance. Looking SE.	Pic 4 Desc.	Safety fence and triple stack compost filter sock along north LOD. Looking NE.

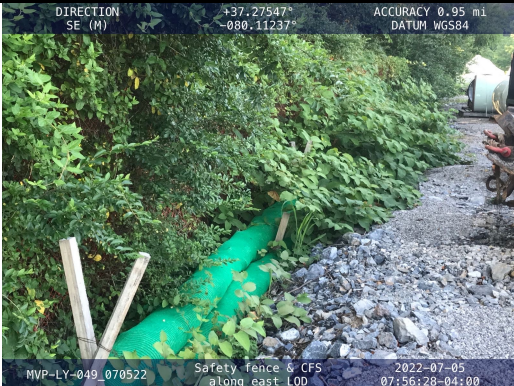
GPS Location	MVP-LY-049 See photo for gps data	GPS Location	MVP-LY-049 See photo for gps data		
Field Station#	+0	Field Station#	+0		
Pic 5 Desc.	Safety fence and triple stack compost filter sock along east LOD. Overgrown with vegetation. Looking SE.	Pic 6 Desc.	Safety fence and triple stack compost filter sock along south LOD. Overgrown with vegetation. Looking SW.

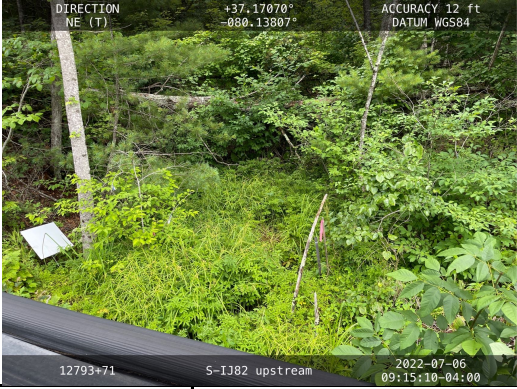
GPS Location	See photo for gps location data.		GPS Location	See photo for gps location data.	
Field Station#	12793+71		Field Station#	12793+71	
Pic 13 Desc.	Photo shows S-IJ82 upstream from the bridge.		Pic 14 Desc.	Photo shows S-IJ82 downstream from the bridge.

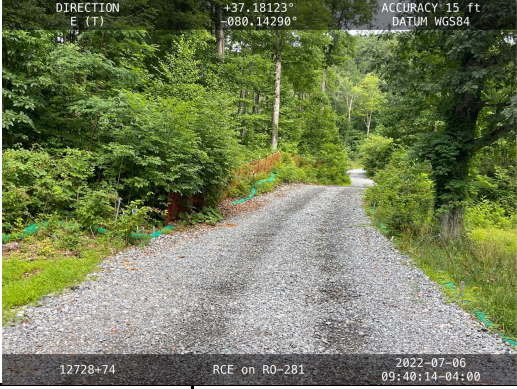
GPS Location	See photo for gps location data.		GPS Location	See photo for gps location data.	
Field Station#	12728+74		Field Station#	12743+70	
Pic 15 Desc.	Photo shows the RCE on RO-281.		Pic 16 Desc.	Photo shows the bridge over stream S-EF34b.

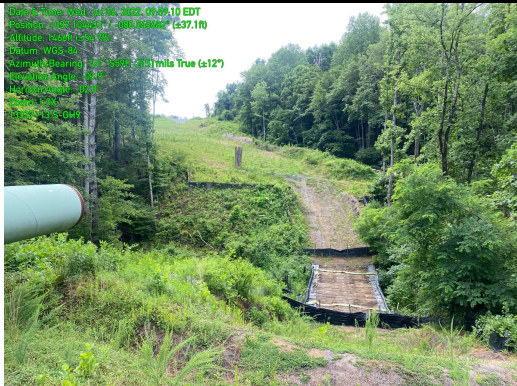
GPS Location	See photo for coordinates.		GPS Location	See photo for coordinates.	
Field Station#	13337+13		Field Station#	13337+13	
Pic 9 Desc.	S-GH9, ROW stabilized and perimeter controls were in acceptable condition along stream crossing perimeters.		Pic 10 Desc.	S-GH9, downstream, slight turbidity noted both upstream and downstream of equipment bridge.

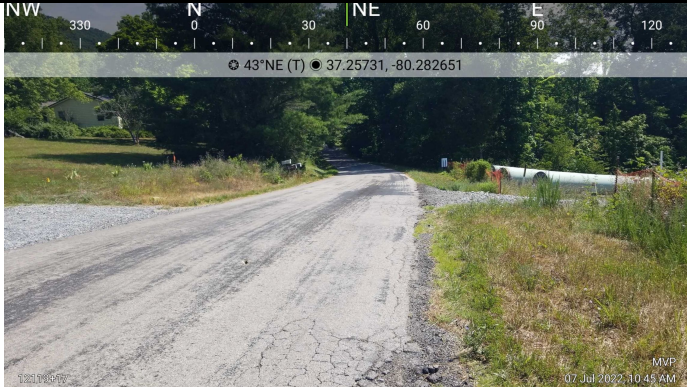
GPS Location	Please see photo for details.		GPS Location	Please see photo for details.	
Field Station#	12119+17		Field Station#	12132+73	
Pic 1 Desc.	Photo shows ST RTE 622 FLATWOODS ROAD and RCE on both the coming in and going away side.		Pic 2 Desc.	Photo shows overview of Stream S-C29 and its buffer zone from the going away side.

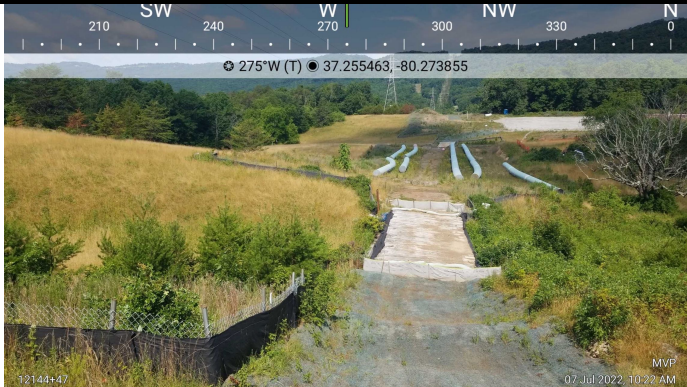
GPS Location	Please see photo for details.		GPS Location	Please see photo for details.	
Field Station#	12144+47		Field Station#	12148+00	
Pic 3 Desc.	Photo shows overview of Wetland W-C5 and its buffer zone from the going away side.		Pic 4 Desc.	Photo shows stabilized ROW conditions and permanent water bars equipped with level spreaders installed.

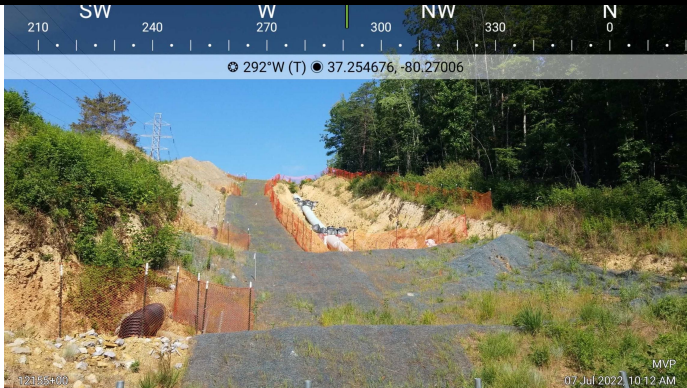
Pic 5 Desc.	Photo shows the stabilized ROW conditions with water bars and that all ECDs are installed and are functioning as designed.		Pic 6 Desc.	Photo shows overview of Stream S-C25 and its buffer zone from the going away side.

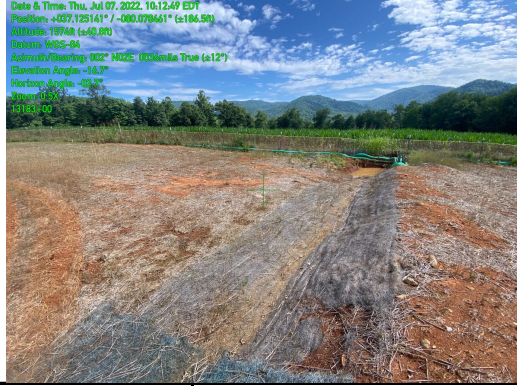
GPS Location	See photo for coordinates.		GPS Location	See photo for coordinates.	
Field Station#	13183+00		Field Station#	13181+00	
Pic 11 Desc.	Waterbar functioning acceptably, sump holding water.		Pic 12 Desc.	ROW stabilized.

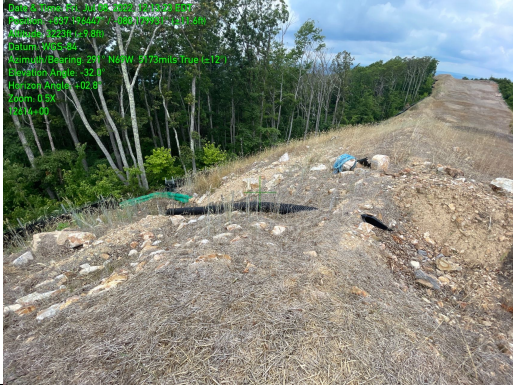
GPS Location	0		GPS Location	0	
Field Station#	12614+00		Field Station#	12616+00	
Pic 1 Desc.	Photo shows the slope drain.		Pic 2 Desc.	Photo shows the ROW condition. ECDs are installed and functioning as designed.

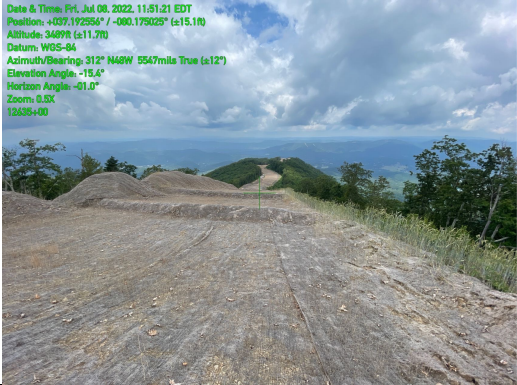
GPS Location	0	GPS Location	0		
Field Station#	12635+00	Field Station#	12638+00		
Pic 7 Desc.	Photo shows the ROW condition. ECDs are installed and functioning as designed.		Pic 8 Desc.	Photo shows the ROW condition. ECDs are installed and functioning as designed.	
<p>Date & Time: Fri, Jul 08, 2022, 10:18:52 EDT Position: +037.191860° / -080.157231° (±15.1ft) Altitude: 3701ft (±11.7ft) Datum: WGS-84 Azimuth/Bearing: 161° S19E 2862mils True (±13°) Elevation Angle: -05.9° Horizon Angle: -01.0° Zoom: 0.5X 12690+43 Honeysuckle Road Crossing</p>

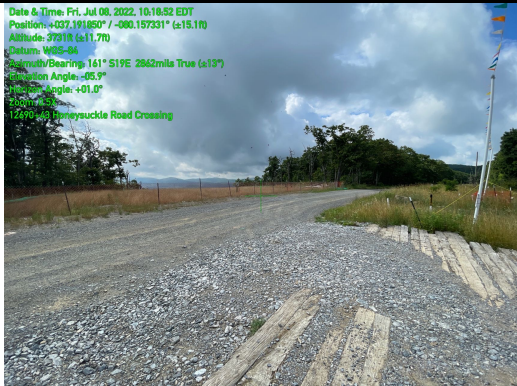
GPS Location	0	GPS Location	0		
Field Station#	12690+43	Field Station#	12702+00		
Pic 9 Desc.	Photo shows Honeysuckle Road Crossing		Pic 10 Desc.	Photo shows the ROW condition. ECDs are installed and functioning as designed.	
<p>Date & Time: Fri, Jul 08, 2022, 10:45:15 EDT Position: +037.190536° / -080.153197° (±20.7ft) Altitude: 3384ft (±2.5ft) Datum: WGS-84 Azimuth/Bearing: 136° S44E 2418mils True (±13°) Elevation Angle: -20.5° Horizon Angle: +02.8° Zoom: 0.5X 12704+00</p>

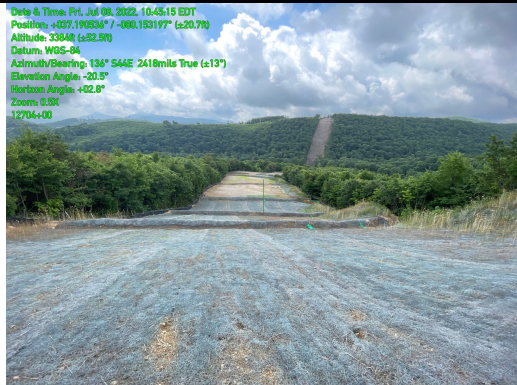
GPS Location	0	GPS Location	0		
Field Station#	12704+00	Field Station#	12708+00		
Pic 11 Desc.	Photo shows the ROW condition. ECDs are installed and functioning as designed.		Pic 12 Desc.	Photo shows the ROW condition. ECDs are installed and functioning as designed.

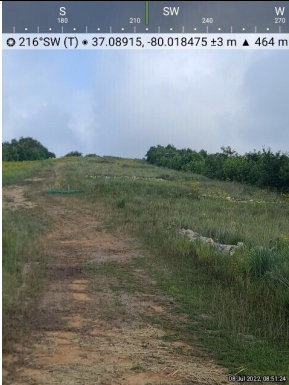
GPS Location	0000	GPS Location	00000		
Field Station#	13444+65	Field Station#	13459+00		
Pic 1 Desc.	Monitored water bars and level spreaders during routine inspection today. No environmental issues observed at the time of inspection.		Pic 2 Desc.	Monitored ECDs and vegetation throughout permanent area of row. No issues were observed at the time of inspection.

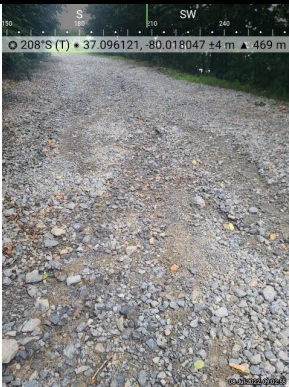
GPS Location	00000	GPS Location	00000		
Field Station#	13437+75	Field Station#	13479+00		
Pic 3 Desc.	Access rd MVP-FR-293.02 requires maintenance due to washes after recent rain events.		Pic 4 Desc.	Materials left after recent ECD replacement needs removed from row. Added to the punch list.

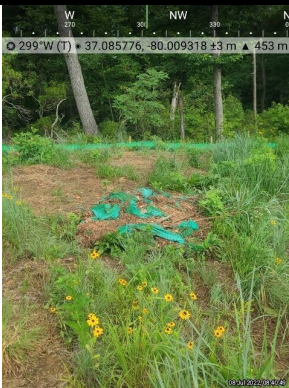
GPS Location	00000	GPS Location	00000		
Field Station#	13479+00	Field Station#	13490+00		
Pic 5 Desc.	Additional materials that needs removed from the row, added to the punch list.		Pic 6 Desc.	Additional photo showing water bars and level spreaders. No issues were observed at the time of inspection.

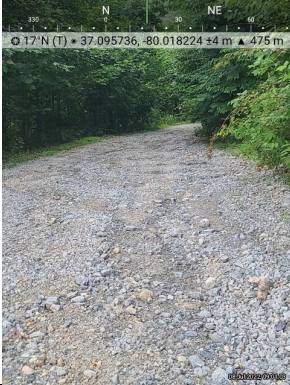
<p>Insert image here</p>		<p>Insert image here</p>	
GPS Location	0000	GPS Location			
Field Station#	13437+75	Field Station#			
Pic 7 Desc.	Additional photo showing MVP-FR-293.02 that requires maintenance after recent rain events caused washes . Added to the punch list to be repaired by the contractor.		Pic 8 Desc.		
<p>Insert image here</p>		<p>Insert image here</p>			
GPS Location			GPS Location		
Field Station#			Field Station#		
Pic 9 Desc.			Pic 10 Desc.		
<p>Insert image here</p>		<p>Insert image here</p>			
GPS Location			GPS Location		
Field Station#			Field Station#		
Pic 11 Desc.			Pic 12 Desc.

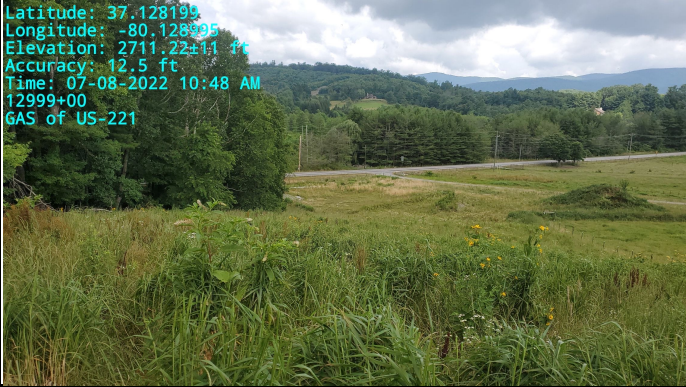
AFE	124300138	Date/Time	7/8/2022 5:23 PM	Report #	
Pictures					
<div>Latitude: 37.128195 Longitude: -80.128995 Elevation: 2711.22±11 ft Accuracy: 12.5 ft Time: 07-08-2022 10:48 AM 12999+00 GAS of US-221</div>

GPS Location	See pic.		GPS Location	See pic.	
Field Station#	12999+00		Field Station#	12993+50	
Pic 7 Desc.	Current ROW conditions.		Pic 8 Desc.	Current ROW conditions.	
<div>Latitude: 37.13217 Longitude: -80.132213 Elevation: 2721.95±17 ft Accuracy: 15.7 ft Time: 07-08-2022 11:04 AM 12964+00 GAS of R0-287</div>

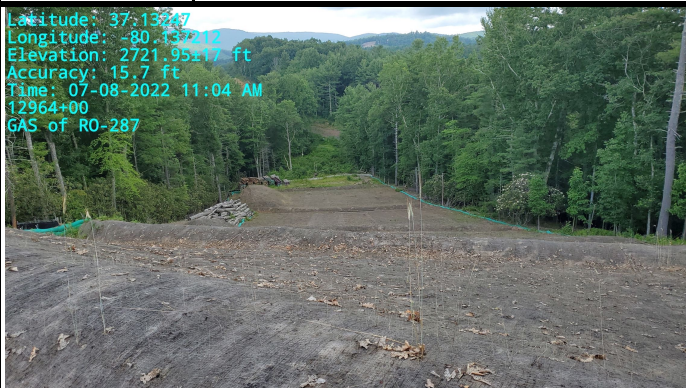
Pic 9 Desc.	Current ROW conditions.		Pic 10 Desc.	Current ROW conditions.	
<div>Latitude: 37.130443 Longitude: -80.136927 Elevation: 2665.62±16 ft Accuracy: 13.1 ft Time: 07-08-2022 11:12 AM 12975+00 GAS of R0-288</div>

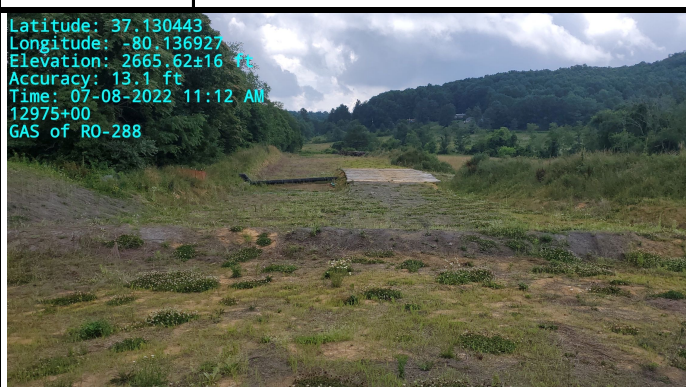
GPS Location	See pic.		GPS Location	See pic.	
Field Station#	12975+00		Field Station#	12956+80	
Pic 11 Desc.	Current ROW conditions.		Pic 12 Desc.	Streams S-Y7 and S-Y9 from the CIS.
