Baseline Assessment – Stream Attributes

Reach S-G17 (Pipeline ROW) * Ephemeral Spread I Franklin County, Virginia

Ephemeral Stream Assessment Form (Form 1a)

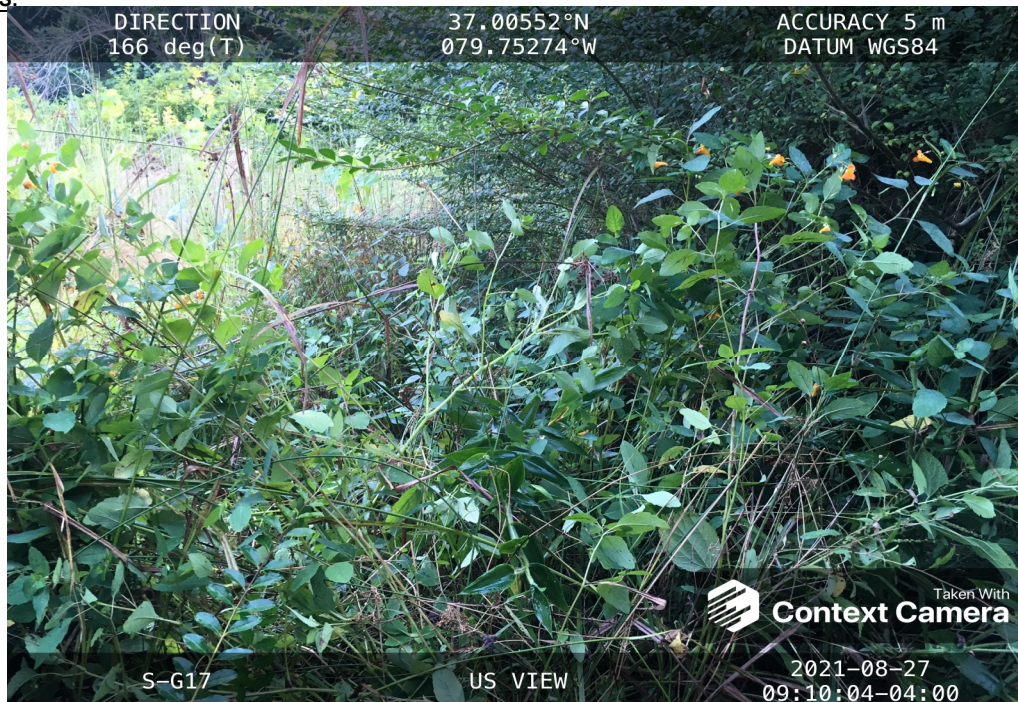
INSERT PHOTOS:

Conditional Category								Stream was not found in the field; however, riparian buffer scores were assigned based on best professional judgement.			
Optimal	Suboptimal		Marginal		Poor						
Riparian Buffers	Tree stratum (dbh > 3 inches) present, with > 60% tree canopy cover and a non-maintained understory. Wetlands areas.	High Suboptimal: Riparian areas with tree stratum (dbh > 3 inches) present, with 30% to 60% tree canopy cover and containing both herbaceous and shrub layers or a non-maintained understory.	Low Suboptimal: Riparian areas with tree stratum (dbh > 3 inches) present, with >30% tree canopy cover and a maintained understory. Recent cutover (dense vegetation).	High Marginal: Non-maintained, dense herbaceous vegetation with either a shrub layer or a tree layer (dbh > 3 inches) present, with <30% tree canopy cover.	Low Marginal: Non-maintained, dense herbaceous vegetation, riparian areas lacking shrub and tree stratum, hay production, ponds, open water. If present, tree stratum (dbh > 3 inches) present, with <30% tree canopy cover with maintained understory.	High Poor: Lawns, mowed, and maintained areas, nurseries; no-till cropland; actively grazed pasture, sparsely vegetated non-maintained area, recently seeded and stabilized, or other comparable condition.	Low Poor: Impervious surfaces, mine spoil lands, denuded surfaces, row crops, active feed lots, trails, or other comparable conditions.
