Baseline Assessment – Stream Attributes

Reach S-H30 (Pipeline ROW) *

Franklin County, Virginia

Project #	Project Name (Applicant)	Locality	Cowardin Class.	HUC	Date	SAR #	Impact Length	Impact Factor
22865.06	Mountain Valley Pipeline (Mountain Valley Pipeline, LLC)	Franklin County	R4	03010101	8/25/2021	S-H30	4	1
Name(s) of Evaluator(s)		Stream Name and Information					SAR Length	
DW JM		UNT to Jacks Creek					7

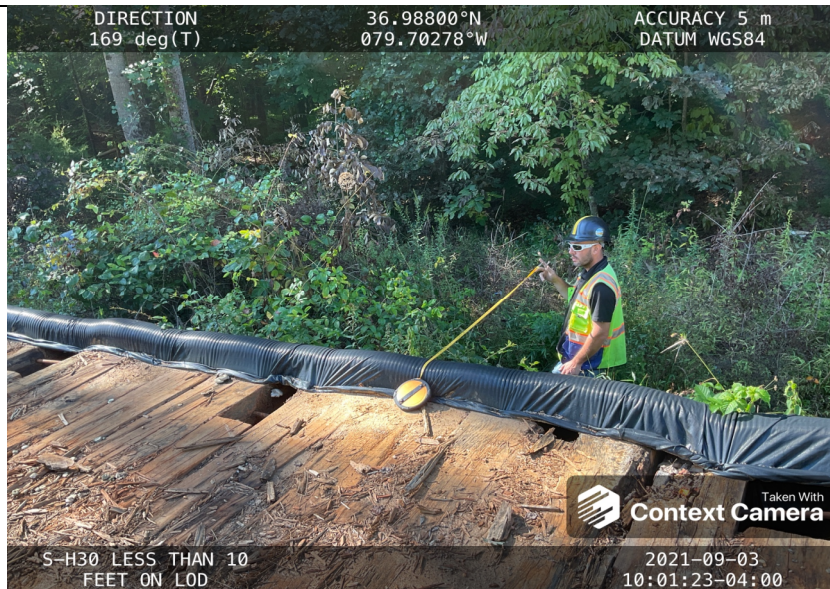
INSERT PHOTOS:

Stream was not found in the field; however, riparian buffer scores were assigned based on best professional judgement
